Keeyask Generation Project  
Terrestrial Effects Monitoring Plan

Invasive Plant Spread and Control Monitoring Report

TEMP-2018-05

Manitoba Hydro

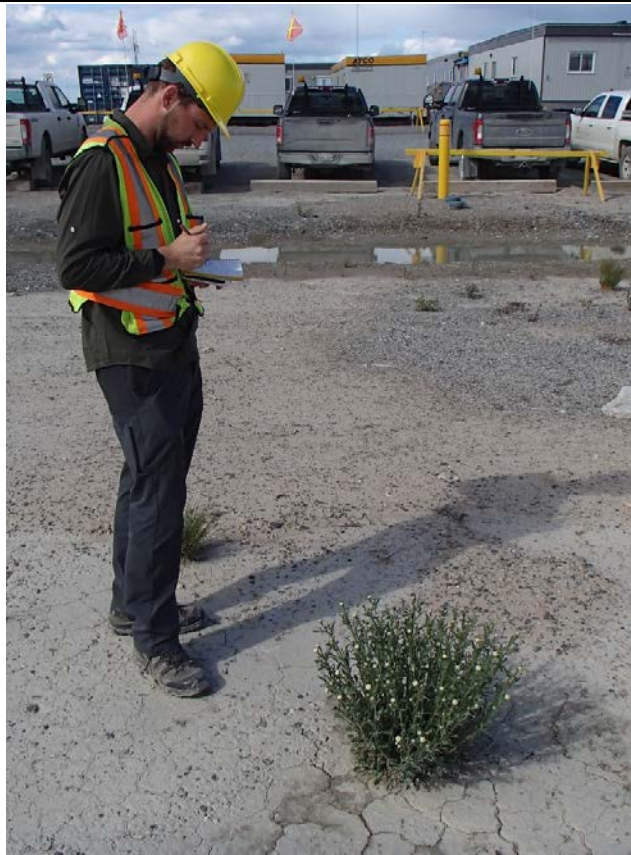
**Figure 3-1: Ox-eye daisy in Work Area B on July 8, 2017**

Of the 22 non-native plant species found in 2017, ox-eye daisy and scentless chamomile are the ones of highest invasive concern for the Project site. ECOSTEM field staff manually removed and disposed of all the ox-eye daisy and scentless chamomile plants as soon as they were found during the surveys. Scentless chamomile was not found at the two locations where it had been removed and disposed of in previous years.

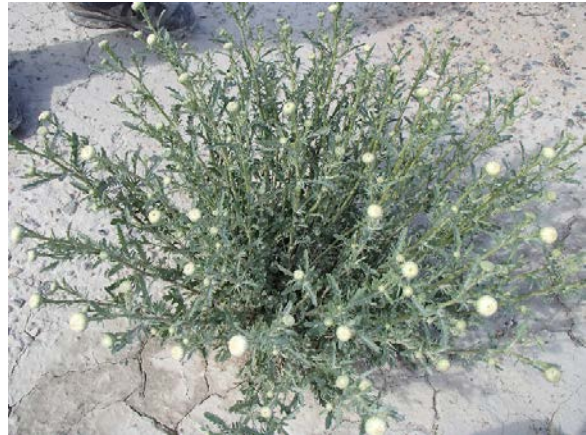
Ox-eye daisy is an introduced ornamental perennial. It can quickly spread by both seed and rhizomes (ISCM 2018). In July 2017, a single ox-eye daisy plant was found for the first time at one location in the ditch in front of the Manitoba Hydro and BBC offices in Work Area B (Figure 3-3, Map 3-17). This plant had not yet seeded, and was immediately removed by ECOSTEM field staff after it was recorded. This species was not found again during late summer 2017 surveys.

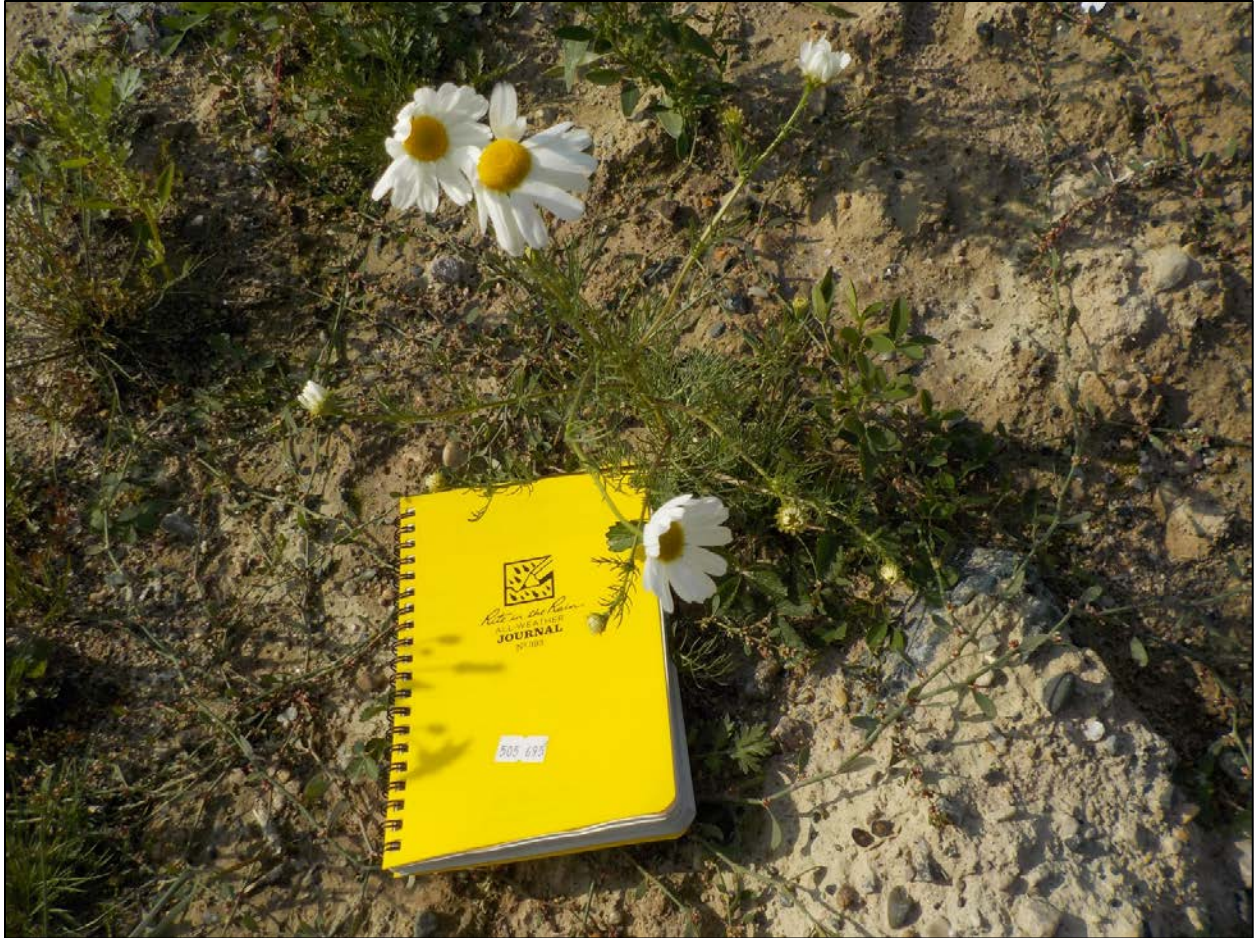
**Photo 3-1: Scentless chamomile growing in EMPA D16 on August 25, 2017**

In August 2017, a single scentless chamomile plant was found growing in EMPA D16 (Photo 3-1). This plant was immediately removed and disposed of by ECOSTEM field staff.

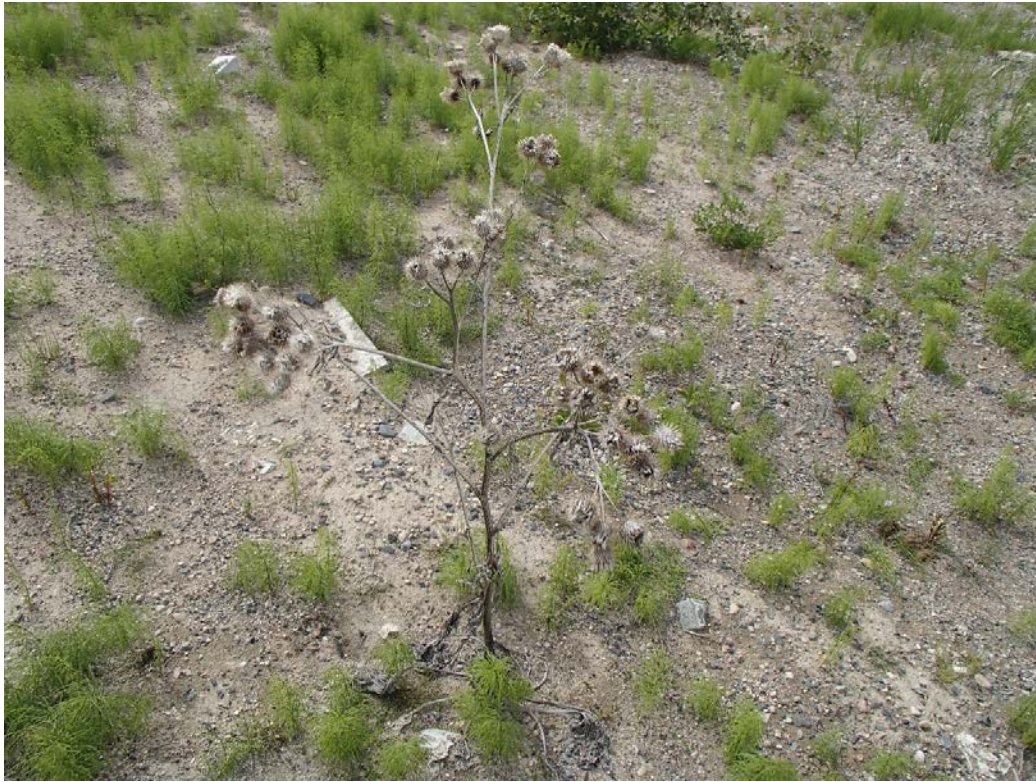
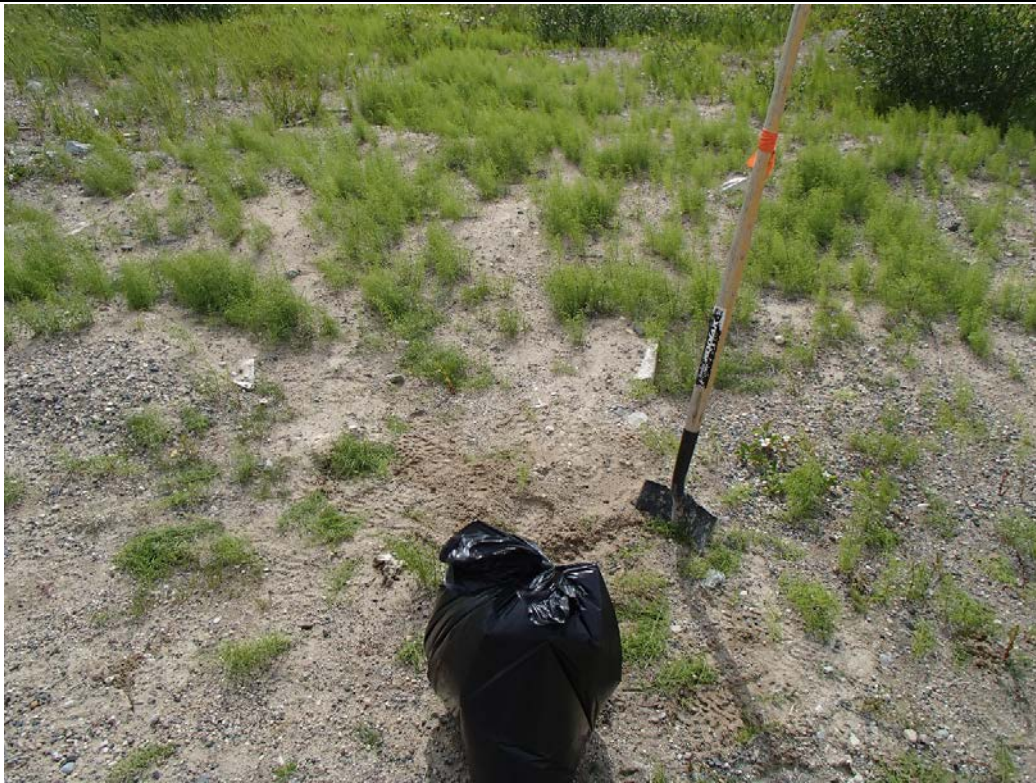
**Figure 3-2: 2016 common burdock plant remains (A) on July 7, 2017, and site after plant removal (B).**

Common burdock is an ISCM “other” species and a Manitoba noxious weed (Table 3-8). One plant was found near the Main Camp during 2016 surveys. The location was visited in early summer, 2017, and the remains of the dead plant, including all burrs, were removed and disposed (Figure 3-2). No living plants were found during 2017 surveys.

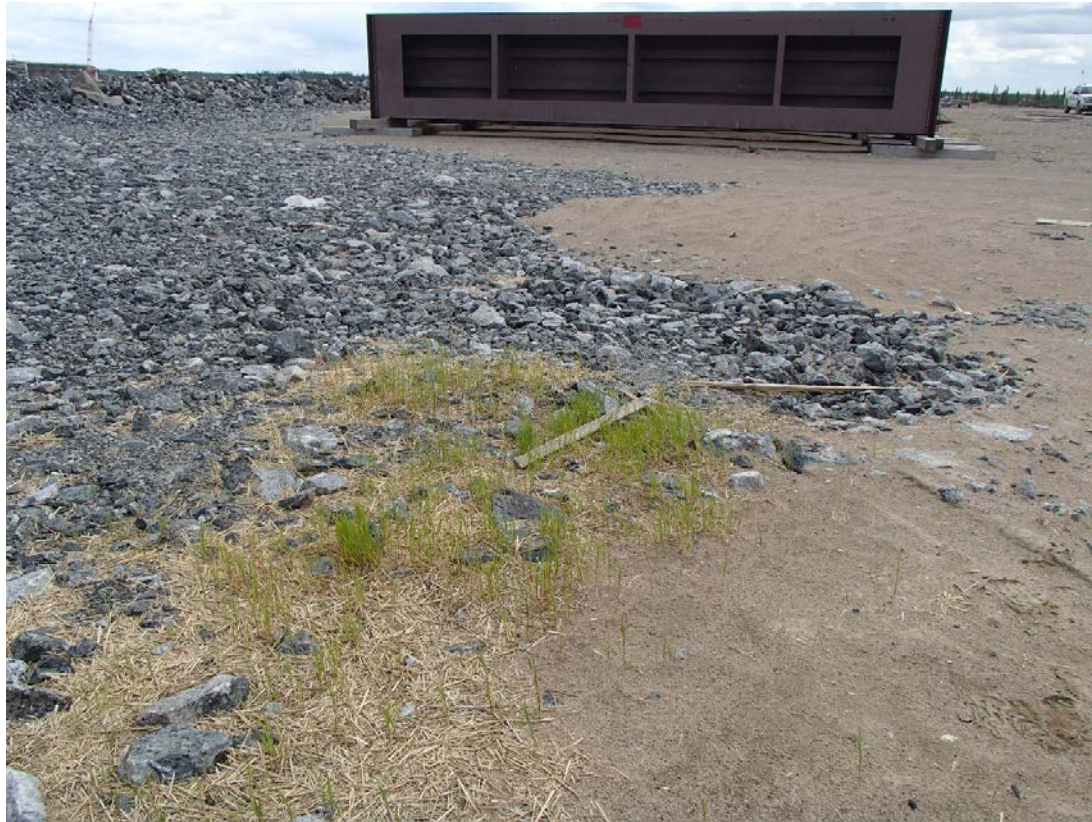
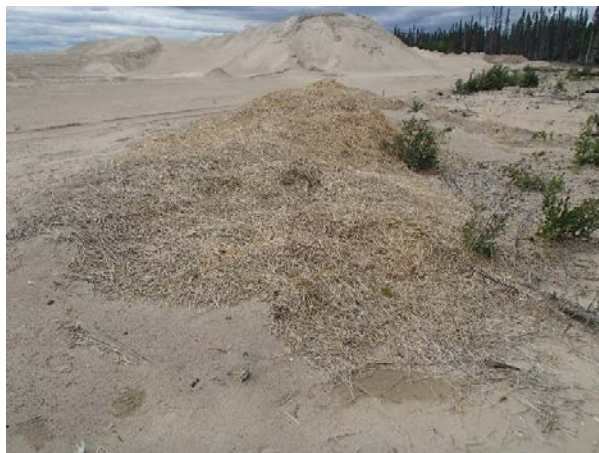
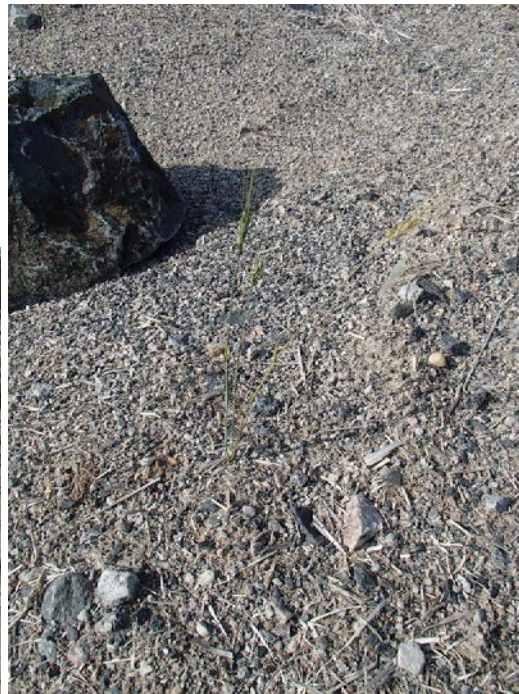
**Figure 3-3: Wheat plants growing on the ground in remnants of wheat straw in 2017.**

Given the developmental stage of the plants at the time of the 2016 surveys, it appeared unlikely that they could produce viable seed before a fall frost would kill the plants. The area was surveyed in early summer 2017, and it was found that the bales had been moved to Borrow Area G-3. A substantial amount of wheat was growing out of the remnants of straw on the

ground in the Spillway Laydown Area (Figure 3-3), indicating that either the plant was able to seed, or that other seed contained in the straw survived the winter to germinate. Plants were also observed growing from straw that was spread in Borrow Area G-3 and in EMPA D16. No plants were found growing outside of areas where straw was spread or stored. If the straw is no longer being used, it is recommended that it be burned to kill any viable seed remaining in it. These locations will continue to be monitored in 2018 to determine if more plants appear.

**A: Spillway Laydown Area on July 8, 2017**

**B: Borrow Area G-3 on July 10, 2017 C: EMPA D16 on August 25, 2017**

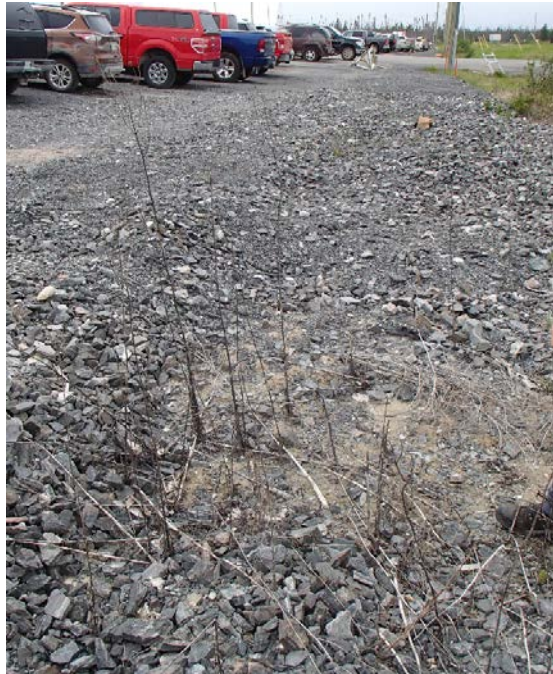
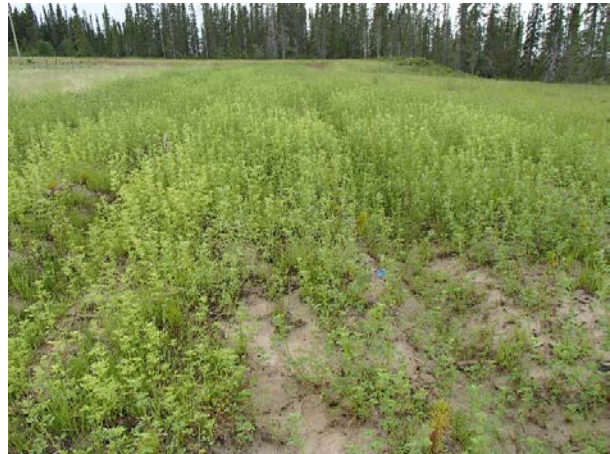
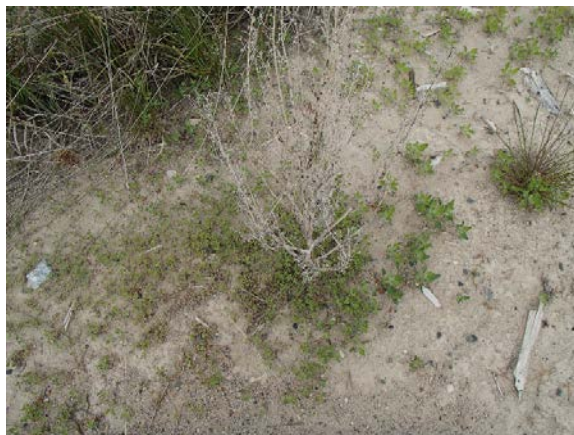
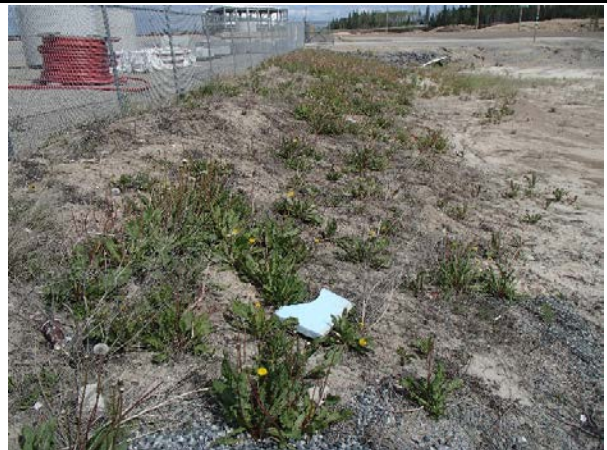
**Figure 3-4: Herbicide treatment areas in July, 2017**

**A: Herbicide-killed perennial sow thistle at Start-up Camp, July 5, 2017**

**B: Regenerating sweet clover in Borrow Area KM-1 herbicide treatment area, July 6, 2017**

**C: Herbicide-killed lamb's quarters surrounded by seedlings in Borrow Area G-1, July 10, 2017**

**D: Herbicide-killed dandelion and sweet clover with regenerating dandelion in Work Area B, July 8, 2017**

The herbiciding treatment completed in 2016 probably was not effective because it was applied after most of the plants had already produced their seed. It is recommended that future herbicide applications occur in the early summer after plants are fully emerged but before they produce their seed.

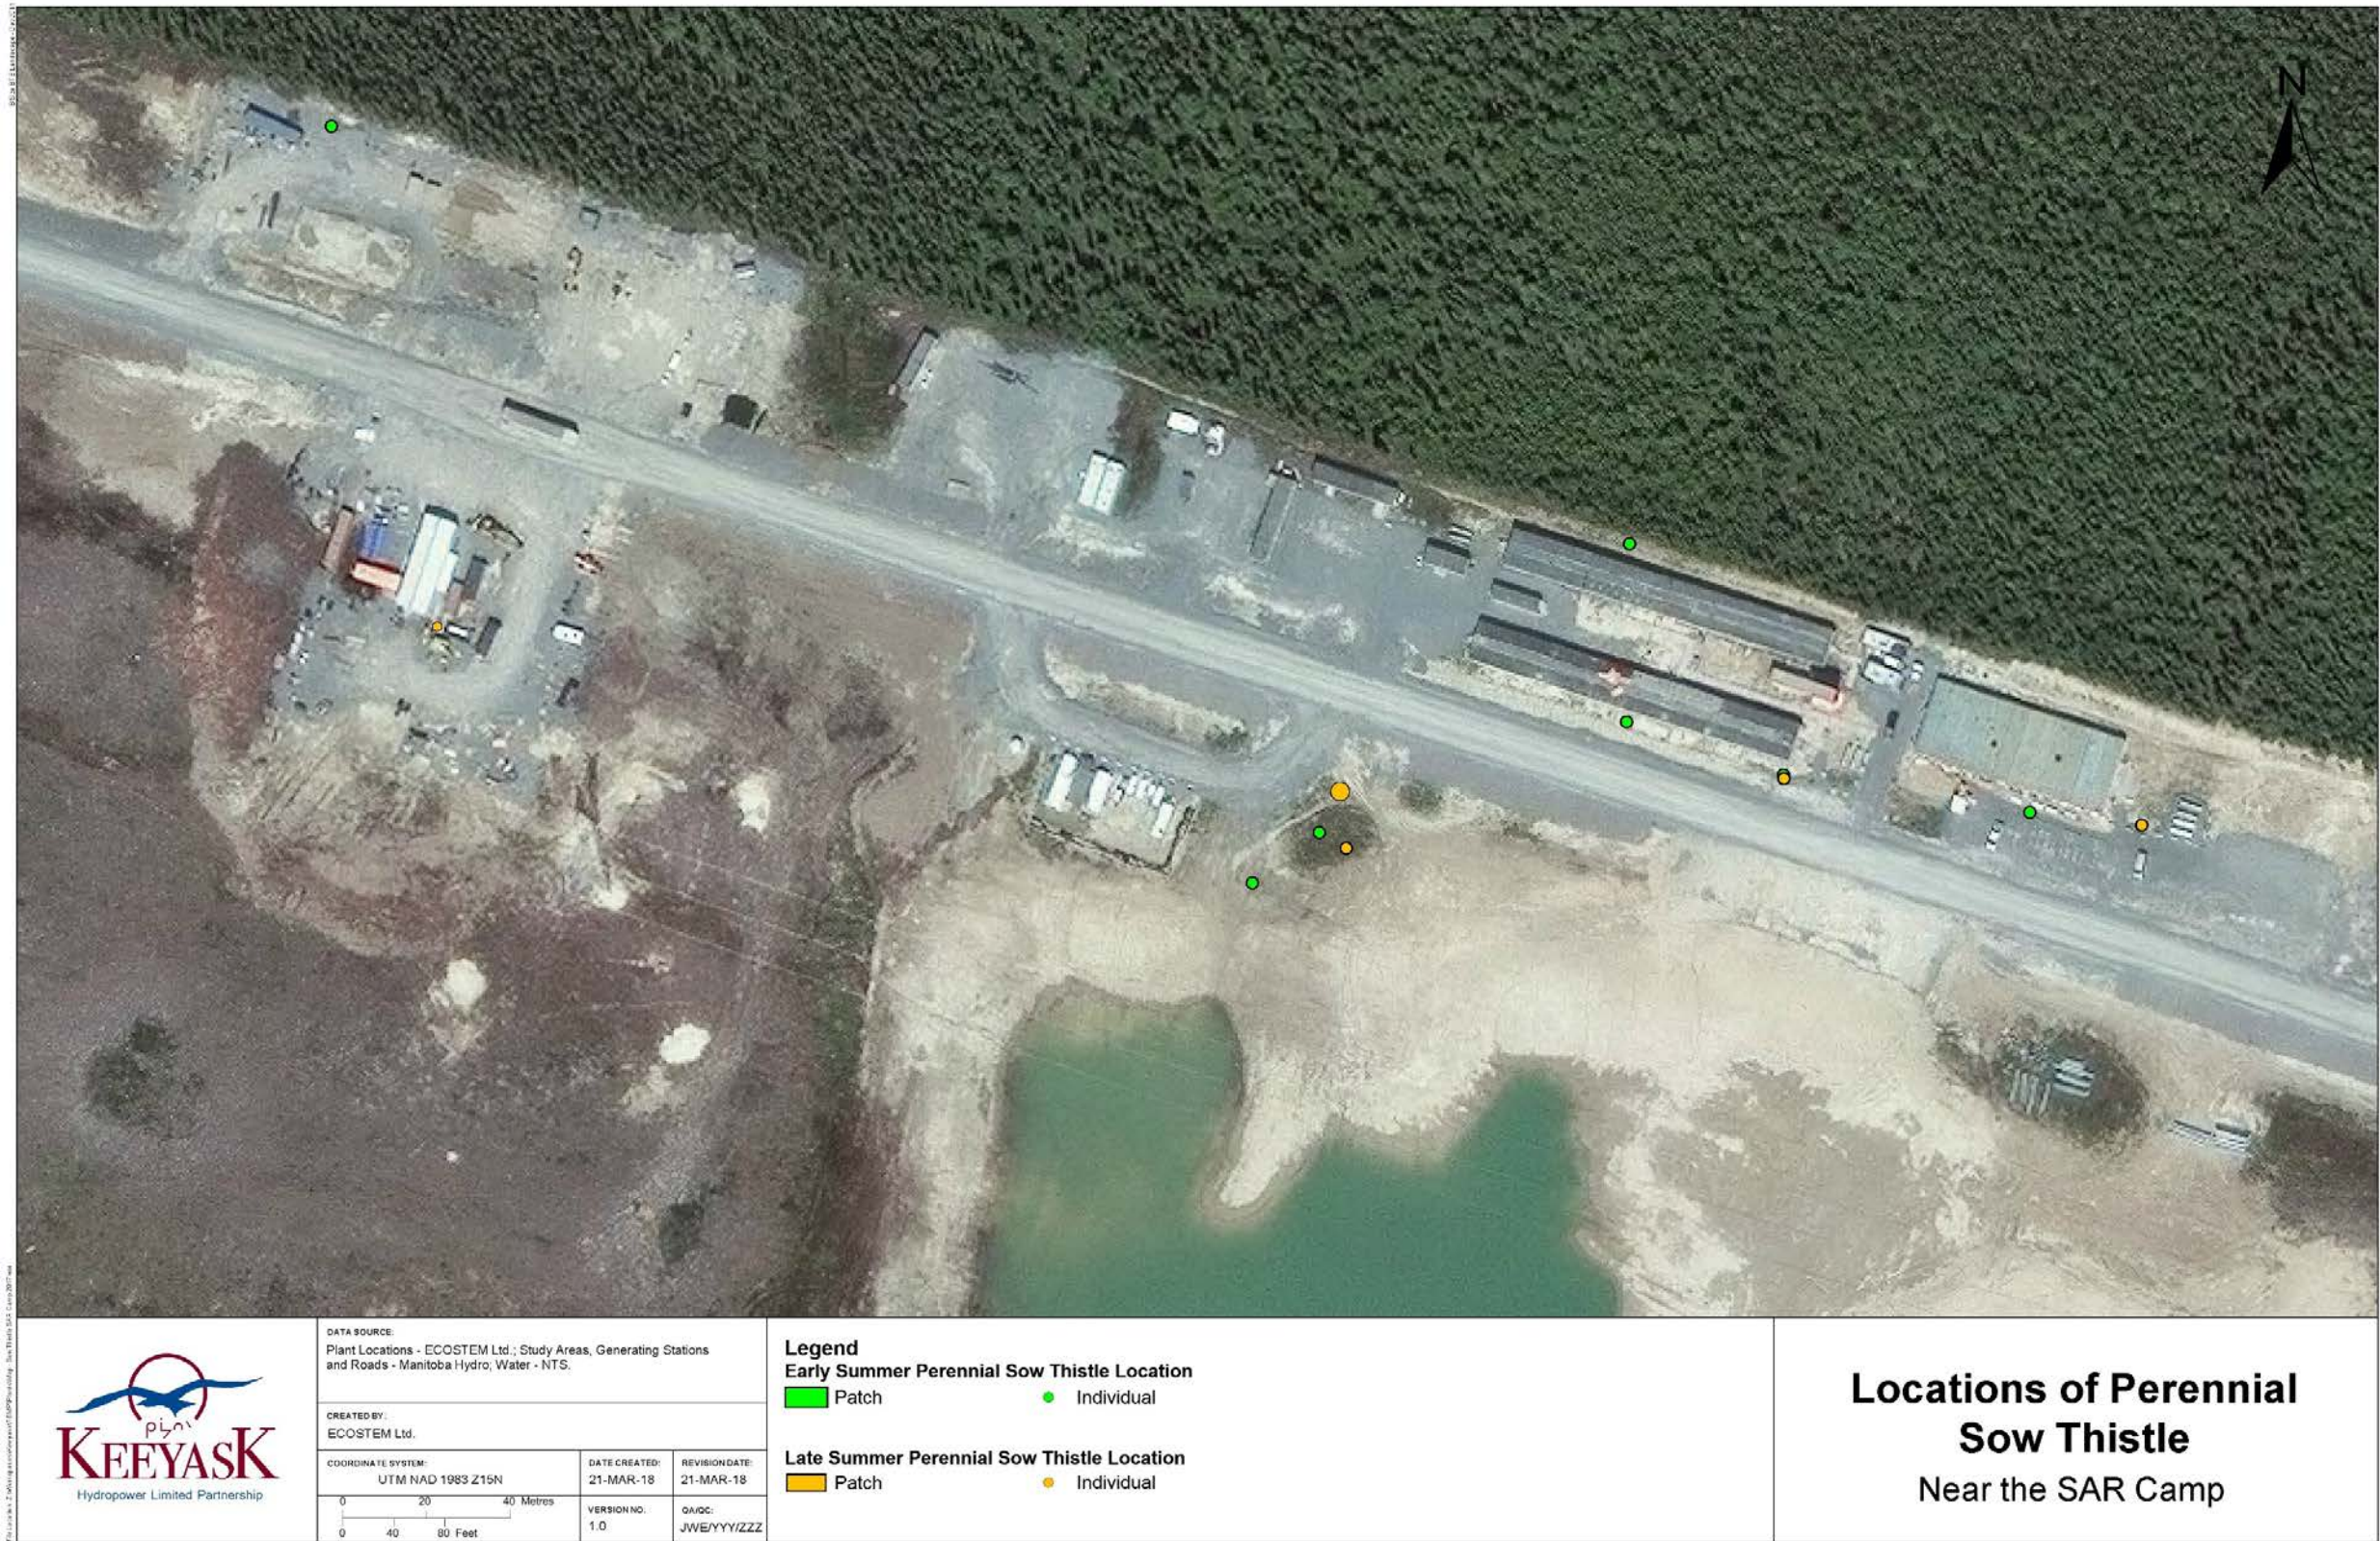
Map 3-20: Perennial sow thistle locations near the South Access Road Camp, 2017

The three specific locations where perennial sow thistle was found were in the SAR Camp during 2017 early summer surveys (Map 3-20). This plant had not been previously well-established there. Plants at all three locations were removed immediately by ECOSTEM field staff. During late summer surveys, new plants were found growing at two of the three locations recorded in early summer, and at an additional seven locations around the SAR Camp. These plants appeared to have germinated from seed after the early summer removal. Plants at eight of these locations were removed immediately by ECOSTEM field staff. The ninth location will be visited in early summer 2018 and removed if practical.
