Keeyask Generation Project  
Terrestrial Effects Monitoring Plan

Colonial Waterbird Habitat Effects Monitoring Report

TEMP-2018-08

## **COLONIAL WATERBIRD HABITAT EFFECTS MONITORING**

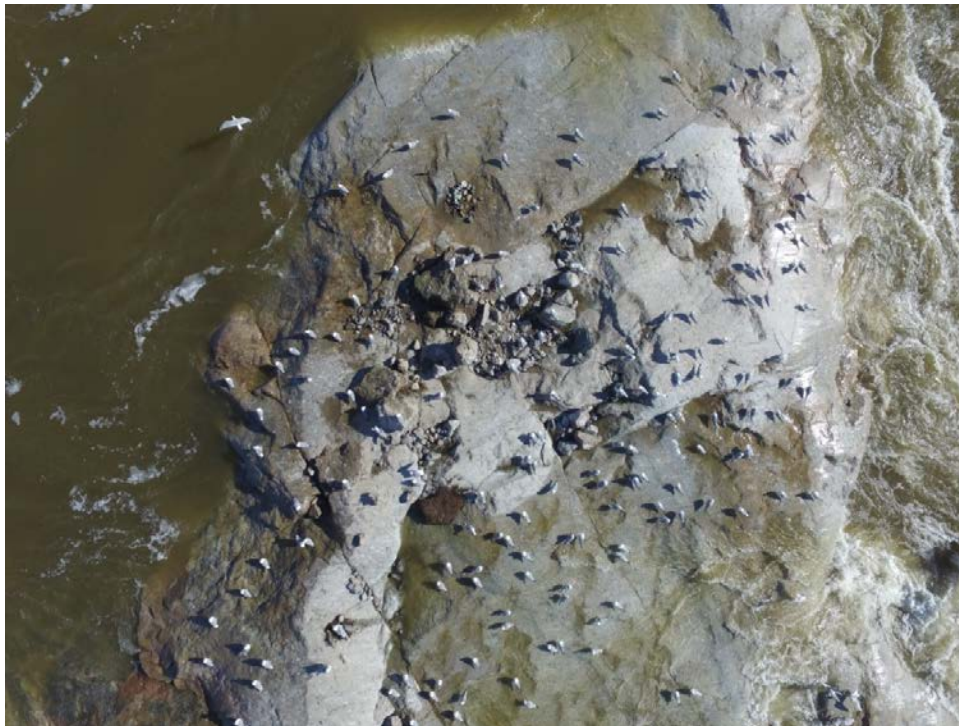
UAV Photo of an Island in Gull Rapids

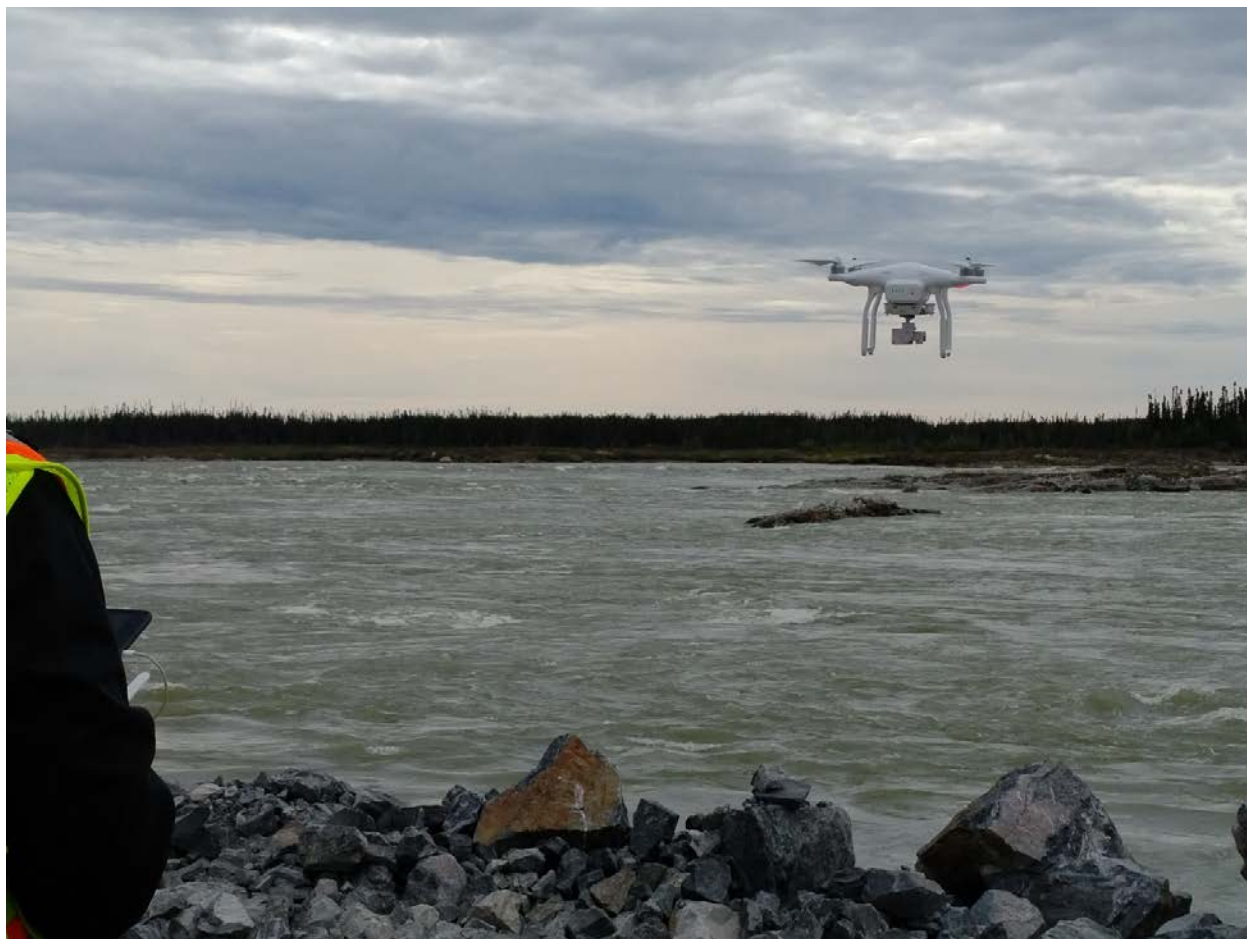
**Photo 1: UAV Used to Photograph Islands in Gull Rapids in 2017**

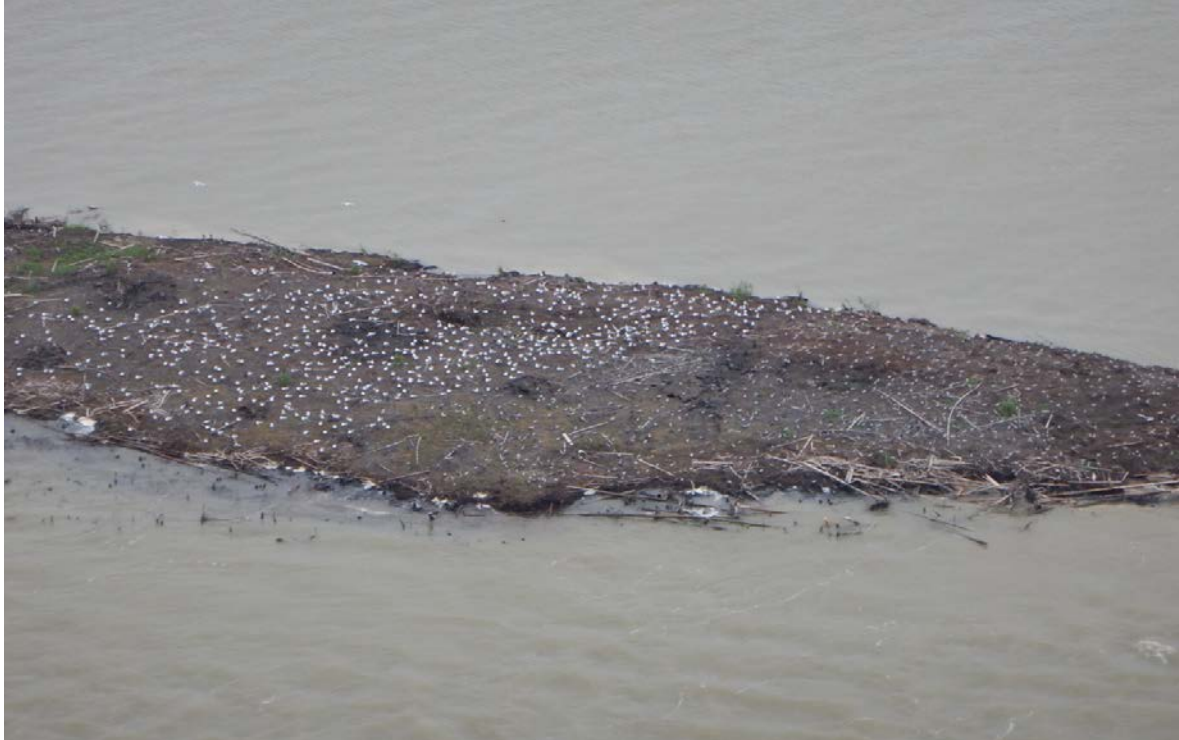
**Photo 2: Colony of Ring-billed Gulls and Common Terns on an Island in the Nelson River on June 23, 2017**

During the survey, numbers of waterbirds at all colony and congregation sites (Photo 2), and all dispersed waterbirds were recorded along with their locations. Dispersed birds were single birds and flocks of waterbirds in flight. Congregated birds were groups of birds that showed no indication of nesting (*i.e.*, nests). A group of birds was considered a colony when there were at least two breeding pairs present and signs of nesting. When a congregation of waterbirds was observed the helicopter slowed and circled the site briefly for survey personnel to photograph and count individuals and nests. Preliminary abundance estimates were made by counting all nests and individuals. In-flight counts and photography were conducted quickly to minimize disturbing birds. All observations were georeferenced with a Garmin GPS 64 global positioning system (GPS). Notes on the terrestrial habitat of congregation sites were recorded and island size (ha) was determined from remotely-sensed data. Island sizes were classified as <0.1 ha, 0.1-0.9 ha, 1.0-1.9 ha, 2.0-2.9, 3.0-3.9 ha, and >4.0 ha.

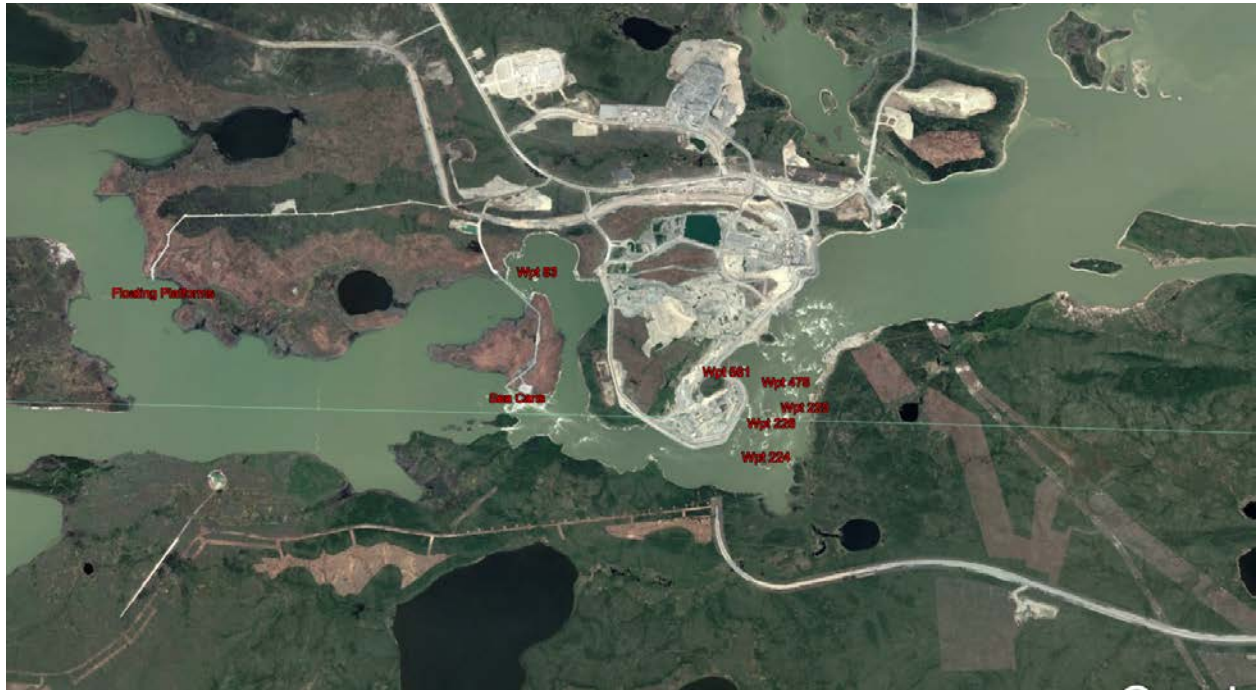
## Appendix 1 – Mission Area

July 20<sup>th</sup> data acquisition of mission areas: "Wpt 83, Wpt 224, Wpt 226, and Wpt 561" commenced early morning Thursday, July 20<sup>th</sup>. The sky condition was overcast and the winds were moderate. The UAV captured 756 images of the proposed mission areas successfully with a total flight time of 229 minutes. All phases of flight were uneventful.

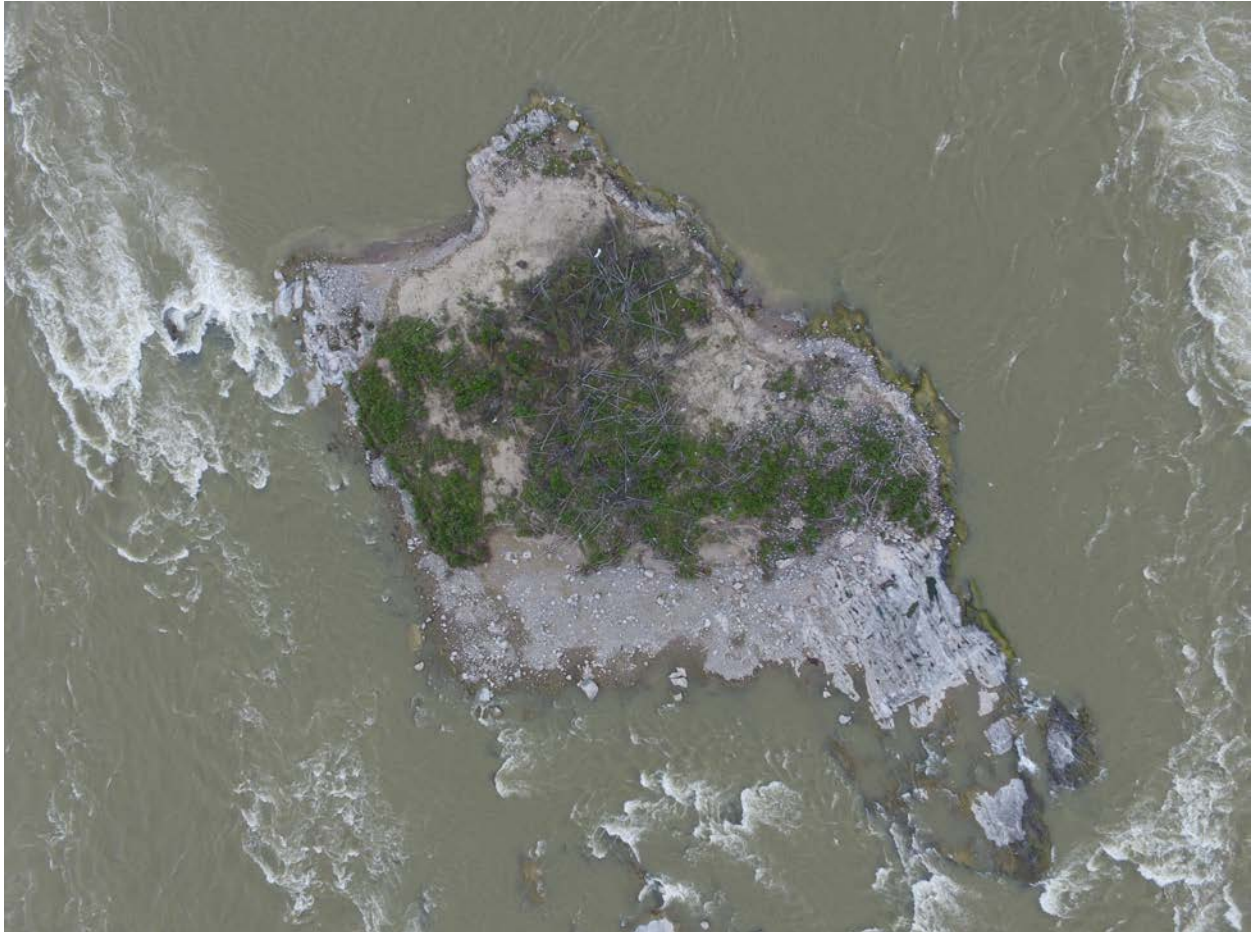
### Top Down Image Nesting Area (Wpt 226) - Approximately 350 feet Above Ground

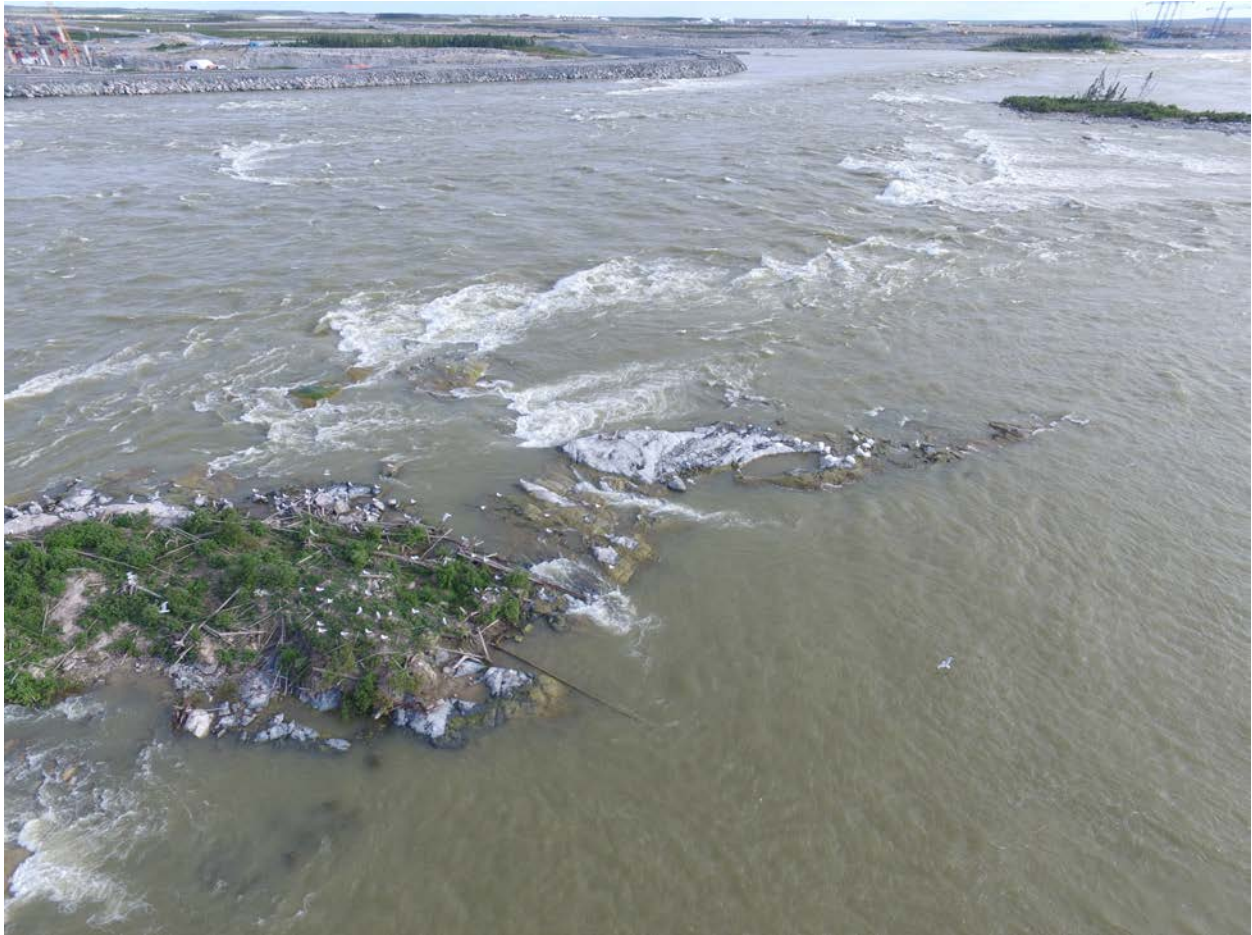
**Grid Flight Image – Camera angle 45 degrees Down – Wpt 224 - Morning**

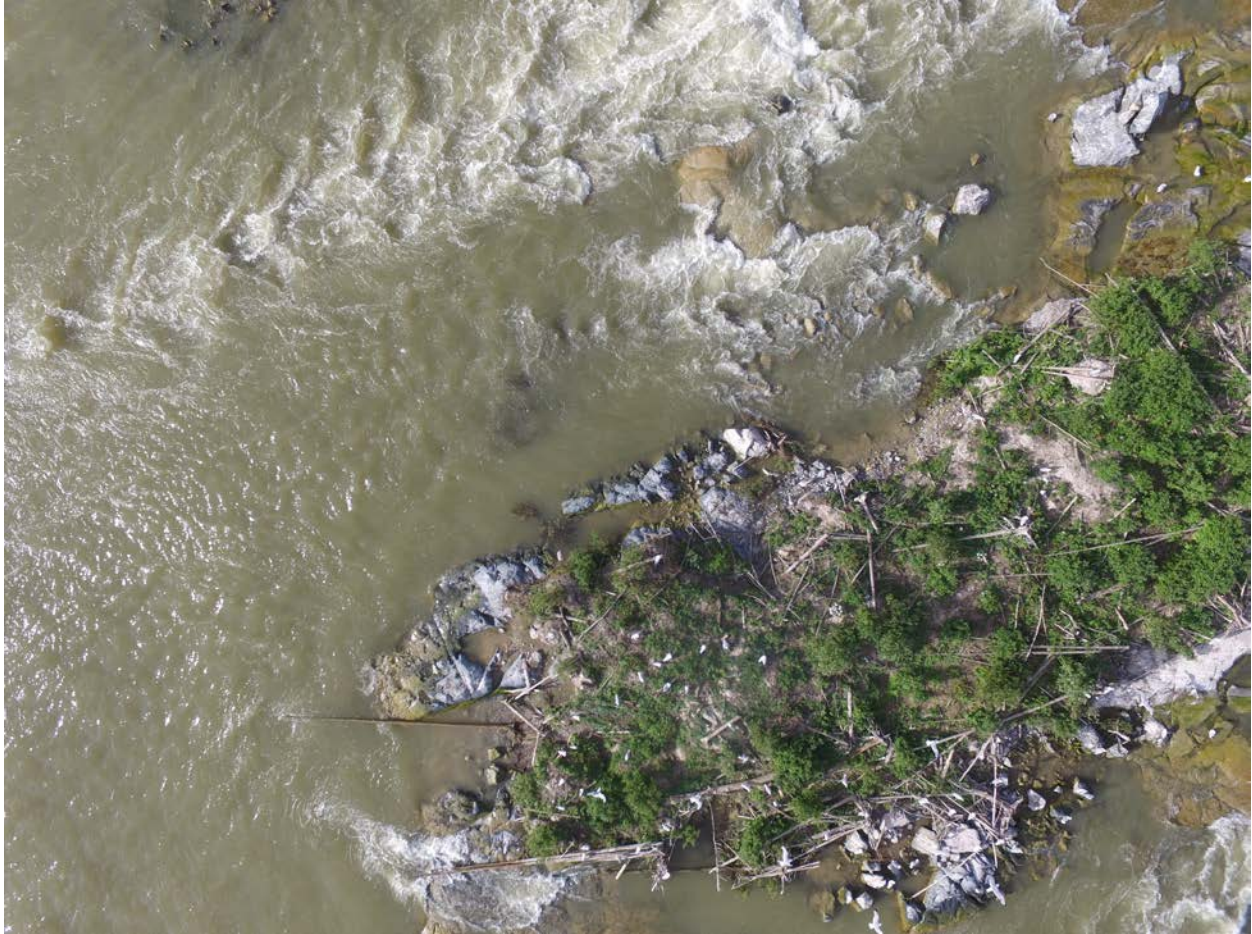
**Grid Flight Image – Camera angle 90 degrees Down – Wpt 224 - Morning**
