Keeyask Generation Project
Terrestrial Effects Monitoring Plan

Colonial Waterbird Habitat Enhancement Monitoring Report

TEMP-2018-09

COLONIAL WATERBIRD HABITAT ENHANCEMENT MONITORING 2017

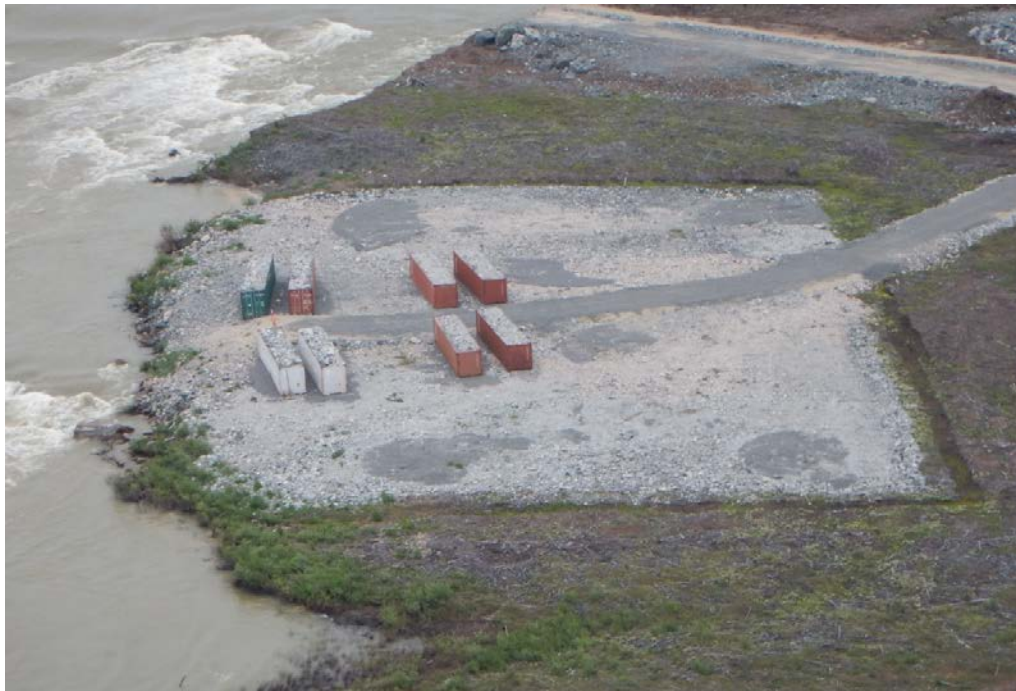
Habitat Enhancement Area for Gulls on William Smith Island

Habitat enhancement areas were designed to provide alternate breeding habitat for colonial waterbirds. As described in the Terrestrial Mitigation Implementation Plan developed for the Project, part of William Smith Island was modified into a nesting area for gulls. This was done by clearing trees, providing rocky substrate, and placing eight large shipping containers (with rocks placed on top) to provide secure nesting habitat elevated from potential ground predators. In previous years, gull decoys and audio equipment broadcasting breeding gulls' sounds were installed in the area in an attempt to attract gulls, and remote cameras were installed to monitor gull use of the areas and predator numbers. However, in 2017, due to high water levels, the road connecting William Smith Island to the mainland was flooded and these items could not be

The gull habitat enhancement area was not used for nesting by gulls in 2017. Remote cameras could not be installed at the site due to flooding of the access road to the island, so it is unknown if the site was used for loafing. However, no gulls or nests were present in photographs from the UAV in May or during the aerial surveys in June and July.

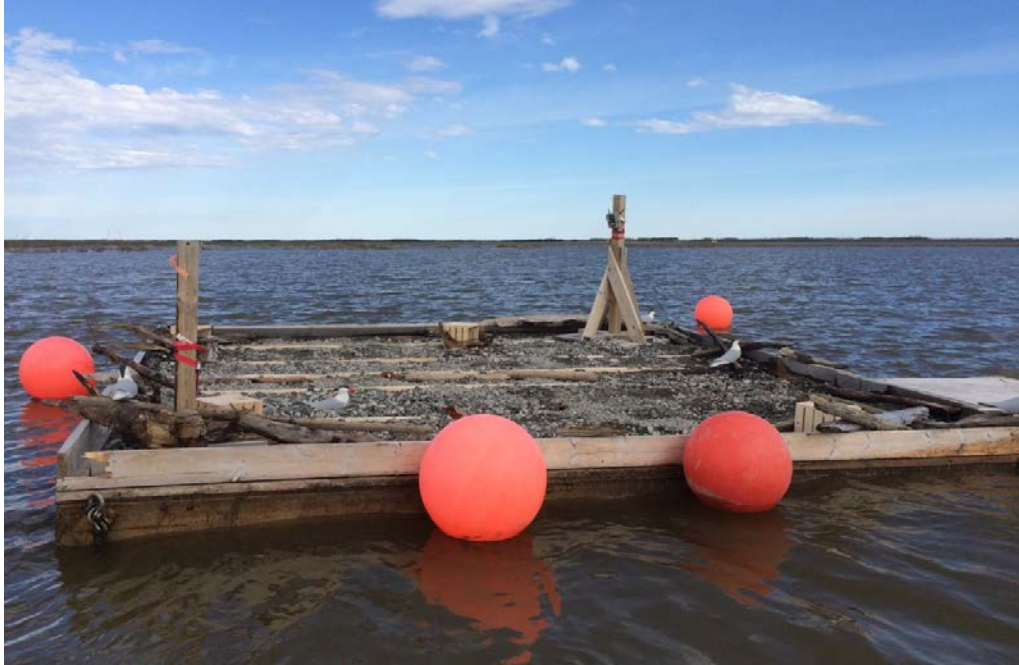
Floating Nest Platform for Common Terns in Gull Lake

For terns, a floating nest platform was deployed in June 2017. In previous years, two nest platforms were deployed, but one was damaged over the winter and was unusable. The useable nest platform was enhanced by adding baffles to prevent shifting of the substrate. This floating platform was towed and anchored in a bay of Gull Lake. Tern decoys were installed to attract breeding terns to the floating platforms and driftwood and shelters (small wooden crates) were added to improve chick survival. Remote cameras were set up on the platforms to watch for birds, nests, chicks, and predators. After the breeding season, the floating platform and cameras were removed from Gull Lake.

Common terns used the floating platform less in 2017 compared to 2016. A single common tern attempted to nest on the floating platform, but abandoned their nest after approximately 14 days for unknown reasons. The platform was mostly used by single, loafing terns throughout 2017.

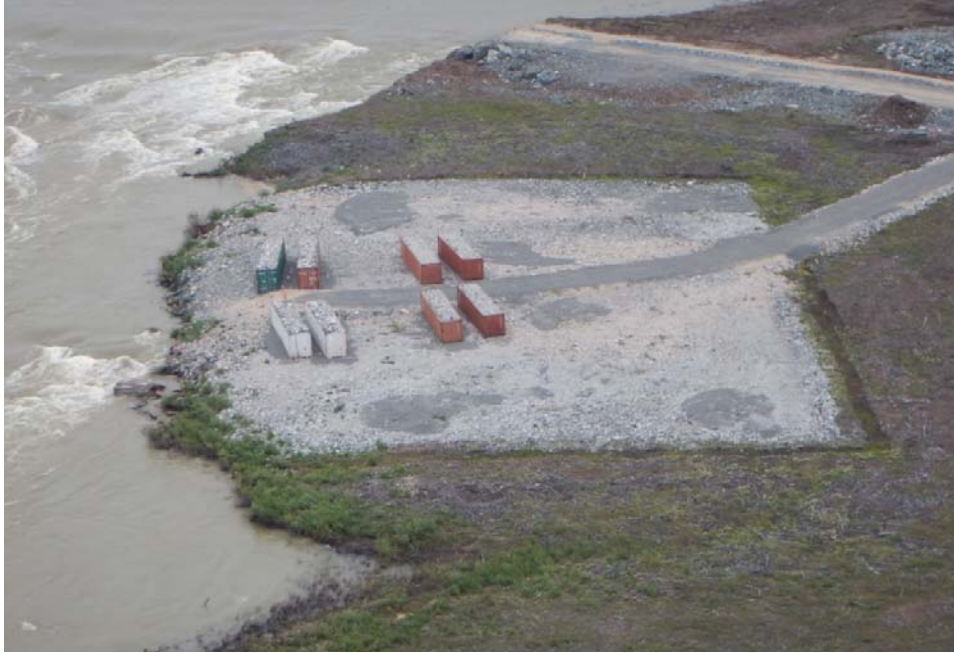
Photo 1: William Smith Island Gull Habitat Enhancement Area

To offset the potential loss of colonial waterbird nesting habitat at Gull Rapids, habitat enhancement areas were implemented in 2015 and monitored from 2015-2017 to determine their effectiveness (KHLP 2015). For gulls, the William Smith Island gull habitat enhancement area was created in 2015 on southern shore of William Smith Island (Map 1). The gull habitat enhancement area (hereafter the habitat enhancement area) was cleared of vegetation and graded with rocky substrate to emulate a natural nesting island (Photo 1). In this area, large shipping containers were also placed in the graded area and rocky substrate was placed on top to provide nesting habitat elevated from potential terrestrial predators (as the island is physically connected to land north of the Nelson River by the North Channel Rock Groin).

- Continue monitoring intrusions of predators and humans in the area using remote cameras.

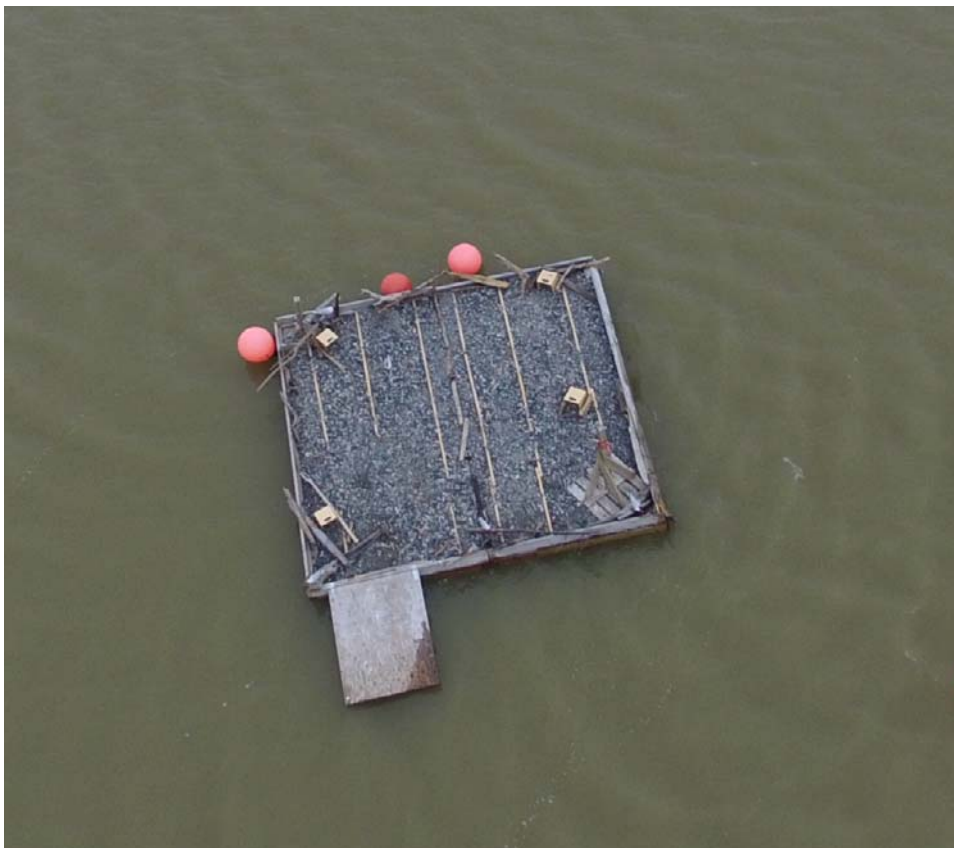
Photo 2: Floating Tern Platform with Common Tern Decoys, Driftwood, and Chick Shelters

two floating platforms were deployed, but over the winter of 2016/17 one floating platform was damaged and was unusable. The floating platform provides approximately 25 m² of replacement nesting habitat, designed to accommodate around 50 tern pairs (Photo 2 - Photo 4).

Several modifications were made to the floating platform in 2017, including baffles to limit substrate from shifting. In addition to driftwood, chick shelters made from wooden crates were installed to enhance chick survival (Photo 2-Photo 4). Due to equipment malfunction, the audio equipment used to broadcast sounds of breeding terns was not installed in 2017. The floating platform was equipped with two Reconyx® PC850 HyperFire Pro cameras (remote cameras), situated on opposite corners of the platform that captured images 4 times per day (at 8 a.m., 12 p.m., 4 p.m., and 8 p.m.) from June 13 to September 14, 2017. These remote cameras were equipped with a 3G cellular modem that transmitted photographs to Winnipeg.

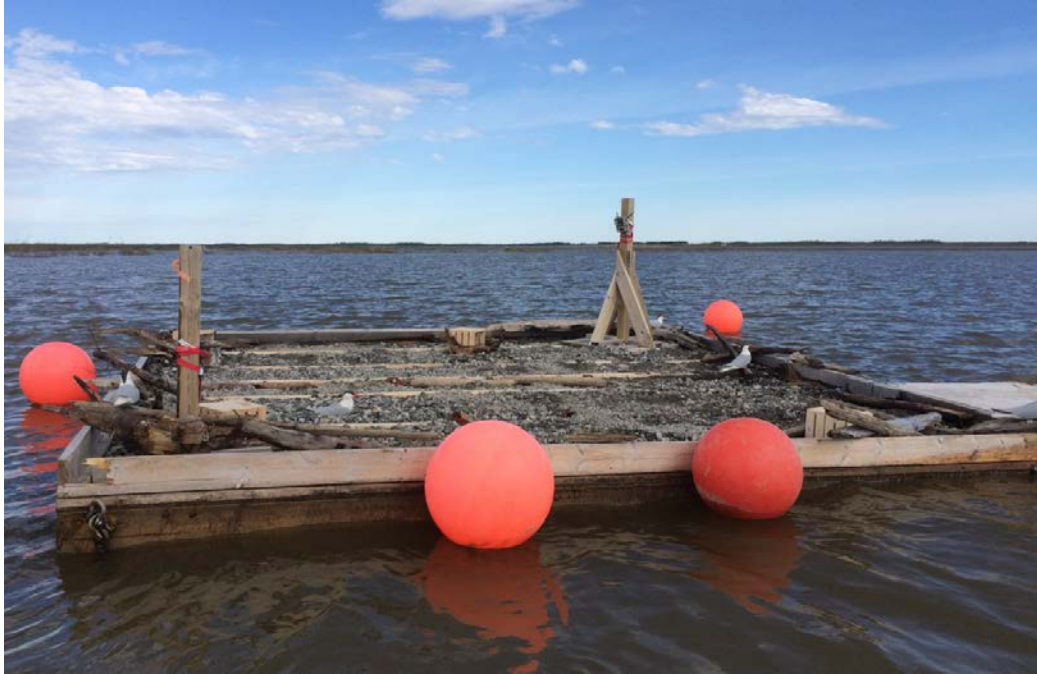
Photo 3: Floating Tern Platform in Gull Lake

For terns, a floating platform was anchored in Gull Lake approximately five km upstream of Gull Rapids in June 2017 (Map 1). This was after most gulls should have initiated their nests, to minimize competition from gulls for the floating platforms. In previous years (2015 and 2016),

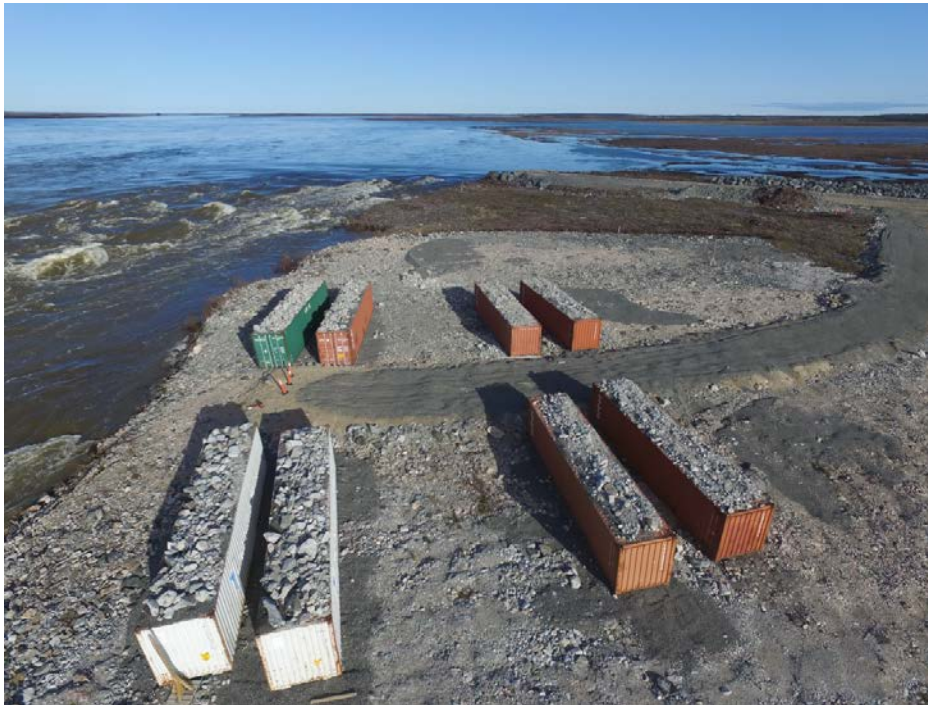
Photo 5: Photograph Taken by UAV of the William Smith Gull Habitat Enhancement Area on May 31, 2017

The William Smith Island gull habitat enhancement area did not appear to be used by gulls for nesting in 2017. No colonial waterbirds were observed during the June or July monitoring conducted during the aerial colonial waterbird survey and no colonial waterbirds were visible in the photographs taken by the UAV in May (Photo 5). As remote cameras were not installed in the area in 2017, it is unknown if the area was used temporarily by loafing gulls or terns.

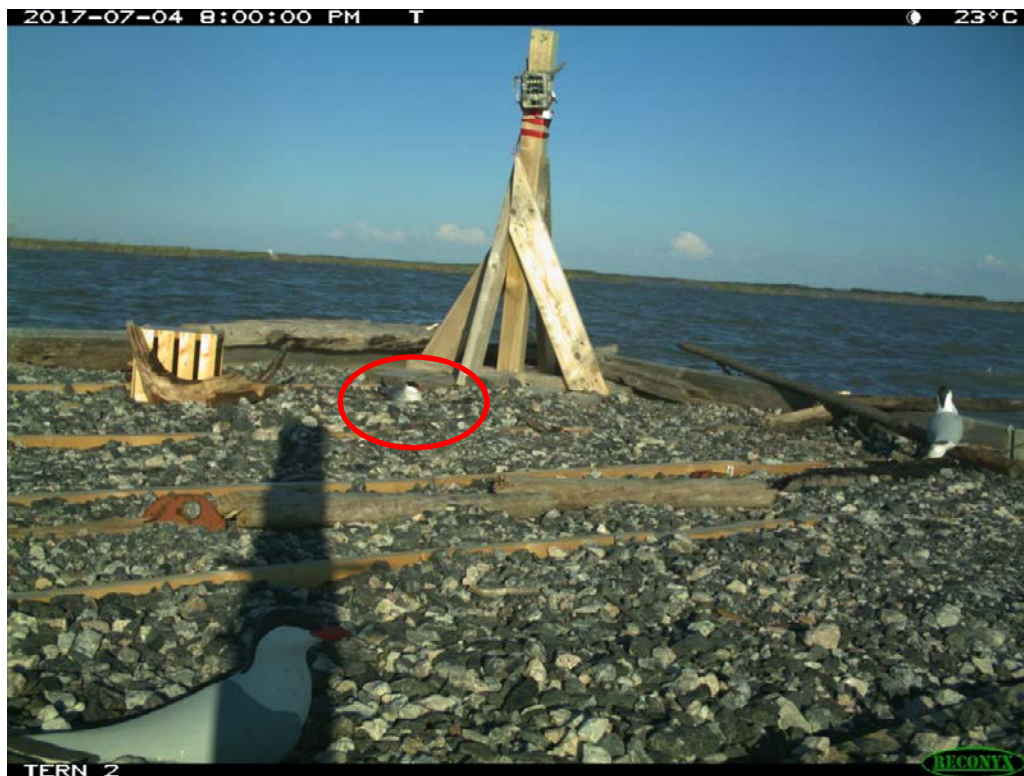
Photo 6: Nesting Common Tern on Floating Platform on July 4, 2017

The floating platform had limited use by common terns in 2017. There were 49 events of terns using the floating platform in 2017 and an additional nine events of terns flying nearby or loafing on the associated buoys (Appendix 1). The majority of the events (38) captured on the platform were of a single common tern sitting tight on a probable nest (Photo 6). This common tern was present from approximately June 22 - July 5 (14 days). Eggs were not visible in the photographs, but the number of days on the nest was not sufficient for egg incubation and it appeared the nest was abandoned for unknown reasons. There were 14 events of terns using the floating platform for loafing and the greatest number of terns present was four, which was observed once (Photo 7). The majority of terns using the floating platform occurred singly. Other observations on the platform included a great blue heron (*Ardea herodias*) and a ring-billed gull (Appendix 2).

Tern use of the floating platform in 2017 (49 events) was lower compared to the use that was observed on one platform in 2016 (127 events). It is uncertain why adult tern use in 2017 was lower than that observed in 2016, but it could be related to the quality of alternate nesting habitat available for colonial waterbirds located about 12 km upstream of Gull Rapids (WRCS 2018). In 2017, a single common tern appeared to attempt to nest on the floating platform that was deployed, but abandoned it after approximately 14 days. In 2016 one common tern nest on the platform was successful at producing three chicks.
