Keeyask Generation Project

Zebra Mussel Monitoring Plan

Zebra Mussel Annual Monitoring Report

ZMMP-2018-01

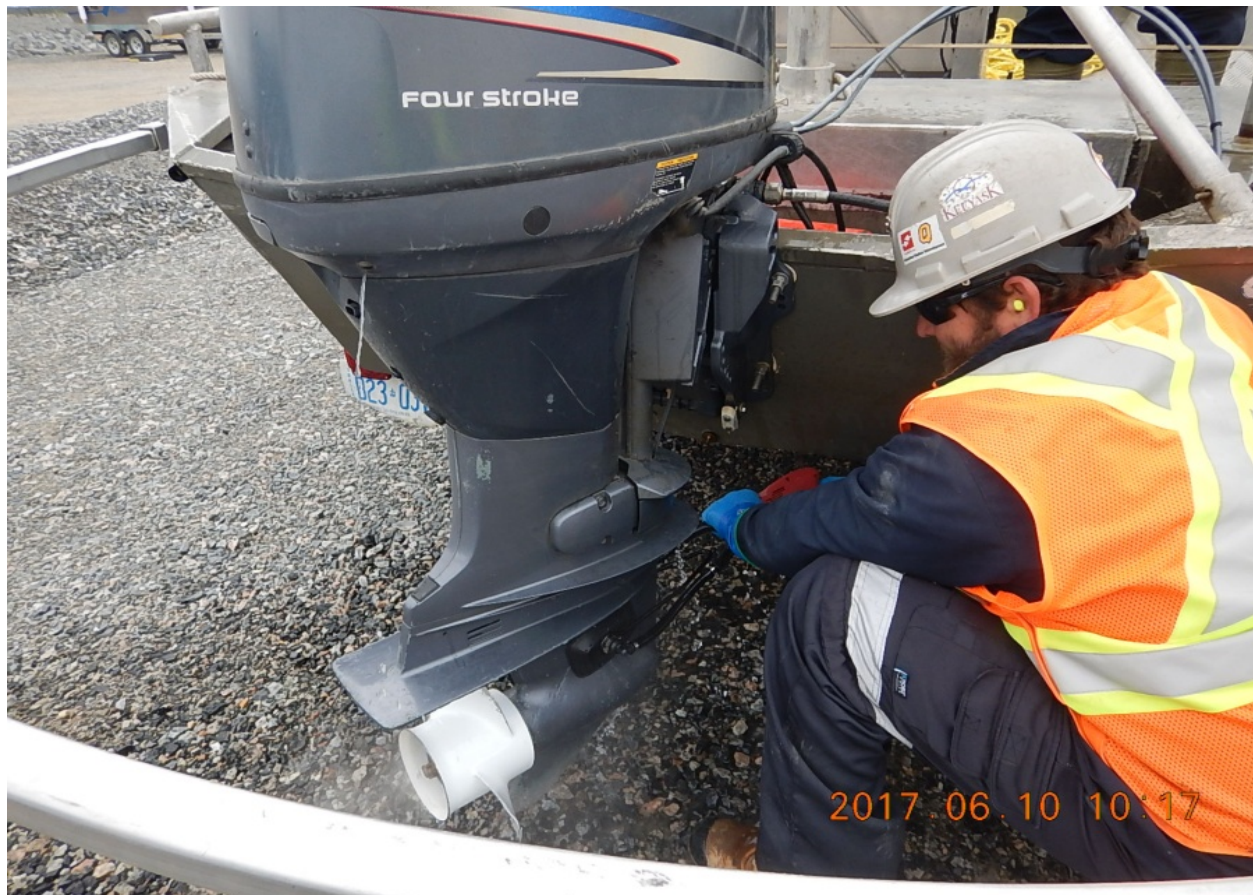
The decontamination water drains down onto a gravel pad designed to allow rapid infiltration into the ground, preventing it from flowing away from the site.

Figure 1: A boat motor being decontaminated by flushing with hot water (≥ 60 °C) on June 10, 2017

From April 2017 to March 2018, all watercraft and water based equipment was inspected for AIS upon arrival and departure from Keeyask. In total, thirty-four inspections were conducted and nine instances of decontamination (Figure 1) were performed on incoming and outgoing watercraft and water-related equipment.

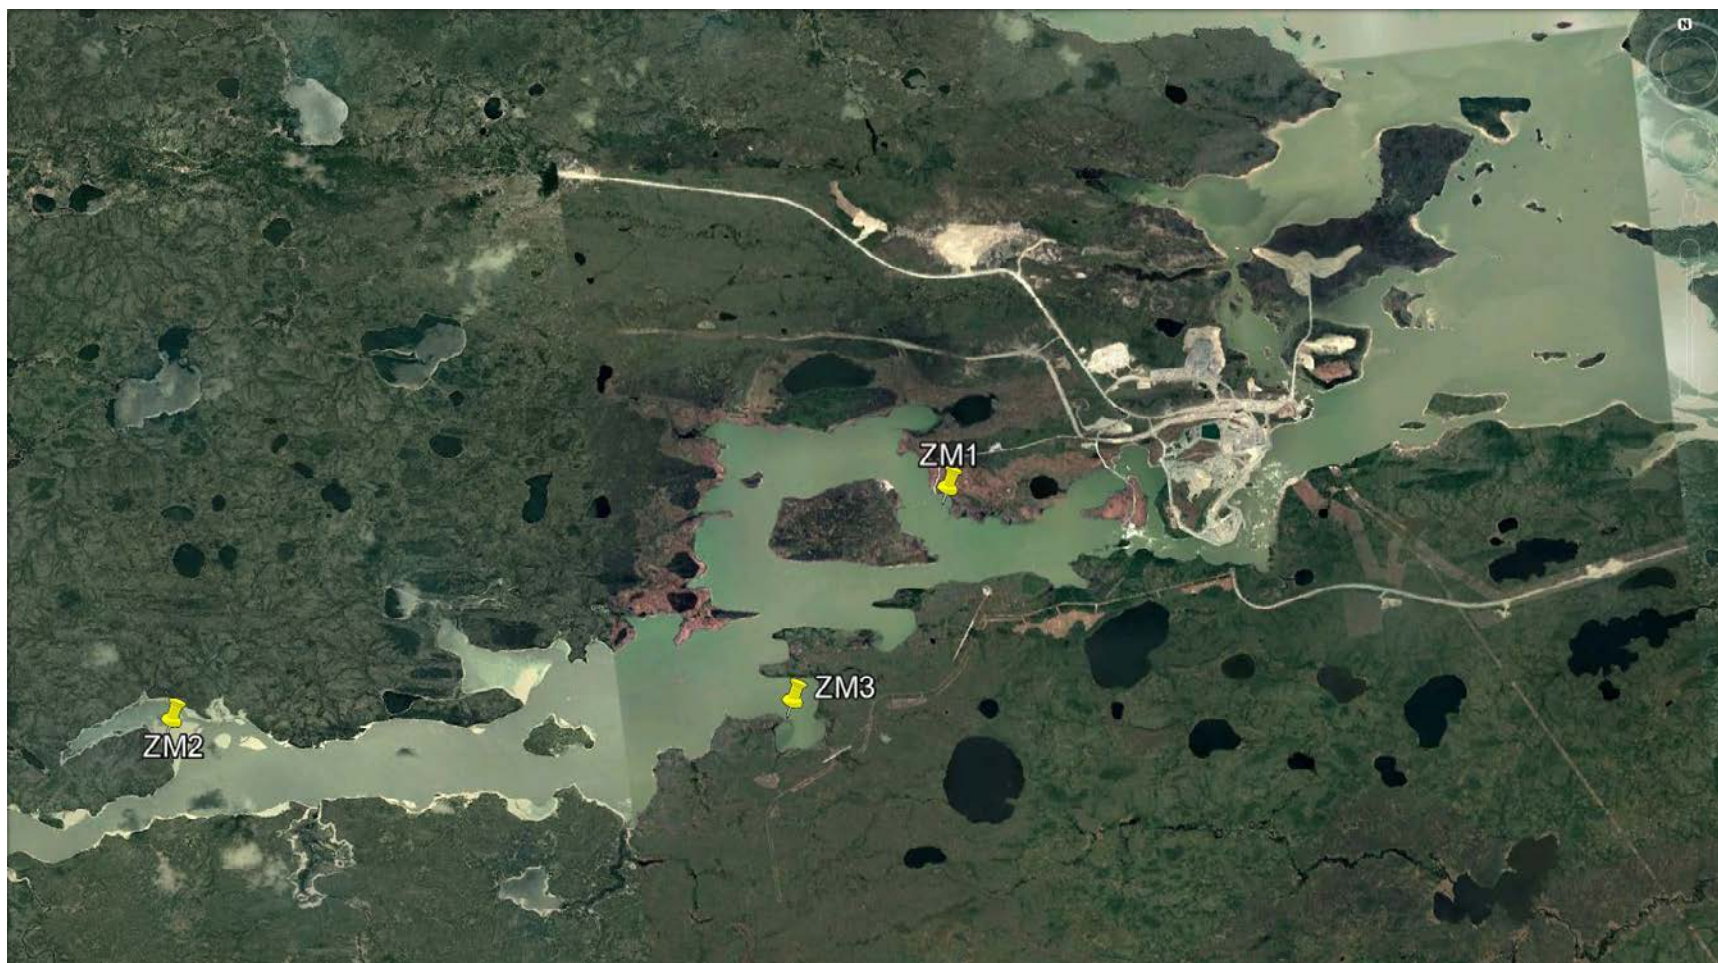
Figure 3: Location of sites in the Keeyask reservoir where artificial substrates were deployed to monitor for zebra mussel colonization

Monitoring for adult zebra mussel colonization was done by establishing three sites in the Keeyask reservoir for placement of artificial substrates. Artificial substrates were deployed on June 4, 2017. Sites were located in low-flow areas (0.1-1.0 m/s) with a depth of approximately 4 m (Figure 3) At each site, terra cotta flower pots were used as artificial substrates; they were suspended in series along a rope at 1, 2, and 3 m depths, anchored in place with a cinderblock, and kept suspended in the water column by a buoy at the surface.

Over the course of the monitoring season, several issues were encountered with the design of the monitoring equipment and anchor system. On July 21, 2017, one of the substrates at ZM1 (Figure 3) was found to be damaged and had to be replaced. On the same day, the monitoring equipment at the south shore site (ZM3) could not be located and new sample substrate was deployed on July 22, 2017. The original substrates that had been lost were recovered at the end of the monitoring season when all of the sites were removed on September 25, 2017. During the

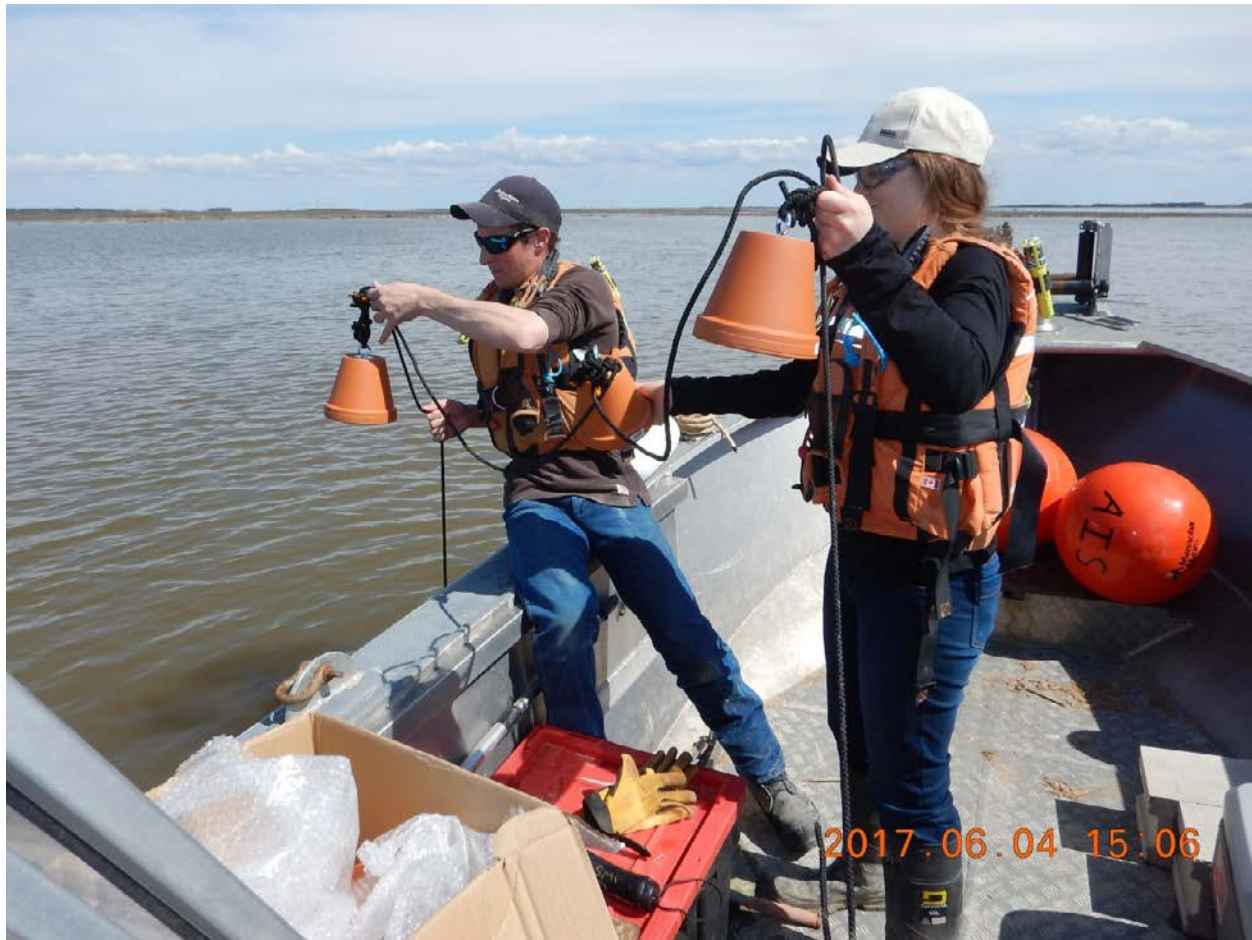
Figure 4: Deploying the artificial substrates at the Keeyask reservoir south shore site (ZM3) on June 4, 2017

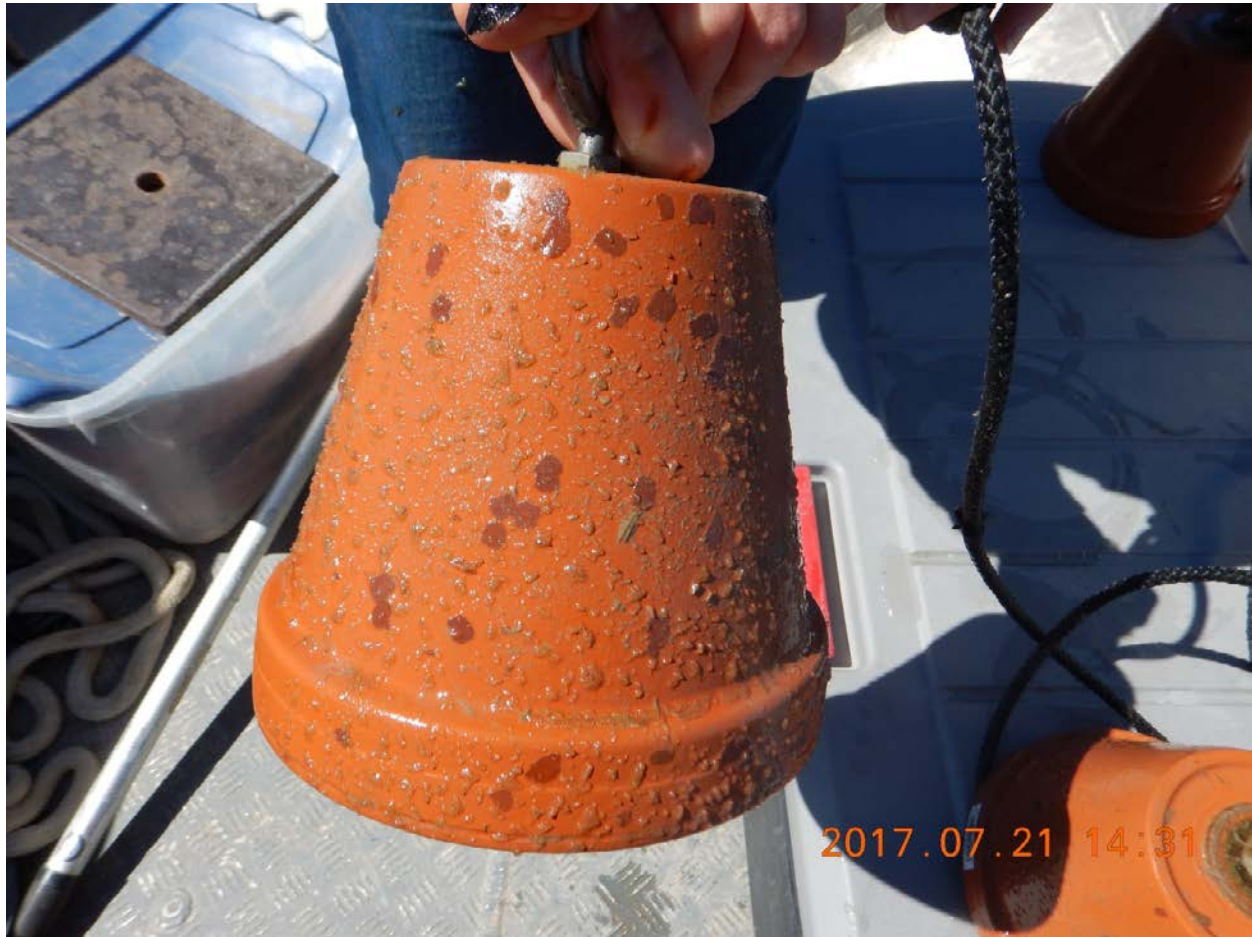
Note: There were many aquatic invertebrates on the substrate but no evidence of zebra mussel colonization.

Figure 5: Photo of a monitoring substrate being checked for colonization by zebra mussels at the Keeyask reservoir north shore site (ZM2) on July 21, 2017

During each site visit in 2017 to inspect and/or remove the artificial substrates (Figure 5) (and cinderblock), and inspect of the surrounding, natural substrates, there was no evidence of zebra mussel colonization (adult or juvenile).

Monitoring will take place again in 2018. In order to prevent the loss of apparatus going forward, separate lines will be used to suspend each pot (substrate) in the water column and they will be anchored in such a way that there is no need to remove the cinderblock each time they are

checked. A more robust anchor line will also be used to prevent it from wear and tear and reduce the potential for the substrates to be lost.

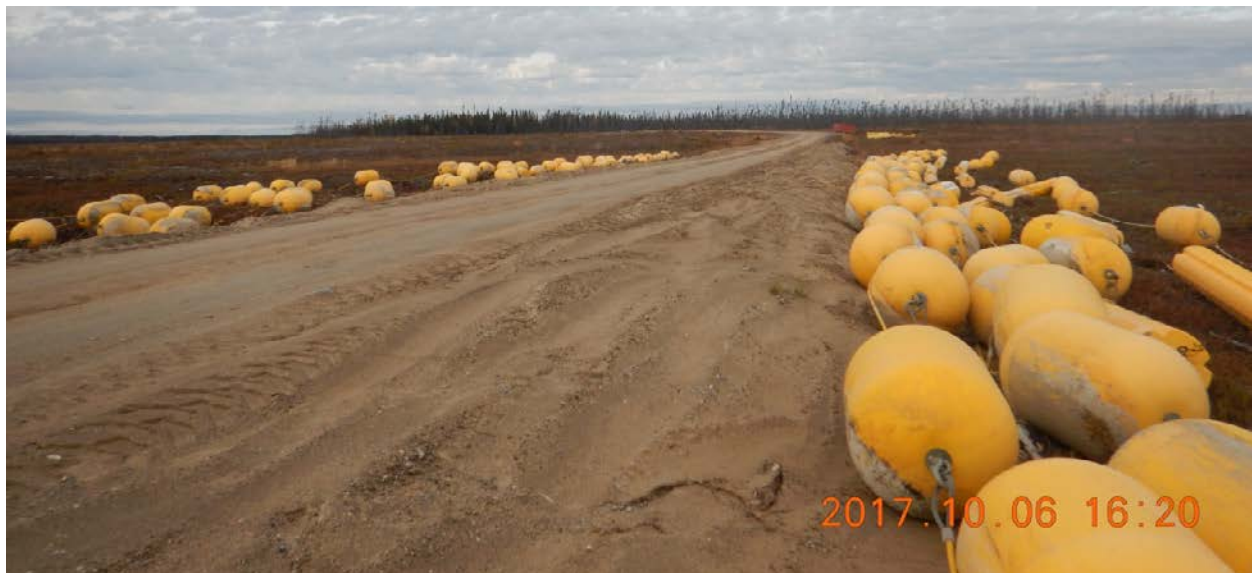
Figure 6: Parts of the open-water safety boom that had been removed for winter storage were visually inspected for the presence of adult and juvenile zebra mussels

The underwater portion of the tern nesting platform and warning buoys, as well as all sections of the safety boom that had been in the river, were carefully inspected for the presence of adult mussels or byssal threads (a tuft of hair-like fibers that zebra mussels use to attach to underwater surfaces). The platform, buoys, and safety boom were also inspected for the presence of young zebra mussels by running a hand over the surfaces, as newly settled mussels on smooth surfaces can feel like sandpaper.

In 2017, no adult or juvenile zebra mussels or evidence of byssal threads were found on any surfaces of the in-water infrastructure.

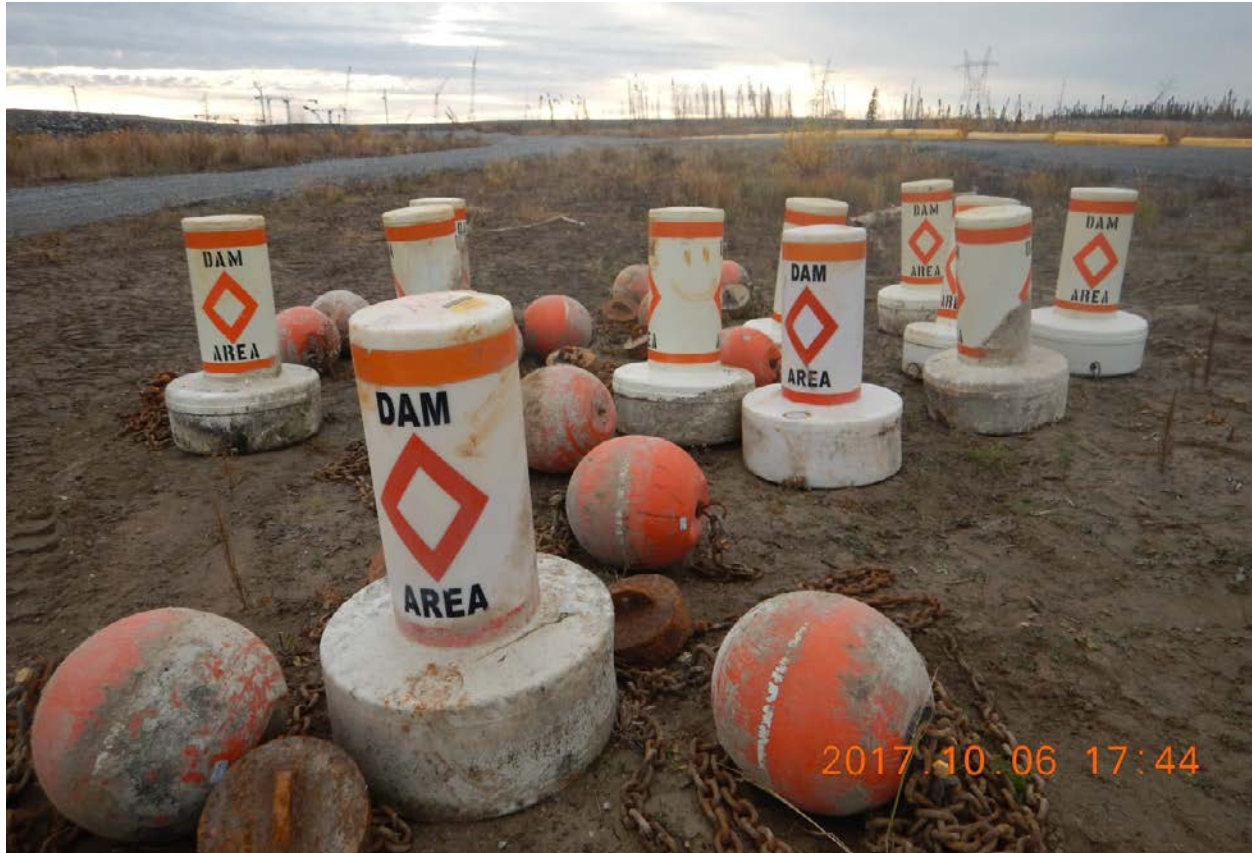
Figure 7: Warning buoys that are deployed downstream of Gull Rapids during the open-water season were removed for winter storage and were visually inspected for the presence of adult and juvenile zebra mussels
