# Keeyask Generation Project Physical Environment Monitoring Plan

## Physical Environment Monitoring Report PEMP-2019-01

REPORT #PEMP-2019-01

### **2018-2019 PHYSICAL ENVIRONMENT MONITORING REPORT: YEAR 5 CONSTRUCTION**

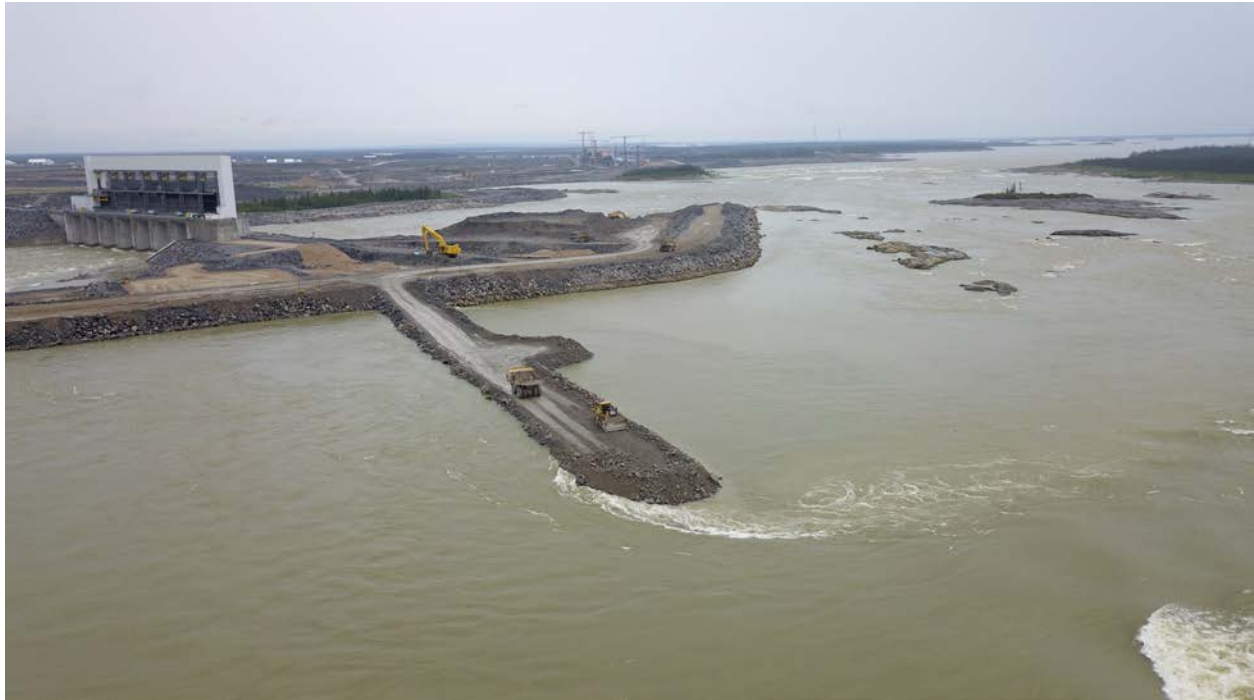
### **Nelson River Being Closed-off with Spillway in Operation**

In August 2018, the spillway came into operation and by mid-August rock had been pushed across the south channel and all water was passing through the spillway. The river closure did not affect water levels at any of the water level gauges.

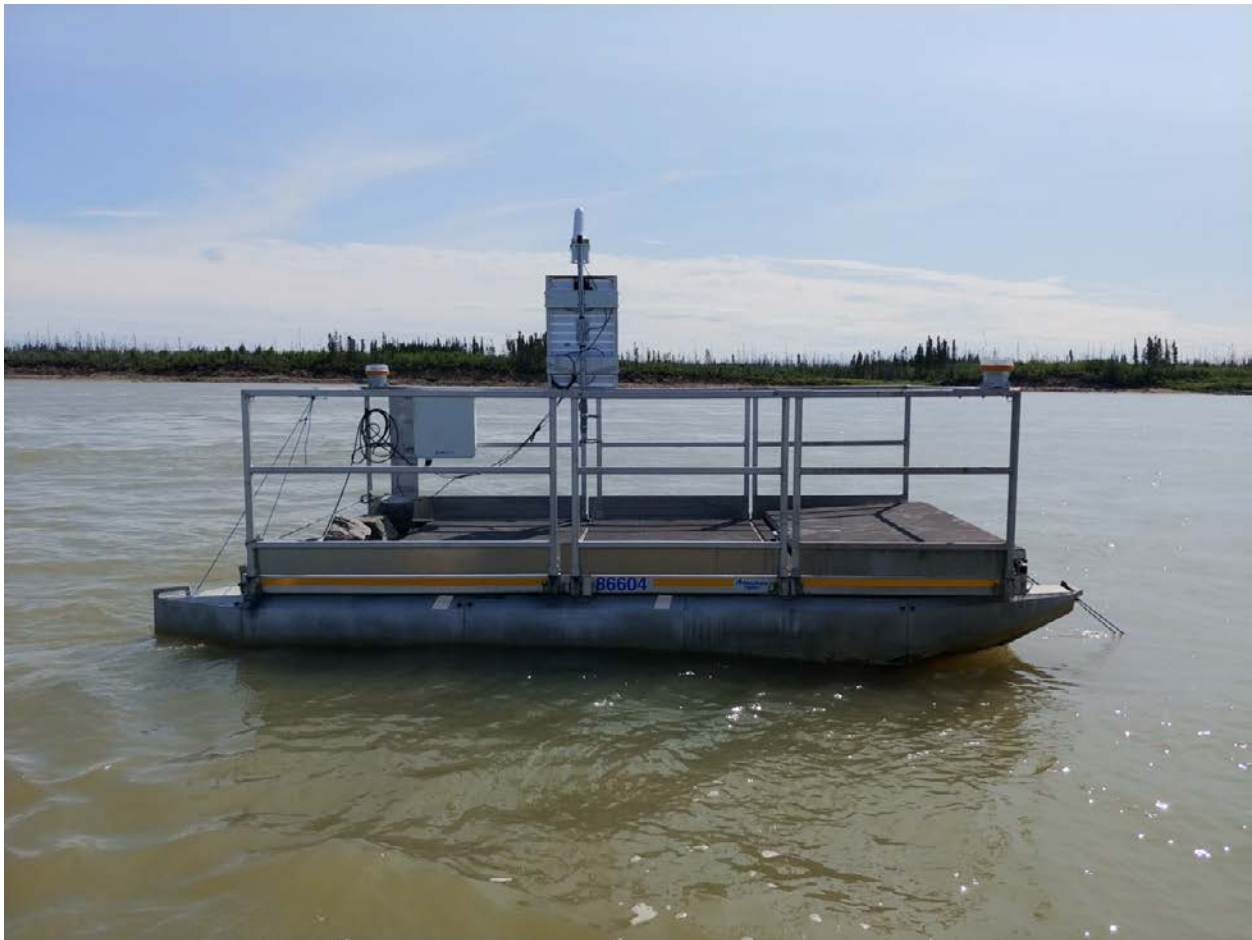
**Continuous turbidity monitoring equipment – electronics cabinet and solar panel on a catamaran below which a turbidity sensor is suspended in the water**

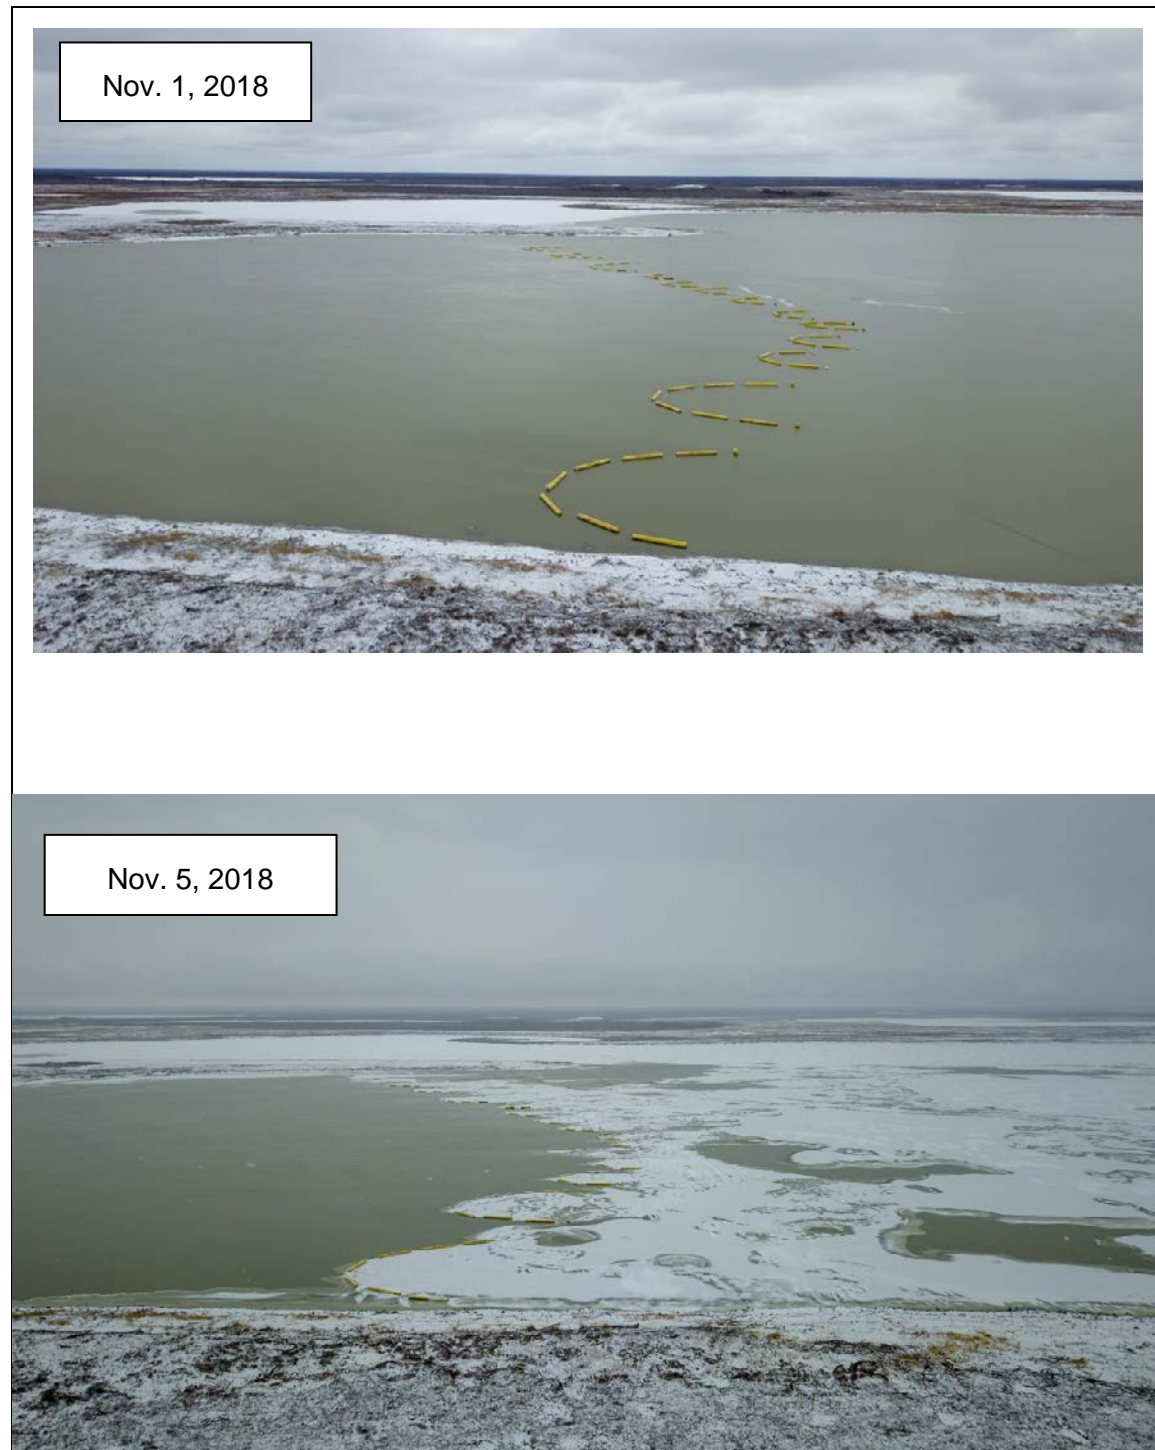
**Photo 2: Ice Boom A on east side of Caribou Island (Nov. 1 & 5, 2018)**

In 2018, temperatures saw a rapid decrease in early November around the time ice formed upstream of the ice booms as seen in Photo 2 which were taken before and after ice developed. Figure 4 shows satellite images of the ice cover as it advances upstream during the winter. By November 14, the leading edge of the ice front was at the upstream end of Gull Lake. The ice front continued to advance upstream reaching Birthday Rapids by late December. The leading edge of the ice front reached about 6 km upstream of Birthday Rapids by late January, remaining there till mid-April, similar to the previous winter. Gull Lake became predominately ice free around May 13-15 about a week earlier than the last two years.

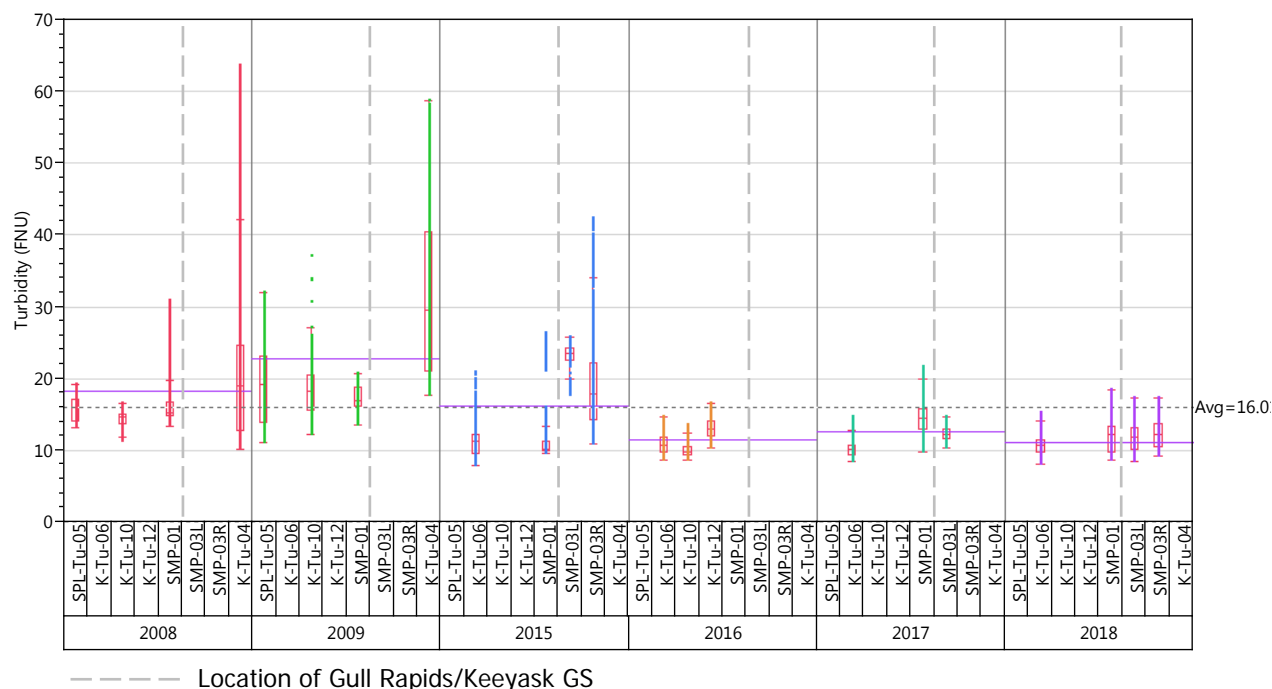
**Figure 6: Summary of Winter Continuous Turbidity**

Results from the 2017-18 winter monitoring show similar results to the past 2 winters with a reduction in turbidity levels in Stephens Lake from pre-construction conditions. The EIS included the prediction that the Project will “significantly reduce erosion potential” downstream of the Project after construction which would result in lower turbidity downstream. Changes were not anticipated during the construction period as some increases in water level due to ice were still expected to cause erosion at the entrance to Stephens Lake. The earlier than expected reduction is likely due to the upstream ice boom creating a more stable upstream ice cover and reduction in the Stephens Lake ice dam and the cofferdams reducing the potential erosion of shorelines..

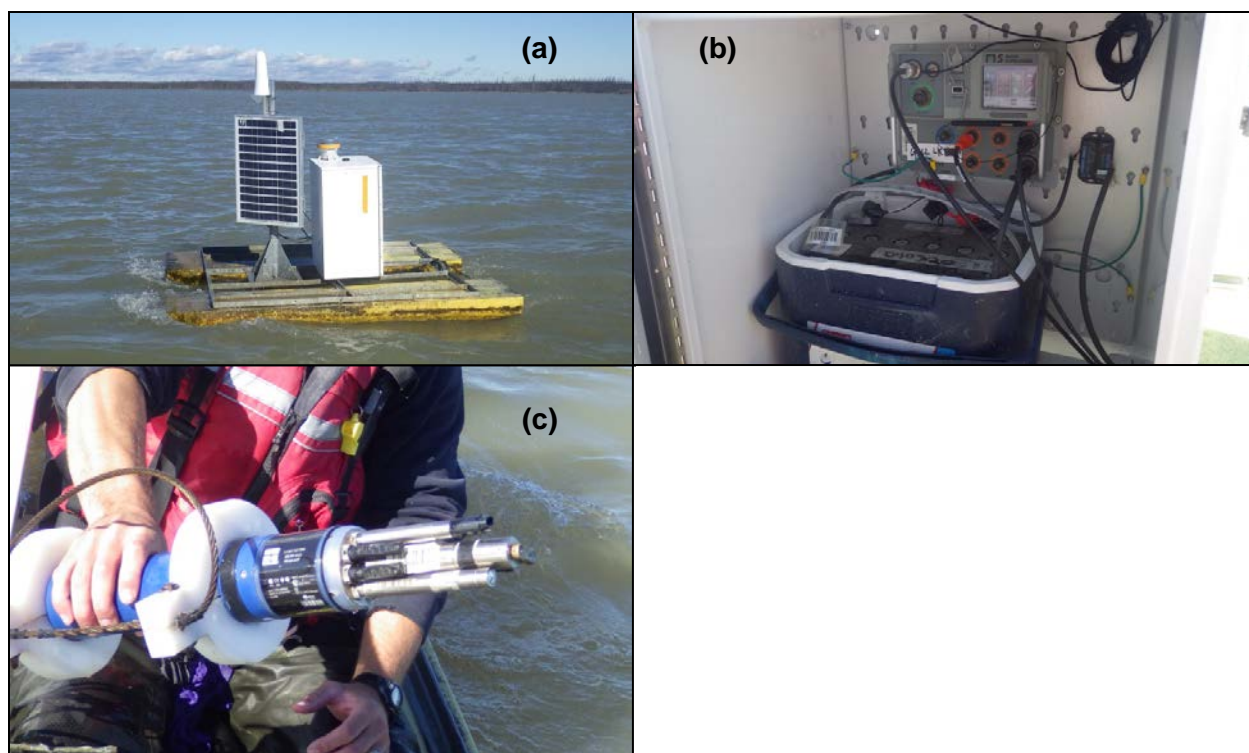
**Photo 3: Continuous turbidity monitoring site: (a) catamaran with solar panel, transmitter and electronics cabinet, (b) electronics in cabinet, (c) probe with turbidity sensor installed**

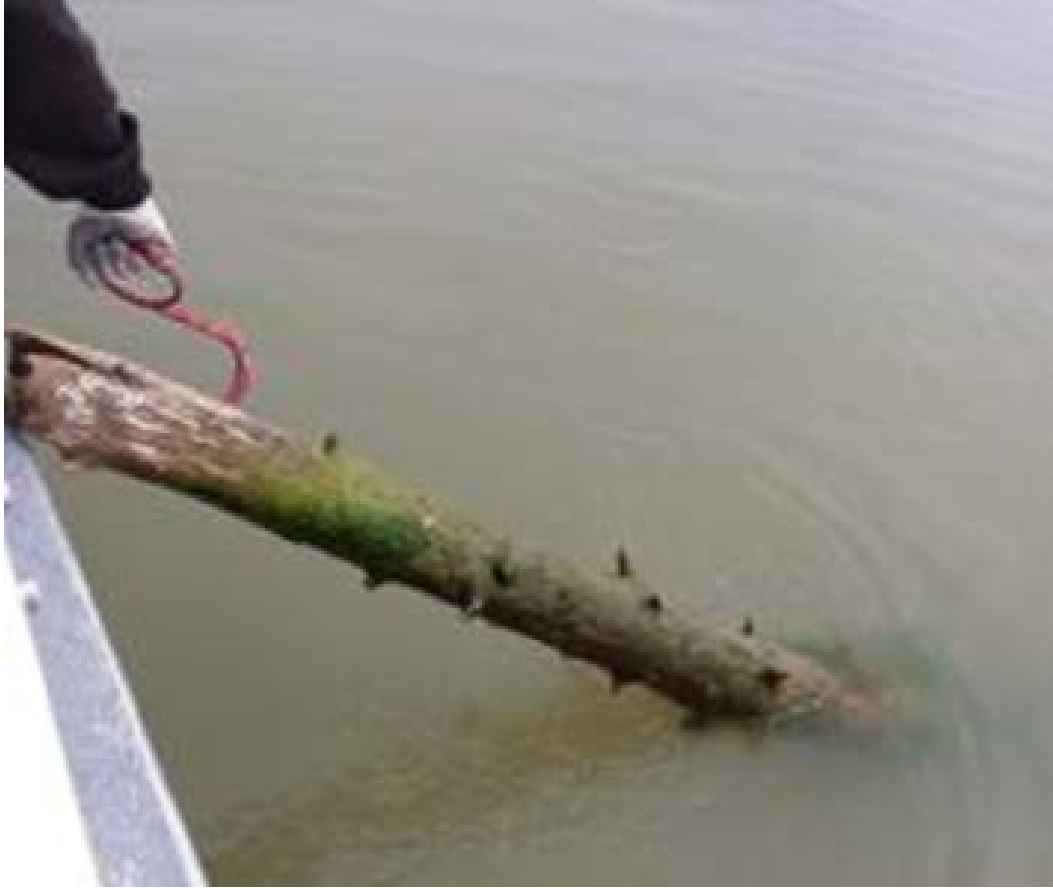
**Photo 5: Large floating debris is removed from the water by the boat patrol team**

As part of the Project, in accordance with the Joint Keeyask Development Agreement (TCN et.al. 2009), a waterways management program was implemented in 2015 for the Project area from Clark Lake to Gull Rapids. A component of this program is the operation of a boat patrol to identify and remove floating woody debris (Photo 5) that may pose a safety hazard to navigation. Prior to 2015, this area was only visited about once each week (20% of the time) and the amount of debris collected in the Clark to Gull Lake area was estimated to be 20% of the total amount of debris collected by the work crew.
