## Keeyask Generation Project Sediment Management Plan for In-stream Construction

## **SEDIMENT MANAGEMENT PLAN FOR IN-STREAM CONSTRUCTION**

REPORT #SMP-2019-01

**April 2018 – March 2019: Year 5 Construction**

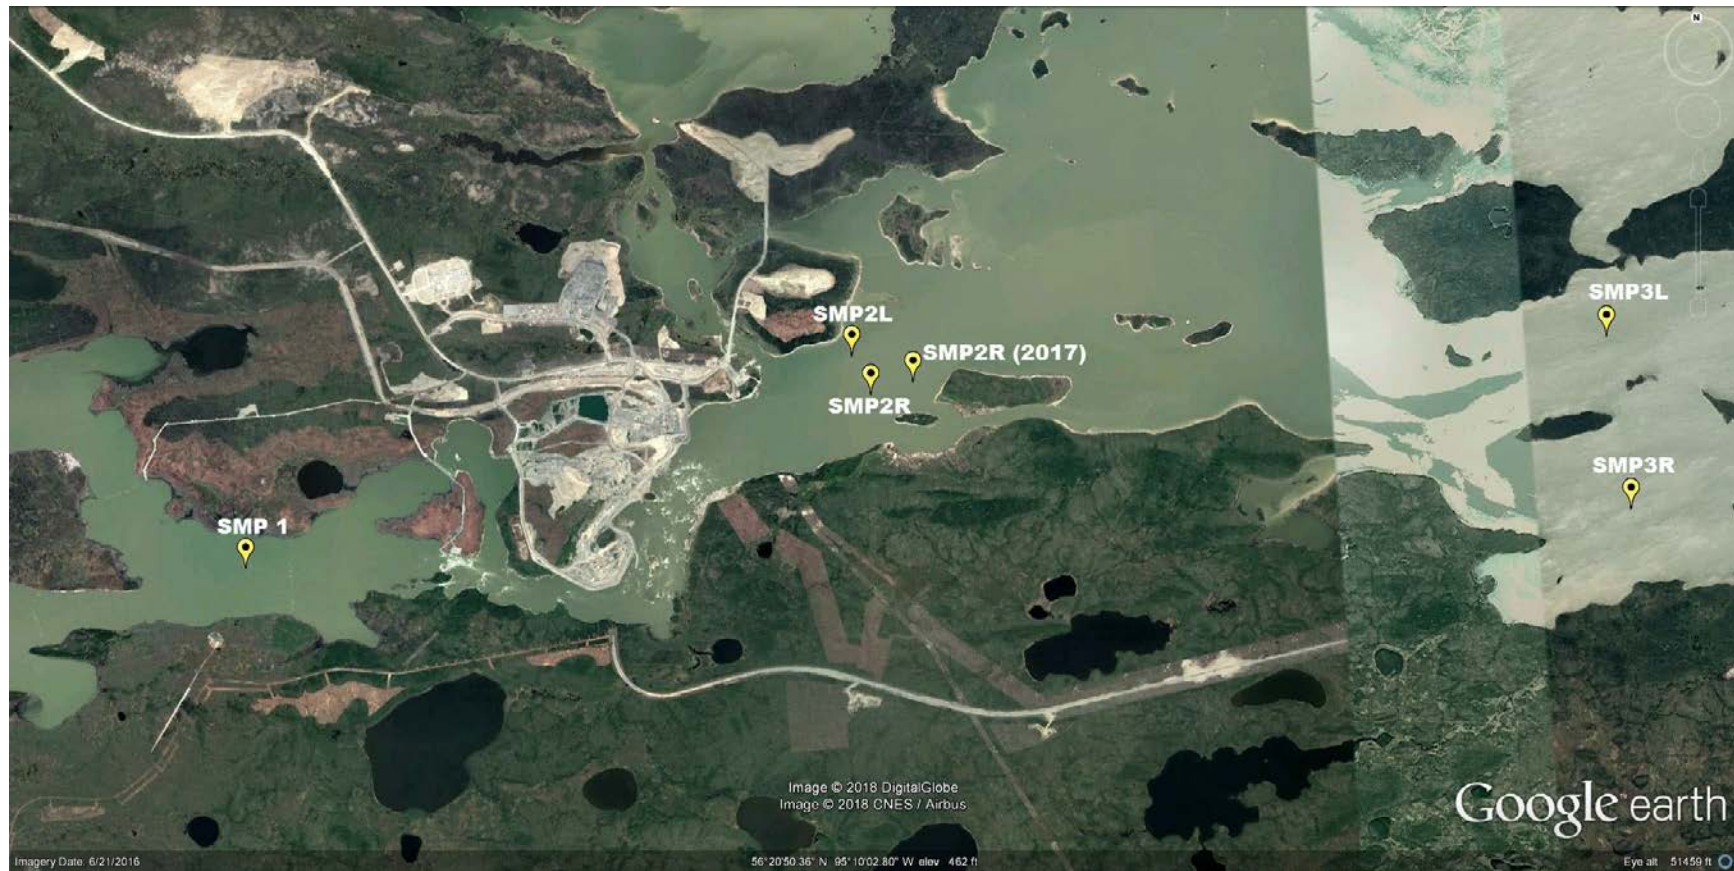
**Figure 2:** Open water monitoring stations for the Keeyask Sediment Management Plan

During the month of June 2018, the open water monitoring stations were installed on the Nelson River. Five monitoring stations (SMP-1, SMP-2L & SMP-2R, SMP-3L & SMP-3R) were deployed as outlined in the SMP to collect turbidity data for the Project. A backup station (SMP-1A) was installed near SMP-1 as a precaution, so background data would be continuously available in the event that SMP-1, which is the sole upstream monitoring station, failed or became damaged. At each station, sensors were installed two meters below the water's surface (designated TSSS) and two meters above the bottom of the channel (designated TSSB). Figure 2 shows the location of each of the SMP open water monitoring stations. The stations are described in more detail below:

- SMP-1 is located upstream of all construction activities in the Nelson River and monitors ongoing background conditions.
- SMP-2 is located approximately 1.5 km downstream of the future Powerhouse. Data loggers are installed on the left and right sides of the channel (SMP-2L and SMP-2R). This location was chosen, as it is a near-field location within the mixing zone prior to fully mixed conditions.
- SMP-3 is located approximately 9 km downstream from the construction site in the fully mixed zone of the primary flow channel, along the deepest part of the river. This location was chosen because the majority of the flow passes through this south channel and it is

where increases in TSS will mostly occur. Data loggers are installed on both the left and right sides of the channel (SMP-3L & SMP-3R).

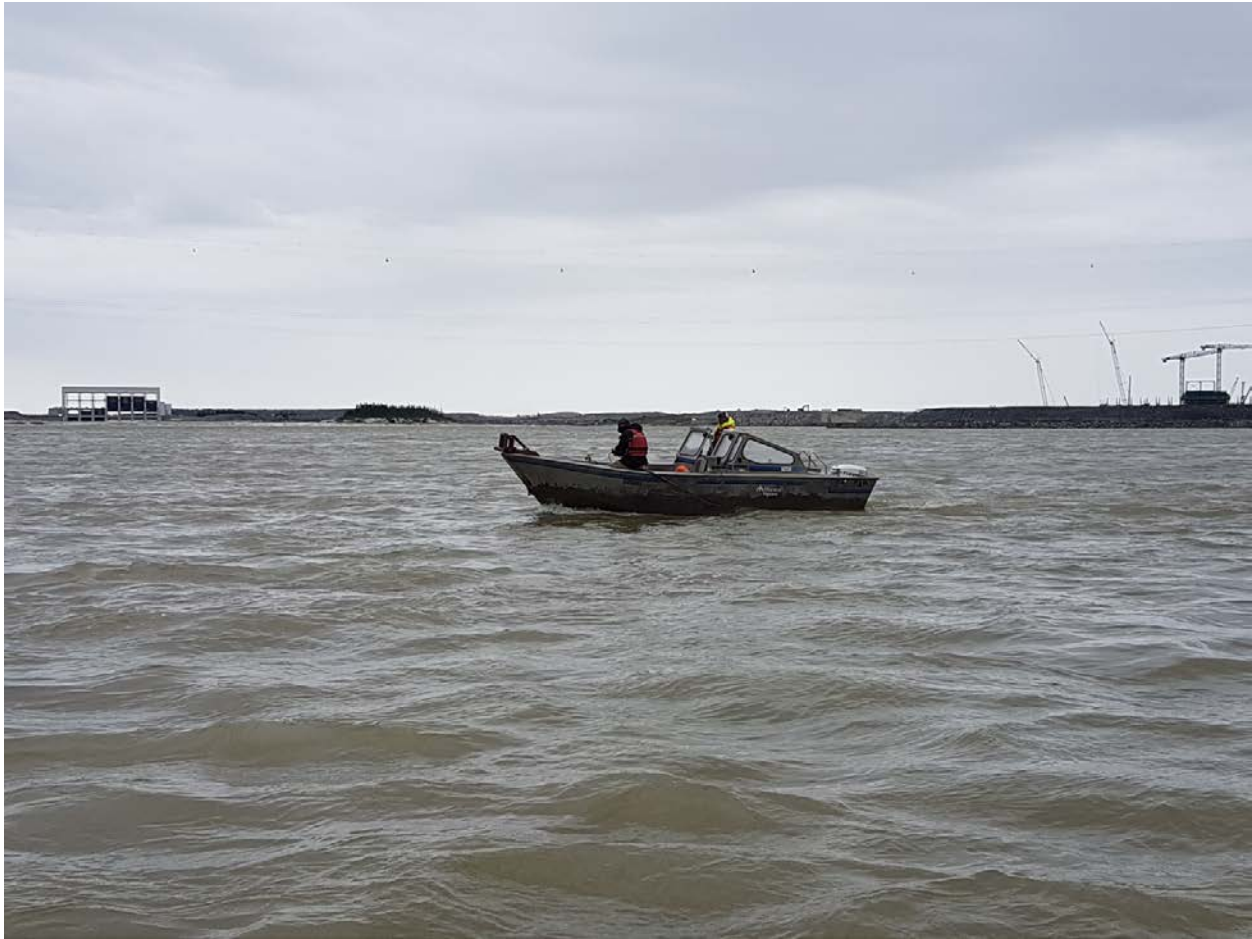
**Figure 4:** A crew moves along a transect with sonde set at depth of 2m travelling from north to south across the Nelson downstream of the safety boom. The Spillway structure can be seen in the background, with 4 of 7 gates raised. On the right is the powerhouse construction area.

Based on the data collected, there were no variations in the turbidity detected across the river when there was no in-stream work taking place. Information on sediment and turbidity measured during the various construction activities, including Spillway commissioning, are discussed in the remainder of the document.

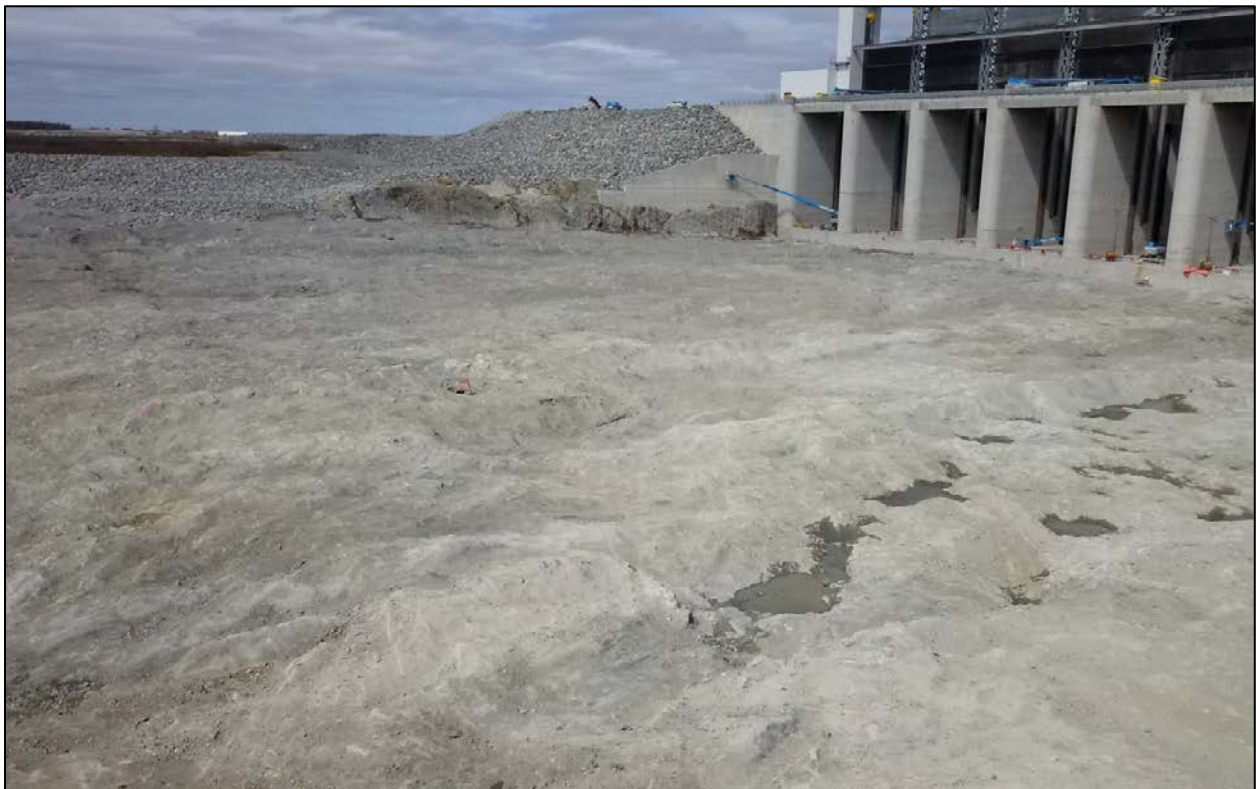
**Figure 5: The Spillway Approach Channel after cleaning**

The upstream and downstream portions of the Spillway Cofferdam were constructed starting in 2015 and were each comprised of an inner and outer rock groin filled with an impervious core of fine material (clay). Prior to removing the rock groins, the approach and discharge channels were cleaned to reduce the material available that would contribute to the suspended sediment load during Spillway Commissioning (Figure 5). On July 4 2018, in-stream work began to breach the rock groins of the downstream cofferdam and begin removal of the impervious material (Figure 6). Removal of the upstream cofferdam began shortly afterwards and both were removed by August 5. As shown in Figure 7, care was taken to reduce the amount of sediment released to the river by removing the impervious core in stages, within the relatively tranquil confines of the rock groins, followed by removing the groins themselves.

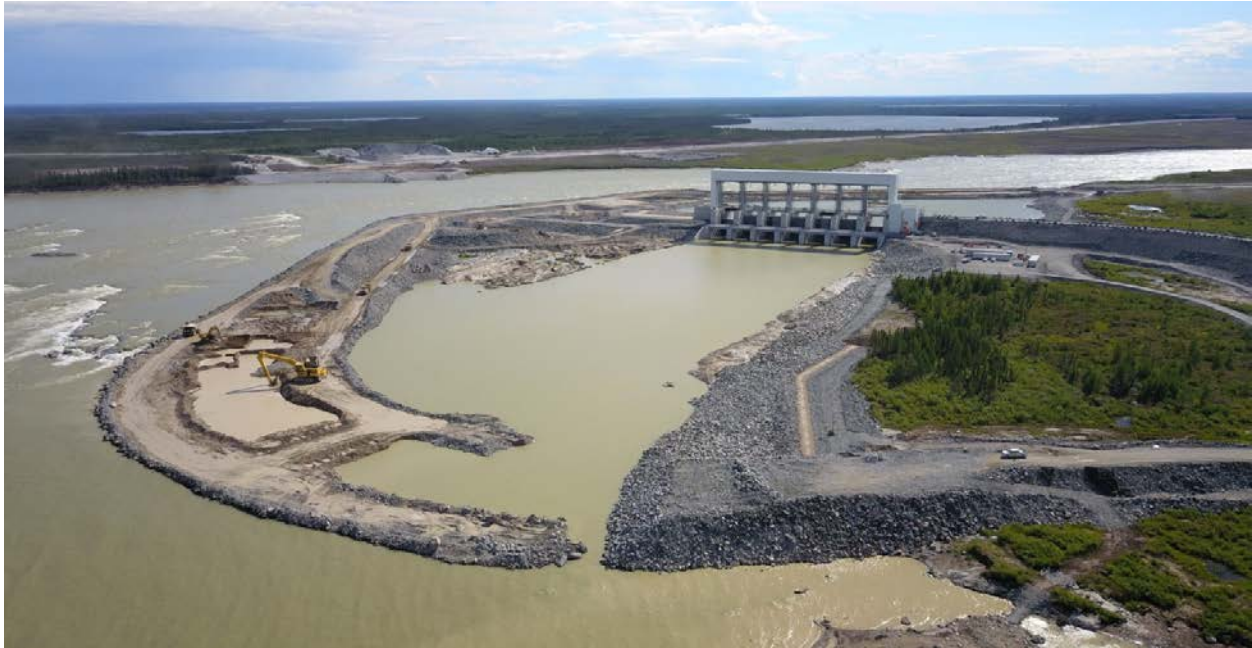
**Figure 6: Removing the downstream Spillway Cofferdam in July 2018**

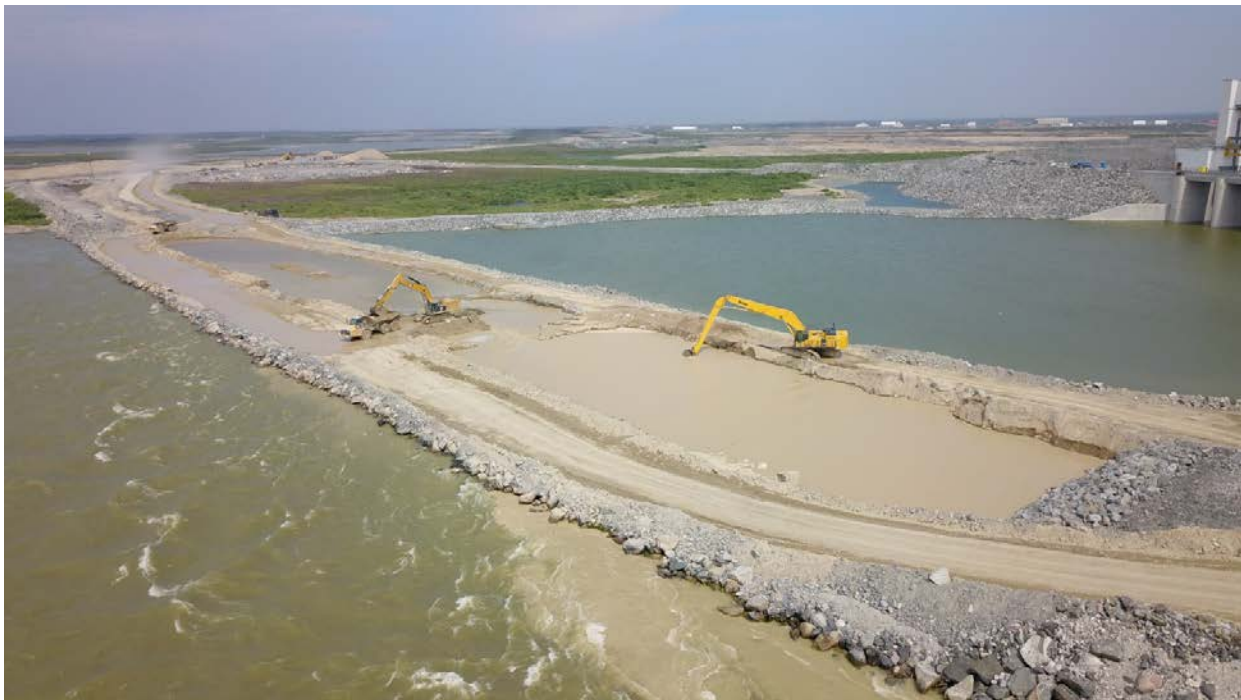
**Figure 7: Excavators remove material from the impervious core and rockfill from the outer groin, July 11, 2018. A small sediment plume can be seen entering the Nelson River in the foreground, although no TSS exceedances were observed at SMP monitoring sites**

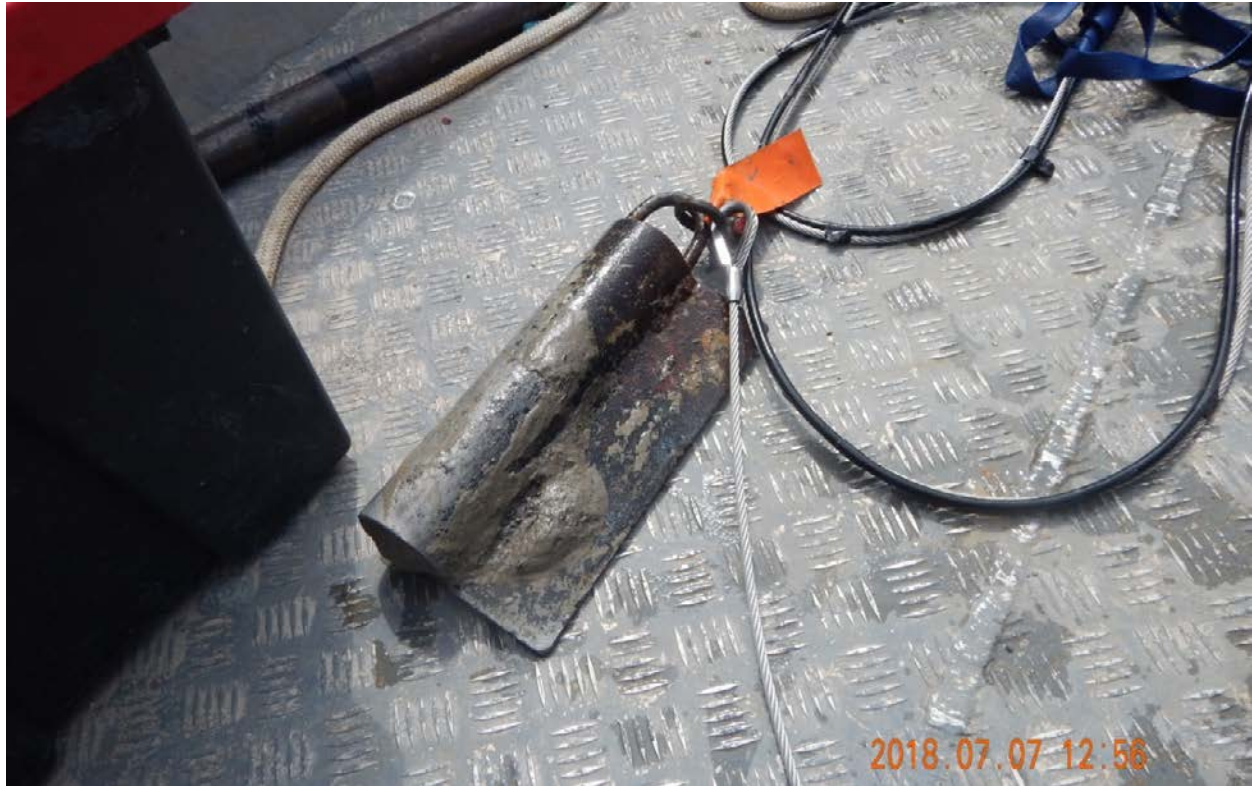
**Figure 10:** A sensor weight that dragged along bottom of Stephens Lake at SMP-3R and resulted in elevated turbidity values at the bottom sensor. The cable was shortened to the correct length on July 7, 2018.

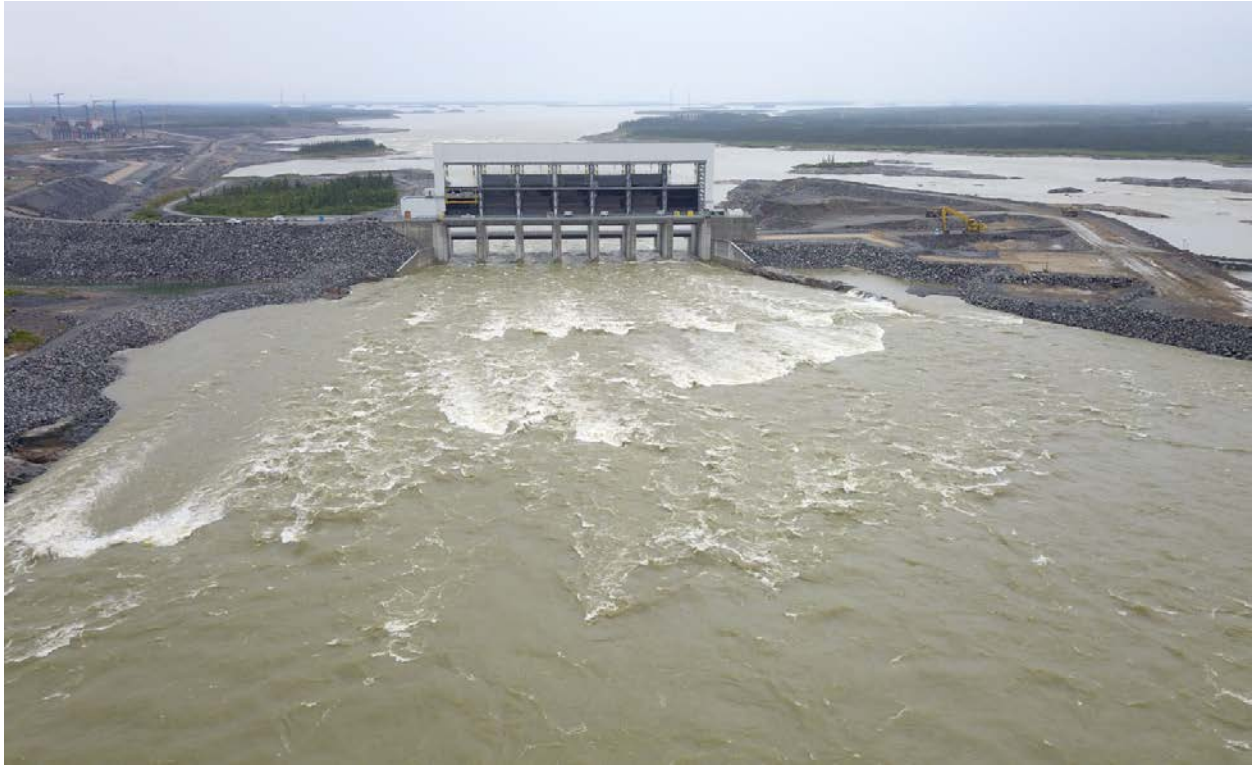
**Figure 11: Looking east (downstream) towards the Spillway structure after commissioning; all 7 gates are open.**

Commissioning the Spillway (Figure 11) was a major milestone during the Keeyask Project, and one of two major events where potential increases in TSS were predicted to be large enough to produce a measurable effect on the Nelson River (the other event is commissioning the Power House). Commissioning took place between August 3 and 7, 2019. As described in Section 2.5.2, many steps, in addition to watching the SMP results in real-time at SMP-2 and SMP-3, were taken to follow the plume while commissioning each gate to provide timely data necessary to make quick decisions in order to mitigate the impacts on aquatic life in the Nelson River.

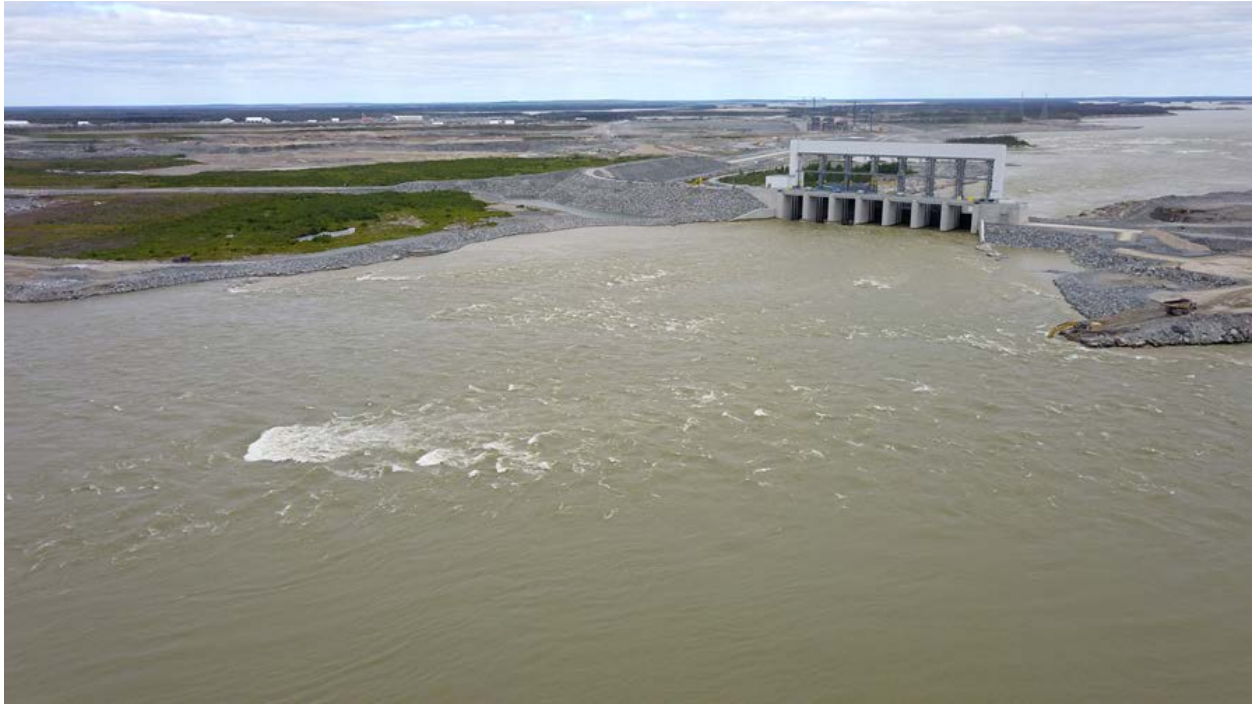
**Figure 14: Spillway Approach Channel (looking downstream) during Spillway commissioning on August 5, 2018. An excavator can be seen at right removing the remainder of the Spillway Cofferdam.**

Gates 3 through 7 were opened gradually over the next 4 days (Figure 14) and monitoring confirmed there were no exceedances of the action levels in the SMP.

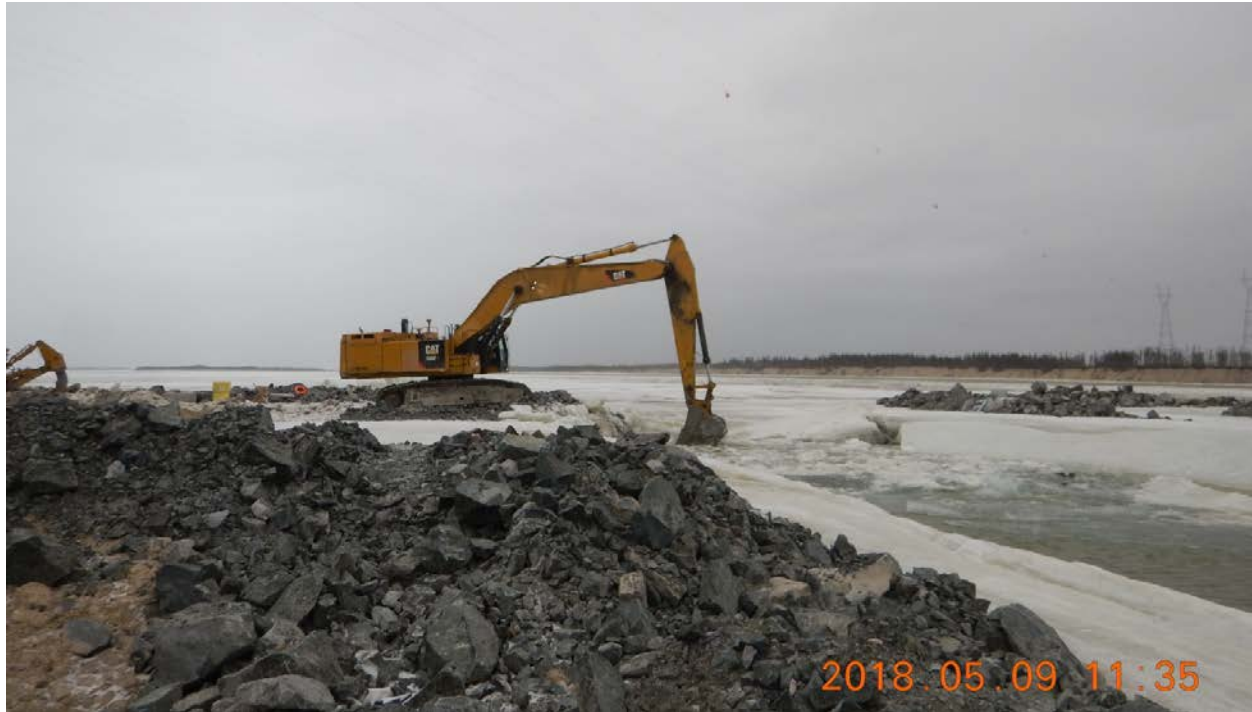
**Figure 16:** An excavator breaks and removes ice from the channel through the Tailrace Cofferdam, May 9, 2018

A Cat 390 excavator removed ice from the opening in the TRCD (Figure 16) on May 9. After the ice was removed, a bulldozer pushed large rock across to fill the gap and close the outer groin (Figure 17). The in-stream work related to the TRCD was finished on May 9 (Figure 18).

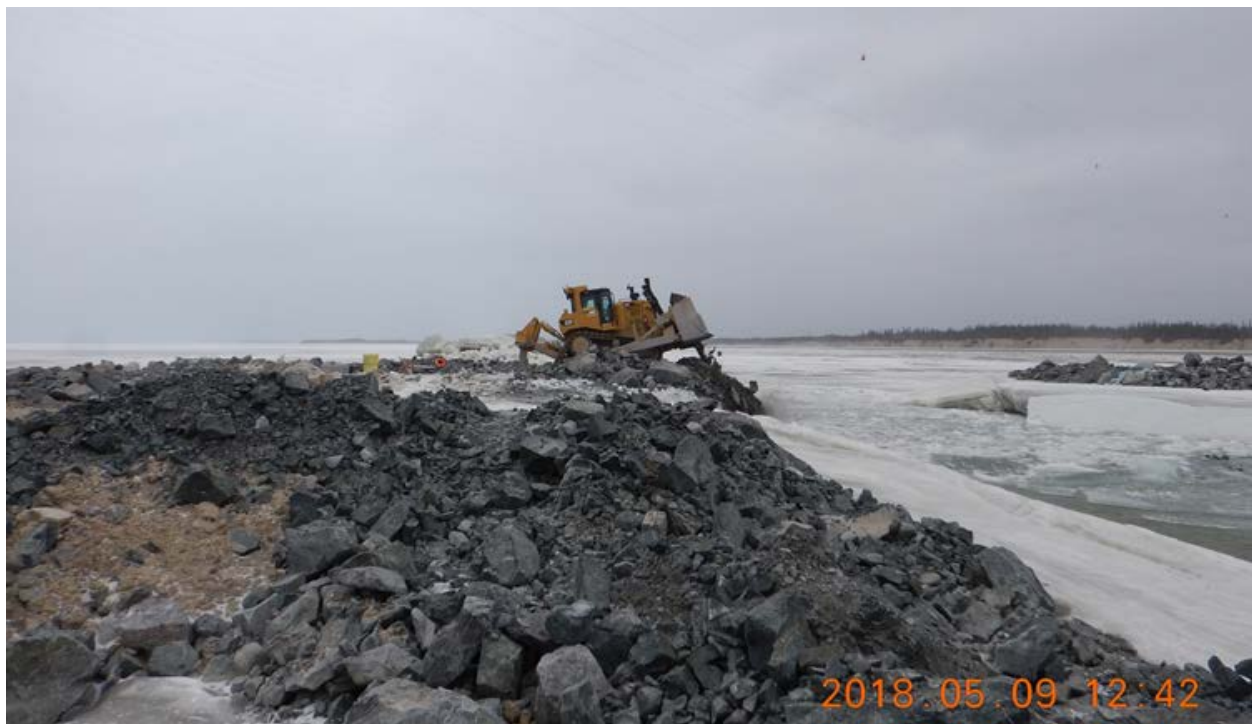
**Figure 17:** A bulldozer pushes large rock in place to close the opening in the Tailrace Cofferdam outer groin

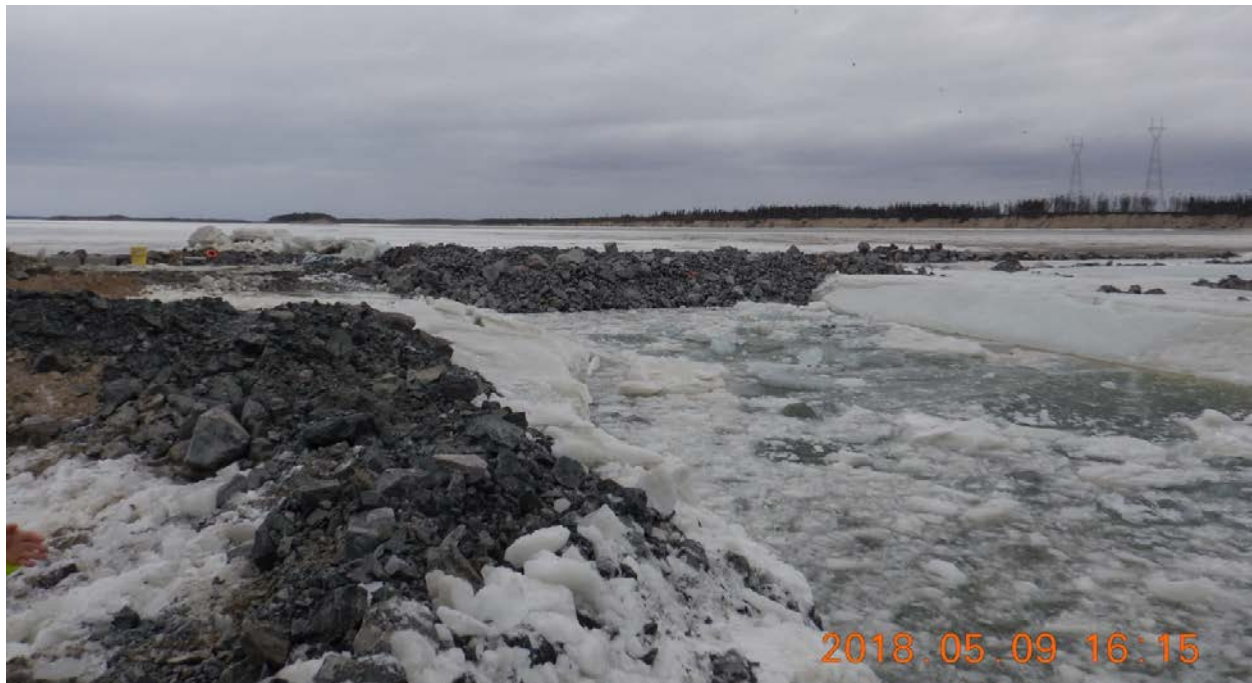
**Figure 18: The Tailrace Cofferdam outer groin after completion**

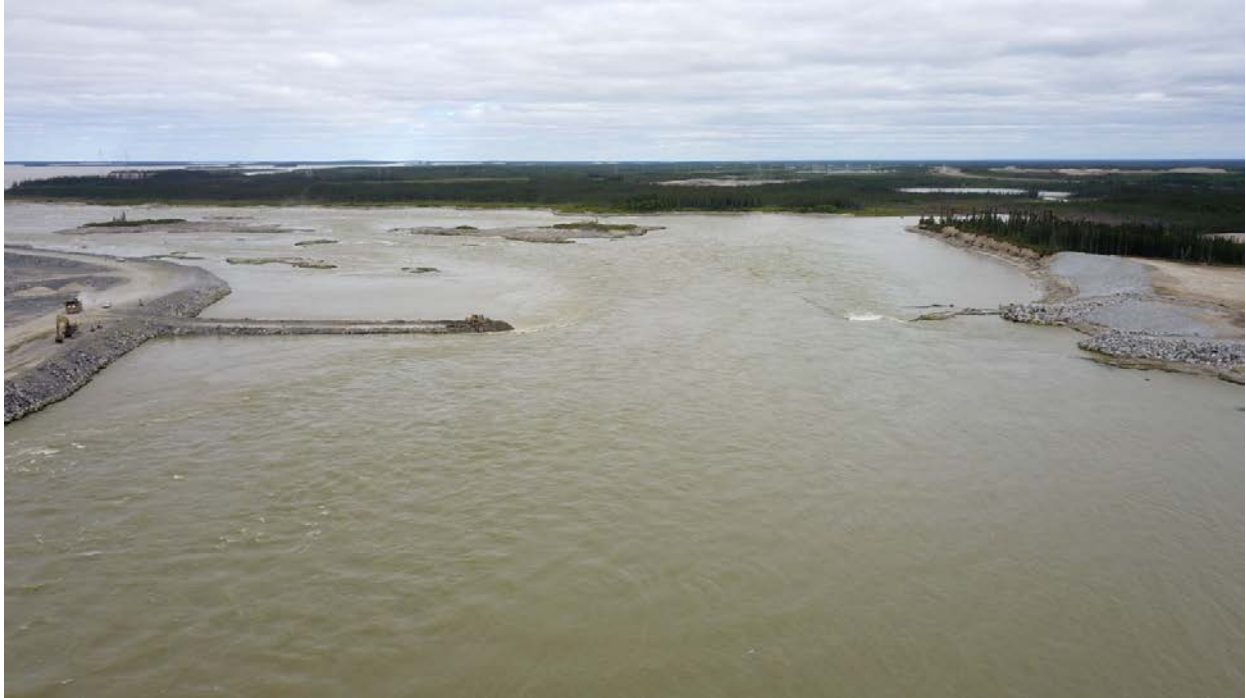
**Figure 19: Initial construction of the Downstream South Dam Cofferdam, looking east. A bulldozer pushes rockfill across the south channel of the Nelson River, August 5, 2018**

To construct each of the South Dam Cofferdams (SDCD), a rock groin was pushed across the south channel of the Nelson River to join the Spillway area to the south shore (Figure 19). Sand was placed on the downstream side of the downstream rock groin, which was followed by placement of impervious material to blanket the sand (Figure 20). This created the Downstream SDCD. Sand and impervious material was placed in the same fashion on the upstream side of the upstream rock groin to create the Upstream SDCD.

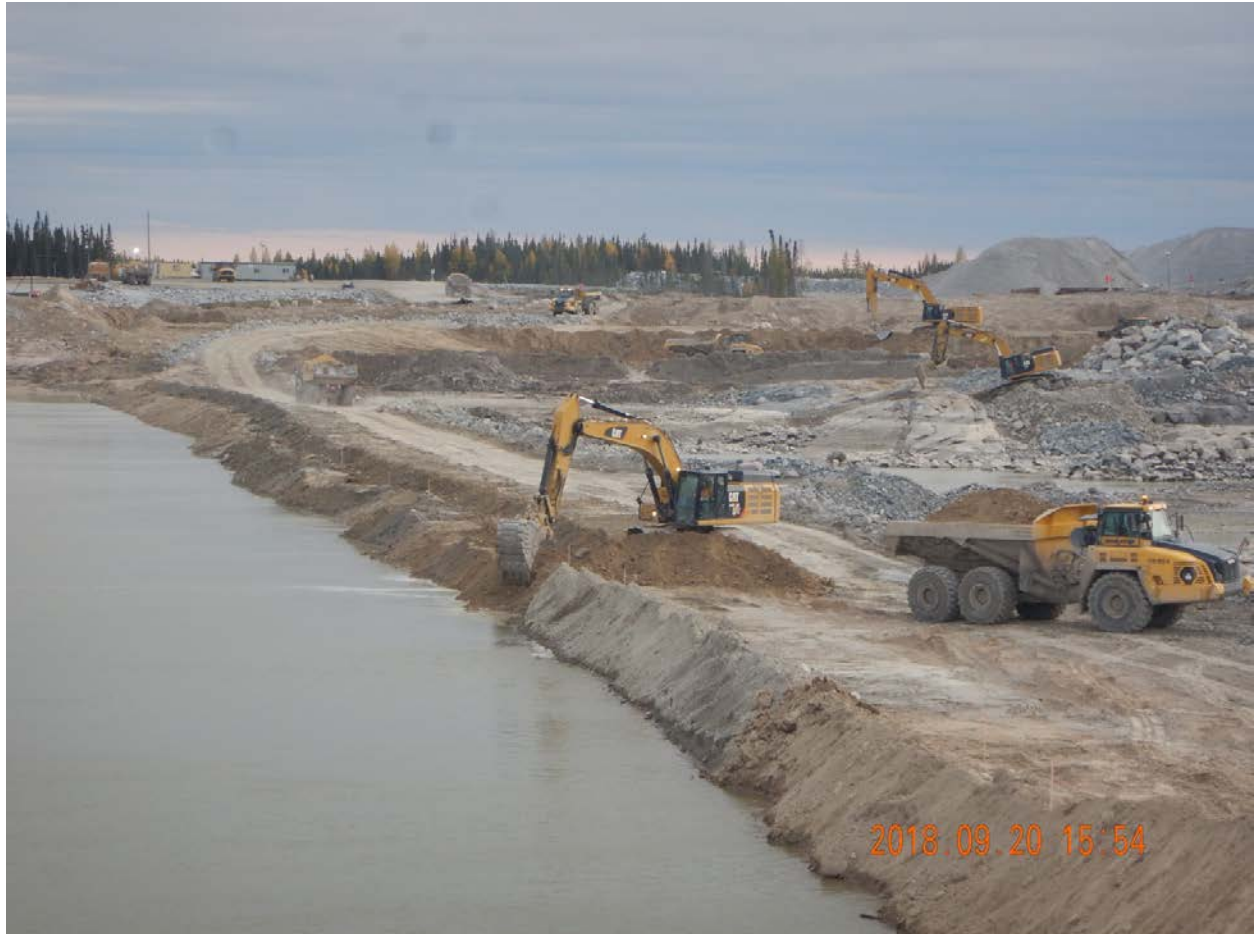
**Figure 20: Excavator placing impervious material over a sand layer along entire length of the downstream side of the South Dam Cofferdam, August 20, 2018**

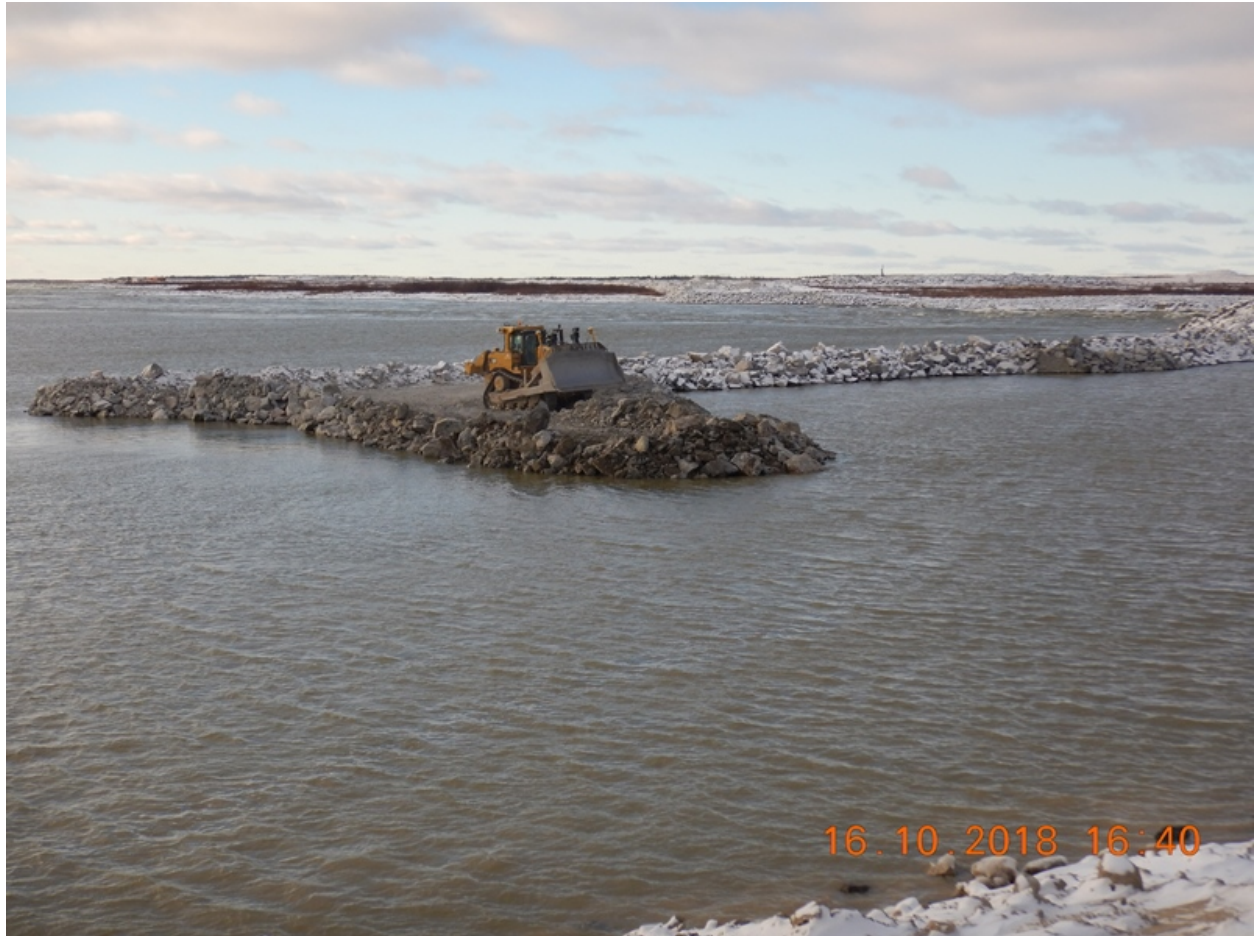
**Figure 21: A bulldozer pushing rockfill to construct the containment groin at the Upstream South Dam Cofferdam, October 16, 2018**

A greater than expected volume of water seeped through the Upstream SDCD after completion on September 24, 2018. To reduce the amount of seepage, a rockfill containment berm was constructed in October to enclose the seepage area (Figure 21) and filled with impervious material to reduce seepage. During placement of the impervious material, a gap was left in the containment berm to allow fish egress (Figure 22).

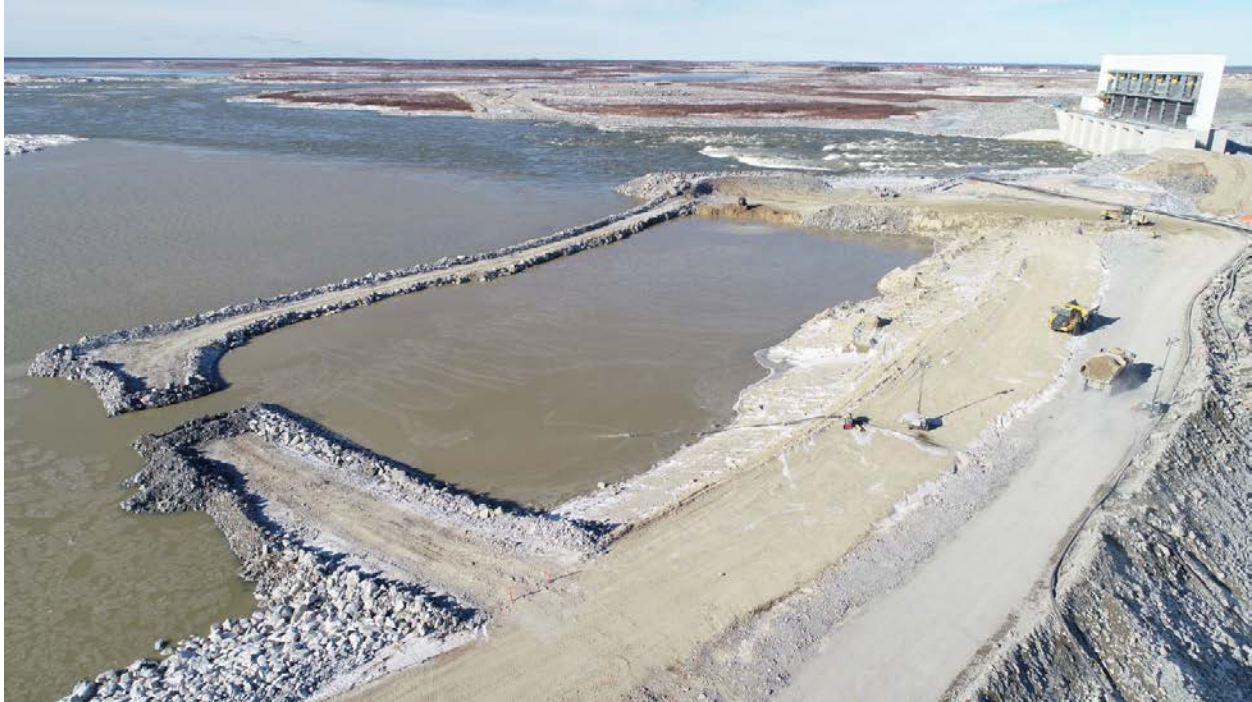
**Figure 22:** The containment groin at the Upstream South Dam Cofferdam, October 26, 2018. The channel for fish egress during placement of impervious material can be seen on the left

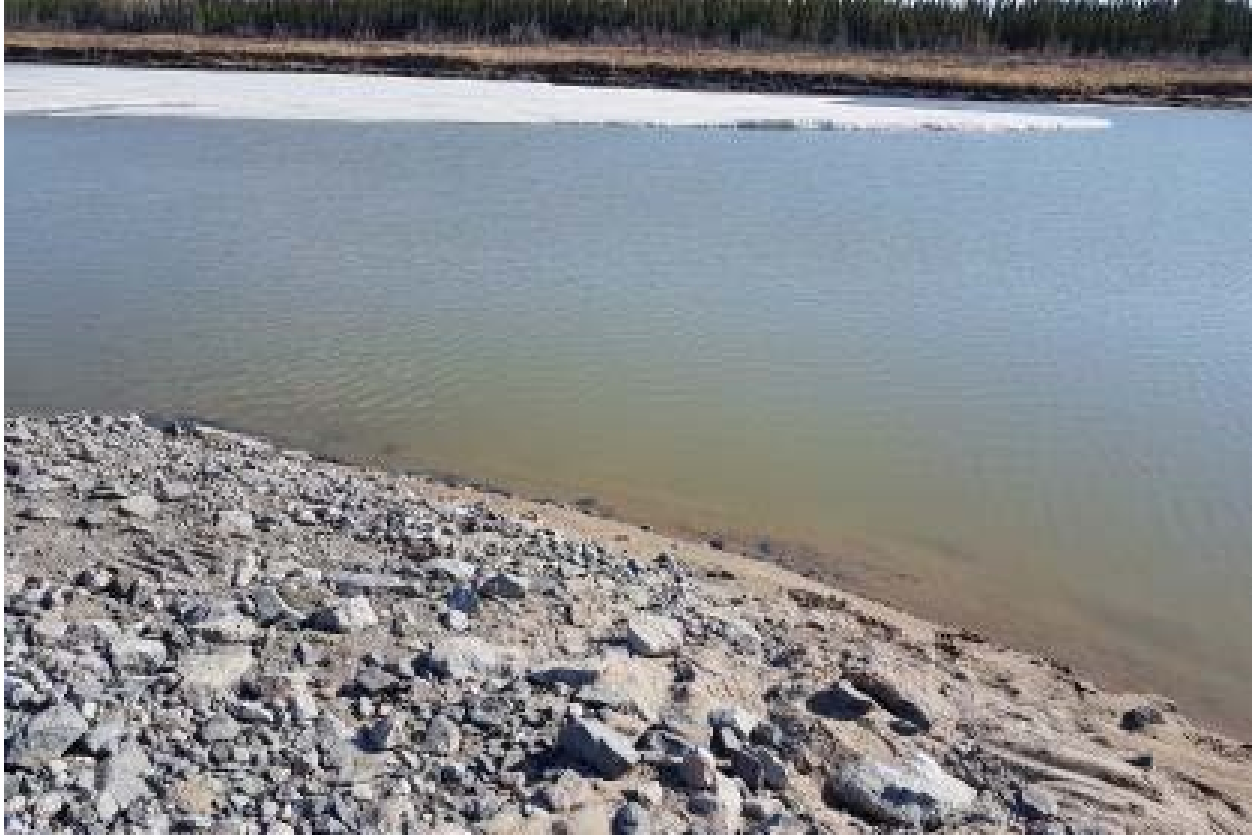
**Figure 25:** The ramp of the temporary downstream boat launch prior to repairs. Soft substrate at the base and into the water made it unusable

The temporary downstream boat launch is a rockfill ramp that extends into Stephens Lake, below Gull Rapids. The design of the boat launch cannot withstand the movement of ice during freeze-up and break-up and must be repaired each spring. In spring 2018, there was soft substrate at the base of the launch, which made it unusable (Figure 25). On May 31, 2018, rock was placed at the water's edge and down into the water to complete the repair (Figure 26).

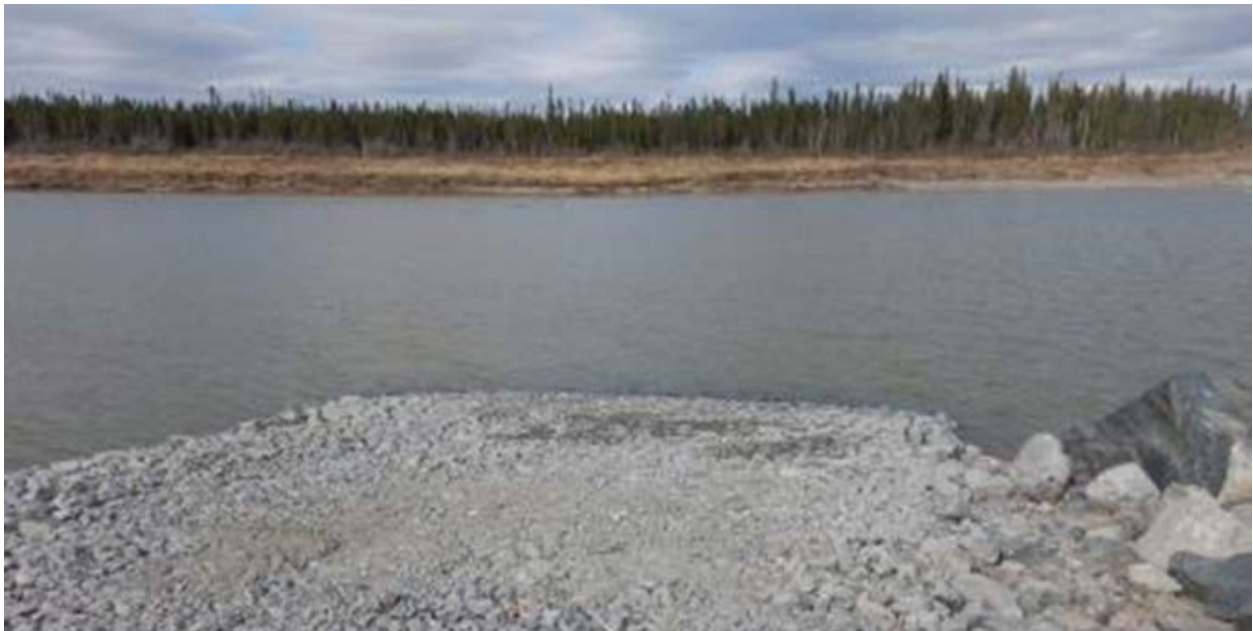
**Figure 26:** The temporary downstream boat launch after rock placement

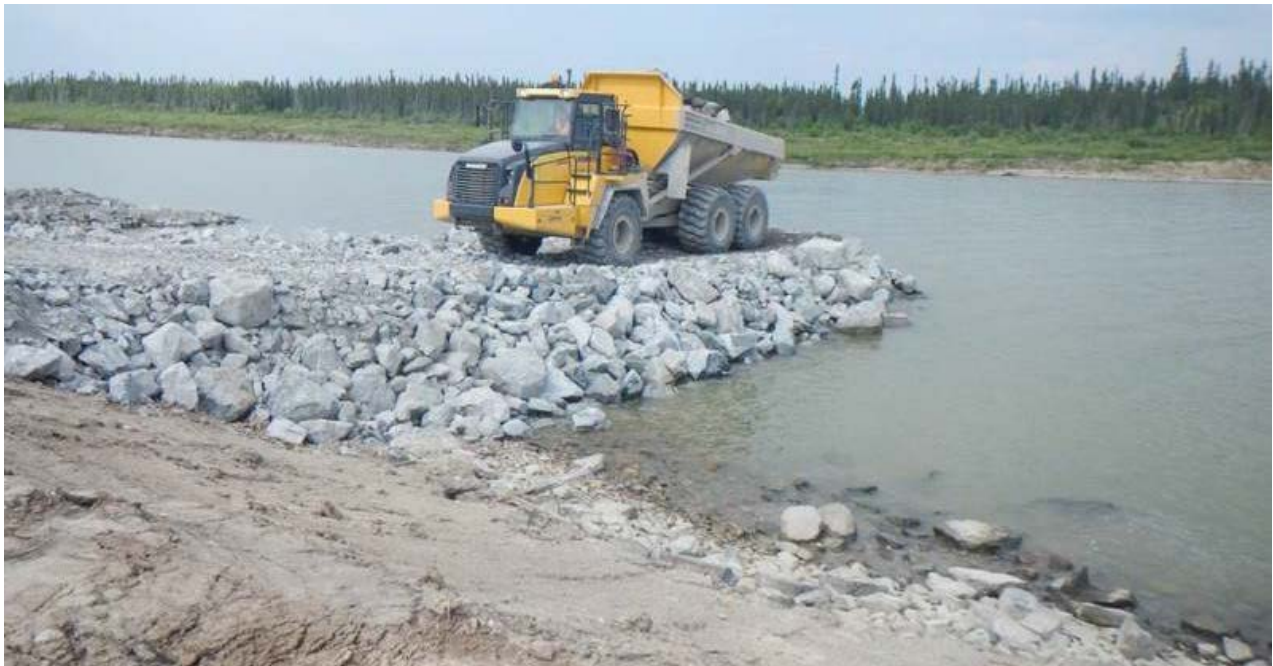
**Figure 27:** A haul truck delivers large class rock to extend the wave break groin on July 27, 2018

In summer 2018, a permanent, downstream boat launch was constructed. Work began on July 20, 2018 when rockfill was placed in the river to create a wave break groin (Figure 27). While this occurred, an excavator shaped the riverbank for the ramp and large rock was placed along the shoreline for future erosion protection. Beginning on August 4, a concrete base was placed to construct the boat launch, but needed to be realigned afterwards, which slowed construction and the boat launch wasn't complete until August 15 (Figure 28). Erosion protection and additional rock placement on the wave break continued until August 18, 2018.

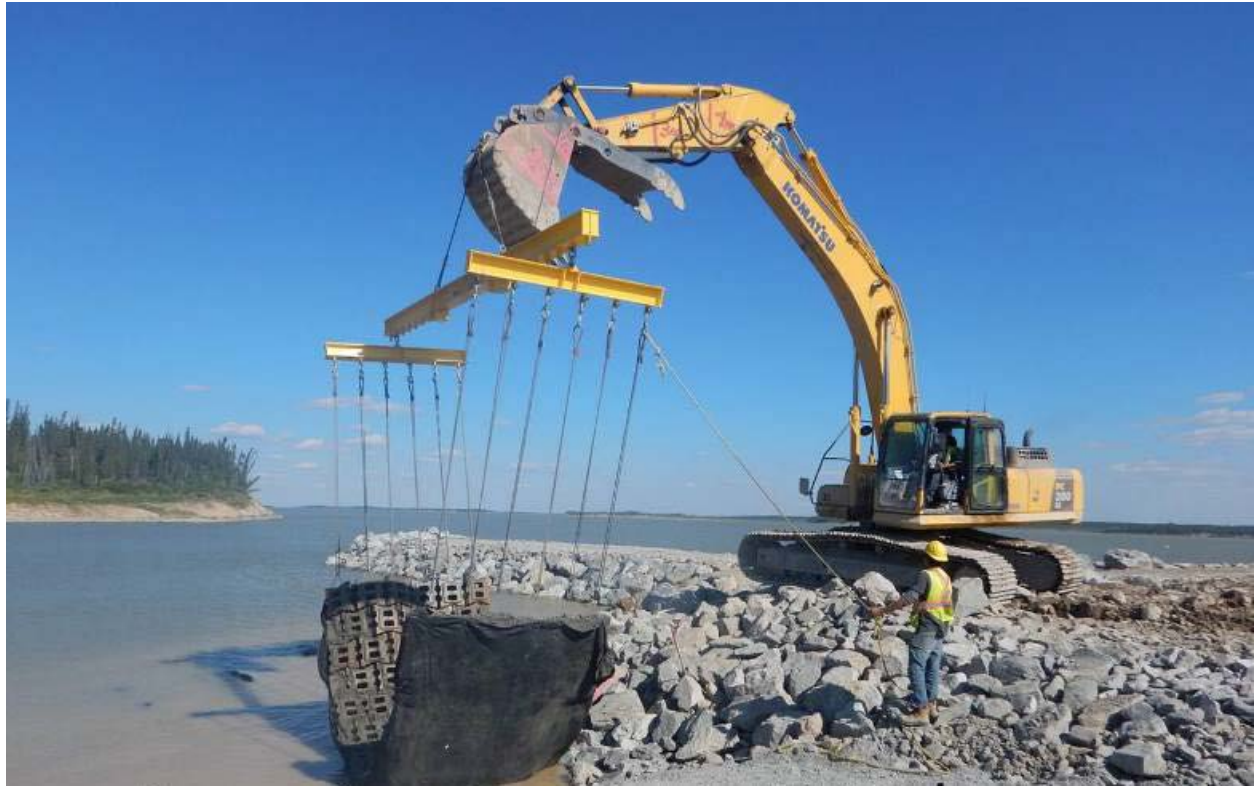
**Figure 28: An excavator removes the concrete “mattress” to adjust the alignment on August 10, 2018**
