## Keeyask Generation Project Sediment Management Plan for In-stream Construction

## **SEDIMENT MANAGEMENT PLAN FOR IN-STREAM CONSTRUCTION**

REPORT #SMP-2019-01

**April 2018 – March 2019: Year 5 Construction**

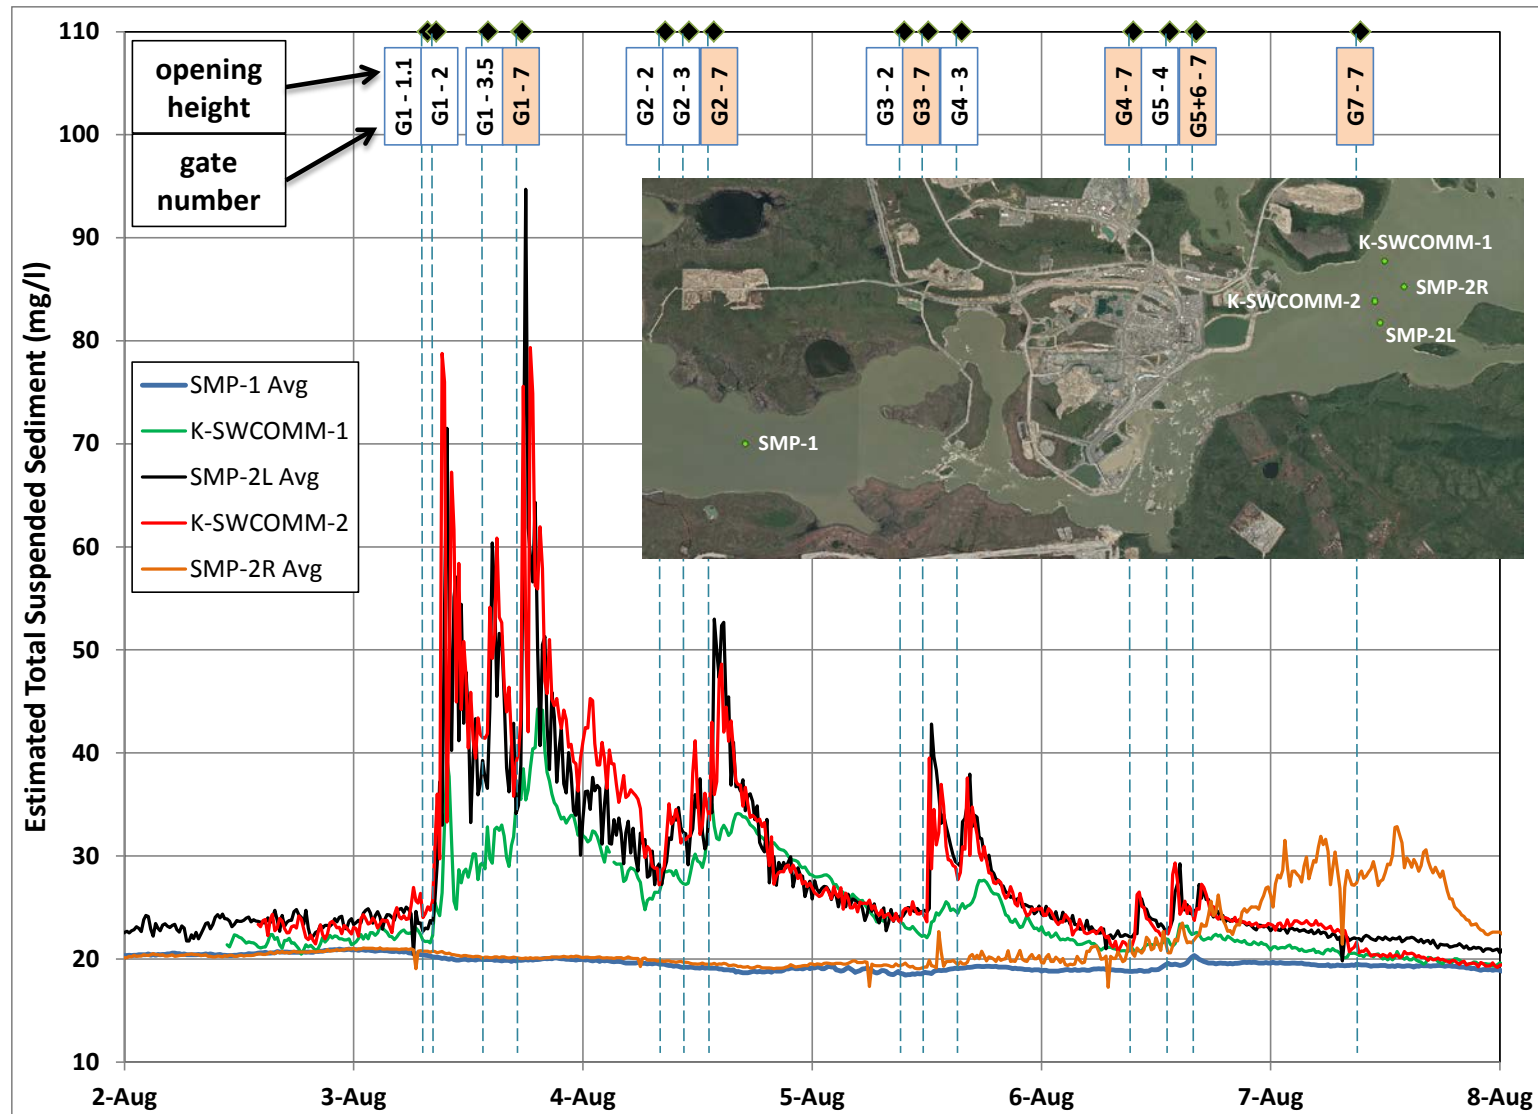
Figure 34: Estimated TSS Concentration during Spillway Commissioning

At SMP-2L and K-SWCOMM-1, the first TSS peaks were respectively about 72 mg/l and 78 mg/l, or about 52-58 mg/l above background, after opening the gate first to 1.1 m and then to 2 m an hour later (Figure 34). The next opening to 3.5 m occurred about 5 hours later, after TSS levels had dropped to about 35-40 mg/l (15-20 mg/l above background) and produced a smaller peak increase to about 60 mg/l (40 mg/l above background). Because observed effects were lower than predicted, the next incremental gate opening was larger at about 3.5 m, raising Gate 1 out of the water. This resulted in the largest effect with peak estimated TSS of about 80 mg/l and 95 mg/l (60-75 mg/l above background) at K-SWCOMM-1 and SMP-2L, respectively. Gate 2 was raised in three increments: first rising to 2 m open, then rising another meter to 3 m open 2.5 hours later, and three hours later it was raised four meters to the fully open position (i.e., 7 m opening). The first two increments produce smaller TSS peaks of about 30-40 mg/l (10-20 mg/l above background), while the large increase to fully open it produced a larger peak TSS of about 50 mg/l (30 mg/l above background). Gates 3 and 4 were opened in larger increments on the third day, but the effects were more diminished, where the TSS peaks of about 38-43 mg/l (18-23 mg/l above background). On the fourth day, gates 4, 5, and 6 were all fully opened, with gate 5 being raised from 3 m open to fully open in one movement while gate 6 was fully opened

The detailed analysis of potential commissioning effects indicated peak increases of about 250-300 mg/l above background might occur near SMP-2L (Figure 33). Observed effects of the Spillway on sediment (Figure 34) showed peak TSS increases that were much lower than predicted, with the largest increase estimated at about 75 mg/l above background. Observed effects did indicate the expected diminishing effects on TSS as commissioning progressed and as a result, the gates could be opened more rapidly as more were opened. Because the effects observed during commissioning were smaller than had been predicted, the gates were all raised to their fully open position in fewer incremental steps than had been assumed in the commissioning model; however, in both situations, the gates were over a period of four days. The smaller effects observed during commissioning, when compared to the detailed model, suggest the model was overly conservative in its estimate of how much remnant material would be left in the approach and discharge channels, as well as from cofferdam removal.
