Keeyask Generation Project
Terrestrial Effects Monitoring Plan

Wetland Loss and Disturbance Monitoring Report

TEMP-2019-03

June 2019

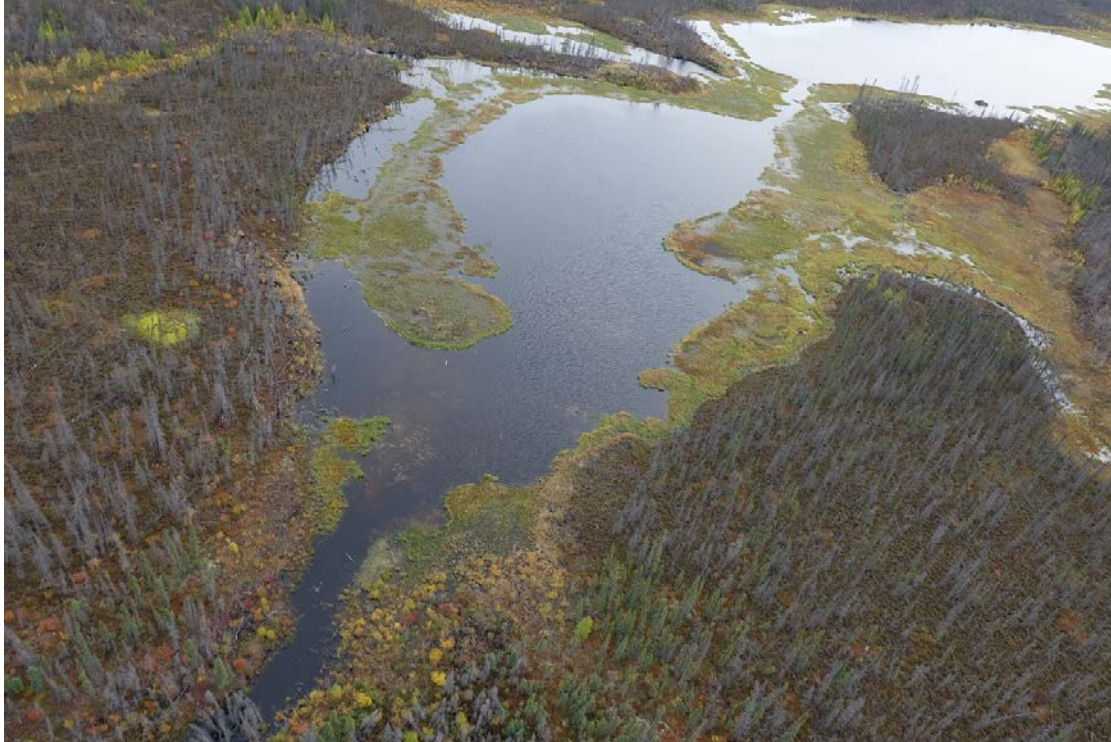
Wetland 3 (September 16)

Figure 3-1: Aerial views of Wetlands 3 and 17 on September 16, 2018

Wetland 3 (Figure 3-1) is 5.0 ha in size (Table 3-1), and located about 1 km from the Nelson River, approximately 21 km west of the generating station site (Map 2-2). This wetland has a direct surface water connection to the Nelson River through a lake and then a short stream. Marsh habitat comprised 1.1 ha of the wetland's total area. The 2013 wildfire (see Section 2.0) burned approximately 90% of the marsh habitat buffer (*i.e.*, a 100 m buffer of the marsh habitat) included in Wetland 3.

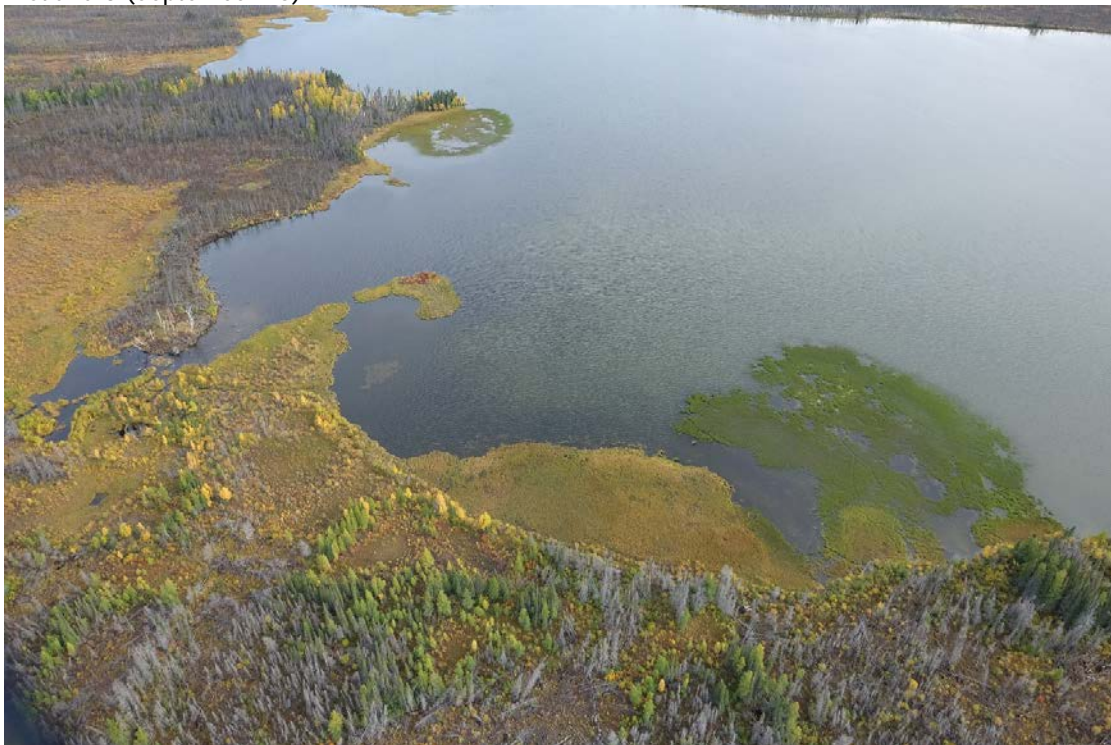
Wetland 17 (September 16)

Wetland 17 (Figure 3-1) is 135.1 ha in size and located on the southwest shore of a small lake located near the kilometer 6 point of the north access road (NAR). Marsh habitat comprised 97.5 ha of the wetland's total area. Approximately 85% of the marsh habitat buffer burned in the 2013 wildfire.

Project disturbance or clearing had not been observed within Wetland 17 up to the time of the 2018 surveys (Map 3-1). Ground surveys conducted from 2015 to 2017 found no incremental changes in the condition of the wetland. Ground surveys were not conducted in 2018 as the aerial surveys found no new clearing or activity nearby. Details about conditions observed in Wetland 17 in previous survey years are provided in ECOSTEM (2018b).

Future surveys will continue to monitor these locations.

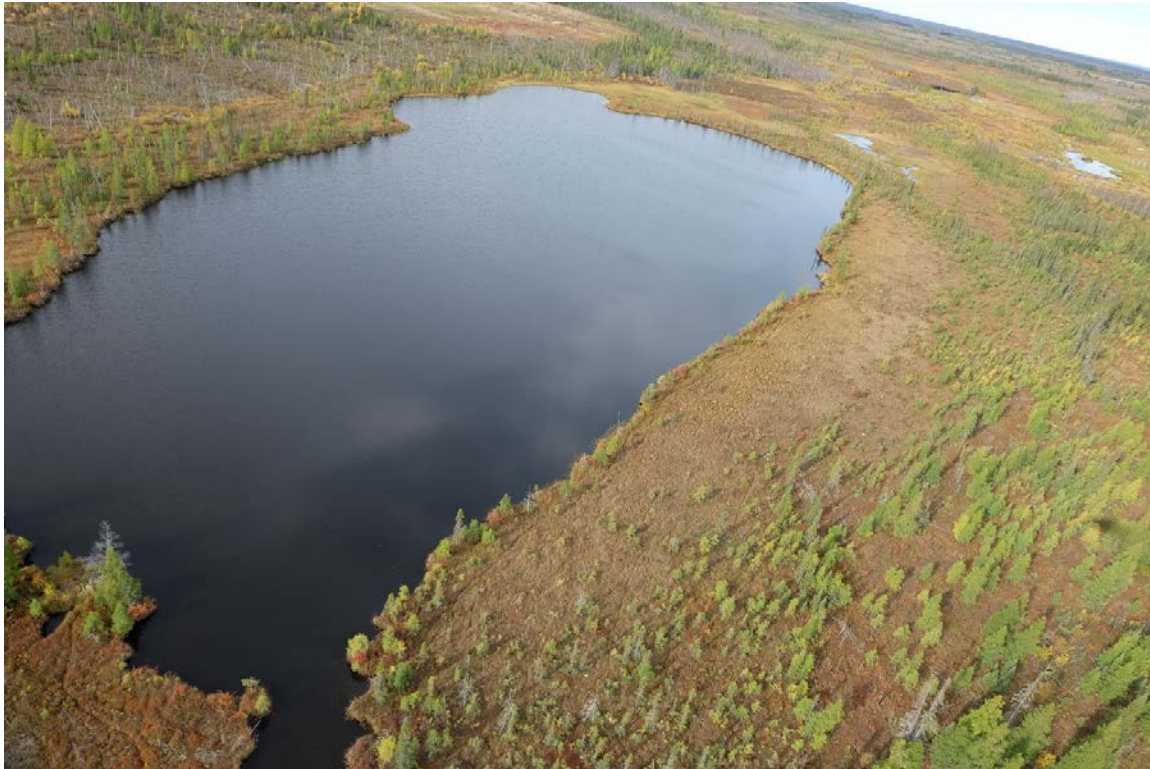
Figure 3-2: Aerial views of Wetlands 37 and 40 on September 16, 2018

Wetland 37 (Figure 3-2) is 17.0 ha in size, and located near the north dyke, adjacent to EMPA D3-E (Map 3-1). Marsh habitat comprised 4.1 ha of the wetland's total area. Approximately 5% of the marsh habitat buffer burned in the 2013 wildfire.

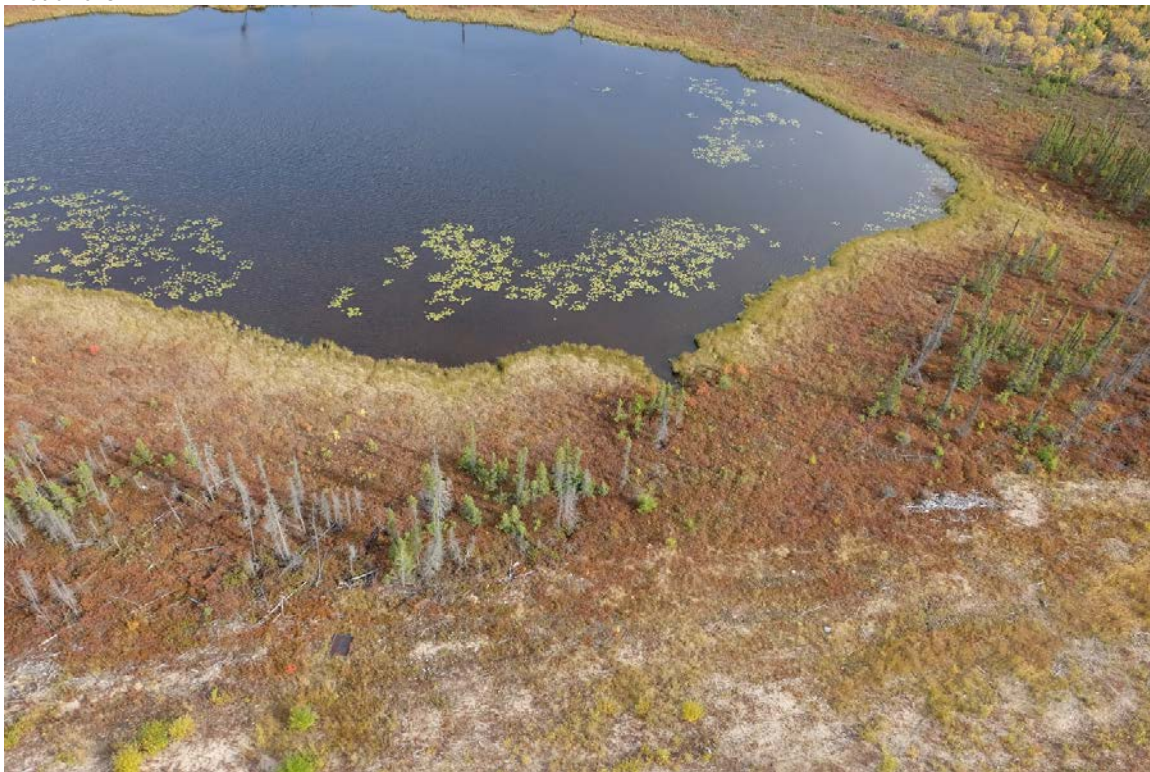
Wetland 40 (Figure 3-2) is 7.9 ha in size, and located along the north dyke, approximately 750 m east of Wetland 37 (Map 2-2). Marsh habitat (Figure 3-11) comprised 1.2 ha of the wetland's total area. Approximately 10% of the marsh habitat buffer burned in the 2013 wildfire.

This report makes two recommendations for Wetlands 40 and 45. Site staff should continue to evaluate and implement sediment control measures where needed to prevent sediment and other runoff from entering the marsh habitat. Additionally, it is recommended that an expansion of the existing clearing (see Figure 3-2 and Figure 3-15) be avoided or minimized, if possible, to minimize additional impacts on these wetlands. In 2017, it was recommended that a silt fence be installed between the dyke clearing and Wetlands 40 and 45. A silt fence was installed at Wetland 45, and there was no evidence of runoff depositing silt at Wetland 45. Based on the 2018 surveys, a silt fence no longer appears to be needed for Wetland 40. There has been limited recent construction activity near both wetlands, and revegetation of the dyke bank adjacent to the wetlands is ongoing. Silt fences should be considered if the slope of the dyke bank needs to be increased in the future.

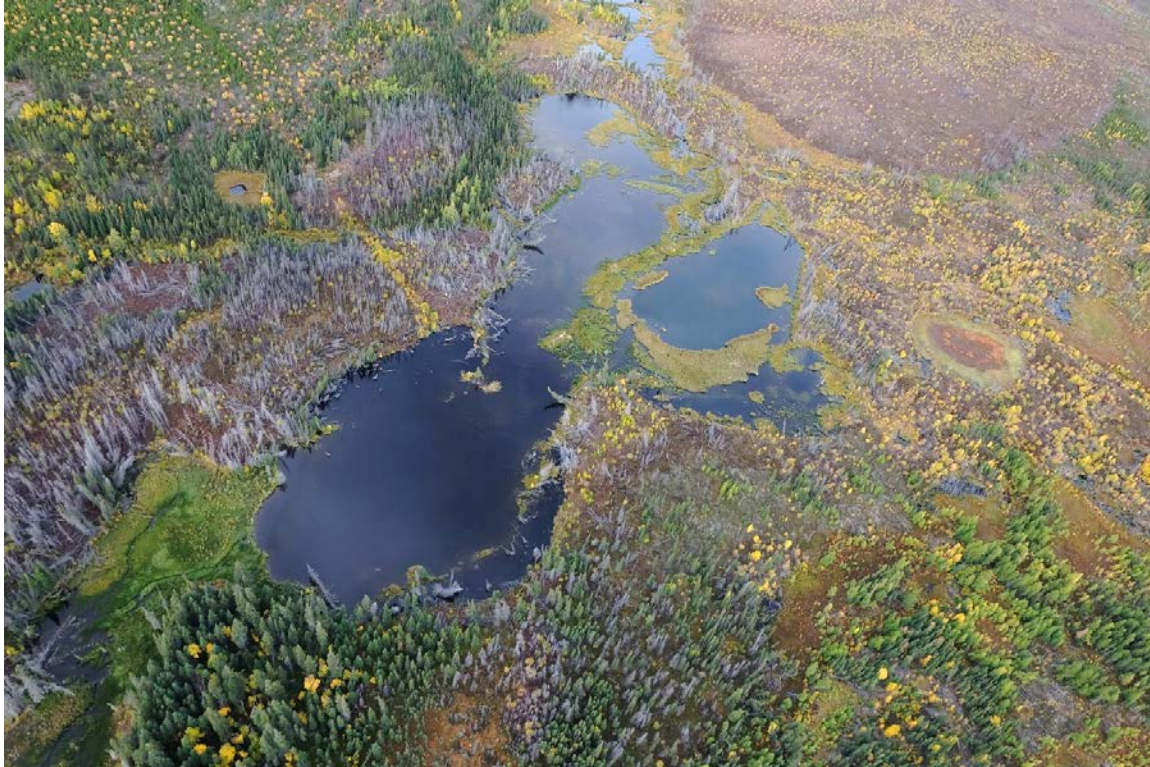
Figure 3-3: Aerial views of Wetlands 42 and 45 on September 16, 2018

Wetland 42 (Figure 3-3) is 15.5 ha in size, and located approximately 750 m north of the NAR at kilometer 14, at the northwestern end of Borrow Area KM15 (Map 2-2). Marsh habitat comprised 2.9 ha of the wetland's total area (Figure 3-13). Approximately 50% of the marsh habitat buffer burned in the 2013 wildfire.

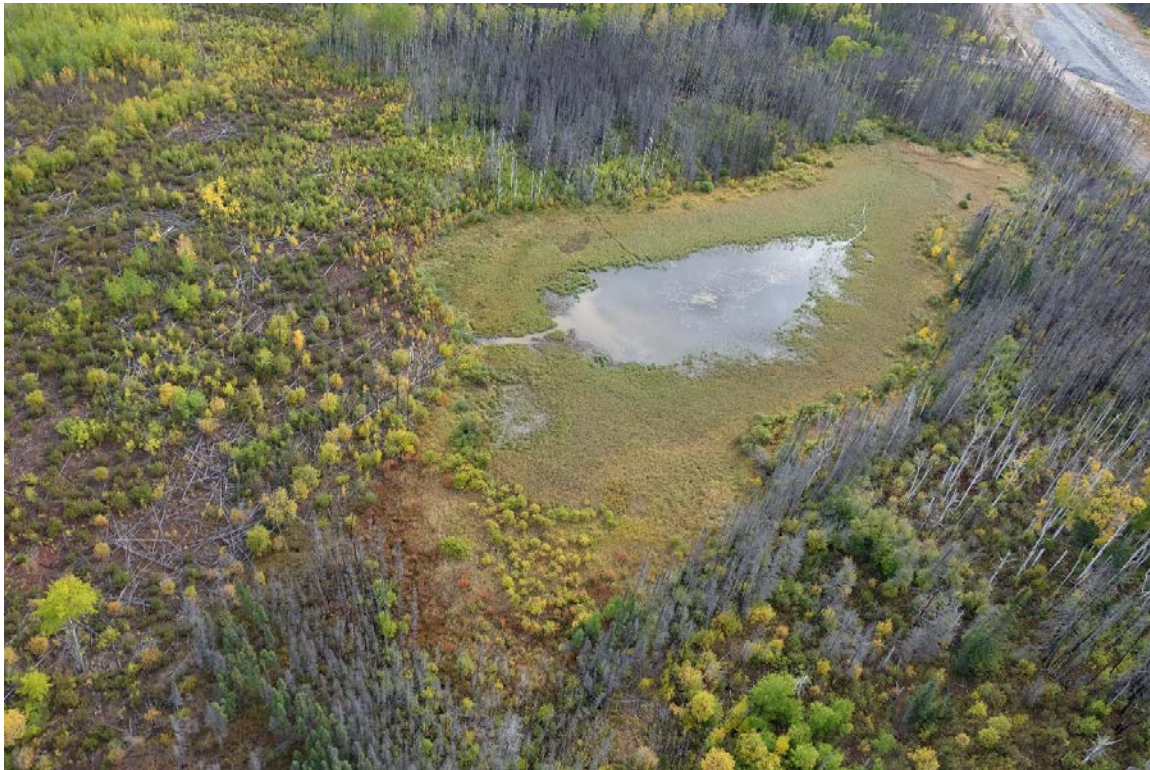
Wetland 45 (Figure 3-3) is 7.3 ha in size, and located along the north dyke, approximately 1.5 km east of Wetland 40 (Map 2-2). Marsh habitat comprised 0.8 ha of the wetland's total area. Approximately 50% of the marsh habitat buffer burned in the 2013 wildfire. Some of the burned area was between the planned north dyke and the marsh habitat, and some sites within this area had either a thin layer of organic matter or exposed mineral substrate.

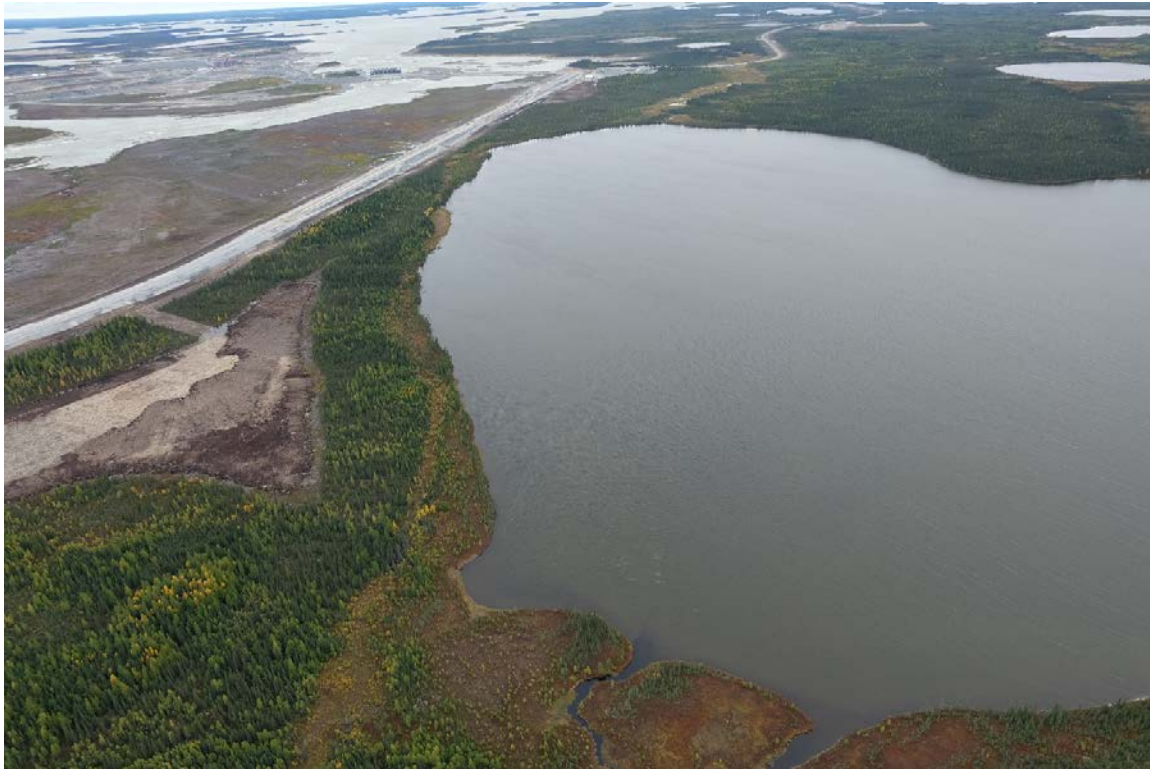
Figure 3-4: Aerial views of Wetlands 47 and 51 on September 16, 2018

Wetland 47 (Figure 3-4; Figure 3-17) is 189.1 ha in size, and located approximately 100 m southeast of EMPA D27(4)-E (Map 2-2). Marsh habitat comprised 140.1 ha of the wetland's total area. None of the marsh habitat buffer burned in the 2013 wildfire.

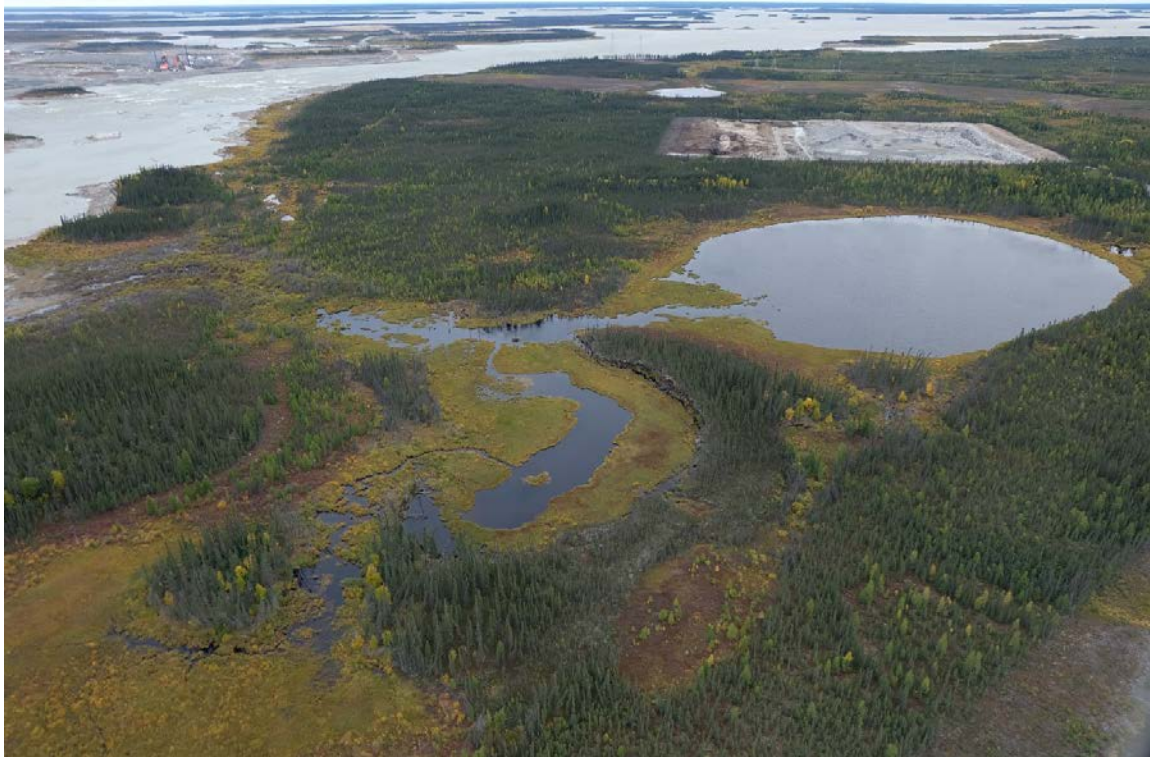
Wetland 52 (September 16, 2018)

Figure 3-5: Aerial views of buffers in Wetlands 52 and 53

Wetland 52 (Figure 3-5) is 28.4 ha in size and located south of Gull Rapids (Map 2-2). Marsh habitat comprised 9.1 ha of the wetland's total area. None of this wetland's buffer was burned in the 2013 wildfire.

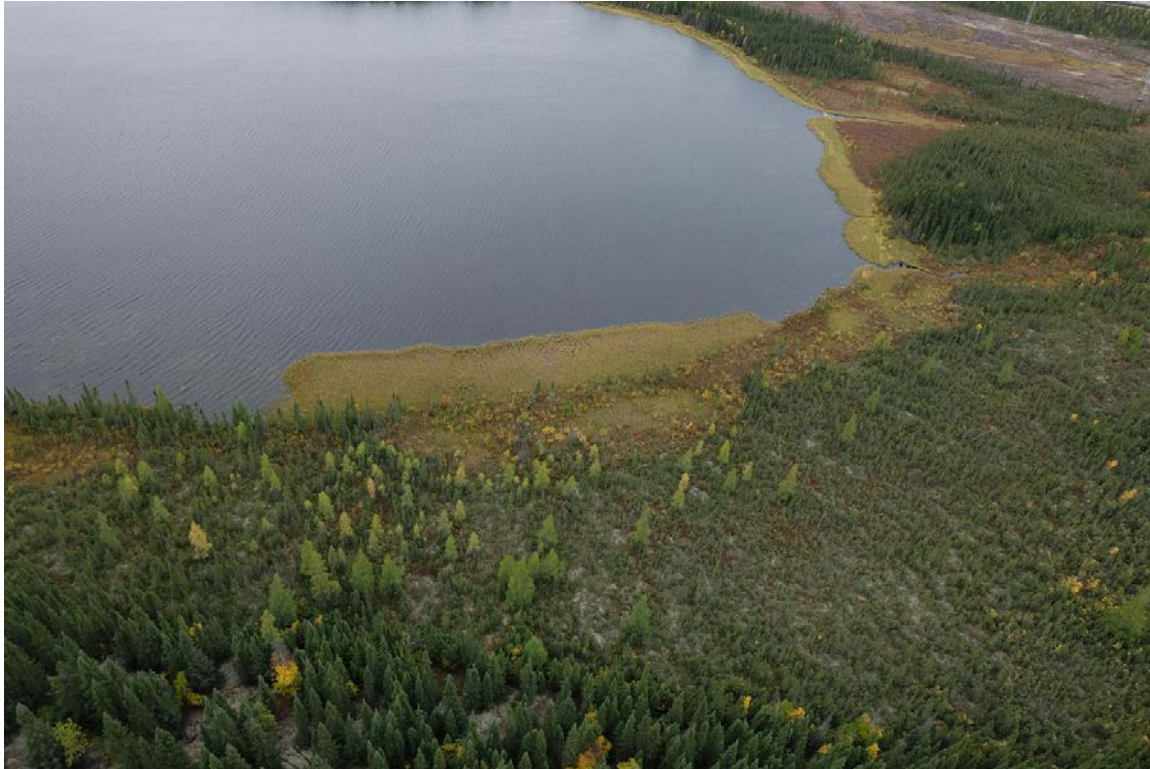
Wetland 54 (west end)

Figure 3-6: Aerial views of Wetlands 54 and 57 on September 16, 2018

Wetland 54 (Figure 3-6) is 113.1 ha in size, and located along the north side of the SAR, north of Borrow Area S-2b (Map 2-2). Marsh habitat comprised 70.1 ha of the wetland's total area. None of the marsh habitat buffer burned in the 2013 wildfire.

Surveys in 2015 and 2016 found clearing and disturbance in the marsh habitat buffer, but this was for the Keeyask Transmission Project ROW. Ground surveys in 2016 and 2017, and aerial surveys in 2018 found no expansion of the impacts recorded in 2015 and 2016. The relatively dense existing low vegetation in the cleared areas within 100 m of the marsh should be adequate to stabilize soils and facilitate revegetation. Specific observations regarding the impacts observed in 2015 and 2016 are provided in ECOSTEM (2018b).

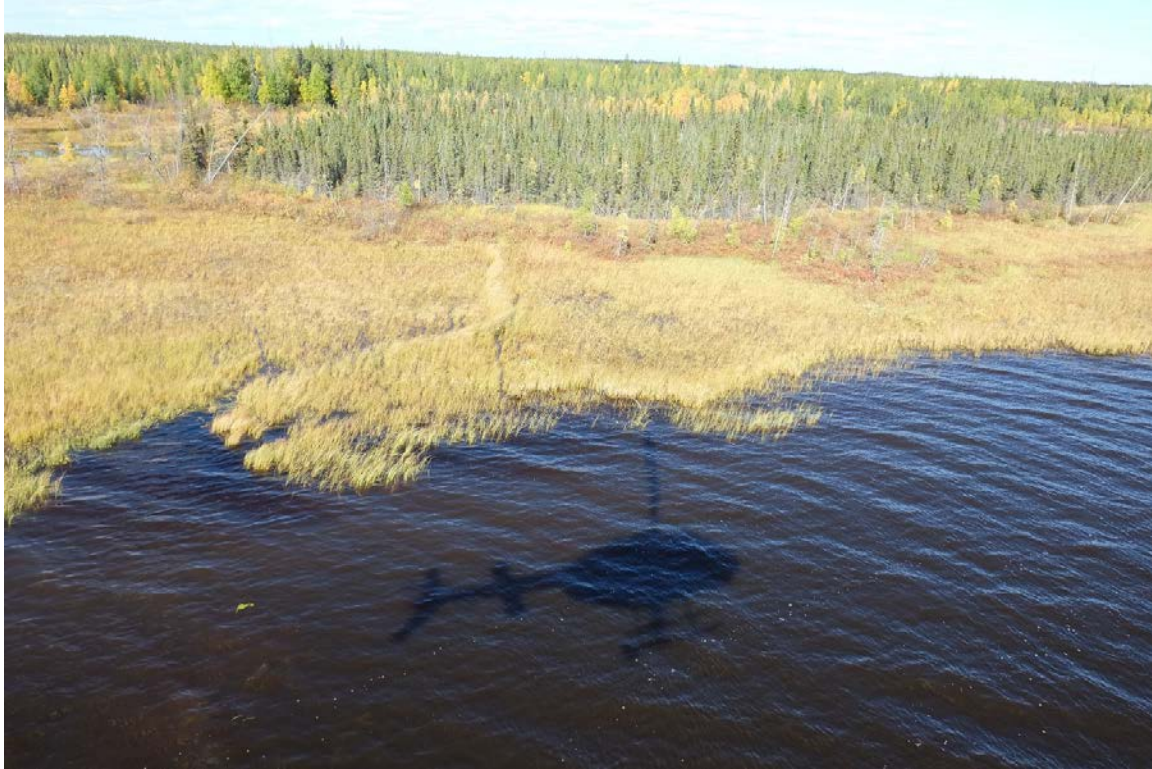
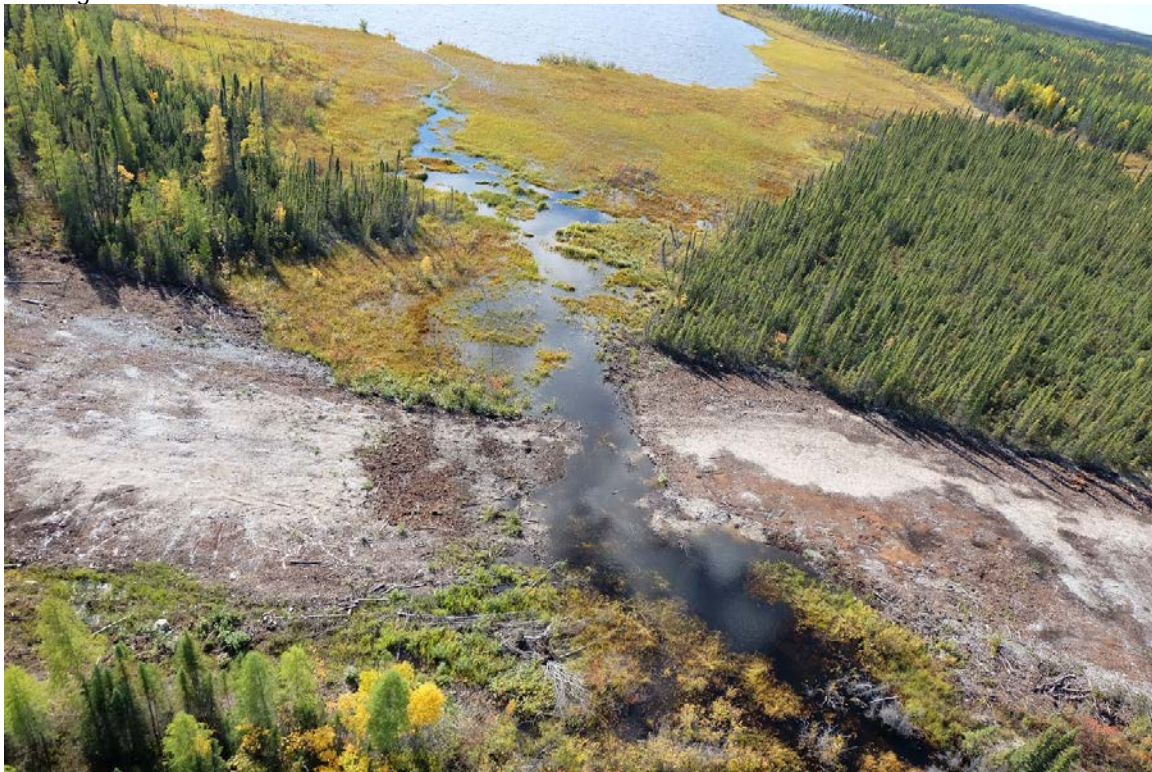
Looking east

Looking west from Ellis Esker access road clearing

Figure 3-7: Aerial views of Wetland 60 on September 16, 2018

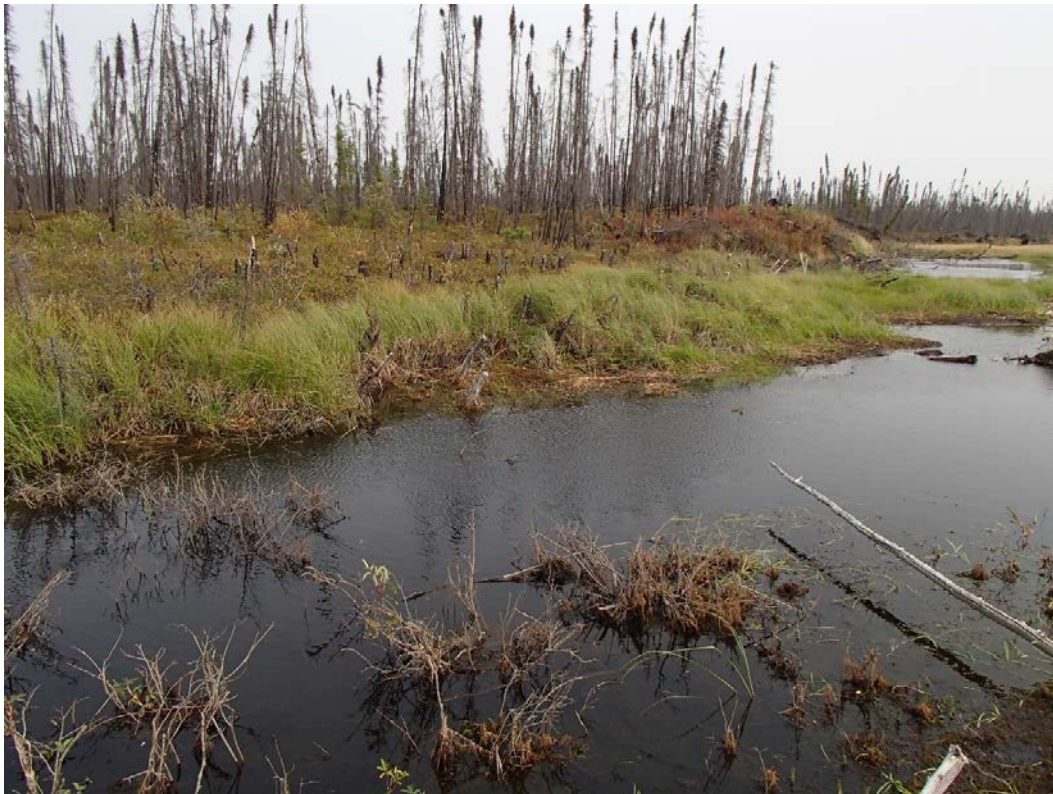
Approximately 0.26 ha of the cleared area was in the marsh habitat buffer and 0.10 ha was in the marsh habitat (Table 3-1). Cleared trees were visible where collapsed or collapsing peatlands outside of the planned Project footprint had become part of the marsh habitat (Figure 3-8).

Figure 3-8: Cleared trees in Wetland 3 on August 31, 2017

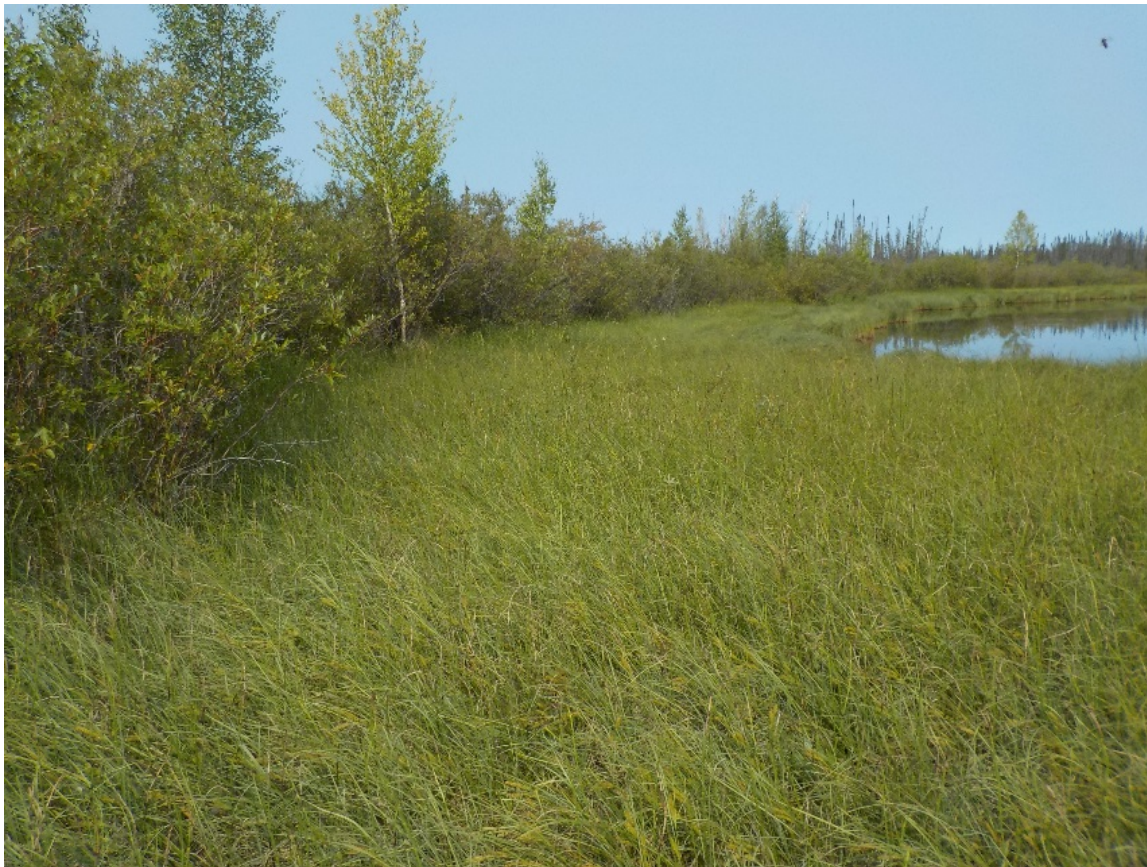
Figure 3-9: Ground photo of Wetland 17 on August 23, 2017

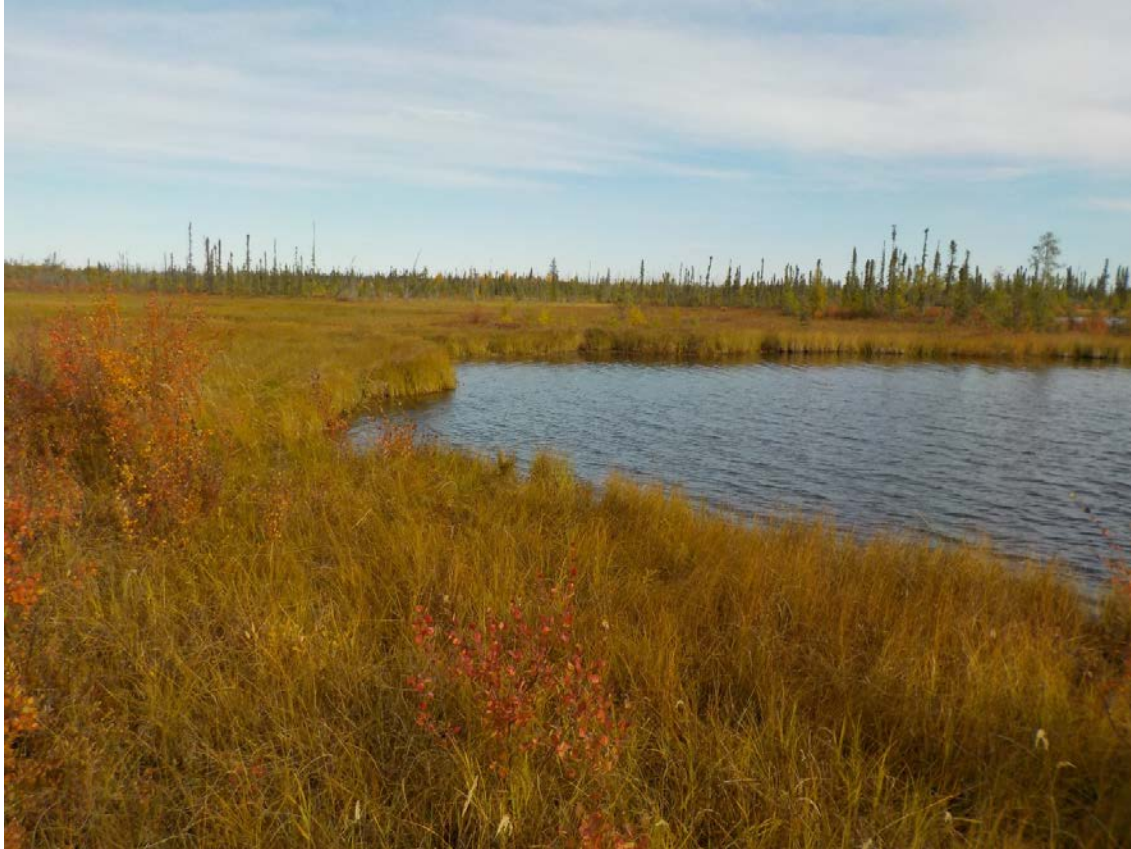
The potential for sediment runoff from the EMPA into the wetland buffer is likely decreasing because the EMPA is becoming increasingly vegetated, which will help stabilize the soil (Figure 3-10).

View along the shores of Wetland 37 (September 16)

Aerial view of Wetland 37 looking northeast with EMPA D3-E in foreground (September 15)

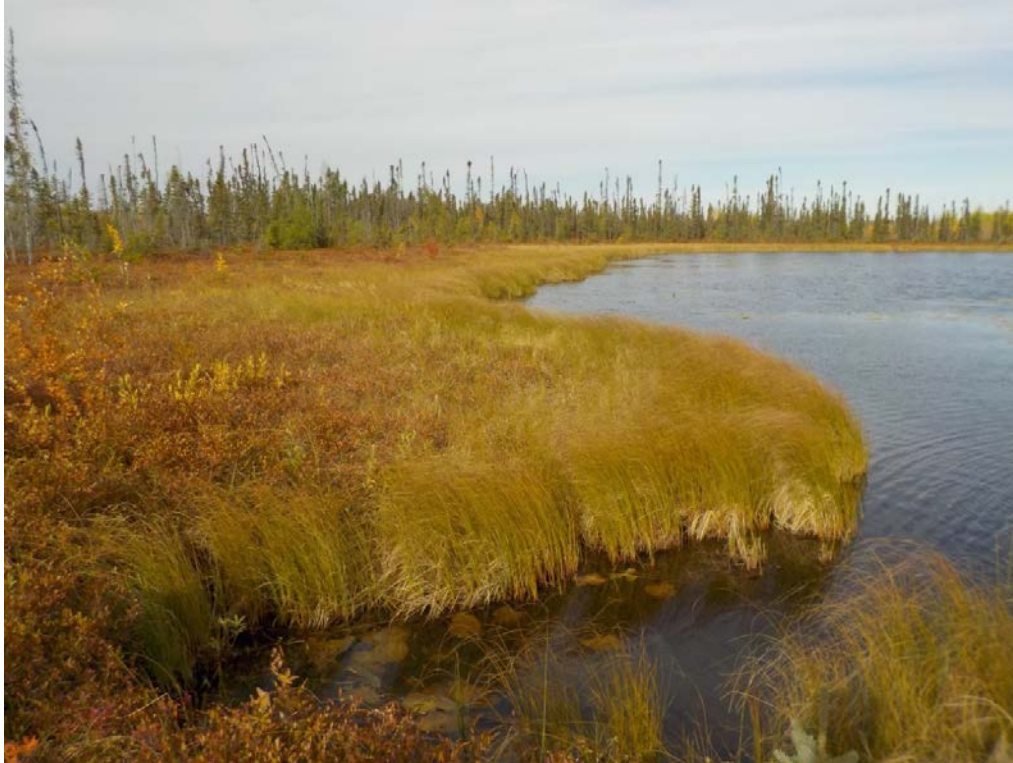
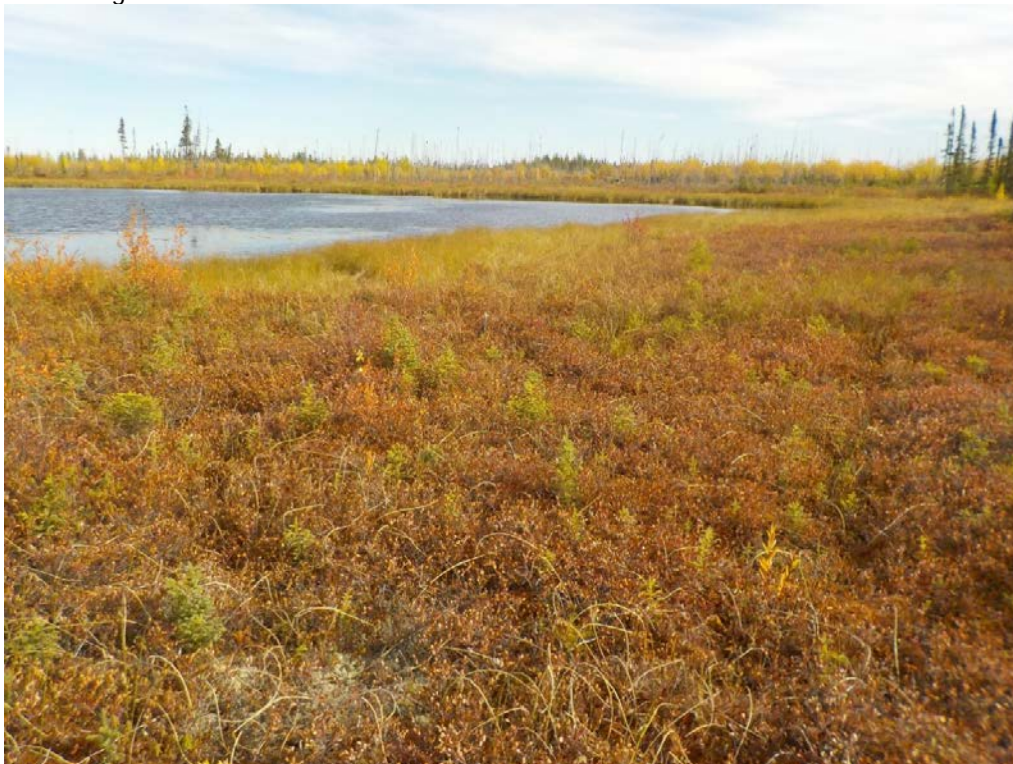
Figure 3-11: Ground photos of Wetland 40 on September 16, 2018

View along the shores of Wetland 40

Regenerating peatland between marsh and dyke clearing

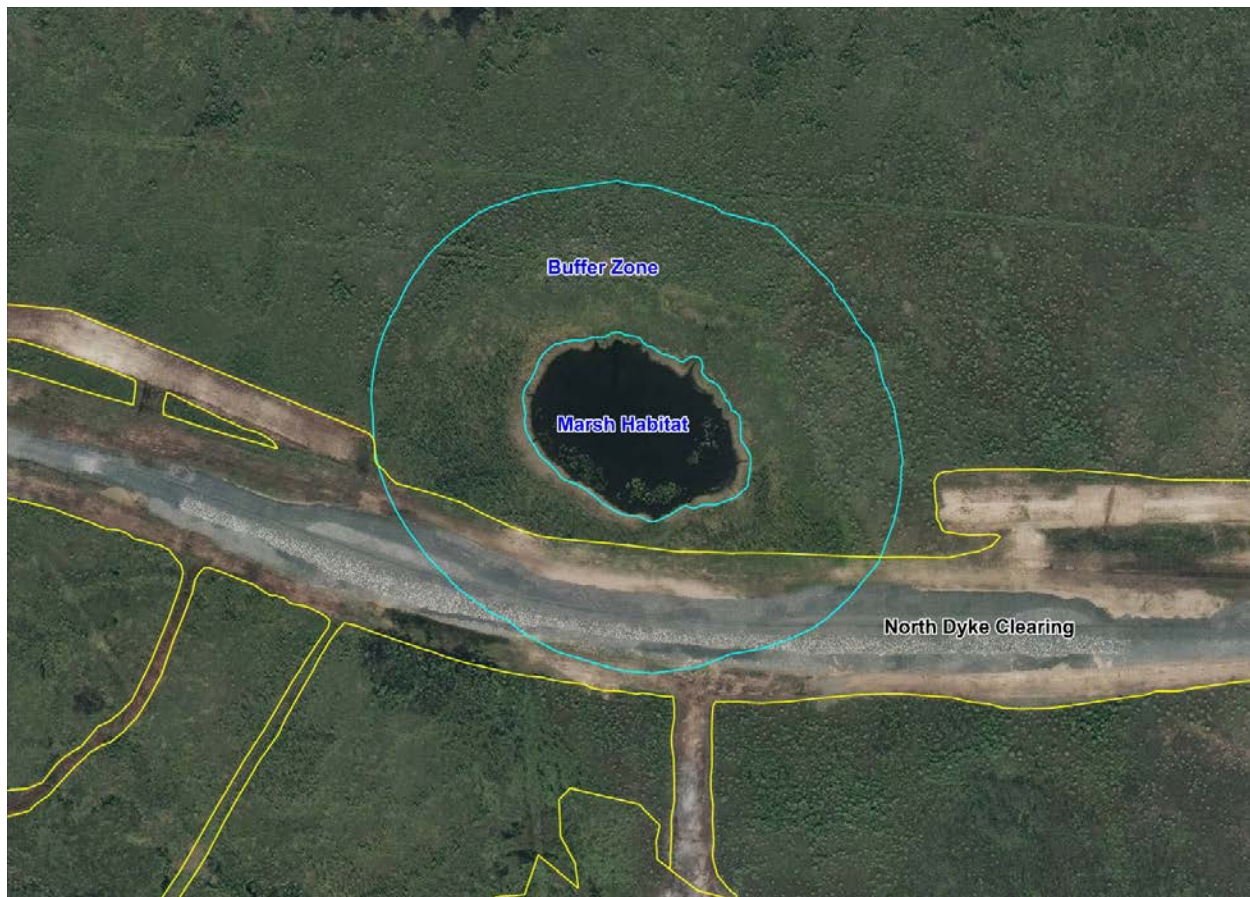
By the time of the 2016 survey, planned Project clearing for the dyke (Map 3-1) had extended through the buffer to approximately 3 m away from the southern portion of the marsh habitat (Figure 3-12). All of this 1.75 ha of clearing was within the planned Project footprint (Table 3-2). By September, 2018, development of the north dyke within the cleared area continued, but no impact to the wetland was observed. It was noted in 2017 that water levels in the marsh habitat at the time of the survey appeared to be lower than the median level based on exposed underwater portions of marsh vegetation. In 2018 water levels appeared to be approximately at the median level.

Figure 3-12: Satellite imagery showing dyke clearing (all within the planned Project footprint) at Wetland 40 in 2018

It was also noted in 2016 that a shallow slope leading from the dyke clearing to the water's edge should be monitored for the potential to transport sediment from the exposed mineral of the dyke into the marsh. In 2017, it was recommended that a silt fence be installed between the dyke clearing and the wetland at the base of the slope. As of September 2018, a fence had not yet been installed.

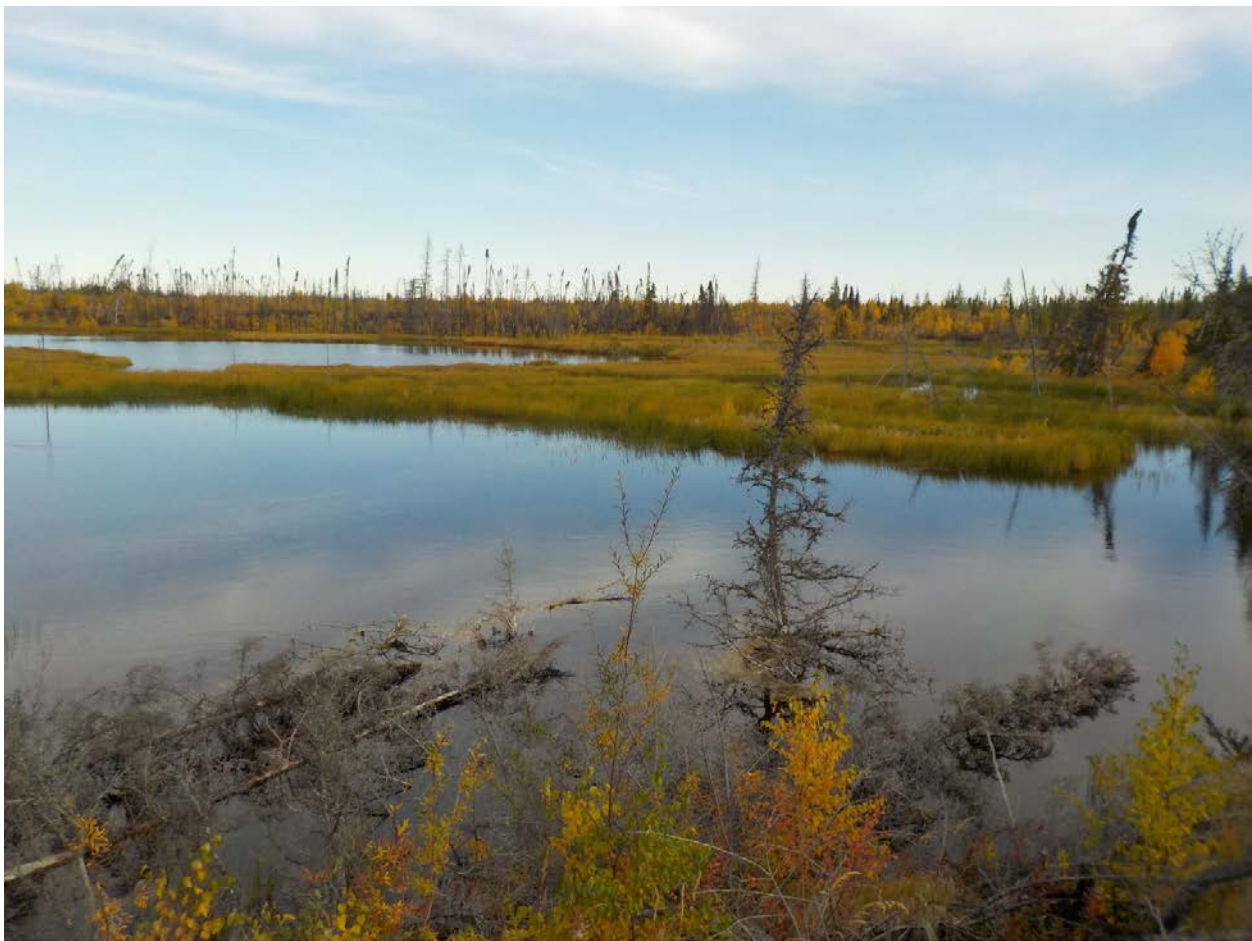
Figure 3-13: Marsh habitat in Wetland 42 on September 16, 2018

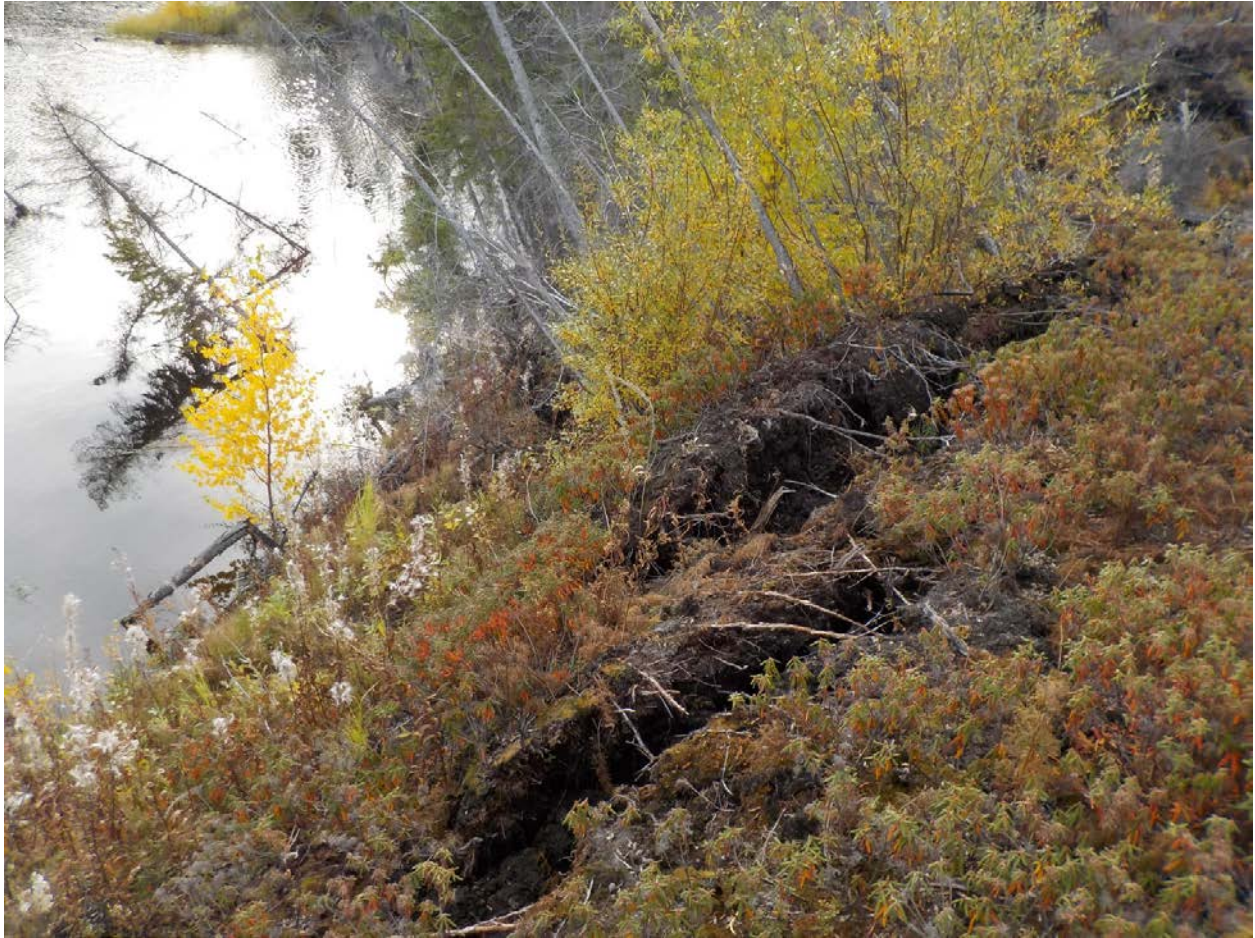
Up to the time of the 2018 surveys, there were no signs of erosion along the slope to the wetland. Also, there were no apparent changes in the undisturbed vegetation between the wetland and the cleared area in G-1, and no new clearing or excavation in the nearby portion of G-1. Ground surveys found that the peat bank at the base of the slope adjacent to the wetland was beginning to slump and break apart (Figure 3-14). This was likely due to melting permafrost in the recently burned peat plateau bog. The band of intact vegetation will continue to be monitored in order to determine if there is any erosion or surface runoff from the slope into the marsh.

Figure 3-14: Slumping peat bank adjacent to Wetland 42 on September 16, 2018

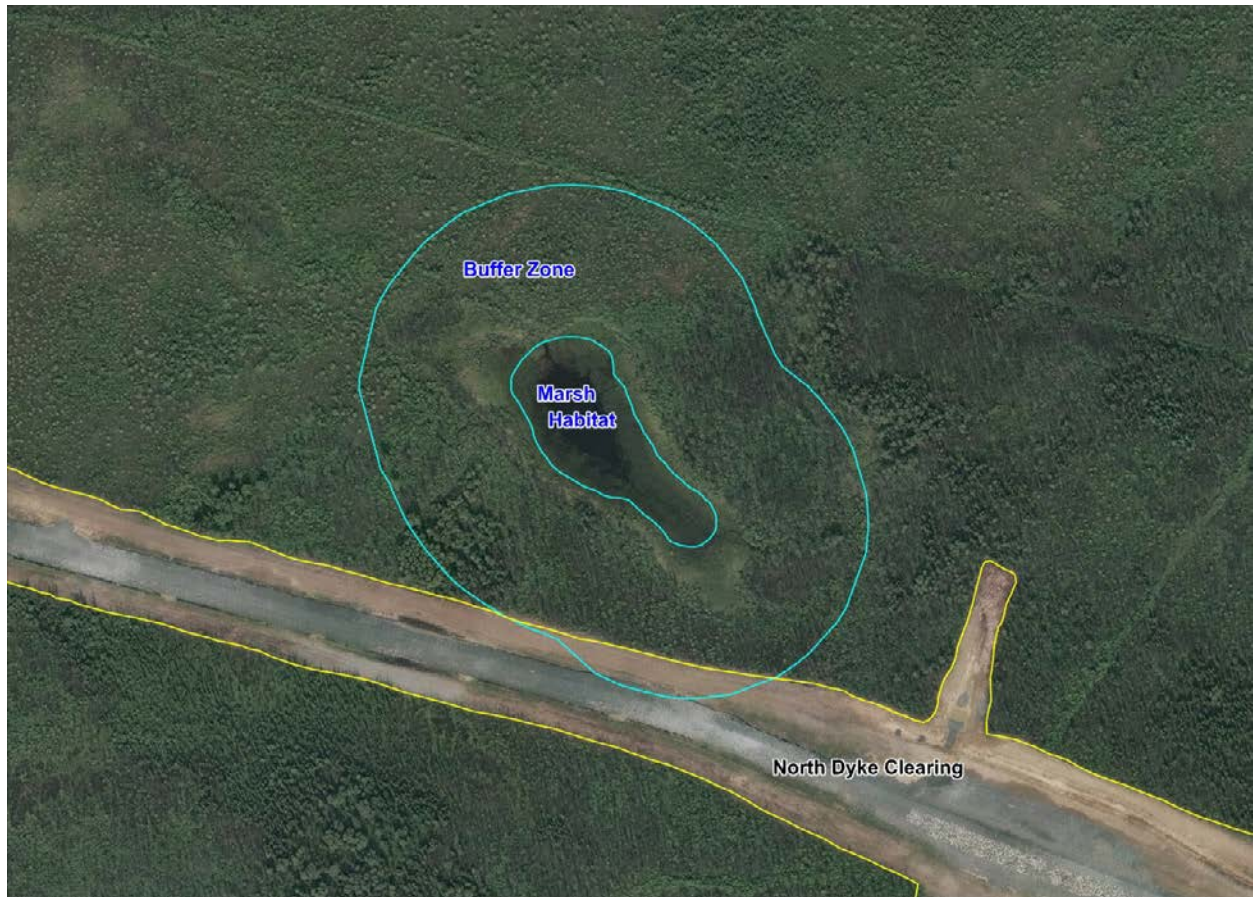
By the time of the 2016 ground survey, north dyke clearing had extended approximately 25 m into the marsh habitat buffer (Figure 3-15 and Figure 3-16; Map 3-1). All of this 0.24 ha of clearing was within the planned Project footprint (Table 3-2) and no other Project impacts were noted at that time. All of the dyke clearing within Wetland 45 was also within the above noted burned area.

Figure 3-15: Satellite imagery showing North Dyke clearing (all within the planned Project footprint) at Wetland 45 in July 2018

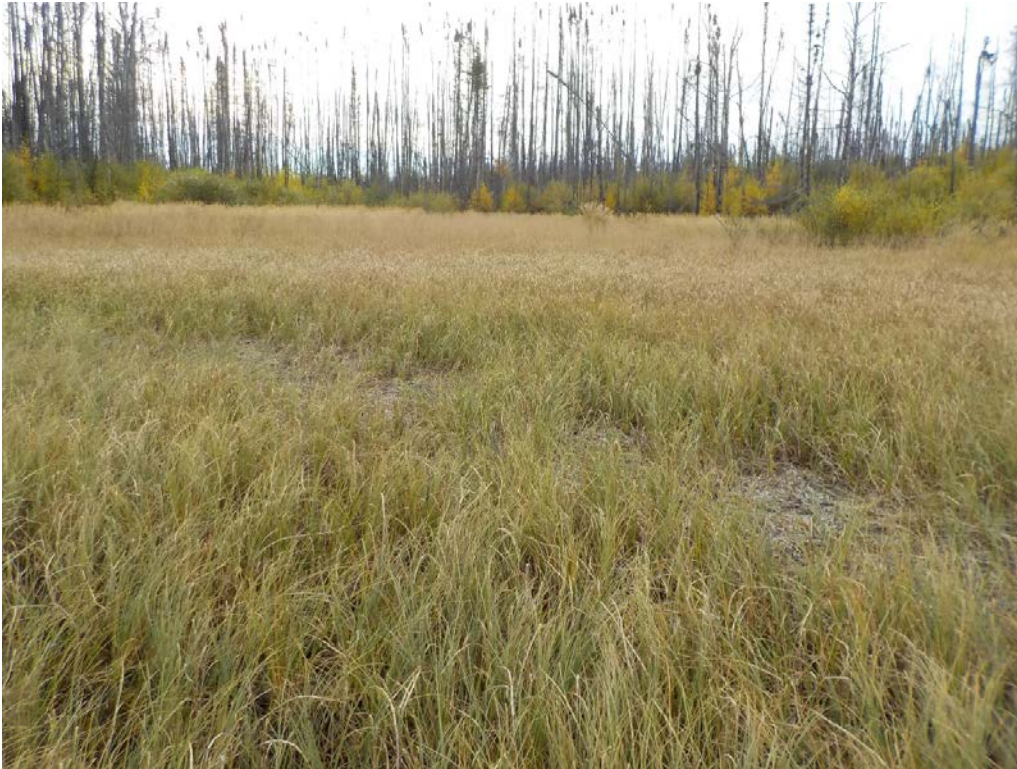
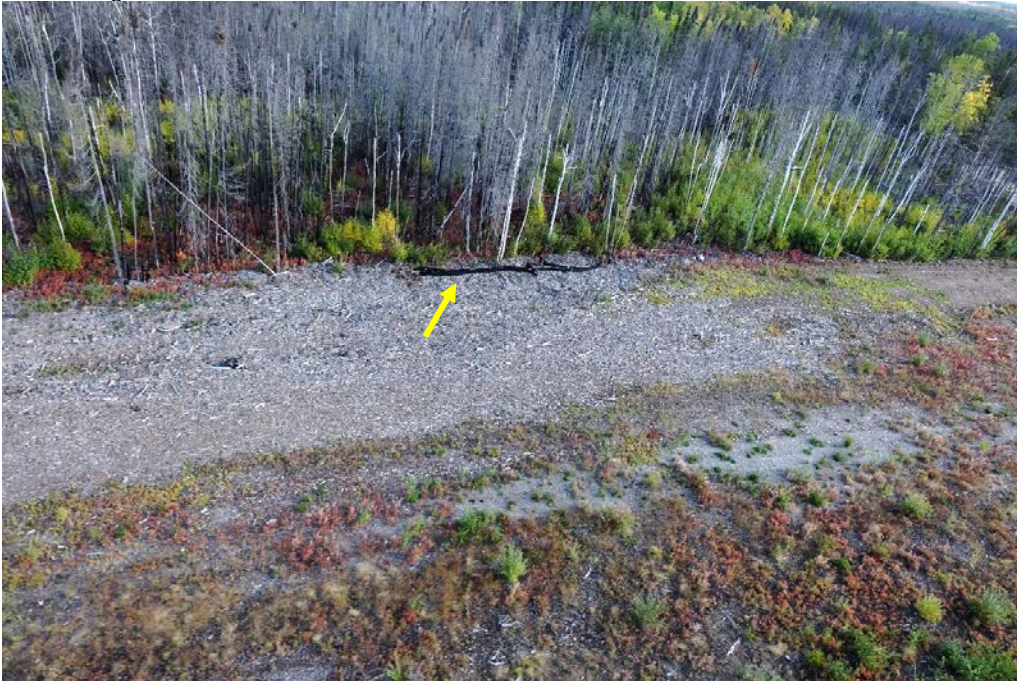
Figure 3-16: Ground and aerial photos of Wetland 45 on September 16, 2018

A 15% slope through the dyke clearing area to the marsh habitat creates the potential for future surface runoff to carry material into the marsh habitat. In addition to the slope containing exposed mineral material in the cleared area (Figure 3-16), the entire slope had been burned with some areas having virtually all vegetation removed. At the time of the 2018 surveys, no runoff or sedimentation was seen entering the marsh habitat. It was noted that there was a small hill between the wetland and the dyke, which may serve as a natural barrier to potential future runoff. In 2017, it was recommended that a silt fence be installed at the base of the dyke as a preventative measure. A short segment of fence was installed at one location following a recommendation that site staff evaluate and implement sediment control measures such as silt fence where needed (Figure 3-16). These areas will continue to be monitored for potential runoff effects.

View along the shore of Wetland 45

Silt fence installed at bottom of North Dyke slope near Wetland 45
