Keeyask Generation Project
Terrestrial Effects Monitoring Plan

Wetland Loss and Disturbance Monitoring Report

TEMP-2019-03

June 2019

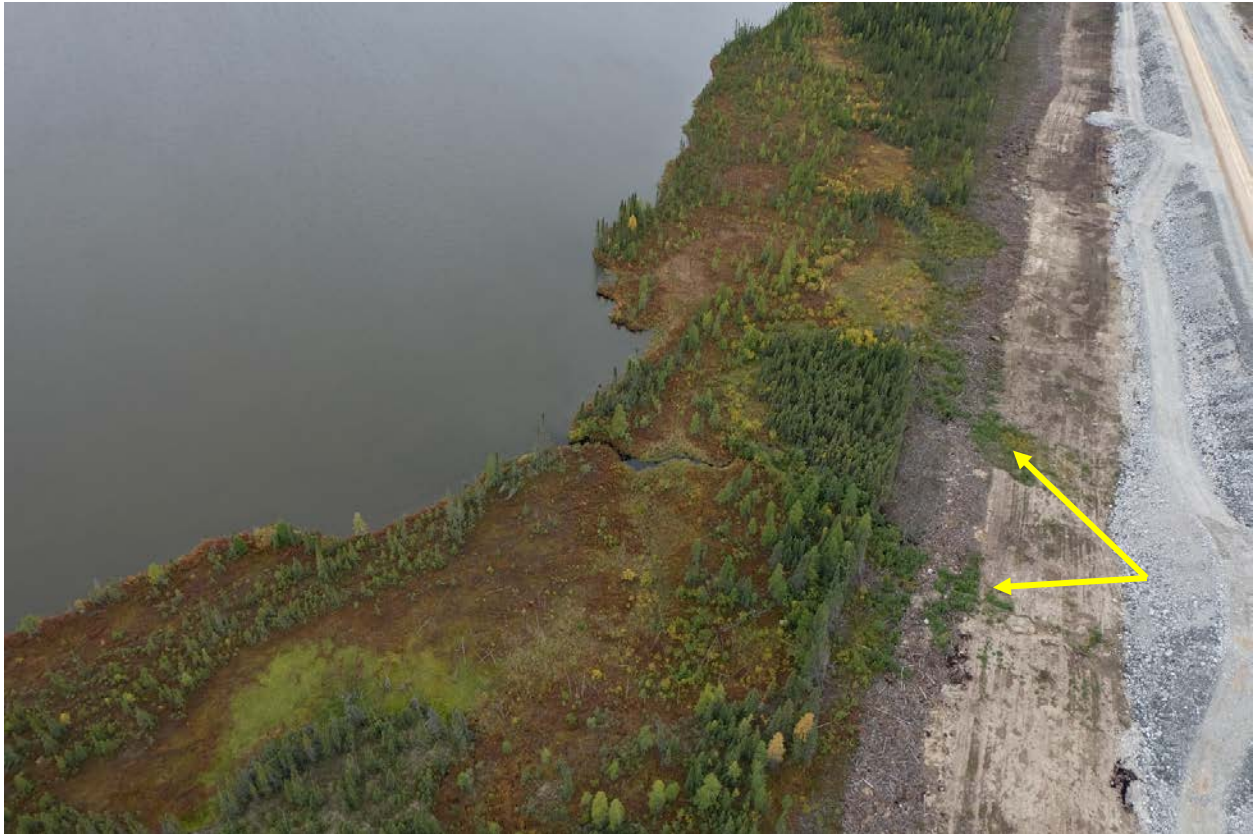
While no further clearing had occurred by September 2018, the South Dyke was under construction near the wetland. Ground surveys were not conducted in 2018 due to heavy construction activity nearby. Aerial surveys found no apparent effects in the marsh habitat due to runoff from the dyke clearing and infrastructure (Figure 3-17).

Figure 3-17: View along the Wetland 47 shore on September 16, 2018. Yellow arrows indicate drainage channels identified in 2017

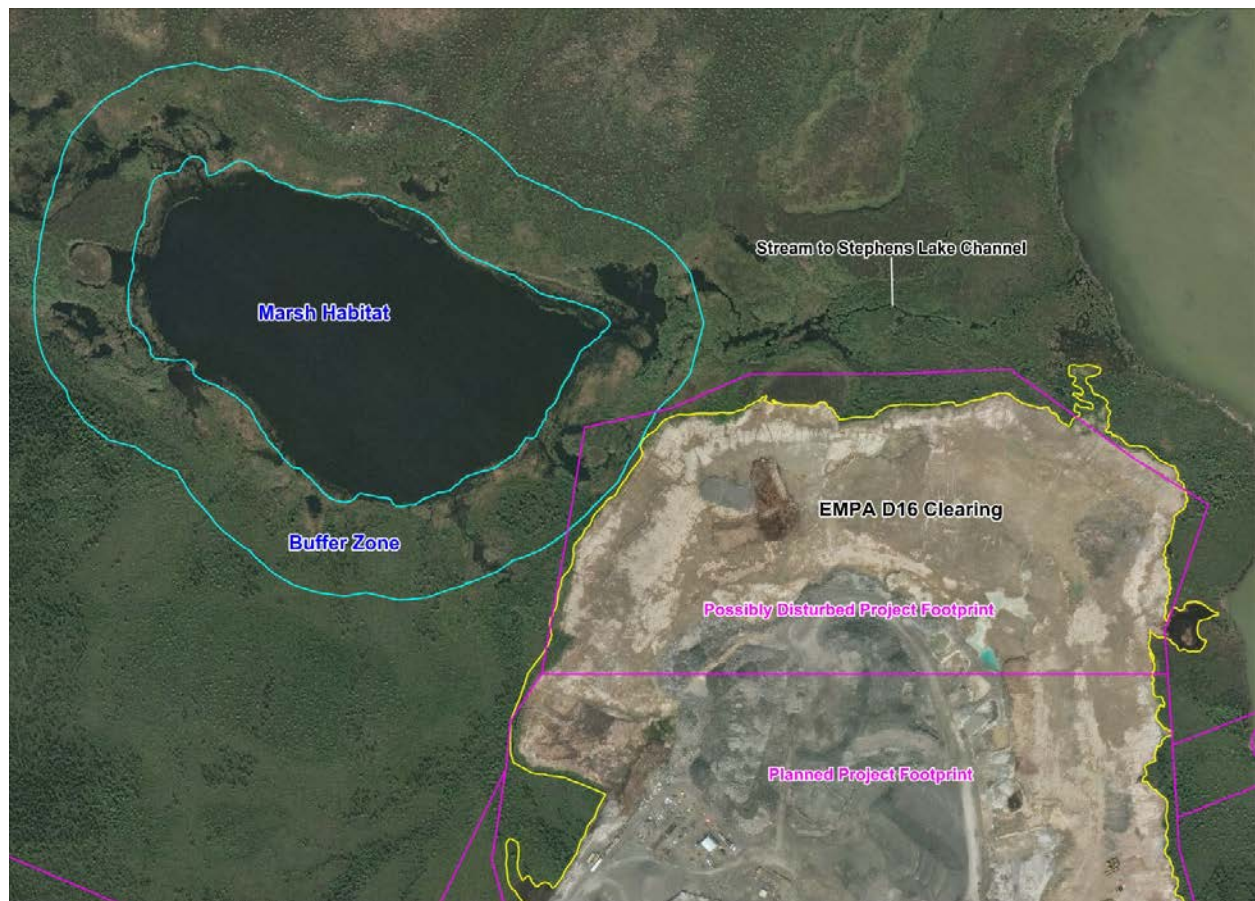
Figure 3-18: Wetland 51 in 2018 satellite imagery showing adjacent EMPA, stream to Stephens Lake channel, 2018 Project clearing (yellow line), and the boundaries of licensed Project footprint (purple line)

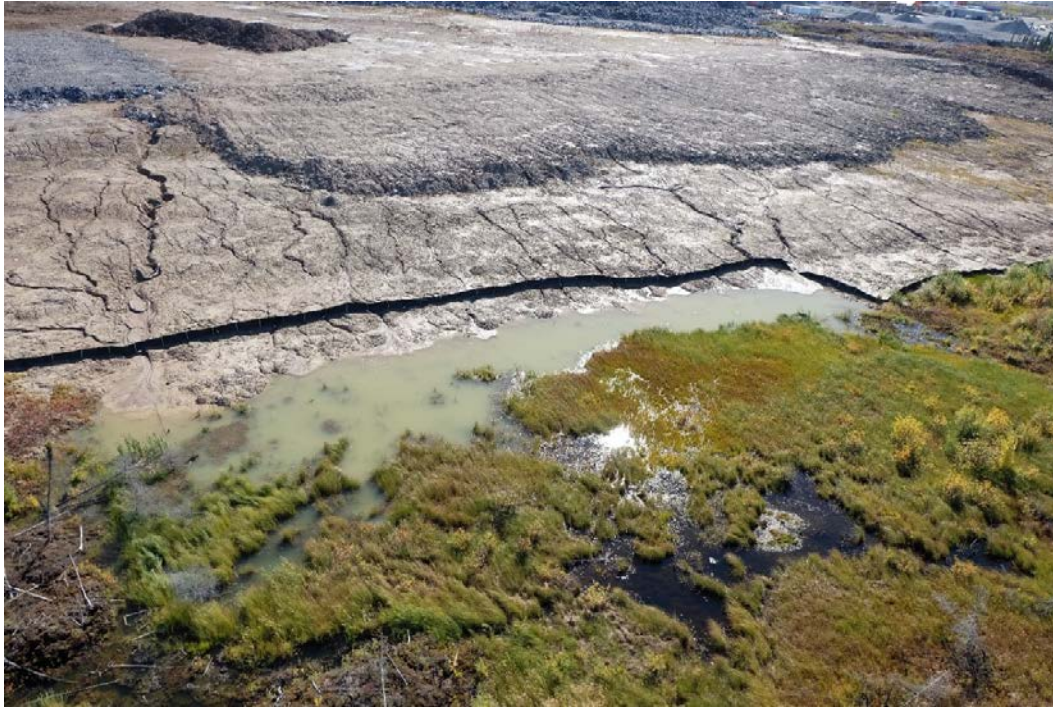
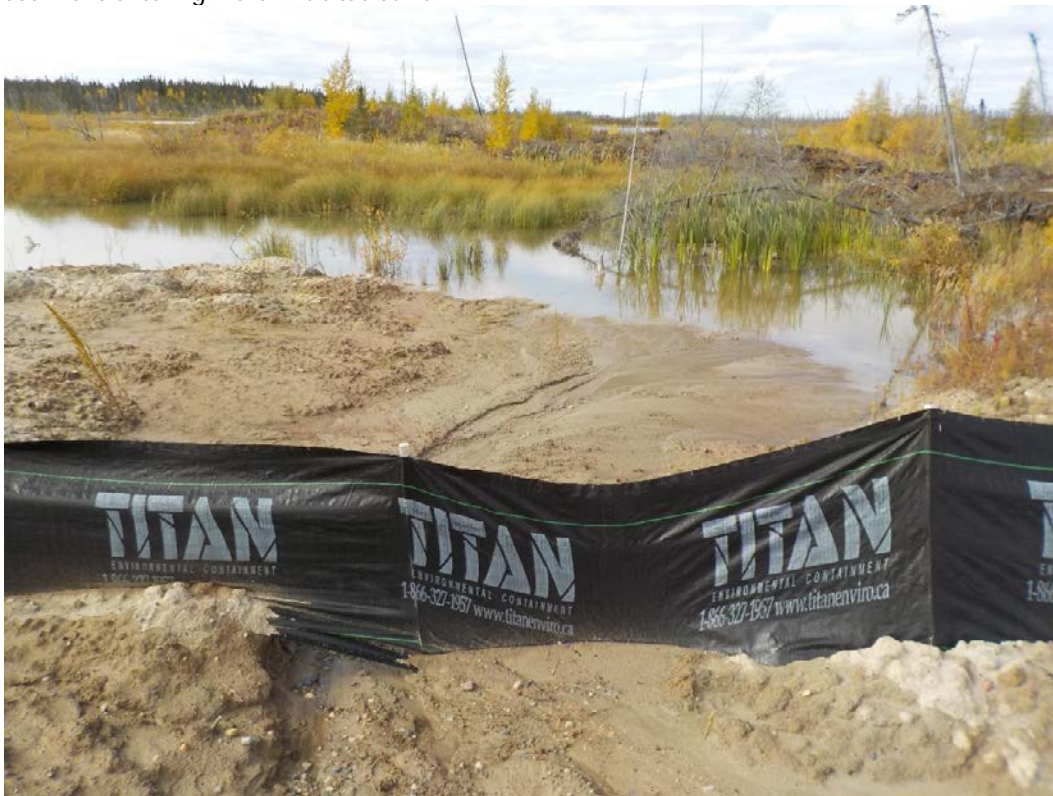
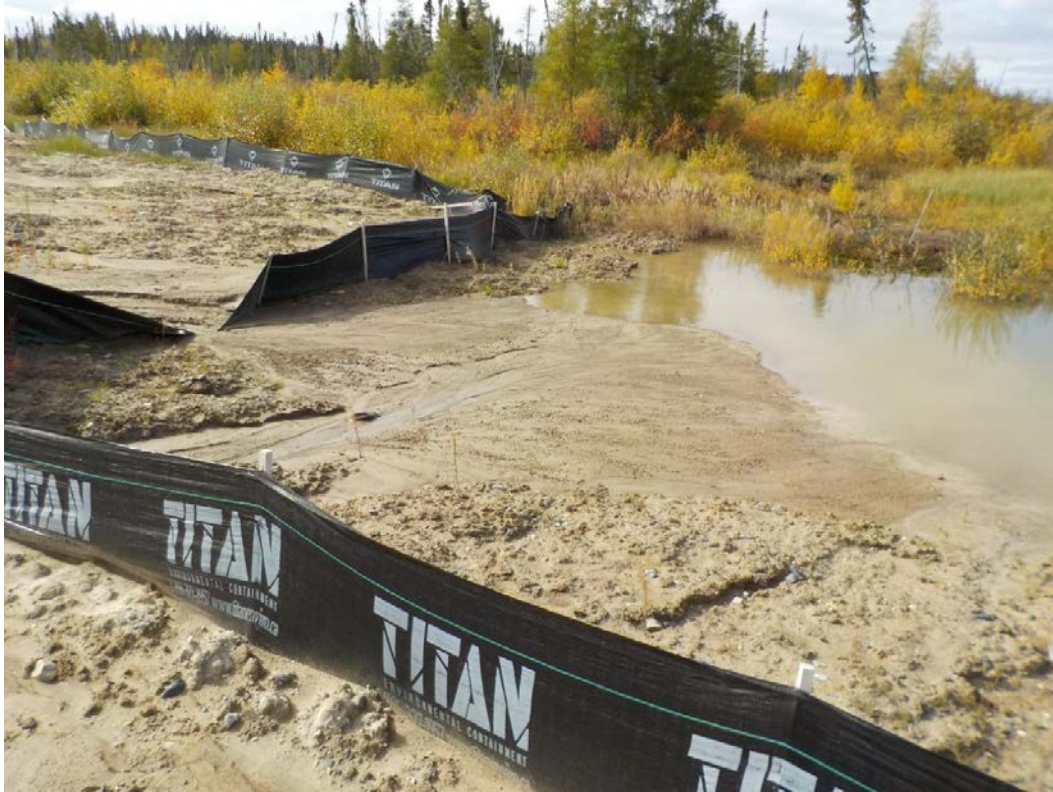
Figure 3-19: Aerial and ground photos of Wetland 51 in September 2018

This sediment deposition into the buffer portion of the wetland was ongoing as of September 2018, despite the installation of silt fences at the base of the EMPA slope. The apparent affected area has not increased since 2017. While the EMPA D16 slopes adjacent to the buffer in Wetland 51 had been graded, erosion channels had developed in the slope. Flow from the larger channels undermined or overtopped the silt fences at a couple locations, and were continuing to deposit sediment into the water adjacent to the wetland (Figure 3-19). While sediment had not covered any of the wetland vegetation within the marsh buffer, sediment may have been deposited underwater in the wetland. As mapping submerged sediment was not undertaken, an approximated area of 0.005 ha was used to record the impact.

Aerial view of EMPA D16 slope near the east shore of Wetland 51, showing erosion channels and sediment entering marsh habitat buffer

Sediment from EMPA D16 passing under a silt barrier and entering Wetland 51 buffer

Upper quadrant of photo shows sediment from EMPA D16 overwhelming a silt barrier and entering Wetland 51 buffer

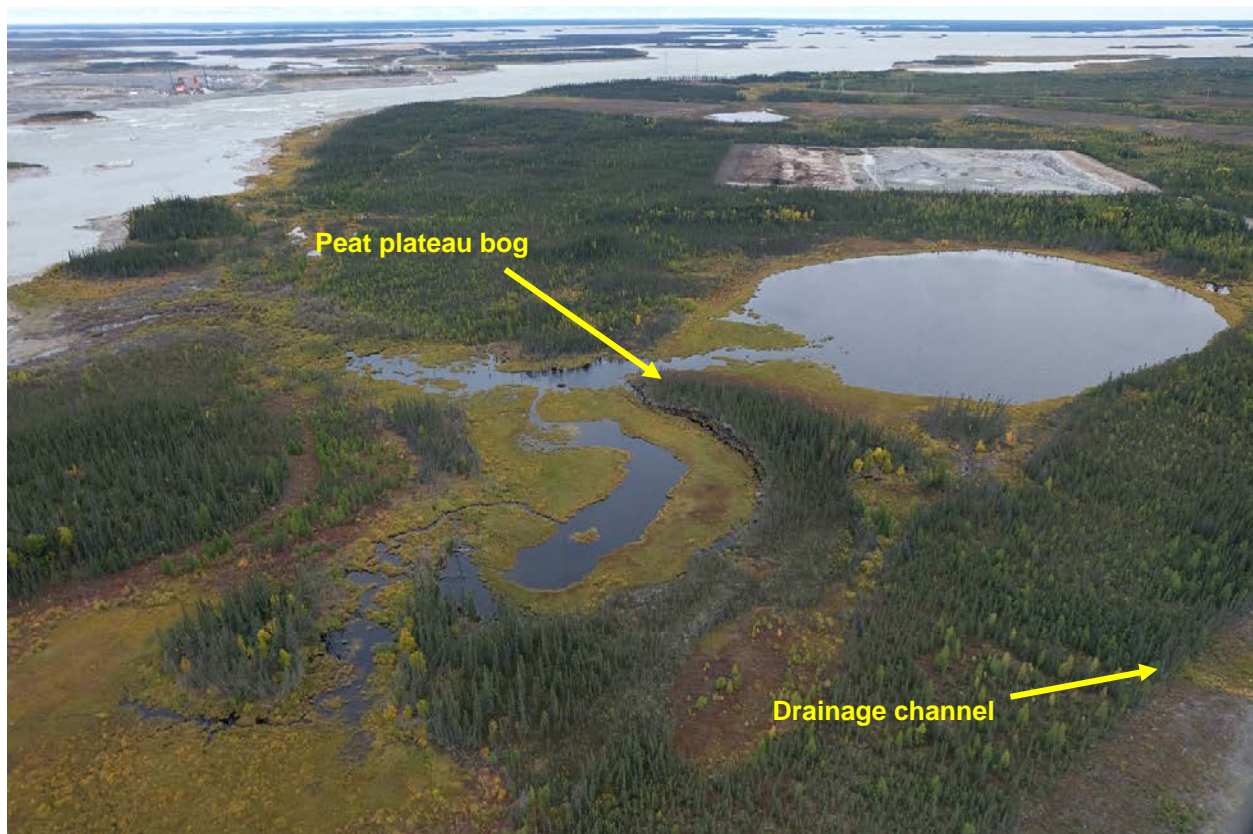
Project clearing or disturbance was not observed within Wetland 52 during the surveys from 2016 to 2018 (Map 3-1). Potential hydrological impacts from the SAR were being monitored, but to date none have been observed. Consequently, ground surveys were not conducted at Wetland 52 in 2018. See ECOSTEM (2018b) for specific observations made in previous survey years.

Figure 3-20: Aerial view of Wetland 52 showing peat plateau bog between the SAR and the wetland on September 15, 2018

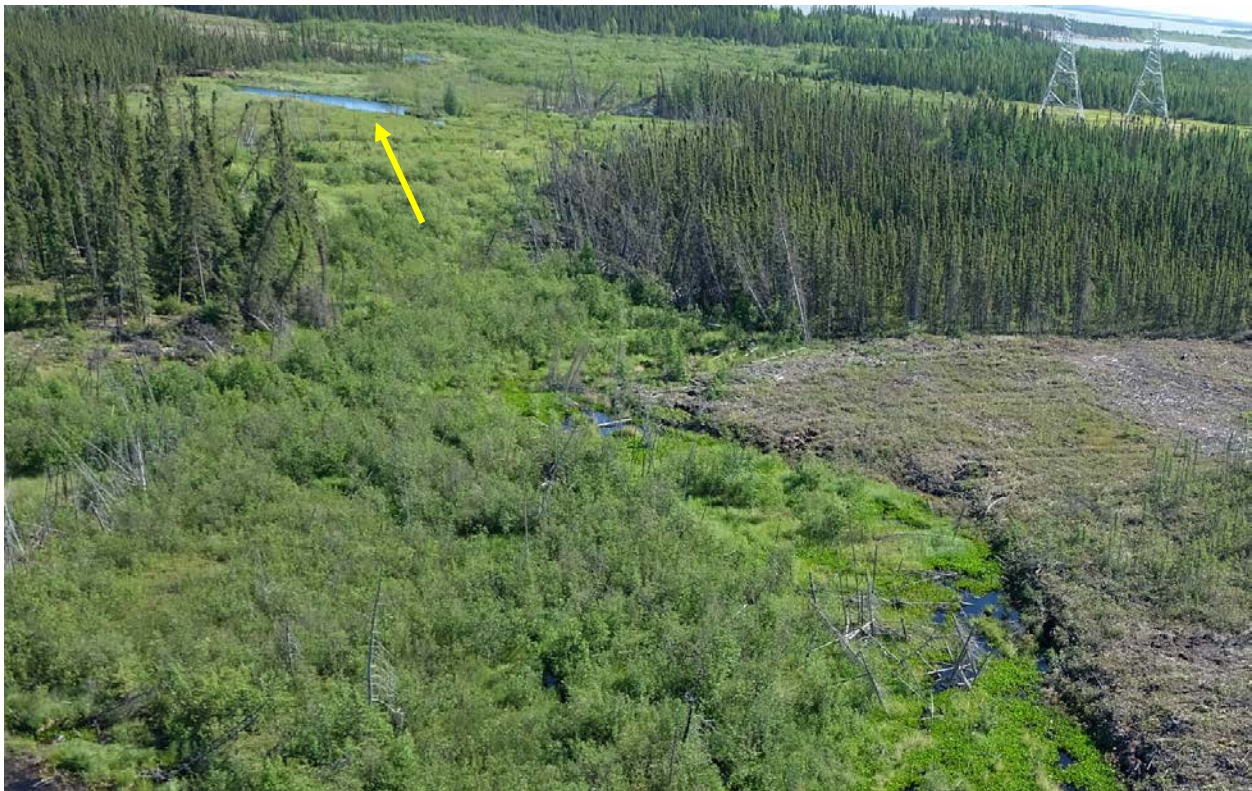
Clearing in the marsh habitat buffer that was observed during the 2015 aerial surveys. This clearing was for the Keeyask Transmission Project ROW, which is a separate project (Figure 3-21).

Figure 3-21: Aerial photo of Wetland 53 (upper left) on July 6, 2018

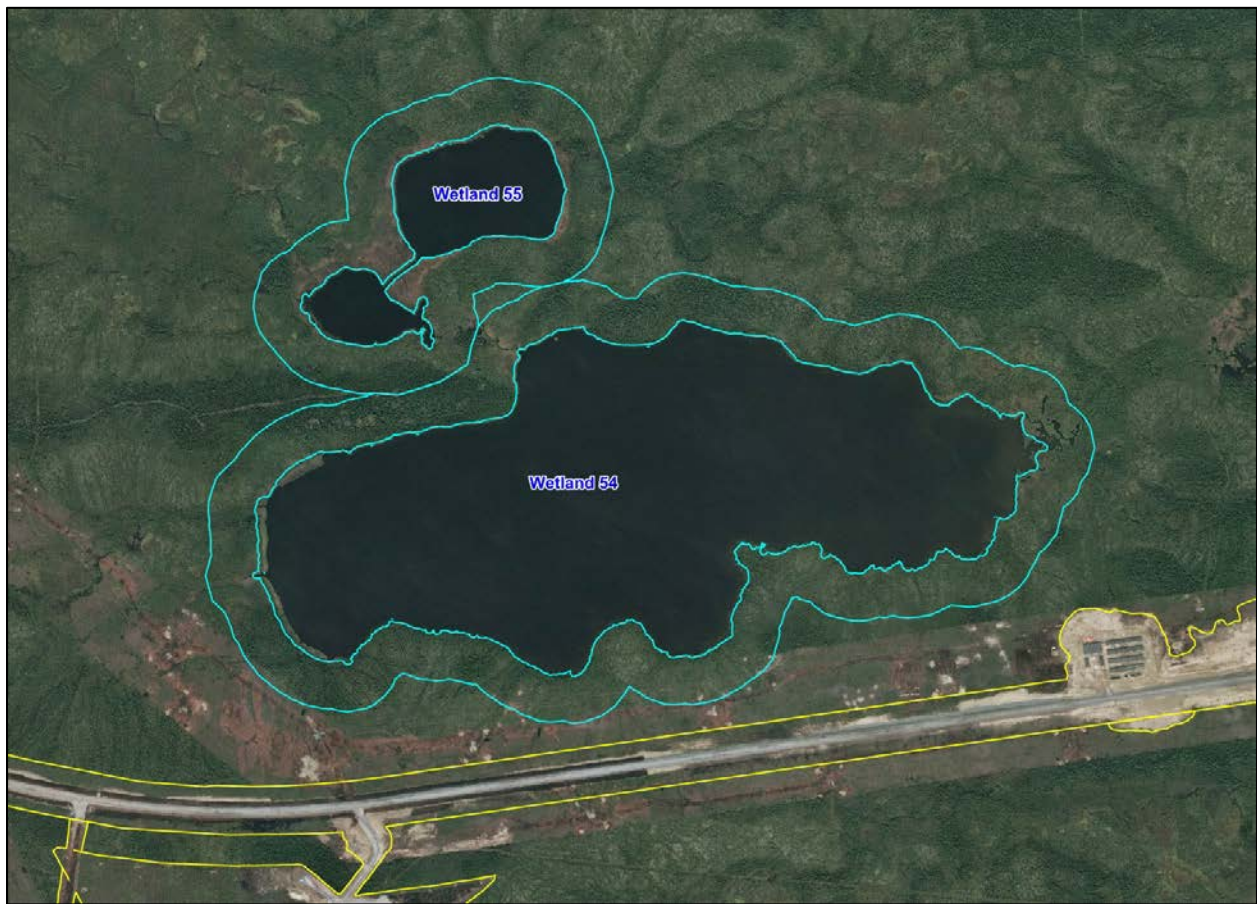
Surveys in 2015 and 2016 found clearing and disturbance in the marsh habitat buffer, but this was for the Keeyask Transmission Project ROW. Ground surveys in 2016 and 2017, and aerial surveys in 2018 found no expansion of the impacts recorded in 2015 and 2016. The relatively dense existing low vegetation in the cleared areas within 100 m of the marsh should be adequate to stabilize soils and facilitate revegetation. Specific observations regarding the impacts observed in 2015 and 2016 are provided in ECOSTEM (2018b).

Figure 3-22: View of Wetlands 54 and 55 in July, 2018 satellite imagery

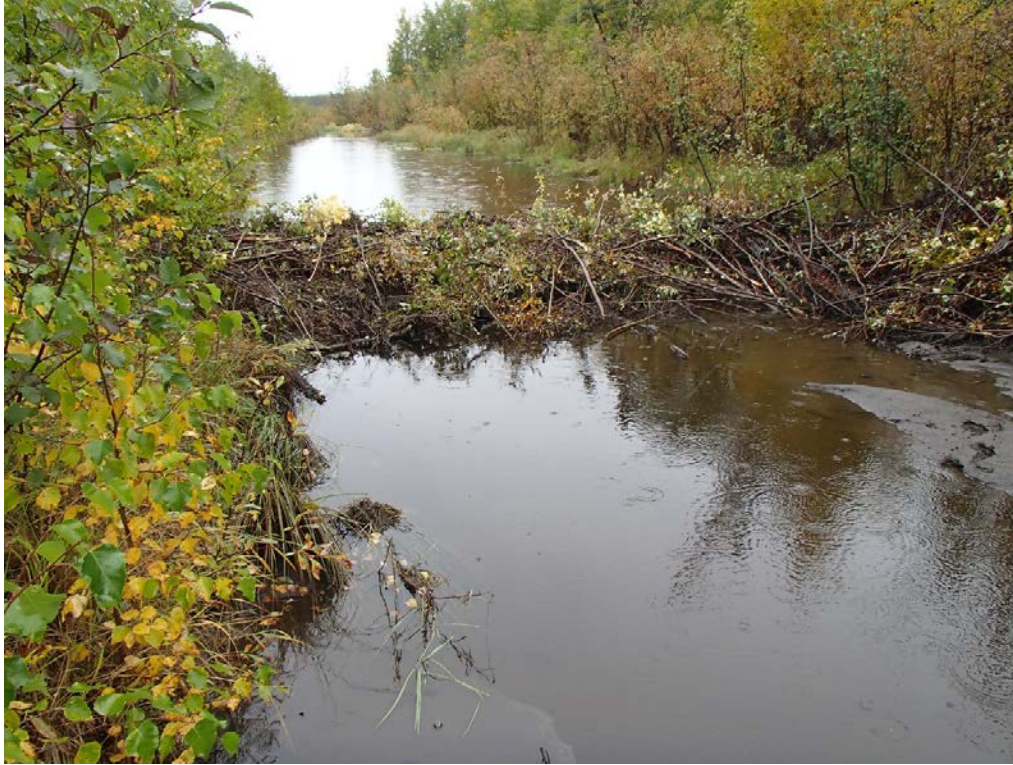
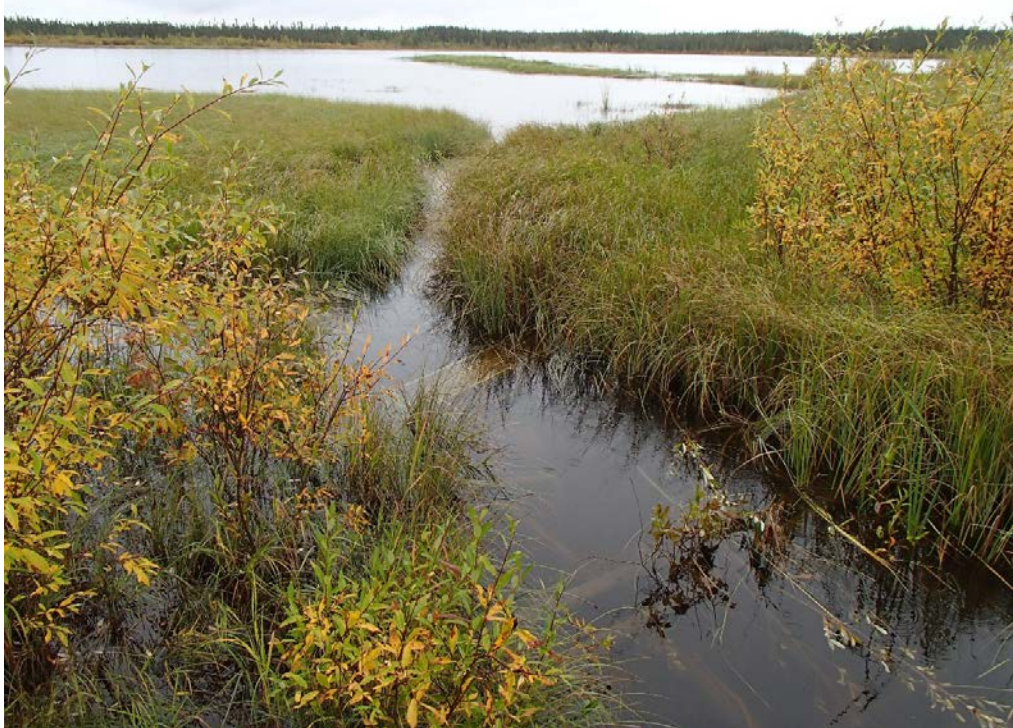
Figure 3-23: Ground photos of Wetland 57 on September 11, 2018

In terms of other potential Project impacts, the wetland drains through a channel into a ditch along the SAR. The observed water levels in the waterbody in 2016 and 2017 were very low compared to those observed in 2015. In 2018 the water levels were similar to those observed in 2015. The most likely reason for the changes was that between 2017 and 2018 a beaver dam that was constructed in the drainage channel to the SAR ditch, raising water levels in the wetland, which is upstream of the dam. Based on this, one possible cause for the low water levels observed in 2016 and 2017 was the construction of the SAR. Improved drainage through the new culvert under the road may have increased the rate of outflow from the wetland, lowering water levels.

Beaver dam in drainage channel of Wetland 57

Marsh habitat upstream of beaver dam

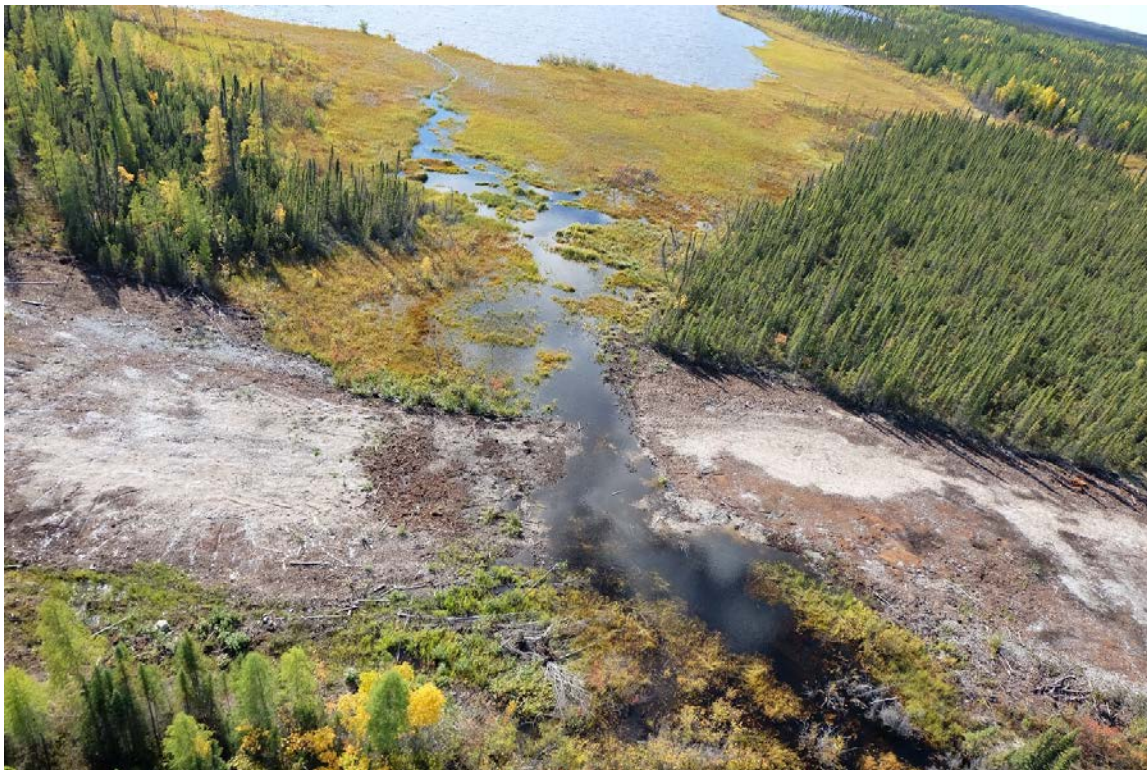
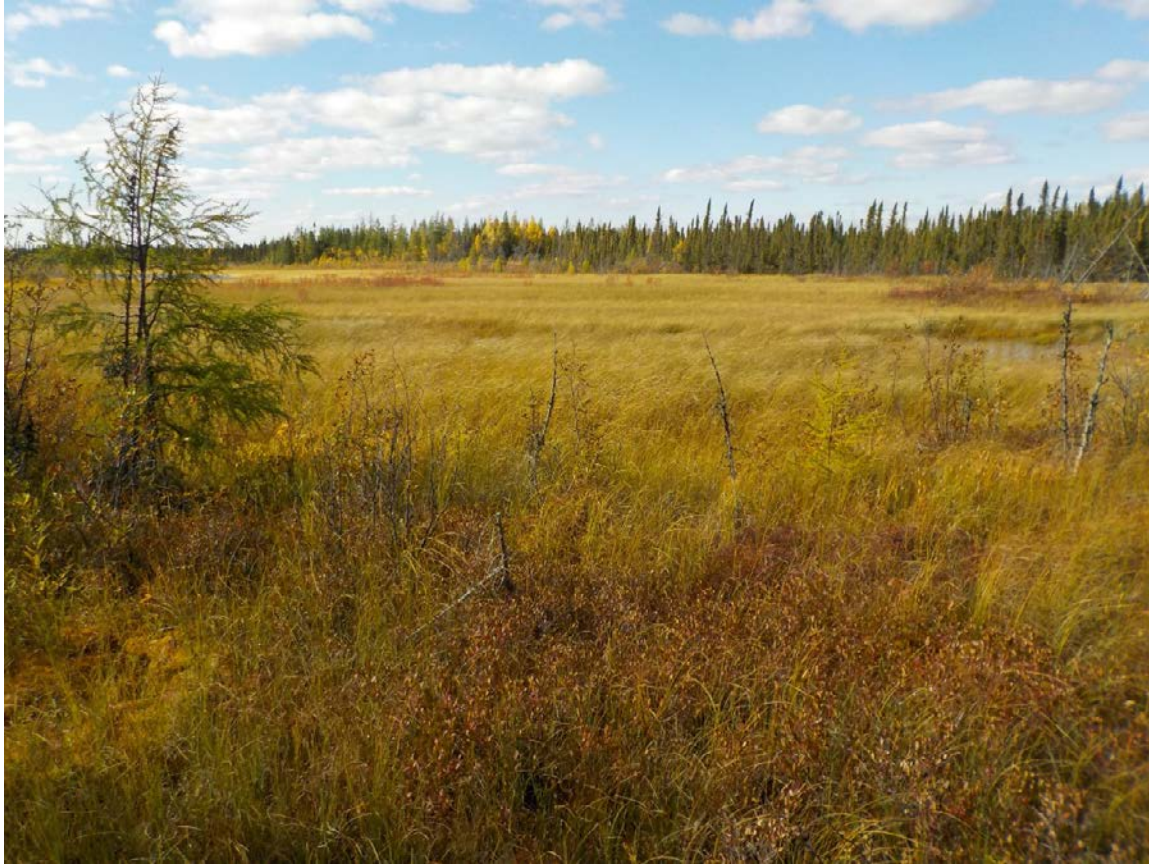
Figure 3-24: Aerial and ground views of Wetland 60 on September 15, 2018

In terms of other potential impacts, Project clearing extended over a drainage channel into the wetland. There is a possibility that the vegetation clearing or continued construction activity could alter water flow into the wetland through localized changes to the moisture regime or soil compaction. However, this is unlikely if construction activity is limited to the winter months.

Ellis Esker access road clearing adjacent to Wetland 60 buffer

Marsh habitat (background) and marsh buffer (foreground)

Wetland 57	2016: Investigate possible causes for low water levels during 2017 surveys.	
Wetland 60	2018: Monitor wetland for runoff effects from the Ellis Esker access corridor. Avoid additional clearing or disturbance near this wetland. See Figure 6-6.

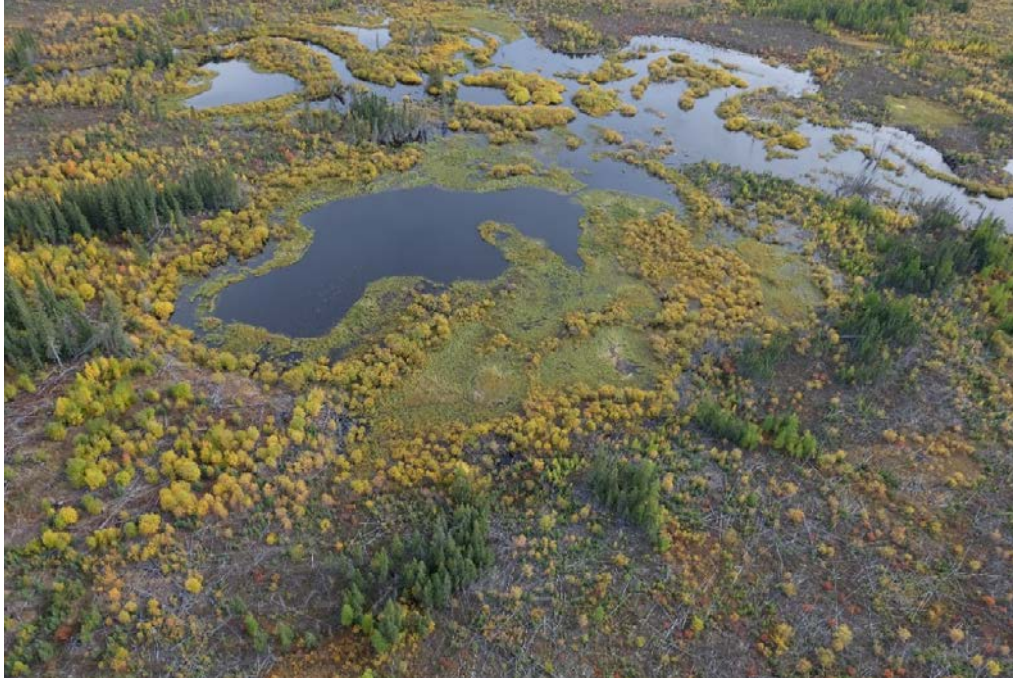
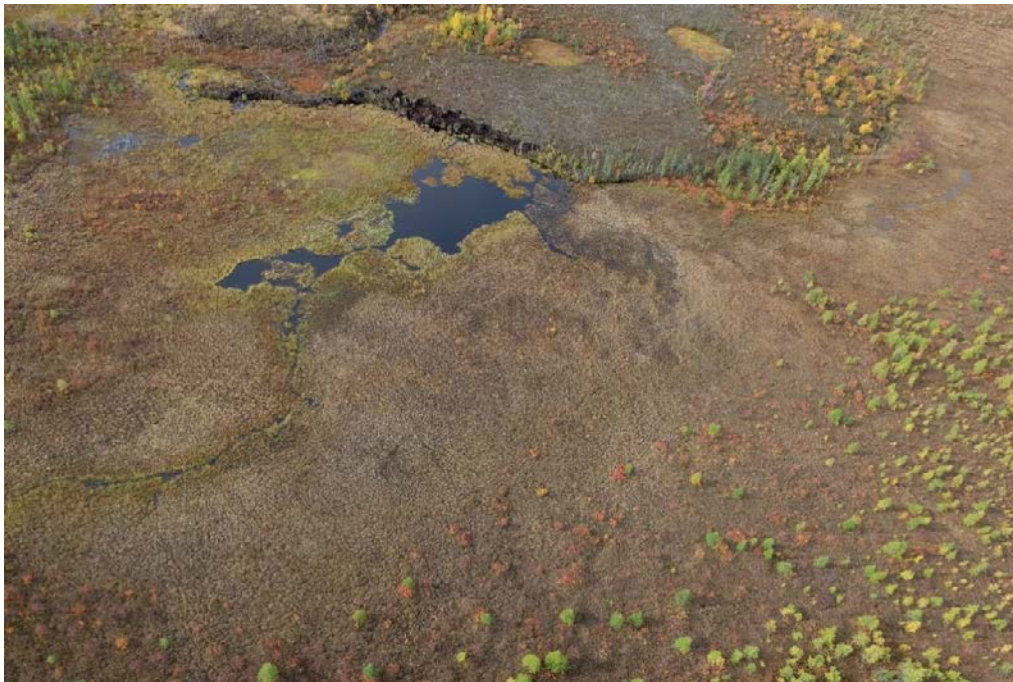
Figure 3-25 shows the state of two of the remaining 31 wetlands visited during the aerial surveys. These wetlands were not closely surveyed because they were more than 100 m from existing Project clearing or disturbance.

Figure 3-25: Aerial photos of Wetlands 38 and 36 on September 16, 2018

Monitoring in 2019 will determine if any of these 31 wetlands have been impacted by the Project since the 2018 surveys.

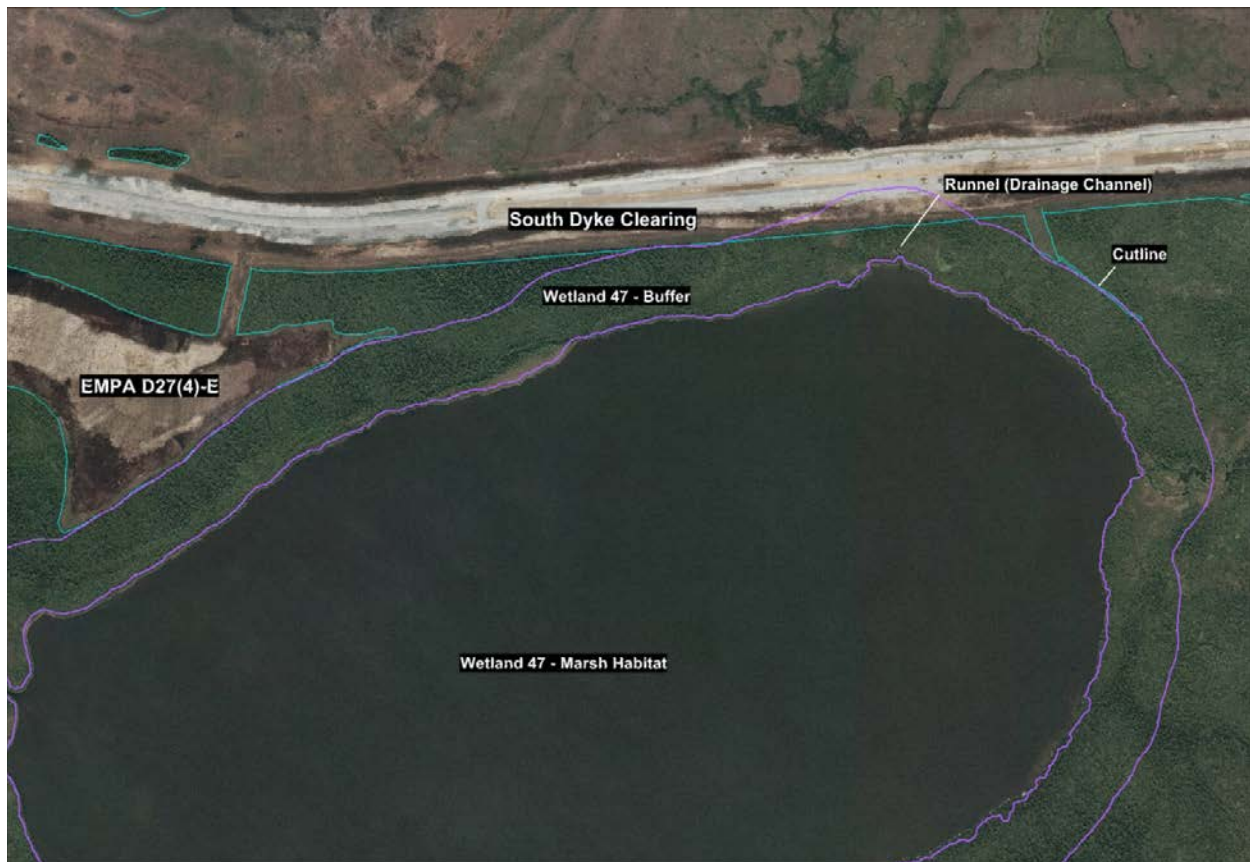
Figure 6-2: Mitigation areas and recommendations for Wetland 47

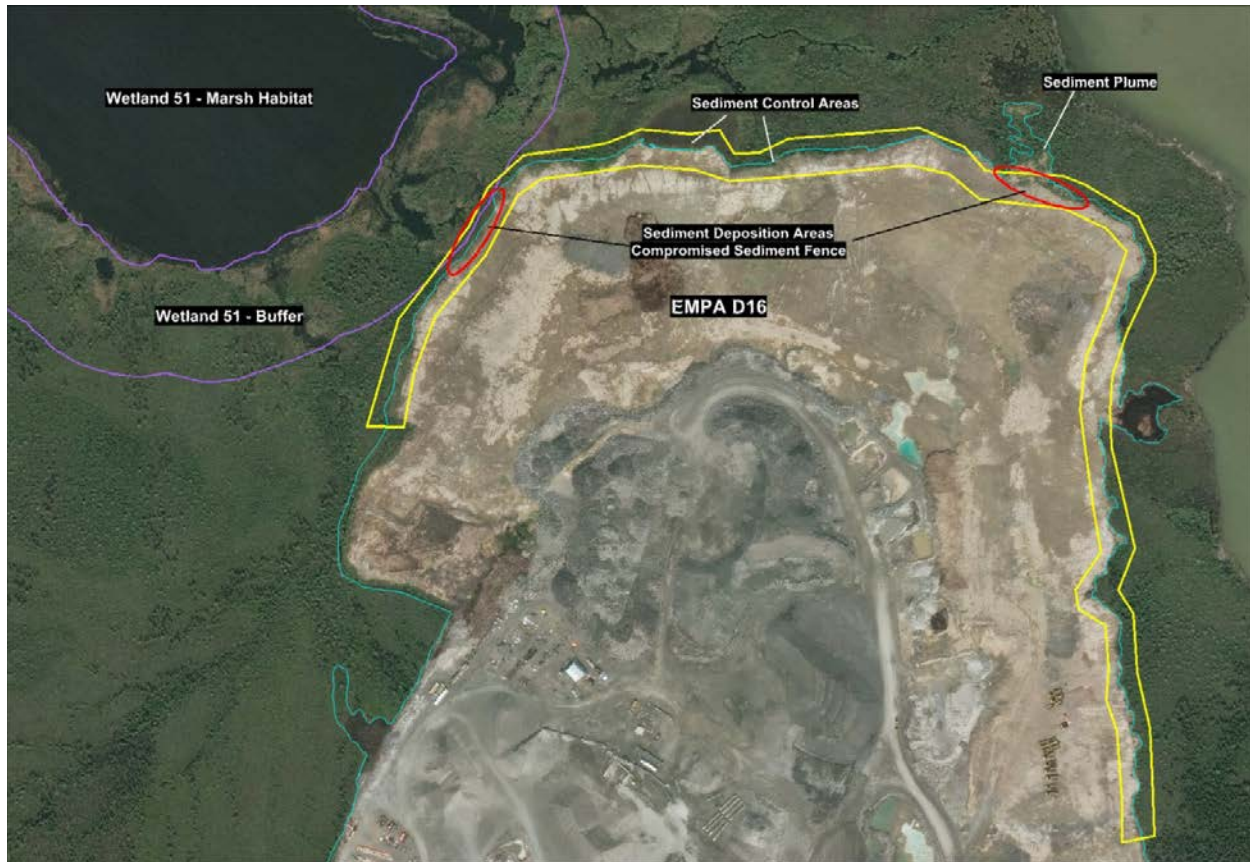
Figure 6-3: Mitigation areas and recommendations for Wetland 51

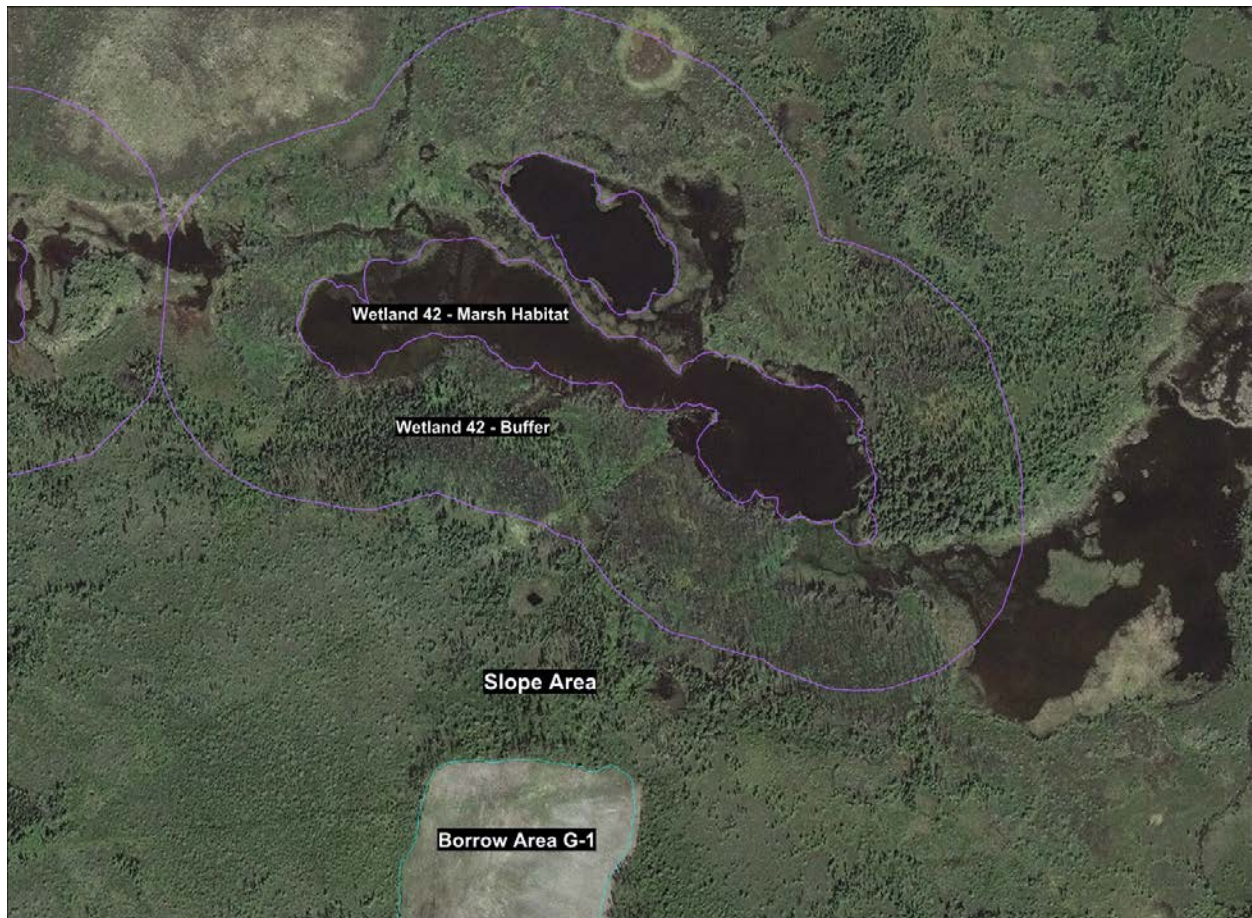
Figure 6-4: Mitigation areas and recommendations for Wetland 42

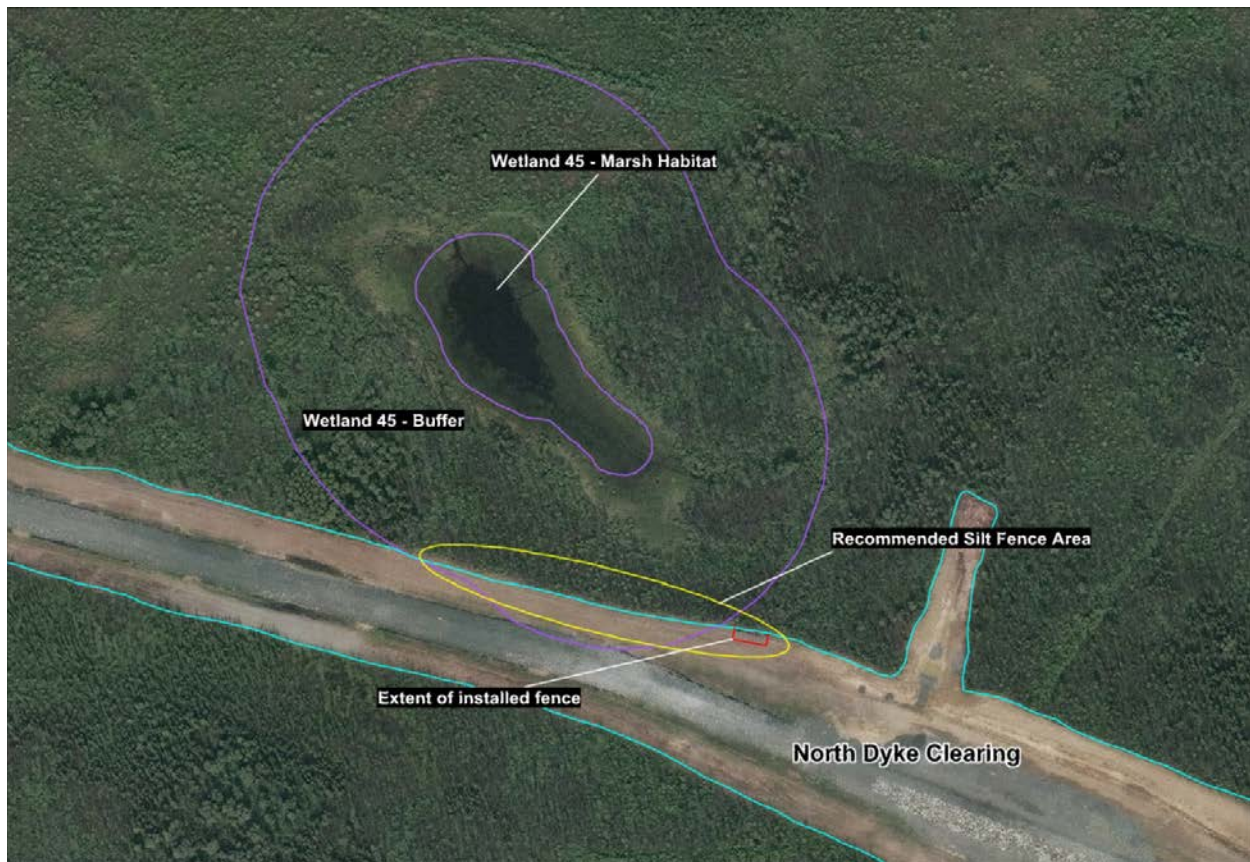
Figure 6-5: Mitigation areas and recommendations for Wetland 45

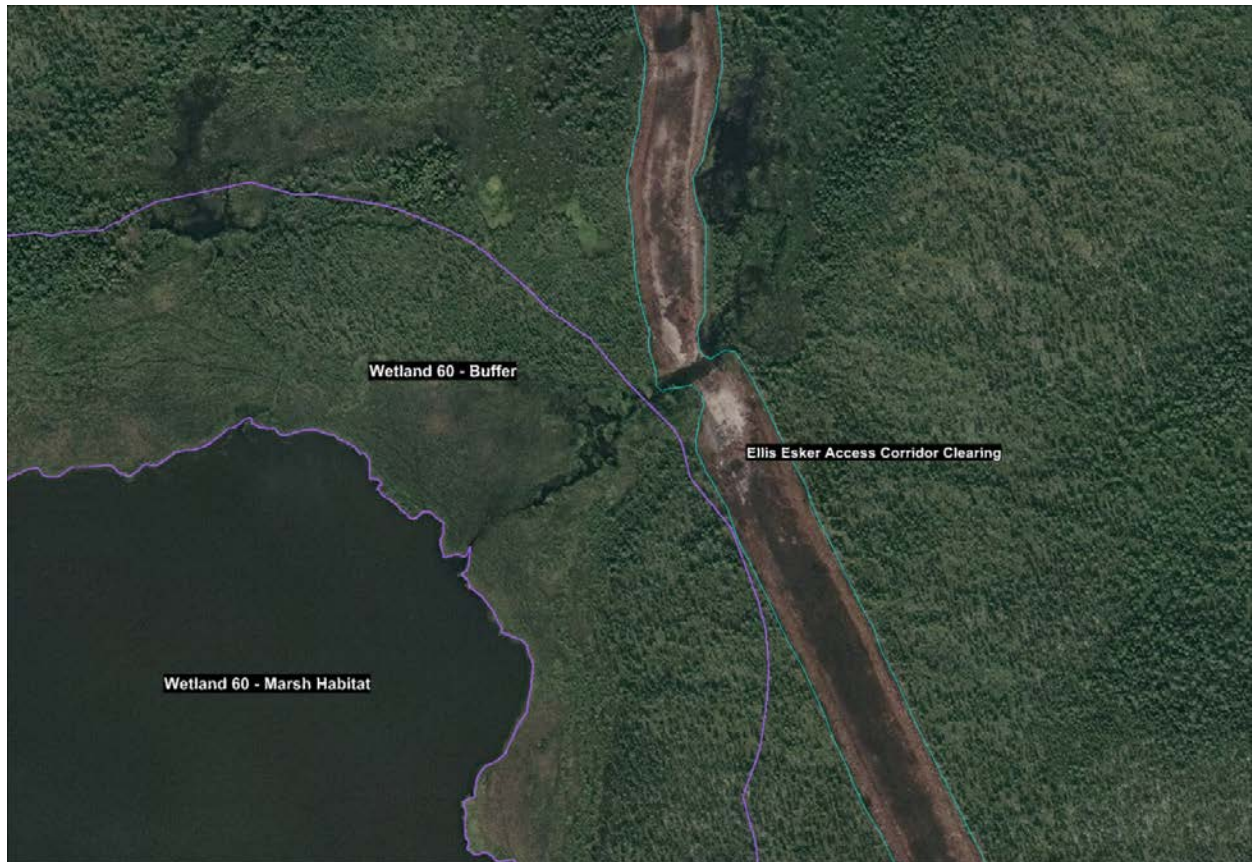
Figure 6-6: Mitigation areas and recommendations for Wetland 60
