Keeyask Generation Project Zebra Mussel Monitoring Plan

Zebra Mussel Annual Monitoring Report ZMMP-2019-01

REPORT #ZMMP-2019-01

ANNUAL REPORT

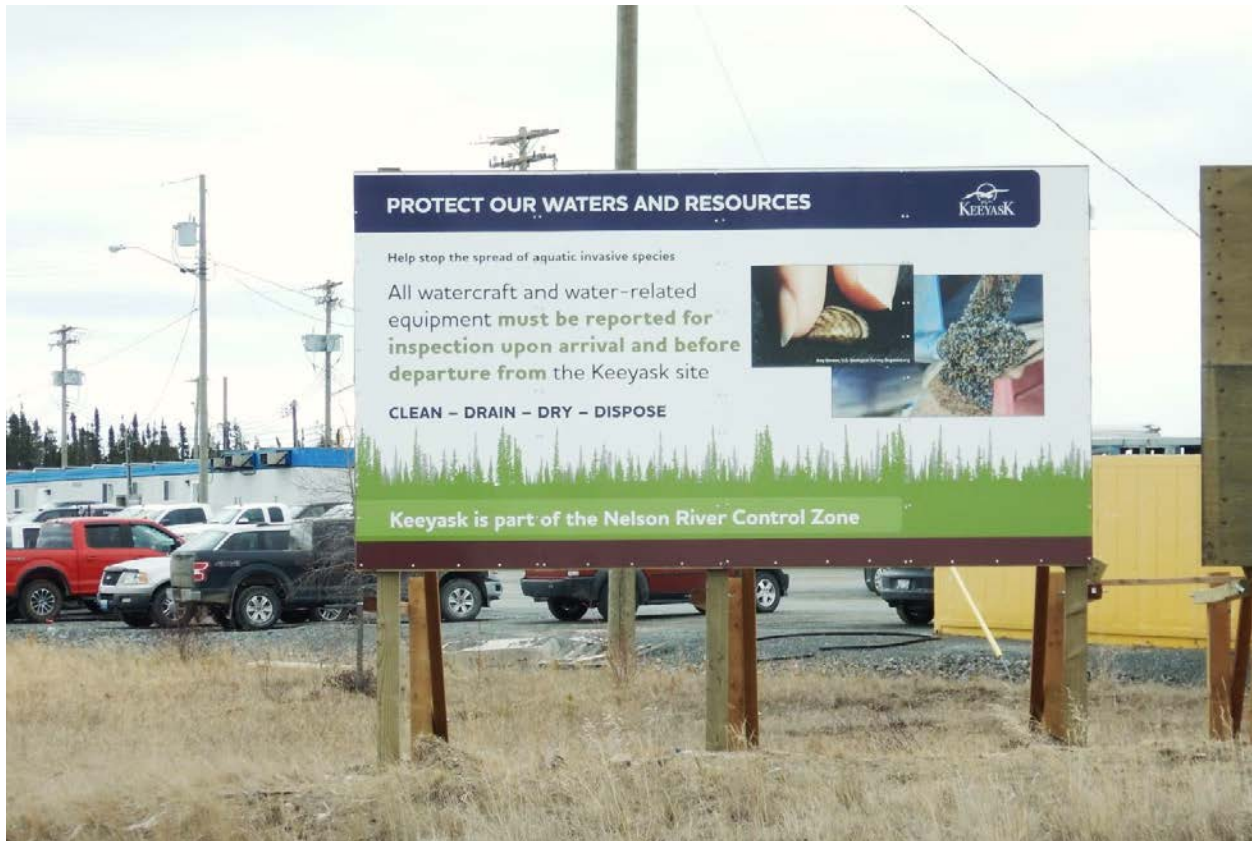
Photo 1: In 2018, a sign was posted at the main gate to remind site users to report for inspection of watercraft and water-related equipment

In the fall of 2018, a sign was posted at the main gate to notify those groups bringing watercraft to the Keeyask site, that Keeyask is in the Nelson River Control Zone and personnel must report for an inspection and/or decontamination of watercraft and water-related equipment when entering and leaving the Project site (Photo 1).

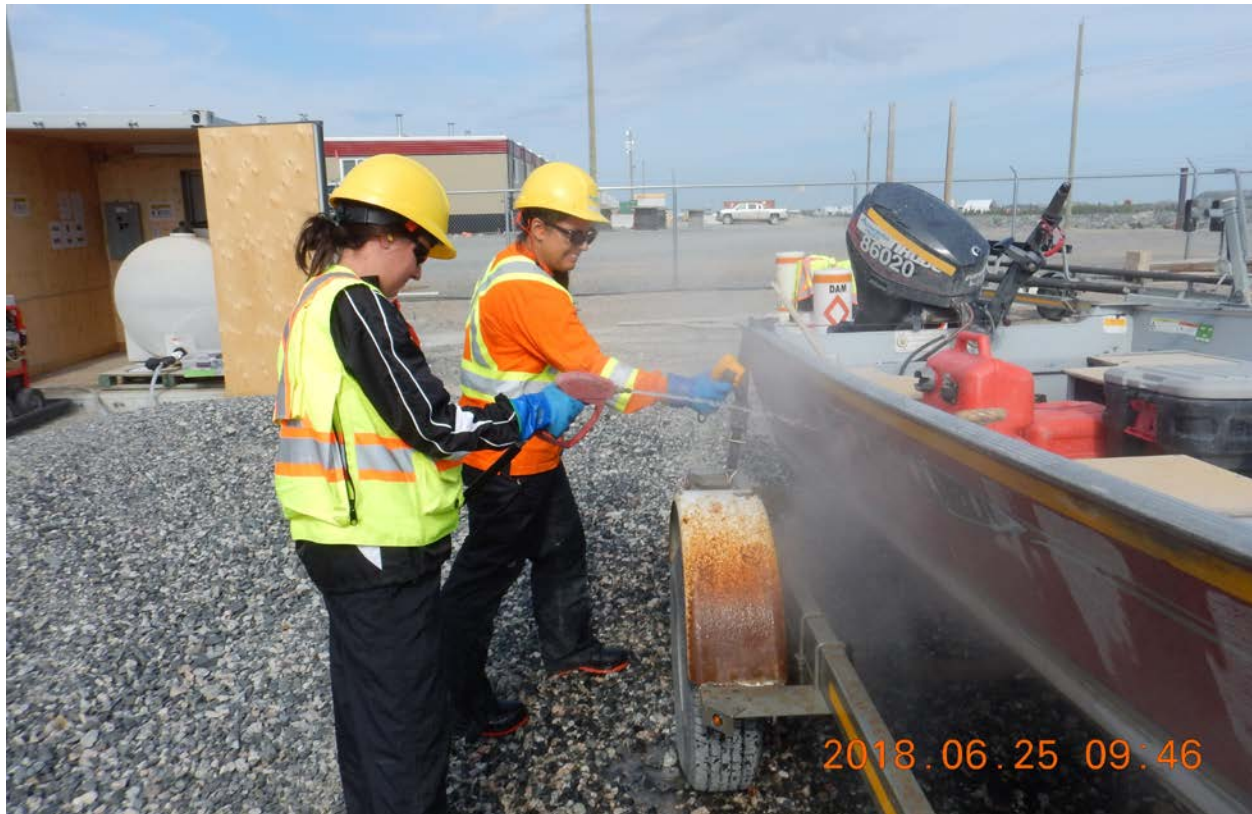
The decontamination water drains down onto a gravel pad designed to allow rapid infiltration into the ground, preventing it from flowing away from the site.

Photo 2: A boat being decontaminated by rinsing with hot water ($\geq 60^{\circ}\text{C}$) on June 25, 2018

From April 2018 to March 2019, all watercraft and water-related equipment was inspected for AIS upon arrival and departure from Keeyask. In total, eighty-eight inspections were conducted and one decontamination (Photo 2) was performed on incoming and outgoing watercraft and water-related equipment.

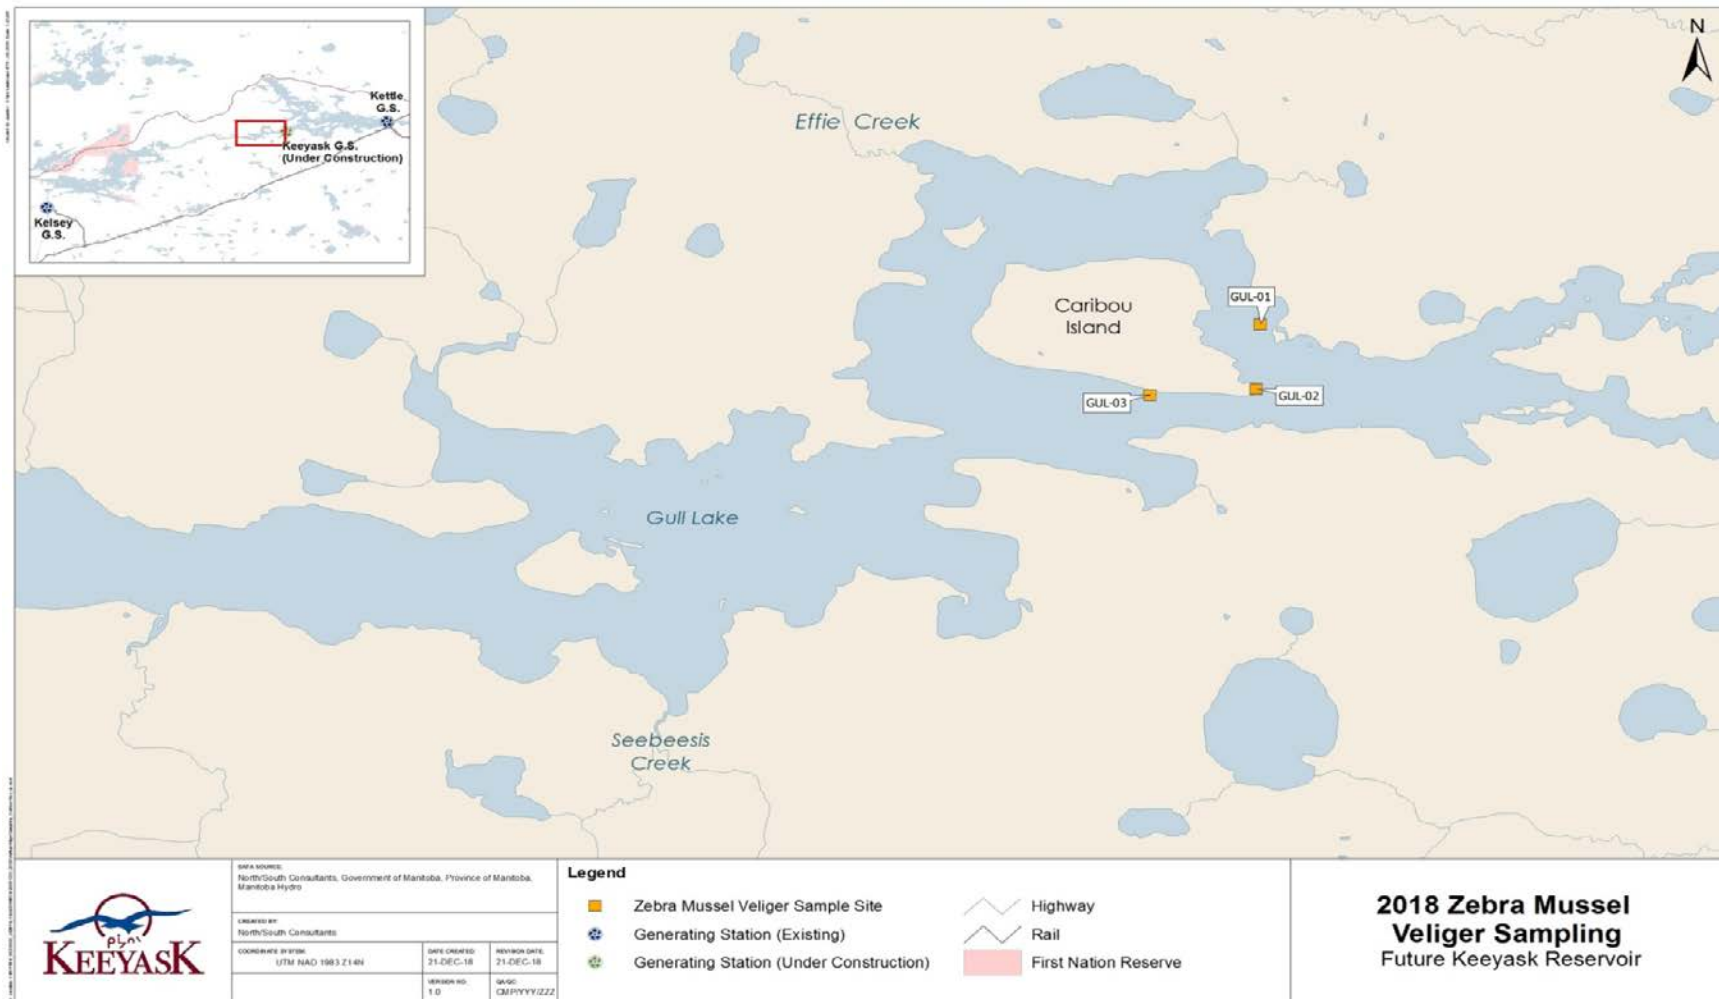
Zebra mussel veligers (larval mussels) were sampled upstream of the Keeyask GS construction site on September 18, 2018. One sample (tow) was collected from three locations within 7 km upstream of the construction site (Map 1). Sites were similar to those sampled in September 2017. These sites were chosen in areas that were near a structure suitable for zebra mussel

colonization (*i.e.*, ice booms at GUL-03 and acoustic receiver at GUL-02) and subject to heavy use with the potential for zebra mussel introduction (*i.e.*, Gull Lake boat launch; GUL-01).

Map 1: Sampling sites for zebra mussel veliger monitoring in the Keeyask Study Area, September 18, 2018

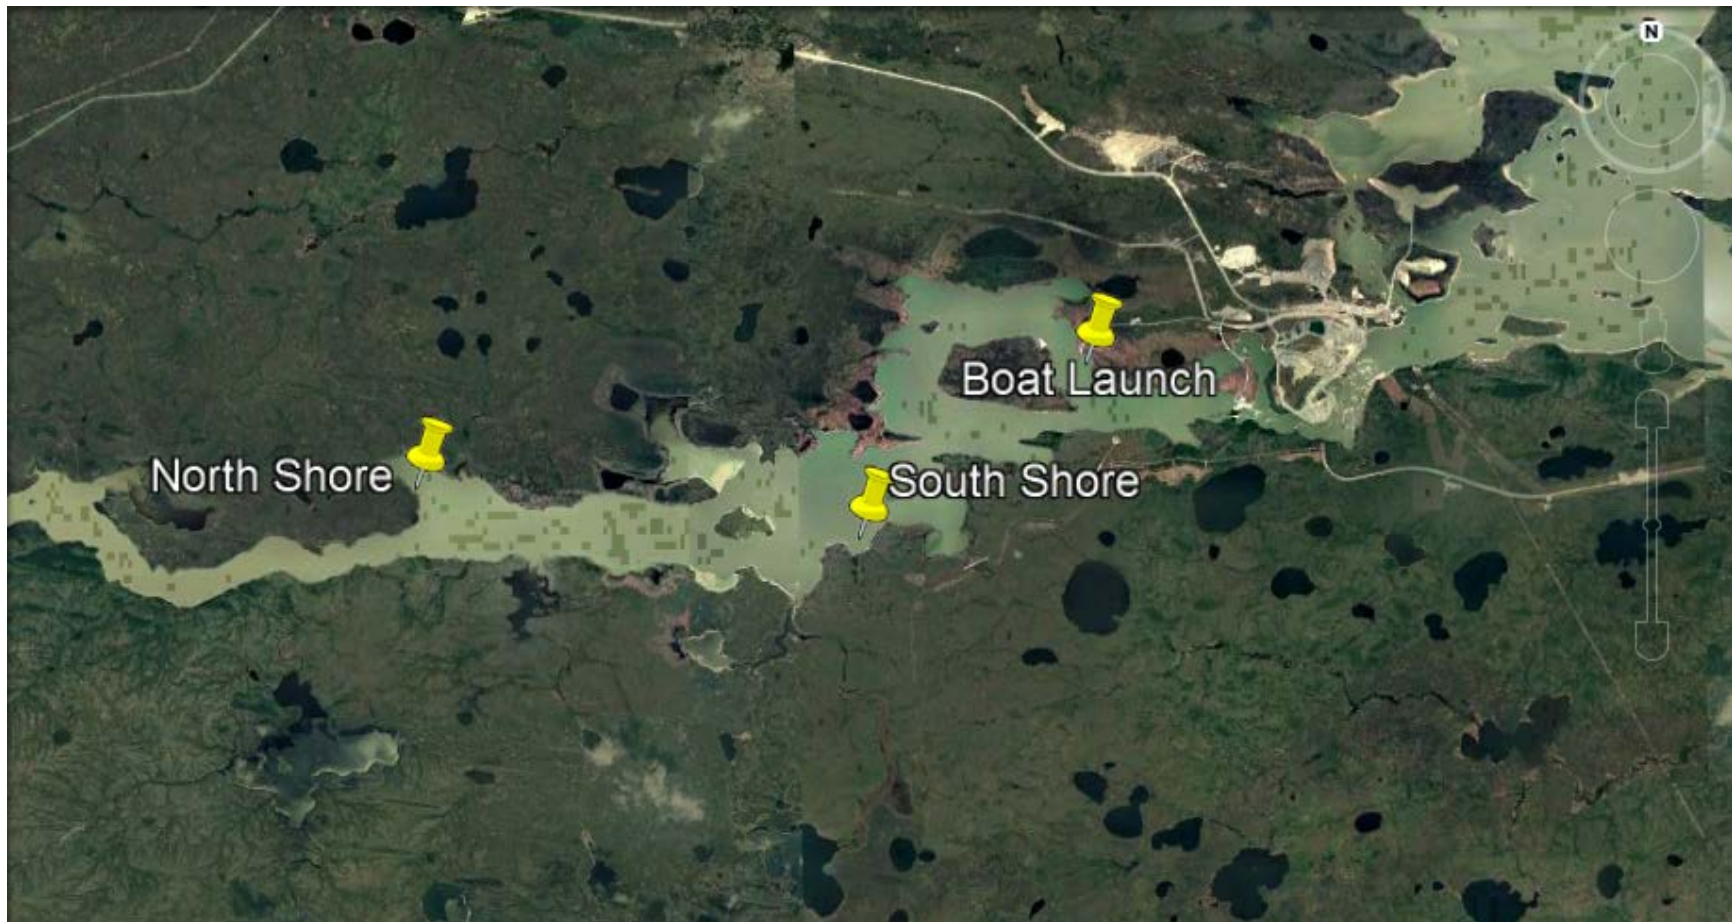
Monitoring for adult zebra mussel colonization was done by establishing three sites in the Keeyask reservoir for placement of artificial substrates. Artificial substrates were deployed on May 30, 2018. Sites were located in low-flow areas (0.1-1.0 m/s) with a depth of approximately 4 m (Map 2). At each site, terra cotta flower pots were used as artificial substrates; they were suspended in series along a rope at 1, 2, and 3 m depths (Photo 3), anchored in place with a cinderblock, and kept suspended in the water column by a buoy at the surface.

Map 2: Location of sites in the Keeyask reservoir where artificial substrates were deployed to monitor for zebra mussel colonization

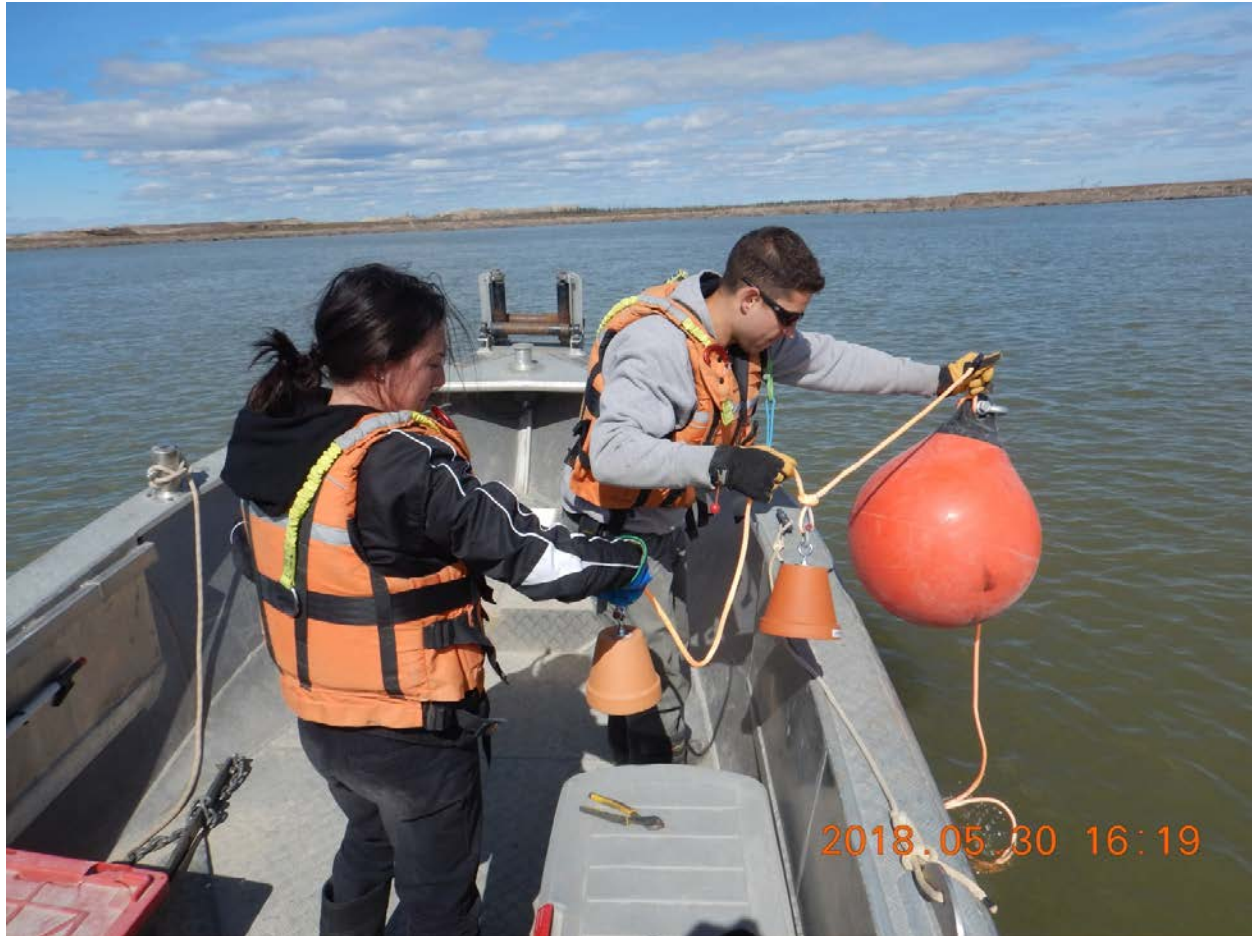
Photo 3: Deploying the artificial substrates at the Keeyask reservoir boat launch site on May 30, 2018

A more robust design was used for the deployments this monitoring season and fewer issues with lost or damaged equipment were encountered compared to 2017. At each location, separate lines were used to suspend the pots (substrates) and anchor the monitoring site, so there was no need to remove the cinderblock each time the substrates were checked. More durable ropes were also used to protect from wear and tear and reduce the potential for the substrates to be lost. Nonetheless, due to the fragility of the terra cotta substrates, there were a few instances where substrates were found to be damaged and were replaced.

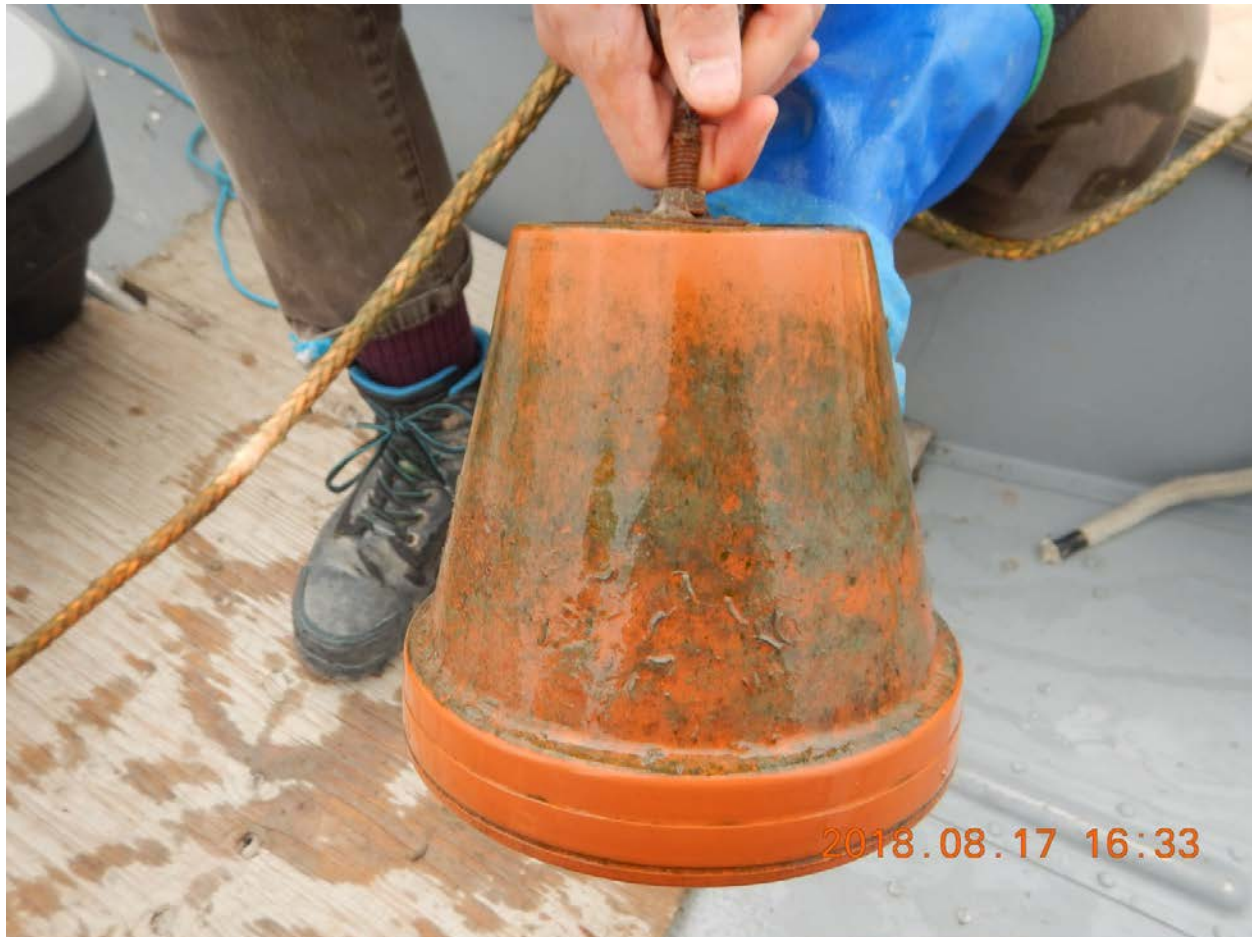
Note: Algae and aquatic invertebrates were present on the substrate but there was no evidence of zebra mussel colonization.

Photo 4: Photo of a monitoring substrate being checked for colonization by zebra mussels at the Keeyask reservoir boat launch site on August 17, 2018

During each site visit in 2018 to inspect and/or remove the artificial substrates (Photo 4), and inspect of the surrounding, natural substrates, there was no evidence of zebra mussel colonization (adult or juvenile).

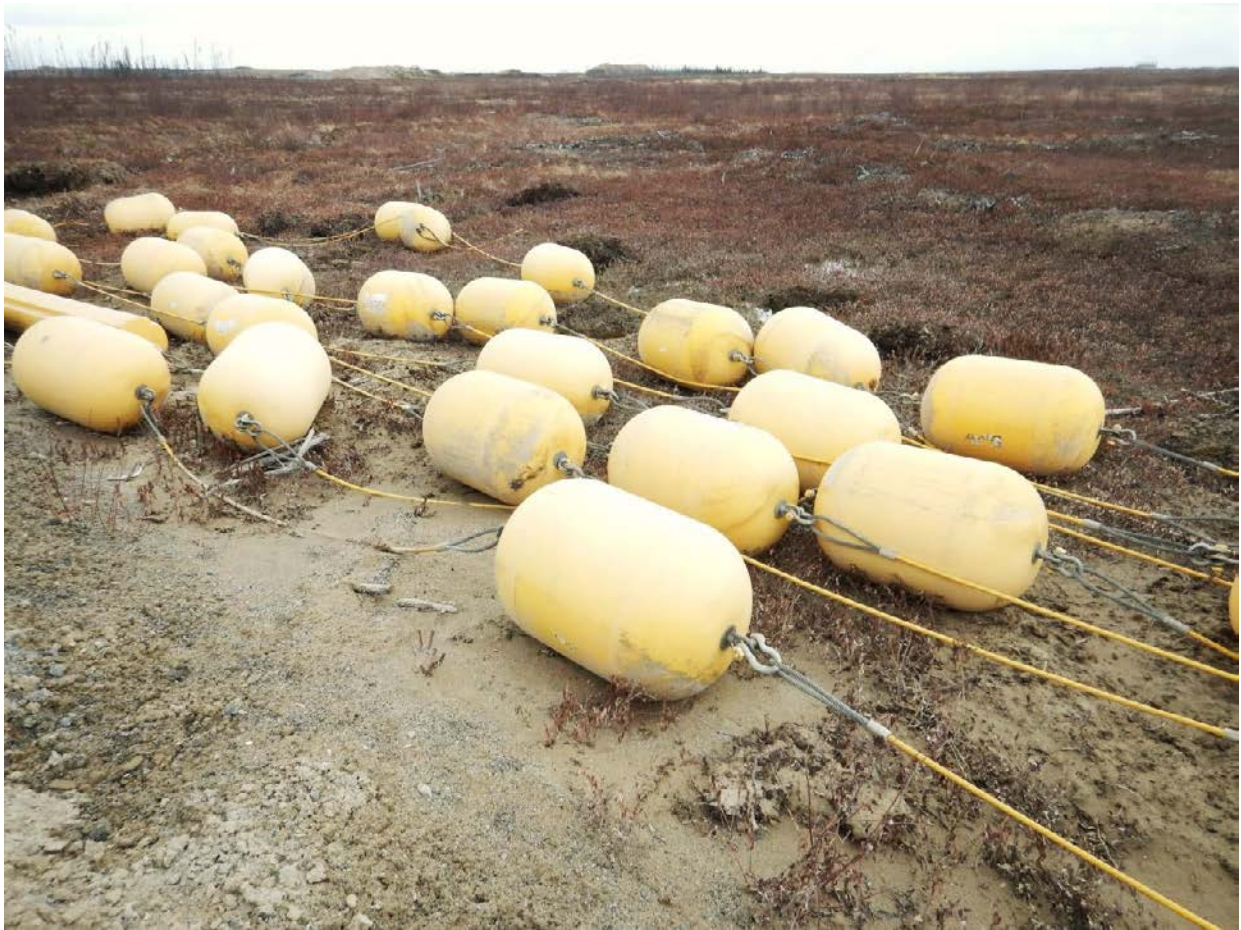
Photo 5: Parts of the open-water safety boom that had been removed for winter storage were visually inspected for the presence of adult and juvenile zebra mussels

The warning buoys and sections of the safety boom that had been in the river were carefully inspected for the presence of adult mussels or byssal threads (a tuft of hair-like fibers that zebra mussels use to attach to underwater surfaces). The buoys and safety boom were also inspected

for the presence of young zebra mussels by running a hand over the surfaces, as newly settled mussels on smooth surfaces can feel like sandpaper.

In 2018, no adult or juvenile zebra mussels or evidence of byssal threads were found on any surfaces of the in-water infrastructure.

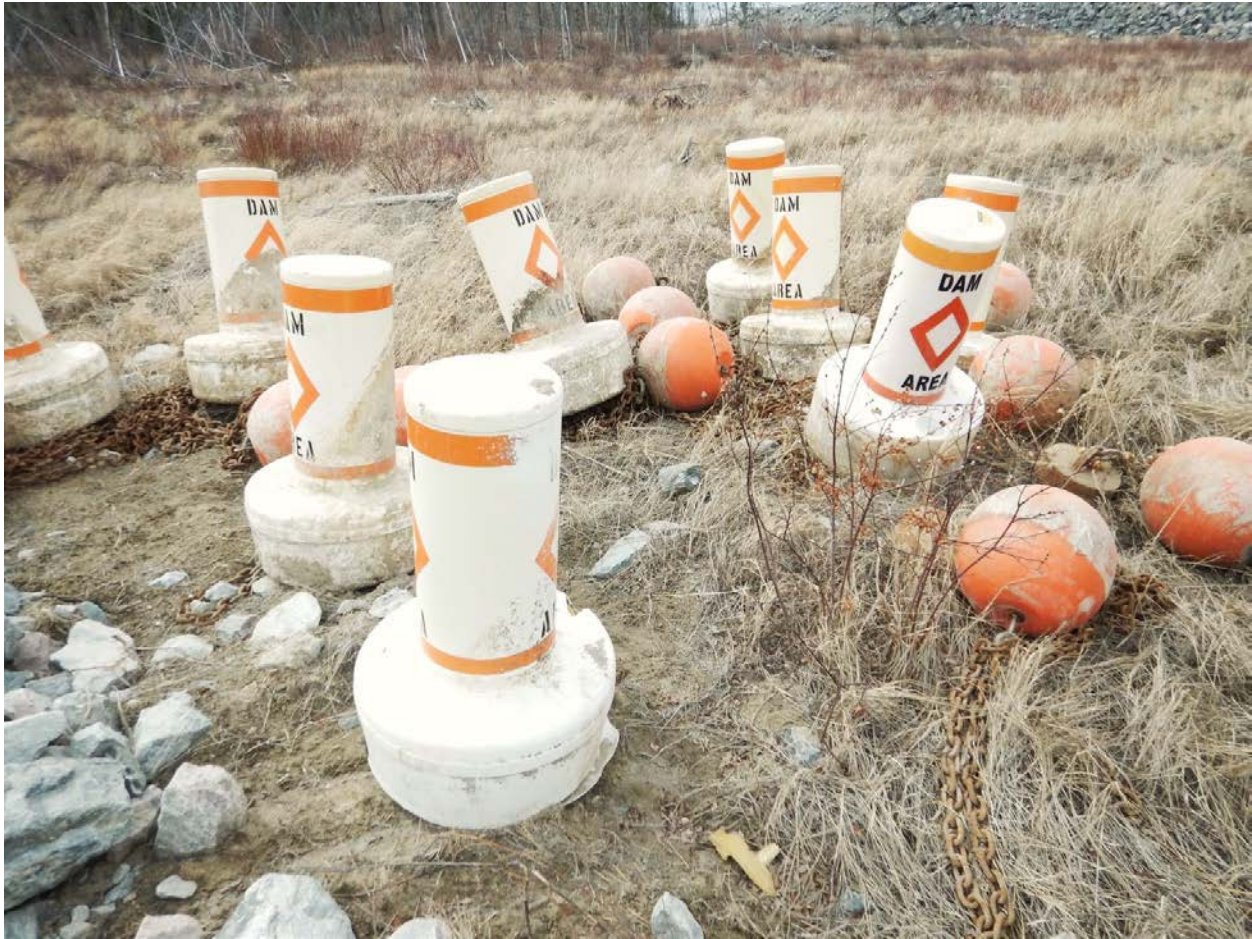
Photo 6: Warning buoys that are deployed downstream of Gull Rapids during the open-water season were removed for winter storage and were visually inspected for the presence of adult and juvenile zebra mussels
