Keeyask Generation Project Aquatic Effects Monitoring Plan

REPORT #AEMP-2020-02

JUVENILE LAKE STURGEON MOVEMENT MONITORING IN THE NELSON RIVER BETWEEN CLARK LAKE AND THE LIMESTONE GENERATING STATION, OCTOBER 2018 TO OCTOBER 2019: YEAR 6 CONSTRUCTION

By C.L. Hrenchuk June 2020

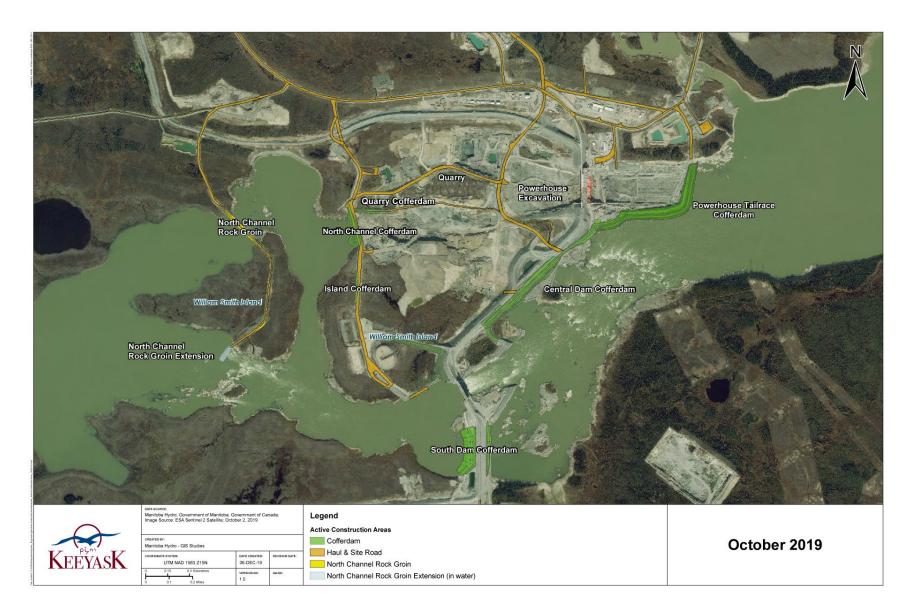
Map illustrating instream structures at the Keeyask Generating Station site, October 2019.

Construction of the Keeyask GS began in mid-July 2014 with the construction of cofferdams that blocked flow in the north and central channels of Gull Rapids (see instream structures map below). During the winter of 2015/2016 the Spillway Cofferdam, which partially blocks the south channel, was constructed. Beginning late in 2016 and continuing in 2017, the Tailrace Cofferdam was constructed. Work was completed in fall 2017 with the exception of an opening that was left to allow fish movement into and out of the cofferdam over the 2017/18 winter. This opening was closed in spring 2018, and the area was dewatered. The spillway was commissioned in August 2018. The South Dam Cofferdam was completed in fall 2018, blocking the channel and forcing the entire flow of the river through the spillway. Almost all work in 2019 was in the dry. The construction activities included the excavation of the tailrace, construction of the tailrace spawning shoal, and completion of the dams and dykes.

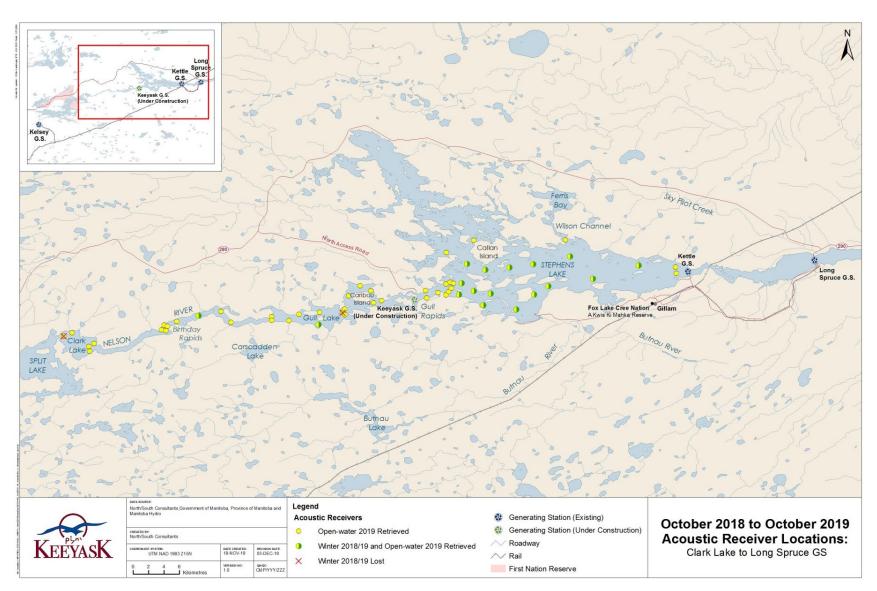
Map showing the study area. The dots represent the locations of receivers in the river. The different colours represent receivers that were in the river at different times of the year.

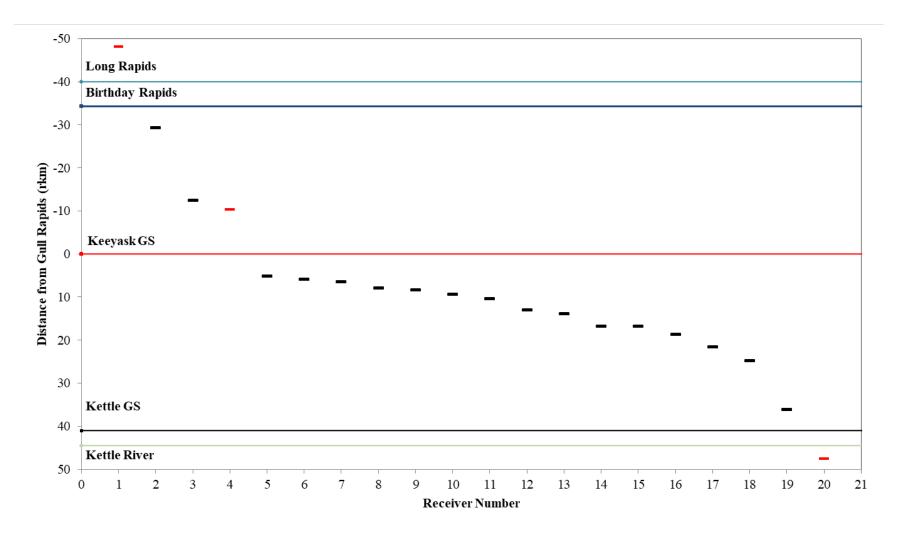
Figure 1: Locations of stationary acoustic receivers (dashes) in relation to the base of the Keeyask GS (rkm 0) and other major landmarks (lines) in the Nelson River between Clark Lake and the Long Spruce GS between October 2018 and June 2019. Red dashes indicate lost receivers.

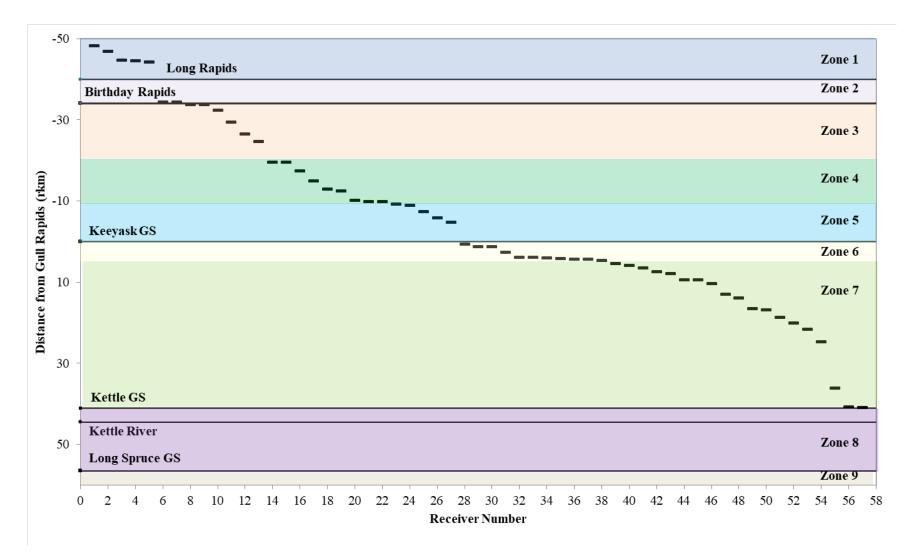
Figure 2: Locations of stationary acoustic receivers (dashes) in relation to the base of the Keeyask GS (rkm 0) and other major landmarks (lines) in the Nelson River between Clark Lake and the Long Spruce GS between June and October, 2019. River zones are indicated by different colours.

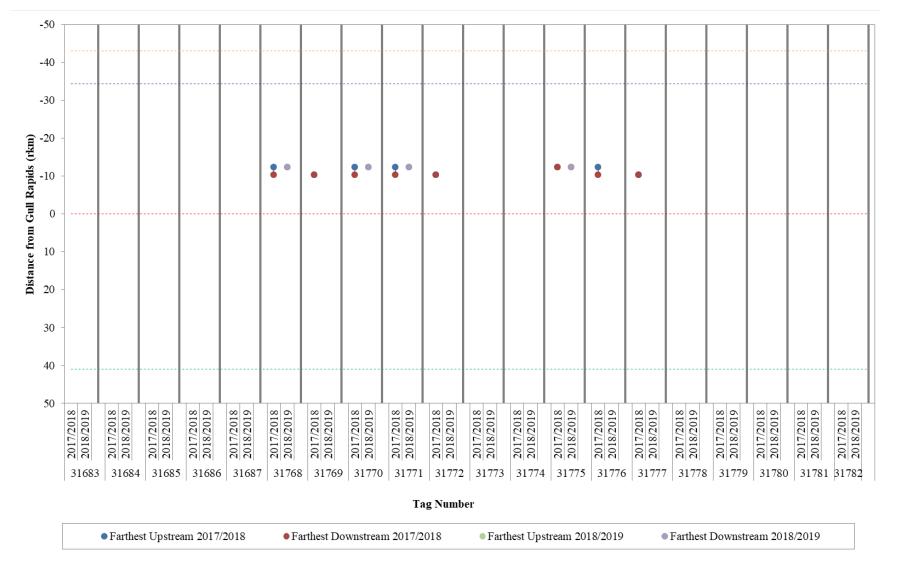
Figure 3: Detection ranges for acoustic tagged juvenile Lake Sturgeon detected between Clark Lake and the Keeyask GS during the winter period (2017–2019). Horizontal dotted lines indicate locations of landmarks (orange = Clark Lake outlet; blue = Birthday Rapids, red = the Keeyask GS; green = Kettle GS).

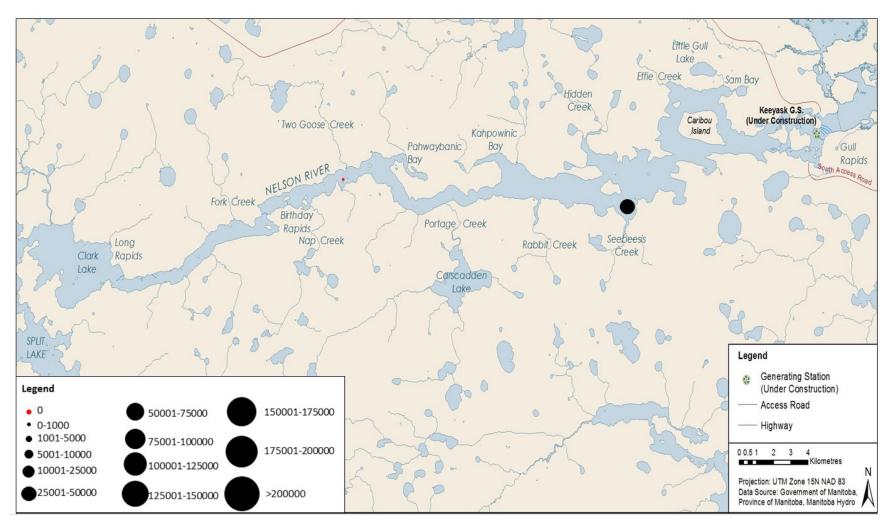
Figure 4: Relative number of detections at each acoustic receiver set between Clark Lake and the Keeyask GS during winter 2018/2019 (October 11, 2018, to April 30, 2019). Number of detections indicated by size of bubble (defined in legend). Receivers with no detections indicated with red dot.

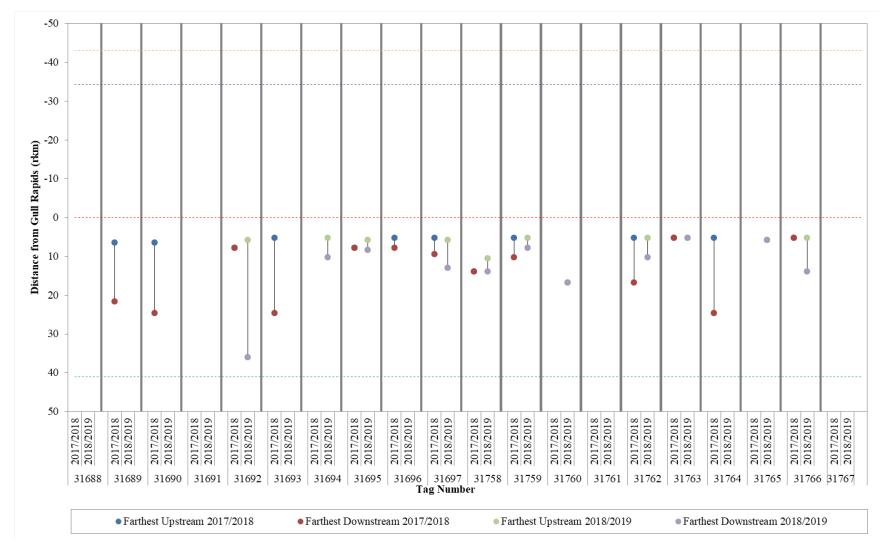
Figure 5: Detection ranges for acoustic tagged juvenile Lake Sturgeon detected in Stephens Lake during the winter period (2017–2019). Horizontal dotted lines indicate locations of landmarks (orange = Clark Lake outlet; blue = Birthday Rapids, red = the Keeyask GS; green = Kettle GS).

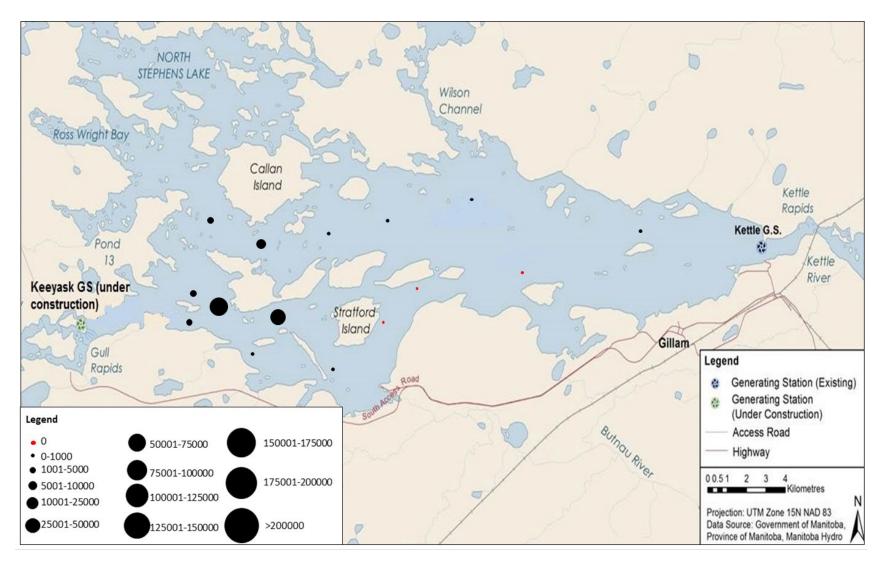
Figure 6: Relative number of detections at each acoustic receiver set in Stephens Lake during winter 2018/2019 (October 11, 2018, to April 30, 2019). Number of detections indicated by size of bubble (defined in legend). Receivers with no detections indicated with red dot.

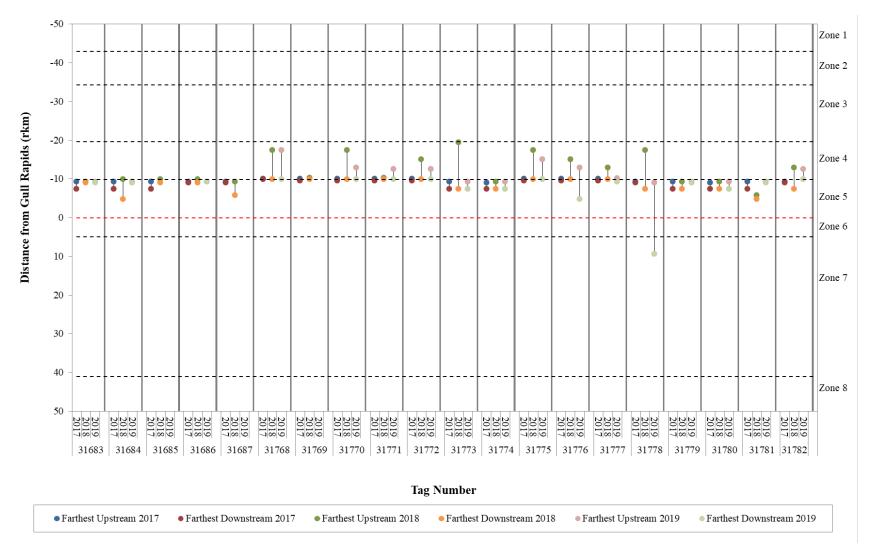
Figure 7: Detection ranges for individual juvenile Lake Sturgeon tagged with acoustic transmitters upstream of Gull Rapids/the Keeyask GS during the open-water period (2017–2019). Horizontal dotted lines demarcate zones with the red line representing the Keeyask GS.

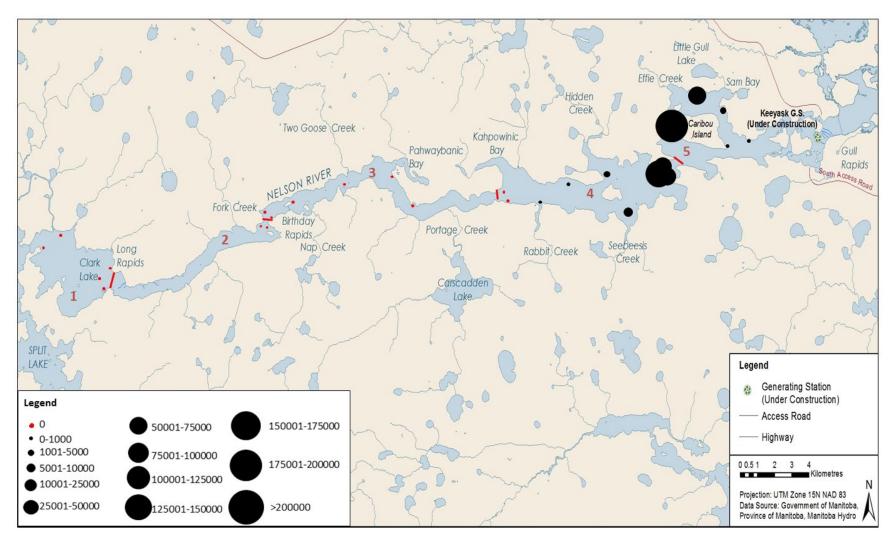
Figure 8: Relative number of detections at each acoustic receiver set in the Nelson River between Clark Lake and the Keeyask GS during the 2019 open-water period (May 1 to October 7). Number of detections indicated by size of bubble (defined in legend). Receivers with no detections indicated with red dot. The river is divided into five "zones" based on placement of receiver "gates."

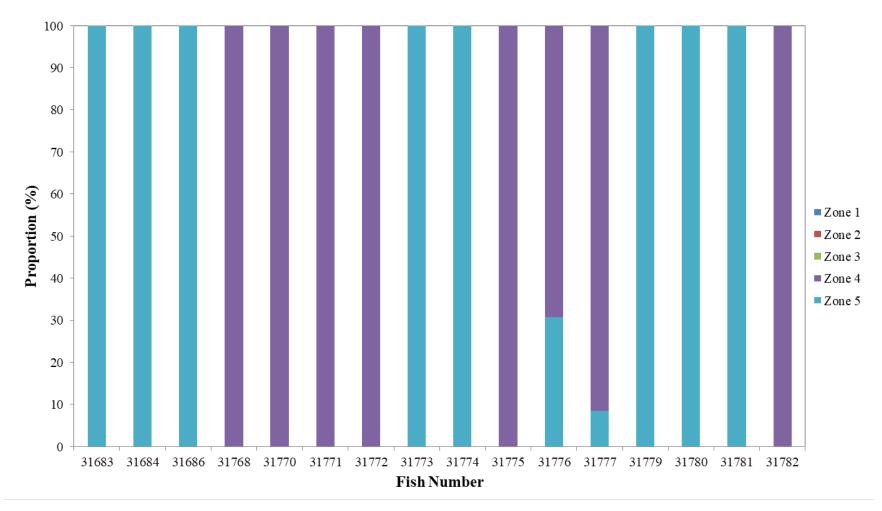
Figure 9: Proportional distributions by zone for individual juvenile Lake Sturgeon between Clark Lake and the Keeyask GS during a portion of the 2019 open-water period (June 2 to October 7). The single fish that moved downstream through the Keeyask GS during open-water 2019 was not included in the analysis.

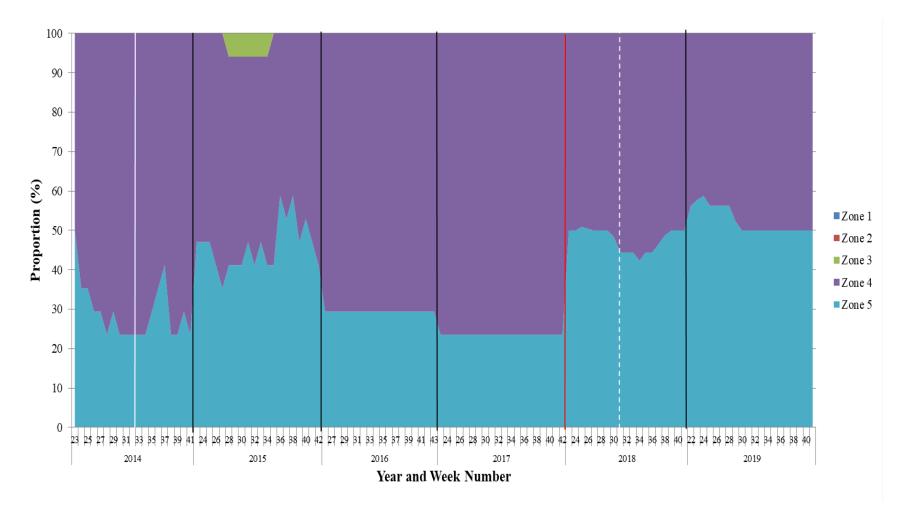
Figure 10: Proportional distribution by zone per week for juvenile Lake Sturgeon between Clark Lake and Gull Rapids/the Keeyask GS during a portion of the open-water periods of 2014 (June 4 to October 10), 2015 (June 4 to October 11), 2016 (June 25 to October 19), 2017 (June 7 to October 16), 2018 (June 6 to October 10), and 2019 (June 2 to October 7). White solid line indicates start of construction while white dashed line indicates start of spillway operation. Red solid line indicates when tags expired and new fish were tagged.

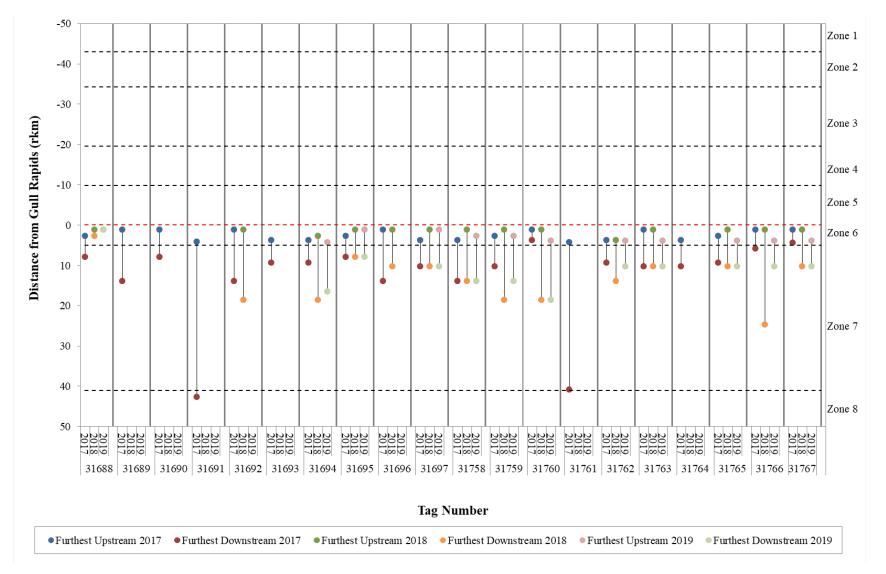
Figure 11:Detection ranges for acoustic tagged juvenile Lake Sturgeon in Stephens Lake during the open-water periods of
2017–2019. Horizontal dotted lines demarcate zones with the red line representing the Keeyask GS.

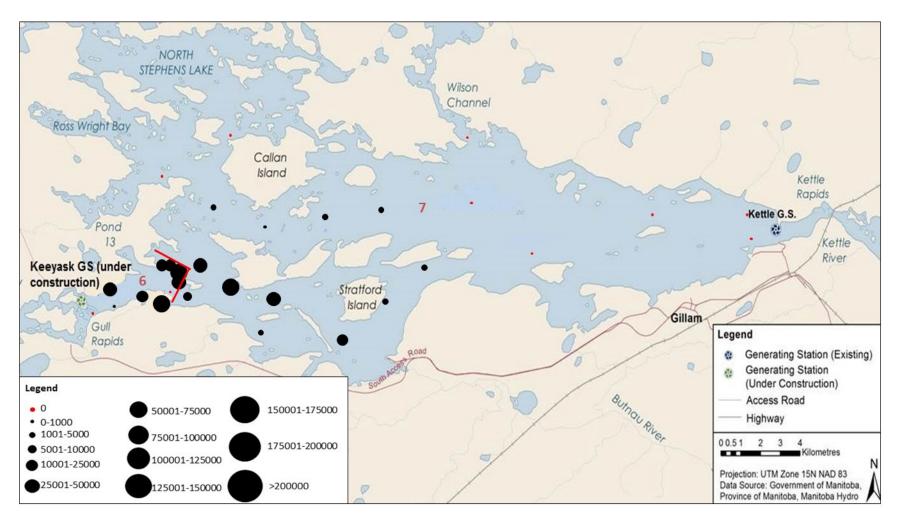
Figure 12: Relative number of detections at each acoustic receiver set in Stephens Lake during the 2019 open-water period (May 1 to October 7). Number of detections indicated by size of bubble (defined in legend). Receivers with no detections indicated with red dot.

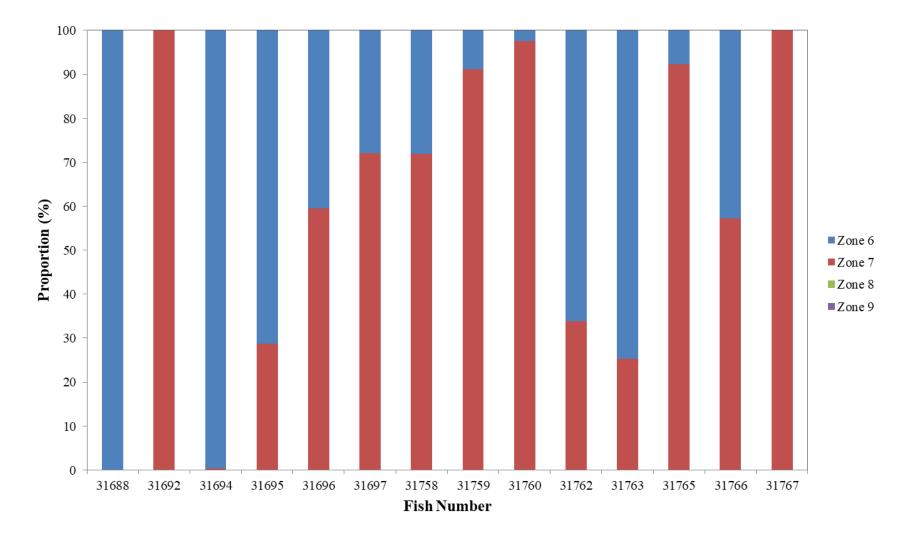
Figure 13: Proportional distributions by zone, for individual juvenile Lake Sturgeon tagged with acoustic transmitters in Stephens Lake during a portion of the 2019 open-water period (June 2 to October 2).

On average, fish spent more time in Zone 7, farther from the Keeyask GS (average = 59%; StDev = 36%), than in Zone 6 (average: 41%; StDev = 36%) (Table 3; Figure 13). Time spent in Zone 6 increased at the end of August, then remained relatively stable for the remainder of the open-water period (Figure 14). Fish spent an average of 36% of the time in Zone 6 between June 1 and August 26 (StDev = 9%) and 50% of the time between August 27 and October 7 (StDev = 3%). This is similar to the pattern observed in 2018.

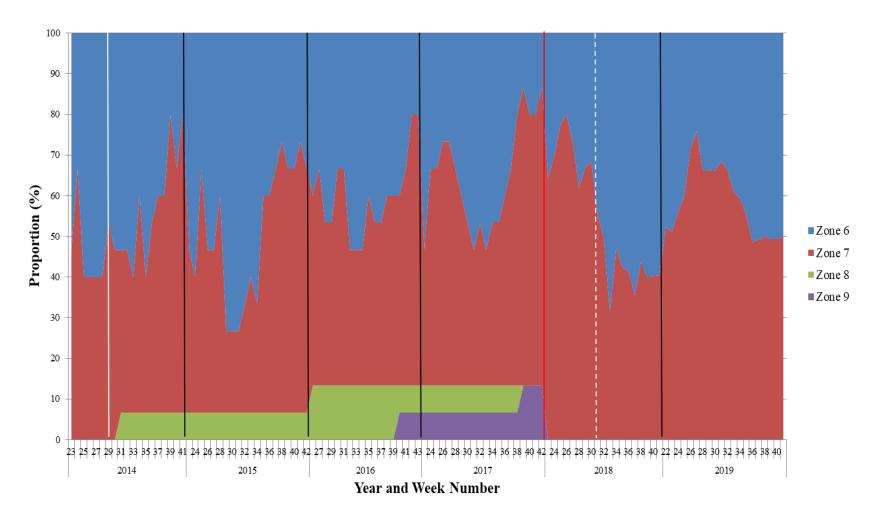
Figure 14: Proportional distribution by zone per week for juvenile Lake Sturgeon downstream of Gull Rapids/the Keeyask GS during a portion of the open-water periods of 2014 (June 4 to October 10), 2015 (June 4 to October 11), 2016 (June 25 to October 19), 2017 (June 7 to October 16), 2018 (June 6 to October 10), and 2014 (June 2 to October 7). White solid vertical line indicates start of construction while white dashed line indicates start of spillway operation. No receivers were in place in zones 8 or 9 in 2018 or 2019. Red solid line indicates when tags expired and new fish were tagged.

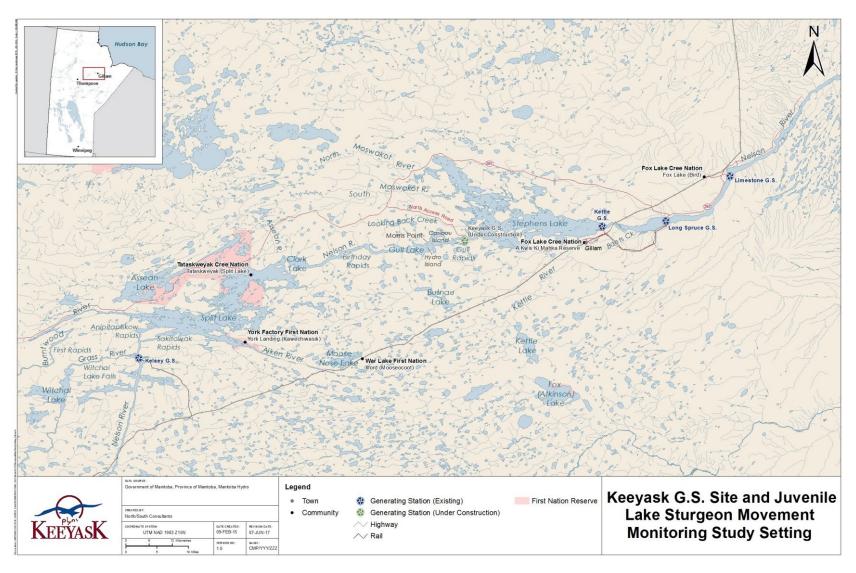
Map 1: Map of the Nelson River showing the site of the Keeyask Generating Station and the juvenile Lake Sturgeon movement monitoring study setting.

The study area encompasses an approximately 110 km long reach of the Nelson River from Clark Lake to the upstream end of the Limestone Reservoir (Map 1). This section of river offers a diversity of physical habitat conditions, including a variety of substrate types, and variable water depths (range 0–30 m) and velocities. Water velocities were classified as low (0.2–0.5 metres per second [m/s]), moderate (0.5–1.5 m/s), or high (greater than 1.5 m/s), as described in the Keeyask AE SV.

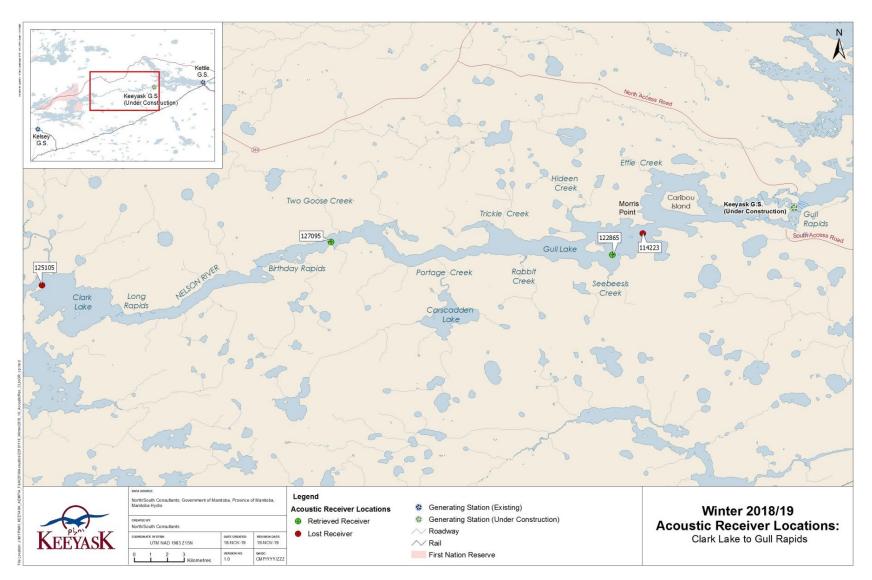
Map 3: Locations of stationary receivers set in the Nelson River from Clark Lake to the Keeyask GS between October 2018 and June 2019.

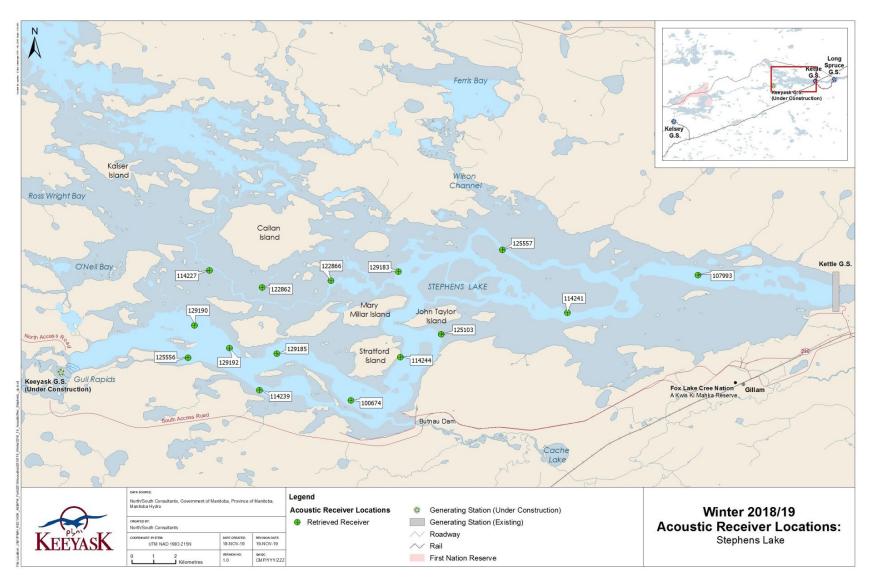
Map 4: Locations of stationary receivers set in Stephens Lake from the Keeyask GS to Kettle GS between October 2018 and June 2019. The former (pre-impoundment at Kettle GS) river channel is shown in light blue.

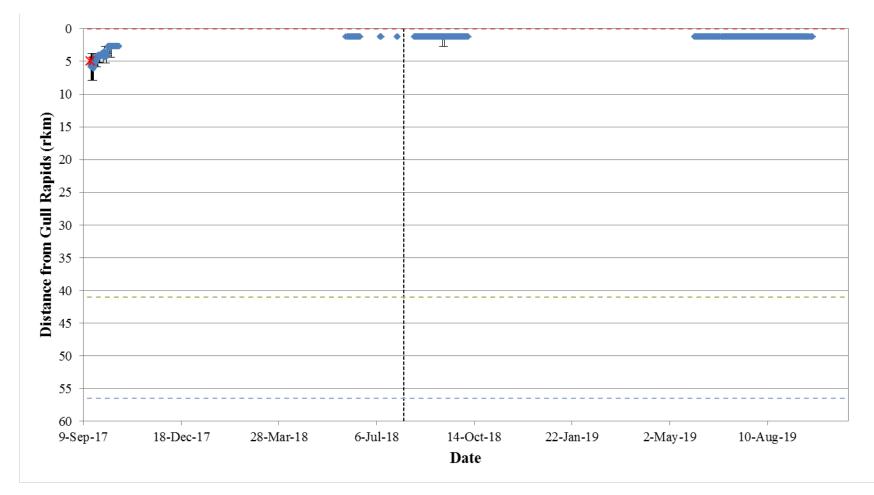
Figure A2-1: Position of a Lake Sturgeon tagged with an acoustic transmitter (code #31668) in Stephens Lake in relation to the Keeyask GS (rkm 0), 9 September 2017 to 7 October, 2019. Date and location of tagging is indicated in red. Error bars are shown in solid black. Horizontal dashed lines indicate the positions of Keeyask GS (red), Kettle GS (green), and Long Spruce GS (blue). Dashed black vertical line indicates start of spillway operation (Aug 3, 2018).

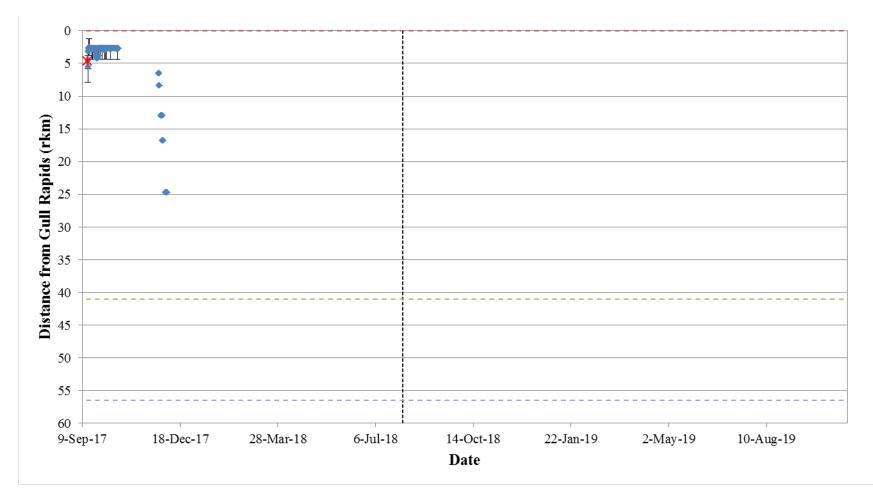
Figure A2-3: Position of a Lake Sturgeon tagged with an acoustic transmitter (code #31690) in Stephens Lake in relation to the Keeyask GS (rkm 0), from September 9, 2017 to October 7, 2019. Date and location of tagging is indicated in red. Error bars are shown in solid black. Horizontal dashed lines indicate the positions of Keeyask GS (red), Kettle GS (green), and Long Spruce GS (purple). Dashed black vertical line indicates start of spillway operation (Aug 3, 2018).
