# Keeyask Generation Project

## Sediment Management Plan for In-stream Construction

# Sediment Management Plan Report

SMP-2020-01

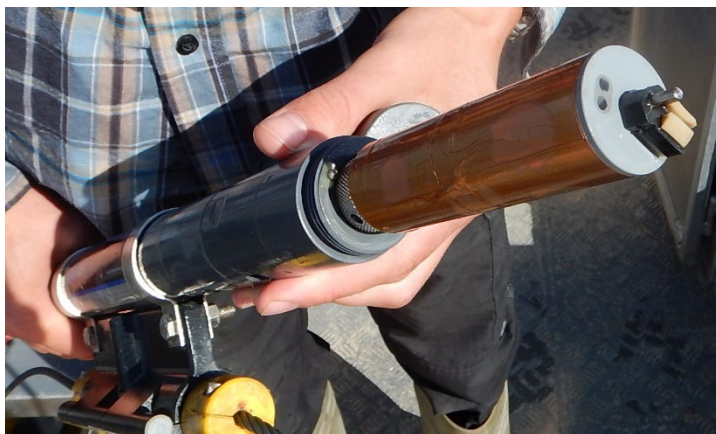
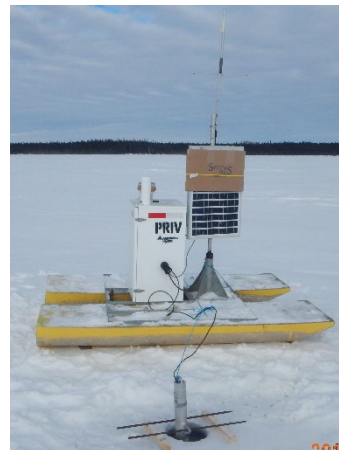
**A turbidity sensor (left) is used for determining the sediment in the water. It is suspended in the water from a catamaran (right), which is used in both summer and winter for the SMP.**

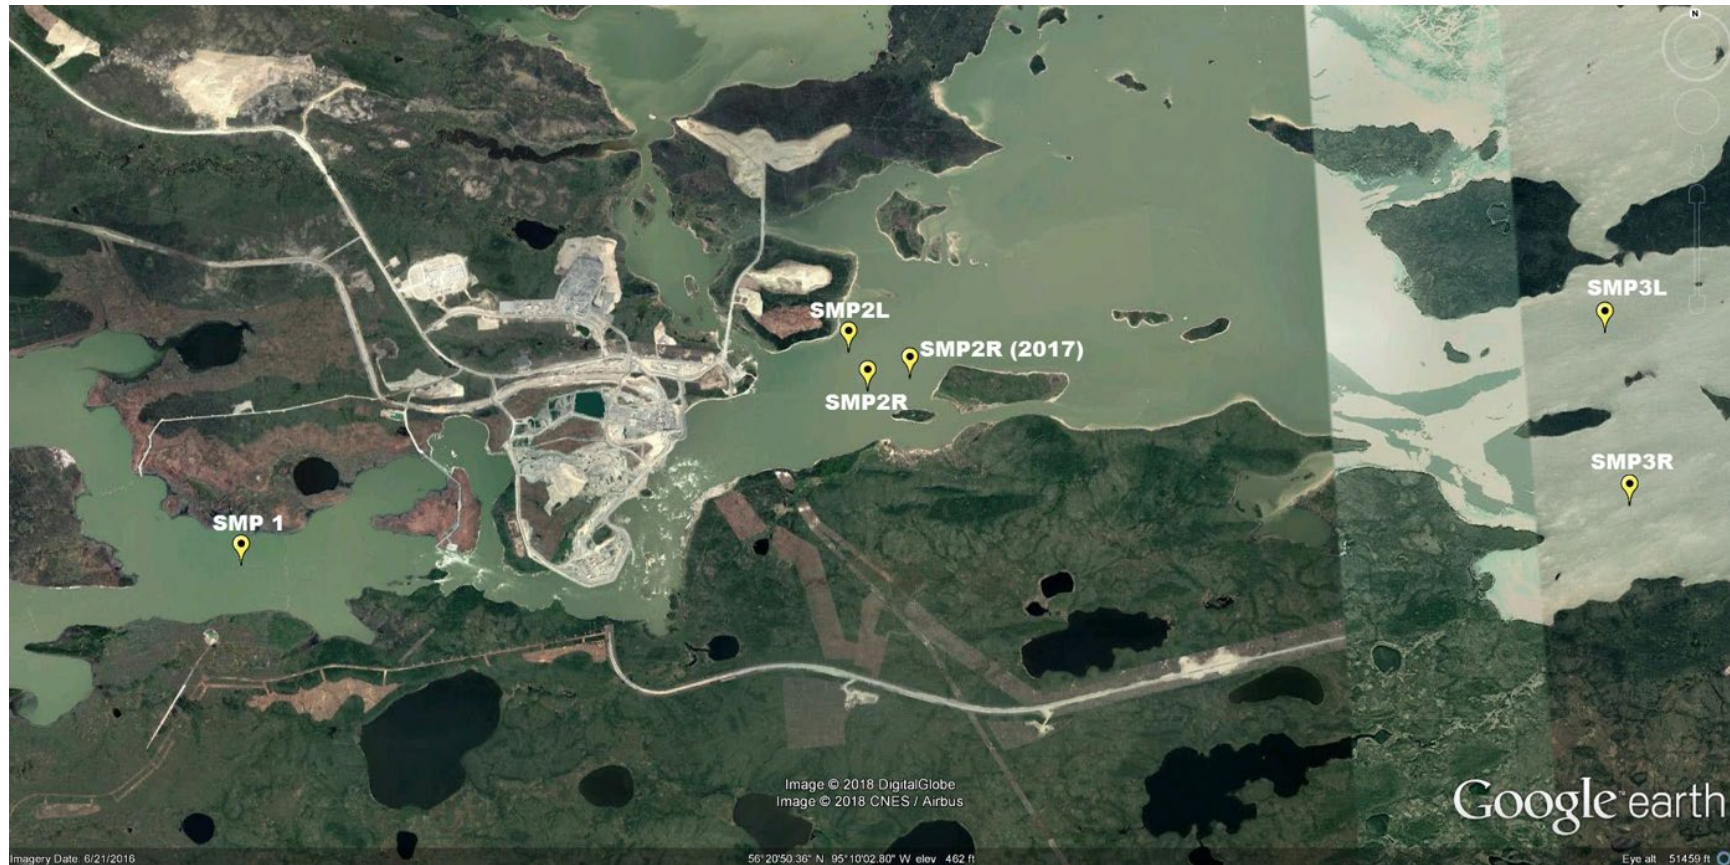
**Figure 2: Open water monitoring stations for the Keeyask Sediment Management Plan**

During the month of June 2019, the open water monitoring stations were installed on the Nelson River. Five monitoring stations (SMP-1, SMP-2L & SMP-2R, SMP-3L & SMP-3R) were deployed as outlined in the SMP to collect turbidity data for the Project. A backup station (SMP-1A) was installed near SMP-1 as a precaution, so background data would be continuously available if SMP-1, which is the sole upstream monitoring station, failed or became damaged. At each station, sensors were installed two meters below the water's surface (designated TSSS) and two meters above the bottom of the channel (designated TSSB). Figure 2 shows the location of each of the SMP open water monitoring stations. The stations are described in more detail below:

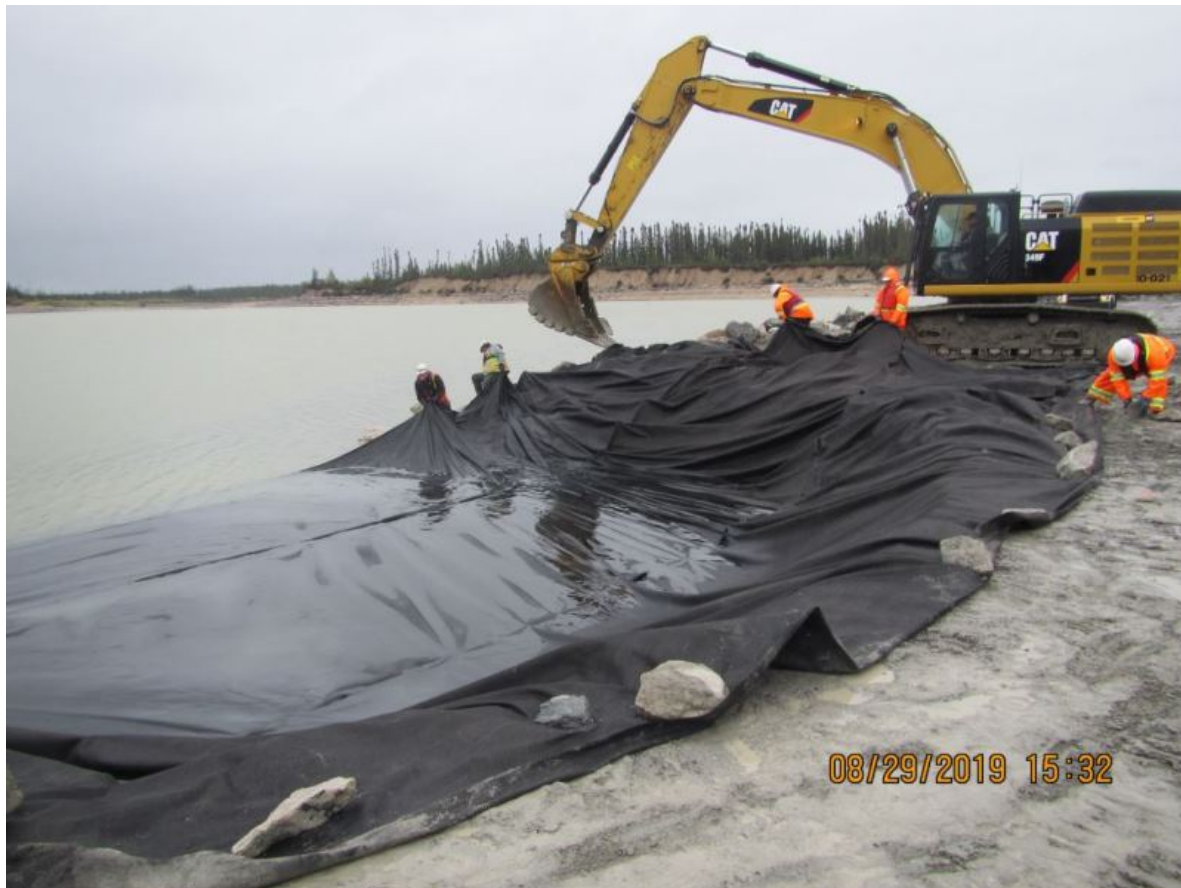
**Figure 5: Geotextile is placed while constructing a finger drain at the South Dam**

Finger drains were constructed between August 28-30, 2019 at four locations along the downstream side of the South Dam to promote drainage (Figure 5). These drains are a permanent feature of the structure. There were no measurable changes to the TSS in the river during this time frame (Figure 6 and Figure 7).

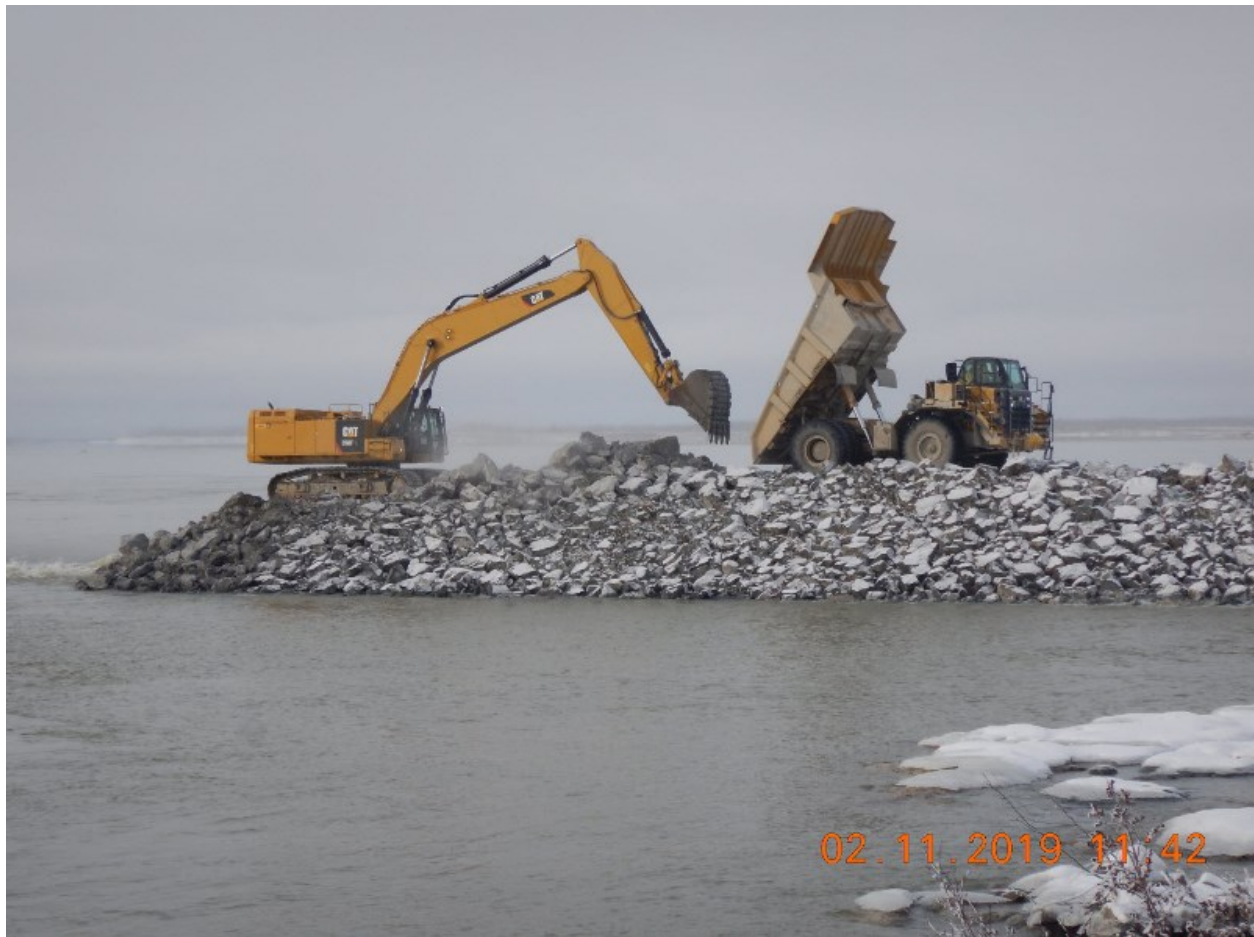
**Figure 8:** An excavator places large rockfill delivered by a haul truck into the river for the NCRG Extension

The North Channel Rock Groin (NCRG) was re-installed from October 26 to November 7, 2019 (Figure 8) to counteract the increasing Nelson River inflows and promote the formation of an ice cover in concert with the Keeyask ice booms. The SMP real-time monitoring stations were not deployed, nor was it possible to safely take spot measurements downstream. There were no sediment plumes observed during this work.

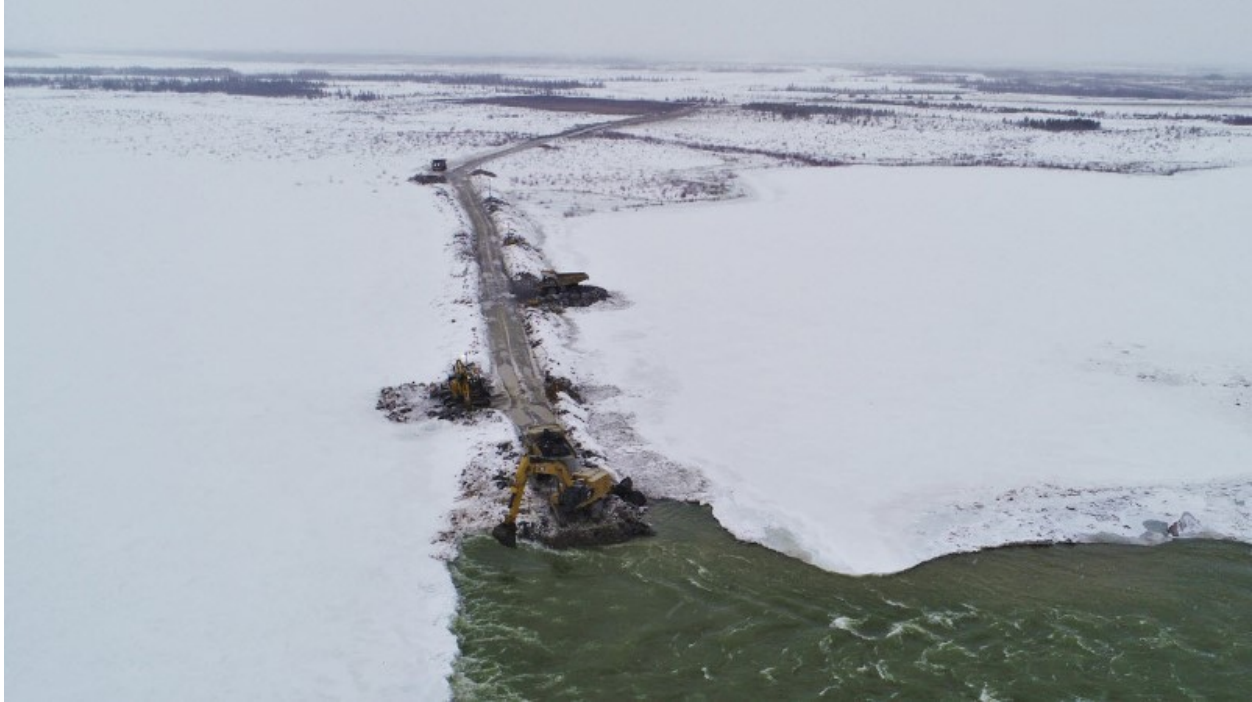
**Figure 9: Excavation of the NCRG. Photo taken facing northwest on March 27, 2020.**

The North Channel Rock Groin (NCRG) was constructed in 2014 and can be seen in Figure 1. Removal of the NCRG occurred between March 21 and April 9, 2020 (Figure 9).

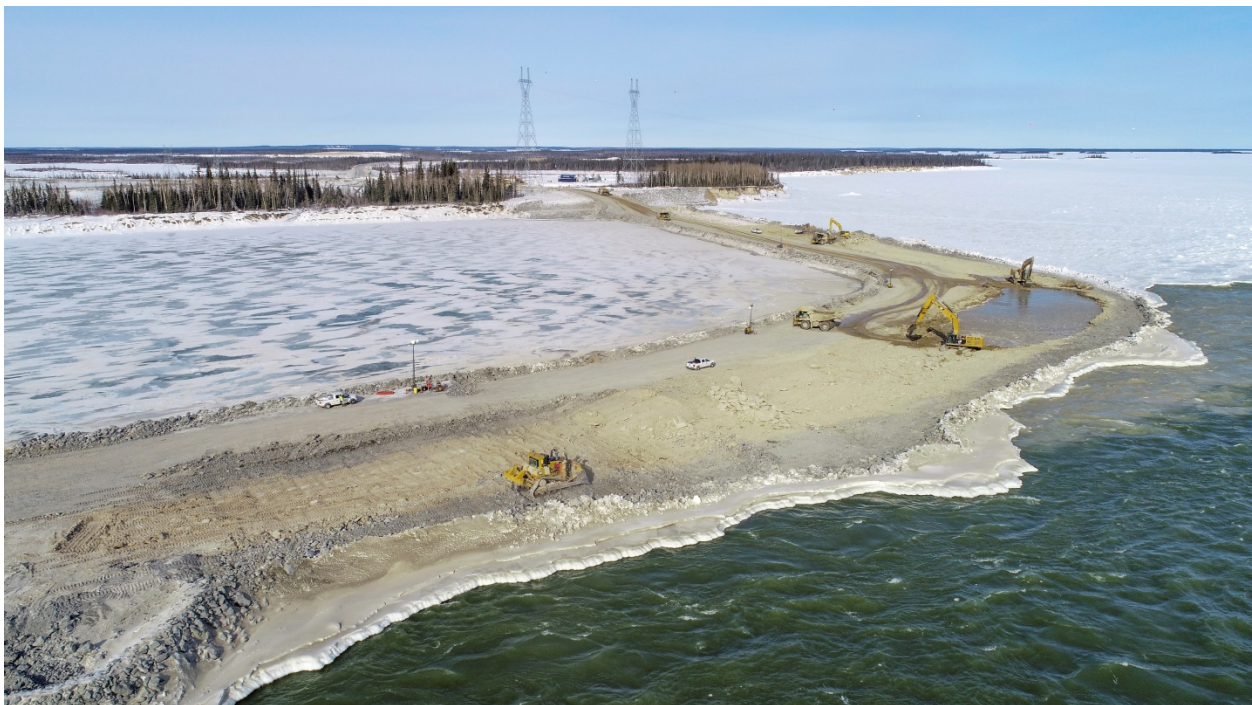
**Figure 12: Removal in the wet of the TRCD. A small sediment plume can be seen on the right side of the photo. Photograph taken facing northeast, March 13, 2020**

The TRCD has an inner and outer rock groin, and between the groins is a central core of semi-pervious and impervious material. Removal of the TRCD in the wet began on March 12, 2020. During the removal of the core material, which consists of fine material, a small sediment plume could be seen in the river (Figure 12). Care was taken to reduce the fine material from being carried away in the current by removing the core in advance of the rock groins to maintain a less turbulent area between the two (Figure 13). No measurable change in the river TSS levels were detected downstream by the SMP sensors (Figure 14 and Figure 15). The TRCD removal continued after March 31, 2020.

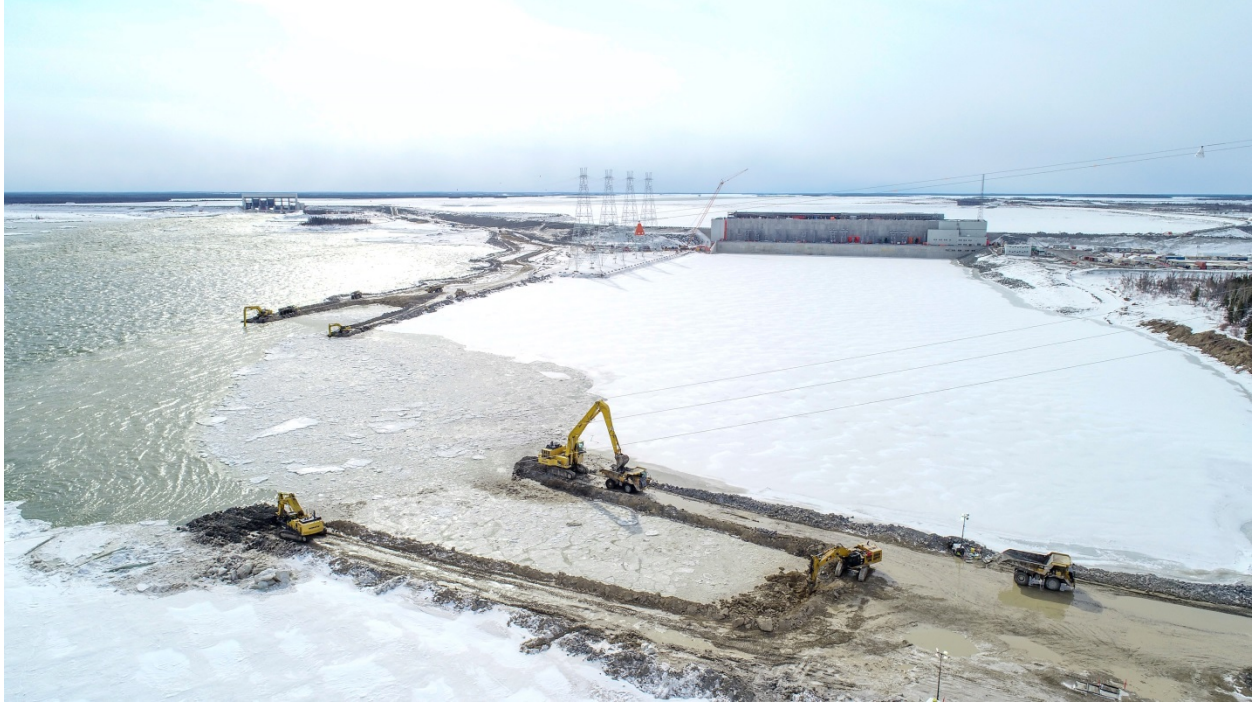
**Figure 13:** Removal of the TRCD facing west towards the Powerhouse. The inner and outer groins can be seen protruding past the core material, which was taken out first to minimize the suspension of the fine material. Photo taken on April 19, 2020.

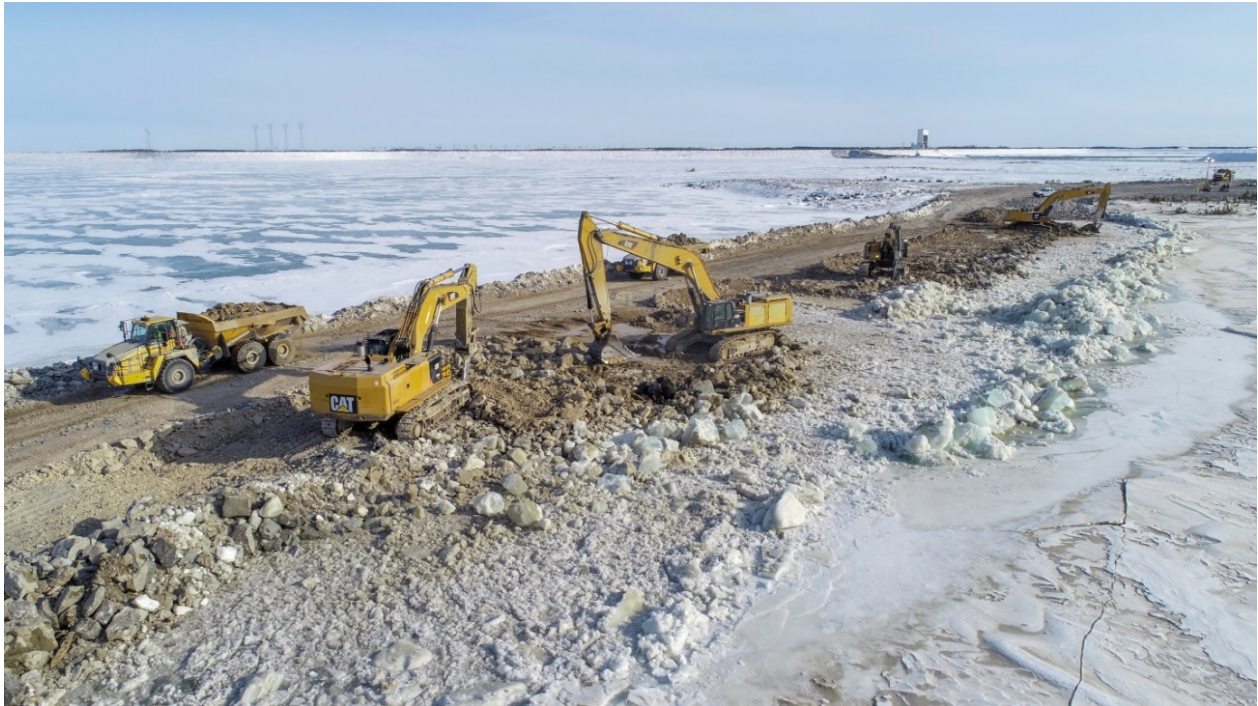
**Figure 16: Removal of the NCCD. Photo facing south and taken March 13, 2020.**

Excavation of the NCCD in the wet commenced on March 13 and continued until March 20, 2020. Numerous excavators were used to conduct the work, starting on the upstream side (Figure 16) and moving to the downstream side. (Figure 17). There was no measurable effect on instream TSS levels measured by the SMP sensors during the work (Figure 18 and Figure 19).

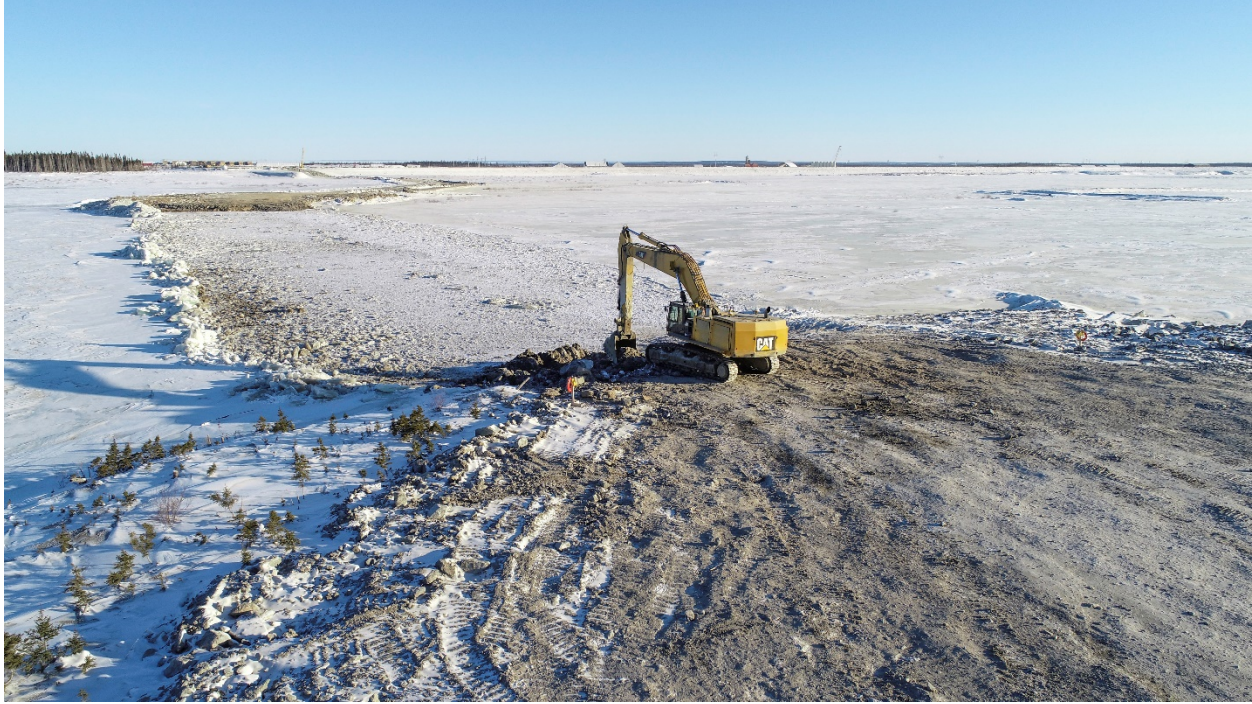
**Figure 17:** Removal of the NCCD after completion. The photo was taken facing north on March 20, 2020.
