Keeyask Generation Project
Aquatic Effects Monitoring Plan

Zebra Mussel Monitoring Report
ZMMP-2020-01

ZEBRA MUSSEL MONITORING PLAN

ANNUAL REPORT

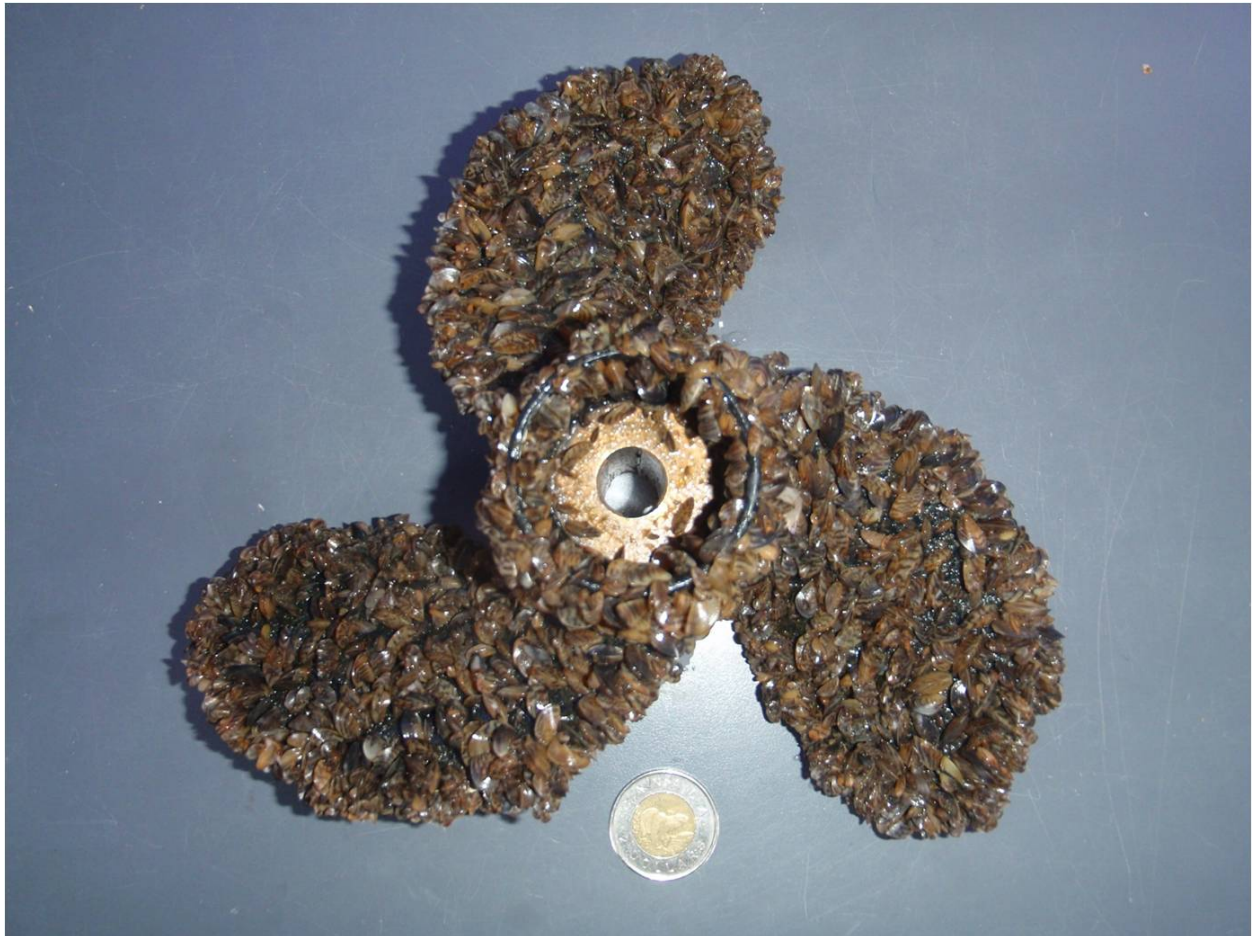
Figure 1: Once present, zebra mussels grow on hard surfaces that are in the water, as shown on this boat propeller. Each mussel is approximately the size of a finger nail.

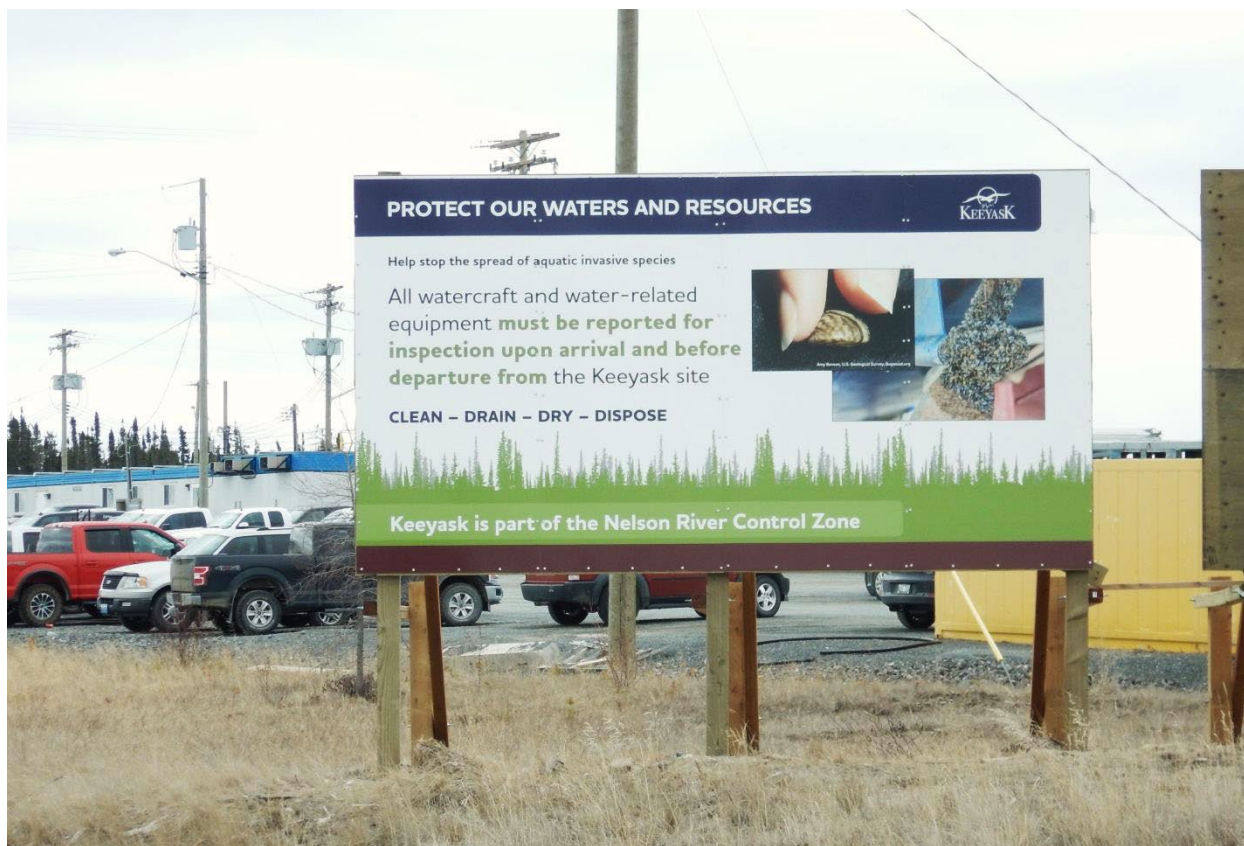
Figure 2: A sign is located at the main gate to remind site users to report for inspection of watercraft and water-related equipment

In fall 2019, the Keeyask Watercraft Transport Procedure was sent to all Manitoba Hydro staff and contractors on site to ensure all Aquatic Invasive Species regulatory requirements are met. Site environmental inspectors received refresher training regarding the requirements related to aquatic invasive species legislation, as well as provincially approved inspection and decontamination techniques for zebra mussels and other common aquatic invasive species (AIS). The site orientation session given to all Keeyask employees, contractors, and visitors includes a section on AIS and provides the regulatory requirements for decontaminating watercraft and water-related equipment. Aquatic invasive species information posters are also displayed in Manitoba Hydro and contractor lunch rooms around the construction site to help familiarize people regarding what to look for, and how they can follow up if they find something. An information bulletin on zebra mussels and other aquatic invasive species was distributed to all contractors on site in May 2018 and it continues to be handed out. A sign posted at the main gate in 2018 remains in place to notify site users that Keeyask is in the Nelson River Control Zone and to remind personnel to report for inspection/decontamination of watercraft and water-related equipment when entering and leaving Keeyask (Figure 2).

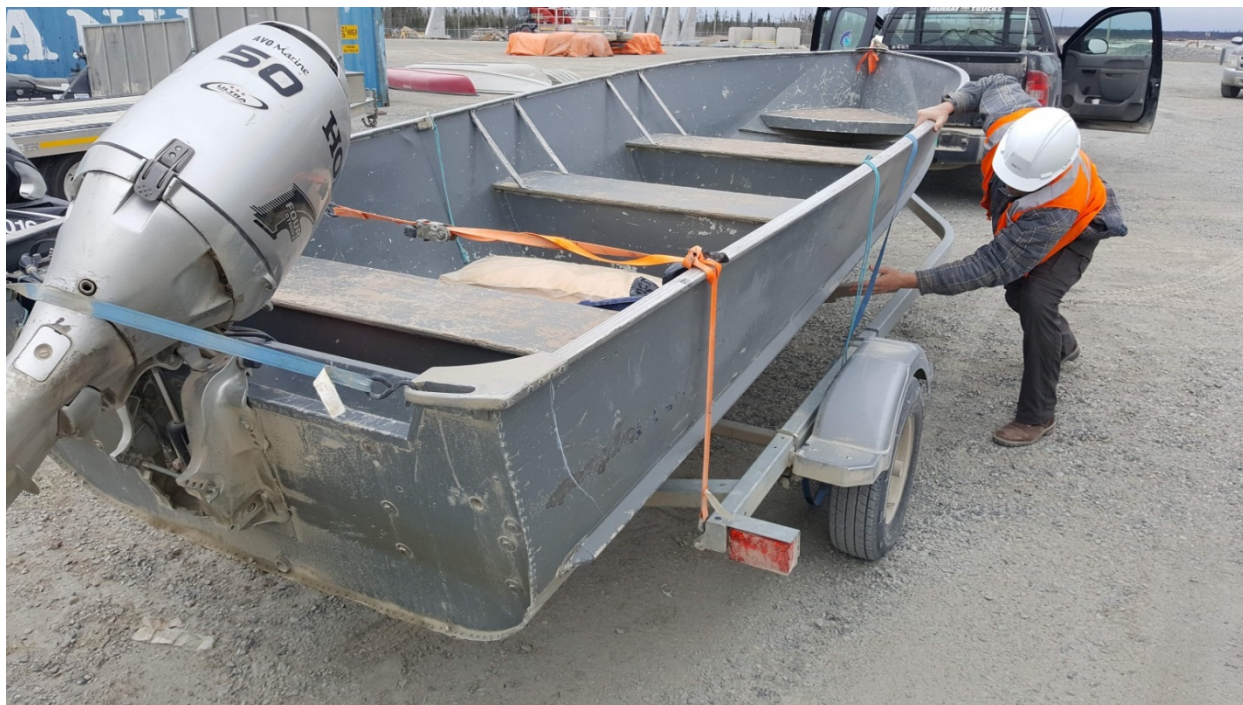
Figure 3: A boat being inspected for AIS upon arrival before entering the Nelson River on May 24, 2019.

From April 2019 to March 2020, all watercraft and water-related equipment was inspected for AIS upon arrival and departure from Keeyask. In total, seventy-two inspections (Figure 3) were conducted and four hot water decontaminations were performed on incoming and outgoing watercraft and water-related equipment.

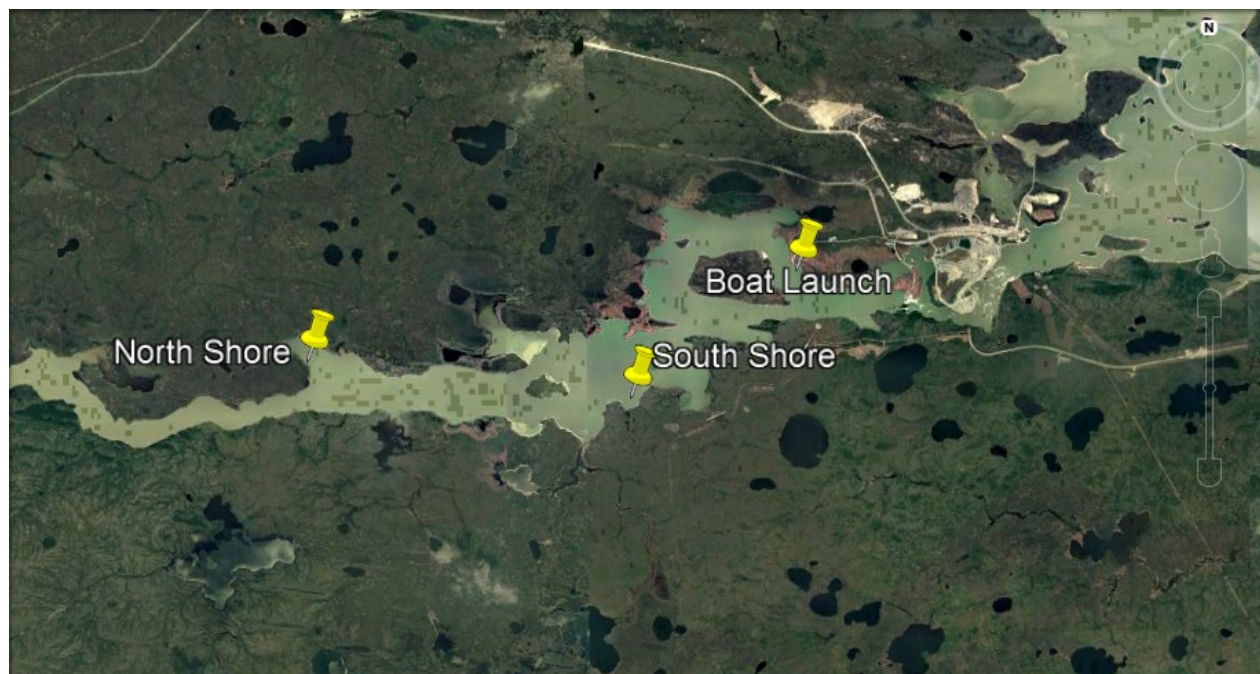
Figure 5: Location of sites in the Keeyask reservoir where artificial substrates were deployed to monitor for zebra mussel colonization.

Monitoring for adult zebra mussel colonization was done by establishing three sites in the Keeyask reservoir for placement of artificial substrates. Artificial substrates were deployed on May 30, 2019. Sites were located in low-flow areas (0.1-1.0 m/s) with a depth of approximately 4 m (Figure 5). At each site, terra cotta flower pots were used as artificial substrates; they were suspended in series along a rope at 1, 2, and 3 m depths, anchored in place with a cinderblock, and kept suspended in the water column by a buoy at the surface (Figure 6).

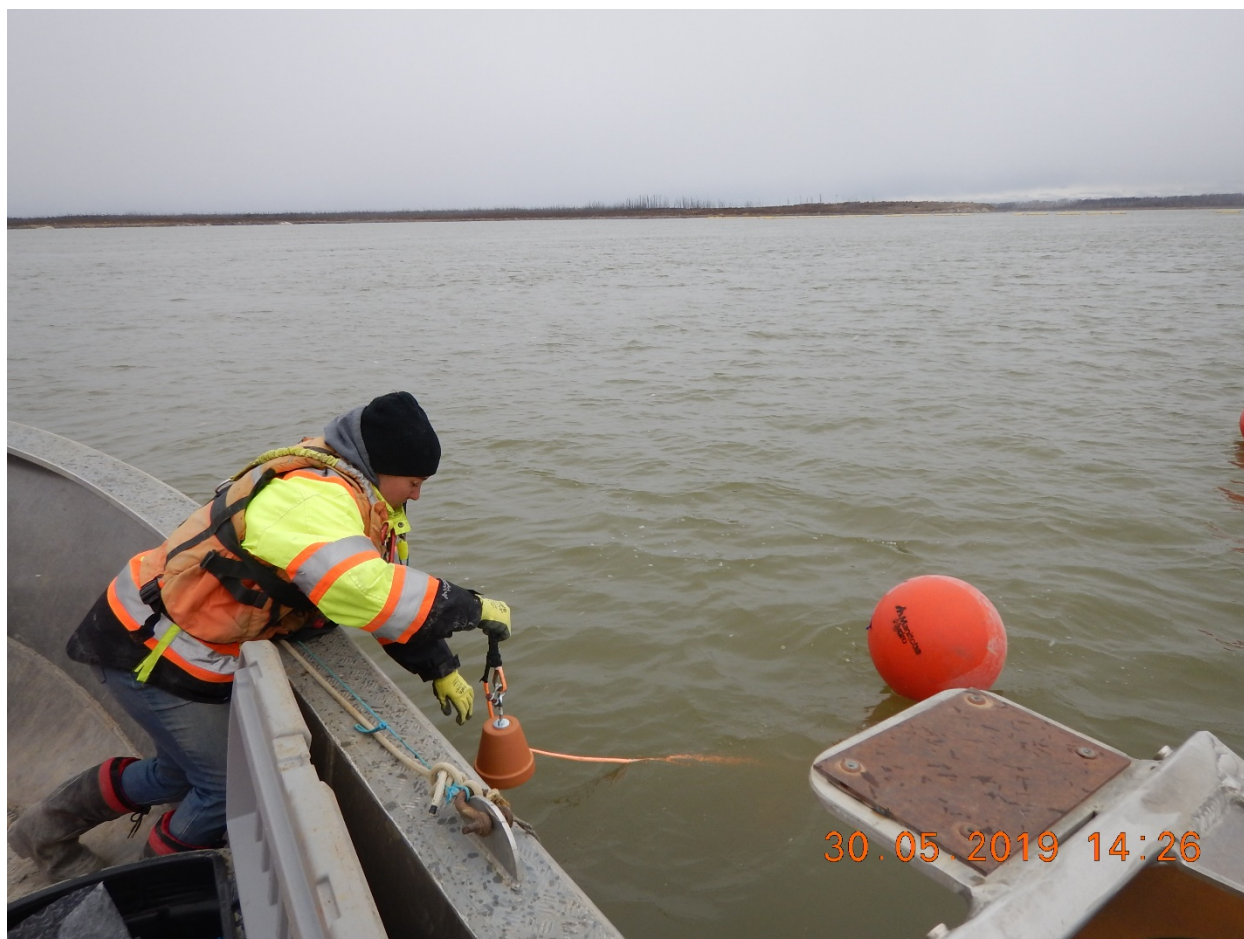
Figure 6: Installing artificial substrate to monitoring for zebra mussel colonization, May 30, 2019.

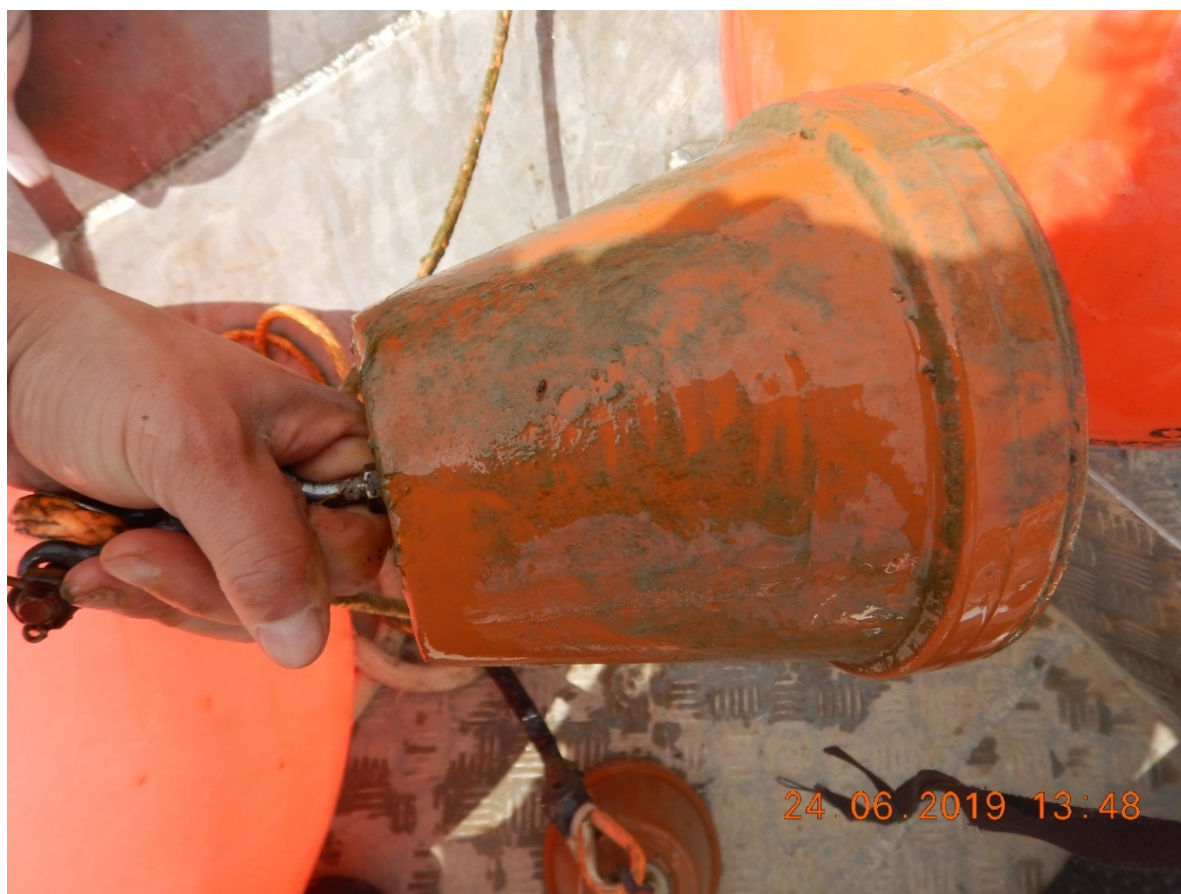
Figure 7: Photo of a monitoring substrate being checked for colonization by zebra mussels at the upstream boat launch site on June 24, 2019.

All three sites were checked monthly during the open-water period for the presence/absence of zebra mussels and a photograph was taken of each side of the substrate. If present, adult zebra mussels were to be counted and recorded. Site visits also included visual inspections of adjacent rocks, crevices, woody debris, docks, and vegetation for the presence of zebra mussels. On September 23, 2019, the artificial substrate and anchors (cinderblocks) were removed for the season, were inspected for the presence of zebra mussels and were photographed on all sides.
