Keeyask Generation Project  
Aquatic Effects Monitoring Plan

Adult Lake Sturgeon Movement Monitoring Report  
AEMP-2021-01

### **ADULT LAKE STURGEON MOVEMENT MONITORING IN THE NELSON RIVER BETWEEN CLARK LAKE AND THE LIMESTONE GENERATING STATION, OCTOBER 2019 TO SEPTEMBER 2020: YEAR 7 CONSTRUCTION**

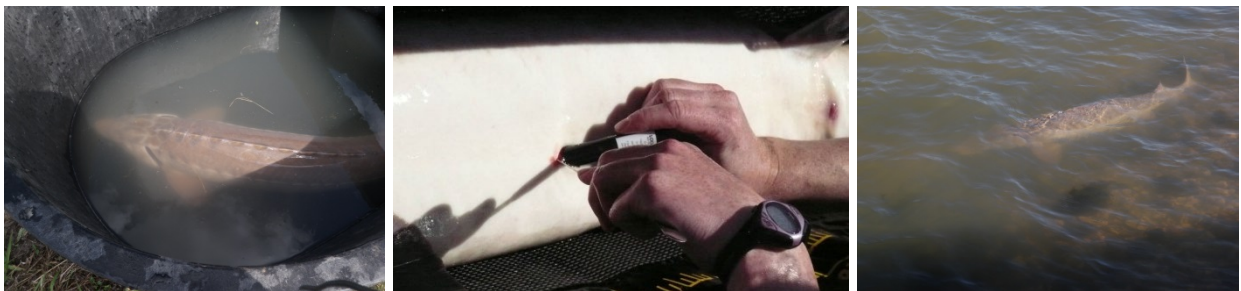
**Adult Lake Sturgeon being held in a tank prior to surgery (left). Acoustic tag being implanted in an adult Lake Sturgeon (middle). Adult Lake Sturgeon released into the river after acoustic surgery (right).**

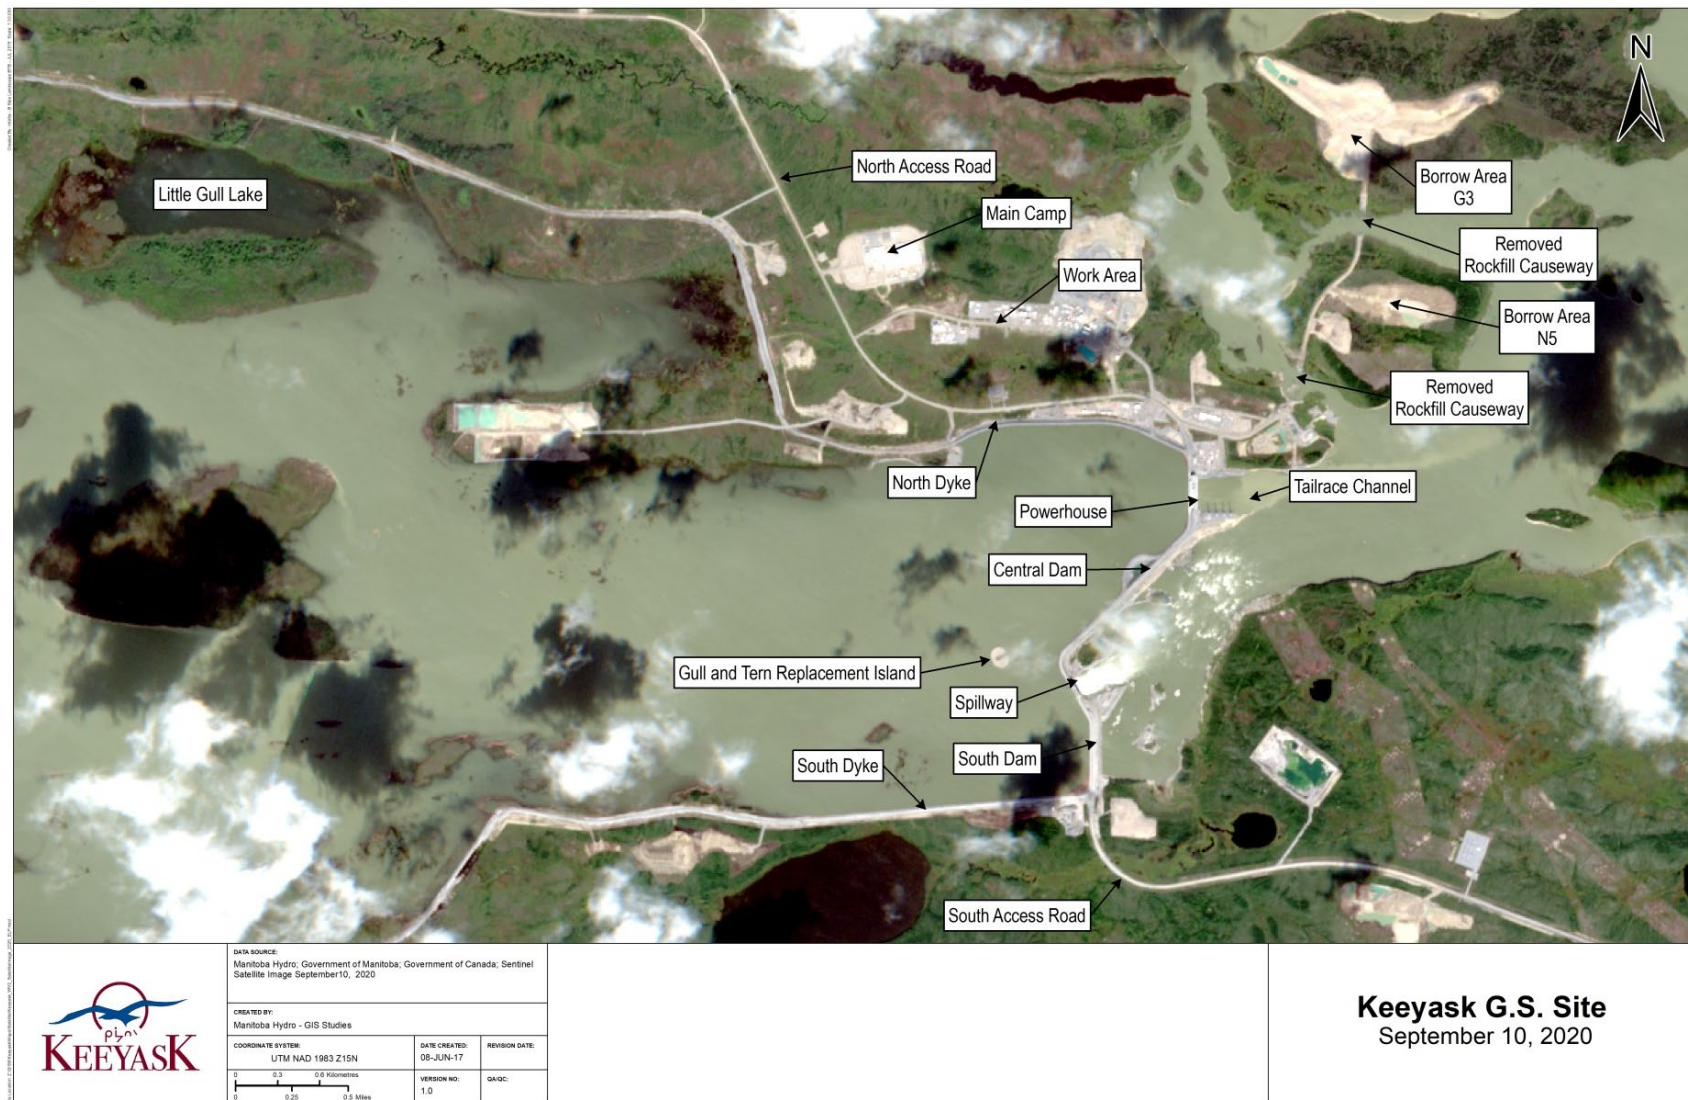
**Map illustrating instream structures at the Keeyask Generating Station site after reservoir flooding, September 2020.**

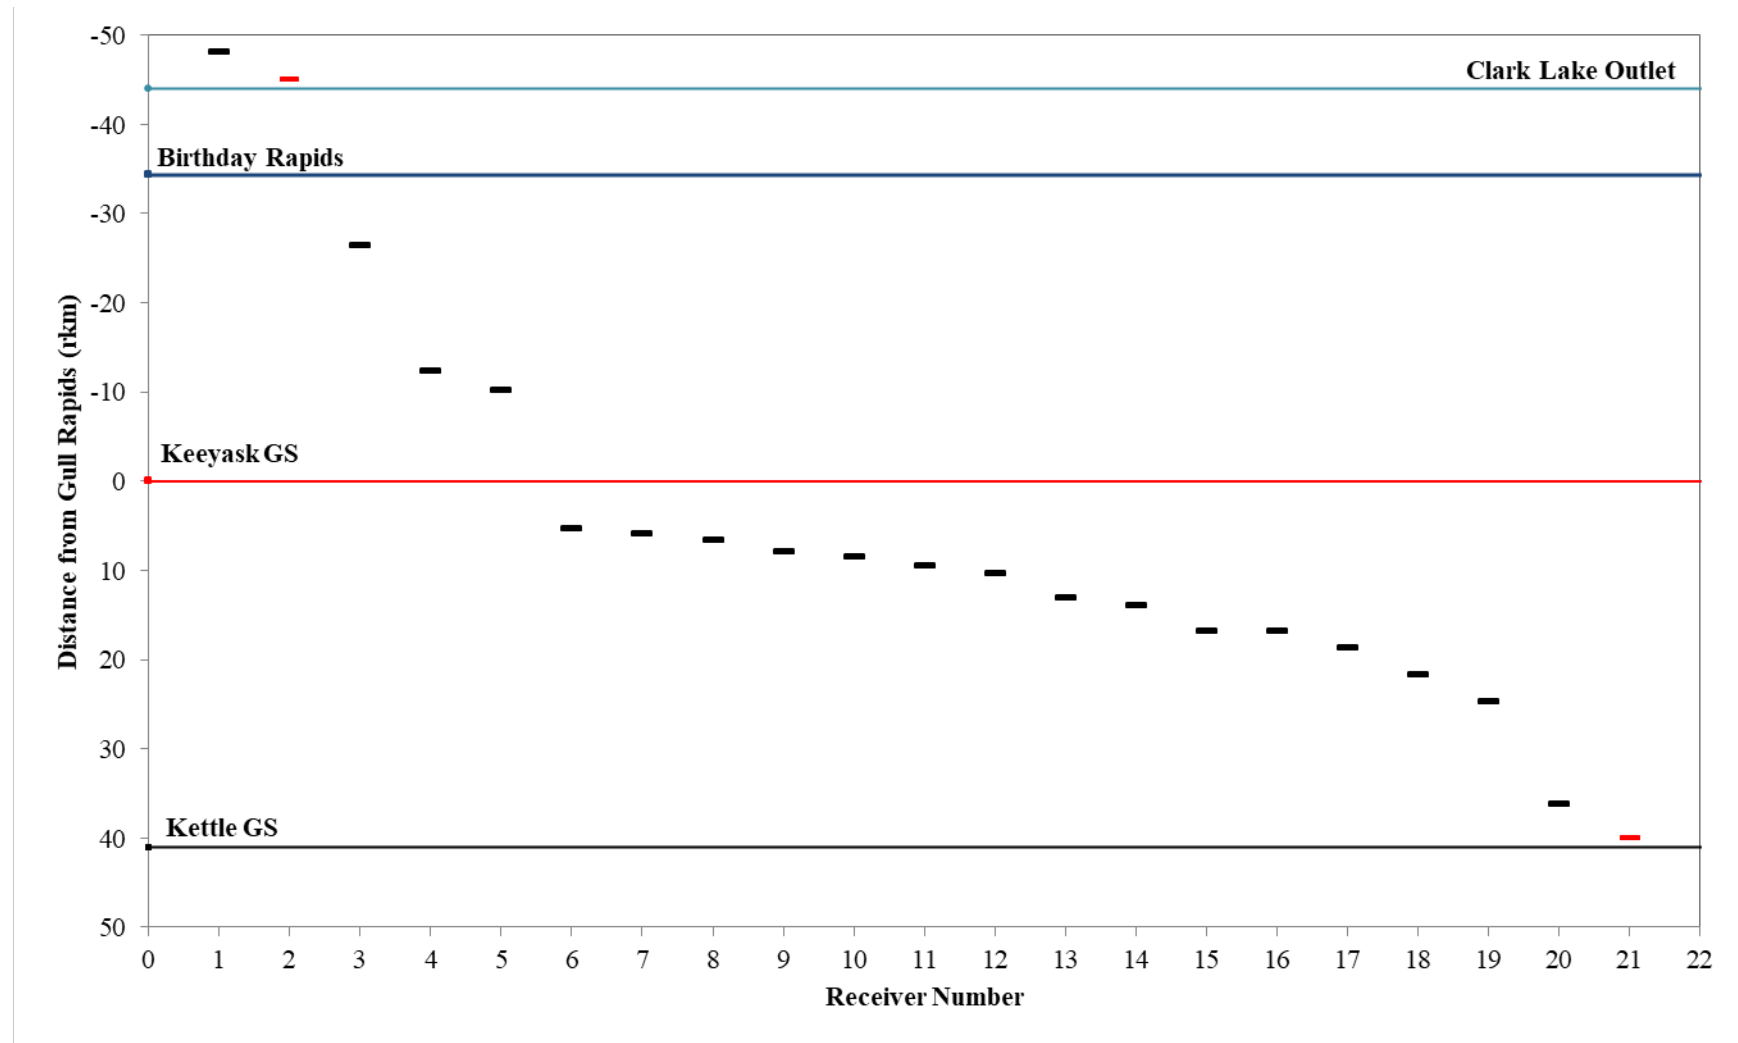
**Figure 1:** Locations of stationary acoustic receivers (dashes) in relation to the base of the Keeyask GS (rkm 0) and other major landmarks (lines) in the Nelson River between Clark Lake and the Kettle GS between October, 2019 and June, 2020. A red dash indicates a receiver that was lost.

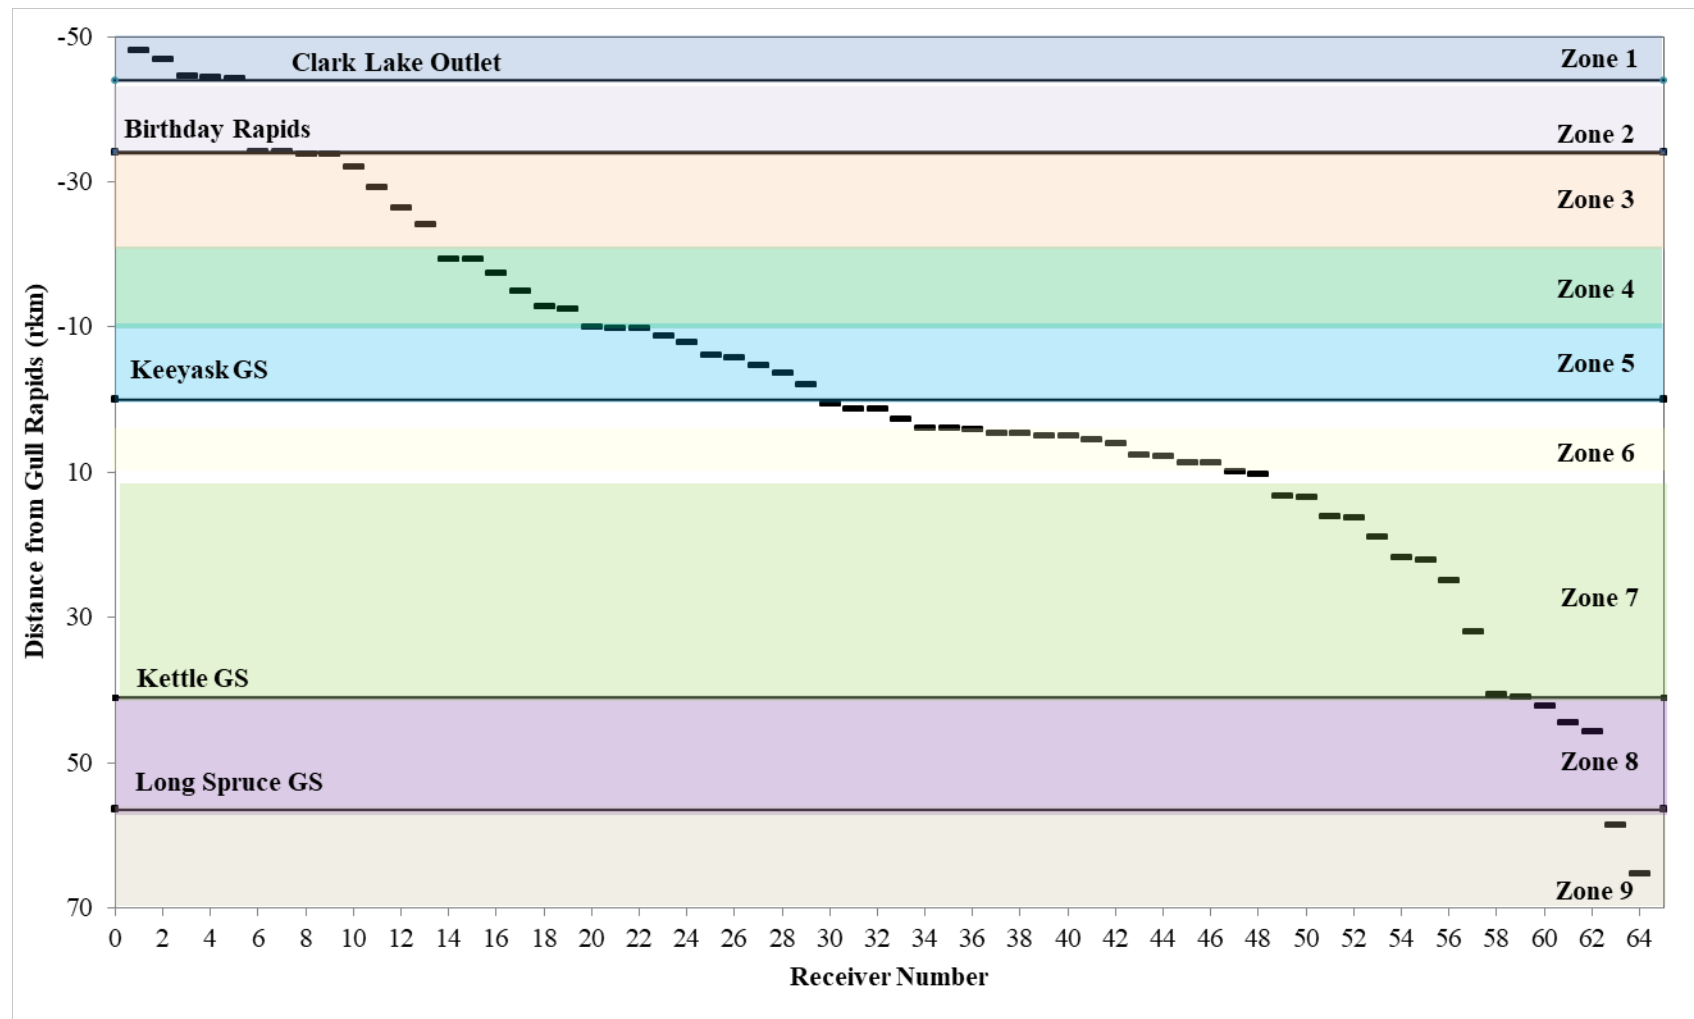
**Figure 2:** Locations of stationary acoustic receivers (dashes) in relation to the base of the Keeyask GS (rkm 0) and other major landmarks (lines) in the Nelson River between Clark Lake (zone 1) and the Limestone GS reservoir (Zone 9) between June and October, 2020. River zones upstream and downstream of Gull Rapids are indicated by shading.

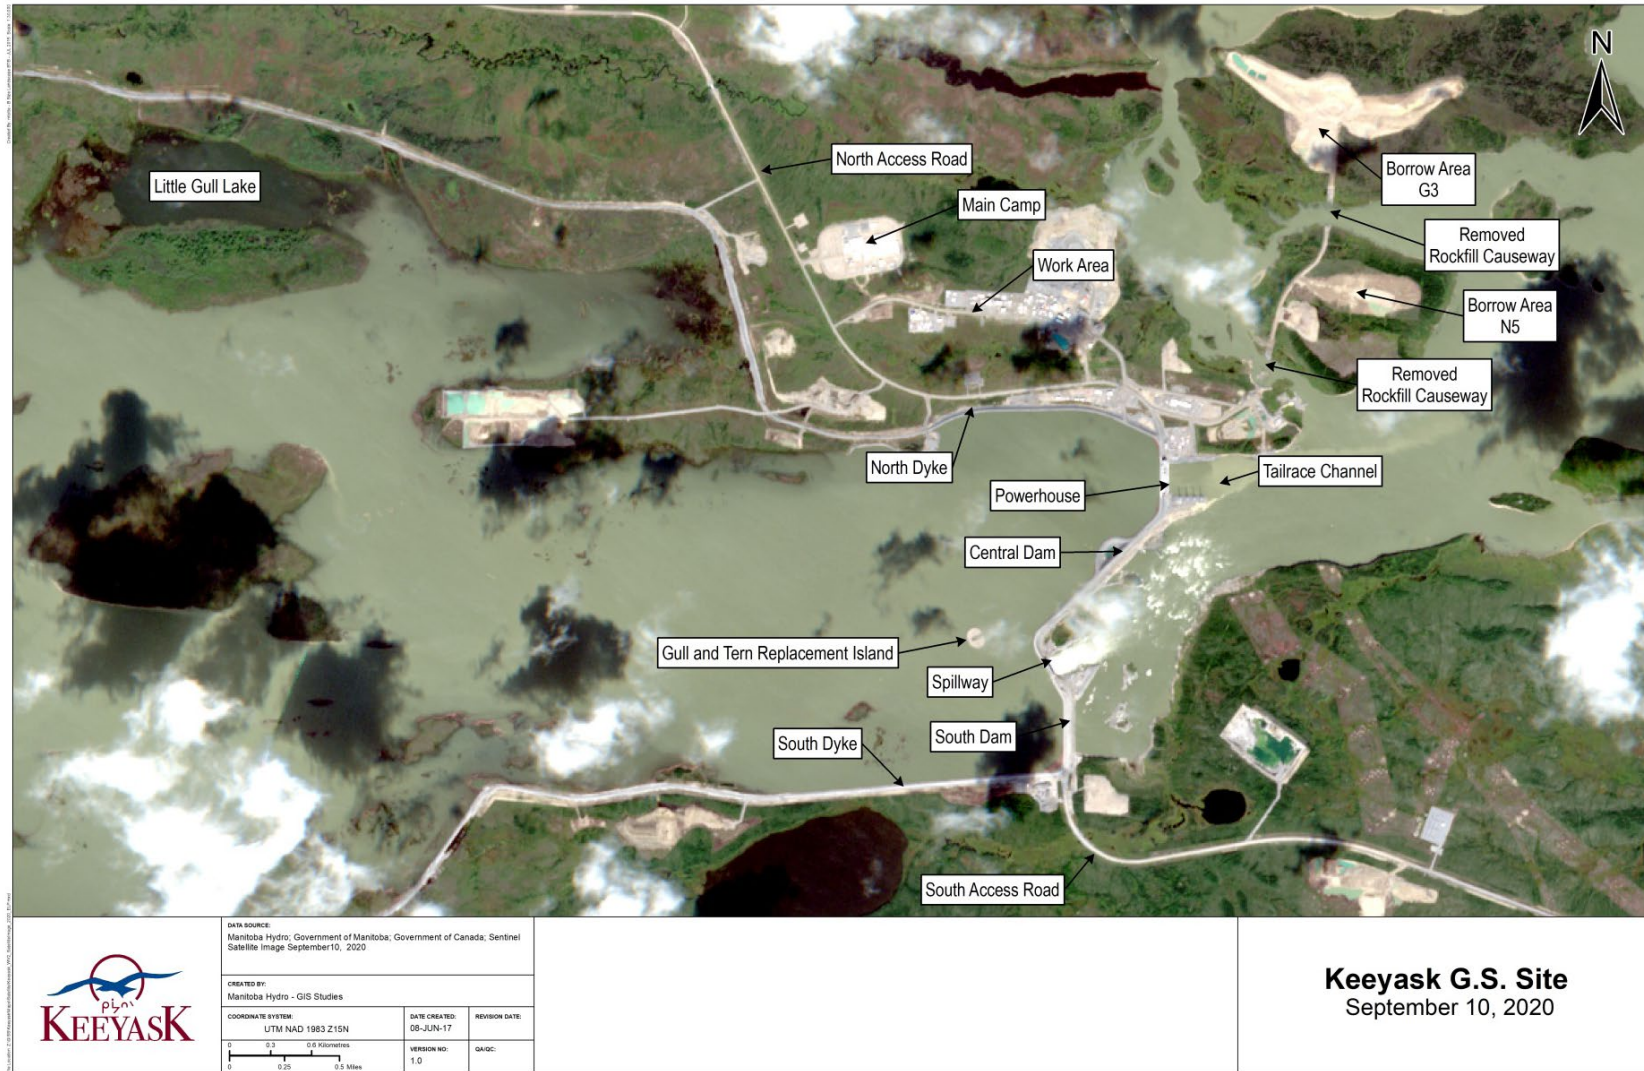
**Map 2: Map illustrating instream structures at the Keeyask Generating Station site after reservoir flooding, September 2020.**

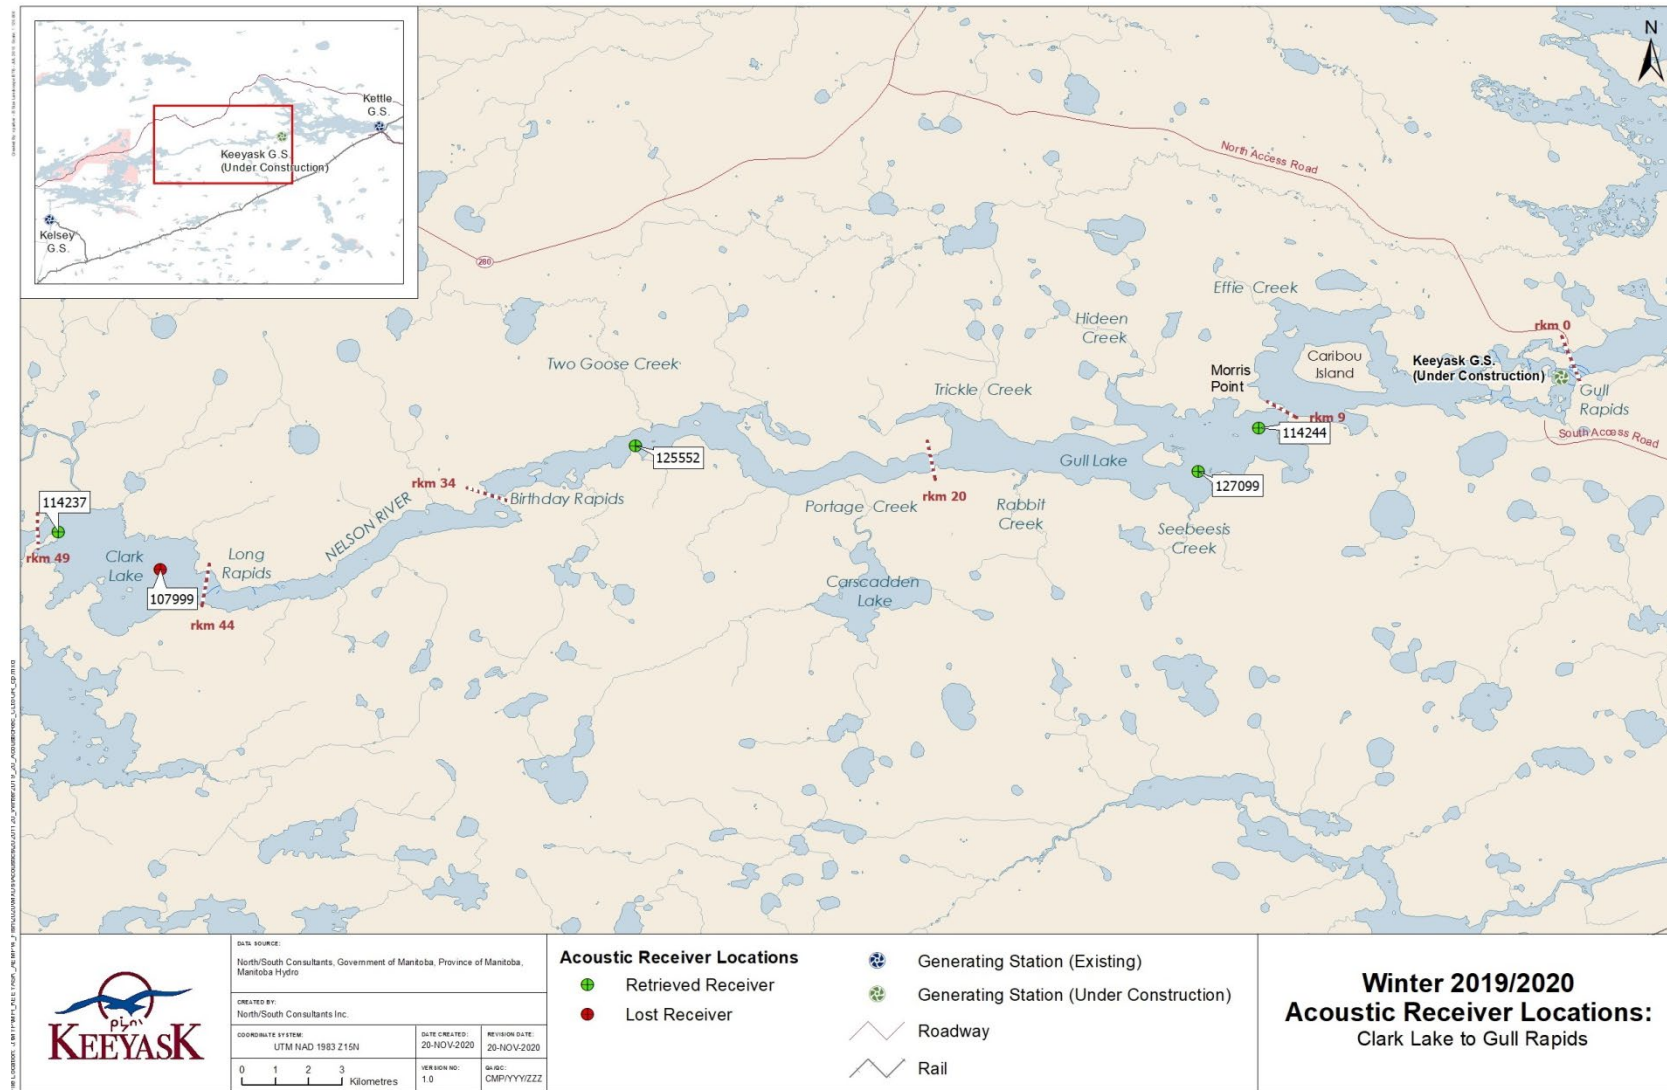
**Map 3: Locations of stationary receivers set in the Nelson River from Clark Lake to the Keeyask GS between October 2019 and July 2020. River kilometer (rkm) distances are indicated with a red dotted line.**

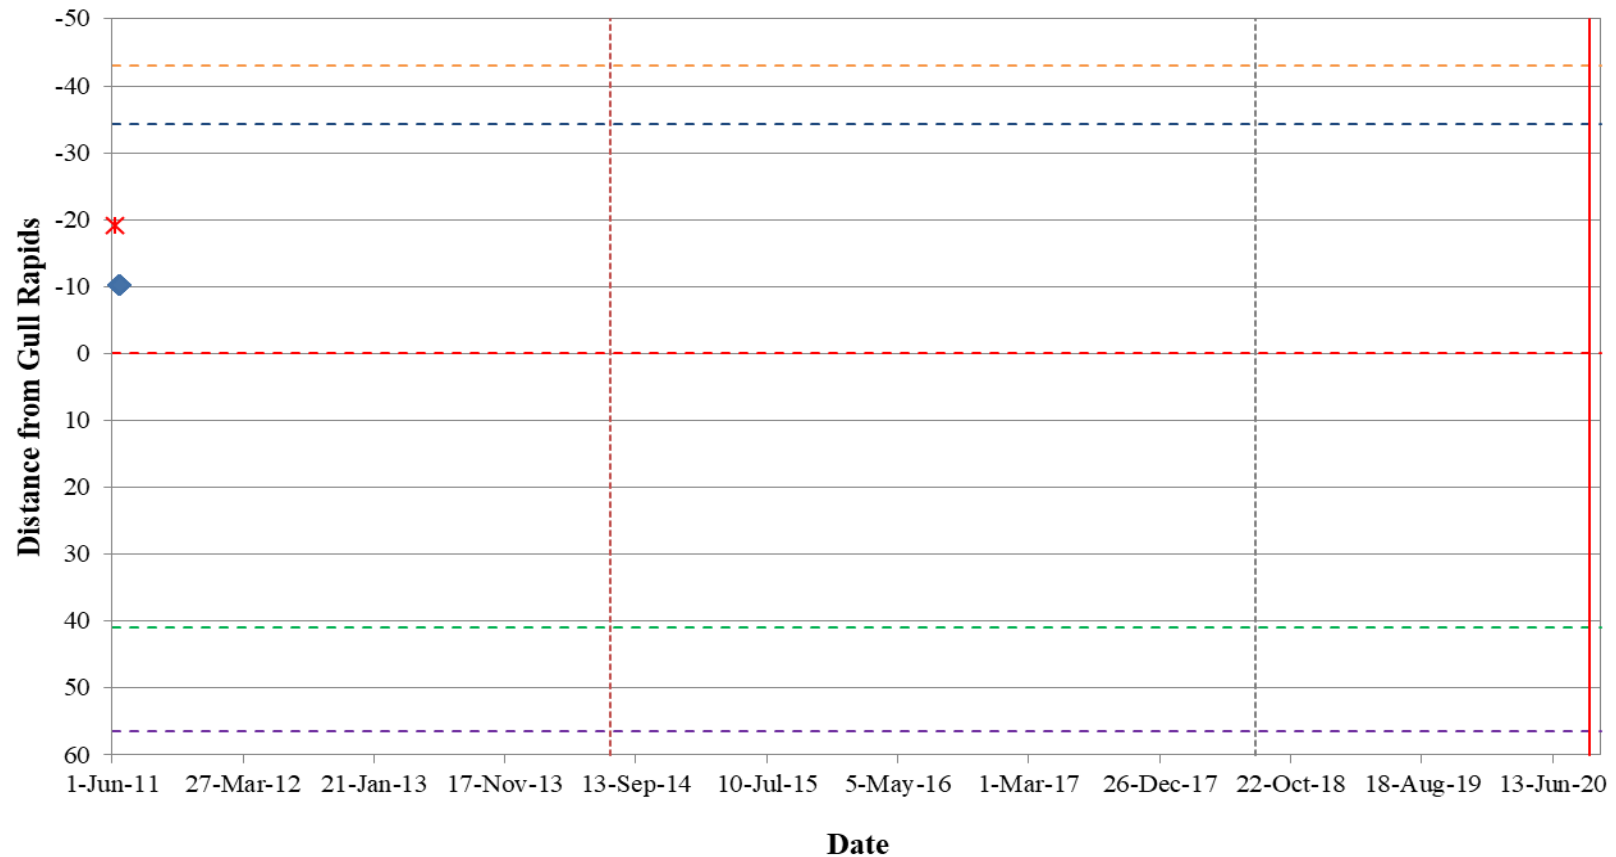
**Figure A2-31: Position of a Lake Sturgeon tagged with an acoustic transmitter (code #16077) in the Nelson River between Clark Lake and the Keeyask GS in relation to the Keeyask GS (rkm 0), from June 1, 2011 to September 23, 2020. Date and location of tagging is indicated by a star. Beginning of Keeyask construction is indicated with a vertical dotted red line, beginning of spillway commissioning is indicated with a vertical dotted grey line, and end of reservoir impoundment is indicated with a vertical solid red line. Landmarks are indicated with horizontal dotted lines (orange = Clark Lake outlet; blue = Birthday Rapids, red = the Keeyask GS; green = Kettle GS; purple = Long Spruce GS).**

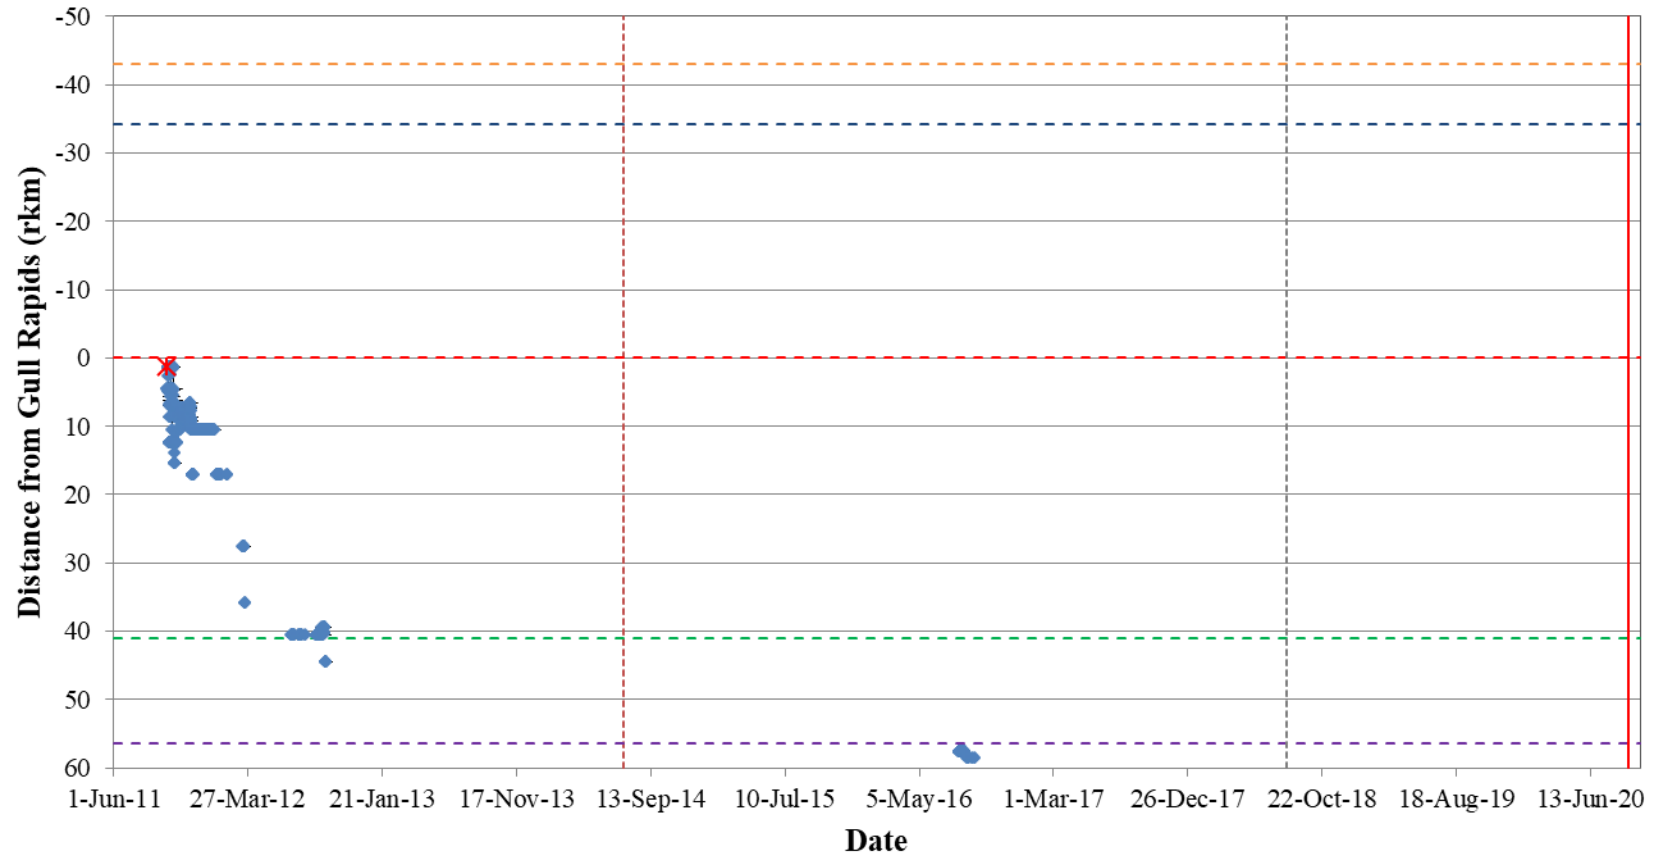
**Figure A3-4: Position of a Lake Sturgeon tagged with an acoustic transmitter (code #16021) in Stephens Lake in relation to the Keeyask GS (rkm 0), from June 1, 2011 to September 23, 2020. Date and location of tagging is indicated by a star. Beginning of Keeyask construction is indicated with a vertical dotted red line, beginning of spillway commissioning is indicated with a vertical dotted grey line, and end of reservoir impoundment is indicated with a vertical solid red line. Landmarks are indicated with horizontal dotted lines (orange = Clark Lake outlet; blue = Birthday Rapids, red = the Keeyask GS; green = Kettle GS; purple = Long Spruce GS).**

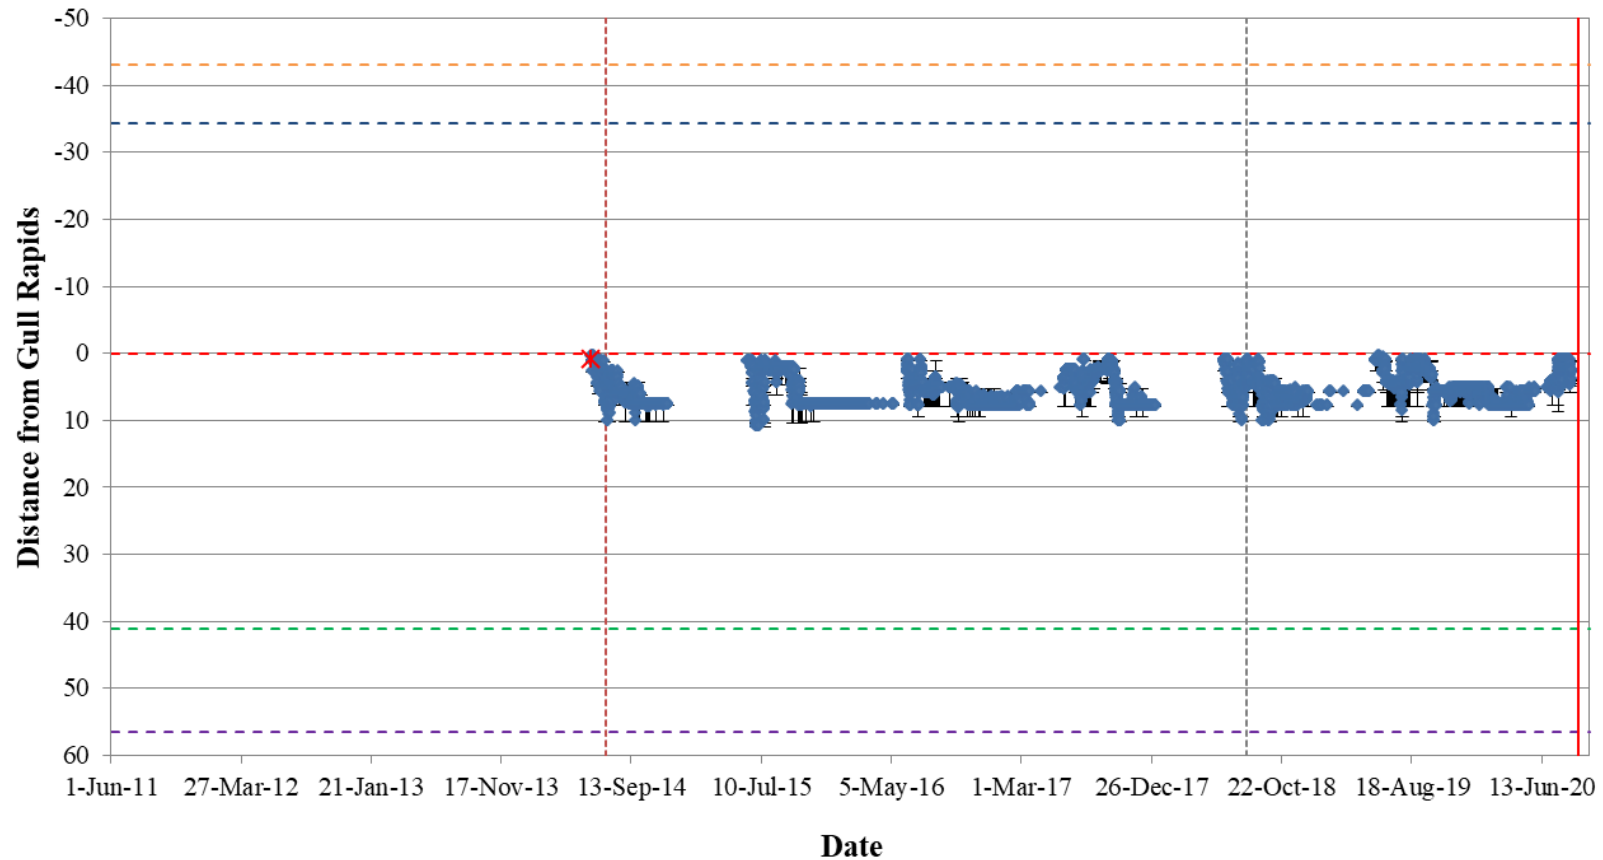
**Figure A3-35: Position of a Lake Sturgeon tagged with an acoustic transmitter (code #32173) in Stephens Lake in relation to the Keeyask GS (rkm 0), from June 1, 2011 to September 23, 2020. Date and location of tagging is indicated by a star. Beginning of Keeyask construction is indicated with a vertical dotted red line, beginning of spillway commissioning is indicated with a vertical dotted grey line, and end of reservoir impoundment is indicated with a vertical solid red line. Landmarks are indicated with horizontal dotted lines (orange = Clark Lake outlet; blue = Birthday Rapids, red = the Keeyask GS; green = Kettle GS; purple = Long Spruce GS).**
