Keeyask Generation Project  
Aquatic Effects Monitoring Plan

Juvenile Lake Sturgeon Movement Monitoring Report  
AEMP-2021-02

REPORT #AEMP-2021-02

### **JUVENILE LAKE STURGEON MOVEMENT MONITORING IN THE NELSON RIVER BETWEEN CLARK LAKE AND THE LIMESTONE GENERATING STATION, OCTOBER 2019 TO SEPTEMBER 2020: YEAR 7 CONSTRUCTION**

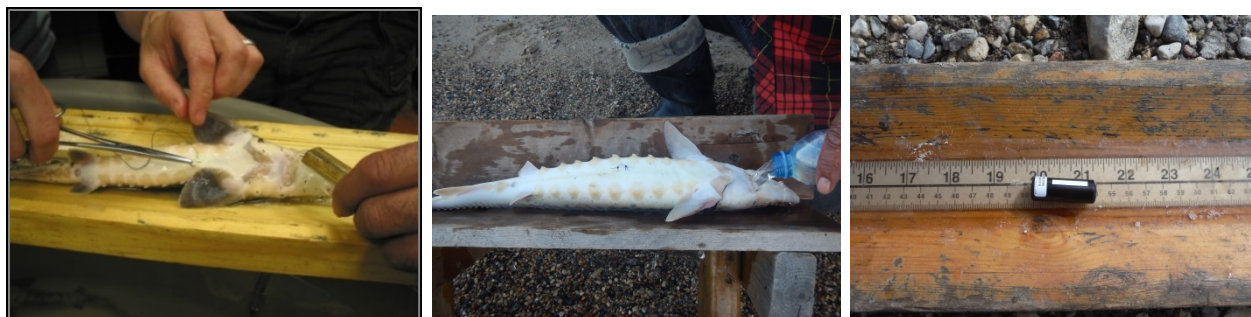
**Surgery on a juvenile Lake Sturgeon (left and middle) to implant an acoustic tag (right).**
