KEEYASK GENERATION PROJECT

REPORT #AEMP-2021-03

LAKE WHITEFISH MOVEMENT MONITORING IN THE NELSON RIVER BETWEEN CLARK LAKE AND THE LIMESTONE GENERATING STATION, OCTOBER 2019 TO SEPTEMBER 2020: YEAR 7 CONSTRUCTION

June 2021

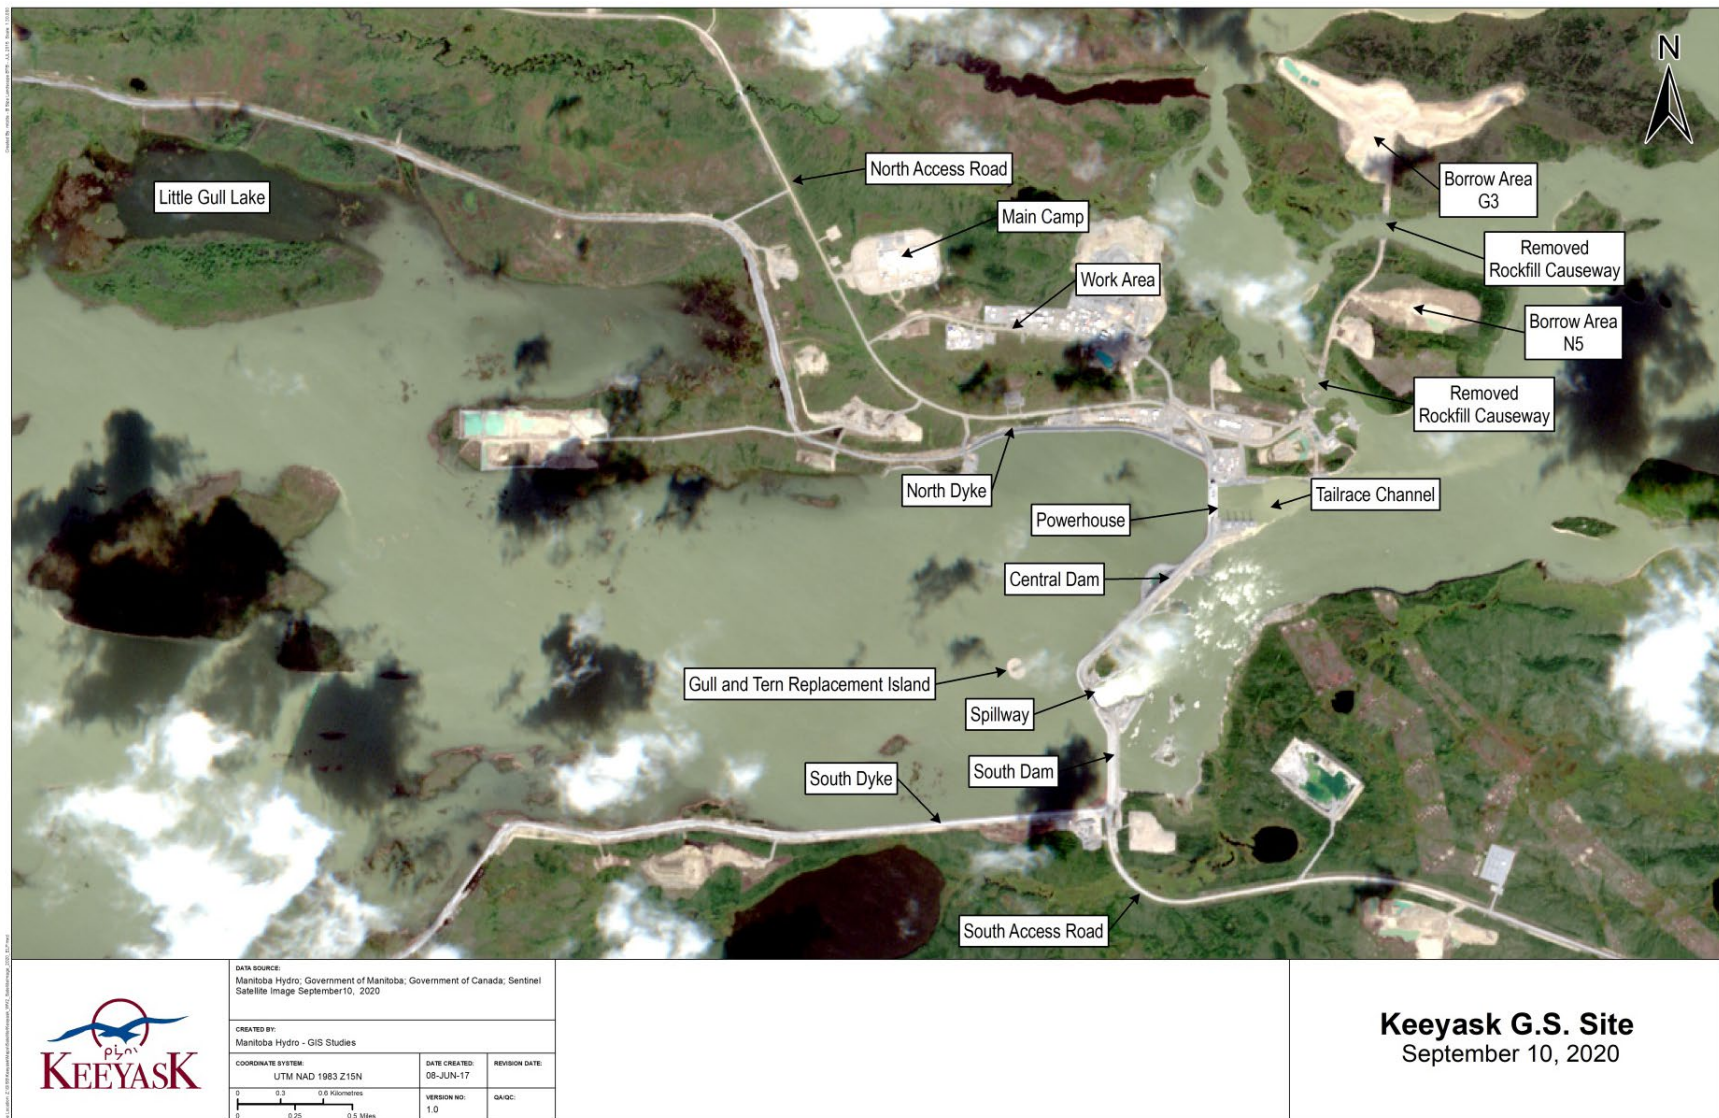
Map illustrating instream structures at the Keeyask Generating Station site after reservoir flooding, September 2020.

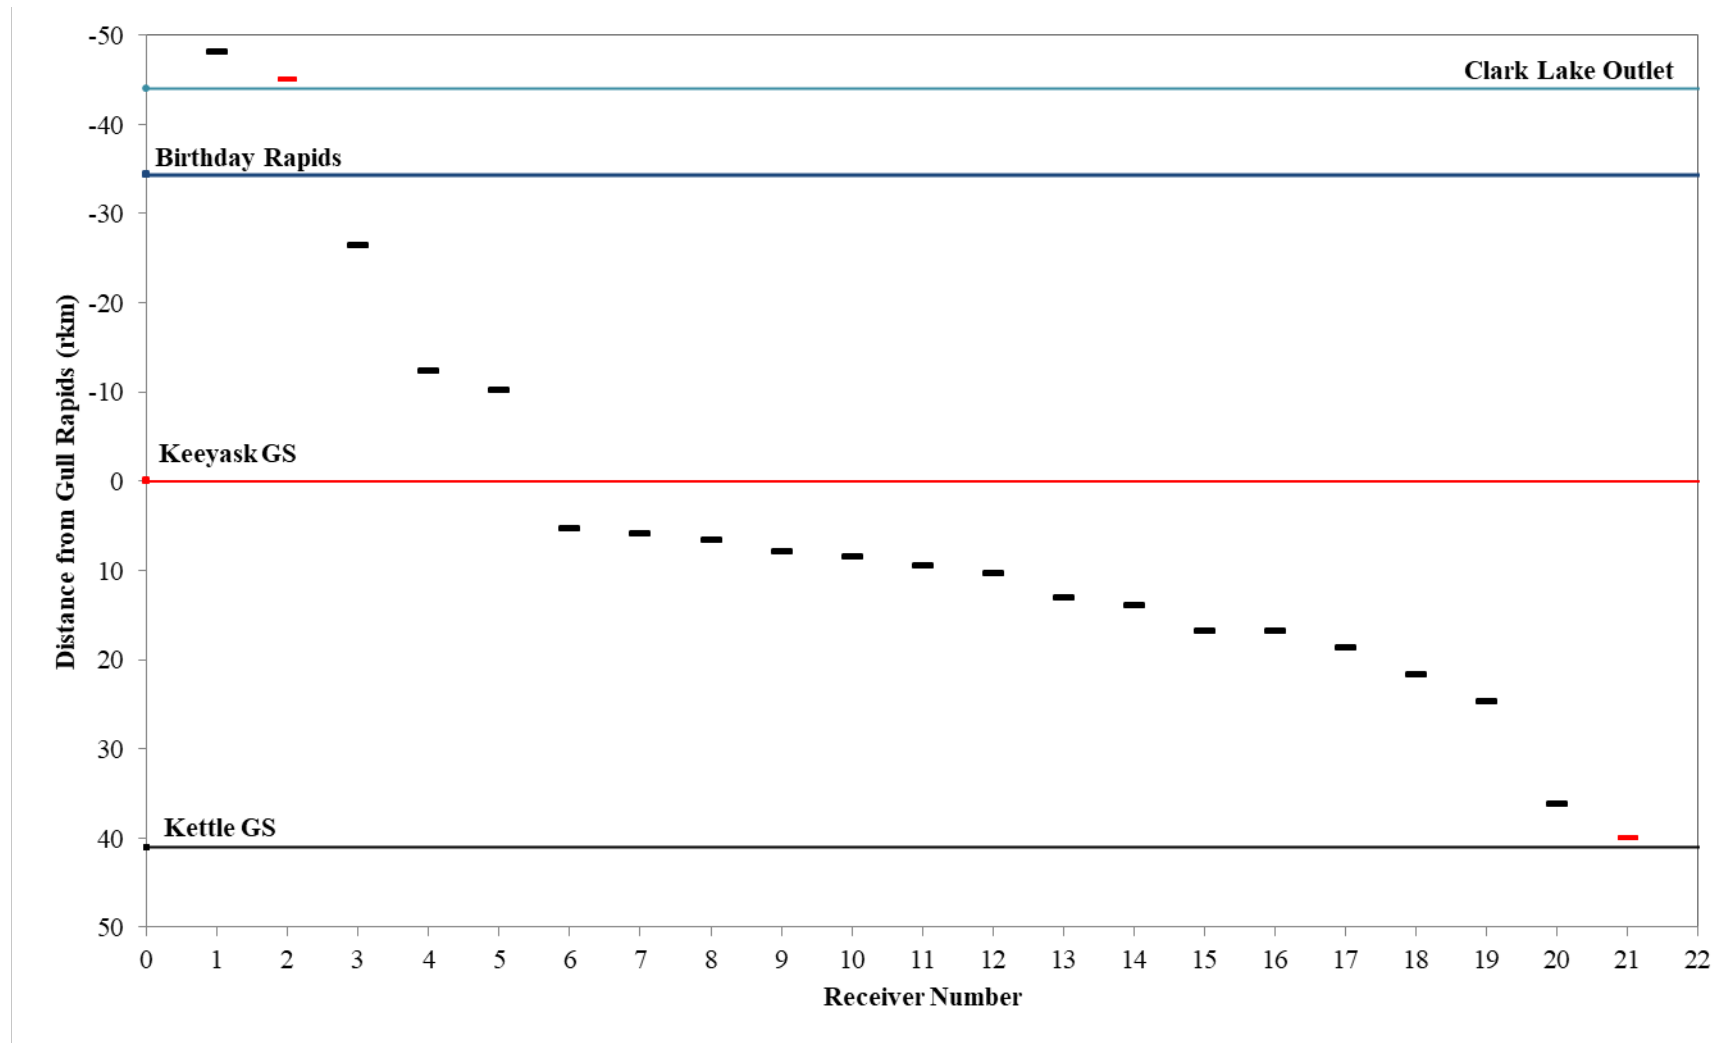
Figure 1: Locations of stationary acoustic receivers (dashes) in relation to the base of the Keeyask GS (rkm 0) and other major landmarks (lines) in the Nelson River between Clark Lake and the Limestone GS between October, 2019 and July, 2020. A red dash indicates a receiver that was lost.

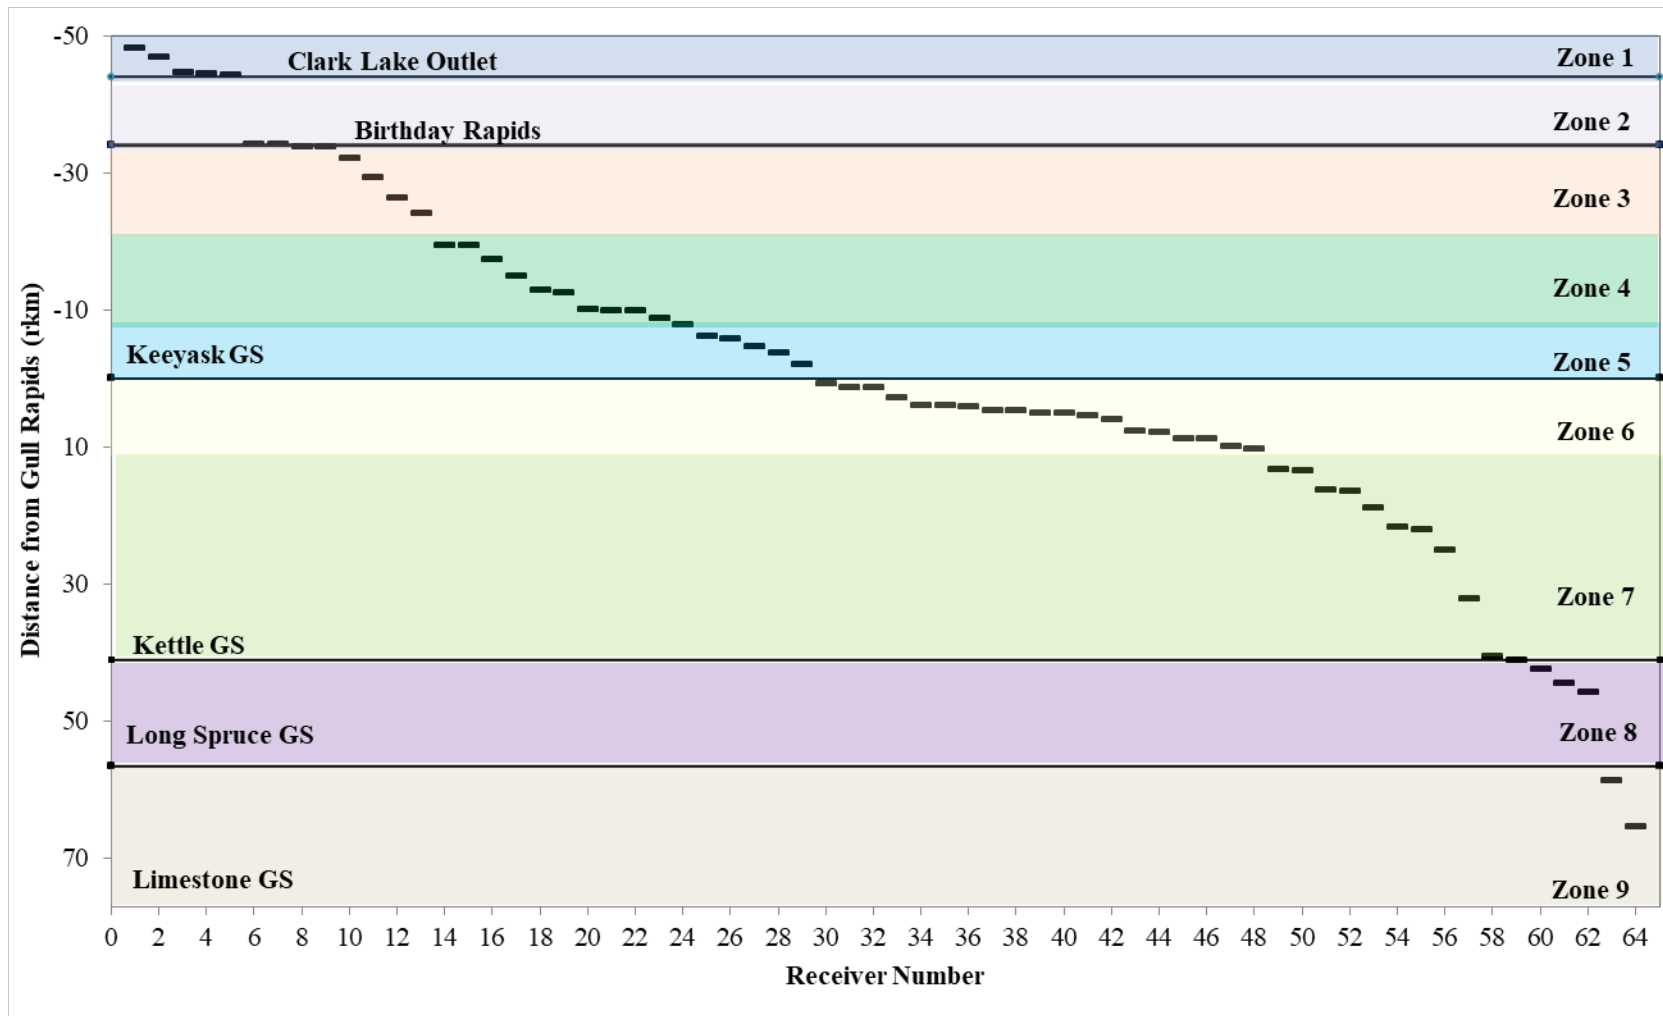
Figure 2: Locations of stationary acoustic receivers (dashes) in relation to the base of the Keeyask GS (rkm 0) and other major landmarks (lines) in the Nelson River between Clark Lake (Zone 1) and the Limestone GS (Zone 9) between July and September, 2020. River zones upstream and downstream of Gull Rapids are indicated by shading.

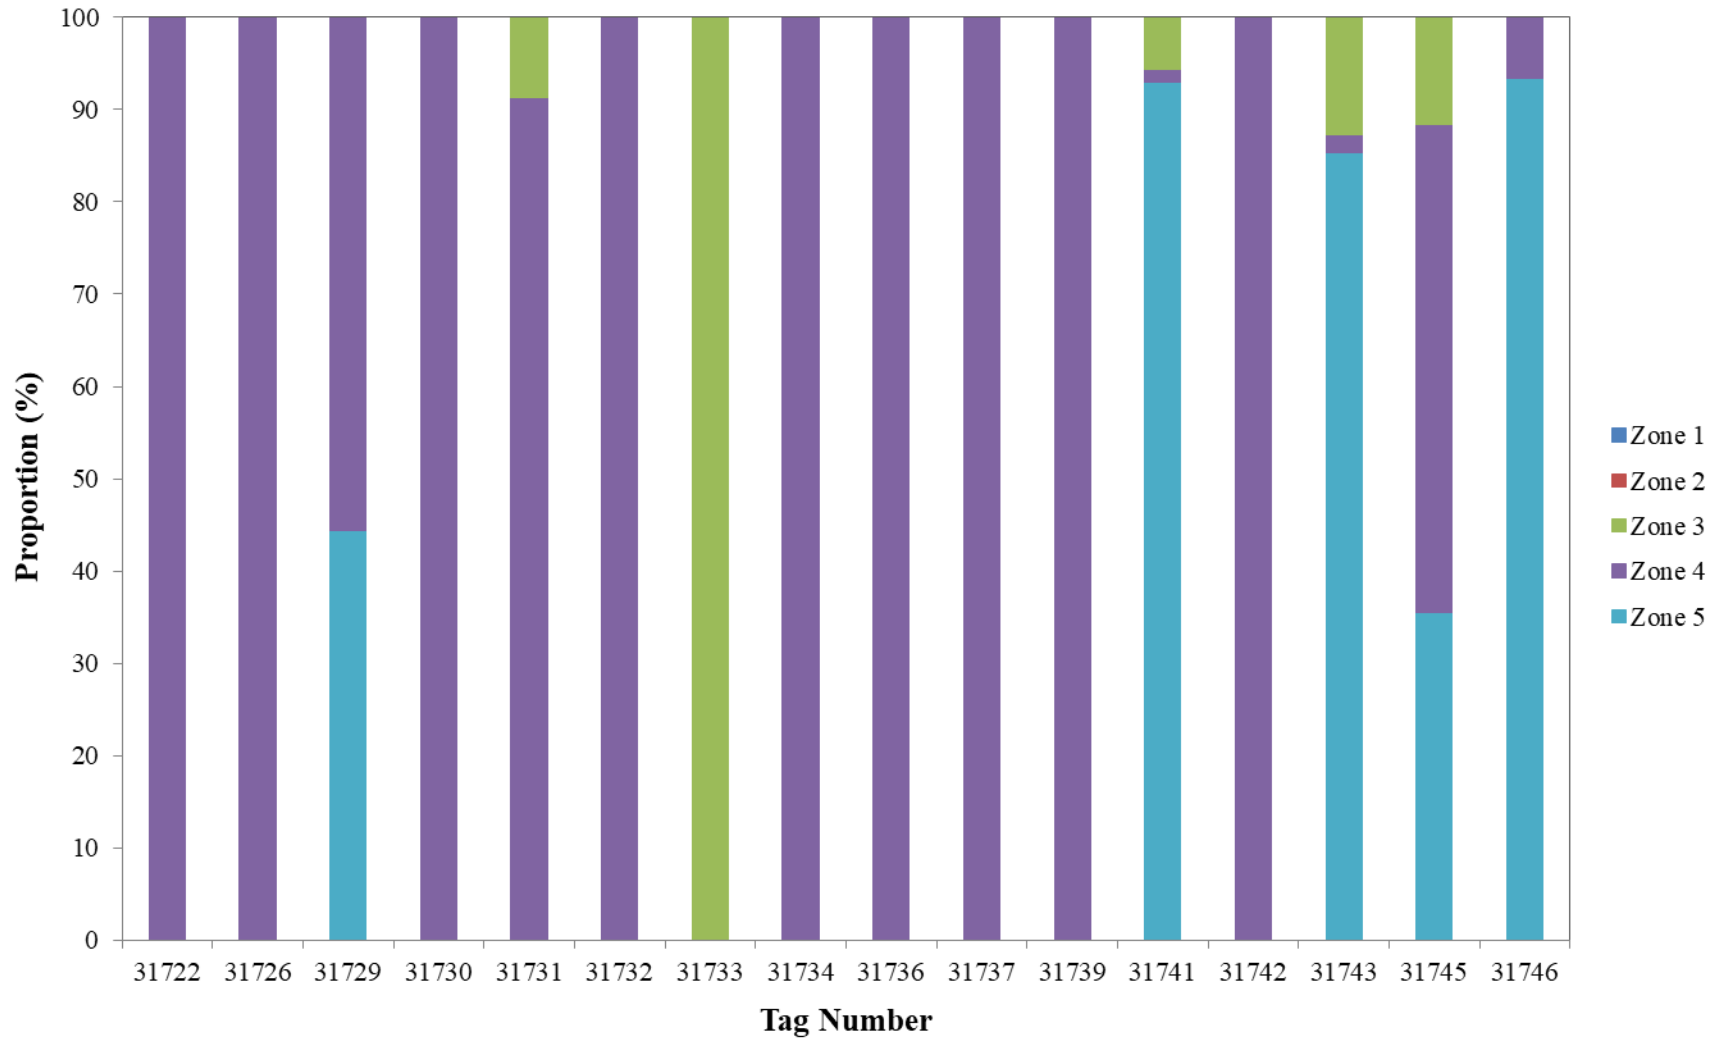
Figure 10: Proportion of time spent within five river zones between Clark Lake and the Keeyask GS by individual acoustic-tagged Lake Whitefish during a portion of the 2020 open-water period (July 3 to September 23).

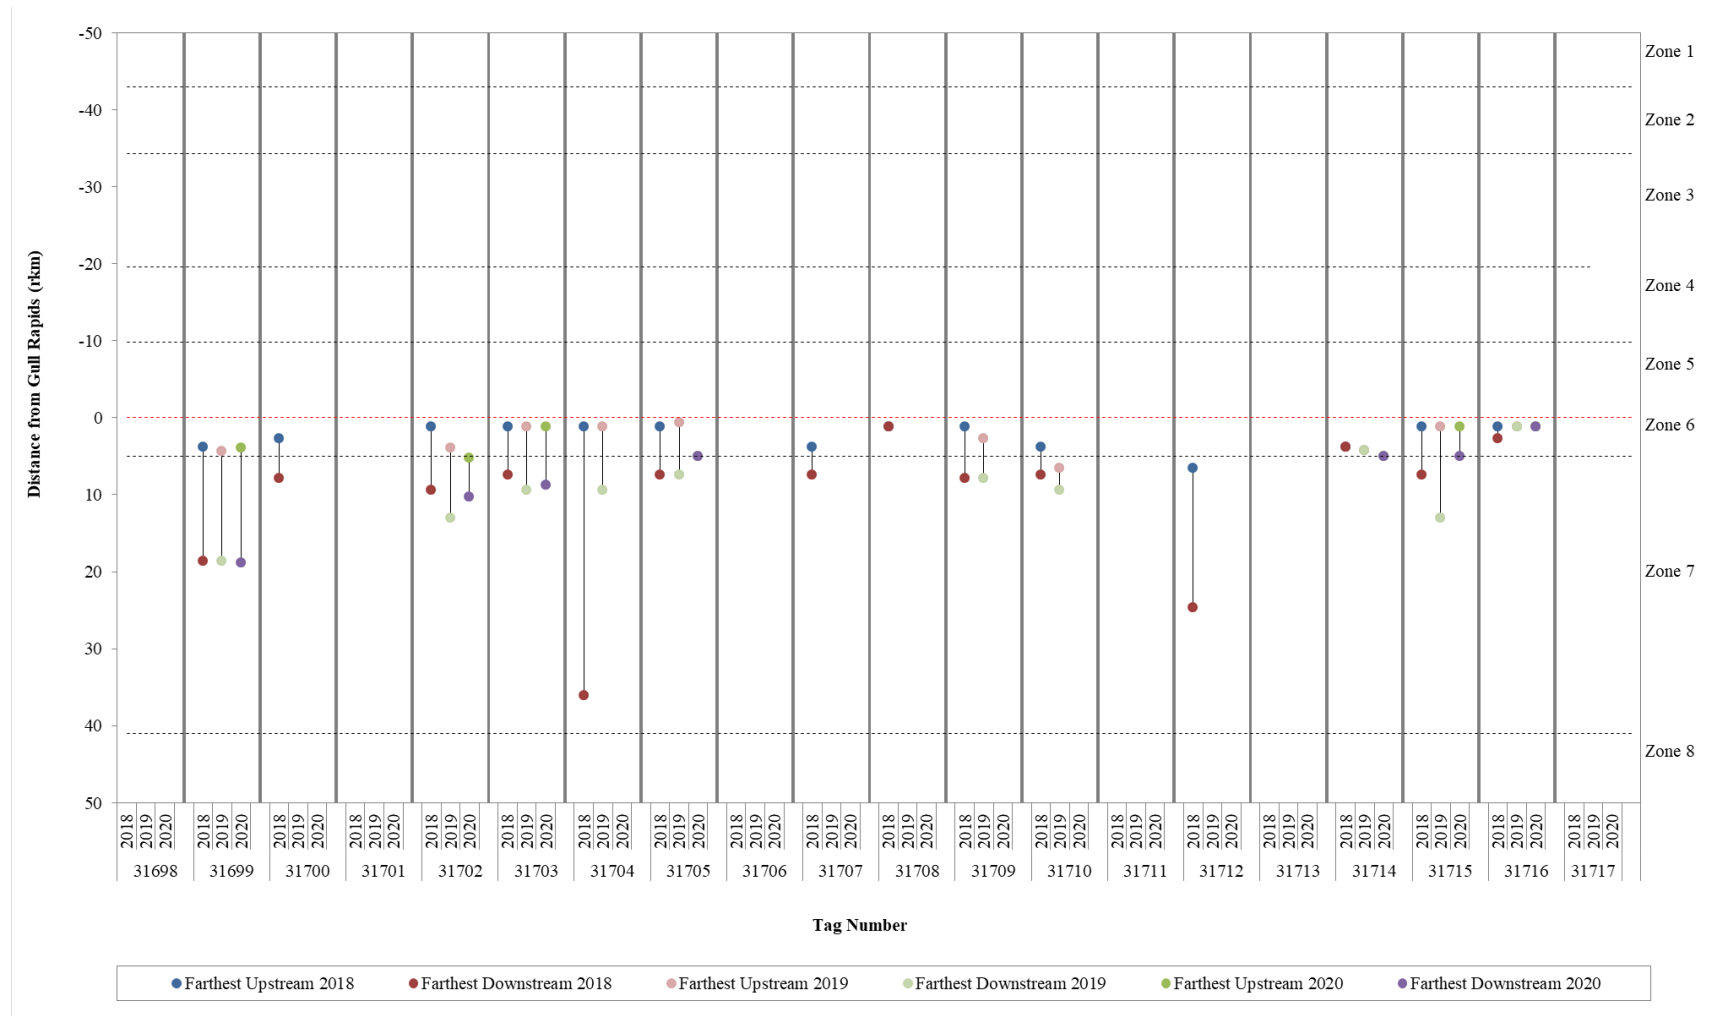
Figure 13: Detection ranges for individual Lake Whitefish (n = 40) tagged with acoustic transmitters in Stephens Lake during the 2018 (May 1 to October 10), 2019 (May 1 to October 7), and 2020 (July 3 to September 23) open-water periods. Horizontal dotted lines demarcate zones with the red line representing the Keeyask GS.

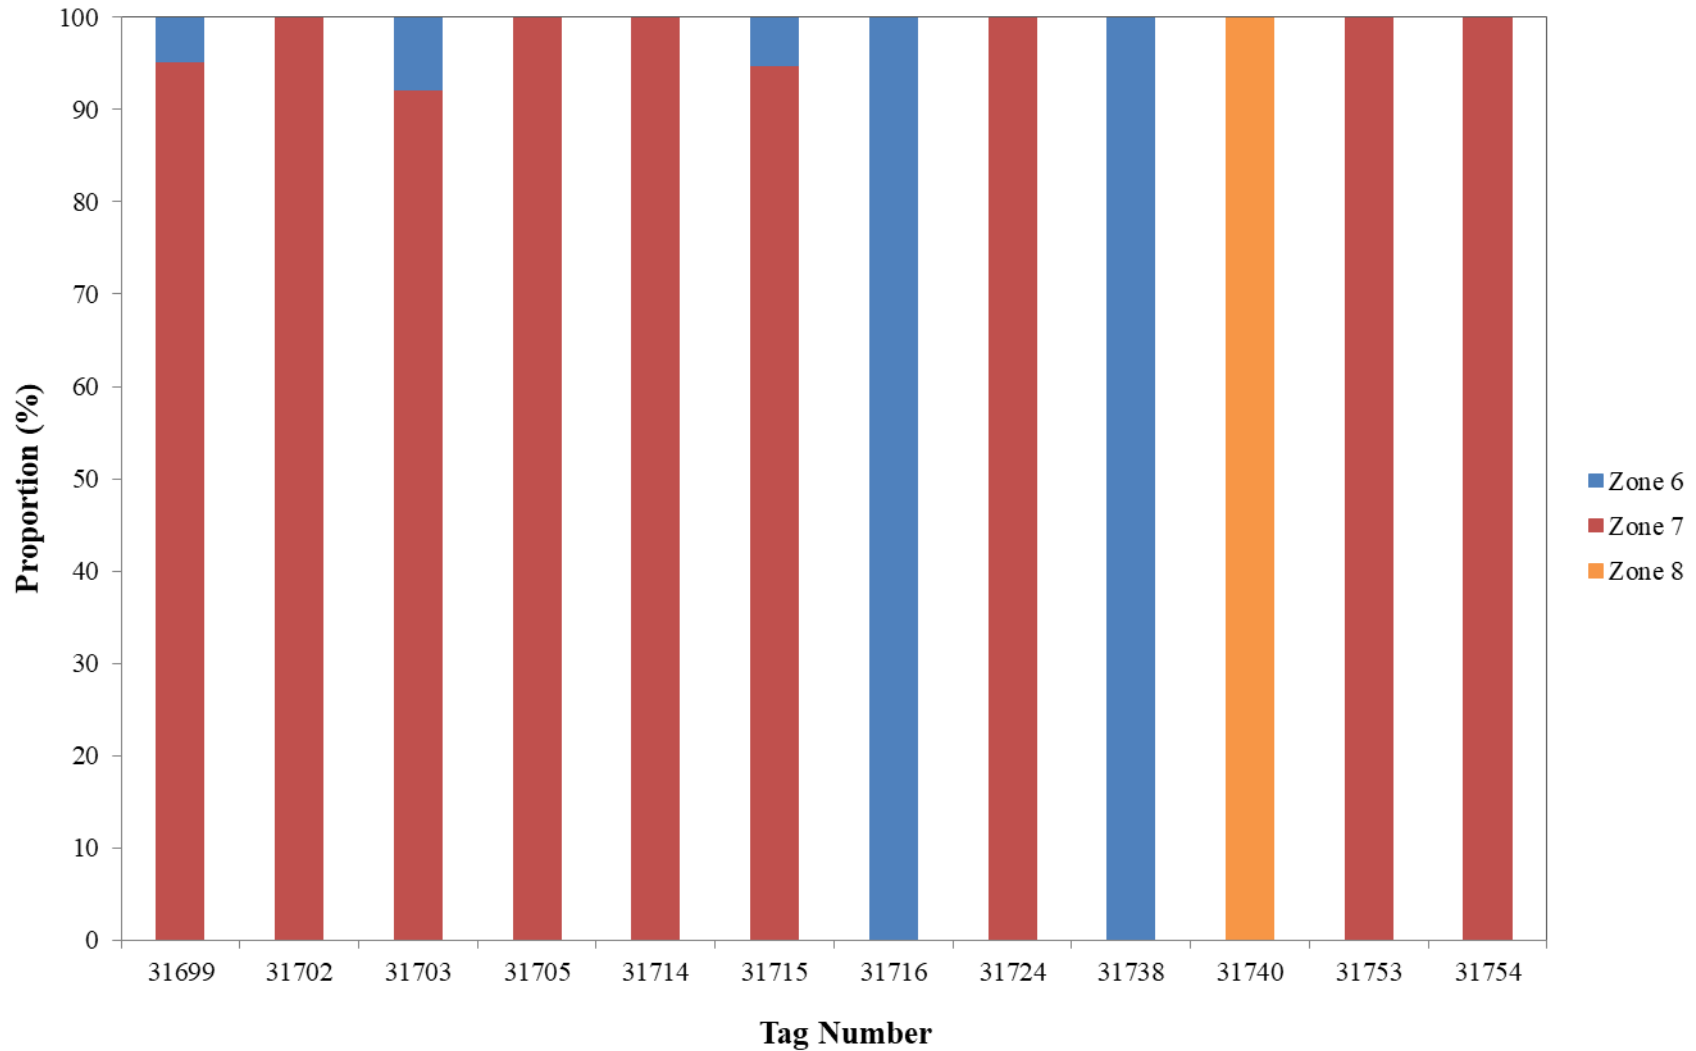
Figure 14: Proportion of time spent in Stephens Lake between the Keeyask GS and the Long Spruce GS by individual acoustic-tagged Lake Whitefish during a portion of the 2020 open-water period (July 3 to September 23).

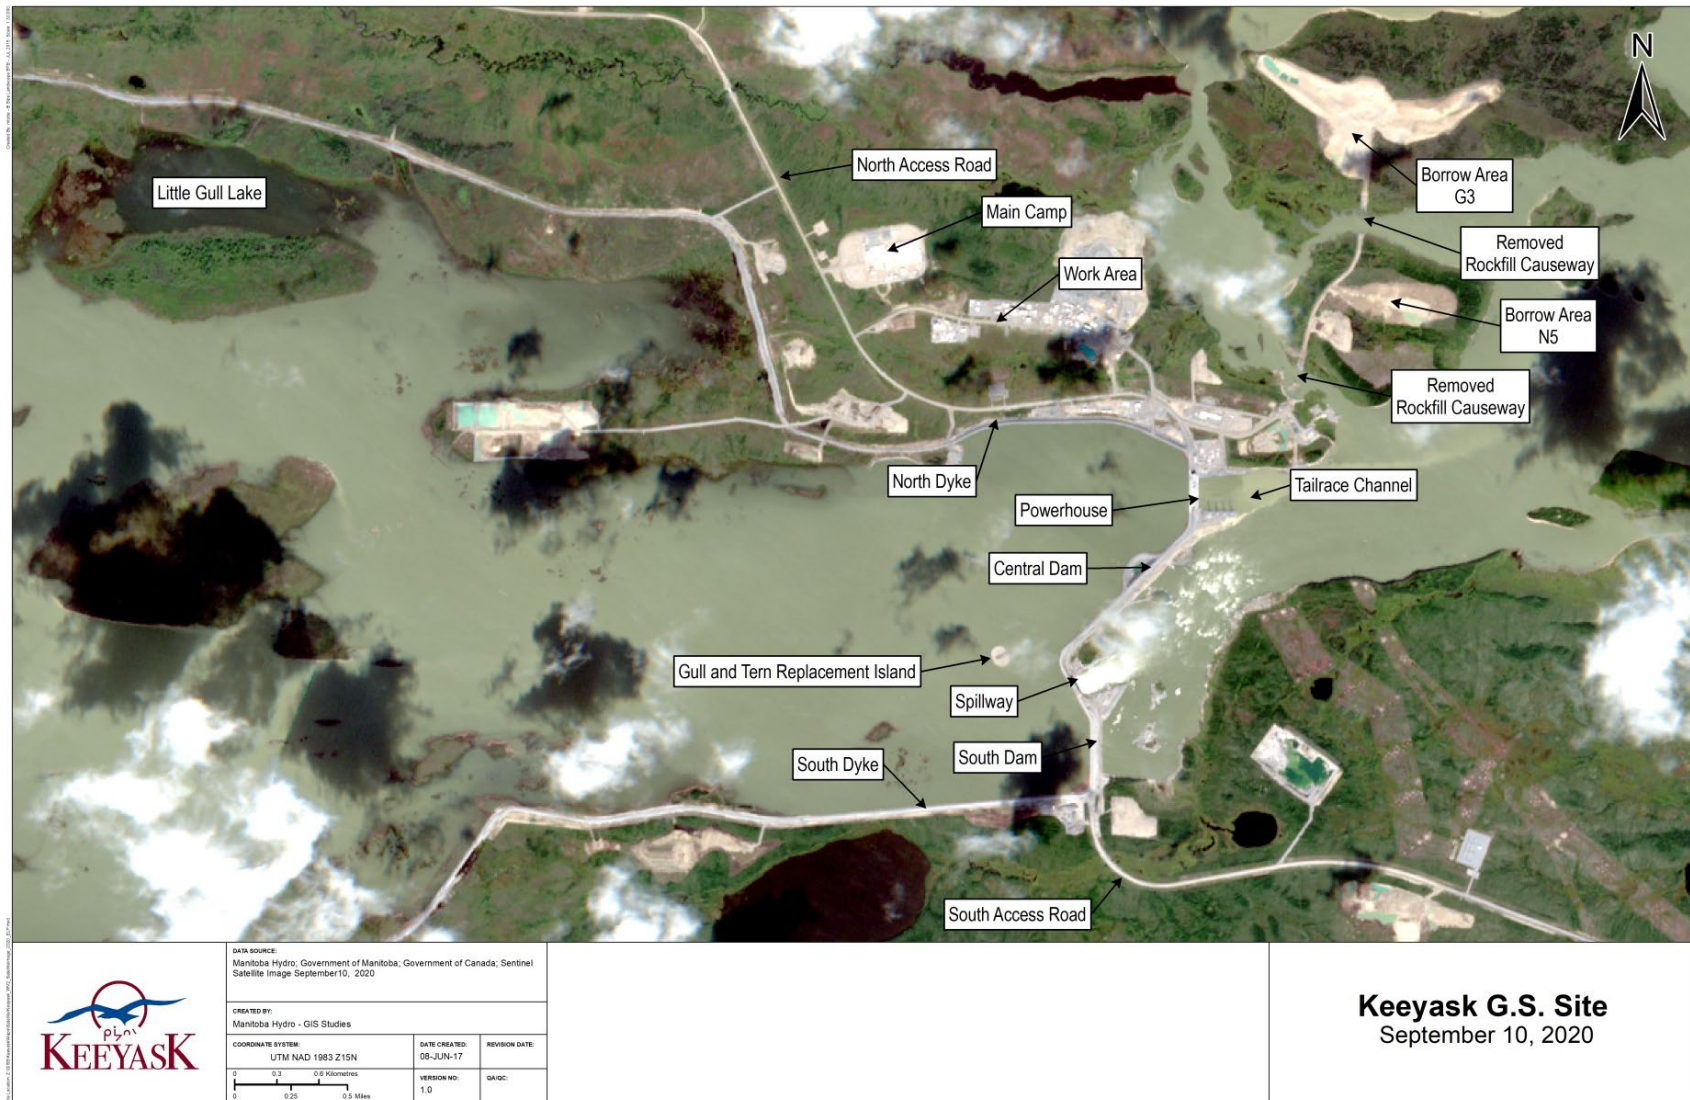
Map 2: Map of instream structures at the Keeyask Generating Station site after reservoir flooding, September 2020.

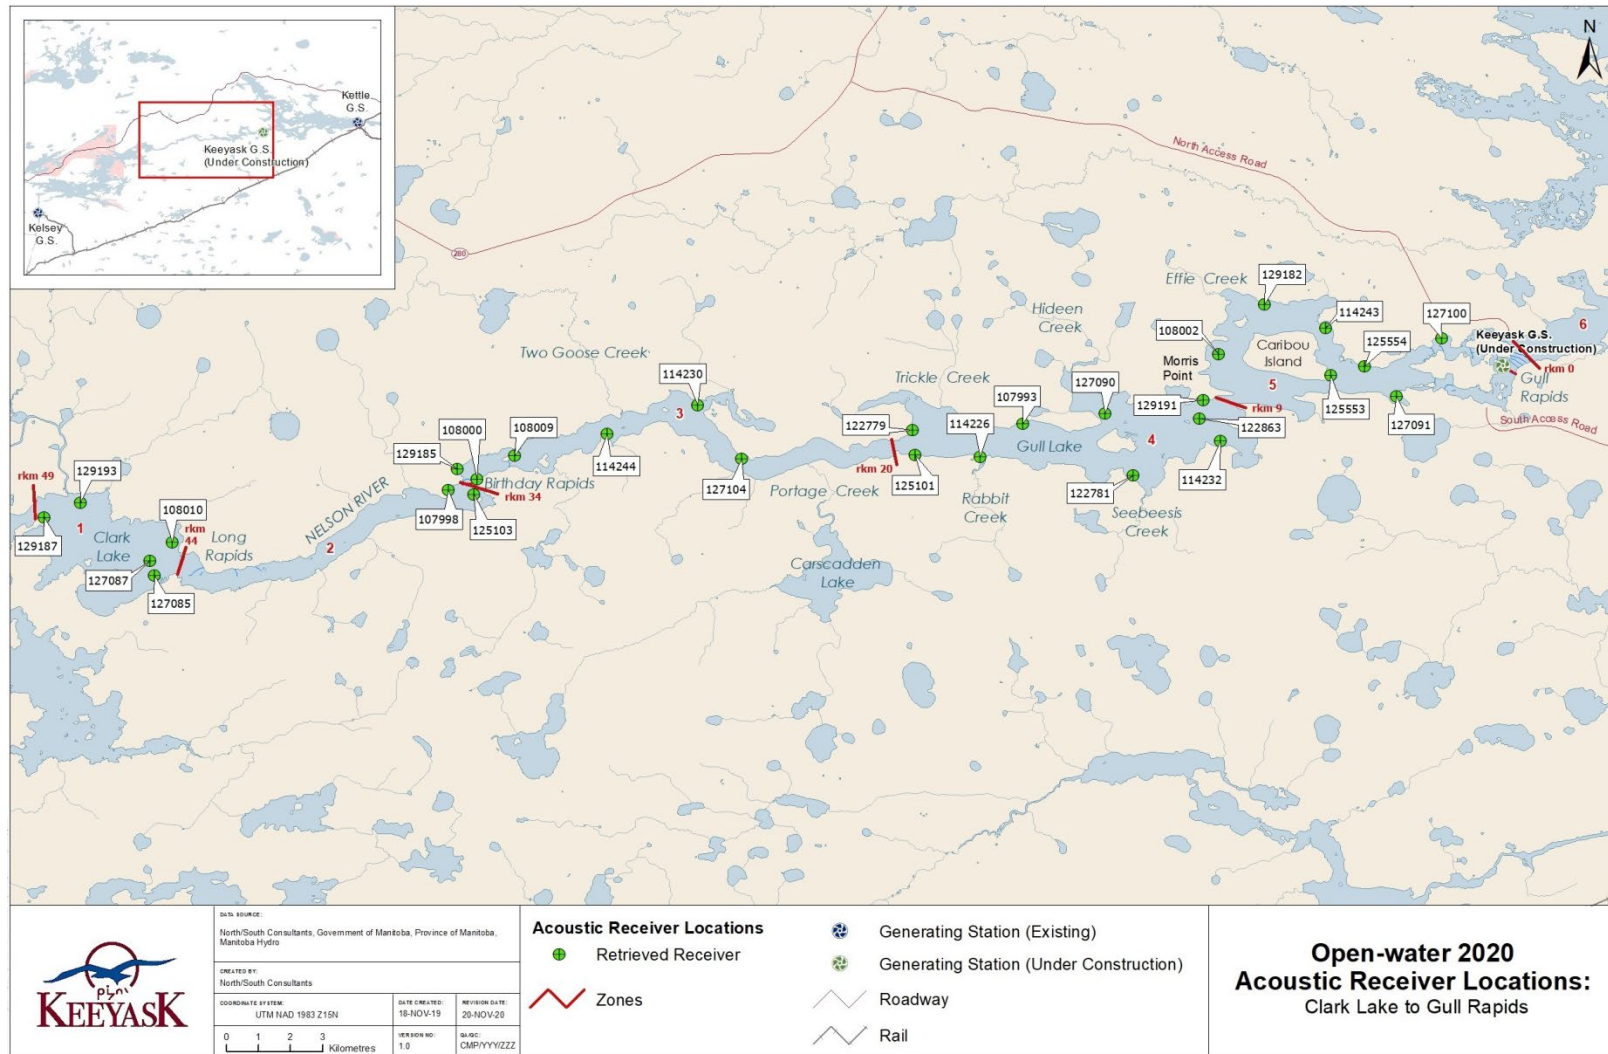
Map 5: Locations of stationary receivers set in the Nelson River from Clark Lake to the Keeyask GS between July and September 2020. The river is divided into five "zones" based on placement of receiver "gates." River kilometer (rkm) distances at zone divisions are indicated in red.

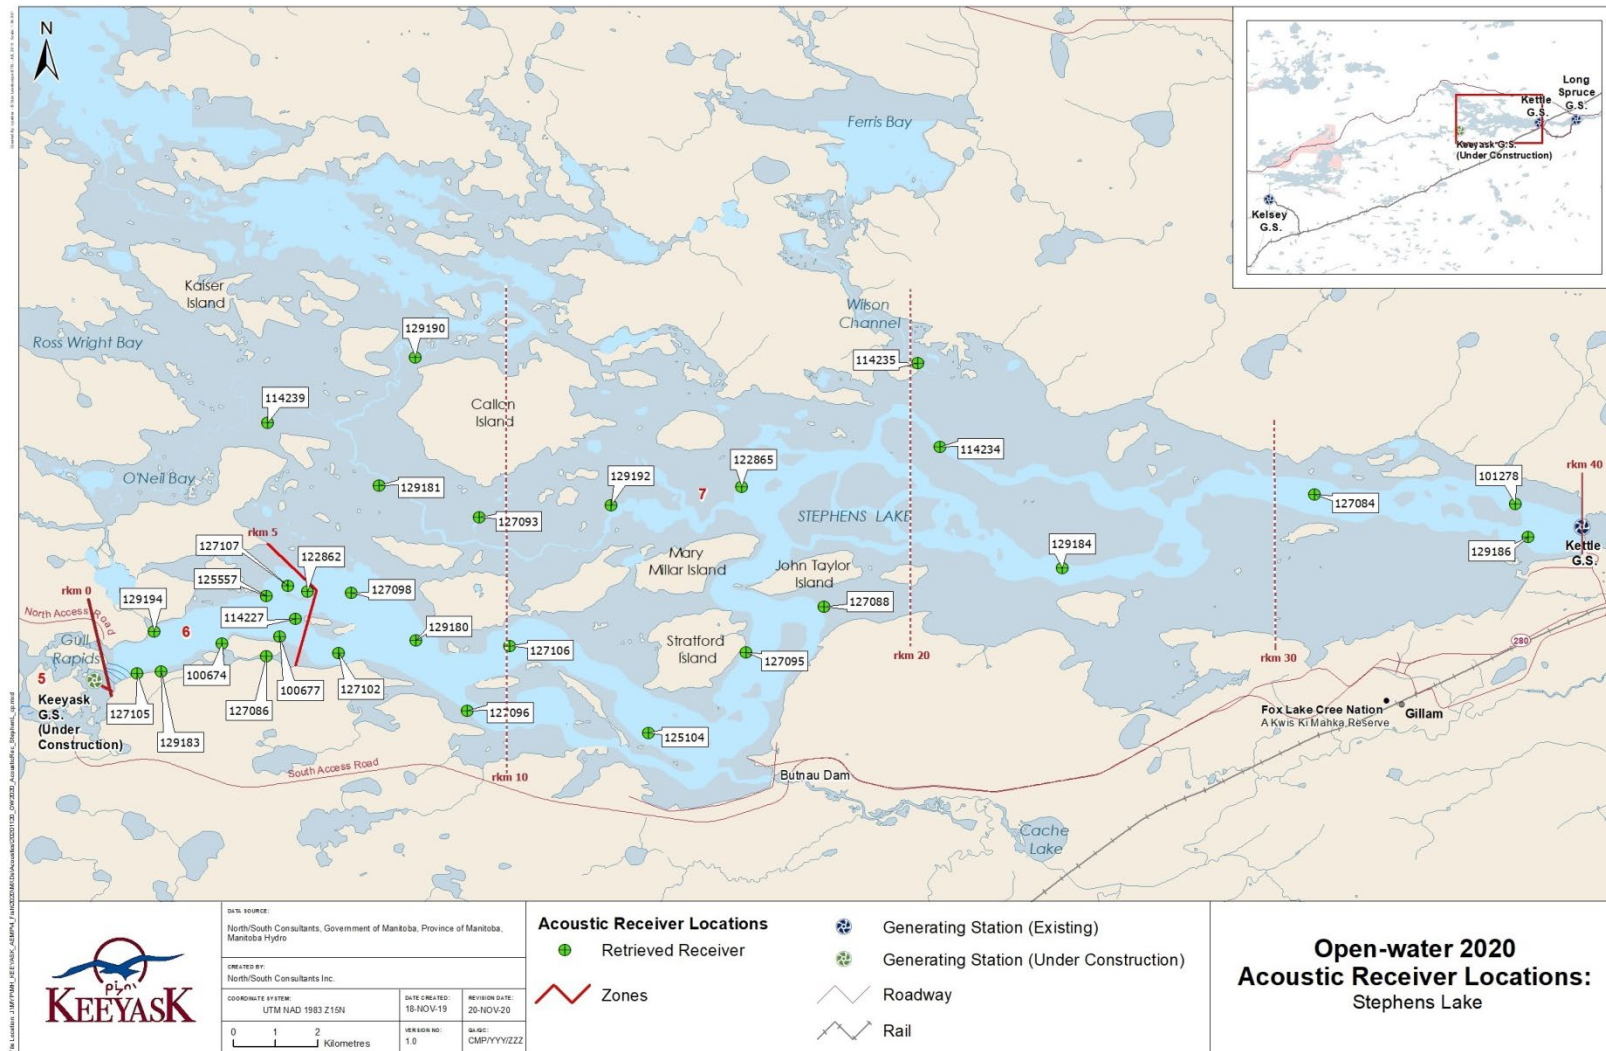
Map 6: Locations of stationary receivers set in Stephens Lake between July and September 2020. The river is divided into two "zones" based on placement of receiver "gates." The pre-impoundment river channel is shown in light blue. River kilometer (rkm) distances are indicated with a dotted red line.
