Keeyask Generation Project Aquatic Effects Monitoring Plan

Walleye Movement Monitoring Report AEMP-2021-04

WALLEYE MOVEMENT MONITORING IN THE NELSON RIVER BETWEEN CLARK LAKE AND THE LIMESTONE GENERATING STATION, OCTOBER 2019 TO SEPTEMBER 2020: YEAR 7 CONSTRUCTION

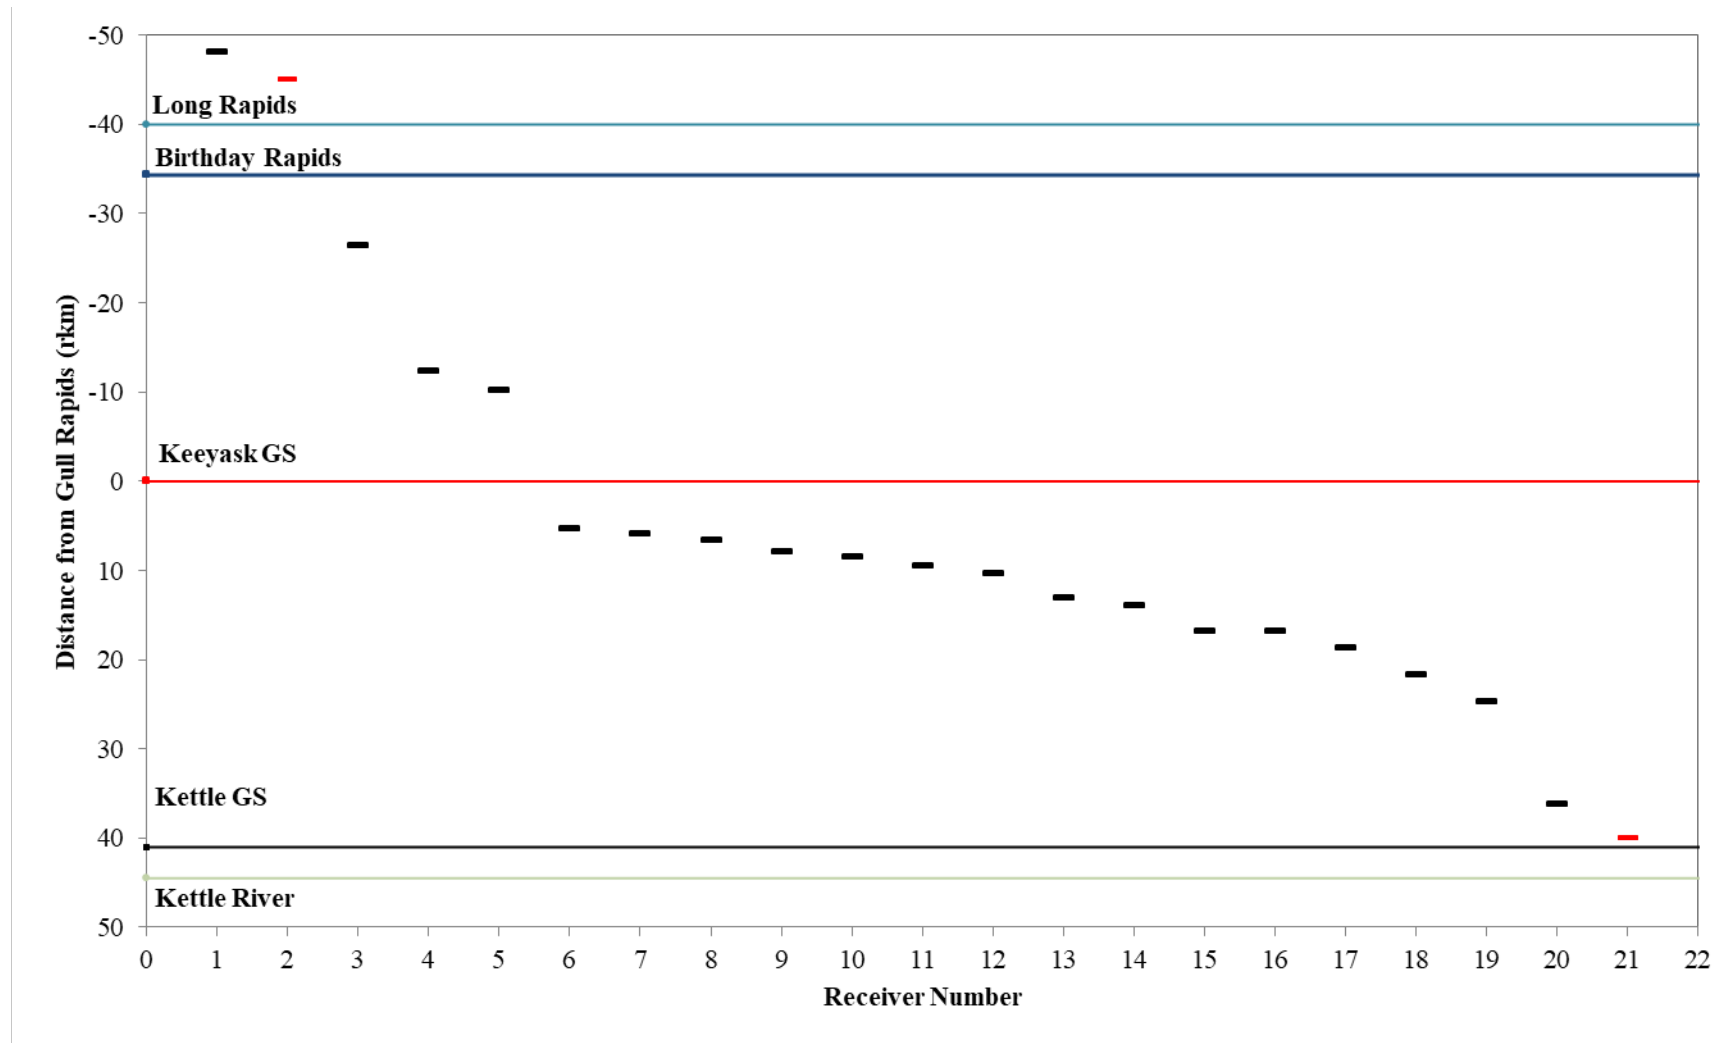
Figure 1: Locations of stationary acoustic receivers (dashes) in relation to the base of the Keeyask GS (rkm 0) and other major landmarks (lines) in the Nelson River between Clark Lake and the Limestone GS between October, 2019 and July, 2020. A red dash indicates a receiver that was lost.

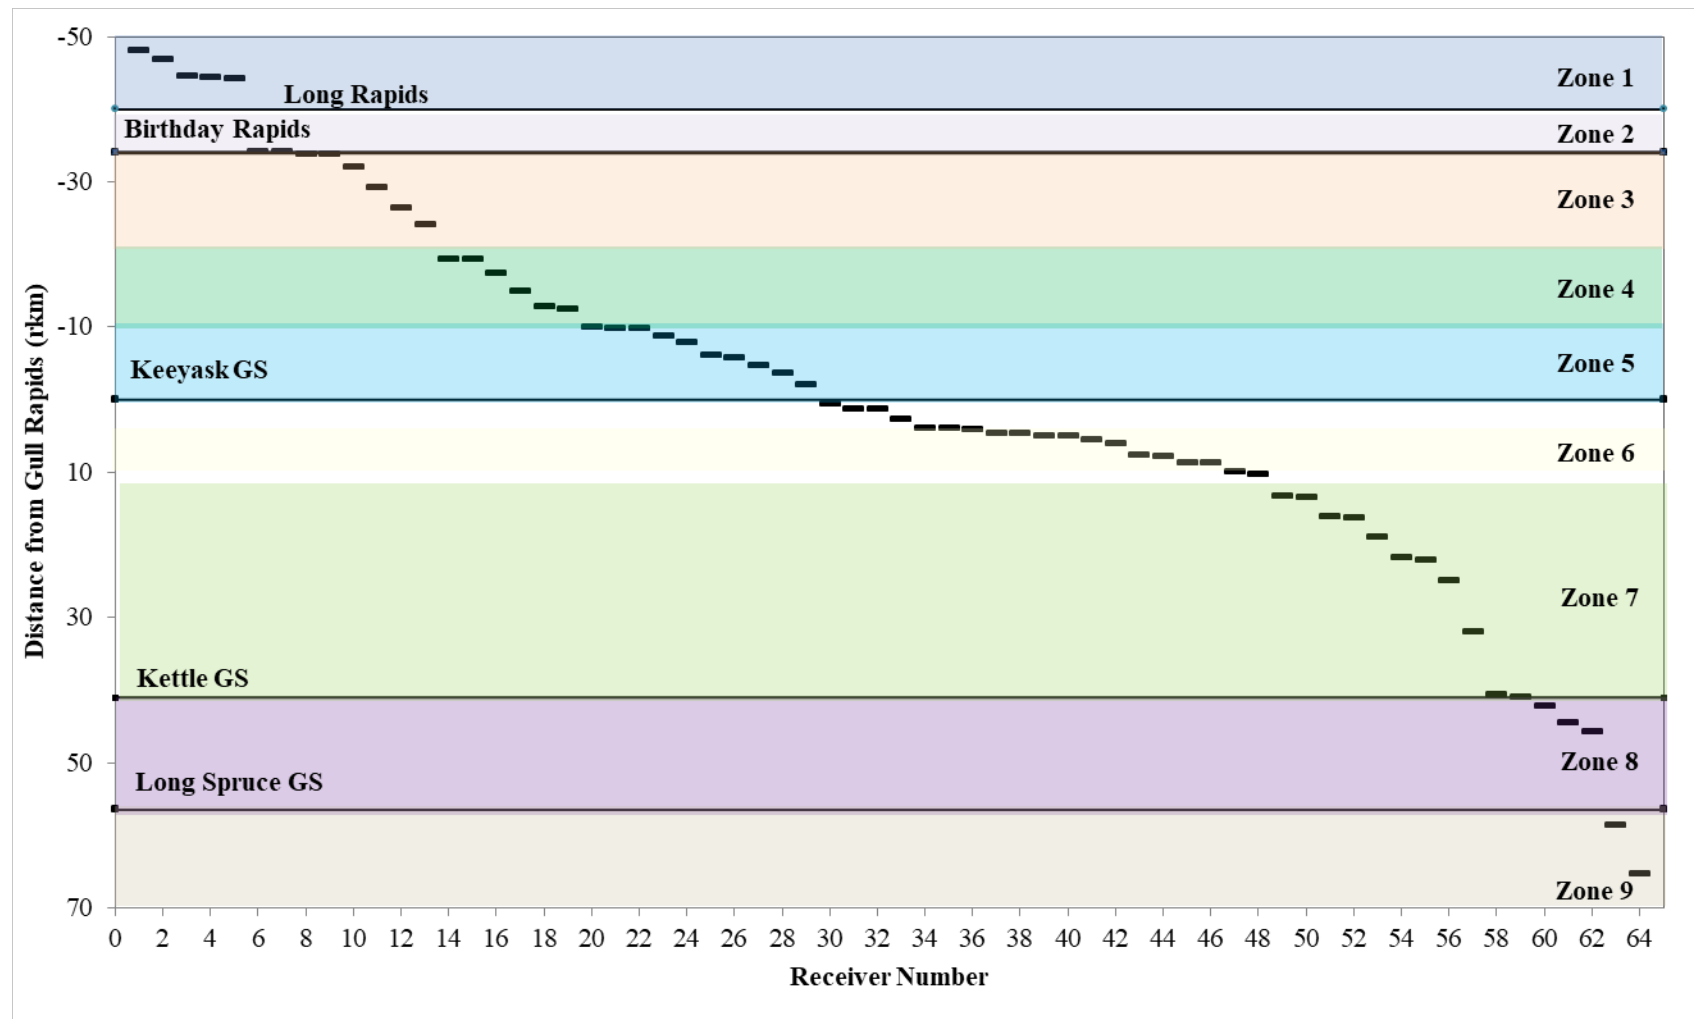
Figure 2: Locations of stationary acoustic receivers (dashes) in relation to the base of the Keeyask GS (rkm 0) and other major landmarks (lines) in the Nelson River between Clark Lake and the Limestone GS between July and October, 2020. River zones upstream and downstream of the Keeyask GS are indicated by shading.

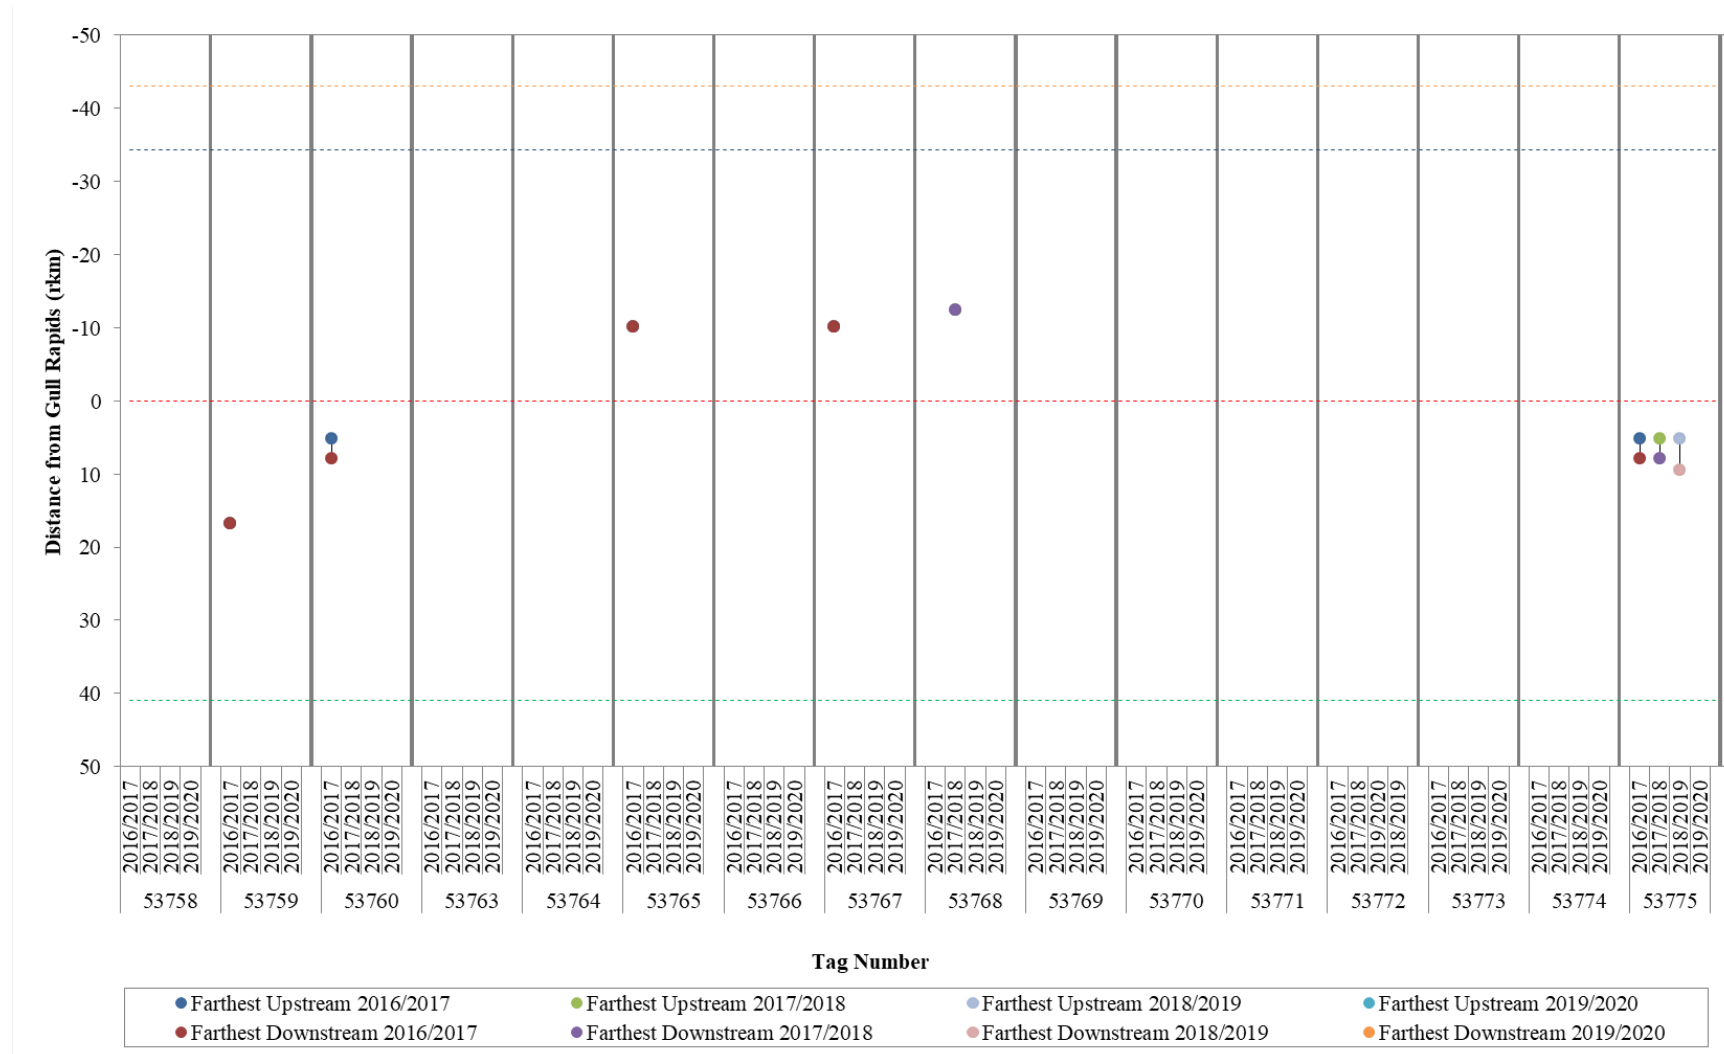
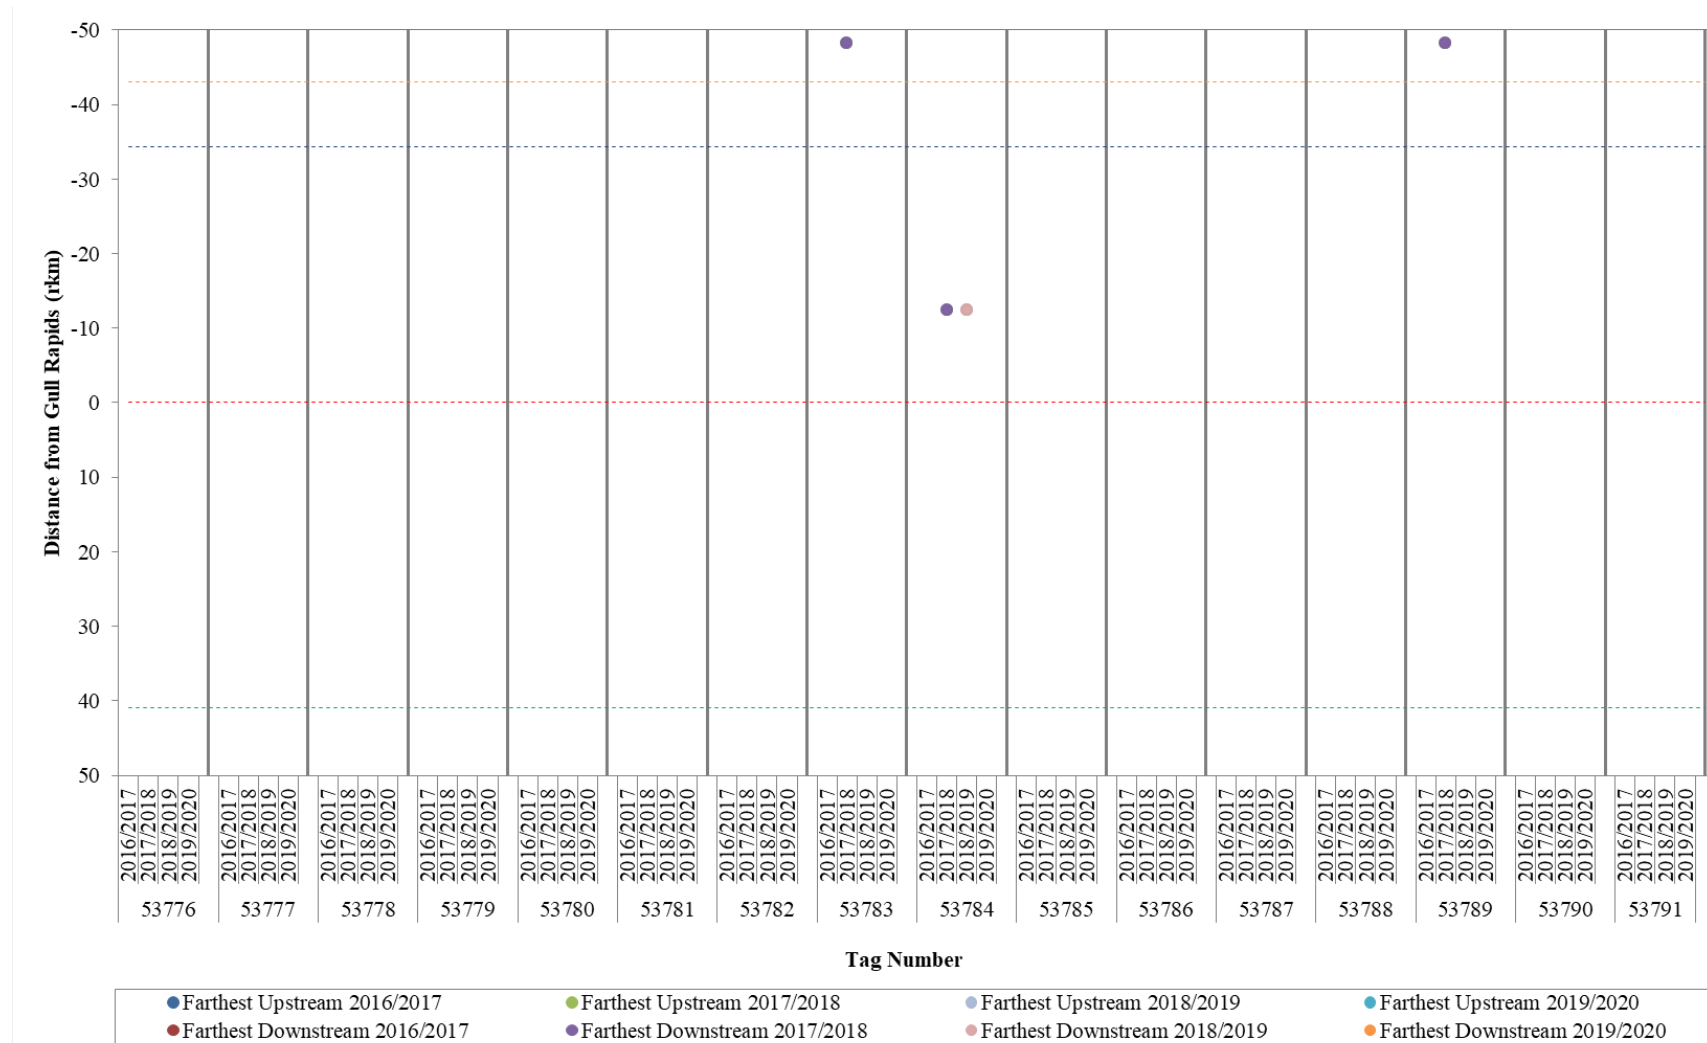
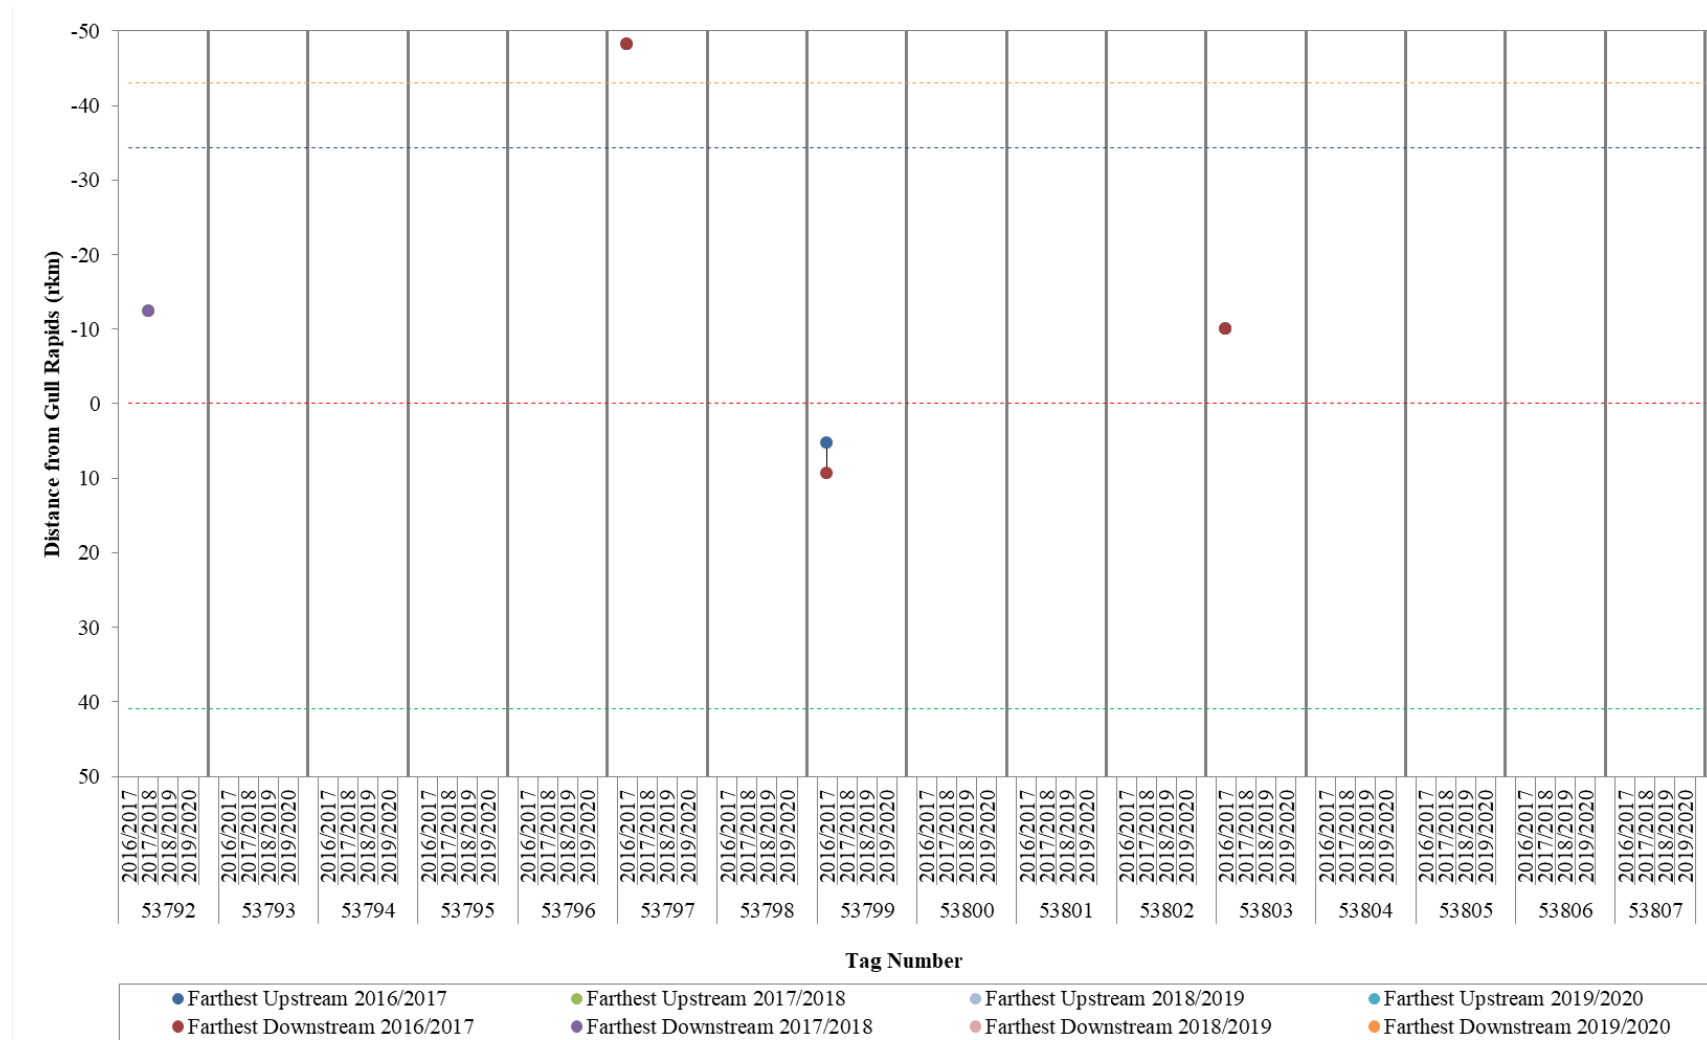
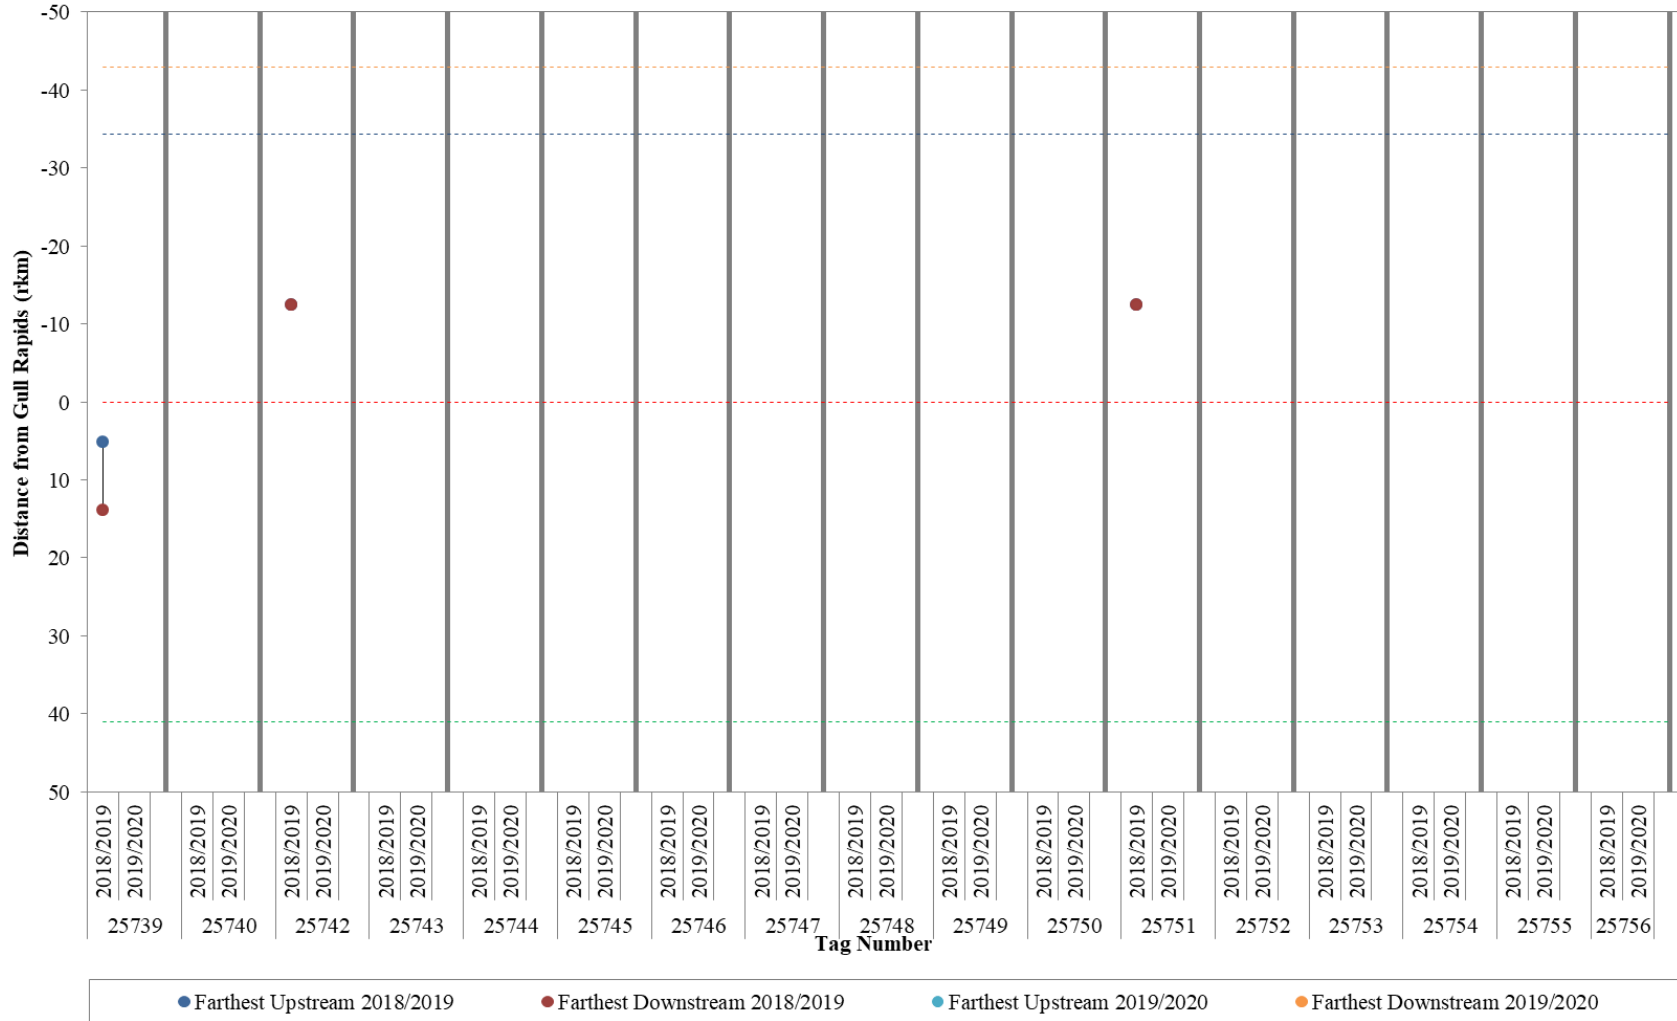
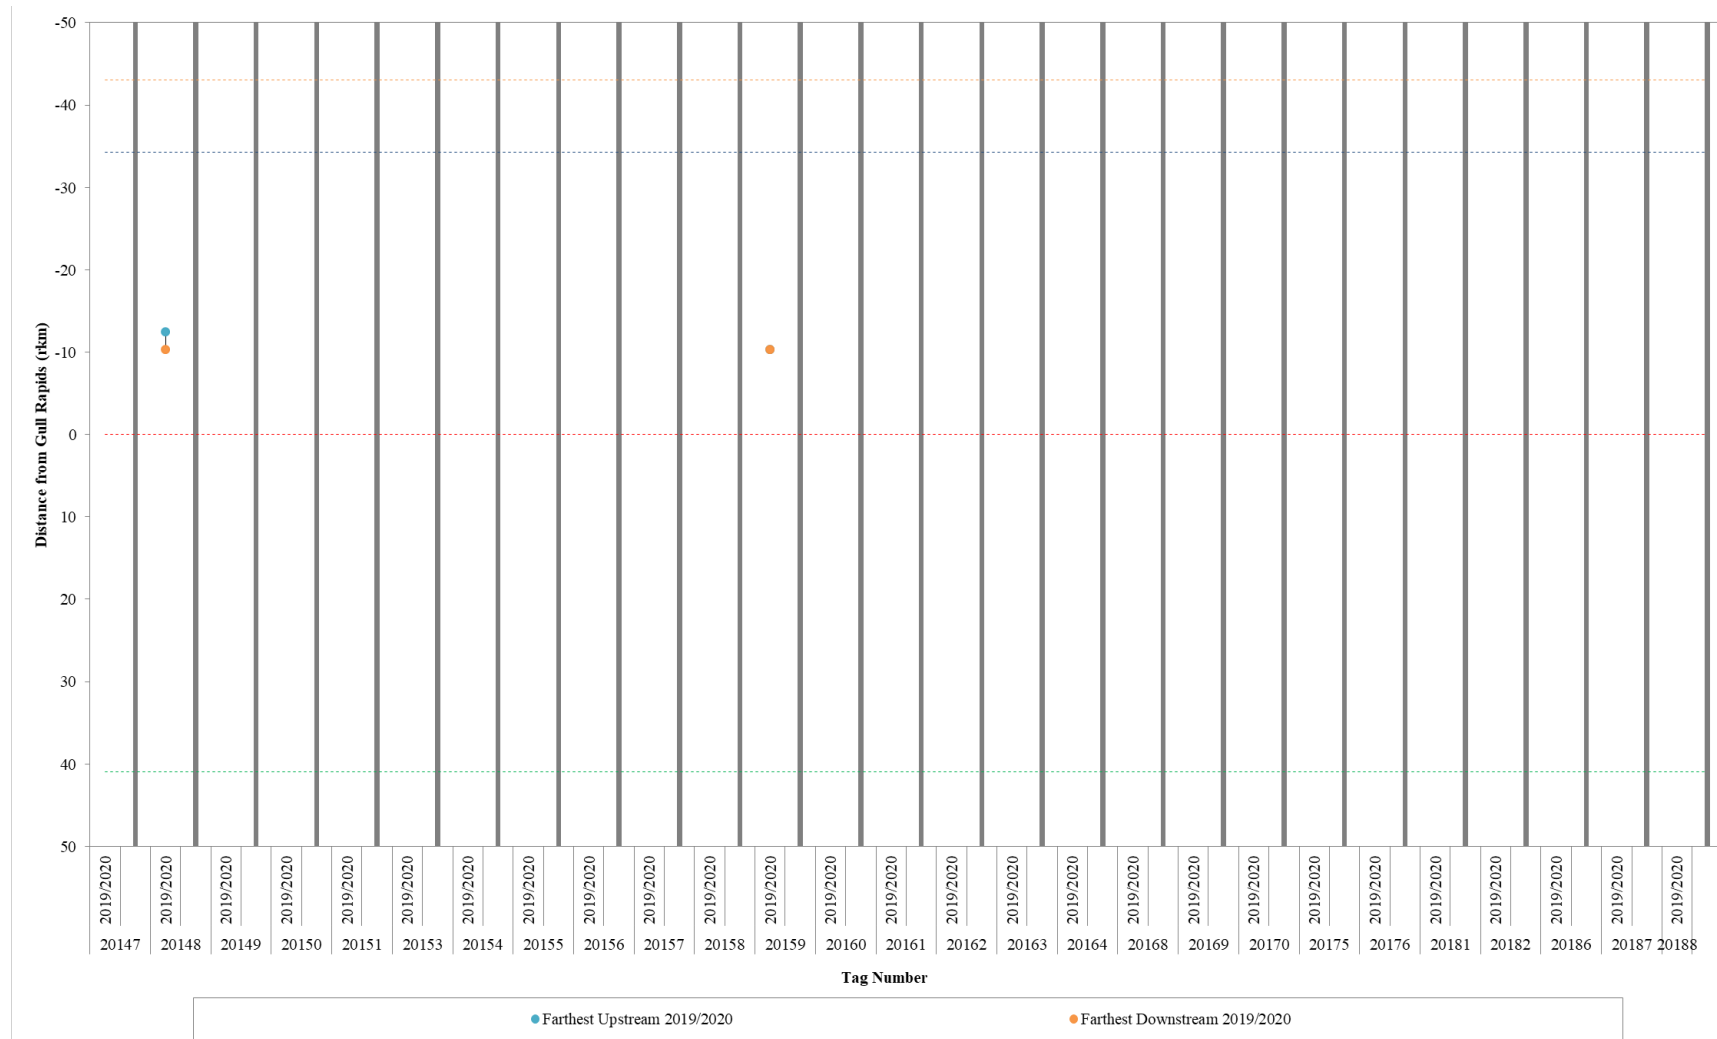
Figure 3: Detection ranges for individual Walleye tagged with acoustic transmitters upstream of the Keeyask GS during the winter period (2016–2020). Horizontal dotted lines indicate locations of landmarks (orange = Clark Lake outlet; blue = Birthday Rapids, red = the Keeyask GS; green = Kettle GS).

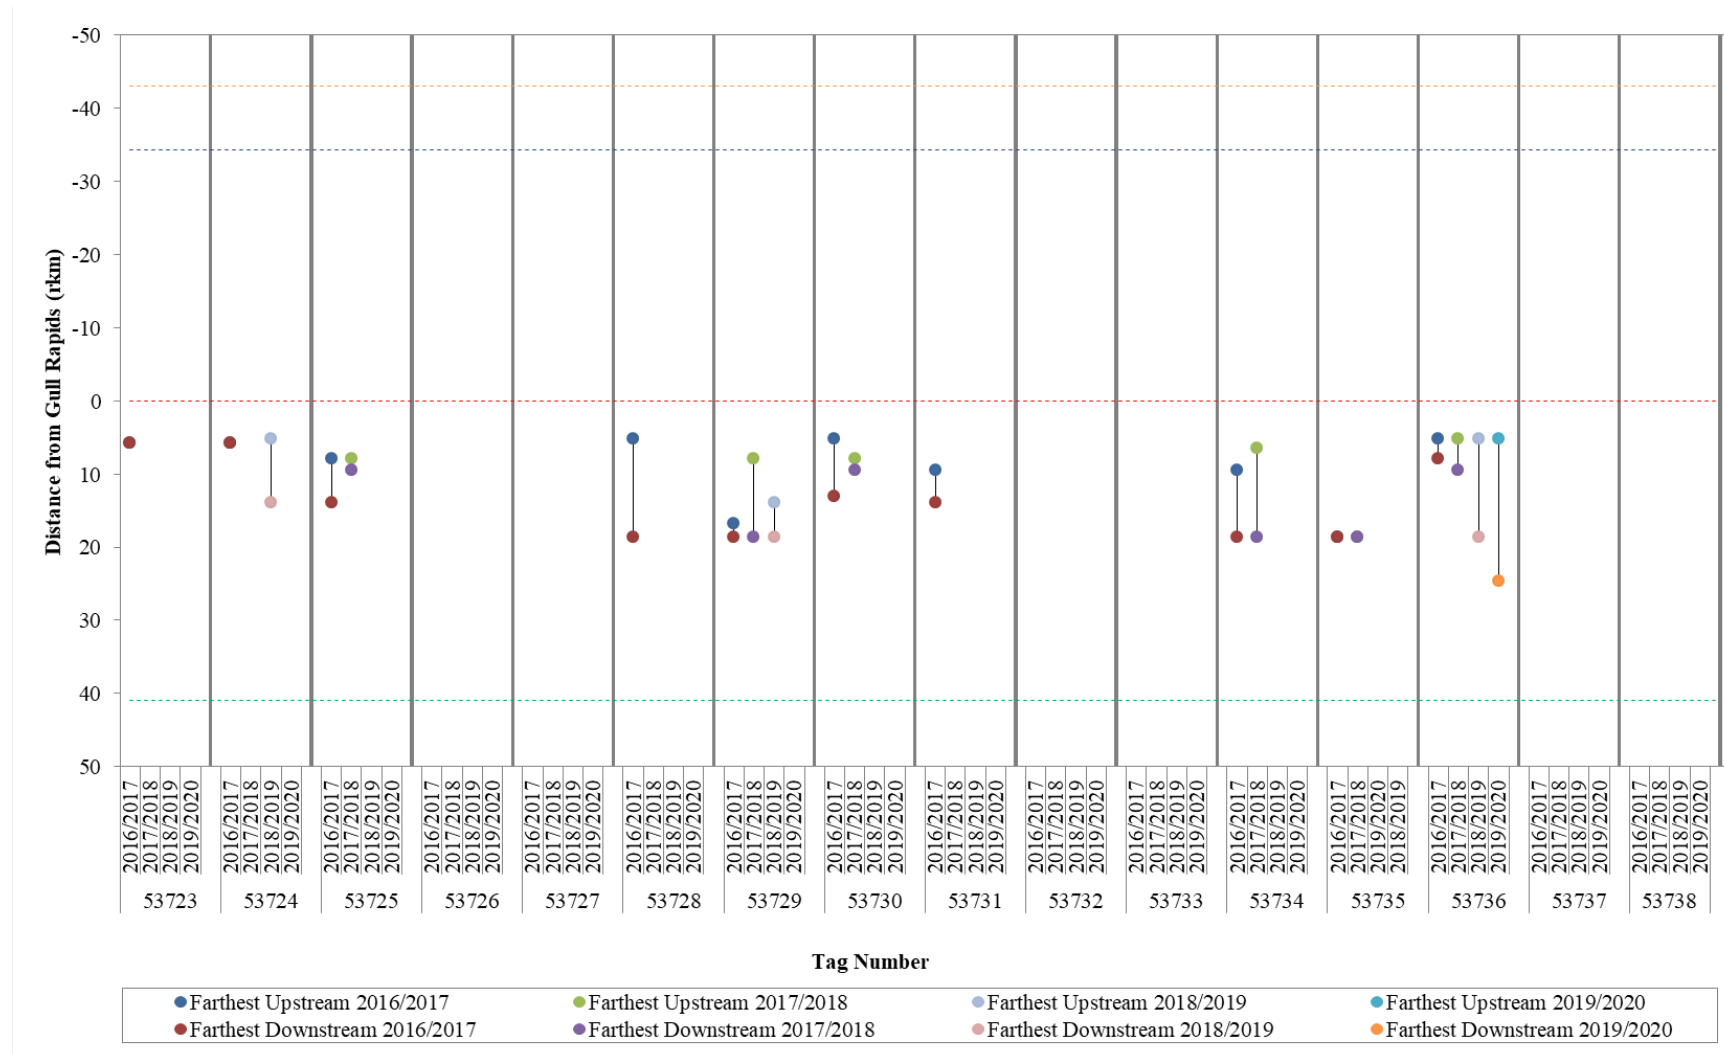
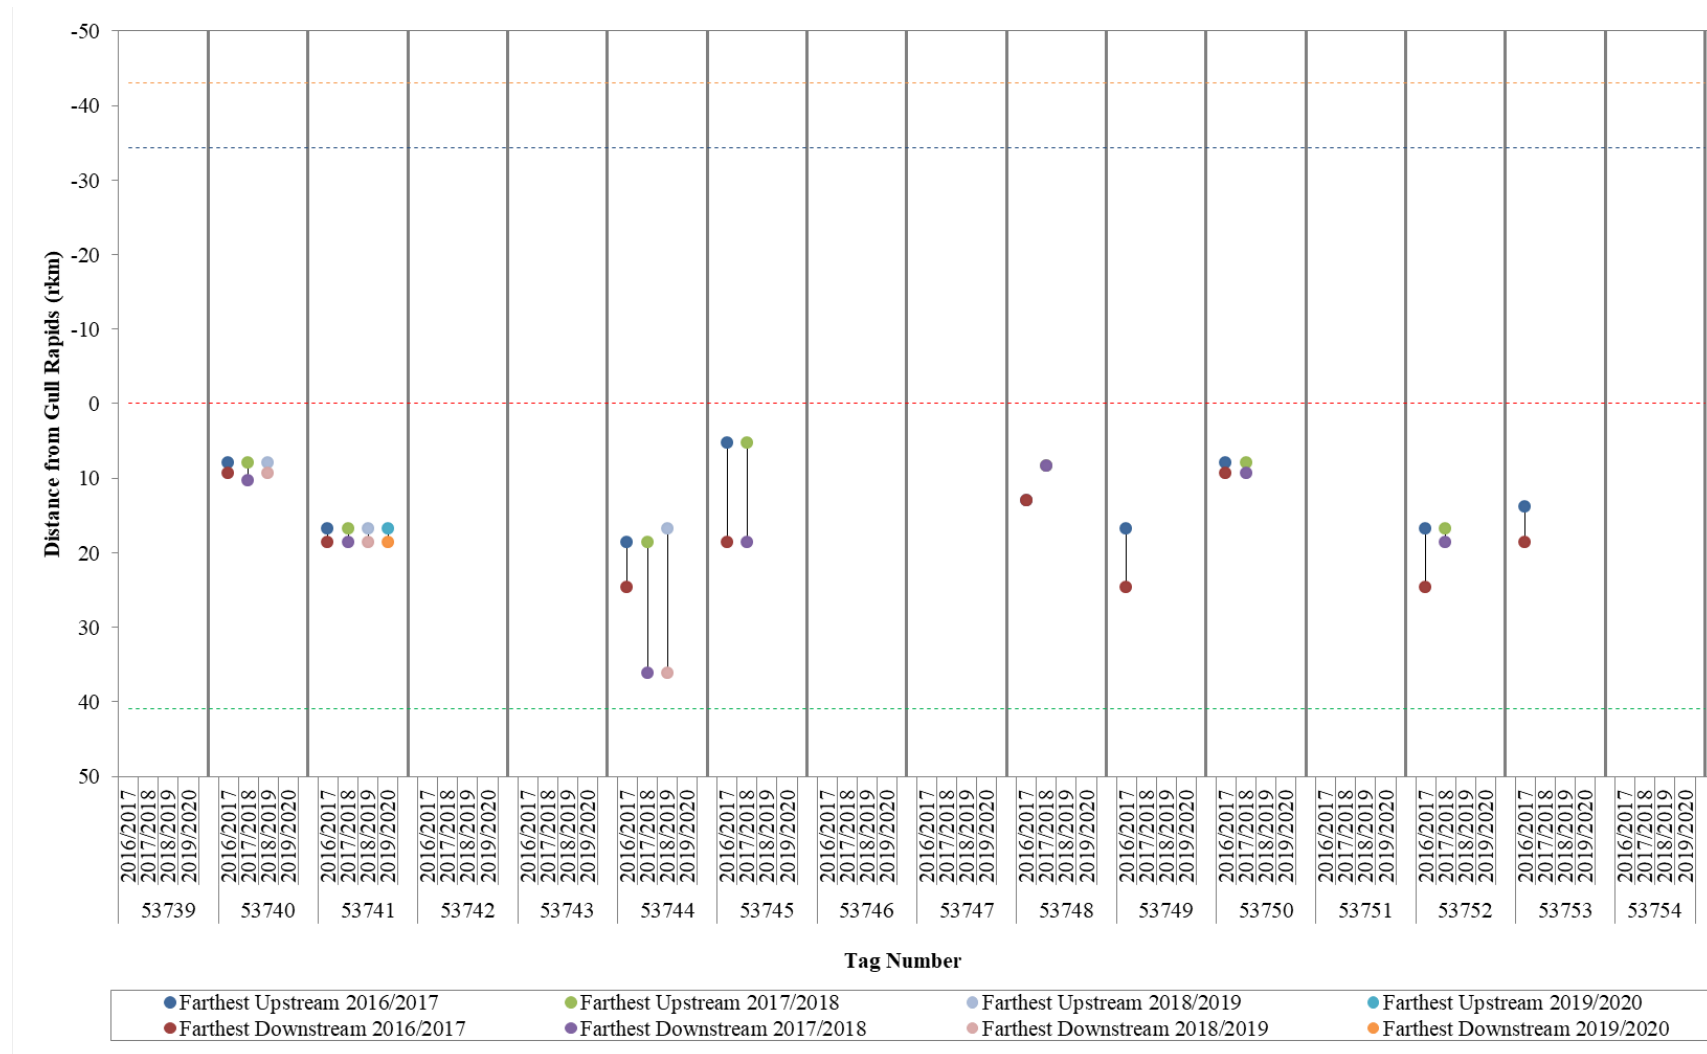
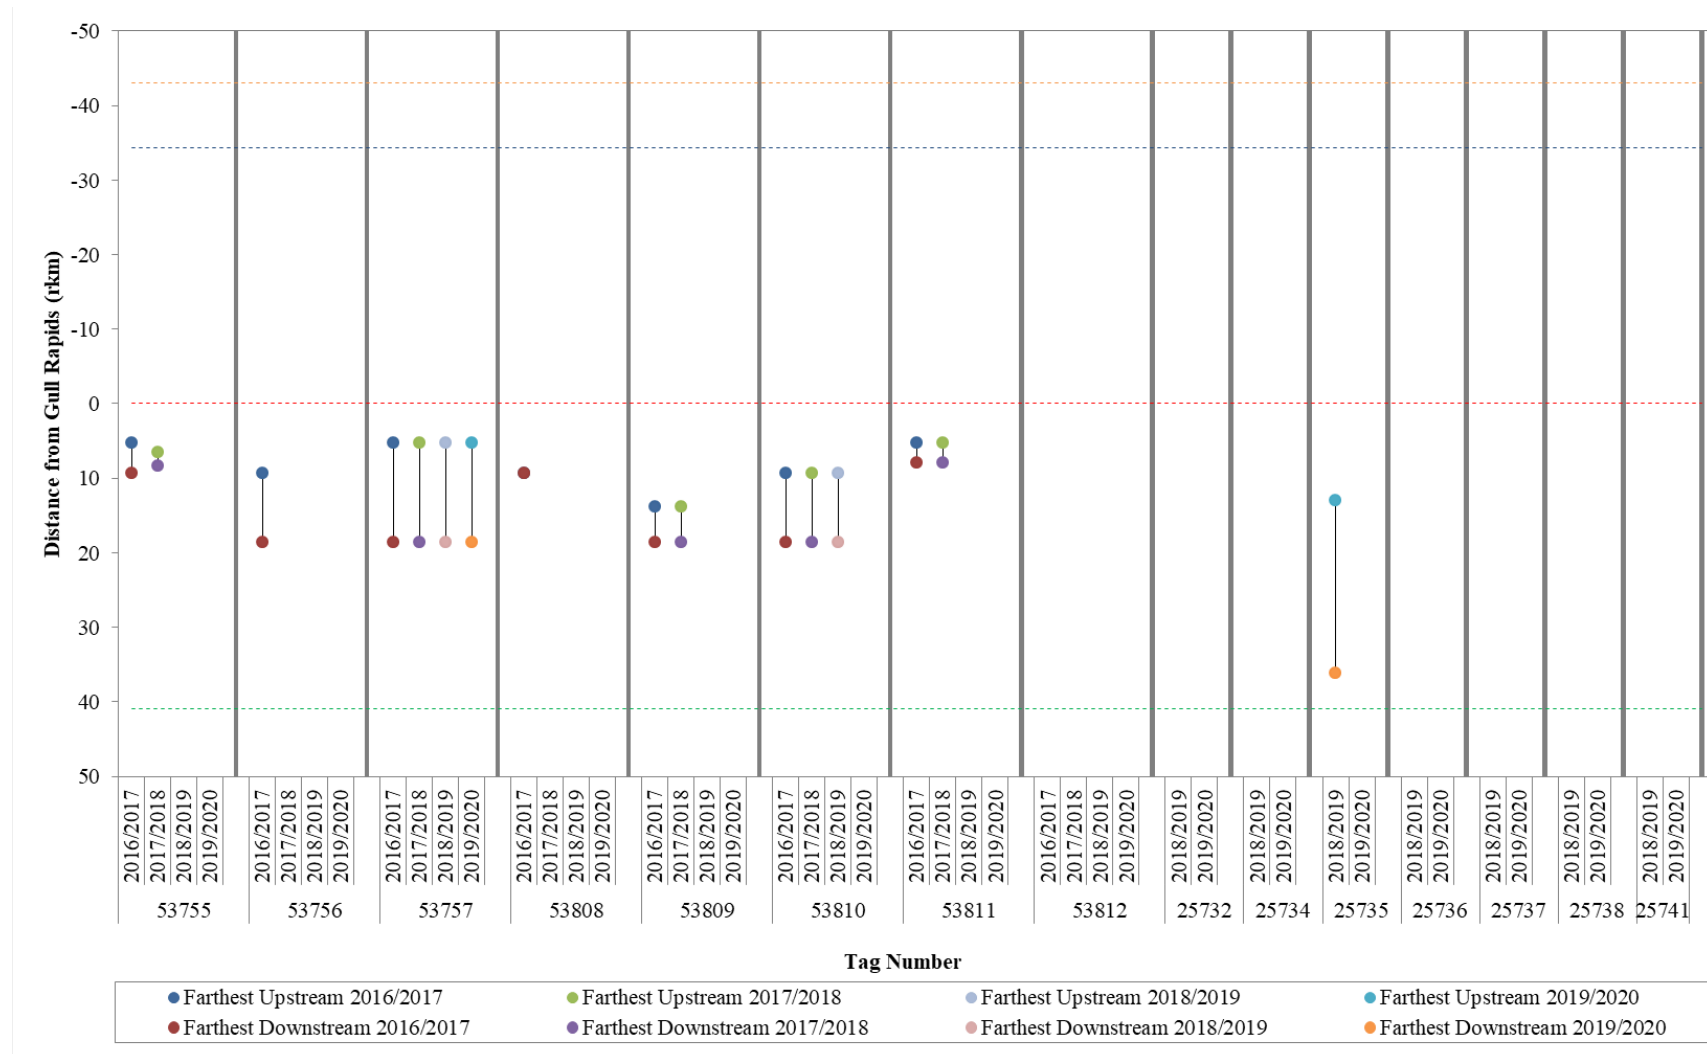
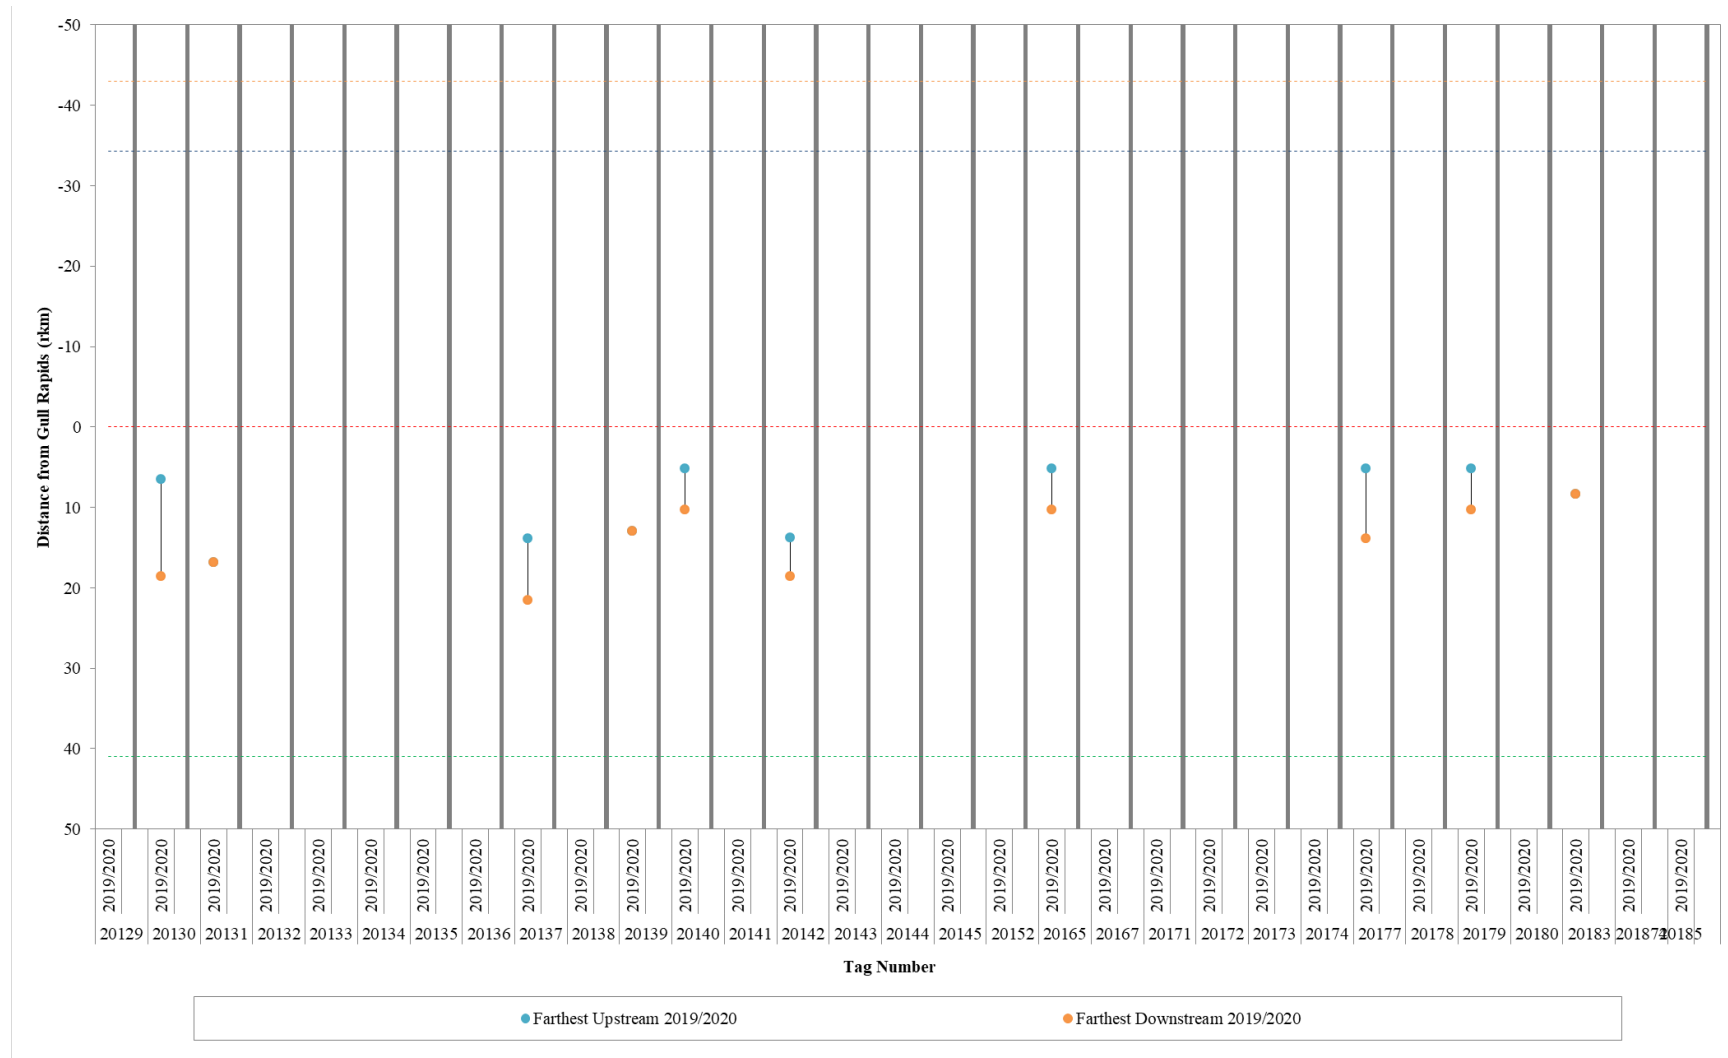
Figure 5: Detection ranges for individual Walleye tagged with acoustic transmitters in Stephens Lake during the winter period (2016–2020). Horizontal dotted lines indicate locations of landmarks (orange = Clark Lake outlet; blue = Birthday Rapids, red = the Keeyask GS; green = Kettle GS).
