Keeyask Generation Project Aquatic Effects Monitoring Plan

Walleye Movement Monitoring Report AEMP-2021-04

WALLEYE MOVEMENT MONITORING IN THE NELSON RIVER BETWEEN CLARK LAKE AND THE LIMESTONE GENERATING STATION, OCTOBER 2019 TO SEPTEMBER 2020: YEAR 7 CONSTRUCTION

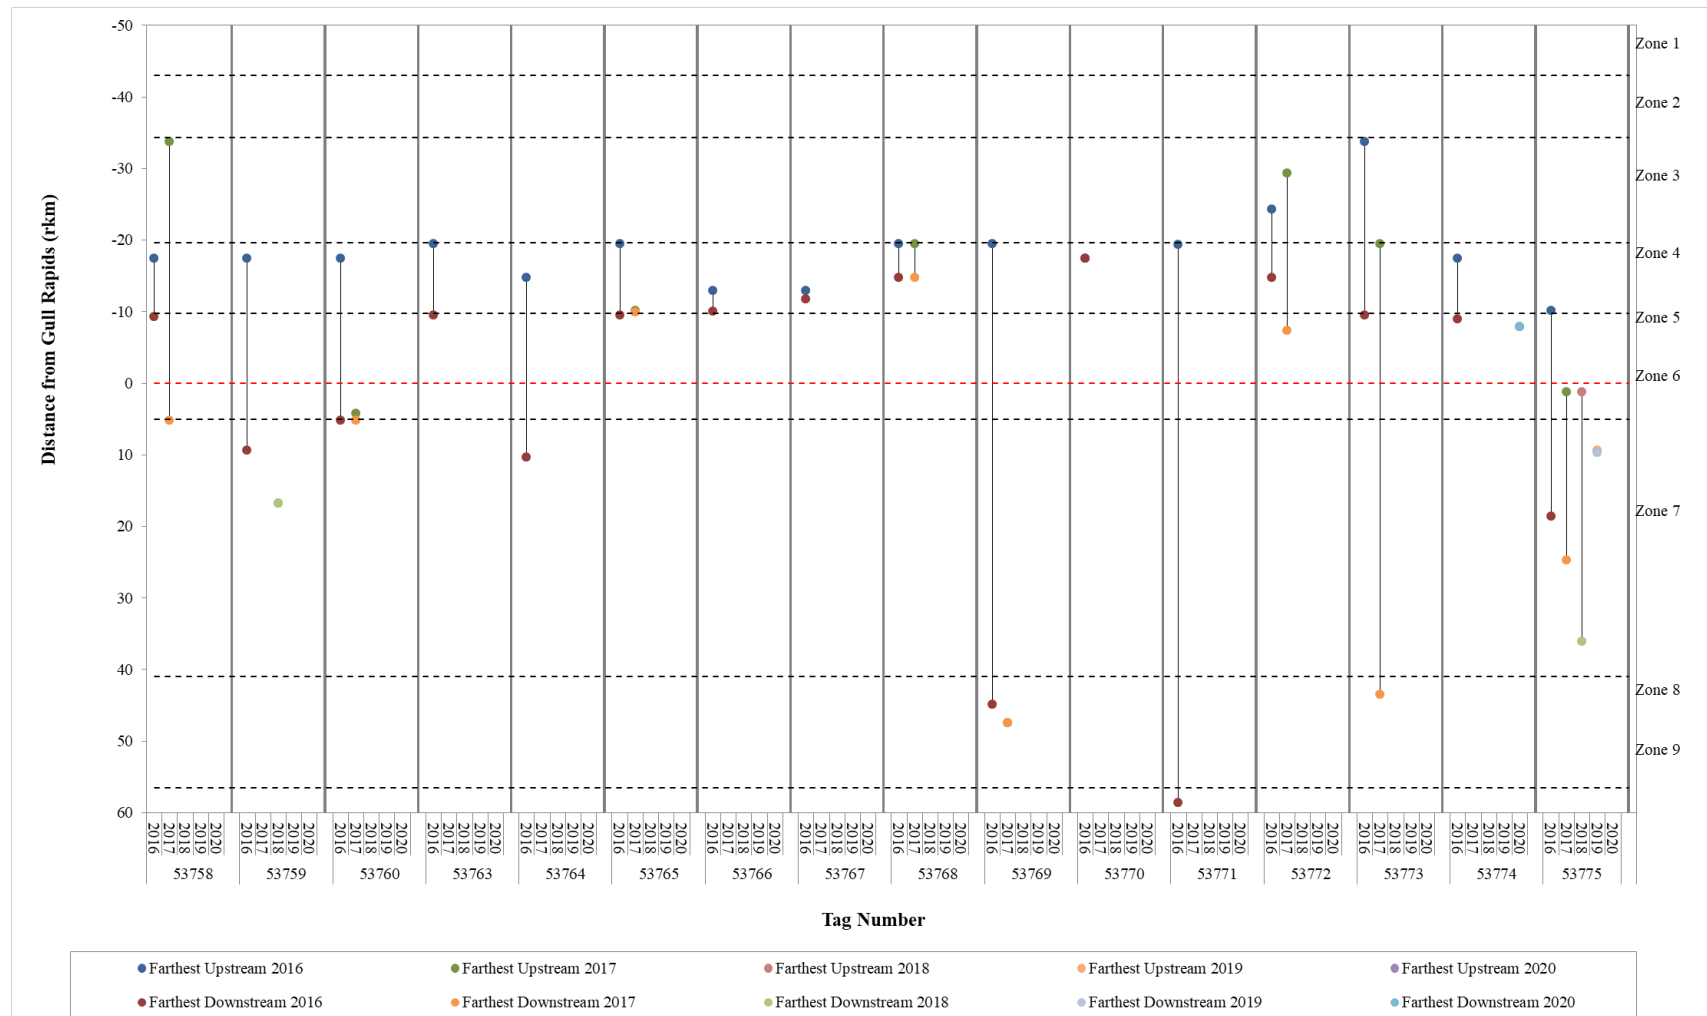
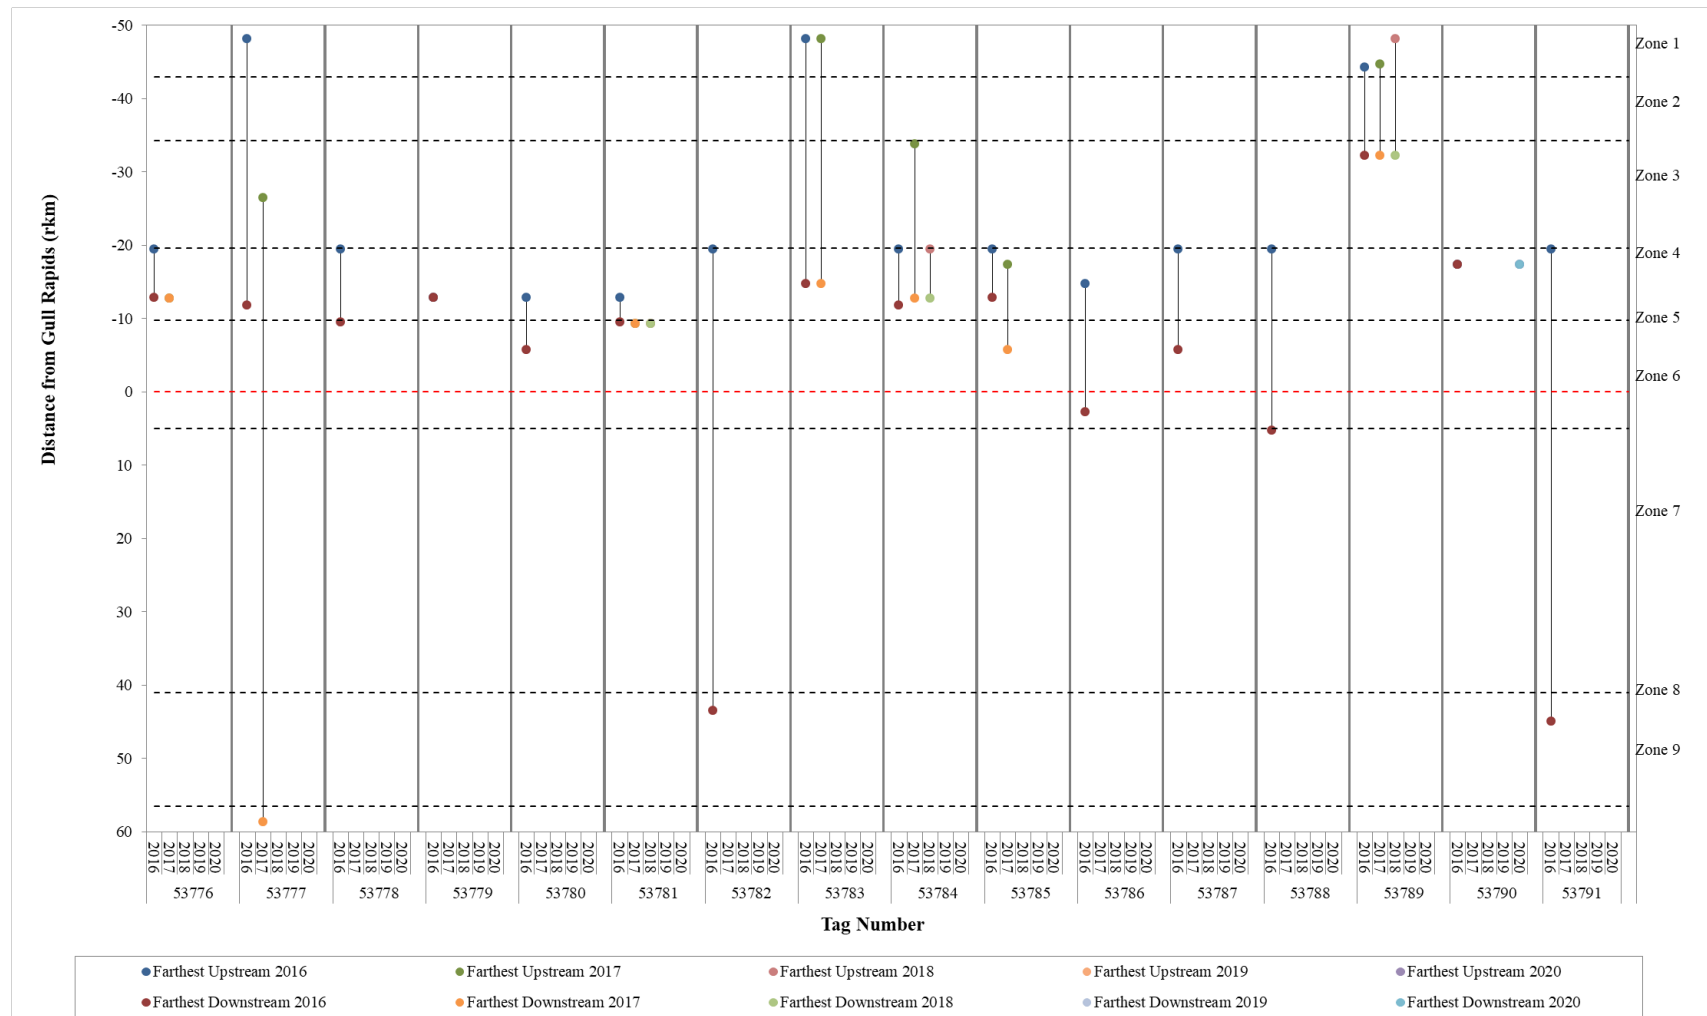
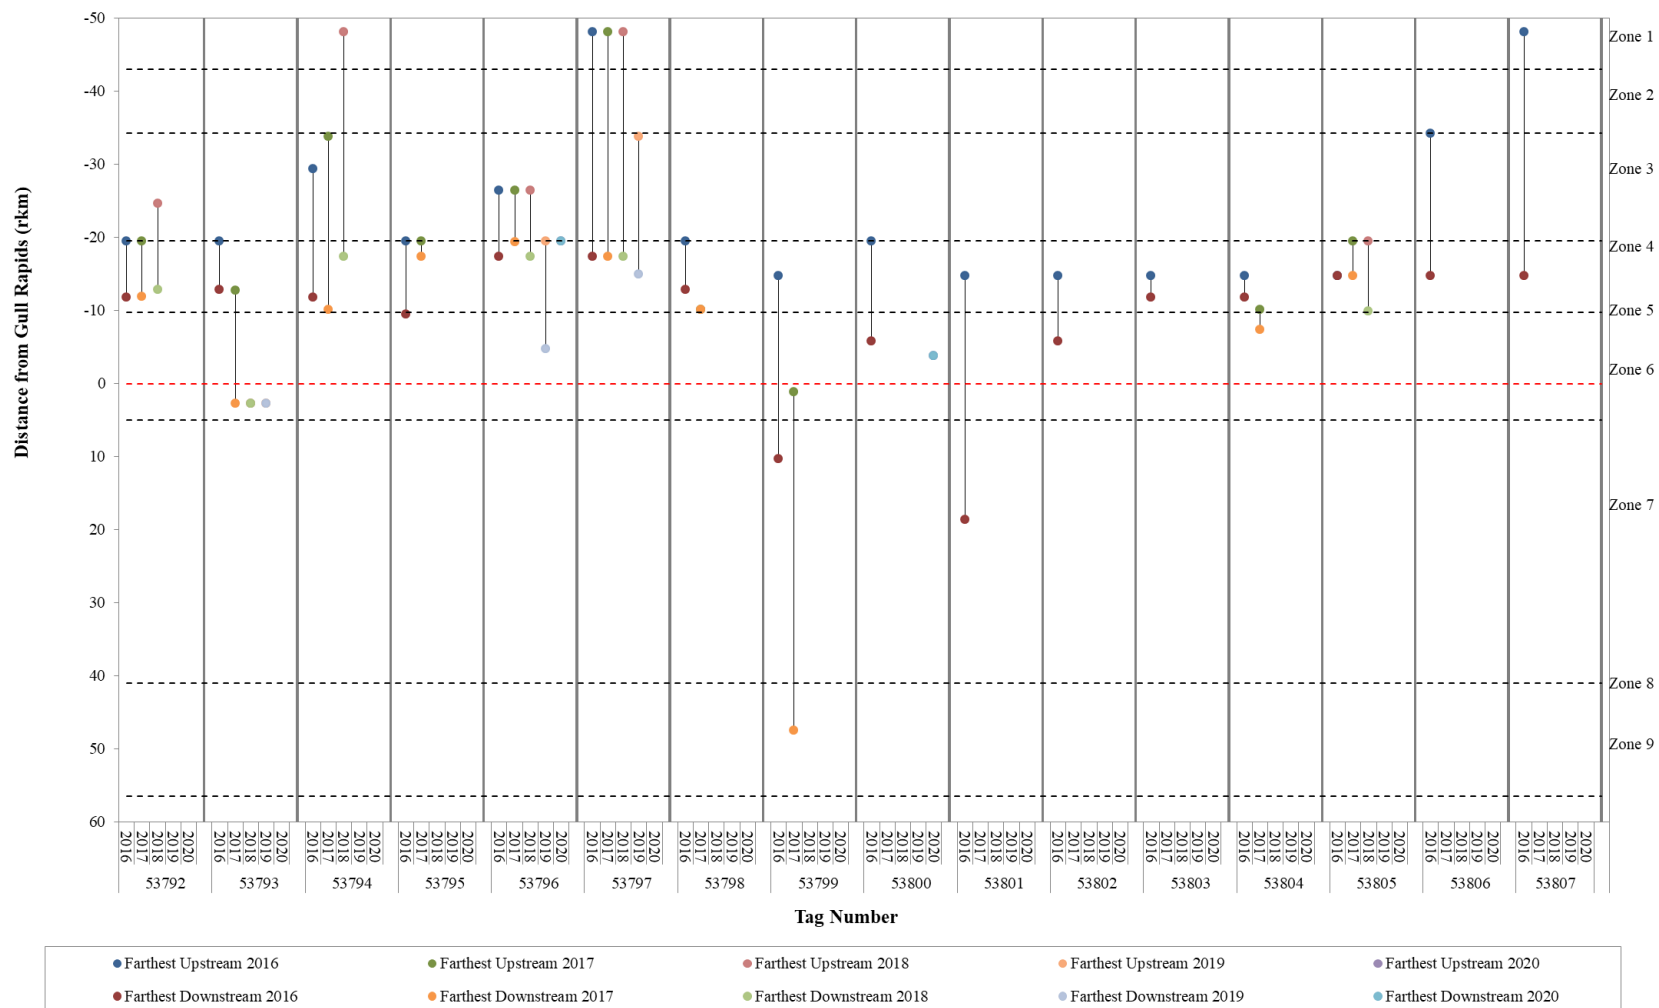
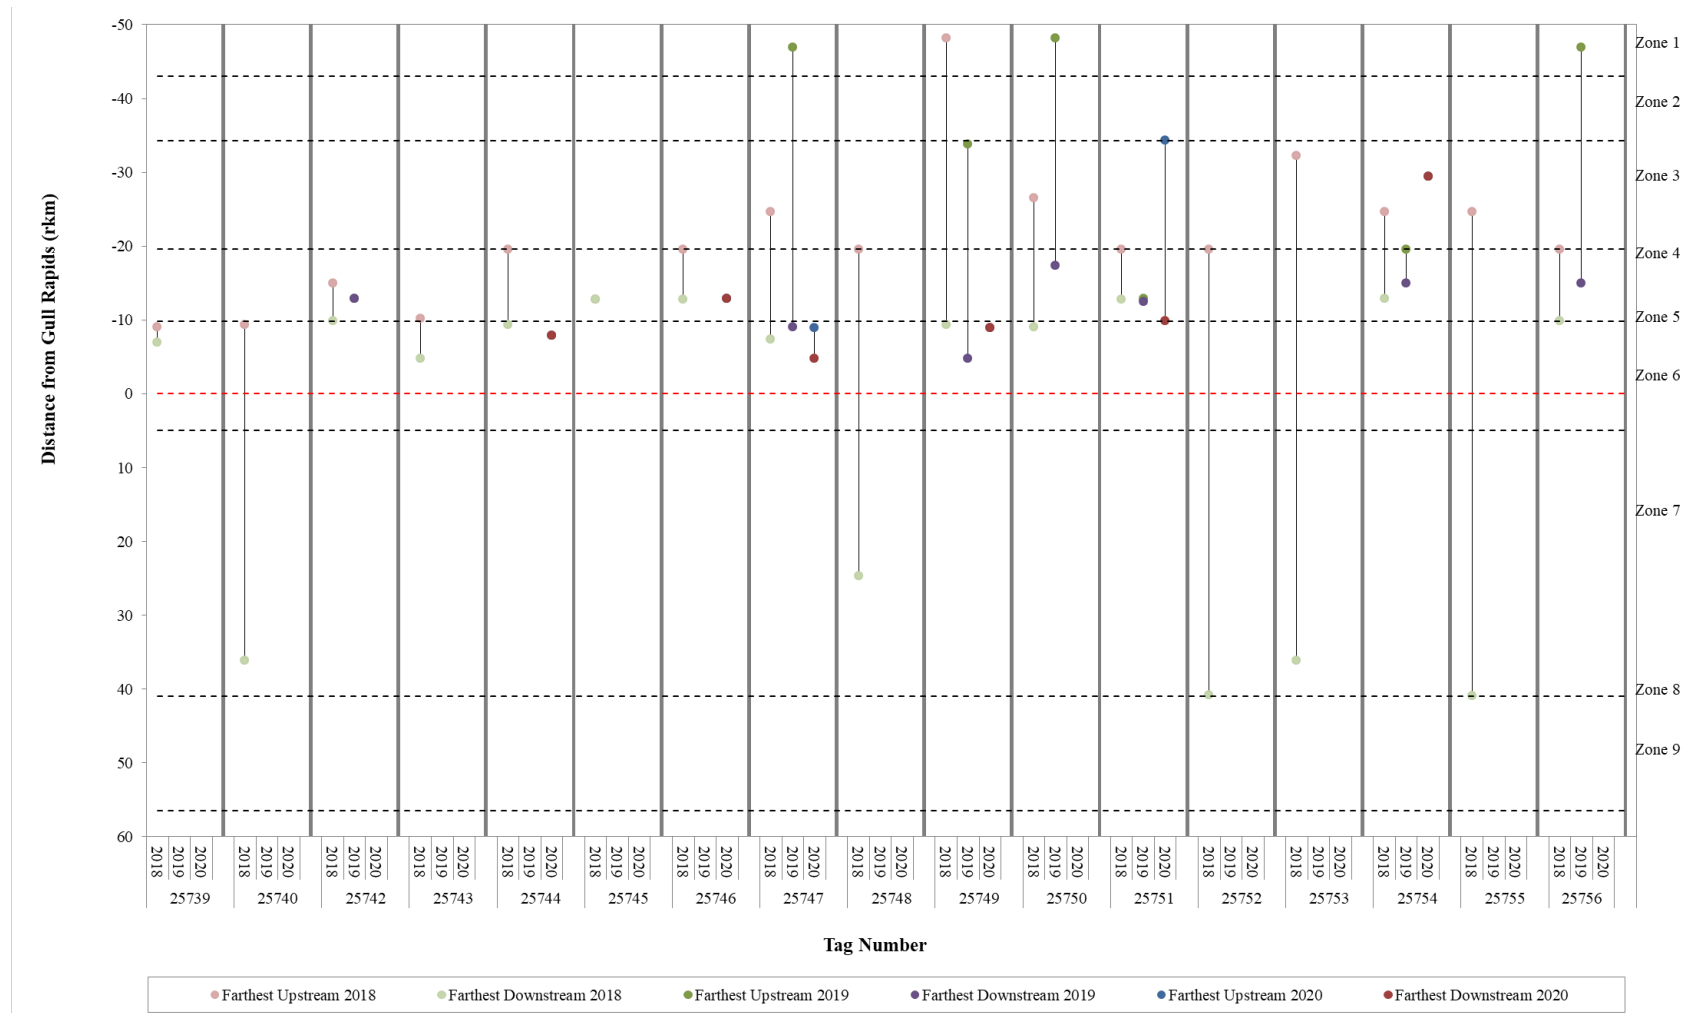
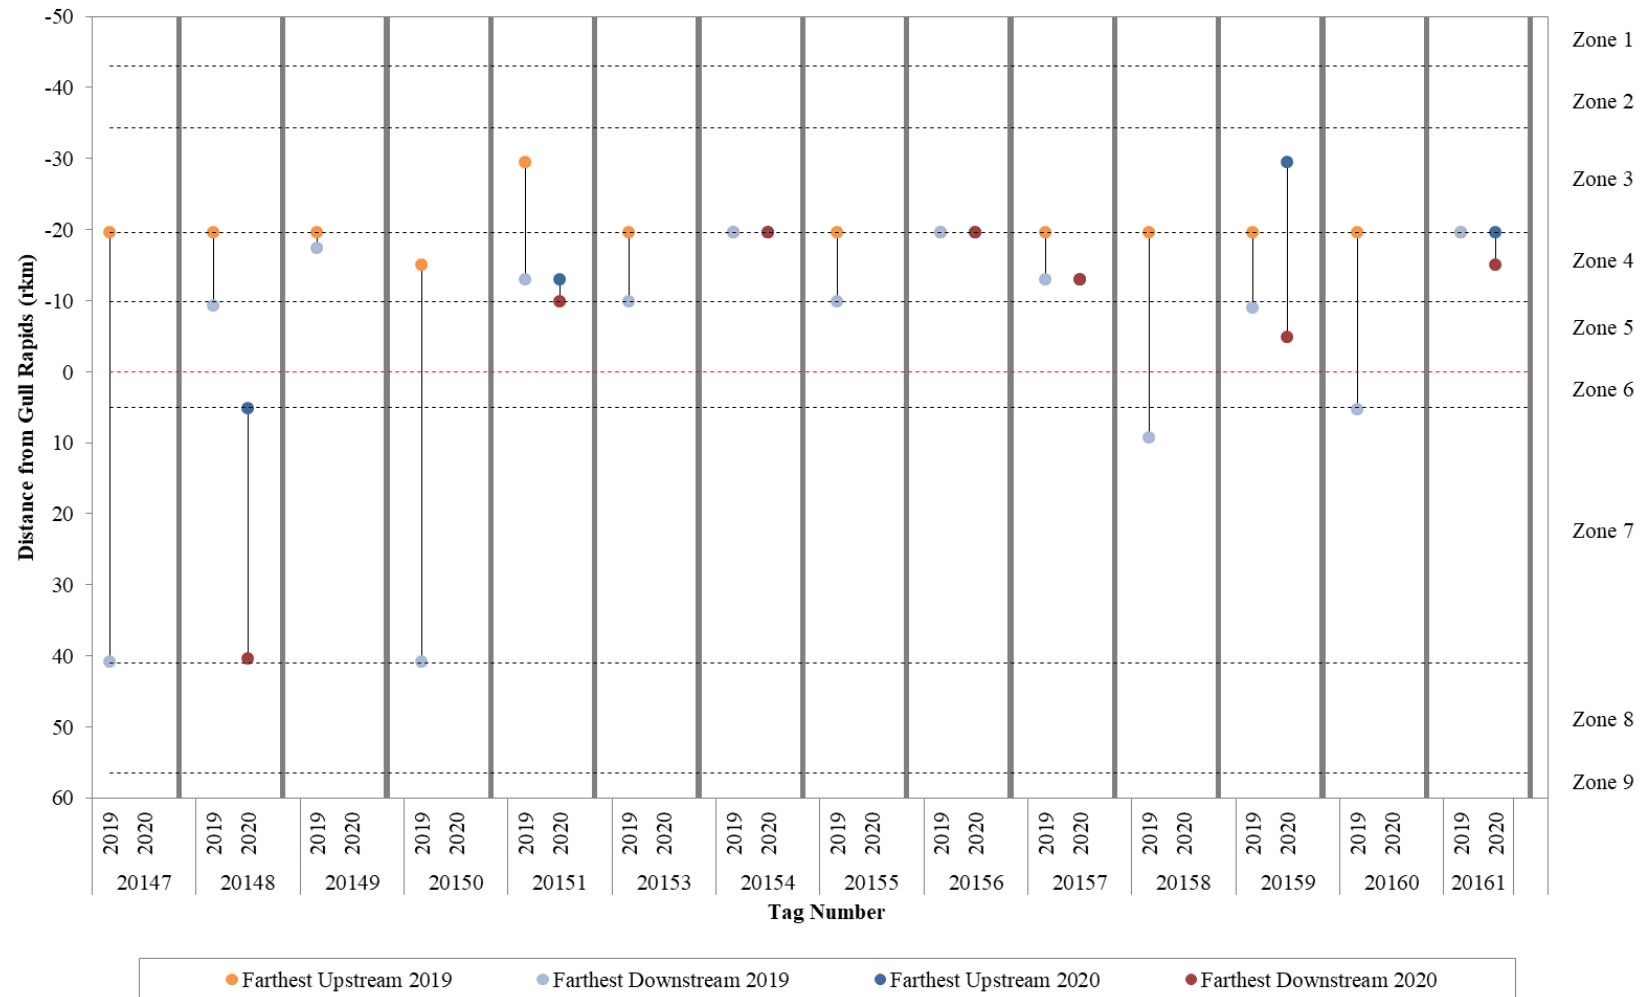
Figure 7: Detection ranges for individual Walleye tagged with acoustic transmitters upstream of the Keeyask during the open-water period (2016–2020). Horizontal dotted lines demarcate zones. Horizontal dotted lines demarcate zones. Blue represents the outlet of Clark Lake, dark pink represents Birthday Rapids, red represents the Keeyask GS, light pink represents the Kettle GS, and light green represents the Long Spruce GS.

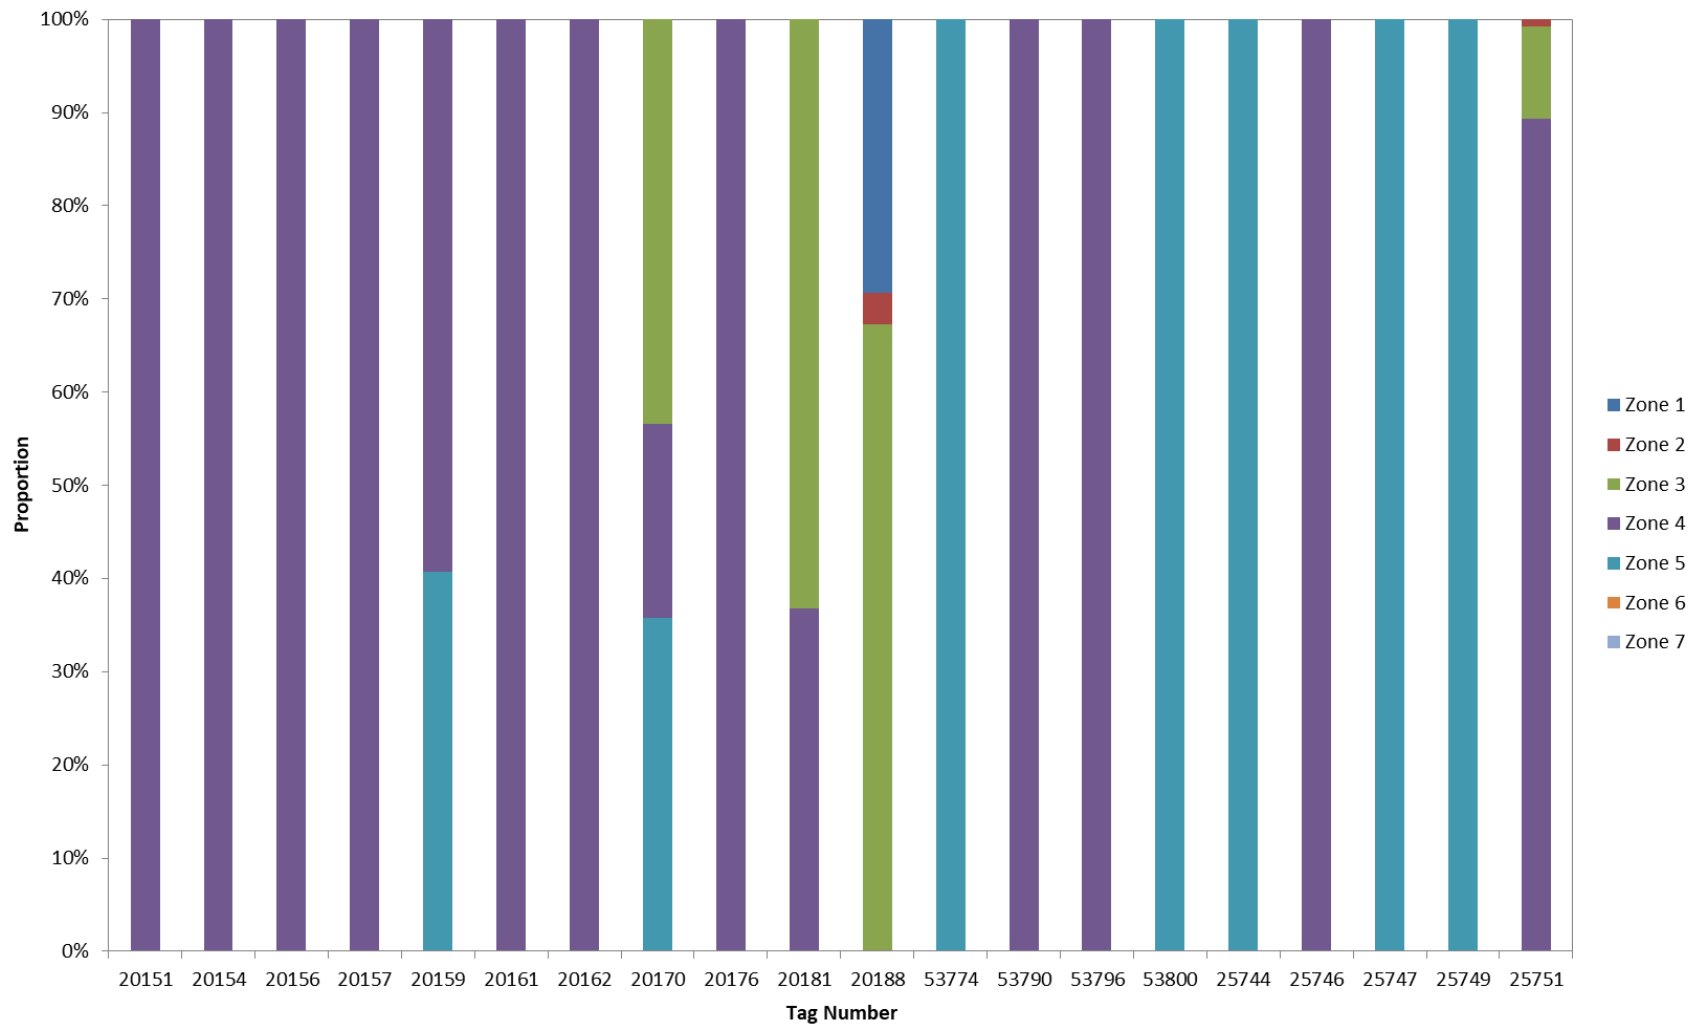
Figure 9: Proportional distributions by zone for individual Walleye tagged with acoustic transmitters upstream of Keeyask GS during a portion of the 2020 open-water period (July 3 to September 23).

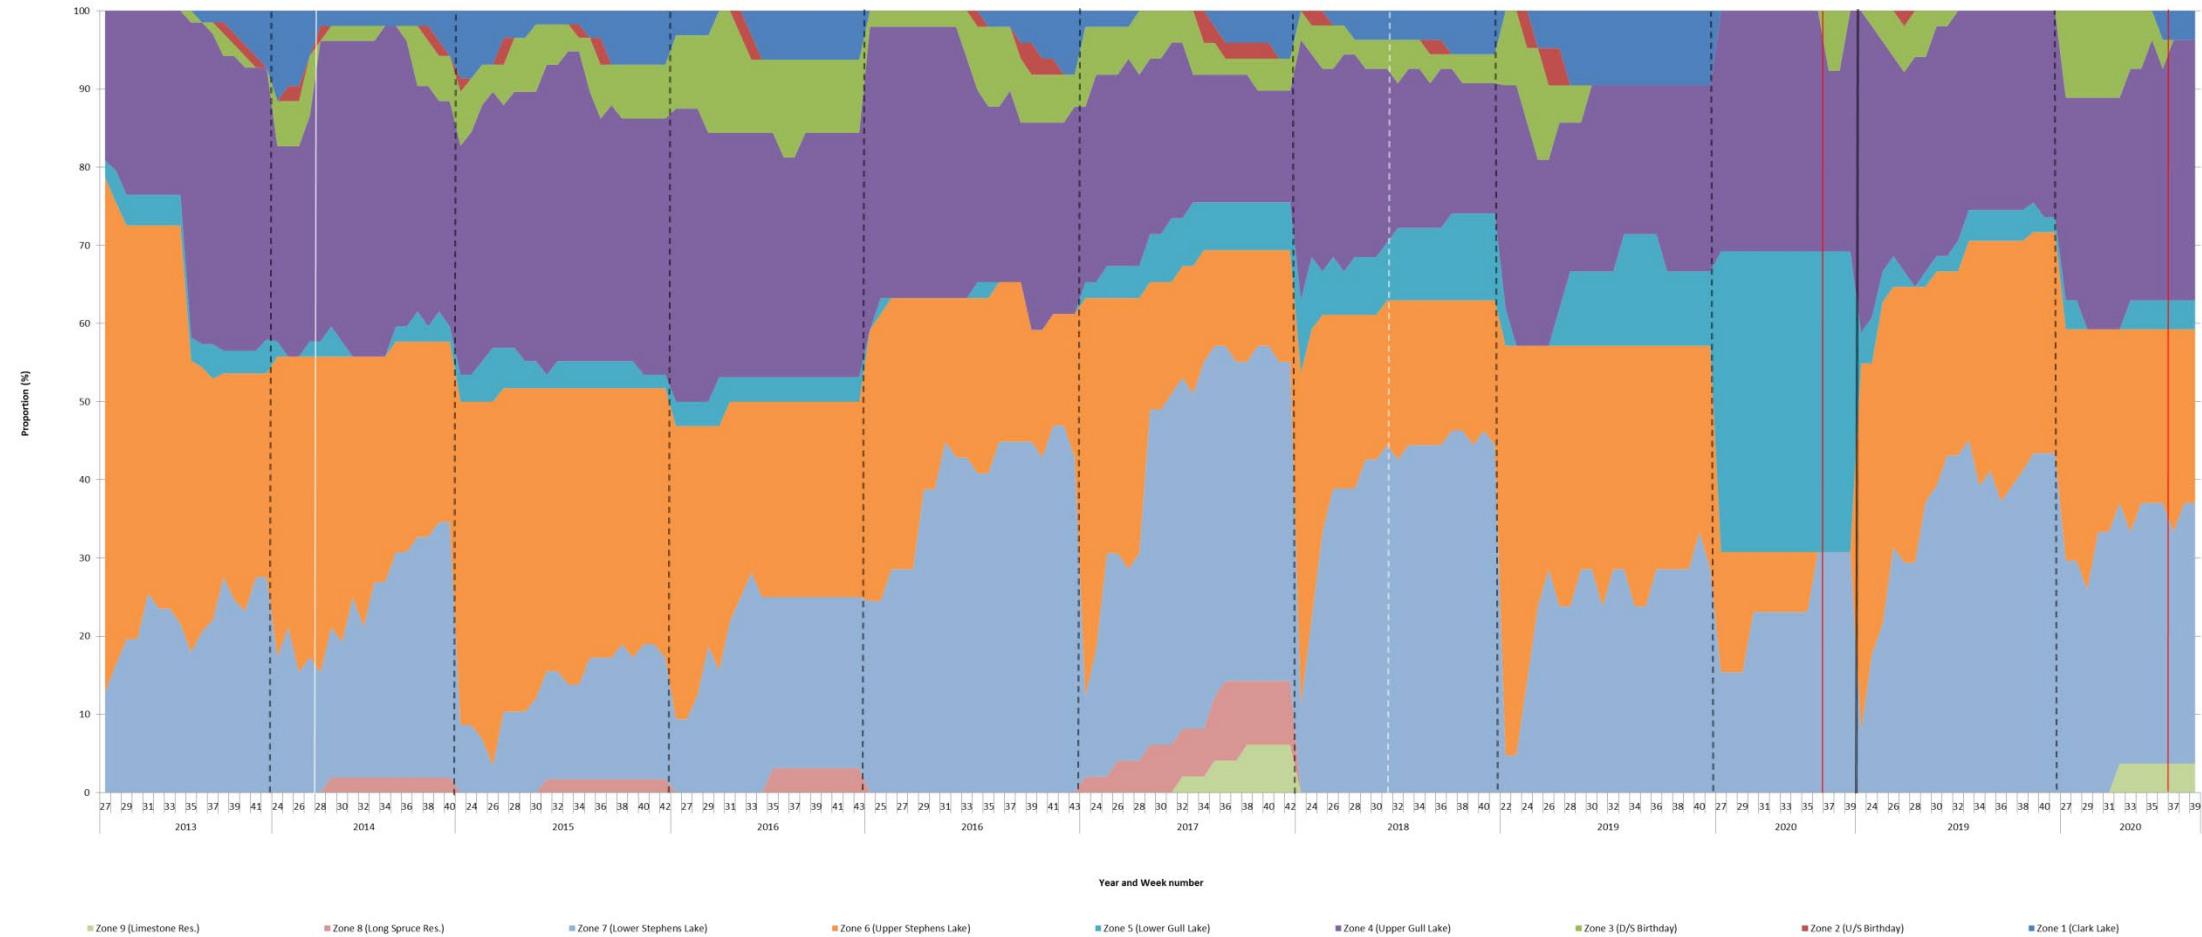
Figure 10: Proportional distribution by zone, for Walleye tagged with acoustic transmitters in the Keeyask GS Area during a portion of the 2013 (June 4 to October 15), 2014 (June 4 to October 3), 2015 (June 4 to October 11), 2016 (June 4 to October 19), 2017 (June 7 to October 16), 2018 (June 6 to October 10), 2019 (June 2 to October 7), and 2020 (July 3 to September 23) open-water periods. Black dashed lines indicate study years. Solid black line indicates new fish tagged. Solid white line indicates start of Keeyask construction. Dashed white line indicates start of Keeyask spillway commissioning. Red line indicates completion of Keeyask GS reservoir impoundment.

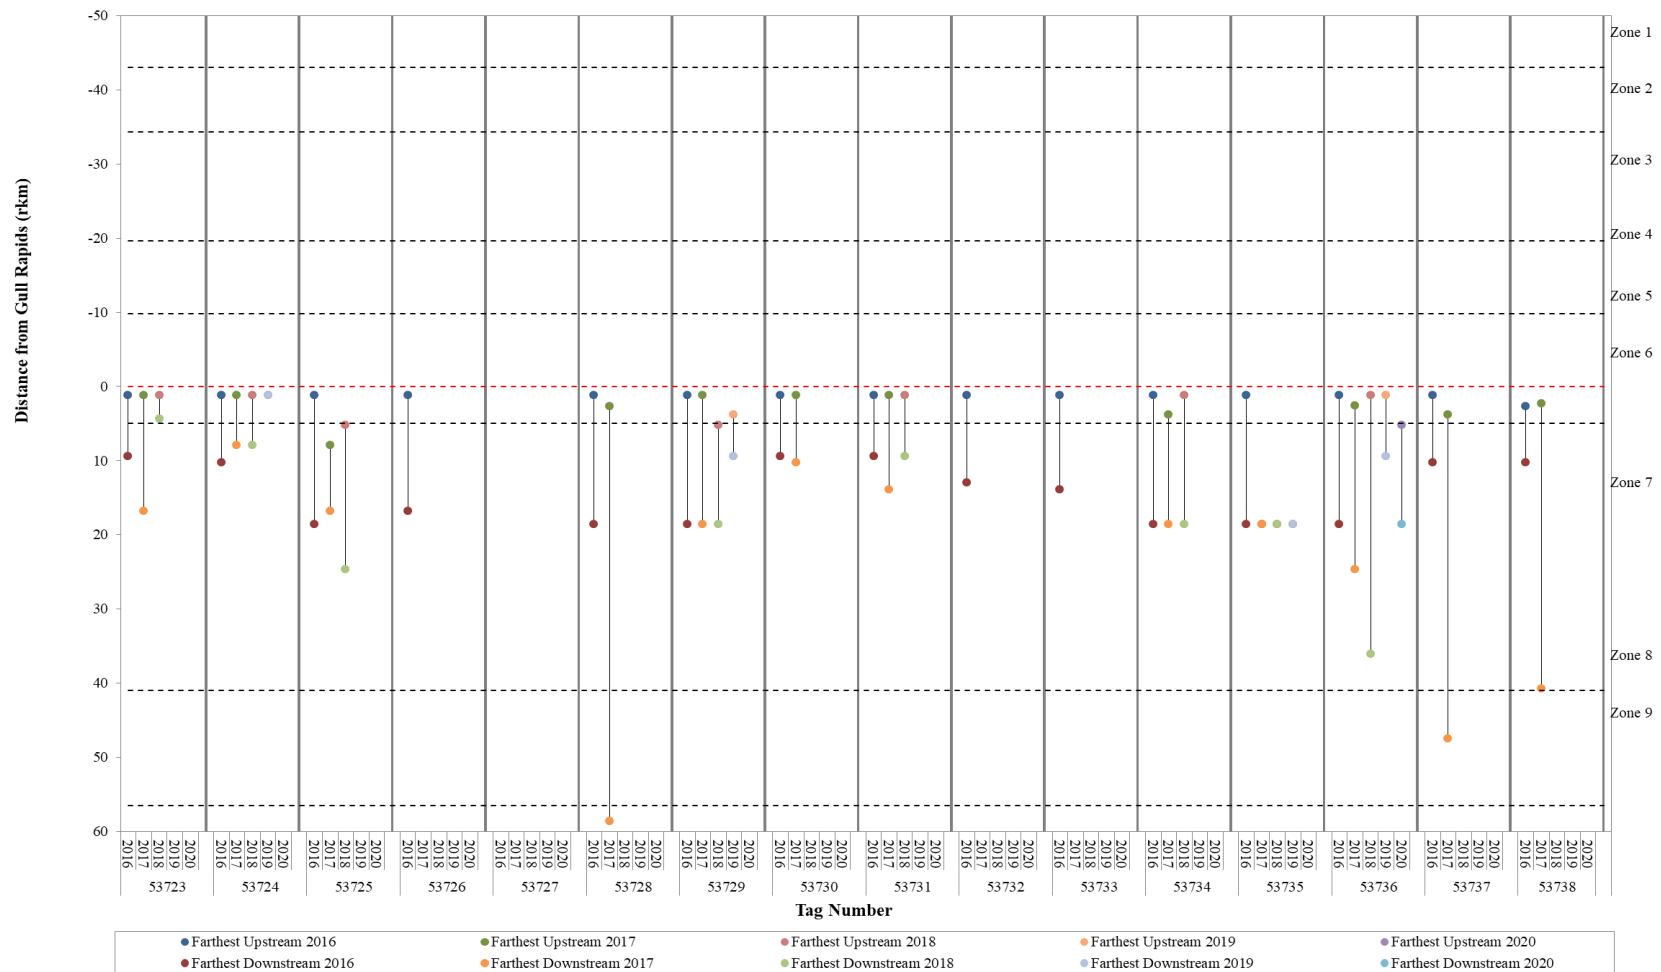
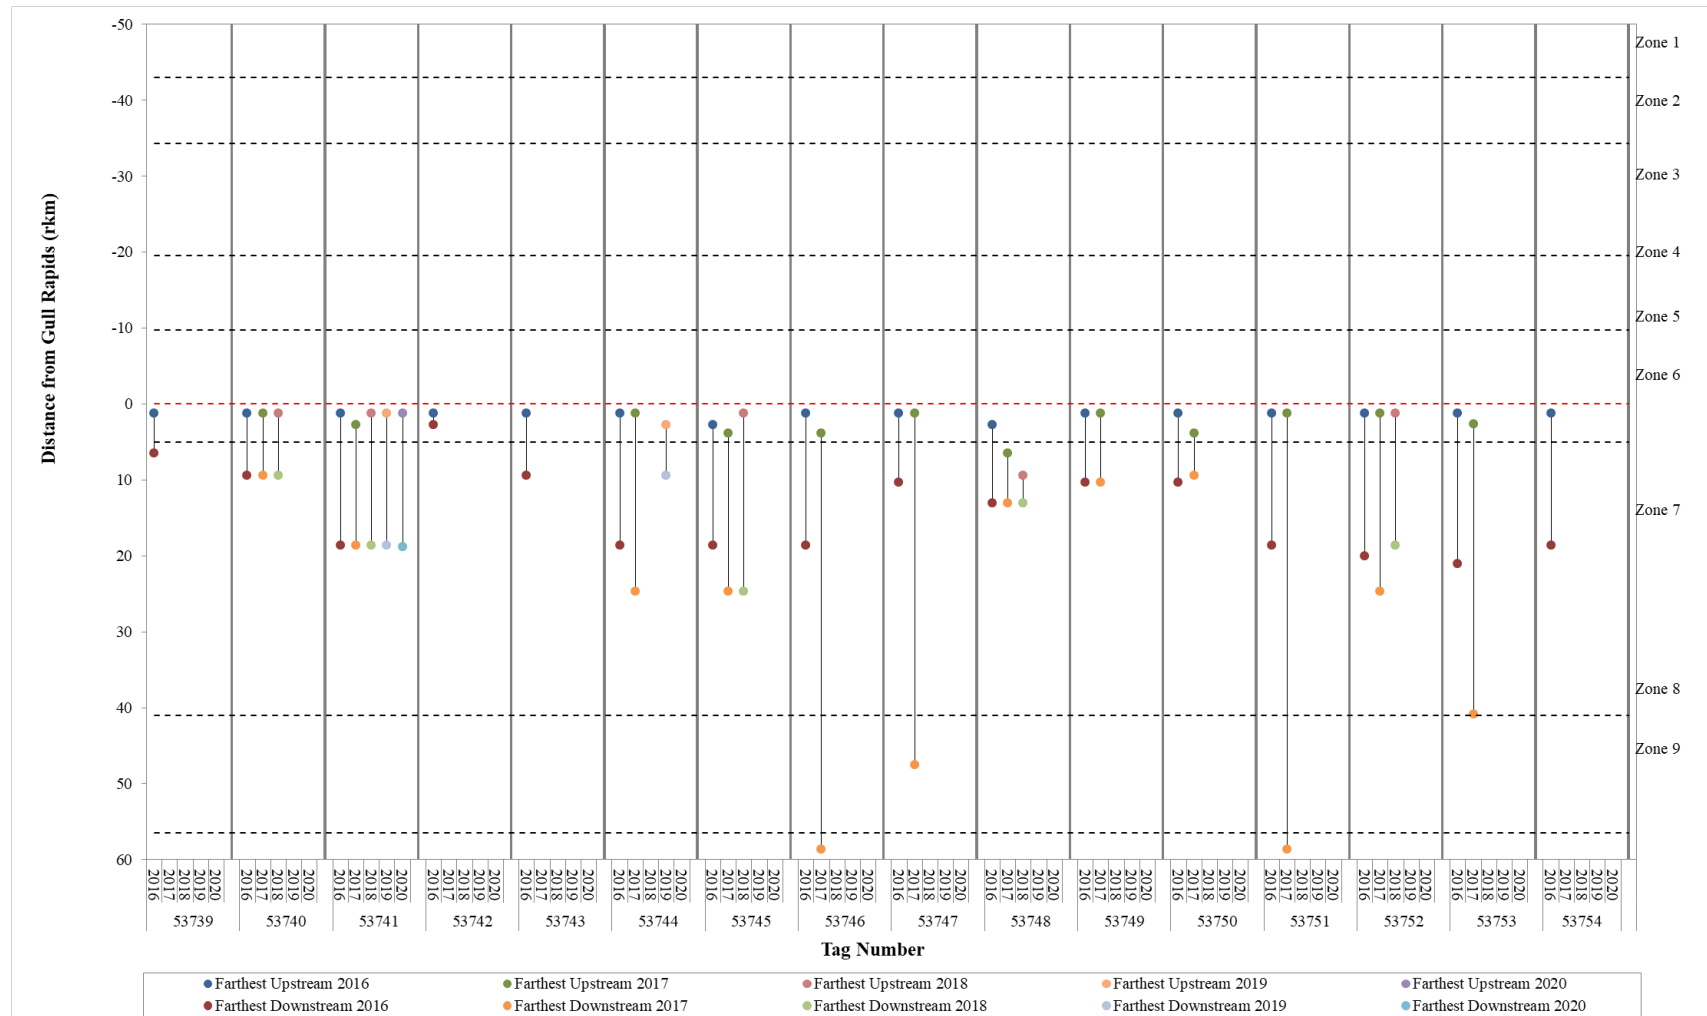
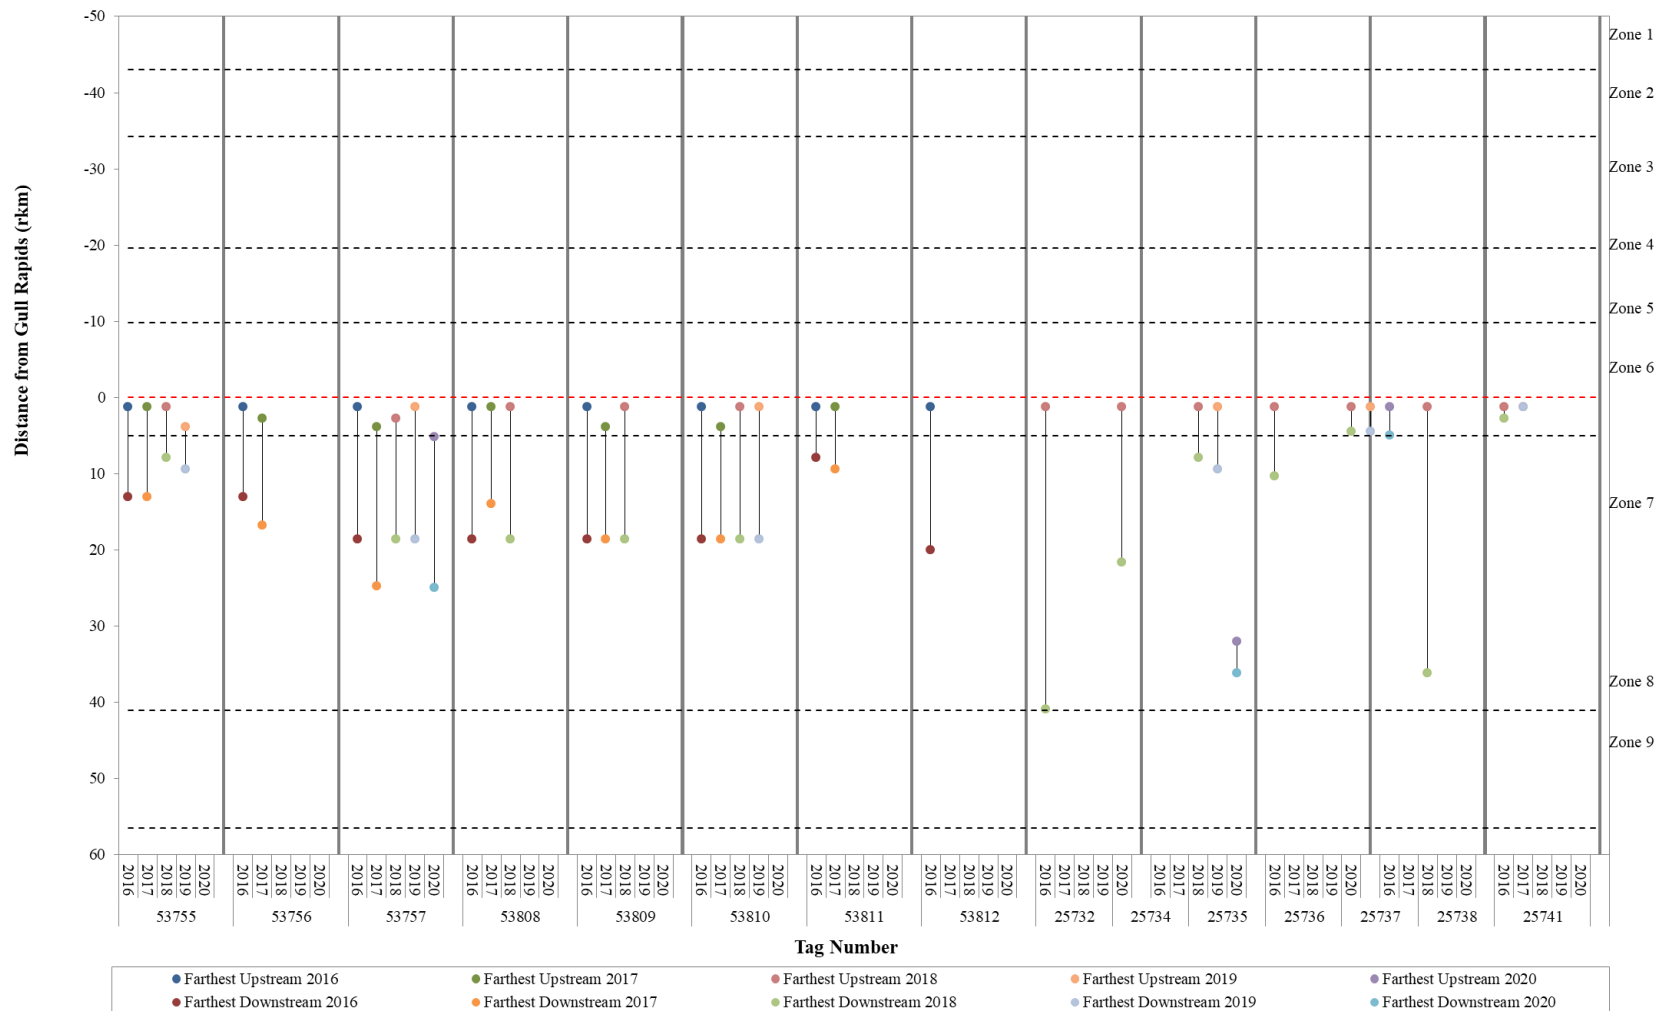
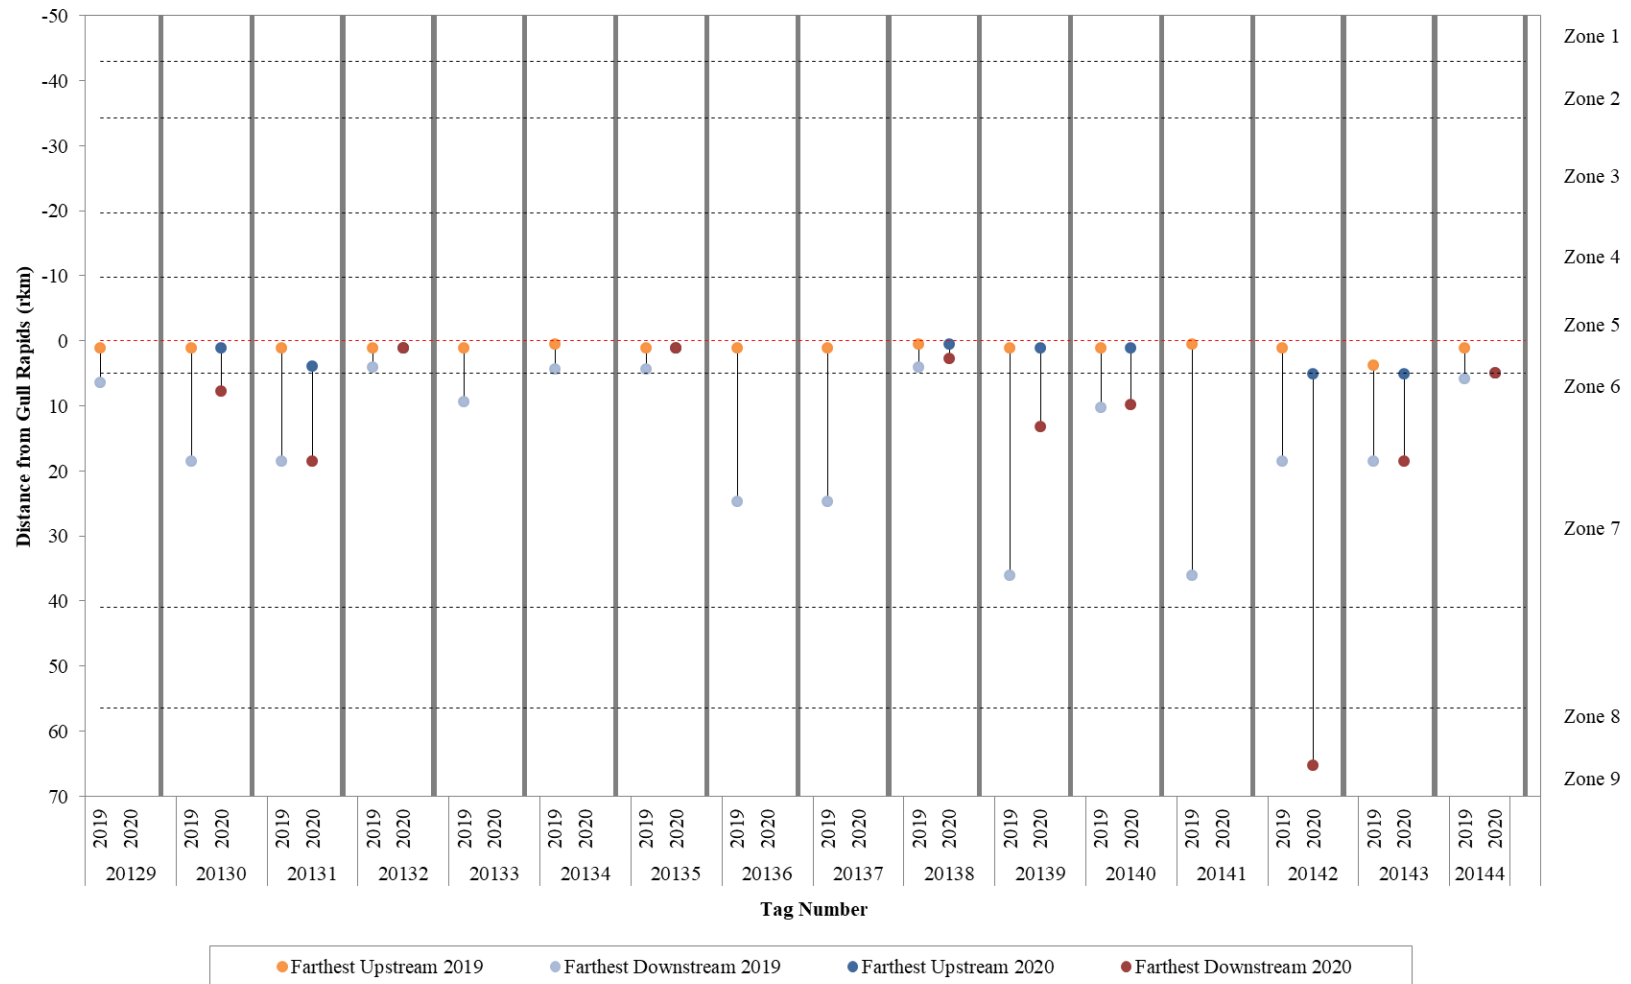
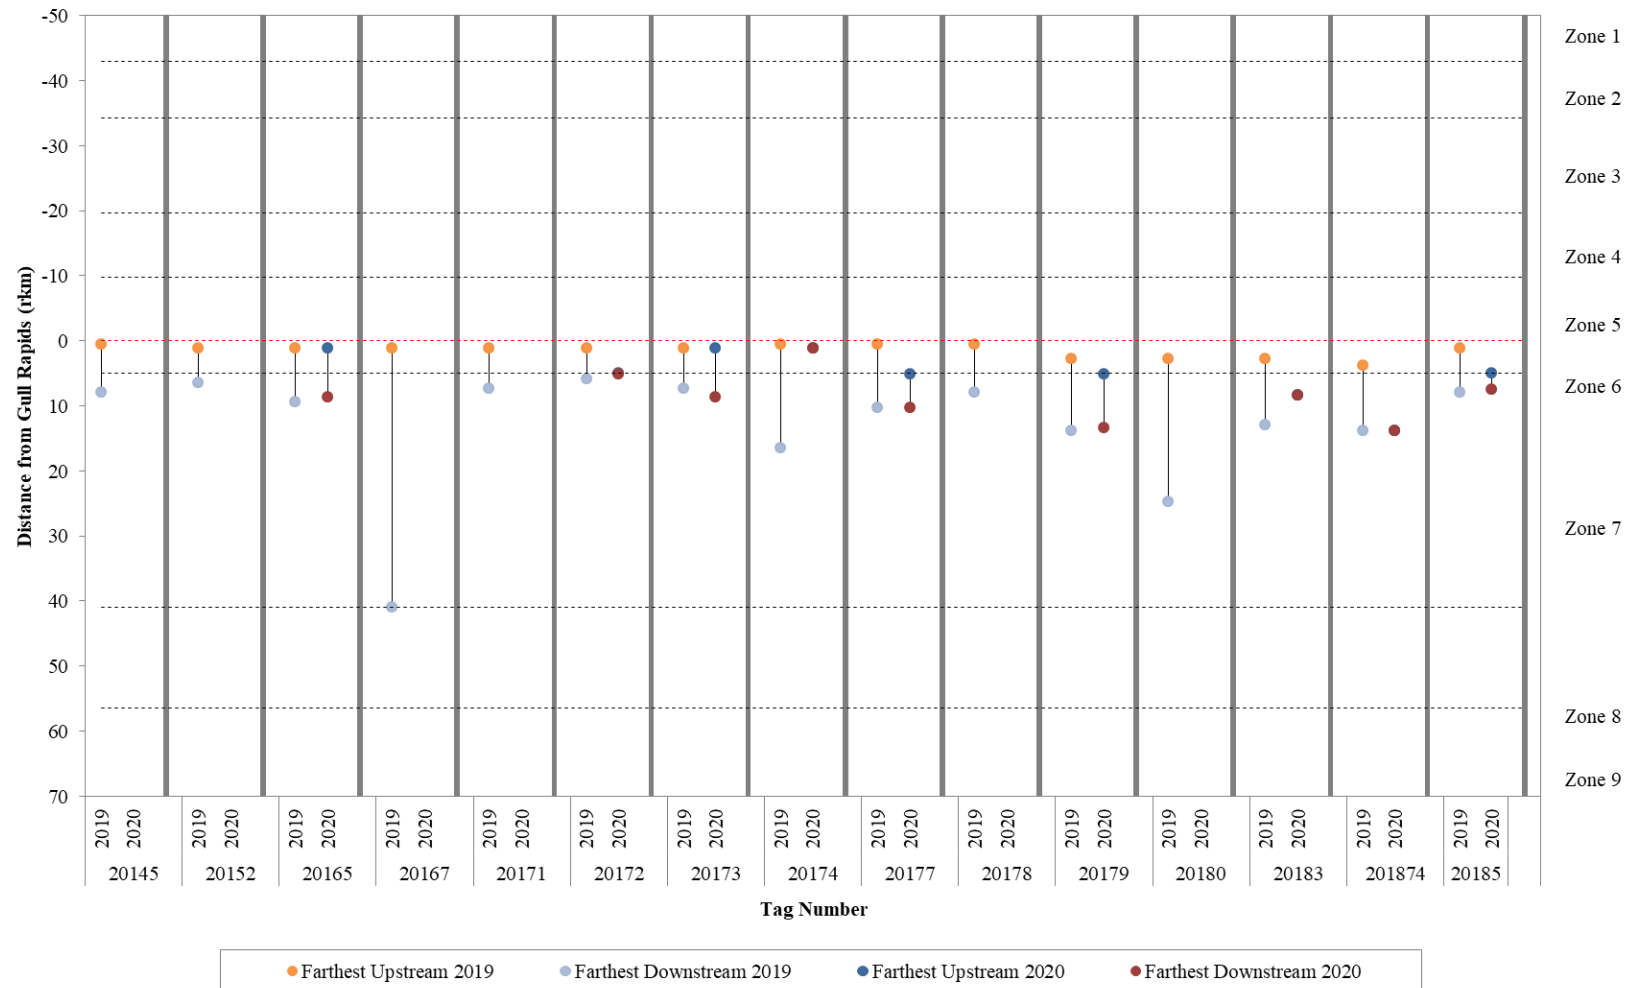
Figure 11: Detection ranges for individual Walleye tagged with acoustic transmitters in Stephens Lake during the open-water period (2016–2020). Horizontal dotted lines demarcate zones. Blue represents the outlet of Clark Lake, dark pink represents Birthday Rapids, red represents the Keeyask GS, light pink represents the Kettle GS, and light green represents the Long Spruce GS.

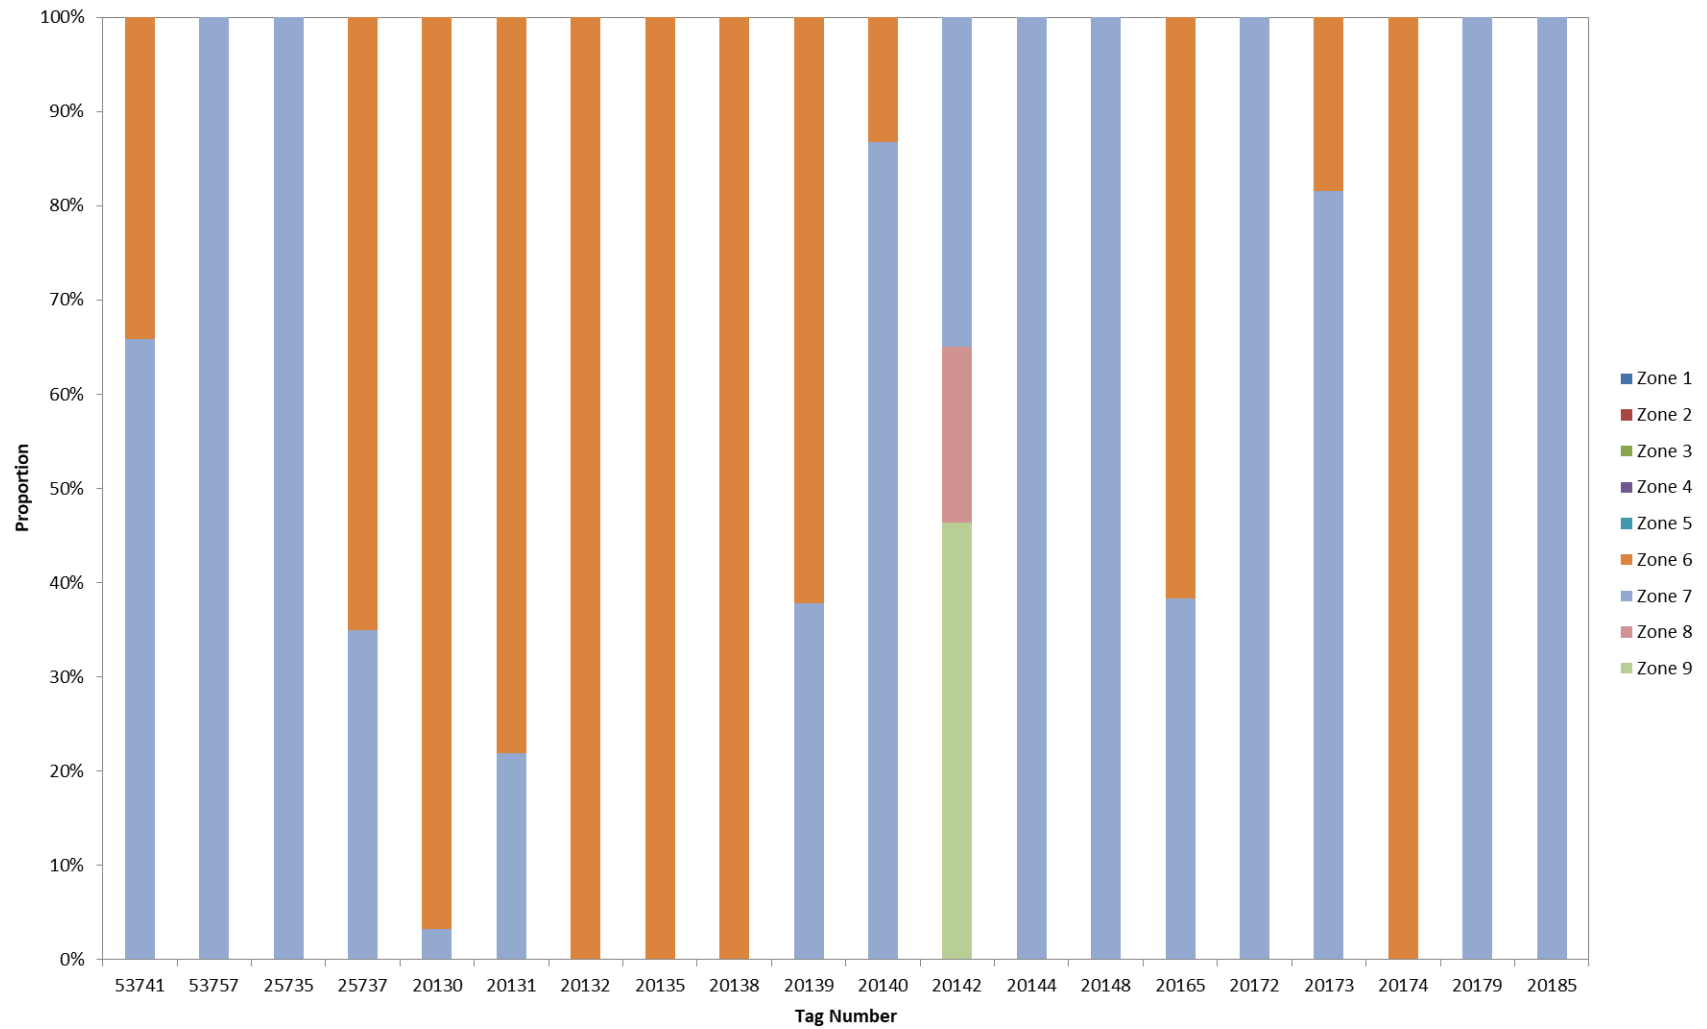
Figure 13: Proportional distributions by zone for individual Walleye tagged with acoustic transmitters in Stephens Lake during a portion of the 2020 open-water period (July 3 to September 23).
