Keeyask Generation Project Aquatic Effects Monitoring Plan

Walleye Movement Monitoring Report AEMP-2021-04

WALLEYE MOVEMENT MONITORING IN THE NELSON RIVER BETWEEN CLARK LAKE AND THE LIMESTONE GENERATING STATION, OCTOBER 2019 TO SEPTEMBER 2020: YEAR 7 CONSTRUCTION

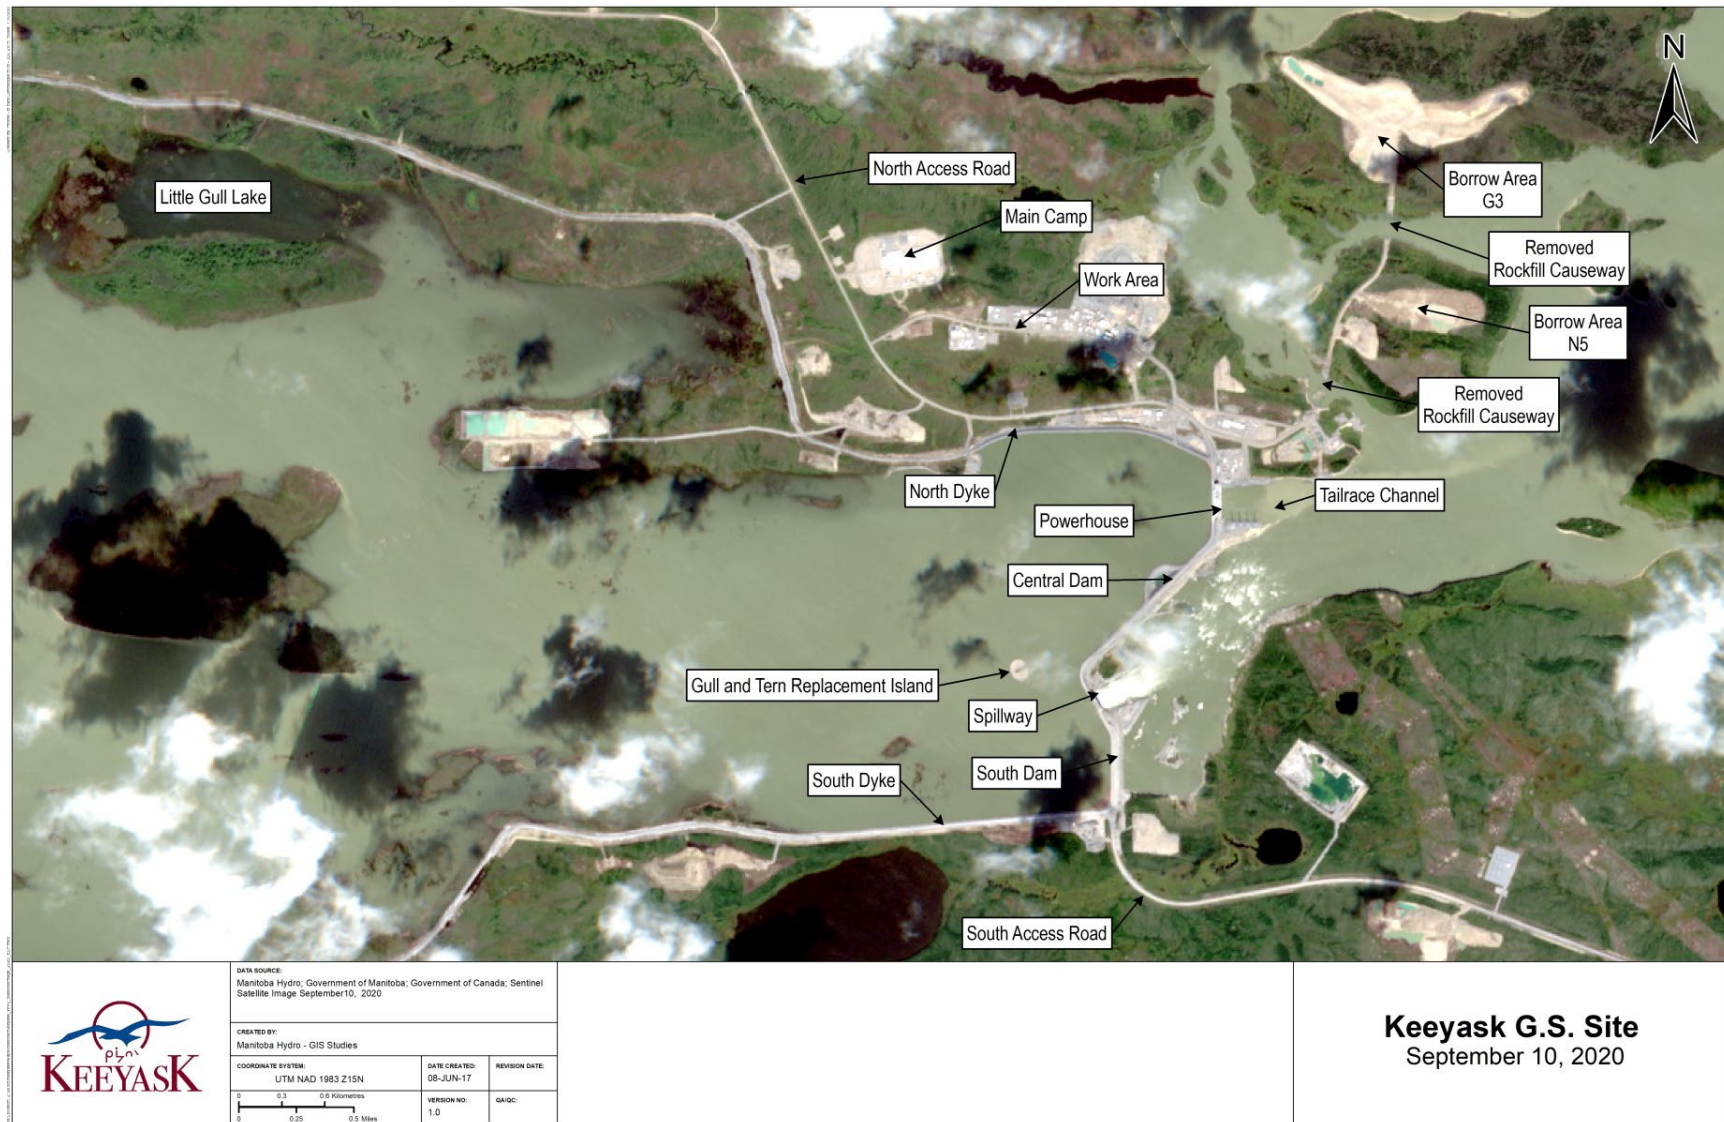
Map 2: Map of in-stream structures at the Keeyask Generating Station site, September 2020.

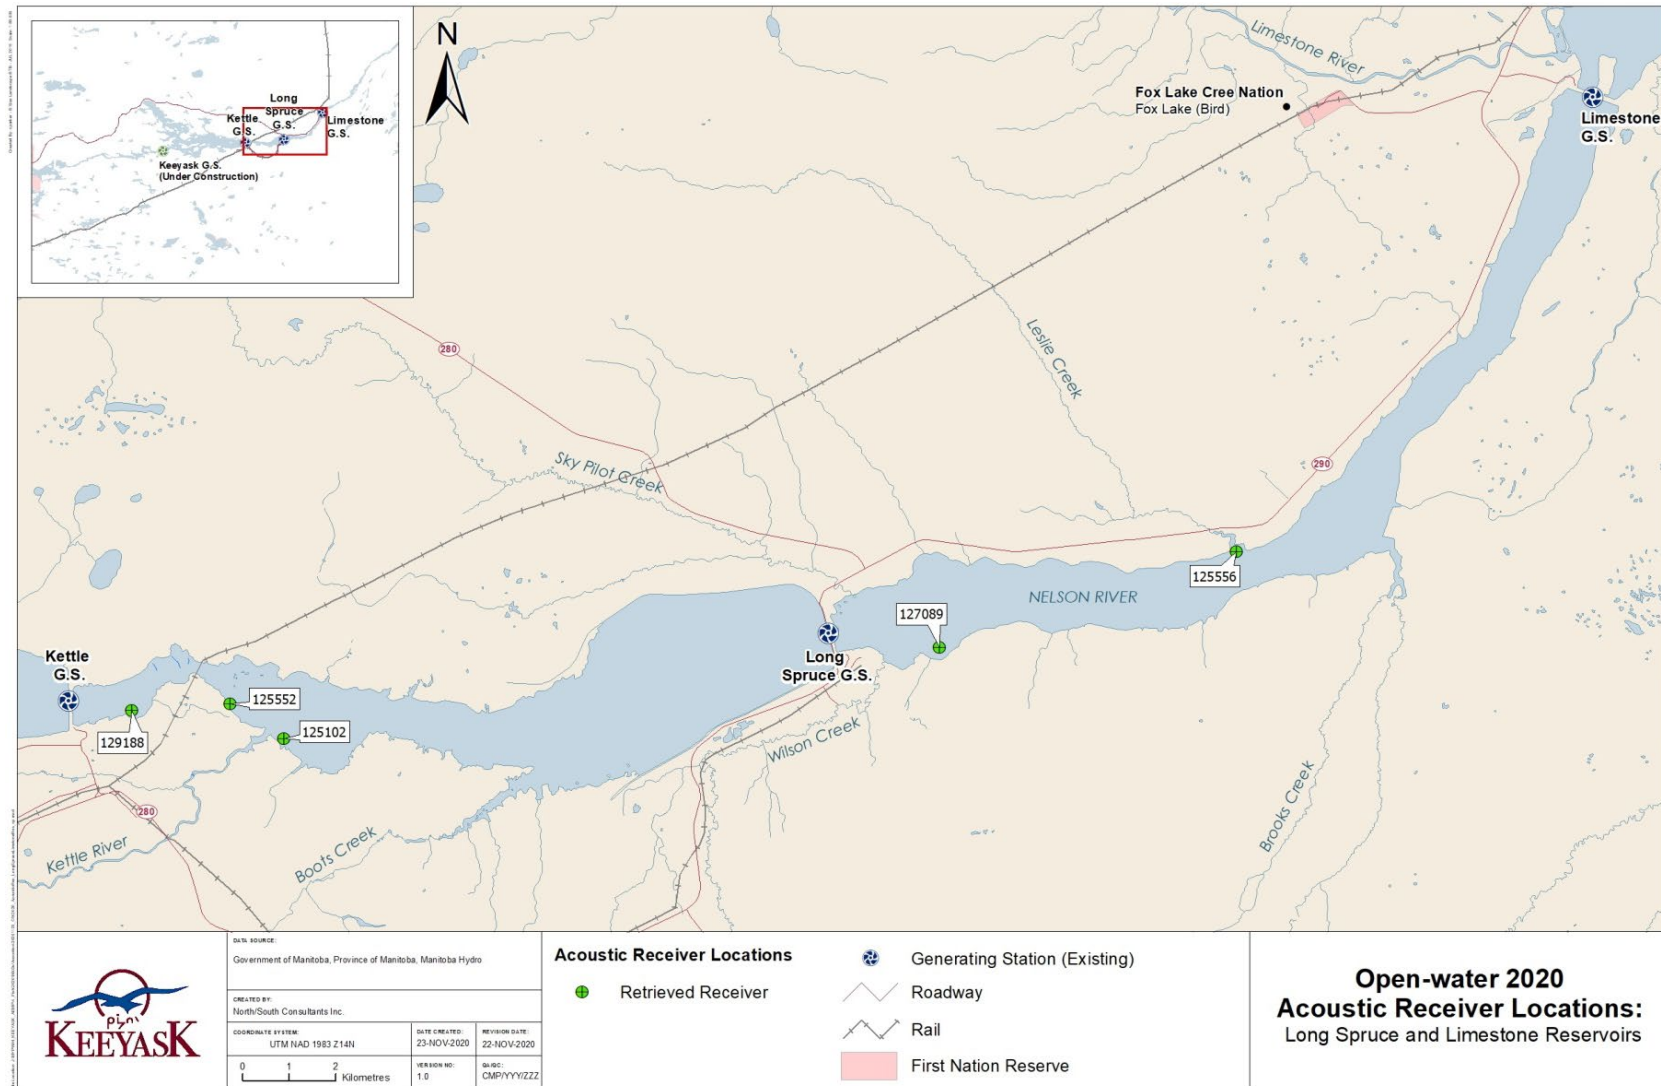
Map 7: Locations of stationary receivers set between the Kettle and Limestone Generating Stations, August to September 2020.

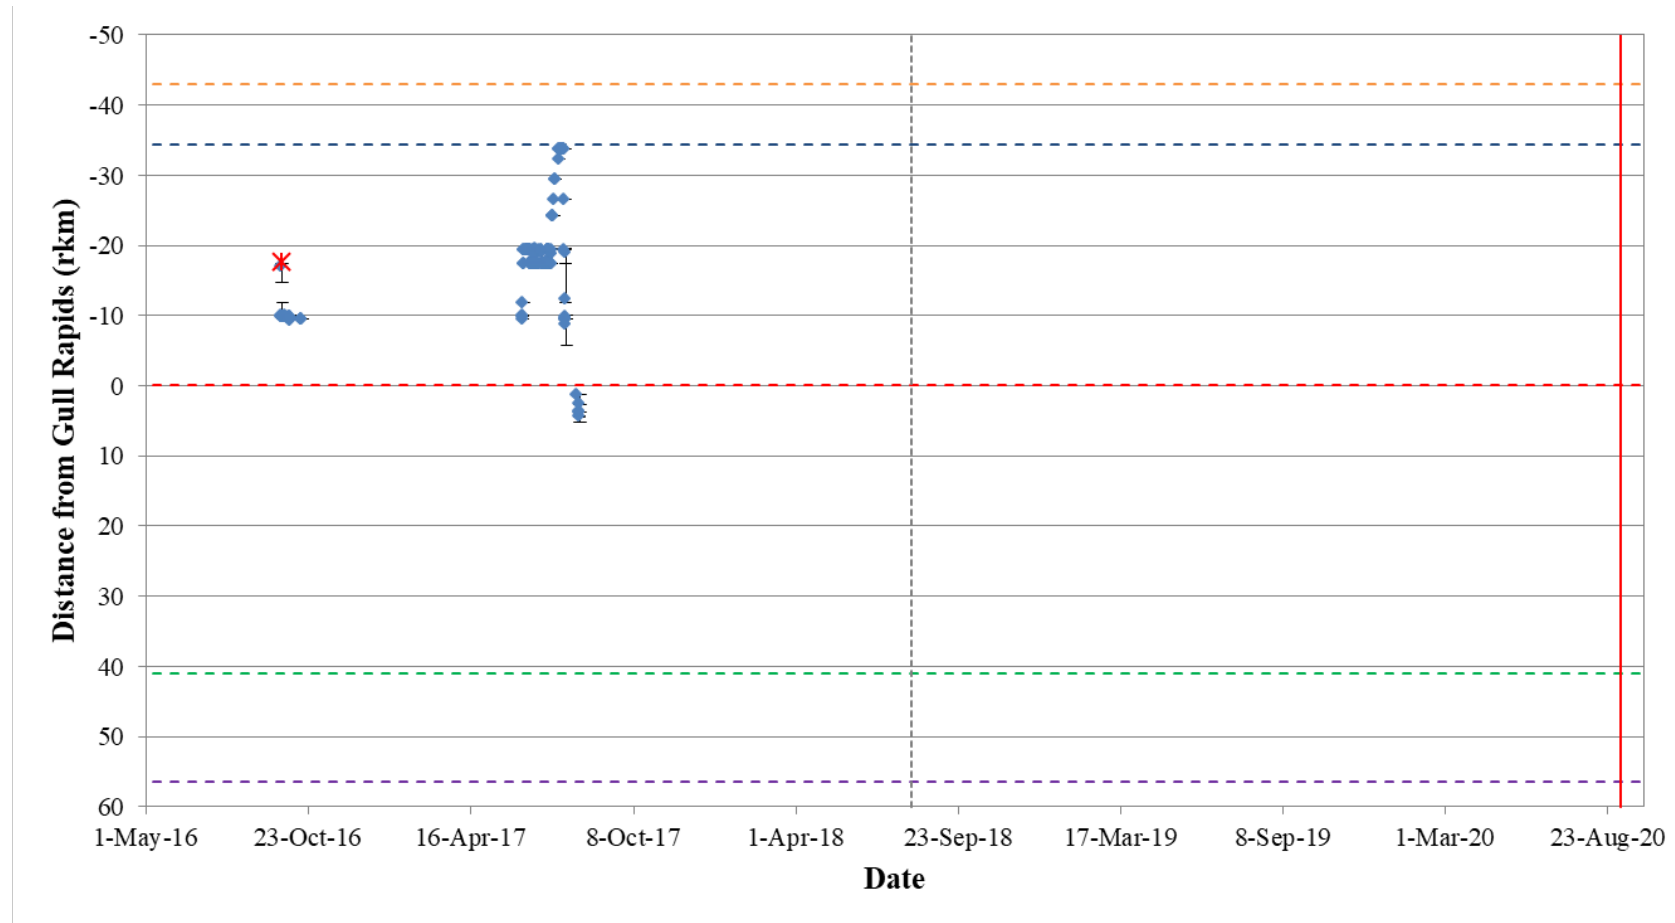
Figure A2-1: Position of a Walleye tagged with an acoustic transmitter (code #53758) in the Nelson River between Clark Lake and the Keeyask GS in relation to the Keeyask GS (rkm 0) from May 1, 2016, to September 23, 2020. Date and location of tagging is indicated by a star. Beginning of Keeyask spillway commissioning is indicated with a vertical dotted line and end of reservoir impoundment is indicated with a solid vertical red line. Dotted horizontal lines indicate landmarks in the study area: entrance to Clark Lake (orange), Birthday Rapids (blue), Keeyask GS (red), Kettle GS (green), and Limestone GS (purple).

- #53758 was tagged on September 24, 2016 in upper Gull Lake and moved downstream through Gull Rapids between July 28 and August 11, 2017. This fish has not been detected since moving downstream and is now considered missing (Appendix A2-1).

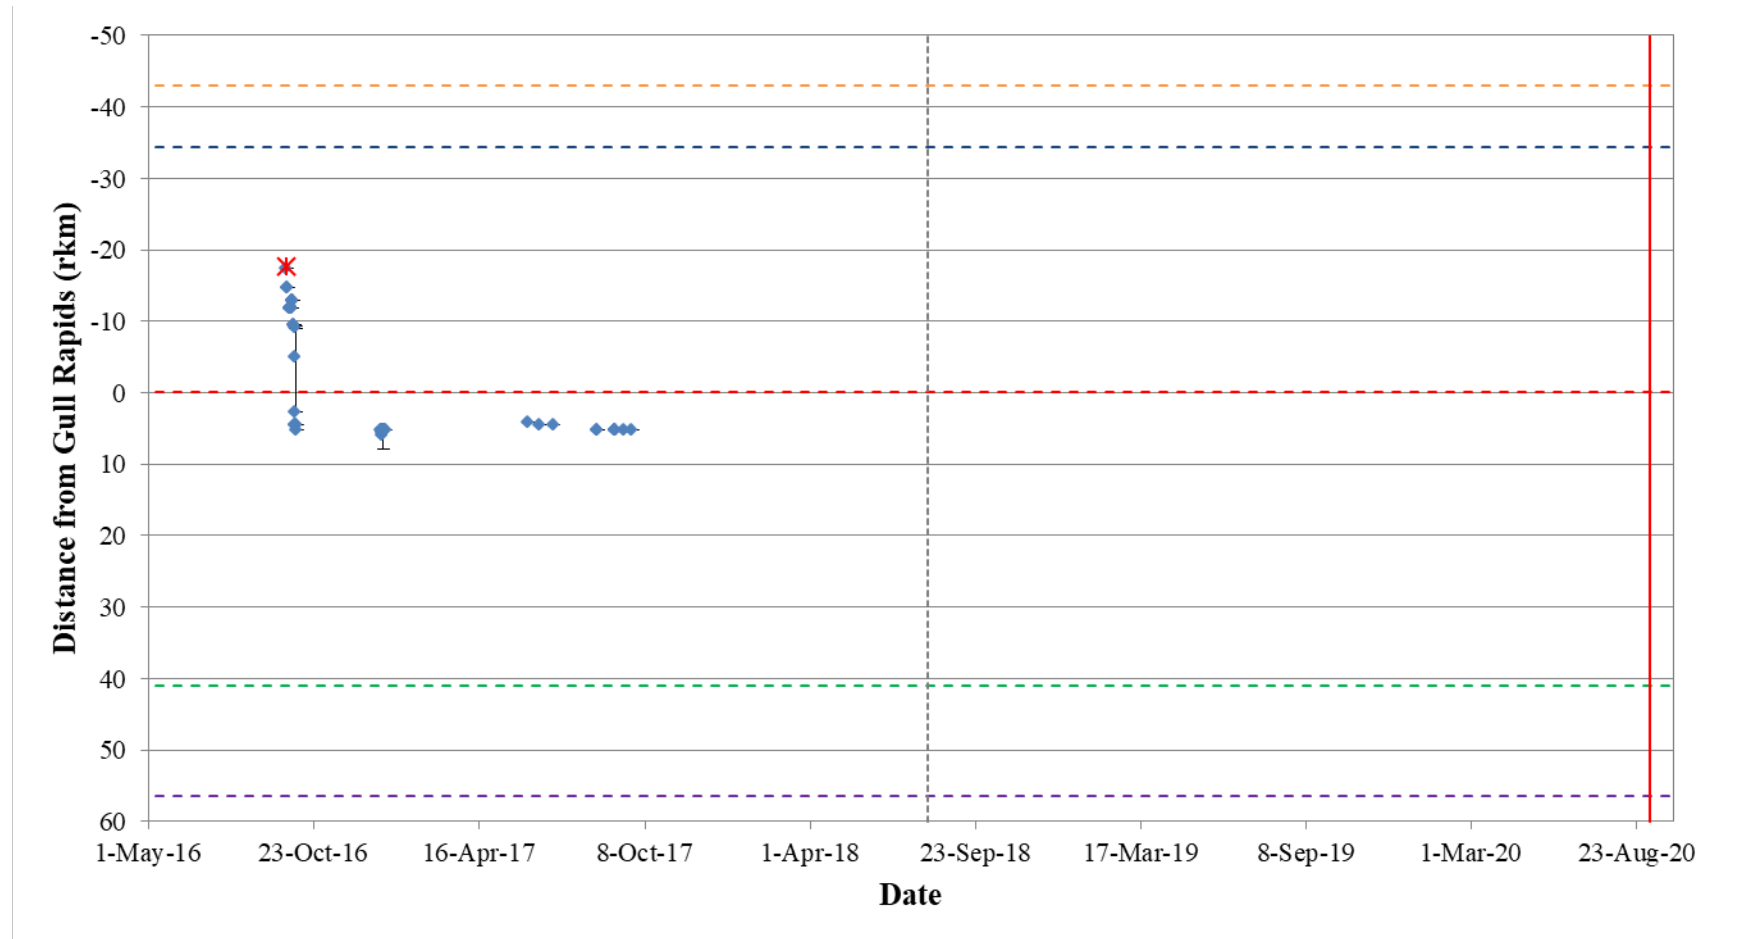
Figure A2-3: Position of a Walleye tagged with an acoustic transmitter (code #53760) in the Nelson River between Clark Lake and the Keeyask GS in relation to the Keeyask GS (rkm 0) from May 1, 2016, to September 23, 2020. Date and location of tagging is indicated by a star. Beginning of Keeyask spillway commissioning is indicated with a vertical dotted line and end of reservoir impoundment is indicated with a solid vertical red line. Dotted horizontal lines indicate landmarks in the study area: entrance to Clark Lake (orange), Birthday Rapids (blue), Keeyask GS (red), Kettle GS (green), and Limestone GS (purple).

- #53760 was tagged on September 24, 2016 in upper Gull Lake and moved downstream through Gull Rapids on October 3, 2016. It remained in Stephens Lake and was last detected on September 25, 2017 and is now considered missing (Appendix A2-3).

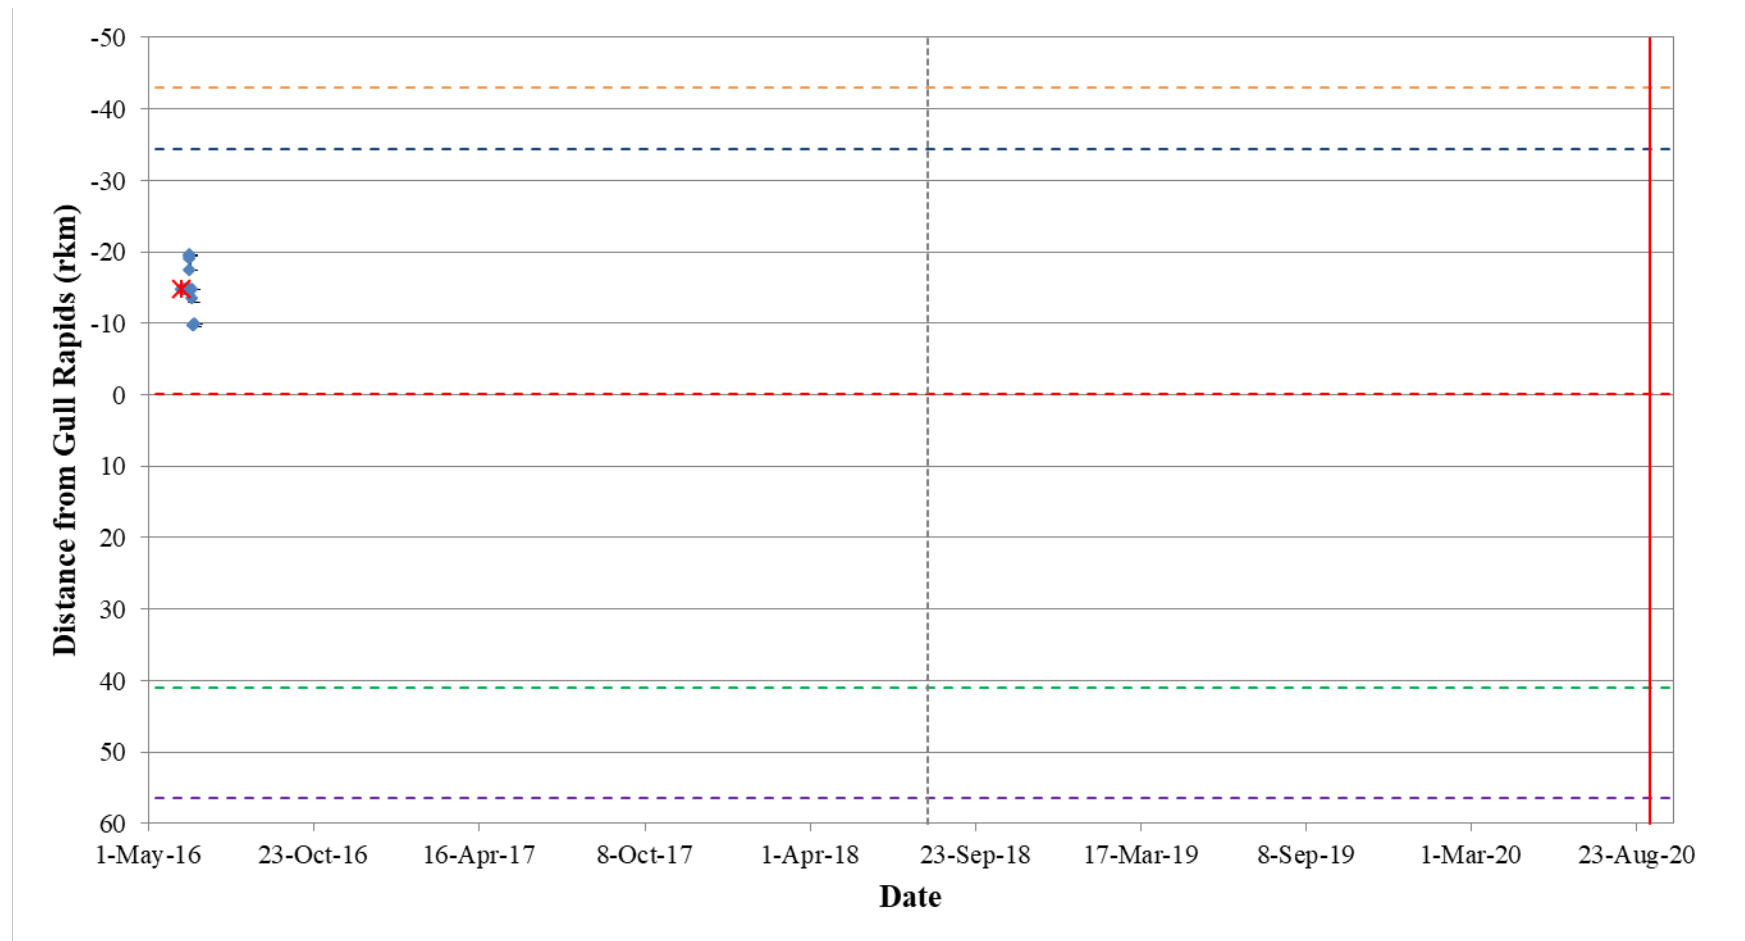
Figure A2-4: Position of a Walleye tagged with an acoustic transmitter (code #53763) in the Nelson River between Clark Lake and the Keeyask GS in relation to the Keeyask GS (rkm 0) from May 1, 2016, to September 23, 2020. Date and location of tagging is indicated by a star. Beginning of Keeyask spillway commissioning is indicated with a vertical dotted line and end of reservoir impoundment is indicated with a solid vertical red line. Dotted horizontal lines indicate landmarks in the study area: entrance to Clark Lake (orange), Birthday Rapids (blue), Keeyask GS (red), Kettle GS (green), and Limestone GS (purple).

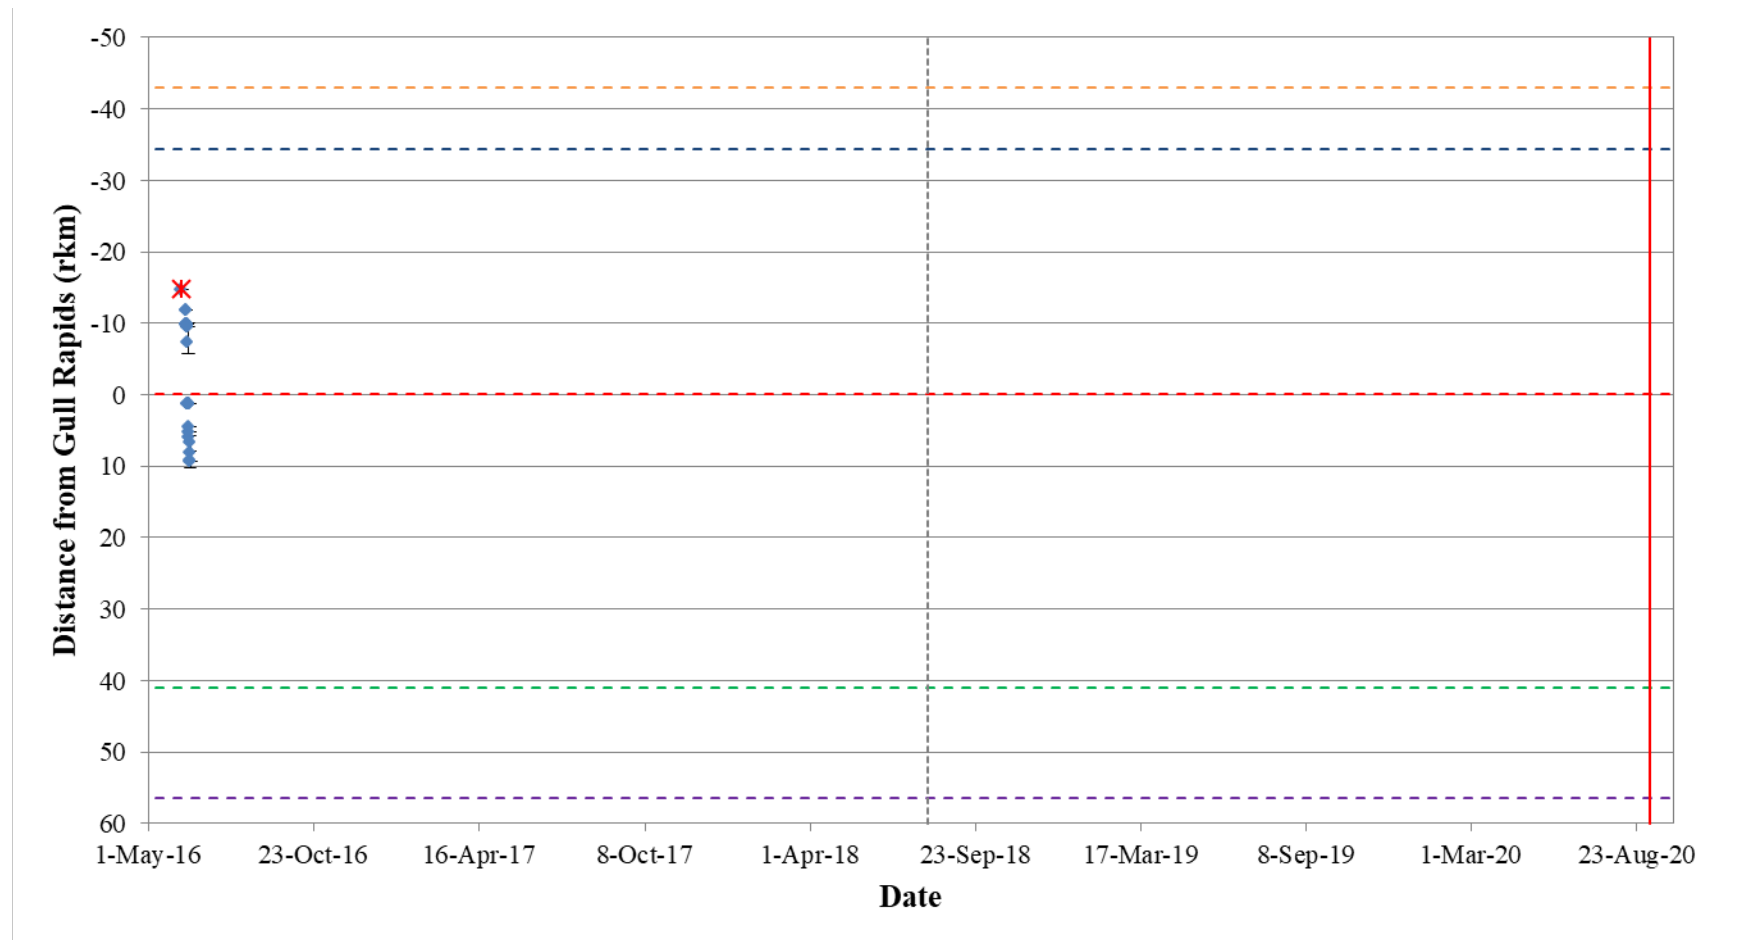
Figure A2-5: Position of a Walleye tagged with an acoustic transmitter (code #53764) in the Nelson River between Clark Lake and the Keeyask GS in relation to the Keeyask GS (rkm 0) from May 1, 2016, to September 23, 2020. Date and location of tagging is indicated by a star. Beginning of Keeyask spillway commissioning is indicated with a vertical dotted line and end of reservoir impoundment is indicated with a solid vertical red line. Dotted horizontal lines indicate landmarks in the study area: entrance to Clark Lake (orange), Birthday Rapids (blue), Keeyask GS (red), Kettle GS (green), and Limestone GS (purple).

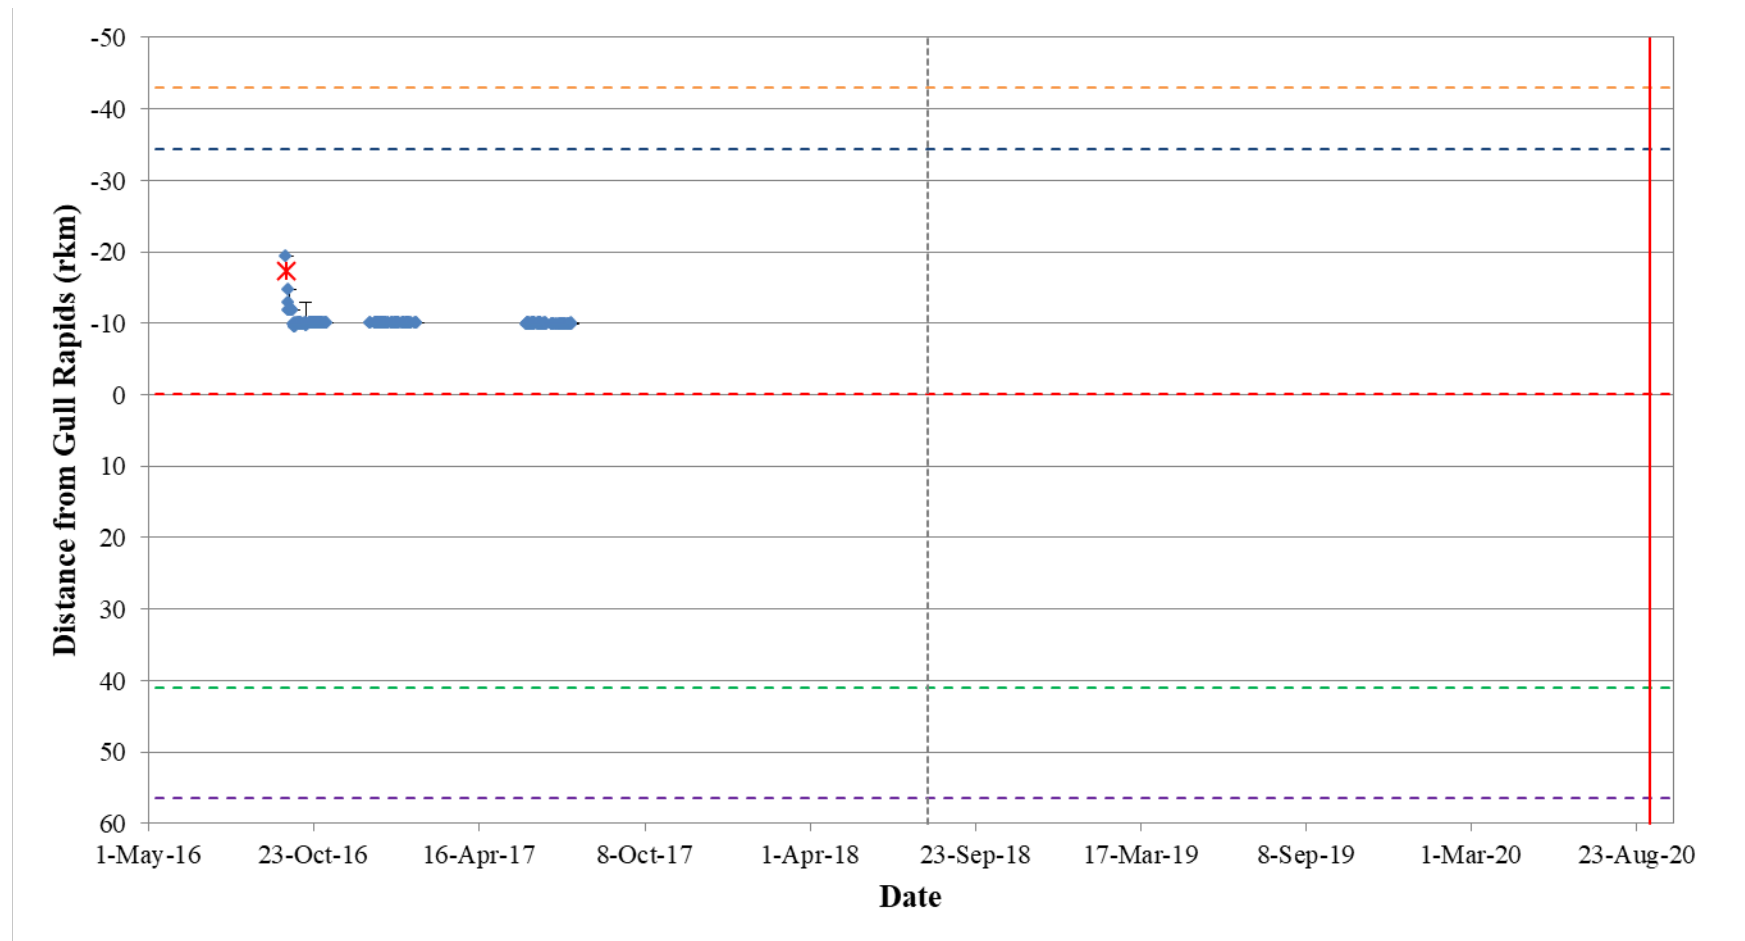
Figure A2-6: Position of a Walleye tagged with an acoustic transmitter (code #53765) in the Nelson River between Clark Lake and the Keeyask GS in relation to the Keeyask GS (rkm 0) from May 1, 2016, to September 23, 2020. Date and location of tagging is indicated by a star. Beginning of Keeyask spillway commissioning is indicated with a vertical dotted line and end of reservoir impoundment is indicated with a solid vertical red line. Dotted horizontal lines indicate landmarks in the study area: entrance to Clark Lake (orange), Birthday Rapids (blue), Keeyask GS (red), Kettle GS (green), and Limestone GS (purple).

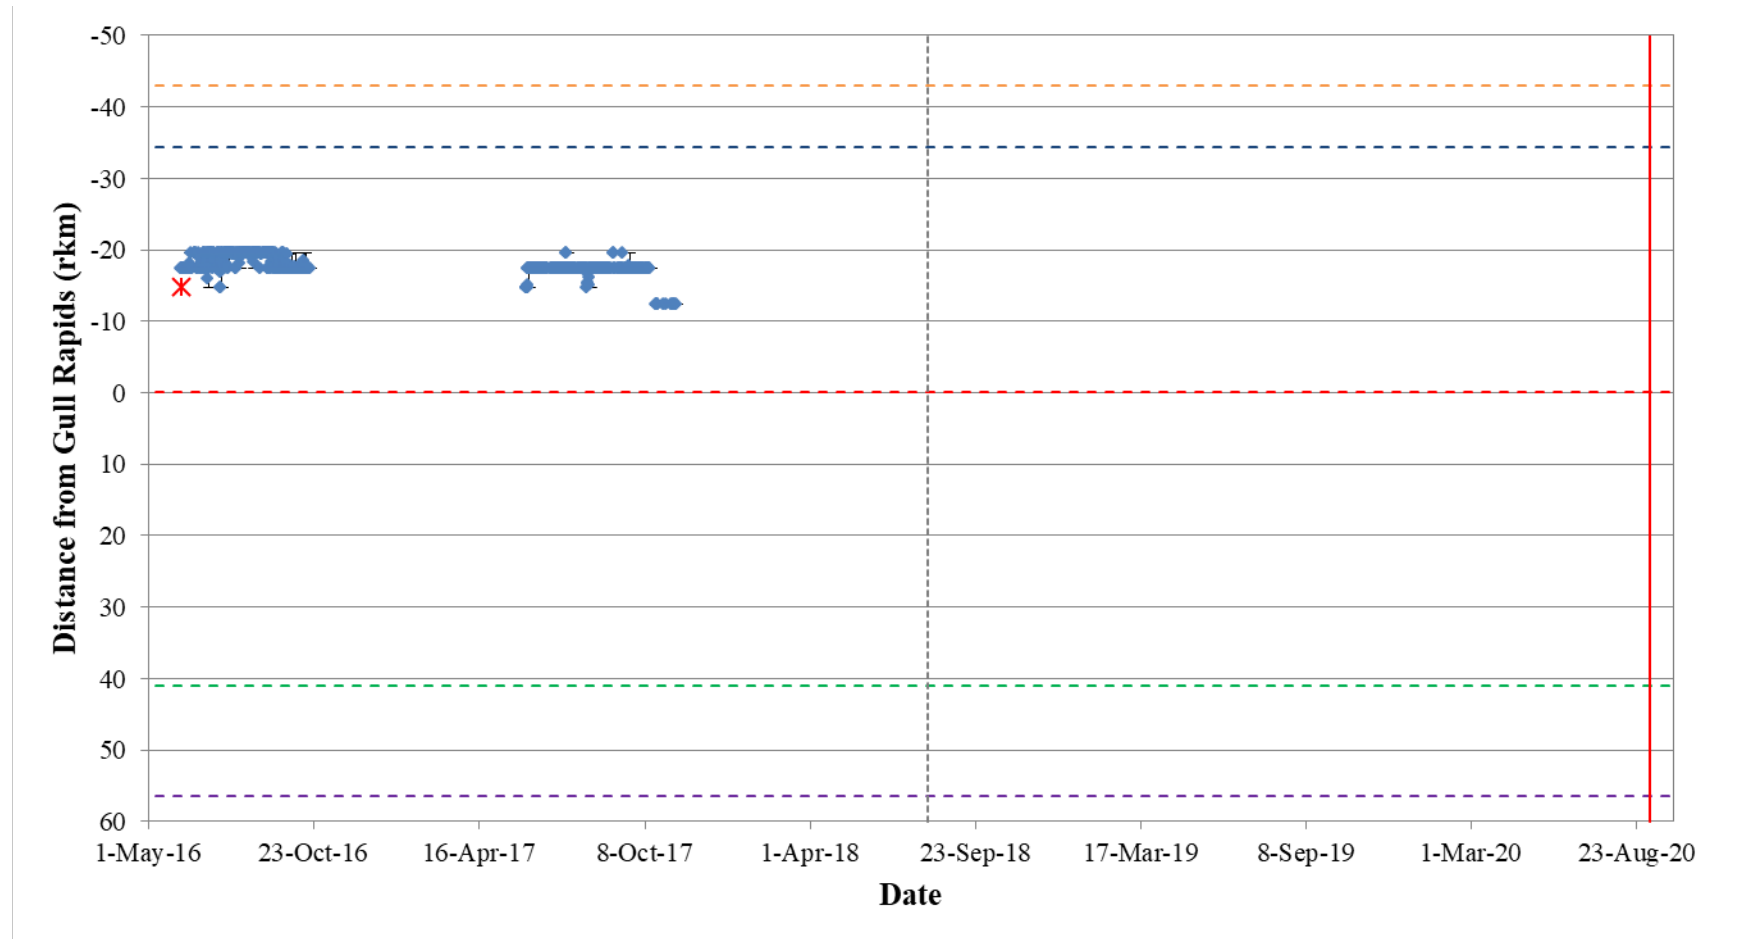
Figure A2-9: Position of a Walleye tagged with an acoustic transmitter (code #53768) in the Nelson River between Clark Lake and the Keeyask GS in relation to the Keeyask GS (rkm 0) from May 1, 2016, to September 23, 2020. Date and location of tagging is indicated by a star. Beginning of Keeyask spillway commissioning is indicated with a vertical dotted line and end of reservoir impoundment is indicated with a solid vertical red line. Dotted horizontal lines indicate landmarks in the study area: entrance to Clark Lake (orange), Birthday Rapids (blue), Keeyask GS (red), Kettle GS (green), and Limestone GS (purple).

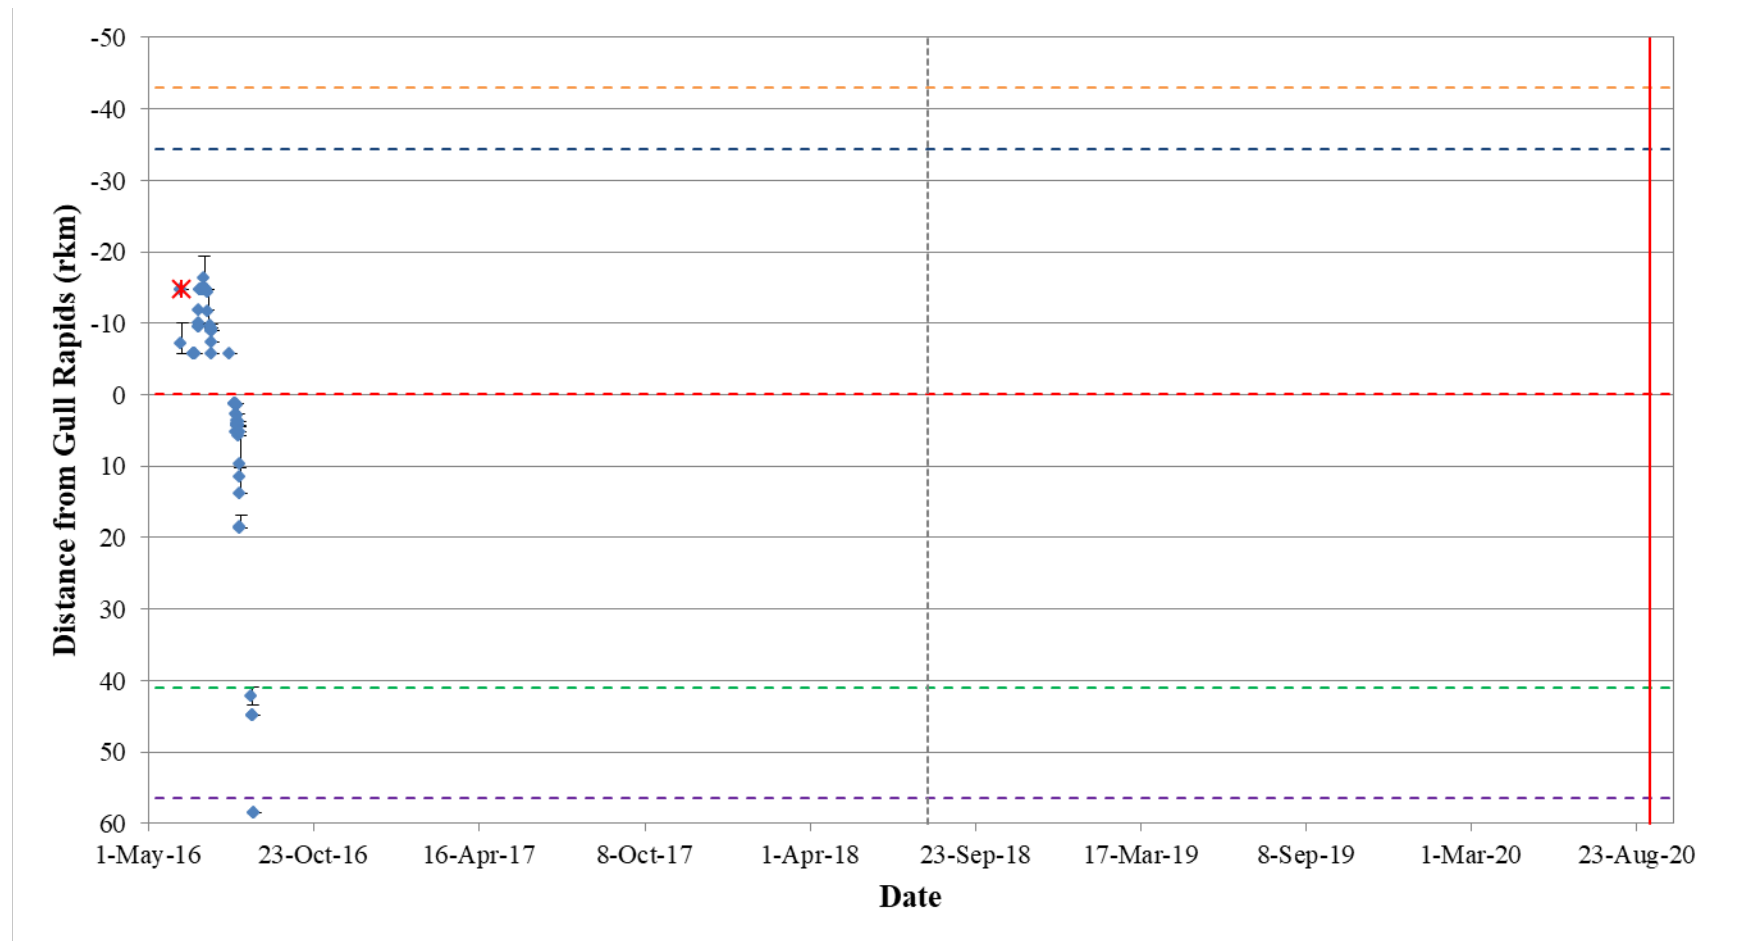
Figure A2-12: Position of a Walleye tagged with an acoustic transmitter (code #53771) in the Nelson River between Clark Lake and the Keeyask GS in relation to the Keeyask GS (rkm 0) from May 1, 2016, to September 23, 2020. Date and location of tagging is indicated by a star. Beginning of Keeyask spillway commissioning is indicated with a vertical dotted line and end of reservoir impoundment is indicated with a solid vertical red line. Dotted horizontal lines indicate landmarks in the study area: entrance to Clark Lake (orange), Birthday Rapids (blue), Keeyask GS (red), Kettle GS (green), and Limestone GS (purple).

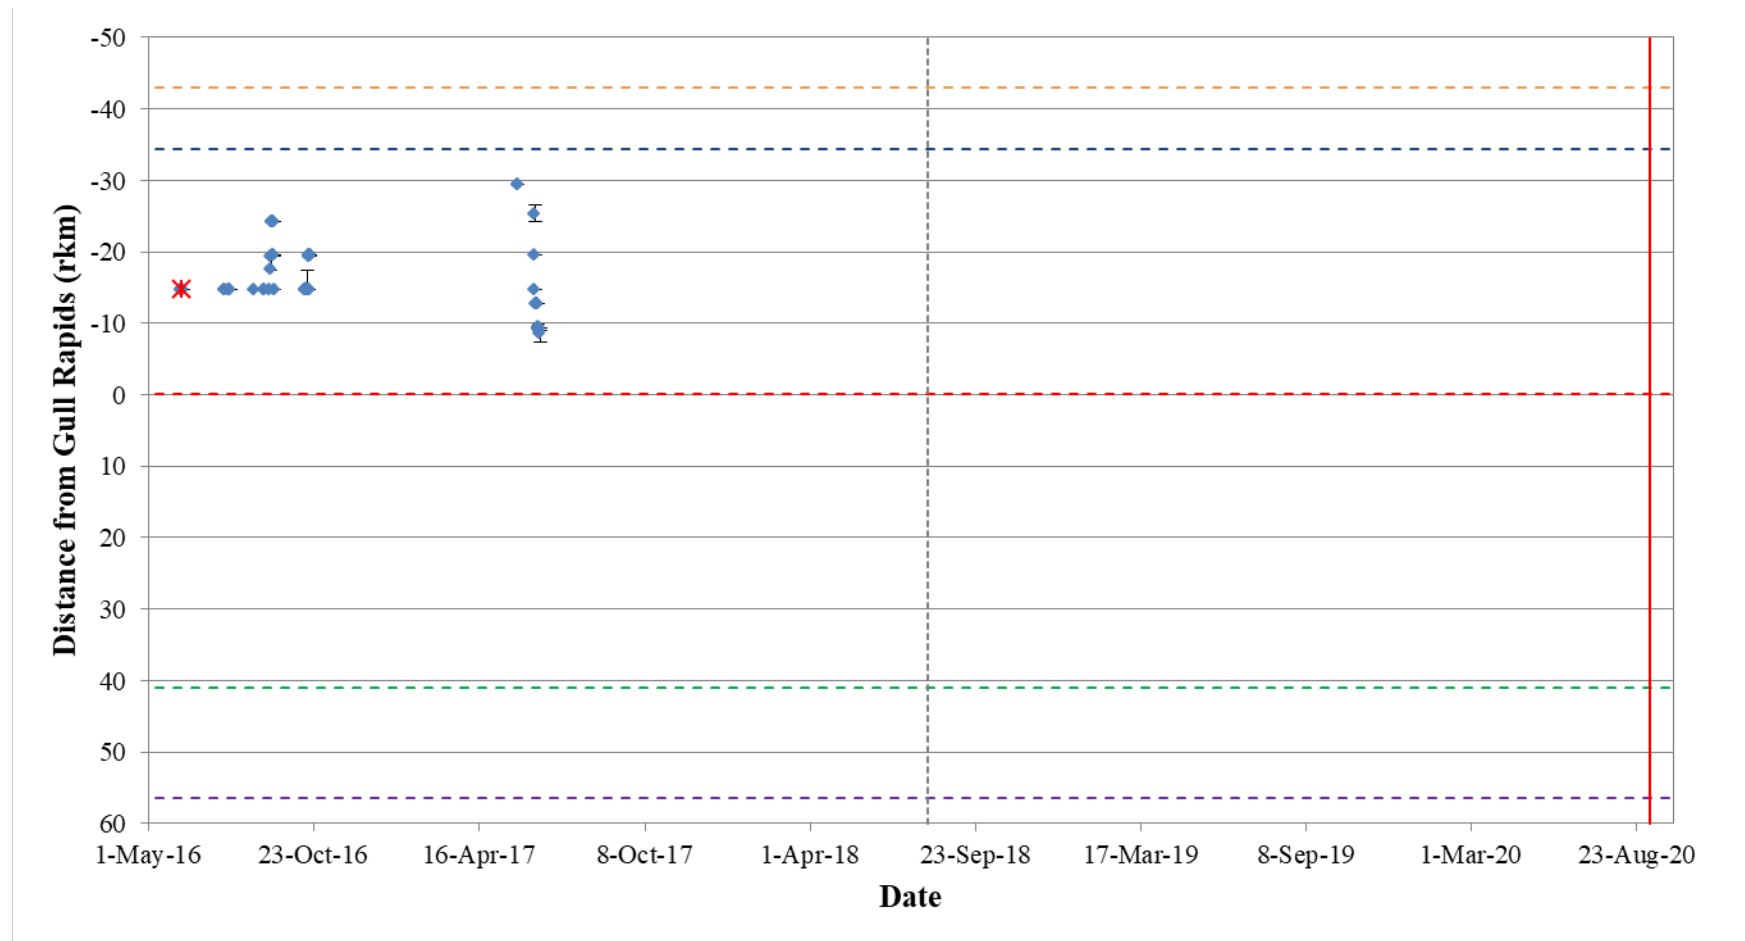
Figure A2-13: Position of a Walleye tagged with an acoustic transmitter (code #53772) in the Nelson River between Clark Lake and the Keeyask GS in relation to the Keeyask GS (rkm 0) from May 1, 2016, to September 23, 2020. Date and location of tagging is indicated by a star. Beginning of Keeyask spillway commissioning is indicated with a vertical dotted line and end of reservoir impoundment is indicated with a solid vertical red line. Dotted horizontal lines indicate landmarks in the study area: entrance to Clark Lake (orange), Birthday Rapids (blue), Keeyask GS (red), Kettle GS (green), and Limestone GS (purple).

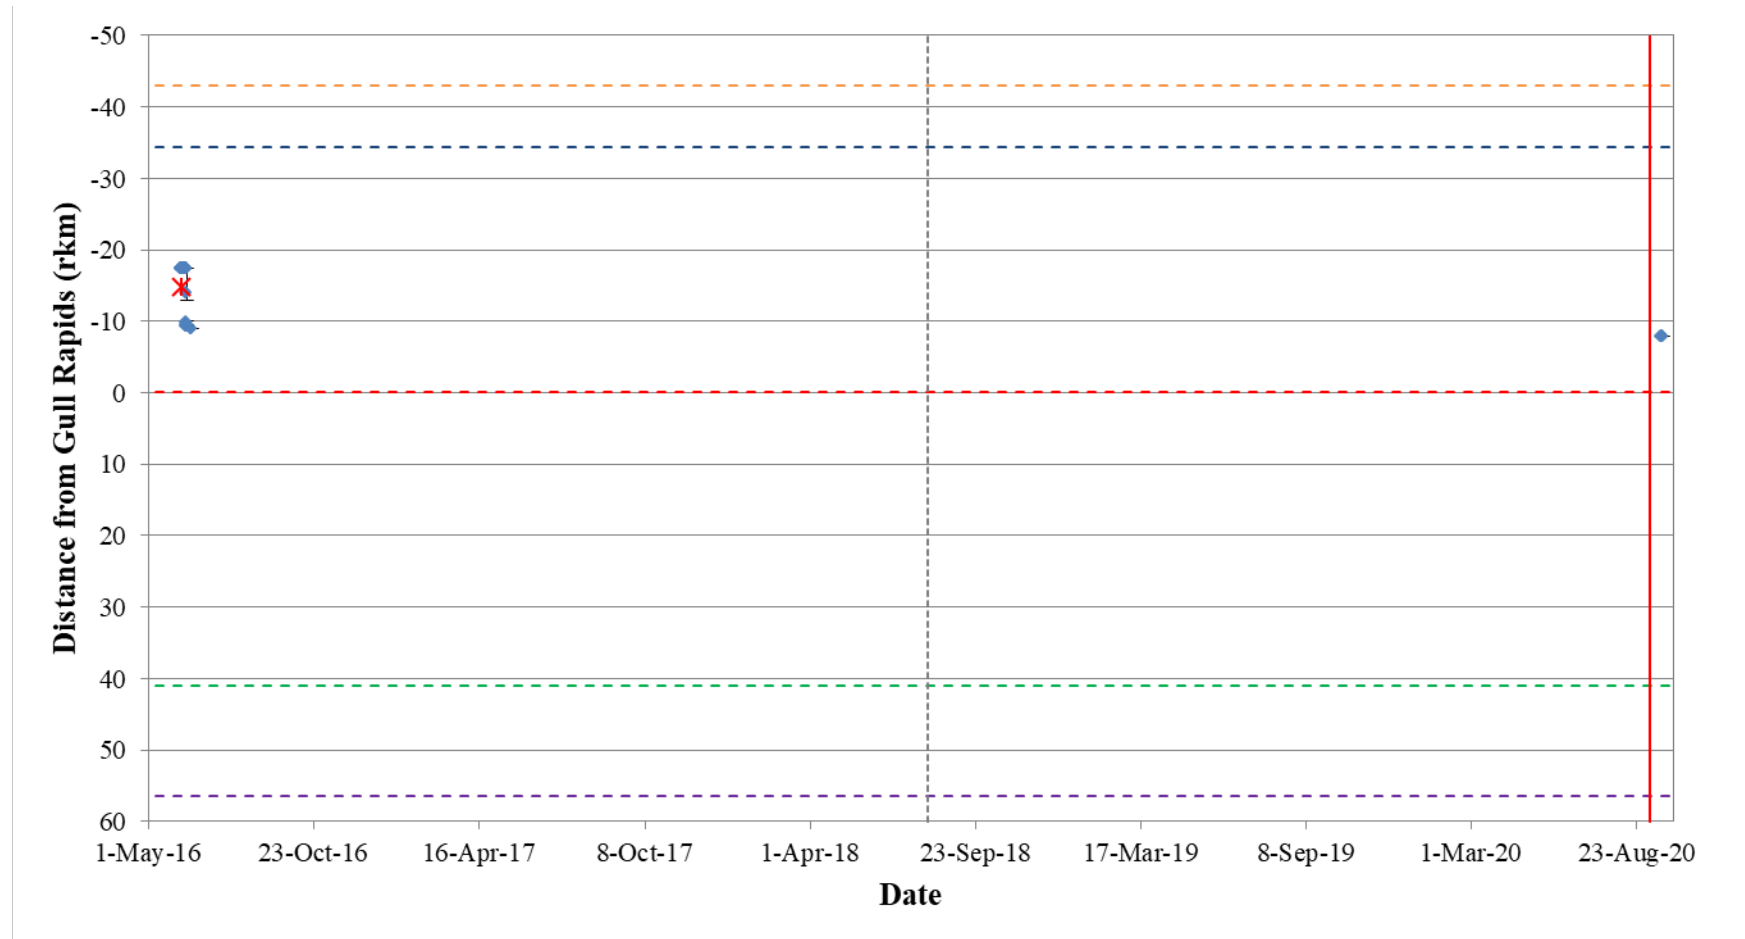
Figure A2-15: Position of a Walleye tagged with an acoustic transmitter (code #53774) in the Nelson River between Clark Lake and the Keeyask GS in relation to the Keeyask GS (rkm 0) from May 1, 2016, to September 23, 2020. Date and location of tagging is indicated by a star. Beginning of Keeyask spillway commissioning is indicated with a vertical dotted line and end of reservoir impoundment is indicated with a solid vertical red line. Dotted horizontal lines indicate landmarks in the study area: entrance to Clark Lake (orange), Birthday Rapids (blue), Keeyask GS (red), Kettle GS (green), and Limestone GS (purple).

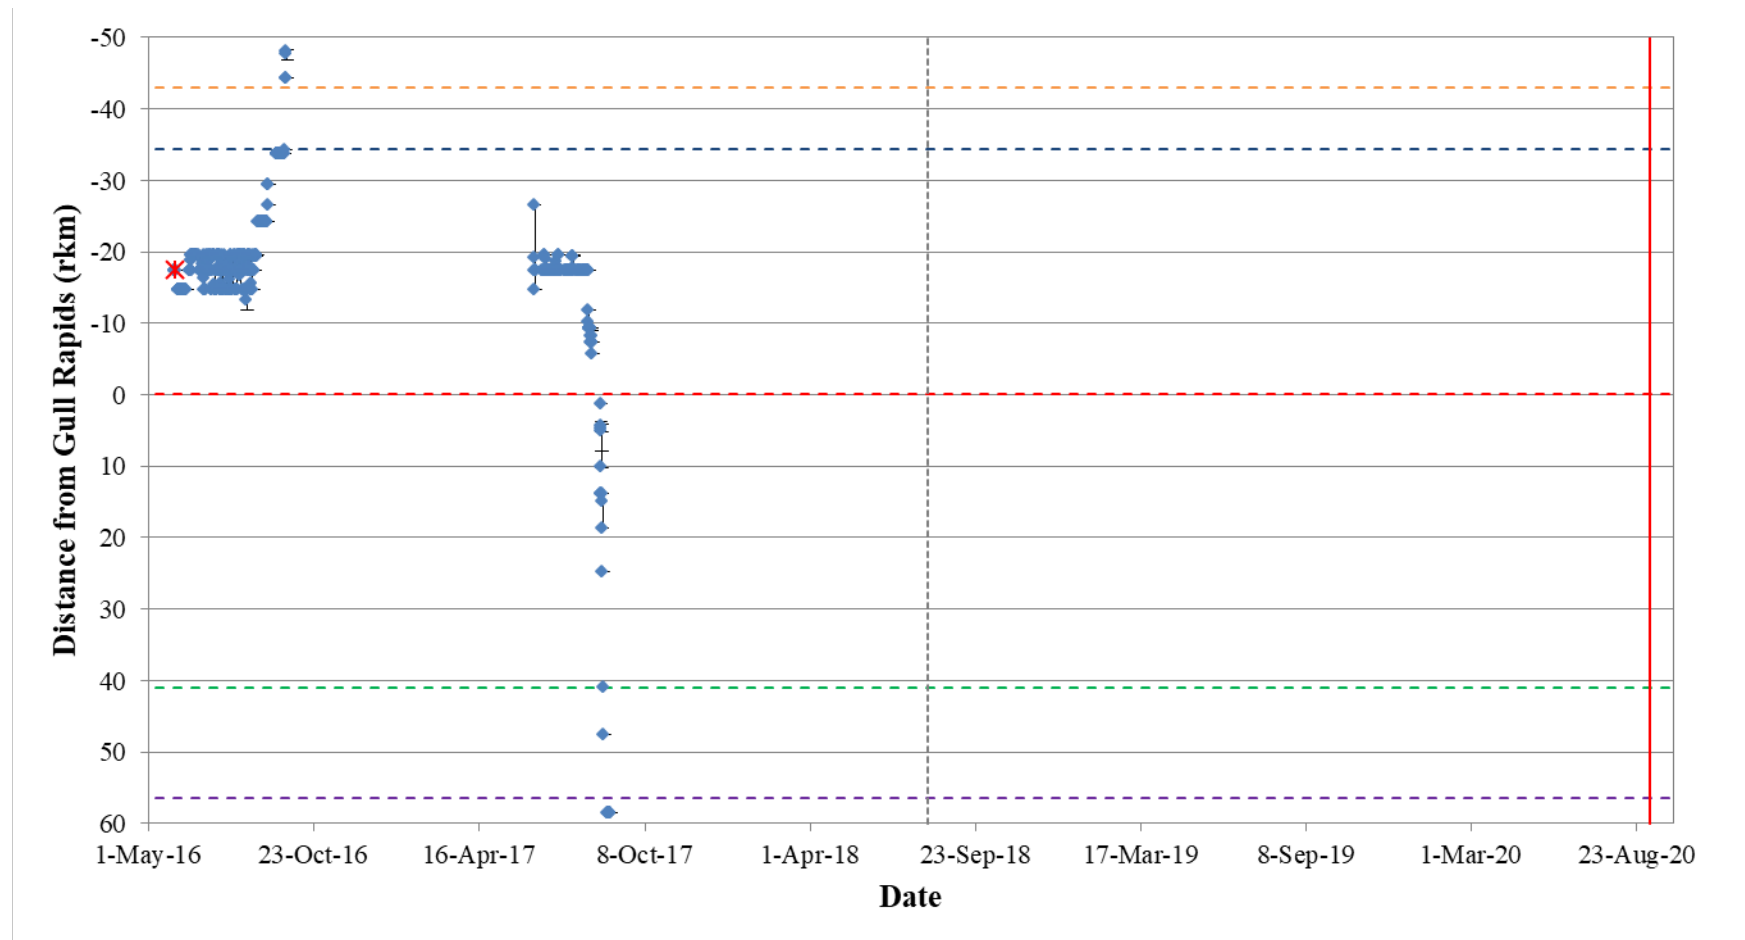
Figure A2-18: Position of a Walleye tagged with an acoustic transmitter (code #53777) in the Nelson River between Clark Lake and the Keeyask GS in relation to the Keeyask GS (rkm 0) from May 1, 2016, to September 23, 2020. Date and location of tagging is indicated by a star. Beginning of Keeyask spillway commissioning is indicated with a vertical dotted line and end of reservoir impoundment is indicated with a solid vertical red line. Dotted horizontal lines indicate landmarks in the study area: entrance to Clark Lake (orange), Birthday Rapids (blue), Keeyask GS (red), Kettle GS (green), and Limestone GS (purple).
