Keeyask Generation Project Aquatic Effects Monitoring Plan

Walleye Movement Monitoring Report AEMP-2021-04

WALLEYE MOVEMENT MONITORING IN THE NELSON RIVER BETWEEN CLARK LAKE AND THE LIMESTONE GENERATING STATION, OCTOBER 2019 TO SEPTEMBER 2020: YEAR 7 CONSTRUCTION

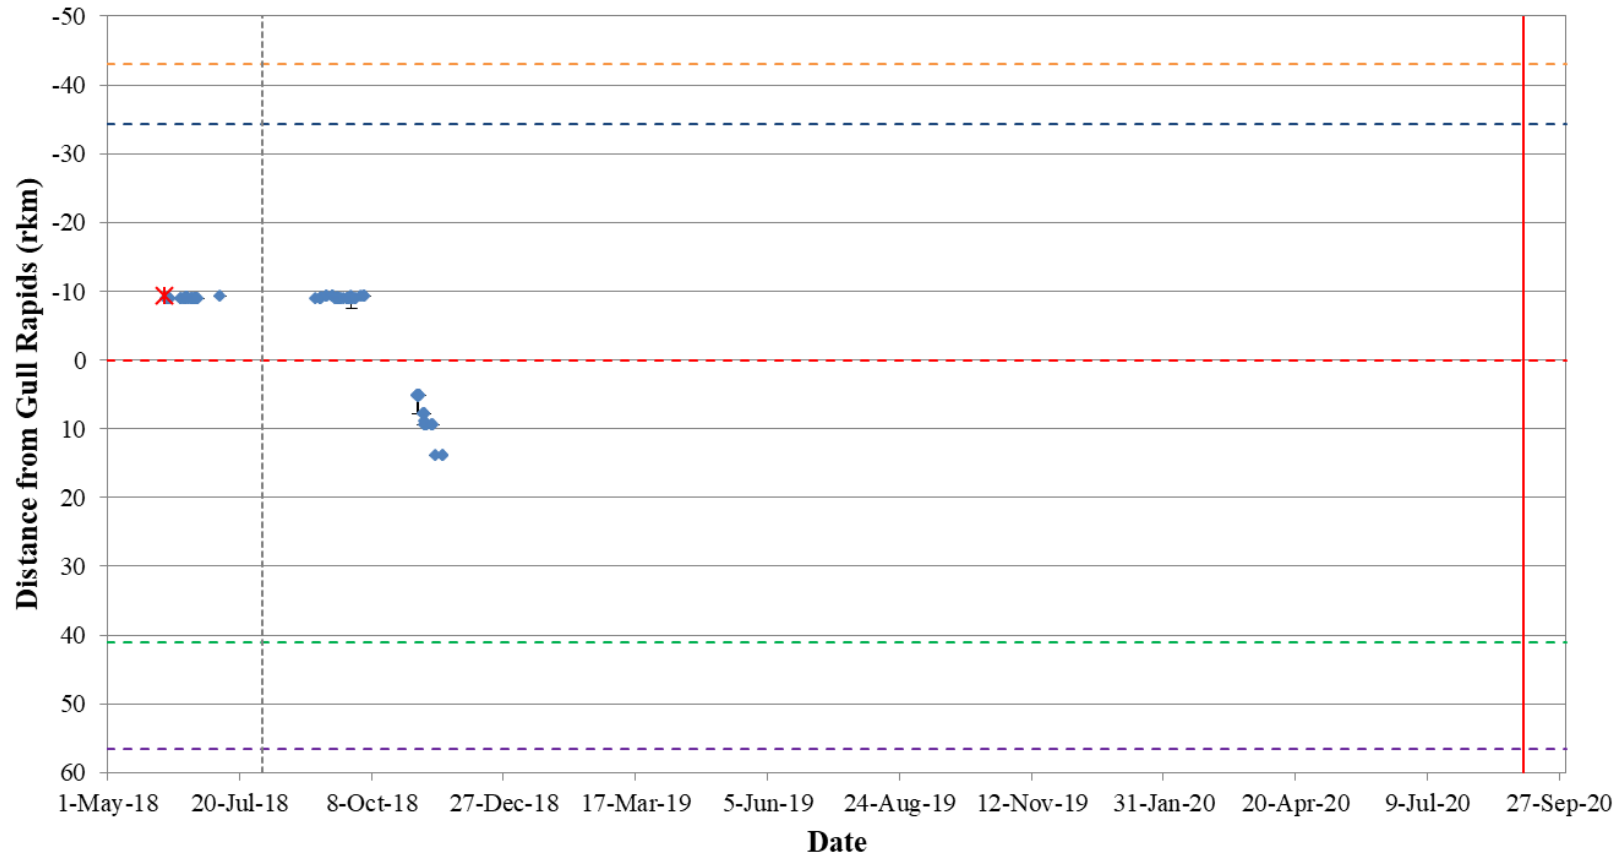
Figure A2-49: Position of a Walleye tagged with an acoustic transmitter (code #25739) in the Nelson River between Clark Lake and the Keeyask GS in relation to the Keeyask GS (rkm 0) from May 1, 2018, to September 23, 2020. Date and location of tagging is indicated by a star. Beginning of Keeyask spillway commissioning is indicated with a vertical dotted line and end of reservoir impoundment is indicated with a solid vertical red line. Dotted horizontal lines indicate landmarks in the study area: entrance to Clark Lake (orange), Birthday Rapids (blue), Keeyask GS (red), Kettle GS (green), and Limestone GS (purple).

- until August 10 when it moved downstream through the Keeyask GS spillway (Appendix A4-24).
- #25739 was tagged on June 5, 2018 in lower Gull Lake and moved downstream through the Keeyask GS spillway between October and November. It was last detected in Stephens Lake (rkm 13.9) on November 20, 2018 and is now considered missing (Appendix A2-49).

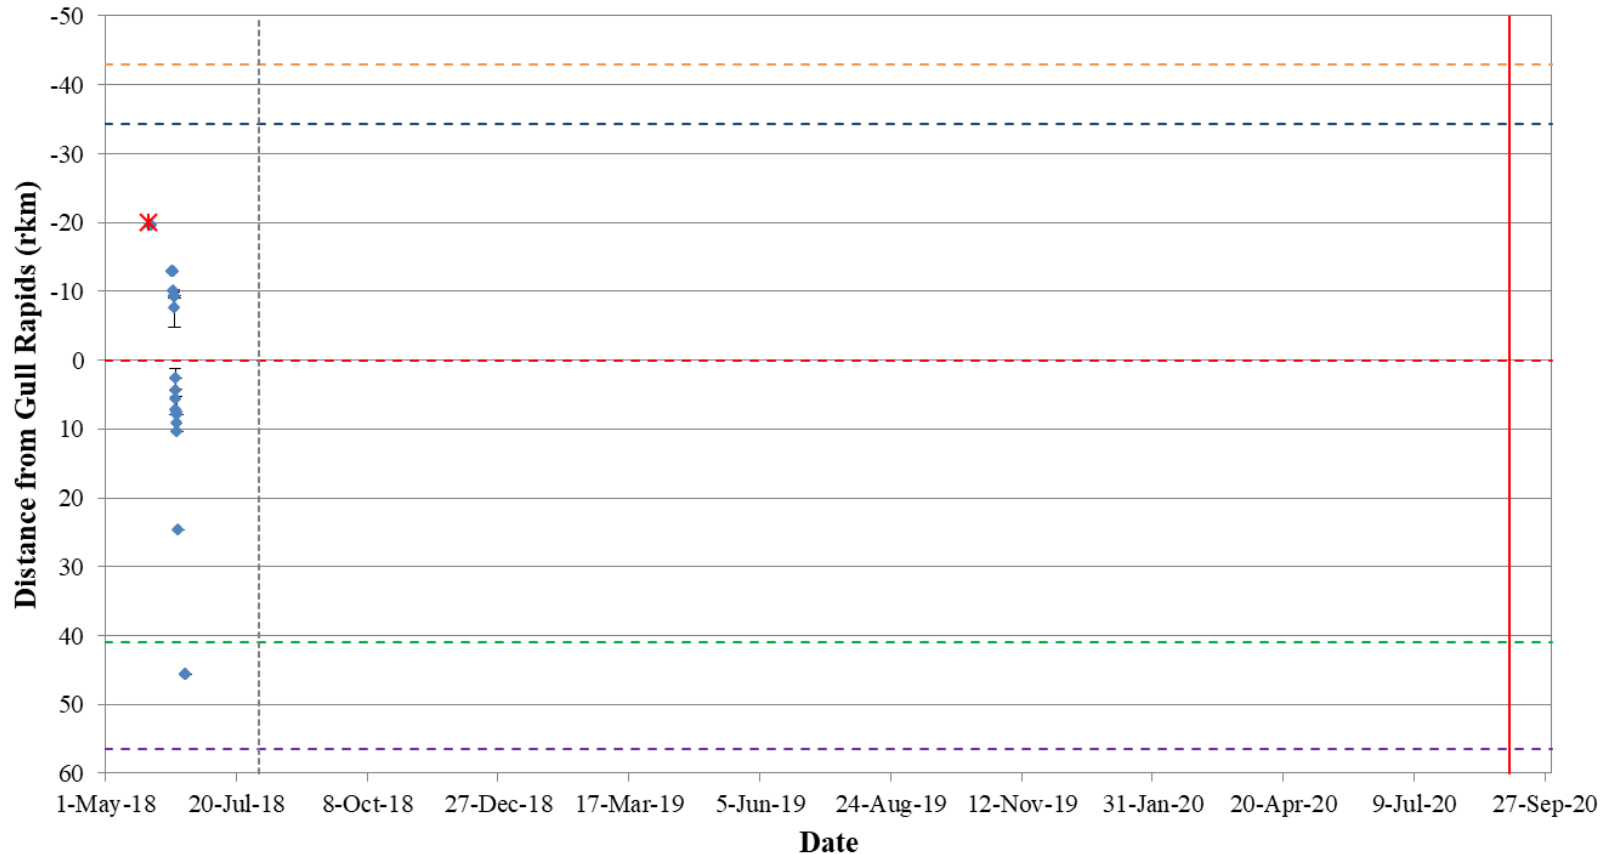
Figure A2-57: Position of a Walleye tagged with an acoustic transmitter (code #25748) in the Nelson River between Clark Lake and the Keeyask GS in relation to the Keeyask GS (rkm 0) from May 1, 2018, to September 23, 2020. Date and location of tagging is indicated by a star. Beginning of Keeyask spillway commissioning is indicated with a vertical dotted line and end of reservoir impoundment is indicated with a solid vertical red line. Dotted horizontal lines indicate landmarks in the study area: entrance to Clark Lake (orange), Birthday Rapids (blue), Keeyask GS (red), Kettle GS (green), and Limestone GS (purple).

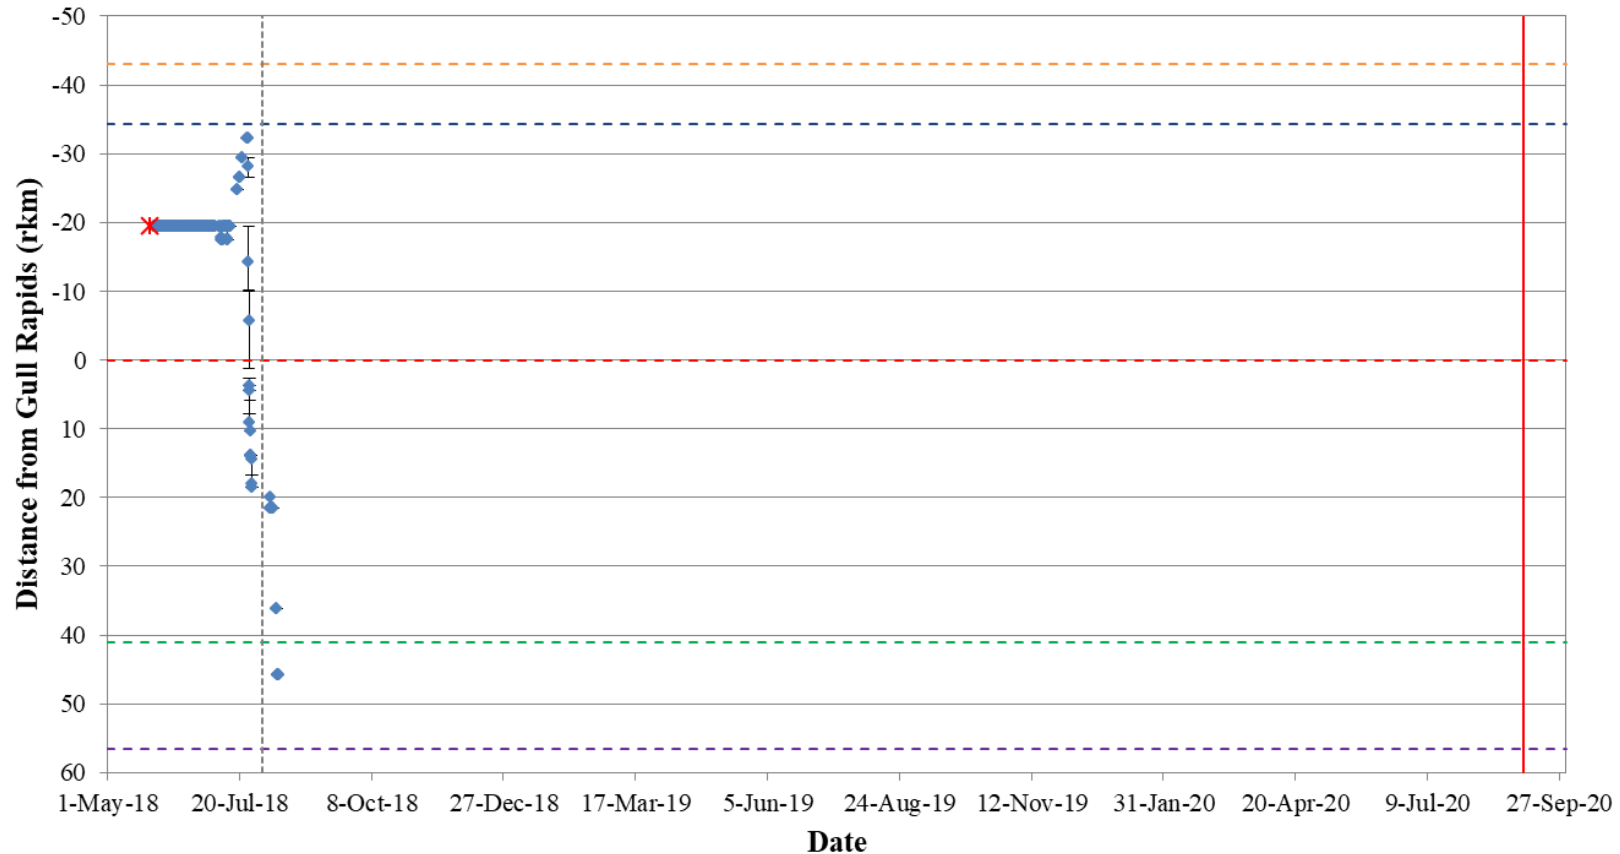
Figure A2-62: Position of a Walleye tagged with an acoustic transmitter (code #25753) in the Nelson River between Clark Lake and the Keeyask GS in relation to the Keeyask GS (rkm 0) from May 1, 2018, to September 23, 2020. Date and location of tagging is indicated by a star. Beginning of Keeyask spillway commissioning is indicated with a vertical dotted line and end of reservoir impoundment is indicated with a solid vertical red line. Dotted horizontal lines indicate landmarks in the study area: entrance to Clark Lake (orange), Birthday Rapids (blue), Keeyask GS (red), Kettle GS (green), and Limestone GS (purple).

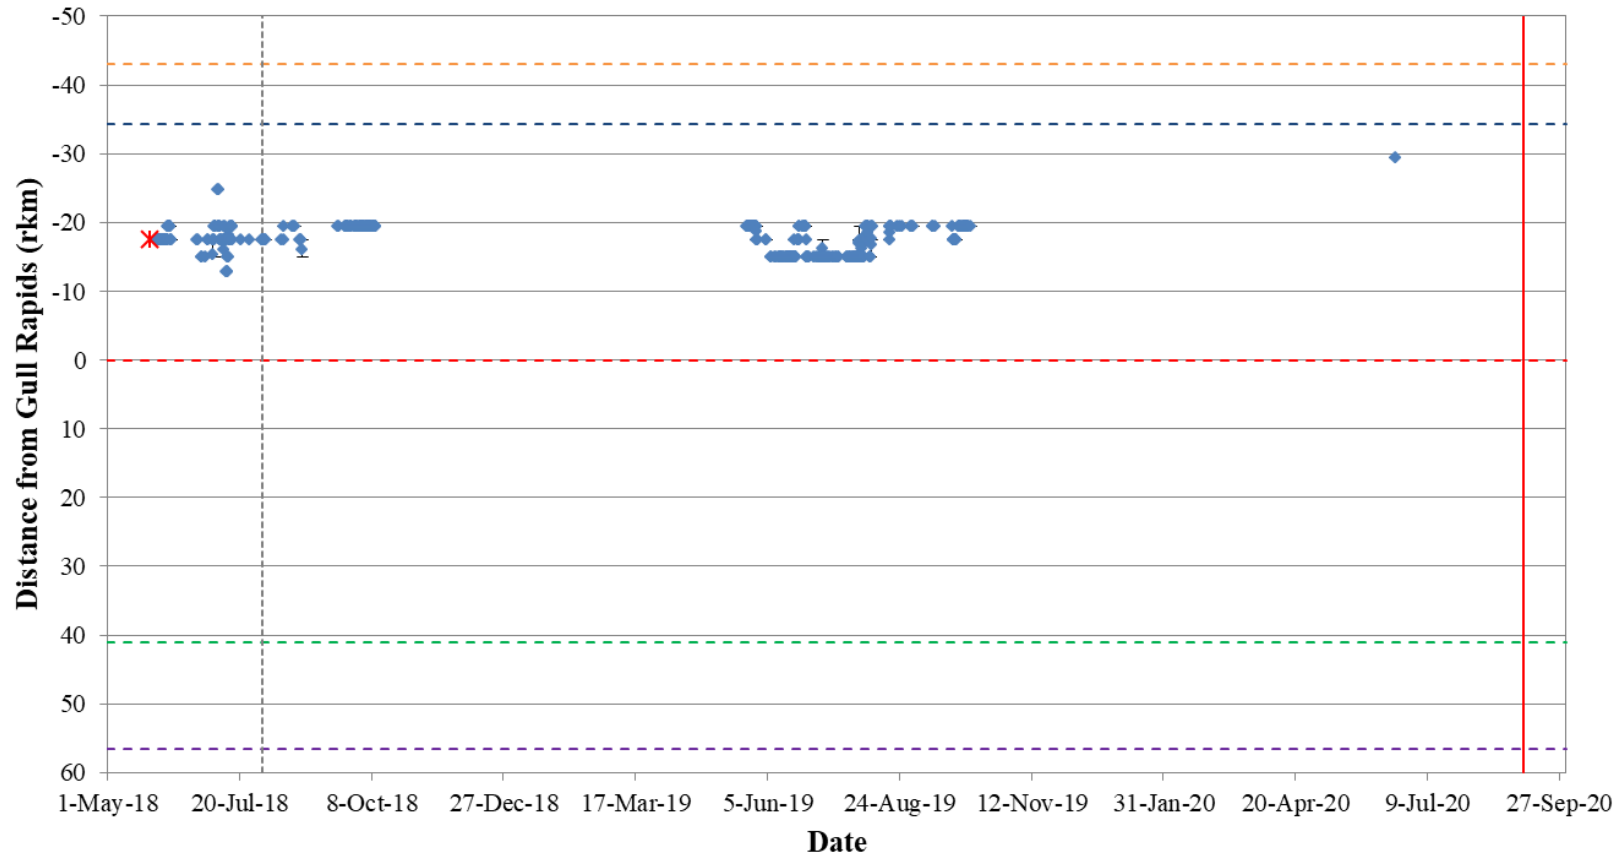
Figure A2-63: Position of a Walleye tagged with an acoustic transmitter (code #25754) in the Nelson River between Clark Lake and the Keeyask GS in relation to the Keeyask GS (rkm 0) from May 1, 2018, to September 23, 2020. Date and location of tagging is indicated by a star. Beginning of Keeyask spillway commissioning is indicated with a vertical dotted line and end of reservoir impoundment is indicated with a solid vertical red line. Dotted horizontal lines indicate landmarks in the study area: entrance to Clark Lake (orange), Birthday Rapids (blue), Keeyask GS (red), Kettle GS (green), and Limestone GS (purple).
