Keeyask Generation Project Physical Environment Monitoring Plan

Physical Environment Monitoring Report

PEMP-2021-01

2020-2021 PHYSICAL ENVIRONMENT MONITORING REPORT: YEAR 7 CONSTRUCTION

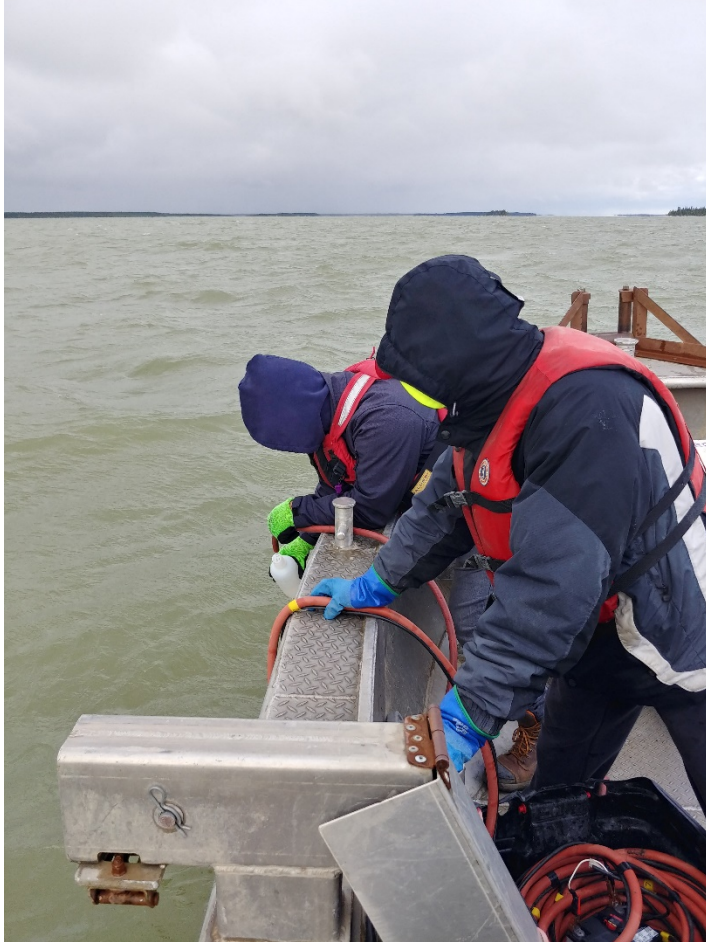
Collecting Water Samples for Sedimentation Monitoring

Between Clark Lake and the Kettle GS, continuous turbidity probes were installed at five locations in summer and three locations in winter. In addition, water samples were obtained on roughly a monthly basis at 10 different locations, in this stretch of the river. At some of the 10 locations, samples were taken from across the width of the river. In total there were 25 different sampling sites.

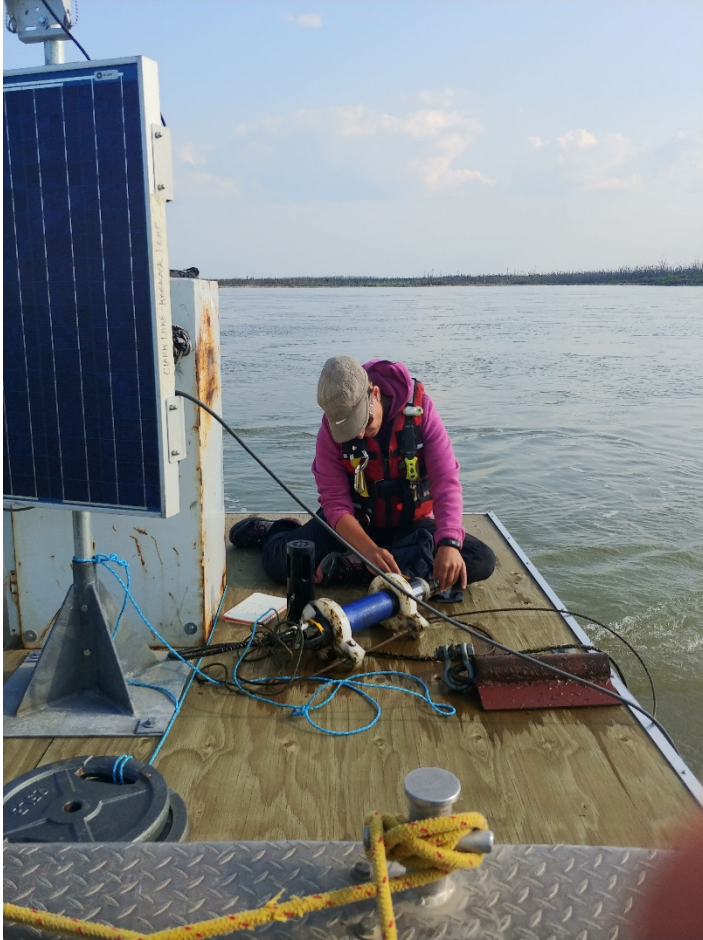
Continuous turbidity monitoring equipment – setting up a turbidity sensor

data collected at each of the monitoring sites was reviewed to identify and remove poor quality data from factors such as ice, dead batteries, and equipment malfunction. The continuous data (Figure 10 & Figure 11) were also compared with the discrete readings (Figure 12) obtained on each maintenance site visit and adjustments made for any sensor drift.

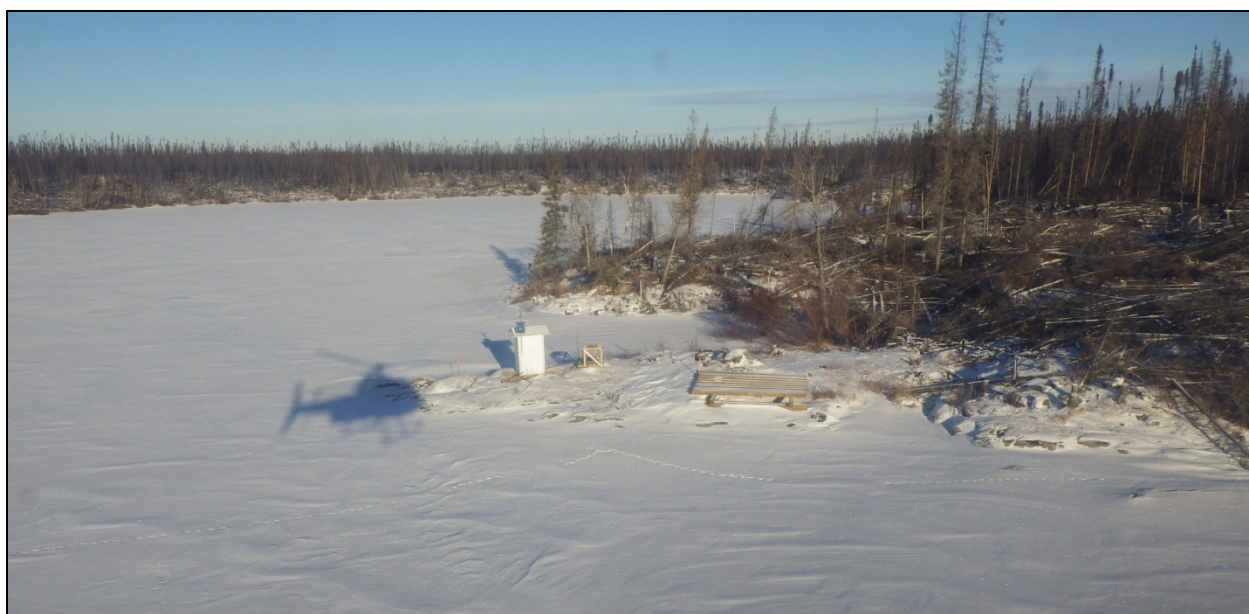
Photo 1: Water level gauging station in winter

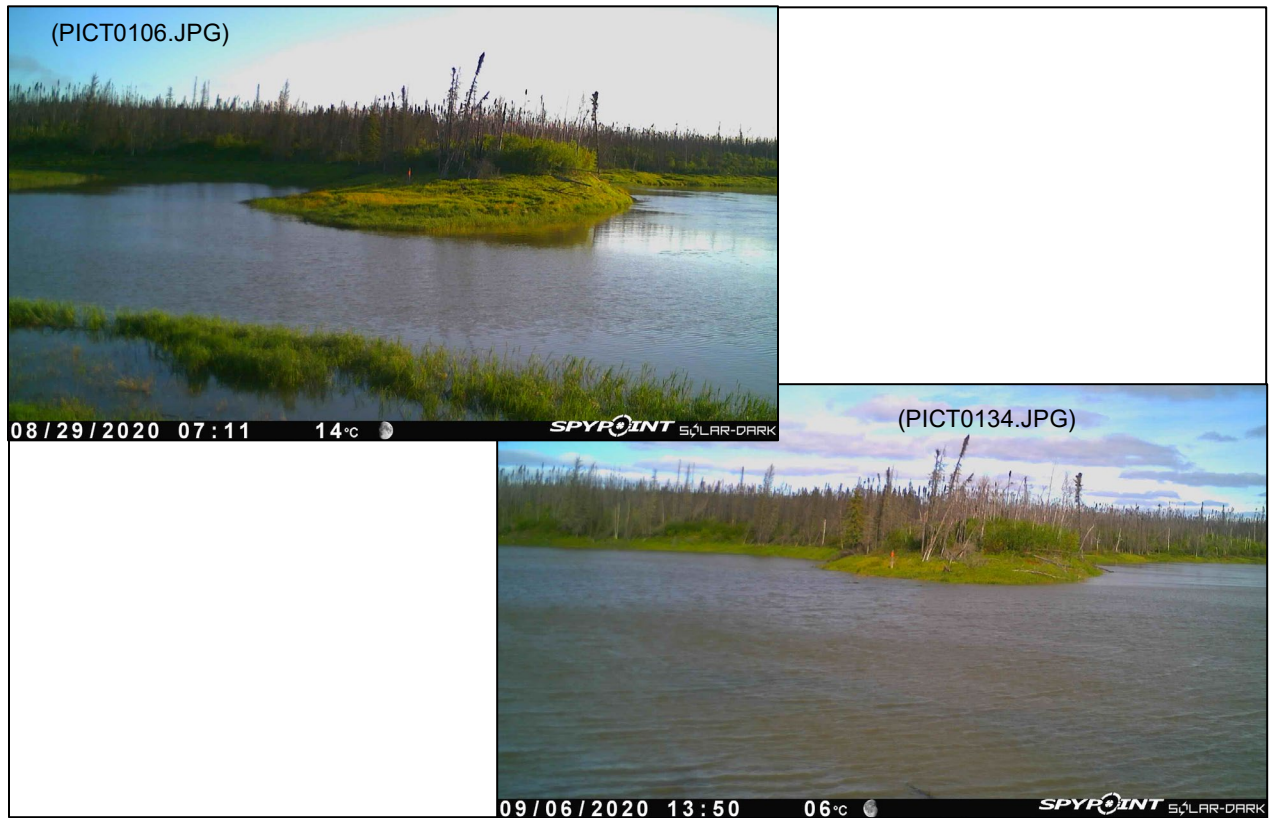
Photo 7: Pre- & post-impoundment images – mouth of Two Goose Creek

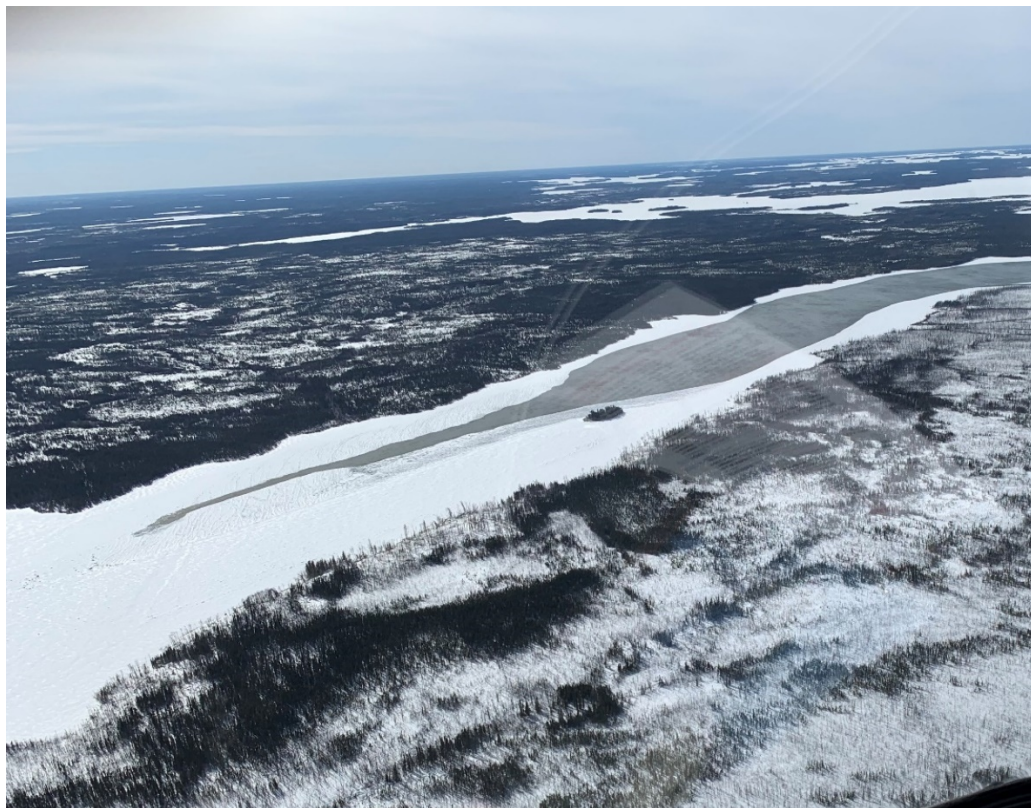
Photo 9: Ice front about 6 km upstream of Birthday Rapids, March 15, 2021

With an ice cover established on Gull Lake the ice advanced up the river as frazil ice accumulated at the leading edge (Figure 8). By the third week in December the ice front had progressed through Birthday Rapids and the maximum ice cover was reached (Photo 9). Ice continued to build up at the ice front as observed through continued water level increases after the maximum cover was reached.

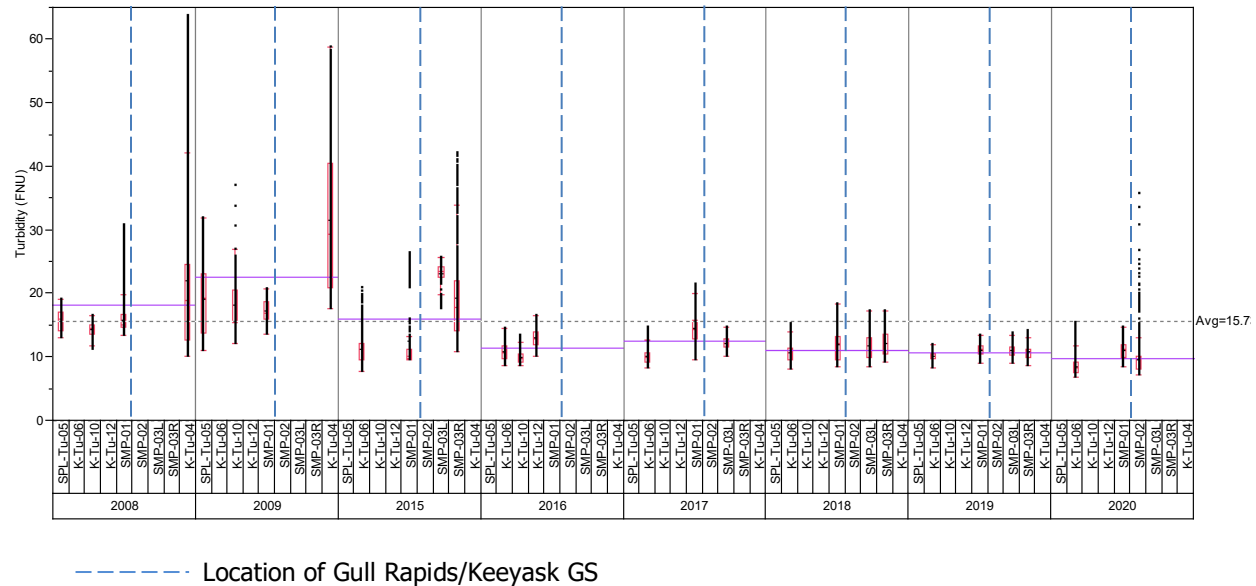
Figure 11: Summary of winter continuous turbidity

Results from the 2019-20 winter monitoring show similar results to the past four winters with a reduction in turbidity levels in Stephens Lake from pre-construction conditions. The EIS included the prediction that the Project will “significantly reduce erosion potential” downstream of the Project after construction which would result in lower turbidity downstream. Changes were not anticipated during the construction period as some increases in water level due to ice were still expected to cause erosion at the entrance to Stephens Lake. The earlier than expected reduction is likely due to the upstream ice boom creating a more stable upstream ice cover and reduction in the Stephens Lake ice dam and the cofferdams reducing the potential erosion of shorelines.

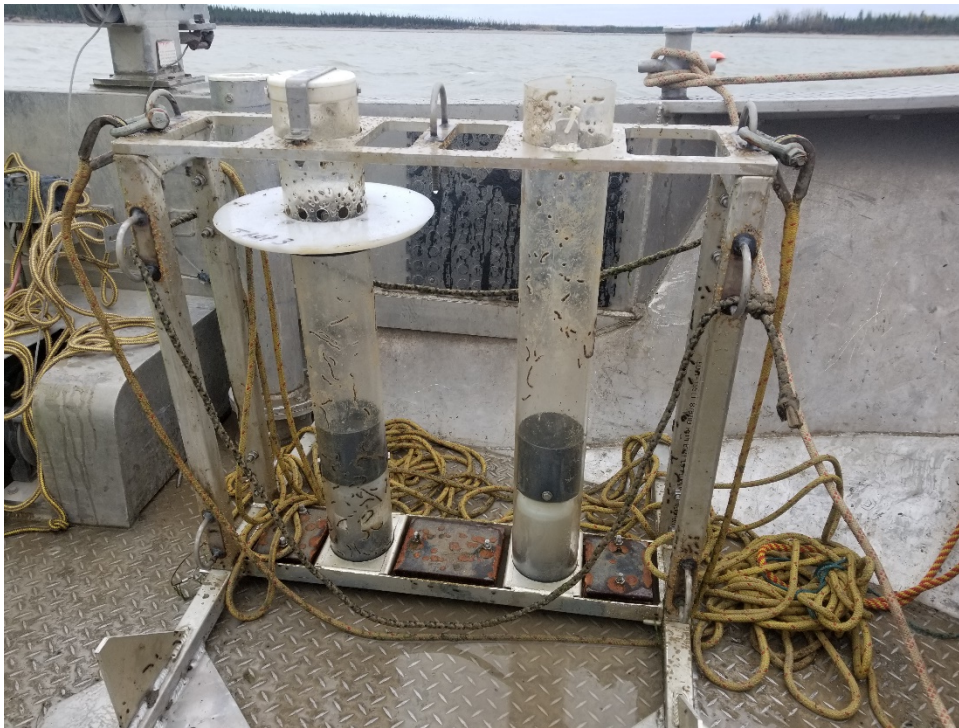
Photo 11: Sediment traps - 2 tube design

Sediment traps with two vertical tubes (Photo 11) were installed in Stephens Lake to monitor the sediment accumulation rate over the 2019/20 winter and the 2020 summer periods. One tube is a settling trap that is open at the top and the second tube is a flow through trap that has holes in the side to allow water and sediment to flow into it.

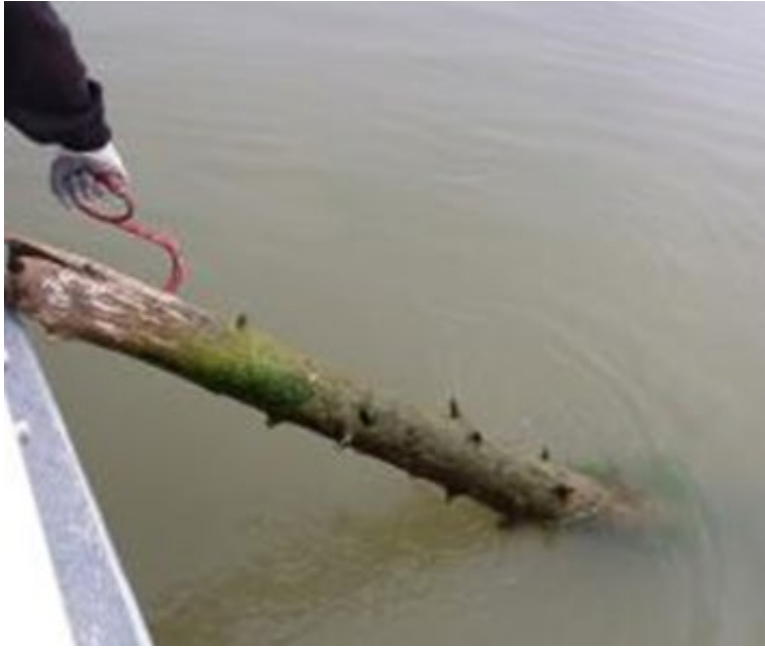
Photo 12: Large floating debris is removed from the water by the boat patrol team

As part of the Project, in accordance with the Joint Keeyask Development Agreement (TCN et.al. 2009), a waterways management program was started in 2015 for the Project area from Clark Lake to Gull Rapids. A component of this program is the operation of a boat patrol to identify and remove floating woody debris (Photo 12) that may pose a safety hazard to navigation. The boat patrol records the amount of debris removed each season, classifying it as either small (<1m length) or large (>1m length), and the large material is further classified as either new or old debris (generally with or without bark) or if it came from beaver activity.

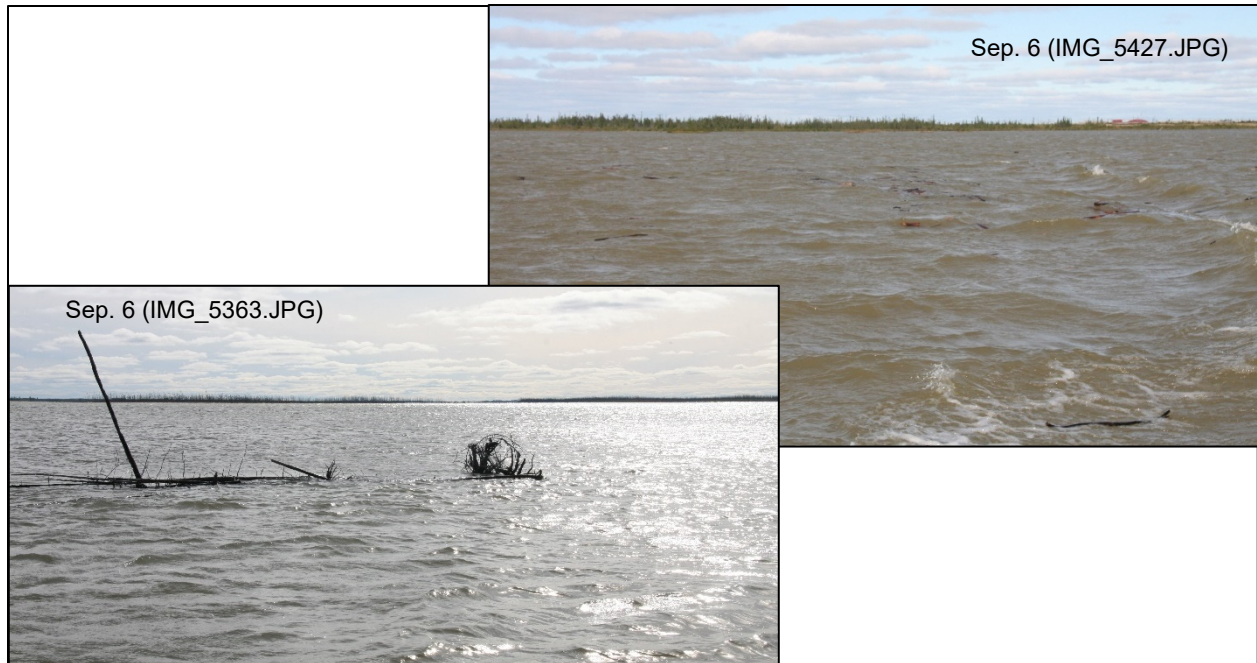
Photo 13: Small & large floating debris after impoundment

The Keeyask reservoir was impounded between Aug. 31 – Sep. 5, with water levels being raised from about 156.9 m ASL to near the full supply level of 159.8 m ASL (see Section 2.2). As the water was raised, it mobilized large and small woody debris from the flooded areas. This debris was observed floating in the reservoir and being transported in a downstream direction towards the Keeyask spillway, through which it could pass into Stephens Lake. While a lot of debris was smaller in size (e.g., twigs, branches), larger trees were not uncommon (Photo 13). There is a large amount of larger woody debris floating adjacent to some sections of the new reservoir shorelines that does not appear to be immediately mobile within the waterway (Photo 14). However, this debris could potentially become mobile depending on conditions like storm events

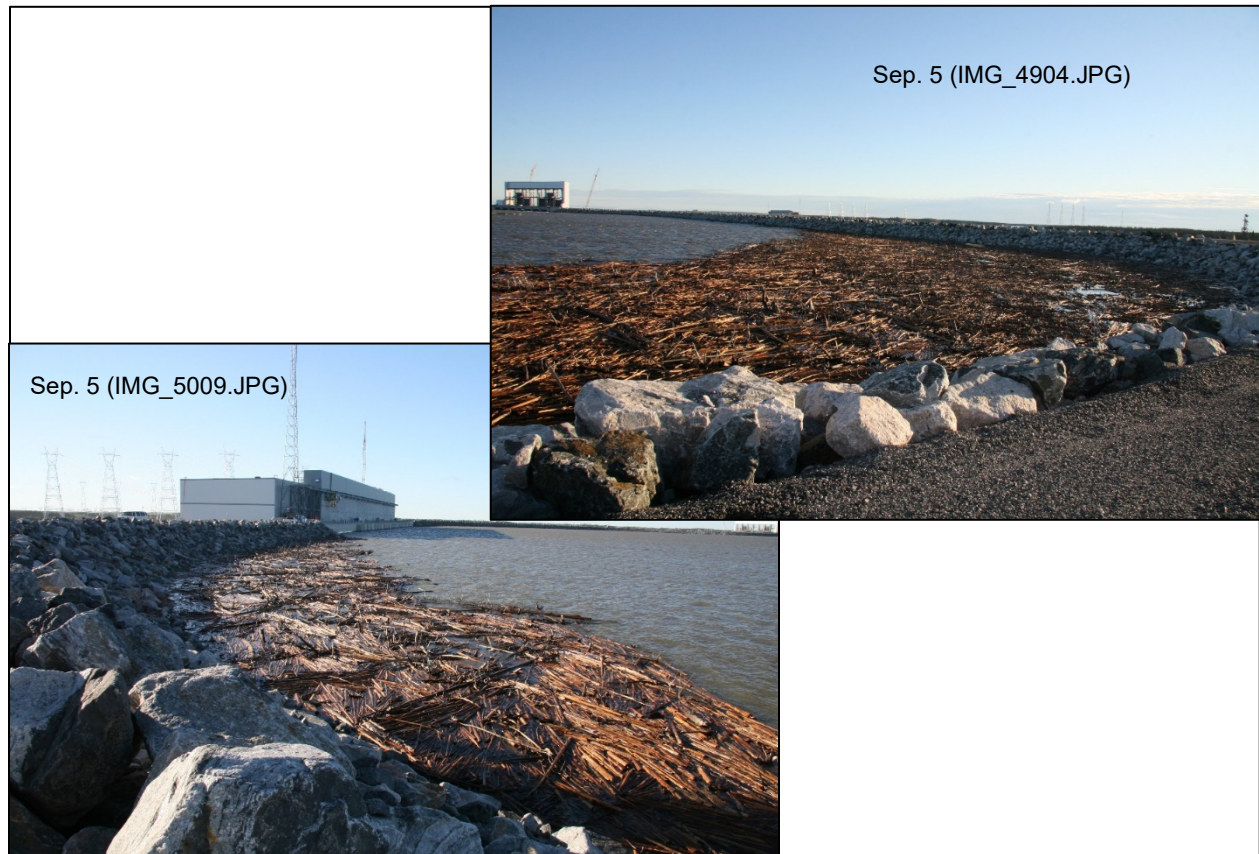
Photo 15: Rafted woody debris where N & S dykes meet N & S dams

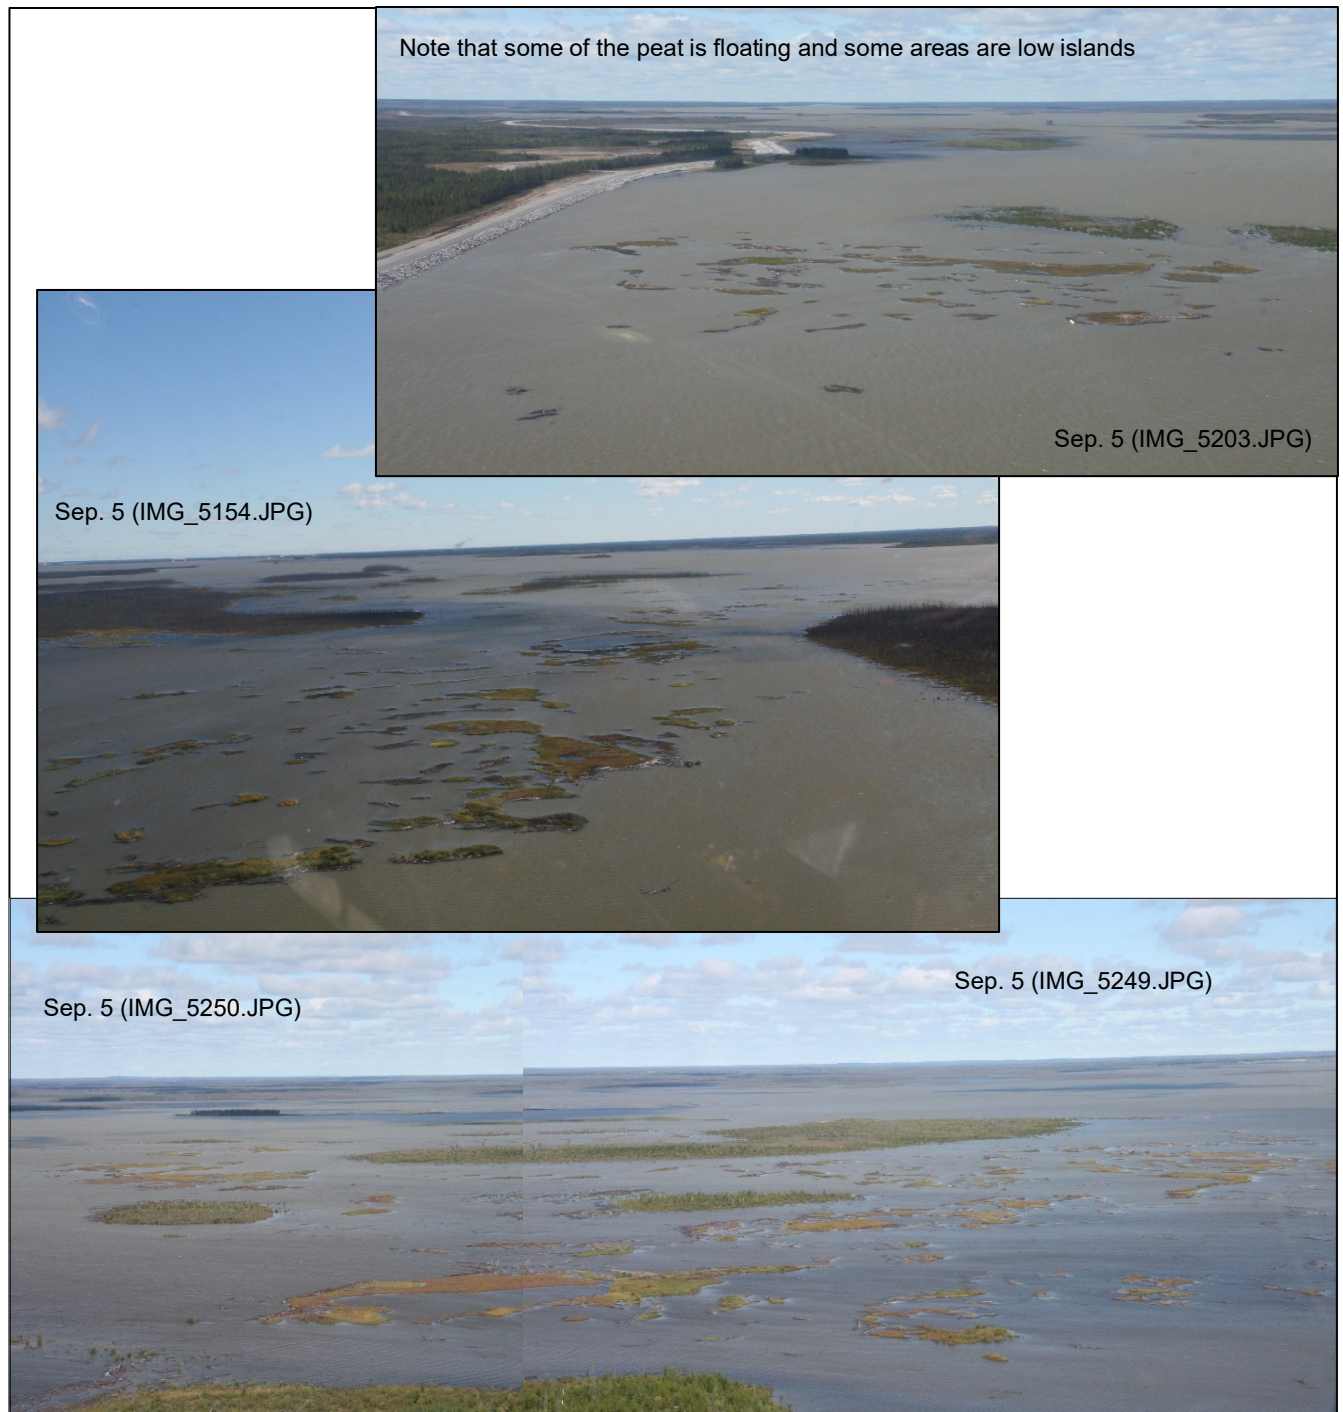
Photo 17: Floating peat in flooded areas

Impoundment of the reservoir flooded terrestrial peatlands. The Keeyask EIS (KHLF 2012) noted that some flooded peat would float up as a result of impoundment and that the floating peat could be mobile within the reservoir. During and following impoundment, floating peat was observed to varying degrees in all the flooded areas around Gull Lake (Photo 17). Although floating peat may become mobile and could be transported to different areas of the reservoir or downstream, no peat islands were observed to be doing so during or shortly after impoundment. It is possible that the floating remains attached to submerged peat and is held in place. It is expected that floating peat will become mobile as the peat breaks down and mats break off. In addition, the Keeyask EIS also predicts that some peat that is currently submerged will eventually break off and float up to become mobile within the reservoir.
