Keeyask Generation Project
Terrestrial Effects Monitoring Plan

Invasive Plant Spread and Control Monitoring Report

TEMP-2021-05

By
ECOSTEM Ltd.
June 2021

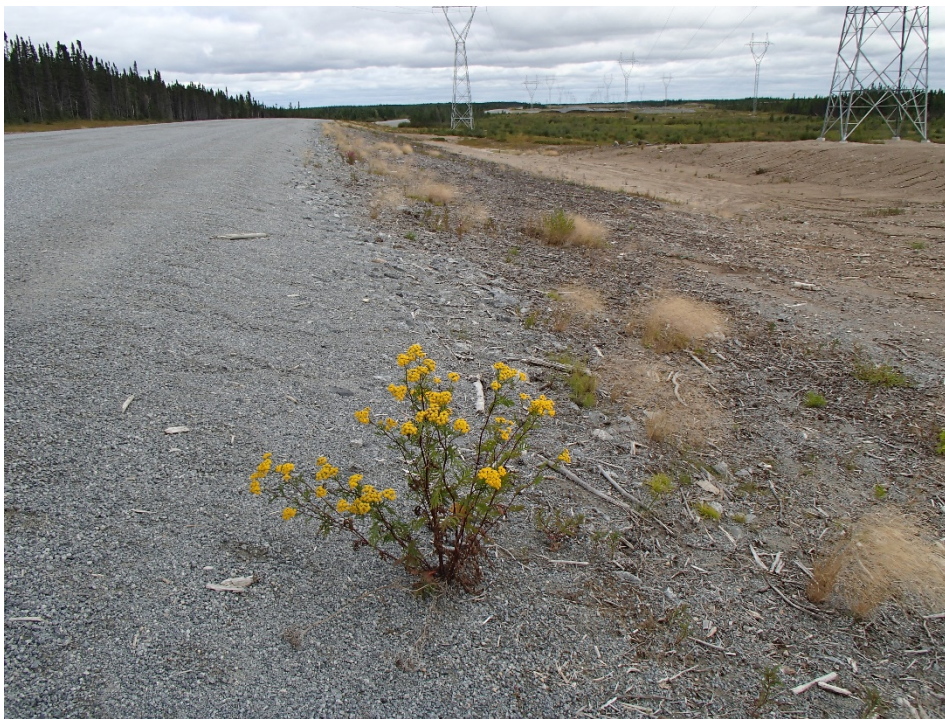
Common tansy, an invasive plant found at the Keeyask site during construction

Of the 27 non-native plant species found in 2020, scentless chamomile and common tansy are the ones of highest invasive concern for the Project site. There was a large increase in the number of sites where common tansy was found, from single sites in the previous two years to 20 sites in 2020.

Species of highest invasive concern are being controlled by manual removal of these plants as soon as they are found during the surveys. This has worked well. Scentless chamomile was not found in 2020 at the sites where they had been removed in previous years, nor was common tansy, with the exception of one site. Ox-eye daisy, which was another species of high invasive concern found in previous years and manually removed, was not found in 2020.

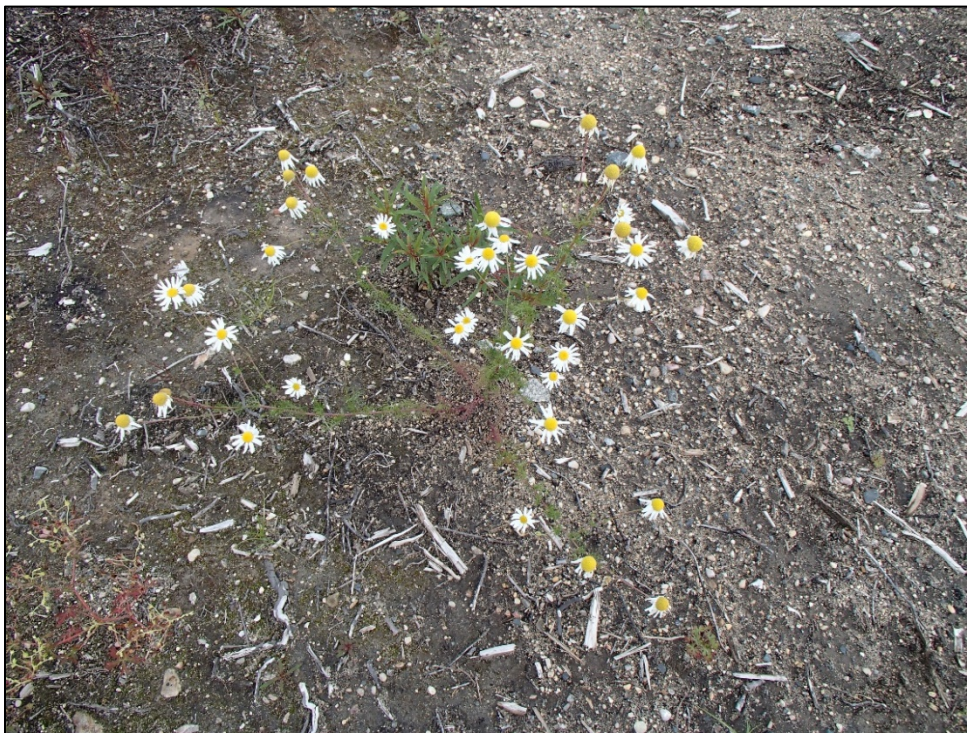
Photo 4-1: Scentless chamomile growing in EMPA D28(1)-E on August 24, 2020

In August 2020, scentless chamomile was found growing at four new sites (Map 7-26): two in the ditch on the north side of the SAR, and two in EMPA D28(1)-E which is attached to the South Dyke (Photo 4-1). All of these plants were immediately removed and disposed of by ECOSTEM field staff.

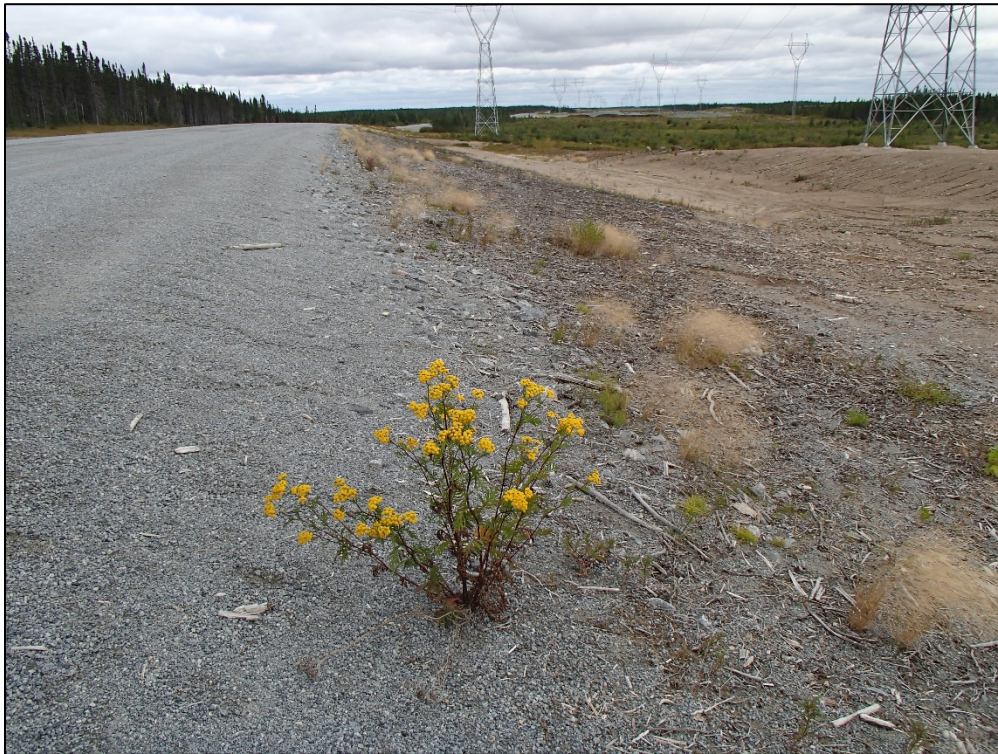
Photo 4-2: Common tansy growing beside the South Access Road on August 24, 2020

Common tansy was found growing at a single site along the North Dyke in late summer, 2018, and at another site nearby in 2019 (Photo 4-2; Appendix 3, Map 7-27). The plants were immediately removed by ECOSTEM field staff.

Common tansy was found growing at eight sites in 2020. This included four sites in the ditch along the SAR, two in the ditch along the NAR, one site in Work Area A, and one site along the North Dyke. Single plants were found at each site, except for the North Dyke, where two plants were growing. The plants found at the North Dyke were growing at the same site that a single plant was found in 2018. All plants were immediately removed by ECOSTEM staff. No plants were found in 2020 growing at the site where a plant was removed in 2019.

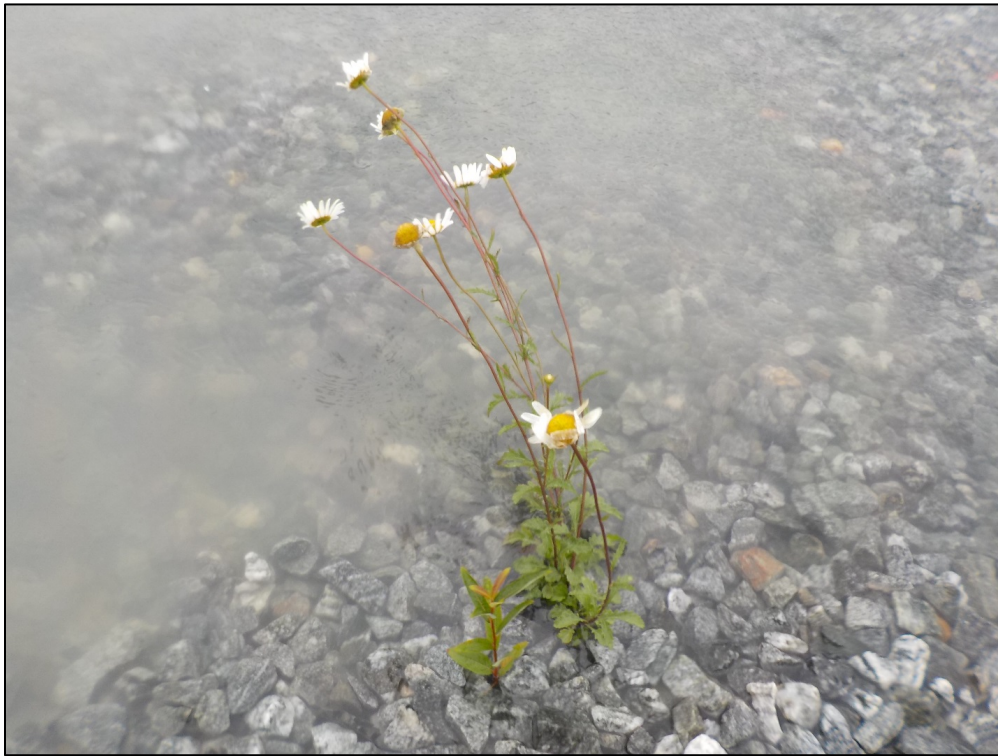
Photo 4-3: Ox-eye daisy growing in Borrow Area Q-9 on August 26, 2019

Single ox-eye daisy plants were found growing in Work Area B in 2017, in Borrow Area G-1 and the Sigfusson Northern/Voltage Camp in 2018, and in Borrow Area Q-9 in 2019. All plants were removed by ECOSTEM field staff.

Sites that had ox-eye daisy plants that were removed were revisited in 2020. No plants were found at any of these sites, and no new plants were found at any other sites during the 2020 surveys.

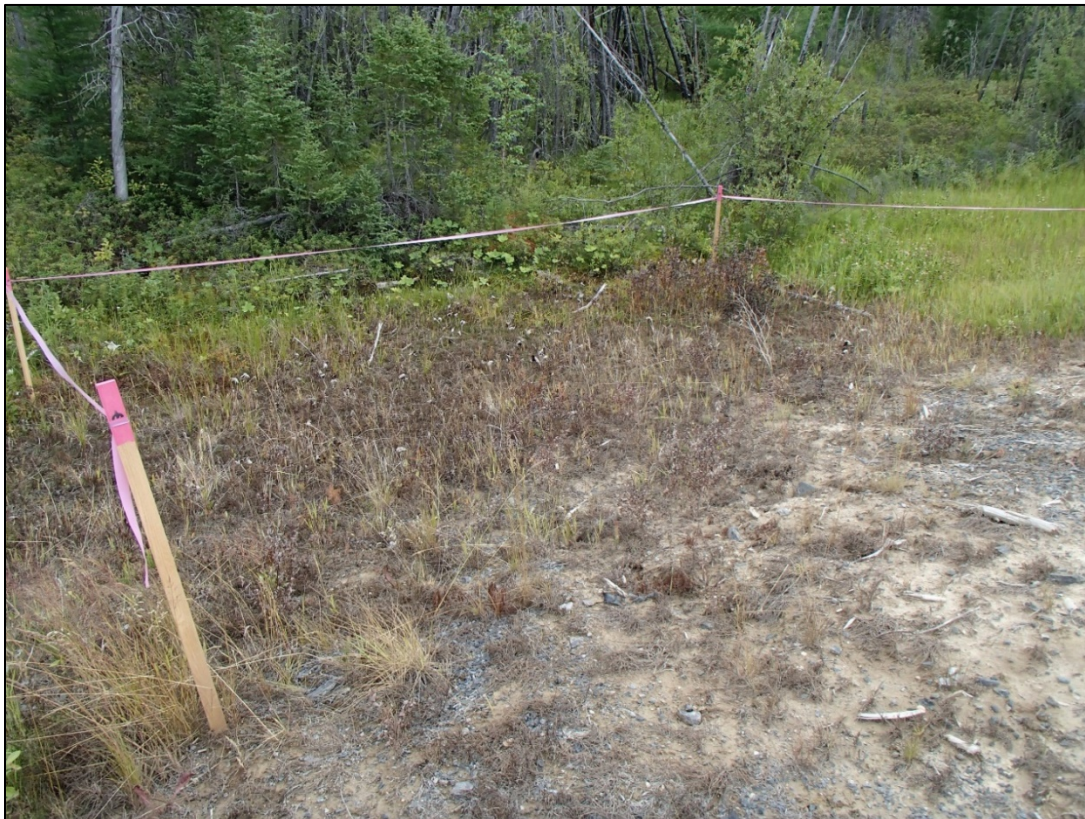
Photo 4-4: Herbicide-treated site in the Start-up Camp with no discernable non-native plants

For the 2020 treated sites, total non-native plant cover over all of the treated sites prior to treatment was approximately 1,341 m² in July, 2020 (Table 4-2; based on the total cover of live and deceased non-native plants). Total non-native plant cover was highest by far in the Borrow Area G-1. This is almost certainly an underestimate, because there were several treated areas in which no non-native plants could be discerned (Photo 4-4). It is likely that target species were present there because the patch was marked for treatment, but the treated plants had disintegrated and were not detectable at the time of the surveys.

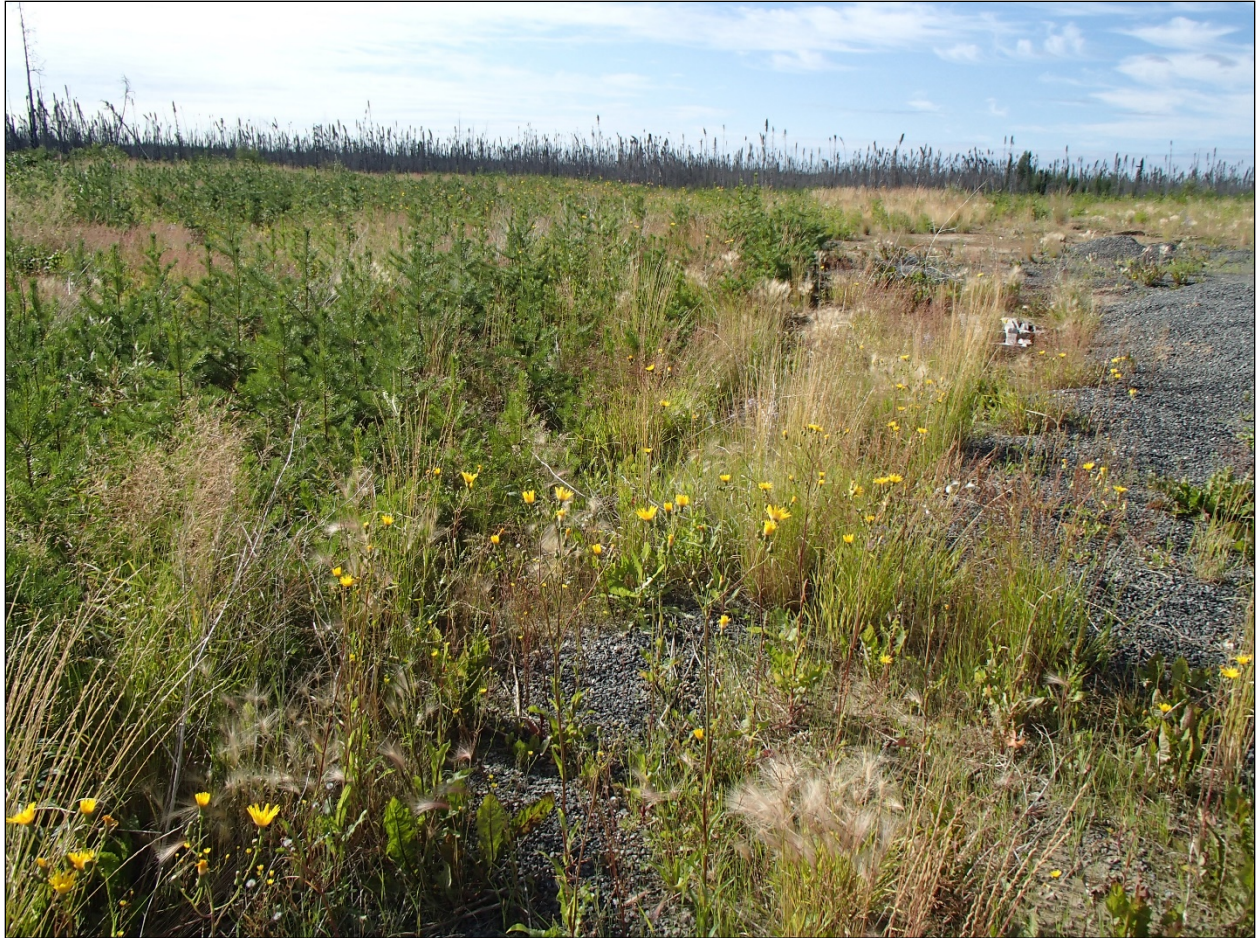
Photo 5-1: Regeneration in Borrow Area KM-1 in August 2020

The decreases seen in portions of the Project footprint components that were used by the KIP and minimally affected by the Project may have resulted from competition with regenerating native vegetation. The sources of native vegetation regeneration were rehabilitation efforts (tree planting) and natural regeneration. This native revegetation was becoming quite advanced in some areas (Photo 5-1). Construction traffic in these areas was minimal, which limited transport of non-native plant seeds into the areas.

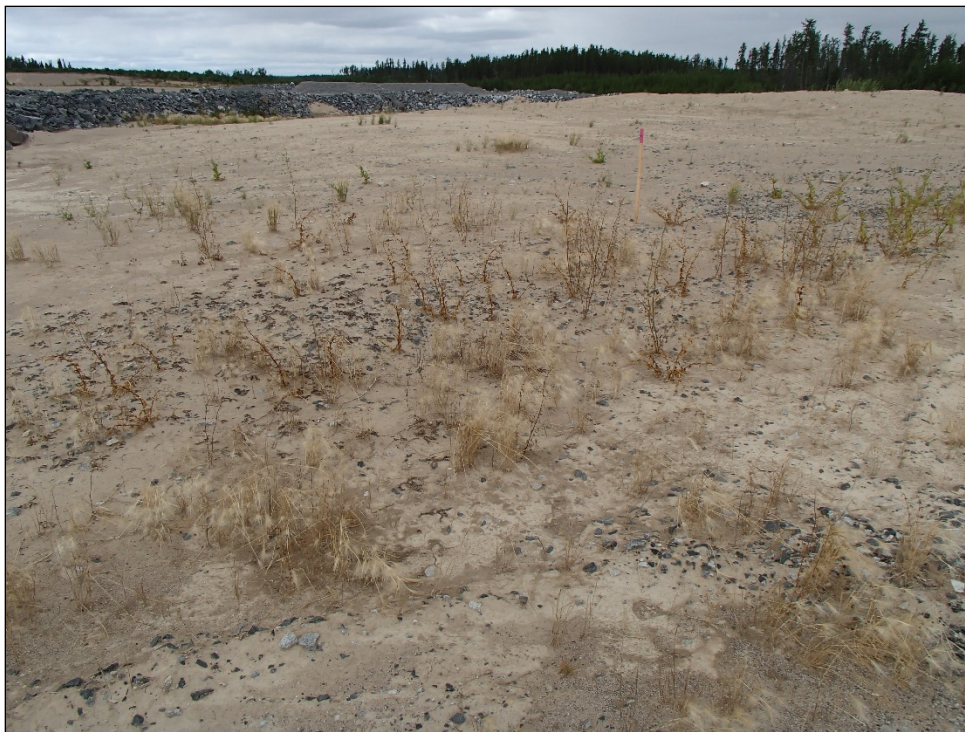
Photo 5-2: General vegetation mortality in an herbicide-treated patch in Borrow Area G-1

For the 2020 treatments, inspection of the patches where herbicide damage was present showed that the mortality rate of all contacted vegetation was very high (Photo 5-2). In some cases, the treated patches were much larger than the patches where plants were still identifiable at the time of the surveys. It was unclear if the effectiveness of the herbicide on field sow-thistle (one of the major target species) was poor in some of the treated patches. Many of the plants in these patches were no longer unidentifiable to species at the time of the surveys as it had been at least three weeks since the herbicide application.

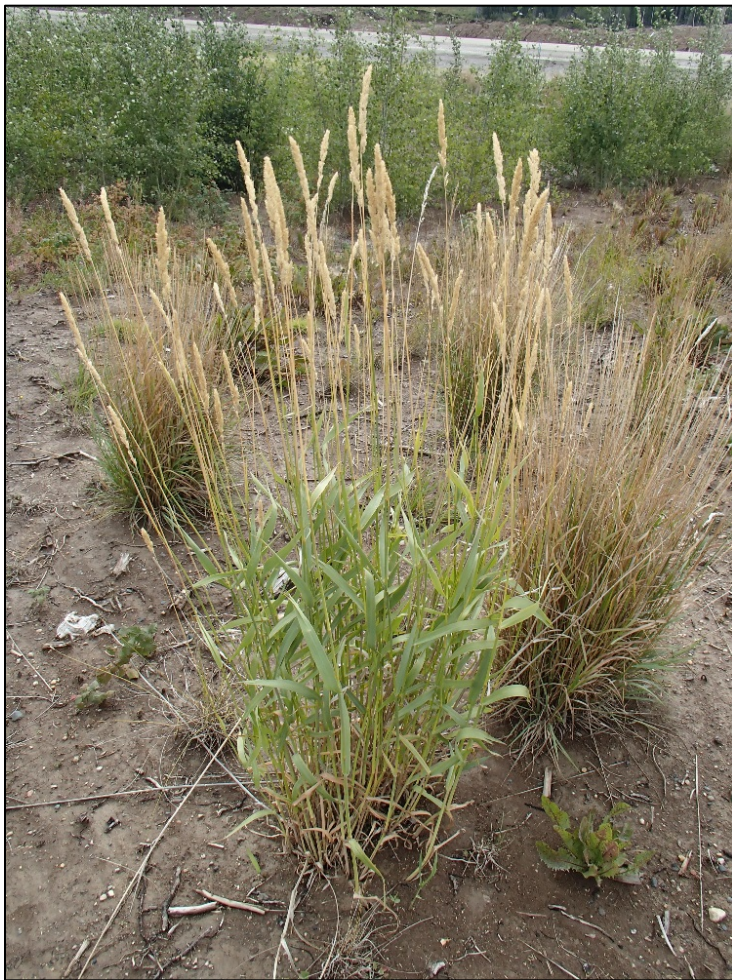
Photo 7-1: Reed canarygrass growing in Work Area B on August 26, 2018

Due to the reasons stated in Section 2.7, reed canarygrass found during the monitoring is not being included as a non-native species. Recorded plant locations will be monitored, however, and mitigation options will be considered in the future if the plant appears to become invasive.
