Keeyask Generation Project
Aquatic Effects Monitoring Plan

Zebra Mussel Monitoring Report
ZMMP-2021-01

REPORT #ZMMP-2021-01

ANNUAL REPORT

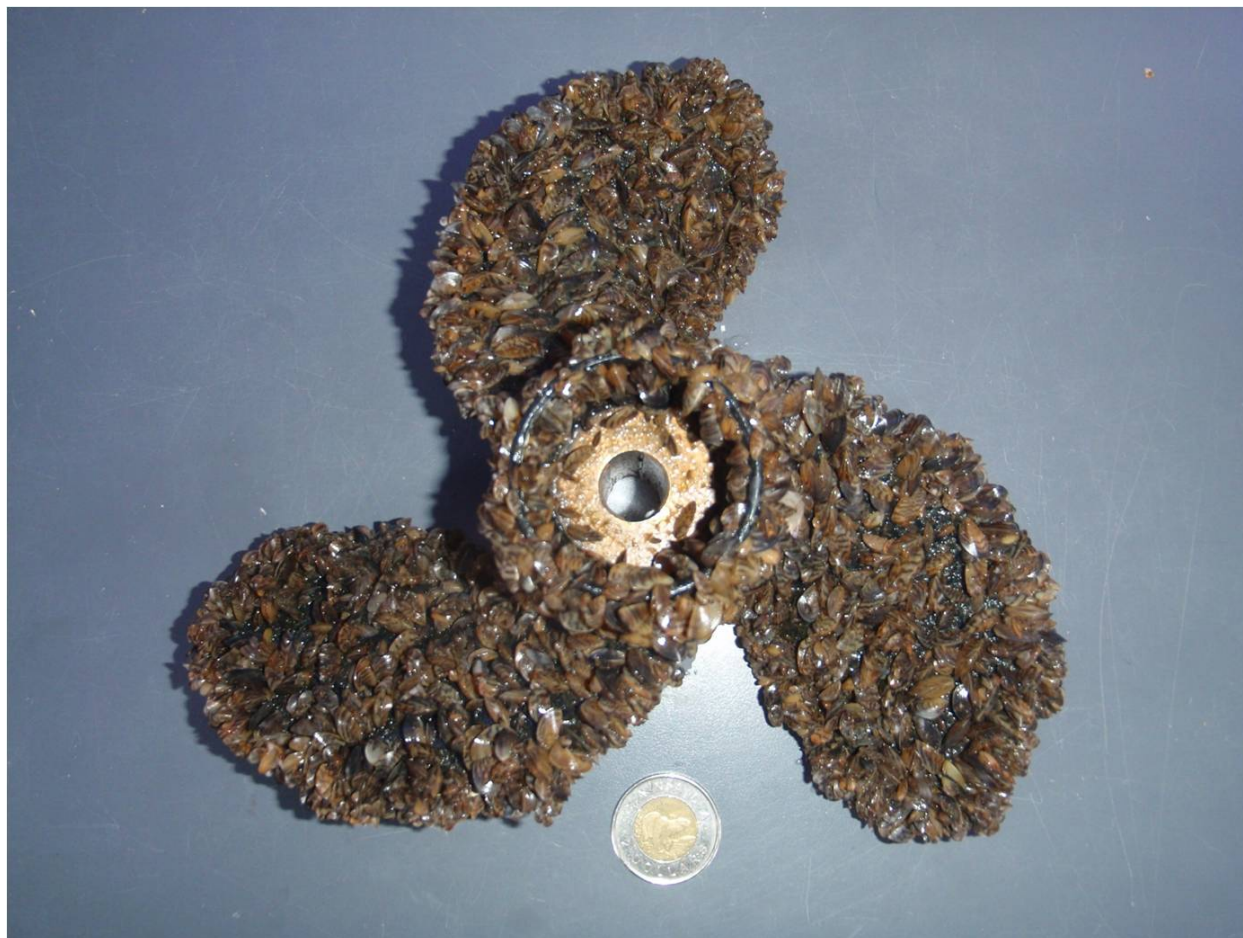
Figure 1: Once present, zebra mussels grow on hard surfaces that are in the water, as shown on this boat propeller. Each mussel is approximately the size of a fingernail.

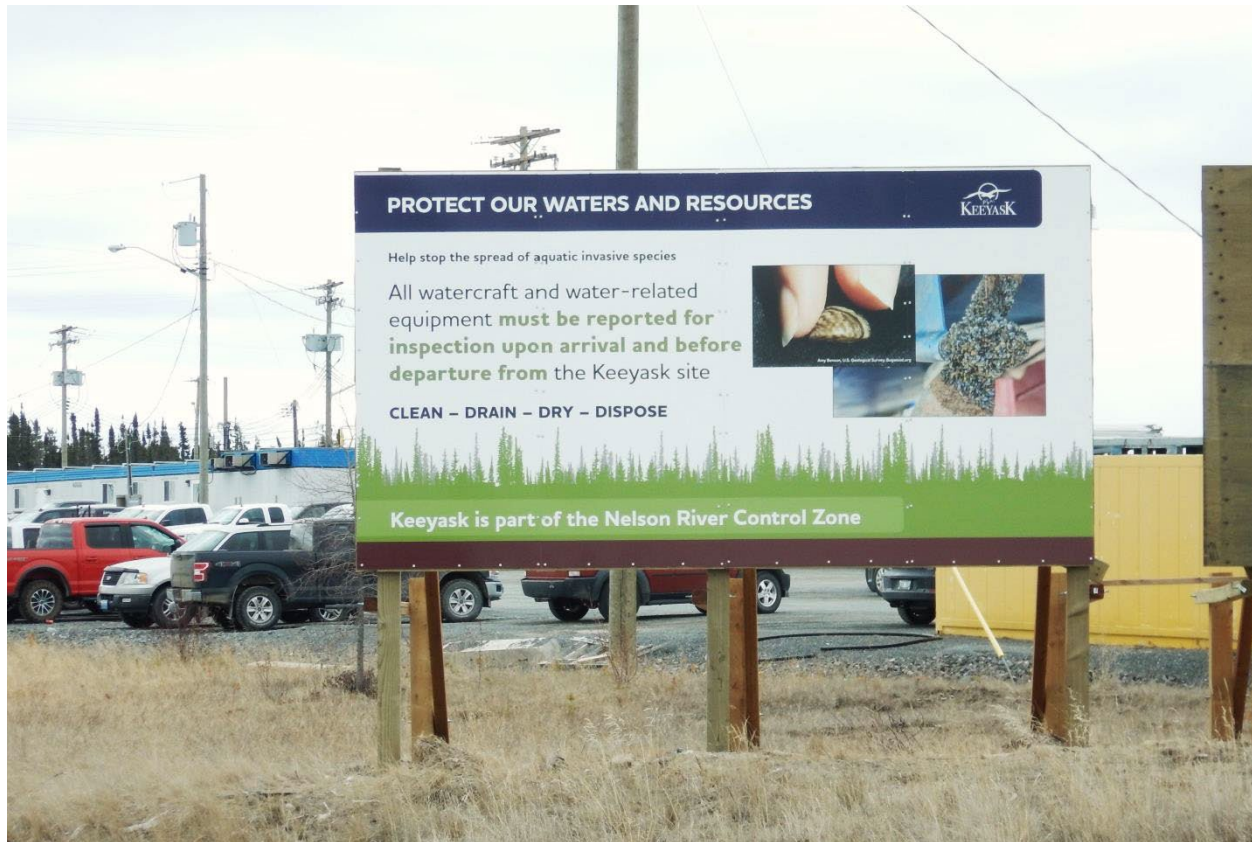
Figure 2: A sign is located at the main gate to remind site users to report for inspection of watercraft and water-related equipment.

Site Environmental Inspectors received refresher training regarding requirements related to aquatic invasive species legislation, as well as provincially approved inspection and decontamination techniques for zebra mussels and other common aquatic invasive species (AIS). The site orientation session given to all Keeyask employees, contractors, and visitors includes a section on AIS and outlines the regulatory requirements for decontaminating watercraft and water-related equipment. Aquatic invasive species information posters are also displayed in Main Camp as well as Manitoba Hydro and contractor lunchrooms around the construction site; this helps familiarize people regarding what to look for, and how they can follow up if they find something. An information bulletin on zebra mussels and other aquatic invasive species was distributed to all contractors on site beginning in May 2018 and continues to be distributed annually in the spring. A sign posted at the main gate in 2018 remains in place to notify site users that Keeyask is in the Nelson River Control Zone and to remind personnel to report for inspection/decontamination of watercraft and water-related equipment when entering and leaving Keeyask (Figure 2).

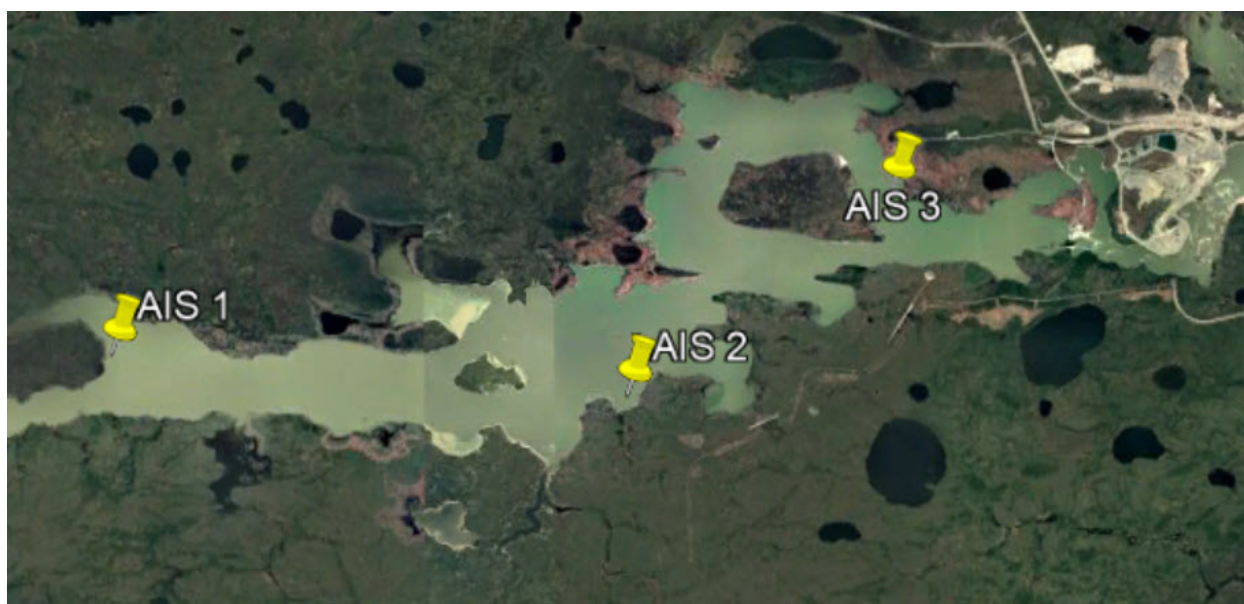
Figure 4: Location of sites in the Keeyask reservoir where artificial substrates were deployed to monitor for zebra mussel colonization.

Monitoring for adult zebra mussel colonization was done by establishing three sites in the Keeyask reservoir for placement of artificial substrates. Sites were located in low-flow areas (0.1-1.0 m/s) with a depth of approximately 4 m (Figure 4). At each site, terra cotta and plastic flowerpots were used as artificial substrates. These pots were suspended in series along a rope at 1, 2, and 3 m depths, anchored in place with a cinderblock, and kept suspended in the water column by buoys at the surface (Figure 5). The design has gradually evolved since 2017 to use more robust ropes, plastic pots, and an additional buoy to help prevent equipment damage while in the river.

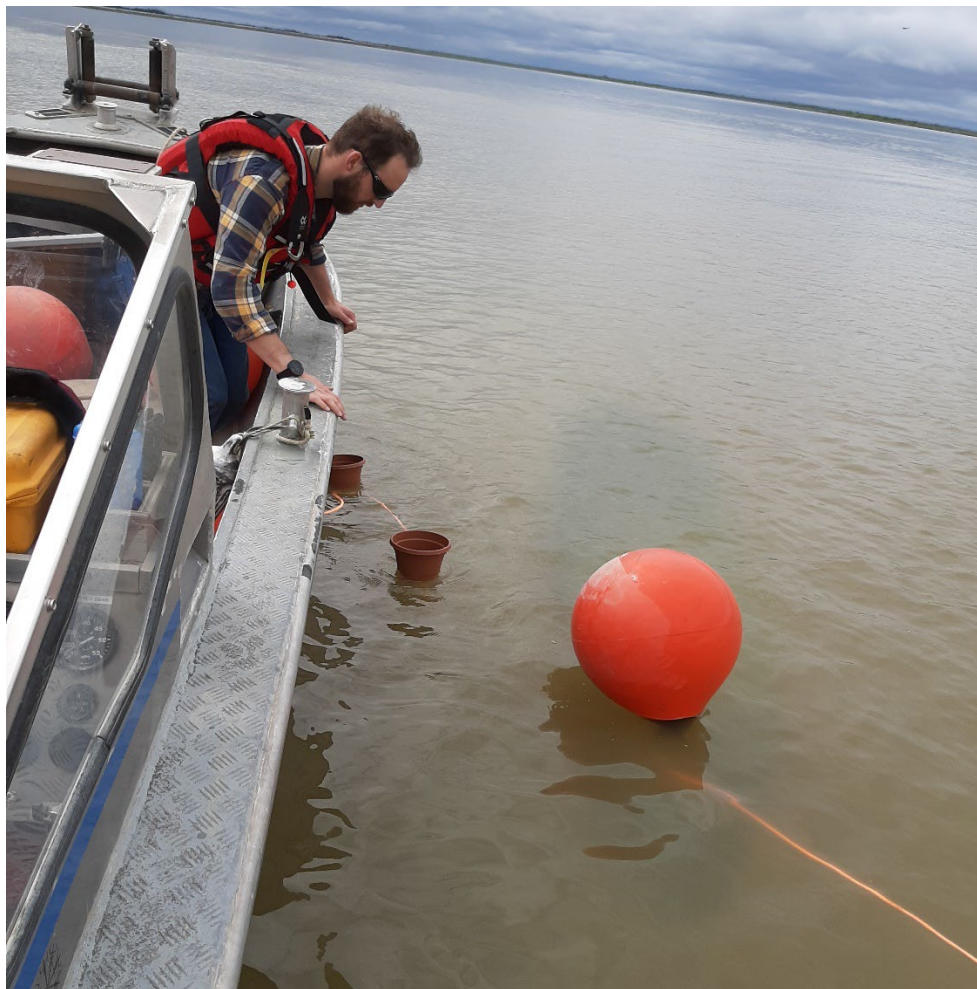
Figure 5: Installing artificial substrate to monitoring for zebra mussel colonization, June 2020.

All three sites were deployed on June 26, 2020. Terra cotta pots were deployed at site AIS 2, while AIS 1 & 3 were comprised of plastic pots. All three sites were checked on July 20, 2020 for the presence/absence of zebra mussels and a photograph was taken of each side of the substrate. One terra cotta pot had broken at AIS 2, so it was replaced with a plastic pot. Site visits also included visual inspections of adjacent rocks, crevices, woody debris, docks, and vegetation for the presence of zebra mussels. Impoundment of the Keeyask reservoir occurred at the end of August, so the monitoring stations had to be removed earlier in 2020 than previous years. Substrates AIS 2 & 3 were removed for the season on August 22, while AIS 1 remained until it was removed on August 27th. All pots, buoys, rope, and cinder blocks were inspected for the presence of zebra mussels.

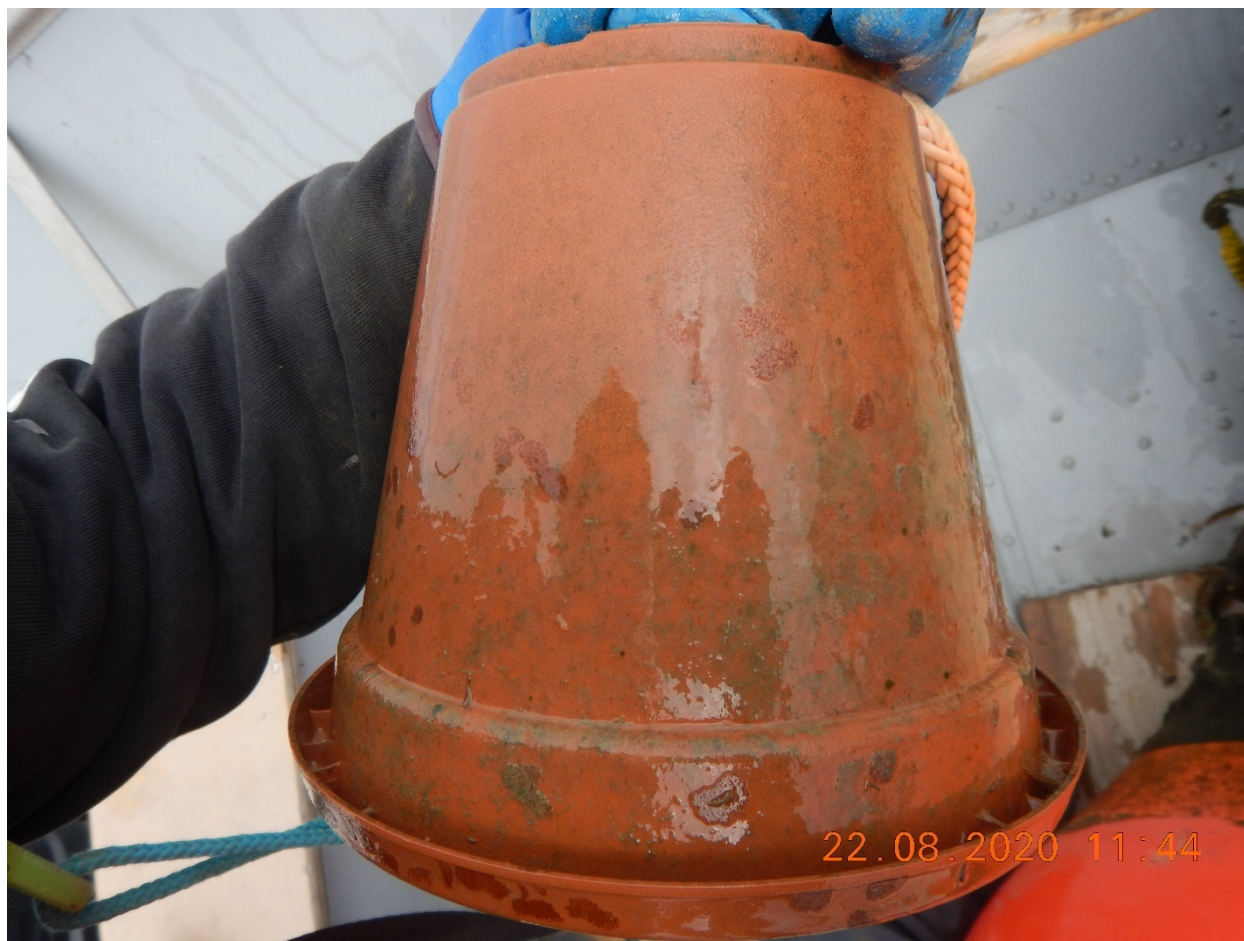
Three pots from the monitoring stations were sent to an external laboratory for analysis and a mature zebra mussel count. The pots sent in were from AIS 2 (top pot), shown in Figure 6, AIS 2 (middle), and AIS 3 (bottom); the zebra mussel counts were 8, 15, and 14 respectively.

Figure 6: Photo of monitoring substrate after removal on August 22, 2020. This pot sat at a depth of 1 m from the surface at AIS 2 and was sent to ALS labs. Eight adult mussels were identified.

All mussels on the remaining hardware and rope were removed and disposed of. The rope itself was also disposed of. The hardware was left outside over the winter to freeze to kill off any remaining mussels that were not visible, if any. The remaining pots were wrapped in plastic bags and placed in a freezer in the event further analysis was required.

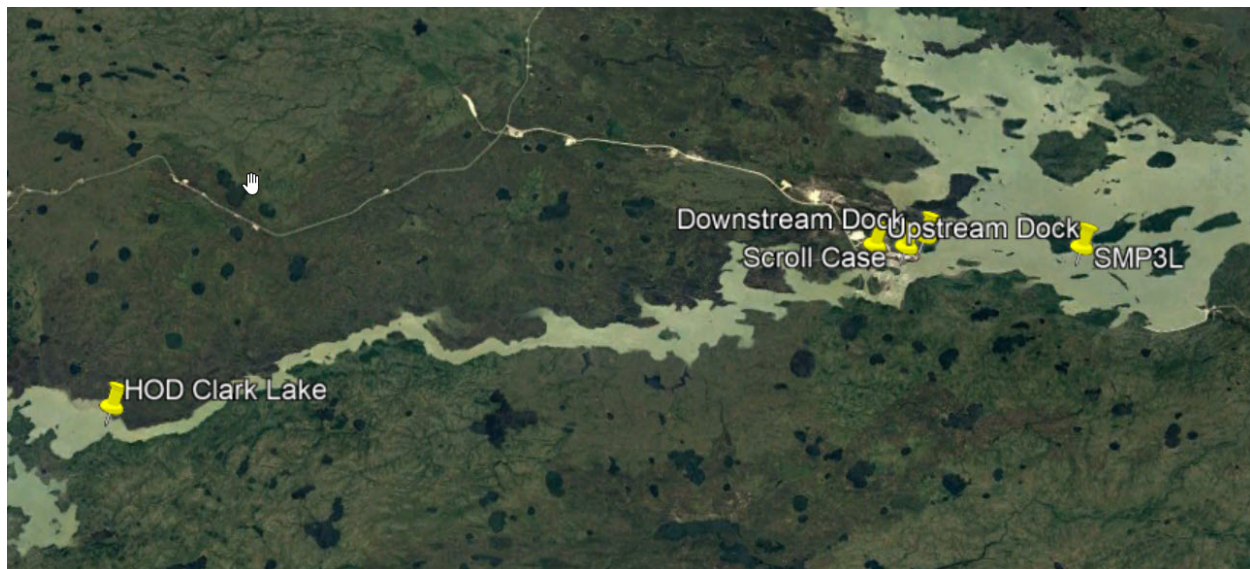
Adult zebra mussels were found within the Powerhouse and submerged infrastructure around the project site (Figure 7). Table 2 lists where and when these findings occurred. Mussels were found attached to anchors and hardware used for water quality instruments (Figure 8 & Figure 9), on the underside of docks (Figure 10), and within the Keeyask Powerhouse itself (Figure 11).

Figure 7: Map of incidental findings of adult zebra mussels in and around the Keeyask Project Site.

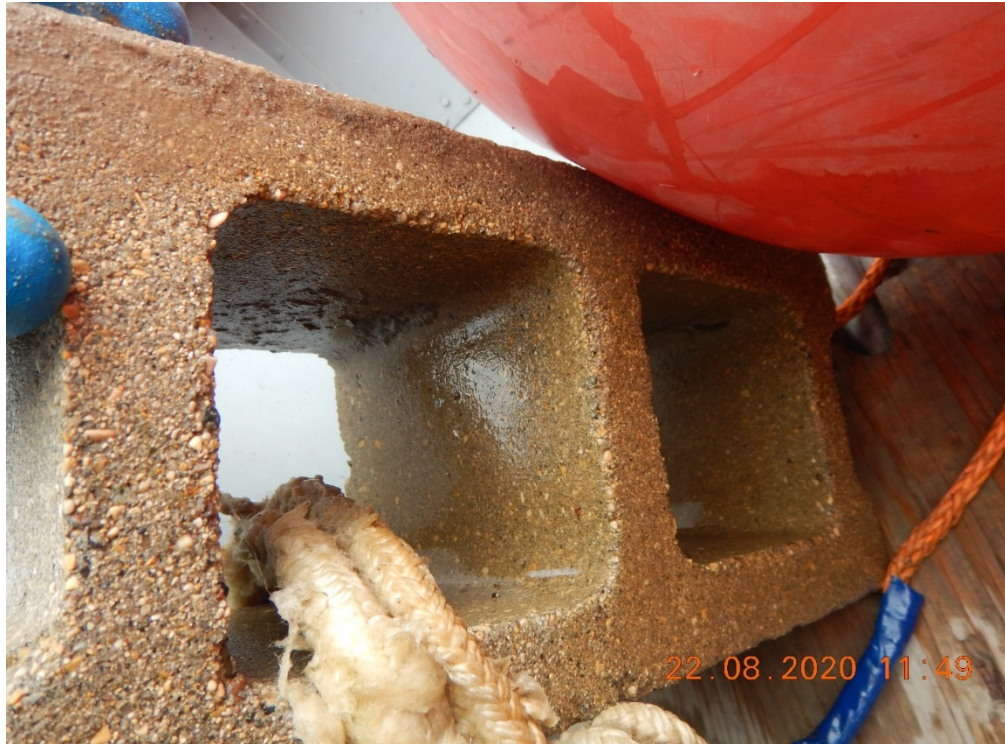
Figure 8: This substrate anchor held AIS 2 in place and was removed from the water on August 22, 2020. Zebra mussels were found attached to it.

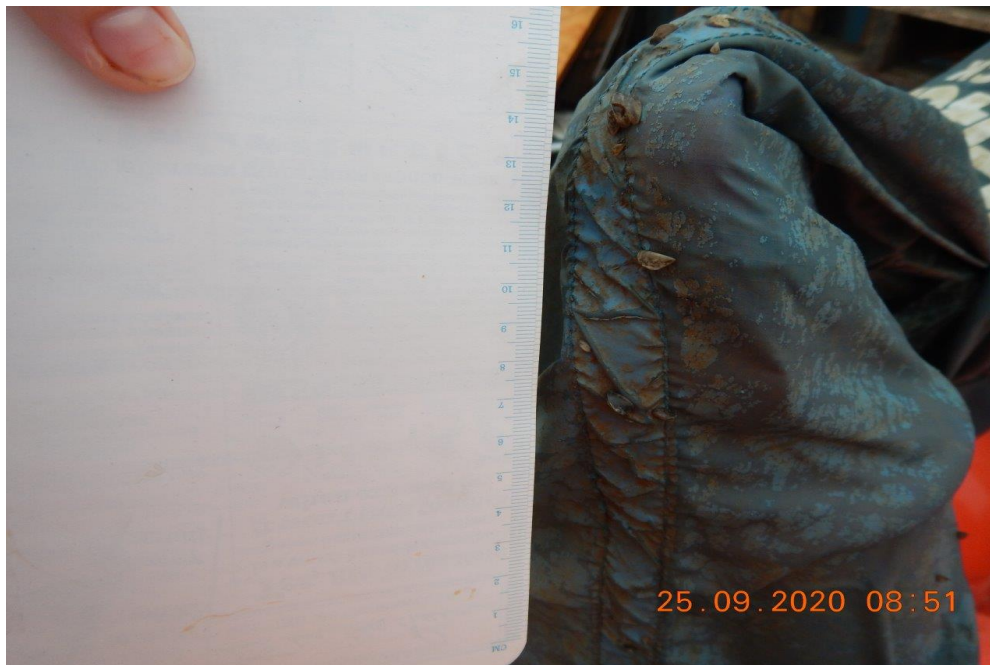
Figure 9: Zebra Mussels colonized a drift sock used at sediment water quality monitoring station located in Stephens Lake. The drift sock is suspended on the anchor line in about 5m of water in the river flow. September 25, 2020.

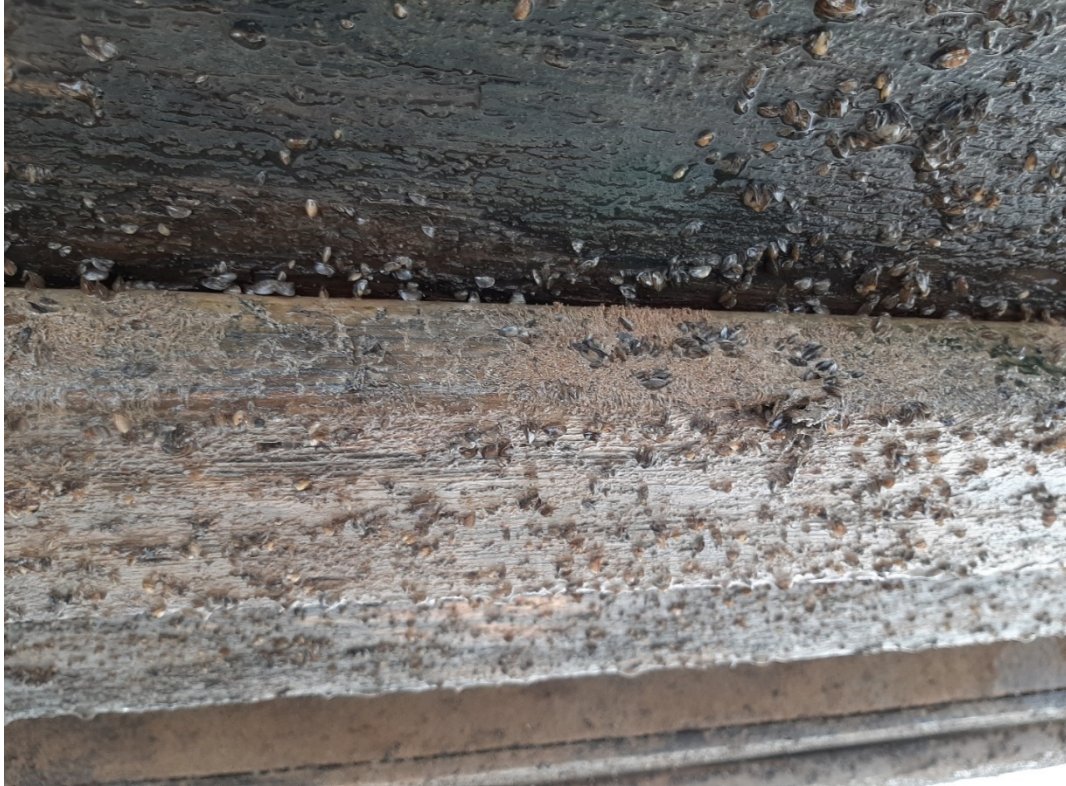
Figure 10: Zebra mussel colony found on the underside of a downstream dock following removal of the dock for the winter. October 22, 2020.

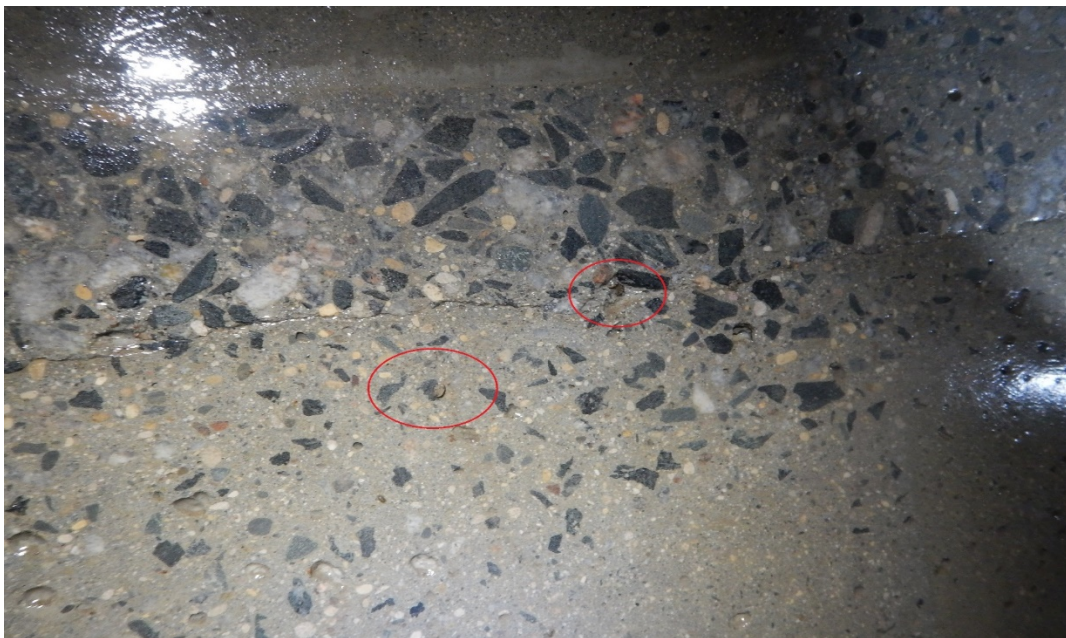
Figure 11: Following dewatering of the Keeyask Unit 1 Scroll case in the Powerhouse, some adult mussels (circled) were located on the concrete of the inner walls. November 28, 2020.

Now that zebra mussels are present at Keeyask, monitoring will take place in 2021 to detect growth upstream, within the reservoir and downstream to measure the change through the Keeyask area.
