## Keeyask Generation Project Aquatic Effects Monitoring Plan

# Juvenile Lake Sturgeon Movement Monitoring Report

AEMP-2022-02

### **JUVENILE LAKE STURGEON MOVEMENT MONITORING IN THE NELSON RIVER BETWEEN CLARK LAKE AND THE LIMESTONE GENERATING STATION, SEPTEMBER 2020 TO OCTOBER 2021: YEAR 8 CONSTRUCTION**

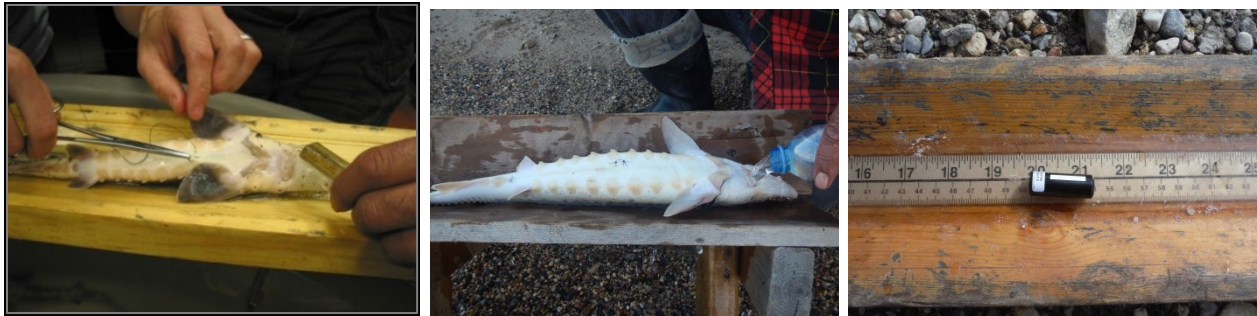
**Surgery on a juvenile Lake Sturgeon (left and middle) to implant an acoustic tag (right).**

The movements of juvenile sturgeon were tracked using acoustic telemetry. This is a technique in which a tag is surgically implanted inside a fish. The tag emits a sound signal (called a “ping”) that is picked up by receivers placed along the Nelson River between Clark Lake and the Limestone GS (see study area map above). Each fish is given a tag that transmits a unique ping which can be detected up to 1 km away from a receiver. By looking at the detections that were recorded by different receivers, the movement of each fish can be tracked. The tags are powered by batteries with a four-year lifespan.

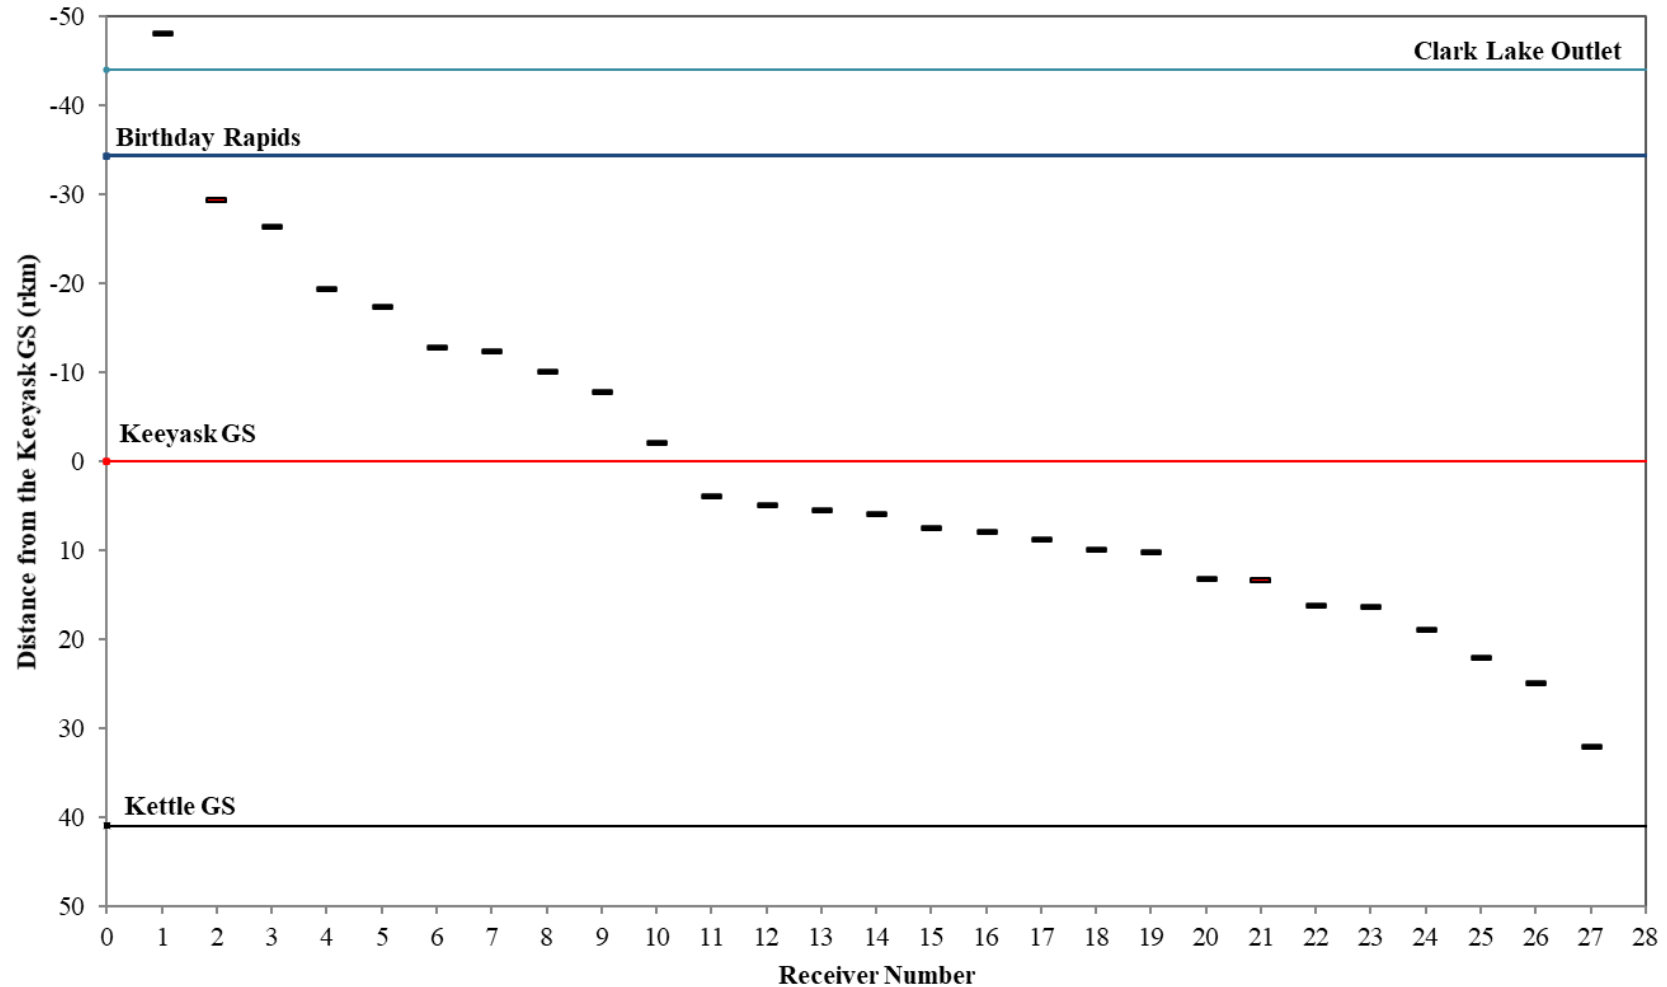
**Figure 1:** Locations of stationary acoustic receivers (dashes) in relation to the base of the Keeyask GS (rkm 0) and other major landmarks (lines) in the Nelson River between Clark Lake and the Kettle GS between October 2019 and May 2021.

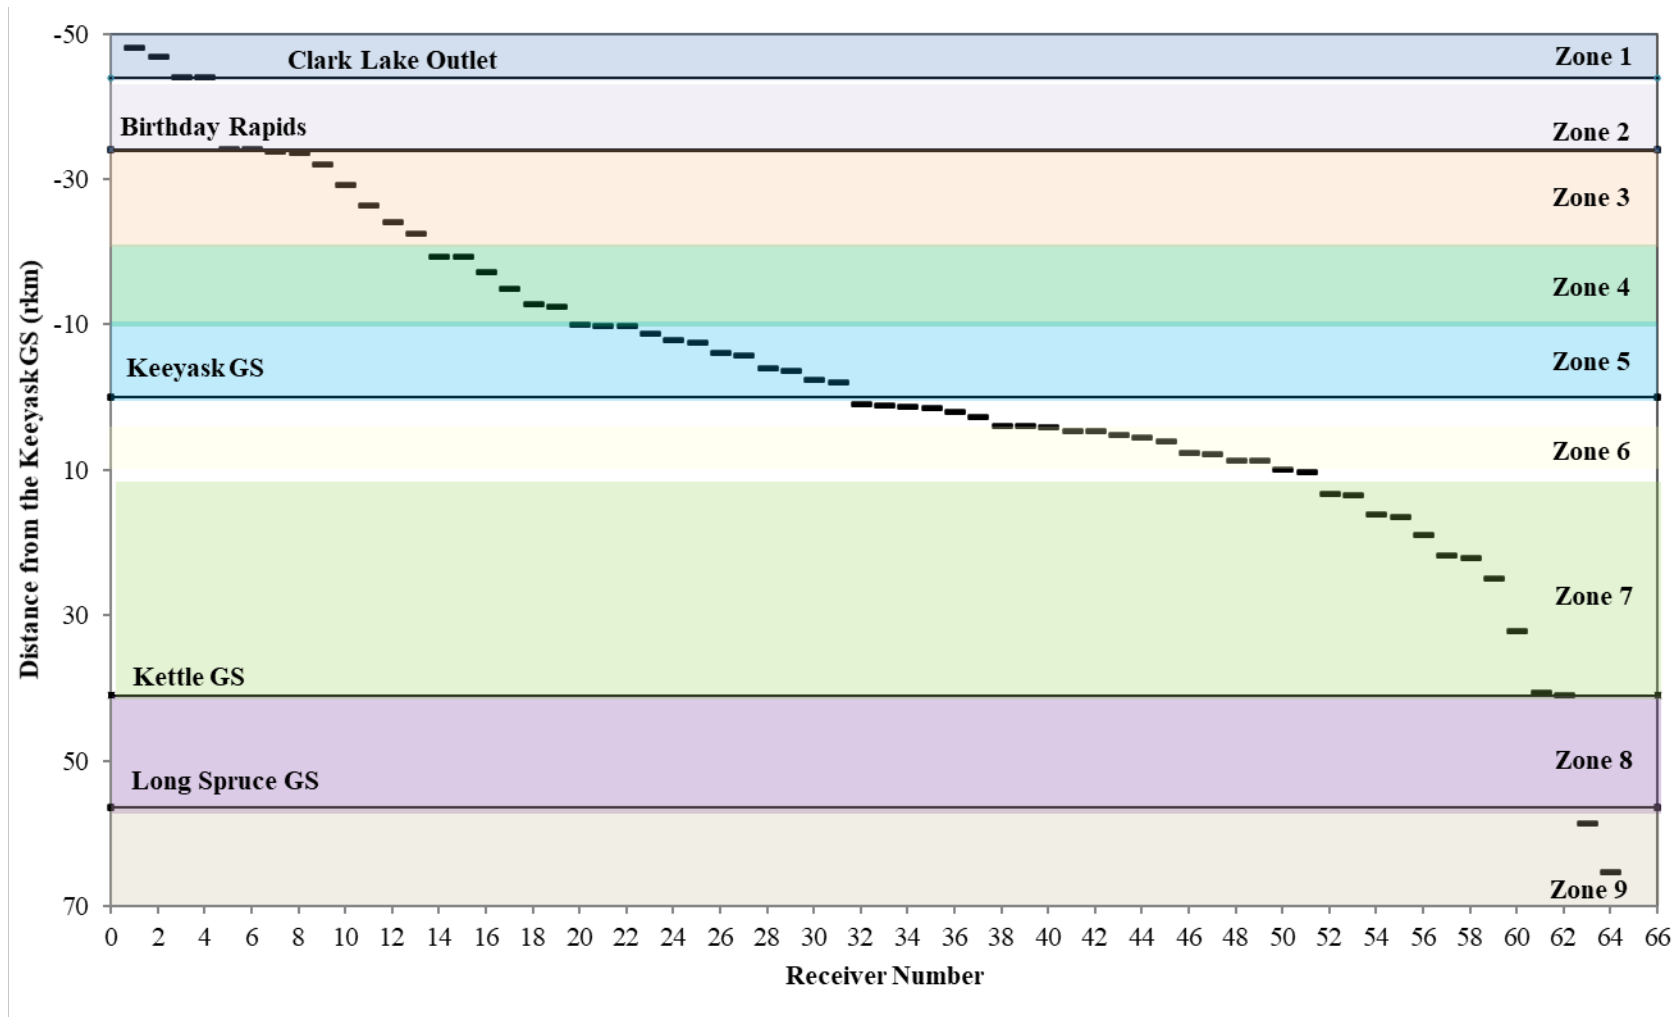
**Figure 2:** Locations of stationary acoustic receivers (dashes) in relation to the base of the Keeyask GS (rkm 0) and other major landmarks (lines) in the Nelson River between Clark Lake (Zone 1) and the Limestone GS (Zone 9) between May and October 2021. River zones are indicated by different colours.

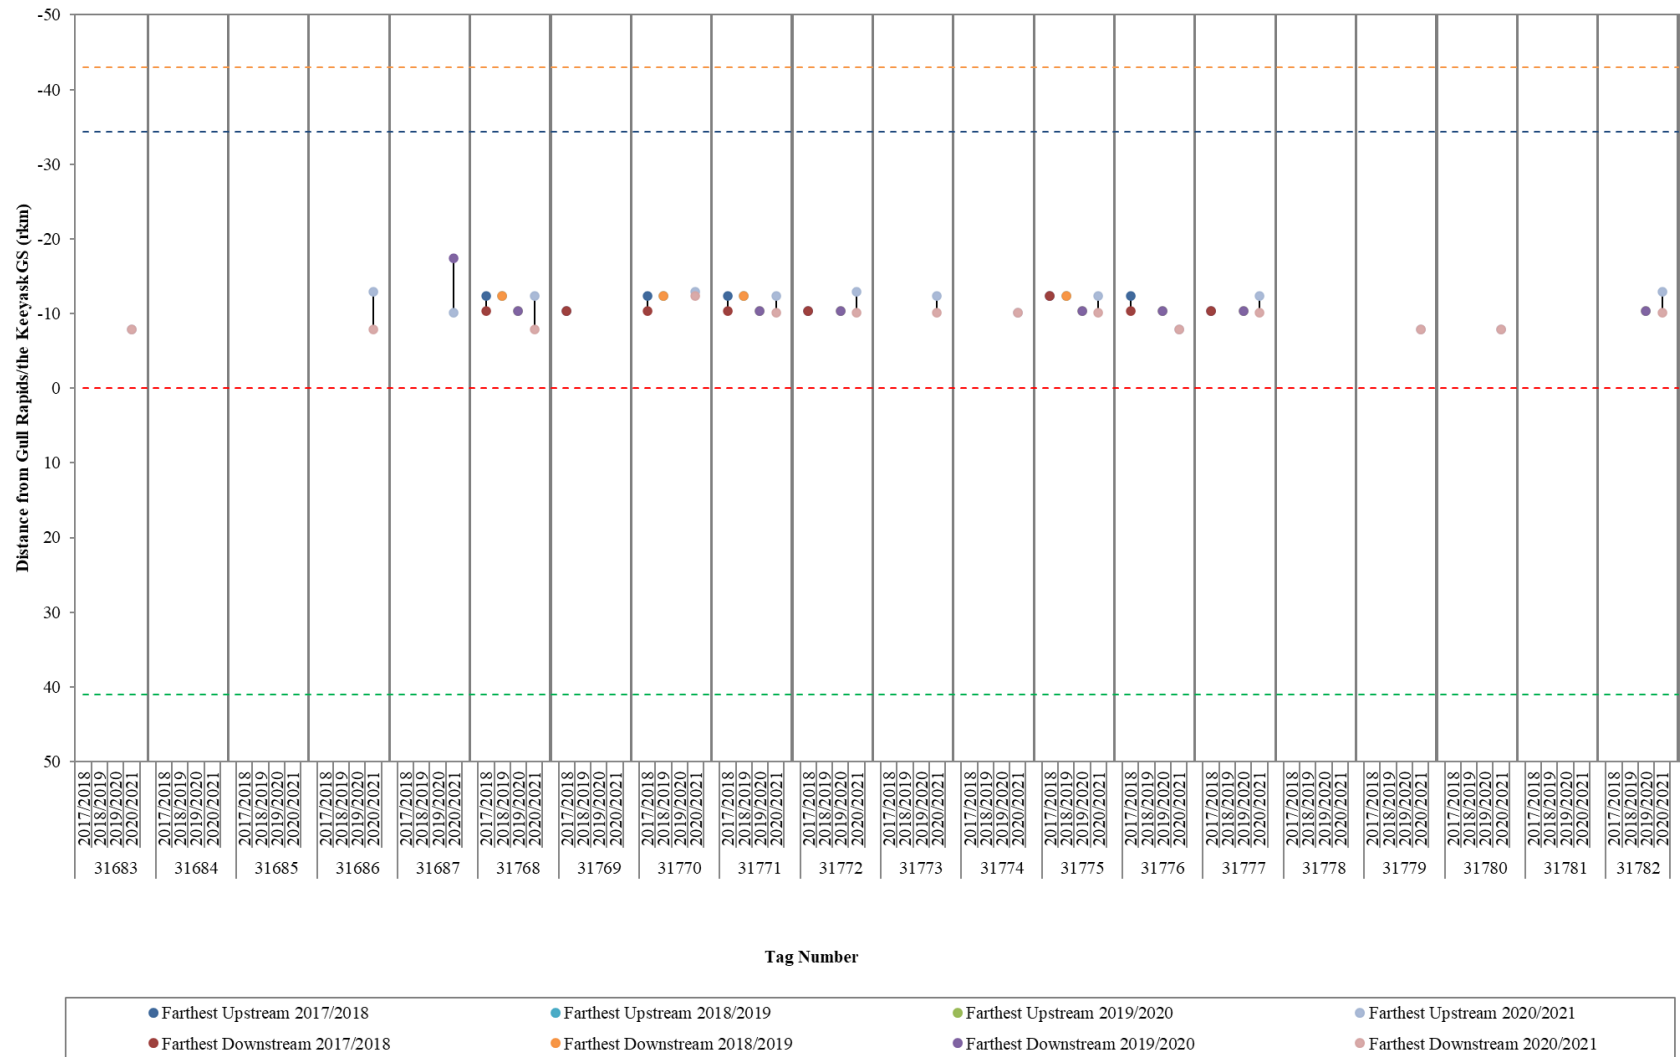
**Figure 3: Detection ranges for acoustic tagged juvenile Lake Sturgeon detected between Clark Lake and the Keeyask GS during the winter period (2017–2021). Horizontal dotted lines indicate locations of landmarks (orange = Clark Lake outlet; blue = Birthday Rapids, red = the Keeyask GS; green = Kettle GS).**

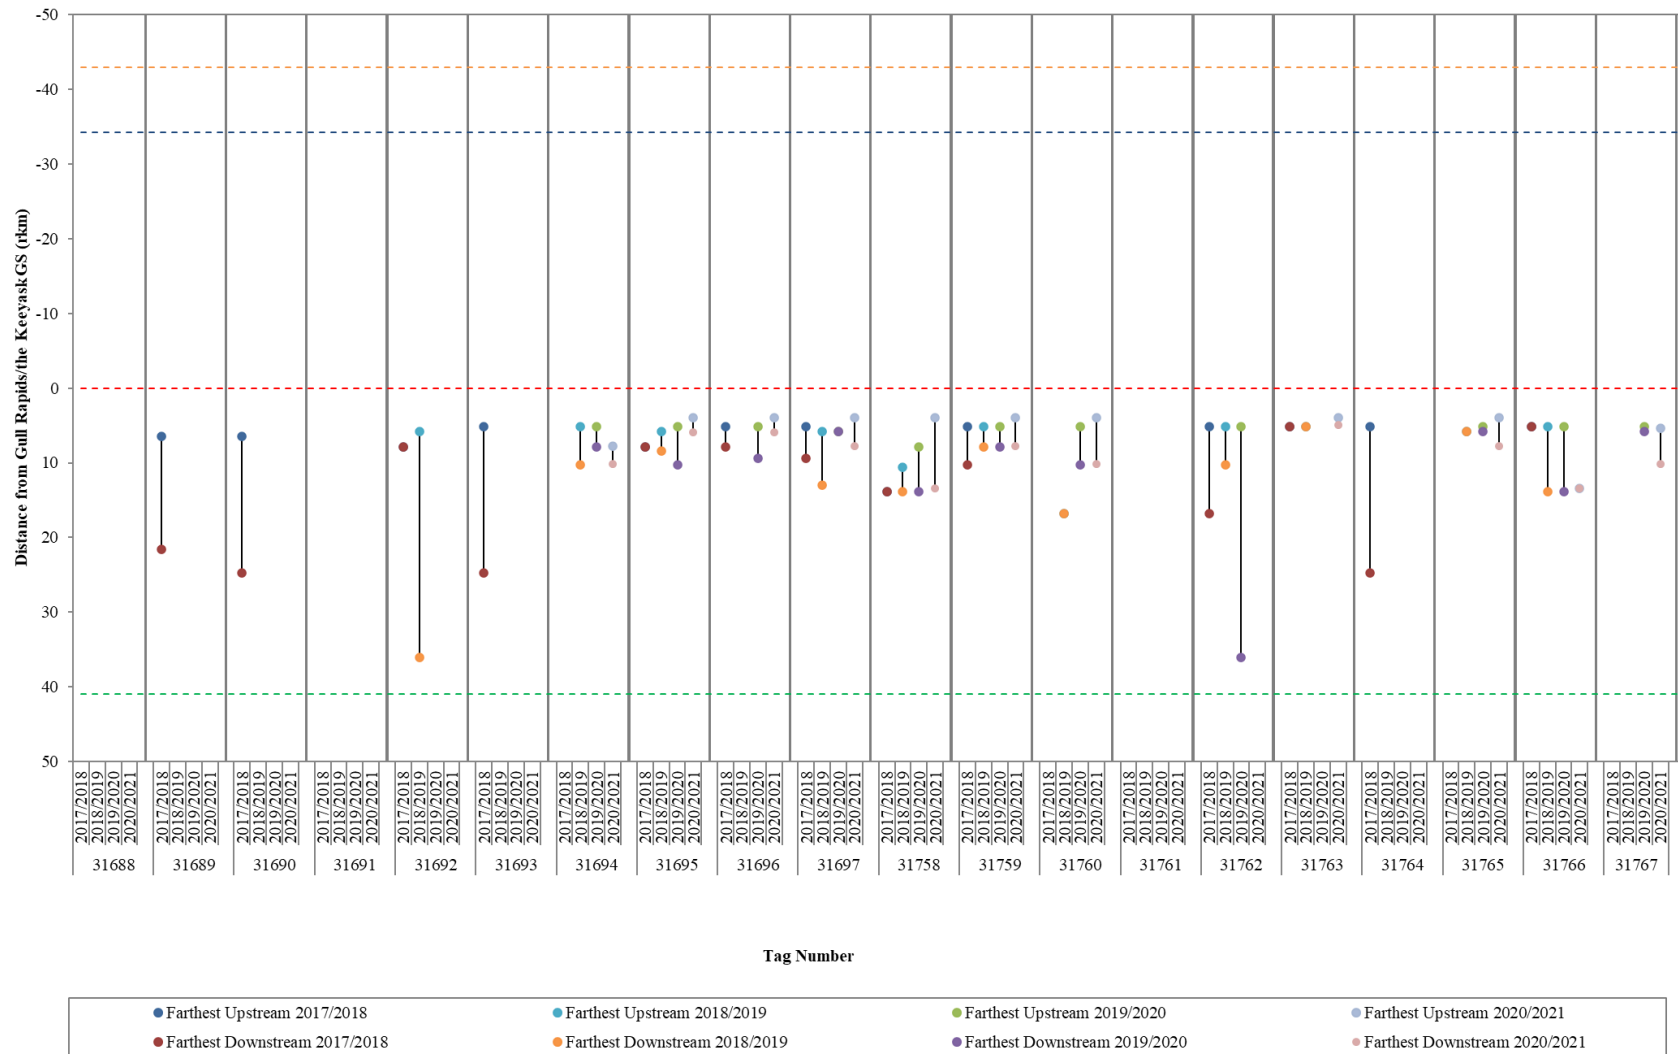
**Figure 5: Detection ranges for acoustic tagged juvenile Lake Sturgeon detected in Stephens Lake during the winter period (2017–2021). Horizontal dotted lines indicate locations of landmarks (orange = Clark Lake outlet; blue = Birthday Rapids, red = the Keeyask GS; green = Kettle GS).**

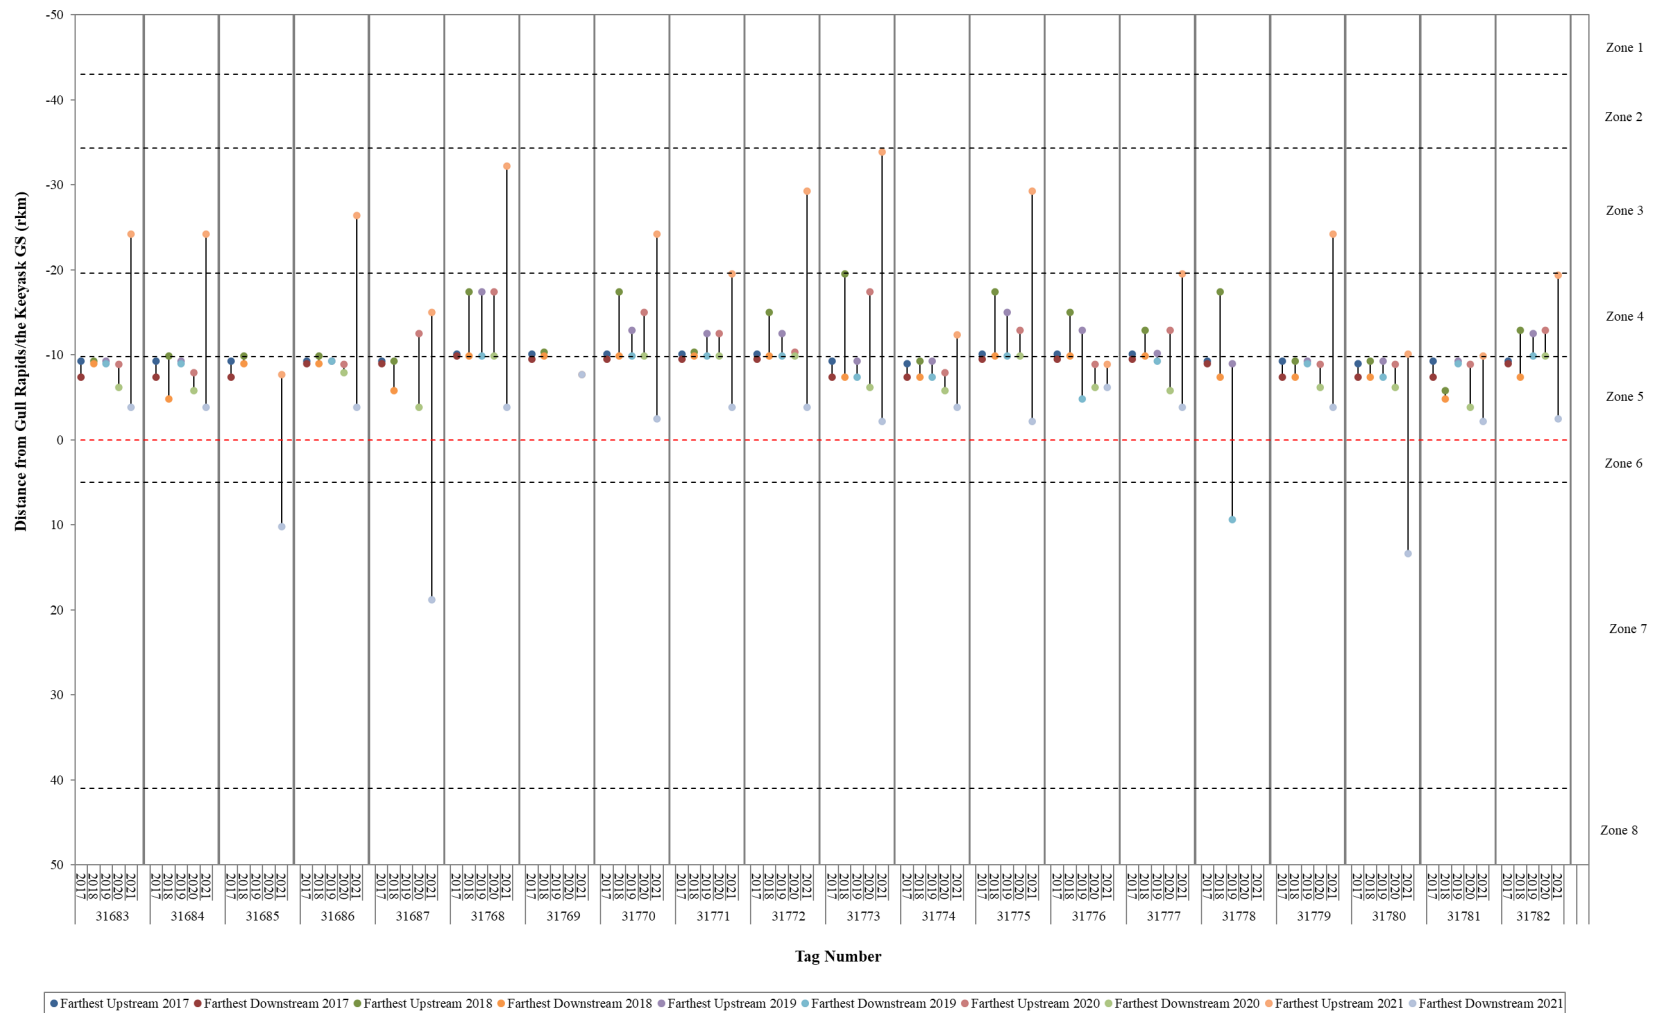
**Figure 7: Detection ranges for individual juvenile Lake Sturgeon tagged with acoustic transmitters upstream of Gull Rapids/the Keyyask GS during the open-water period (2017–2021). Horizontal dotted lines demarcate zones with the red line representing the Keyyask GS.**

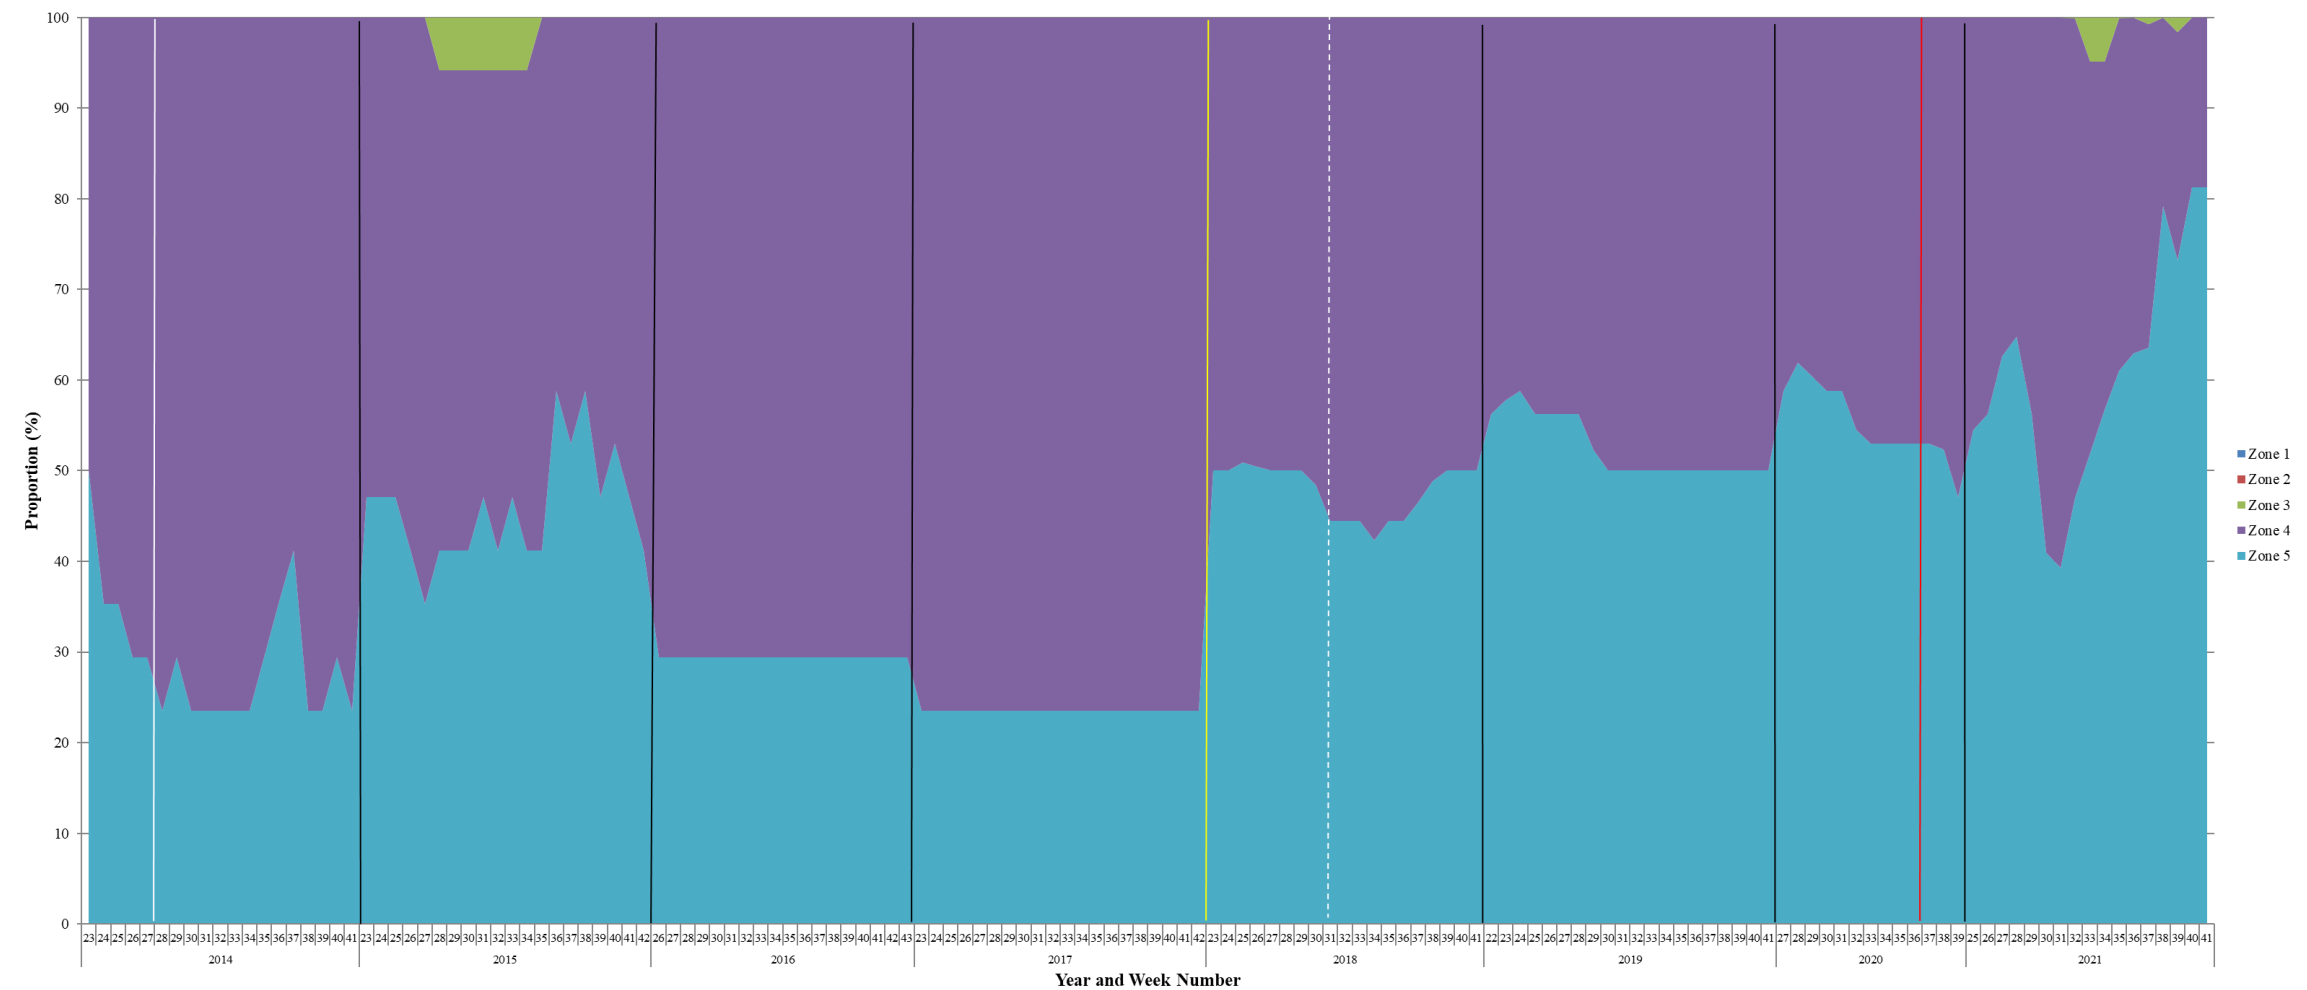
**Figure 9:** Proportional distribution by zone per week for juvenile Lake Sturgeon between Clark Lake and Gull Rapids/the Keeyask GS during a portion of the open-water periods of 2014 (June 4 to October 10), 2015 (June 4 to October 11), 2016 (June 25 to October 19), 2017 (June 7 to October 16), 2018 (June 6 to October 10), 2019 (June 2 to October 7), 2020 (July 3 to September 23), and 2021 (June 13 to October 10). White solid line indicates start of construction while white dashed line indicates start of spillway operation and red solid line indicates completion of reservoir impoundment. Yellow solid line indicates when tags expired, and new fish were tagged.

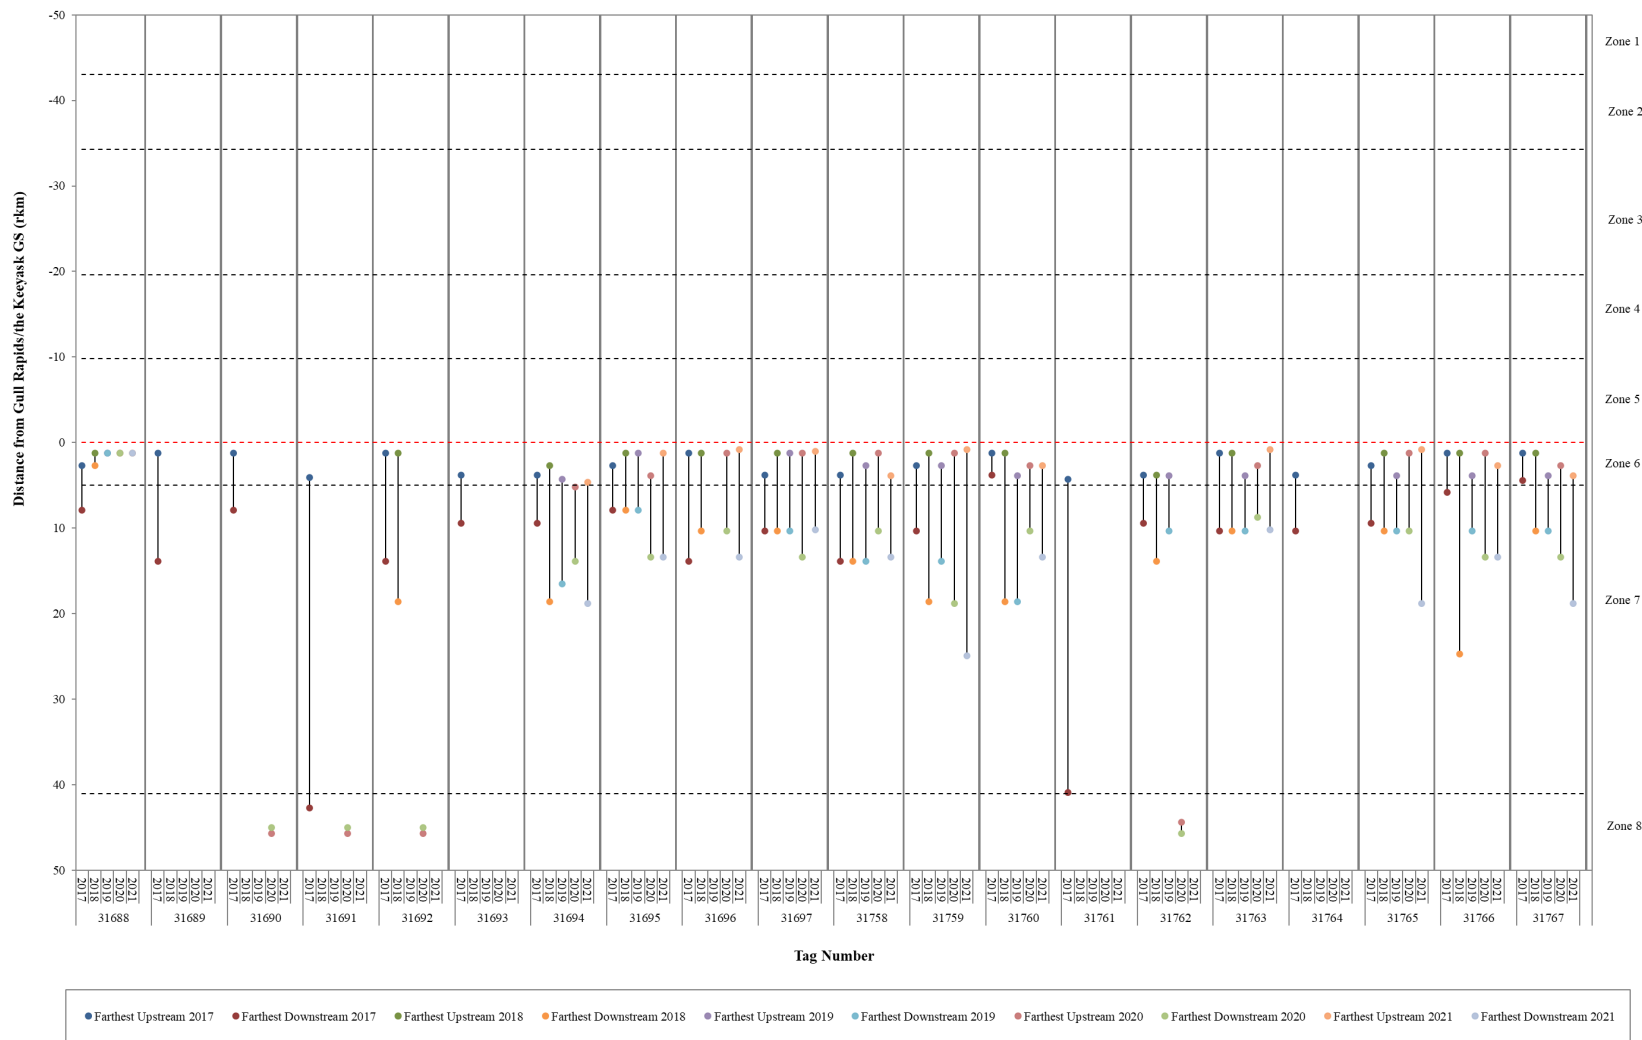
**Figure 10: Detection ranges for acoustic tagged juvenile Lake Sturgeon in Stephens Lake during the open-water periods of 2017–2021. Horizontal dotted lines demarcate zones with the red line representing the Keeyask GS.**

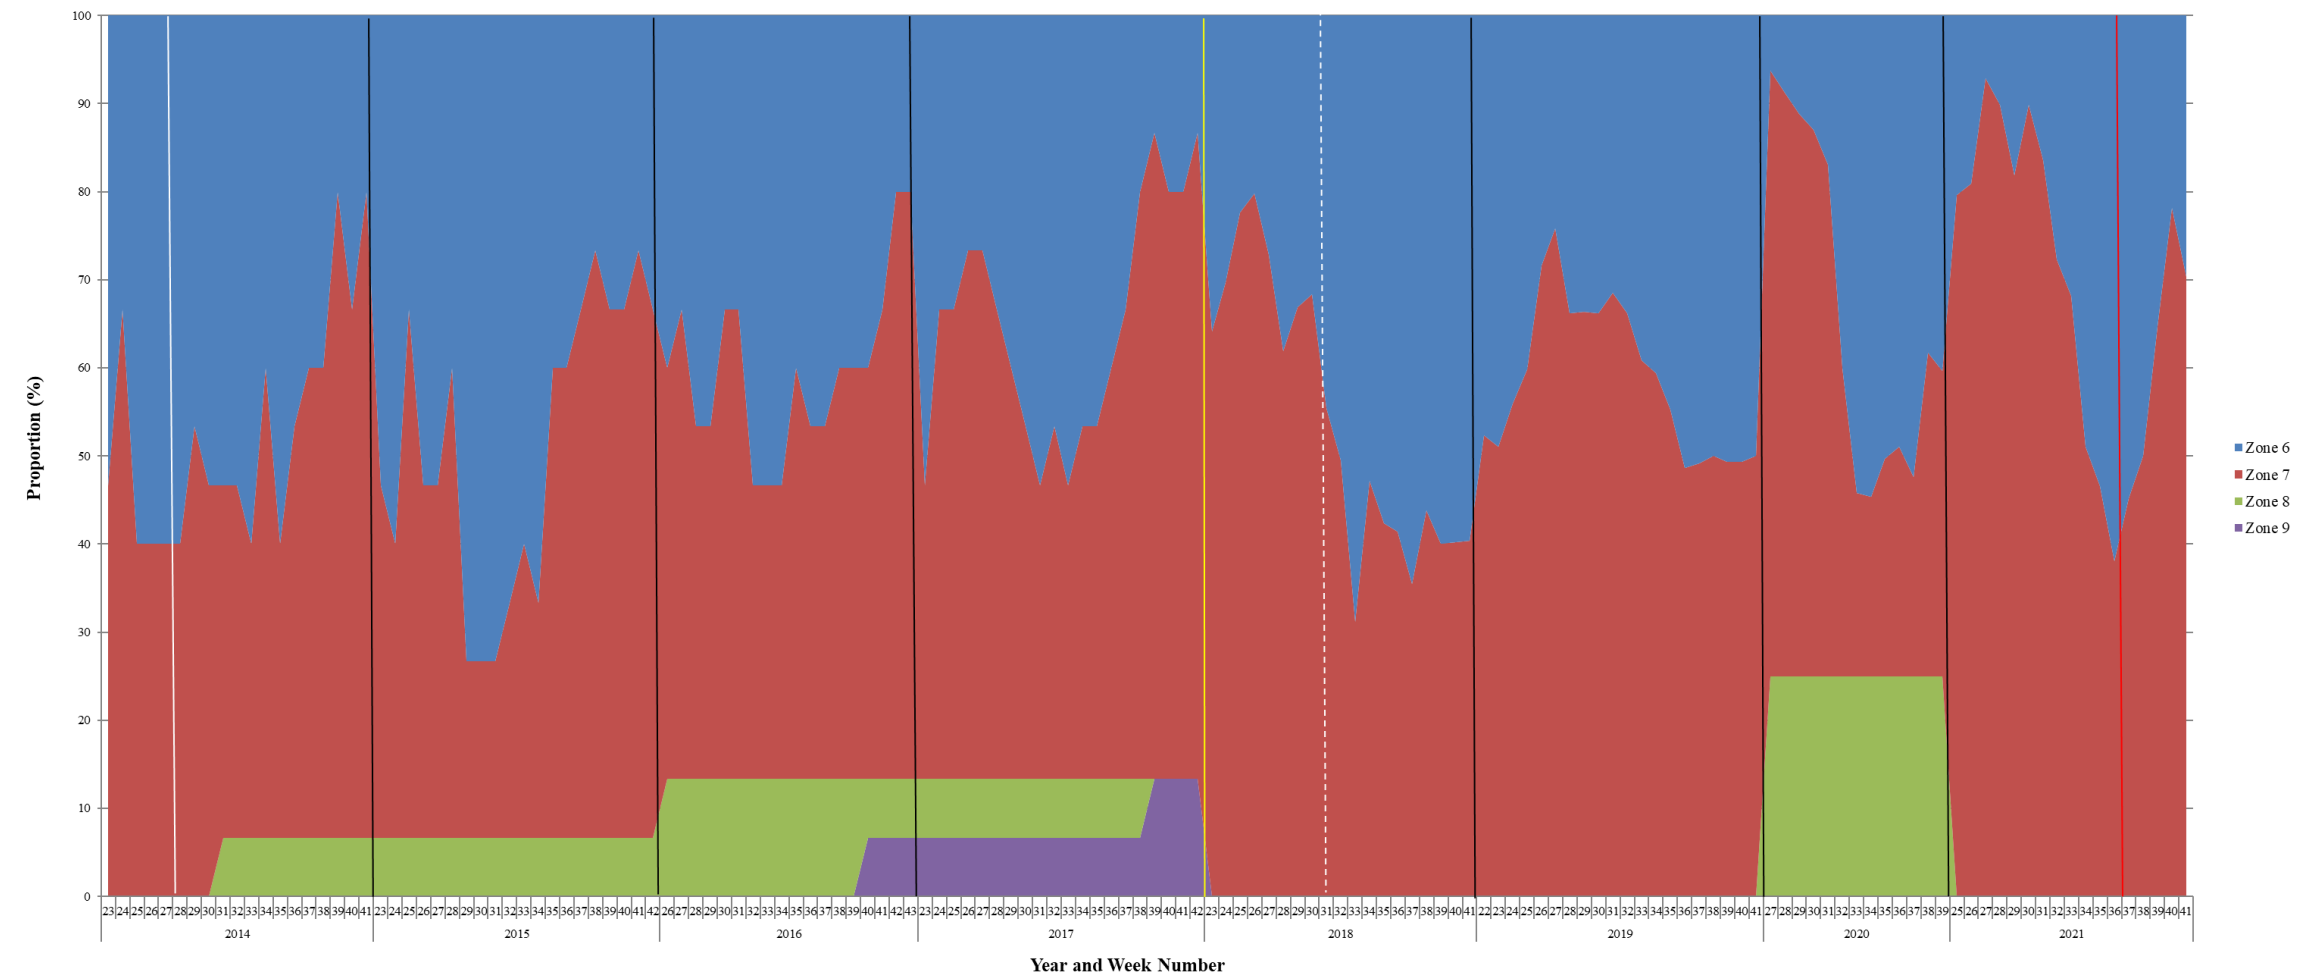
**Figure 12: Proportional distribution by zone per week for juvenile Lake Sturgeon downstream of Gull Rapids/the Keeyask GS during a portion of the open-water periods of 2014 (June 4 to October 10), 2015 (June 4 to October 11), 2016 (June 25 to October 19), 2017 (June 7 to October 16), 2018 (June 6 to October 10), 2019 (June 2 to October 7), 2020 (July 3 to September 23), and 2021 (June 13 to October 10). White solid line indicates start of construction while white dashed line indicates start of spillway operation and red solid line indicates completion of reservoir impoundment. Yellow solid line indicates when tags expired, and new fish were tagged.**
