Keeyask Generation Project Aquatic Effects Monitoring Plan

Lake Whitefish Movement Monitoring Report

AEMP-2022-03

LAKE WHITEFISH MOVEMENT MONITORING IN THE NELSON RIVER BETWEEN CLARK LAKE AND THE LIMESTONE GENERATING STATION, SEPTEMBER 2020 TO OCTOBER 2021: YEAR 8 CONSTRUCTION

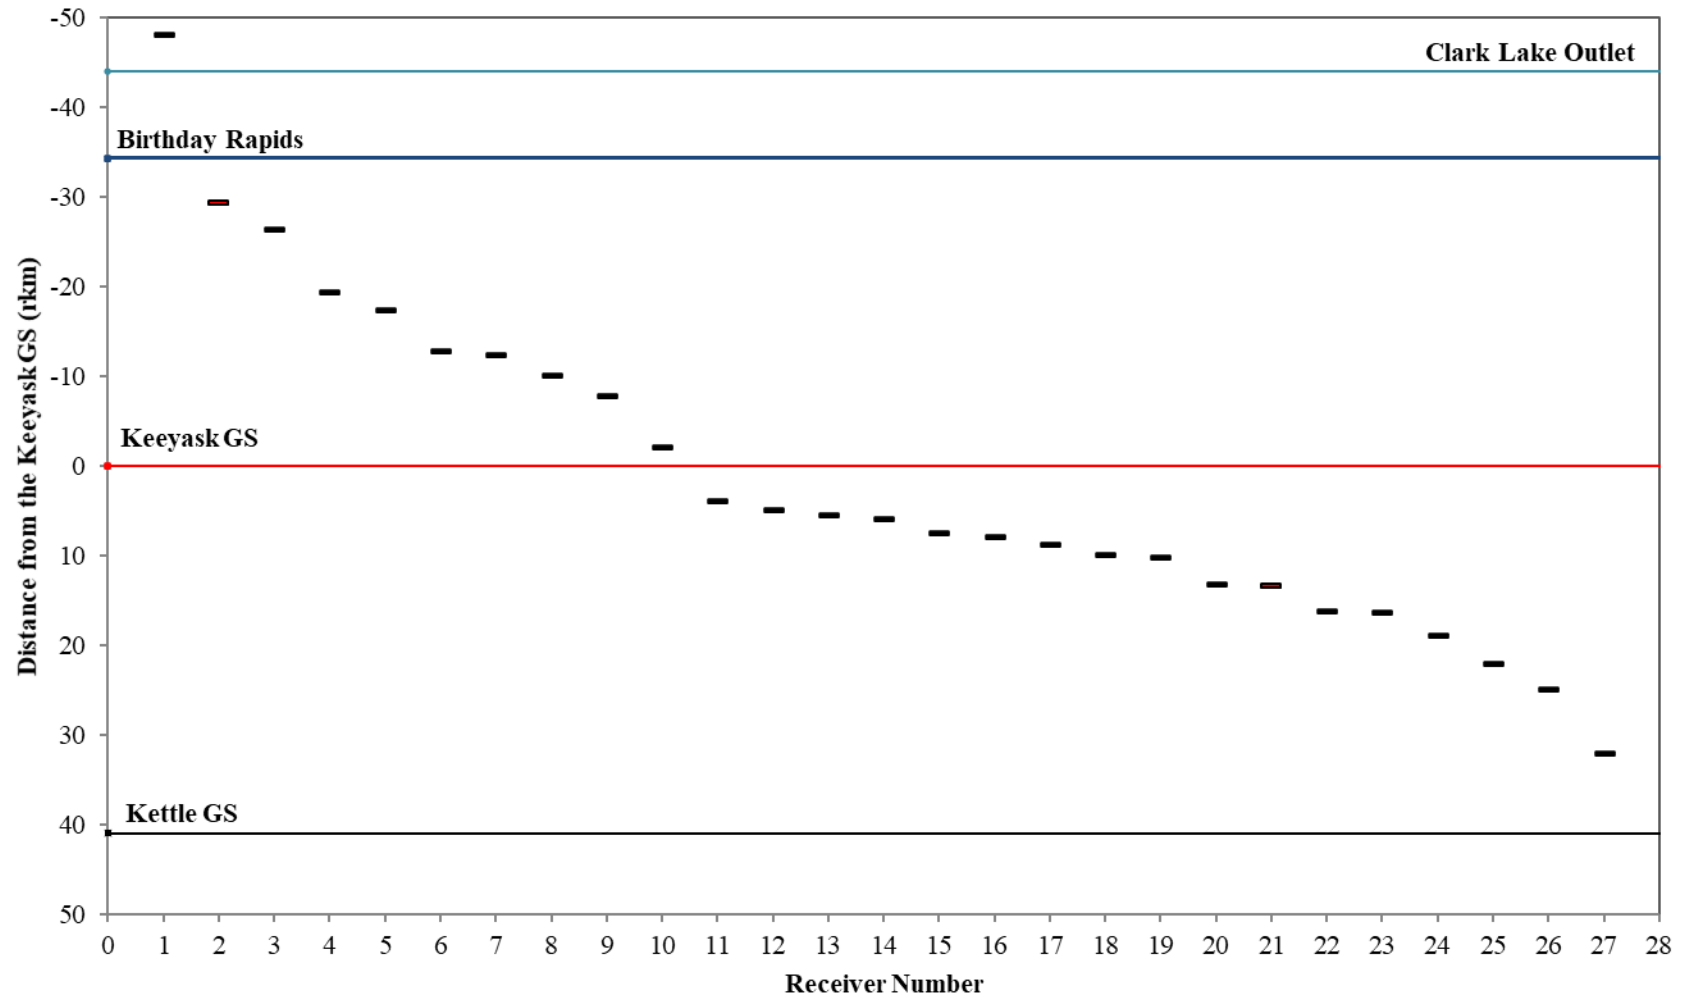
Figure 1: Locations of stationary acoustic receivers (dashes) in relation to the base of the Keeyask GS (rkm 0) and other major landmarks (lines) in the Nelson River between Clark Lake and the Limestone GS between September 2020 and May 2021. A red dash indicates a receiver that was lost.

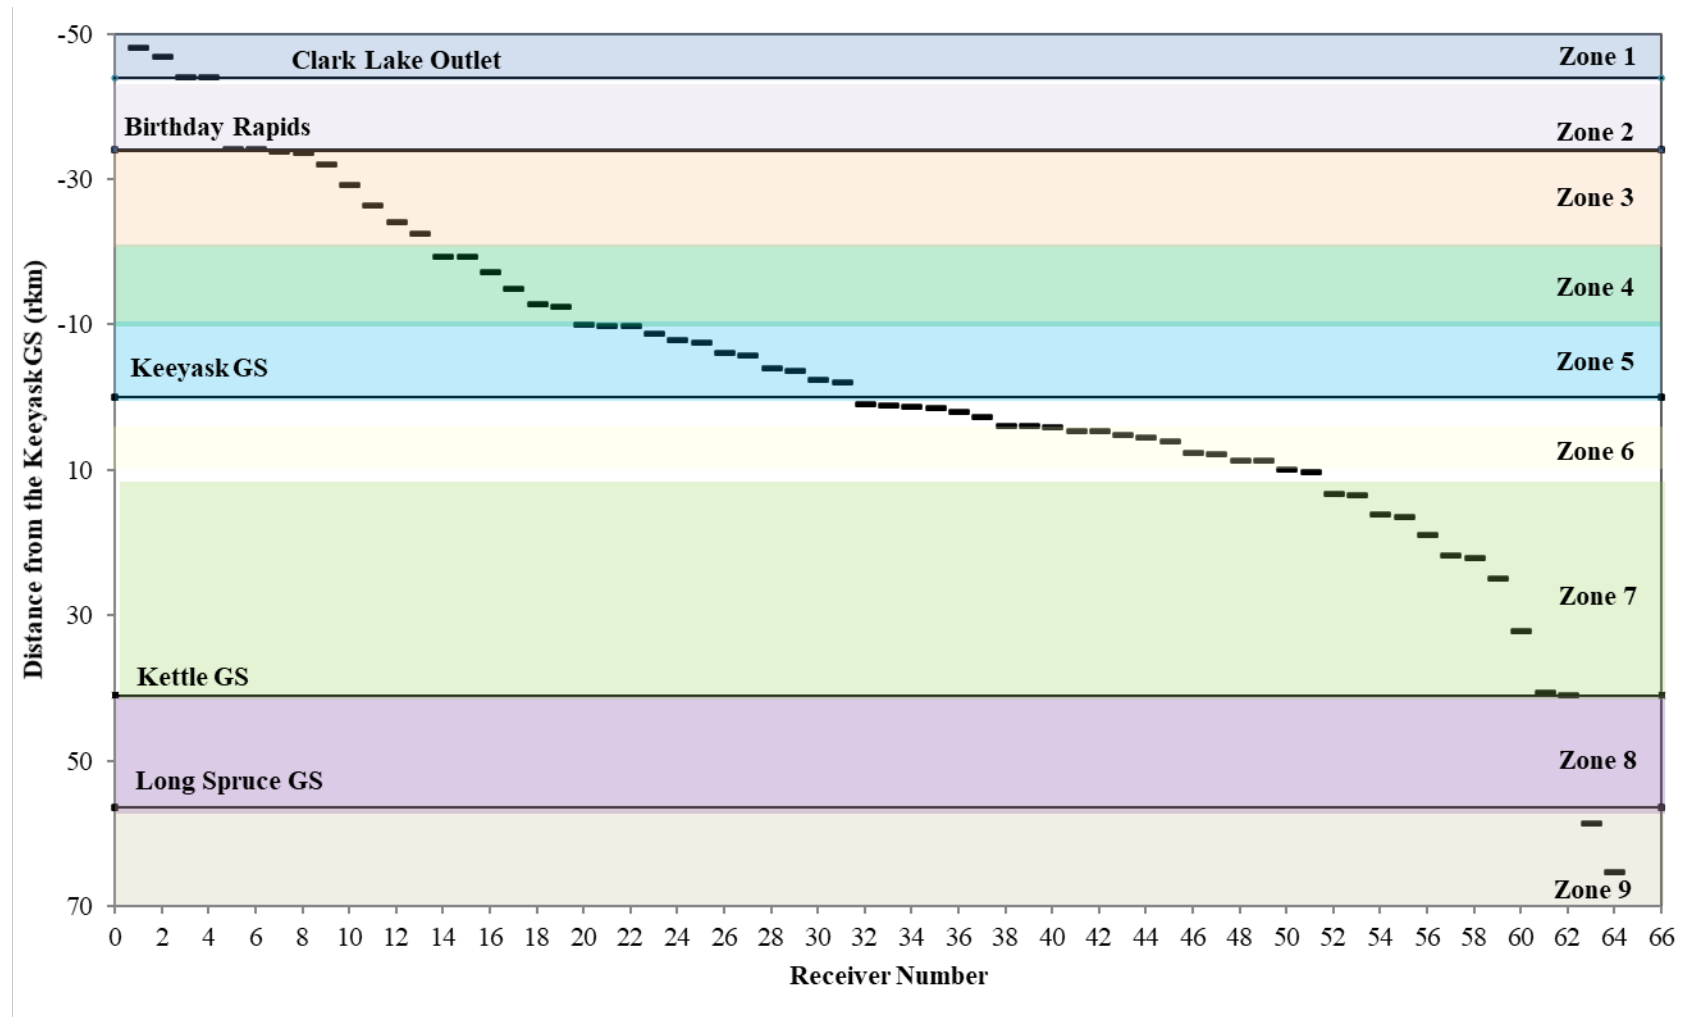
Figure 2: Locations of stationary acoustic receivers (dashes) in relation to the base of the Keeyask GS (rkm 0) and other major landmarks (lines) in the Nelson River between Clark Lake (Zone 1) and the Limestone GS (Zone 9) between June and October, 2021. River zones upstream and downstream of Gull Rapids are indicated by shading.

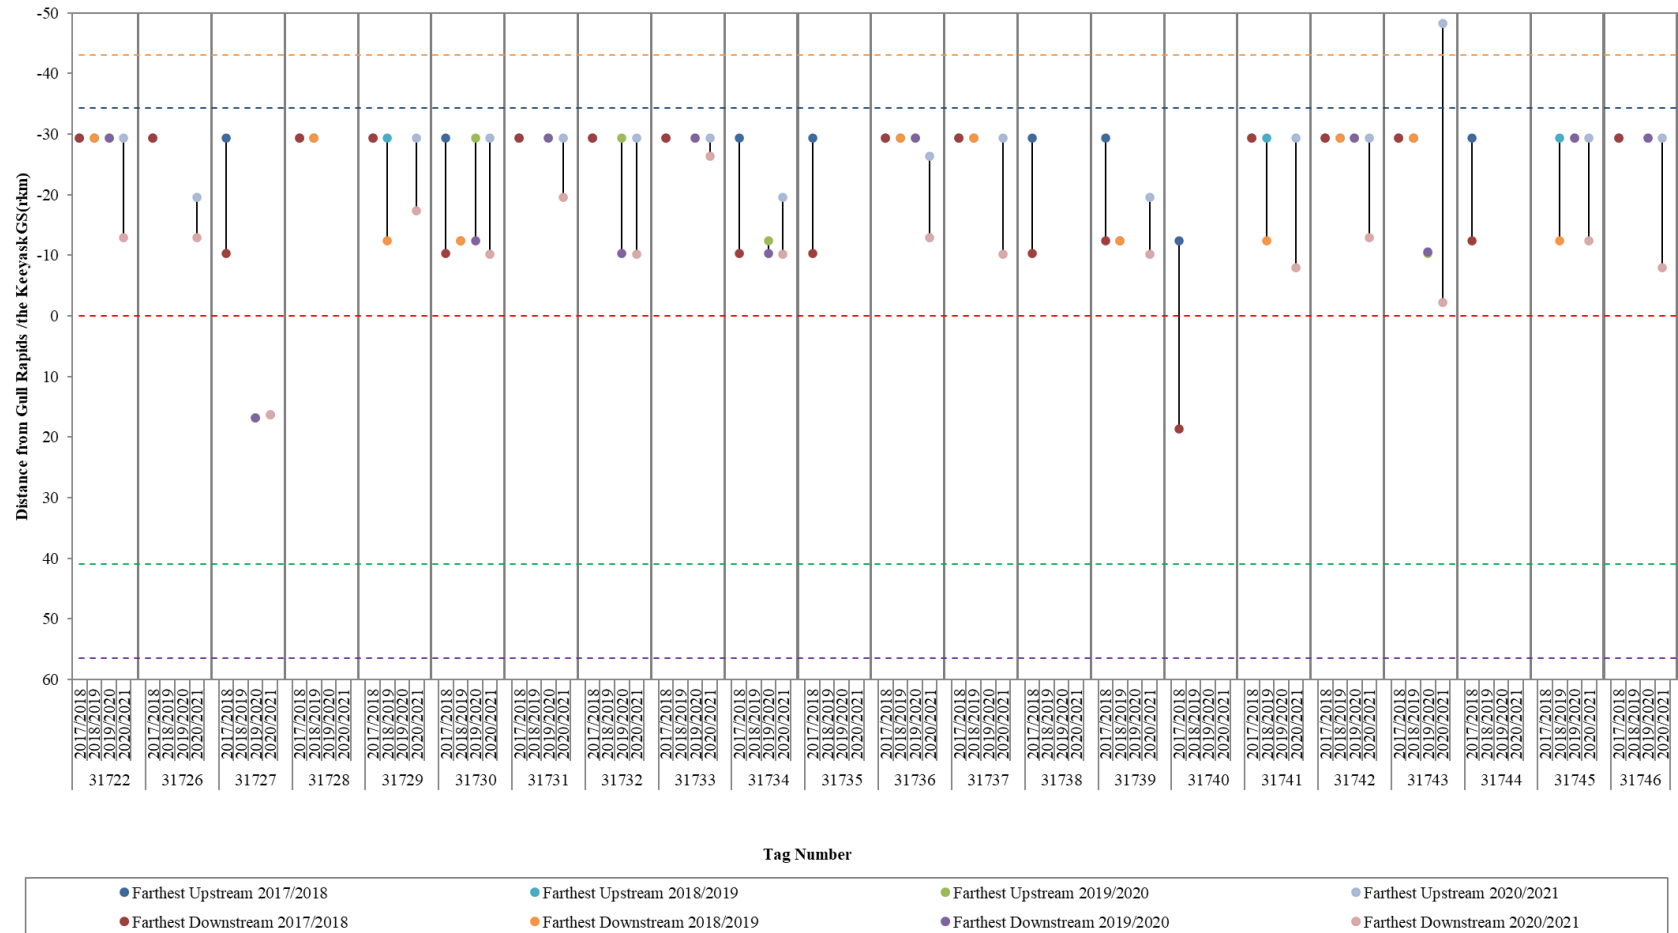
Figure 4: Detection ranges for individual Lake Whitefish (n = 22) tagged with acoustic transmitters upstream of the Keyyask GS during the 2017/2018 (October 17, 2017 to April 30, 2018), 2018/2019 (October 11, 2018 to April 30, 2019), 2019/2020 (October 8, 2019 to April 30, 2020), and 2020/2021 (September 24, 2020 to April 30, 2021) winter periods. Horizontal dotted lines indicate locations of landmarks (orange = Clark Lake outlet; blue = Birthday Rapids; red = Gull Rapids; green = Kettle GS; purple = Long Spruce GS).

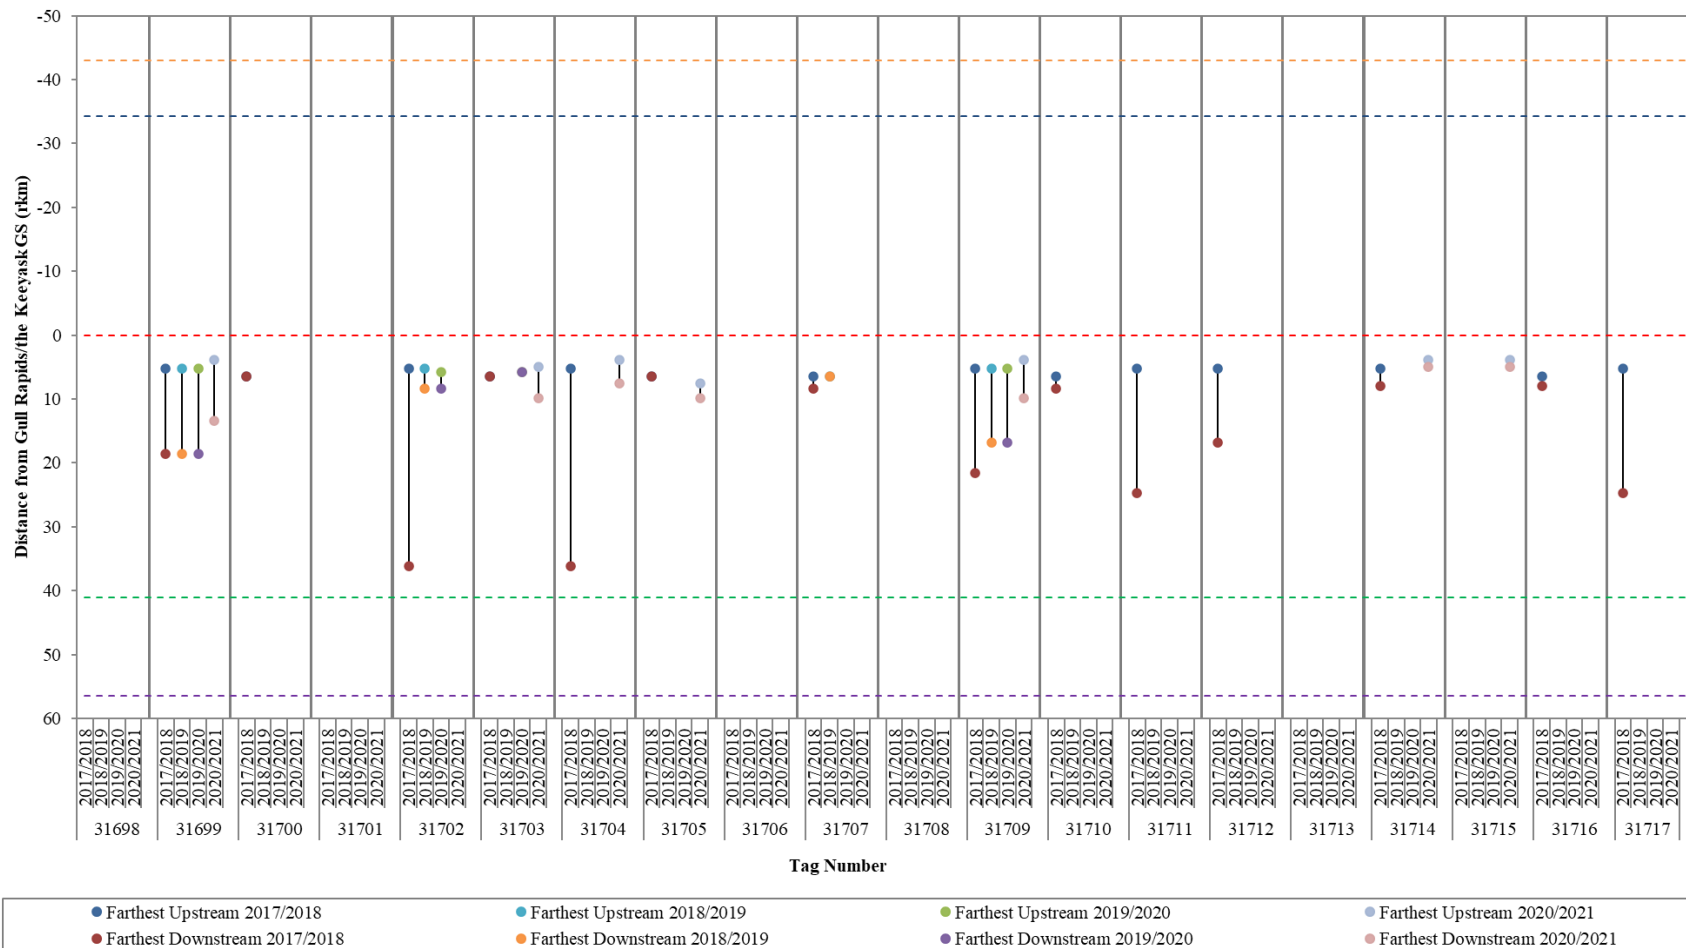
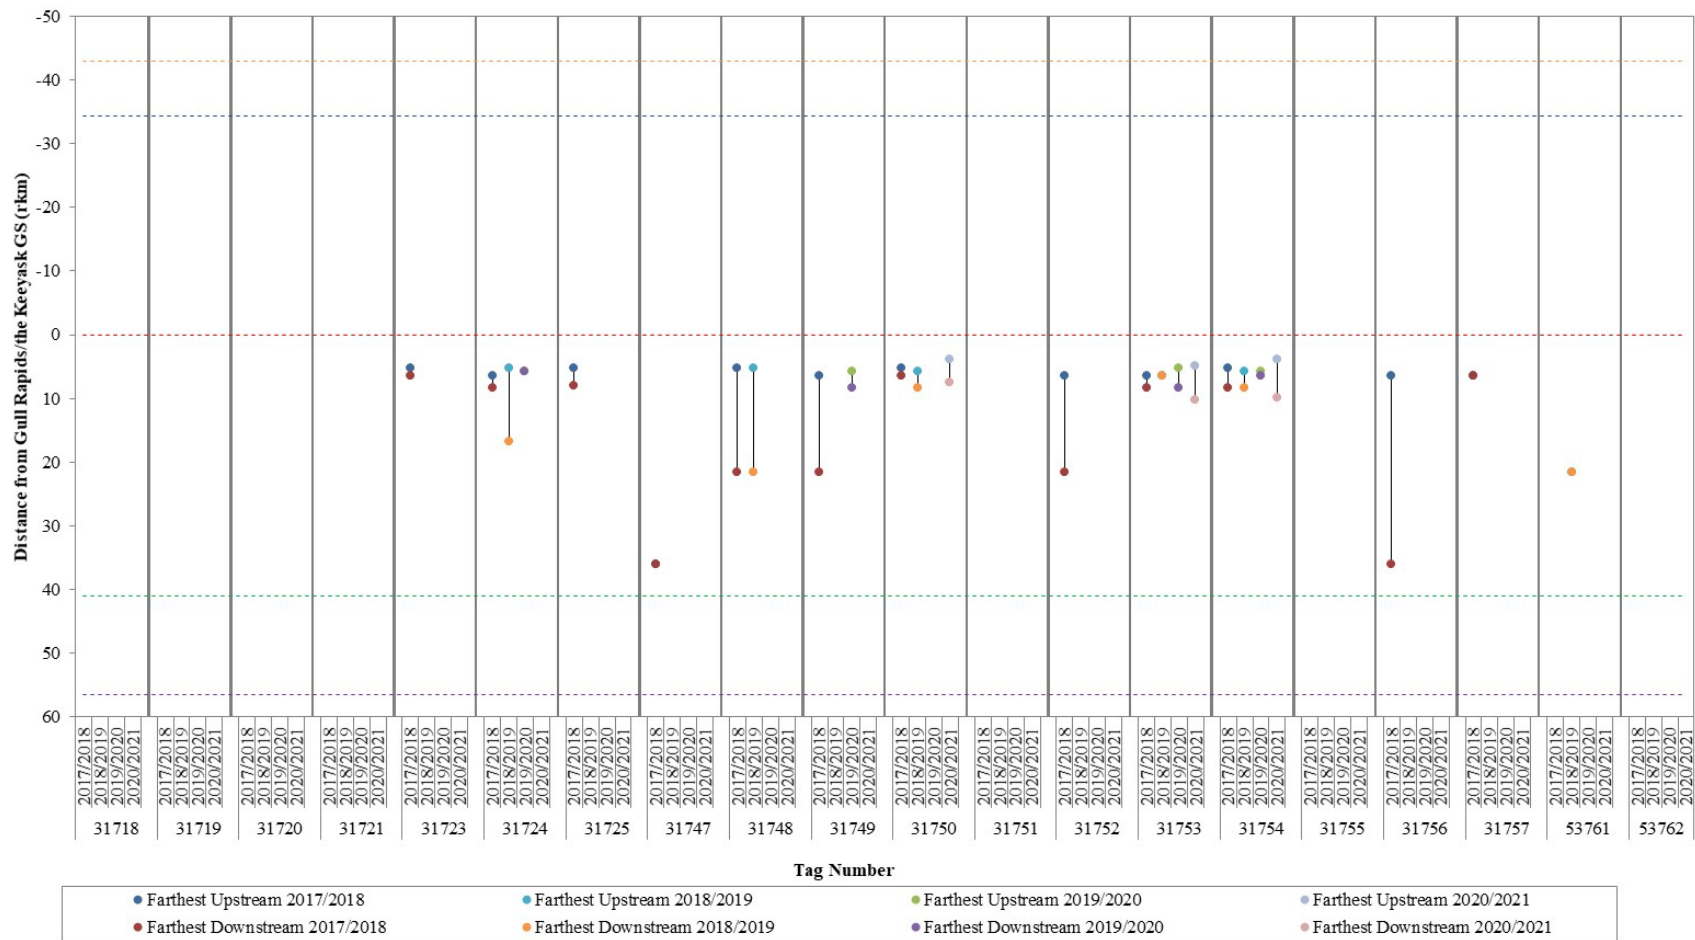
Figure 6: Detection ranges for individual Lake Whitefish (n = 40) tagged with acoustic transmitters in Stephens Lake during the 2017/2018 (October 17, 2017 to April 30, 2018), 2018/2019 (October 11, 2018 to April 30, 2019), 2019/2020 (October 8, 2019 to April 30, 2020), and 2020/2021 (September 24, 2020 to April 30, 2021) winter periods. Horizontal dotted lines indicate locations of landmarks (orange = Clark Lake outlet; blue = Birthday Rapids; red = Gull Rapids; green = Kettle GS; purple = Long Spruce GS).

Figure 6: Detection ranges for individual Lake Whitefish (n = 40) tagged with acoustic transmitters in Stephens Lake during the 2017/2018 (October 17, 2017 to April 30, 2018), 2018/2019 (October 11, 2018 to April 30, 2019), 2019/2020 (October 8, 2019 to April 30, 2020), and 2020/2021 (September 24, 2020 to April 30, 2021) winter periods. Horizontal dotted lines indicate locations of landmarks (orange = Clark Lake outlet; blue = Birthday Rapids; red = Gull Rapids; green = Kettle GS; purple = Long Spruce GS) (continued).

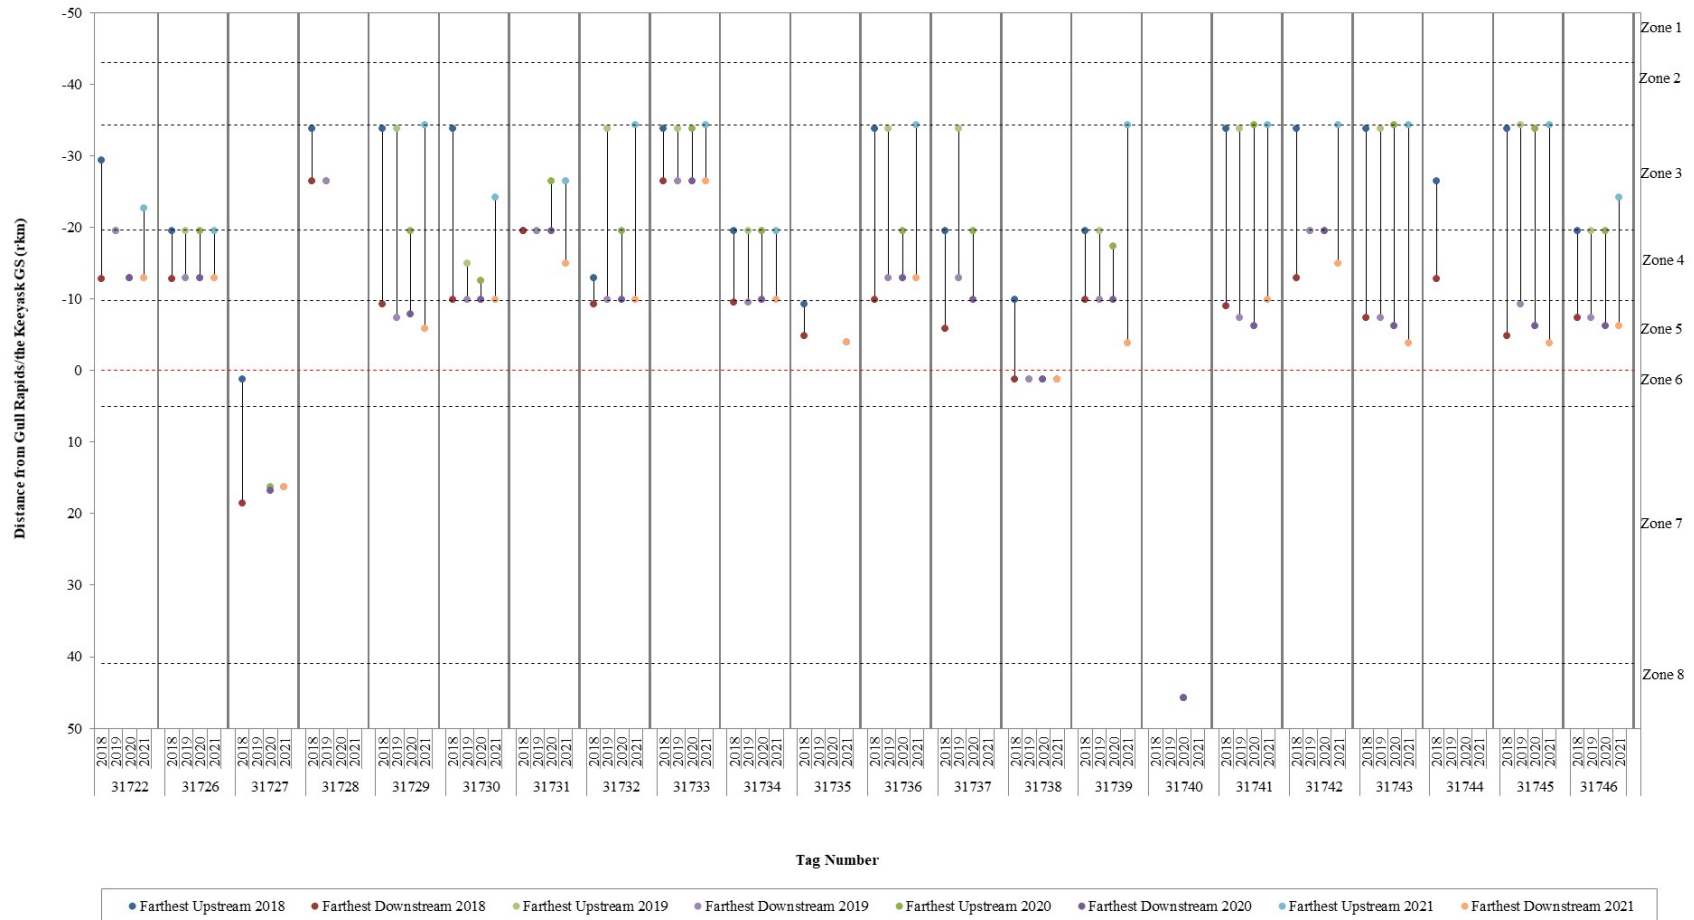
Figure 8: Detection ranges for individual Lake Whitefish ($n = 22$) tagged with acoustic transmitters upstream of the Keyyask GS during the 2018 (May 1 to October 10), 2019 (May 1 to October 7), 2020 (May 1 to September 23), and 2021 (May 1 to October 10) open-water periods. Horizontal dotted lines demarcate zones with the red line representing the Keyyask GS.

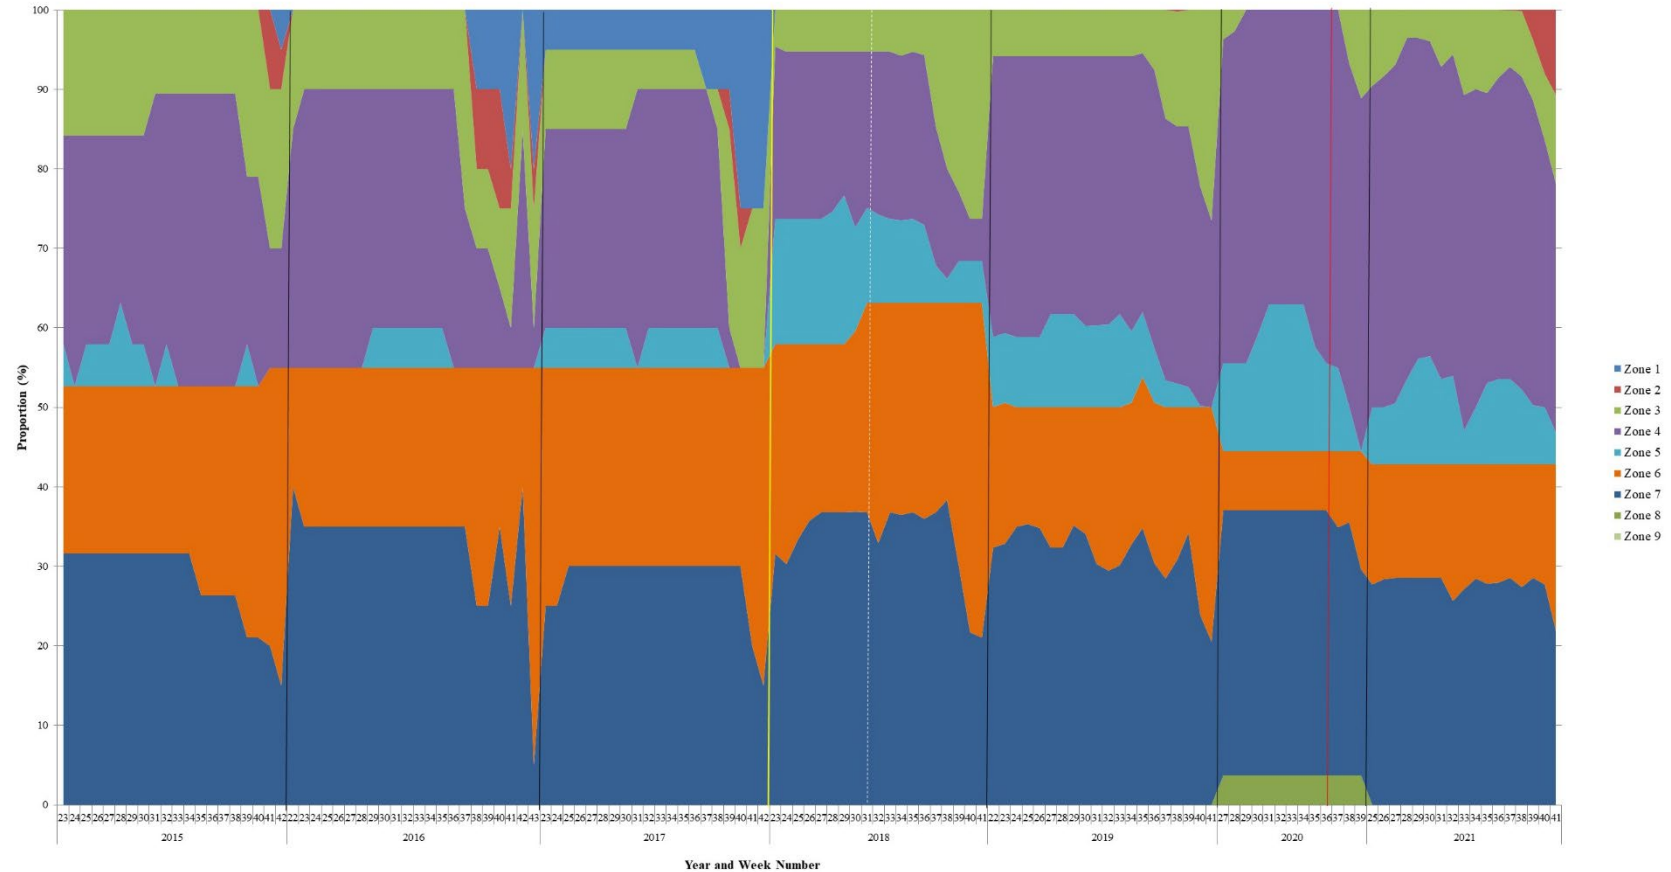
Figure 9: Proportional distribution of Lake Whitefish with acoustic transmitters tagged in 2014 and 2017 within seven river zones between Clark Lake and the Kettle GS during a portion of the 2015 (June 4 to October 11), 2016 (June 25 to October 19), 2017 (June 7 to October 16), 2018 (June 6 to October 10), 2019 (June 2 to October 7), 2020 (July 3 to September 23), and 2021 (June 13 to October 10) open-water periods. Black lines demarcate years, yellow line indicates when tags expired and new fish were tagged, white dashed line indicates start of spillway operation, solid red line indicates to completion of impoundment.

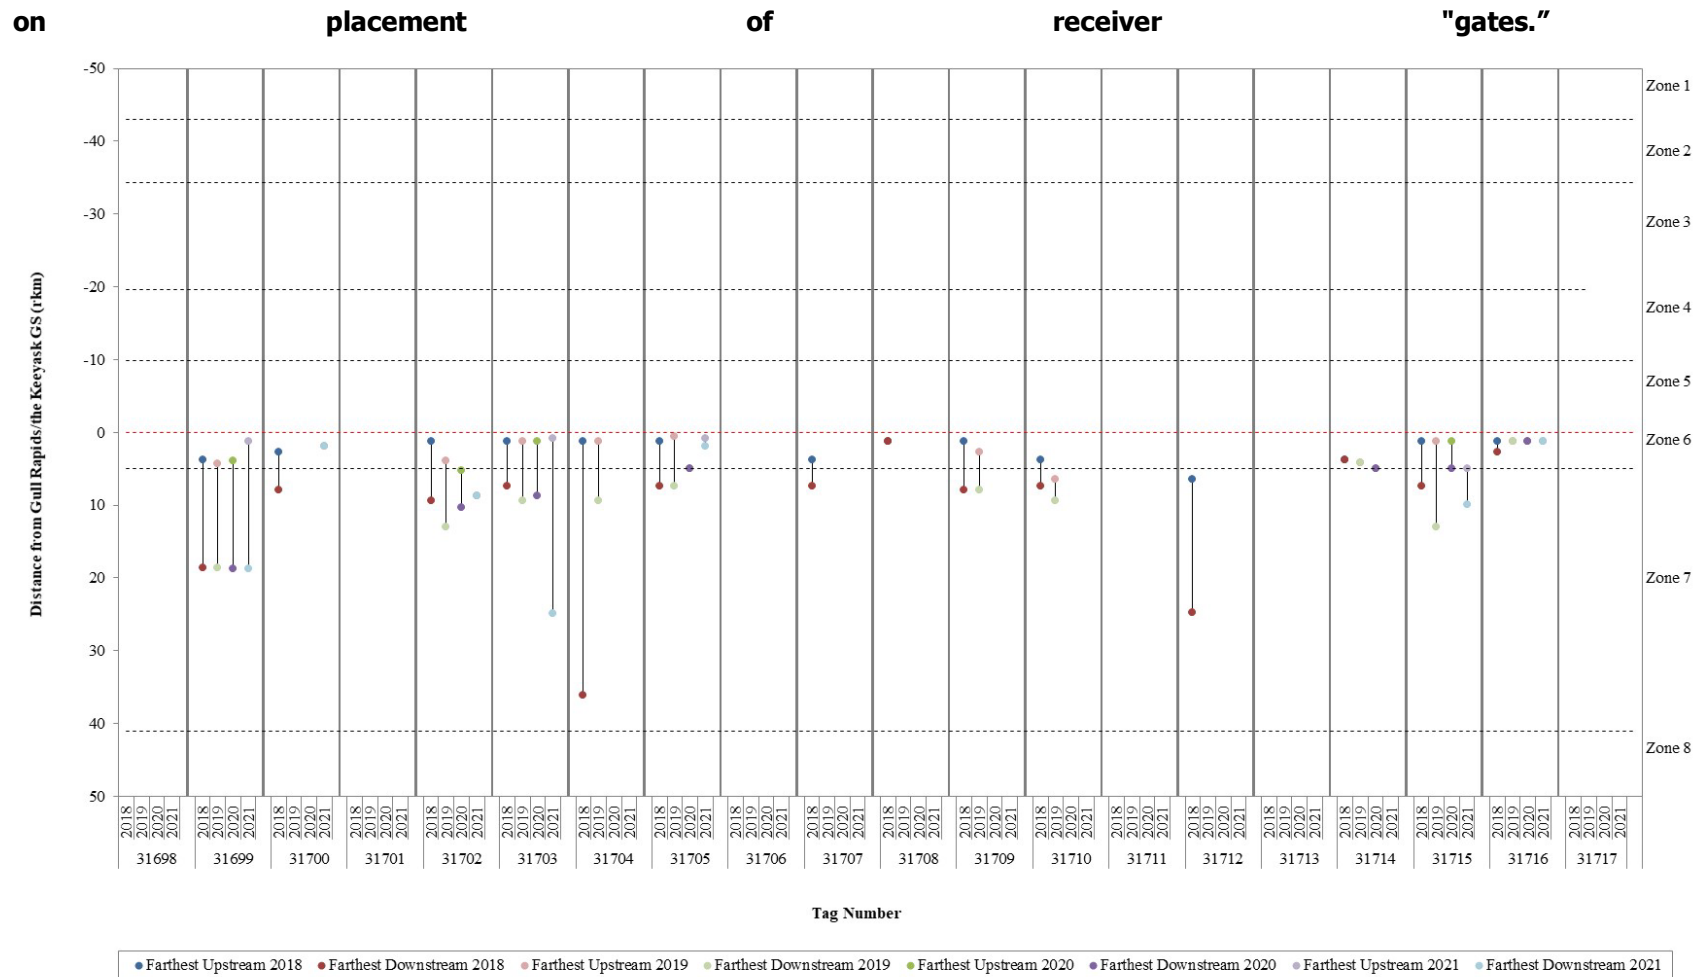
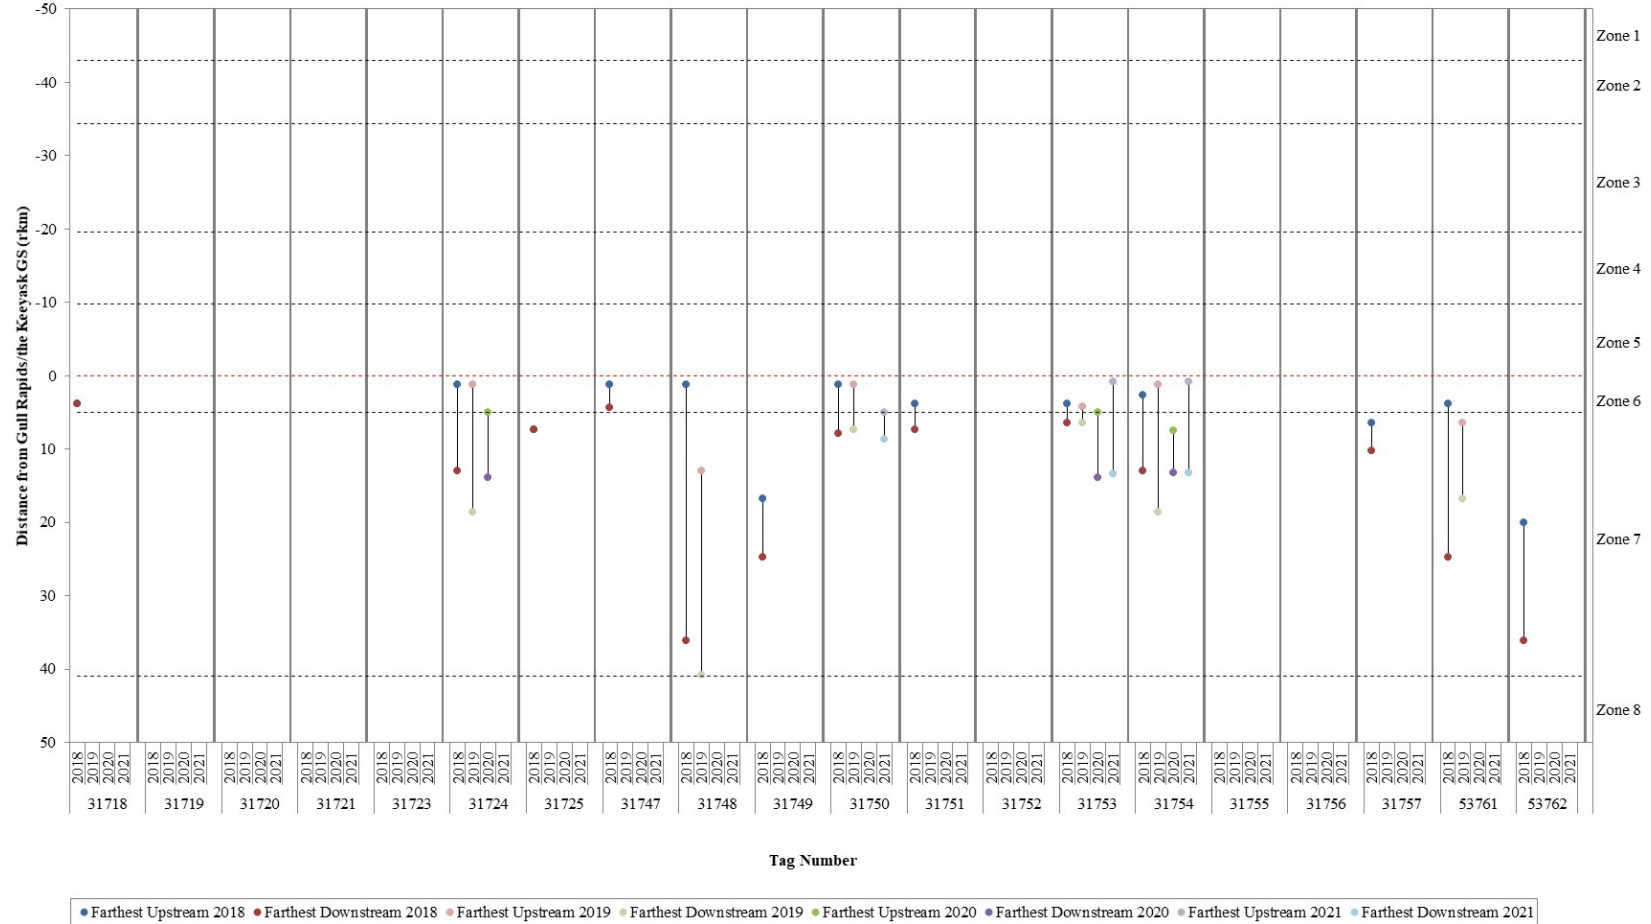
Figure 11: Detection ranges for individual Lake Whitefish ($n = 40$) tagged with acoustic transmitters in Stephens Lake during the 2018 (May 1 to October 10), 2019 (May 1 to October 7), 2020 (July 3 to September 23), and 2021 (June 13 to October 10) open-water periods. Horizontal dotted lines demarcate zones with the red line representing the Keeyask GS.

Figure 11: Detection ranges for individual Lake Whitefish (n = 40) tagged with acoustic transmitters in Stephens during the 2018 (May 1 to October 10), 2019 (May 1 to October 7), 2020 (July 3 to September 23), and 2021 (June 13 to October 10) open-water periods. Horizontal dotted lines demarcate zones with the red line representing the Keeyask GS (continued).

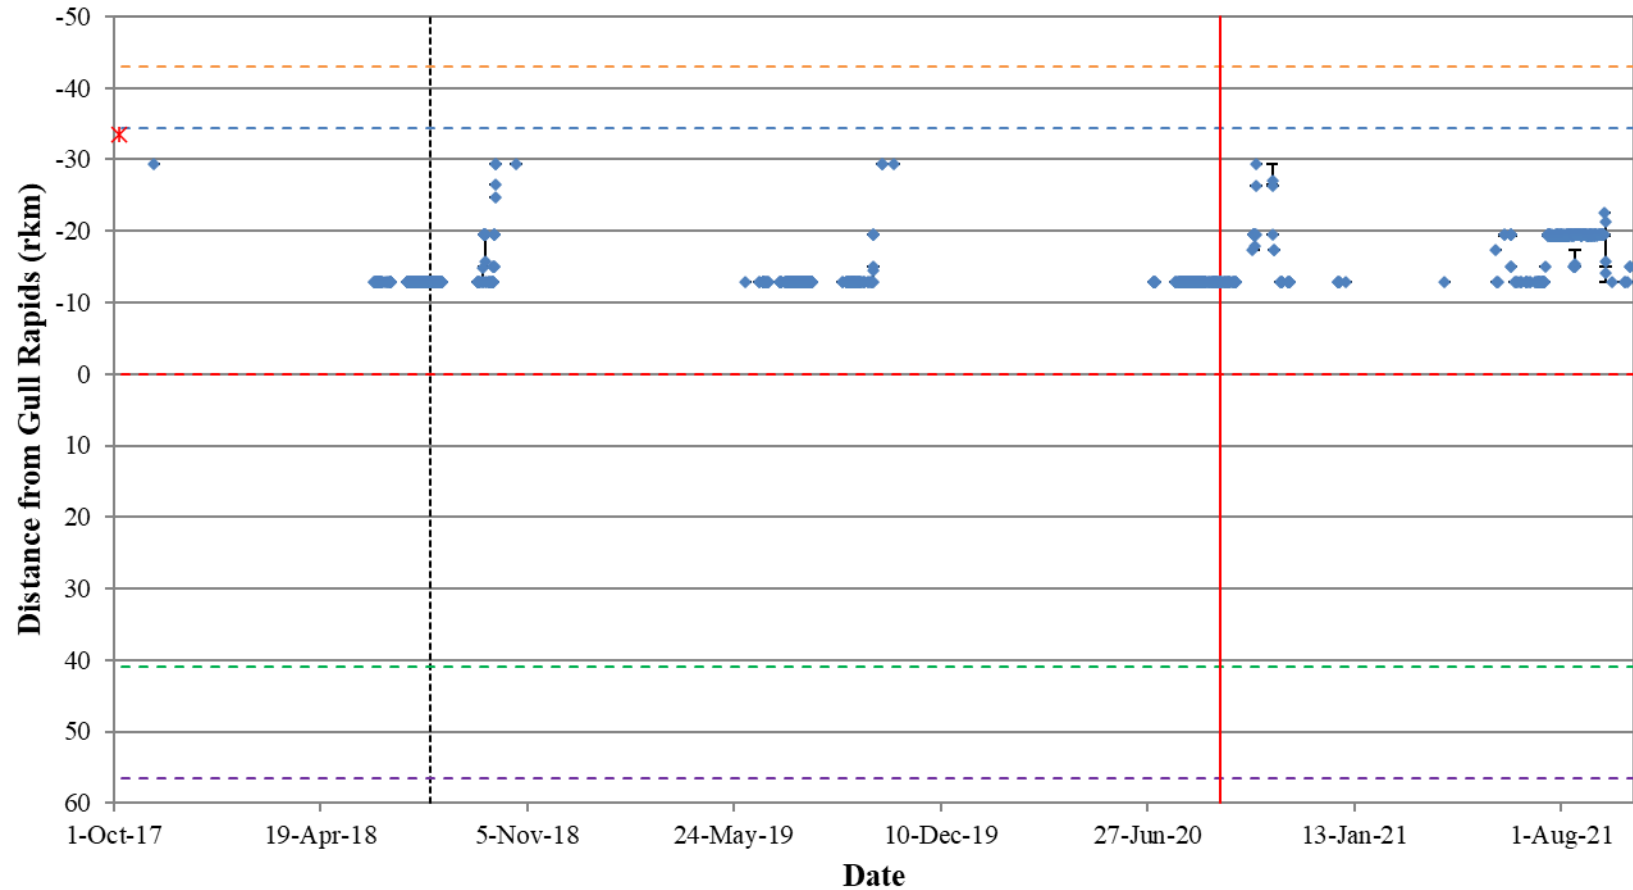
Figure A2-1: Position of a Lake Whitefish tagged with an acoustic transmitter (code #31722) in the Nelson River between Clark Lake and the Keeyask GS, in relation to the Keeyask GS (rkm 0), from October 2017 to October 2021. The date and location of tagging are indicated by a red star. Horizontal dotted lines indicate locations of landmarks (orange = Clark Lake outlet; blue = Birthday Rapids, red = Keeyask GS; green = Kettle GS, purple = Long Spruce GS). Vertical black dotted line indicates start of spillway operation (August 3, 2018). Vertical solid red line indicates the completion of reservoir impoundment (September 5, 2020).

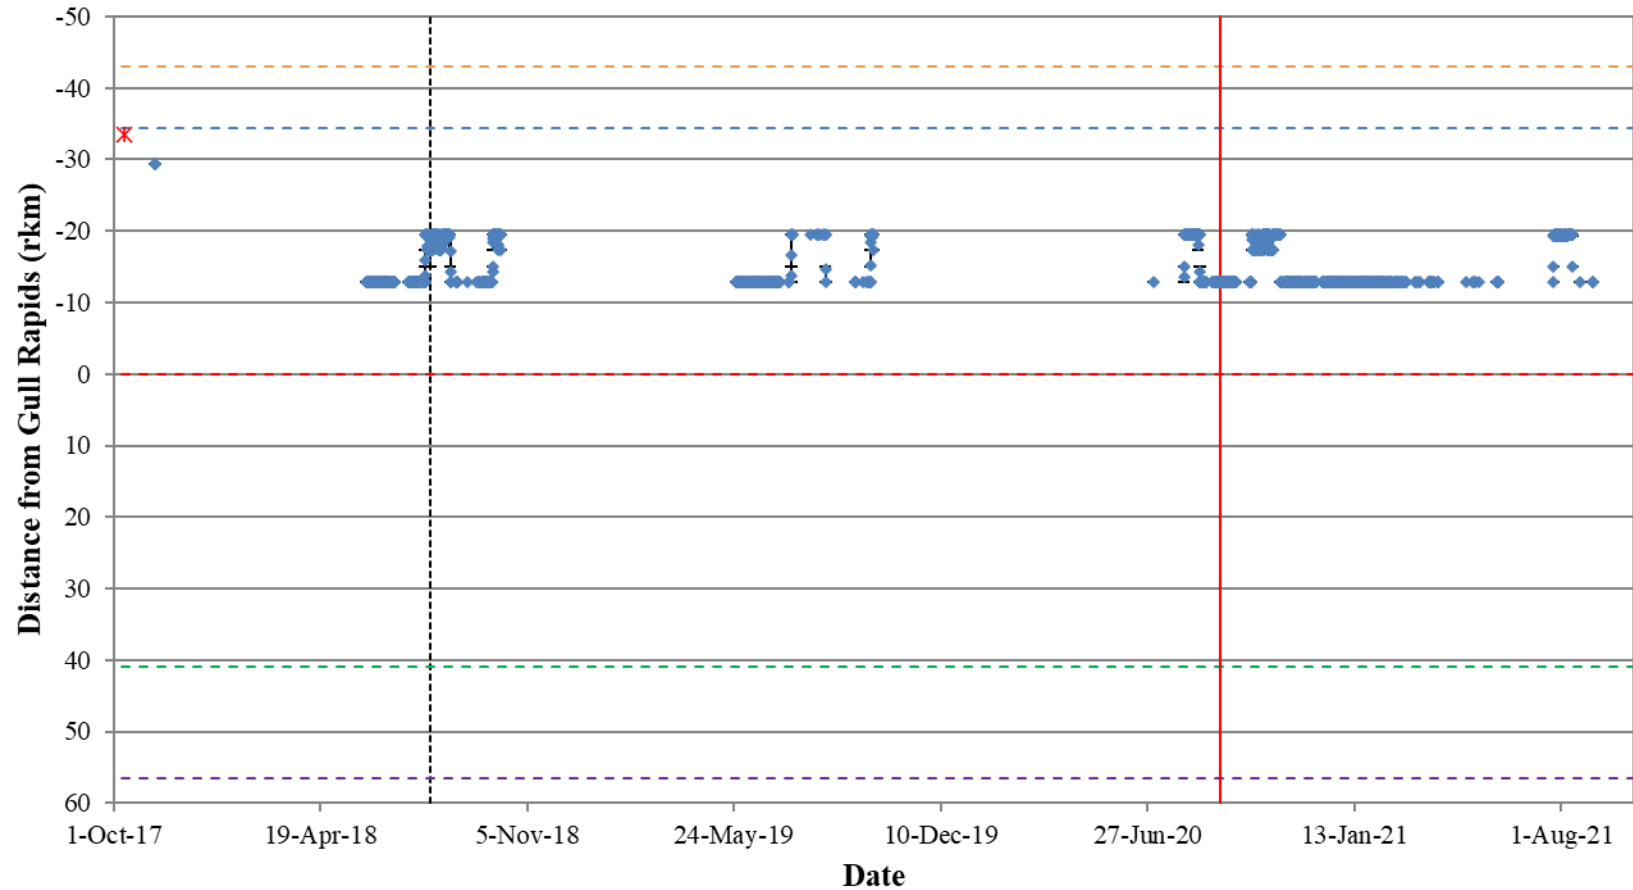
Figure A2-2: Position of a Lake Whitefish tagged with an acoustic transmitter (code #31726) in the Nelson River between Clark Lake and the Keeyask GS, in relation to the Keeyask GS (rkm 0), from October 2017 to October 2021. The date and location of tagging are indicated by a red star. Horizontal dotted lines indicate locations of landmarks (orange = Clark Lake outlet; blue = Birthday Rapids, red = Keeyask GS; green = Kettle GS, purple = Long Spruce GS). Vertical black dotted line indicates start of spillway operation (August 3, 2018). Vertical solid red line indicates the completion of reservoir impoundment (September 5, 2020).

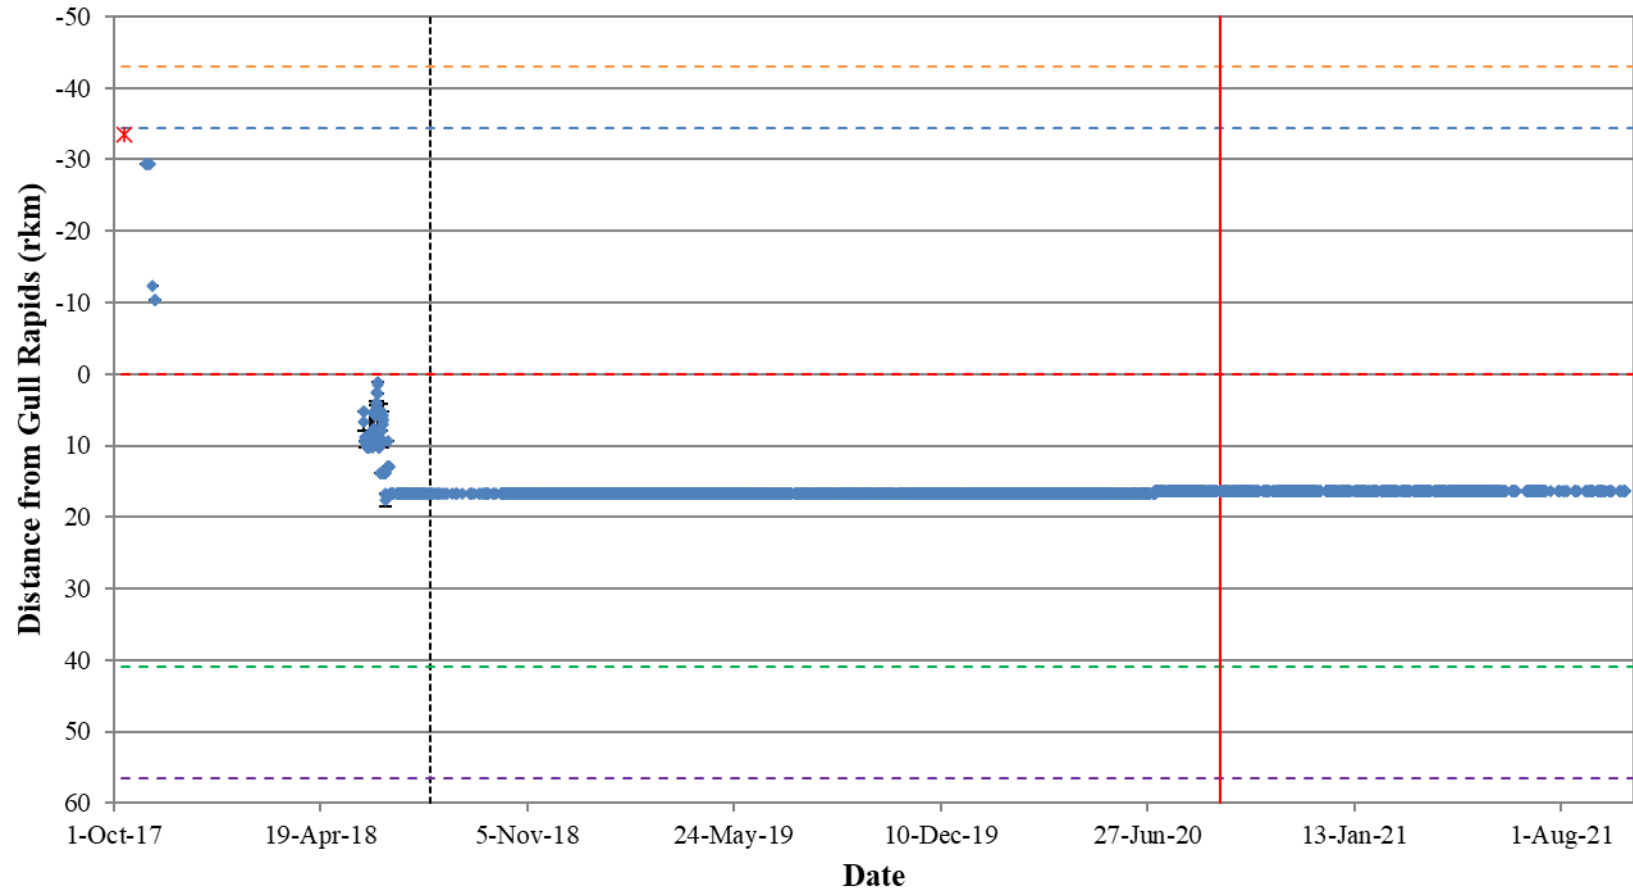
Figure A2-3: Position of a Lake Whitefish tagged with an acoustic transmitter (code #31727) in the Nelson River between Clark Lake and the Keeyask GS, in relation to the Keeyask GS (rkm 0), from October 2017 to October 2021. The date and location of tagging are indicated by a red star. Horizontal dotted lines indicate locations of landmarks (orange = Clark Lake outlet; blue = Birthday Rapids, red = Keeyask GS; green = Kettle GS, purple = Long Spruce GS). Vertical black dotted line indicates start of spillway operation (August 3, 2018). Vertical solid red line indicates the completion of reservoir impoundment (September 5, 2020).

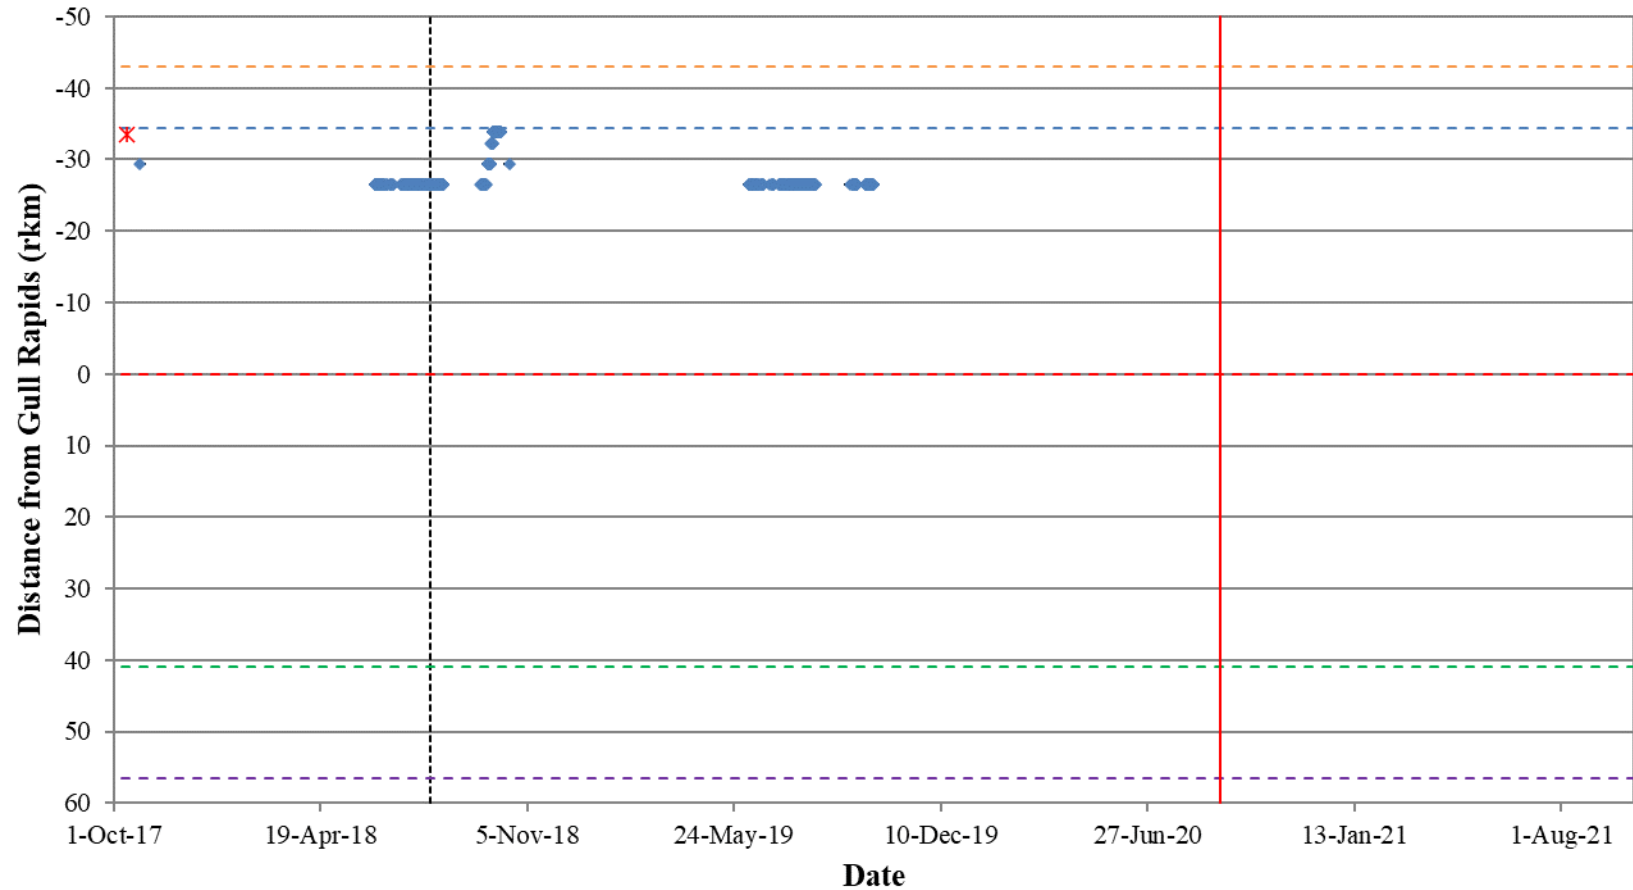
Figure A2-4: Position of a Lake Whitefish tagged with an acoustic transmitter (code #31728) in the Nelson River between Clark Lake and the Keeyask GS, in relation to the Keeyask GS (rkm 0), from October 2017 to October 2021. The date and location of tagging are indicated by a red star. Horizontal dotted lines indicate locations of landmarks (orange = Clark Lake outlet; blue = Birthday Rapids, red = Keeyask GS; green = Kettle GS, purple = Long Spruce GS). Vertical black dotted line indicates start of spillway operation (August 3, 2018). Vertical solid red line indicates the completion of reservoir impoundment (September 5, 2020).
