Keeyask Generation Project Aquatic Effects Monitoring Plan

Lake Whitefish Movement Monitoring Report

AEMP-2022-03

LAKE WHITEFISH MOVEMENT MONITORING IN THE NELSON RIVER BETWEEN CLARK LAKE AND THE LIMESTONE GENERATING STATION, SEPTEMBER 2020 TO OCTOBER 2021: YEAR 8 CONSTRUCTION

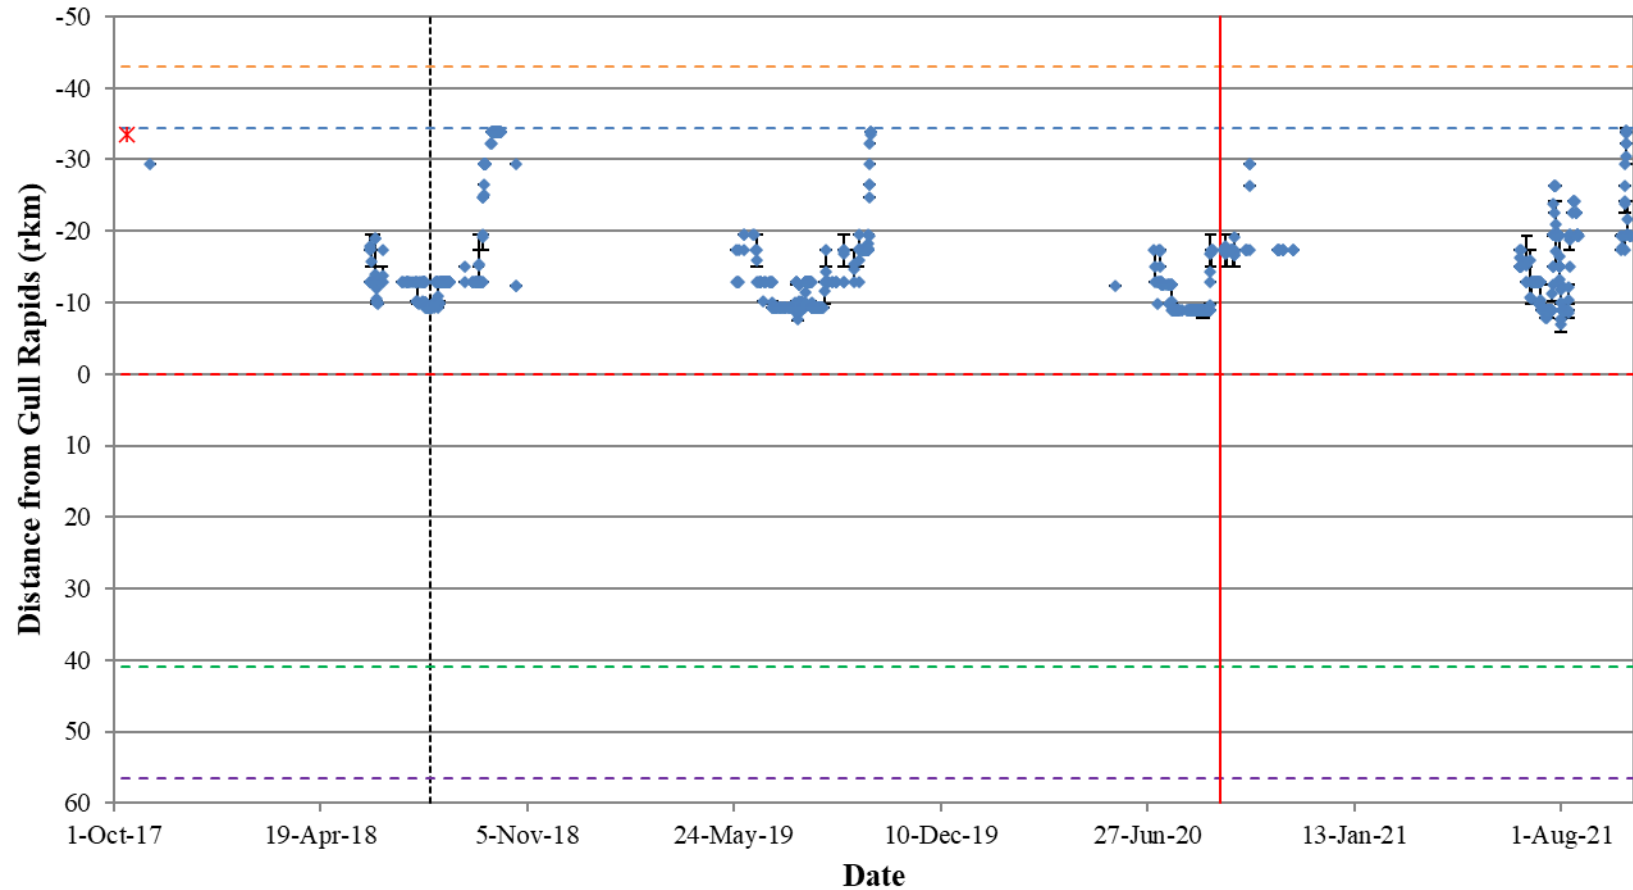
Figure A2-5: Position of a Lake Whitefish tagged with an acoustic transmitter (code #31729) in the Nelson River between Clark Lake and the Keeyask GS, in relation to the Keeyask GS (rkm 0), from October 2017 to October 2021. The date and location of tagging are indicated by a red star. Horizontal dotted lines indicate locations of landmarks (orange = Clark Lake outlet; blue = Birthday Rapids, red = Keeyask GS; green = Kettle GS, purple = Long Spruce GS). Vertical black dotted line indicates start of spillway operation (August 3, 2018). Vertical solid red line indicates the completion of reservoir impoundment (September 5, 2020).

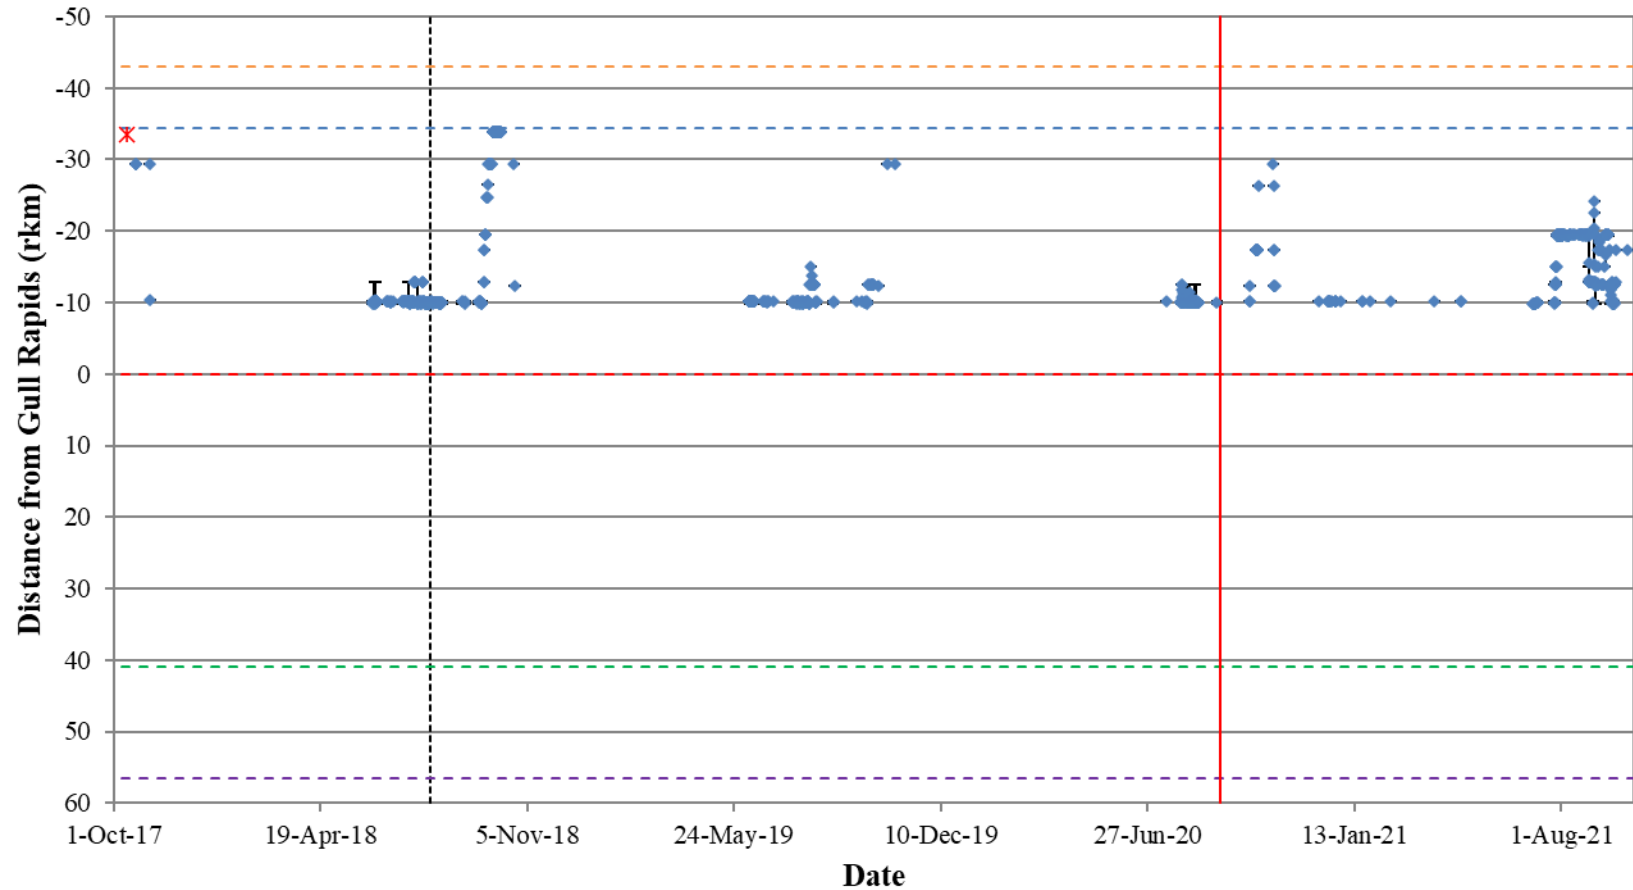
Figure A2-6: Position of a Lake Whitefish tagged with an acoustic transmitter (code #31730) in the Nelson River between Clark Lake and the Keeyask GS, in relation to the Keeyask GS (rkm 0), from October 2017 to October 2021. The date and location of tagging are indicated by a red star. Horizontal dotted lines indicate locations of landmarks (orange = Clark Lake outlet; blue = Birthday Rapids, red = Keeyask GS; green = Kettle GS, purple = Long Spruce GS). Vertical black dotted line indicates start of spillway operation (August 3, 2018). Vertical solid red line indicates the completion of reservoir impoundment (September 5, 2020).

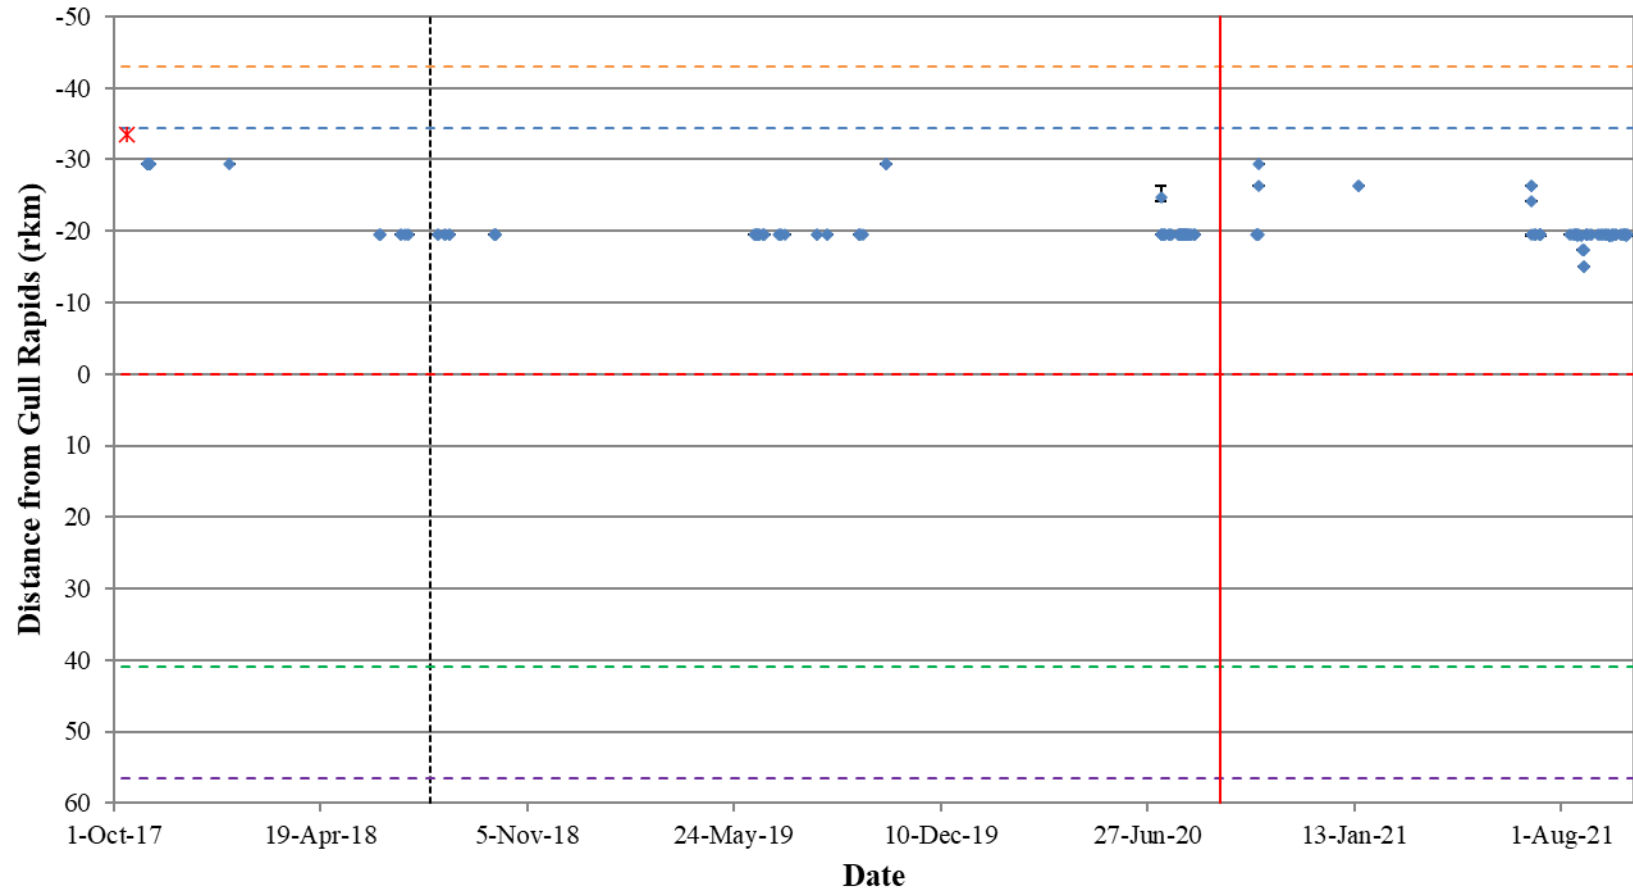
Figure A2-7: Position of a Lake Whitefish tagged with an acoustic transmitter (code #31731) in the Nelson River between Clark Lake and the Keeyask GS, in relation to the Keeyask GS (rkm 0), from October 2017 to October 2021. The date and location of tagging are indicated by a red star. Horizontal dotted lines indicate locations of landmarks (orange = Clark Lake outlet; blue = Birthday Rapids, red = Keeyask GS; green = Kettle GS, purple = Long Spruce GS). Vertical black dotted line indicates start of spillway operation (August 3, 2018). Vertical solid red line indicates the completion of reservoir impoundment (September 5, 2020).

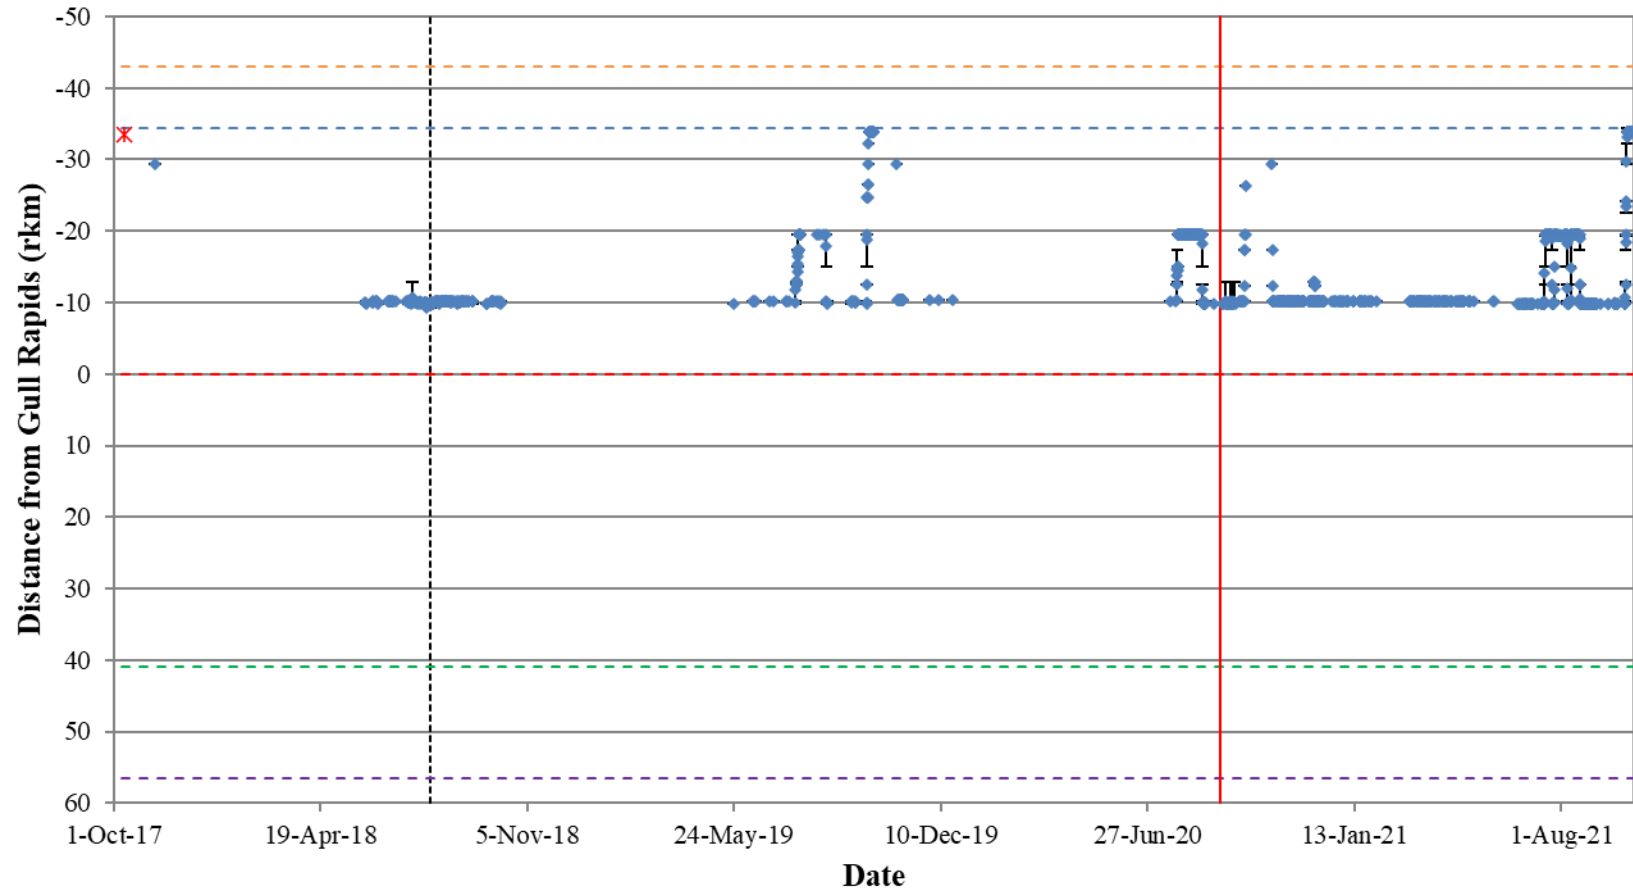
Figure A2-8: Position of a Lake Whitefish tagged with an acoustic transmitter (code #31732) in the Nelson River between Clark Lake and the Keeyask GS, in relation to the Keeyask GS (rkm 0), from October 2017 to October 2021. The date and location of tagging are indicated by a red star. Horizontal dotted lines indicate locations of landmarks (orange = Clark Lake outlet; blue = Birthday Rapids, red = Keeyask GS; green = Kettle GS, purple = Long Spruce GS). Vertical black dotted line indicates start of spillway operation (August 3, 2018). Vertical solid red line indicates the completion of reservoir impoundment (September 5, 2020).

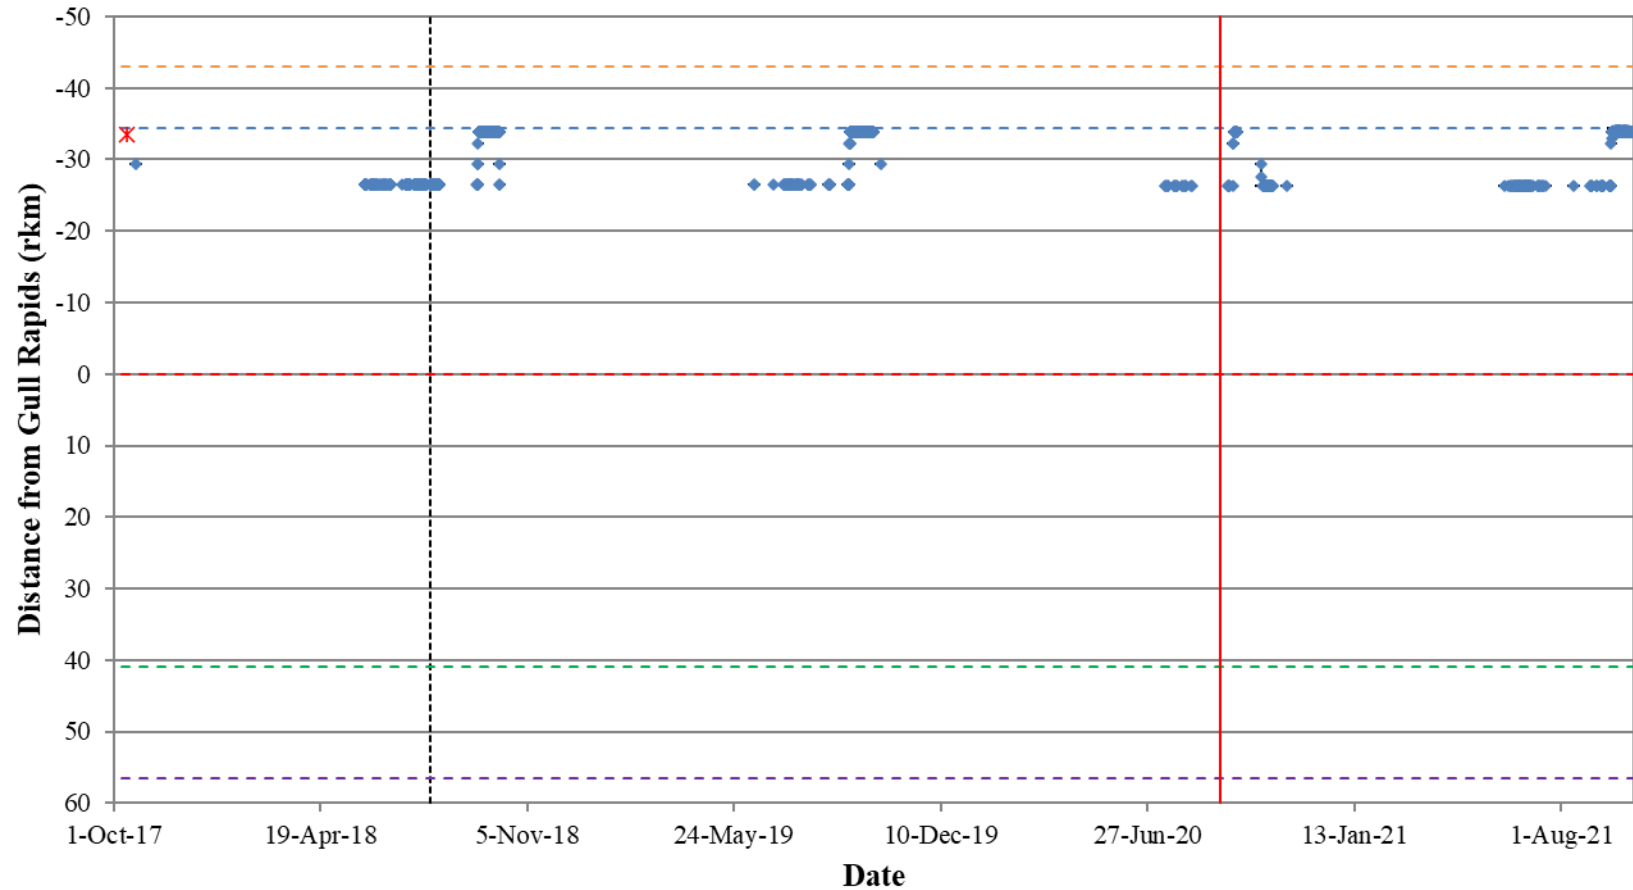
Figure A2-9: Position of a Lake Whitefish tagged with an acoustic transmitter (code #31733) in the Nelson River between Clark Lake and the Keeyask GS, in relation to the Keeyask GS (rkm 0), from October 2017 to October 2021. The date and location of tagging are indicated by a red star. Horizontal dotted lines indicate locations of landmarks (orange = Clark Lake outlet; blue = Birthday Rapids, red = Keeyask GS; green = Kettle GS, purple = Long Spruce GS). Vertical black dotted line indicates start of spillway operation (August 3, 2018). Vertical solid red line indicates the completion of reservoir impoundment (September 5, 2020).

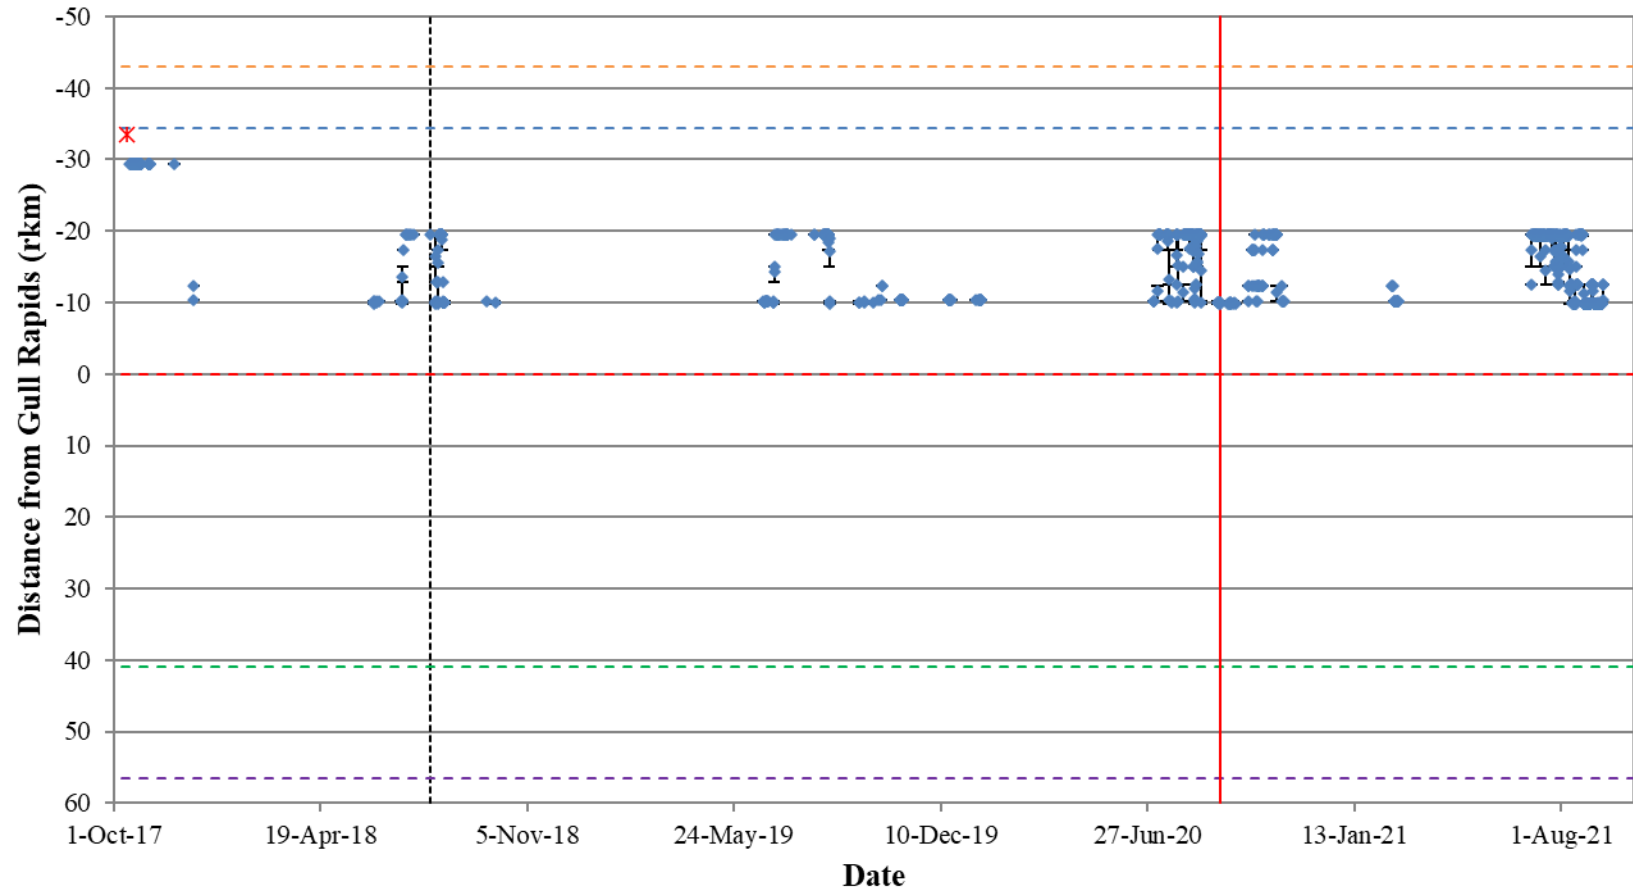
Figure A2-10: Position of a Lake Whitefish tagged with an acoustic transmitter (code #31734) in the Nelson River between Clark Lake and the Keeyask GS, in relation to the Keeyask GS (rkm 0), from October 2017 to October 2021. The date and location of tagging are indicated by a red star. Horizontal dotted lines indicate locations of landmarks (orange = Clark Lake outlet; blue = Birthday Rapids, red = Keeyask GS; green = Kettle GS, purple = Long Spruce GS). Vertical black dotted line indicates start of spillway operation (August 3, 2018). Vertical solid red line indicates the completion of reservoir impoundment (September 5, 2020).

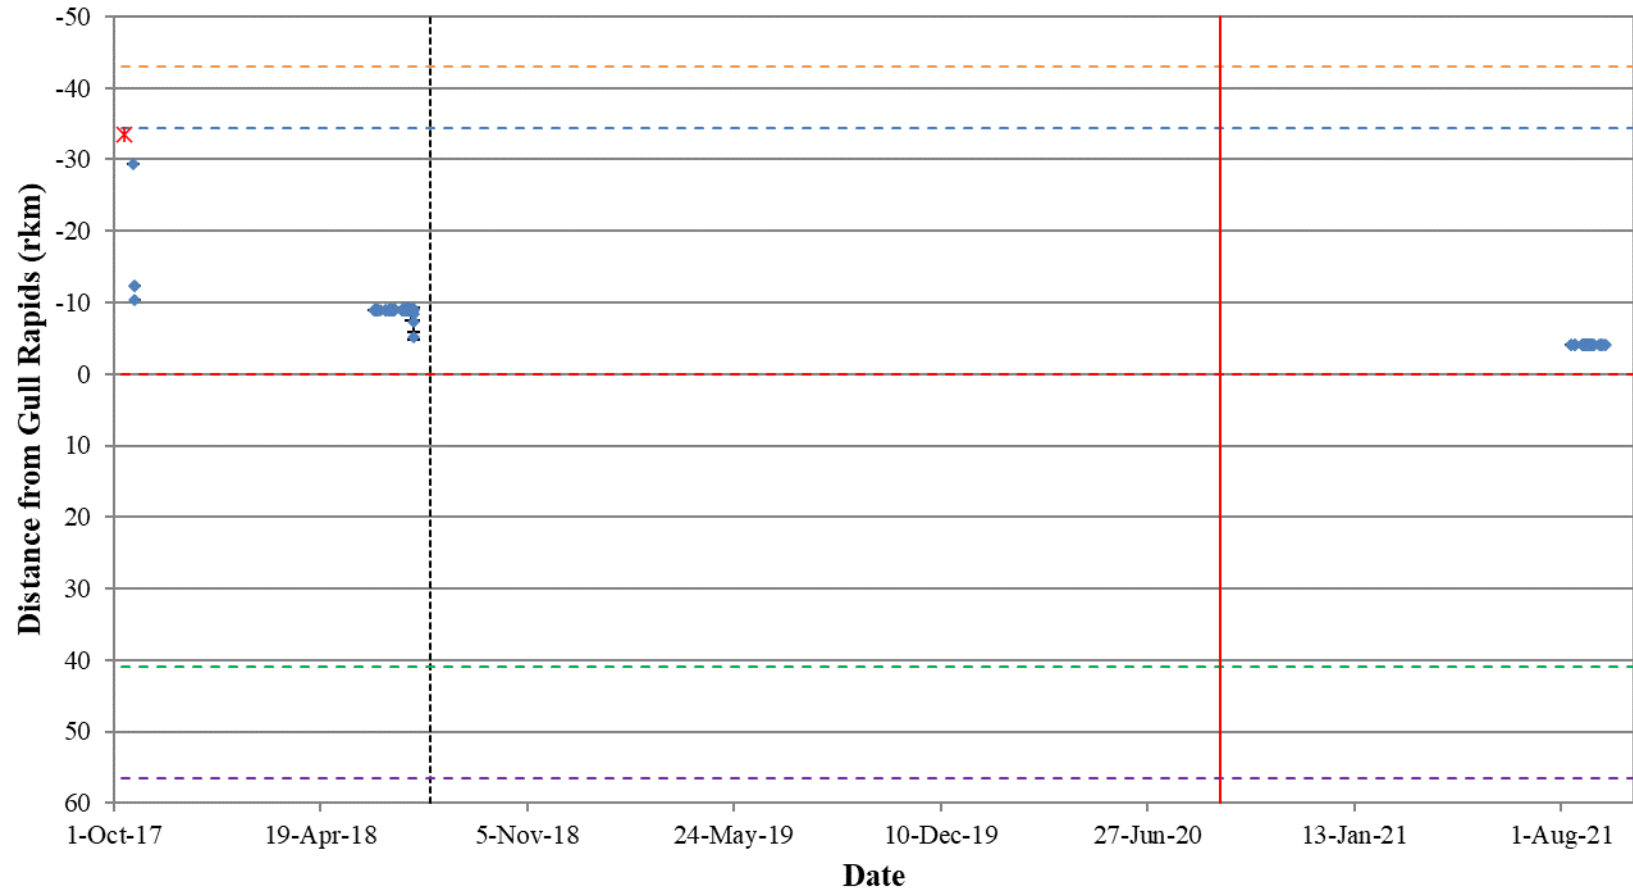
Figure A2-11: Position of a Lake Whitefish tagged with an acoustic transmitter (code #31735) in the Nelson River between Clark Lake and the Keeyask GS, in relation to the Keeyask GS (rkm 0), from October 2017 to October 2021. The date and location of tagging are indicated by a red star. Horizontal dotted lines indicate locations of landmarks (orange = Clark Lake outlet; blue = Birthday Rapids, red = Keeyask GS; green = Kettle GS, purple = Long Spruce GS). Vertical black dotted line indicates start of spillway operation (August 3, 2018). Vertical solid red line indicates the completion of reservoir impoundment (September 5, 2020).

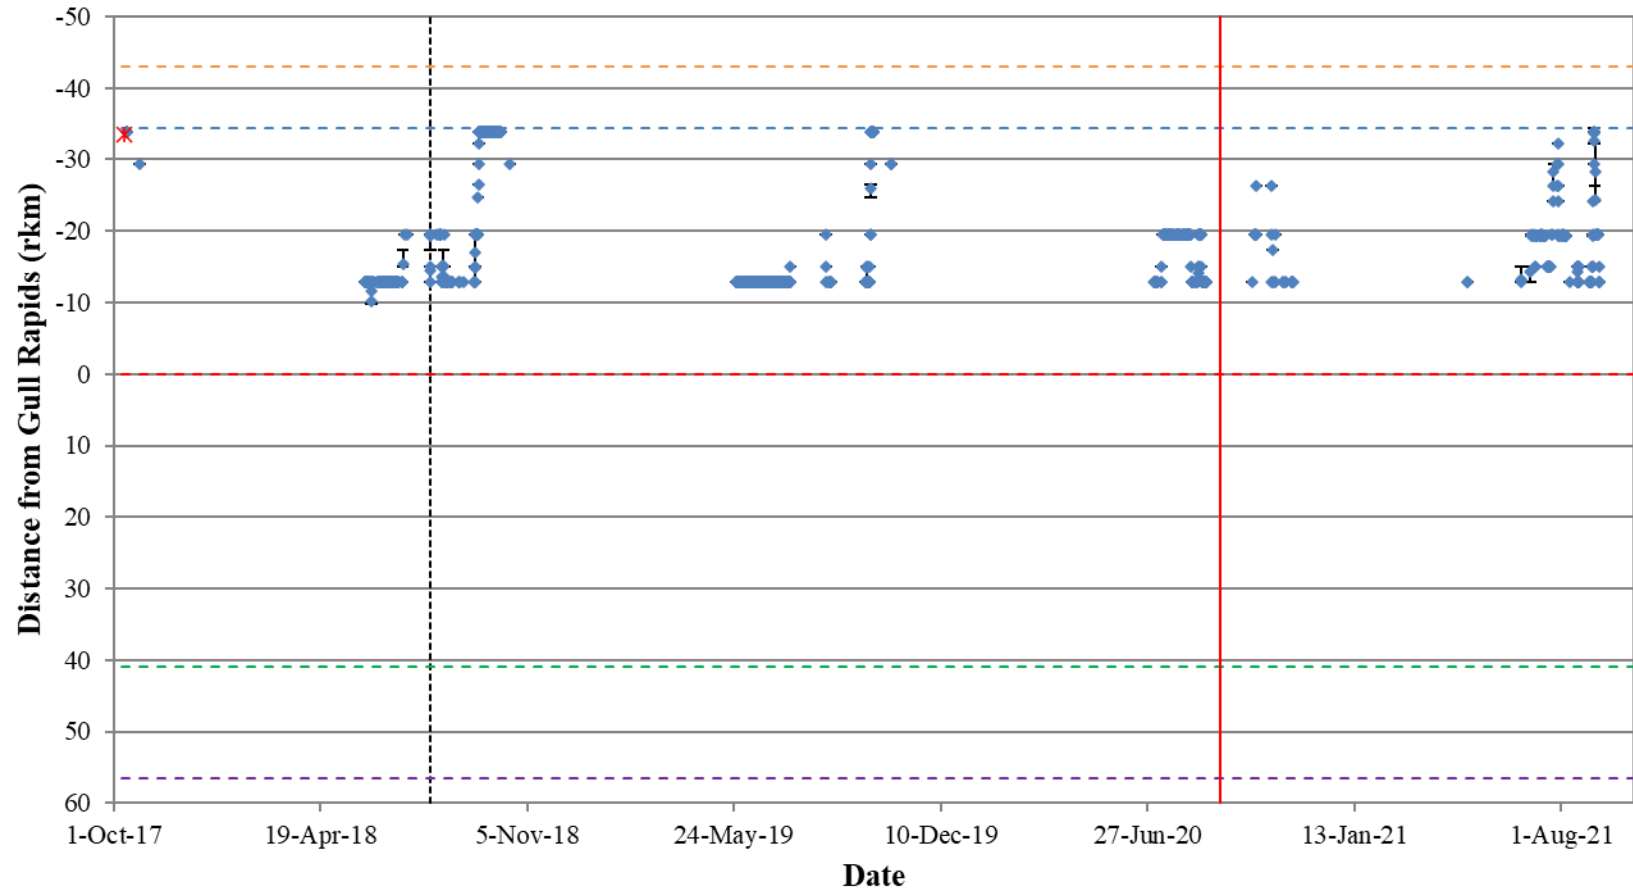
Figure A2-12: Position of a Lake Whitefish tagged with an acoustic transmitter (code #31736) in the Nelson River between Clark Lake and the Keeyask GS, in relation to the Keeyask GS (rkm 0), from October 2017 to October 2021. The date and location of tagging are indicated by a red star. Horizontal dotted lines indicate locations of landmarks (orange = Clark Lake outlet; blue = Birthday Rapids, red = Keeyask GS; green = Kettle GS, purple = Long Spruce GS). Vertical black dotted line indicates start of spillway operation (August 3, 2018). Vertical solid red line indicates the completion of reservoir impoundment (September 5, 2020).

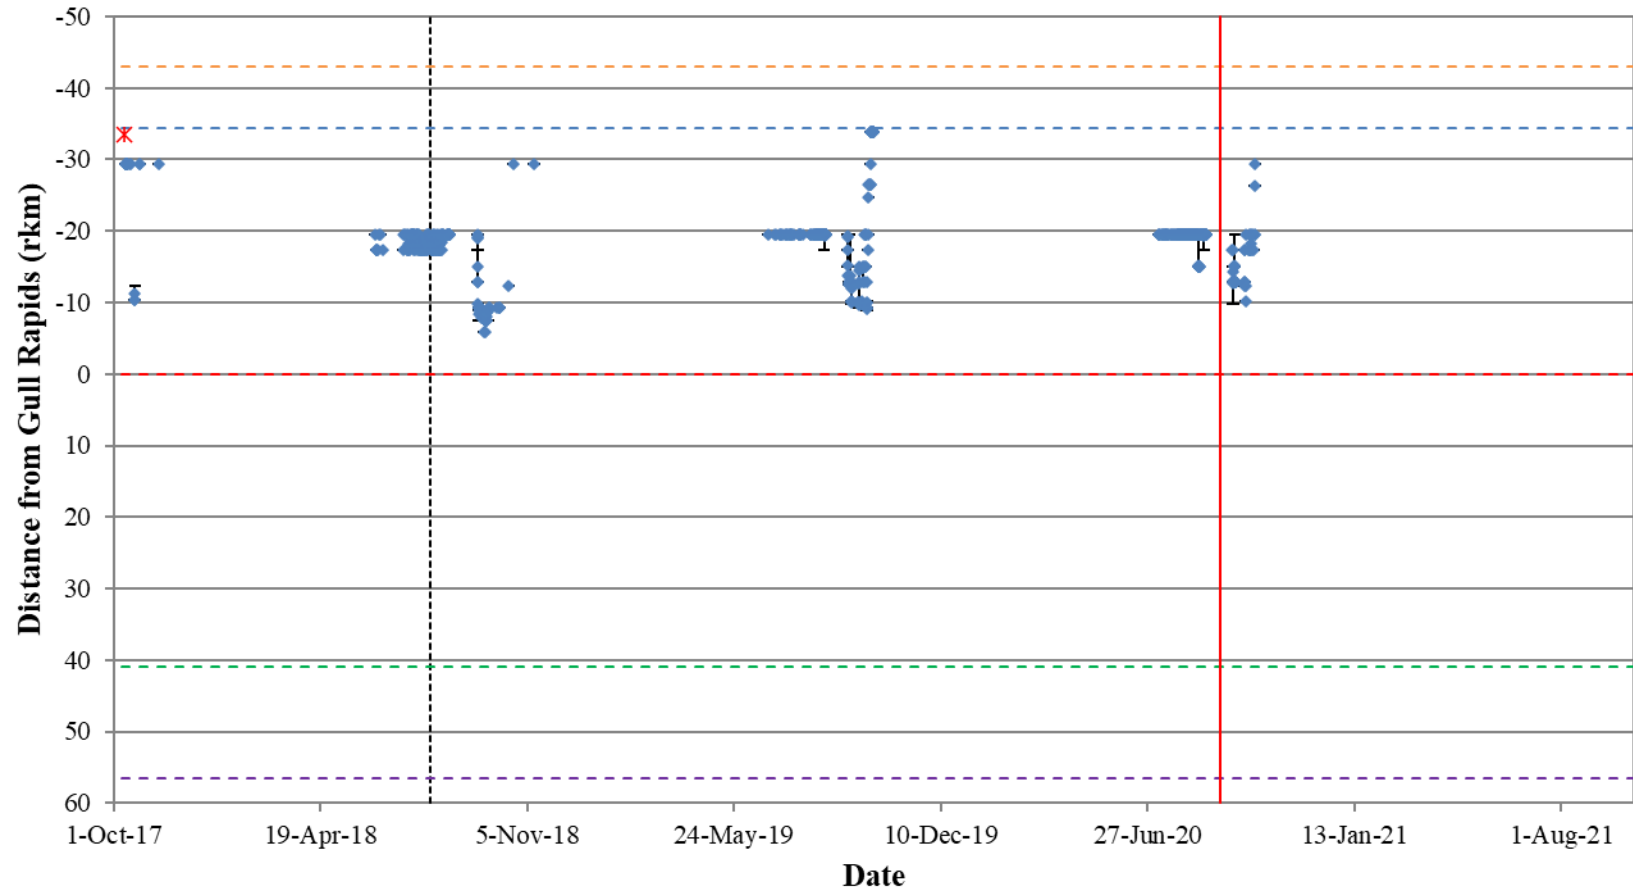
Figure A2-13: Position of a Lake Whitefish tagged with an acoustic transmitter (code #31737) in the Nelson River between Clark Lake and the Keeyask GS, in relation to the Keeyask GS (rkm 0), from October 2017 to October 2021. The date and location of tagging are indicated by a red star. Horizontal dotted lines indicate locations of landmarks (orange = Clark Lake outlet; blue = Birthday Rapids, red = Keeyask GS; green = Kettle GS, purple = Long Spruce GS). Vertical black dotted line indicates start of spillway operation (August 3, 2018). Vertical solid red line indicates the completion of reservoir impoundment (September 5, 2020).

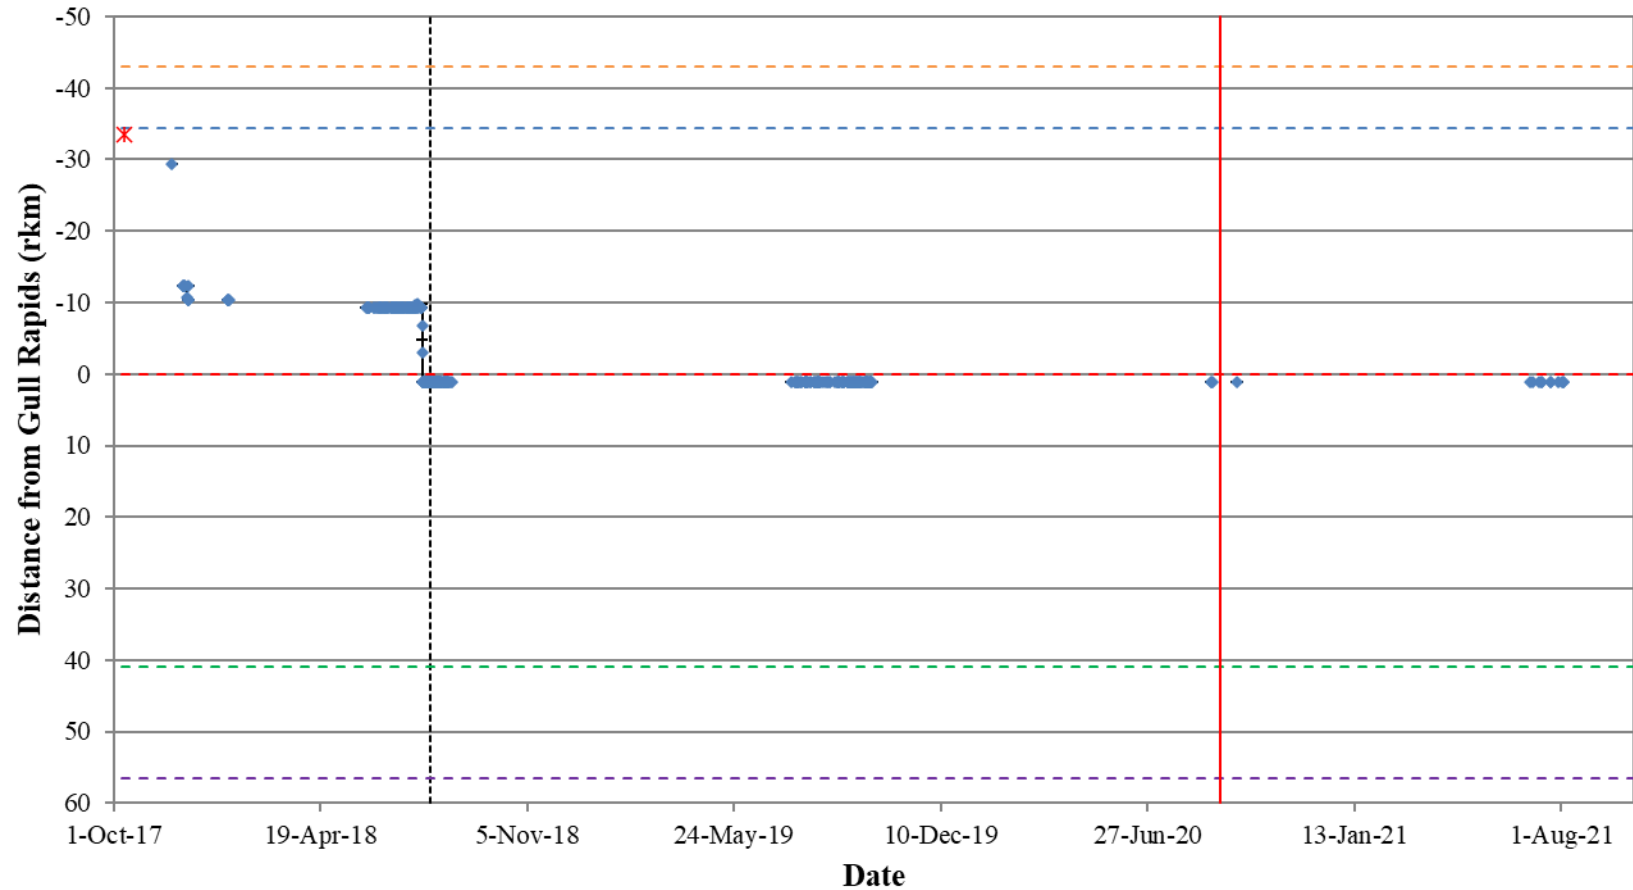
Figure A2-14: Position of a Lake Whitefish tagged with an acoustic transmitter (code #31738) in the Nelson River between Clark Lake and the Keeyask GS, in relation to the Keeyask GS (rkm 0), from October 2017 to October 2021. The date and location of tagging are indicated by a red star. Horizontal dotted lines indicate locations of landmarks (orange = Clark Lake outlet; blue = Birthday Rapids, red = Keeyask GS; green = Kettle GS, purple = Long Spruce GS). Vertical black dotted line indicates start of spillway operation (August 3, 2018). Vertical solid red line indicates the completion of reservoir impoundment (September 5, 2020).

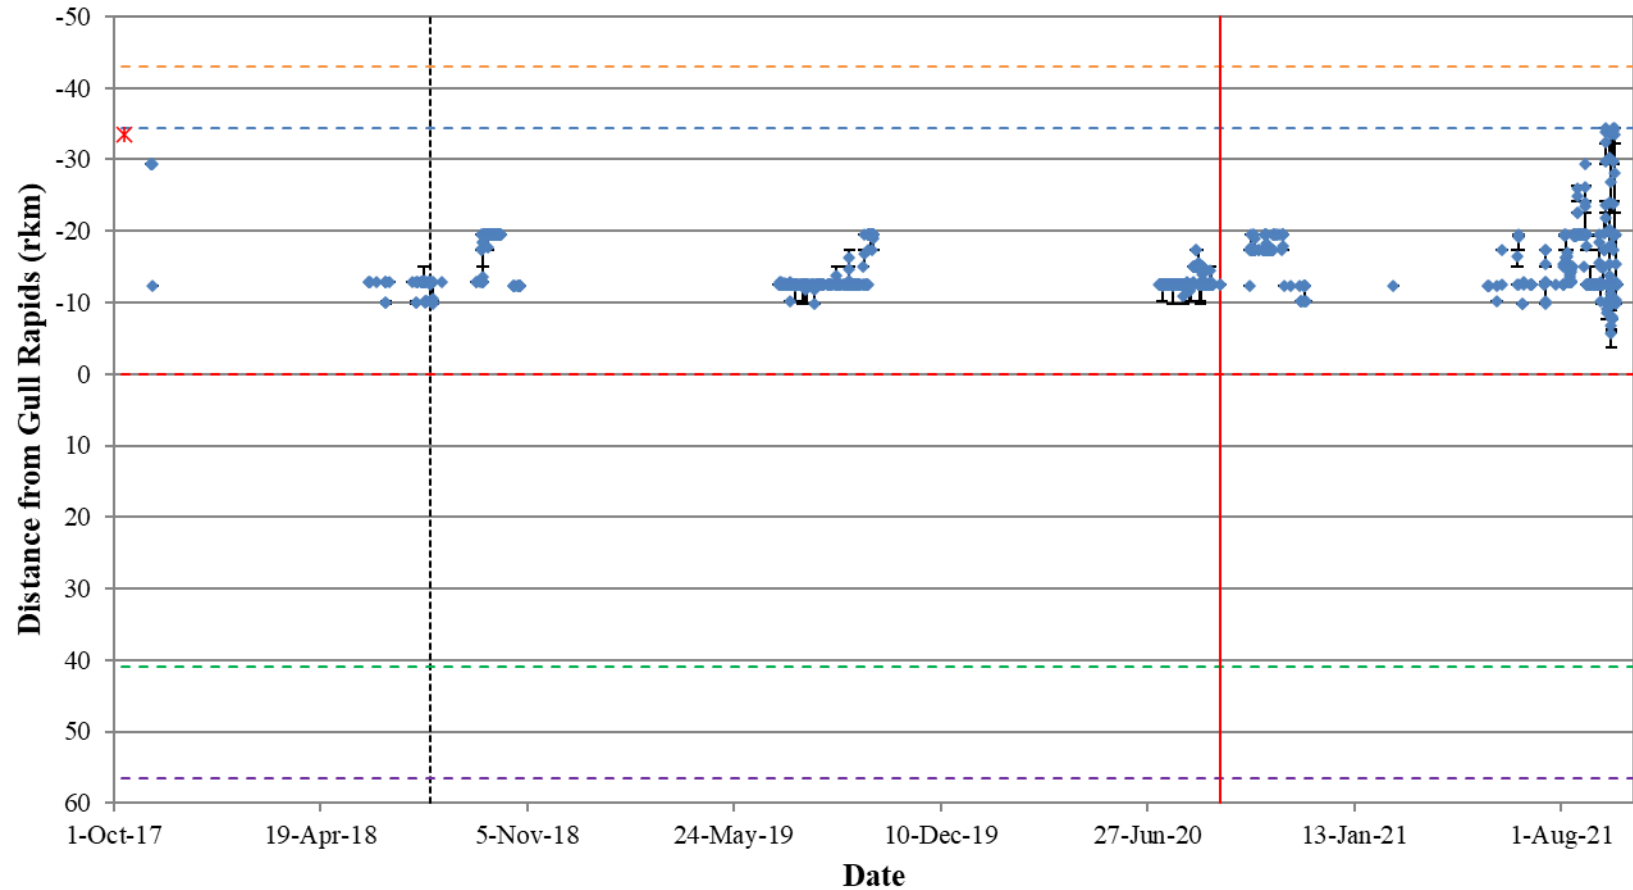
Figure A2-15: Position of a Lake Whitefish tagged with an acoustic transmitter (code #31739) in the Nelson River between Clark Lake and the Keeyask GS, in relation to the Keeyask GS (rkm 0), from October 2017 to October 2021. The date and location of tagging are indicated by a red star. Horizontal dotted lines indicate locations of landmarks (orange = Clark Lake outlet; blue = Birthday Rapids, red = Keeyask GS; green = Kettle GS, purple = Long Spruce GS). Vertical black dotted line indicates start of spillway operation (August 3, 2018). Vertical solid red line indicates the completion of reservoir impoundment (September 5, 2020).

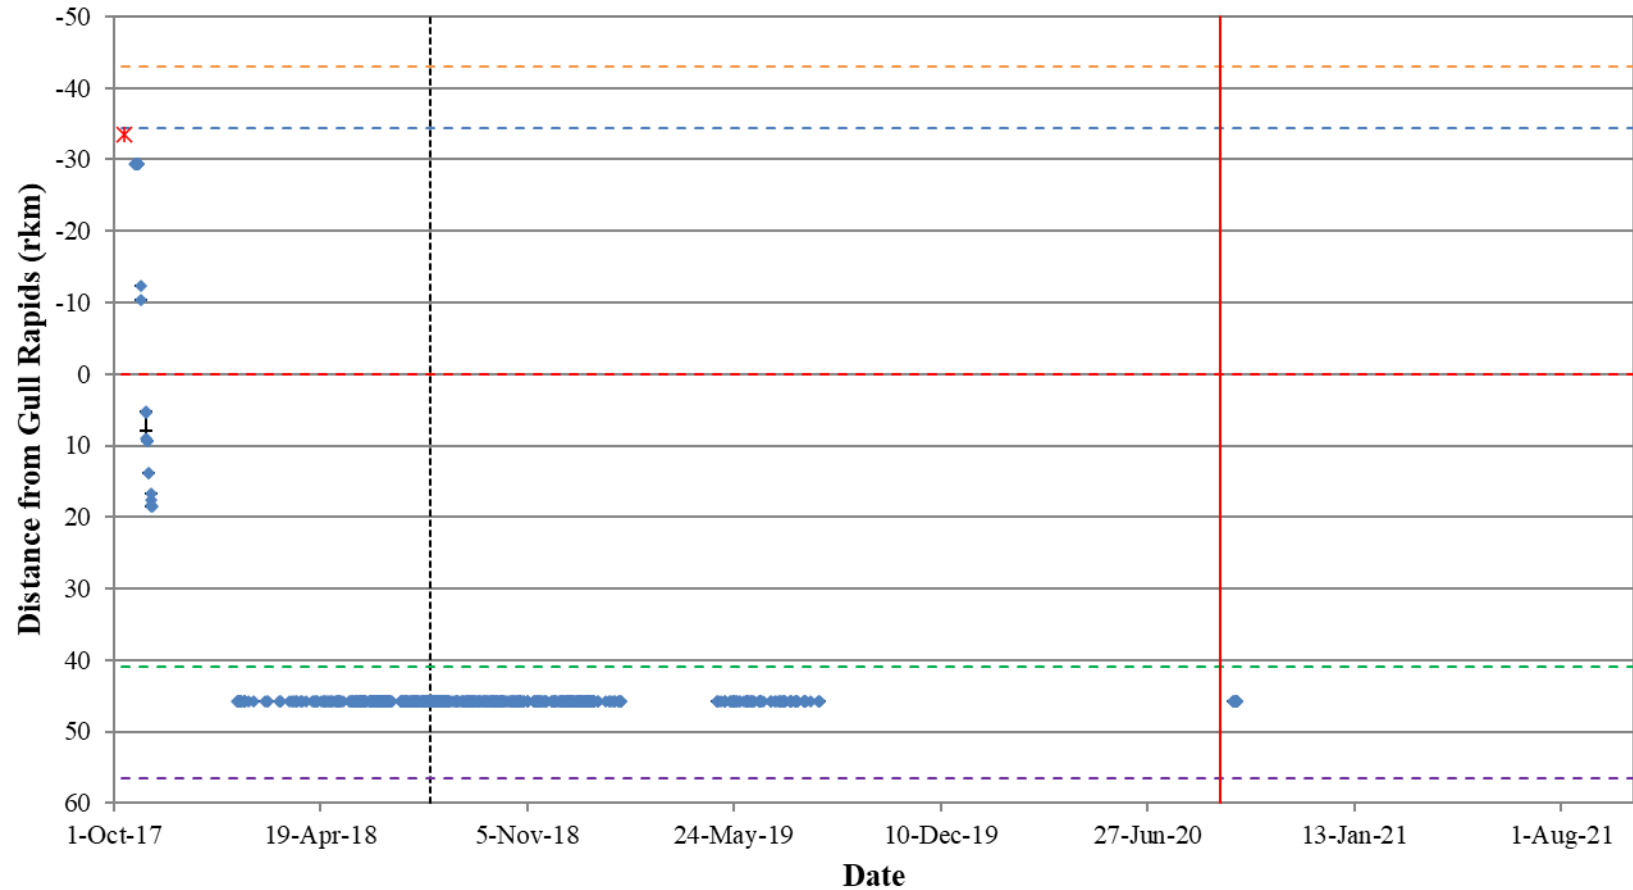
Figure A2-16: Position of a Lake Whitefish tagged with an acoustic transmitter (code #31740) in the Nelson River between Clark Lake and the Keeyask GS, in relation to the Keeyask GS (rkm 0), from October 2017 to October 2021. The date and location of tagging are indicated by a red star. Horizontal dotted lines indicate locations of landmarks (orange = Clark Lake outlet; blue = Birthday Rapids, red = Keeyask GS; green = Kettle GS, purple = Long Spruce GS). Vertical black dotted line indicates start of spillway operation (August 3, 2018). Vertical solid red line indicates the completion of reservoir impoundment (September 5, 2020).

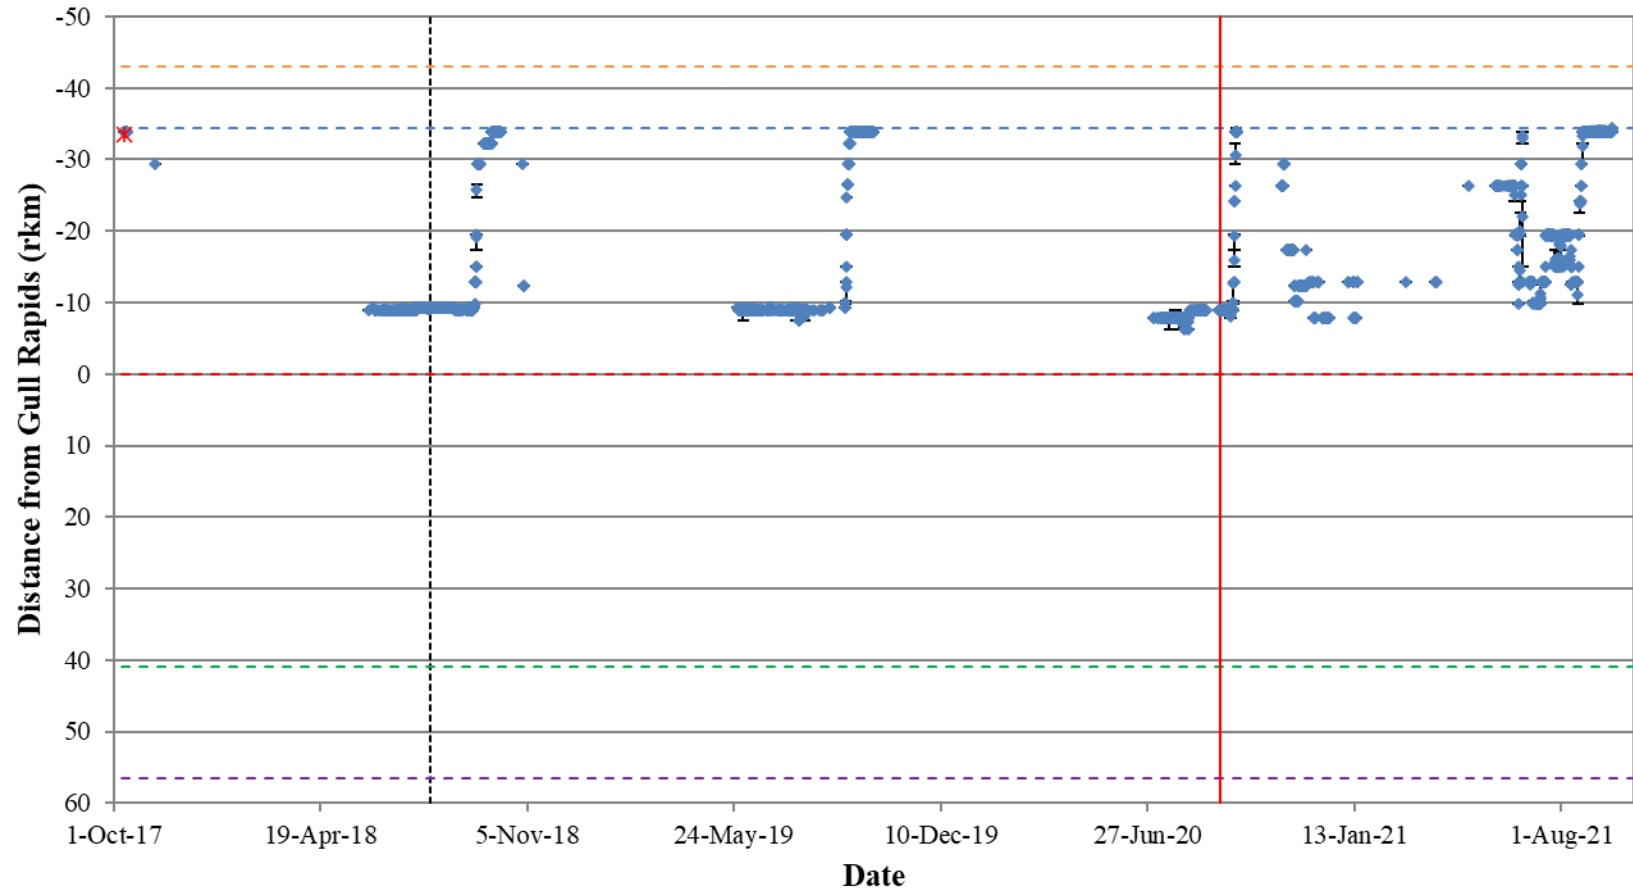
Figure A2-17: Position of a Lake Whitefish tagged with an acoustic transmitter (code #31741) in the Nelson River between Clark Lake and the Keeyask GS, in relation to the Keeyask GS (rkm 0), from October 2017 to October 2021. The date and location of tagging are indicated by a red star. Horizontal dotted lines indicate locations of landmarks (orange = Clark Lake outlet; blue = Birthday Rapids, red = Keeyask GS; green = Kettle GS, purple = Long Spruce GS). Vertical black dotted line indicates start of spillway operation (August 3, 2018). Vertical solid red line indicates the completion of reservoir impoundment (September 5, 2020).

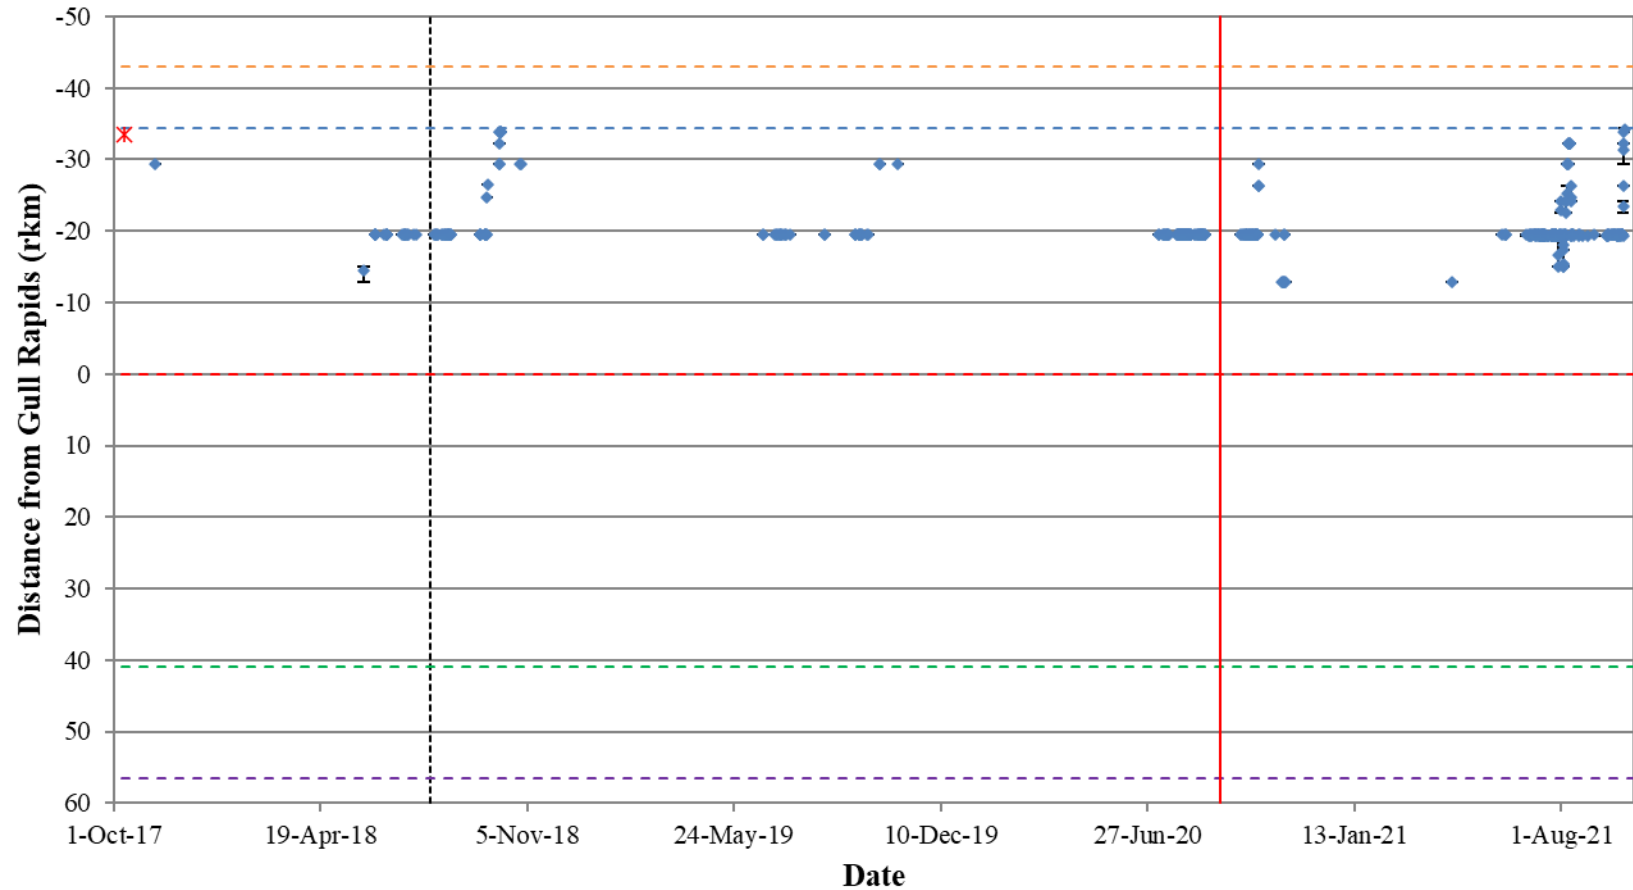
Figure A2-18: Position of a Lake Whitefish tagged with an acoustic transmitter (code #31742) in the Nelson River between Clark Lake and the Keeyask GS, in relation to the Keeyask GS (rkm 0), from October 2017 to October 2021. The date and location of tagging are indicated by a red star. Horizontal dotted lines indicate locations of landmarks (orange = Clark Lake outlet; blue = Birthday Rapids, red = Keeyask GS; green = Kettle GS, purple = Long Spruce GS). Vertical black dotted line indicates start of spillway operation (August 3, 2018). Vertical solid red line indicates the completion of reservoir impoundment (September 5, 2020).
