Keeyask Generation Project Aquatic Effects Monitoring Plan

Lake Whitefish Movement Monitoring Report

AEMP-2022-03

LAKE WHITEFISH MOVEMENT MONITORING IN THE NELSON RIVER BETWEEN CLARK LAKE AND THE LIMESTONE GENERATING STATION, SEPTEMBER 2020 TO OCTOBER 2021: YEAR 8 CONSTRUCTION

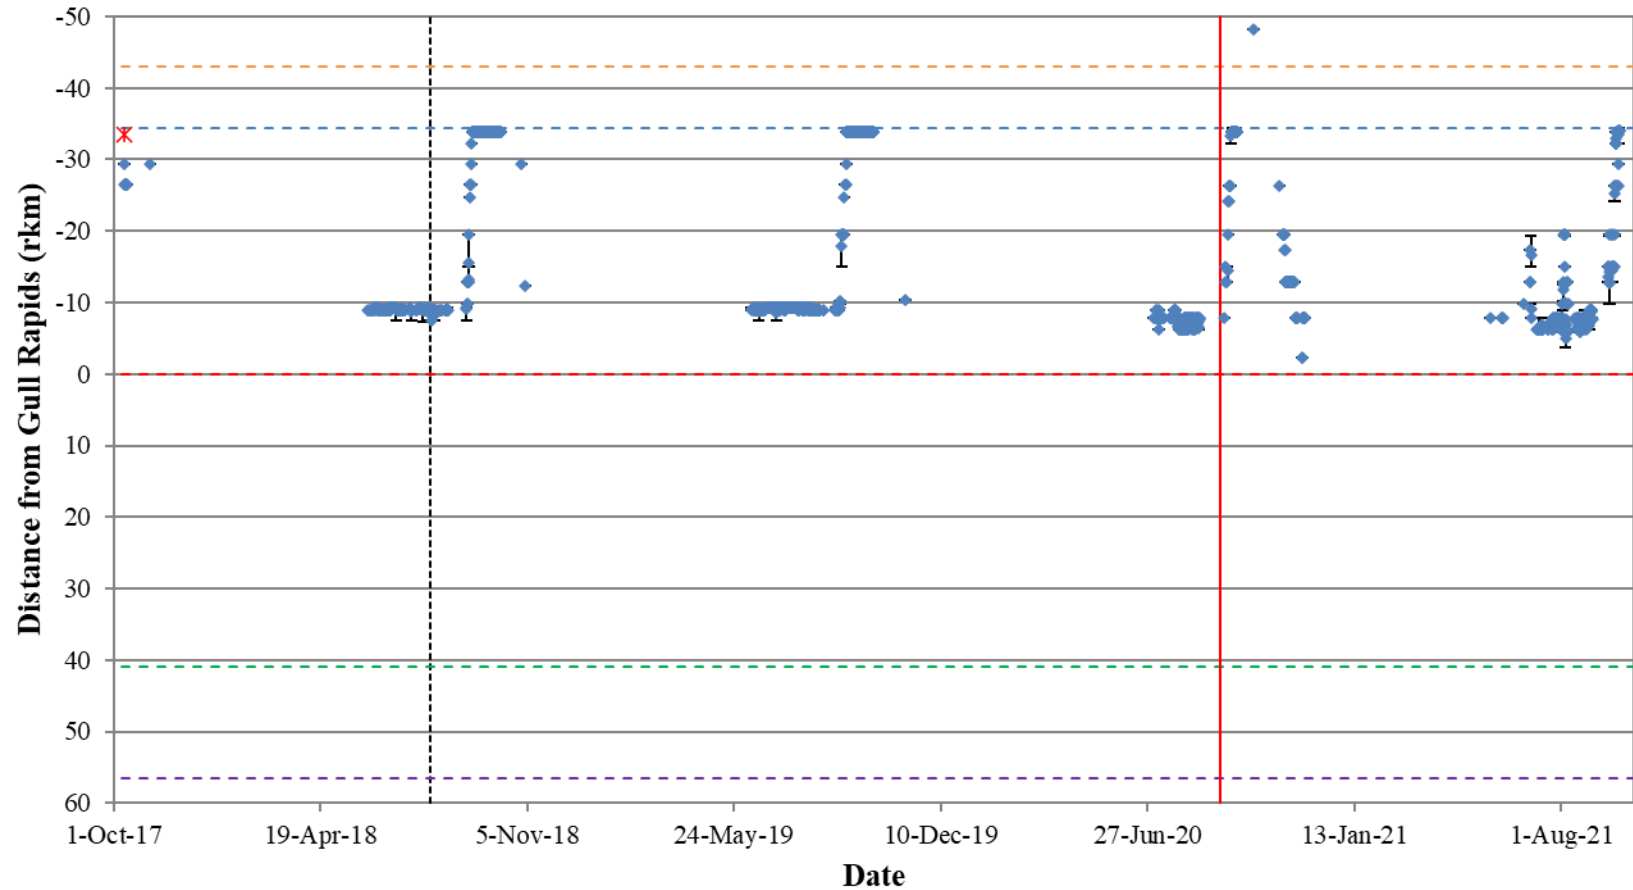
Figure A2-19: Position of a Lake Whitefish tagged with an acoustic transmitter (code #31743) in the Nelson River between Clark Lake and the Keeyask GS, in relation to the Keeyask GS (rkm 0), from October 2017 to October 2021. The date and location of tagging are indicated by a red star. Horizontal dotted lines indicate locations of landmarks (orange = Clark Lake outlet; blue = Birthday Rapids, red = Keeyask GS; green = Kettle GS, purple = Long Spruce GS). Vertical black dotted line indicates start of spillway operation (August 3, 2018). Vertical solid red line indicates the completion of reservoir impoundment (September 5, 2020).

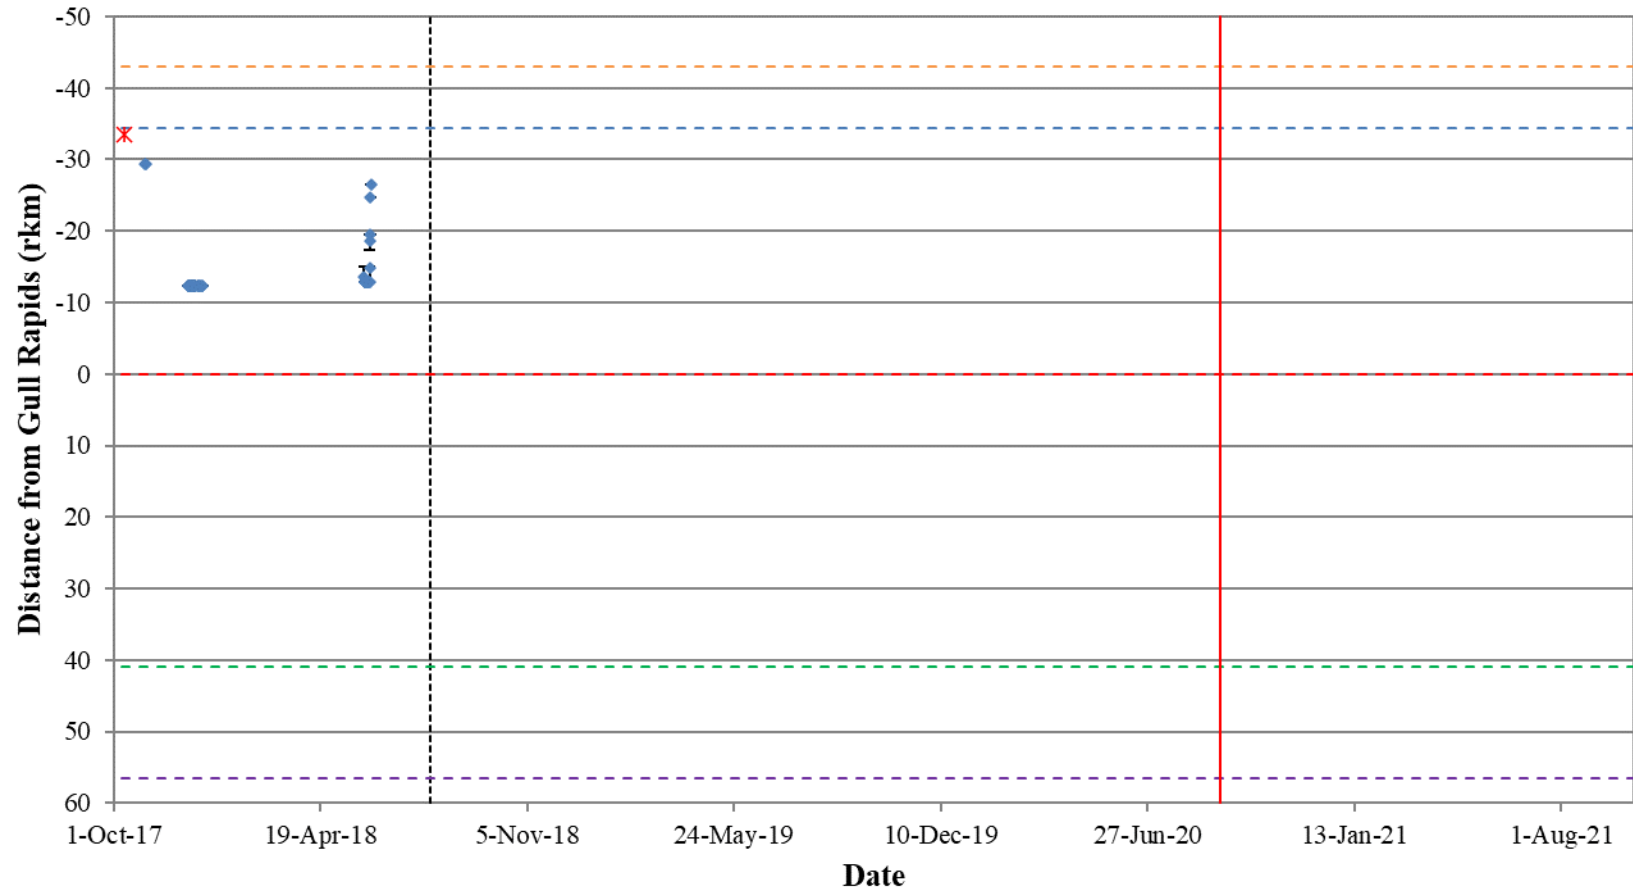
Figure A2-20: Position of a Lake Whitefish tagged with an acoustic transmitter (code #31744) in the Nelson River between Clark Lake and the Keeyask GS, in relation to the Keeyask GS (rkm 0), from October 2017 to October 2021. The date and location of tagging are indicated by a red star. Horizontal dotted lines indicate locations of landmarks (orange = Clark Lake outlet; blue = Birthday Rapids, red = Keeyask GS; green = Kettle GS, purple = Long Spruce GS). Vertical black dotted line indicates start of spillway operation (August 3, 2018). Vertical solid red line indicates the completion of reservoir impoundment (September 5, 2020).

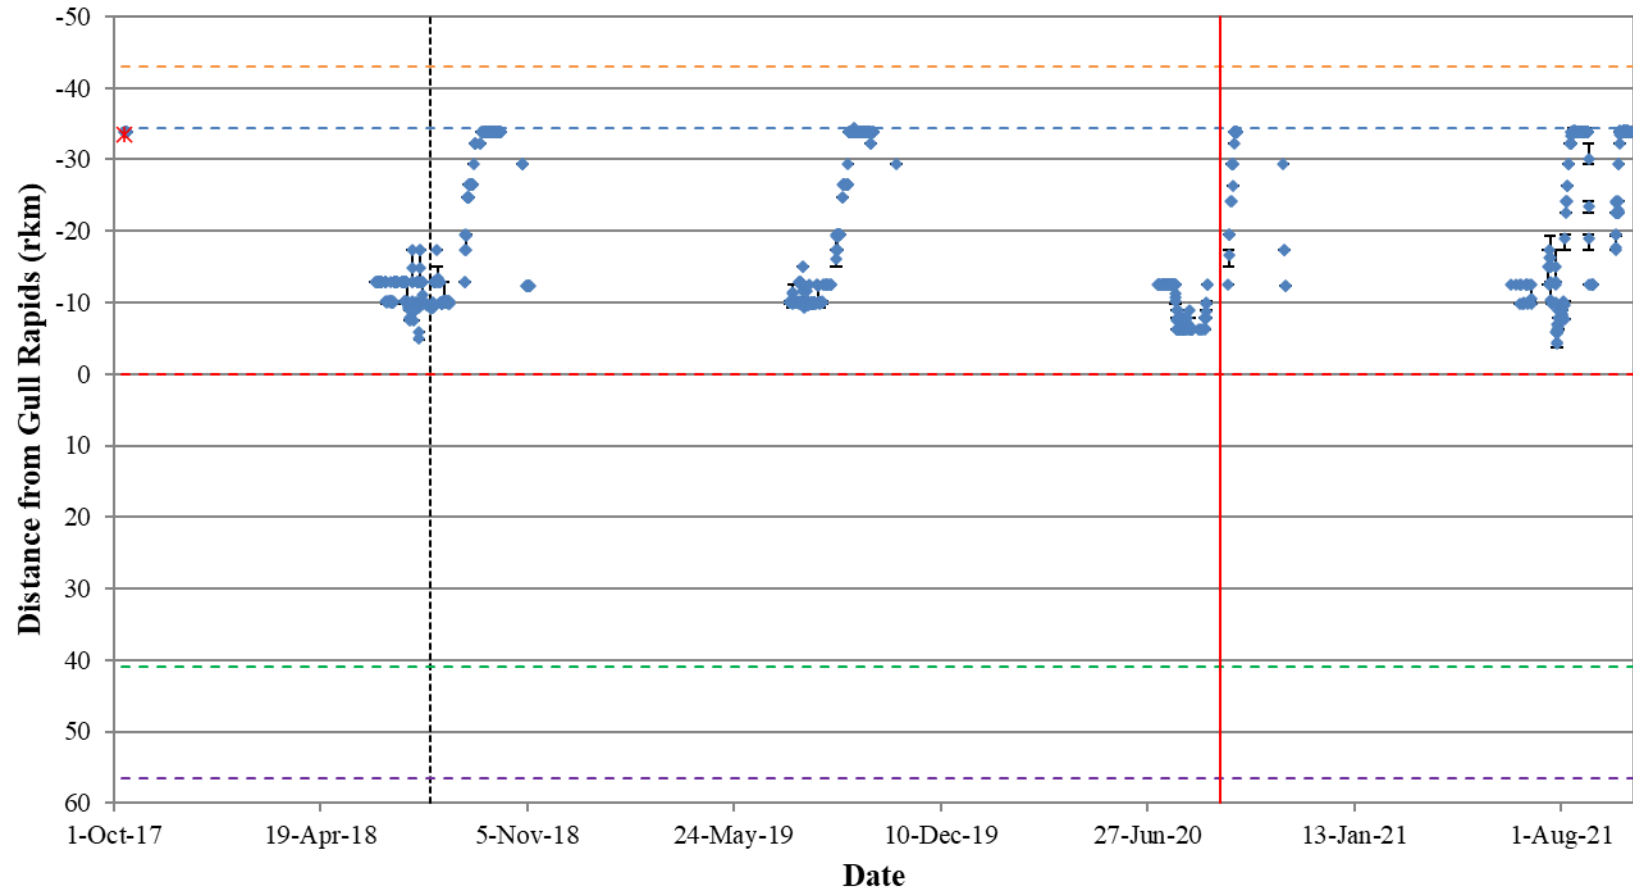
Figure A2-21: Position of a Lake Whitefish tagged with an acoustic transmitter (code #31745) in the Nelson River between Clark Lake and the Keeyask GS, in relation to the Keeyask GS (rkm 0), from October 2017 to October 2021. The date and location of tagging are indicated by a red star. Horizontal dotted lines indicate locations of landmarks (orange = Clark Lake outlet; blue = Birthday Rapids, red = Keeyask GS; green = Kettle GS, purple = Long Spruce GS). Vertical black dotted line indicates start of spillway operation (August 3, 2018). Vertical solid red line indicates the completion of reservoir impoundment (September 5, 2020).

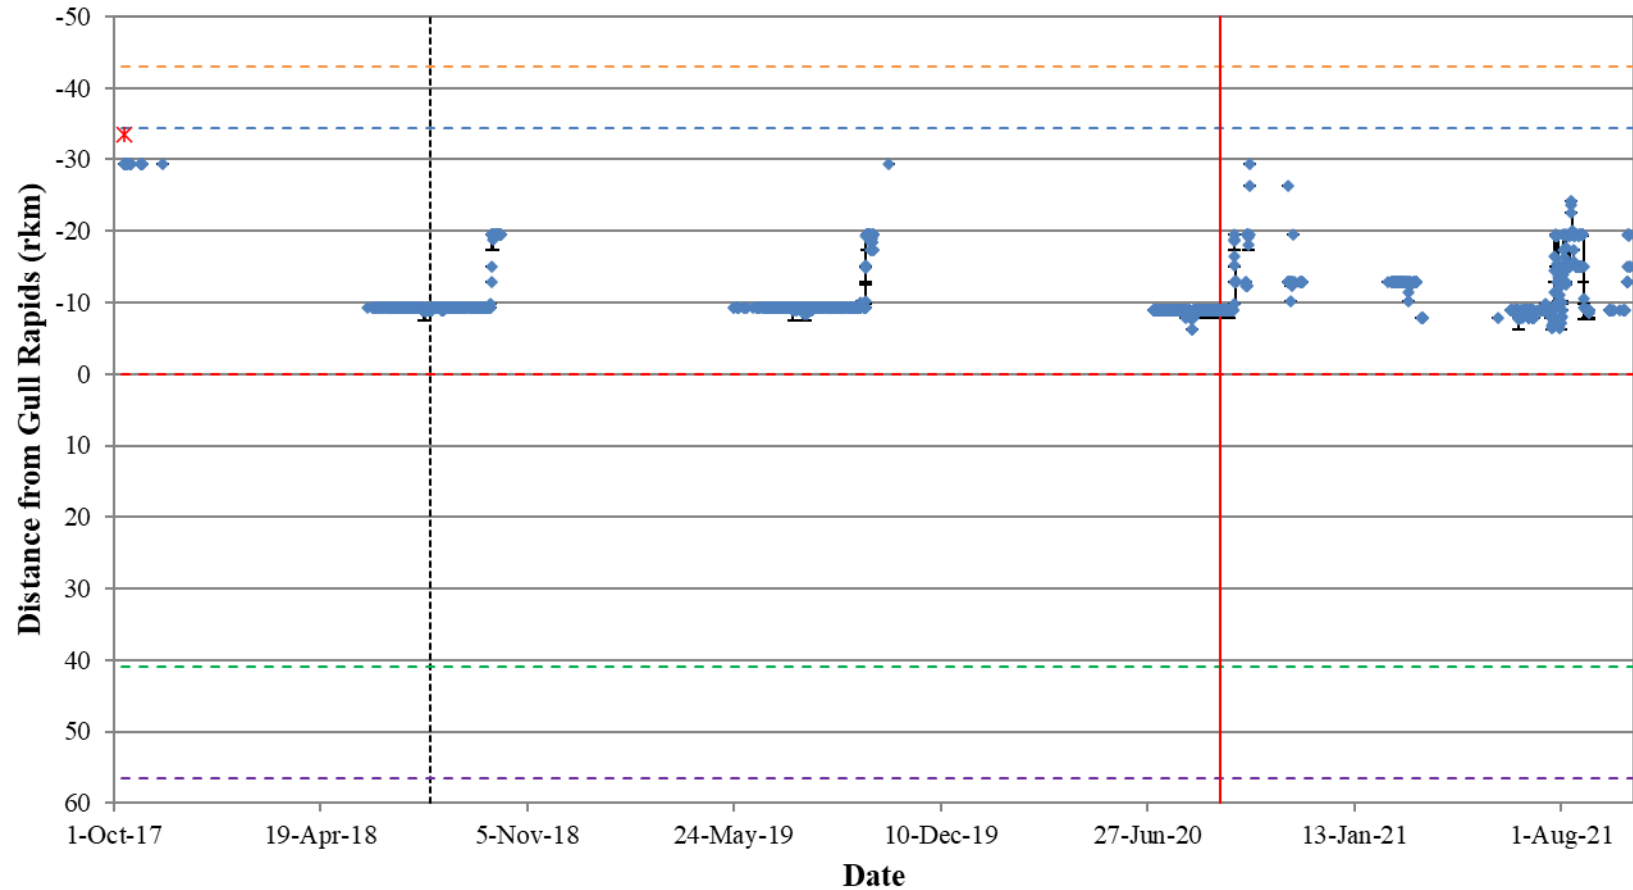
Figure A2-21: Position of a Lake Whitefish tagged with an acoustic transmitter (code #31746) in the Nelson River between Clark Lake and the Keeyask GS, in relation to the Keeyask GS (rkm 0), from October 2017 to October 2021. The date and location of tagging are indicated by a red star. Horizontal dotted lines indicate locations of landmarks (orange = Clark Lake outlet; blue = Birthday Rapids, red = Keeyask GS; green = Kettle GS, purple = Long Spruce GS). Vertical black dotted line indicates start of spillway operation (August 3, 2018). Vertical solid red line indicates the completion of reservoir impoundment (September 5, 2020).

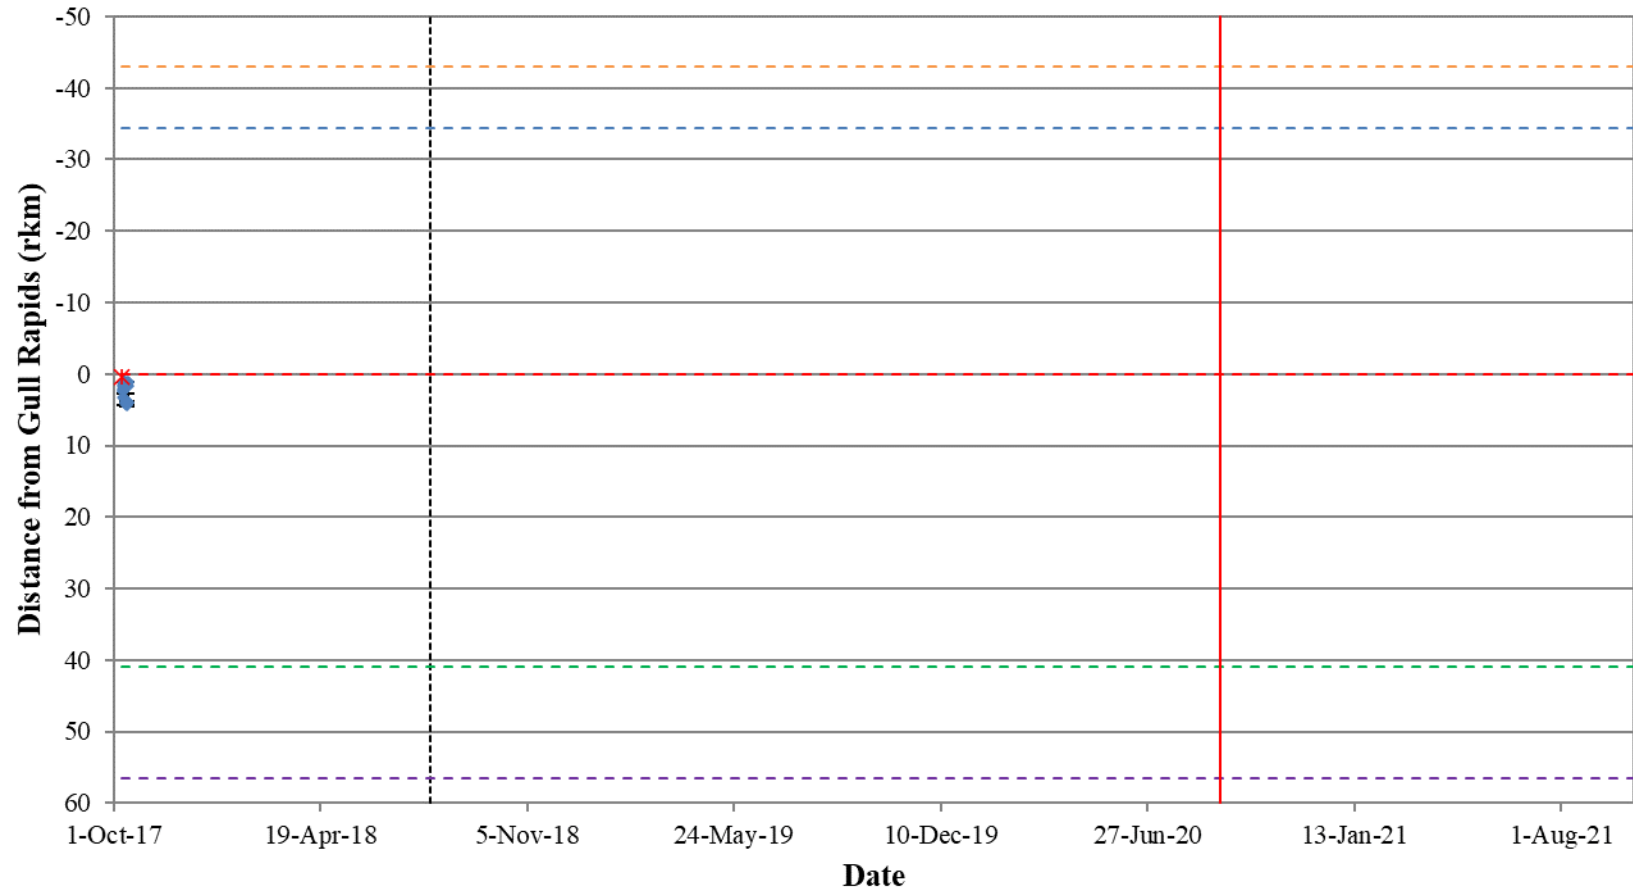
Figure A3-1: Position of a Lake Whitefish tagged with an acoustic transmitter (code #31698) in Stephens Lake, in relation to the Keeyask GS (rkm 0), from October 2017 to October 2021. The date and location of tagging are indicated by a red star. Horizontal dotted lines indicate locations of landmarks (orange = Clark Lake outlet; blue = Birthday Rapids, red = Keeyask GS; green = Kettle GS, purple = Long Spruce GS). Vertical black dotted line indicates start of spillway operation (August 3, 2018). Vertical solid red line indicates the completion of reservoir impoundment (September 5, 2020).

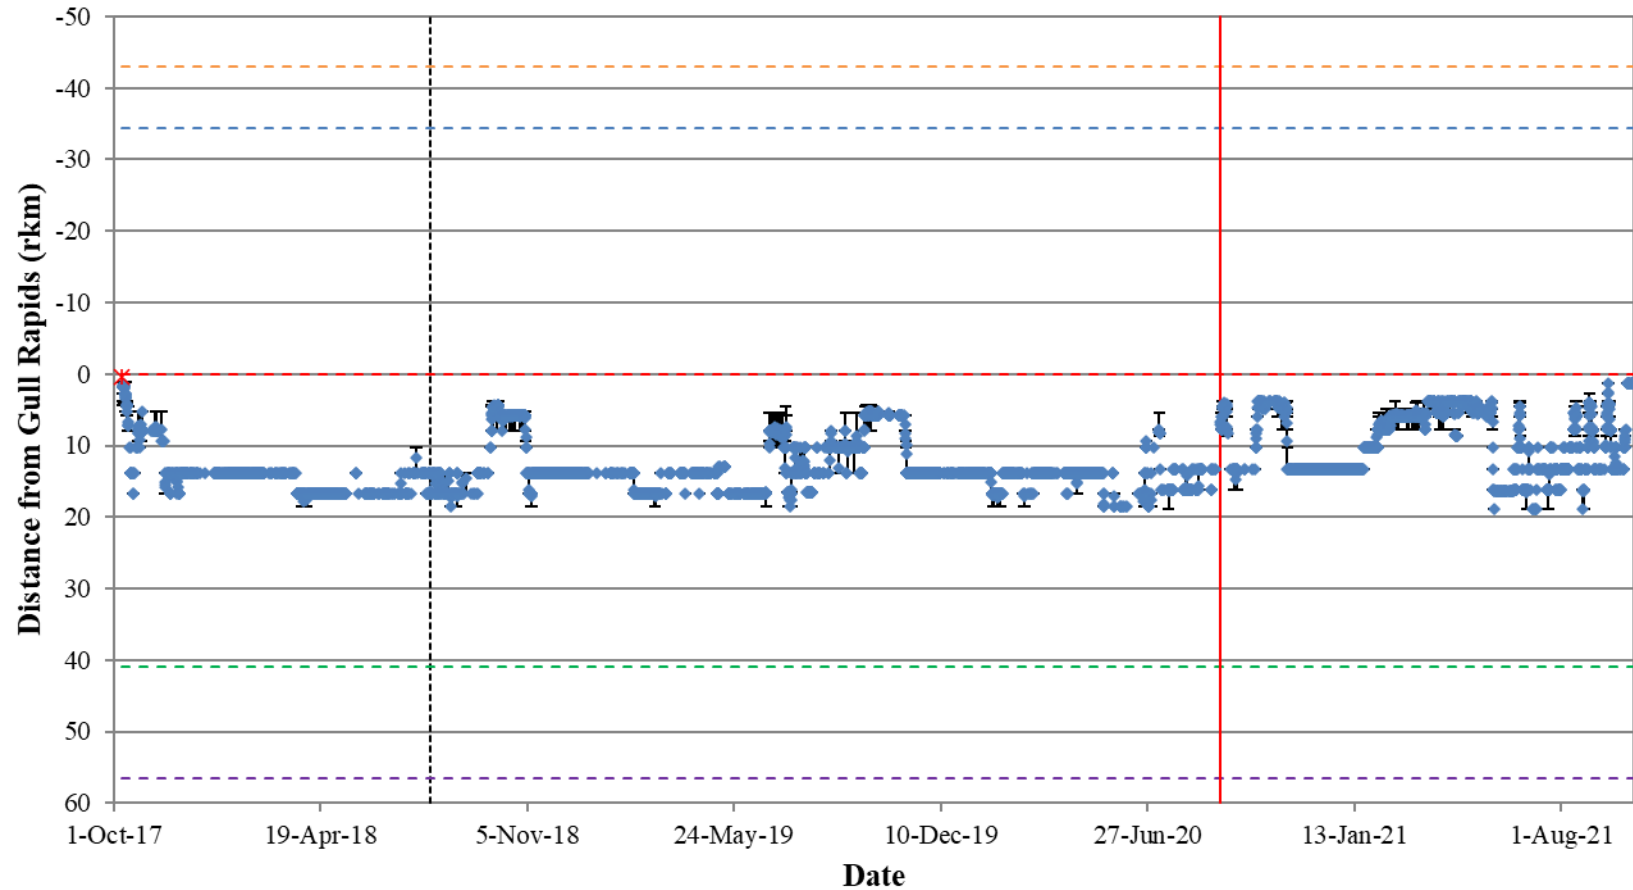
Figure A3-2: Position of a Lake Whitefish tagged with an acoustic transmitter (code #31699) in Stephens Lake, in relation to the Keeyask GS (rkm 0), from October 2017 to October 2021. The date and location of tagging are indicated by a red star. Horizontal dotted lines indicate locations of landmarks (orange = Clark Lake outlet; blue = Birthday Rapids, red = Keeyask GS; green = Kettle GS, purple = Long Spruce GS). Vertical black dotted line indicates start of spillway operation (August 3, 2018). Vertical solid red line indicates the completion of reservoir impoundment (September 5, 2020).

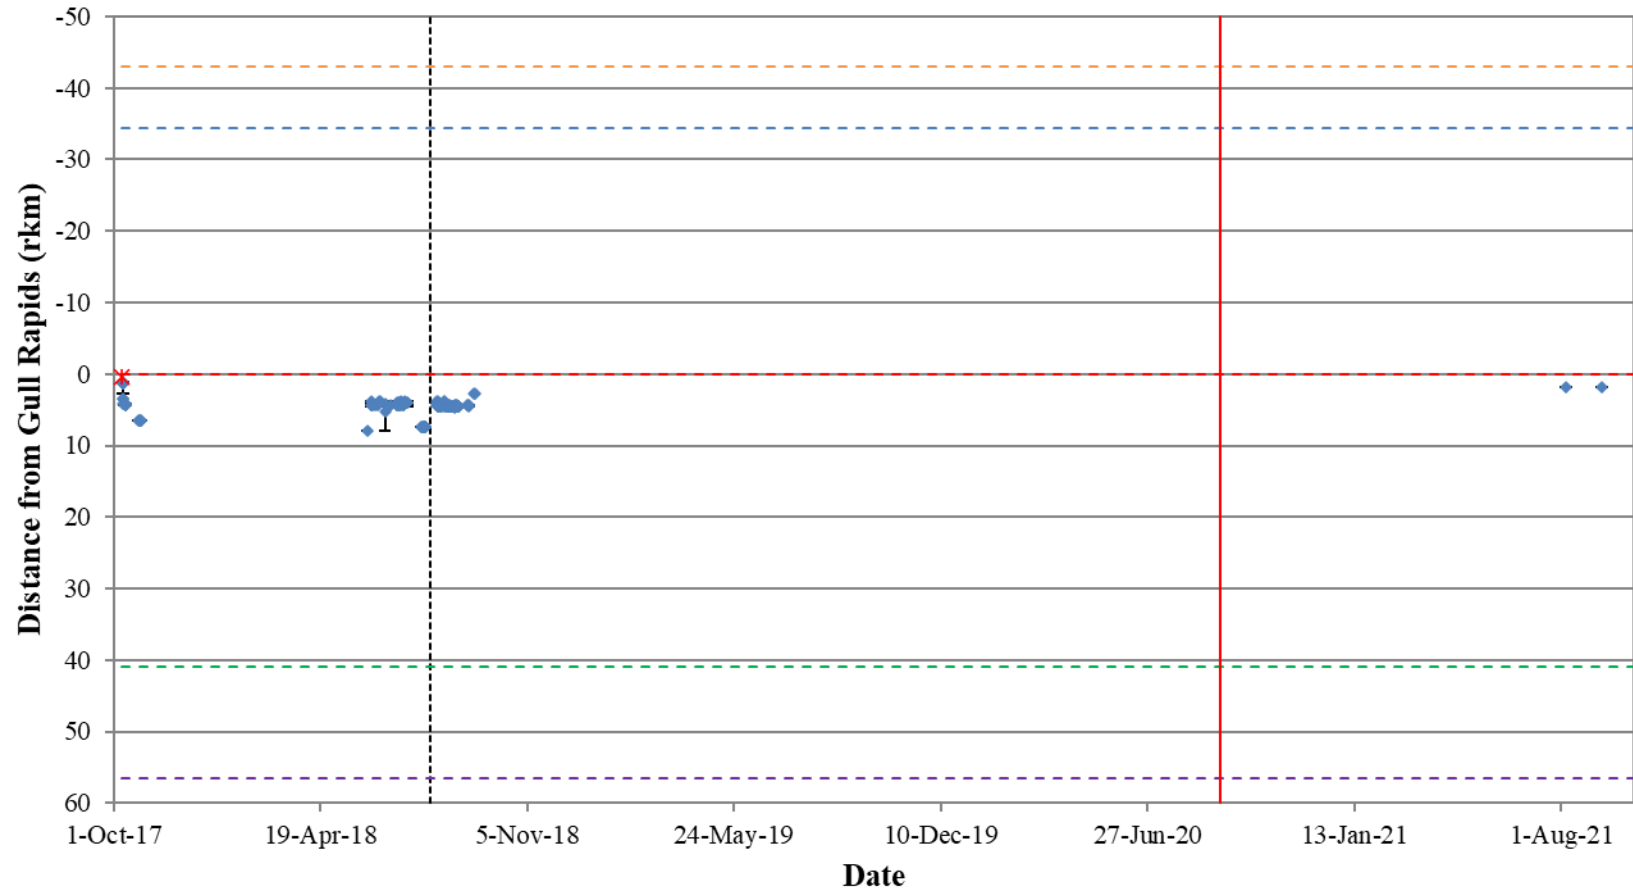
Figure A3-3: Position of a Lake Whitefish tagged with an acoustic transmitter (code #31700) in Stephens Lake, in relation to the Keeyask GS (rkm 0), from October 2017 to October 2021. The date and location of tagging are indicated by a red star. Horizontal dotted lines indicate locations of landmarks (orange = Clark Lake outlet; blue = Birthday Rapids, red = Keeyask GS; green = Kettle GS, purple = Long Spruce GS). Vertical black dotted line indicates start of spillway operation (August 3, 2018). Vertical solid red line indicates the completion of reservoir impoundment (September 5, 2020).

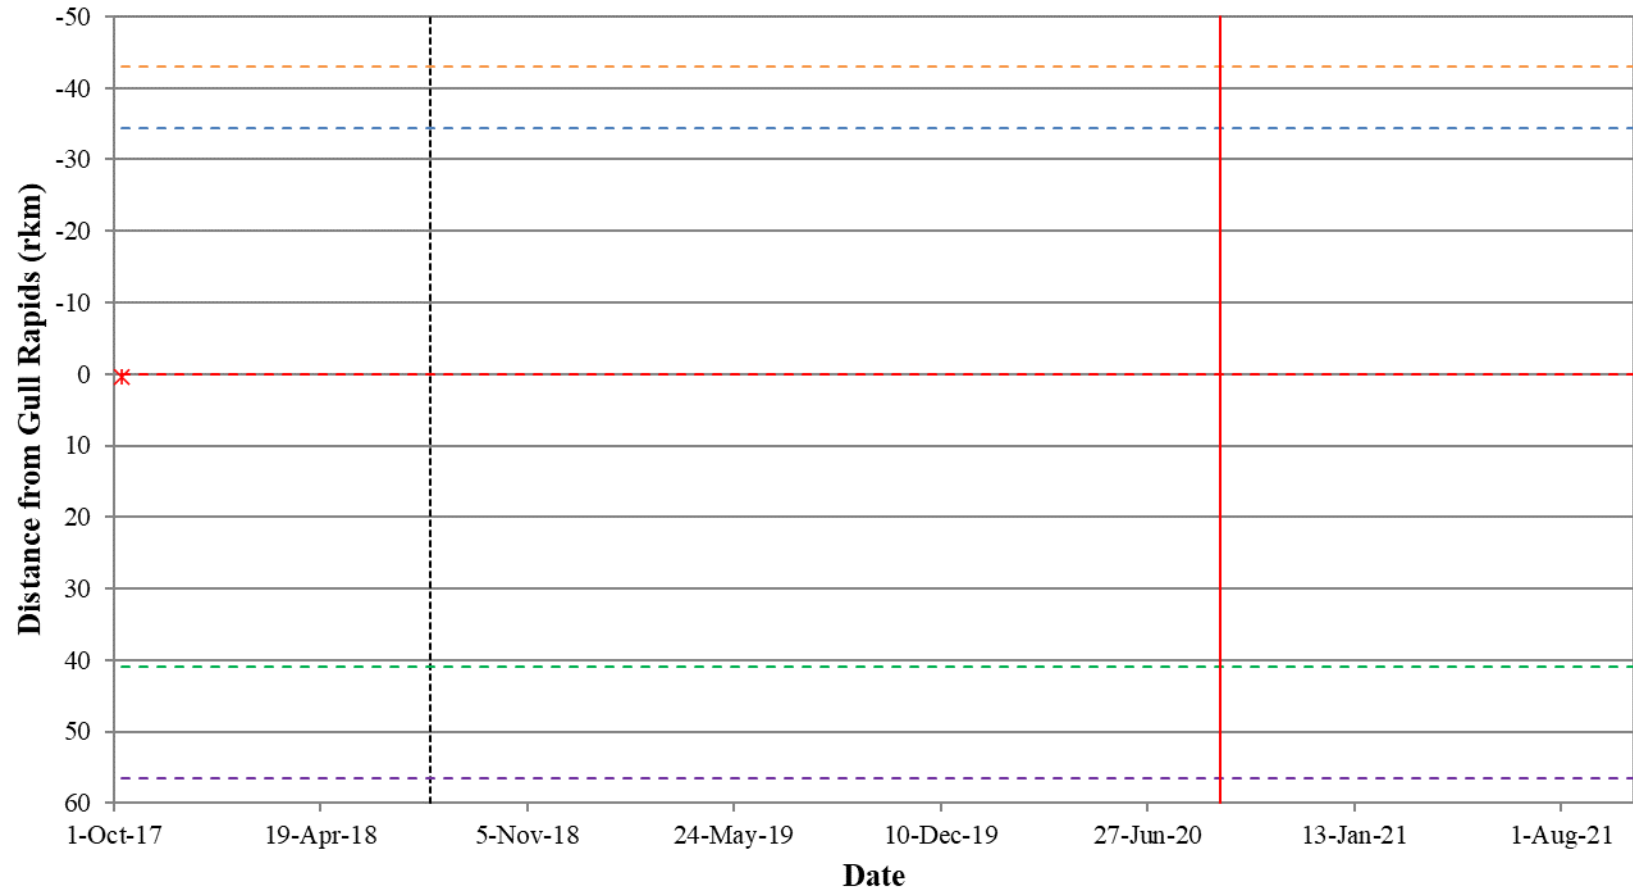
Figure A3-4: Position of a Lake Whitefish tagged with an acoustic transmitter (code #31701) in Stephens Lake, in relation to the Keeyask GS (rkm 0), from October 2017 to October 2021. The date and location of tagging are indicated by a red star. Horizontal dotted lines indicate locations of landmarks (orange = Clark Lake outlet; blue = Birthday Rapids, red = Keeyask GS; green = Kettle GS, purple = Long Spruce GS). Vertical black dotted line indicates start of spillway operation (August 3, 2018). Vertical solid red line indicates the completion of reservoir impoundment (September 5, 2020).
