Keeyask Generation Project Aquatic Effects Monitoring Plan

Sensitive and Constructed Habitat Monitoring Report

AEMP-2022-15

SENSITIVE AND CONSTRUCTED HABITAT MONITORING IN THE KEYYASK STUDY AREA, 2021

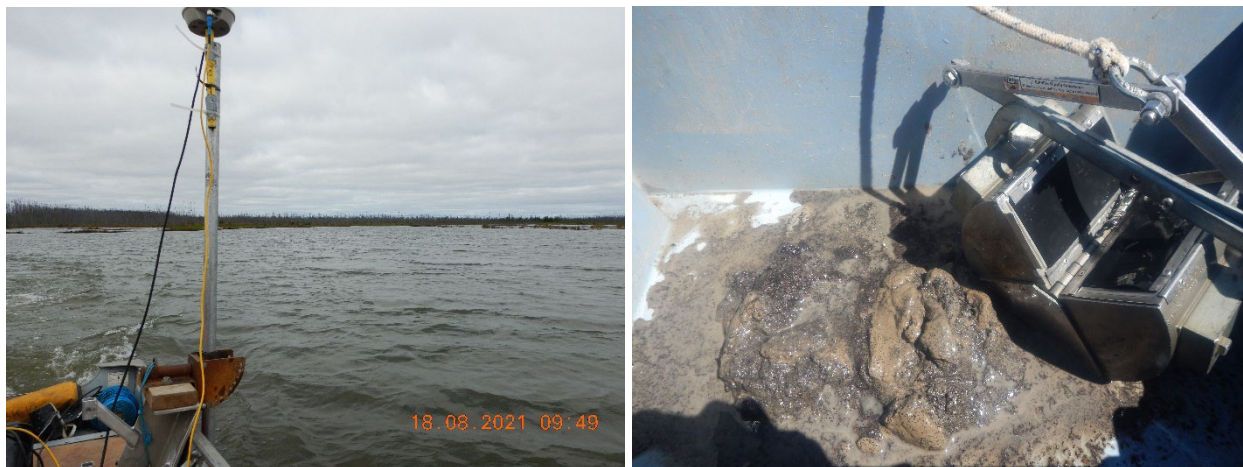
Setup of acoustic equipment (left) and Ponar dredge substrate sampler (right) used to monitor sensitive and constructed habitats in the Keeyask reservoir and Stephens Lake in 2021.

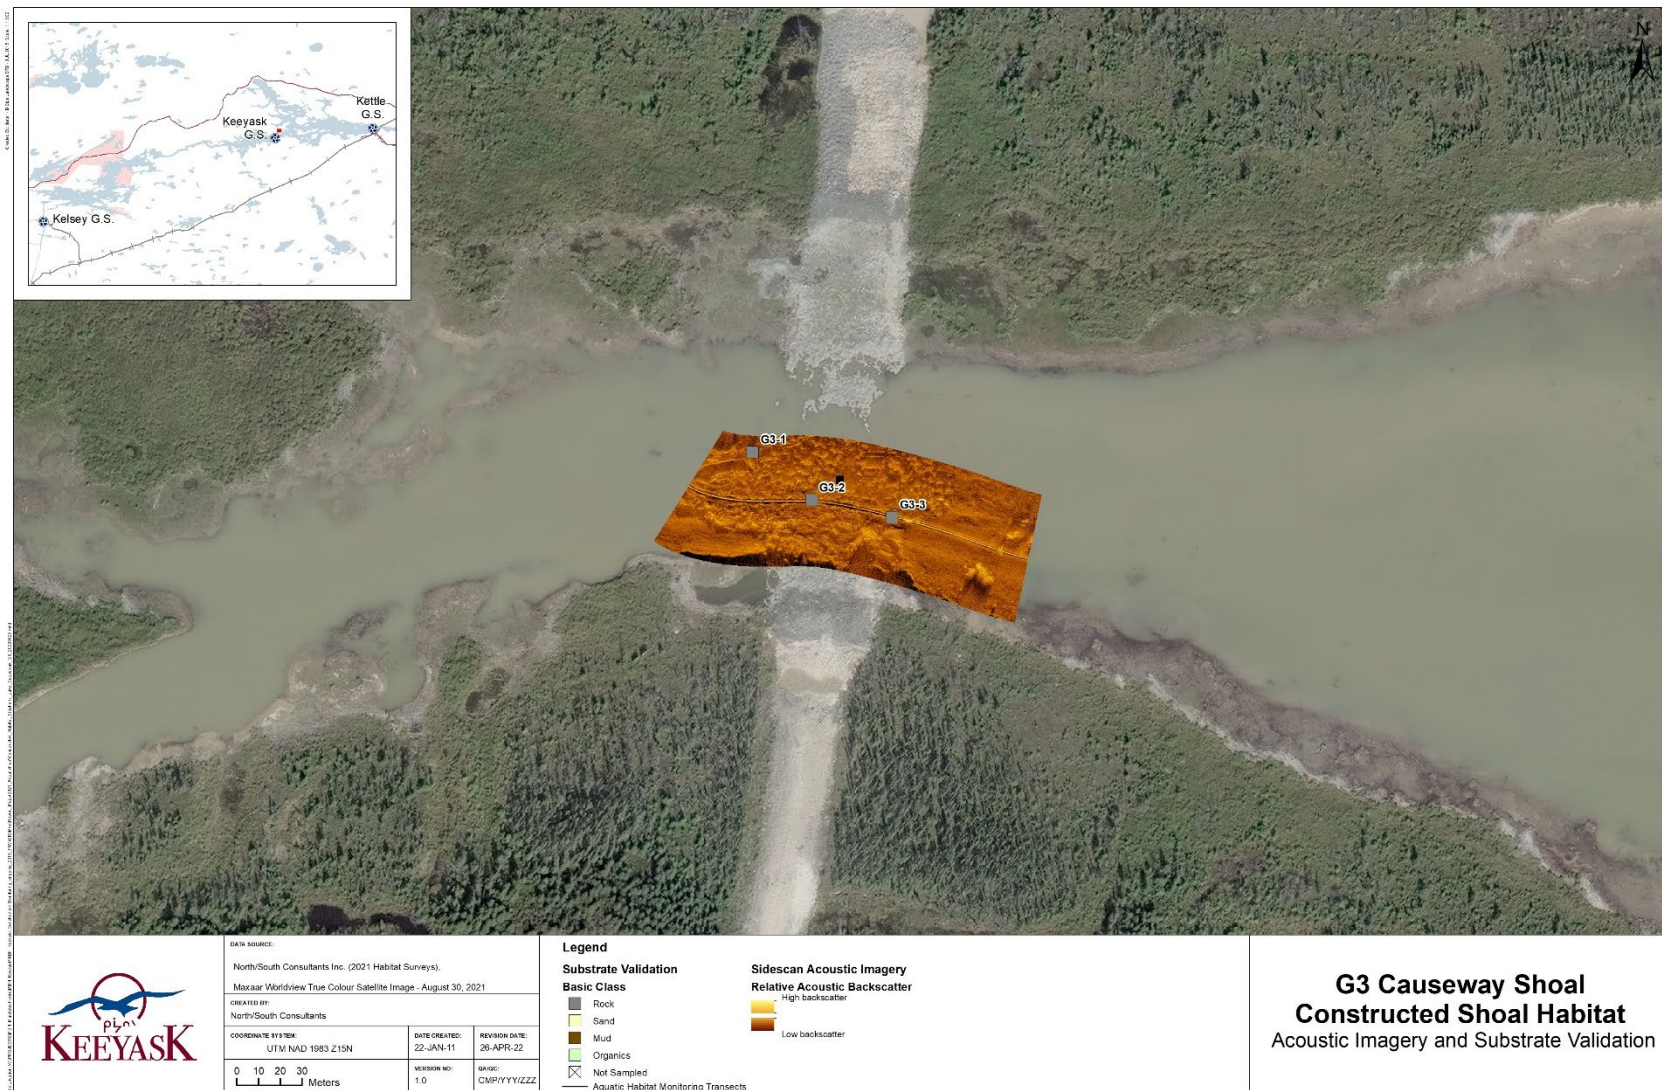
Five pre-selected bottom type validation sites were sampled at the N5 causeway and three at the G3 causeway using a weighted sounding line (Table 20; Maps 25 and 26). Hard boulder substrate was observed at all sites and were confirmed with sidescan imagery. No silt was observed.

Map 26: Map illustrating the results of substrate composition sampling sites and acoustic imaging for the G3 causeway shoal in Stephens Lake, 2021.

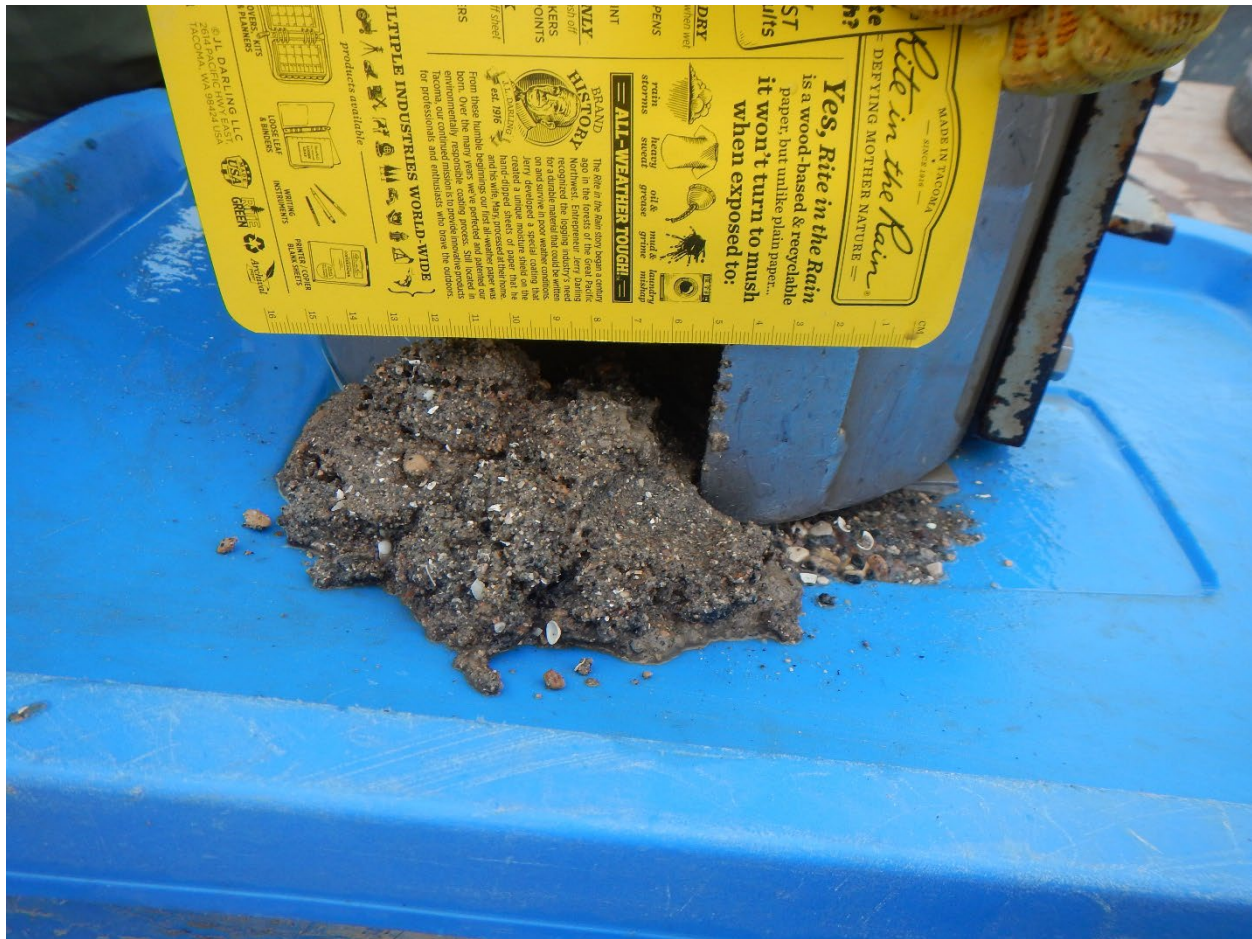
Photo 1: Substrate collected at site DST3-33 in the area of the Keeyask reservoir surrounding Caribou Island showing sand.

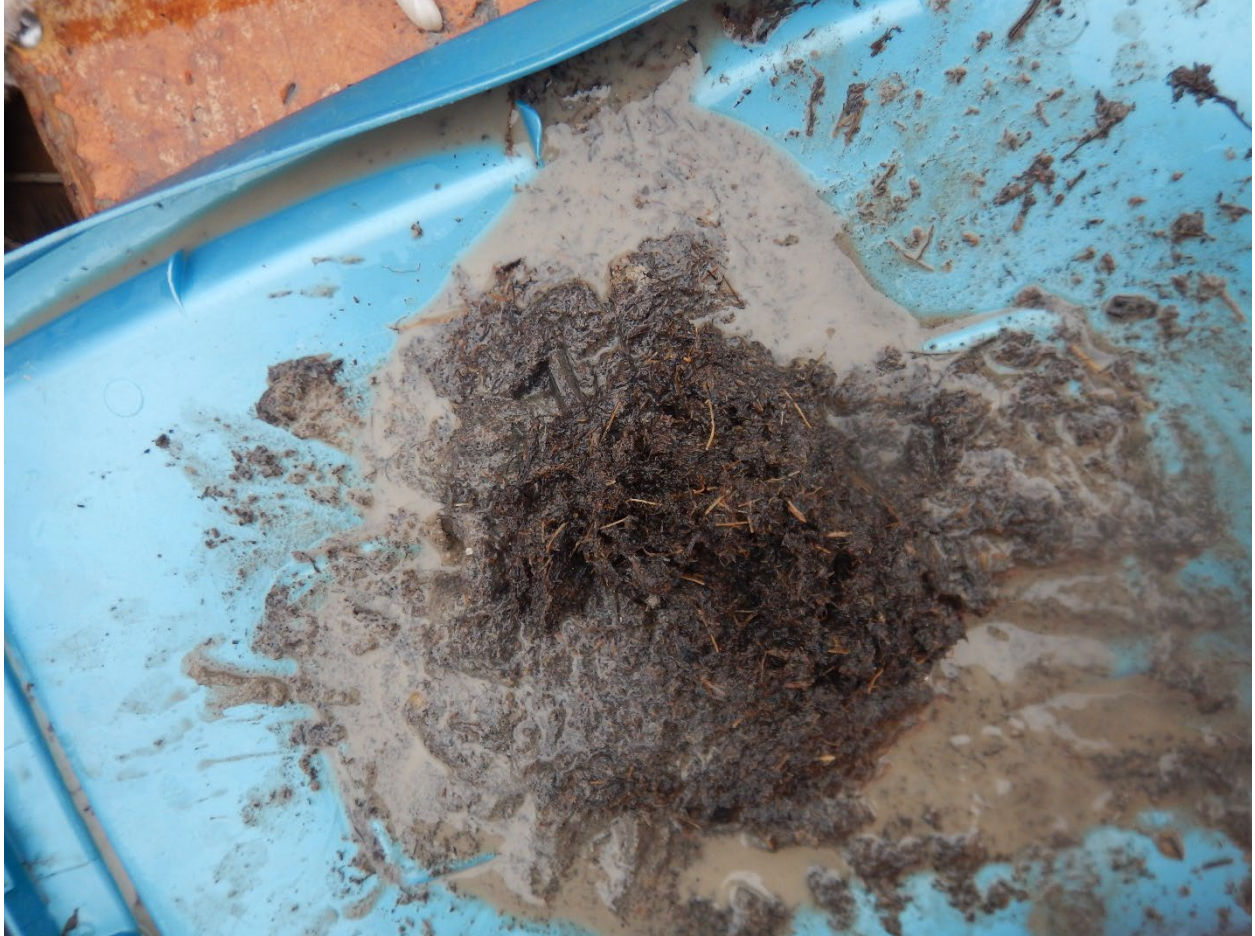
the spring sampling period, beginning approximately half-way through the study area. Organics were evident at ten sampling sites, consisting of detritus and loose, broken-down plant matter (Photo 2).

Photo 2: Substrate collected at site T3-4 in the upper Stephens Lake sensitive habitat area in June 2021 showing organics and silt.
