Keeyask Generation Project Aquatic Effects Monitoring Plan

Development of Nearshore and Aquatic Macrophyte Habitat Report

AEMP-2022-16

DEVELOPMENT OF NEARSHORE AND AQUATIC MACROPHYTE HABITAT IN THE KEYYASK STUDY AREA, 2021

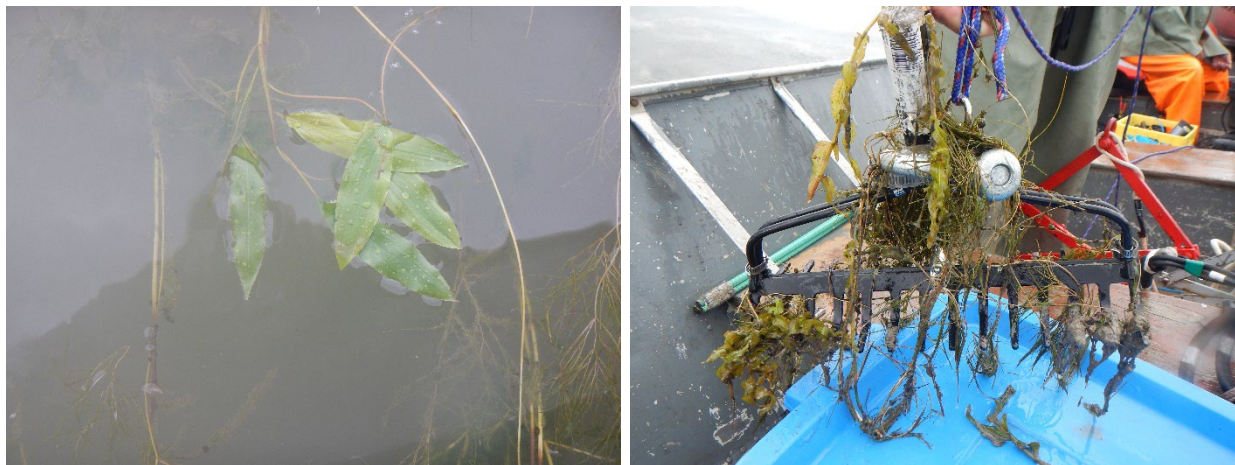
Aquatic plants as seen from the boat (left) and sampled (right).

Substrate composition (what the bottom is made of) and aquatic plant presence were monitored in 12 general areas including nine upstream of the Keeyask GS in the new reservoir and three downstream in Stephens Lake. The results were compared to the substrate composition of an old reservoir (Stephens Lake), which is considered an example of what the Keeyask reservoir will look like over time (map below). Aquatic plants were sampled using a sampling rake (photo above) and identified.

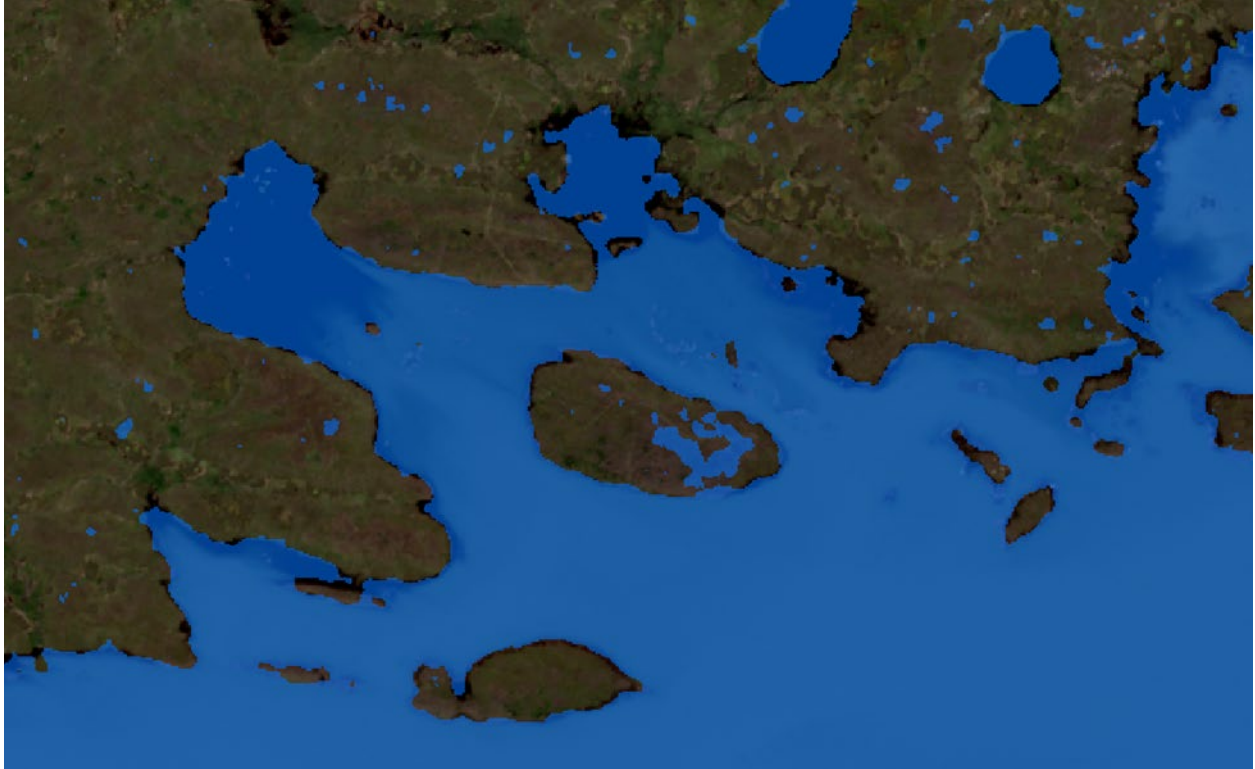
Figure 2: Image of SAR June 12, 2021 threshold value of -18.5 dB used to discriminate water (blue) from land (June 14, 2021 Sentinel-2 image in background) in the Keeyask GS reservoir near the Hidden Creek (MS7) nearshore monitoring site. Note that the method often underestimates open water extent closer to shore, while overestimating water over floating peat, debris, and wetland targets likely saturated with water.

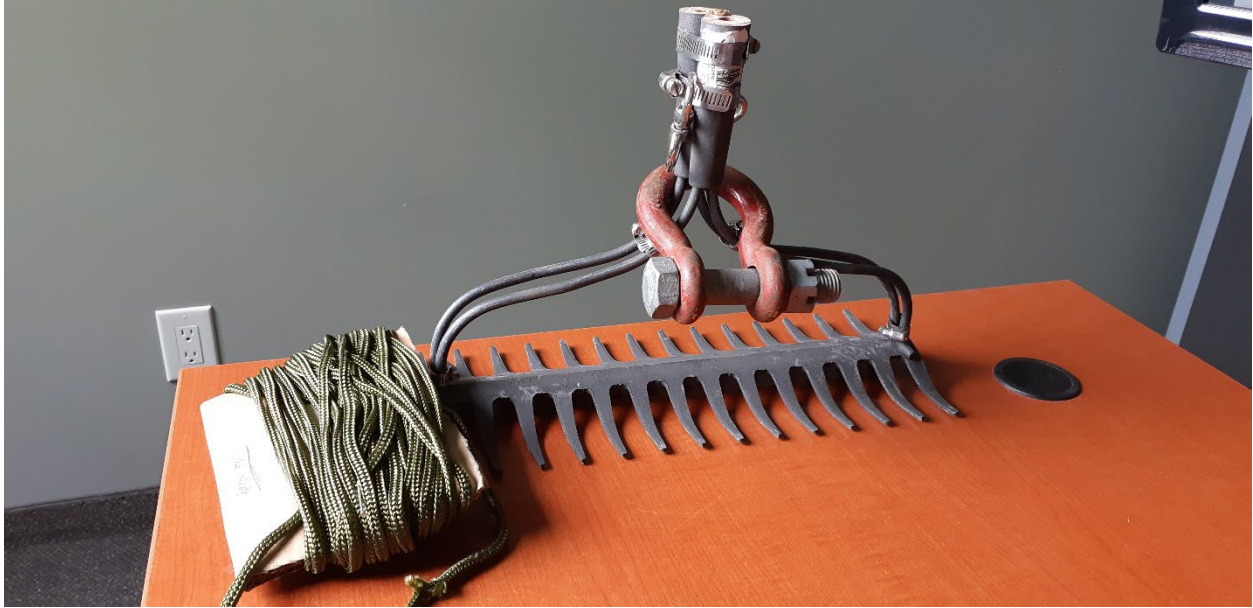
Photo 1: Image of the weighted double headed rake sampler.

Aquatic plants were identified on site based on presence/absence. Relative abundance of aquatic plants at each site was assessed as absent (0), sparse (1), common (2) or abundant (3), and then the proportion of each species within the sample was estimated (1–100%; Dawson *et al.* 2020). In each area, the species of plants were identified as emergent, submergent, and floating. Macroalgae (*Chara* spp. and *Nitella* spp.), filamentous algae, aquatic mosses, and free-floating vascular plants (*Lemna* spp.) were also recorded if observed. A weighted rake sampler was used at each site to assess the relative abundance of the submerged aquatic plants (Figure 1; Hauxwell *et al.* 2010). The rake sampler consists of a double headed rake, constructed back-to-back with hose clamps and U-bolts with a heavy braided rope (10 m long) to assist in keeping the rake along the bottom (Photo 1).

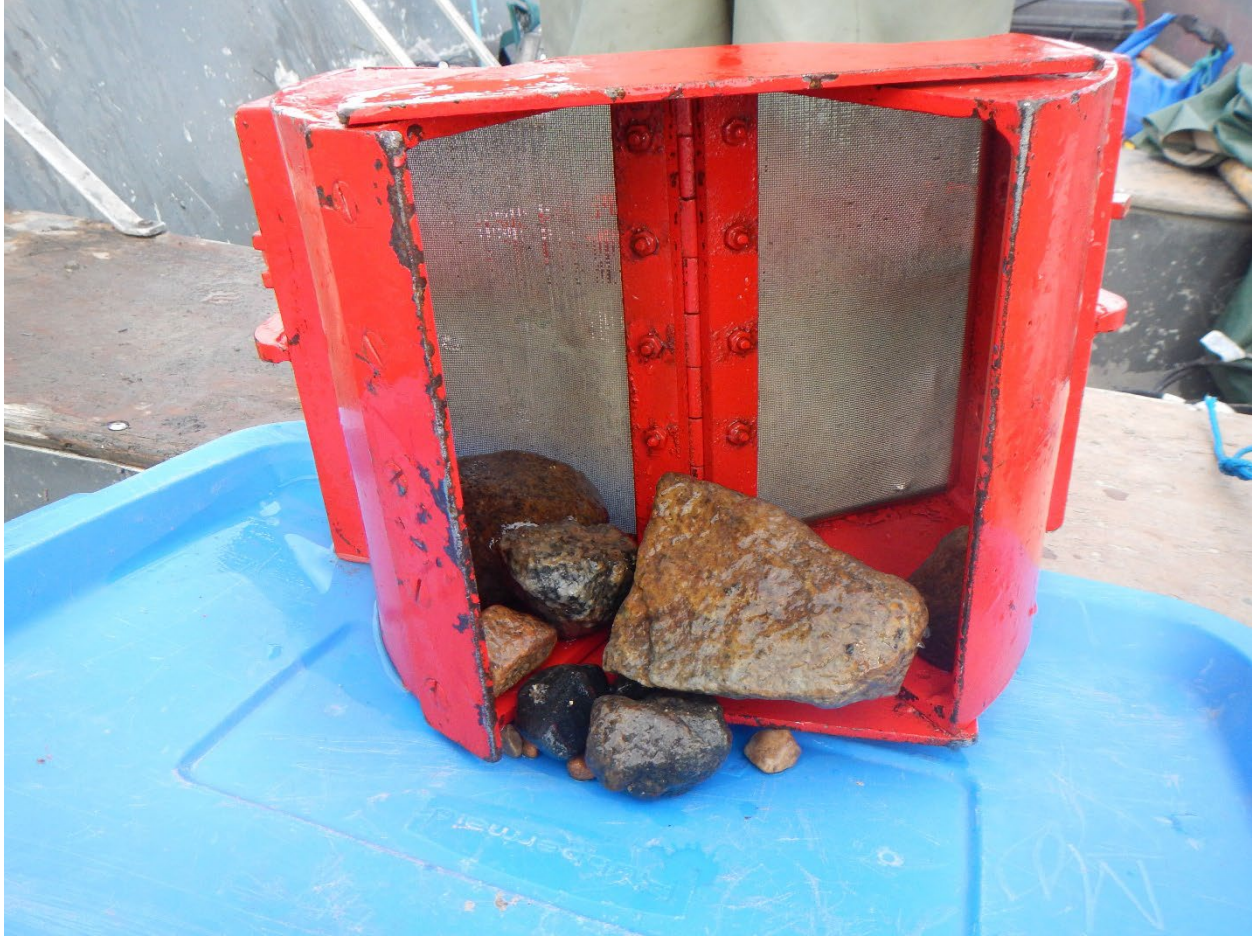
Photo 2: Substrate collected downstream of Birthday Rapids (MS2), showing cobble with smaller gravel substrate.

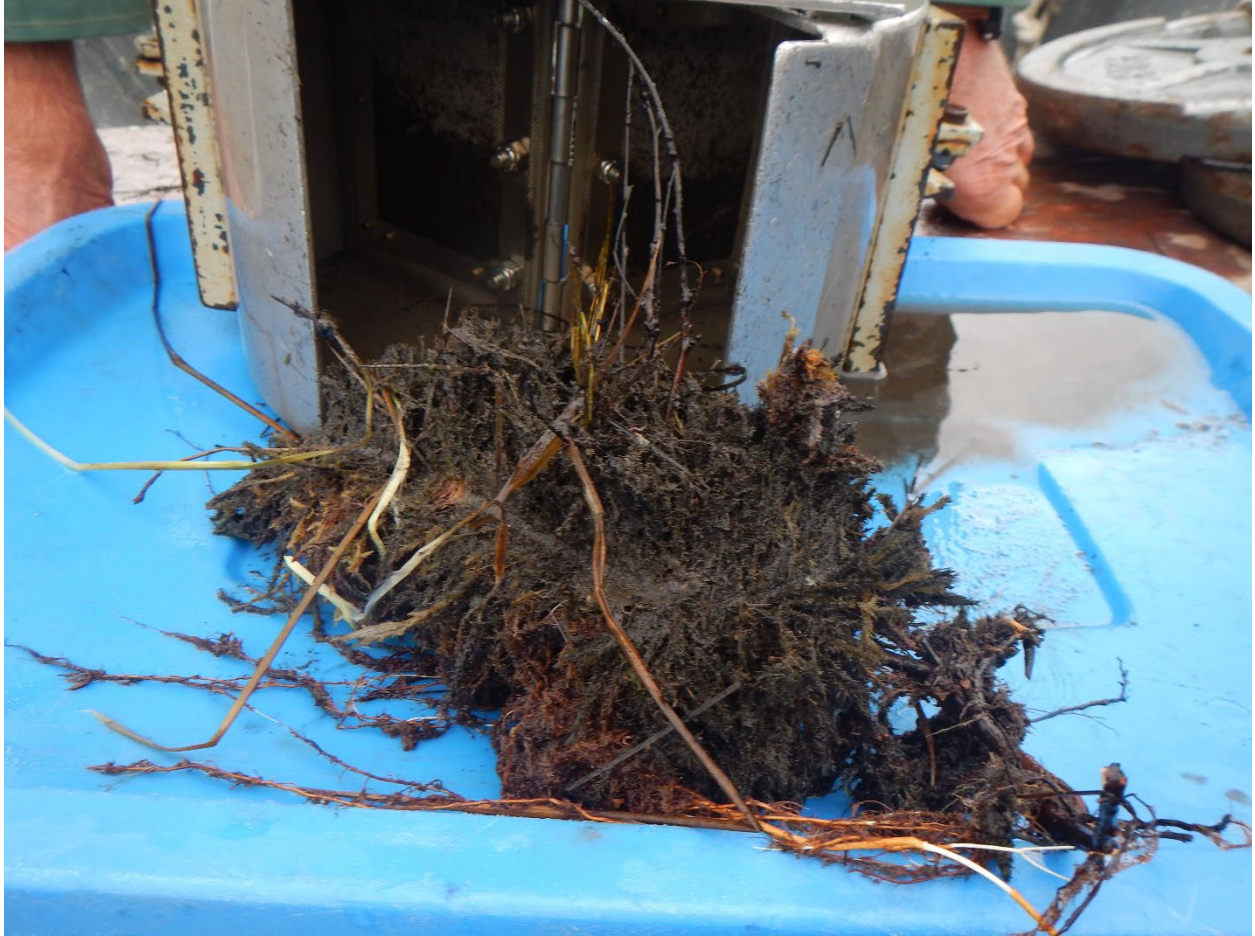
Photo 3: Substrate collected in the Keeyask reservoir backbay Zone 12 (MS4) showing organic matter.

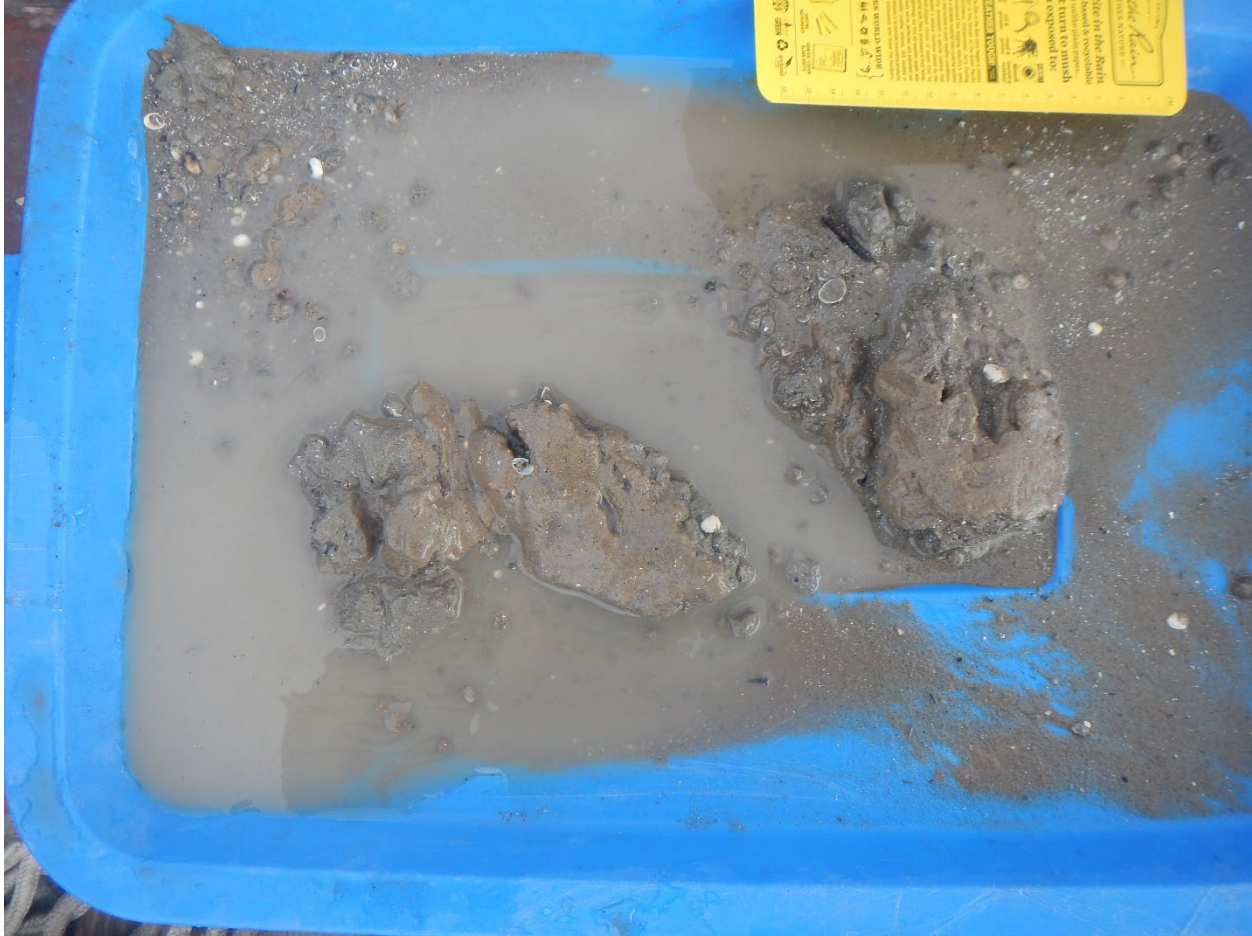
Photo 4: Substrate collected in the lower Keeyask reservoir (MS9), showing sand/silt substrate.

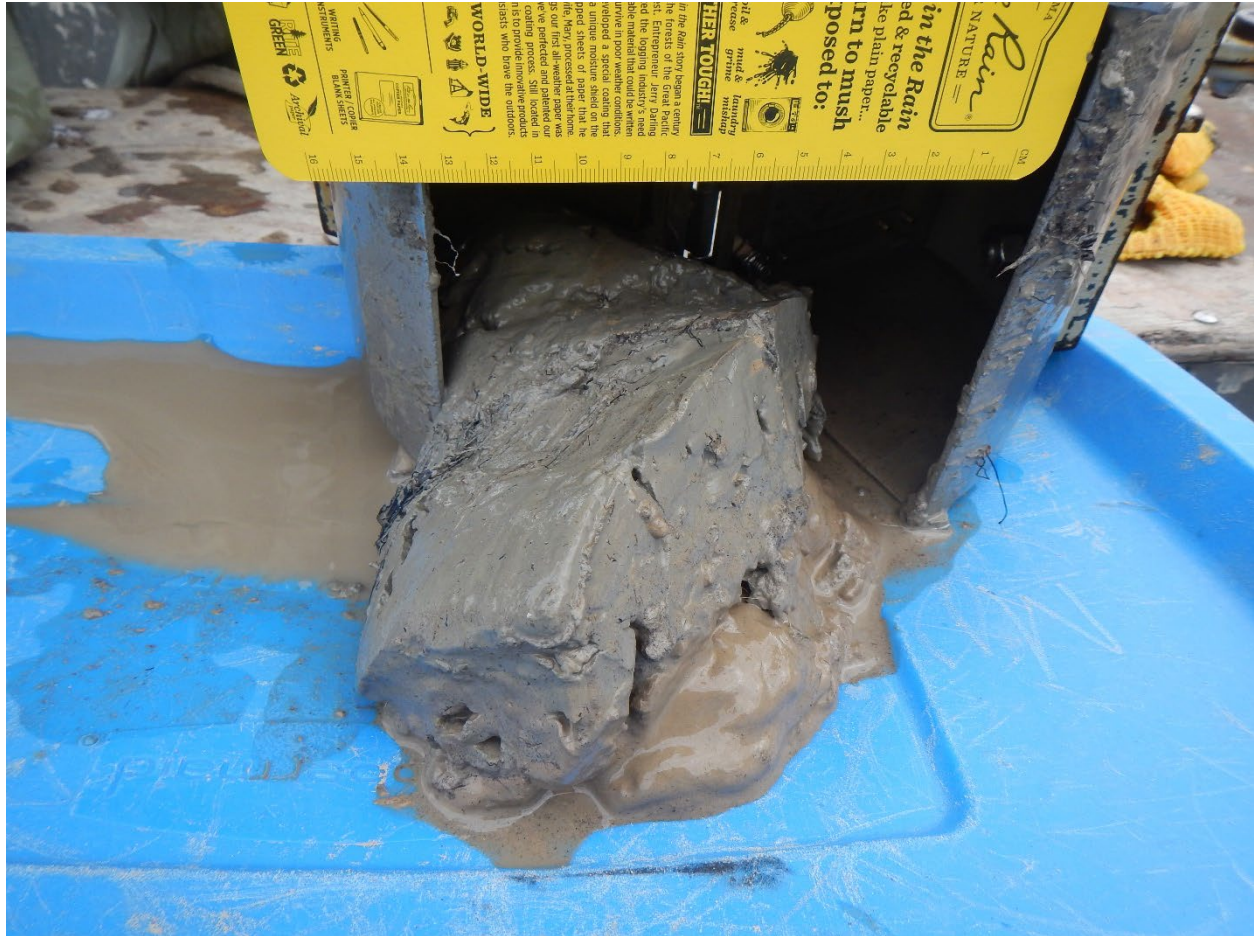
Photo 5: Substrate collected in Stephens Lake (MS10), showing silt/clay/sand and organic substrate.
