Keeyask Generation Project Aquatic Effects Monitoring Plan

Deep Water Substrate Composition Report

AEMP-2022-17

DEEP WATER SUBSTRATE COMPOSITION OF THE KEYYASK STUDY AREA, 2021

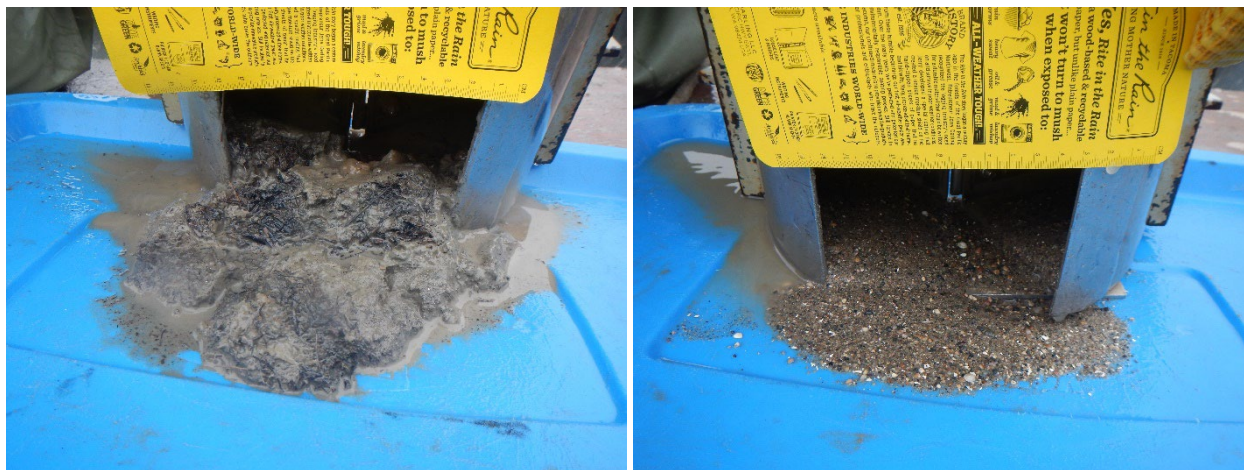
Silty (left) and sandy (right) substrates (river bottom) sampled in the Keeyask reservoir.

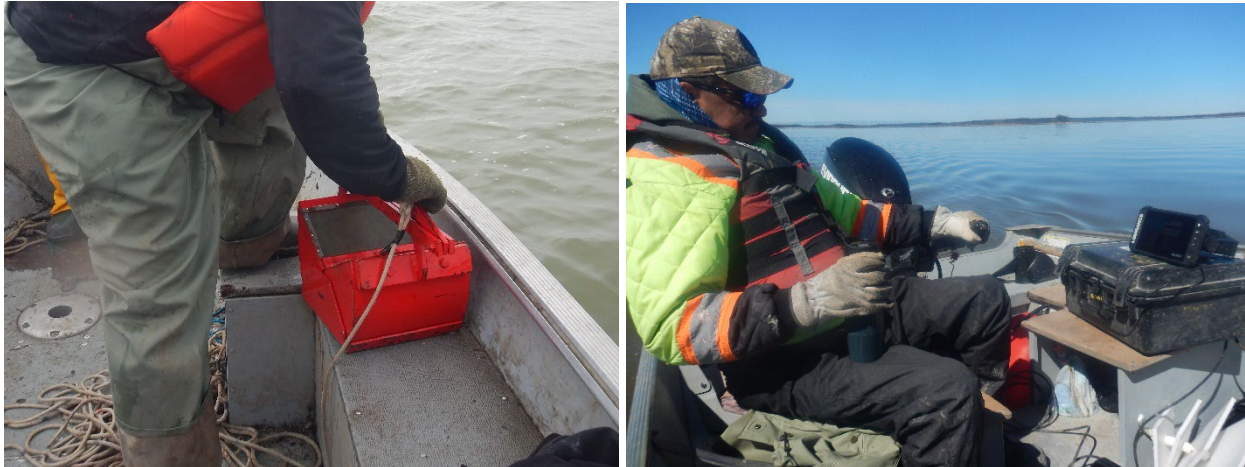
Ponar sampler (left) used to grab samples of substrate and acoustic monitor (right) used to map substrate types.

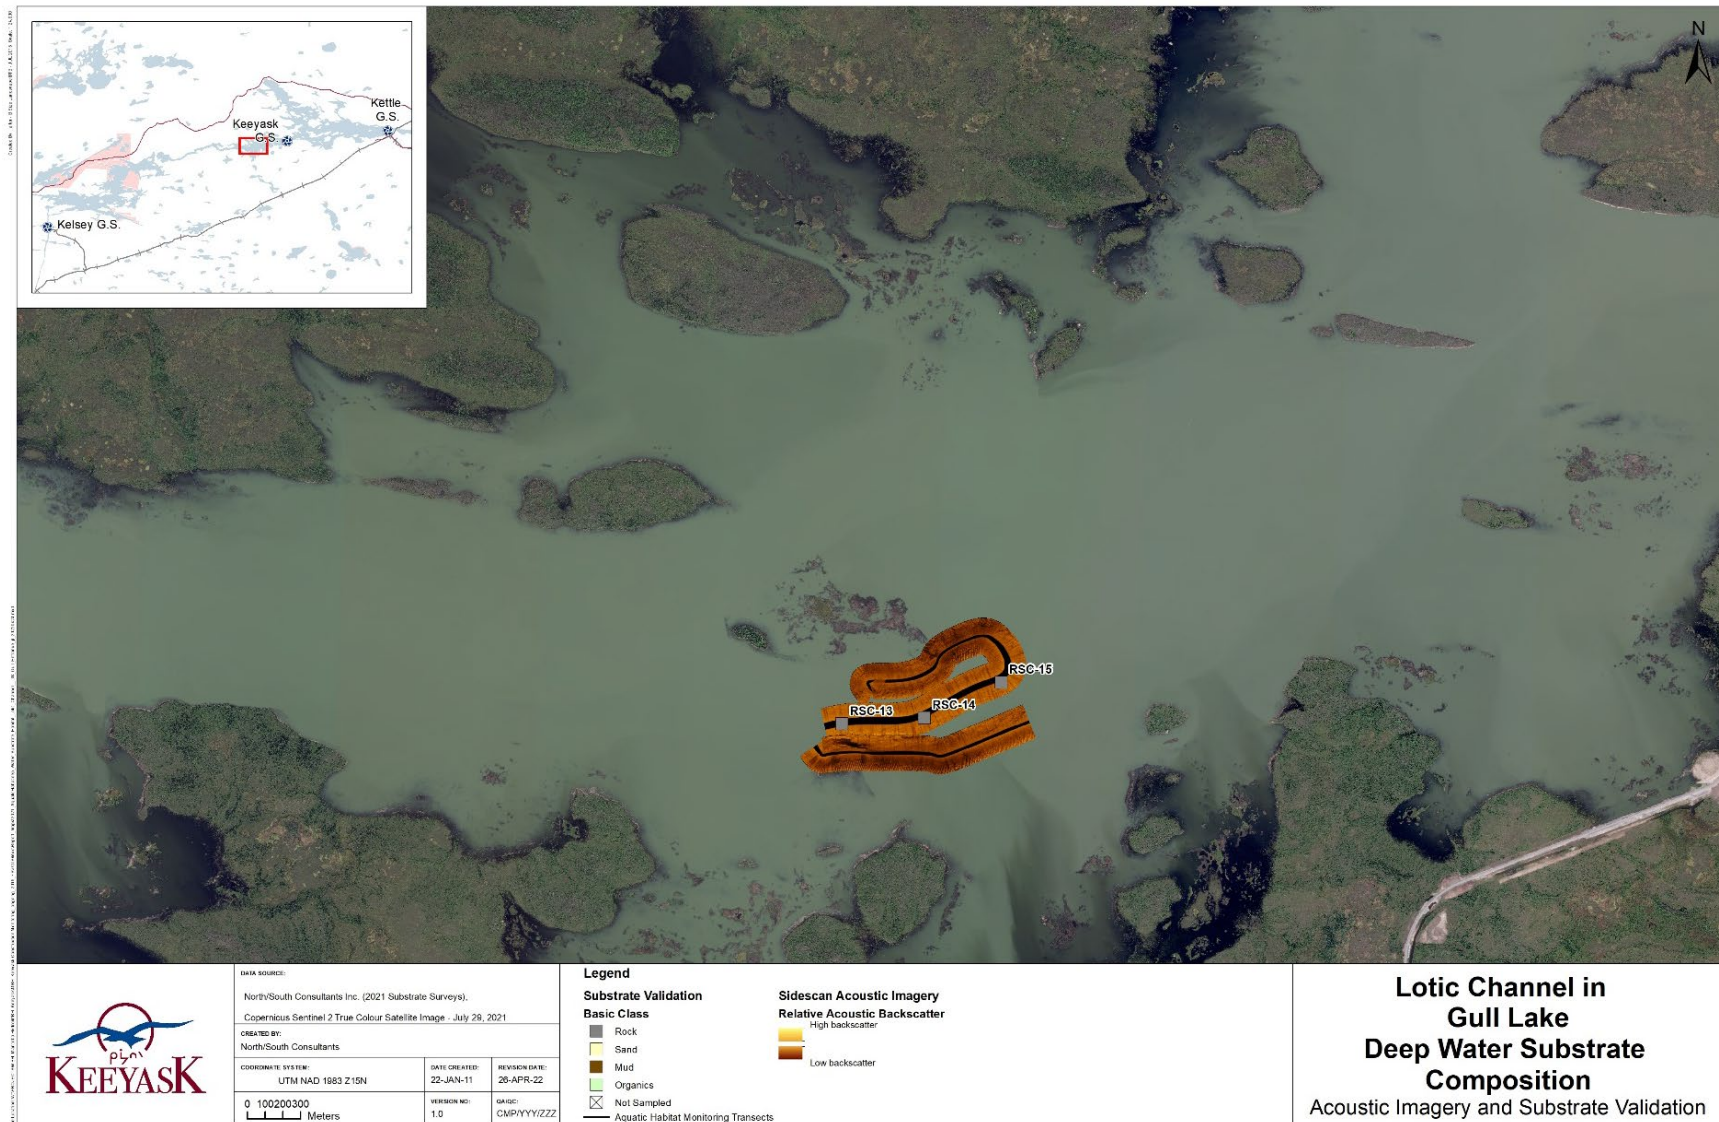
Map 6: Map illustrating the results of substrate composition sampling sites and acoustic imaging for the area of the Keeyask reservoir in the lotic channel downstream of the entrance to Gull Lake, 2021.

One additional area was surveyed within the lotic channel downstream of the Gull Lake entrance (Map 6). Three pre-selected bottom type validation sites were sampled using a weighted sounding line, and bedrock was observed at each site. Substrate mapping derived from analysis of sidescan image data indicated the area was largely composed of cobble and boulder but also contained small amounts of gravel (Table 3). No smaller substrate types were identified.

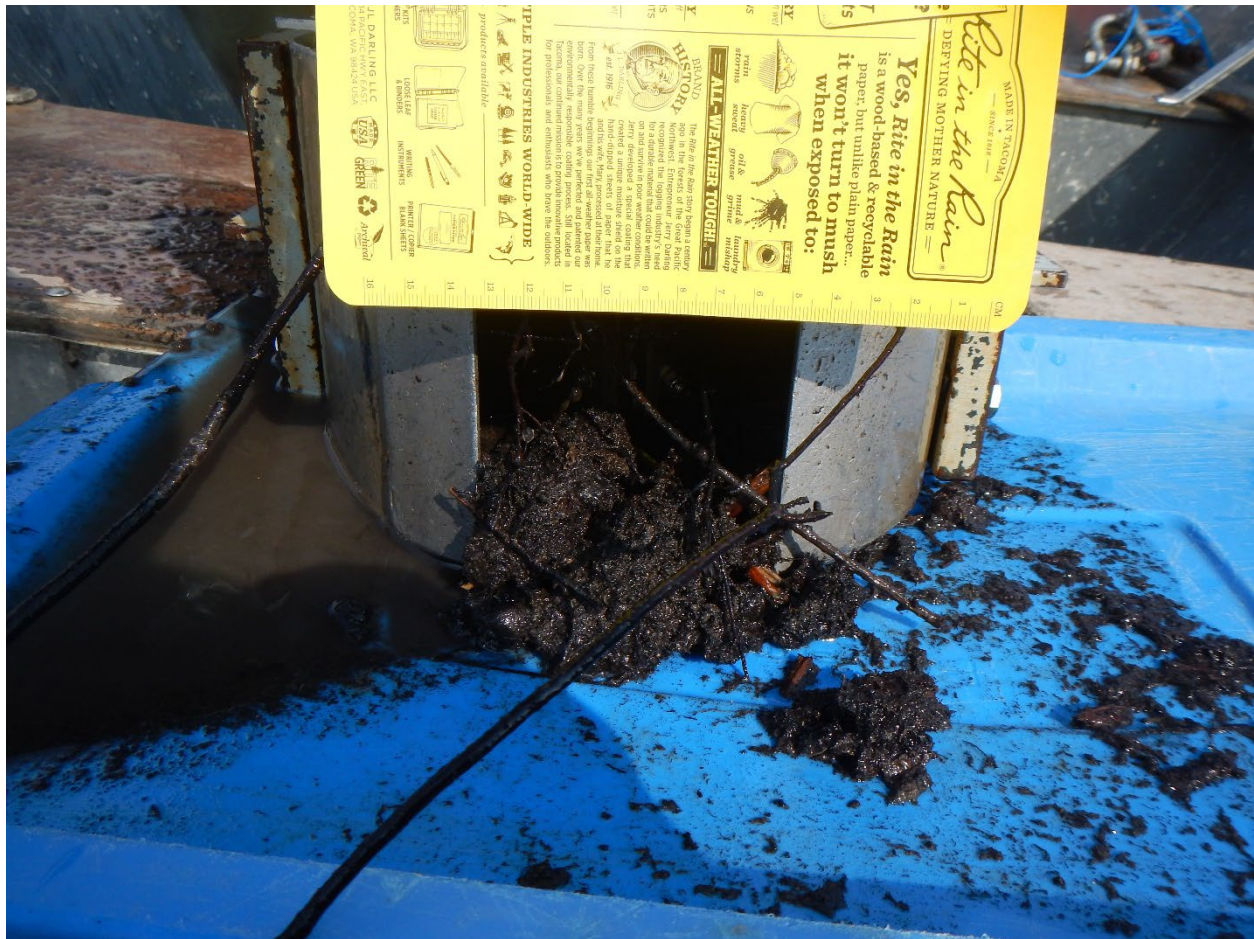
Photo 1: Substrate collected at site DST3-3 in the area of the Keeyask reservoir surrounding Caribou Island showing organic matter.

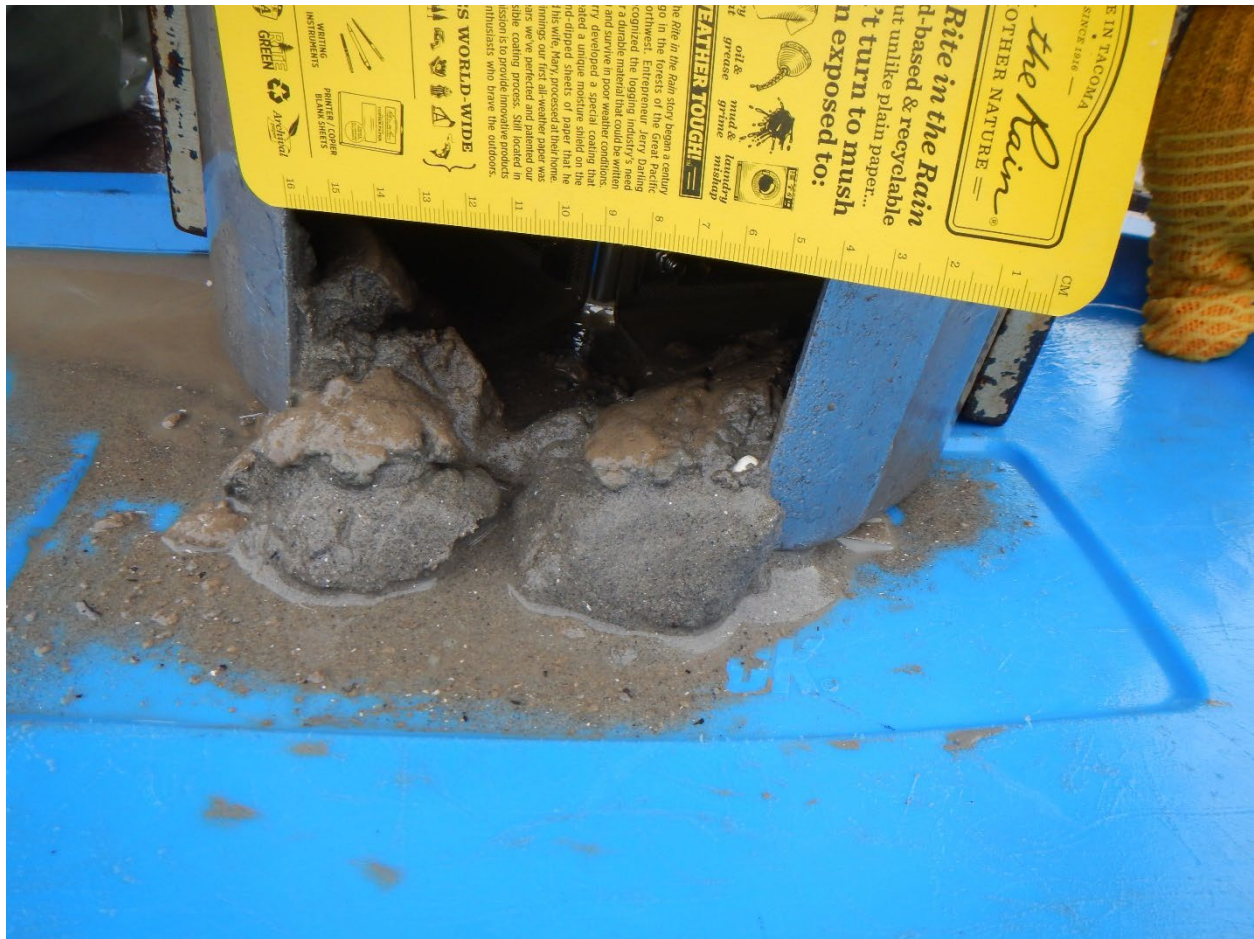
Photo 2: Substrate collected at site DST3-33 in the area of the Keeyask reservoir surrounding Caribou Island showing sand.
