Keeyask Generation Project Terrestrial Effects Monitoring Plan

Wetland Loss and Disturbance Monitoring Report

TEMP-2022-03

June 2022

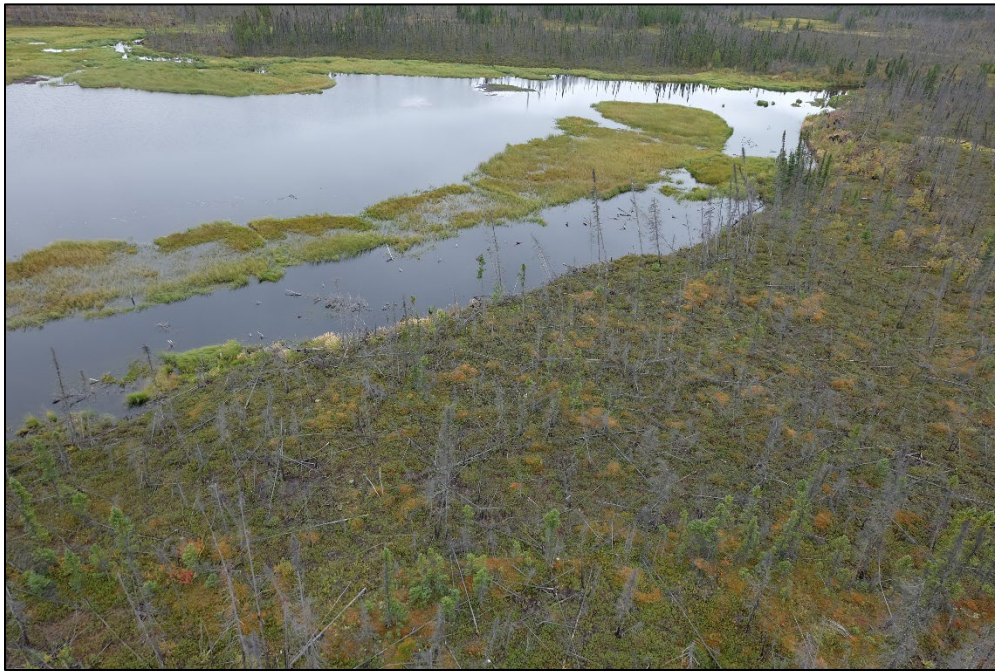
Photo 3-1: Aerial view of Wetland 3 on September 12, 2021

Wetland 3 (Photo 3-1) is 5.0 ha in size (Table 3-1), and is located about 1 km from the Nelson River. It is approximately 21 km west of the generating station site (Map 2-3). This wetland is directly connected to the Nelson River through a lake and then a short stream. Marsh habitat comprised 1.0 ha of the wetland's total area. The 2013 wildfire (see Section 2.4) burned approximately 90% of the marsh habitat buffer (*i.e.*, a 100 m buffer of the marsh habitat) included in Wetland 3.

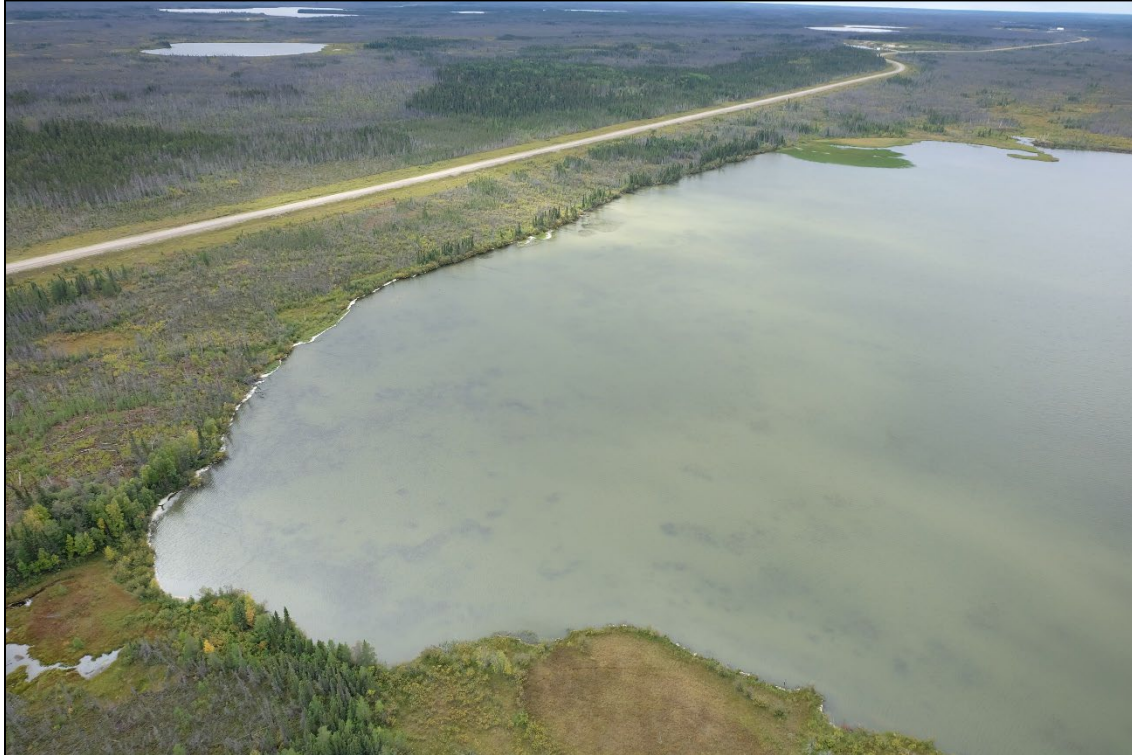
Wetland 17 (Photo 3-3) is 135.1 ha in size and located on the southwest shore of a small lake located near the kilometre 6 point of the north access road (NAR) (Map 3-1). Marsh habitat comprised 97.4 ha of the wetland's total area. Approximately 85% of the marsh habitat buffer burned in the 2013 wildfire.

Photo 3-3: Aerial view of southern portion of Wetland 17 on September 12, 2021

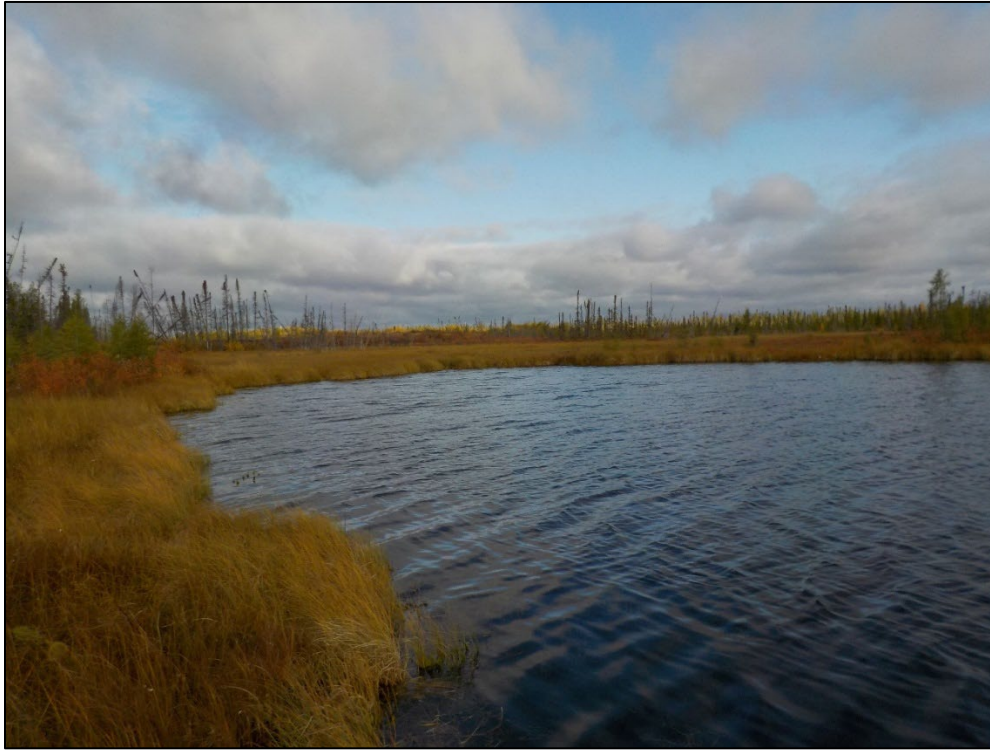
Wetland 37 (Photo 3-5, Photo 3-6) is 17.0 ha in size, and located near the north dike, adjacent to EMPA D3-E (Map 3-1). Marsh habitat comprised 4.1 ha of the wetland's total area. Approximately 5% of the marsh habitat buffer burned in the 2013 wildfire.

Photo 3-5: Ground photo of Wetland 37 in 2019

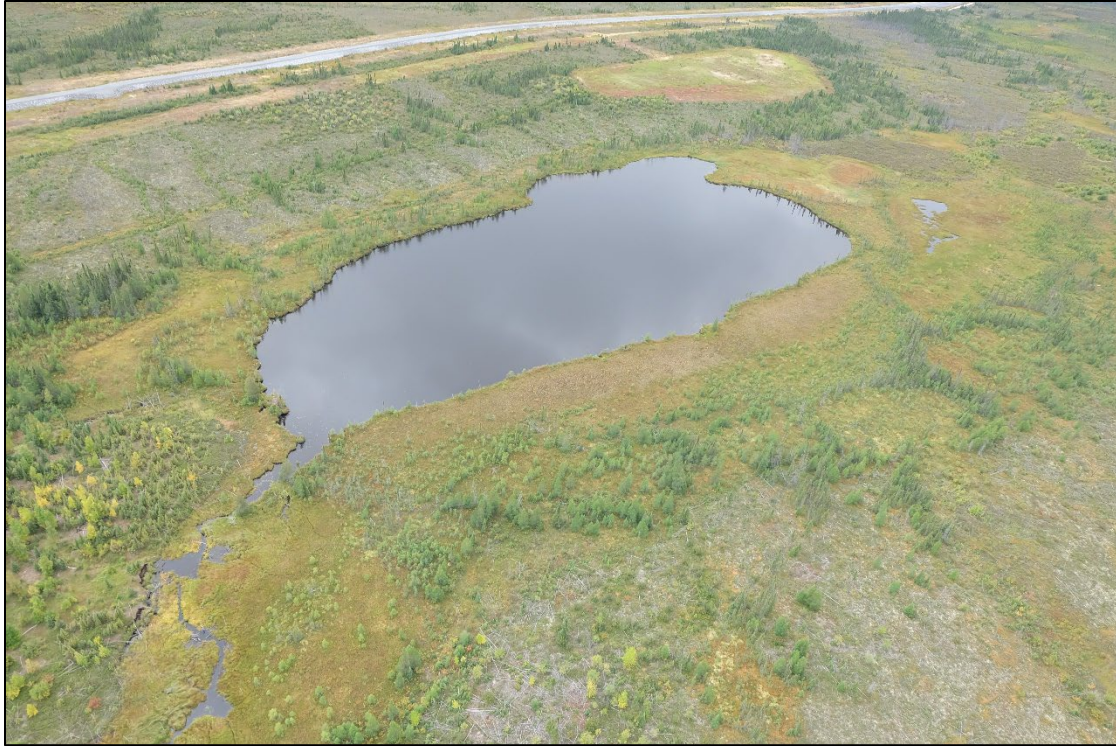
Photo 3-6: Aerial photo of Wetland 37 in September 2021, looking south

The potential for sediment runoff from EMPA D3-E into the wetland buffer is likely decreasing as the EMPA is becoming increasingly vegetated, which will help stabilize the soil (Photo 3-6). Evidence of runoff has not been recorded since 2016.

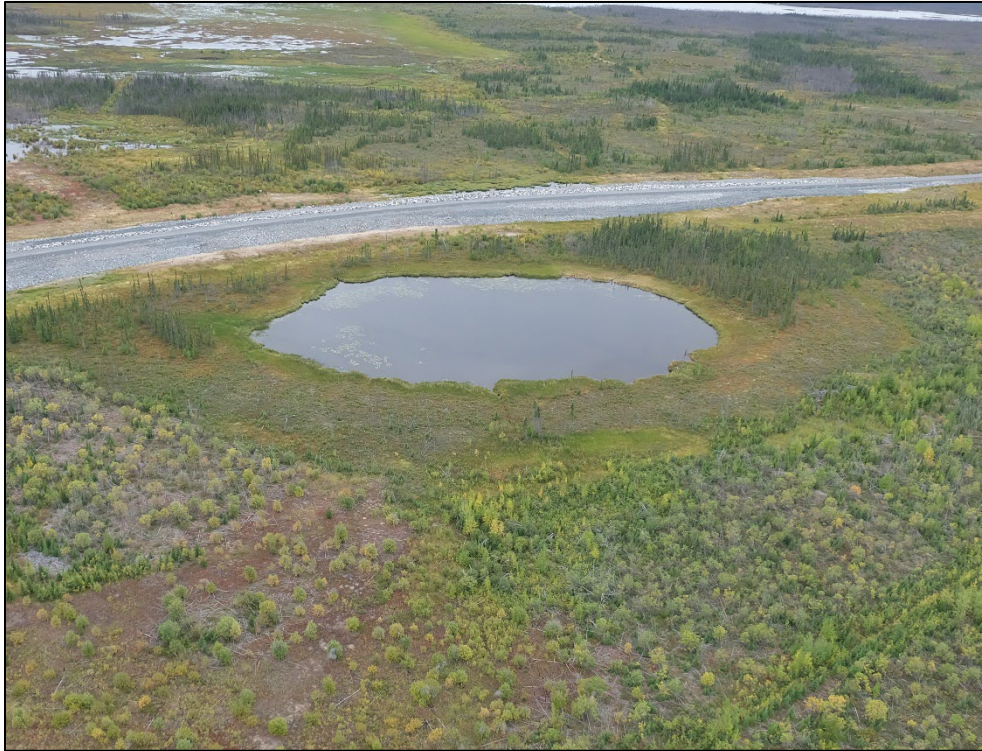
Wetland 40 (Photo 3-7) is 7.9 ha in size, and located along the north dike, approximately 750 m east of Wetland 37 (Map 2-3). Marsh habitat comprised 1.2 ha of the wetland's total area. Approximately 10% of the marsh habitat buffer burned in the 2013 wildfire.

Photo 3-7: Aerial view of Wetland 40 on September 12, 2021

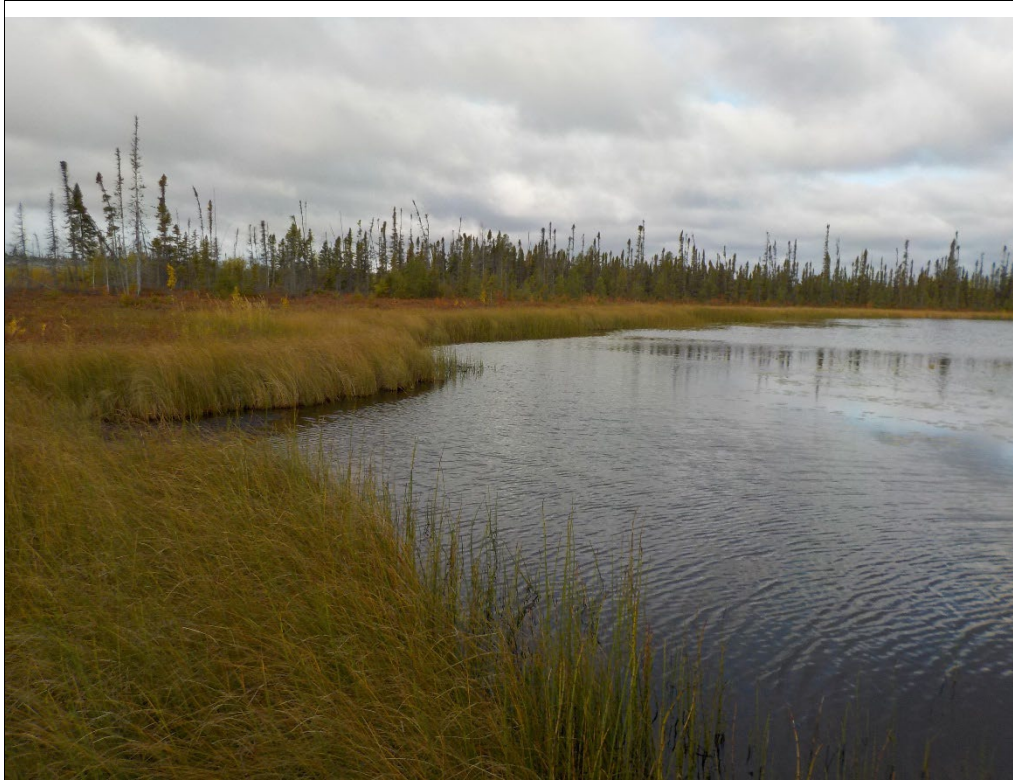
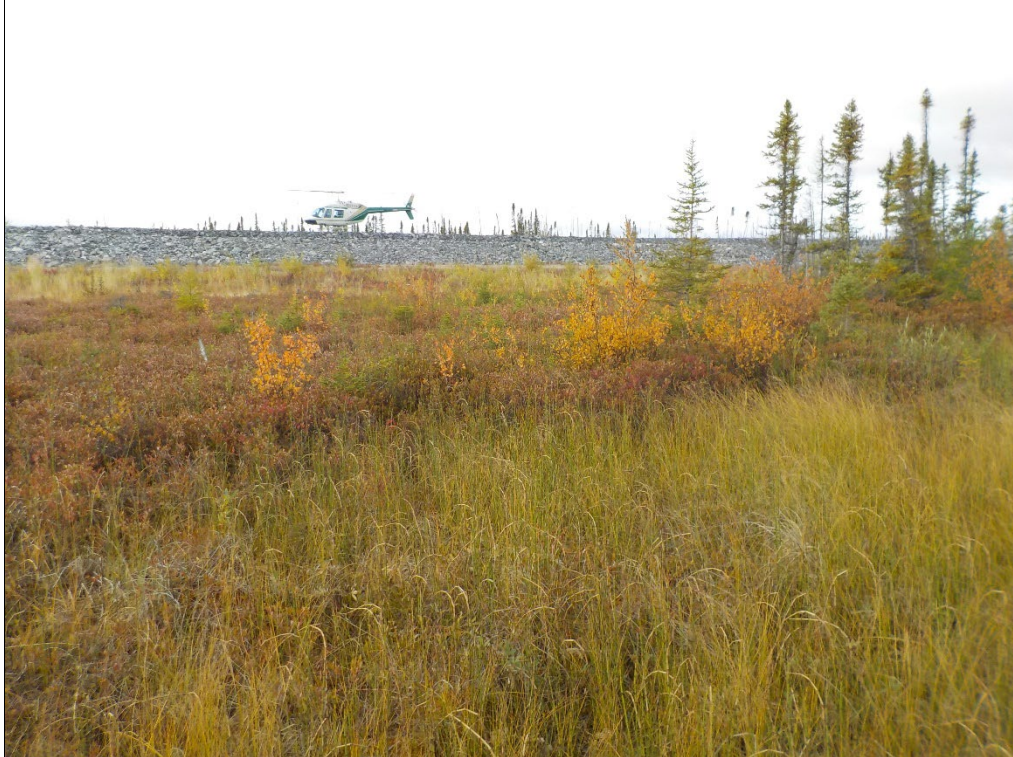
View along the shores of Wetland 40

Regenerating peatland between marsh and dike clearing

The 2016 surveys noted that a shallow slope leading from the dike clearing to the water's edge should be monitored for the potential to transport sediment from the exposed mineral of the dike into the marsh. In 2017, it was recommended that a sediment fence be installed between the dike clearing and the wetland at the base of the slope. No sediment fencing had been installed as of September 2021, however no clearing, sedimentation or runoff from the dike was observed during surveys.

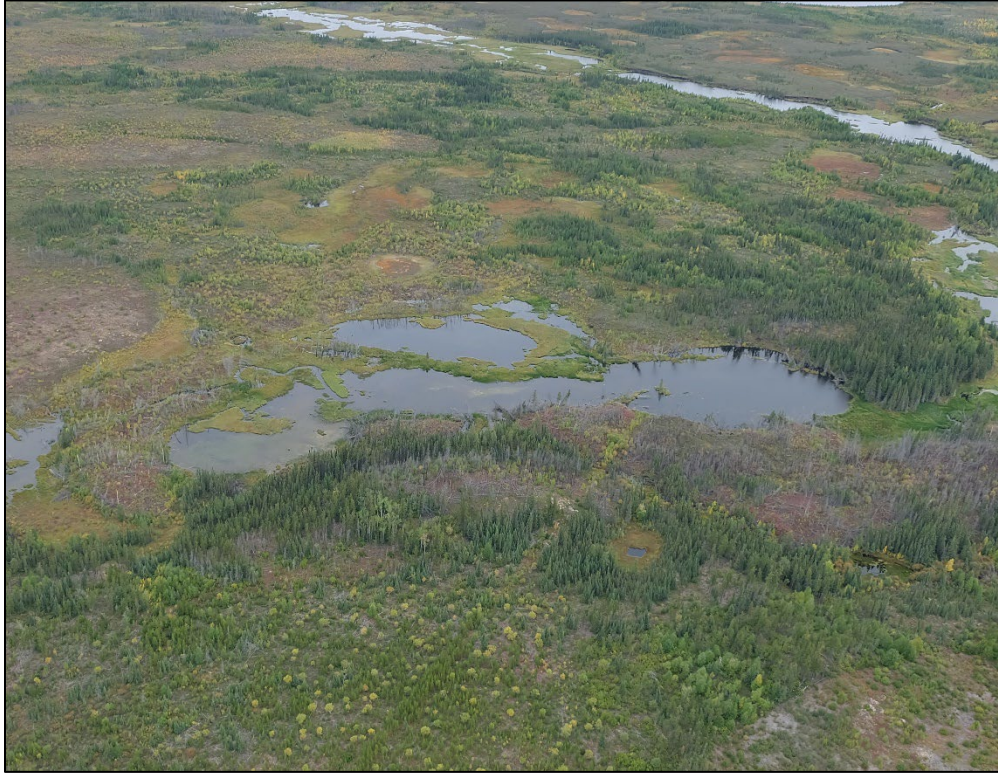
Wetland 42 (Photo 3-8) is 15.7 ha in size, and located approximately 750 m north of the NAR at kilometre 14, at the northwestern end of Borrow Area G-1 (Map 2-3). Marsh habitat comprised 2.9 ha of the wetland's total area. Approximately 50% of the marsh habitat buffer burned in the 2013 wildfire.

Photo 3-8: Aerial view of Wetland 42 on September 12, 2021

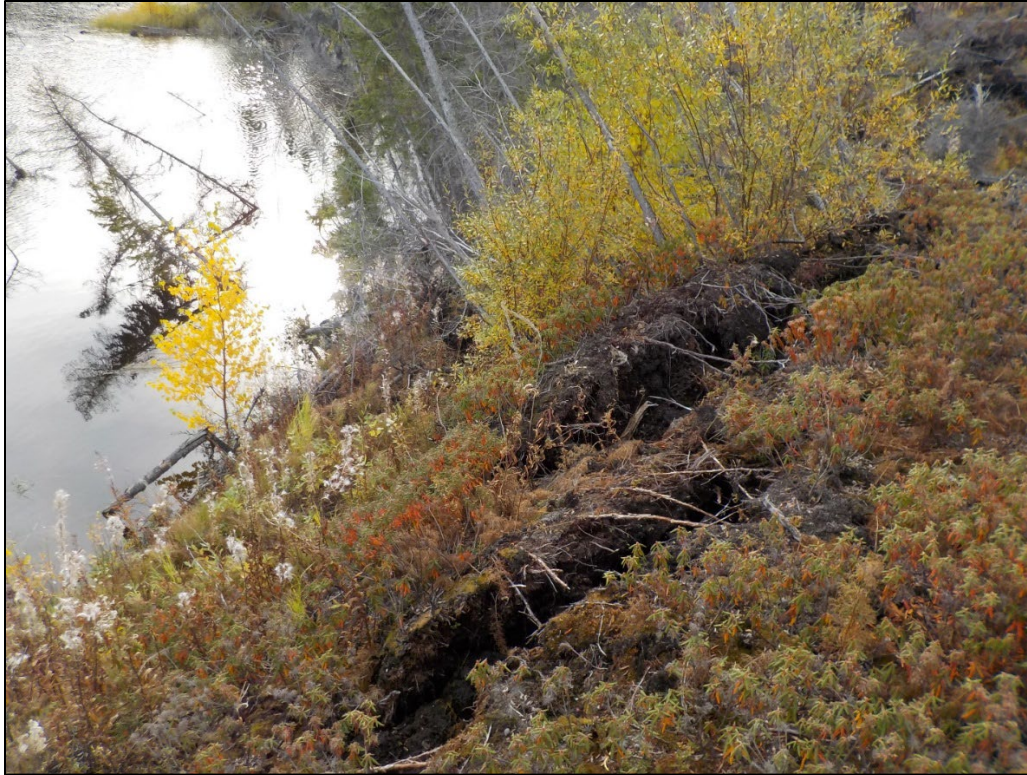
Photo 3-9: Slumping peat bank adjacent to Wetland 42 on September 16, 2018

Up to the time of the 2021 surveys, there was no clearing or excavation in the adjacent borrow area and there were no signs of erosion along the slope to the wetland. Ground surveys in 2018 found that the peat bank at the base of the slope adjacent to the wetland was beginning to slump and break apart (Photo 3-9). This slumping was attributed to melting permafrost in the peat related to having been recently burned in the wildfire.

The band of intact vegetation will continue to be monitored in order to determine if there is any erosion or surface runoff from the slope into the marsh, but the risk for this continues to decline due to the vegetation regeneration occurring in Borrow Area G-1.

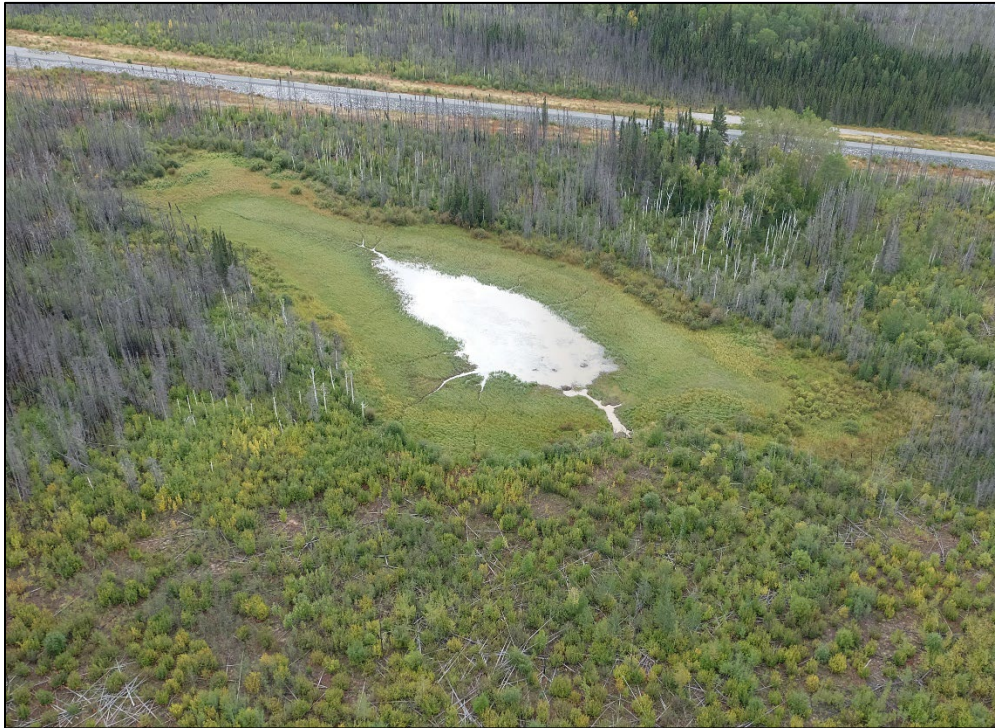
Wetland 45 (Photo 3-10) is 7.3 ha in size, and located along the north dike, approximately 1.5 km east of Wetland 40 (Map 2-3). Marsh habitat comprised 0.8 ha of the wetland's total area. Approximately 50% of the marsh habitat buffer burned in the 2013 wildfire. Some of the burned area was between the planned north dike and the marsh habitat, and some sites within this area had either a thin layer of organic matter or exposed mineral substrate.

Photo 3-10: Aerial view of Wetland 45 on September 12, 2021

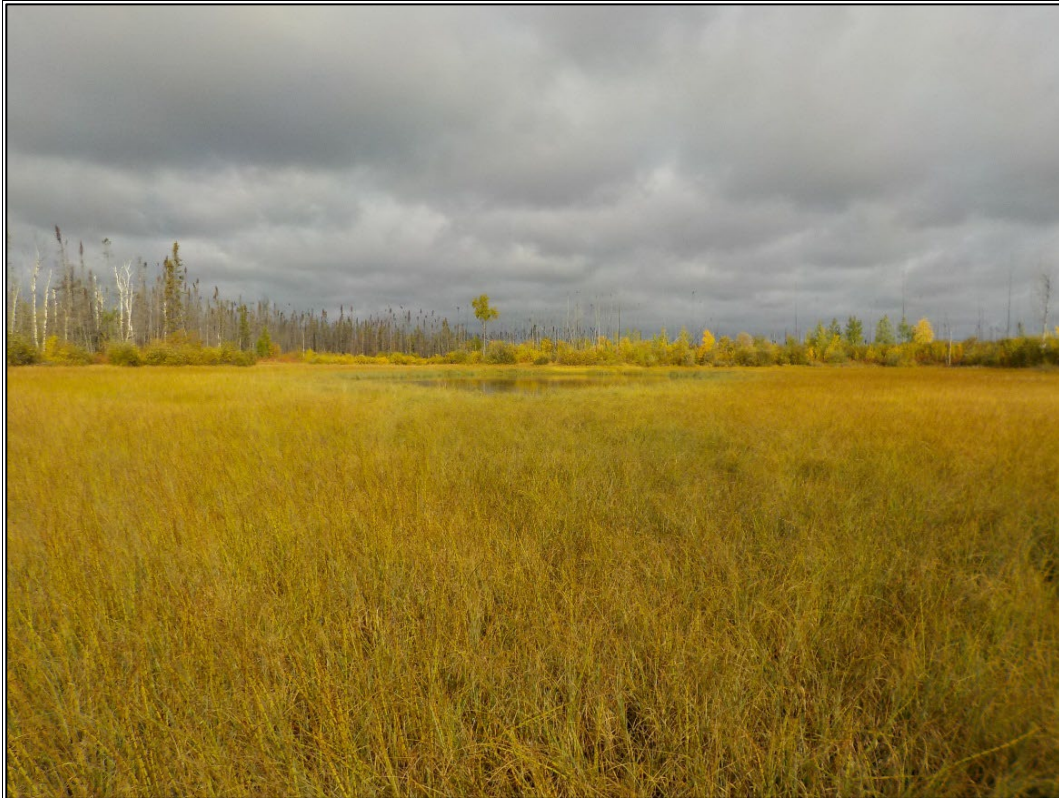
An approximately 15% slope running through the dike clearing area to the marsh habitat creates the potential for surface runoff to carry material into the marsh habitat. In addition to the slope containing exposed mineral material in the cleared area (Figure 3-8), the entire slope had been burned with some areas having virtually all vegetation removed. In 2017, it was recommended that staff evaluate and implement sediment control measures such as sediment fence where needed as a preventative measure (e.g., a sediment fence at the base of the dike). A short sediment fence was installed at one location (Figure 3-8).

At the time of the 2021 surveys, no runoff or sedimentation was seen entering the marsh habitat. In addition to the existing sediment fences, a small ridge between the wetland and the dike may be serving as a natural barrier to sediment transport further downslope. Additional sediment fences appear to be unnecessary at this time. These areas will be monitored for any future runoff effects.

View along the shore of Wetland 45

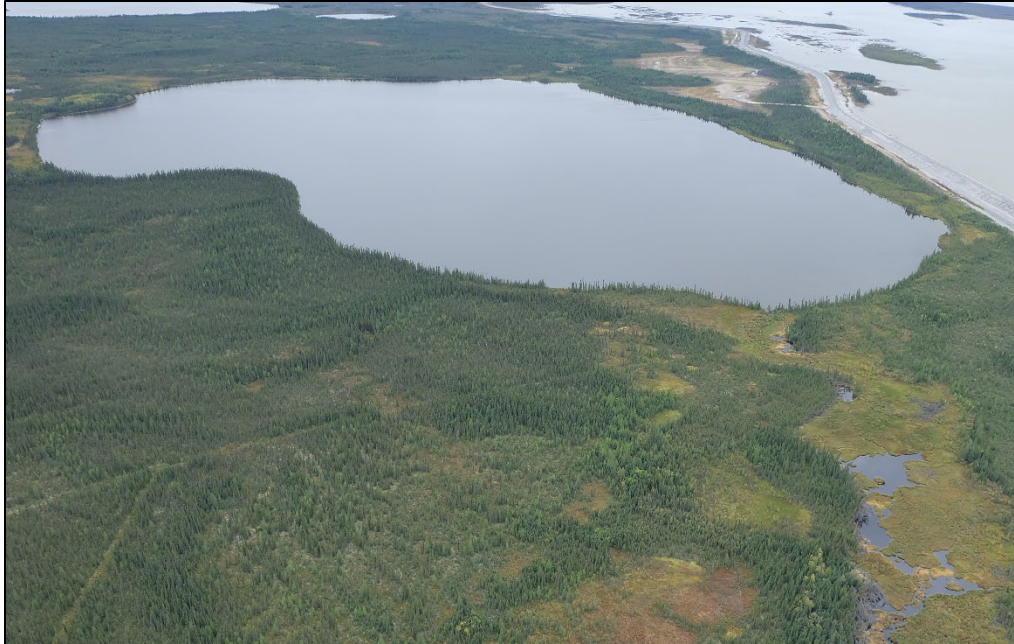
Photo 3-11: Aerial view of Wetland 47 on September 12, 2021

Project clearing or disturbance in this wetland was not observed during the 2015 aerial survey. In 2016, a small amount of clearing within the possibly disturbed Project footprint (0.02 ha in total) extended into the northwestern and northeastern edges of Wetland 47 (Map 3-1), all of which was in the marsh habitat buffer. Approximately half of this clearing was for an EMPA, and the other half was for a cutline.

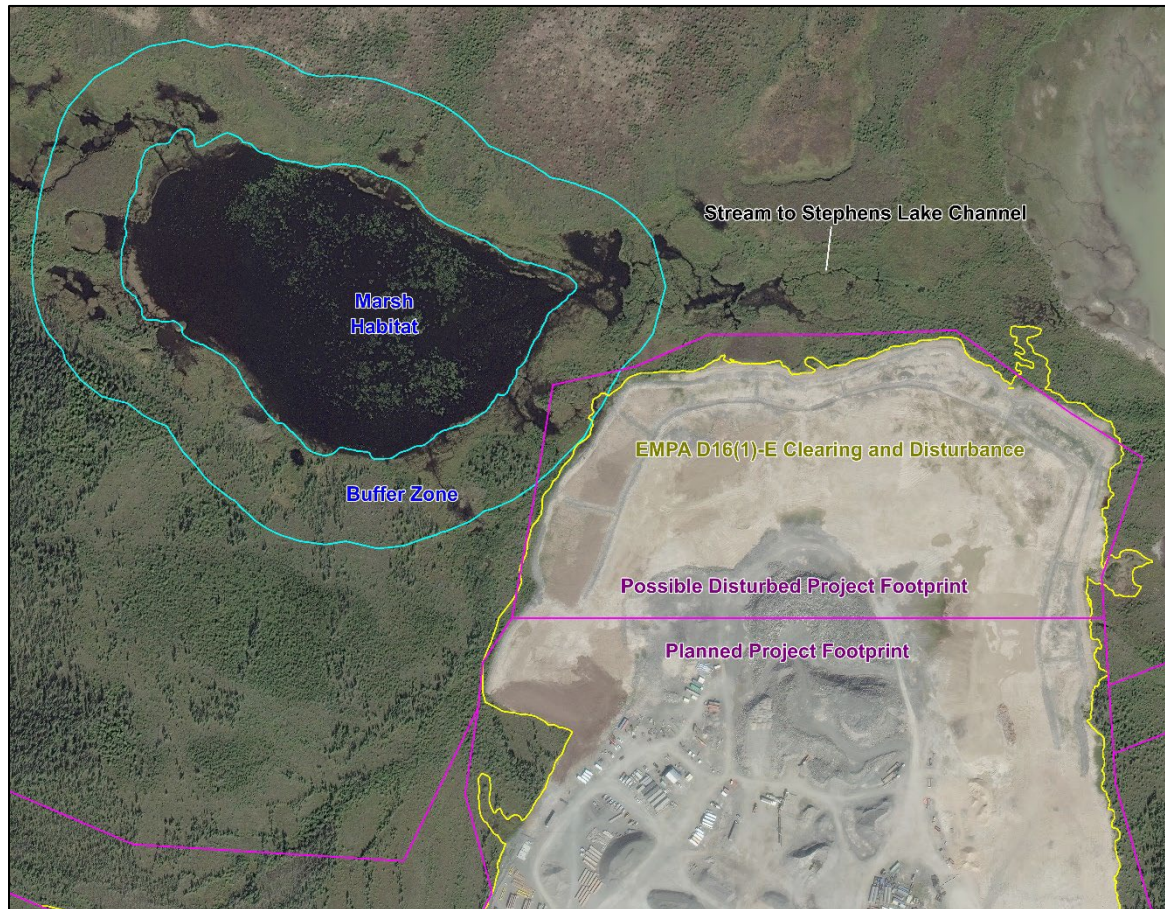
Figure 3-10: Wetland 51 (in blue) in 2021 satellite imagery showing adjacent EMPA, stream to Stephens Lake channel, 2021 Project clearing and disturbance (yellow line), and the boundaries of licensed Project footprint (purple line)

Wetland 51 is 25.7 ha in size and located immediately northwest of EMPA D16(1)-E (Map 2-3, Figure 3-10). Marsh habitat comprised 10.5 ha of the wetland's total area. Approximately 20% of the marsh habitat buffer burned in the 2013 wildfire.

Ground surveys in August 2015 identified EMPA clearing within 25 m of the edge of Wetland 51. Various disturbances have been observed in the area between EMPA D16(1)-E and Wetland 51 since 2015 (e.g. machinery rutting, sediment deposition). Several measures were implemented to mitigate erosion and sediment deposition in this area such as slope grading, installation of soil berms and sediment fences as well as the placement of straw wattles within erosion channels.

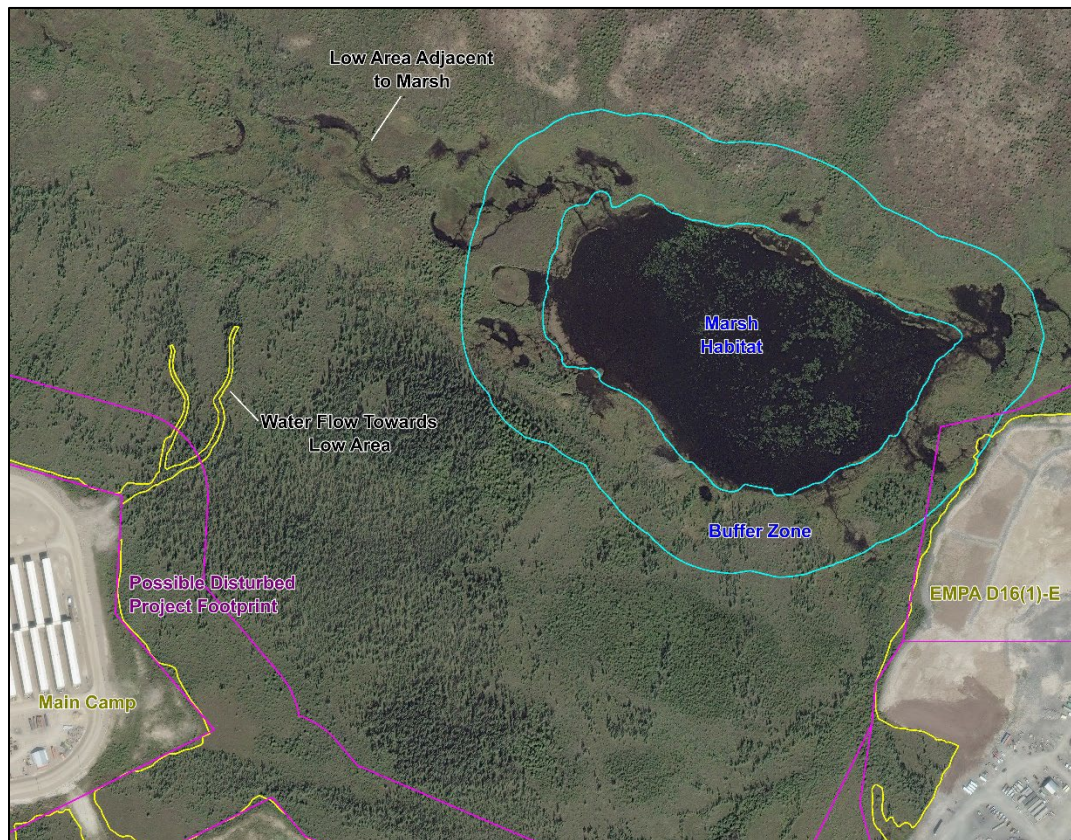
Figure 3-13: Extent of water flow from culvert (in yellow to the west) with potential to affect Wetland 51 (in blue) as of September, 2021

Significant output from a drainage culvert at the northeastern corner of the Main Camp created a channel of running water through the previously undisturbed adjacent forest by September 2020. This channel of water flowed northeast towards a low area directly adjacent to Wetland 51 (Figure 3-13; see ECOSTEM (2022) for further details). At the time of the 2020 survey, this disturbance was approximately 185 m away from entering the low-lying area adjacent to the wetland and by September 2021, the disturbance was approximately 165 m away. Although no effects were observed in the low-lying area during aerial surveys, this disturbance has the potential to affect

water levels in the marsh. Air and ground surveys in 2022 will continue to monitor for adverse effects in the area.

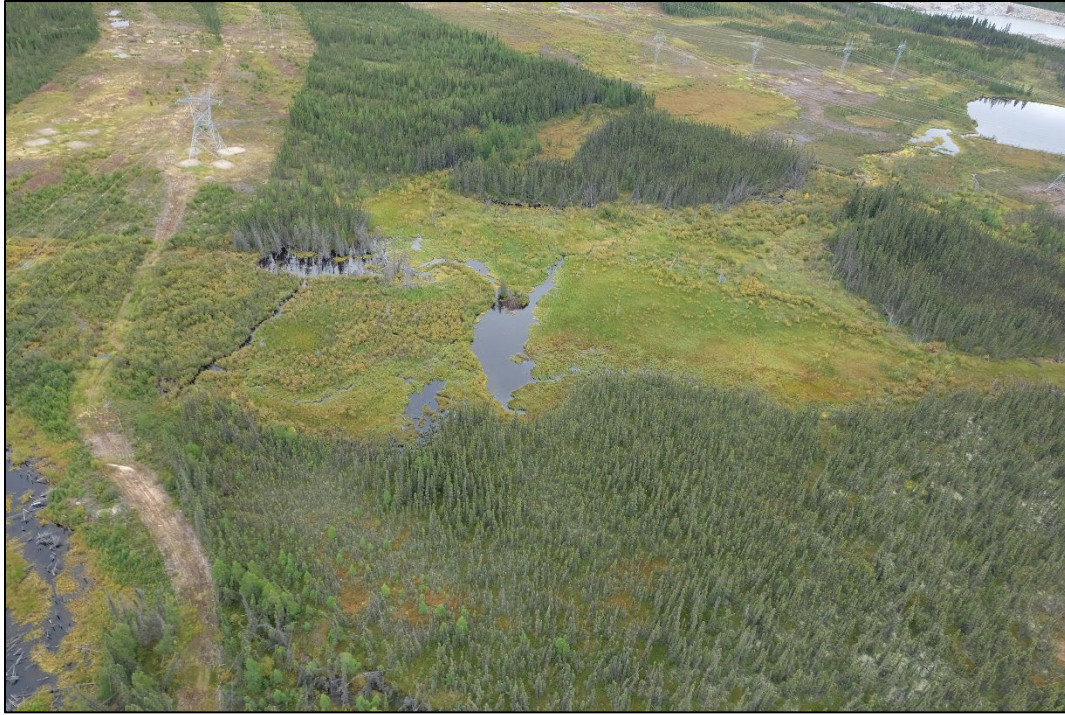
Clearing in the marsh habitat buffer was observed during the 2015 aerial surveys. This clearing was for the Keeyask Transmission Project right-of-way (RoW), which is a separate project (Figure 3-15; Photo 3-12). See ECOSTEM (2018) for details.

Photo 3-12: Aerial photo of Wetland 53 on September 12, 2021

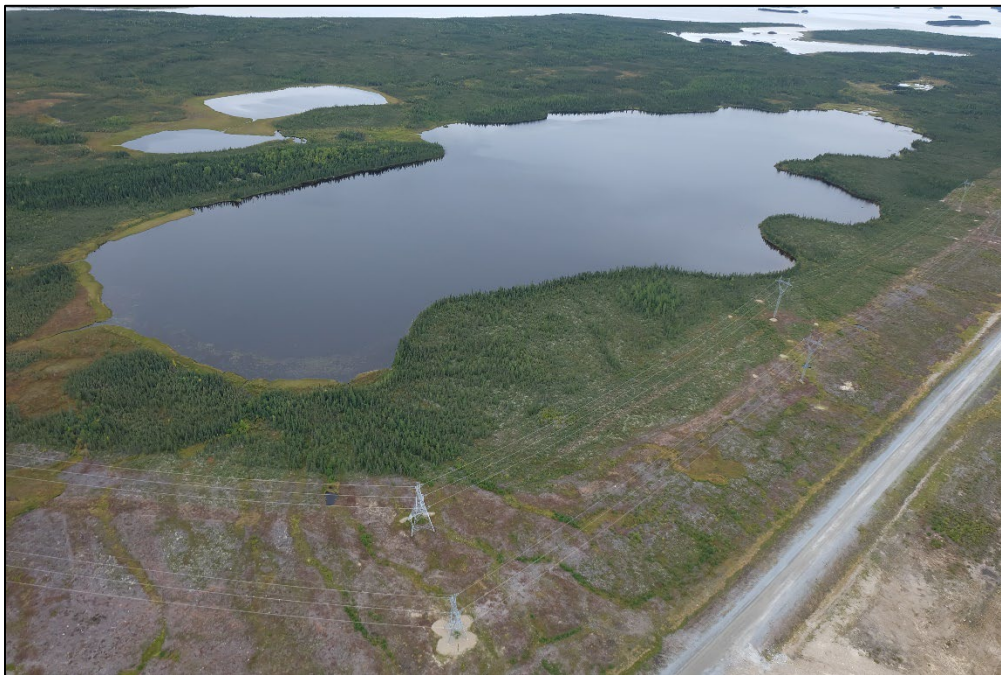
Wetland 54 (Photo 3-13) is 113.1 ha in size, and located along the north side of the SAR, north of Borrow Area S-2b (Map 2-3). Marsh habitat comprised 70.1 ha of the wetland's total area. None of the marsh habitat buffer burned in the 2013 wildfire.

Photo 3-13: Aerial view of Wetland 54 (western end) on September 12, 2021

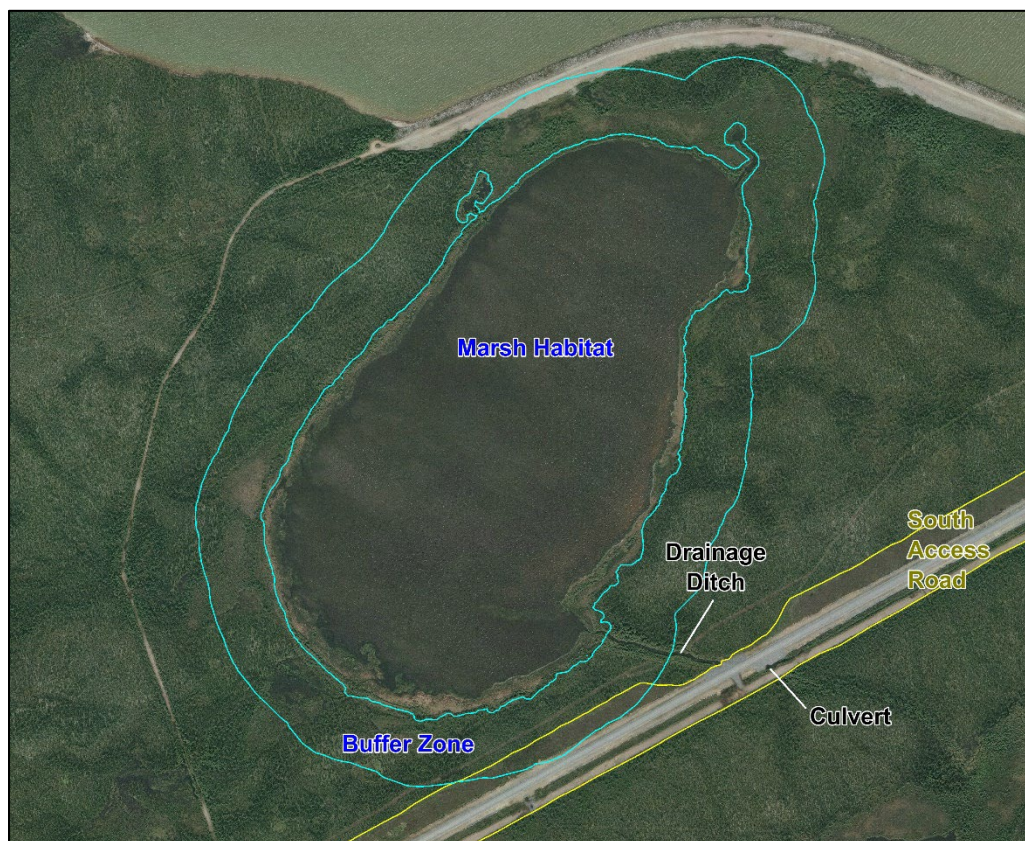
Figure 3-17: Satellite imagery showing South Access Road clearing (in yellow) in the Wetland 57 (in blue) buffer zone

Ground surveys in 2016 found that clearing in the marsh habitat buffer had increased to 0.79 ha (Table 3-2), which was 0.58 ha higher than in 2015. All of the clearing was still within the planned Project footprint and no clearing or disturbance was found in the marsh habitat.

Surveys from 2017 to 2021 found no additional clearing or disturbance in the marsh habitat buffer or marsh habitat.

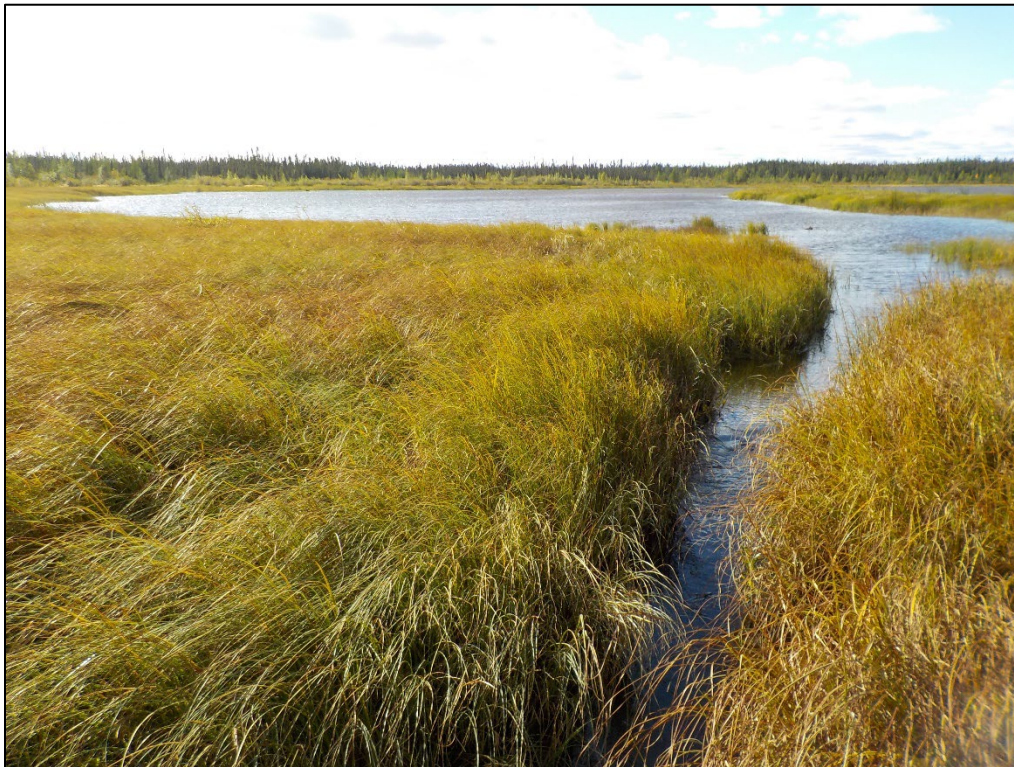
Photo 3-14: Marsh habitat upstream of beaver dam in Wetland 57 on September 10, 2020

An expansion of shore zone wetland vegetation was observed during the 2017 monitoring. New vegetation was establishing on the lake bottom exposed by low water levels, and in the shallow water. The extent of shore zone vegetation has remained approximately the same or perhaps increased from 2018 to 2021.

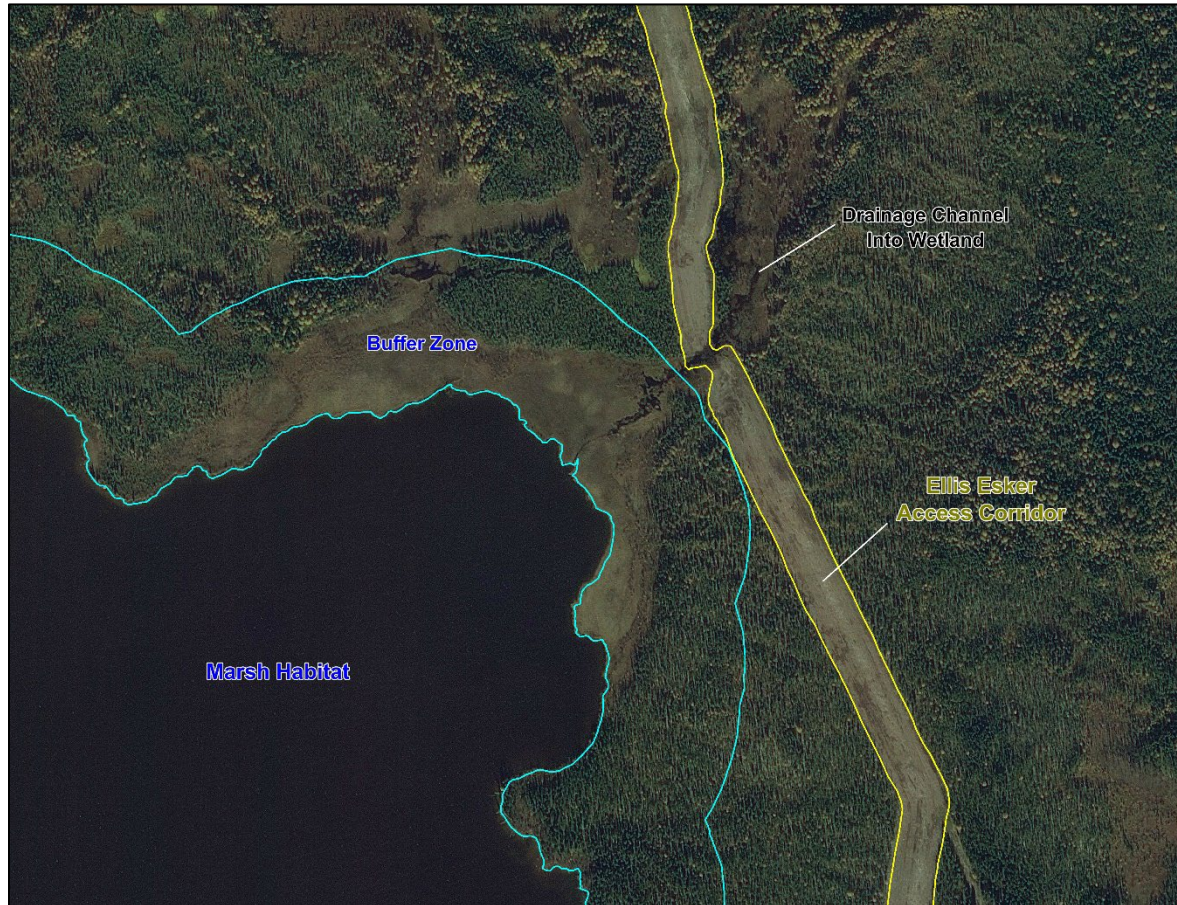
Wetland 60 is 232.4 ha in size. It is located approximately 6.6 km south of Stephens Lake, just west of the access road corridor for the Ellis Esker borrow area (E-1) (Figure 3-19; Map 2-3). Marsh habitat comprised 150 ha of the wetland's total area. None of the marsh habitat buffer burned in the 2013 wildfire.

Figure 3-19: Satellite imagery showing proximity of Project clearing (in yellow) to Wetland 60 (in blue)

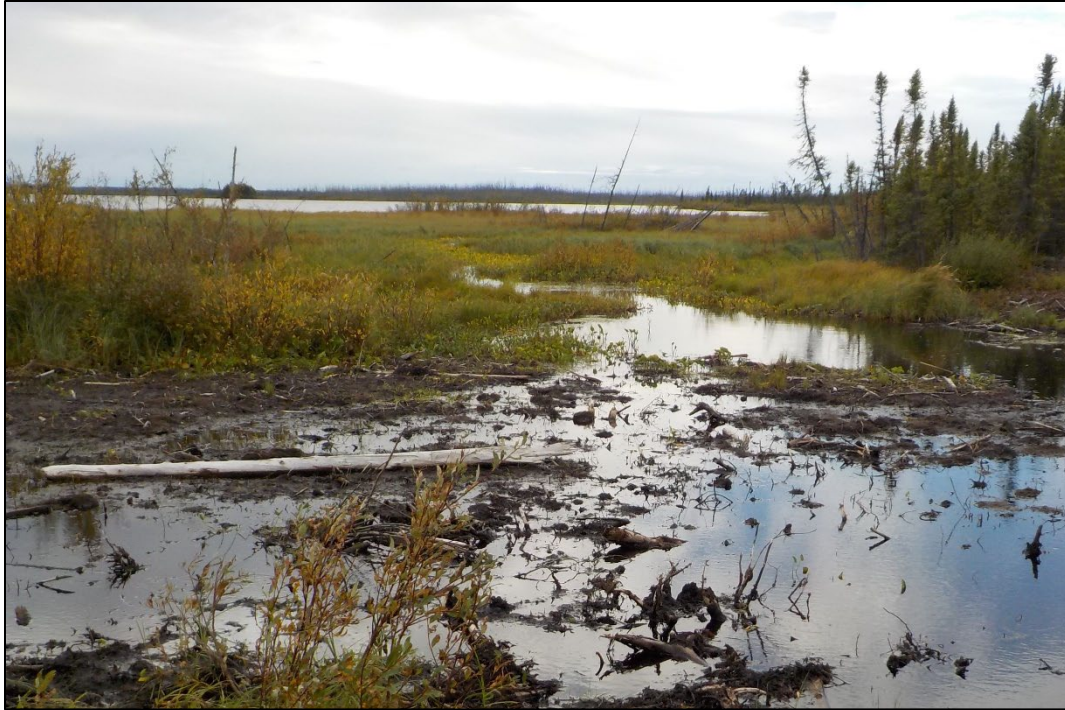
Photo 3-15: Ground view of marsh habitat (background), marsh buffer (center) and drainage channel (foreground) at Wetland 60 on September 12, 2021

Surveys from 2018 to 2021 did not find any apparent effects of Project clearing on the marsh vegetation or hydrology (Photo 3-15).

Surveys in 2022 will monitor for any adverse effects in this area and within the wetland habitat.

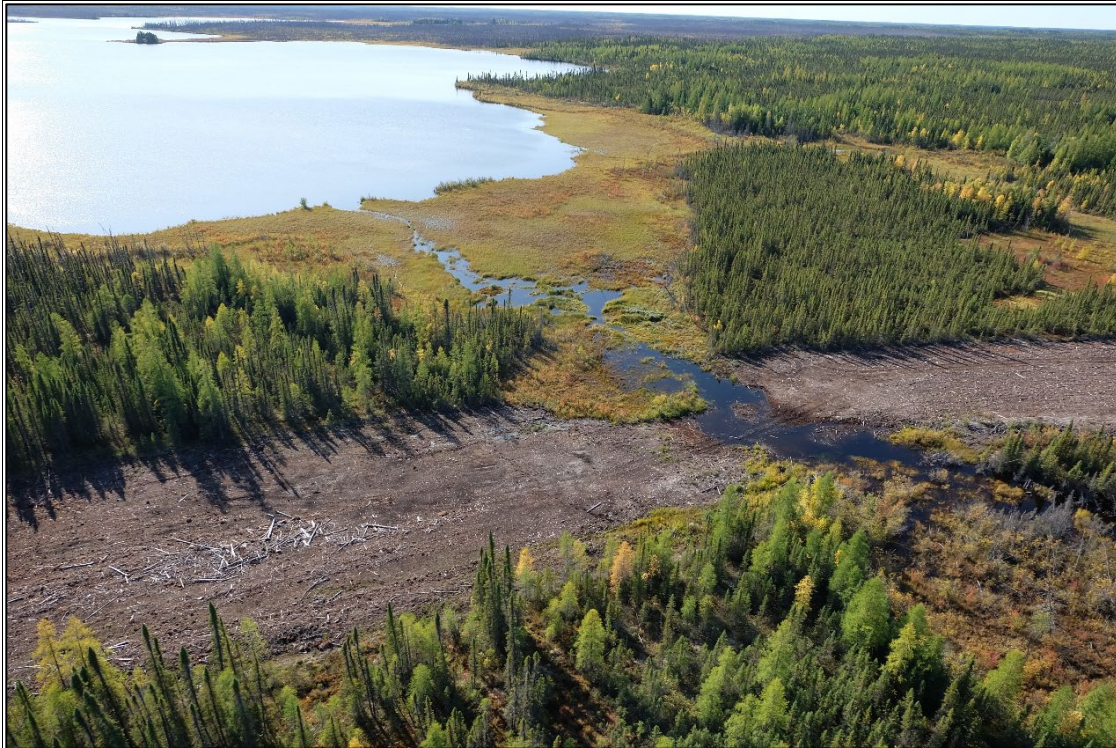
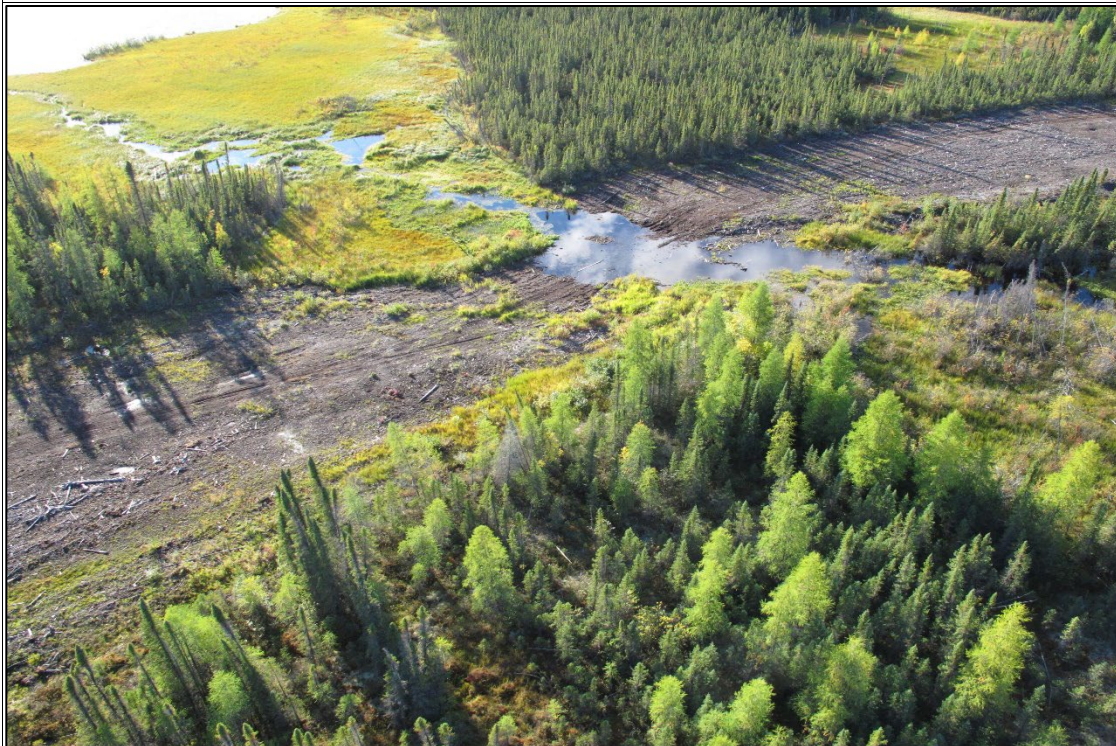
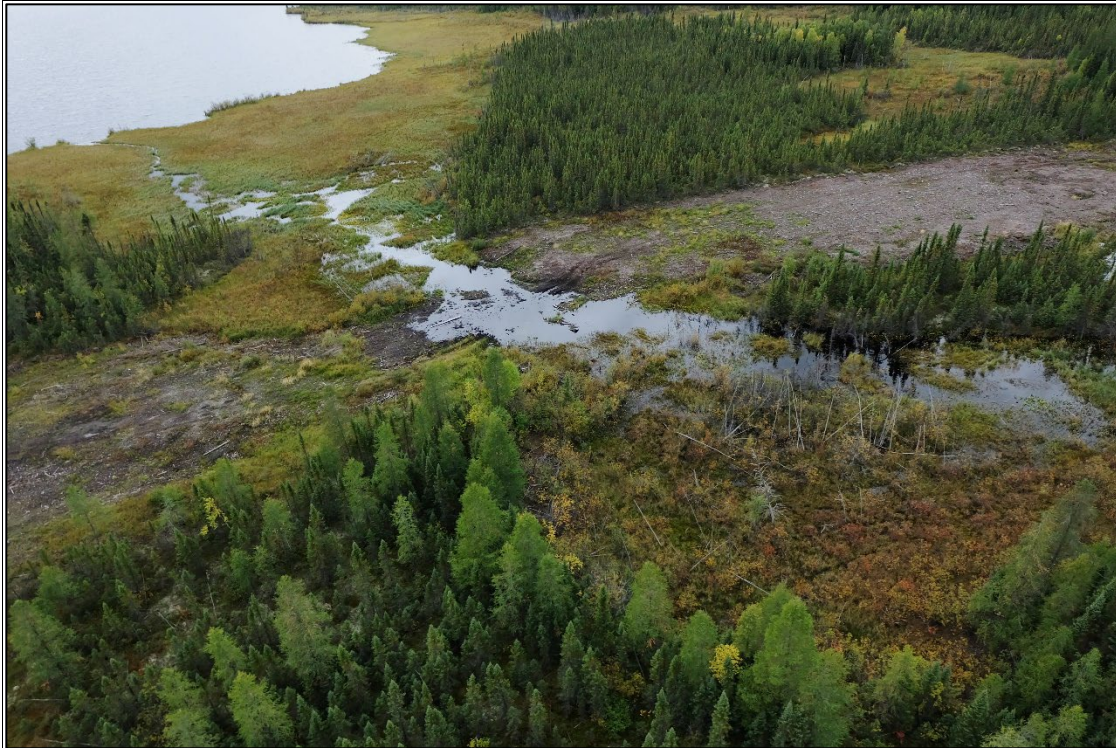
Figure 3-20: Aerial views of the Wetland 60 channel from 2019 to 2021

In terms of other potential Project impacts, a natural drainage channel into the wetland ran through the clearing (Figure 3-20). There is a possibility that the vegetation clearing, past construction activity or future revegetation activity could alter water flow into the wetland through localized changes to the moisture regime or soil compaction. Although surveys in 2020 and 2021 found that the access road corridor was being actively used by ATVs, the channel itself did not appear to be substantially disturbed and the adjacent vegetation appeared to be unaffected (Figure 3-20). This may have been due to the fact that the ATVs appeared to only be using one path in the center of the right-of-way. If usage continues, there is the potential for alternate paths through the channel to be made, creating a disturbance outside of previously cleared bounds.

Ellis Esker access road and channel to wetland in 2019

Ellis Esker access road and channel to wetland in 2020

Ellis Esker access road and channel to wetland in 2021

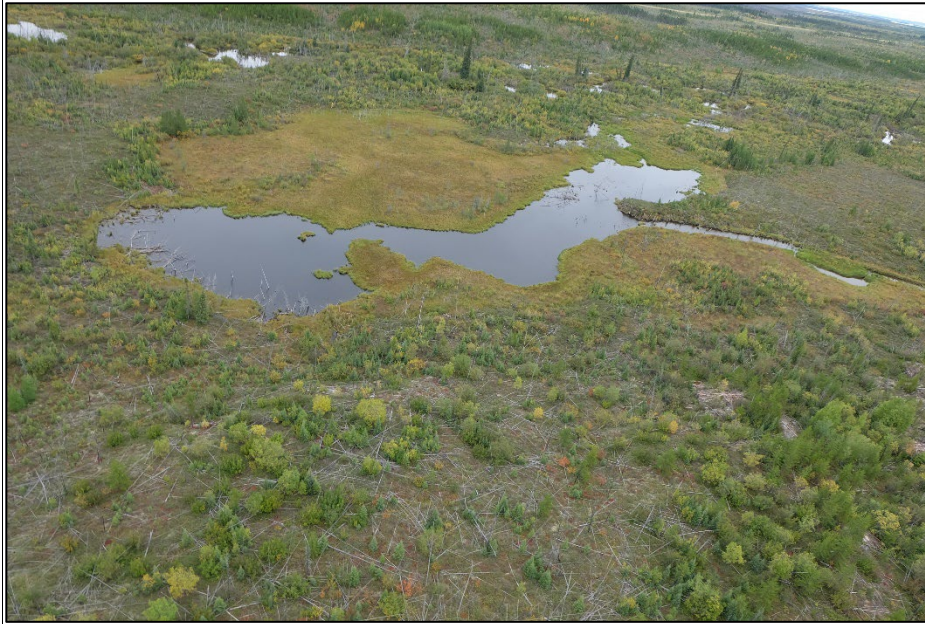
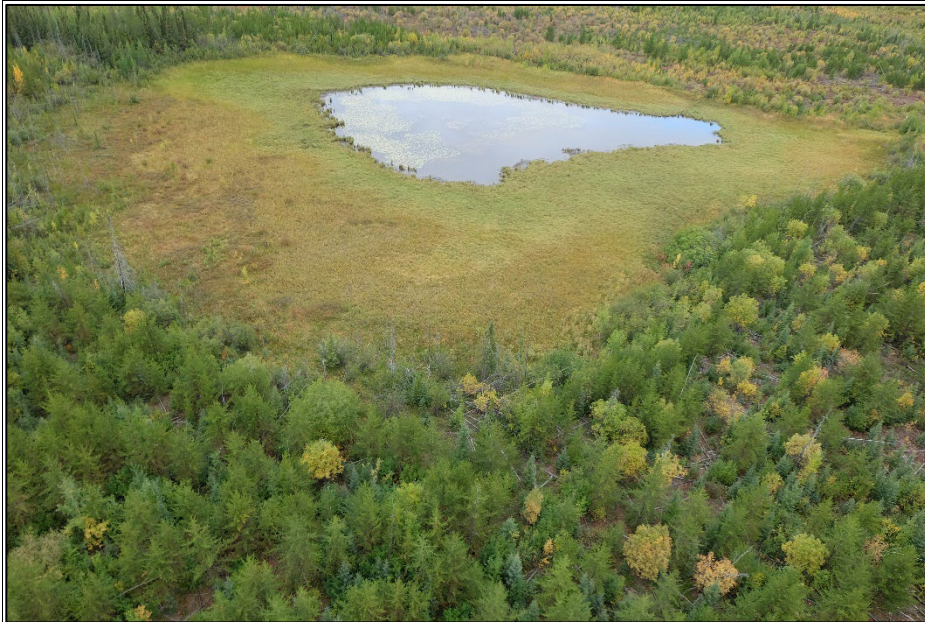
Figure 3-21: Aerial photos of Wetlands 34 and 49 on September 12, 2021

Figure 3-21 shows the state of two of the remaining 28 wetlands visited during the aerial surveys. These wetlands were not closely surveyed because they were more than 100 m from existing Project clearing or disturbance, and there were no visible Project effects in them.

Wetland 34

Wetland 49
