# Keeyask Generation Project Aquatic Effects Monitoring Plan

## Deep Water and Constructed Habitat Monitoring Report

AEMP-2023-14

### DEEP WATER AND CONSTRUCTED HABITAT MONITORING IN THE KEYYASK STUDY AREA, 2022

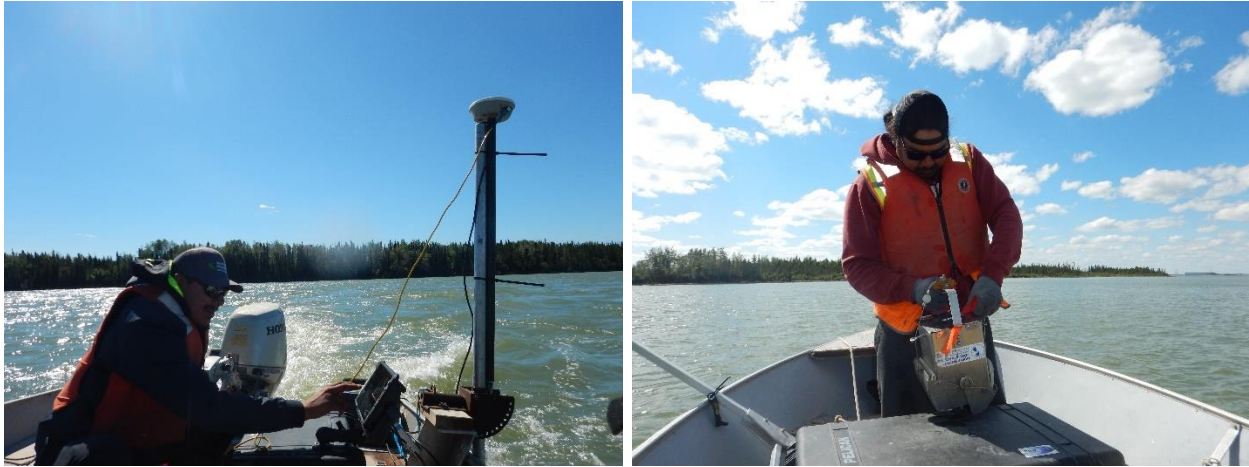
**Setup of acoustic equipment (left) and Ponar dredge substrate sampler (right) used to monitor deep water and constructed habitats in the Keeyask reservoir and Stephens Lake in 2022.**

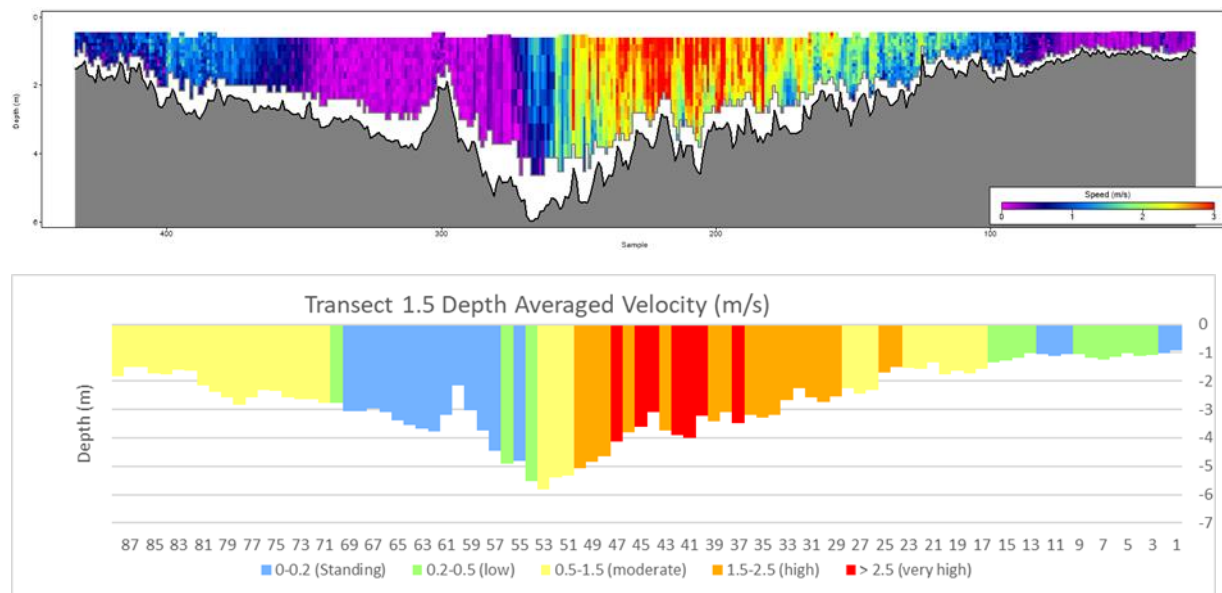
**Figure 1: Full ADCP profile (top) sampled with the SonTek M9 ADCP and classified sub-sampled depth averaged velocity representation (bottom). Cross sections are viewed looking downstream (left to right bank).**

Mean, minimum, and maximum depth and velocity were calculated for each survey area. ArcGIS mapping software was used to plot each transect and classify each as standing/lentic (<0.2 m/s); and low (0.2-0.5 m/s), moderate (0.5 – 1.5 m/s), high (1.5-2.5 m/s), and very high (>2.5 m/s) water velocity.

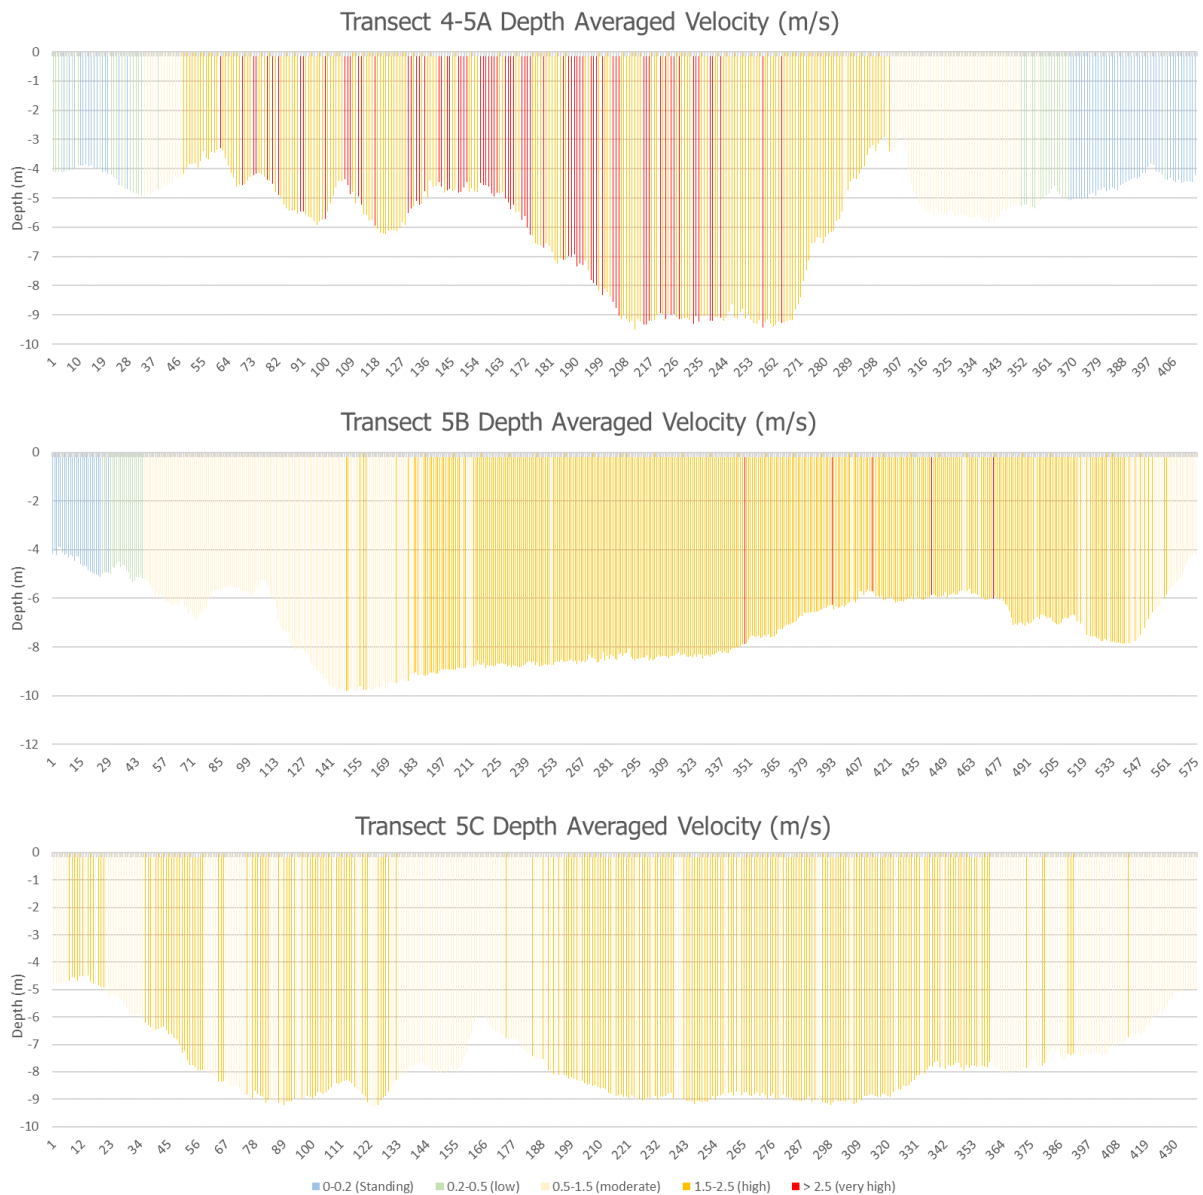
**Figure 2: Classified sub-sampled depth averaged velocity representation of three transects sampled using an ADCP at the Long Rapids sensitive habitat area, 2022. Cross sections are viewed looking upstream (left to right bank).**

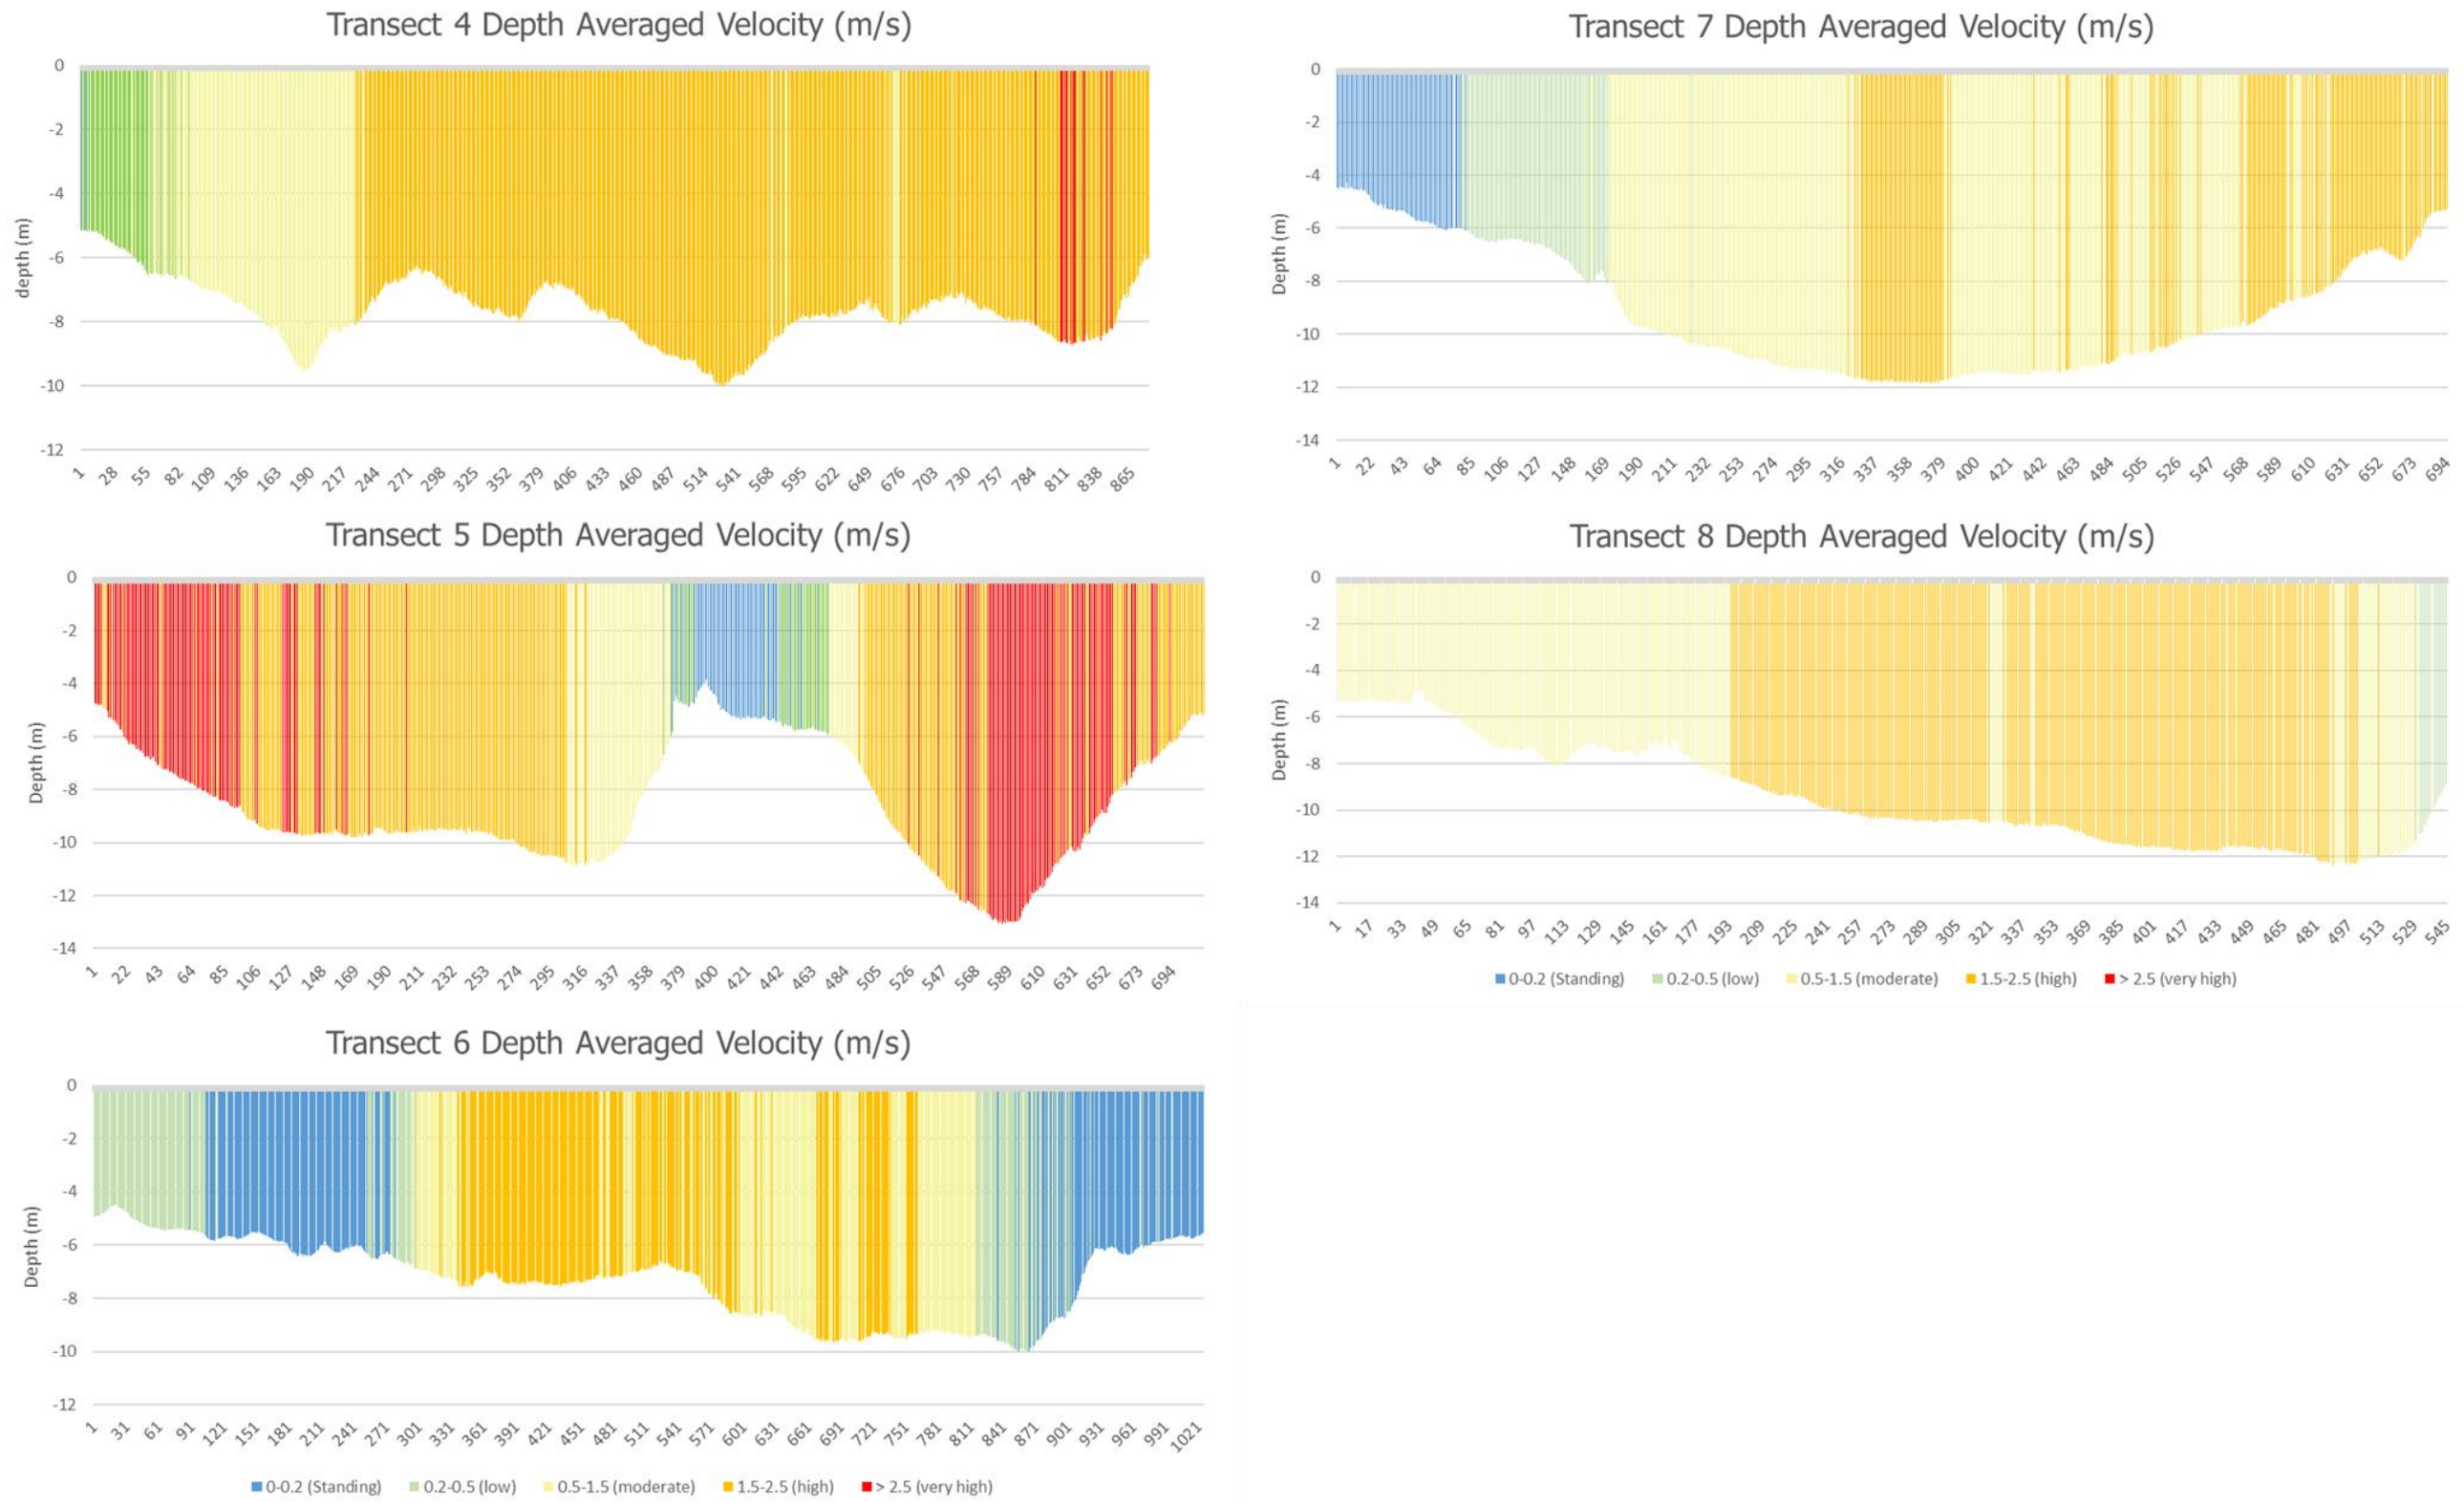
**Figure 3: Classified sub-sampled depth averaged velocity representation of five transects sampled using an ADCP at the Birthday Rapids sensitive habitat area, 2022. Cross sections are viewed looking upstream (left to right bank).**

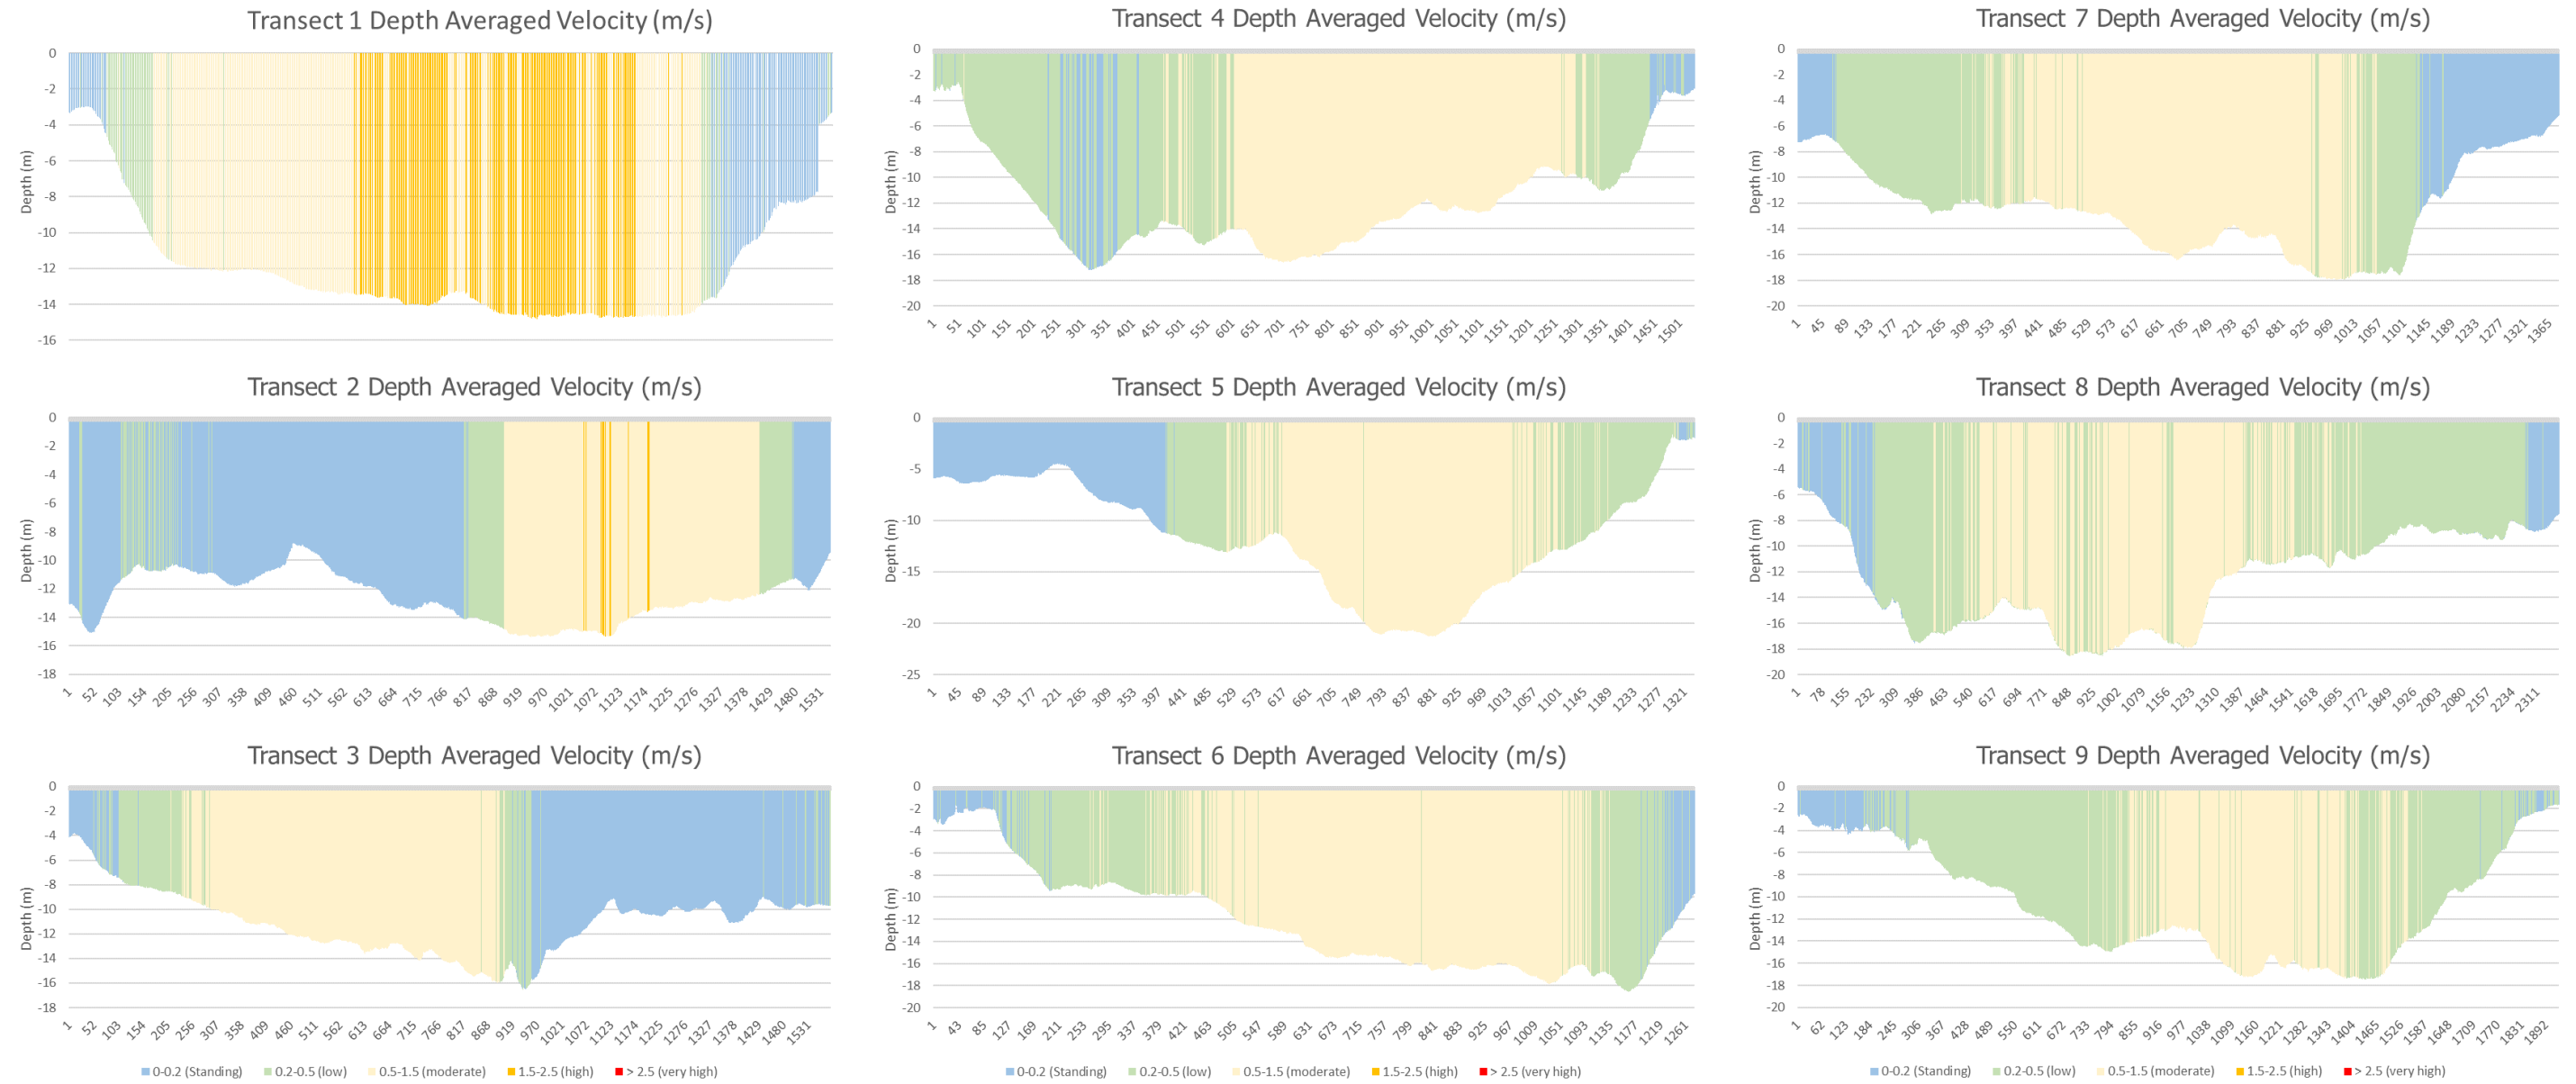
**Figure 4: Classified sub-sampled depth averaged velocity representation of nine transects sampled using an ADCP in the Keyyask reservoir at the Gull Lake entrance sensitive habitat area, 2022. Cross sections are viewed looking upstream (left to right bank).**

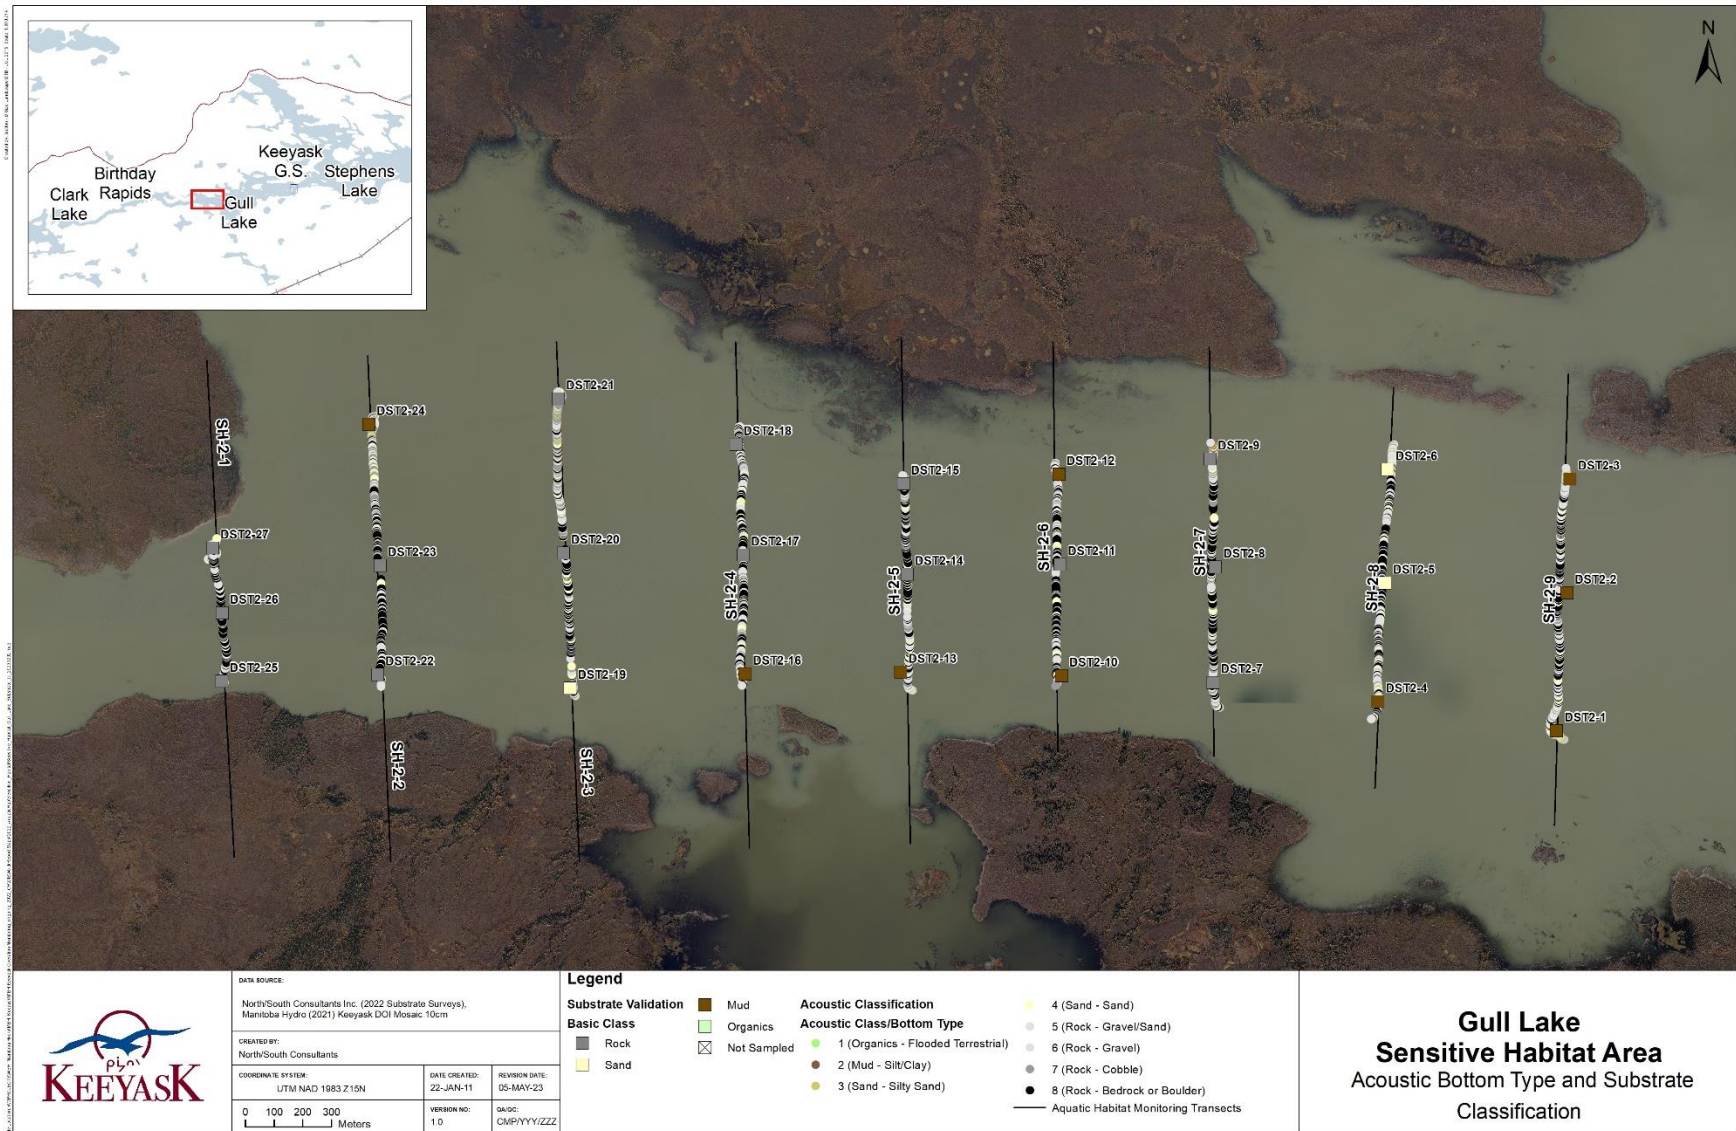
**Map 8: Classified acoustic bottom type data and substrate validation results from substrate transect surveys conducted in the Keeyask reservoir at the Gull Lake entrance sensitive habitat area, 2022.**

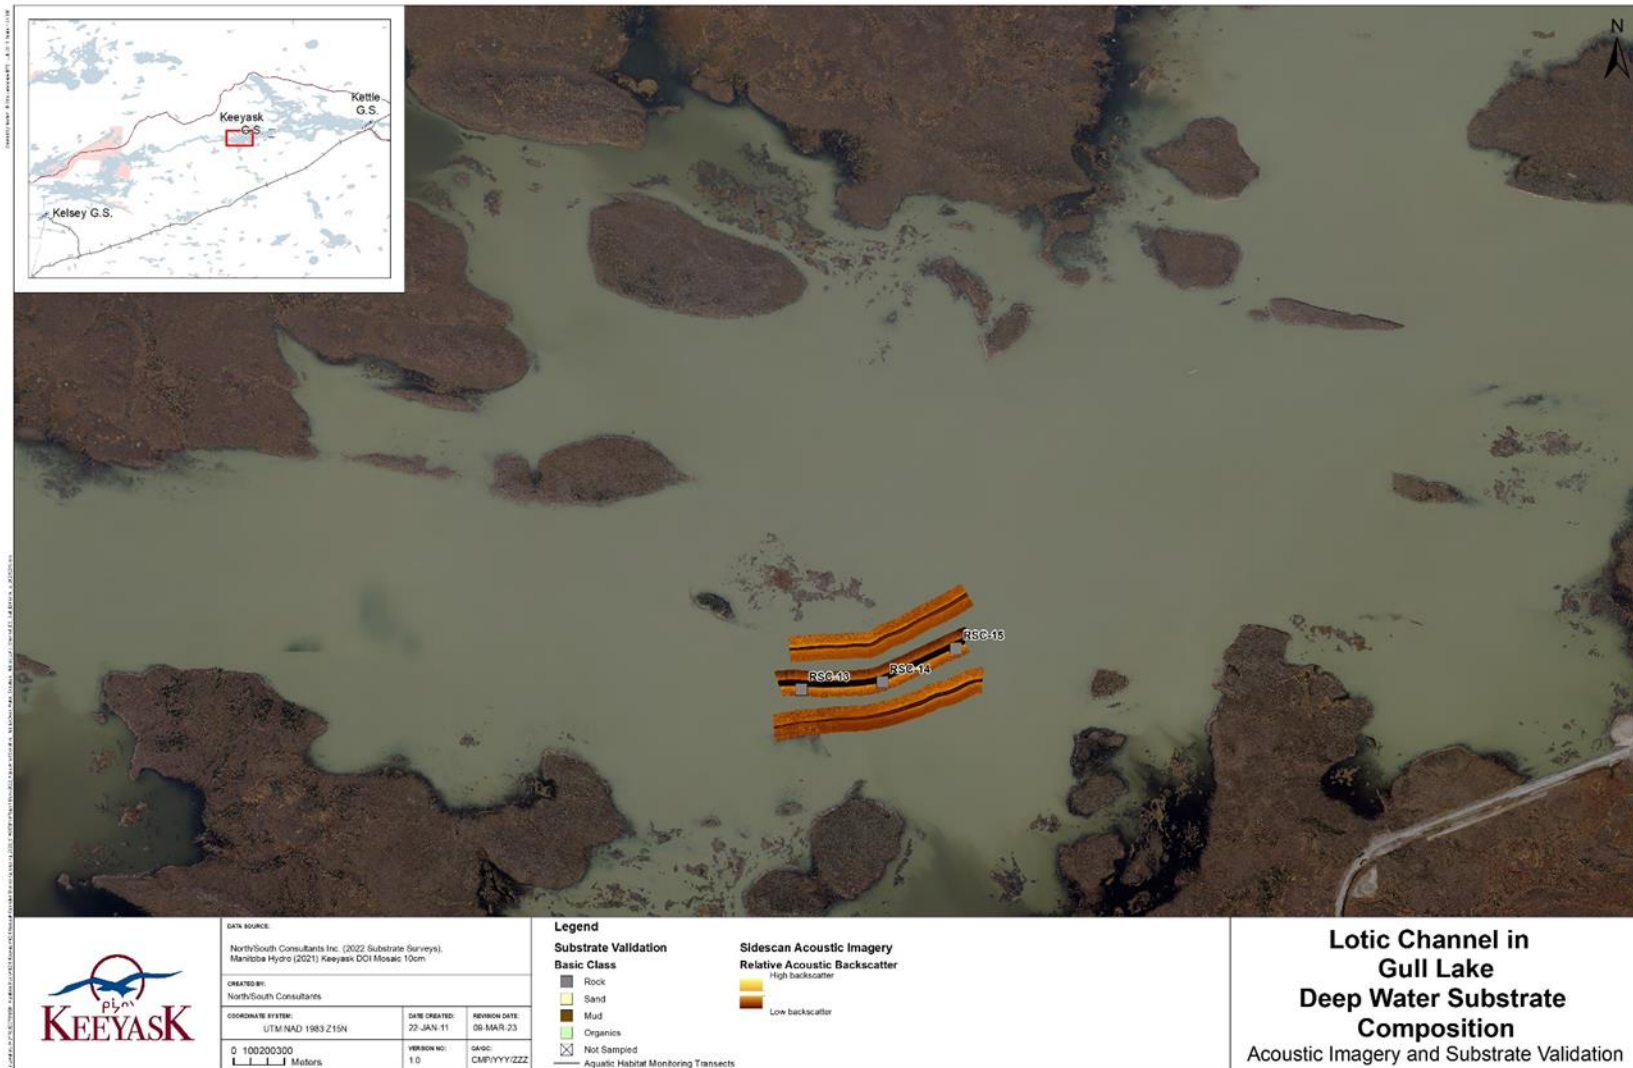
Substrate validation and single-beam acoustic surveys were conducted within a lotic channel in upper Gull Lake on August 18, 2022. Three substrate validation sites were sampled using a weighted sounding line (Table 12). Hard substrates were found, classified as boulder and cobble. Substrate mapping derived from analysis of sidescan image data confirmed boulder and cobble were present at each site (Map 9).

**Map 9:** Map illustrating the results of substrate composition sampling sites and acoustic imaging in the lotic portion of upper Gull Lake, 2022. Lighter colours in the acoustic imagery indicate harder substrates while darker colours indicate softer substrates.

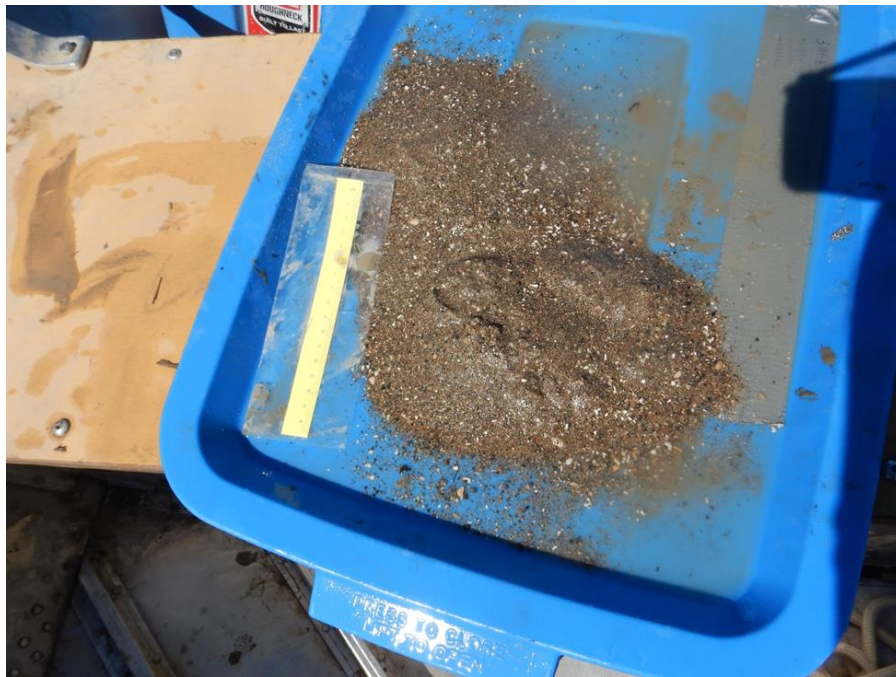
Substrates were varied throughout the reach, ranging from hard boulder to areas of soft silt. Sand was the dominant substrate type in six sites located within the middle of the channel to the north of Caribou Island, previously identified as important Lake Sturgeon rearing habitat (Map 11; Photo 1). Five of these sites were sampled for PSA which confirmed that sand was the predominant substrate from four (DST3-16, -22, -25, and -28). This area of sand was bordered on the upstream and downstream sides by areas of mud (*i.e.*, silt and clay). Silt deposition was evident at two of the six sites.

**Photo 1:** Substrate collected at site DST3-28 in the area of the Keyyask reservoir surrounding Caribou Island showing sand.

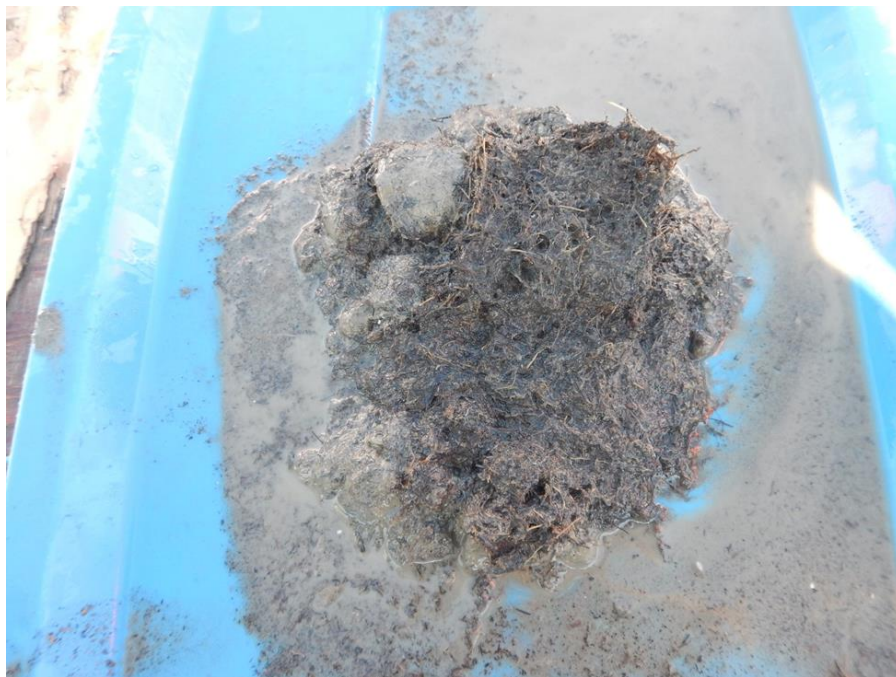
Spring substrate validation and acoustic surveys were conducted within the Stephens Lake sensitive habitat area on June 5 and 6, 2022. Twenty sites were sampled using a petite Ponar (Table 17). Sandy substrates were predominant (30–100%) at 11 sites within the reach (Map 13). PSA indicated that sand was the dominant substrate type at four of five samples collected (representing 49–67% of each sample) (Table A-1). Silt deposition was evident at the majority (n = 16) of sites. Organics, consisting of detritus and loose, broken-down plant matter (Photo 2), were evident at 12 sampling sites.

**Photo 2:** Substrate collected at site T4-4 in the upper Stephens Lake sensitive habitat area in June showing sand, clay, organics, and silt.

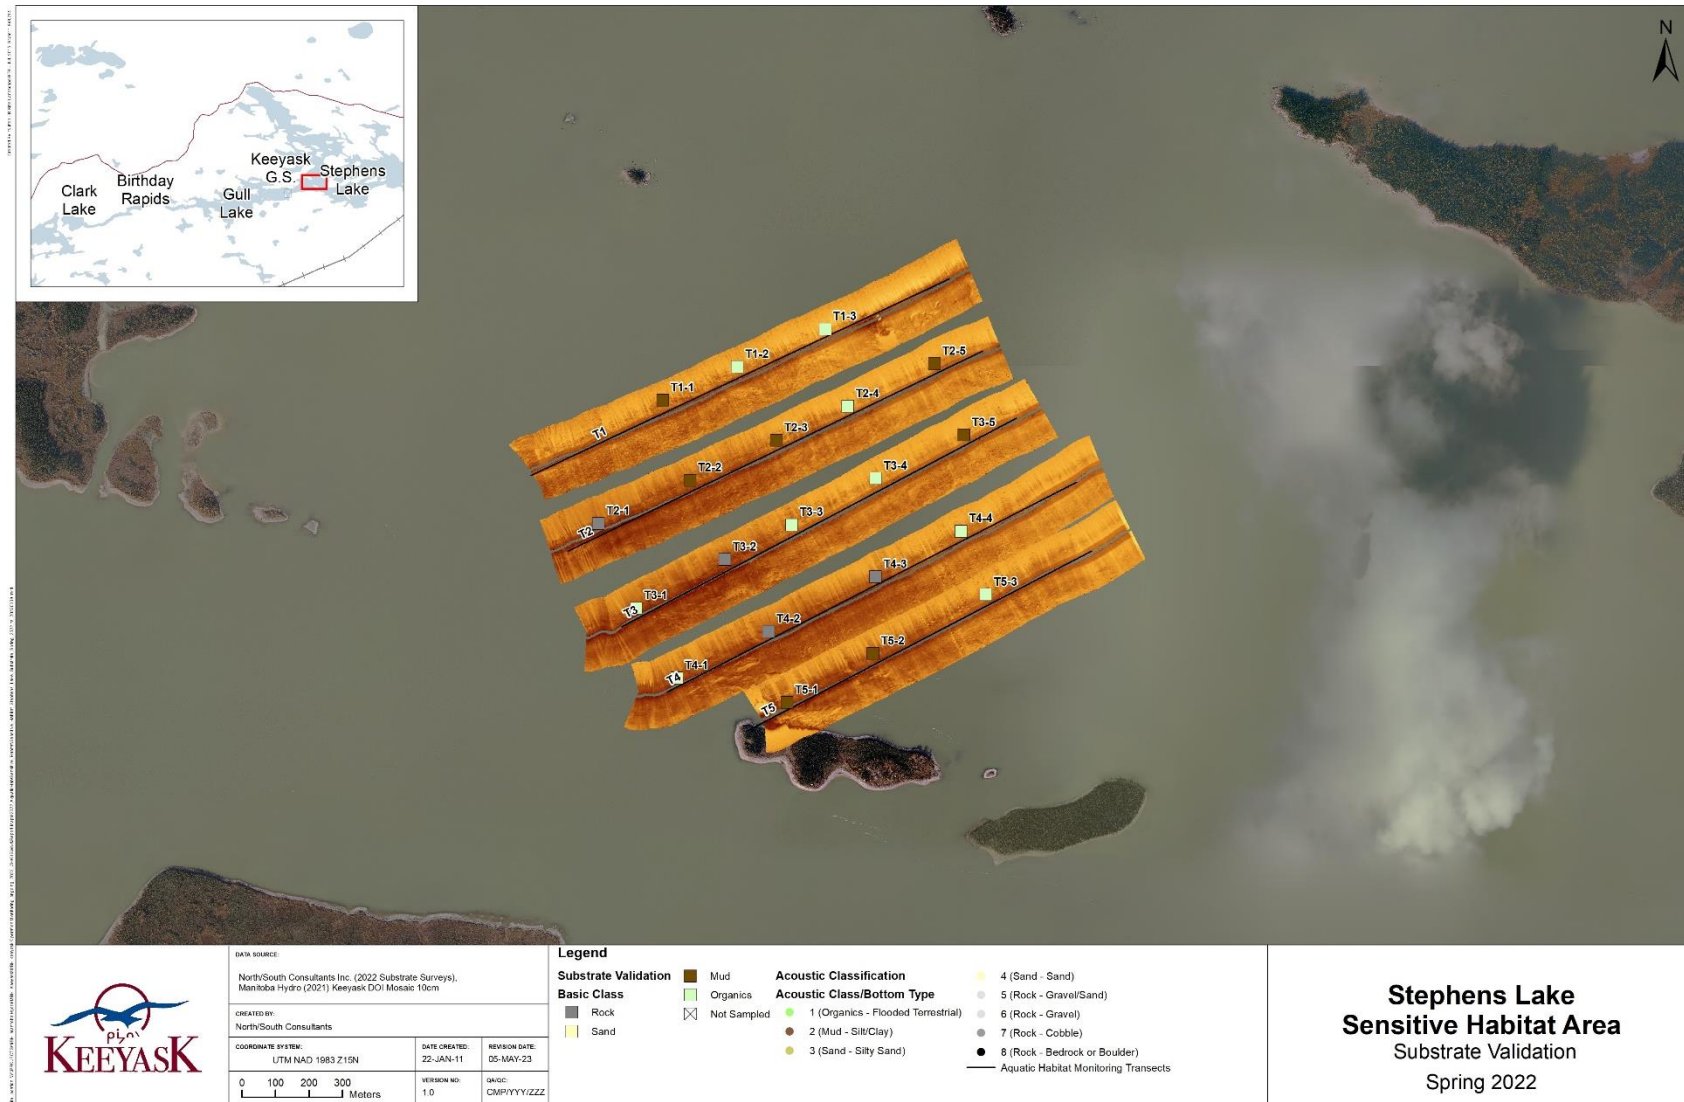
**Map 13:** Map illustrating the results of substrate composition sampling sites and acoustic imaging for the Stephens Lake sensitive habitat area, June 2022. Lighter colours in the acoustic imagery indicate harder substrates while darker colours indicate softer substrates.

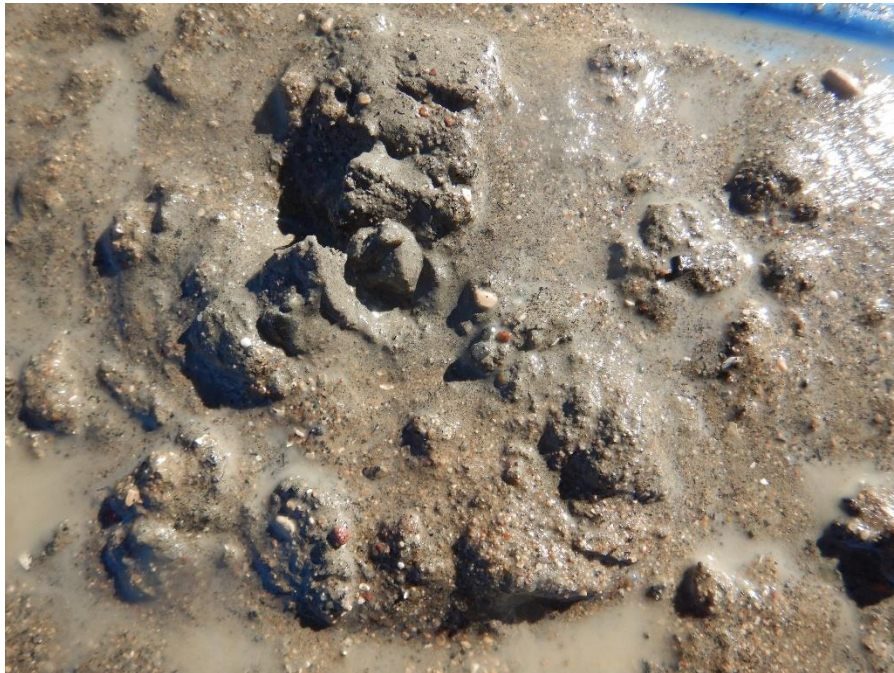
**Photo 3:** Substrate collected at site DST4-14 in the upper Stephens Lake sensitive habitat area in August showing sand and silt.

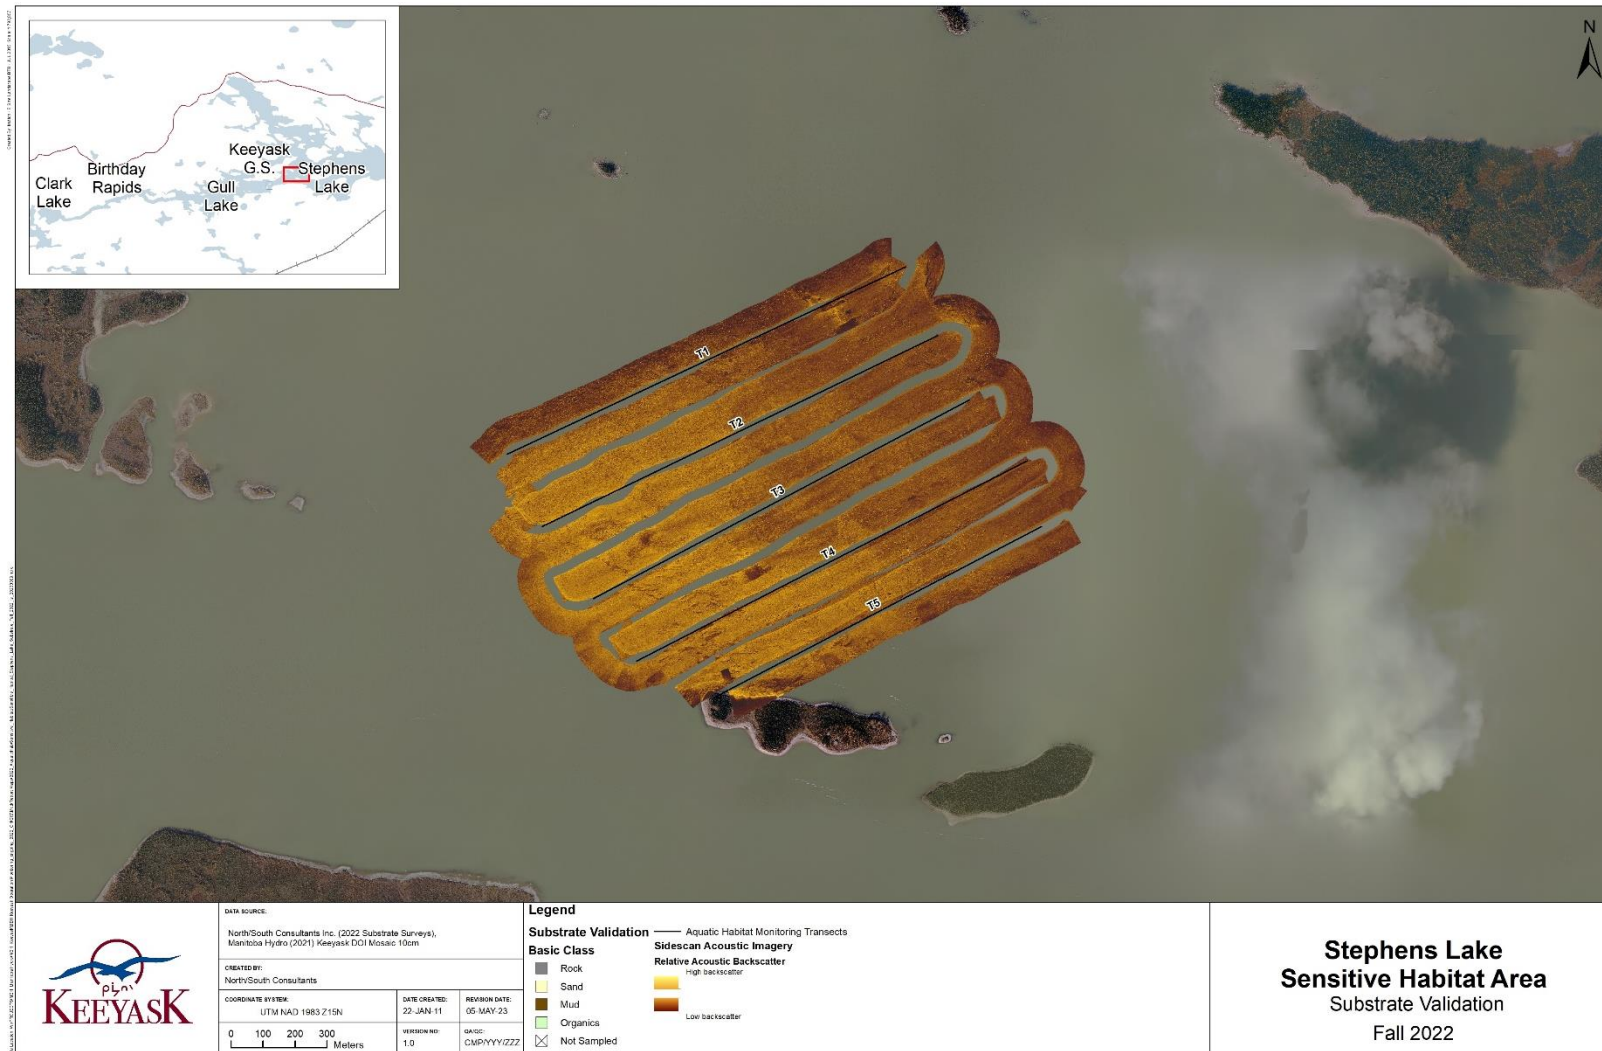
Acoustic classification was conducted a single time on August 13 (Table 19). The acoustic classification model indicated that all substrate types are found within the area, with only marginal difference in proportions. Bedrock/boulder composed the majority (25%) of the area, followed by cobble (21%), gravel/sand (16%), and gravel (15%). Silt/clay and organics each comprised 10% with sand and silt/clay/sand (each 7%) making up the lowest proportion of the substrate of the reach.

**Map 15:** Map illustrating the results of substrate composition sampling sites and acoustic imaging for the Stephens Lake sensitive habitat area, September 2022. Lighter colours in the acoustic imagery indicate harder substrates while darker colours indicate softer substrates.

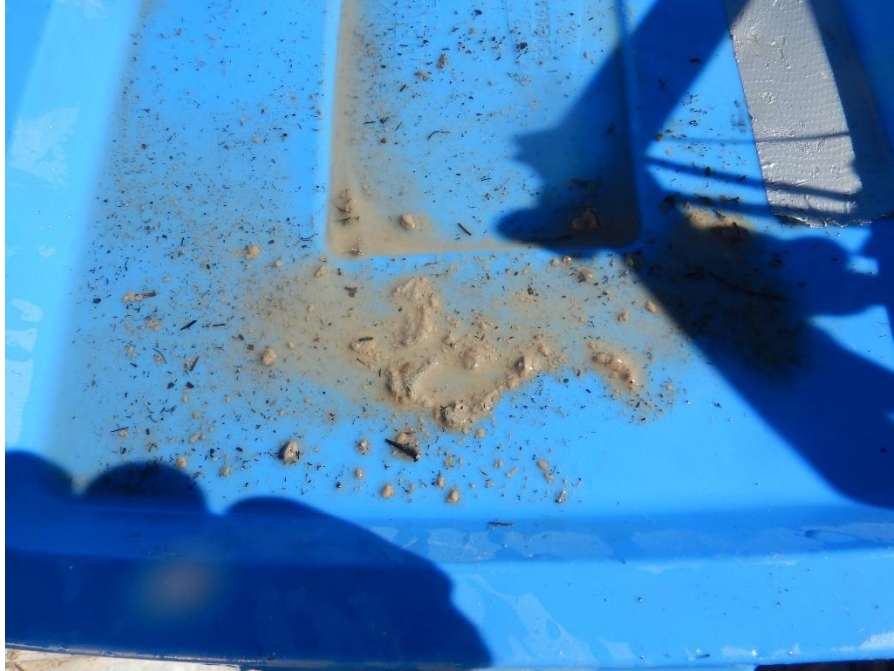
Substrate validation and single-beam acoustic surveys were conducted on August 14, 2022 (Maps 17–25). Substrate was sampled on each shoal using either a petite Ponar or a weighted sounding line (Table 21). Hard cobble substrate was observed at eight sites, with three of these sites consisting of 50% cobble and 50% boulder. A single site (F-North) contained small amounts of sand and organics overlying hard cobble and boulder substrates. These smaller substrates were present in small quantities (Photo 4).

**Photo 4:** Small amounts of sand and organic substrates collected from constructed shoal F-North in the Keeyask reservoir, 2022. These substrates were overlying hard cobble and boulder.

- All nine constructed spawning shoals in the Keeyask reservoir were composed of boulders and cobble. One (F-North) showed deposition of small amounts of sand and organics over top of the rocky substrate near the middle portion of the shoal.
- In Stephens Lake, one site on the N5 causeway remnant contained largely soft substrate (silt/clay/sand) deposition, while organic matter was found at a portion of the other (G3).
- Sampling in 2022 represents the second year of monitoring at sensitive, deep water, and constructed habitats. Surveys will be repeated in 2023 and a comprehensive report will follow that includes a detailed analysis of changes in deep water and constructed habitats in the three years following reservoir impoundment, including responses to key questions outlined in the AEMP.

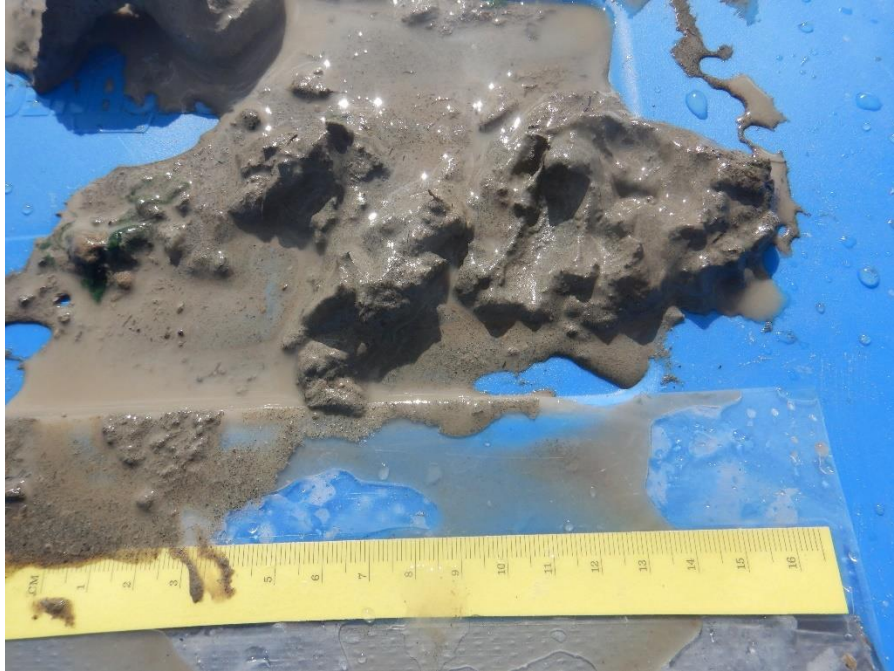
Substrate was sampled from five sites at the N5 causeway and three at the G3 causeway using a petite Ponar and a weighted sounding line (Maps 27 and 28). Hard rocky substrates (e.g., boulder and cobble) were the dominant substrate at four of five sites at the N5 causeway and two of three sites at the G3 causeway. Silt (45%) and clay (40%) were the dominant substrates at a single site on the N5 shoal (N5-4) (Table 23; Photo 5). Organics composed 100% of the substrate at a single site on the G3 shoal (G3-3) (Table 23; Photo 6).

**Photo 5:** Silt and clay substrates collected from one sampling site located on the former N5 causeway, 2022.

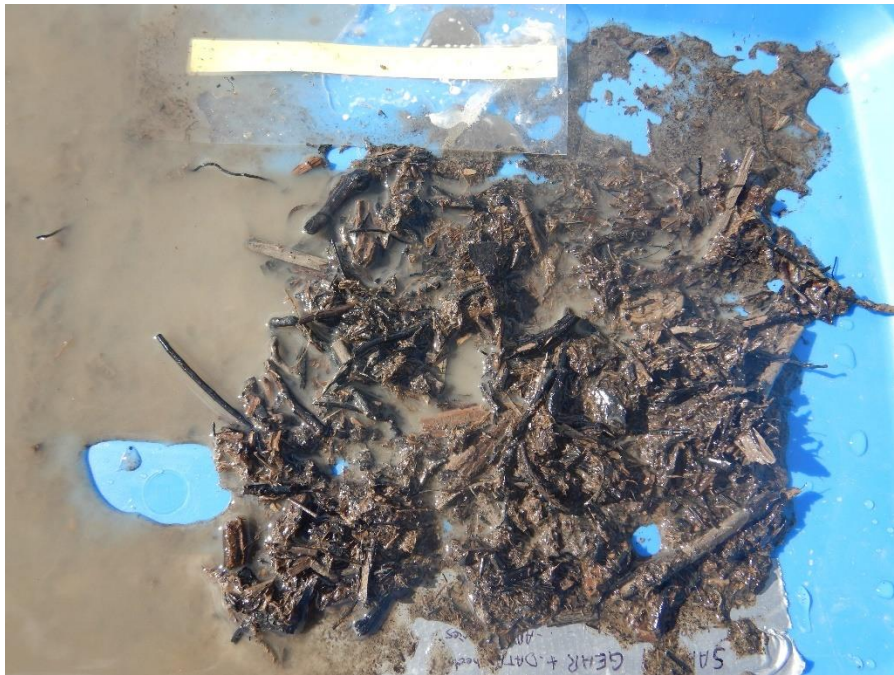
**Photo 6:** Organics collected from one sampling site located on the former G3 causeway, 2022.
