Keeyask Generation Project Physical Environment Monitoring Plan

Physical Environment Monitoring Report

PEMP-2023-01

2022-2023 PHYSICAL ENVIRONMENT MONITORING REPORT: YEAR 2 OPERATION

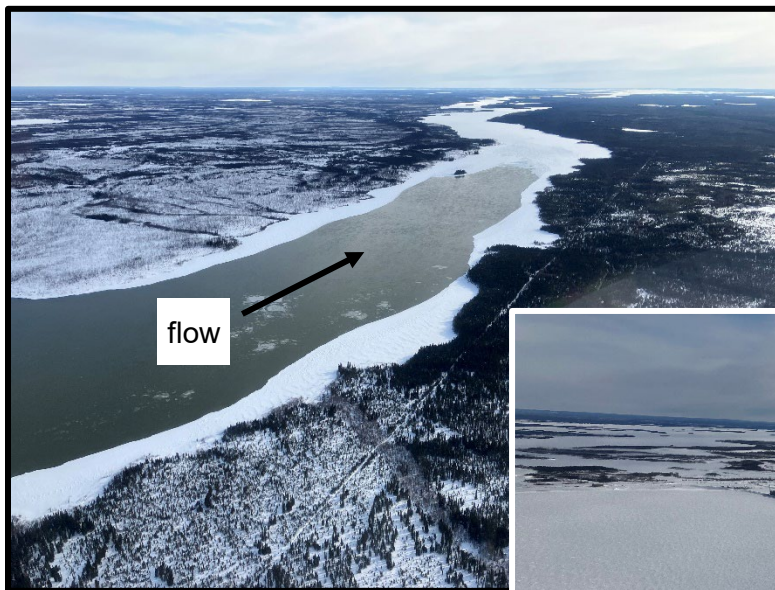
Downstream of Clark Lake

March 22, 2023

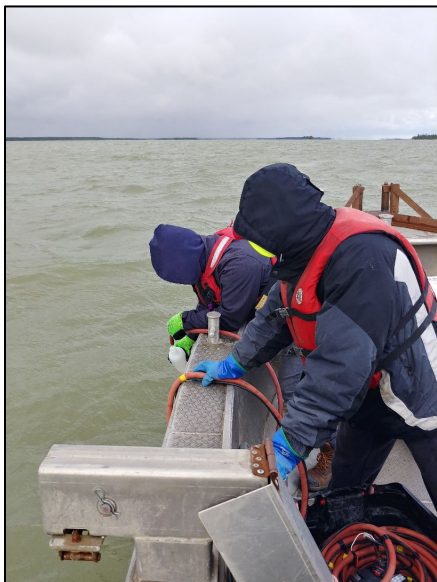
Collecting Water Samples for Sedimentation Monitoring

Sedimentation monitoring includes studying how sediment is carried (sediment transport) in the water and where it is deposited. It involves collecting water samples to measure the amount of sediment suspended in the water (done in a laboratory), using electronic devices that continuously measure turbidity (i.e., the murkiness of the water) over time and by taking readings with a hand-held meter when visiting monitoring sites. Sediment traps are used to collect sediment from the water over time to monitor the potential for sediment to settle out (deposit) near areas of potentially important sturgeon habitat.

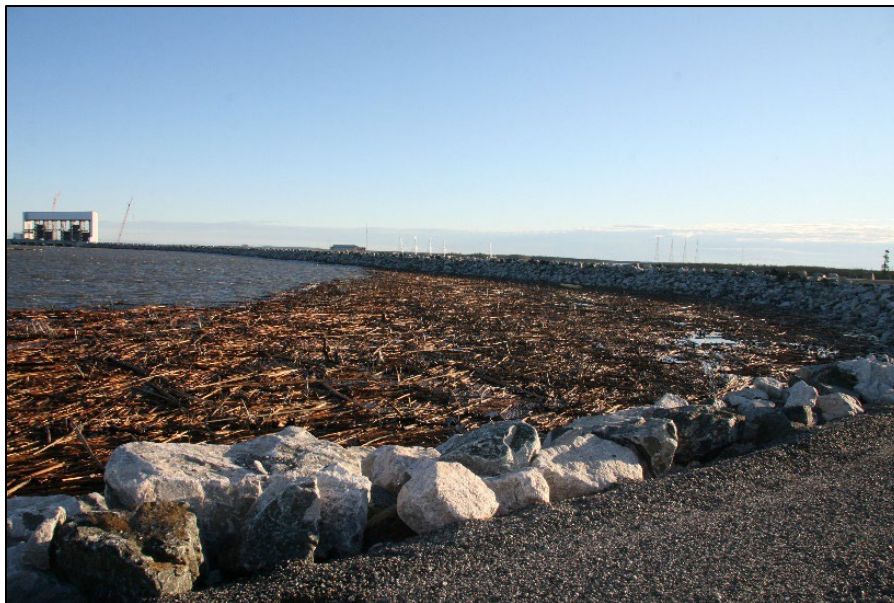
Woody Debris Adjacent to the South Dike

In summer 2022, the woody debris management program consisted of two parts, the first being two boat patrols on the reservoir, and the second being a 20-person work crew on shore. As in 2021, the large work crew focussed its clean-up efforts in the vicinity of the Keeyask GS and the north and south dikes where quantities of woody debris accumulate on an ongoing basis. The crews removed debris near the powerhouse and upstream on the north dike that affected water flow into the powerhouse. It also worked along a few kilometres of the south dike, west of the spillway. Debris collected in 2021 that was stockpiled beside the south dike and left to dry was burned in May 2022, and debris collected in 2022 was stockpiled in the same location where it could dry before being burned in 2023.

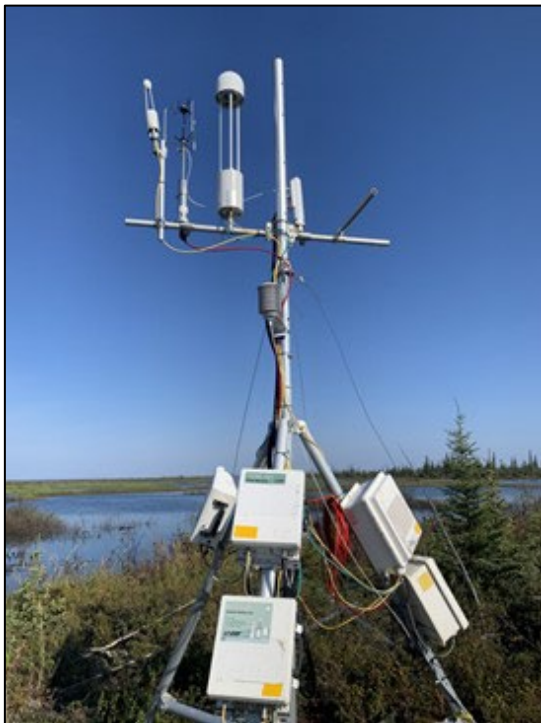
GHG Monitoring Tower

Reservoir greenhouse gas emissions (GHG) were monitored after reservoir impoundment from 2021 to 2022, during the water-up period in 2020, and during the pre-impoundment periods of 2009-2010, 2012 to 2014, and 2017 to 2019. GHG emissions are being measured by above ground towers and underwater sensors that continuously record carbon dioxide (CO₂) and methane (CH₄). Water samples are also taken to give point-in-time measurements of GHGs. Monitoring in the last year indicates that GHG emissions remain elevated after flooding compared to pre-impoundment levels, as predicted in the EIS. A large portion of the post-flood GHG emissions are coming from the newly flooded, shallow regions of the reservoir. The organic material in these areas is decomposing and releasing CO₂ and CH₄. The amount of emissions released from the shallow waters of the reservoir are similar to those of northern beaver ponds. As planned, monitoring will continue to be conducted to observe changes in GHG emissions over time.

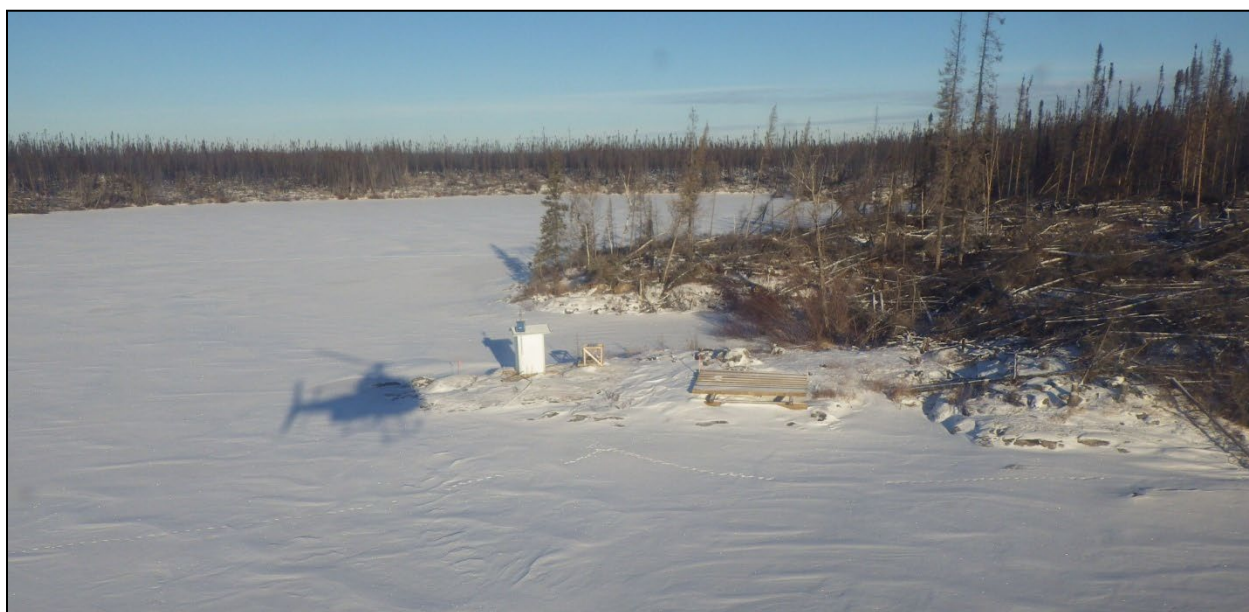
Photo 1: Water level gauging station in winter

Water levels are monitored at six sites from Clark Lake to Gull Rapids (Table 2, Map 2). A typical water level gauge is shown in Photo 1. The two Clark Lake sites have been monitored regularly since 2003, while the Gull Lake gauge was installed at the start of construction in mid July 2014. The other three sites were installed after construction started, once the necessary permits and heritage surveys were complete, which were applied for and done after the Environment Act licence was received in early July 2014. The original gauge at the upstream end of Gull Lake (05UF749) was wrecked by ice and was discontinued in May 2016. The gauge was relocated about 3 km upstream to the mouth of Portage Creek and began operation in September 2016 (site 05UF587). In addition to data from the PEMP gauges, data is reported from the existing gauge on Split Lake at the community of Split Lake.

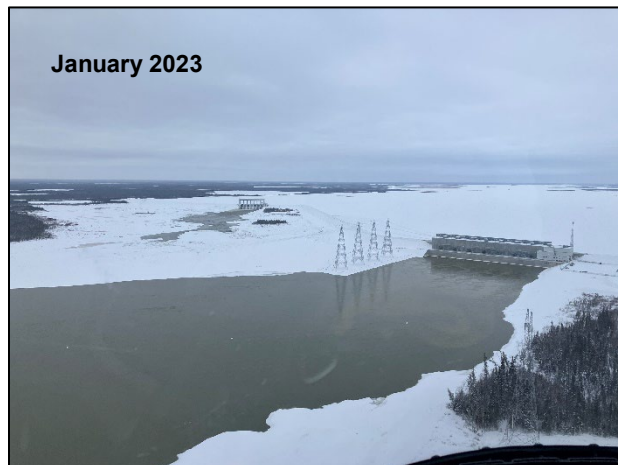
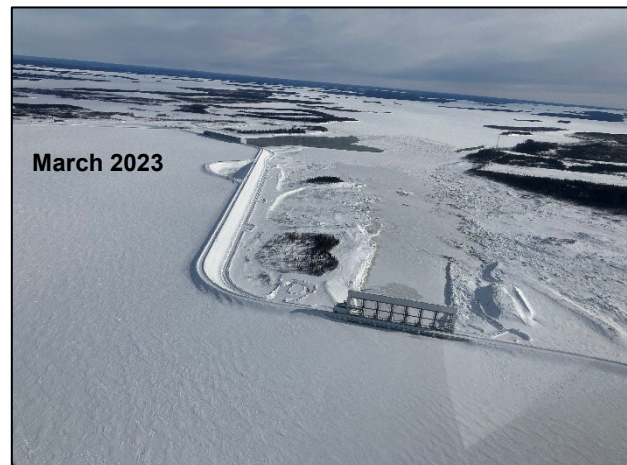
Photo 2: Ice formation Downstream of Keeyask

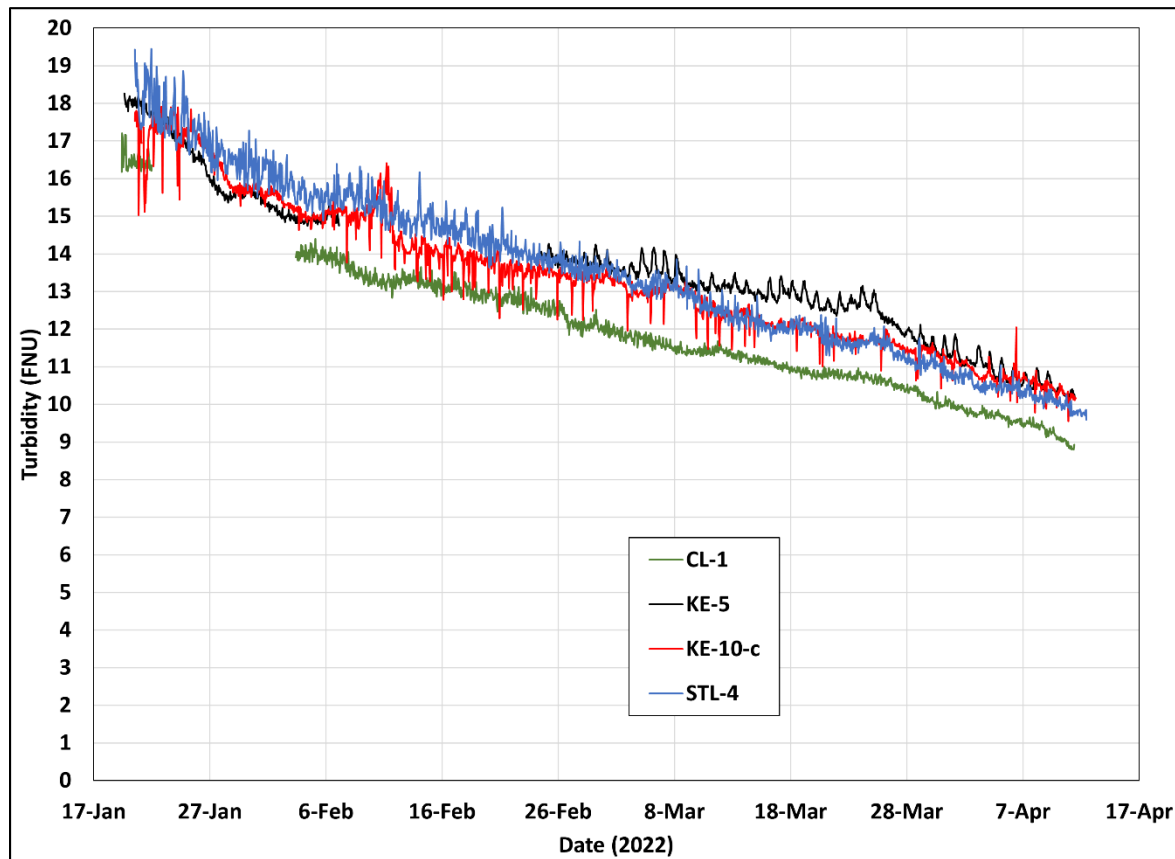
Figure 16: 2021-2022 winter continuous TU

Turbidity levels at the two Gull Lake sites and just downstream (KE-5, KE-10-c, STL-4) were all generally within about 1 FNU of each other and turbidity steadily decreased from about 18-19 FNU at the start of monitoring to about 10 FNU at the end (Figure 16). Turbidity at the Clark Lake site (CL-1) was generally lower than the downstream sites by about 1-2 FNU, and steadily decreased from about 16 FNU to 9 FNU from January to April. While the turbidity in January was somewhat higher than observed the last several winter seasons, the pattern of winter decrease and the low values at the end are similar to past observations.

In addition to turbidity monitoring at the four mainstem sites (Figure 16), discrete monitoring was performed twice, once early in winter in December/January and again in April, at 11 backbays upstream of the project and in a backbay on Stephens Lake that is unaffected by the project (Figure 20). At each site the turbidity levels in Dec/Jan are generally higher than in April. With a few exceptions, KE-Z9-1 had lower turbidity across its 4 sampling locations (a to d) than observed at other sites, with three of four locations below 8 FNU in Dec/Jan while April levels were 4-5 FNU. For the remaining locations, the Dec/Jan turbidities largely varied from about 10-16 FNU except for a few locations that were lower. As in 2021, turbidity averaged about 5 FNU lower in April, and in 2022 generally ranged from about 6-9 FNU. This is consistent with the decline in turbidity over the course of winter that was observed from the continuous data.

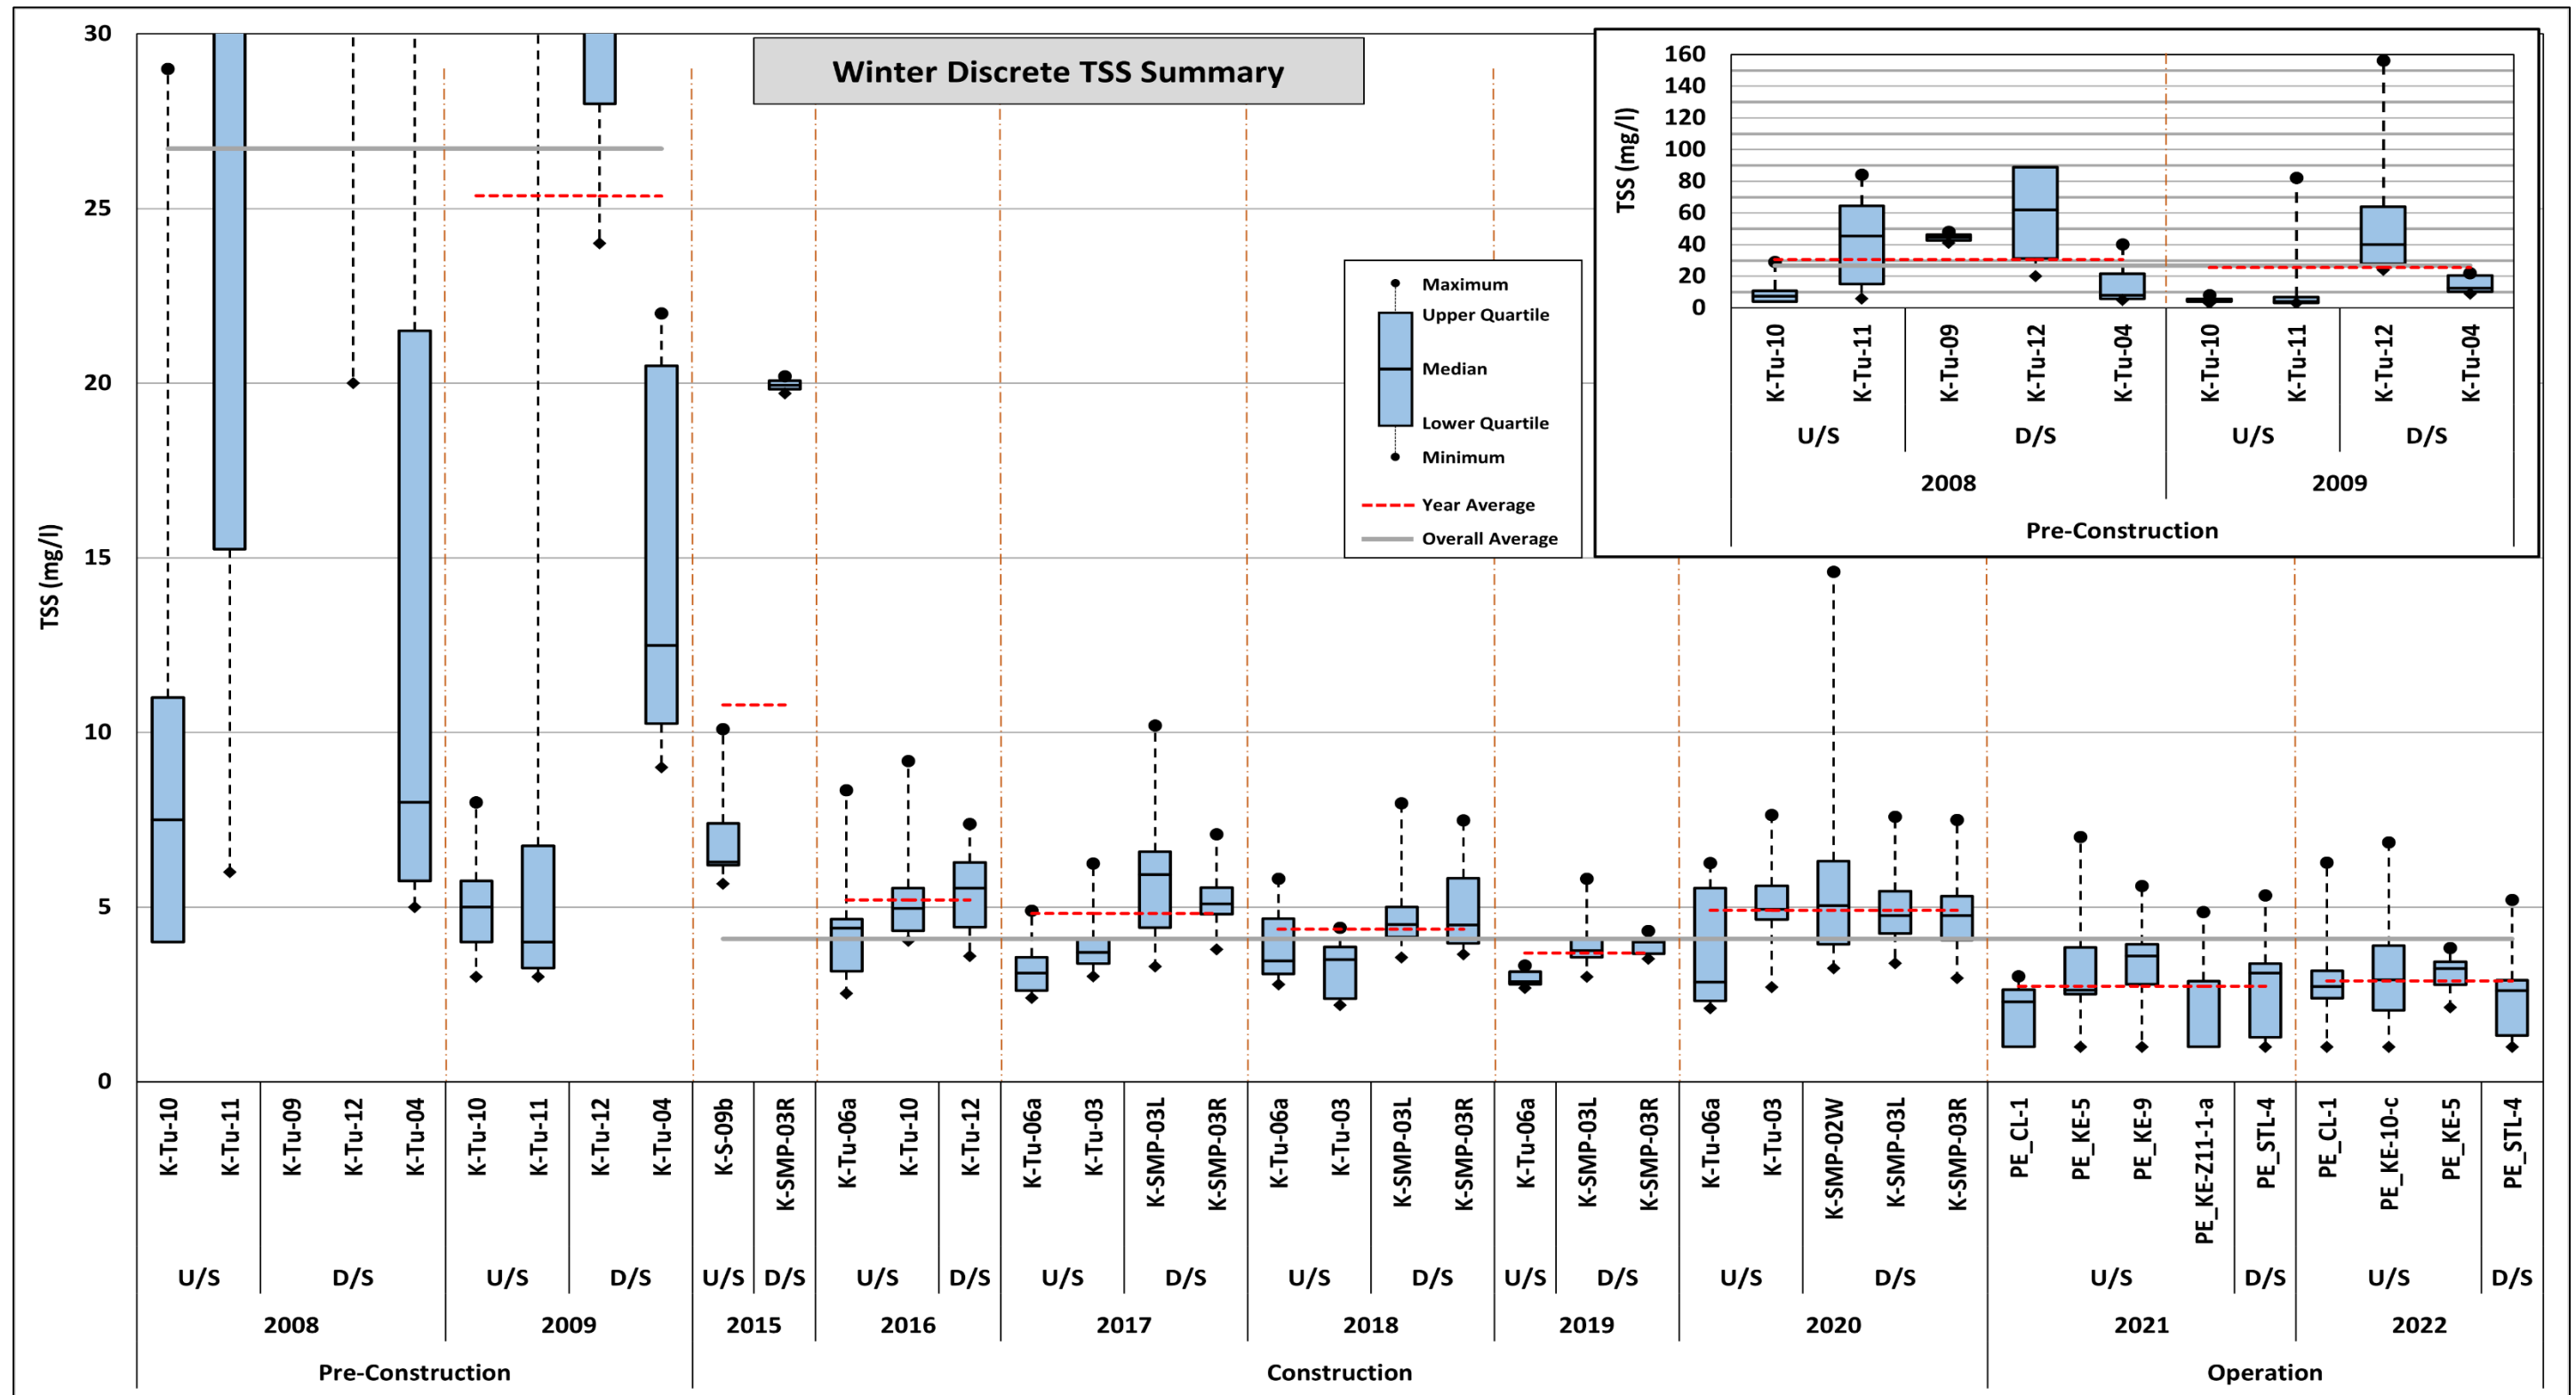
Discrete TSS and turbidity data show consistent results with the continuous data (Figure 18, Figure 19). With the ice boom working to produce a stable ice cover upstream of the Project the downstream TSS and turbidity are lower than compared with pre-project conditions. Results from both years of operation are similar and generally slightly lower than conditions observed in the previous years during construction. The average TSS in 2022 was low at about 3 mg/l, or about the same as in 2021, and lower than the averages of about 4-5 mg/l in the previous years of construction. While average TSS concentrations in 2022 were about the same as 2021 and lower than previous years of construction, the turbidity in 2022 was slightly higher but still low like previous years of construction.

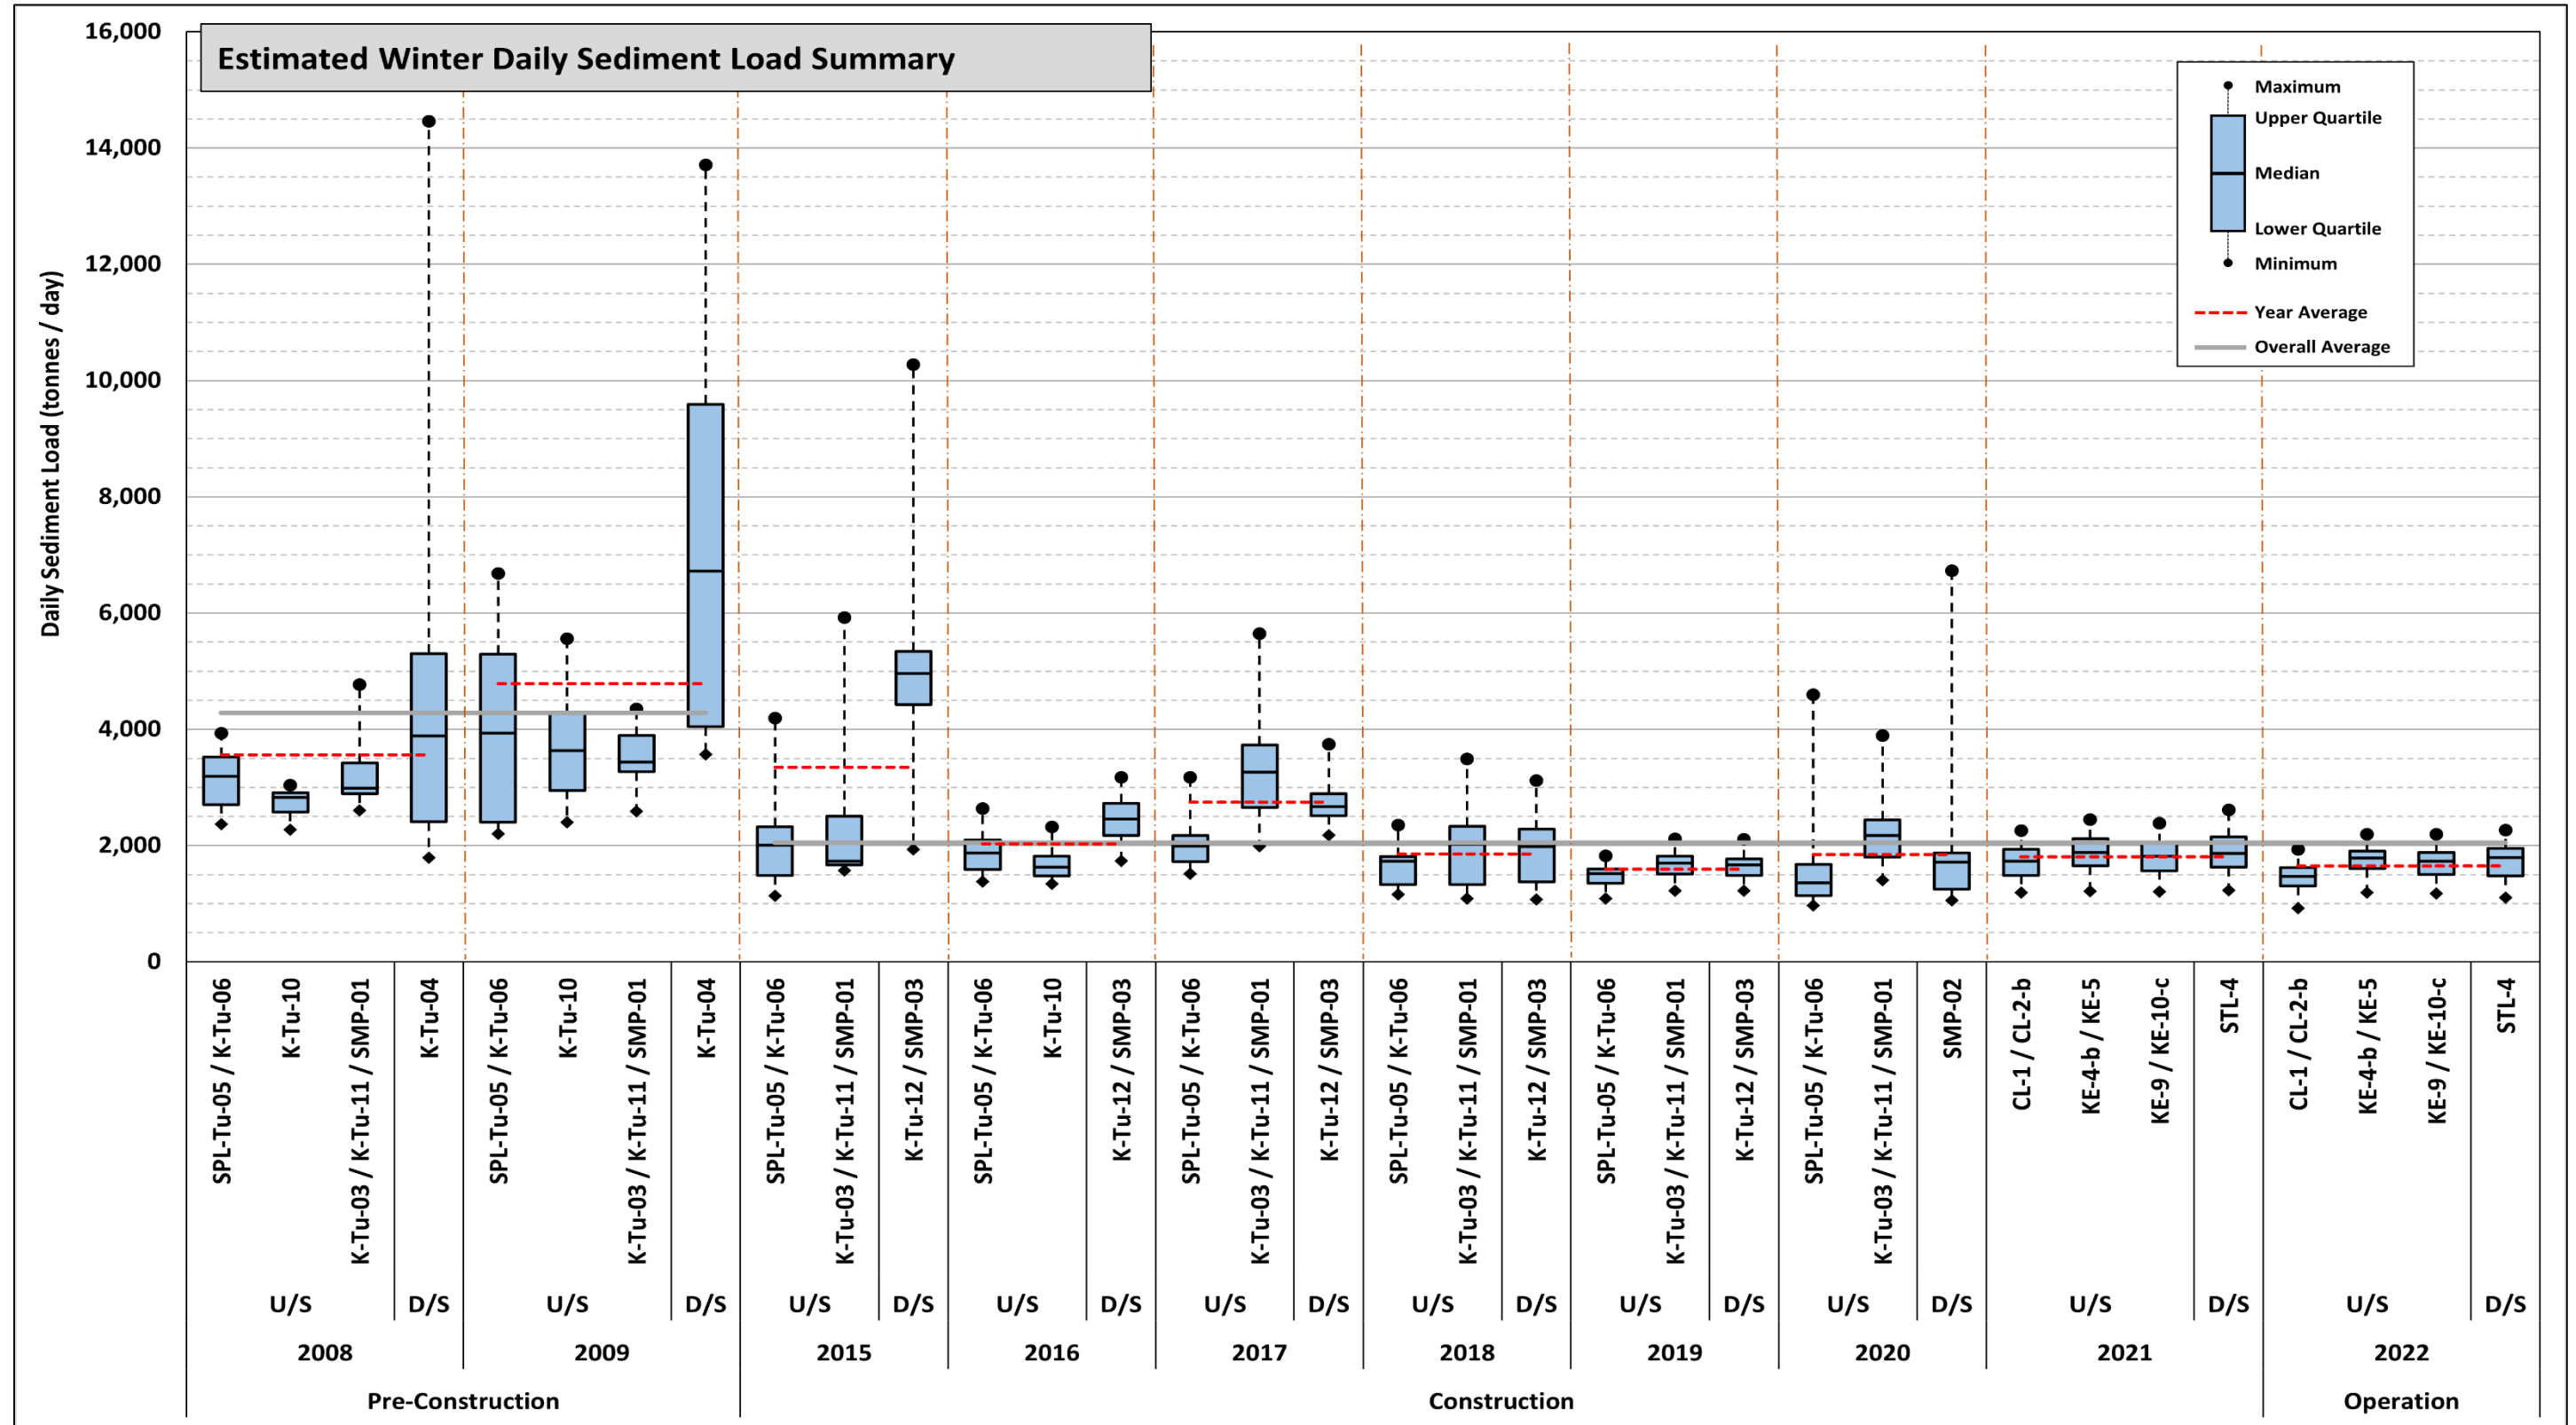
Figure 21: Summary of winter daily suspended sediment load (2008-2022)

The estimated daily sediment load at Clark Lake (sites SPL-Tu-05 & K-Tu-06 before operation, and CL-1 & CL-2-b during operation) upstream of expected hydraulic effects due to Keeyask indicates that the winter average was higher during the two pre-construction years than the winters monitored since 2015. In 2022, the sediment loads at sites downstream of Clark Lake were about 20% greater than at Clark Lake, which is consistent with previous years during construction when the downstream loadings have generally been about 10-30% greater (Figure 21). The overall average load in 2022 was about 1,650 t/d, which is comparable with previous years during construction when loads have ranged from roughly 1,600-2,000 t/d with the exception of 2017, which was about 2,700 t/d.

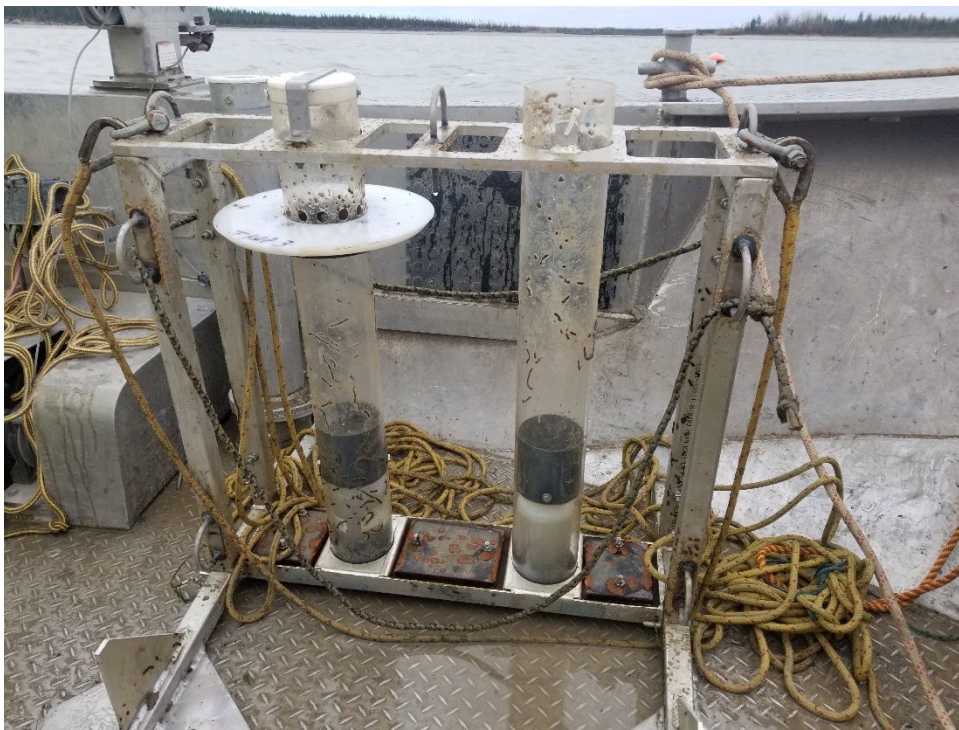
Photo 5: Sediment traps - 2 tube design

Sediment traps with two vertical tubes (Photo 5) were installed in Gull Lake and Stephens Lake to monitor the sediment accumulation rate over the 2021/22 winter and the 2022 summer periods. One tube is a settling trap that is open at the top and the second tube is a flow through trap that has holes in the side to allow water and sediment to flow into it. Sediment trap data from 2022/23 and previous years are under combined review that will need to consider data from 2023/24 and reporting will therefor be deferred to subsequent annual report.

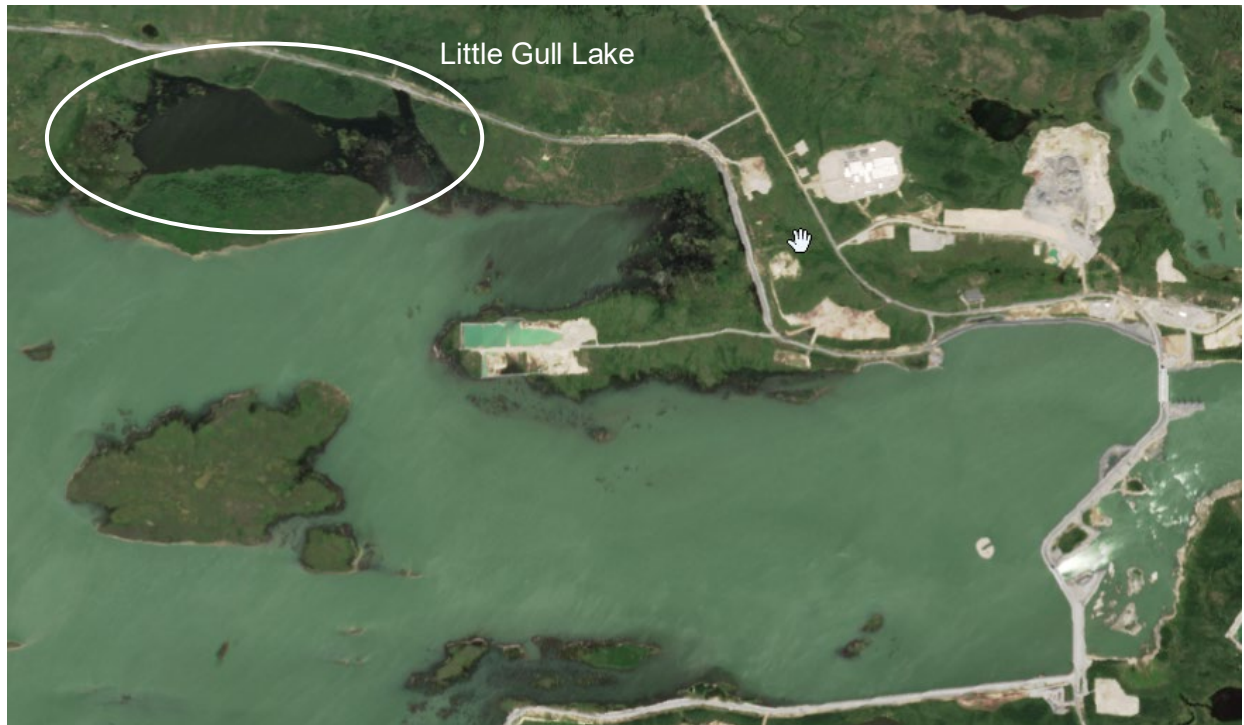
Figure 46: Location of Little Gull Lake

Little Gull Lake was a small lake developed within peat bogs approximately 900 m to the north of Gull Lake (Figure 46). After impoundment of the Keeyask reservoir in fall 2020, Little Gull Lake was incorporated into the overall reservoir. Dissolved oxygen (DO) modeling conducted during the Keeyask environmental assessment indicated that this area would become anoxic during winter, due to restricted flows and the high oxygen demand from organic substrate. It was also identified that the water depth between the former Little Gull Lake and Gull Lake within the reservoir would be very shallow and could freeze to the bottom in the winter. This could restrict the movement of fish to areas of higher DO creating the risk of winterkill.

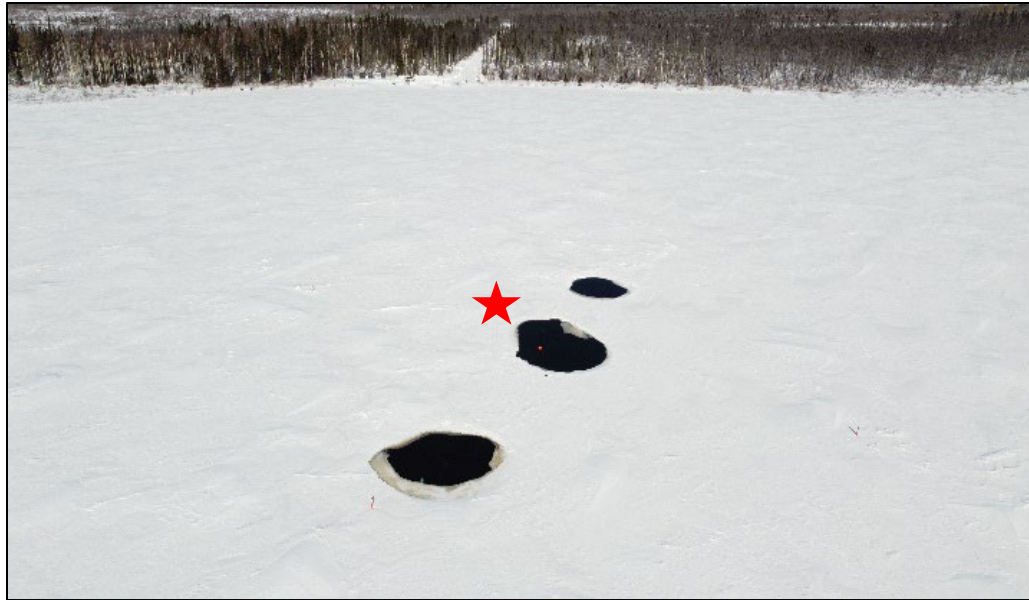
Photo 6: Typical ice conditions and approximate location of DO logger installation (image from March 2022 looking north)

As 2020/21 monitoring indicated that the aeration system has a limited influence on DO levels outside of the aeration field it was determined that for the 2021/22 winter season discrete monitoring would be discontinued. Monitoring of DO for the 2021/22 season focused on the collection of continuous DO data at a location within the aeration field. Two continuous HOBO DO (U26-001) loggers were deployed within the aeration field between the internal and external ring of aeration heads. Figure 47 presents a diagram of the aeration field layout and the approximate location (**Error! Reference source not found.**) of the monitoring equipment. The HOBO DO loggers were attached to a metal rod that was driven through the aqueous 'muck layer' of the lake substrate into the underlying firm substrate. The loggers were placed at approximately 0.33 and 0.66 metres above the lakebed in the Northwest corner of the field. The equipment recorded DO and water temperature from October 22, 2021 to May 22, 2022.

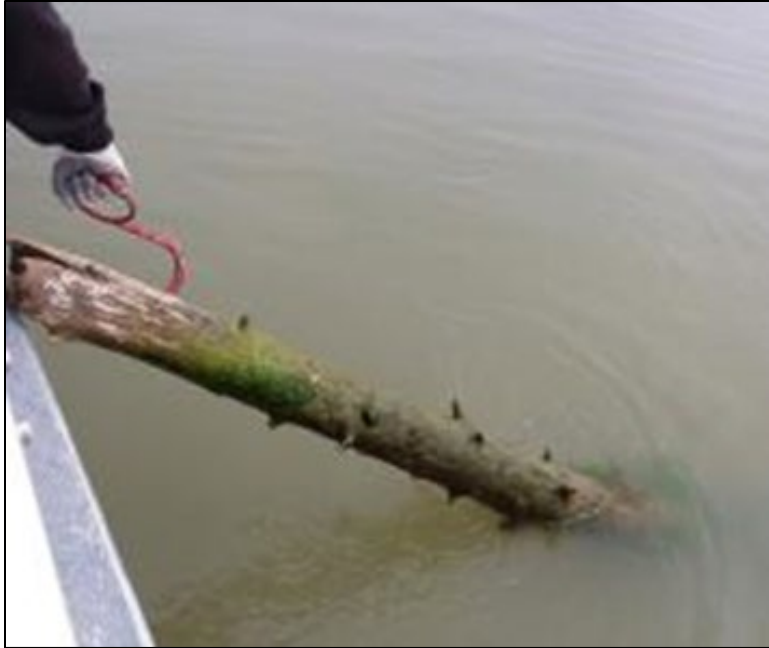
Photo 7: Large floating debris is removed from the water by the boat patrol team

Boat patrols identify and remove floating woody debris (Photo 7) that may pose a safety hazard to navigation. The boat patrol typically records the amount of debris removed each season, classifying it as either small (<1m length) or large (>1m length), and the large material is further classified as either new or old debris (generally with or without bark) or if it came from beaver activity.

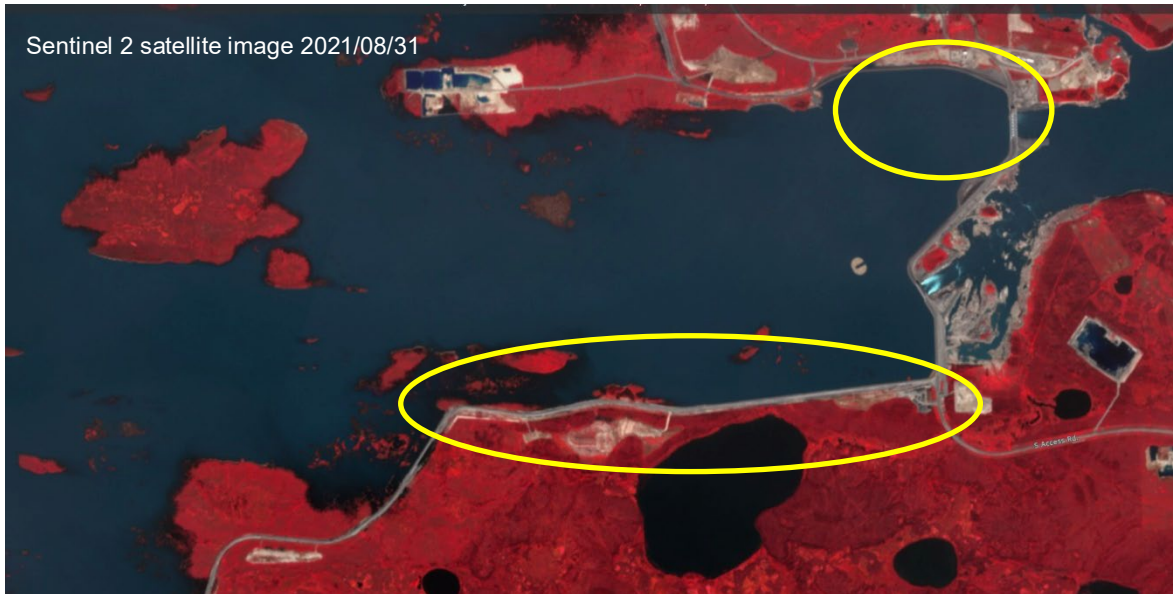
Figure 49: General work areas for work crew debris removal activities

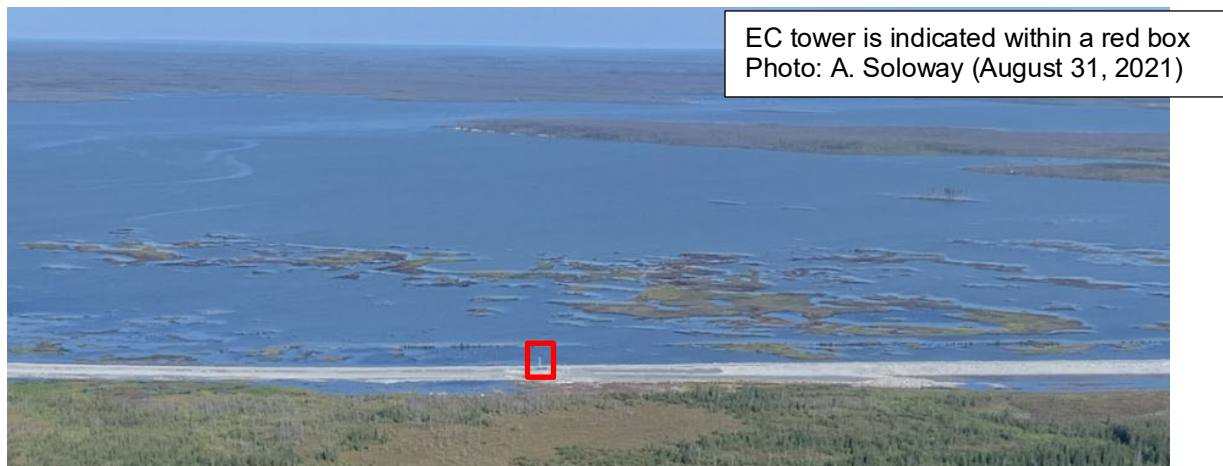
Photo 9: Aerial view of the Dike Road tower site showing emerging peat, peat islands and vegetation

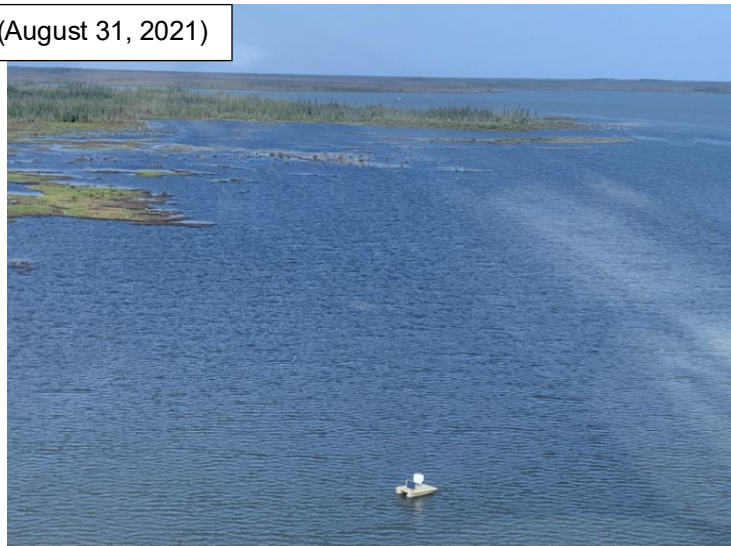
Photo 12: Aerial view of the Backbay raft site: PE-KE-Z11-1-A where point-in-time samples were taken and submersible sensors were deployed

Sensors for the measurement of dissolved CO₂ and CH₄ (as gas partial pressures) were secured to two rafts in the 2021 and three rafts in 2022. Sensors were deployed between June to September, 2021 and 2022. A raft located mid-channel (PE_KE-4-B), and a raft located within the backbay (PE_KE_Z11-1-A, see Figure 50 for raft locations) were equipped with a submersible pCO₂ sensor (CO₂-Pro CV, Pro-Oceanus, Halifax, NS) and a submersible pCH₄ sensor (CONTROS HydroC-CH₄, 4H Jena Engineering, Jena, Germany). A submersible pCO₂ sensor was installed on the third raft (PE_CL-2-b) in Clark Lake (CO₂-Pro CV, Pro-Oceanus, Halifax, NS) in 2022. Data provide insights into high frequency changes in the dissolved GHG concentrations that serve both to underpin the calculation of non-littoral zone fluxes, and provide insight into temporal variability into both dissolved gas concentration, and associated air-river/reservoir GHG exchange.
