Keeyask Generation Project Terrestrial Effects Monitoring Plan

Wetland Loss and Disturbance Monitoring Report

TEMP-2023-04

WETLAND LOSS AND DISTURBANCE MONITORING YEAR 1 OPERATION 2022

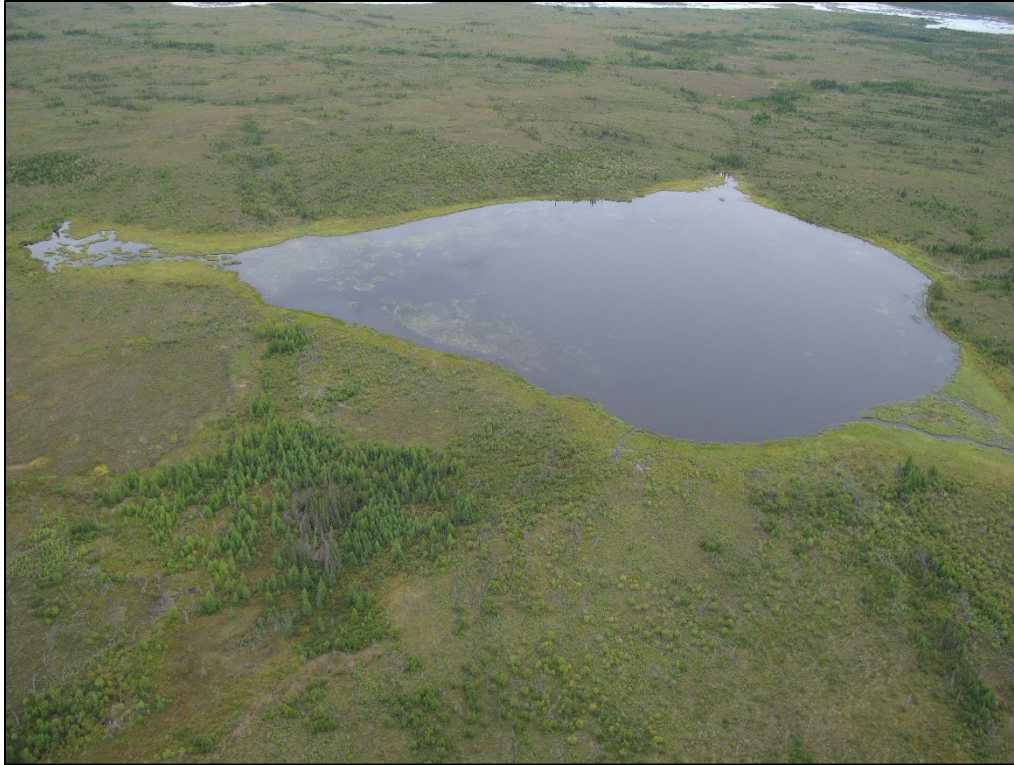
Photo 3-1 to Photo 3-3 provide an aerial view of conditions in a few of the surveyed wetlands that were more than 100 m from the Construction Footprint.

Photo 3-1: Wetland 15 marsh habitat on August 31, 2022

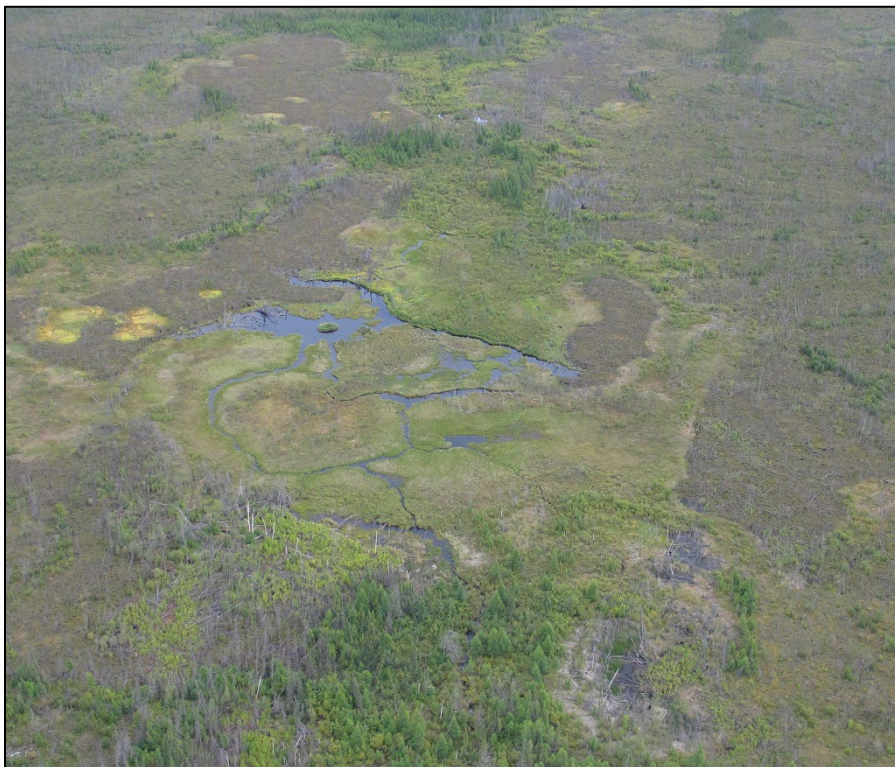
Photo 3-2: Wetland 20 marsh habitat on August 31, 2022

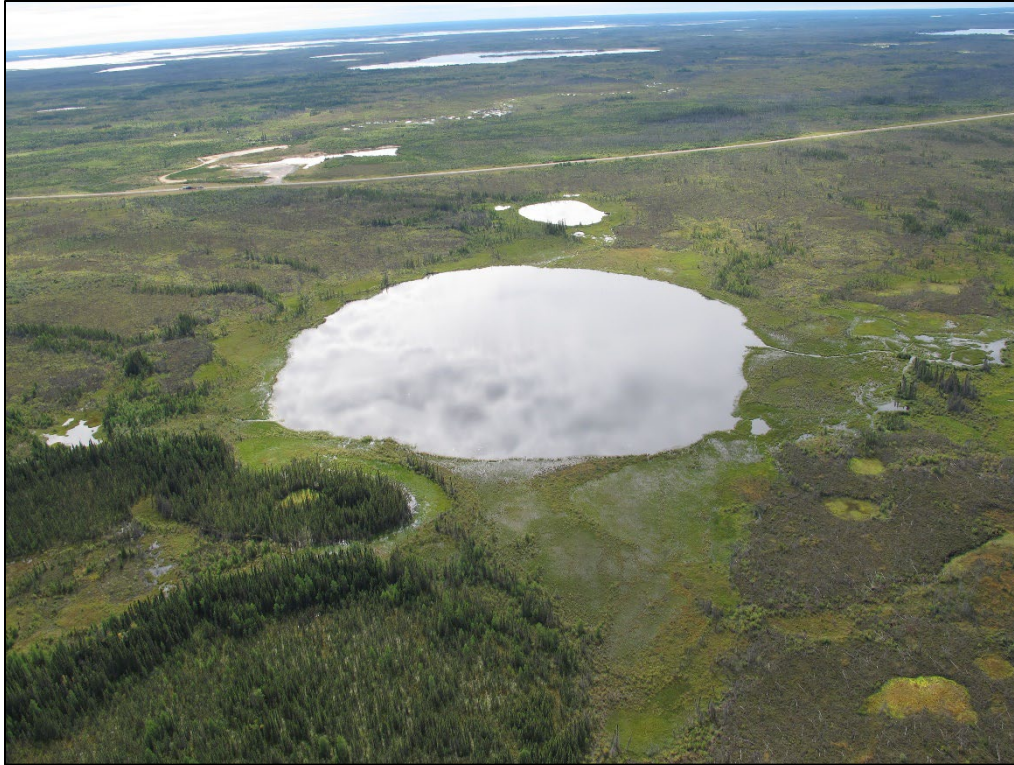
Photo 3-3: Wetland 28 marsh habitat on August 31, 2022

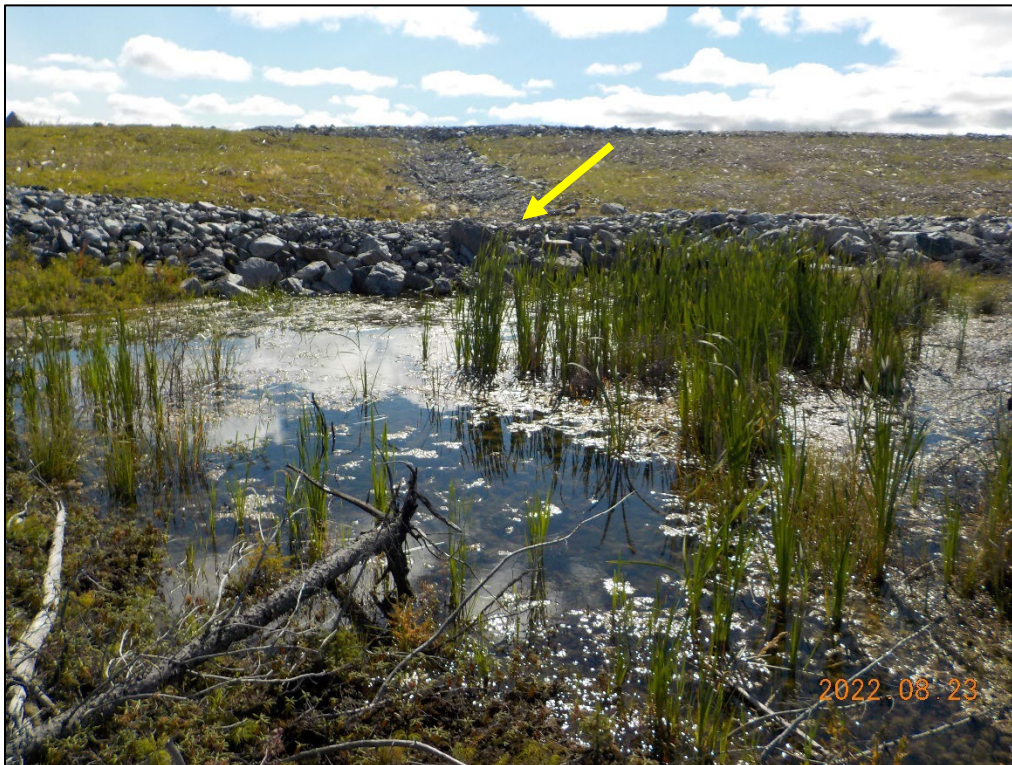
A gap in the rock berm surrounding the adjacent excavated material placement area (EMPA) in 2021 had been filled at the time of the 2022 surveys (Photo 3-4). The erosion and sediment deposition into the wetland buffer had stopped, and the ponding water in the disturbed area had less visibly suspended particulate matter within it than observed in previous surveys (Photo 3-4).

Photo 3-4: Filled gap in rock berm (yellow arrow) and ponding water in the Wetland 51 buffer zone.

| Wetland | Recommendation¹ | Mitigation or Follow-up Implemented |
|---|---|---|
| Wetland 51 | 2021: Reinforce or repair sediment containment structures to prevent further sediment deposition into the wetland buffer. Revegetate EMPA D16 slopes adjacent to the wetland to stabilize soil. | 2021: Secondary drainage channel with rock-lined drainage turnouts installed parallel to rock barrier, upslope. Gap in rock barrier at wetland edge. Gap in rock berm filled in 2022. |

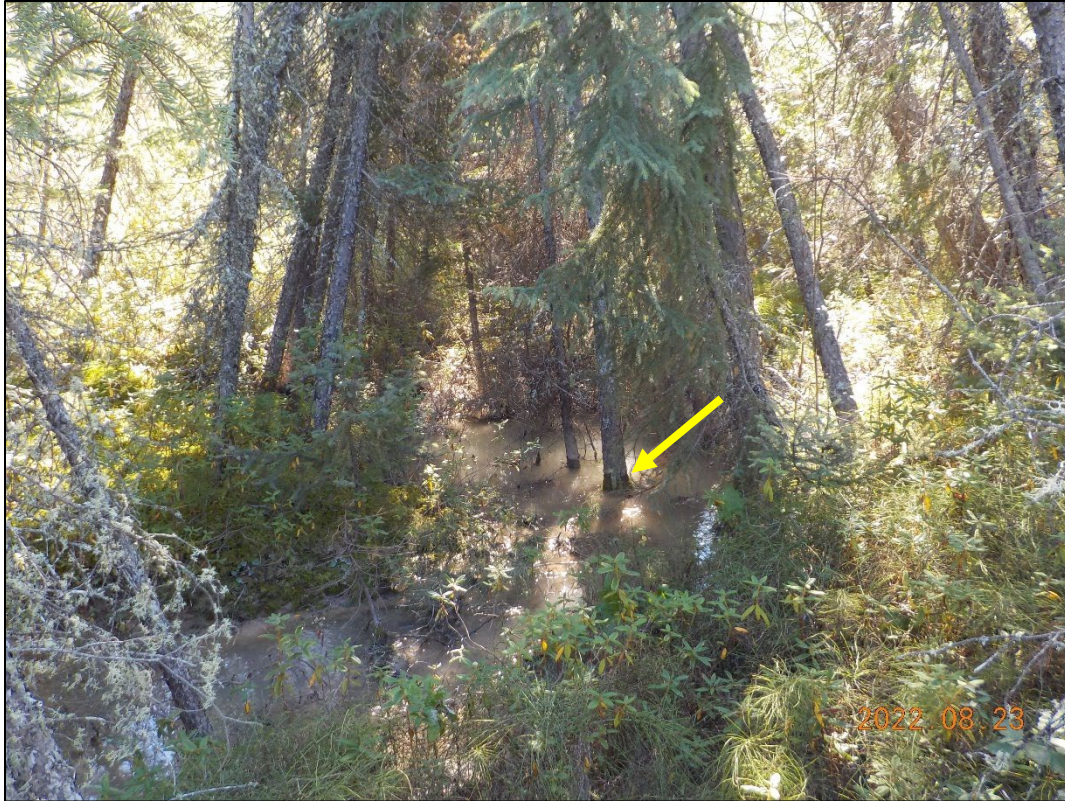
A channel of flowing water from a drainage culvert at the northeastern corner of the Main Camp had reached a low area adjacent to Wetland 51 at the time of the 2022 survey (Figure 3-1). The amount of water flowing through the channel, which was up to two metres in width in some spots (Photo 3-5), was enough to raise concerns that the altered water flows through the adjacent riparian fen into Wetland 51 could negatively impact the marsh habitat. Although no effects were observed in the low-lying area during ground surveys, this disturbance has the potential to affect water levels in the marsh. This area will continue to be monitored for future effects.

Photo 3-5: Flowing water through previously undisturbed forest (yellow arrow) adjacent to Wetland 51.

Surface water drainage flowing from the Main Camp had the potential to alter water flows into Wetland 51. Given that the terrain surrounding the camp currently slopes towards the culvert location, it is not possible to redirect a portion of the flow elsewhere. While the area impacted to date is small and in a common habitat type, it is progressing towards Wetland 51. The Main Camp closed permanently in December, 2022, and decommissioning is underway. It is recommended that measures be implemented to slow or redirect the water flow and contain sediment within the approved Project Footprint.

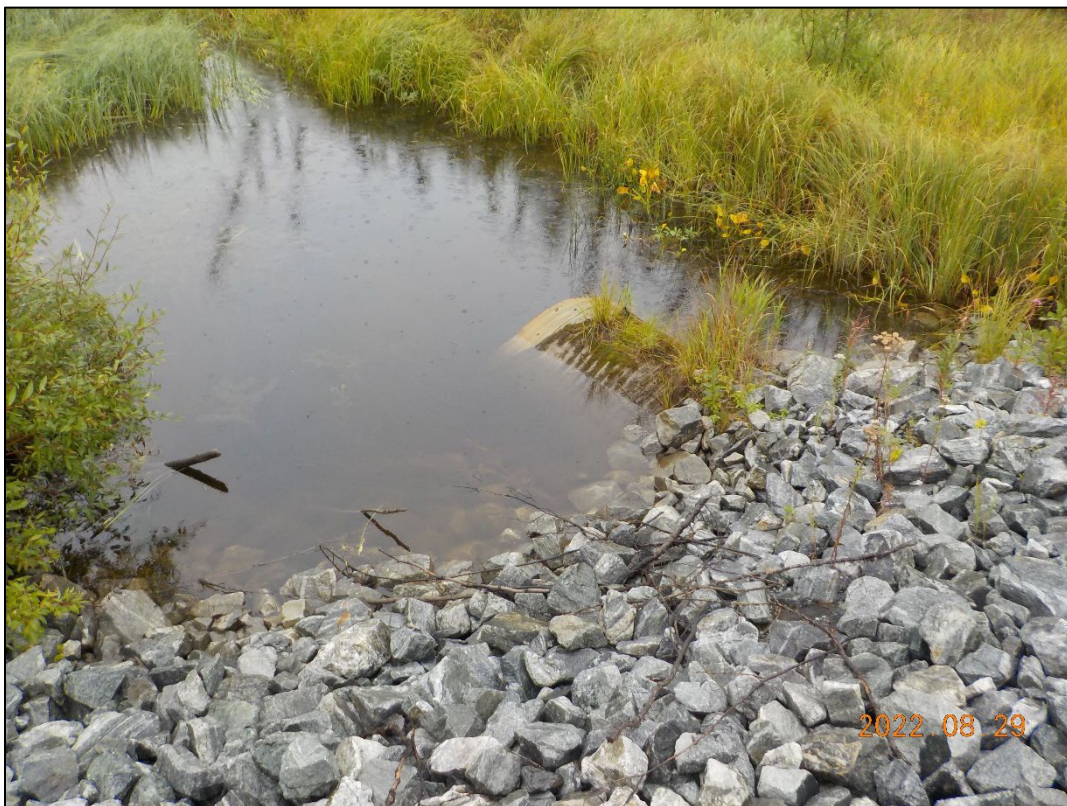
At the time of the 2022 survey, water levels at Wetland 57 were at the highest level observed since Project construction began (Figure 3-2). They were also higher relative to the differences observed in the other surveyed wetlands. The water levels in the drainage channel were relatively high as well, however the level at the South Access Road (SAR) culvert was not higher than observed in previous years (Photo 3-6). The beaver dam within the drainage channel was partially intact as of August 29, 2022 and a small flow of water was spilling over the top (Photo 3-7).

Photo 3-6: Culvert at the SAR in drainage channel at Wetland 57.

| Wetland | Recommendation¹ | Mitigation or Follow-up Implemented |
|---|---|---|
| | 2022: Continue to monitor for water level changes and wetland development. | No mitigation recommended at this time. Continue ground surveys. |

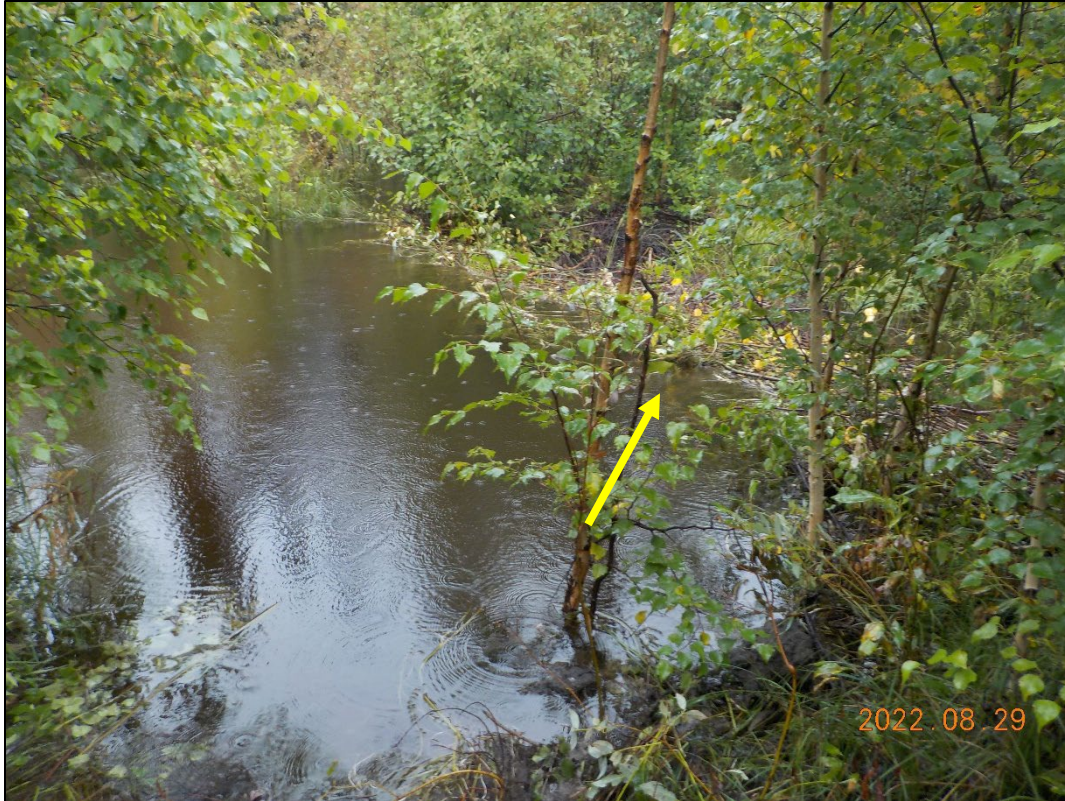
Photo 3-7: Flowing water over top partial beaver dam (yellow arrow) in drainage channel at Wetland 57.

The reason for the increase in water levels could not be fully determined during ground surveys. It is believed that the high water was due to the beaver dam that may have been recently breached by local duck hunters, just prior to the 2022 survey, as had been done in previous years (see ECOSTEM 2022b).

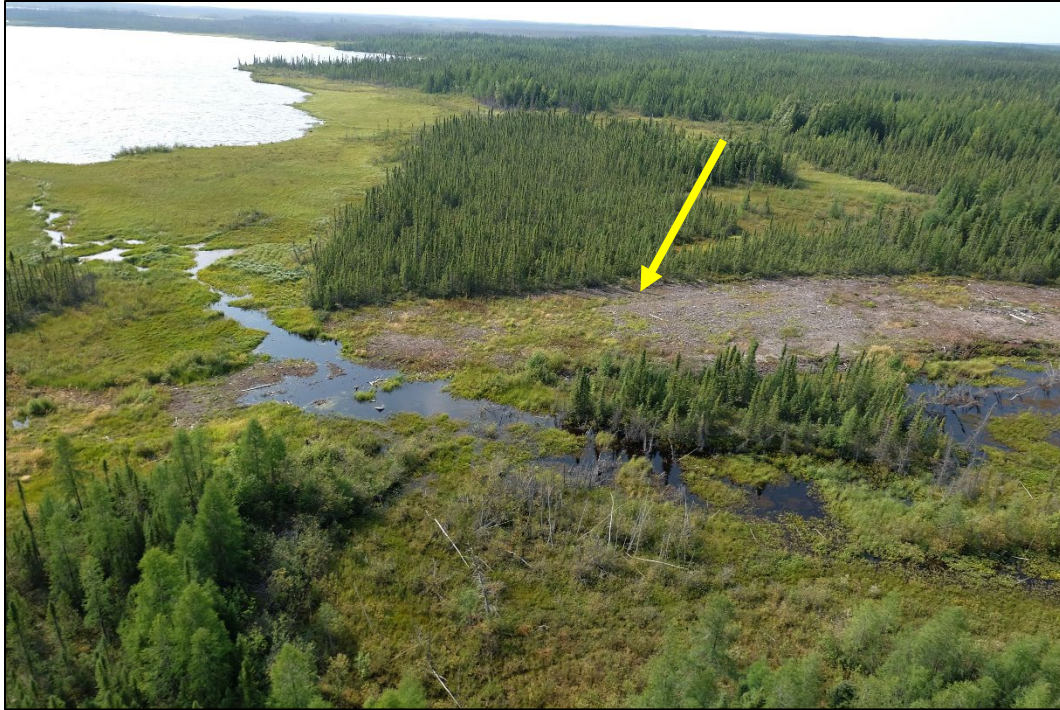
In terms of other potential impacts, surveys in 2022 found that the adjacent Ellis Esker access corridor was being actively used by ATVs (Photo 3-8). If the usage of the ATV trails that spanned across the natural drainage channel into the wetland were to continue, there could be potential for alternate paths through the channel to be made, creating a disturbance outside of previously cleared bounds. The channel itself did not appear to be substantially disturbed and the adjacent vegetation appeared to be unaffected as of September, 2022 (Photo 3-9). This may have been due to the fact that the ATVs appeared to only be using one path near the center of the right-of-way.

Photo 3-8: Aerial view of channel into Wetland 60 and ATV trail (yellow arrow) on August 26, 2022.

| Wetland | Recommendation¹ | Mitigation or Follow-up Implemented |
|---|---|---|
| | 2022: Potential for disturbance in wetland from adjacent local ATV use (not Project related). Monitor for adverse effects to wetland habitat. | No mitigation recommended at this time. |

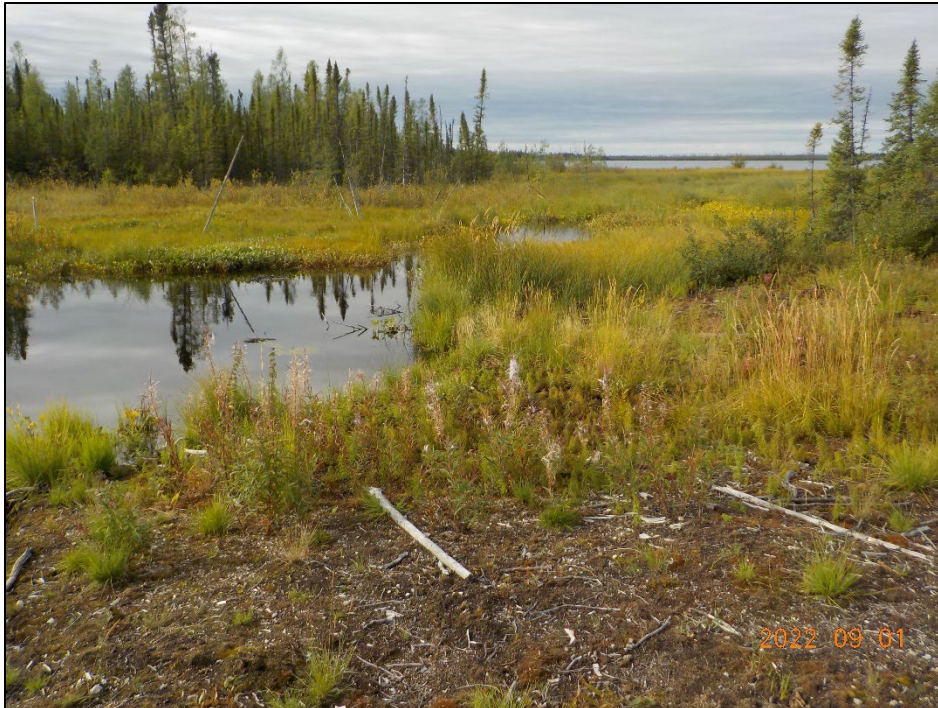
Photo 3-9: Ground view of marsh habitat (background), and drainage channel (foreground - left) at Wetland 60 on September 1, 2022.

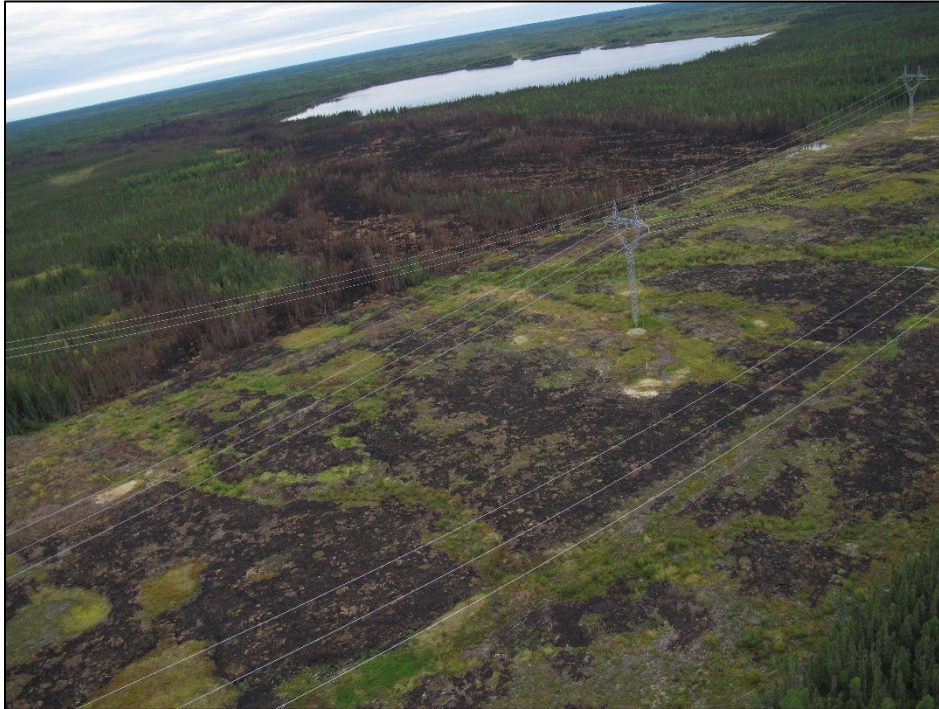
A wildfire in 2022 adjacent to Wetland 61 burned about 6.8 ha (15%) of area within the marsh habitat buffer. The wildfire was not caused by the Project, and Wetland 61 was not within 100 m of the Construction Footprint.

Wetland 61 was not within 100 m of the Construction Footprint, however a wildfire in 2022 burned approximately 6.8 ha (15%) within the buffer zone (Photo 3-10).

Photo 3-10: Fire in and around Wetland 61 as of September 1, 2022.
