Keeyask Generation Project Terrestrial Effects Monitoring Plan

Long-Term Effects on Wetland Habitat Monitoring Report

TEMP-2023-05

LONG-TERM EFFECTS ON WETLANDS MONITORING YEAR 1 OPERATION 2022

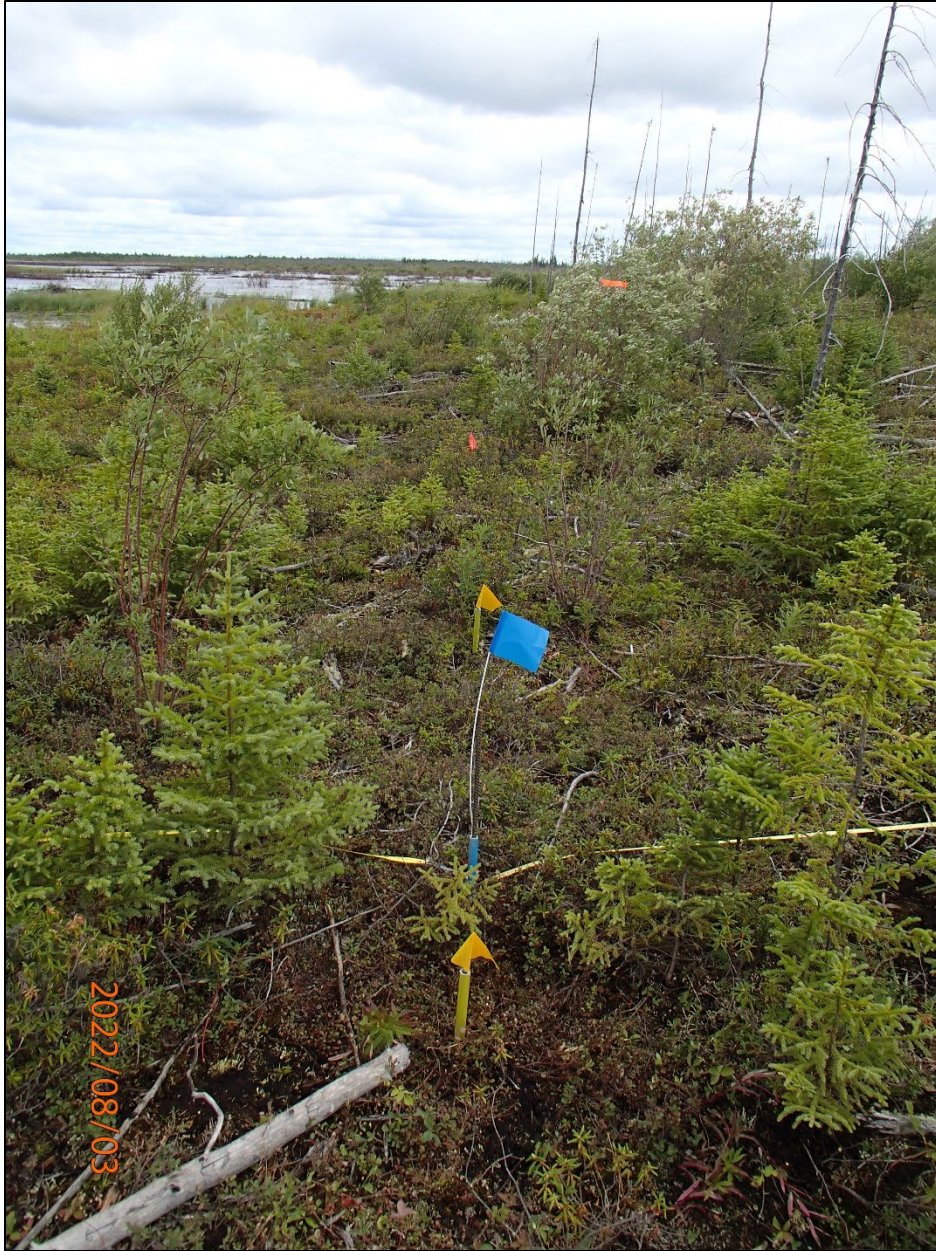
Photo 2-1: Transect setup at LRK22SE12 on August 3, 2022

At each sample location, two roughly parallel transects were established 20m apart. The transect origin was located at the edge of visible Project disturbance (Photo 2-1). The origin was either at the edge of the Project clearing (Figure 2-1A), or where evidence of previous reservoir inundation was obvious (Figure 2-1B), whichever was further inland. Each transect was oriented perpendicular to the overall orientation of the disturbance edge (Figure 2-1).

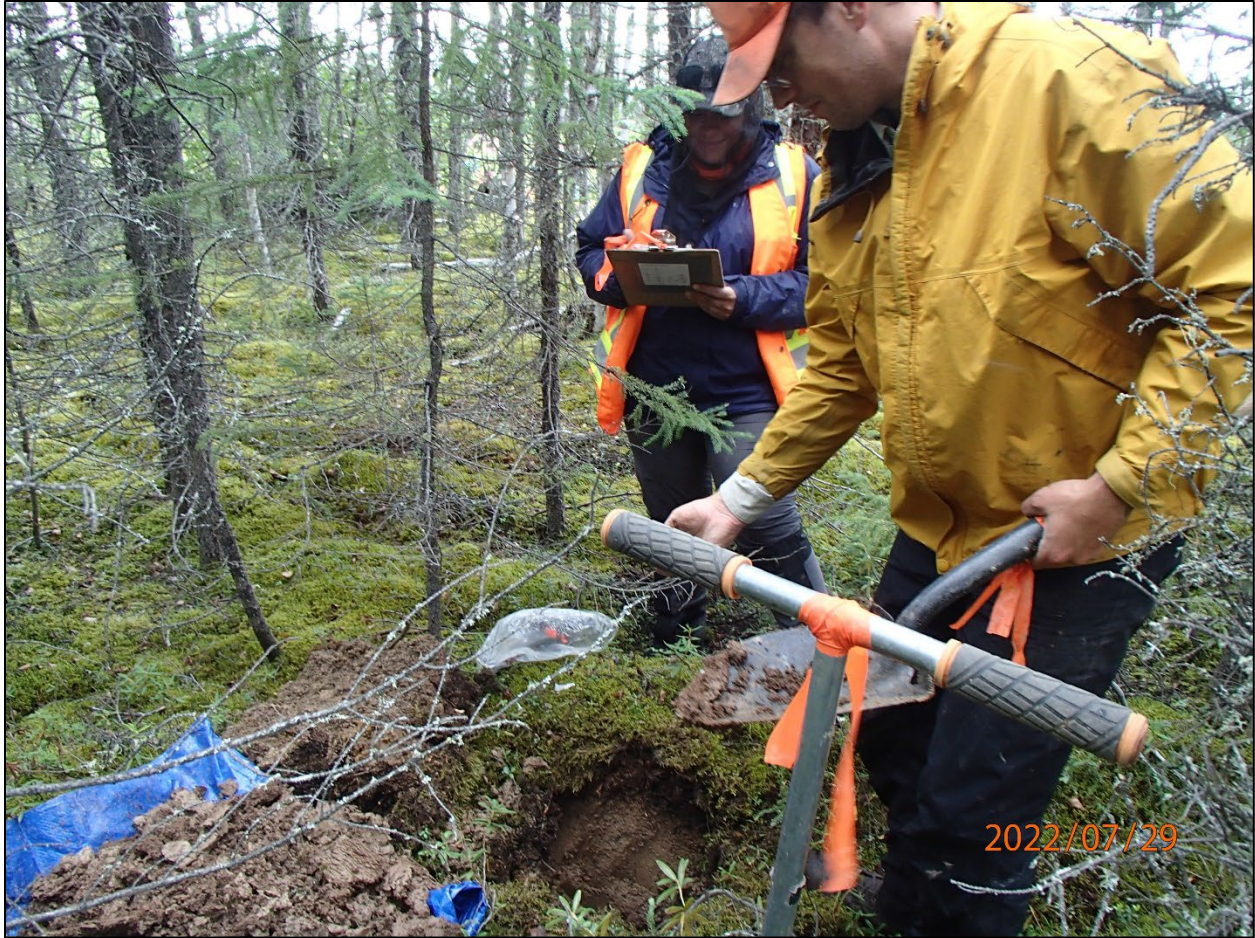
Photo 2-2: Pedologist collecting data at a soil pit

The soil sampling method was intended to be sufficient to detect moisture regime changes in the rooting zone. Soils were sampled in pits (Photo 2-2) and from soil cores obtained using a Dutch auger. The soil pits collected detailed soil information while the soil cores focused on moisture regime (Figure 2-3). Soil pits were dug at 1m and 10m along the undisturbed portion of the transect. Soil cores was completed at 5m, 15m, 20m and 30m on the undisturbed section of the transect, and at 1m and 5m on the disturbed section unless those distances were under water.
