# Keeyask Generation Project Terrestrial Effects Monitoring Plan

## Invasive Plant Spread and Control Monitoring Report

REPORT #TEMP-2023-06

### **INVASIVE PLANT SPREAD AND CONTROL MONITORING YEAR 1 OPERATION 2022**

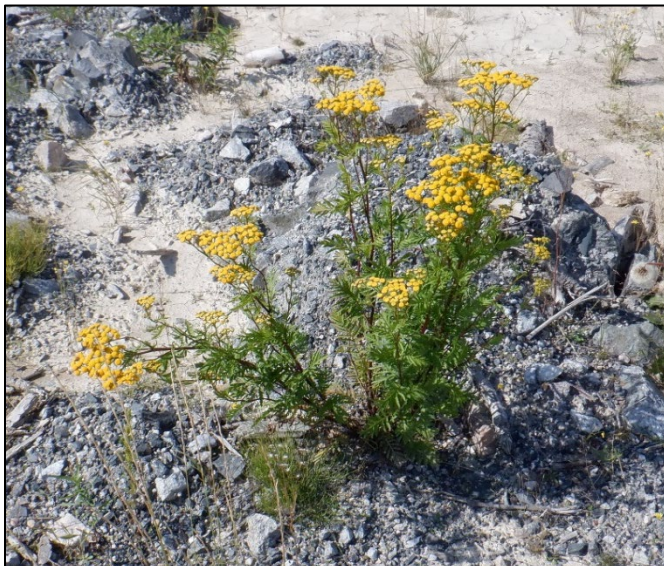
**Common tansy, an invasive plant found at the Keeyask site during construction and operation**

The species of highest invasive concern are being controlled by manually removing the plants as soon as they are found during the surveys. For the most part, scentless chamomile, ox-eye daisy and common tansy were not found in 2022 at the sites where they had been removed in previous years.

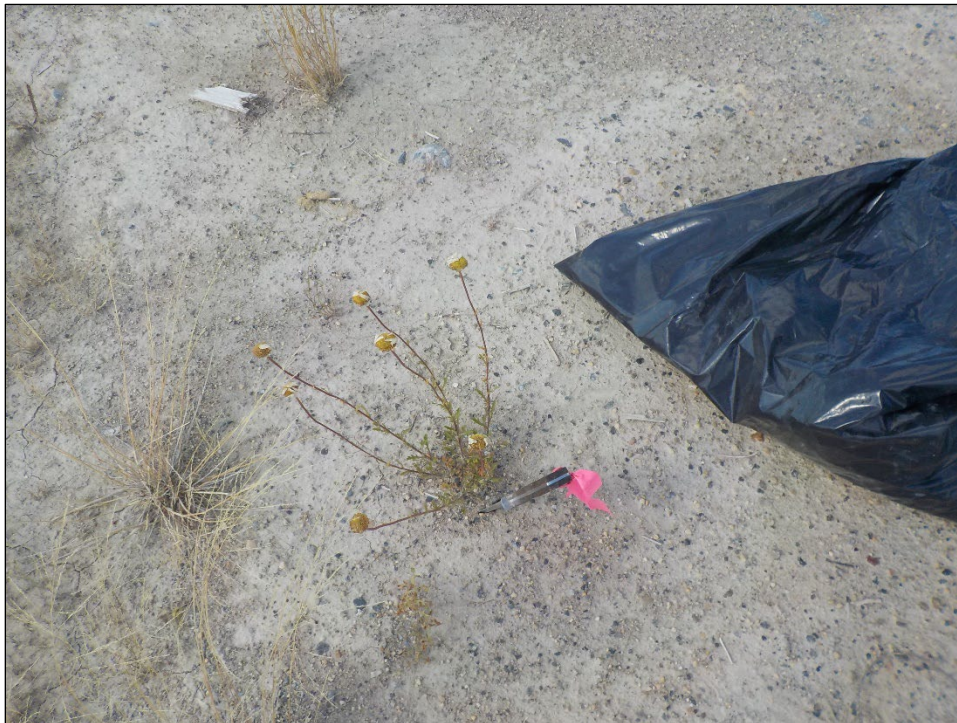
In 2022, scentless chamomile was found growing at ten new sites in Borrow Area B-2 (Appendix 3, Map 6-1; Photo 3-1, and in one large new patch in Borrow Area N-5. All these plants were immediately removed and disposed of by ECOSTEM field staff (Photo 3-2).

**Photo 3-1: Scentless chamomile patch growing in Borrow Area B-2 on August 28, 2022**

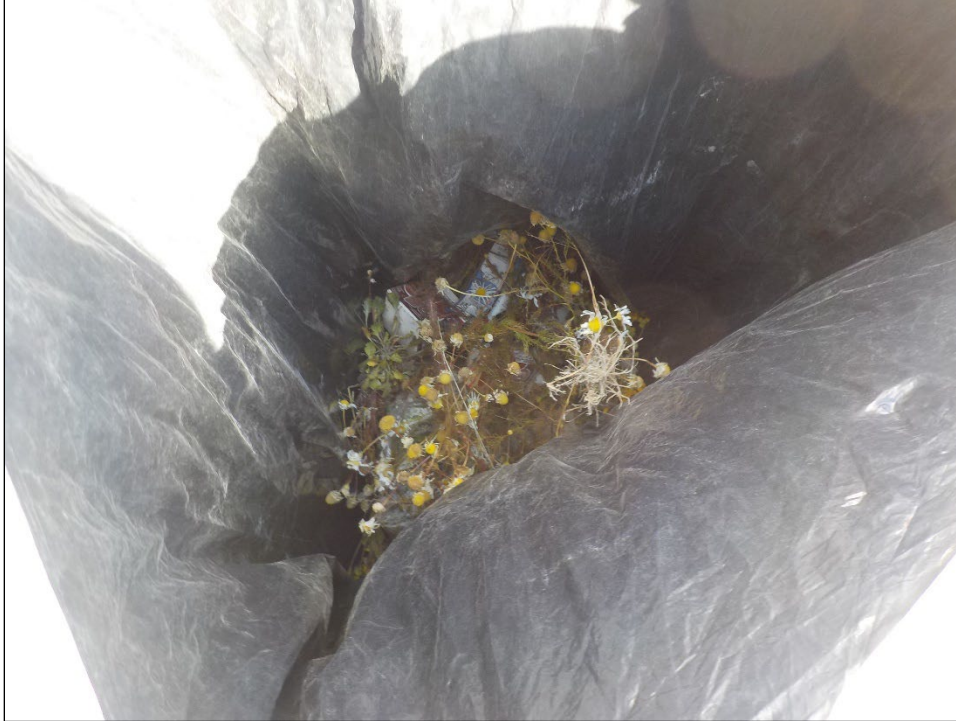
**Photo 3-2: ECOSTEM staff removing scentless chamomile plants growing in Borrow Area B-2 on August 28, 2022**

The largest patch of scentless chamomile was recorded in Borrow Area N-5, where it had not previously been recorded. Approximately 100 plants were found in that patch and manually removed (see Photo 3-2). The other location was in Borrow Area B-2, where it had previously been recorded and removed, including in 2020 and 2021. Although all the plants previously found had been removed, it is possible that a seed bank may have developed in those two locations. Those locations will be monitored closely for additional individuals of this species in coming years. It is recommended that traffic be limited or avoided at those locations to reduce opportunities for seed to be spread to other areas.

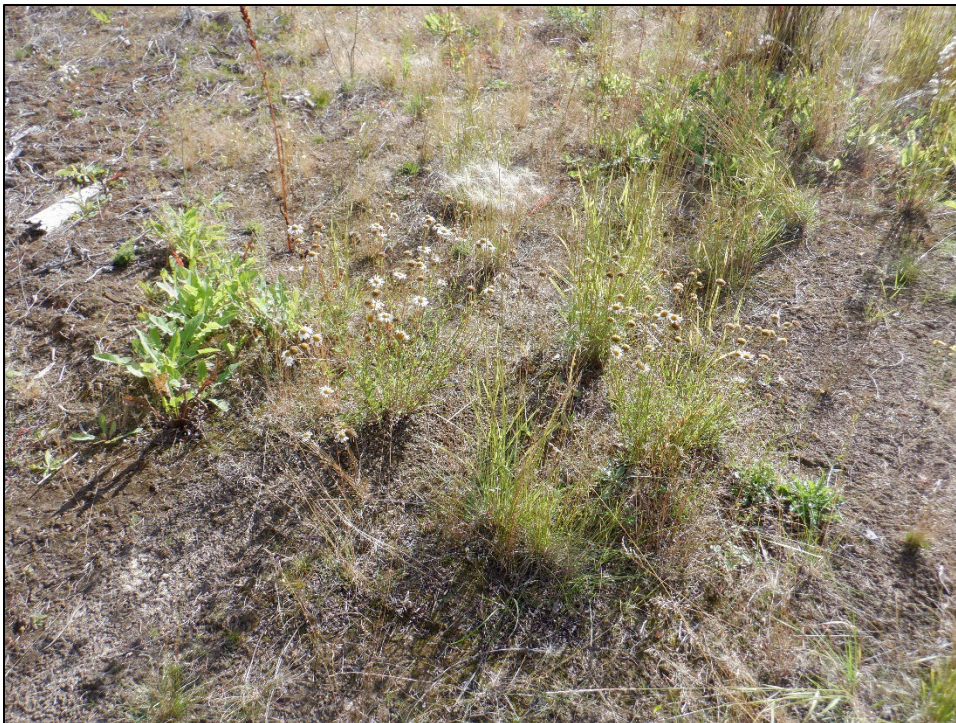
Ox-eye daisy (Photo 3-3) was recorded at five sites in 2022, in Borrow Areas KM-15 and B-2 (Appendix 3, Map 6-2). Two of the sites in Borrow Area G1 at KM-15 were located near (within approximately 7 m) a site recorded in 2018. In total ten plants were recorded at the locations in G1. Two individuals were recorded at two separate sites in Borrow Area B-2. All plants found were removed by ECOSTEM staff.

**Photo 3-3: Ox-eye daisy (white flowers) growing in Borrow Area G1 at KM-15 on August 24, 2022**

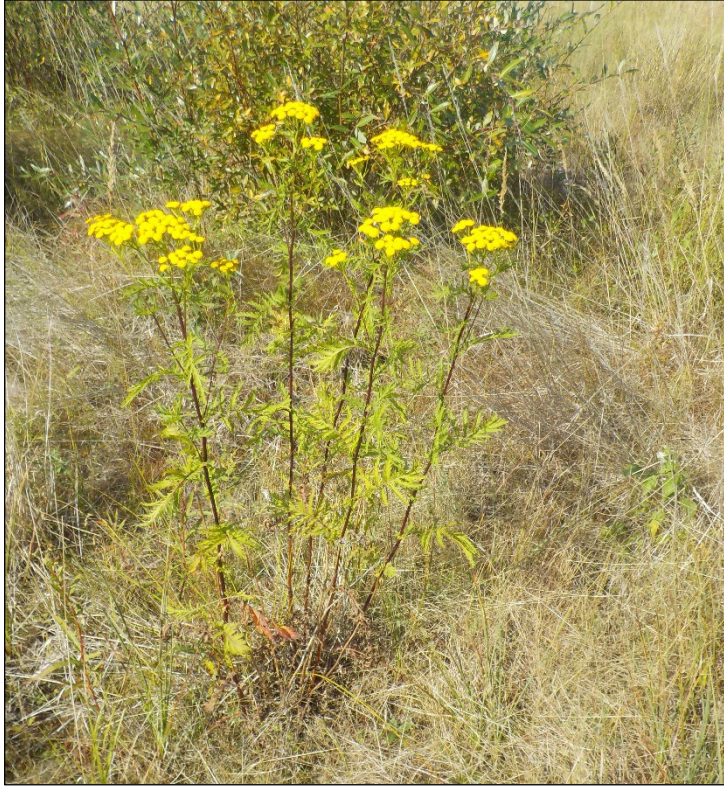
Common tansy was found growing at two sites in 2022 (Appendix 3, Map 6-3). This included one location in EMPA D35(1)-E and one in Borrow Area B-2 approximately 17 m west of the sites recorded in 2021 (Photo 3-4). Single plants were found at both sites. All plants found were immediately removed by ECOSTEM staff.

**Photo 3-4: Common tansy growing beside Borrow Area B-2 on August 28, 2022**

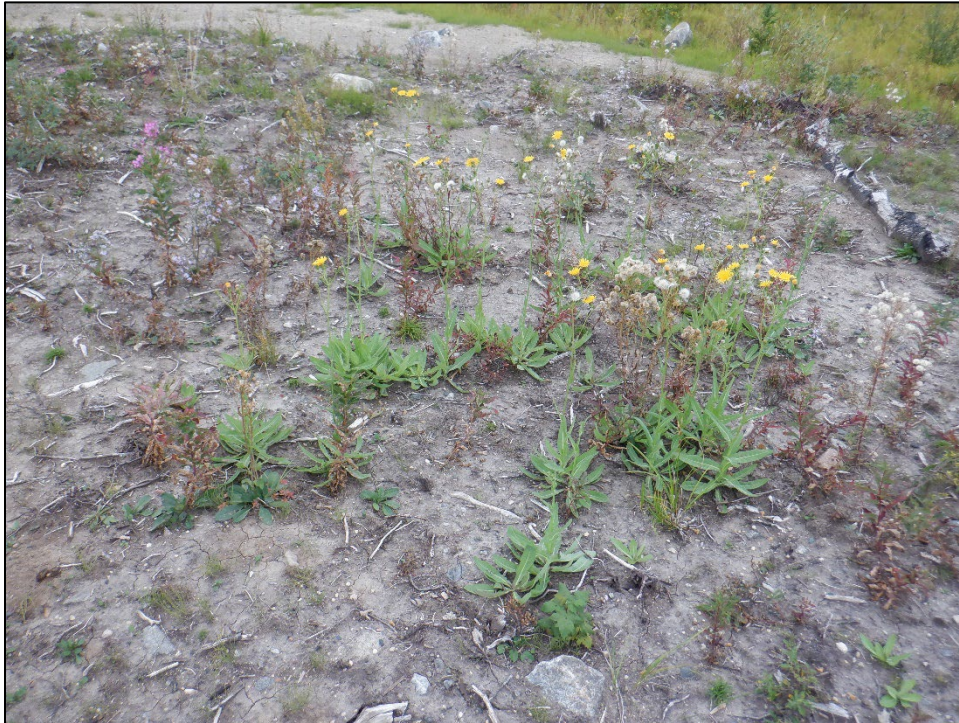
Several sites containing field sow-thistle (Photo 3-5) in 2021 were selected for herbicide and/or mowing treatment in 2022 (see Section 3.3.2). Sites located in the Start-up and Main Camp areas, portions of Borrow Area G-1 at KM-15 and KM-17, along the North Dike, in Work Areas A, C and X and in areas along the NAR and SAR were marked for herbicide application. Large areas at the Downstream Boat Launch and near Borrow Area B-3 were marked for mowing.

Results from the 2022 late summer survey indicated that field sow-thistle cover persisted in all sites where it was already established and increased in a few new areas (Appendix 3, Map 6-4 to Map 6-8). Total cover increased between 2021 and 2022. Total cover increase was highest in Borrow Areas B-2, G-1 at KM-15, N-21, N-22 and along the NAR. Total cover decreased in many of the KIP Borrow Areas, the Main Camp and Borrow Area B-3.

**Photo 3-5: Field sow-thistle growing in Borrow Area B-2, August 28, 2022**

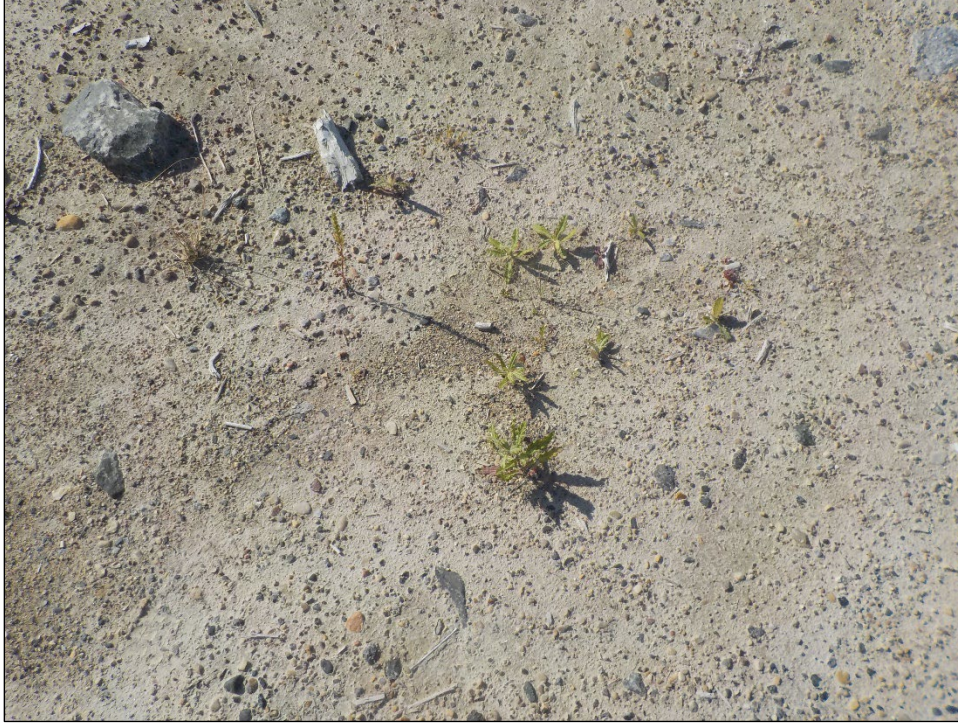
**Photo 3-6: Canada thistle growing in Borrow Area B-2, August 28, 2022**

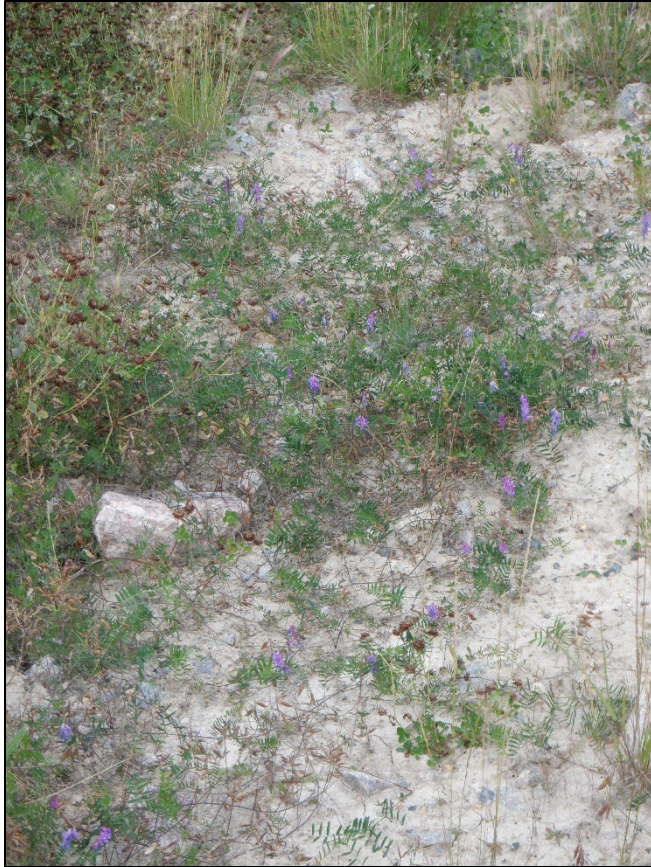
Tufted vetch plants (Photo 3-7) were found in two new areas during the 2022 surveys (Appendix 3, Map 6-10 and Map 6-11). These included scattered individuals in Borrow Area B-2 and Borrow Area G-1 at KM-17. Tufted vetch continued to grow in or around most of the sites where it had previously occurred.

**Photo 3-7: Tufted vetch growing in Borrow Area G-1 at KM-15, August 24, 2022**

Rapid manual removal was not employed (and not recommended) at the remaining tufted vetch sites along the SAR and in adjacent borrow areas east of the Butnau Marina. In these cases, the plants were well established at these sites and in areas adjacent to or near the Project footprint.

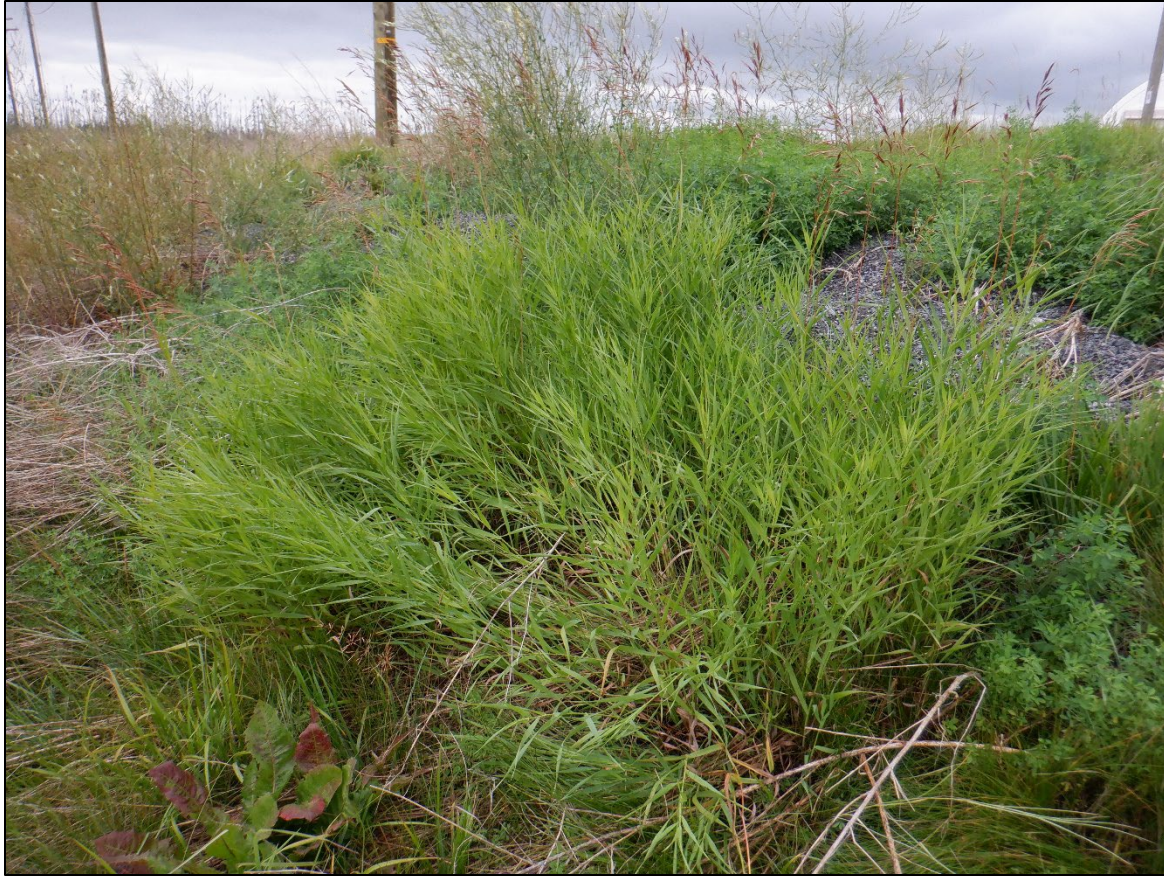
Smooth brome (Photo 3-8) is a rhizomatous perennial that has a has the capacity to proliferate from roots left in the ground after manual removal and may be susceptible to frequent and timely cutting and particular herbicide treatments (Otfinowski et al. 2007). Small patches or individual plants may be mowed, burned or herbicided frequently and at particular times of the year, where feasible (Grilz and Romo 1995; Otfinowski et al. 2007).

Smooth brome was found at several locations in Borrow Area G-1 at KM-15 and KM-17, and at two sites in the Start-up Camp (Appendix 3, Map 6-12). Because the plants were established patches, they were not removed manually. They will be targeted for herbicide treatment and/or mowing in 2023.

**Photo 3-8: Smooth brome growing in the Start-up Camp, August 21, 2022**

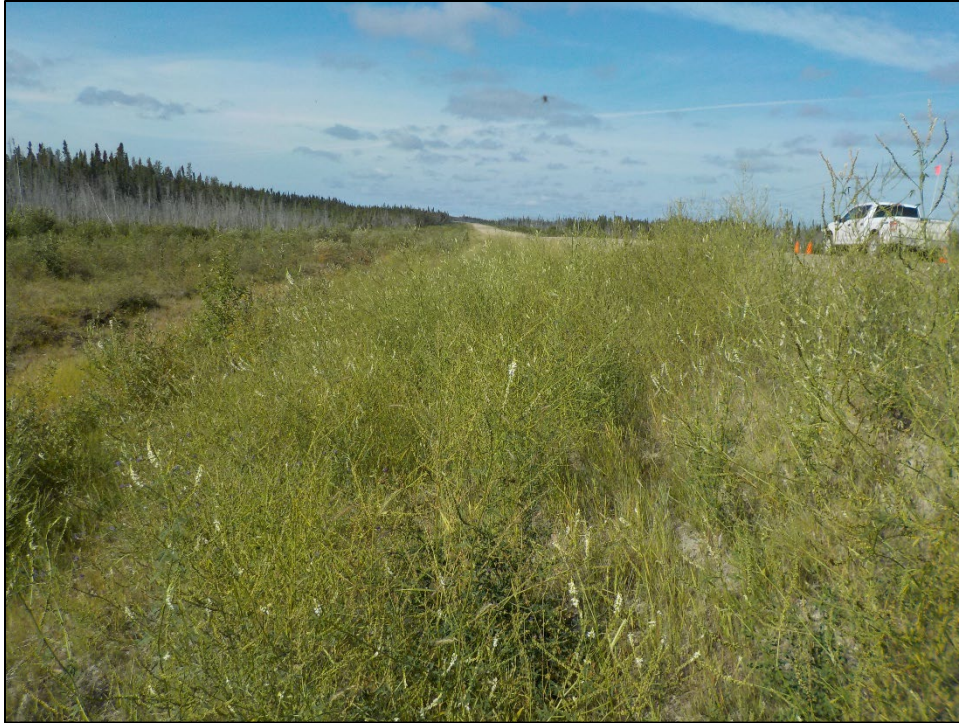
The rapid manual removal protocol was not applied for white and yellow sweet clover. White sweet clover (Photo 3-9) was already widespread in the Project footprint, and in disturbed areas throughout the Keeyask region, prior to the Project. As of August 2022, the two species were collectively the second most abundant non-native species.

**Photo 3-9: White sweet clover growing in the ditch of the NAR, August 25, 2022**

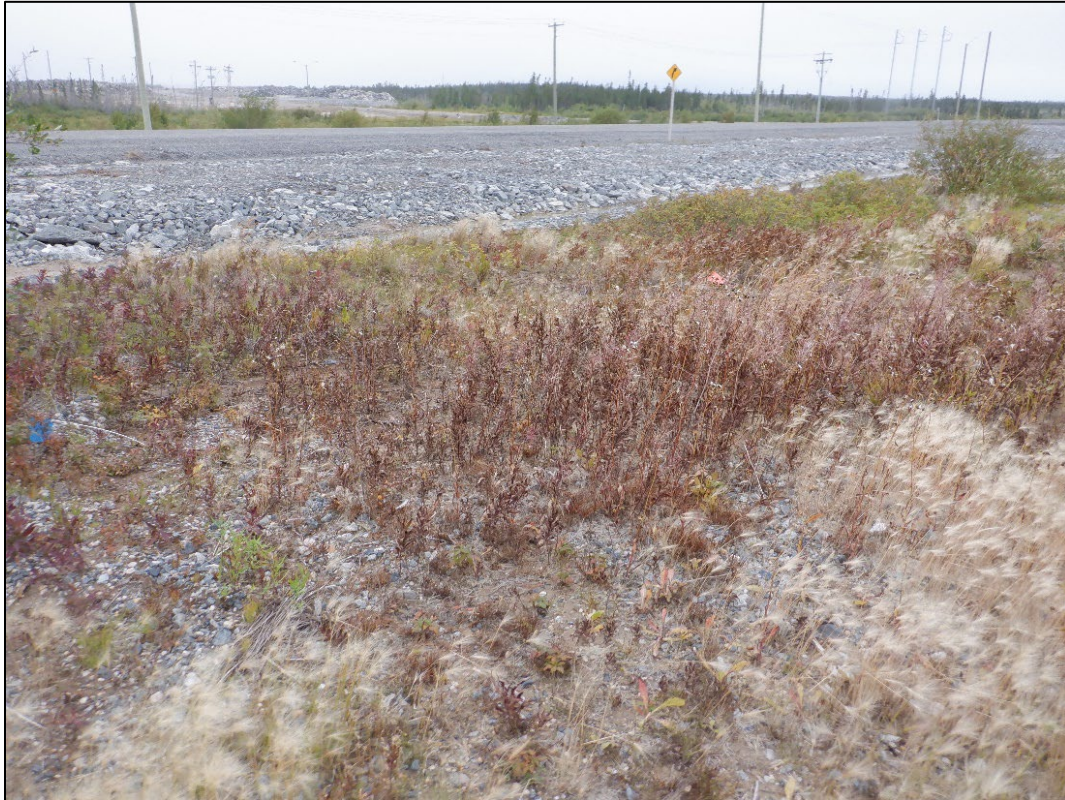
**Photo 3-10: Flagged site near Work Area X after herbicide treatment**

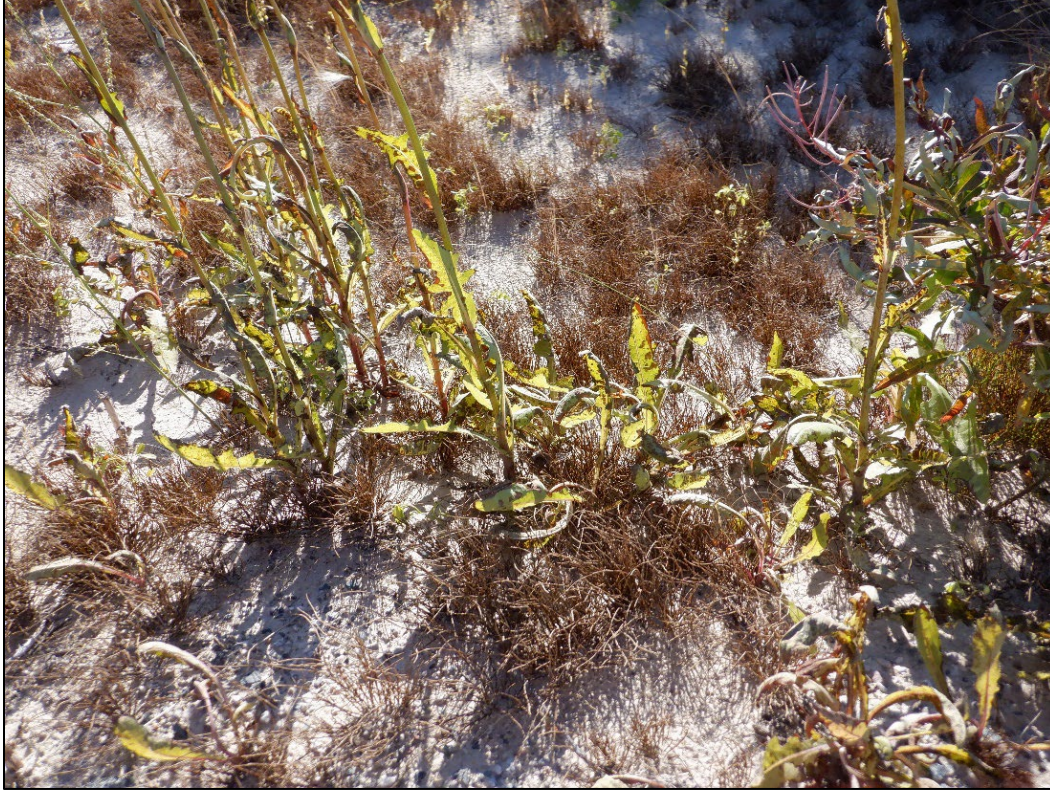
**Photo 3-11: Field sow-thistle after herbicide treatment**

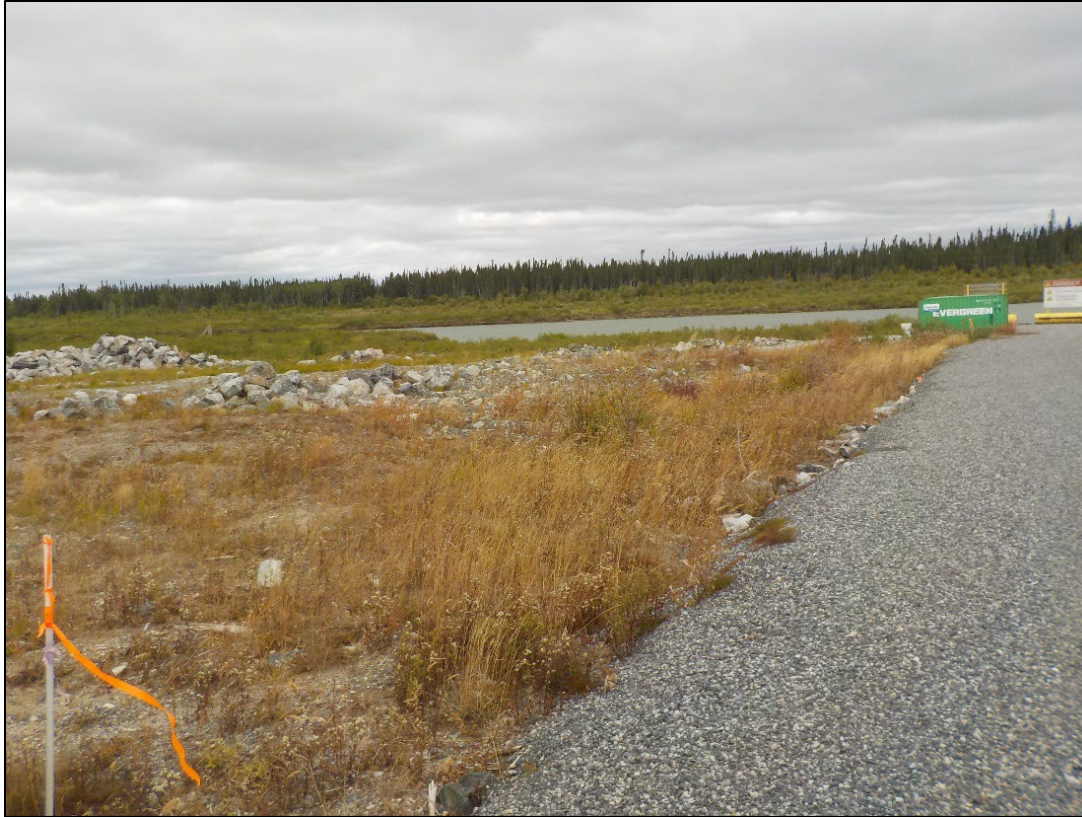
During invasive plant surveys in late August, it was observed that the areas around the Downstream Boat Launch that had been marked for mowing (because of their proximity to the water) had in fact been treated with herbicide (Photo 3-12). Most of the non-native high concern species present had already seeded while they were also showing the effects of the herbicide application.

**Photo 3-12: Herbicide treatment in the mowing area near the downstream boat launch, August 30, 2022**
