Keeyask Generation Project Terrestrial Effects Monitoring Plan

Colonial Waterbird Habitat Effects Monitoring Report

TEMP-2023-13

YEAR 1 OPERATION

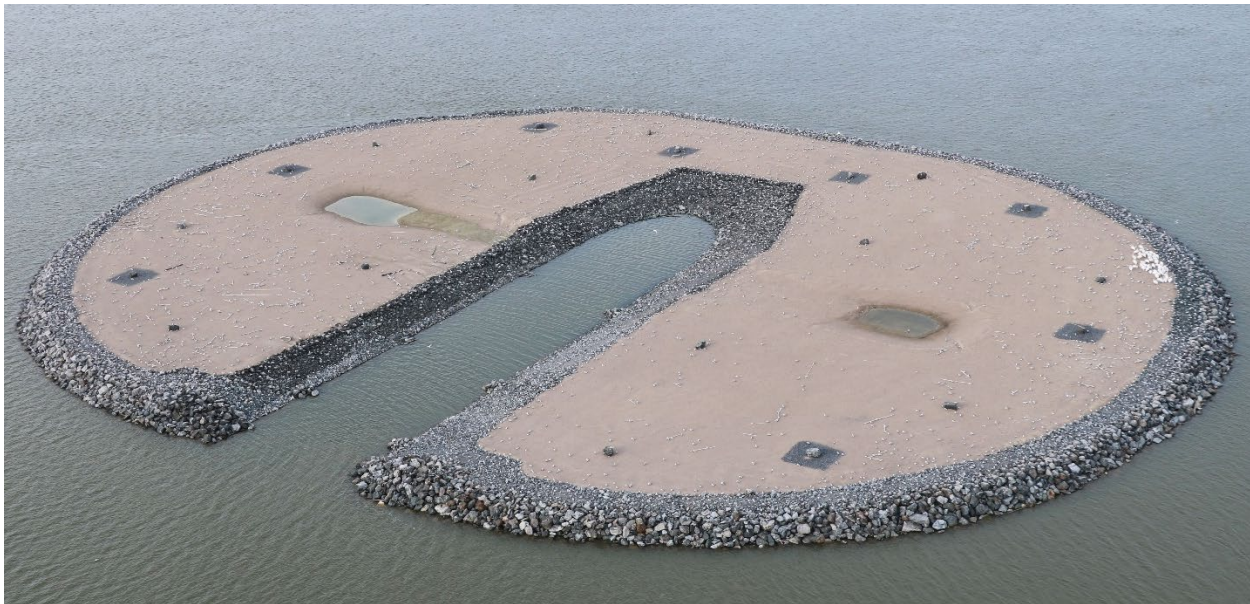
The number of ring-billed gull chicks observed on the Habitat Compensation Island appeared to be low in comparison to the number of nests that were present and may have been a result of the structure of rocks on the island, sheltering chicks from view, and/or the relatively high number of bald eagles also present on the island.

Colonial Waterbirds on the Habitat Compensation Island, June 2022

It is recommended that additional woody debris be added to the Habitat Compensation Island to further enhance the nesting habitat and provide shelter for chicks.

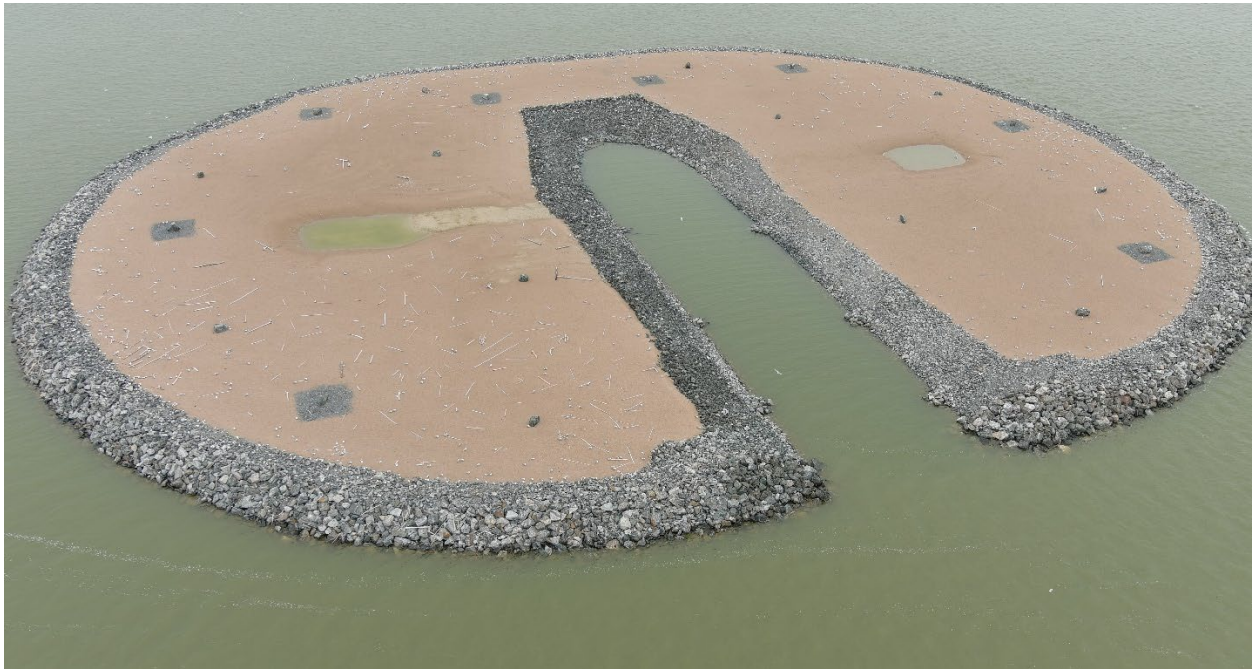
Photo 1: Habitat Compensation Island, June 2022

HCI and naturalize the area, woody debris removed from the reservoir by Manitoba Hydro's Waterways Management Program was placed on the surface of the HCI in a random, scattered manner in the fall of 2021.

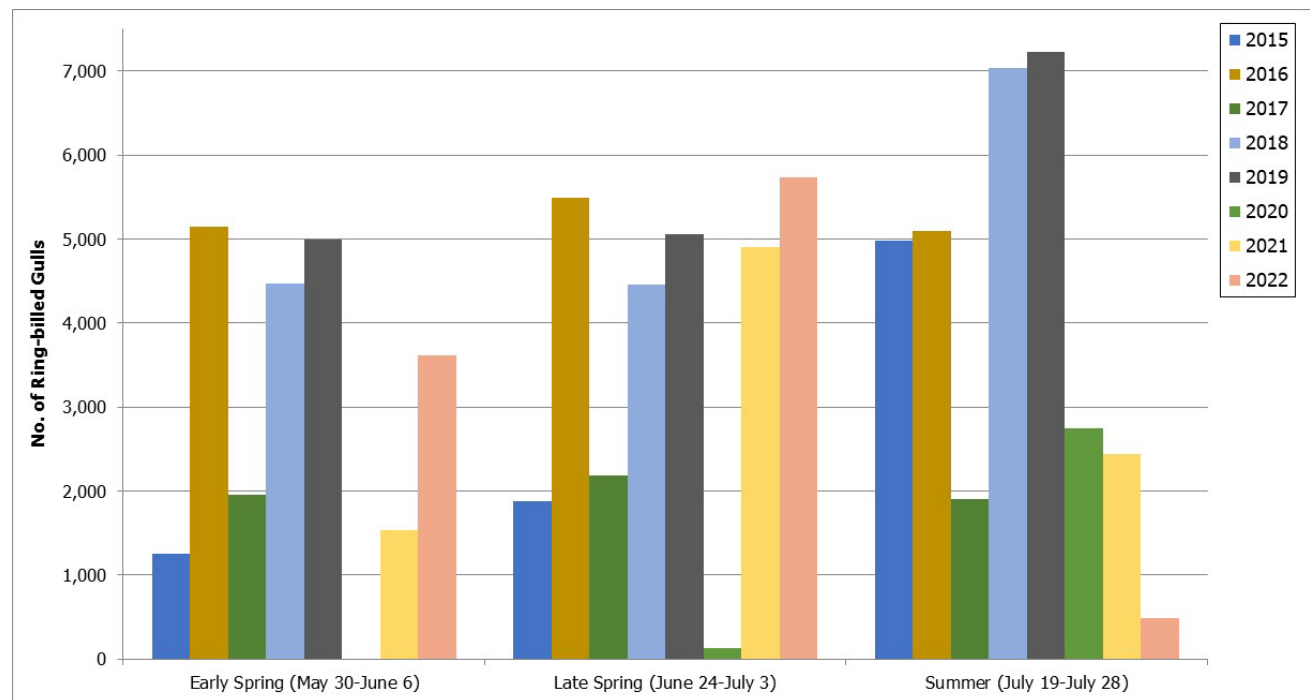
Figure 1: Total Number of Ring-billed Gulls (With and Without Nests) Observed in the Former Gull Rapids Area by UAV During Early Spring, Late Spring, and Summer Surveys from 2015-2022. *Note that the early spring survey was not conducted in 2020.

As observed in previous years, ring-billed gulls were the most common species of colonial waterbird observed in the former Gull Rapids area in 2022 (Table 1; Figure 1). The number of ring-billed gulls observed in the former Gull Rapids area during the early spring survey was within the ranges observed previously during the construction-phase surveys from 2015-2021. During the late-spring survey in 2022, the number of ring-billed gulls observed was the highest seen compared to all previous surveys. The subsequent summer 2022 survey indicated the lowest number of ring-billed gulls observed compared to previous surveys (Table 1; Figure 1). The relatively low number of ring-billed gulls during the summer survey was likely affected by the presence of up to seven immature, bald eagles on the HCI.

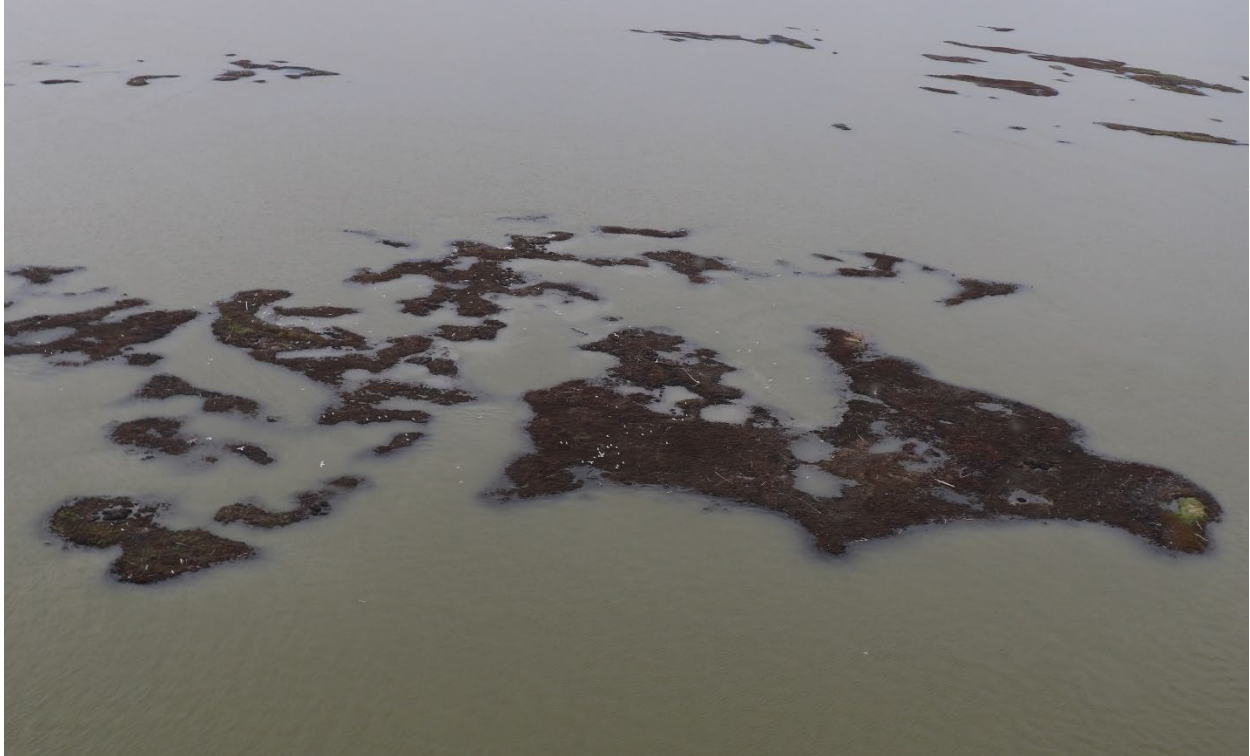
Photo 3: Common Terns Congregating on Recently formed Peat Islands, June 18, 2022

In July 2022, common terns were observed congregating at two sites and nesting was again observed on the HCI (Table 5; Map 9). No common tern chicks were observed on the HCI in 2022 as they were in 2021, but this may have been a result of fireweed (*Epilobium angustifolium*) growth near the nesting area, providing cover for the chicks and making them less visible (Photo 3).

Relatively large numbers of common terns also used two floating peat islands in the reservoir in June 2022, resulting in the greatest number of common terns observed during any of the previous surveys. These peat islands are expected to disintegrate over time and reduce the amount of temporary available nesting and loafing habitat for common terns in the area.

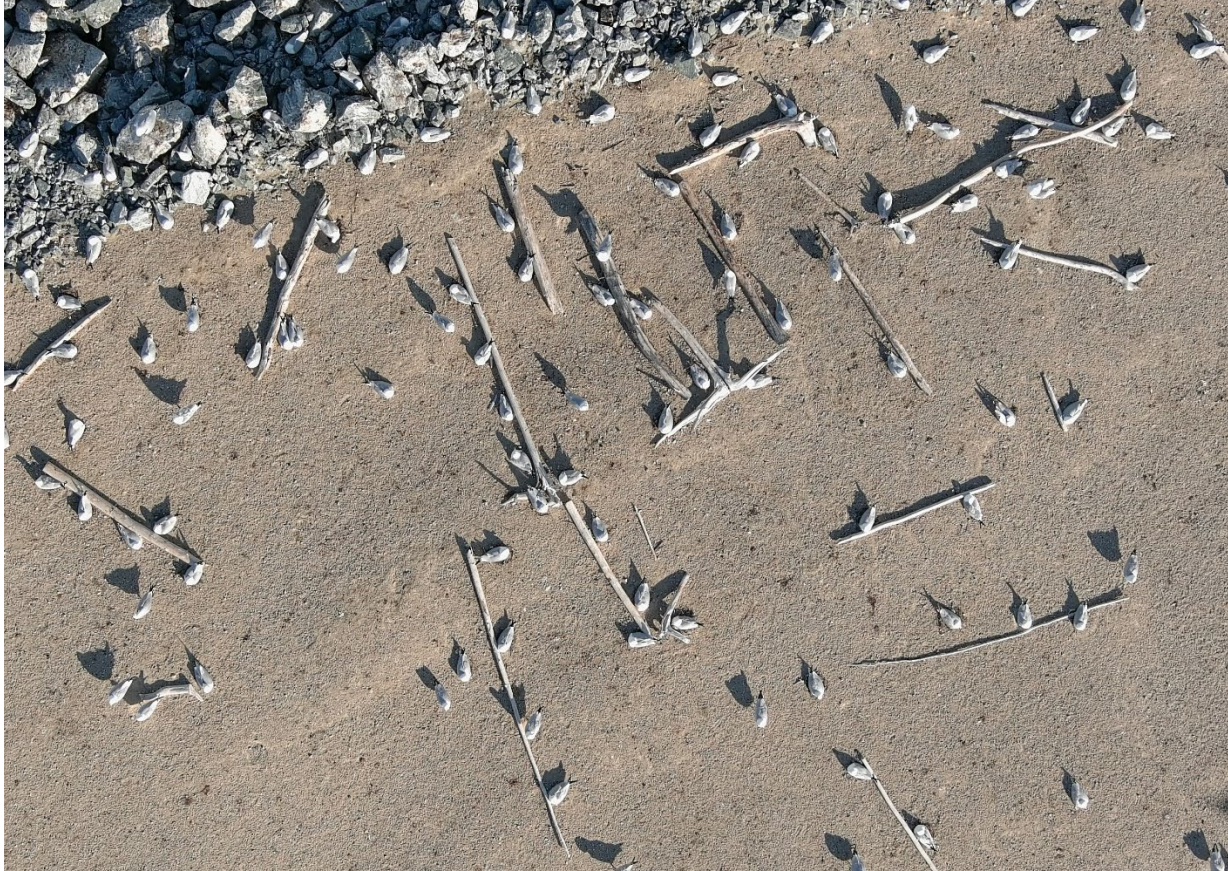
Photo 4: Ring-billed Gulls Nesting Against Woody Debris on the Habitat Compensation Island, June 21, 2022

The number of ring-billed gull chicks observed on the HCI was relatively low compared to the number of nests that were observed. The presence of up to seven immature, bald eagles on the HCI in July 2022 may have affected the number and visibility of ring-billed chicks to count. All the chicks observed on the HCI were located along the edge, where the large, rip-rap rocks are placed for shoreline stability. The crevices and openings provided by these rocks were likely used as shelter from the predators and for thermal cover by the chicks, making them difficult to detect for counting. It is also possible that the bald eagles directly reduced the reproductive success of the ring-billed gulls present on the island by preying on adults, eggs, or chicks, or indirectly, by increasing the amount of time and energy spent by adults being vigilant for predators and less for foraging or caring for eggs or young (Parrish *et al.* 2001; White *et al.* 2006). Small numbers of immature bald eagles (two) have been observed on the islands in the former Gull Rapids area during past surveys. However, the relatively high number observed on the HCI in 2022 suggests

that they may be attracted to the island. The addition of more woody debris is recommended on the HCI to provide chicks with more cover from predators and the elements, as well as increasing the appeal to nesting birds.
