Keeyask Generation Project Aquatic Effects Monitoring Plan

Deep Water and Constructed Habitat Monitoring Report

AEMP-2024-12

DEEP WATER AND CONSTRUCTED HABITAT MONITORING IN THE KEYYASK STUDY AREA, 2023

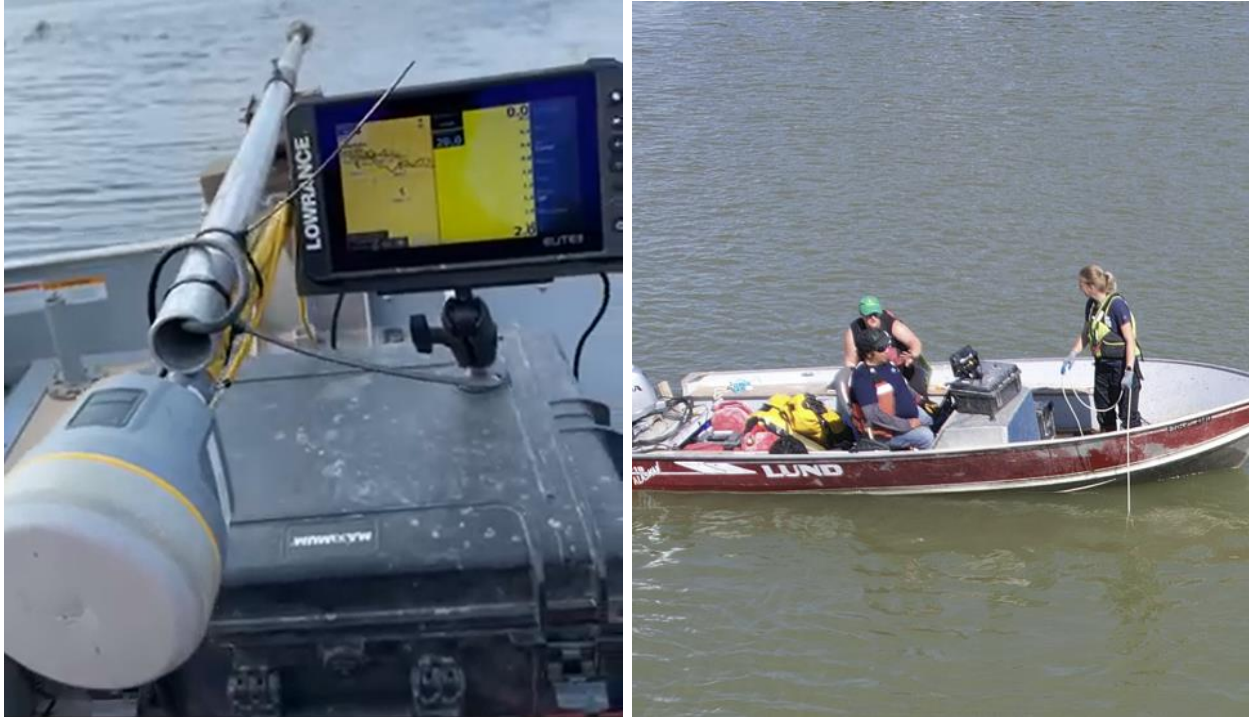
Setup of acoustic equipment (left) and Ponar dredge substrate sampling (right) used to monitor deep water and constructed habitats in the Keeyask reservoir and Stephens Lake in 2023.

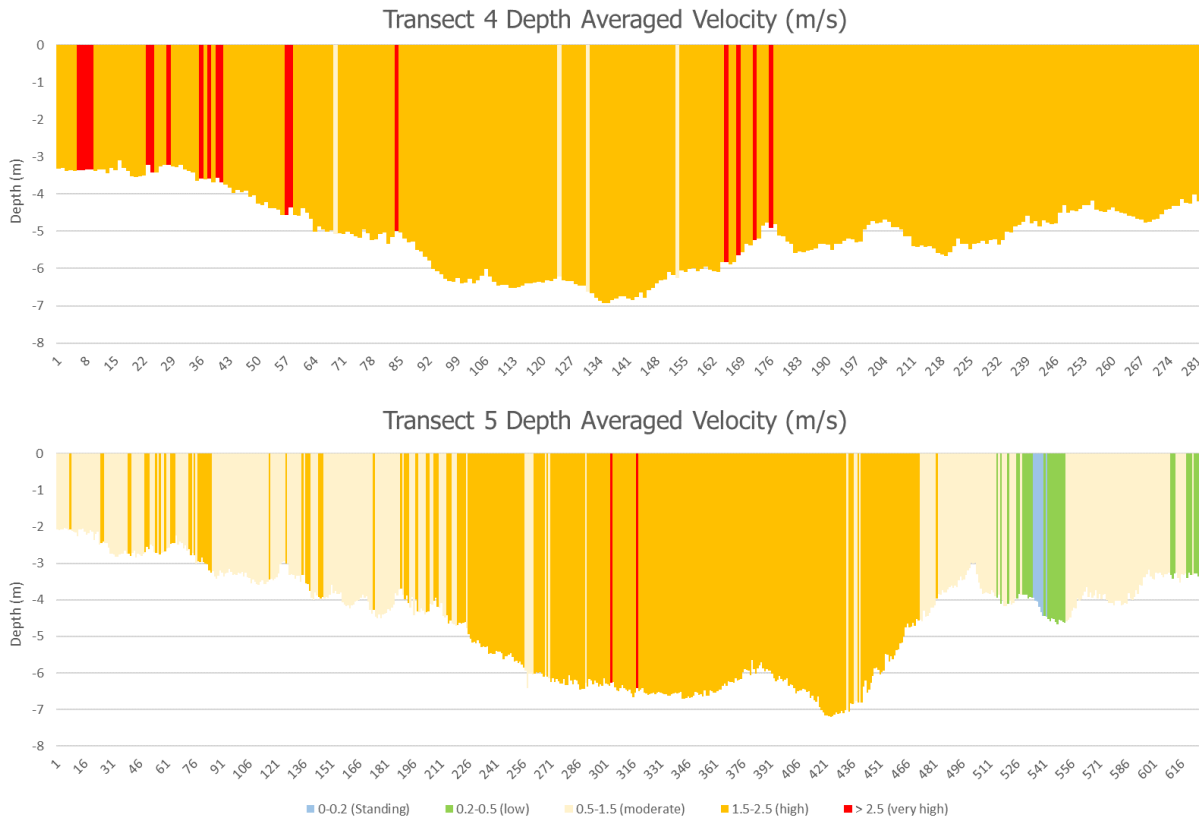
Figure 2: Depth averaged water velocity from two transects sampled using an ADCP at the Long Rapids sensitive habitat area, 2023. Cross sections are viewed looking upstream (left to right bank).

Water surface elevation at the time of the survey was estimated at 160.2 m within the Long Rapids reach. Water velocities at Transect 4 (farthest upstream) ranged from 1.08 to 2.68 m/s, with a mean cross section velocity of 2.16 m/s. The mean depth at Transect 4 was 5.06 m with a range of 3.09 to 6.94 m. Water velocities were high across the entire river section in Transect 4, with small areas of very high velocity. Water velocity in Transect 5 was mostly high in the center of the river with moderate to low water velocities along the banks (Figure 2). Velocities ranged from 0.11 to 2.59 m/s with a mean cross section velocity of 1.41 m/s. The depth at Transect 5 ranged from 2.03 to 7.20 m with a mean depth of 4.58 m.

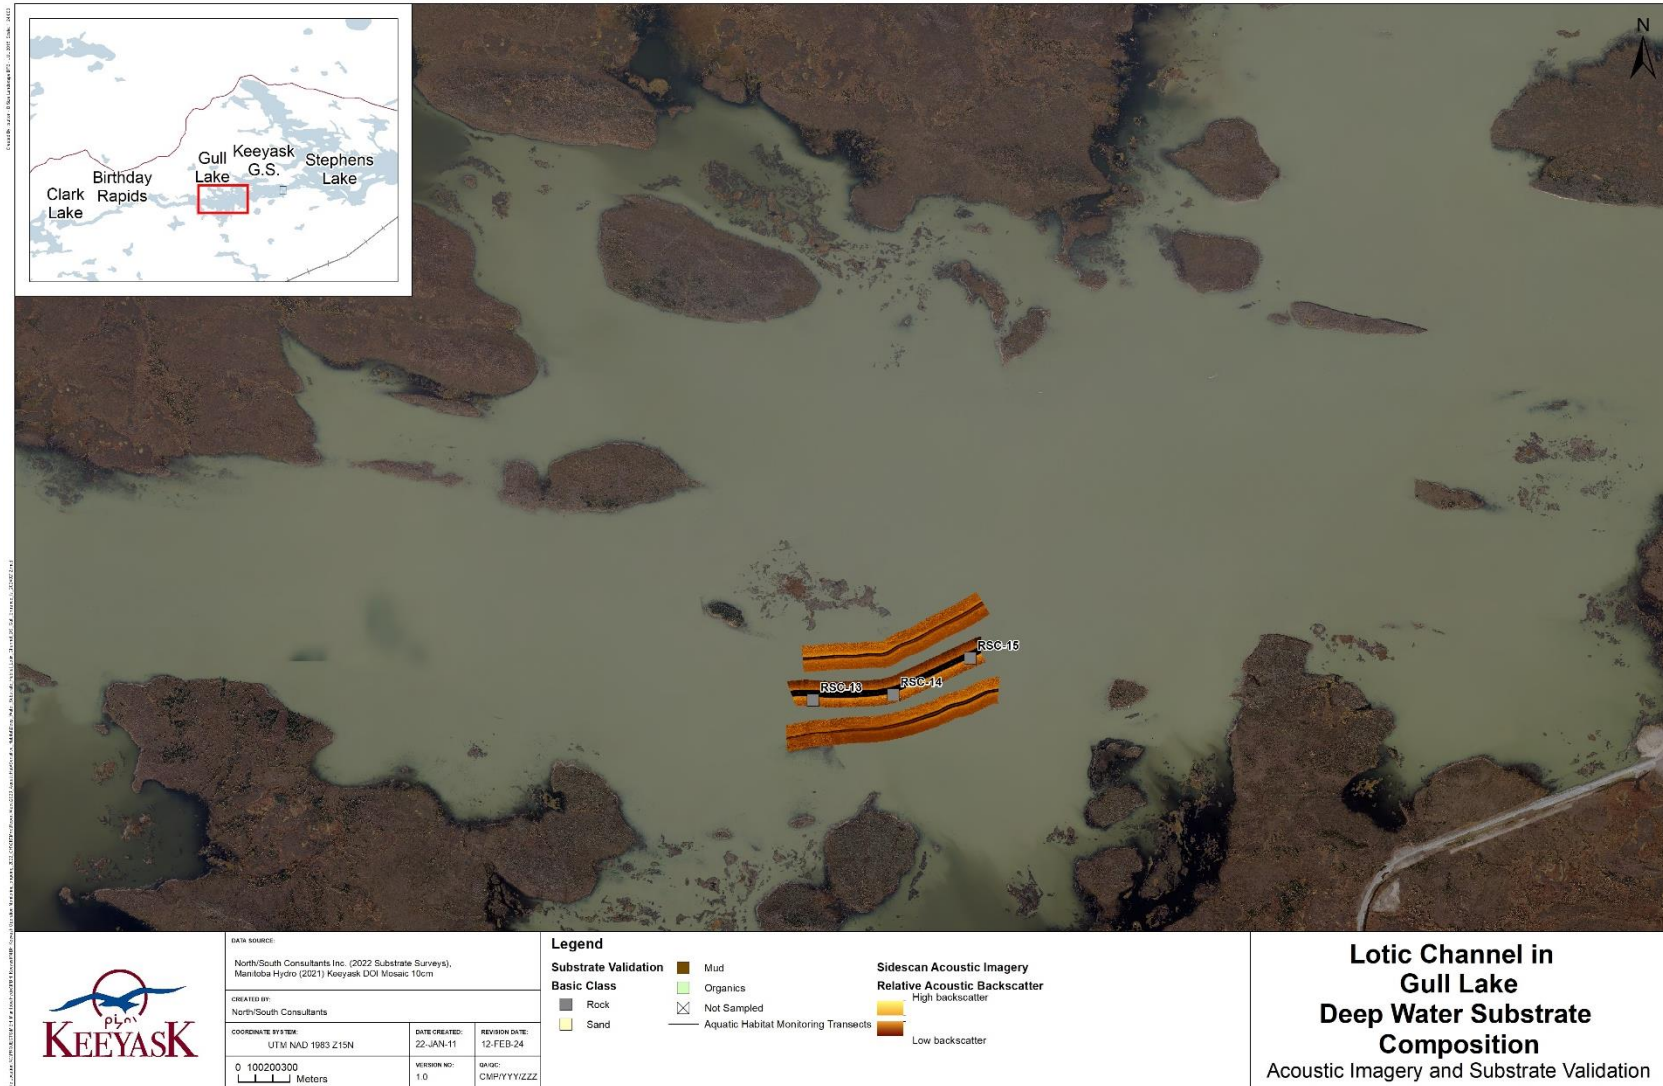
Map 9: Map illustrating the results of substrate composition sampling sites and acoustic imaging in the lotic portion of upper Gull Lake, 2023. Lighter colours in the acoustic imagery indicate harder substrates while darker colours indicate softer substrates.

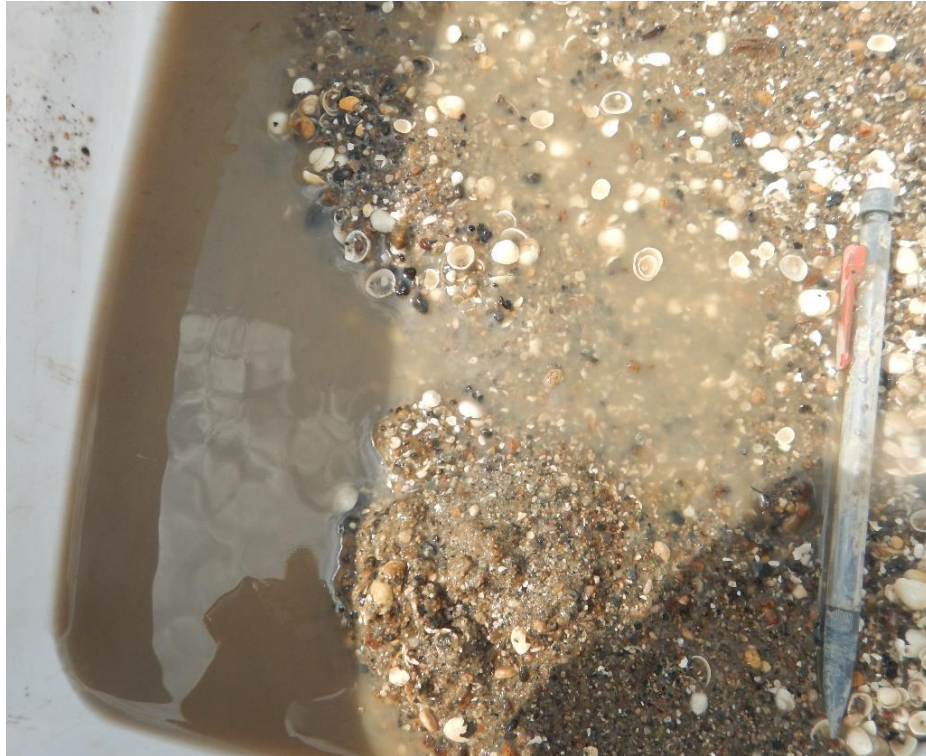
Photo 1: Substrate collected at site DST3-28 in the area of the Keeyask reservoir surrounding Caribou Island showing sand and shells.

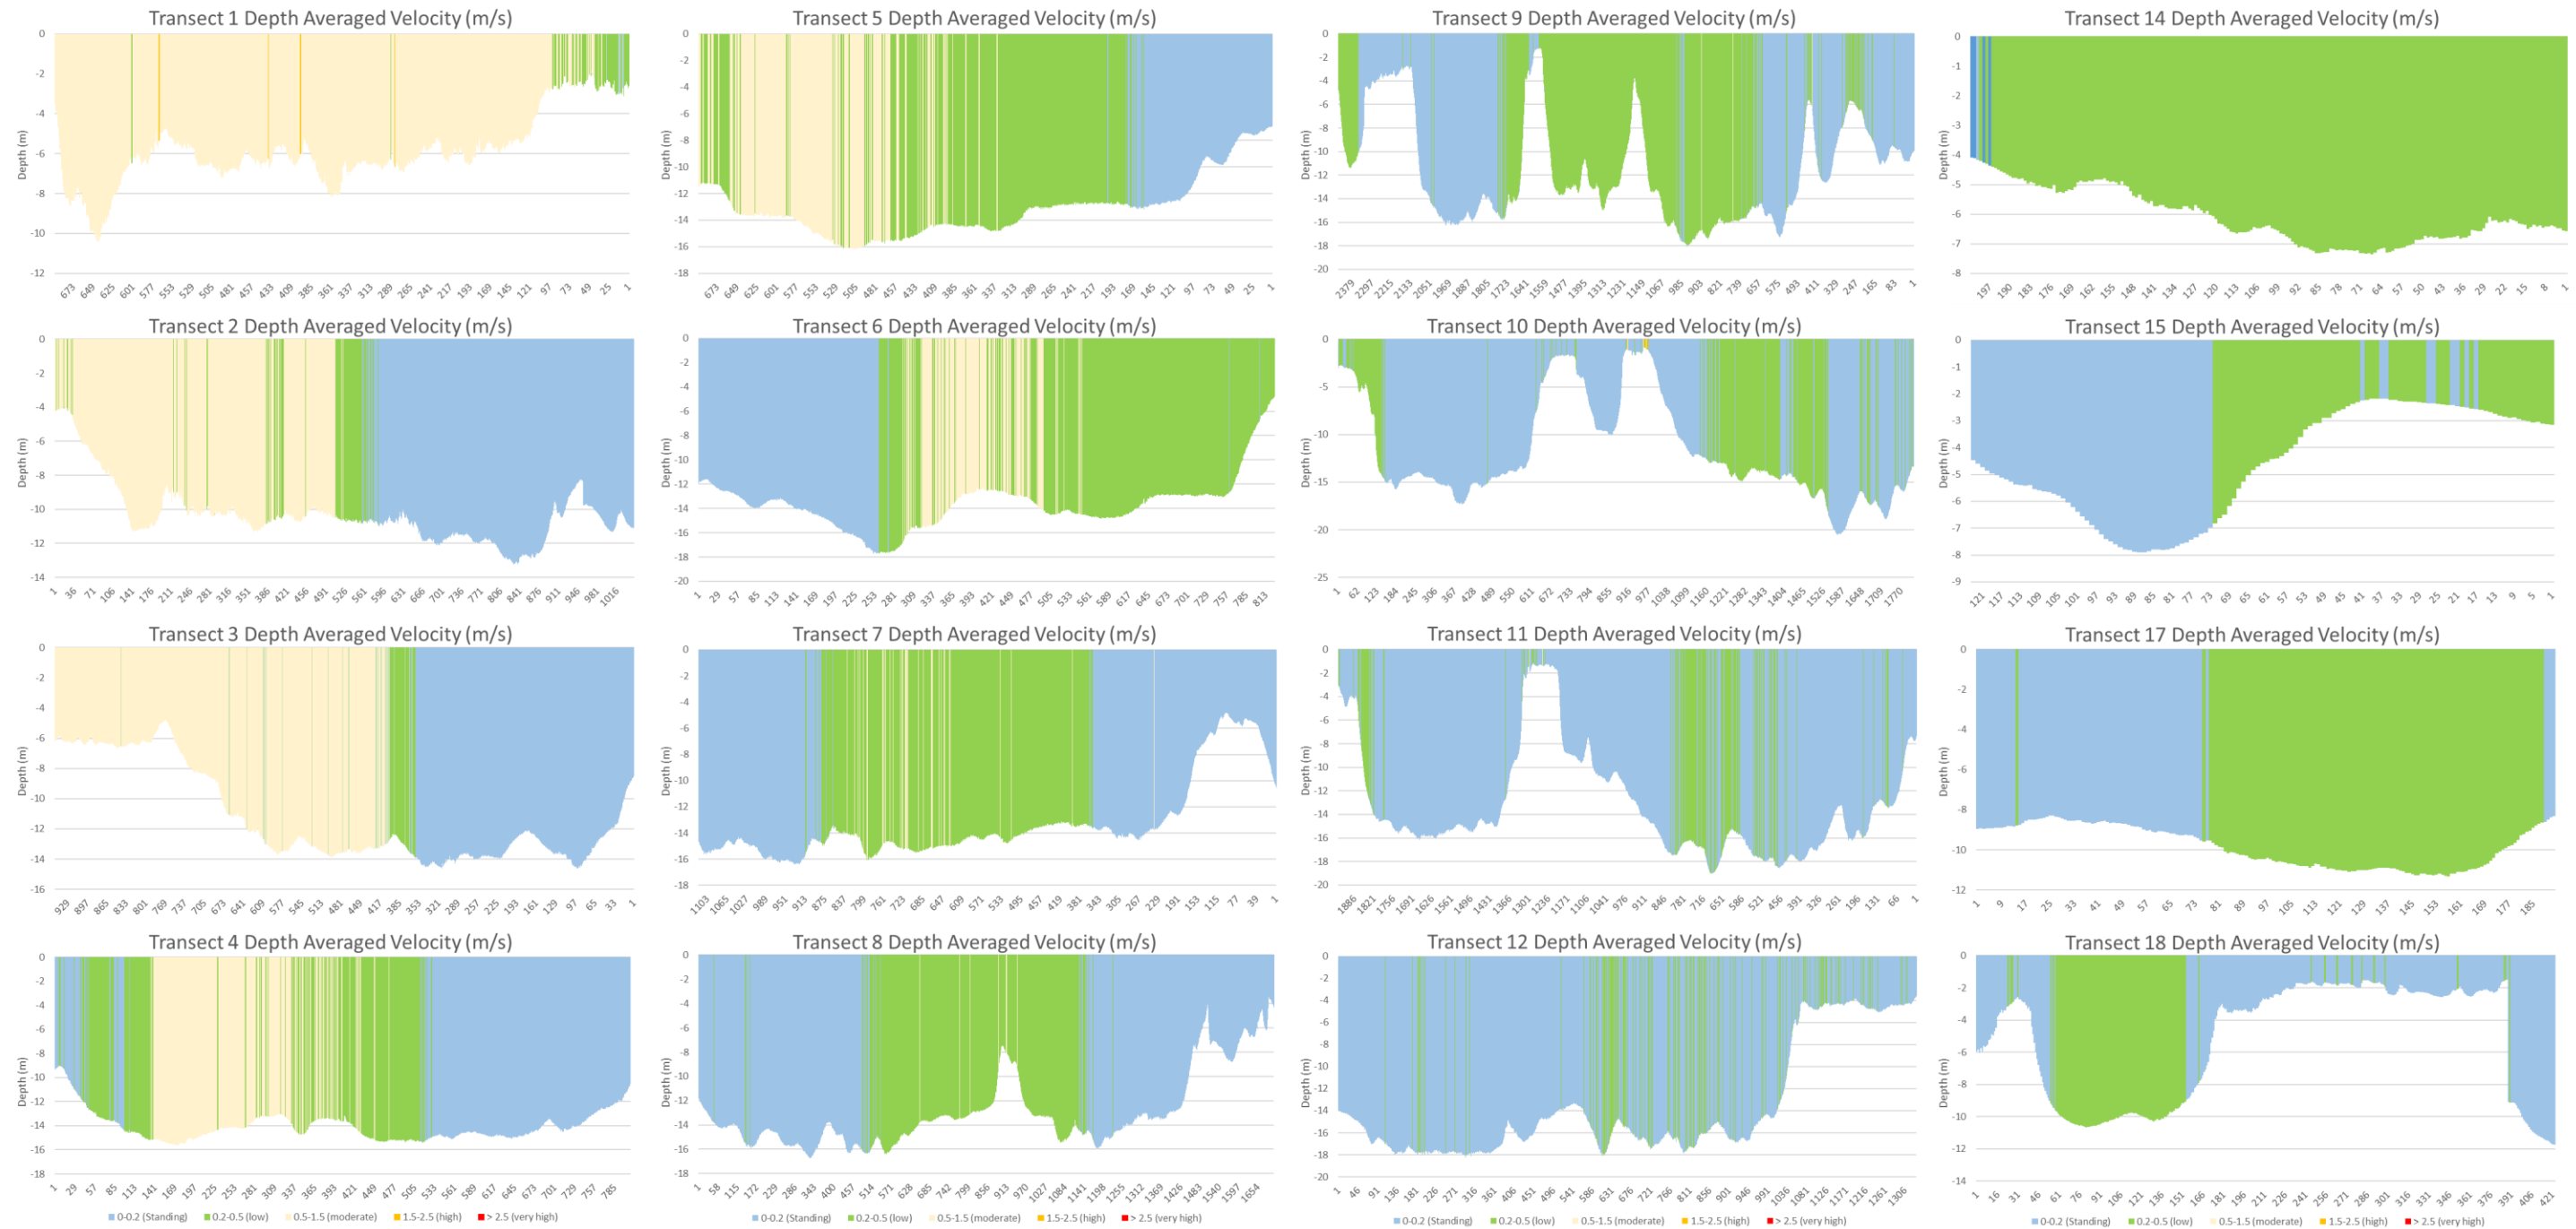
Figure 6: Depth averaged water velocity from 18 transects sampled using an ADCP in Stephens Lake downstream of the Keyyask GS, 2023. Cross sections are viewed looking upstream (left to right bank).

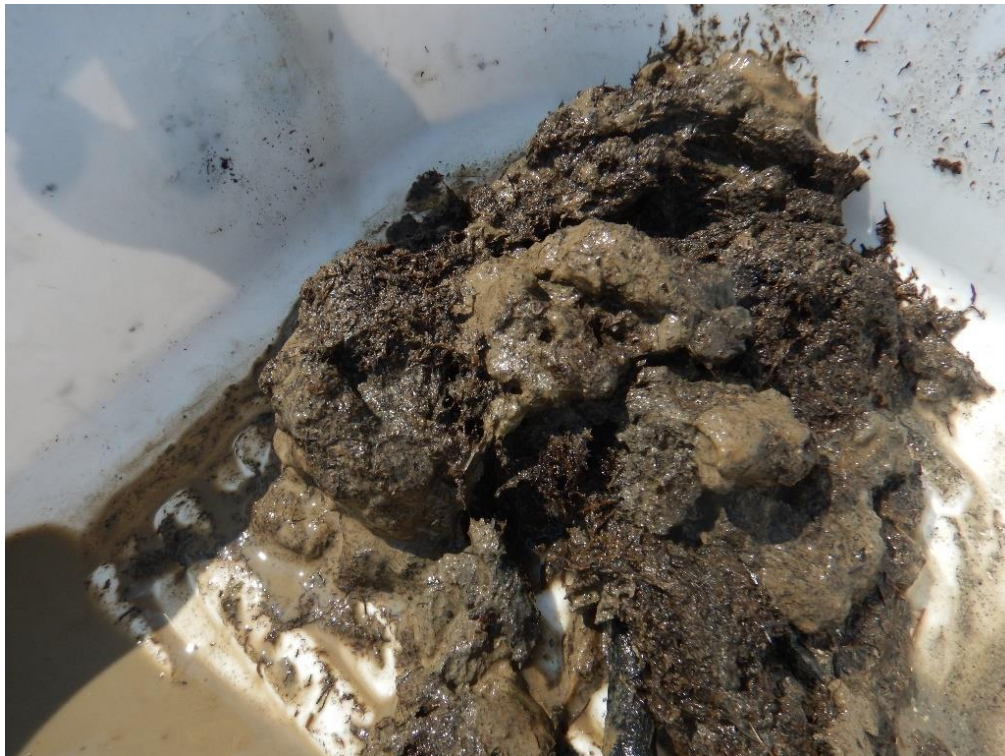
Photo 2: Substrate collected at site T1-3 in the upper Stephens Lake sensitive habitat area in June showing organics, clay, and silt.

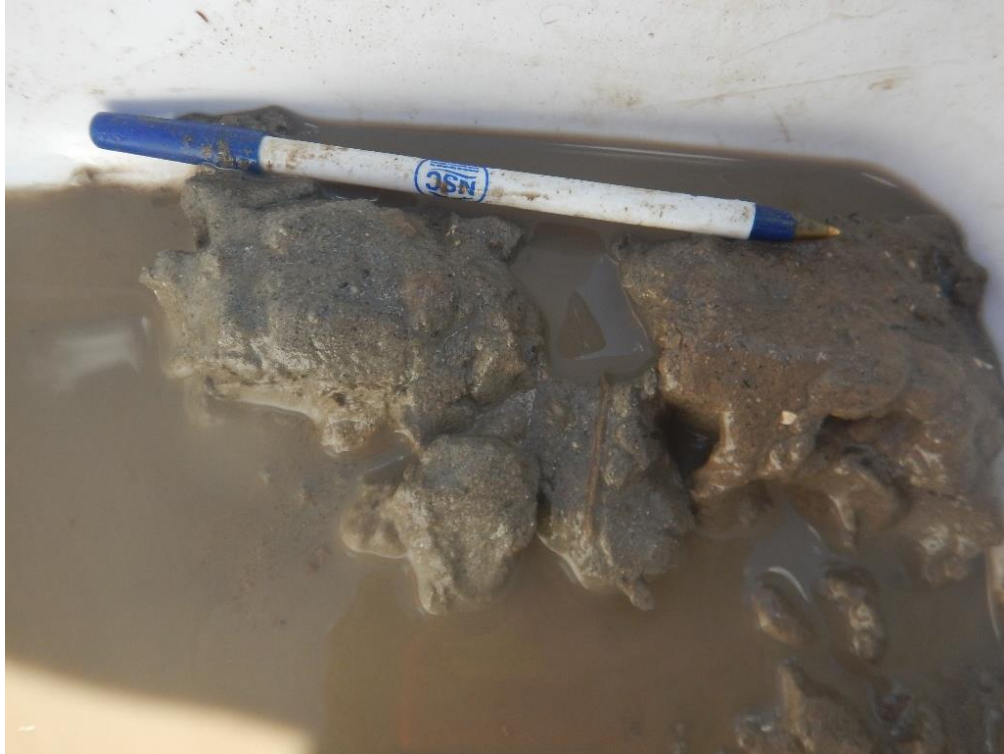
Photo 3: Substrate collected at site DST4-3 in the upper Stephens Lake sensitive habitat area in August showing sand and clay.

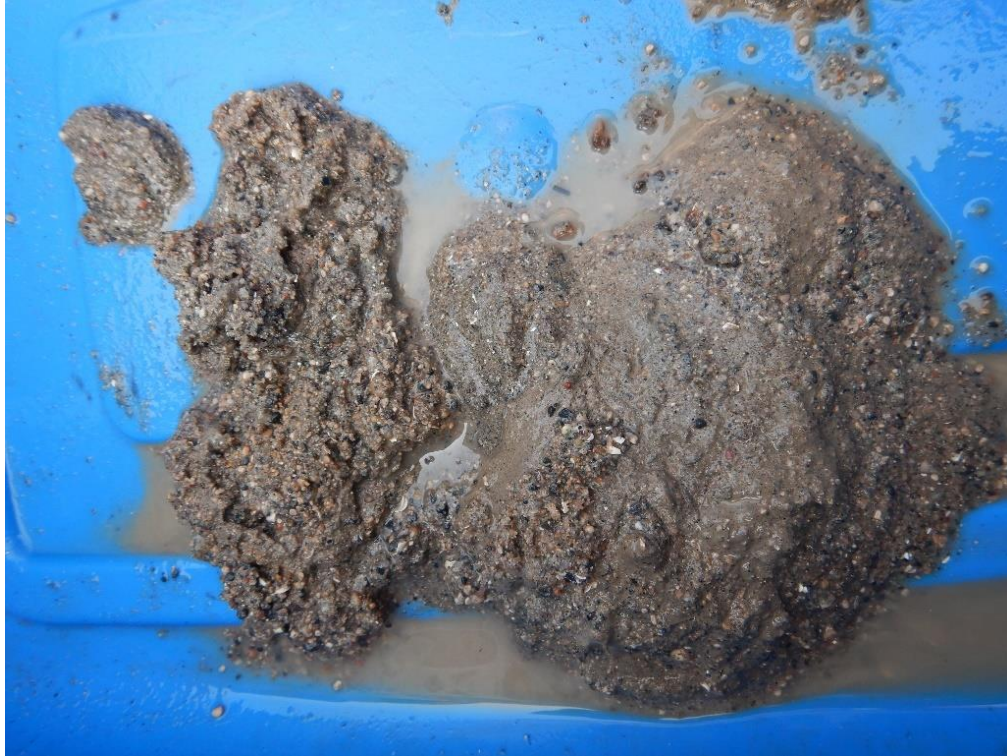
Photo 4: Substrate collected at site T3-2 in the upper Stephens Lake sensitive habitat area in September showing sand, silt, and shells.

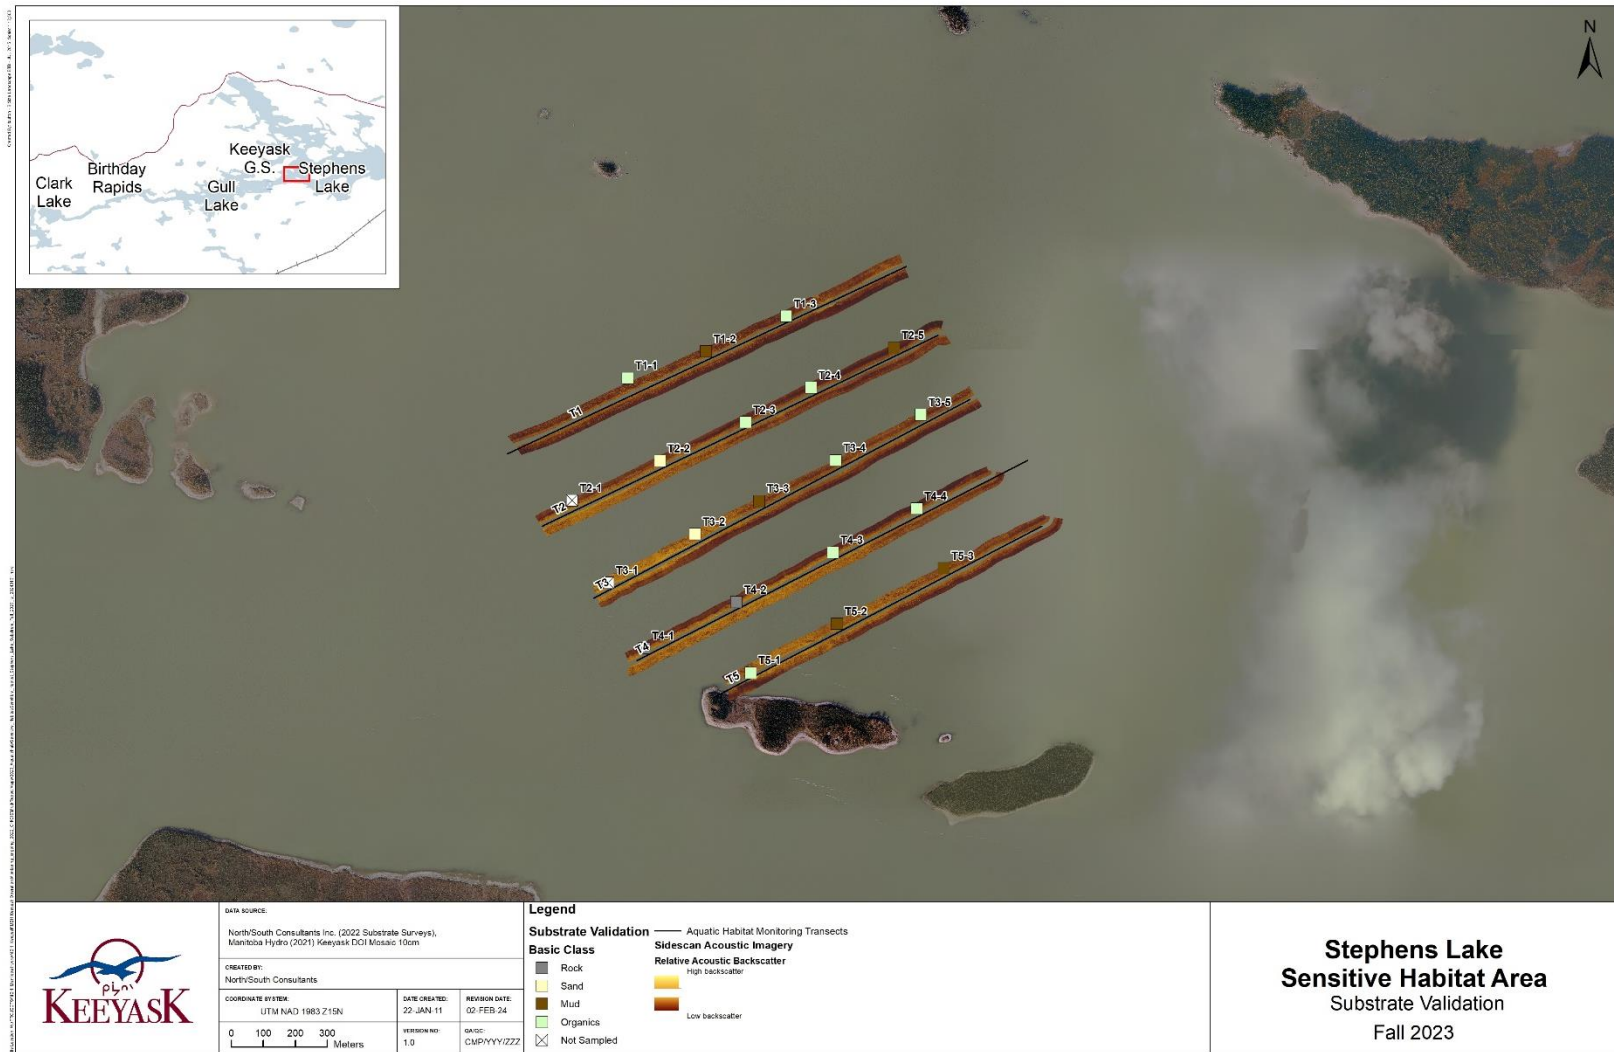
Map 15: Map illustrating the results of substrate composition sampling sites and acoustic imaging for the Stephens Lake sensitive habitat area, September 2023. Lighter colours in the acoustic imagery indicate harder substrates while darker colours indicate softer substrates.

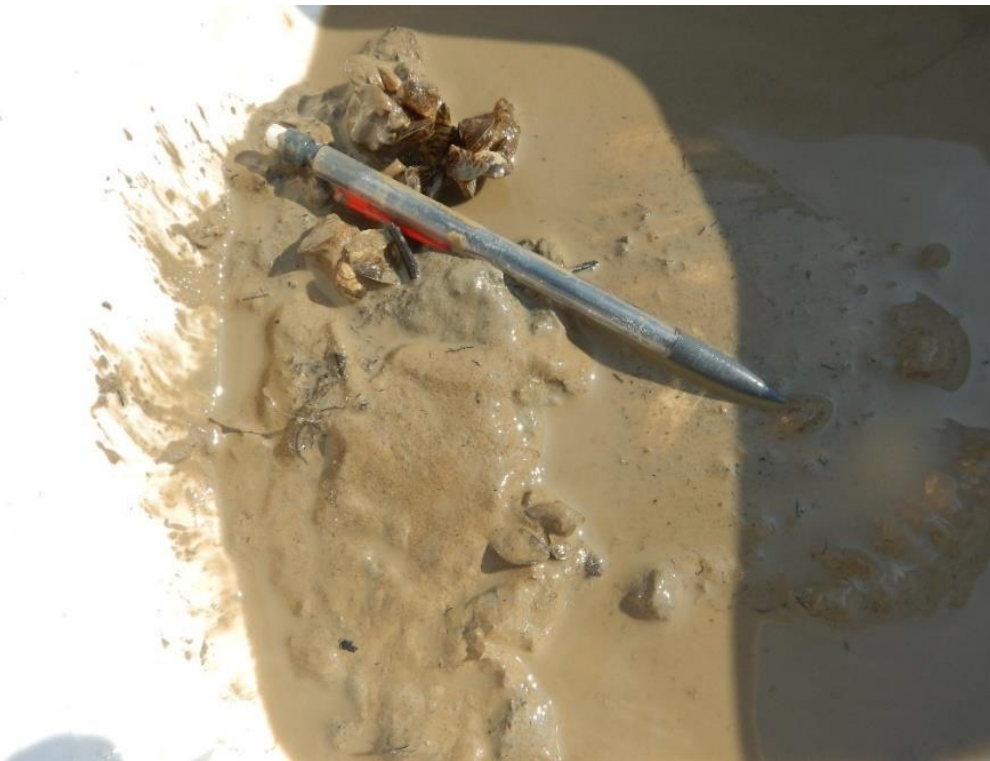
Photo 5: Substrates collected from constructed shoal F-East-2 in the Keeyask reservoir, showing clay and silt.

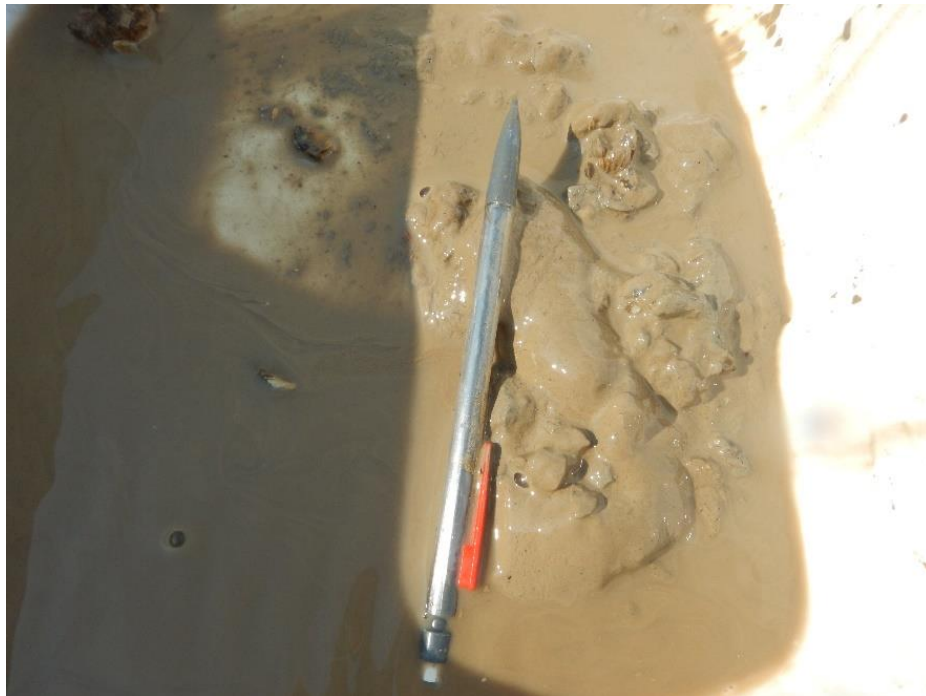
Photo 6: Substrates collected from constructed shoal F-South-3 in the Keeyask reservoir, showing clay and silt, 2023.

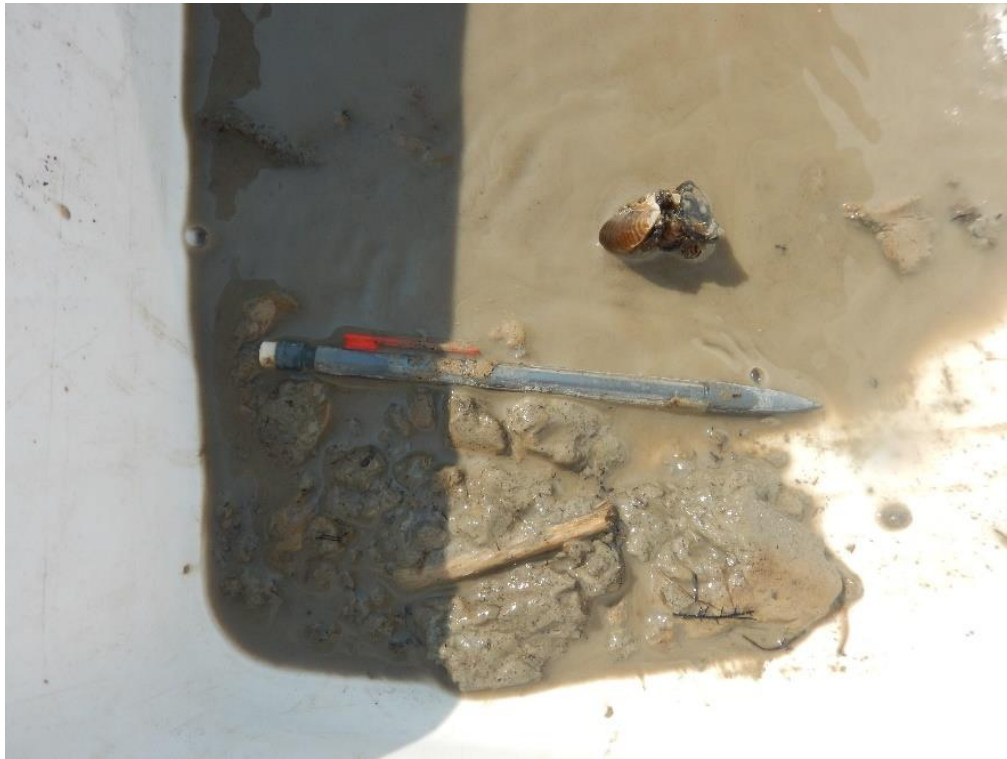
Photo 7: Substrates collected from constructed shoal G-North-2 in the Keeyask reservoir, showing clay and silt and collected zebra mussels, 2023.

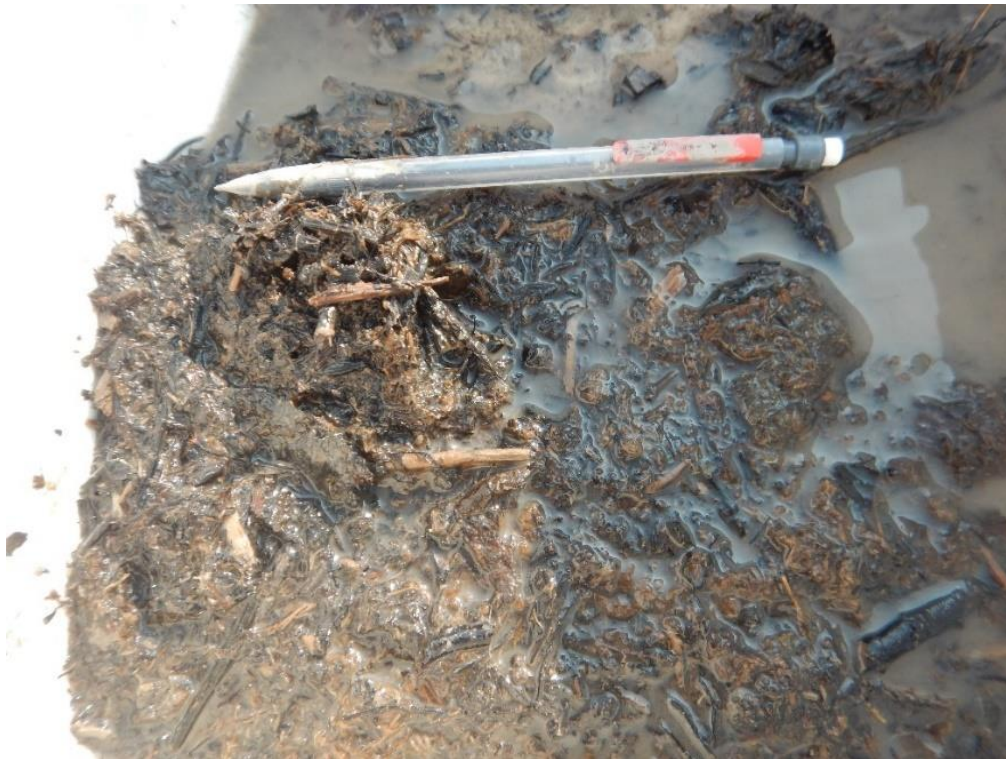
Photo 9: Substrates collected from constructed shoal H-North-4 in the Keeyask reservoir, showing organics and silt.

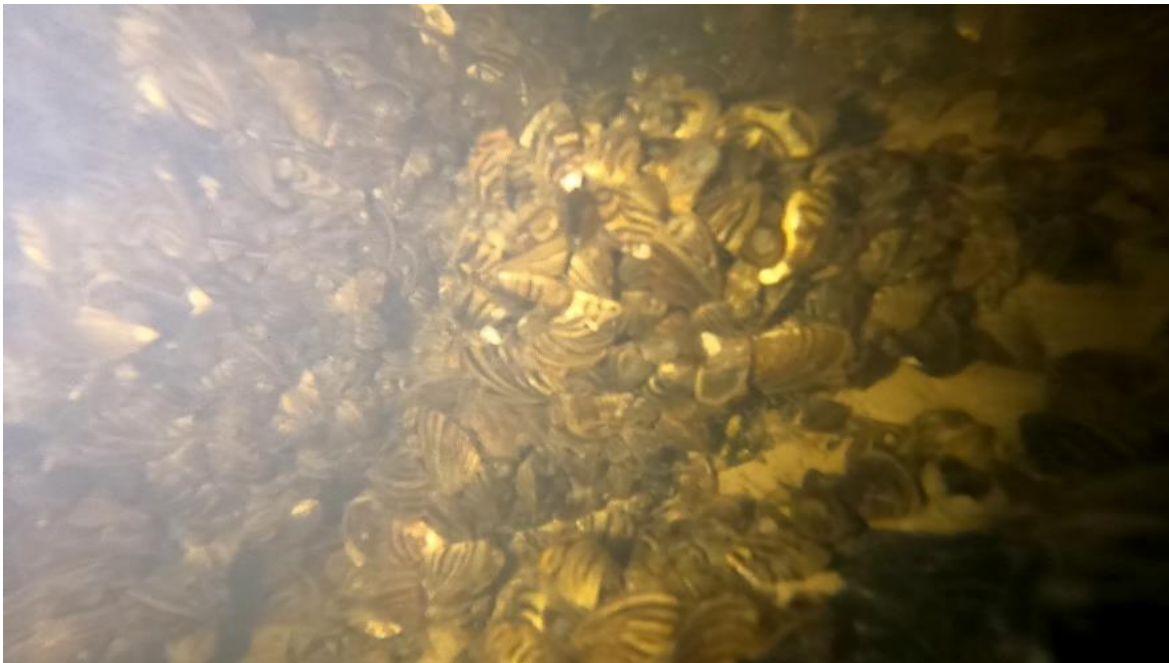
Photo 10: Zebra mussels observed on the constructed spawning shoal L using an underwater camera, 2023.
