Keeyask Generation Project Aquatic Effects Monitoring Plan

Development of Nearshore and Aquatic Macrophyte Habitat Report

AEMP-2024-13

DEVELOPMENT OF NEARSHORE AND AQUATIC MACROPHYTE HABITAT IN THE KEYYASK STUDY AREA, 2023

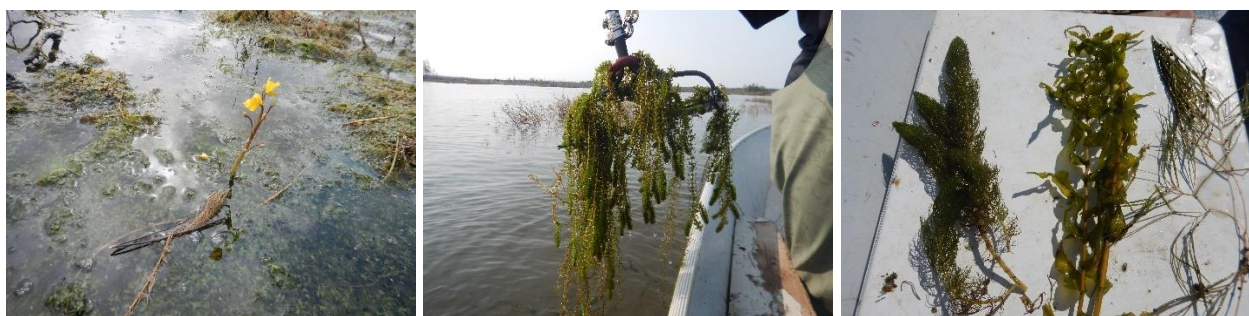
Aquatic plants as seen from the boat (left), sampled using the rake (middle), and identified by species (right) in the Keeyask reservoir in 2023.

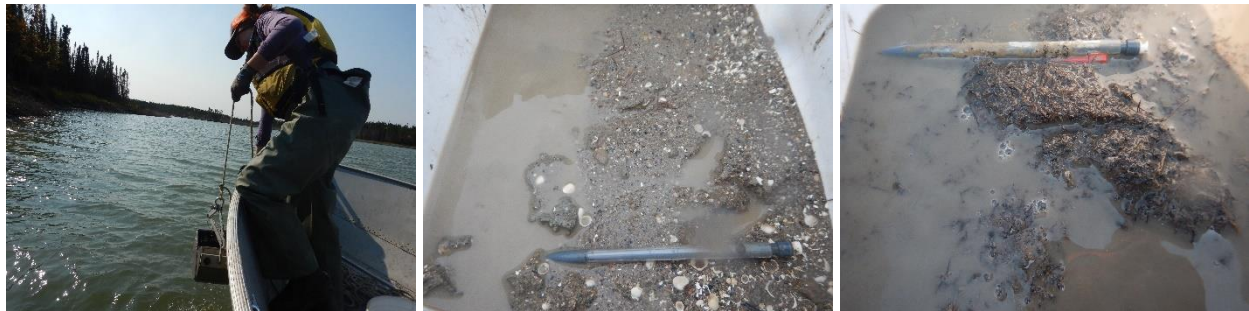
Substrates sampled with a Ponar dredge (left) showing sand (middle) and organics (right) from the Keeyask reservoir in 2023.

Substrates and water depth were mapped using a sonar system. Substrate type was confirmed at each site by using a Ponar dredge to grab a sample of the bottom (pictured below) or a sounding line (to hear or feel if the bottom is rocky or soft). A few Ponar grab samples were also sent to the lab to confirm classifications done in the field.

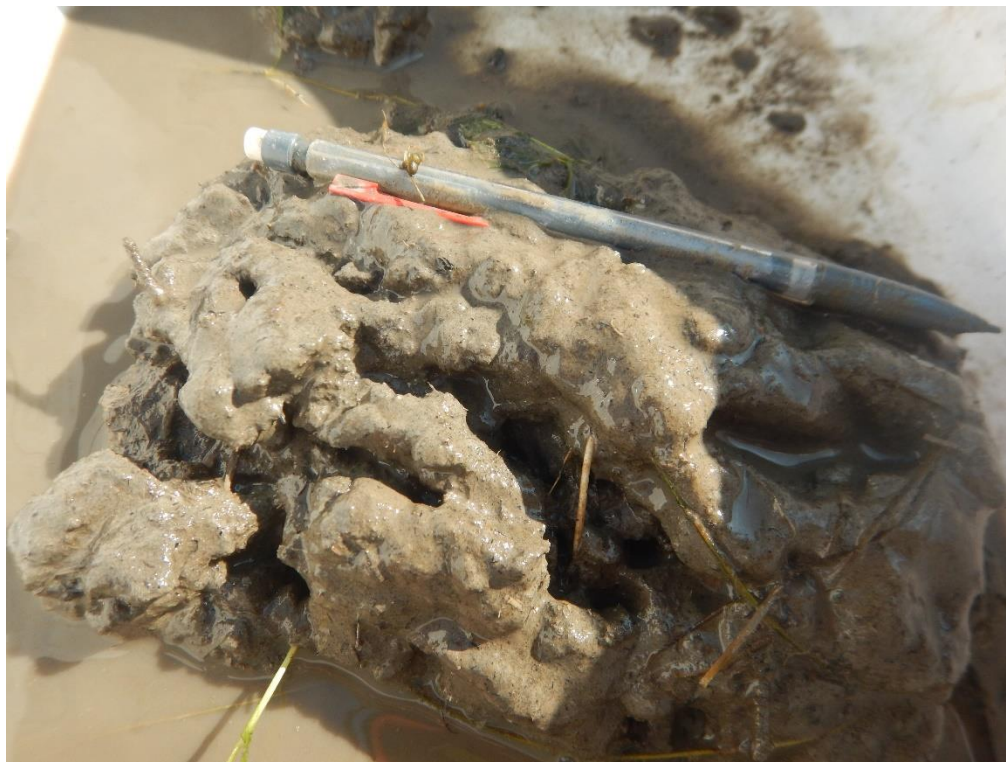
Photo 2: Substrate collected upstream of Birthday Rapids (MS1) in 2023, showing clay mixed with sand and organics.

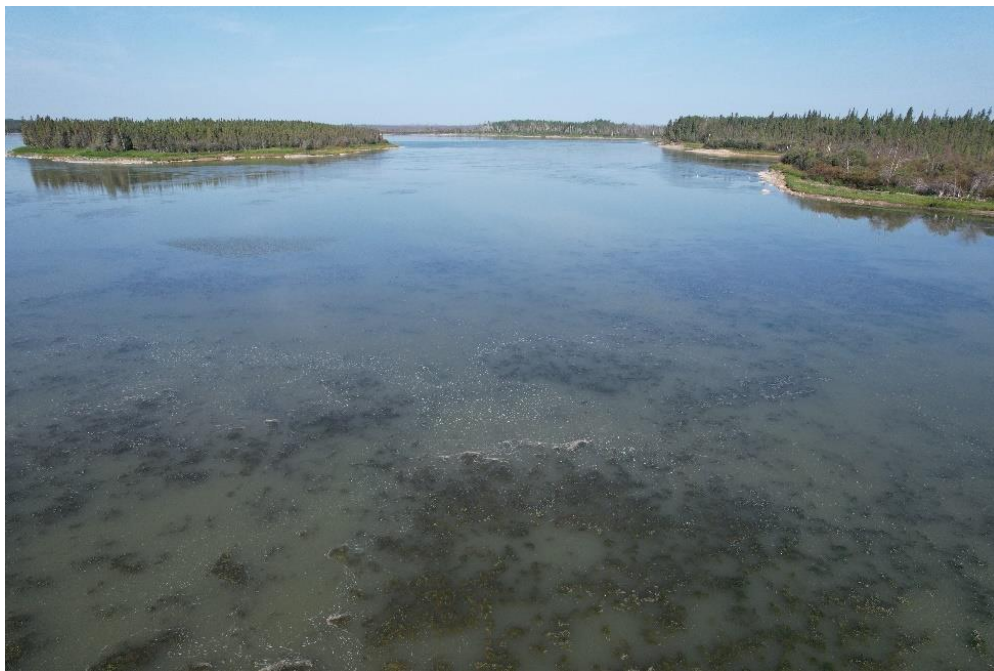
Photo 3: Aerial view of plant beds visible at the surface of the water upstream of Birthday Rapids (MS1; from the eastern edge looking west to the river mainstem) in 2023.

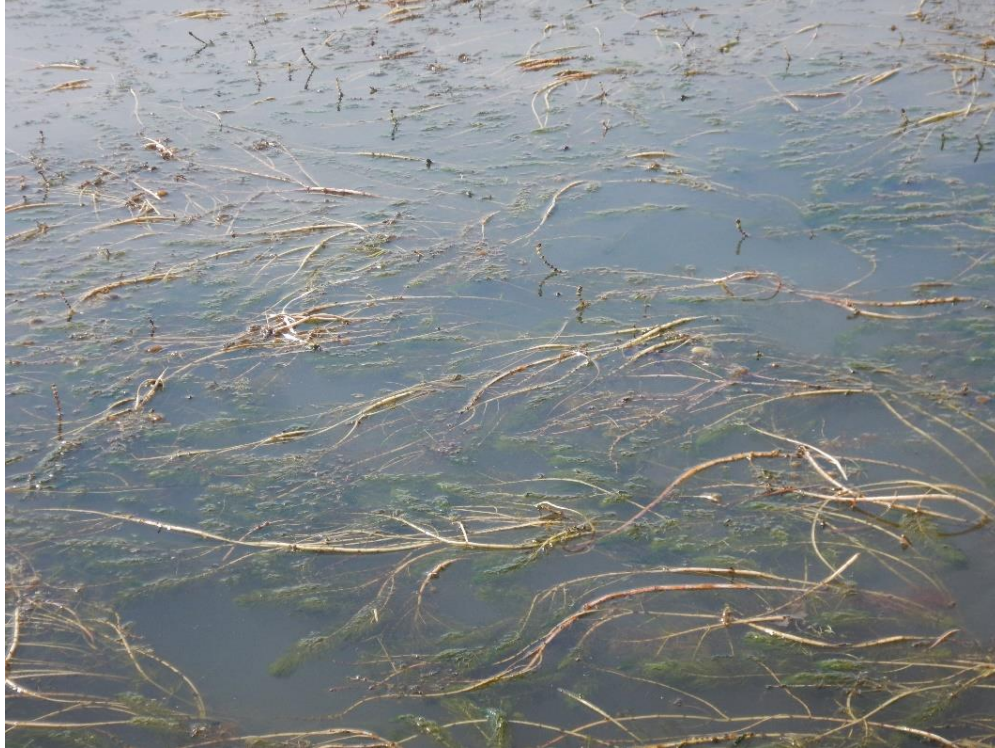
Photo 4: Plant beds visible at the surface of the water upstream of Birthday Rapids (MS1) in 2023.

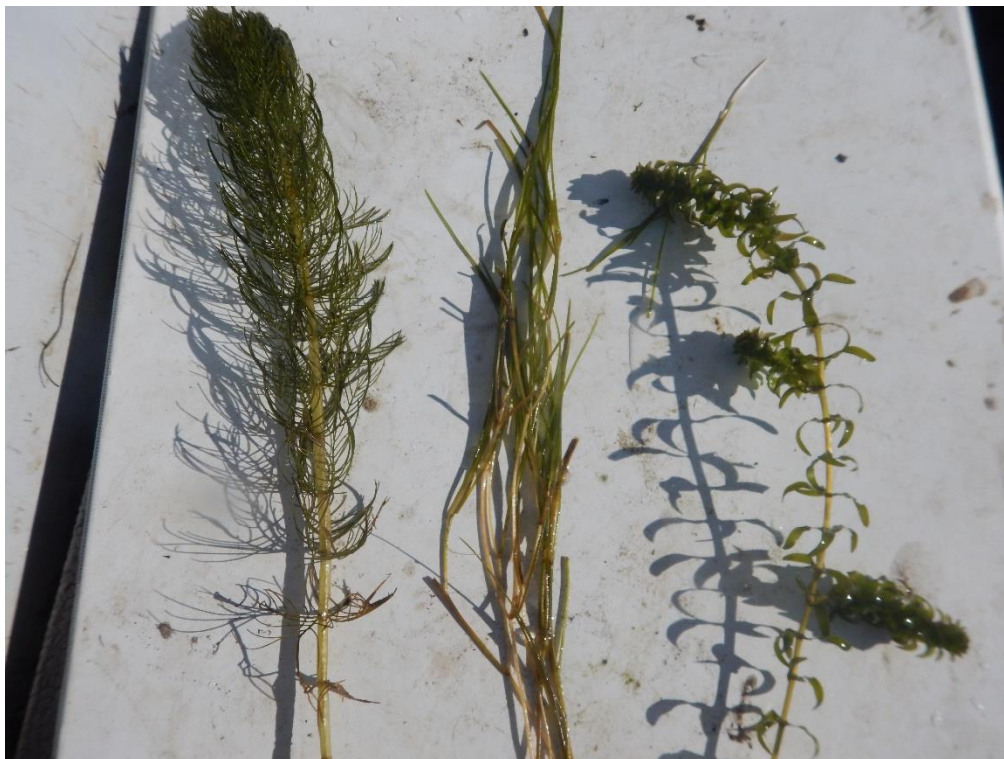
Photo 5: Aquatic plants collected from the Keeyask reservoir (MS2) in 2023, showing Watermilfoil (left), Sago pondweed (middle), and Canada waterweed (right).

Plants were observed at two sampling sites at 1.5 and 6.5 m deep ([Table A1-2](#)). Three species were present including Watermilfoil (*Myriophyllum* spp.), Canada waterweed (*Elodea canadensis*), and Sago pondweed (*Stuckenia pectinate*; [Photo 5](#)).

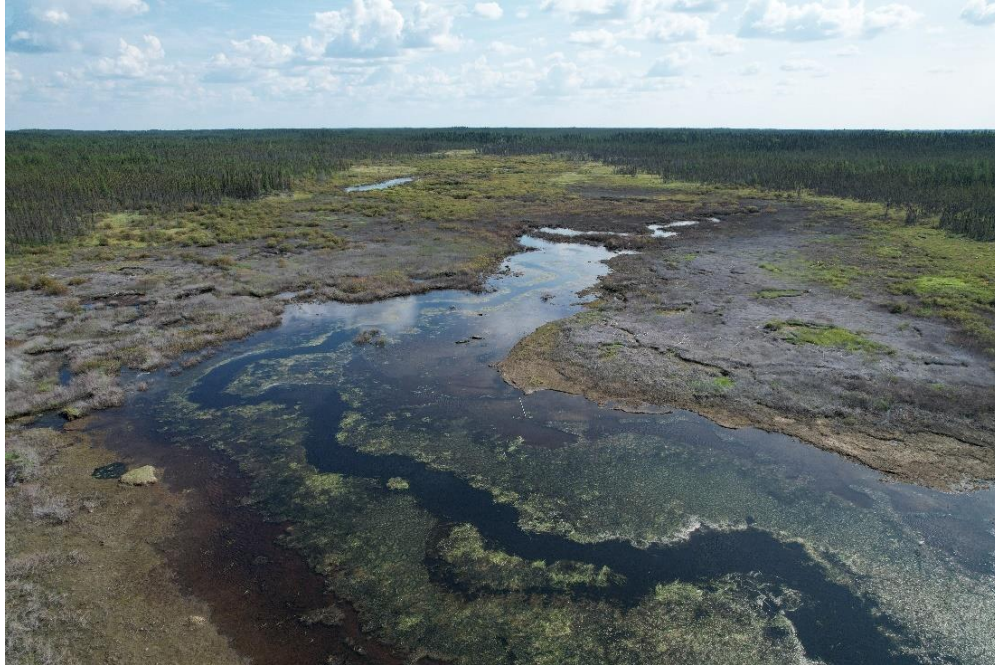
Photo 6: Plant beds visible at the surface of the water at the mouth of Nap Creek (MS2) in 2023.

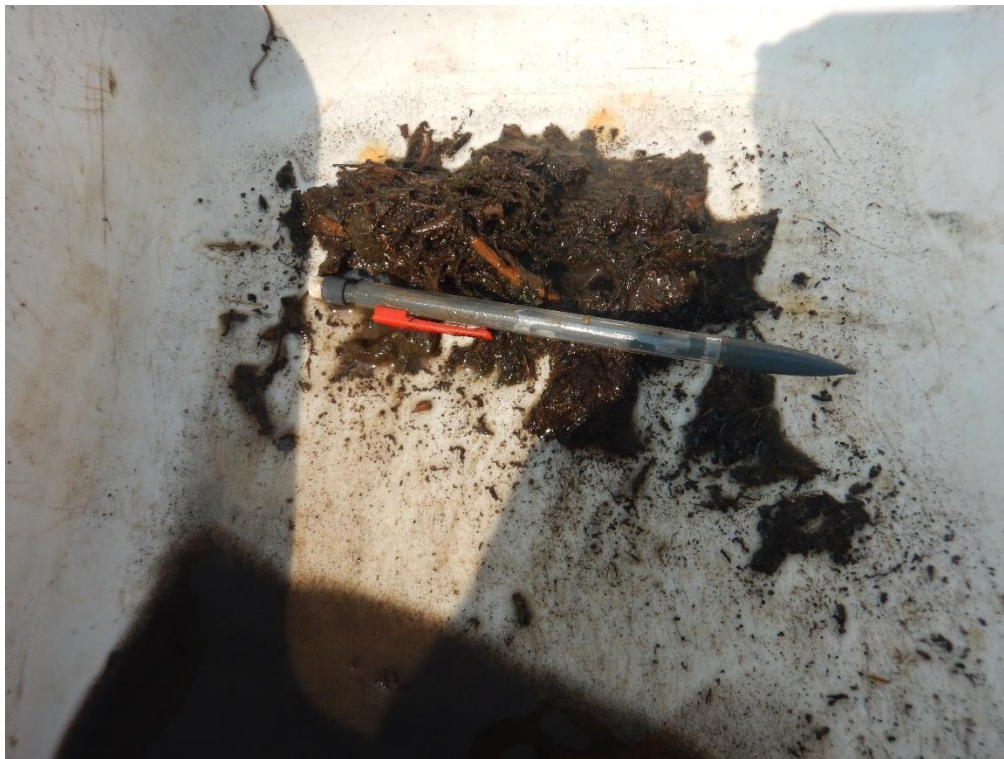
Photo 7: Substrate collected from the Keeyask reservoir backbay Zone 4 (MS3) in 2023, showing organics.

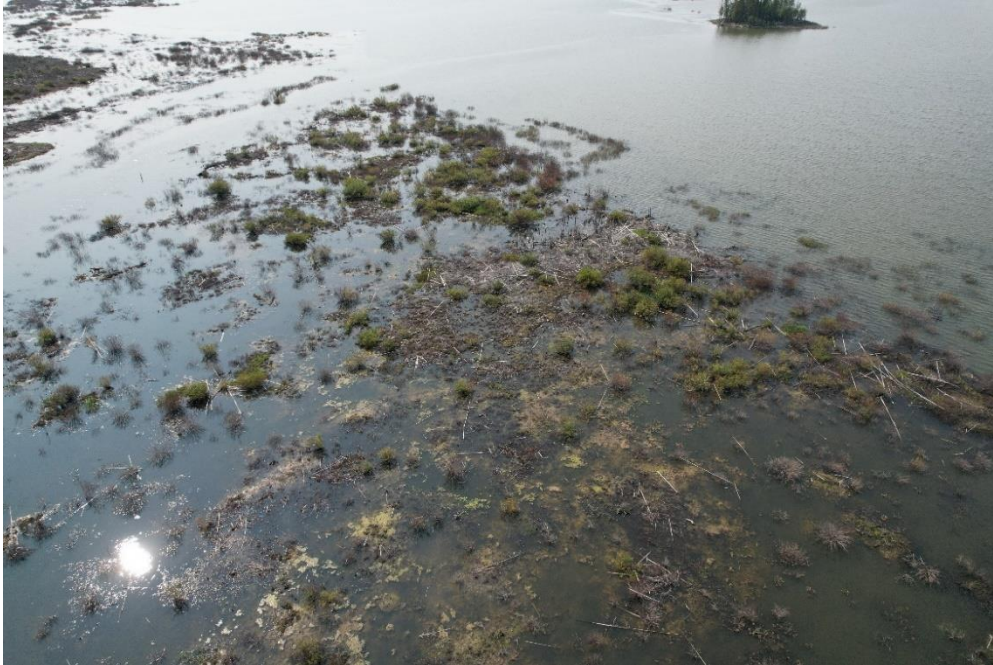
Sampling area MS3 is located within the farthest upstream flooded backbay (Zone 4), located within the middle Keeyask reservoir (maps [2](#) and [4](#)). Flooding was more extensive within this area compared to the two upstream sites, although was largely limited to the edges of the bay ([Photo 8](#)). The middle of the bay contains habitat that was wetted prior to impoundment.

Photo 8: Flooded terrestrial habitat at the edges of flooded reservoir backbay Zone 4 (MS3) in 2023.

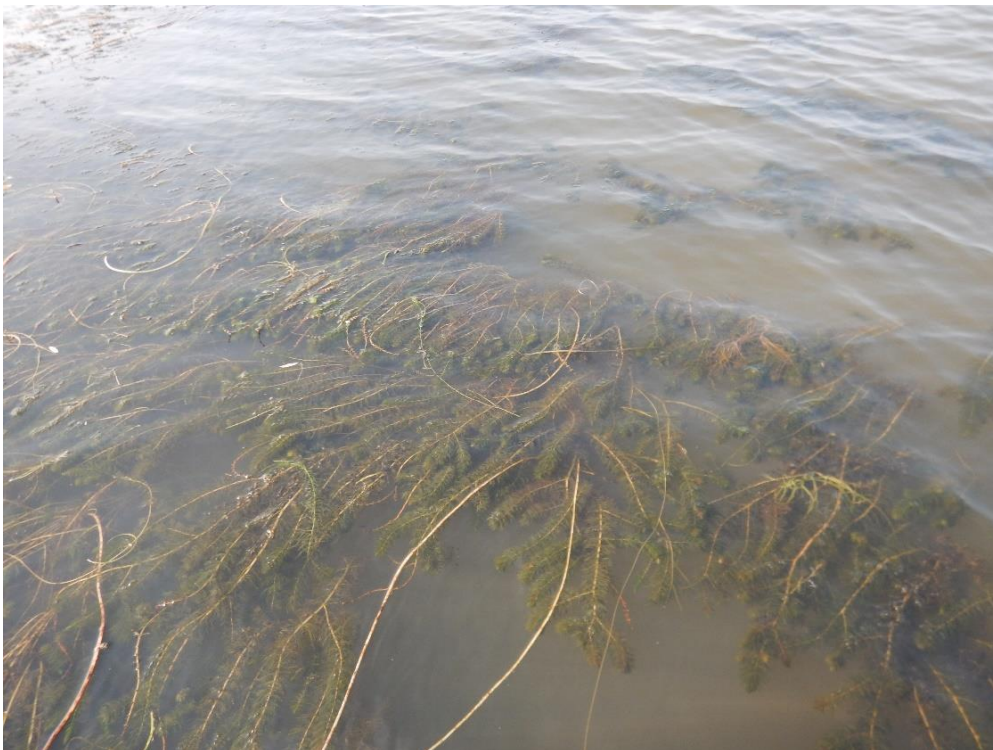
In the third year following reservoir impoundment, plant beds were present within approximately 28% of the sampling area in MS3 ([Map 18](#); photos [8](#) and [9](#)). The majority of plant beds were present along the shorelines where shallow water was present. No plant beds were present in the middle of the backbay where deep (*i.e.*, > 3.01 m) water is present. In all years, light extinction sampling suggests that little (<6% of surface) light penetrates to 2.5 m of depth, while at 1 m, between 16 and 31% of surface light may be present ([Figure 4](#)).

Photo 9: Plant beds visible at the surface of the water in the Keeyask reservoir backbay Zone 4 (MS3) in 2023.

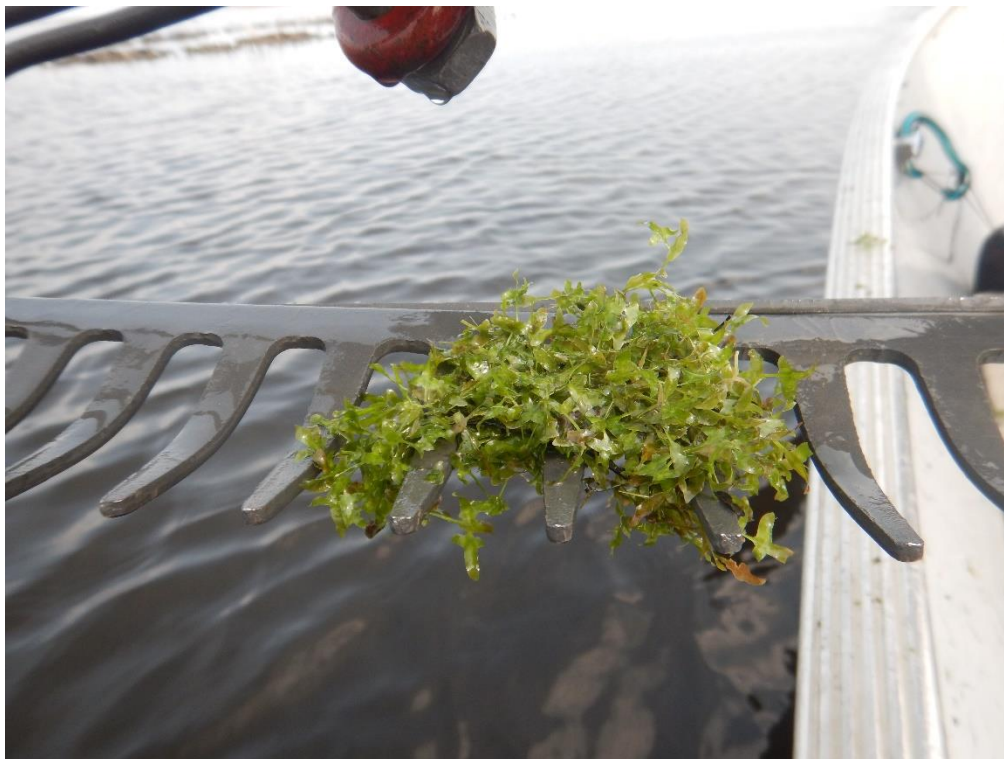
Photo 10: Star duckweed collected using a rake sampler from the Keeyask reservoir backbay Zone 12 (MS4) in 2023.

Aquatic plant species were observed at 14 sites ranging in depth from 0.3–1.6 m ([Table A1-4](#)). Five species of aquatic plants were observed. Star duckweed (*Lemna trisulca*) was the most abundant and was present at 14 sites ([Photo 10](#)). Bladderwort, Watermilfoil, Flat-stemmed pondweed (*Potamogeton zosteriformis*), Canada waterweed, and Whitewater buttercup (*Ranunculus aquatilis*) were present but sparse.

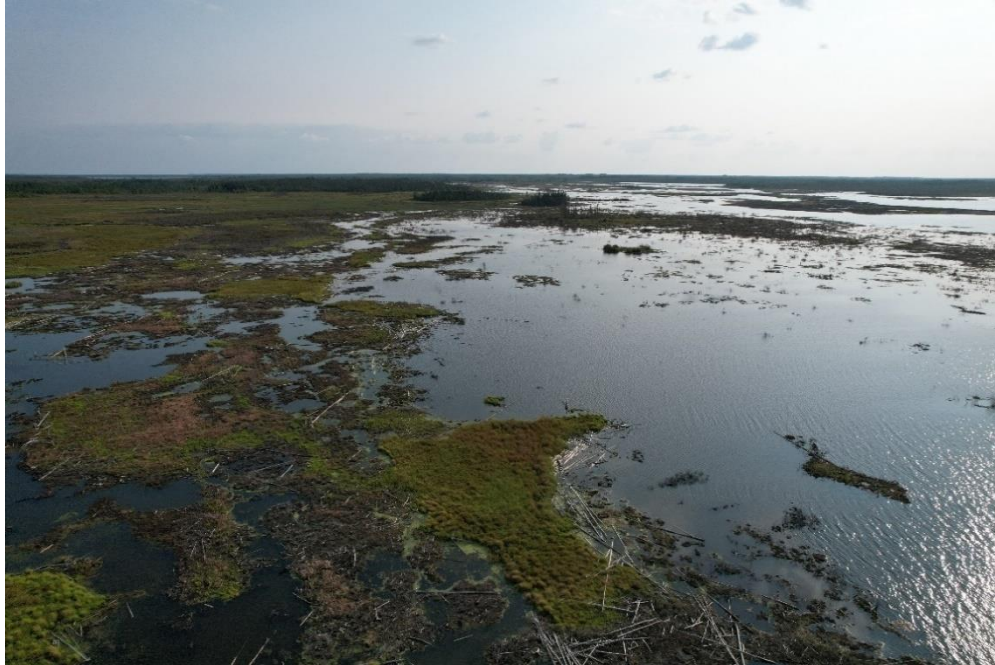
Sampling area MS4 is located within the flooded reservoir backbay Zone 12, along the south shore of Gull Lake (maps [2](#) and [4](#)). Prior to impoundment, much of Zone 12 was terrestrial habitat, with small creeks leading to inland ponds. Flooding was extensive within this area, and much of the backbay consists of flooded terrestrial vegetation and peatland ([Photo 11](#)). Sampling was conducted entirely within a flooded portion of Zone 12 that was terrestrial prior to reservoir impoundment. As such, organic substrate composed of detritus and loose, broken-down plant matter was predominant in all three years ([Map 19](#); [Photo 12](#)). Substrate mapping in 2023 showed that approximately 23% of the sampling area was comprised of organic substrate, while 43% contained mud; however, 31% of the study area could not be mapped due to the presence of floating peat islands ([Table 16](#)).

Photo 11: Flooded terrestrial habitat and peat islands in the Keeyask reservoir backbay Zone 12 (MS4) in 2023.

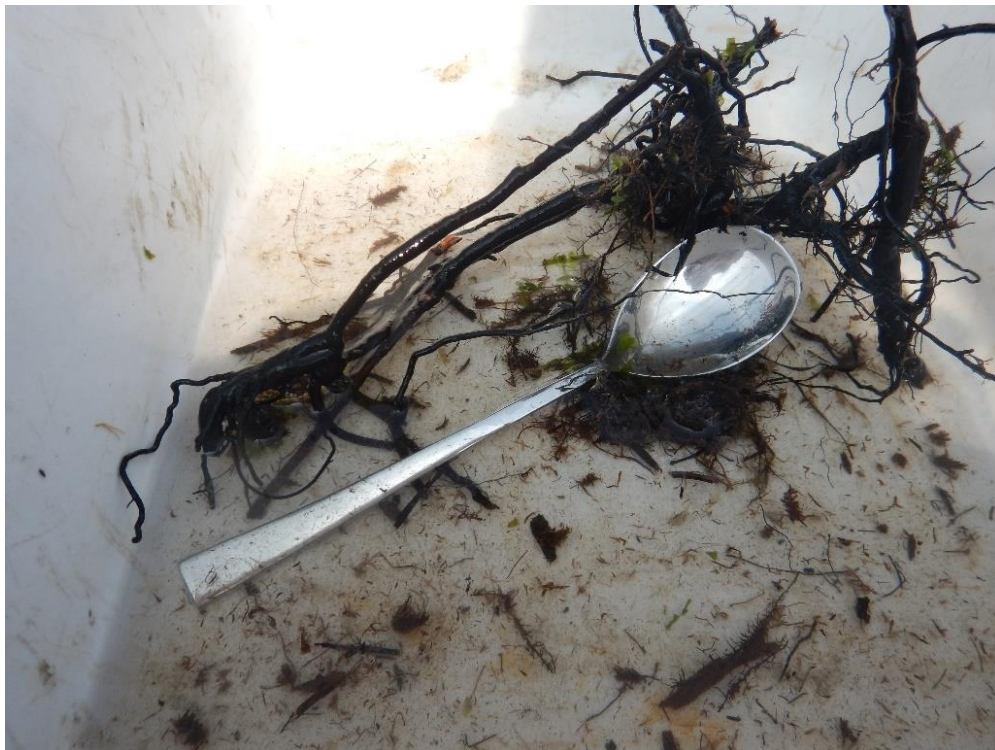
Photo 12: Substrate collected in the Keeyask reservoir backbay Zone 12 (MS4) in 2023 showing organic, flooded terrestrial substrate.

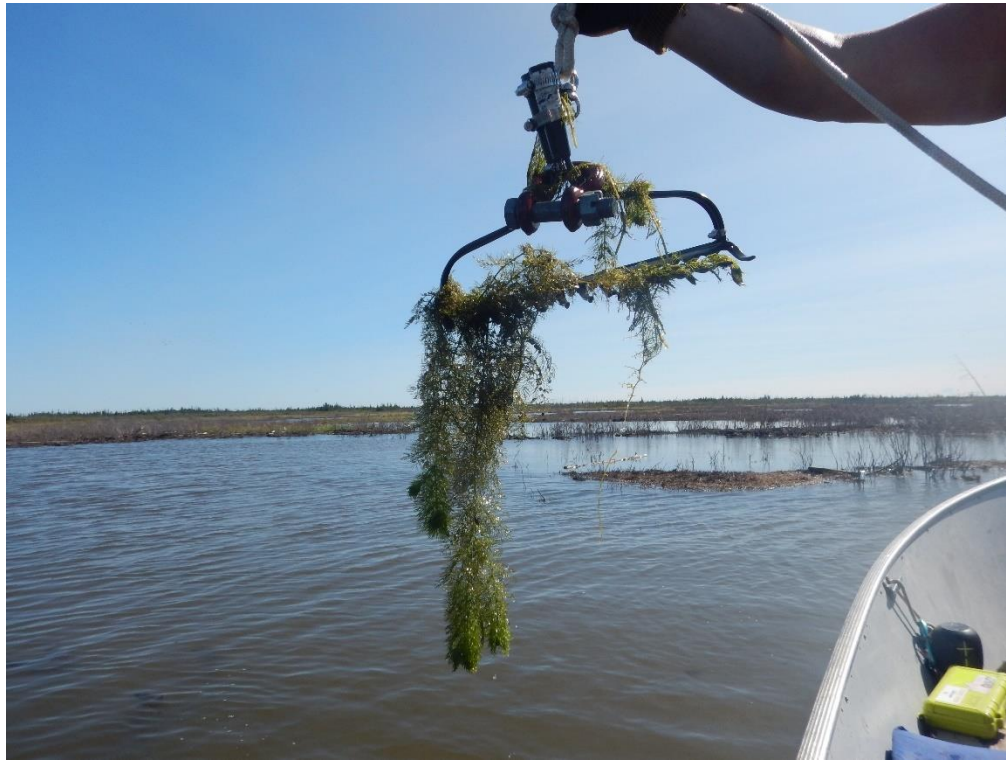
Photo 13: Watermilfoil collected using a rake sampler on the south shore of Gull Lake (MS5) in the Keeyask reservoir in 2023.

Plants were observed at five sampling sites ranging in depth from 0.5–1.9 m ([Table A1-5](#)). Two aquatic plant species were observed: Bladderwort and Watermilfoil ([Photo 13](#)).

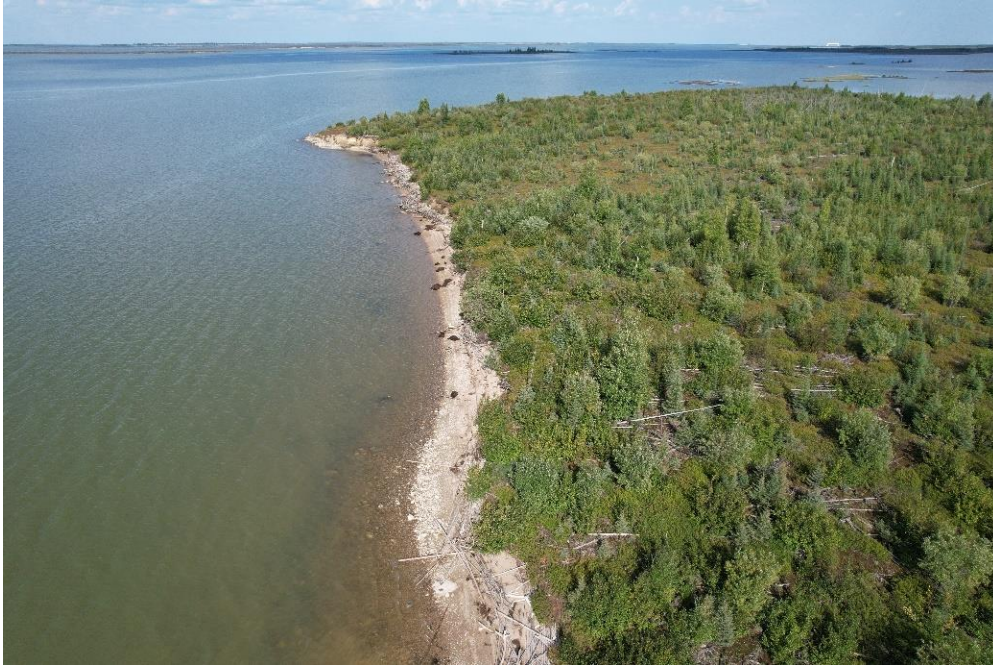
Photo 14: Portion of the sampling area on the south shore of Gull Lake (MS5) showing little flooded area in 2023.

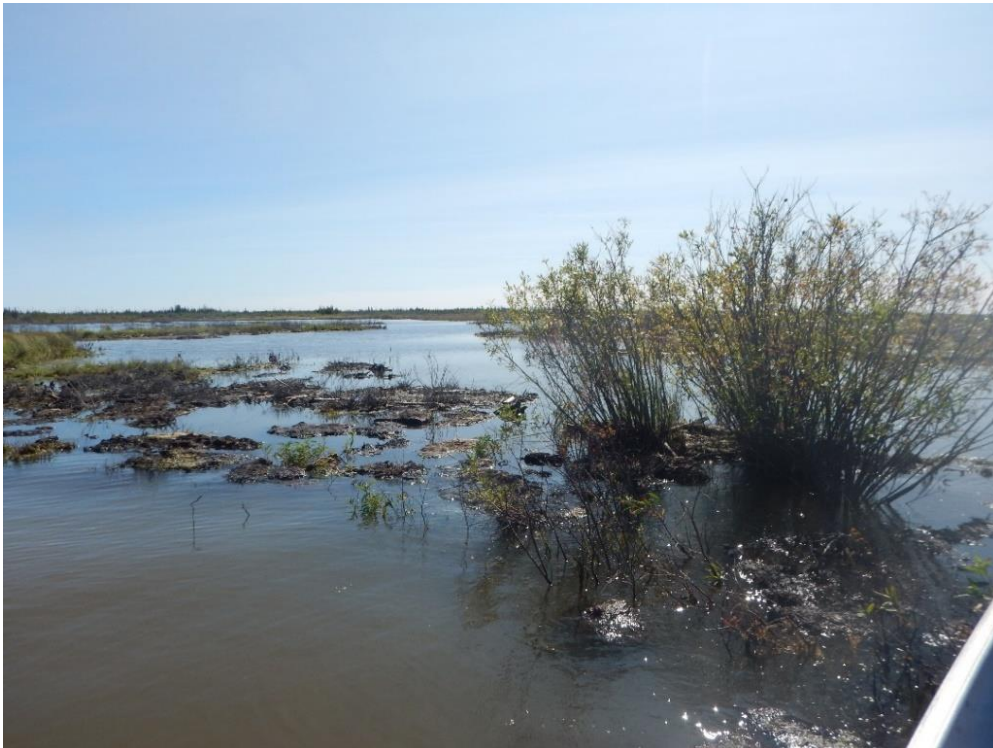
Photo 15: Areas of flooded terrestrial vegetation located within the sampling area on the south shore of Gull Lake (MS5) in 2023.

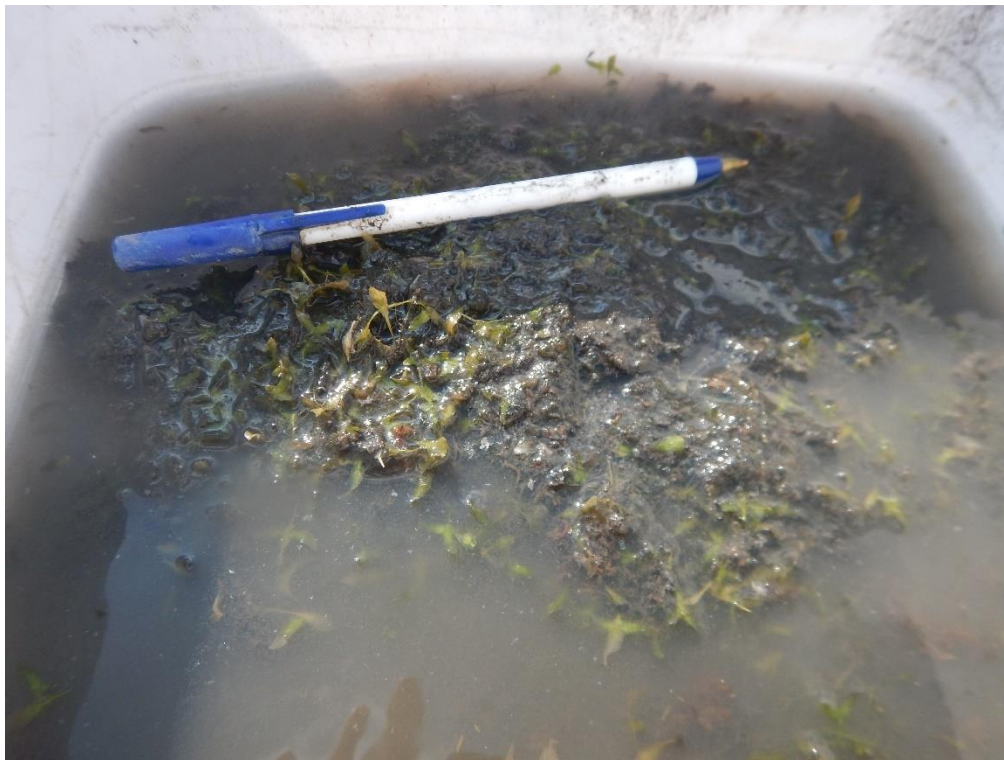
Photo 16: Star duckweed located within the sampling area on the north shore of Gull Lake (MS6) in 2023.

Aquatic plants were observed at six sampling sites, ranging in depth from 0.3–1.0 m ([Table A1-6](#)). Two aquatic plant species were observed; Watermilfoil was present at all six sites, and Star duckweed ([Photo 16](#)) was present at one site.

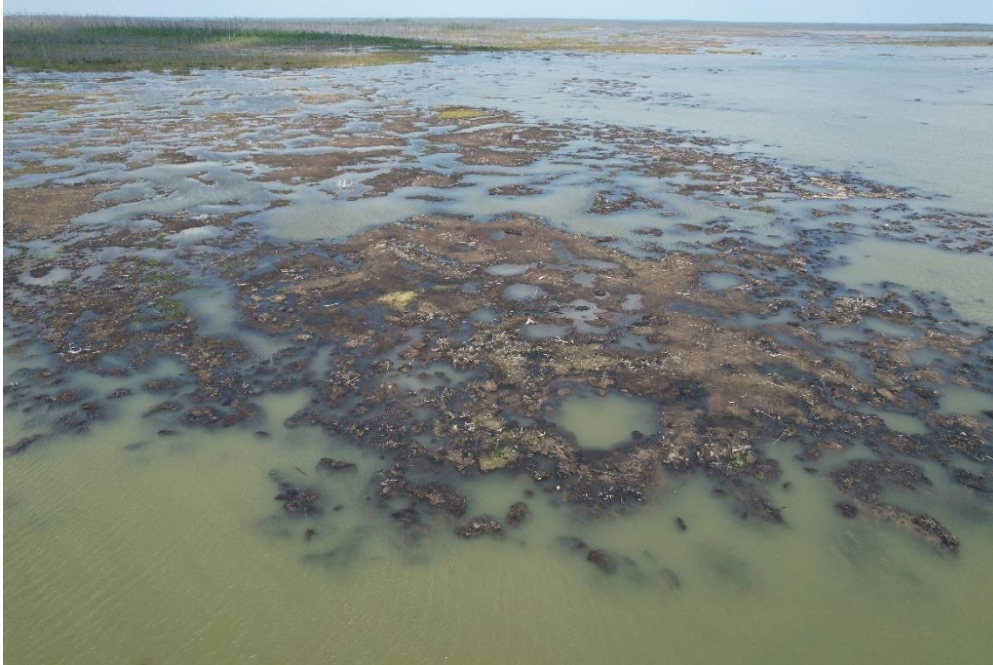
Photo 17: Peat and terrestrial debris observed on the north shore of Gull Lake (MS6) in 2023.

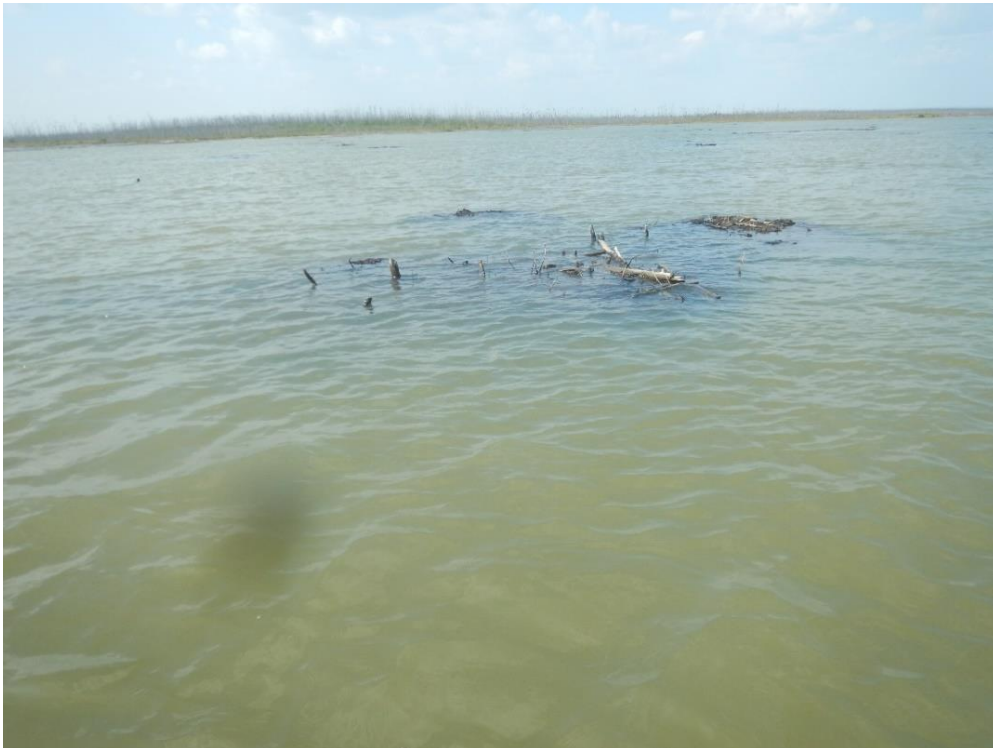
Photo 18: Rafted peat and terrestrial debris observed on the north shore of Gull Lake (MS6) in 2023.

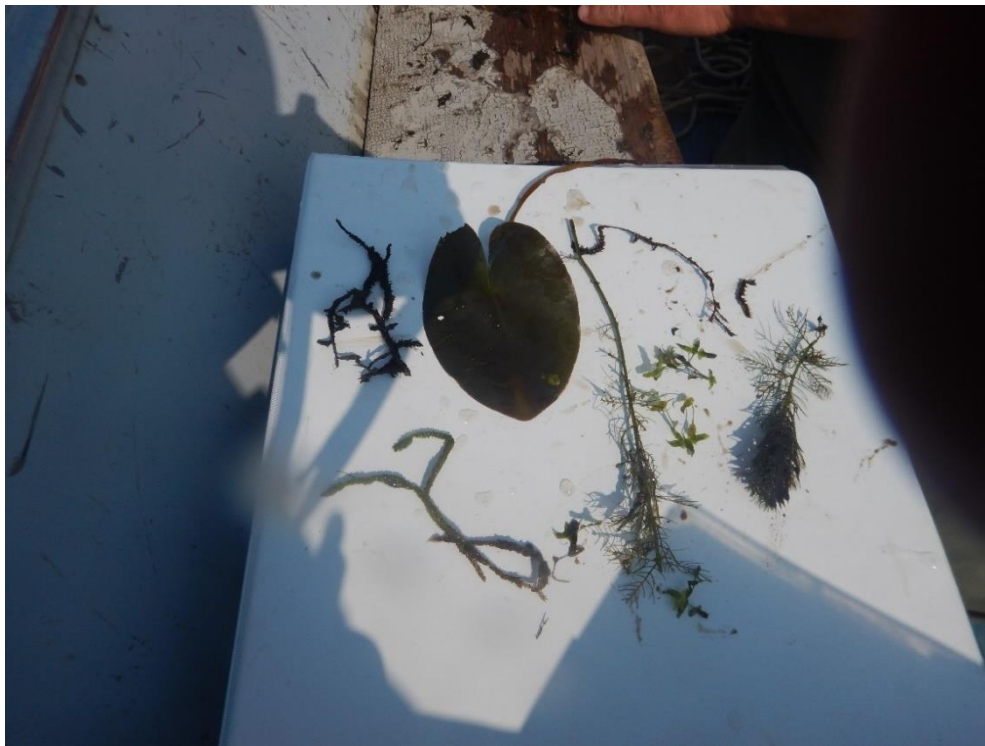
Photo 19: Aquatic plants collected from the Keeyask reservoir backbay Zone 7 (MS7) in 2023, including Lily species, Star duckweed, Watermilfoil, and Bryophytes (including terrestrial mosses and leafy liverworts).

Aquatic plants were observed at nine sampling sites, which ranged in depth from 0.2–1.8 m ([Table A1-7](#)). Eight aquatic plant species were identified, the most common of which was Watermilfoil. Bladderwort, Star duckweed, and Lily species (*Nuphar* spp.) were present at multiple sites but in small numbers. Sedges (*Carex* spp.), Water arum (*Calla palustris*), Bryophytes (terrestrial mosses), and water nymph (*Najas* spp.) were also observed ([Photo 19](#)).

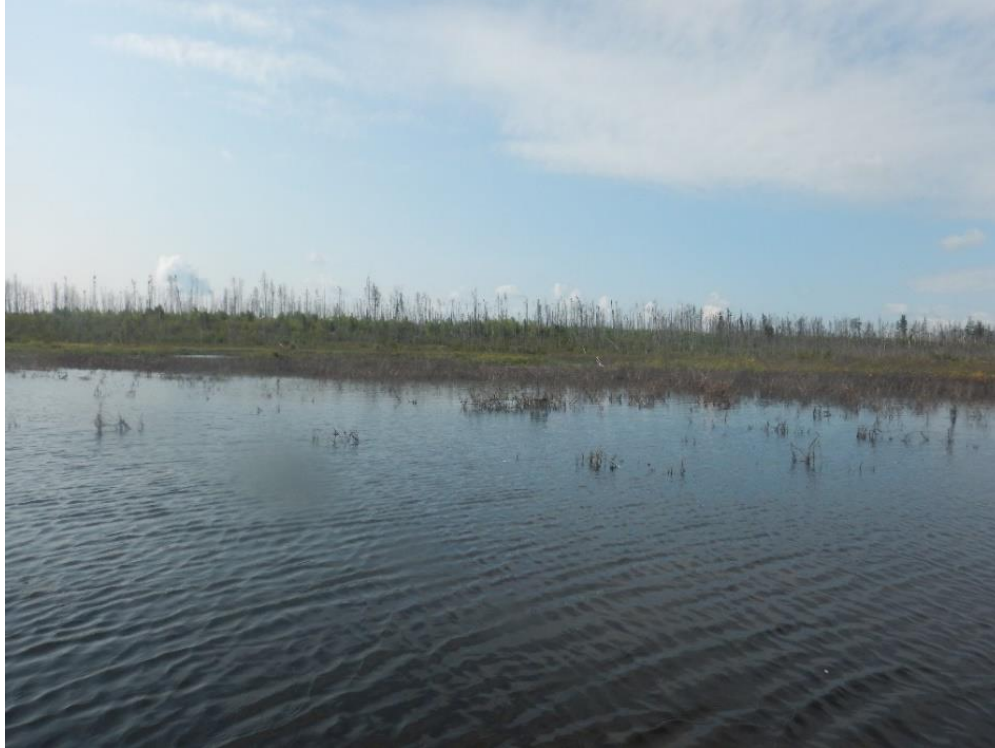
Photo 20: Flooded terrestrial vegetation observed in the Keeyask reservoir backbay Zone 7 (MS7) in 2023.

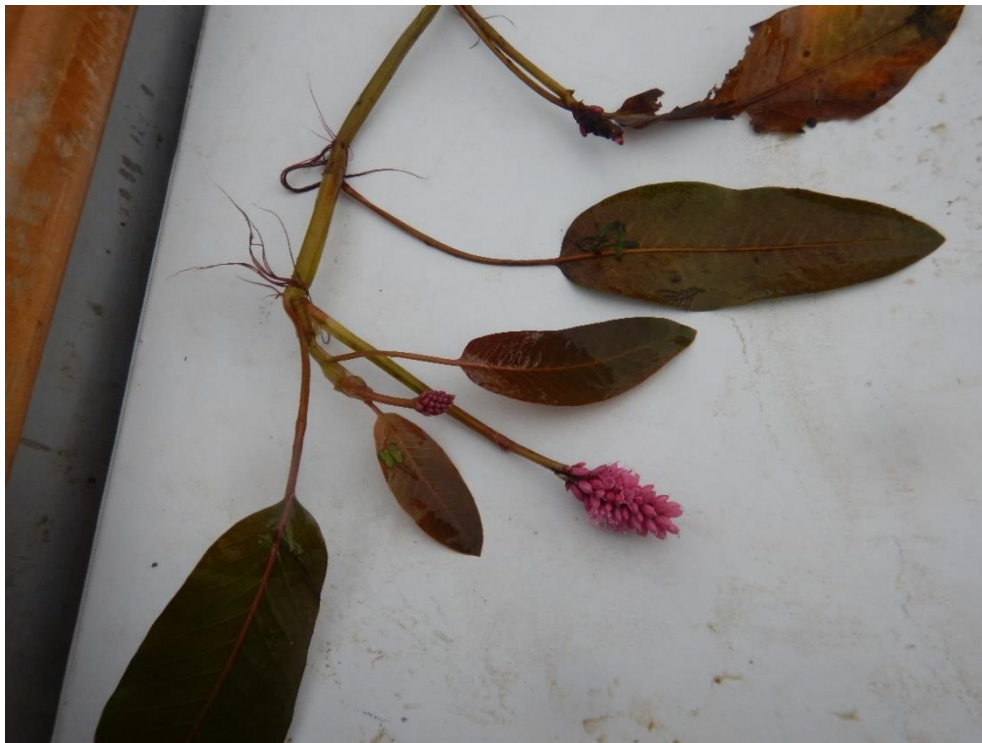
Photo 21: Water knotweed collected from the Keeyask reservoir backbay Zone 8 (MS8) in 2023.

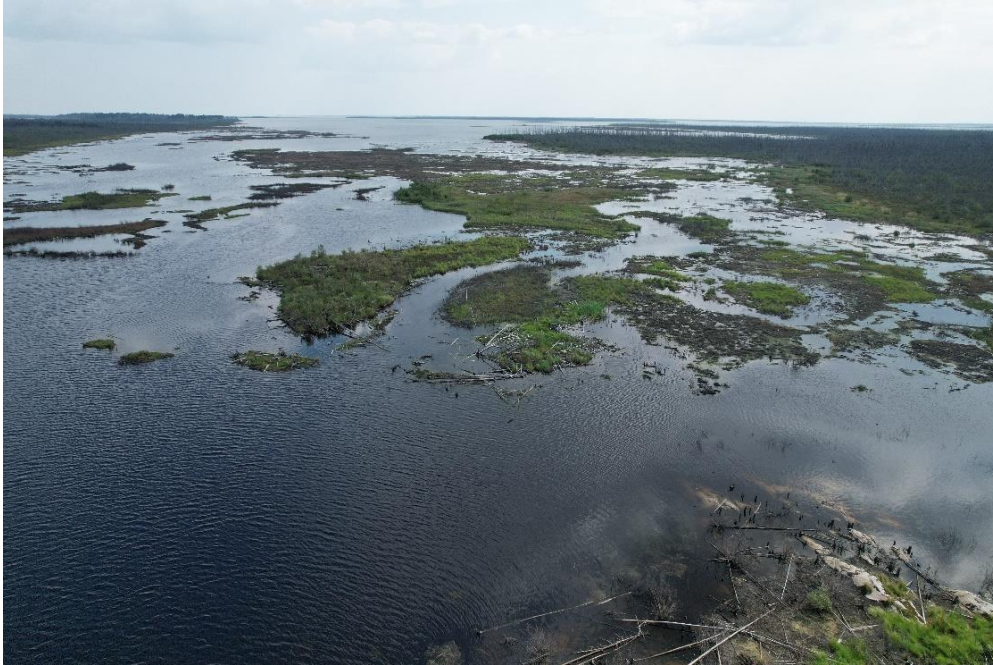
Photo 22: Flooded terrestrial habitat within the Keeyask reservoir backbay Zone 8 (MS8) in 2023.

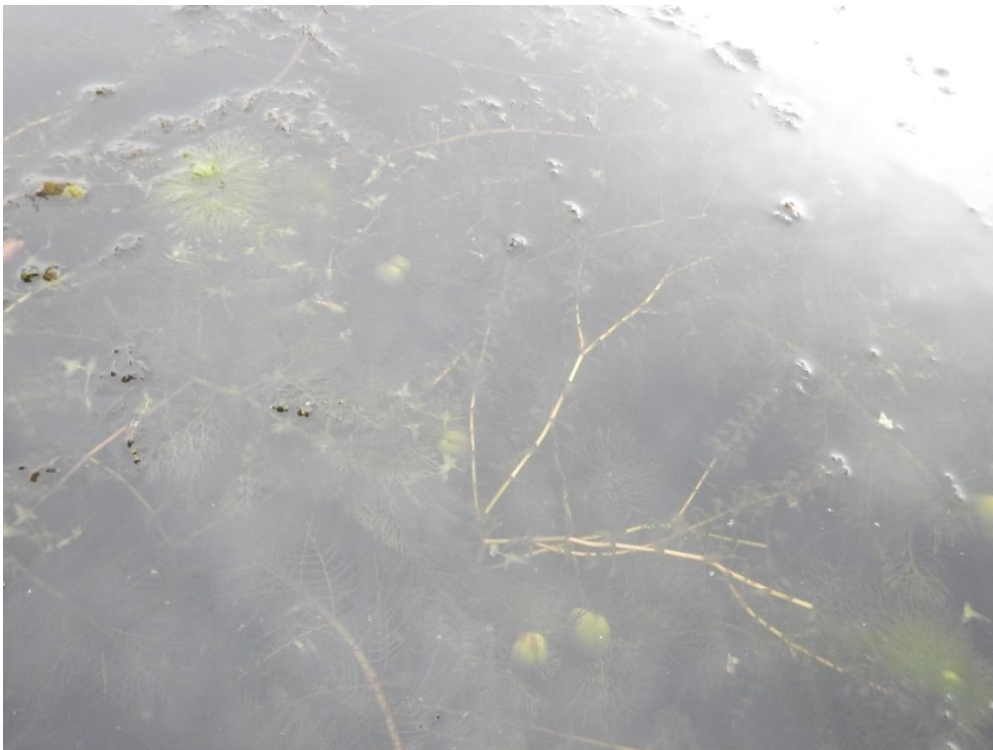
Photo 23: Aquatic macrophyte beds observed in the Keeyask reservoir backbay Zone 8 (MS8) in 2023.

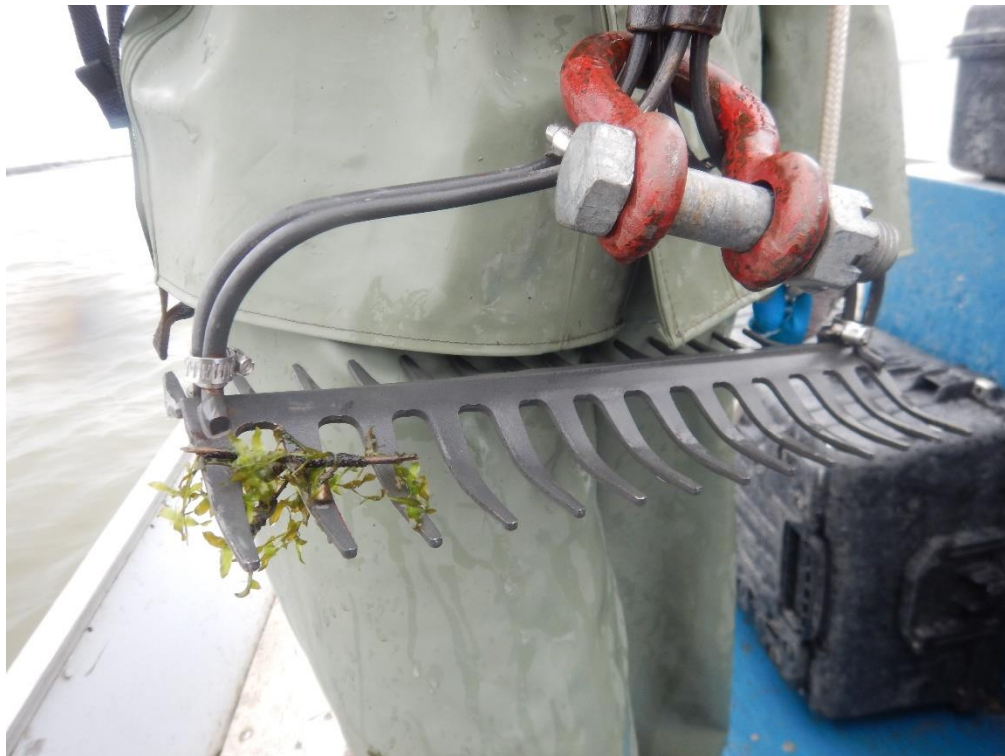
Photo 24: Small amounts of Star duckweed collected from the Keeyask reservoir in lower Gull Lake (MS9) in 2023.

Star duckweed was the only aquatic plant species observed and was present only at a single site ([Table A1-9](#); [Photo 24](#)).

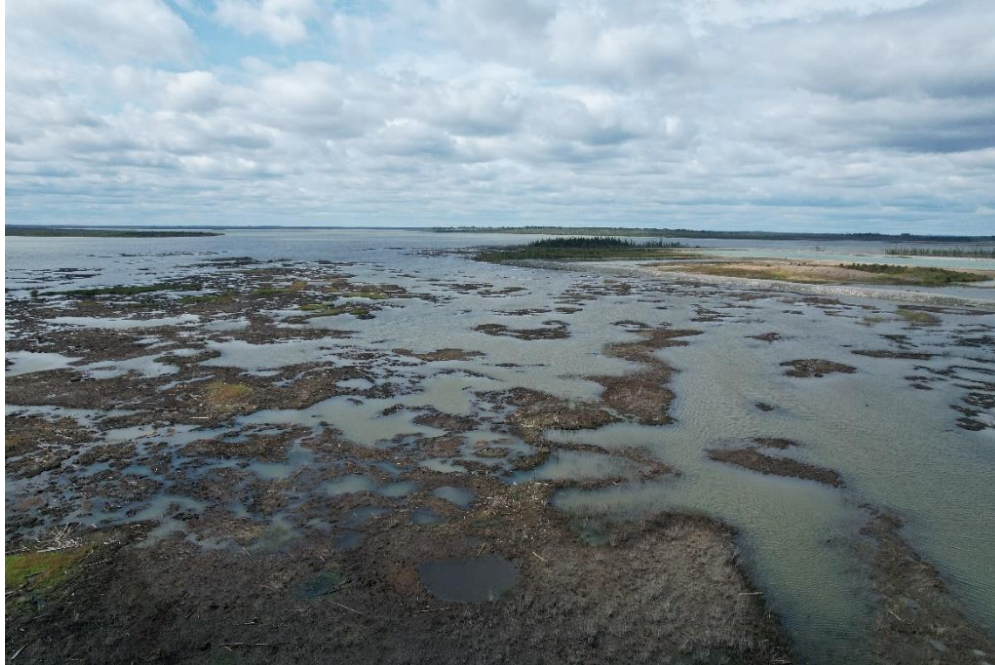
Photo 25: Large amounts of flooded terrestrial habitat including peat in the Keeyask reservoir in lower Gull Lake (MS9) in 2023.

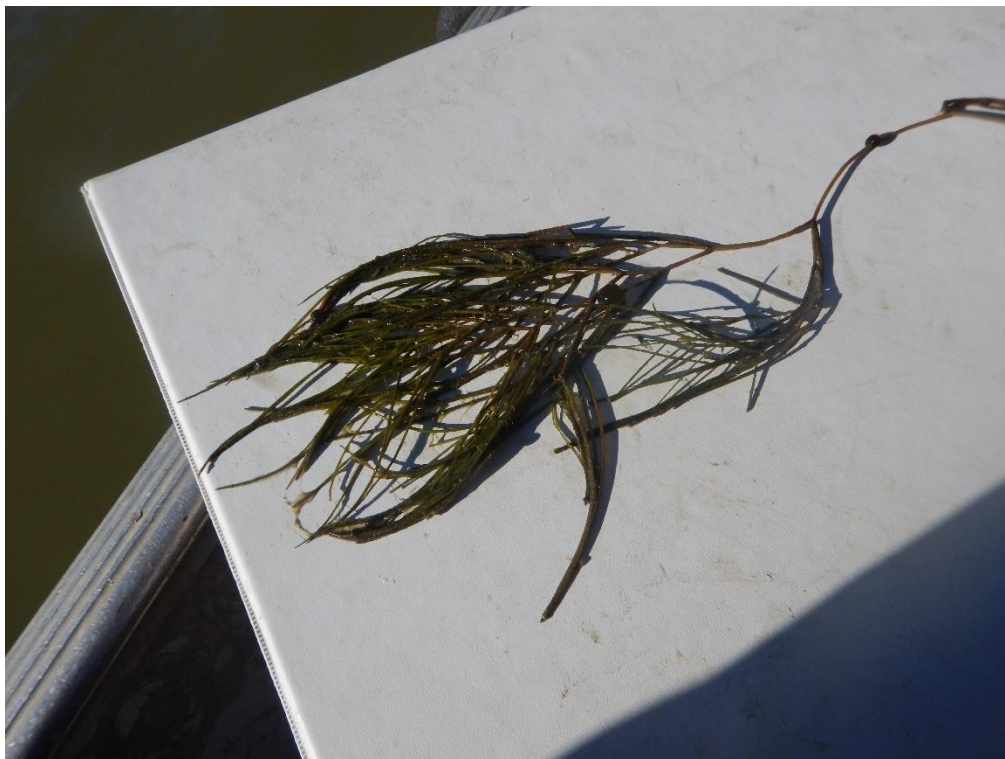
Photo 26: Sago pondweed collected from Stephens Lake (MS10) in 2023.

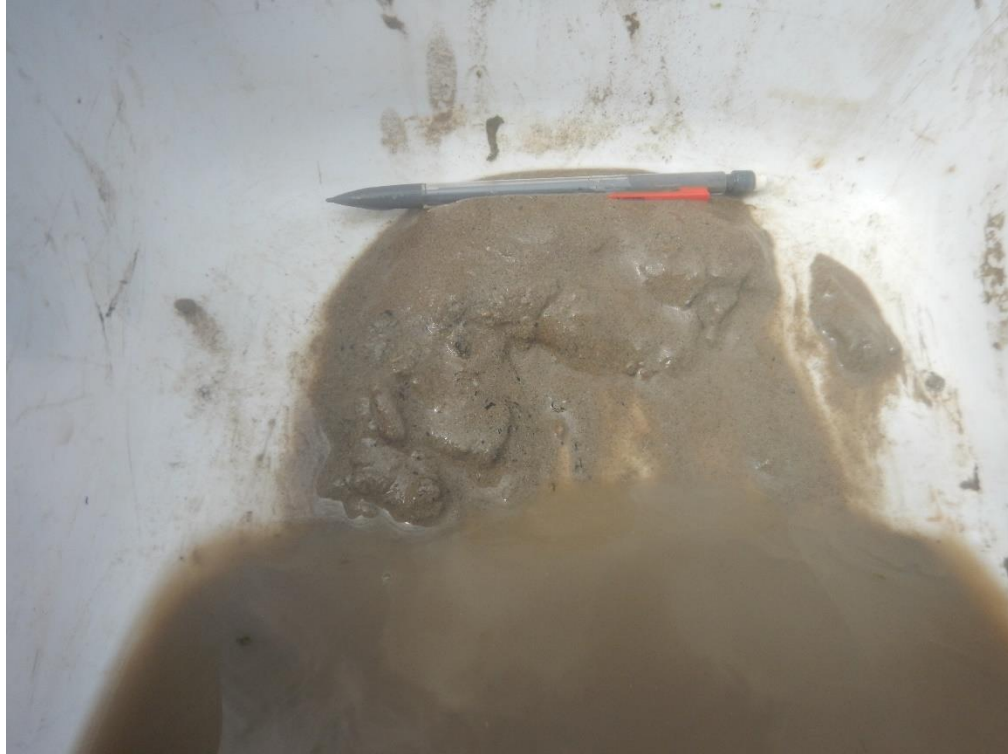
Photo 27: Substrate collected in Stephens Lake (MS10), showing sand substrate.

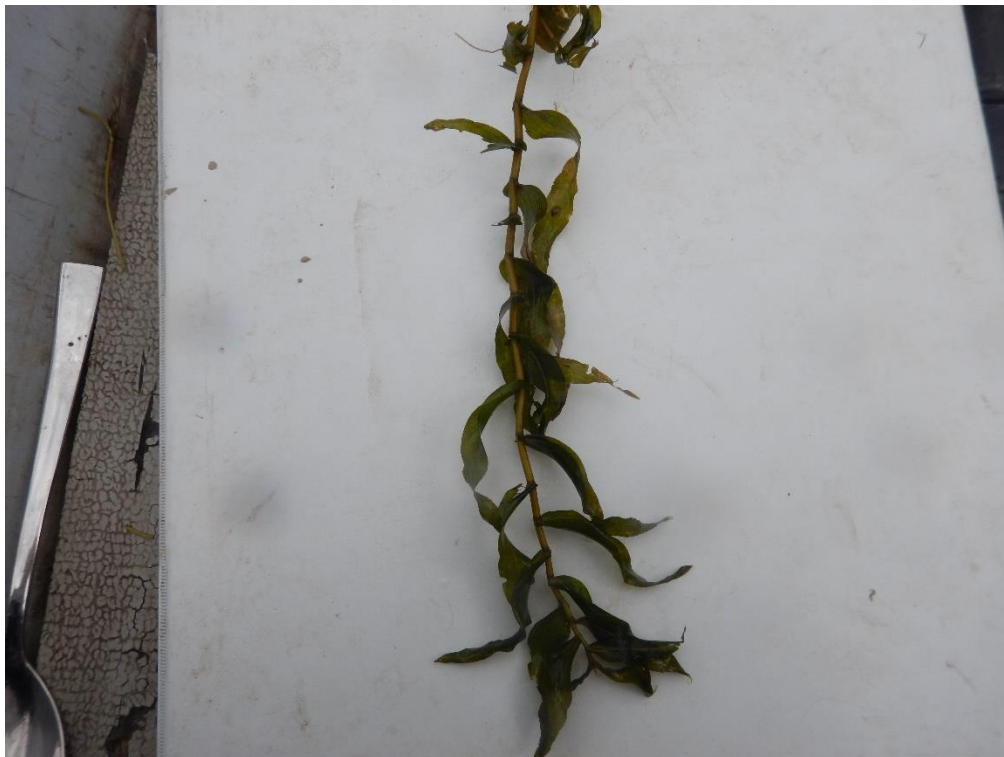
Photo 28: Richardson pondweed collected from Stephens Lake (MS11) in 2023.

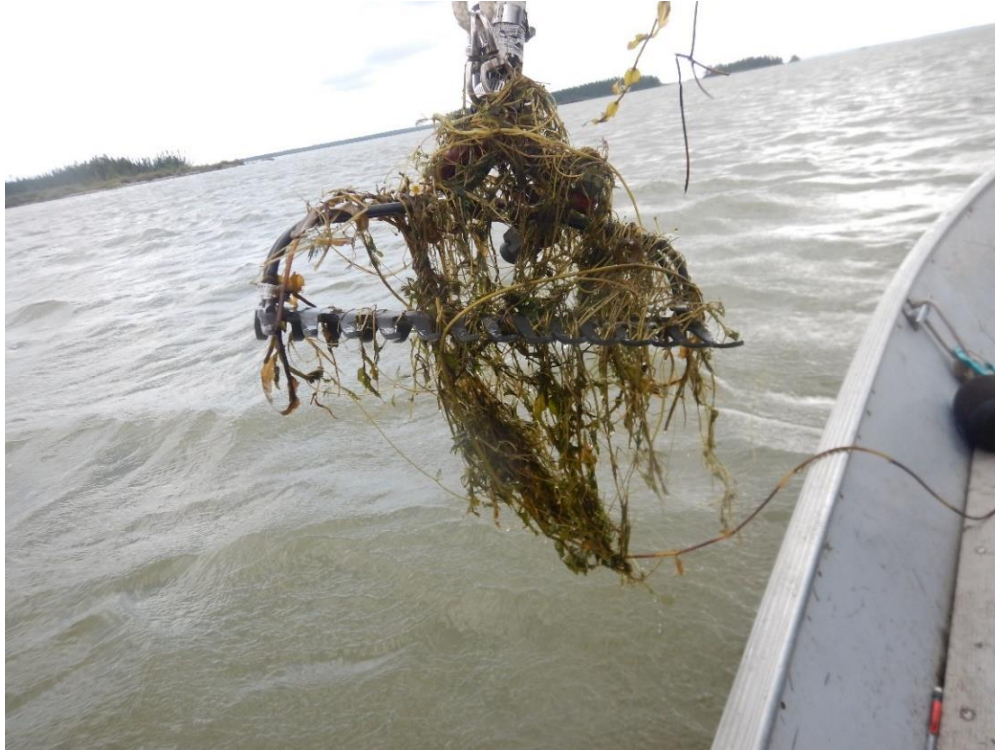
Photo 29: Aquatic plants collected in Stephens Lake (MS11) in 2023.
