Keeyask Generation Project Aquatic Effects Monitoring Plan

Development of Nearshore and Aquatic Macrophyte Habitat Report

AEMP-2024-13

DEVELOPMENT OF NEARSHORE AND AQUATIC MACROPHYTE HABITAT IN THE KEYYASK STUDY AREA, 2023

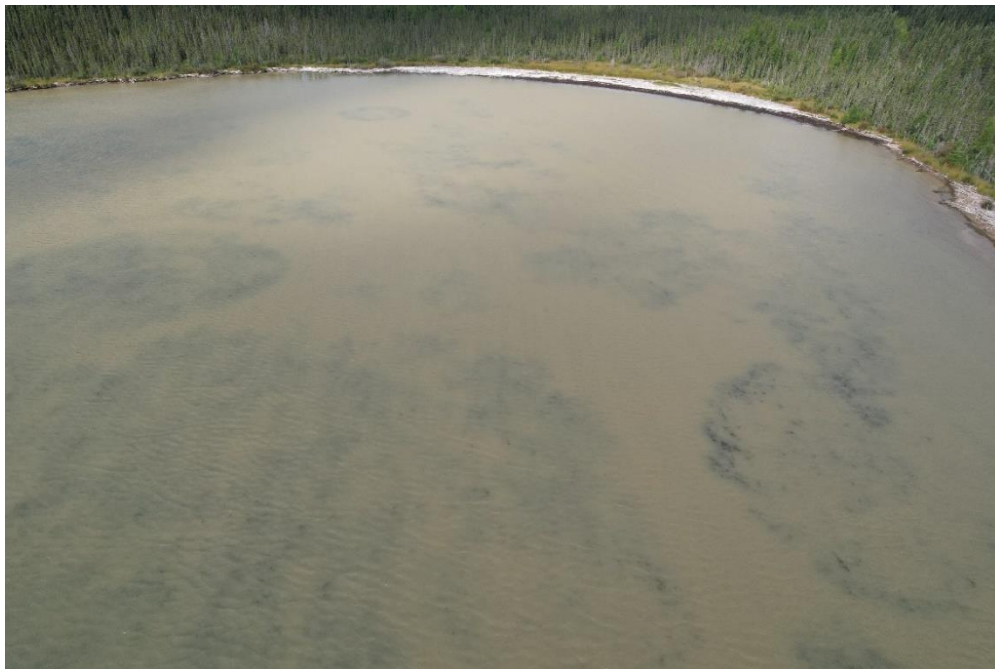
Photo 30: Aquatic plant beds seen at the water surface in Stephens Lake (MS11) in 2023.

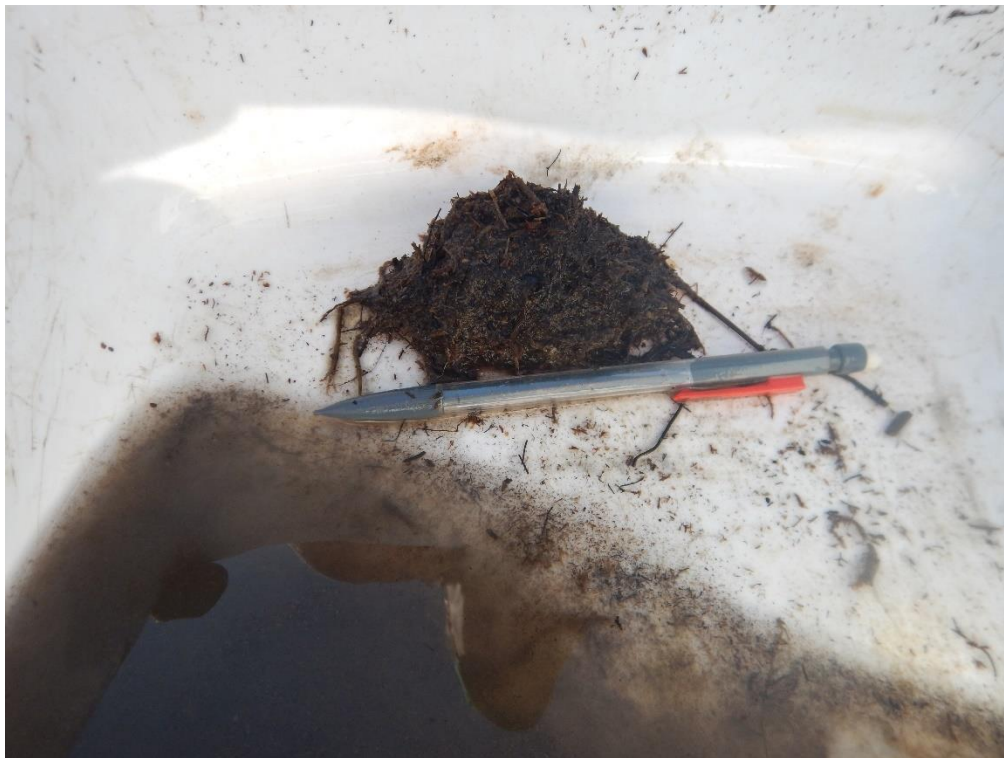
Photo 31: Organic sediment collected from Stephens Lake (MS12) in 2023.
