Keeyask Generation Project Fisheries Offsetting and Mitigation Plan

Spillway Fish Salvage Report

FOMP-2024-02

KEYYASK GS SPILLWAY FISH SALVAGE, 2023

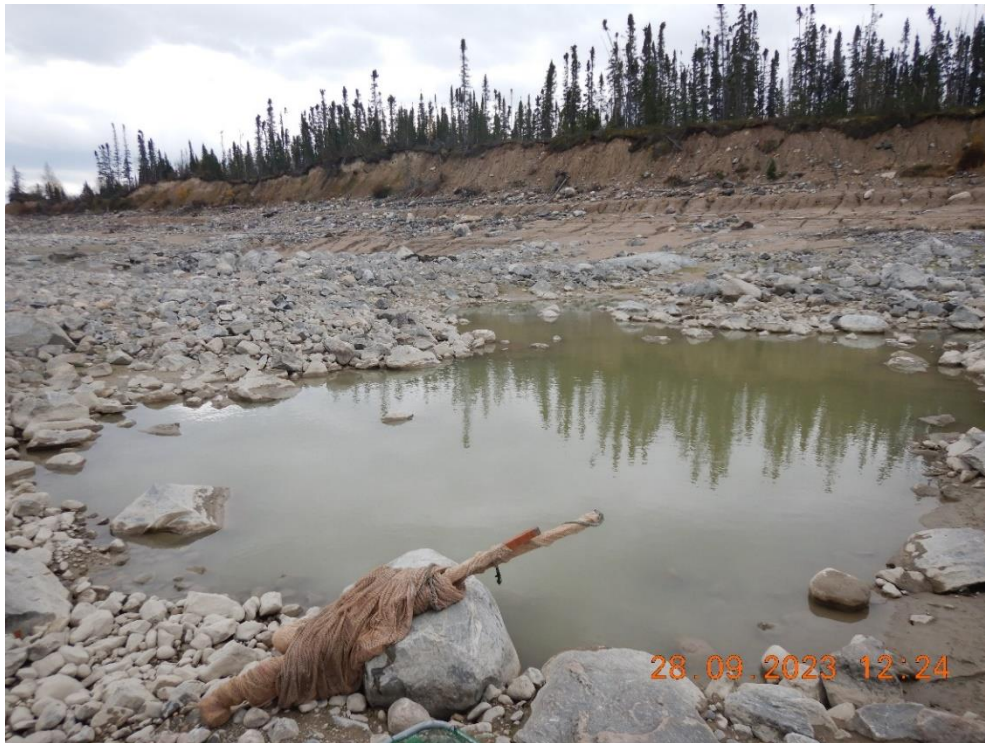
Photo 1. Small, isolated pool (pool 5) downstream of the Keeyask GS spillway where seine netting and backpack electrofishing was conducted to capture stranded fish, September 28, 2023.

Fishing was conducted within all nine isolated pools within the salvage area. Eight pools (numbers 1 and 3–9) were fished using a seine net, a backpack electrofisher, and dip nets ([Photo 1](#)). In total, 1,031 seconds of electrofishing effort and ten seine tows were conducted. Fish were captured in seven of the nine pools, with no fish captured in pools 8 or 9.

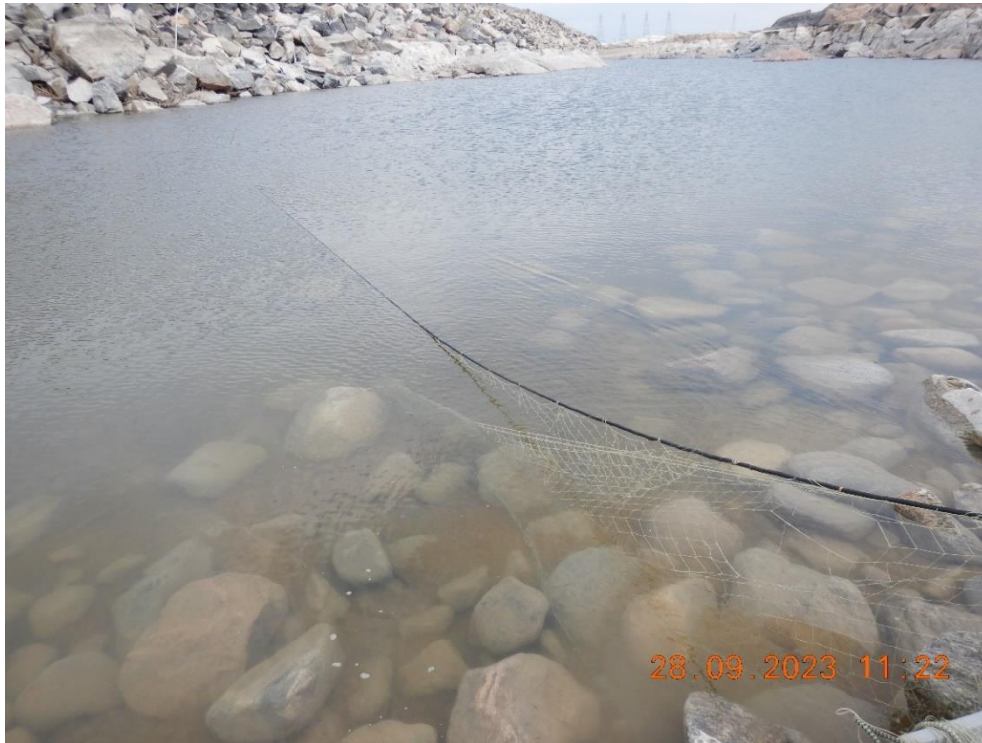
Photo 2. Gill net set in a large pool (Pool 2) downstream of the Keeyask GS spillway, September 28, 2023.

Access to a single larger pool (Pool 2) was limited based on its depth (>2 m), therefore a seine net was used to sample areas <1 m and a gill net was set along its length ([Photo 2](#)). The gill net was set twice for a total of six hours.
