Keeyask Generation Project Physical Environment Monitoring Plan

Physical Environment Monitoring Report

REPORT #PEMP-2024-01

2023-2024 PHYSICAL ENVIRONMENT MONITORING REPORT: YEAR 3 OPERATION

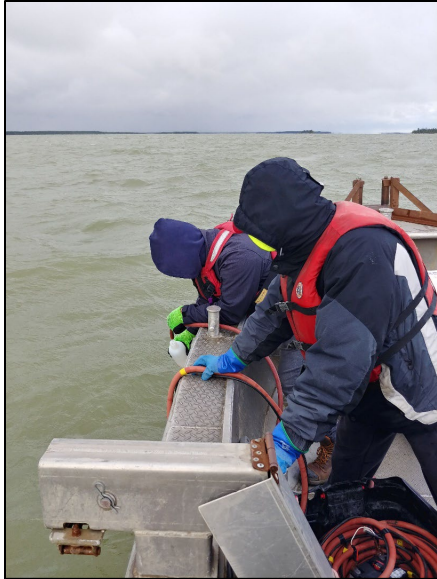
Collecting Water Samples for Sedimentation Monitoring

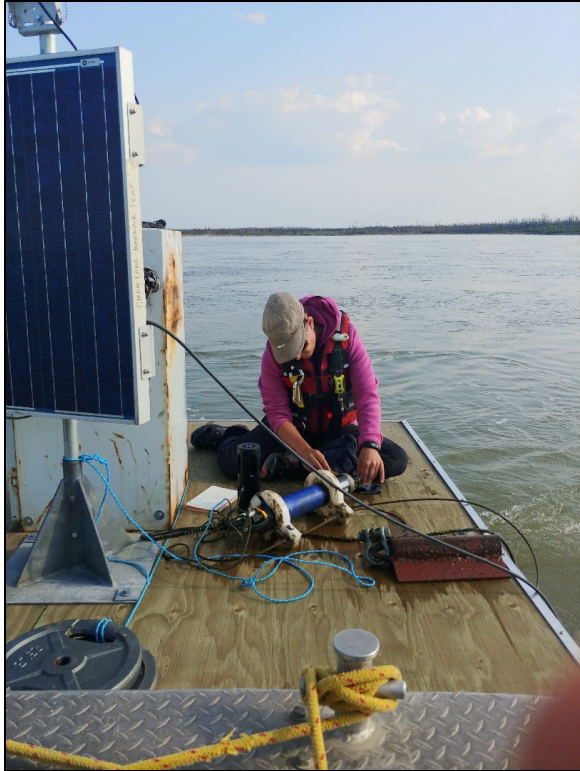
Continuous Turbidity Monitoring Equipment – Setting Up a Turbidity Sensor

The continuous turbidity monitoring stations consist of either a catamaran equipped for satellite data transmission (Photo 4) or a stand-alone buoy system requiring manual downloading of data. Both systems were equipped with a YSI multi-parameter sonde (EXO series) suspended two metres below the surface of the water.

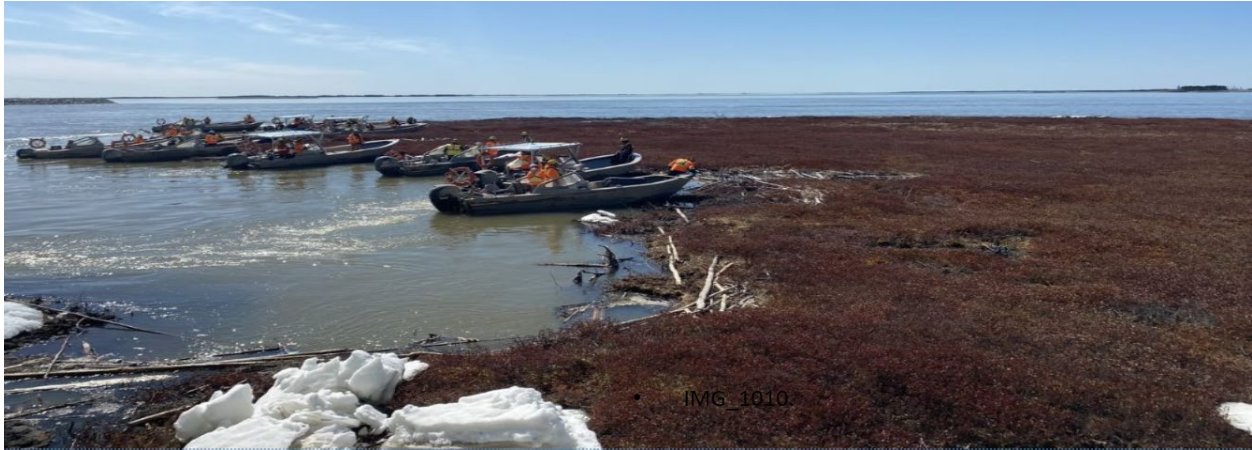
Woody Debris Adjacent to the South Dike

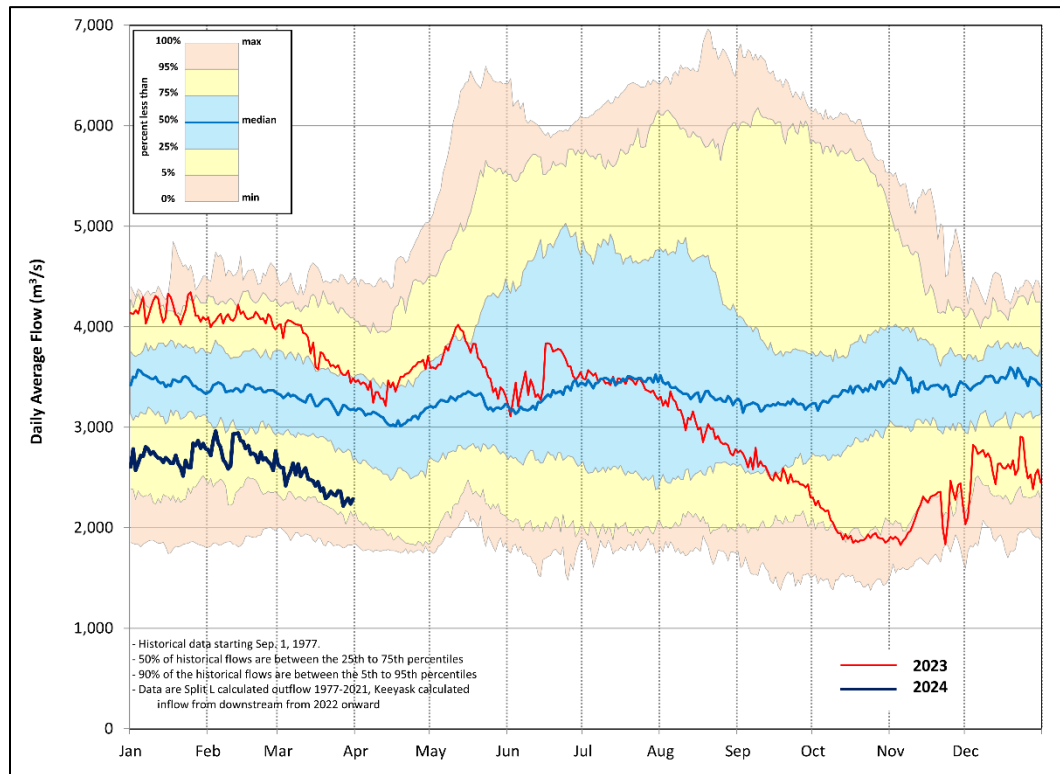
Figure 1: 2023/2024 Keeyask Daily Average Inflow and Historical Statistics

The seasonal mean daily discharge of 4,048 m³/s during the 2022/23 winter season (Table 1) is above average, resulting from persistence of high system flows from summer 2022. Flow declined in spring 2023 but was still above average from April to June (Figure 1). With dry conditions in the basin, the flow steadily decreased from about median in July to below the 5th percentile by November when it reached a minimum of about 1,851 m³/s. The summer mean flow of about 3,032 m³/s was below the long-term average of about 3,300 m³/s. Where summer 2022 was very wet (Manitoba Hydro 2023), summer 2023 trended toward very dry conditions. The low flows persisted into winter 2023/24, varying between the 5th and 25th percentile levels, higher than the low flow of about 1,827 m³/s at the start of the season in November.

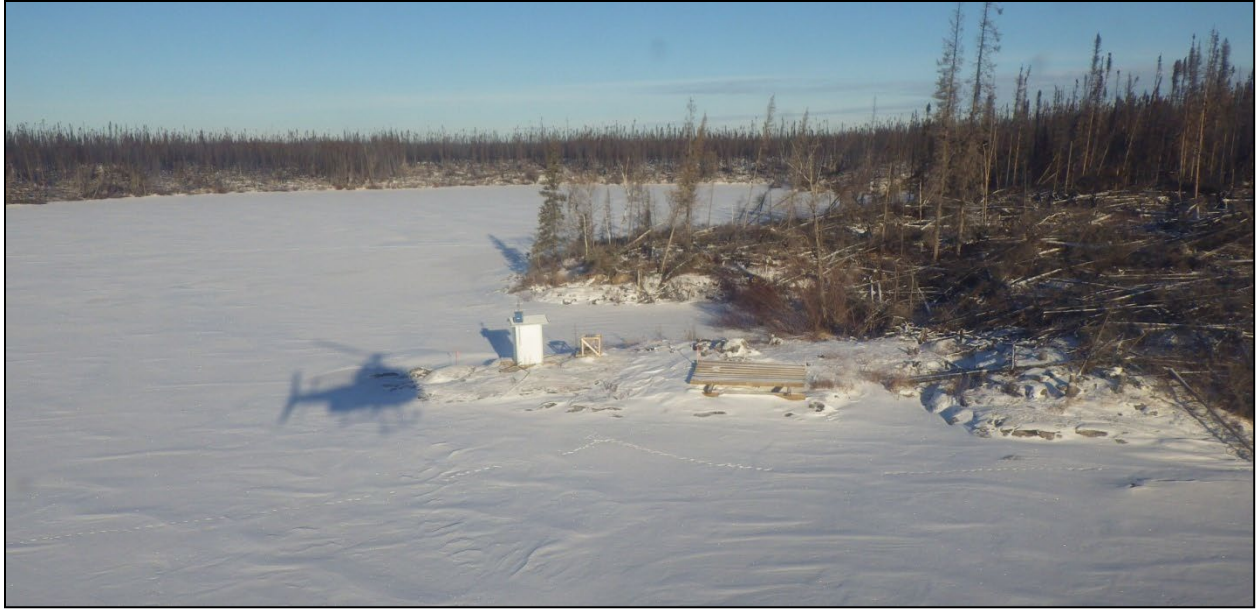
Photo 1: Water level gauging station in winter

Water levels are monitored at six sites from Clark Lake to Gull Rapids (Table 2, Map 2). A typical water level gauge is shown in Photo 1. The two Clark Lake sites have been monitored regularly since 2003, while the Gull Lake gauge was installed at the start of construction in mid July 2014. The other three sites were installed after construction started, once the necessary permits and heritage surveys were complete, which were applied for and done after the Environment Act licence was received in early July 2014. The original gauge at the upstream end of Gull Lake (05UF749) was wrecked by ice and was discontinued in May 2016. The gauge was relocated about 3 km upstream to the mouth of Portage Creek and began operation in September 2016 (site 05UF587). In addition to data from the PEMP gauges, data is reported from the existing gauge on Split Lake at the community of Split Lake.

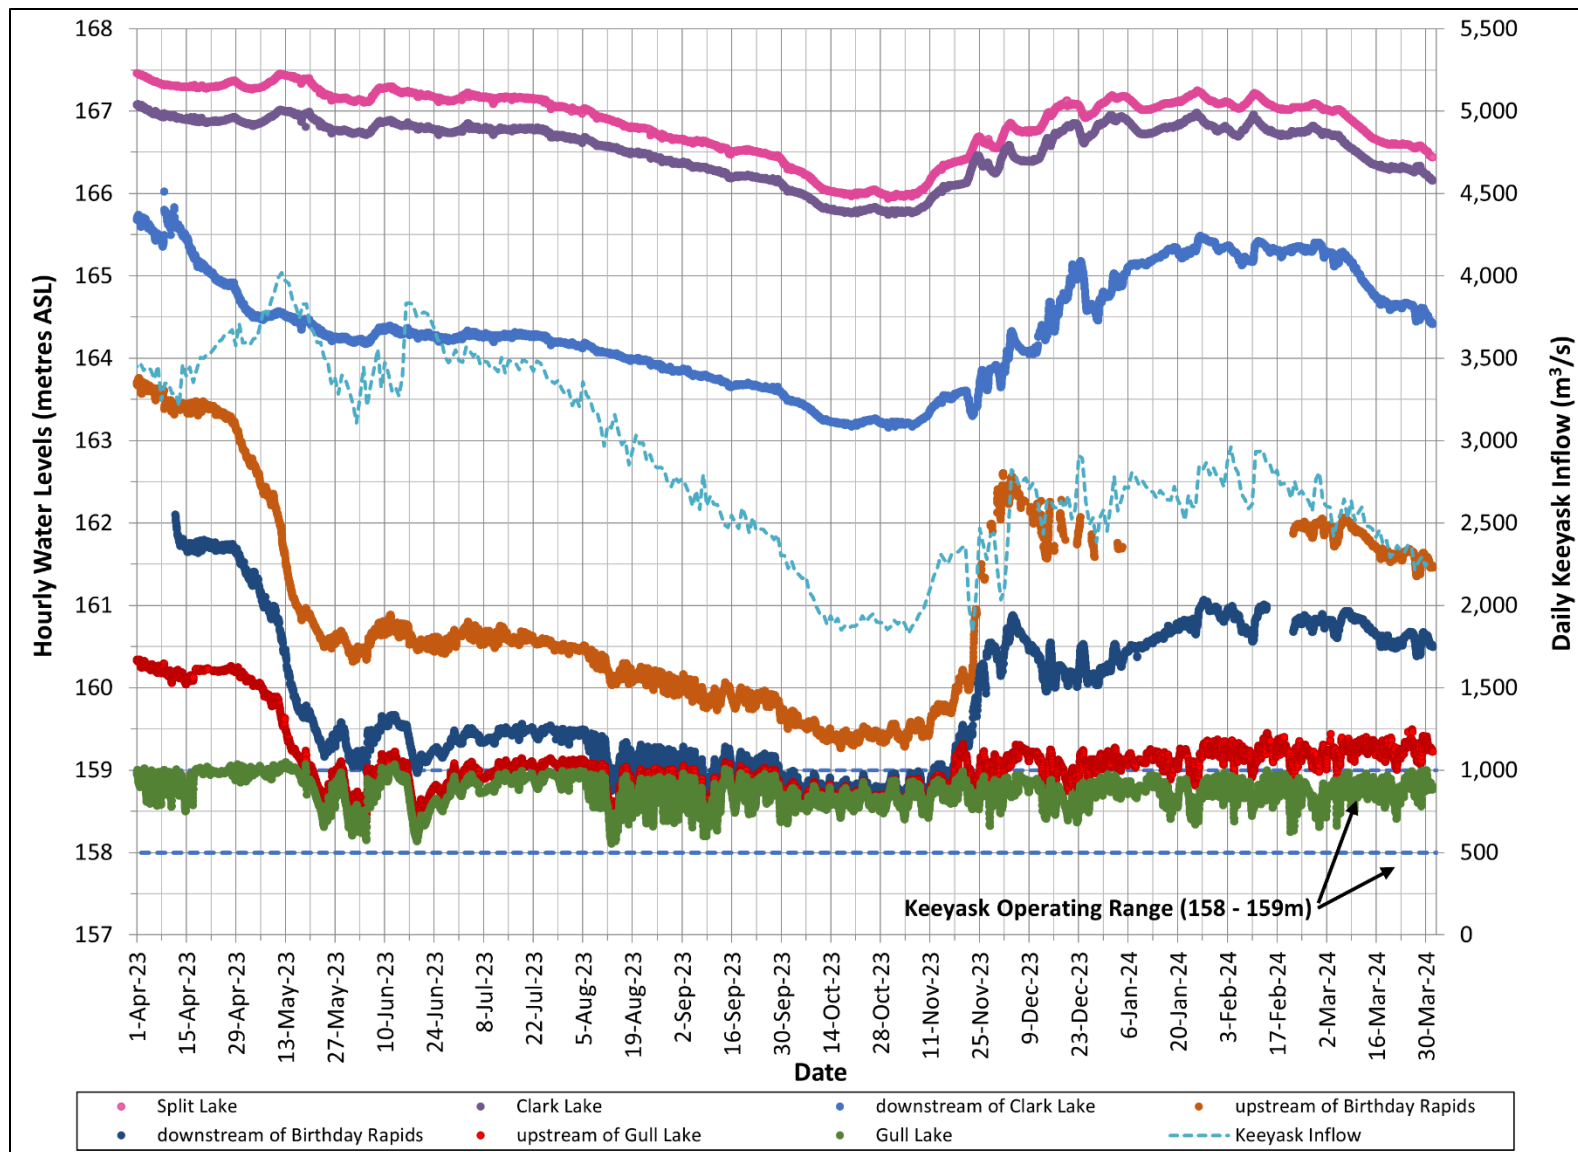
Figure 3: Observed water levels at PEMP monitoring sites in 2023/2024

In the late winter and spring of 2023 water levels were influenced by river ice. Even as flows increased, the levels generally decreased until the latter part of May as ice effects diminished (Figure 3). Water levels gradually declined over the summer in conjunction with the corresponding decrease in flows up to the beginning of November. Due to low flow conditions, the water level difference between the Keeyask dam and the foot of Birthday Rapids about 33 km upstream was only about 0.6 m at the start of summer and the decreased to about 0.1 m by November. Starting in early August, the Keeyask reservoir levels varied daily as the system operated in a peaking mode of operation where levels were drawn down during the day when more flow was passed through the powerhouse and were raised at night when less flow was passed.

The water levels on Clark and Split lakes show the same pattern of variation due to flow and ice effects, differing by about 0.4 m in April 2023 under ice affected conditions (Figure 3). In summer, the difference between the two lakes decreased as flows declined, so that by November Split Lake was only about 0.2 m higher than Clark Lake and then through winter the difference increased to about 0.3 m.

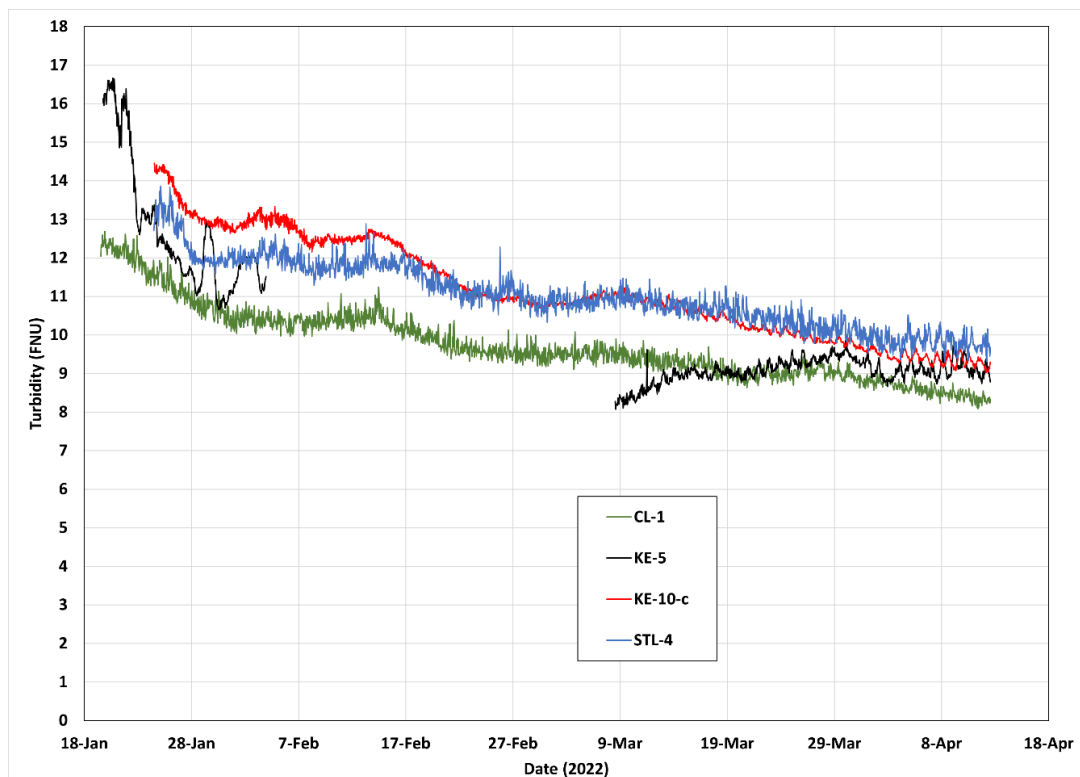
Figure 15: 2022-2023 winter continuous TU

Turbidity levels at the Clark Lake site (CL-1) were generally 1-2 FNU lower than the sites KE-10-c and STL-4 just upstream and downstream of the Keeyask dam (Figure 15). Each site started out higher in January at about 12-14 FNU and gradually declined over winter to 8-10 FNU. This is a typical turbidity pattern over winter with higher levels in January that gradually and steadily decline until the probes are removed in April. KE-10-c levels were about 1 FNU higher than STL-4 to start, but the two converged by mid February and were about the same after that. Turbidity at site KE-5 was high initially at about 16 FNU but then dropped to within the range of the other sites. There is a gap due to poor quality data, but the last month of data is near the level at other sites but rising somewhat from March to April. It is unclear why the pattern of turbidity at KE-5 is different than the other sites, but it may be related to ice conditions or high flows during the winter.

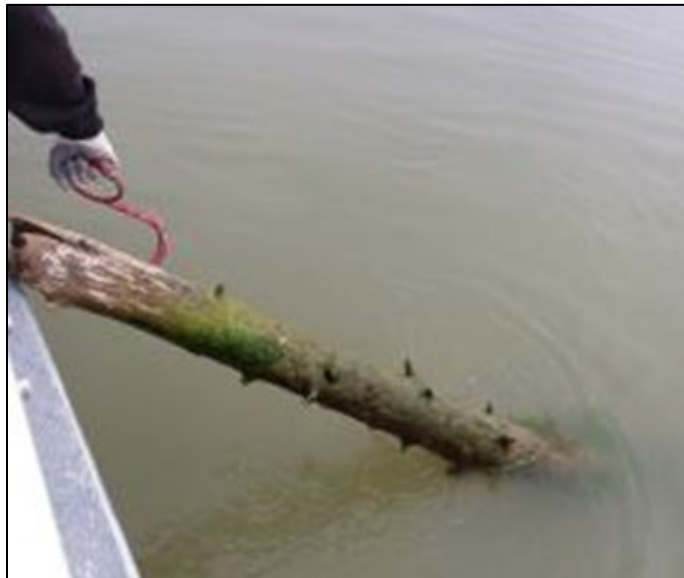
Photo 7: Large floating debris is removed from the water by the boat patrol team

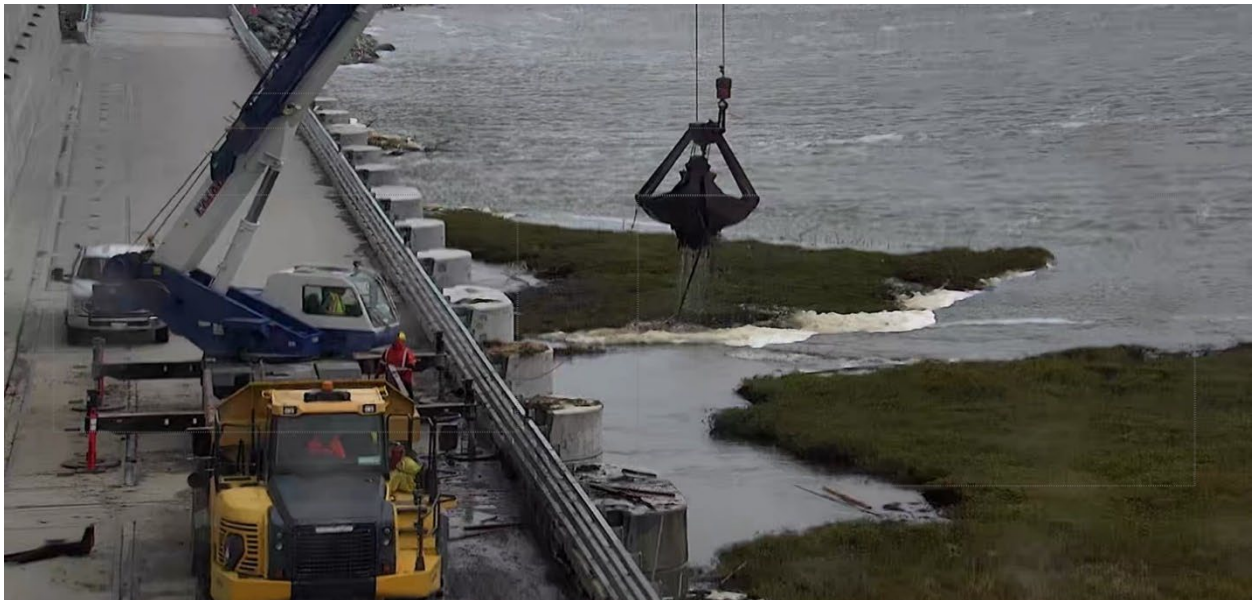
In addition to the woody debris, Keeyask also had to manage a peat island that floated up against the powerhouse in May. During ice breakup, a peat island that had existed since the reservoir was impounded in 2020 was pulled free and transported to the powerhouse. As the island began

to break apart it began to plug the trash racks in front of the dam, which resulted in a need to shut down the powerhouse for some time. Attempts to push the island away from the dam were unsuccessful so it was removed using a crane with a bucket to dig it out and to clean the trash racks, which affected powerhouse operation for more than a month.

Photo 9: Crane with clam shell bucket on powerhouse deck removing peat island
