Keeyask Generation Project Terrestrial Effects Monitoring Plan

Long-Term Effects on Habitat Monitoring Report

TEMP-2024-01

LONG-TERM EFFECTS ON INLAND HABITAT MONITORING YEAR 2 OPERATION 2023

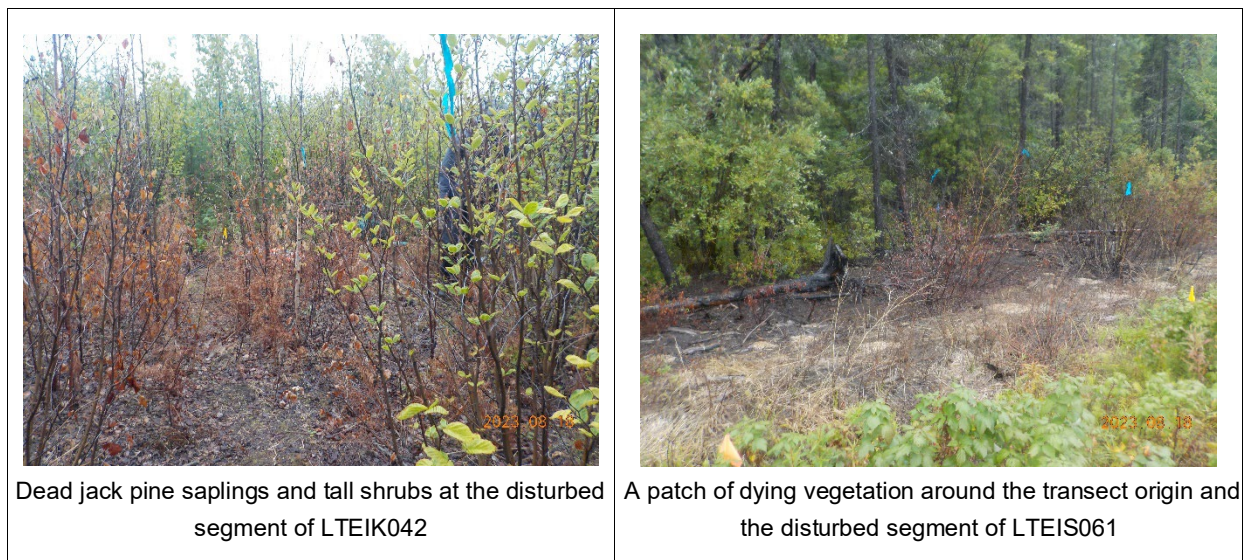
Figure 2-1: Locations surveyed in 2022 that were accidentally herbicided, as of August 18, 2023

During the 2023 surveys it was observed that portions of four of the transects established in 2022 at two stands were inadvertently sprayed with herbicide, which killed or damaged the vegetation it contacted (Figure 2-1). As a result, all four transects were re-established at different locations within the same stands in 2023. Transect origins were shifted to a new location approximately 30m away to leave a 10m buffer between the damaged vegetation and the outer edge of the environment belt. In the field, it was confirmed that the new transect locations maintained the criteria for separation and fell within the same stand as the original locations.

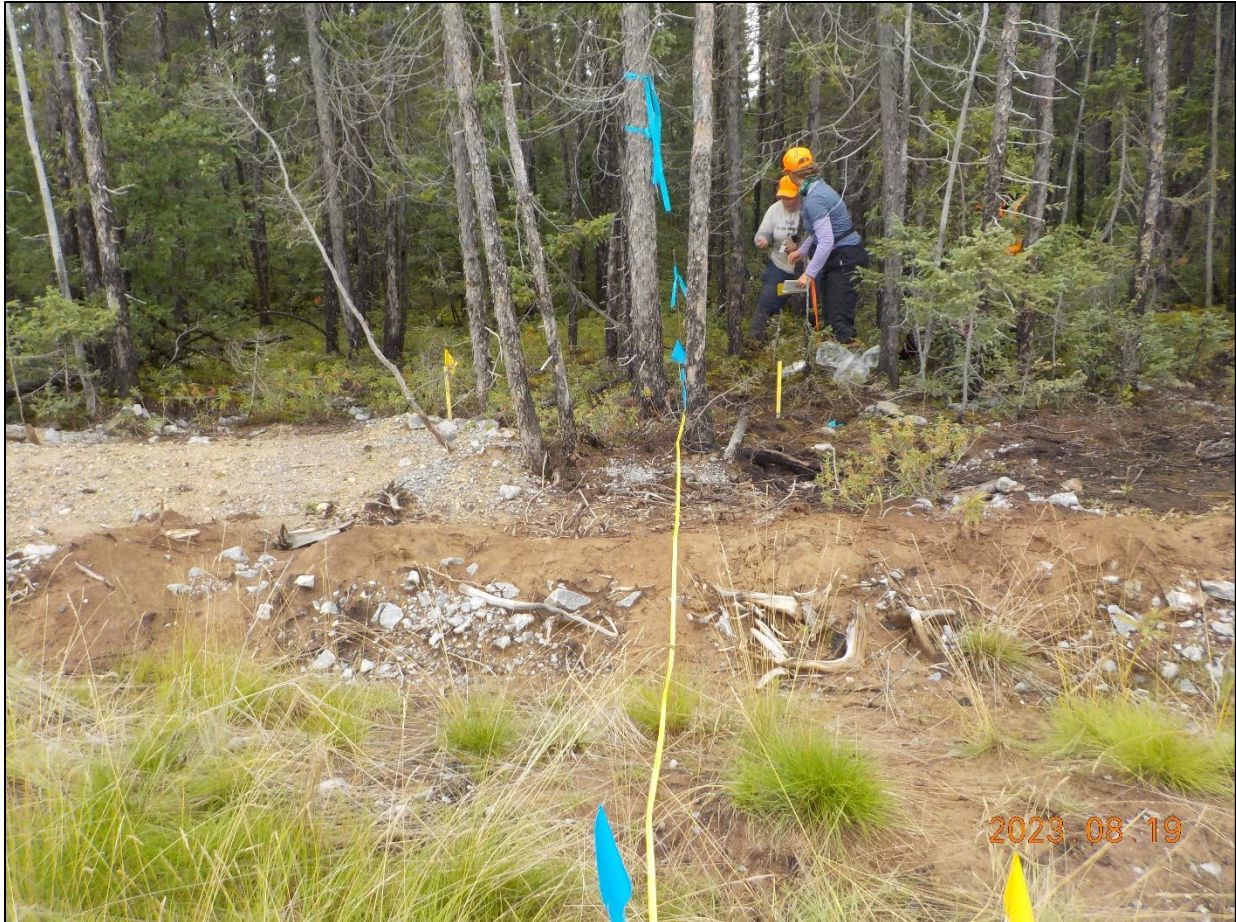
Photo 2-1: Belt transect setup showing a perpendicular view from disturbed to undisturbed segment of the transect at LTEIS064, on August 19, 2023

For the disturbed segment of the belt transect, the same attributes were recorded in the same way as for the undisturbed segment, except that the vegetation structure and environment belt was a 10 m X 5 m quadrat.

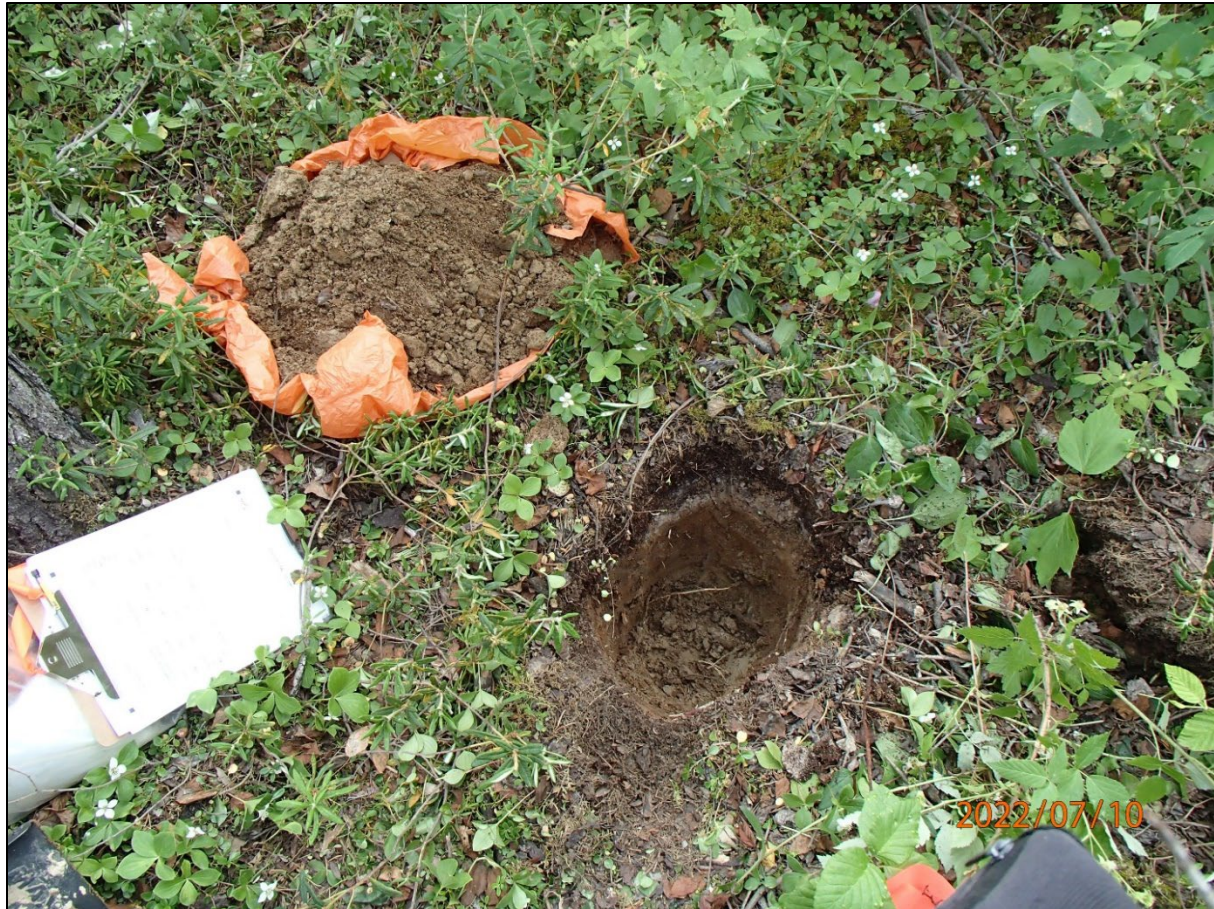
Photo 2-2: Full soil pit from Stand 4, Transect 2

The soil sampling method was intended to be sufficient, at a minimum, to detect moisture regime changes in the rooting zone. Soils were sampled in pits (Photo 2-2) and from soil cores obtained using a Dutch auger. The soil pits collected detailed soil information while the soil cores focused on moisture regime (Figure 2-4). Soil pits were dug at 1m and 10m. Soil cores was completed at 5m, 15m, 20m and 30m on the undisturbed segment of the transect, and at 1m and 5m on the disturbed segment.

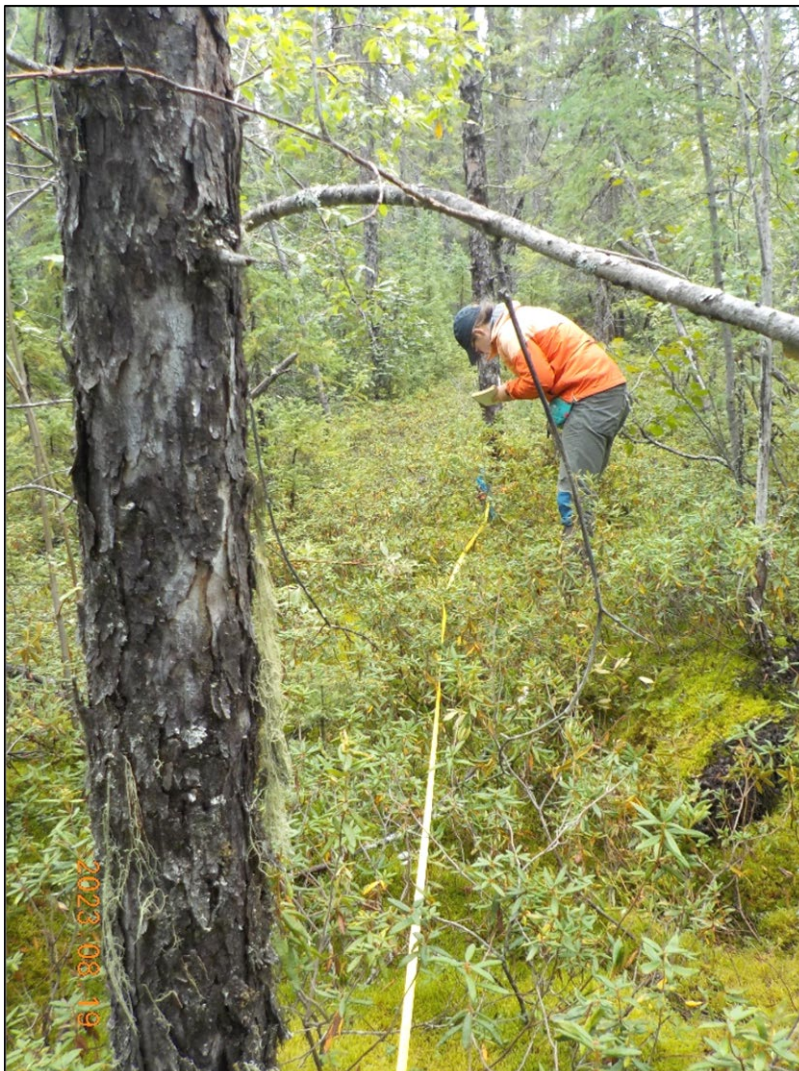
Photo 2-3: Recording plant species composition from low vegetation belt in undisturbed segment of the transect at LTEIS064, on August 19, 2023

Plants recorded in the belt transects were identified to species if it was a taxon for which this was generally feasible in the field and to a taxon otherwise (Photo 2-3). Trees were recorded as pseudospecies based on growth form (Section 2.3.1). In this report, the singular “taxon” and plural “taxa” are used to refer to species, broader taxa, and pseudospecies collectively.

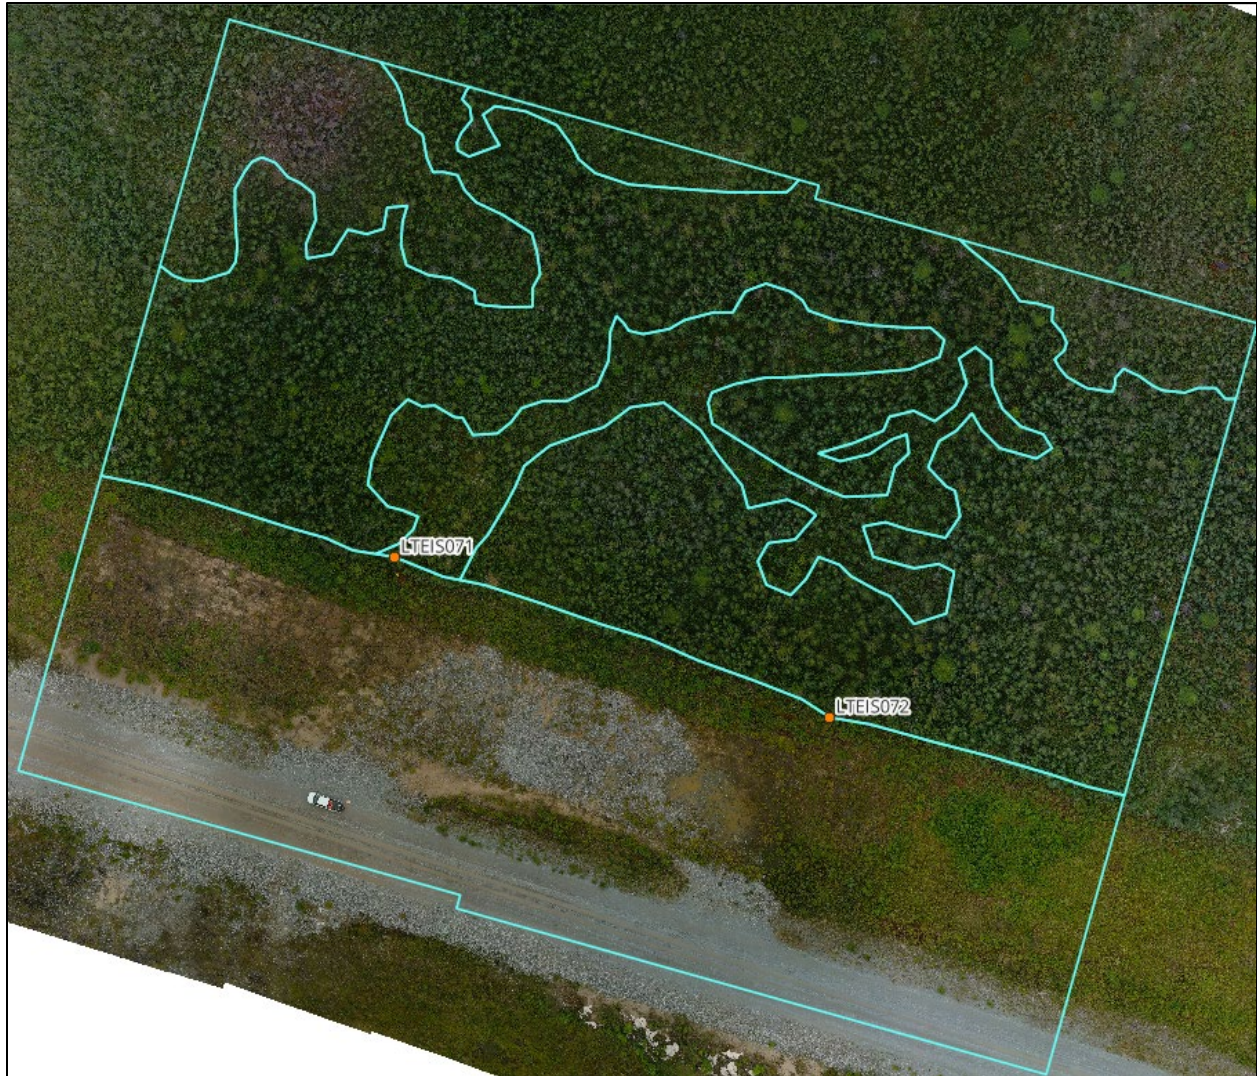
Figure 3-1: Example of DOI created for LTEIS07 (Stand 7, Transect 1 and 2) with interpreted fine-scale habitat polygons overlain. Blue outlined area is the 110m-wide band of habitat centred on the transect, with the undisturbed area subdivided by structure type and cover

The total area covered by the DOIs (Figure 3-1) for the five stands sampled in 2022 and 2023 was 20.2 ha (Table 3-1). The area covered for each stand ranged from 2.1 ha to 3.8 ha, depending on the distance between the two transects (separation less than 110 m resulted in overlap of the bands centred on each transect). The total area in undisturbed portions of the stands ranged from 1.2 ha to 2.2 ha (Table 3-1).

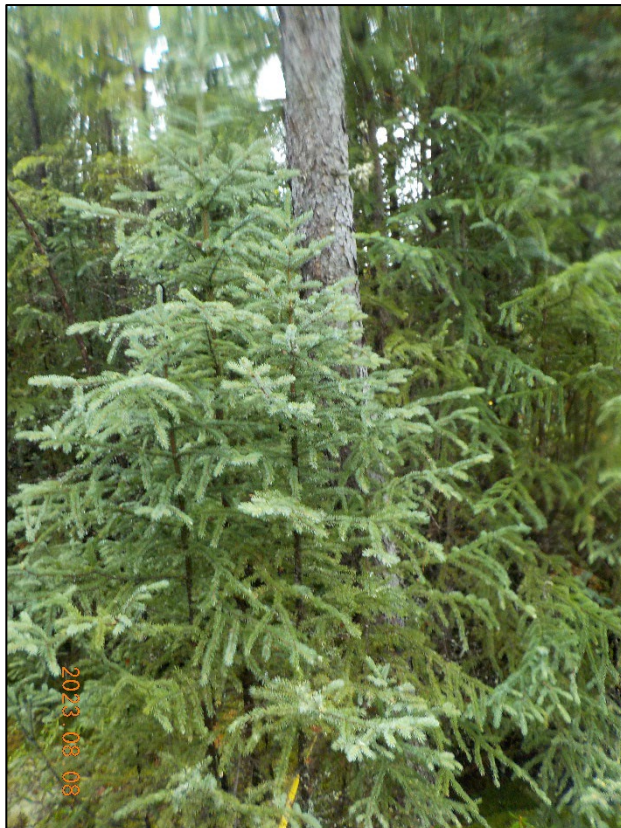
Photo 3-1: Black spruce trees growing along the undisturbed segment of the transect at LTEIS081 on August 8, 2023

Very widespread species included black spruce (Photo 3-1), Labrador-tea (*Rhododendron groenlandicum*) (Photo 3-2), prickly rose (Photo 3-3), bog cranberry (*Vaccinium vitis-idaea*), red-stemmed feather moss (*Pleurozium schreberi*) and stairstep moss (*Hylocomium splendens*). Black spruce, bog cranberry, red-stemmed feather moss and stairstep moss were found in all undisturbed segments. All the remaining very widespread taxa were found in the undisturbed segment of all but one of the locations.

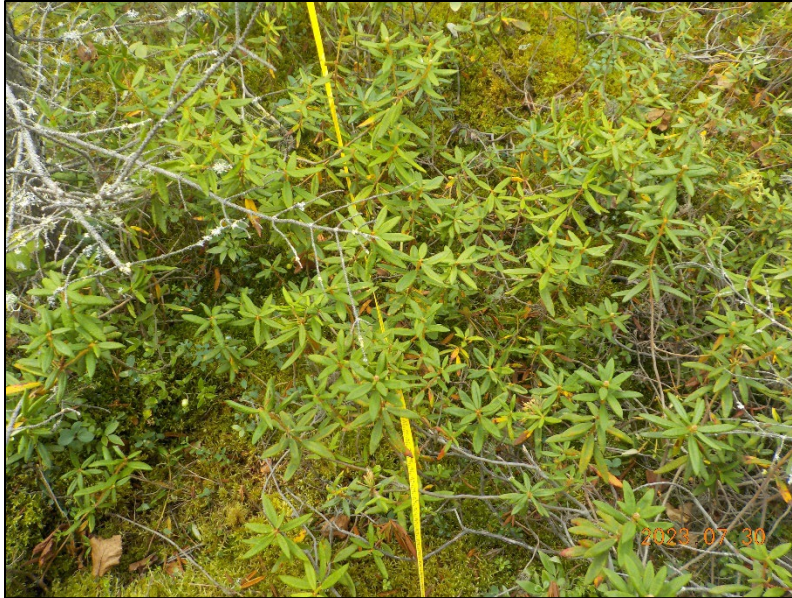
Photo 3-2: Labrador tea growing in the undisturbed segment at LTEIS072 on July 30, 2023

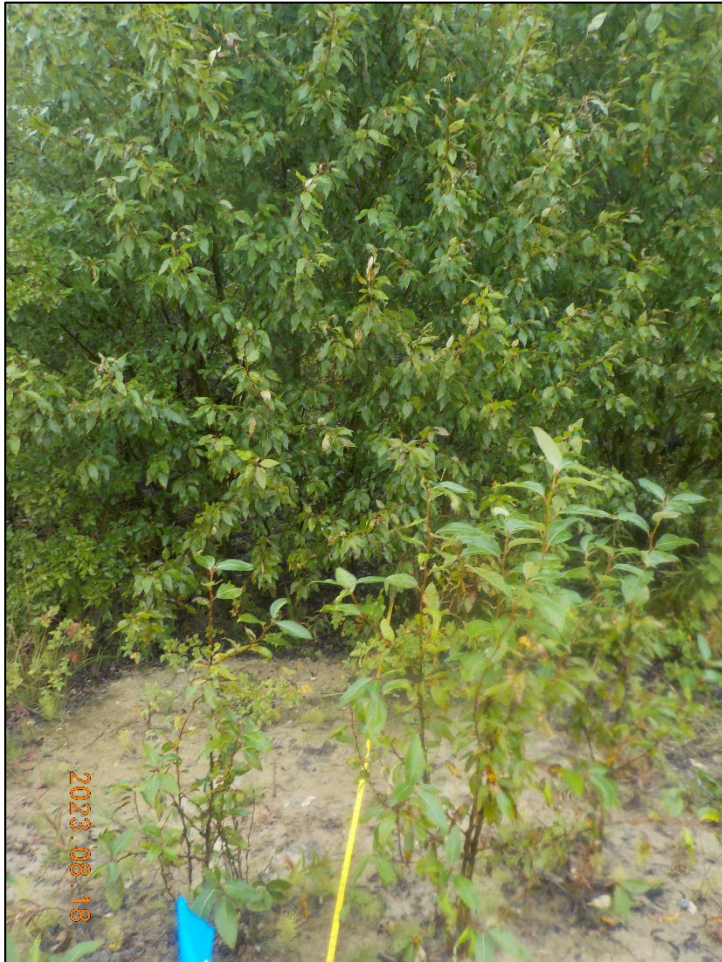
Photo 3-4: A healthy patch of balsam poplar at the disturbed segment of LTEIS063 as of August 18, 2023

In the disturbed portion of the transects, tree recruitment (seedlings and saplings) included the same four species as in the undisturbed segment. Black spruce seedlings and saplings accounted for 67% of the stems counted in the disturbed portion of the transects (Table 3-9). Balsam poplar saplings and seedlings made up 20% of the tree recruitment stems (Photo 3-4).

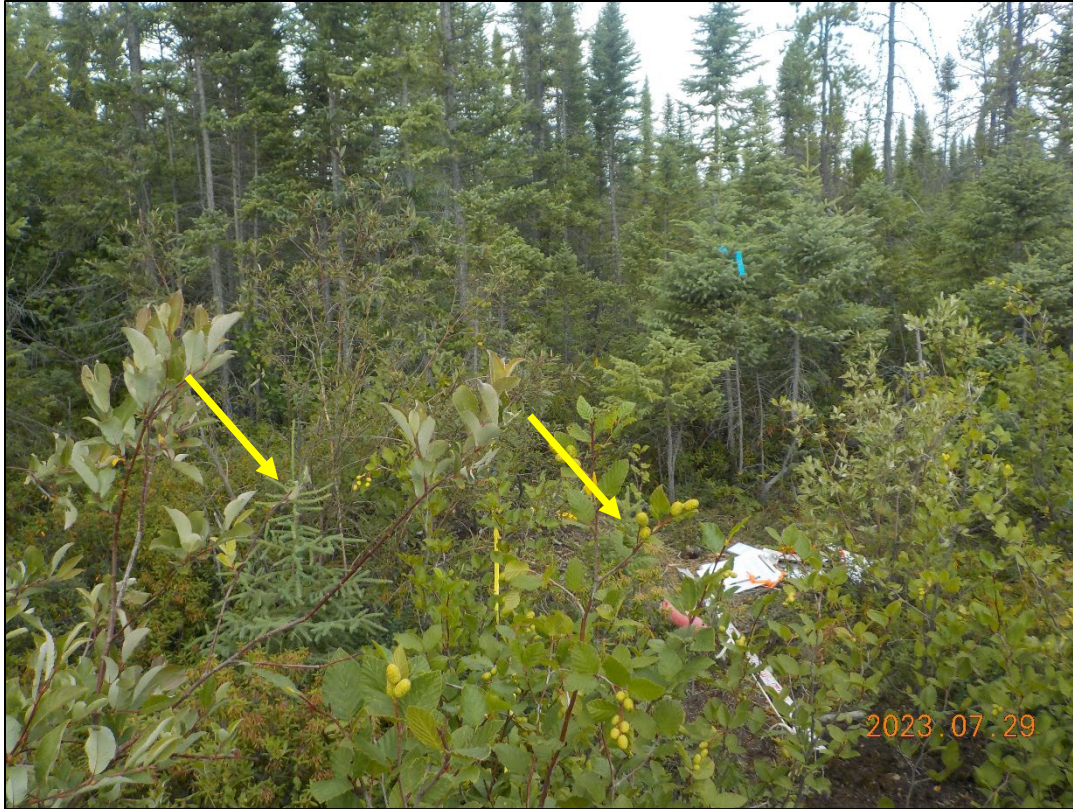
Photo 3-5: Black spruce (*yellow arrows*) and tall shrubs along the disturbed segment at LTEIS071 as of July 29, 2023

In the disturbed segment of the transects only a single species, black spruce, was widely distributed (Table 3-11; Photo 3-5). The remaining species recorded either had a scattered or localized distribution in the disturbed portions of transects overall.

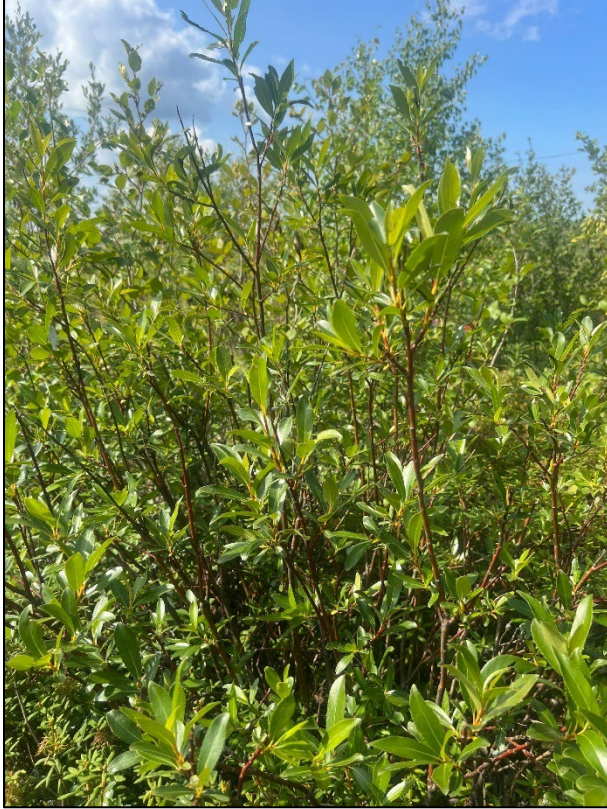
Photo 3-6: Shrubby willow recorded in the disturbed segment of transect at LTEIS071 in 2023

Bebb’s willow (Photo 3-6) and thick-spike wildrye (*Elymus lanceolatus*), were the only provincially possibly imperiled (S2S3) or vulnerable species recorded during habitat surveys. One individual of each was found along two different transects during the 2023 survey. None of the remaining provincially critically imperiled to vulnerable species that had been identified in the EIS (KHLP 2012a) were found along the sampled transects, or incidentally during surveys.

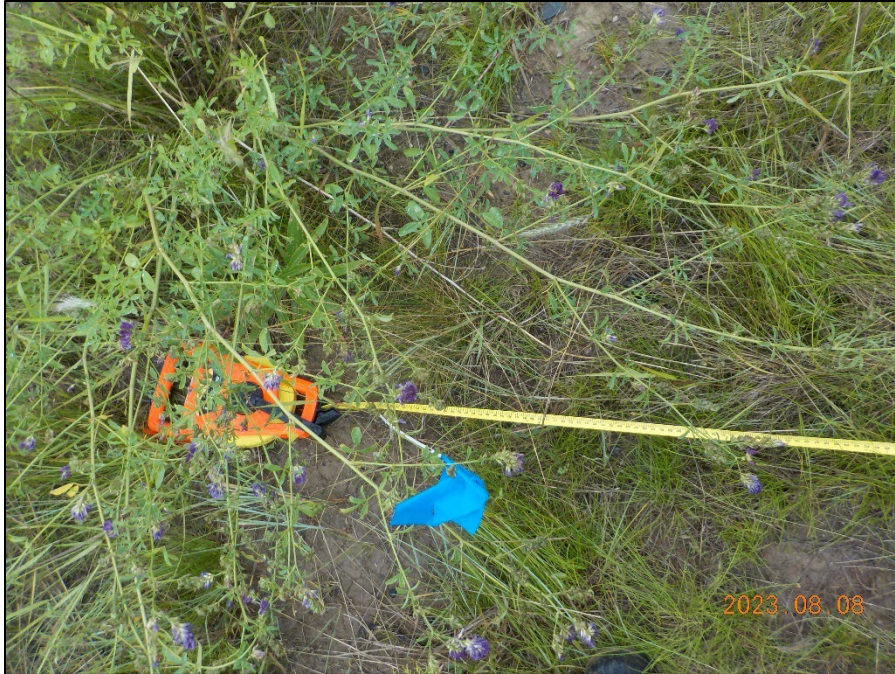
Photo 3-7: Alfalfa growing right at the end of disturbed segment at LTEIS081 on August 08, 2023

Only two Level 3 invasive species, alfalfa (*Medicago sativa*; Photo 3-7) and dandelion (*Taraxacum officinale*), were recorded on the disturbed segment of both transects in stand 8 during the 2023 surveys.
