Keeyask Generation Project Terrestrial Effects Monitoring Plan

Long-Term Effects on Wetlands Monitoring Report

TEMP-2024-02

LONG-TERM EFFECTS ON WETLANDS MONITORING YEAR 2 OPERATION 2023

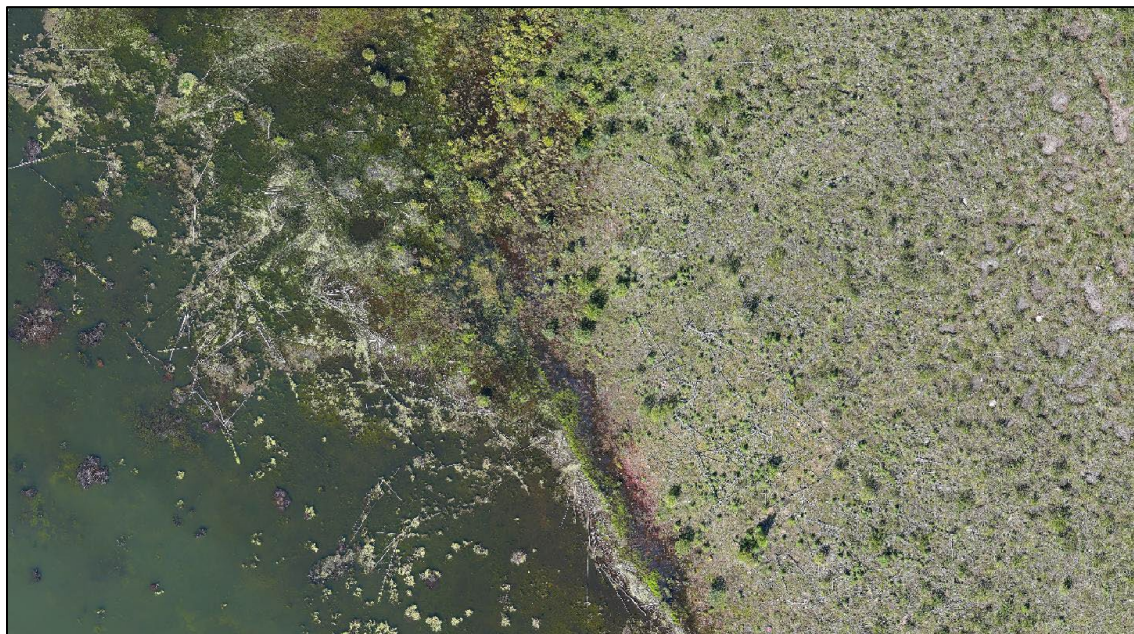
Drone image of the shoreline wetland in the new reservoir

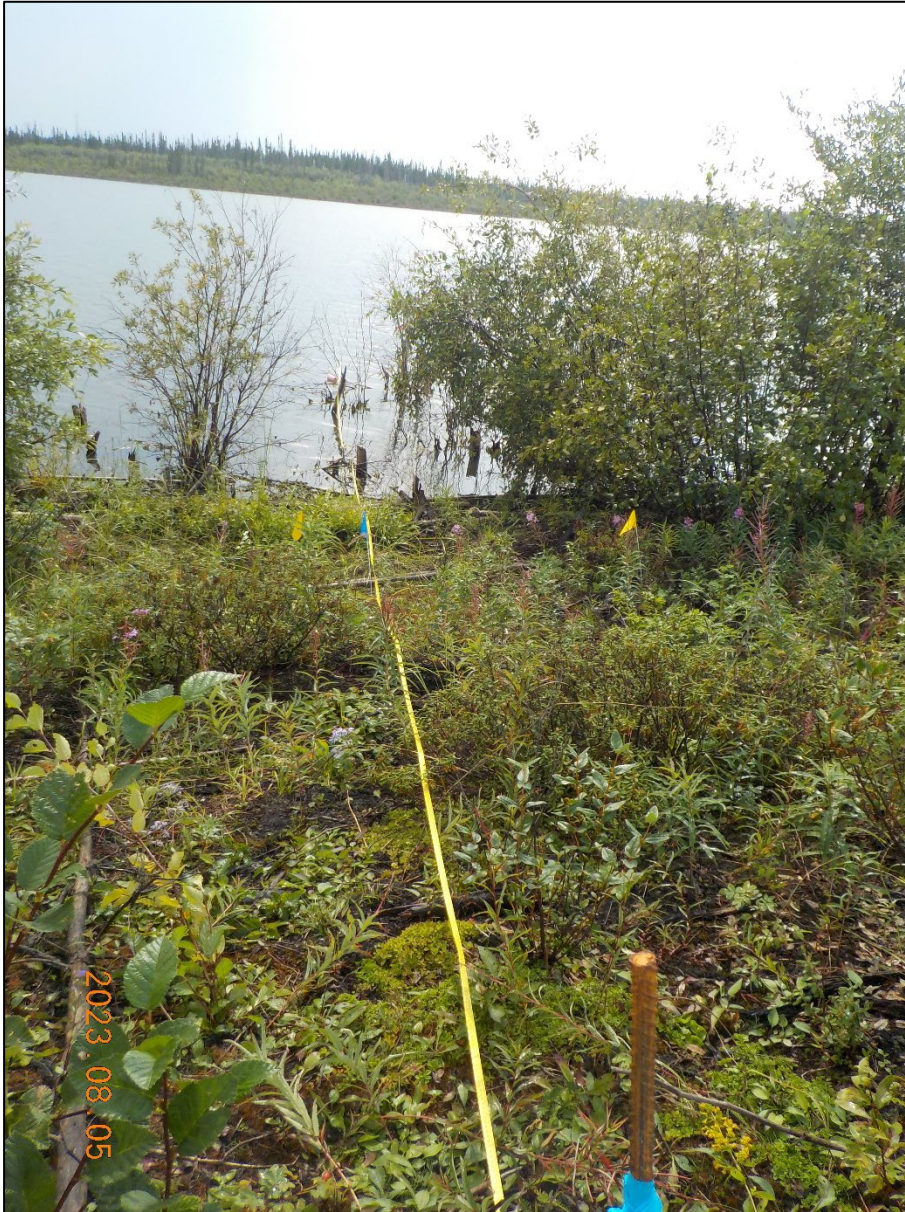
Photo 2-1: Transect setup (Disturbed portion) at LTESKNO3B on August 5, 2023

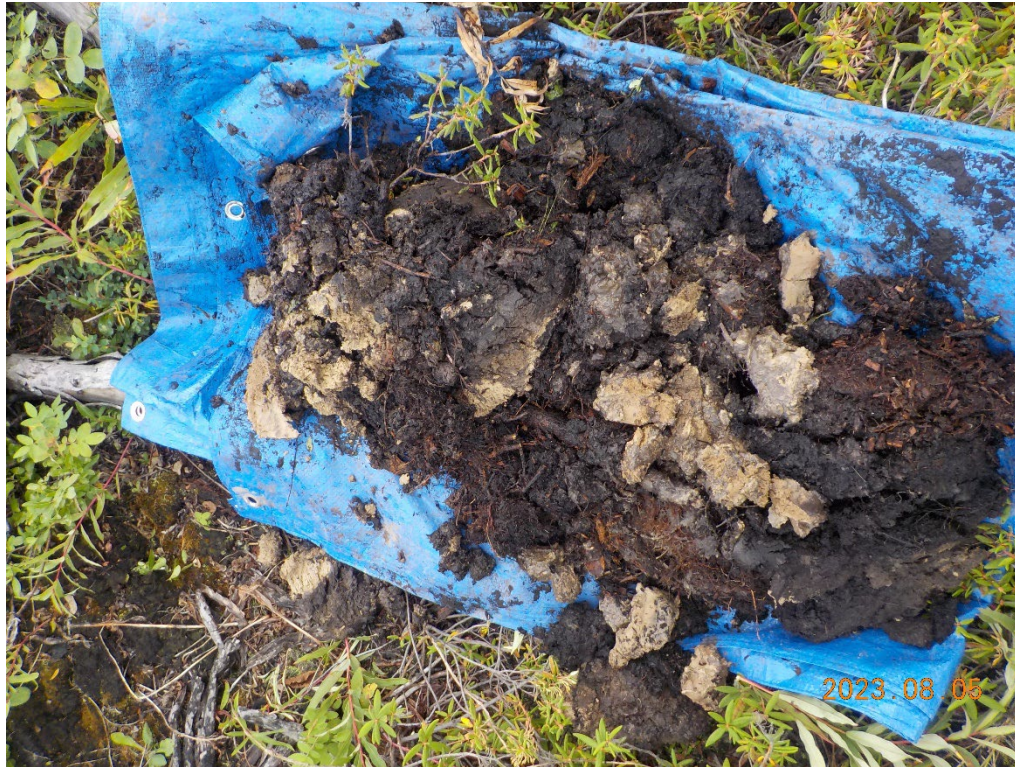
Photo 2-2: Soil pit data being collected

The soil sampling method was intended to be sufficient to detect moisture regime changes in the rooting zone. Soils were sampled in pits (Photo 2-2) and from soil cores obtained using a Dutch auger. The soil pits collected detailed soil information while the soil cores focused on moisture regime (Figure 2-3). Soil pits were dug at 1m and 10m along the undisturbed portion of the transect. Soil cores was completed at 5m, 15m, 20m and 30m on the undisturbed section of the transect, and at 1m and 5m on the disturbed section unless those distances were under water.
