# Keeyask Generation Project Environmental Protection Plan

EnvPP-2017-01

## **ENVIRONMENTAL PROTECTION PLAN ANNUAL REPORT**

**April 2016 – March 2017**

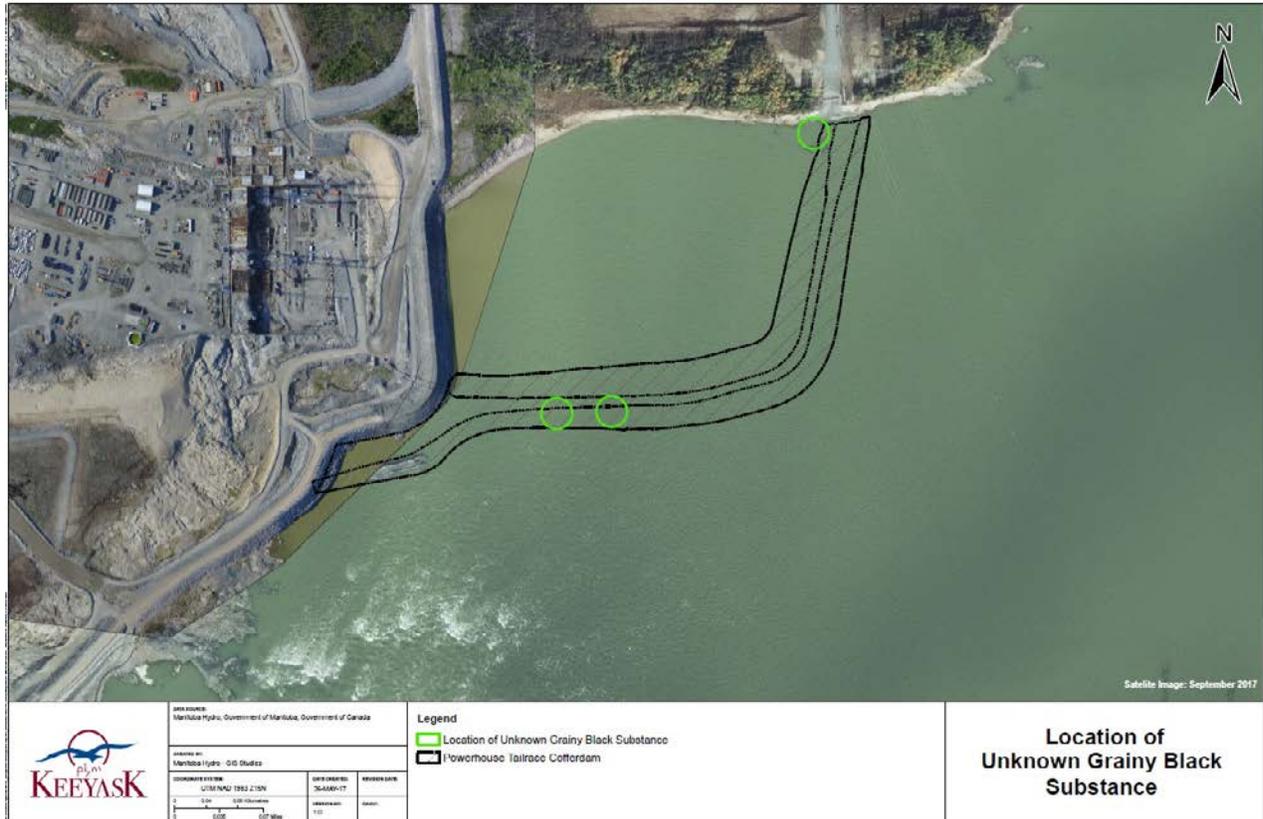
**Map 4: Locations where the grainy, black substance was observed floating on the water inside the inner and outer groins of the Stage II Summer Level Tailrace Cofferdam November 5-7, 2016**

On November 5, 2016, a black, grainy substance was observed on the surface of the water inside the inner groin of the Stage II Summer Level Tailrace Cofferdam while conducting visual inspections of the in-stream work (Photo 10 and Map 4). That same day samples of the water and the substance were collected for analysis by an accredited laboratory and a marine boom was installed between the inner and outer groins to prevent the substance from entering the Nelson River. In-stream work was temporarily suspended between November 7 and 11, 2016, until the sample results provided evidence that the substance was non-hazardous. The analysis results indicated that the substance was mainly comprised of silicon, aluminum, and iron – the main elements that comprise feldspars and pyrite, which are common rocks in the geology around Keeyask. This suggests that the substance was likely rock dust and did not pose a substantial environmental risk in the small volume that had been observed.

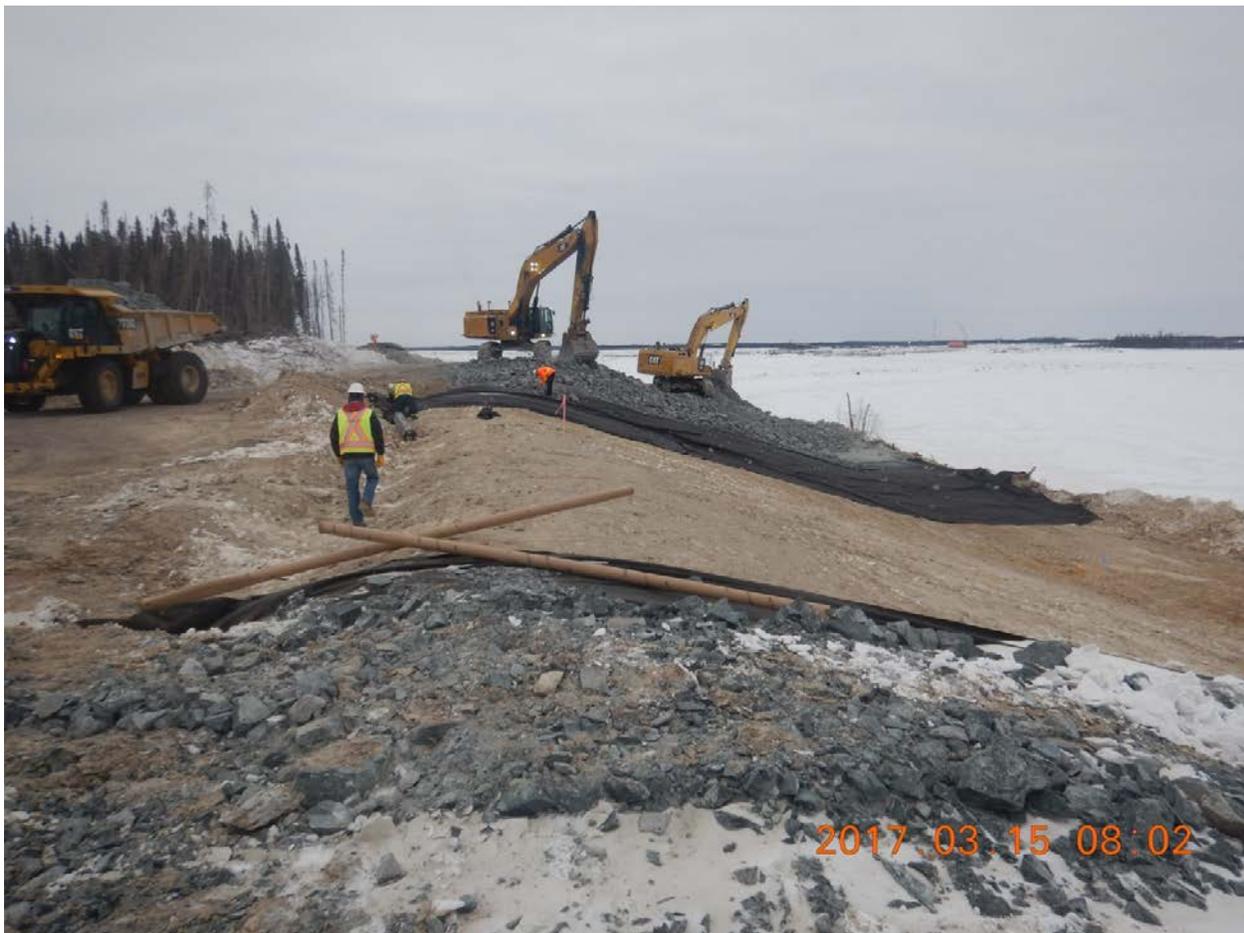
Permanent erosion control (rock armouring) has been installed on the north bank of the Nelson River in preparation for impounding the Reservoir (Photo 16).

**Photo 16: Permanent erosion control measures installed on the north bank of the Nelson River**

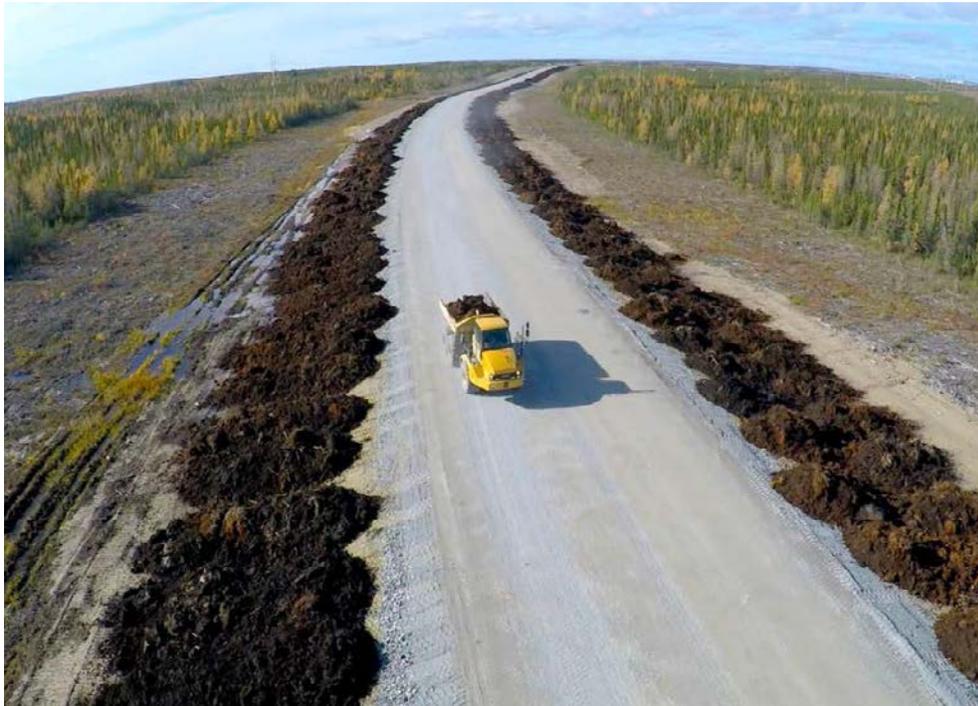
Organic matter was placed along certain sections of the slopes of the South Access Road Right-of-Way (ROW) and the entire length of the slopes were seeded with an approved grass seed mixture to help stabilize the slopes and prevent erosion (Photo 17).

**Photo 17: Organic matter spread along the slope embankments of the South Access Road right-of-way**
