Keeyask Generation Project
Terrestrial Effects Monitoring Plan

Habitat Loss and Disturbance Monitoring Report

TEMP-2018-01

June 2018

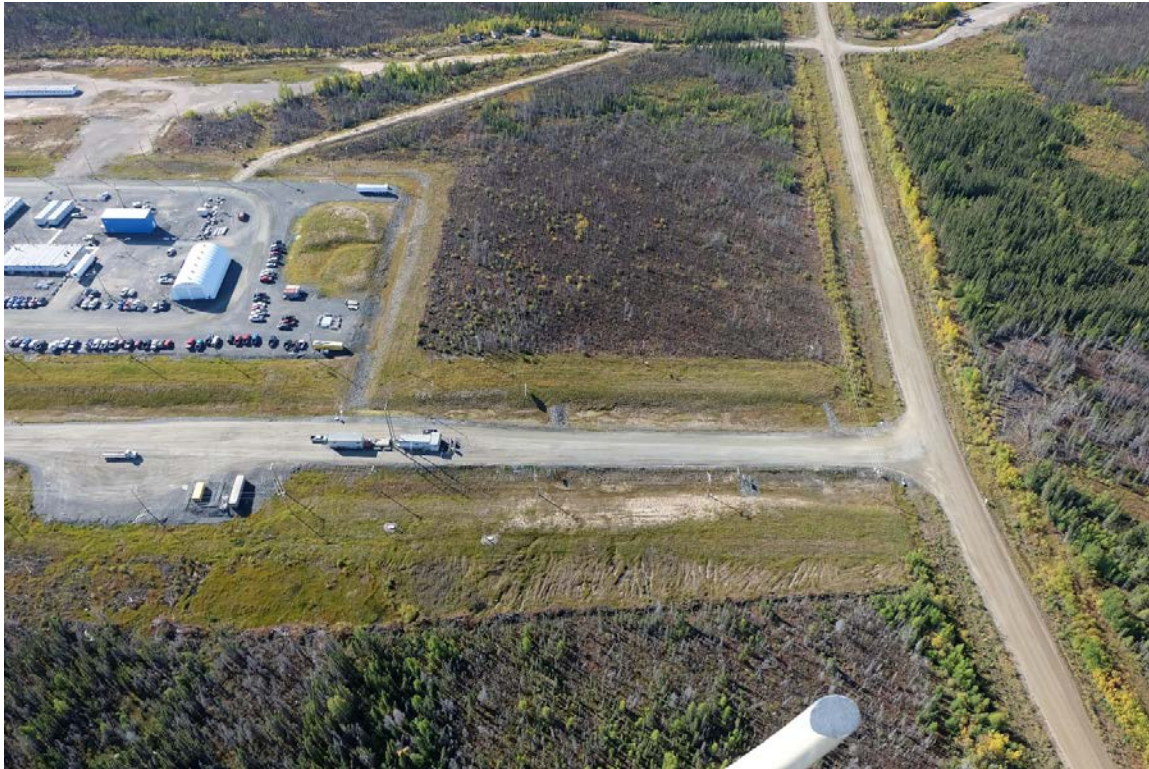
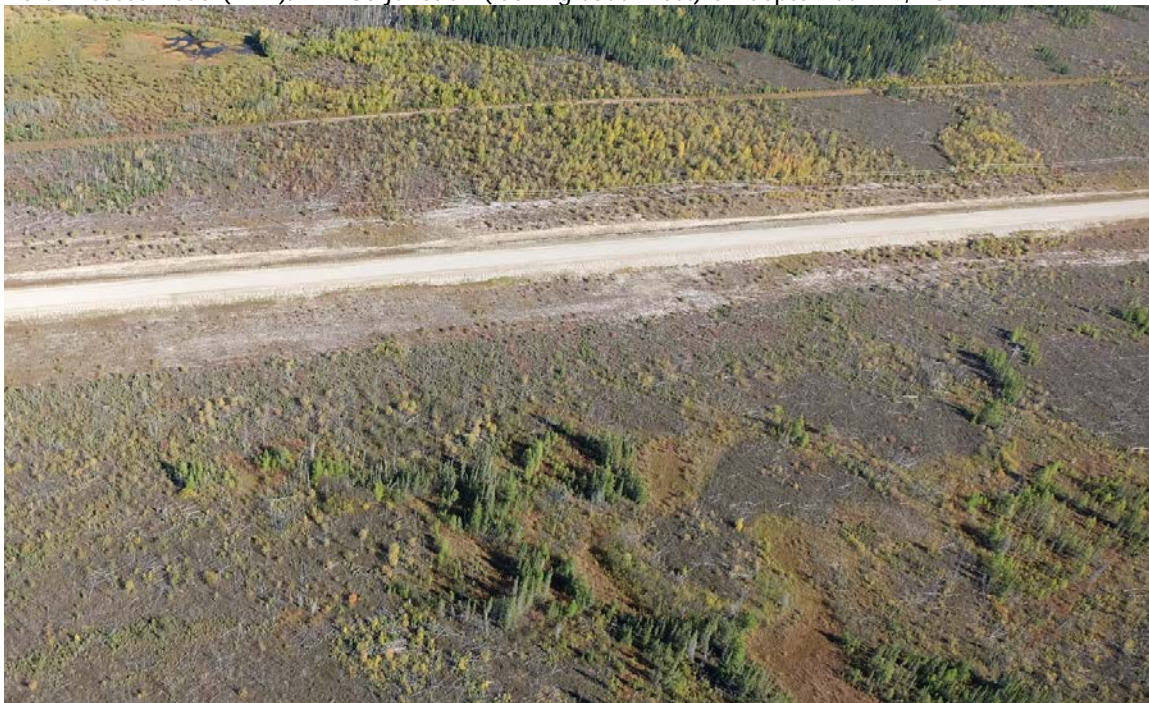
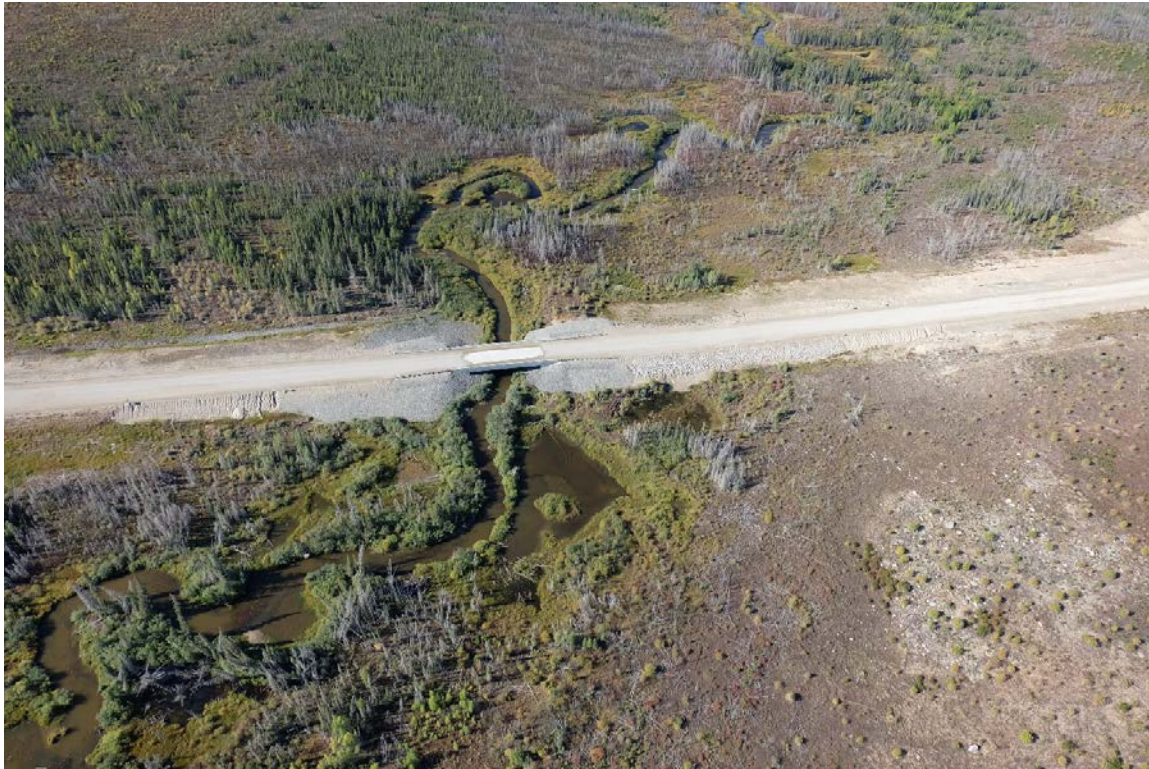
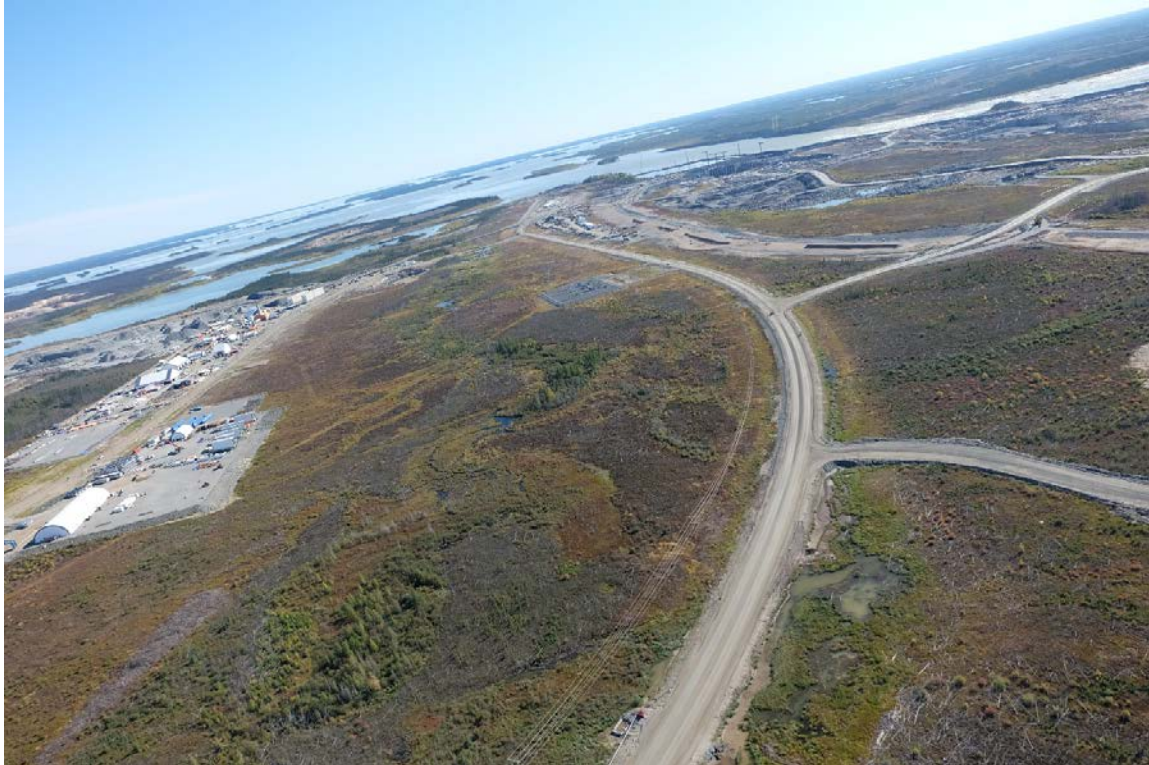
Figure 3–1: Clearing and other impacts along the NAR

North Access Road (NAR)/PR 280 junction (looking southwest) on September 19, 2017

Approximately halfway along the NAR (looking north) on September 19, 2017

Bridge at Looking Back Creek (looking southwest) on September 19, 2017

Near the south end of the NAR (looking east) on September 19, 2017

All NAR and SAR clearing observed in September 2017 was within the planned Project footprint boundary, and was unchanged from September 2016 (Figure 3–1 and Figure 3–2; Table 3–1 and Table 3–3). No road construction activity was observed during 2017 surveys (although road maintenance was ongoing). The visible clearing outside of the SAR ROW was part of the Keeyask Transmission Project (KTP) and, as such, is not included in the results except where a Project borrow area overlaps the same area.

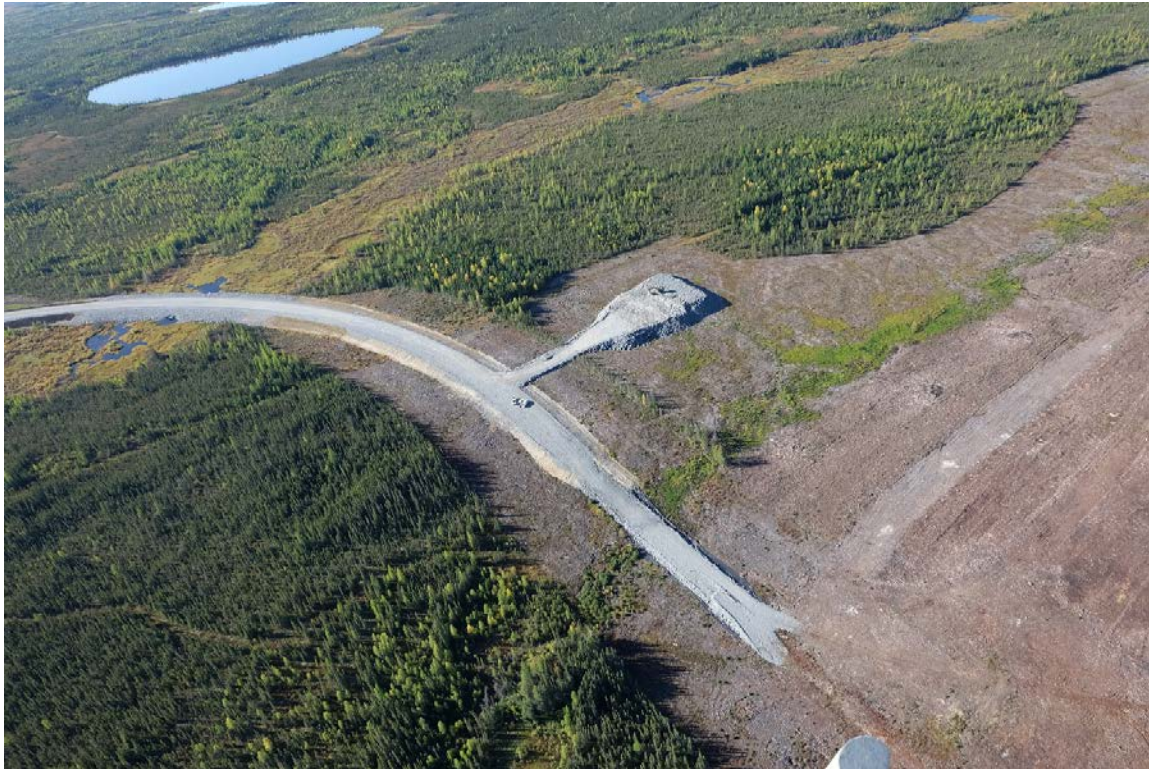
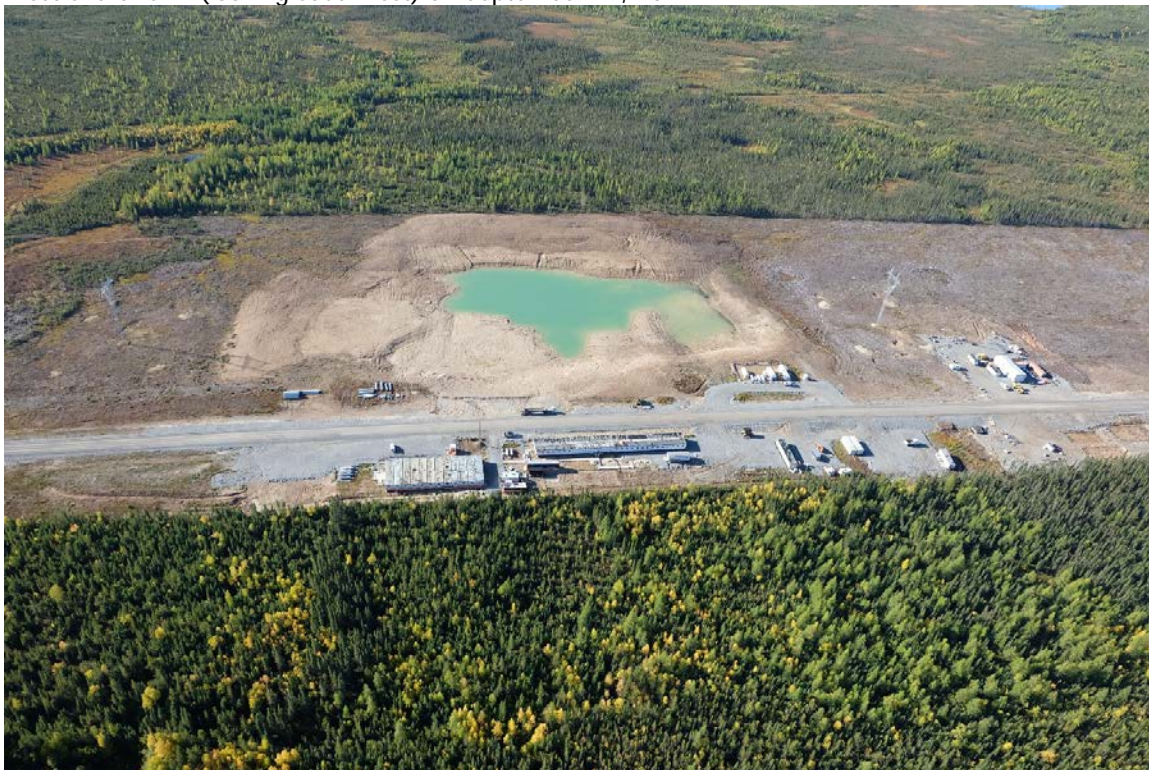
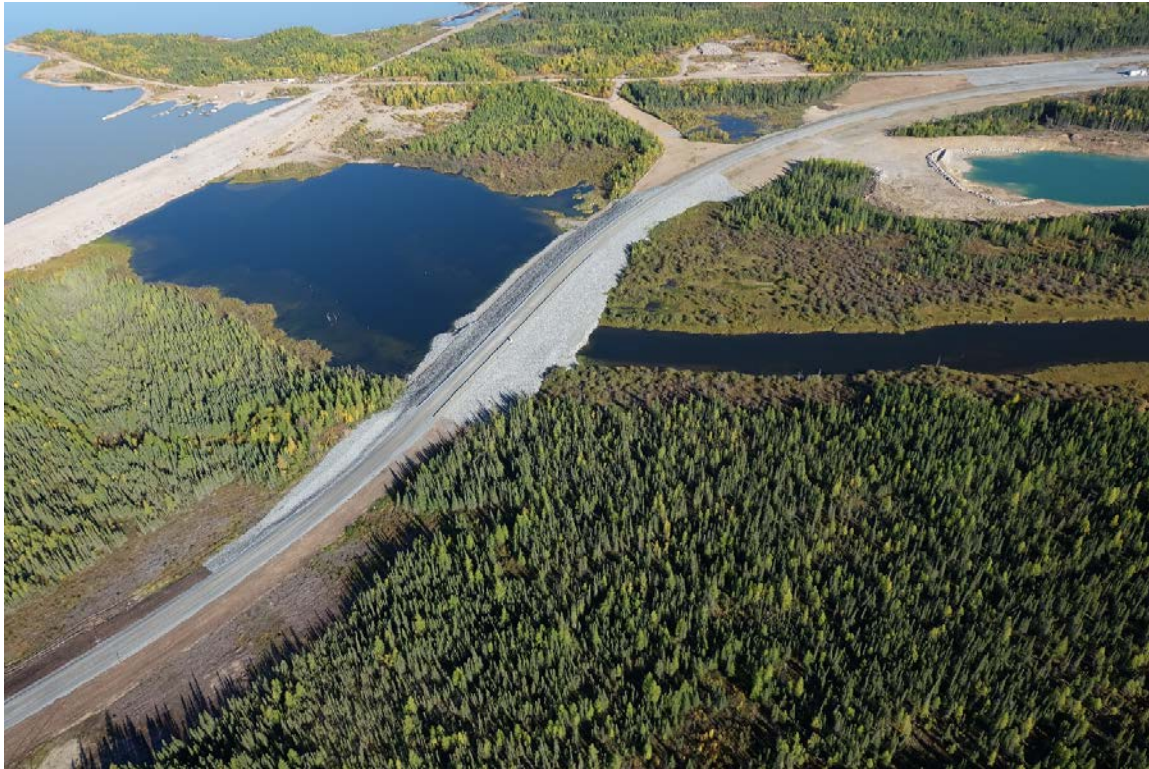
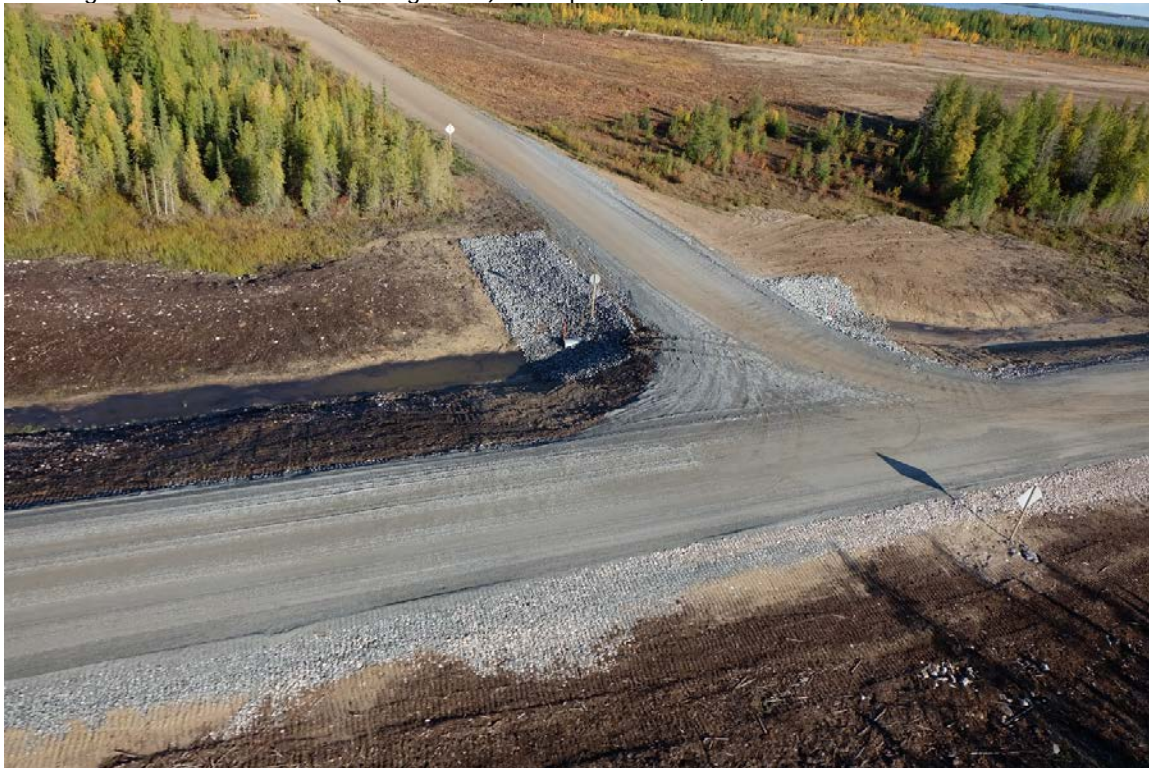
Figure 3–2: Clearing and other impacts along the SAR

West end of SAR (looking southwest) on September 19, 2017

View of the SAR camp and borrow area B-3 (looking south) on September 19, 2017

Crossing at the Butnau River (looking north) on September 19, 2017

Near the east end, junction with the old Butnau Road (looking north) on September 19, 2017

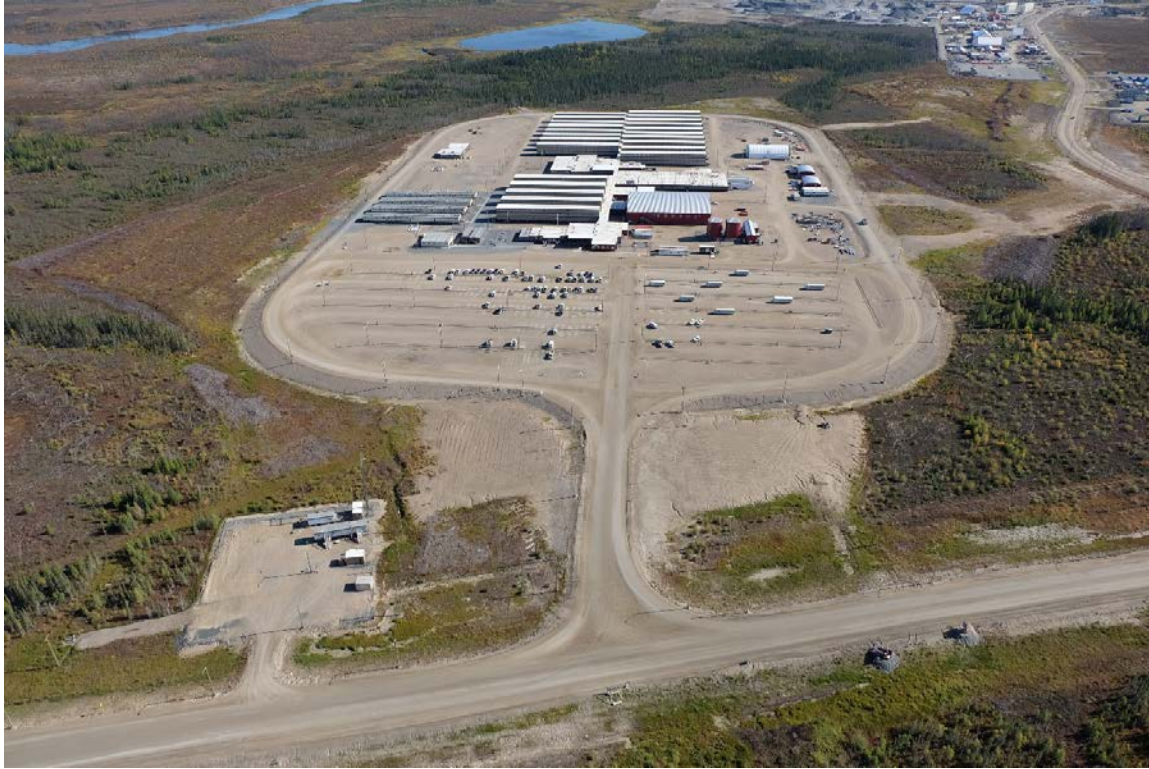
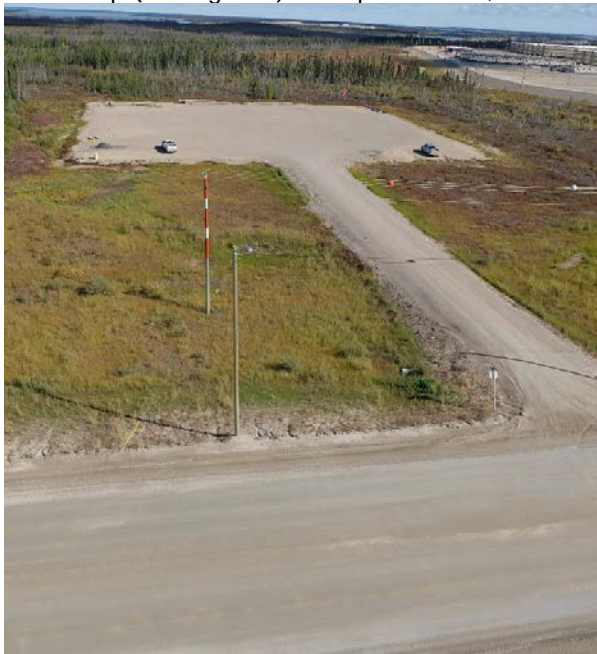
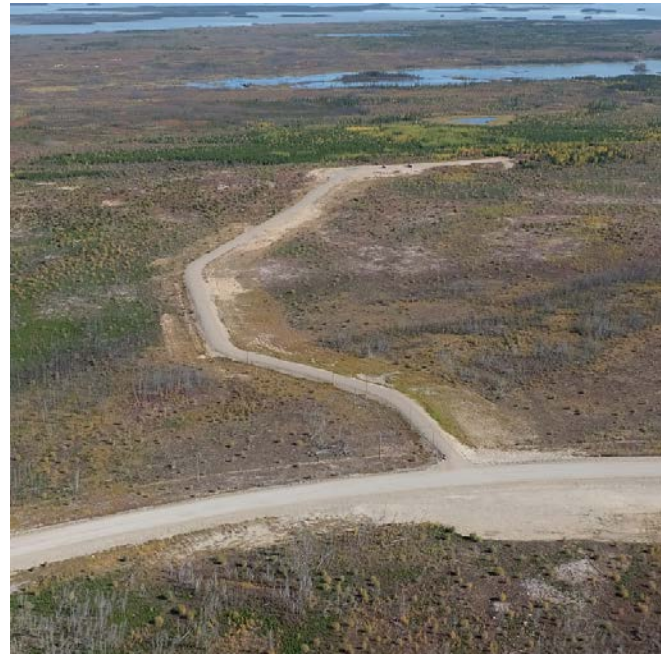
Figure 3–3: Main camp, helicopter pad and well road

Main camp (looking east) on September 19, 2017

Helicopter pad (looking east) on September 19, 2017

Well road (looking northeast) on September 19, 2017

The 0.02 ha of clearing associated with the boat launch was the only new clearing or disturbance within the possibly disturbed Project footprint that was observed for the main camp, north shore work areas or well area footprint components.

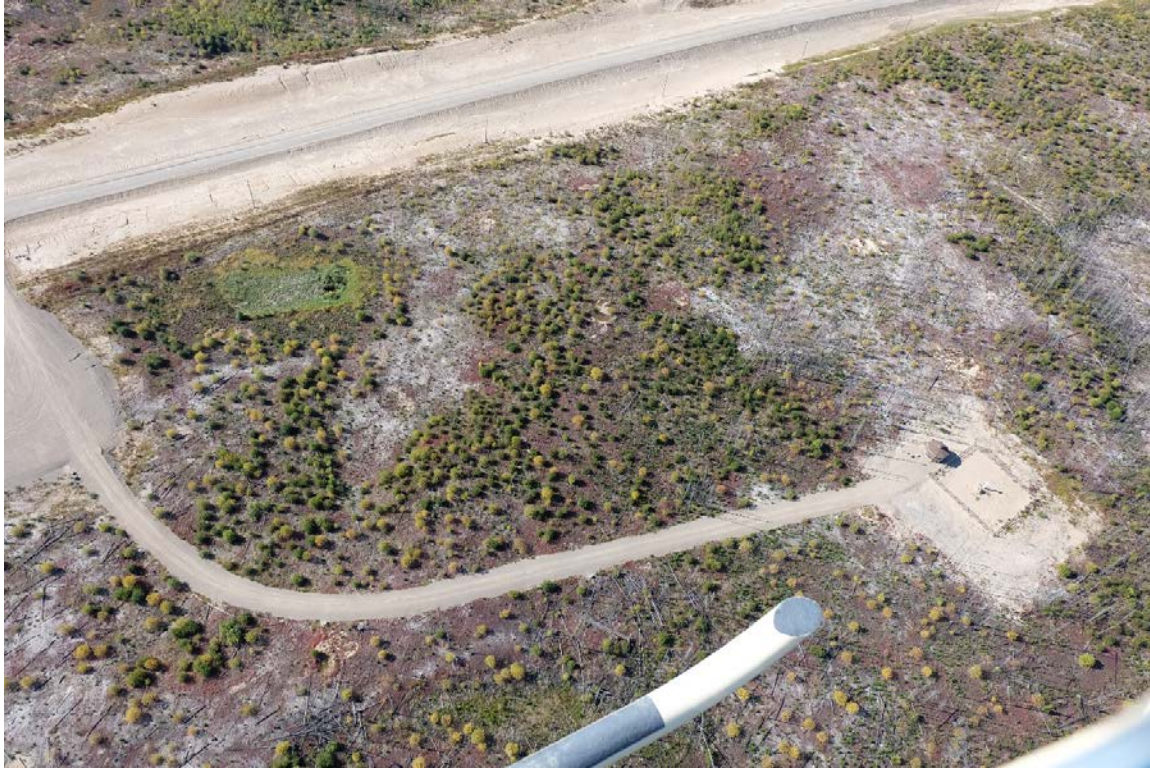
Figure 3–4: Cemetery site along the North Access Road (September 19, 2017)

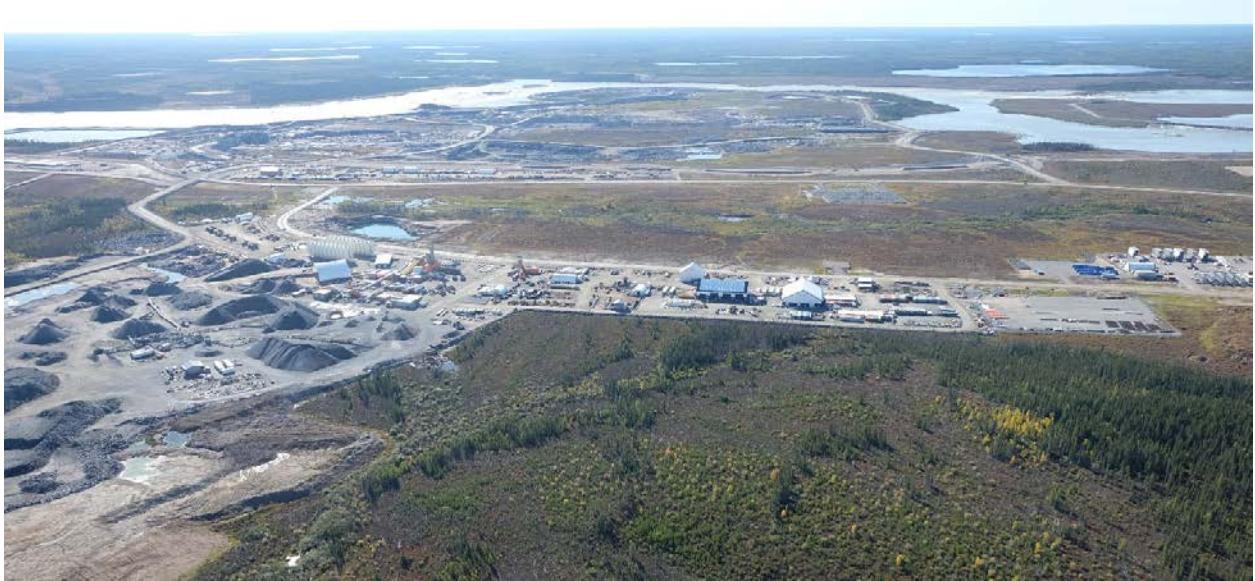
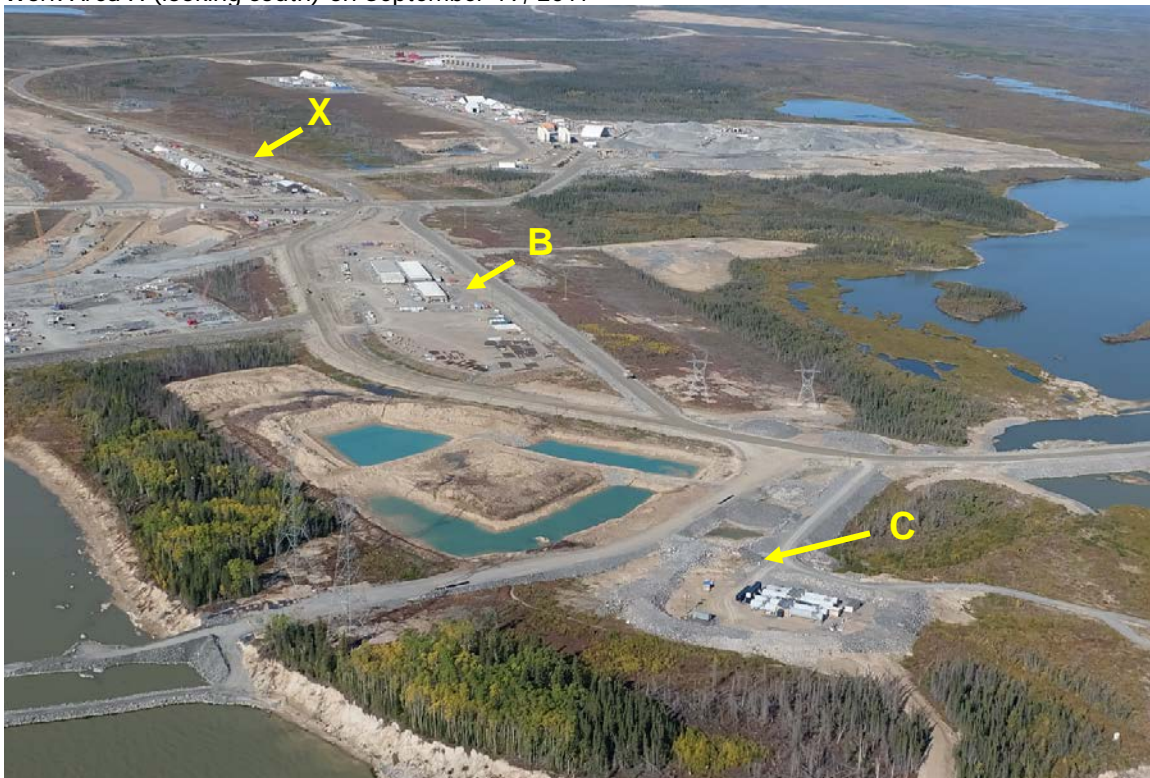
Figure 3–5: Work areas

Work Area A (looking south) on September 19, 2017

Work Area X, B and C (looking west) on September 19, 2017

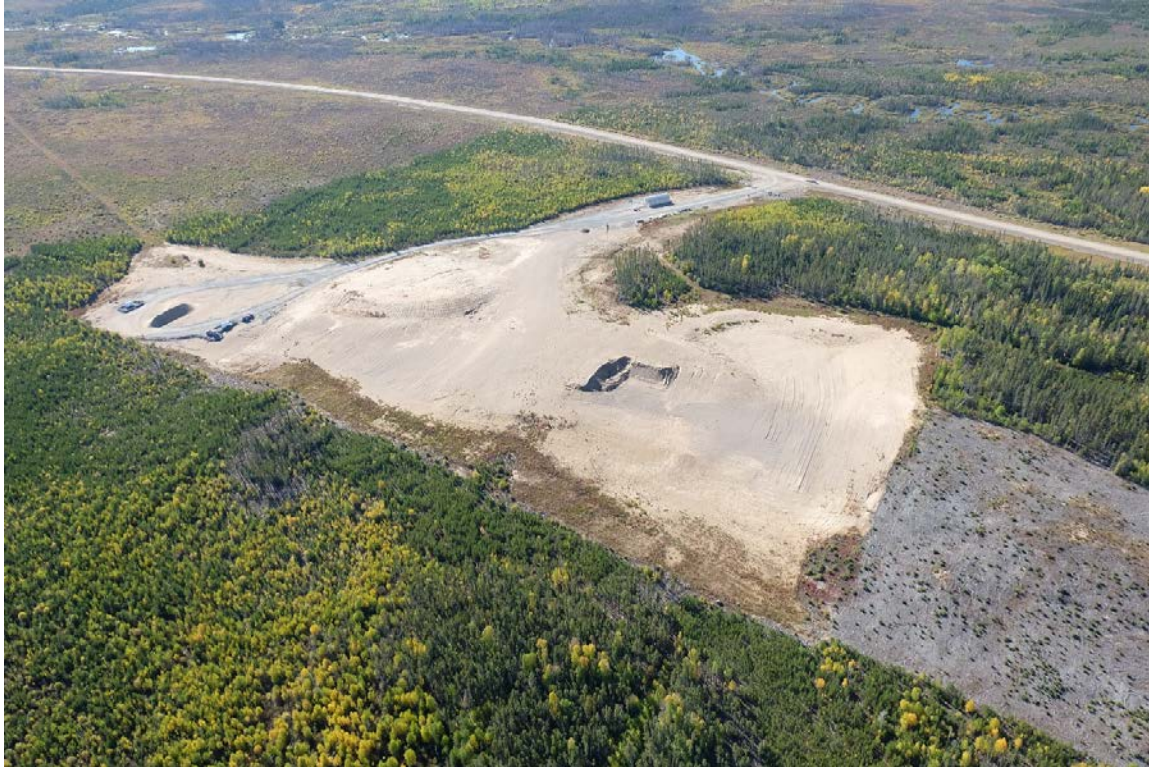
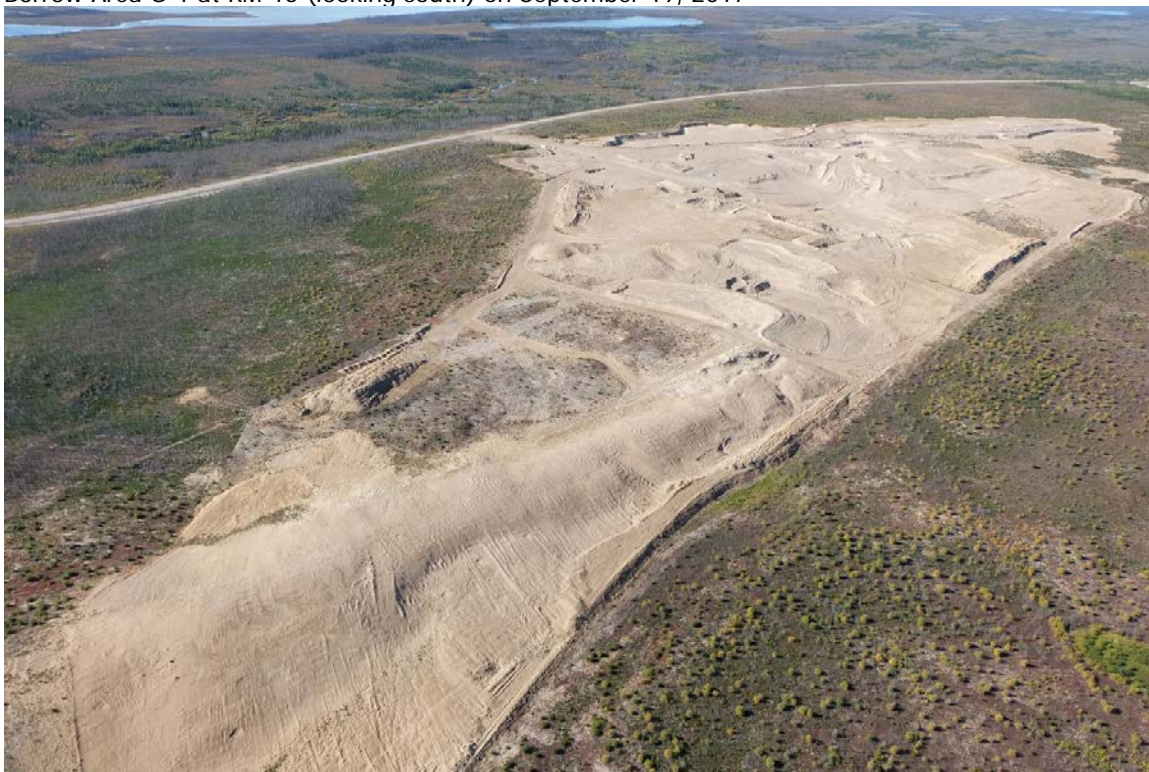
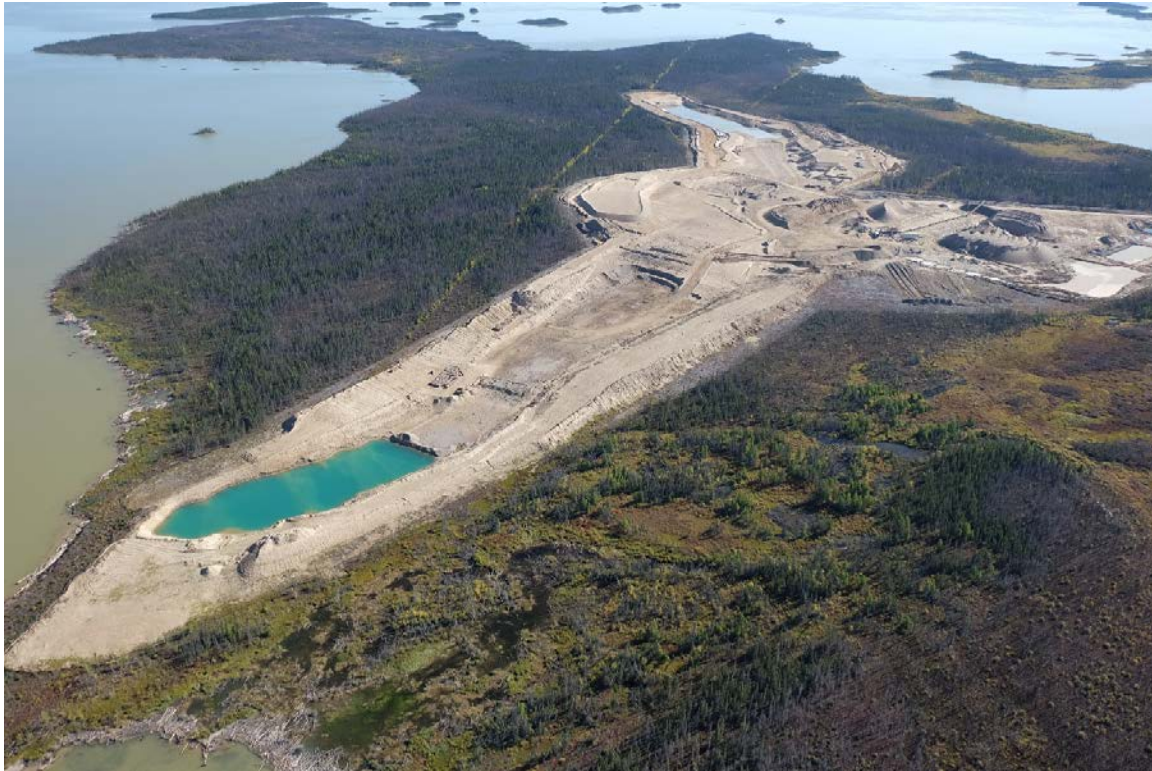
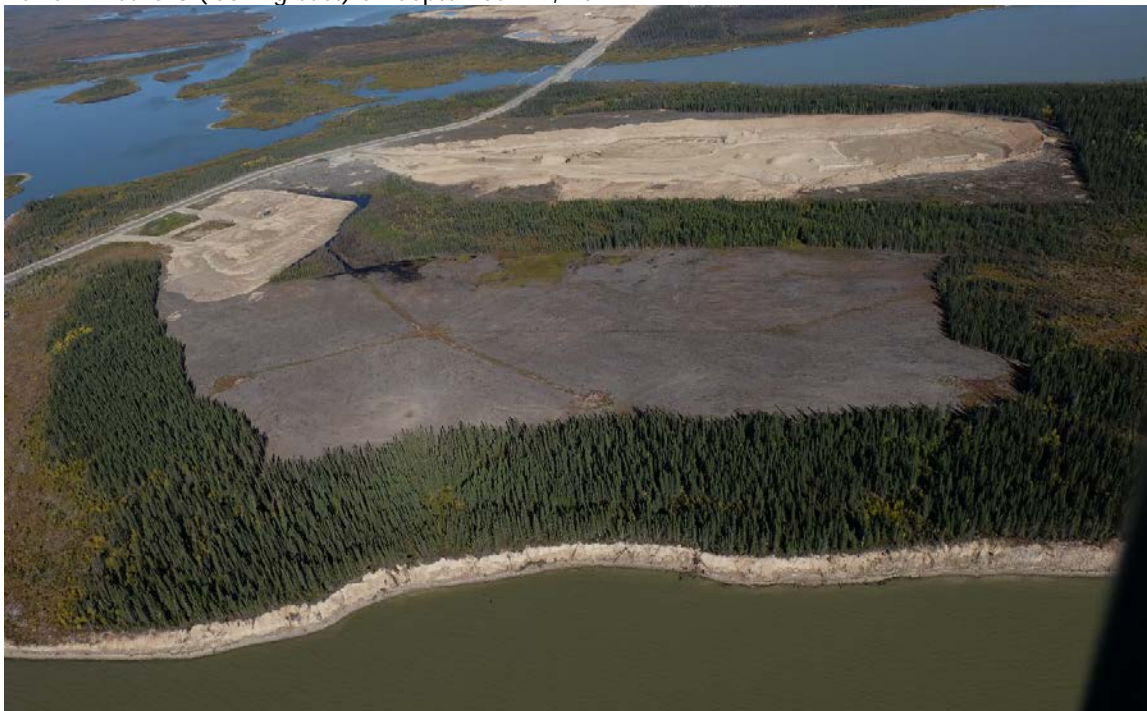
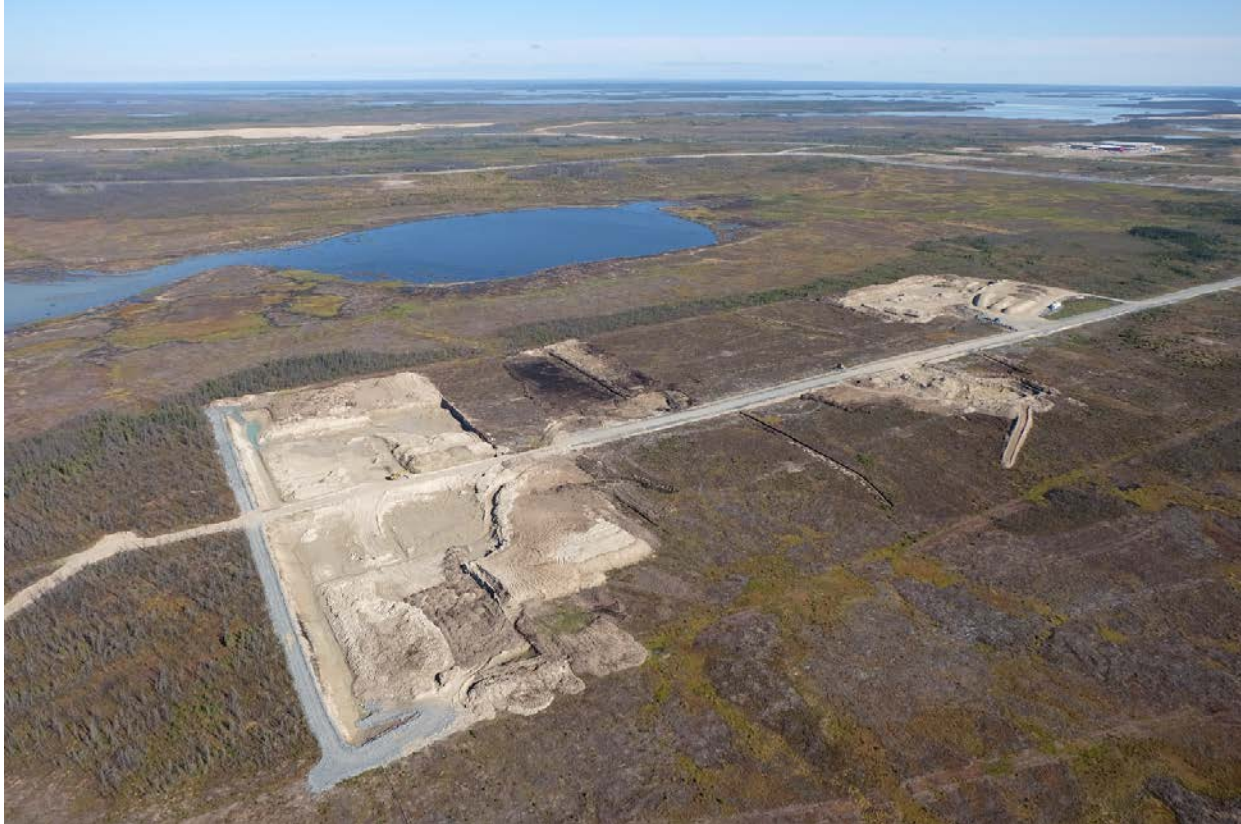
Figure 3–7: Clearing and excavation in borrow areas north of the Nelson River

Borrow Area G-1 at KM-15 (looking south) on September 19, 2017

Borrow Area G-1 at KM-17 (looking southwest) on September 19, 2017

Borrow Area G-3 (looking east) on September 19, 2017

Borrow Area N-5 (looking north) on September 19, 2017

Borrow Area N-21 (looking northeast) on September 19, 2017
