Keeyask Generation Project
Terrestrial Effects Monitoring Plan

Habitat Loss and Disturbance Monitoring Report

TEMP-2018-01

June 2018

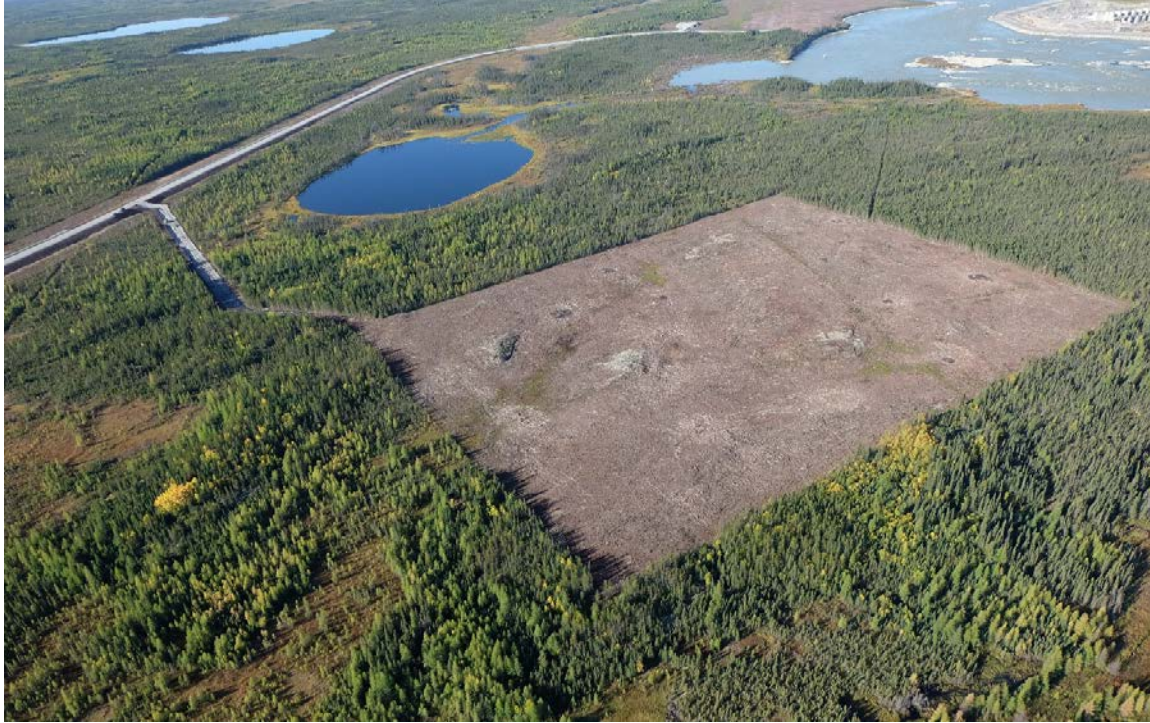
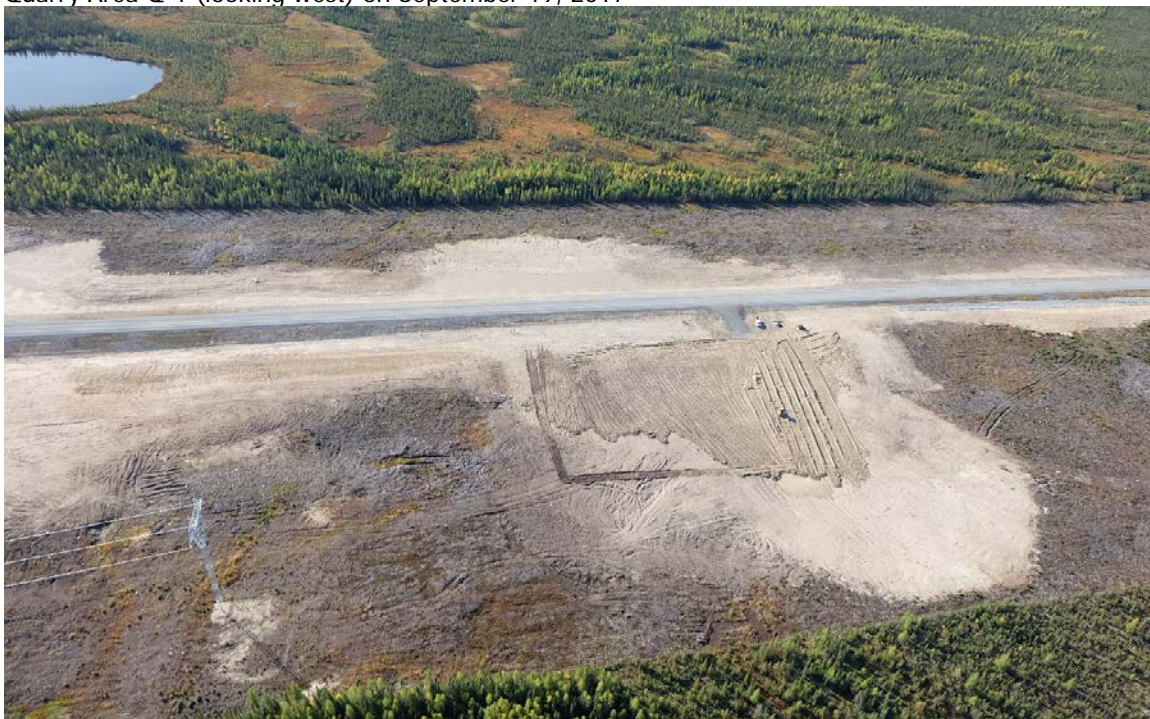
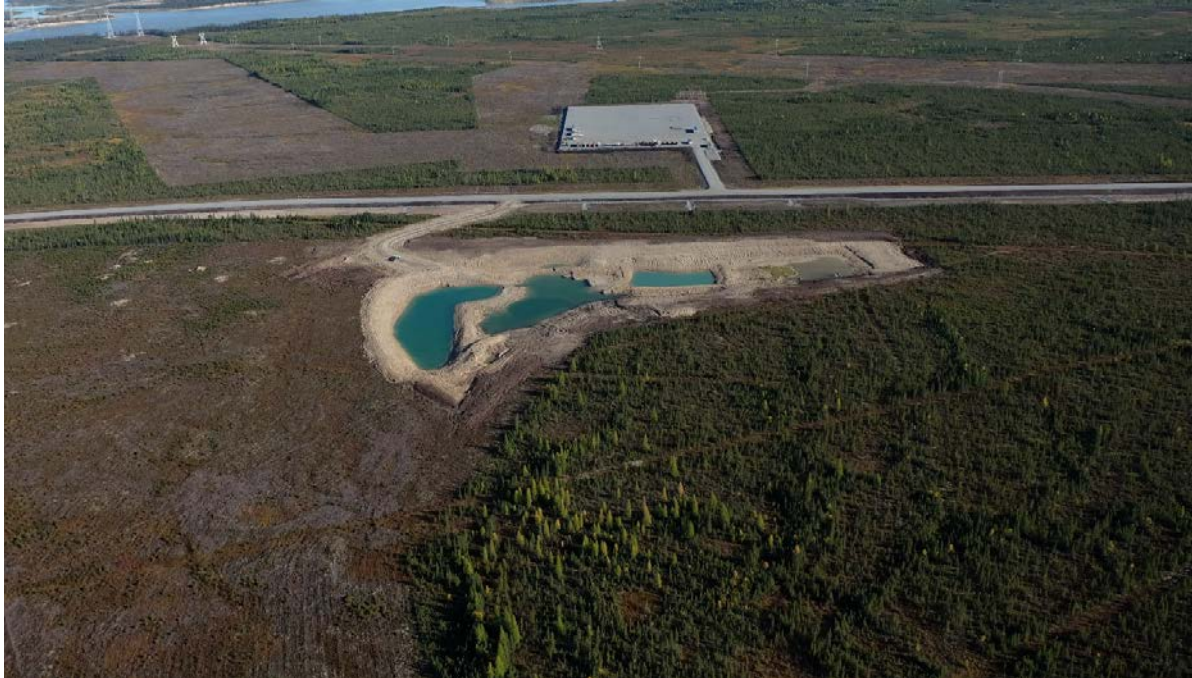
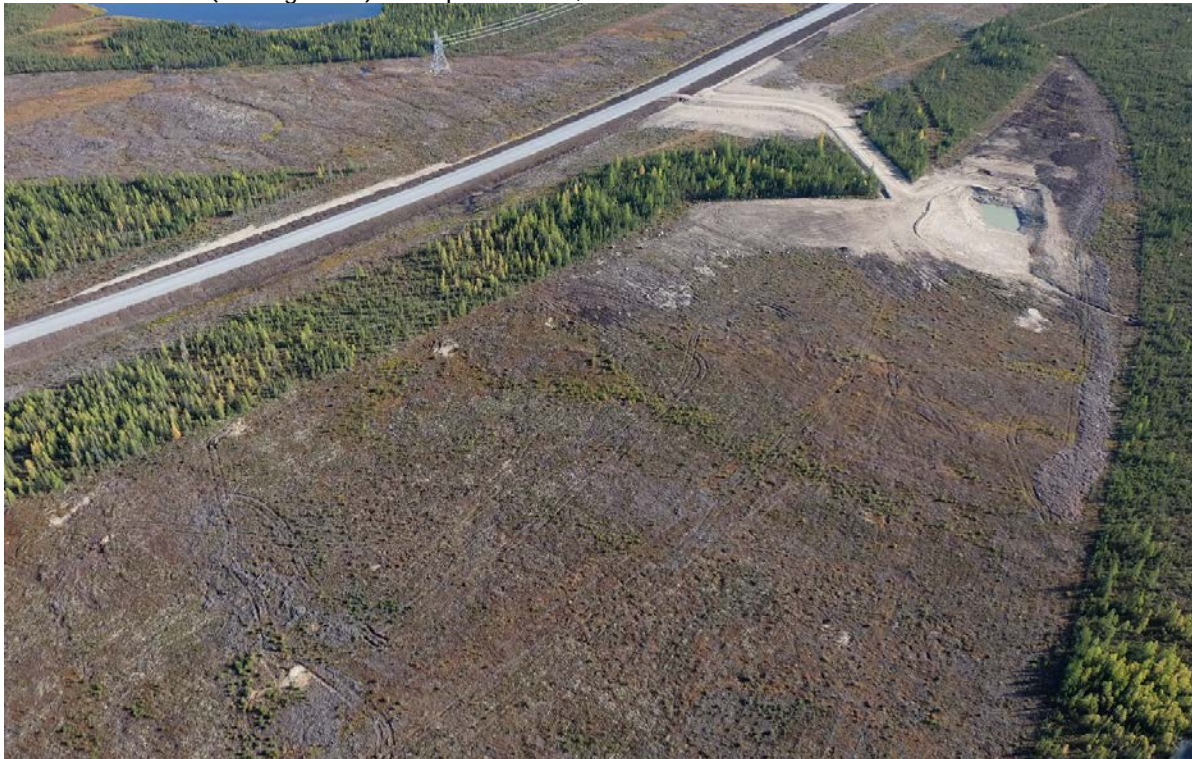
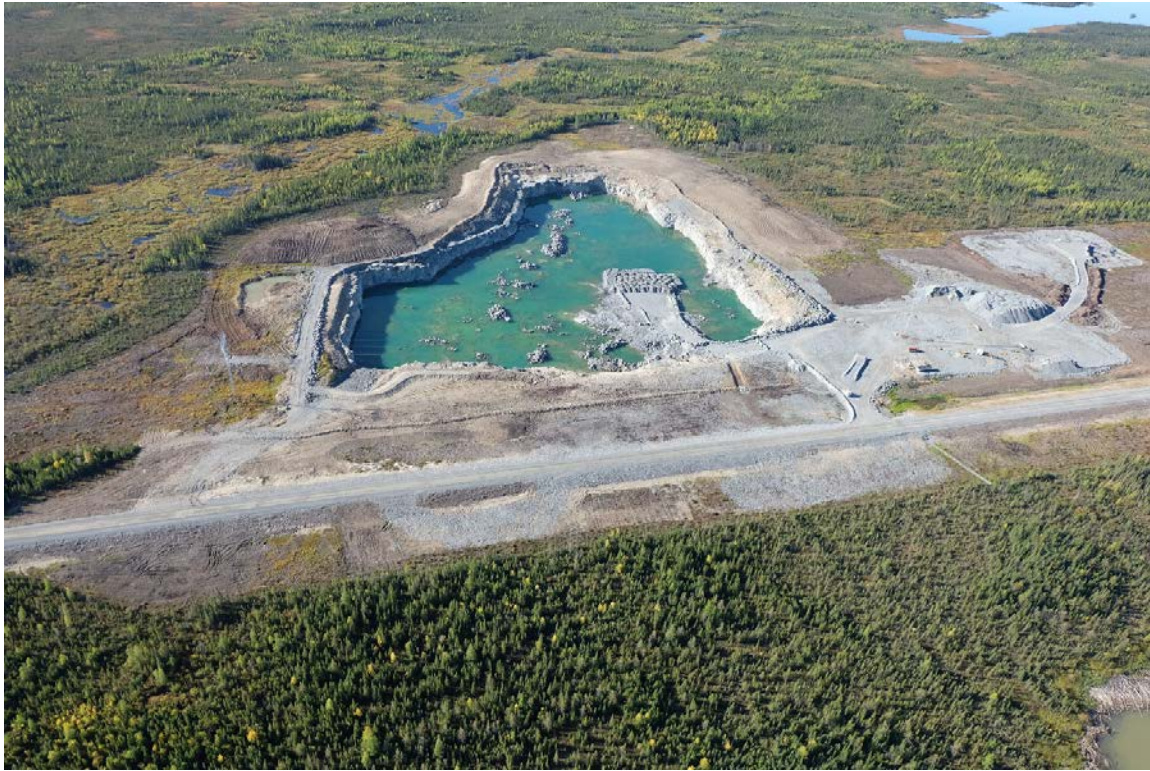
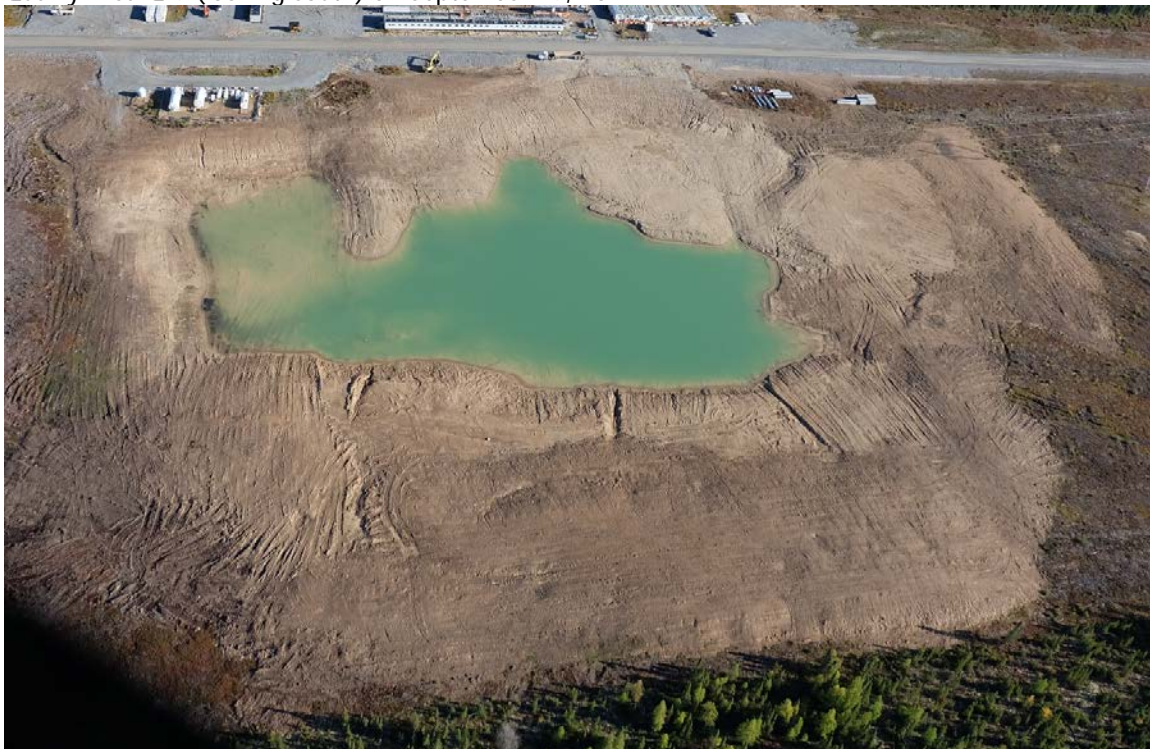
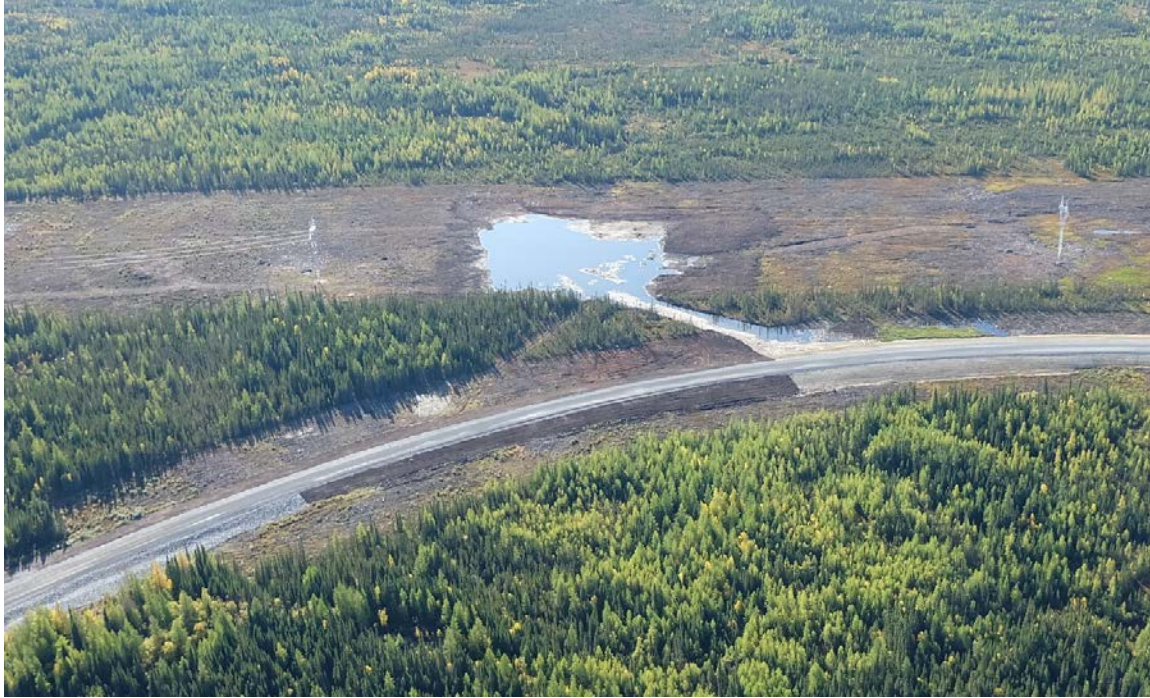
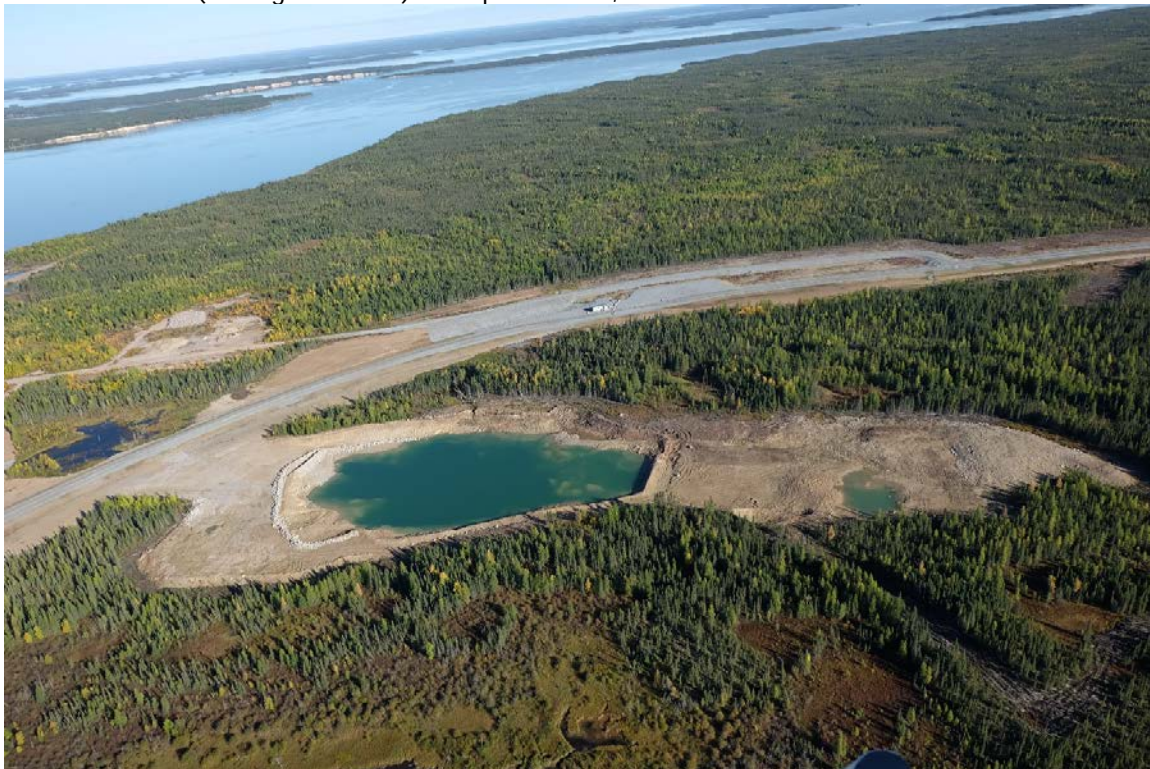
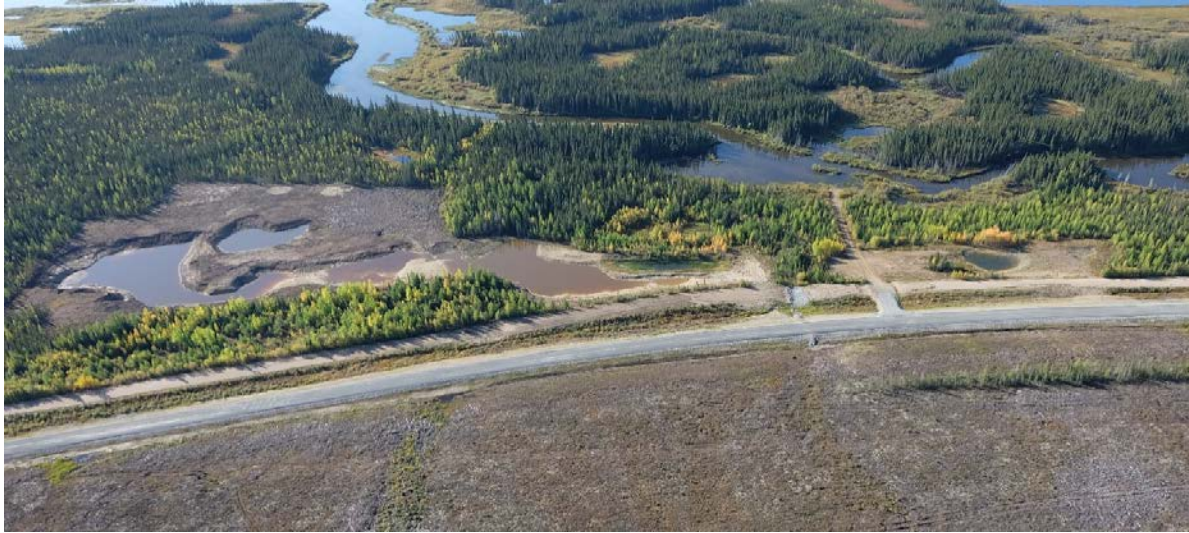
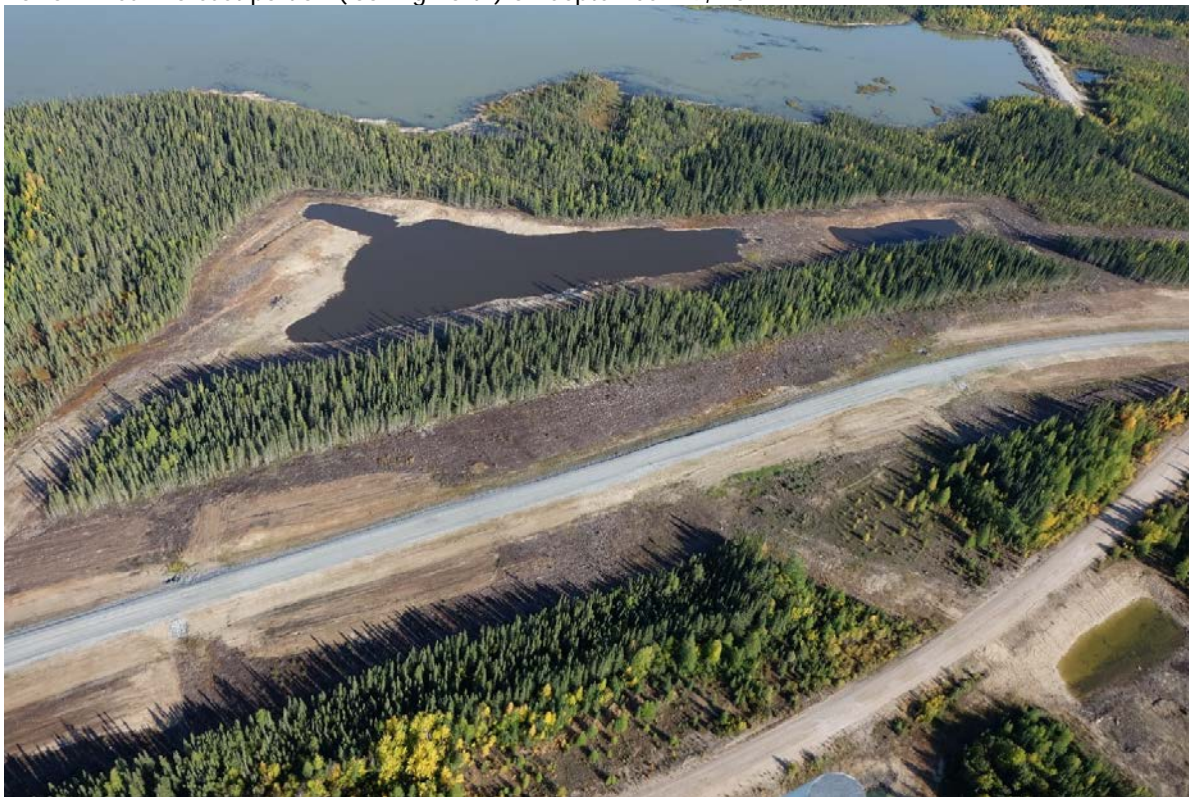
Figure 3–8: Clearing and excavation in borrow areas south of the Nelson River

Quarry Area Q-1 (looking west) on September 19, 2017

Borrow Area B-2 (looking south) on September 19, 2017

Borrow Area S-2a (looking north) on September 19, 2017

Borrow Area S-2b (looking east) on September 19, 2017

Quarry Area Q-9 (looking south) on September 19, 2017

Borrow Area B-3 (looking north) on September 19, 2017

Borrow Area B-5 (looking southeast) on September 19, 2017

Borrow Area B-6 west portion (looking north) on September 19, 2017

Borrow Area B-6 east portion (looking north) on September 19, 2017

Borrow Area B-8 (looking north) on September 19, 2017

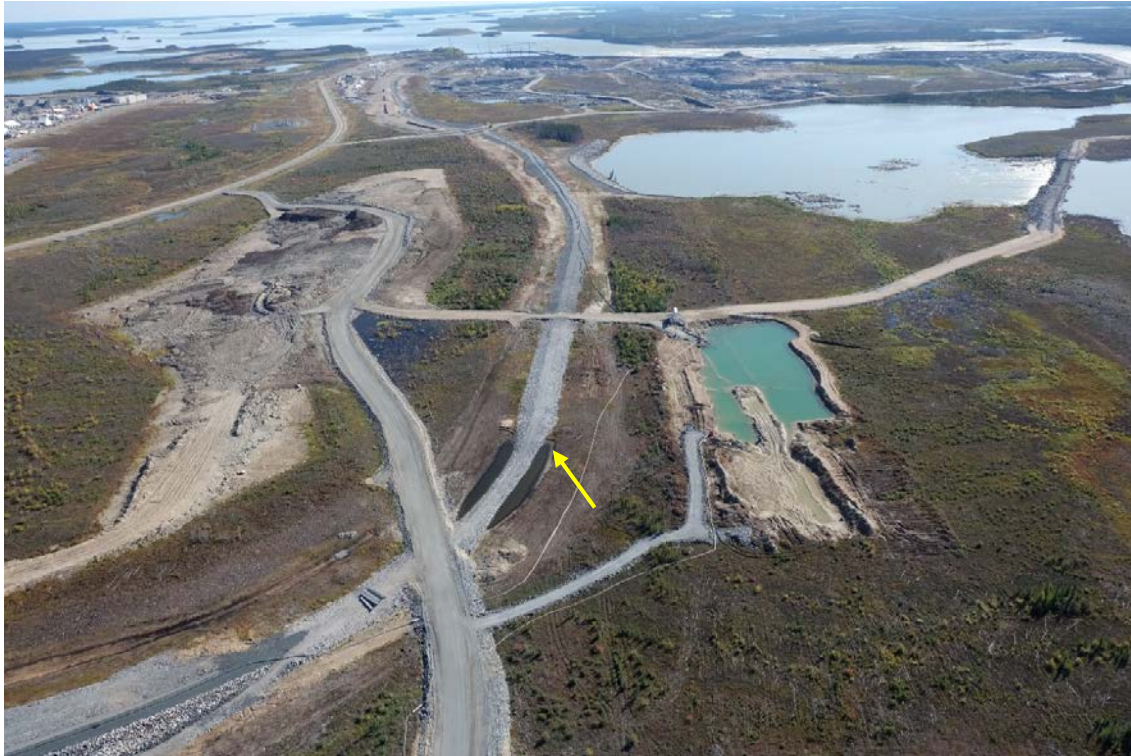
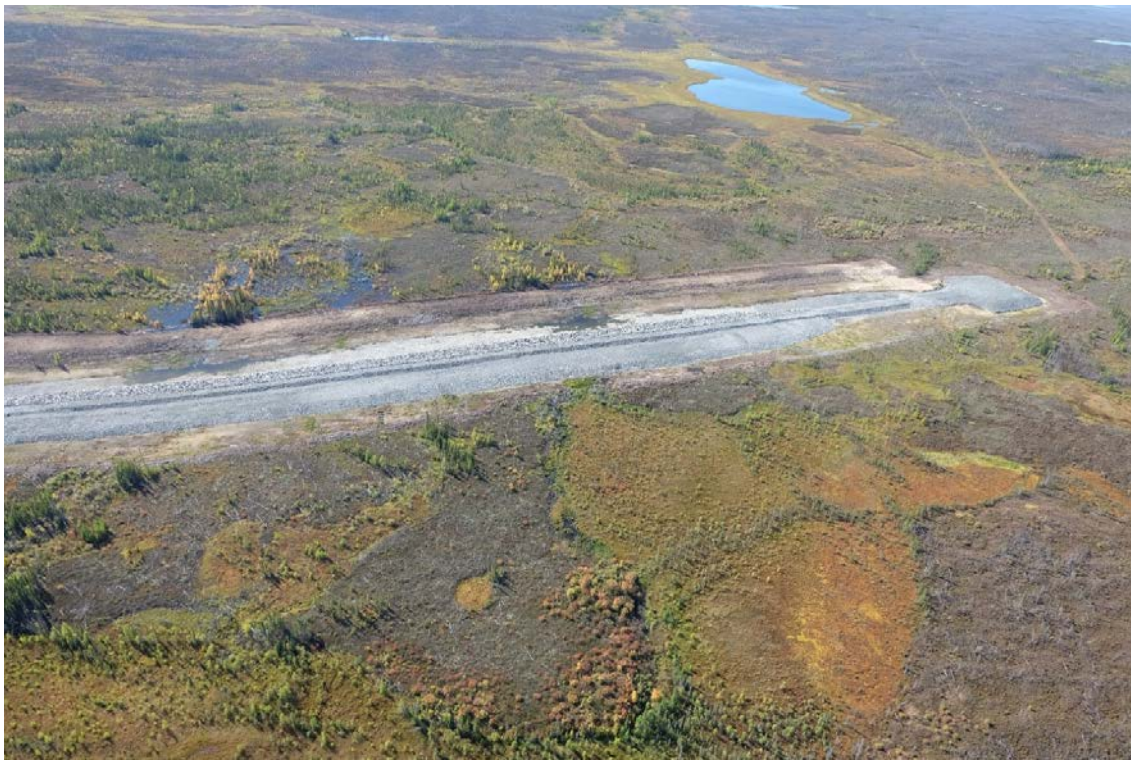
Figure 3–10: North dyke

North dyke, east end (looking east) on September 19, 2017. Yellow arrow identifies dyke.

North dyke, west end (looking southwest) on September 19, 2017

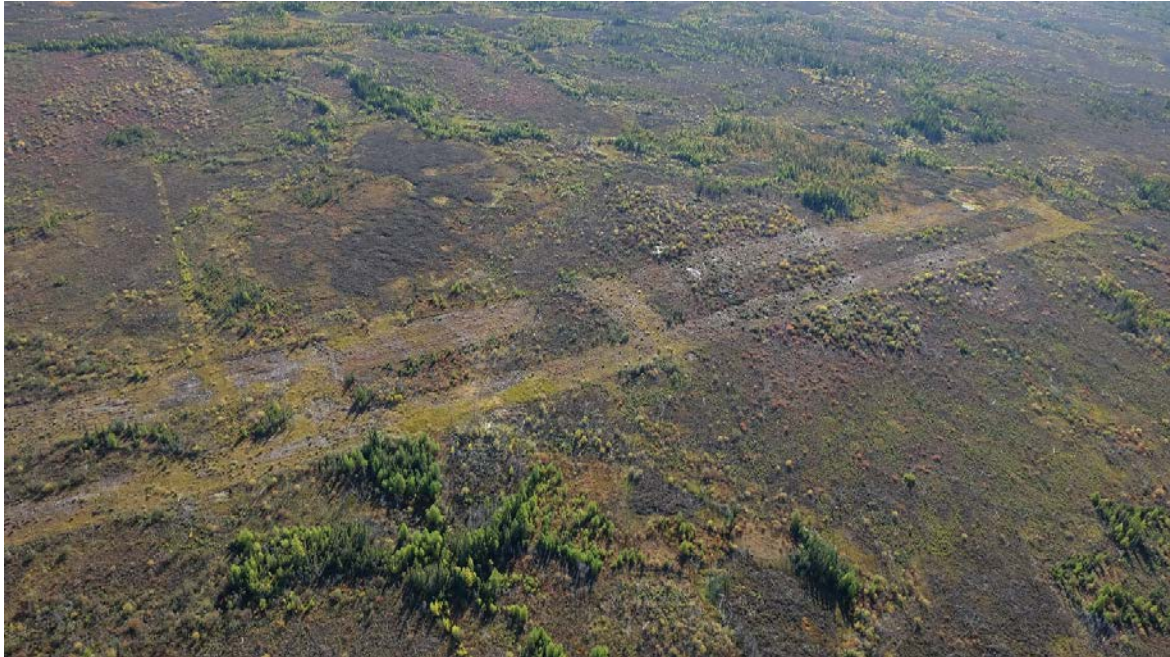
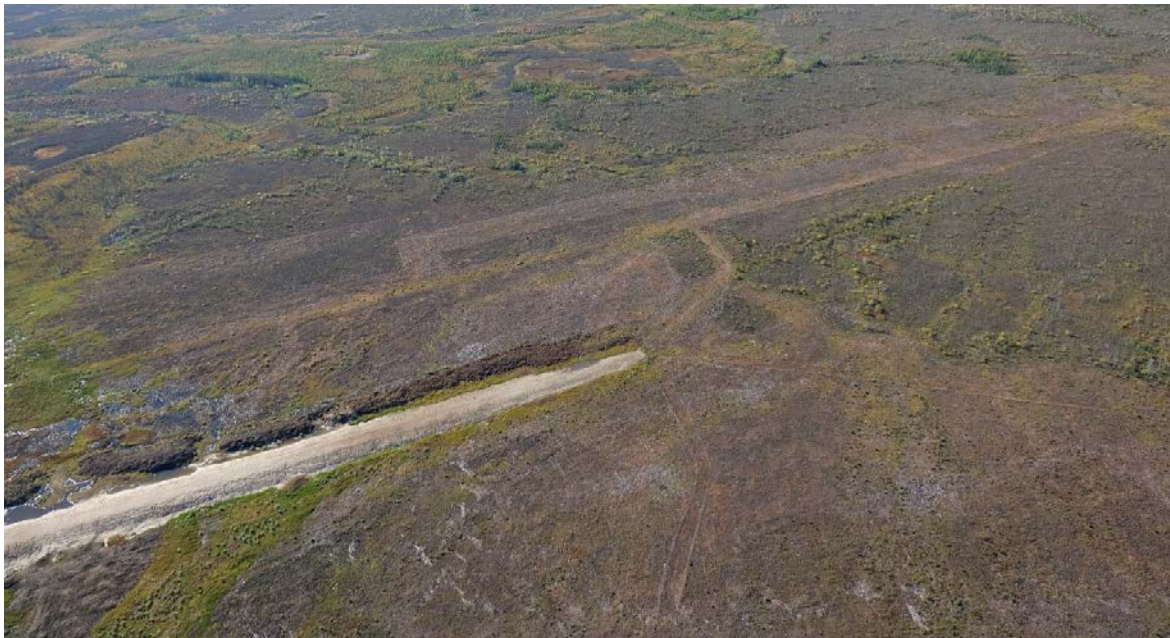
Figure 3–11: South dyke

South dyke, southwest end (looking southeast) on September 19, 2017

South dyke, central area (looking south) on September 19, 2017

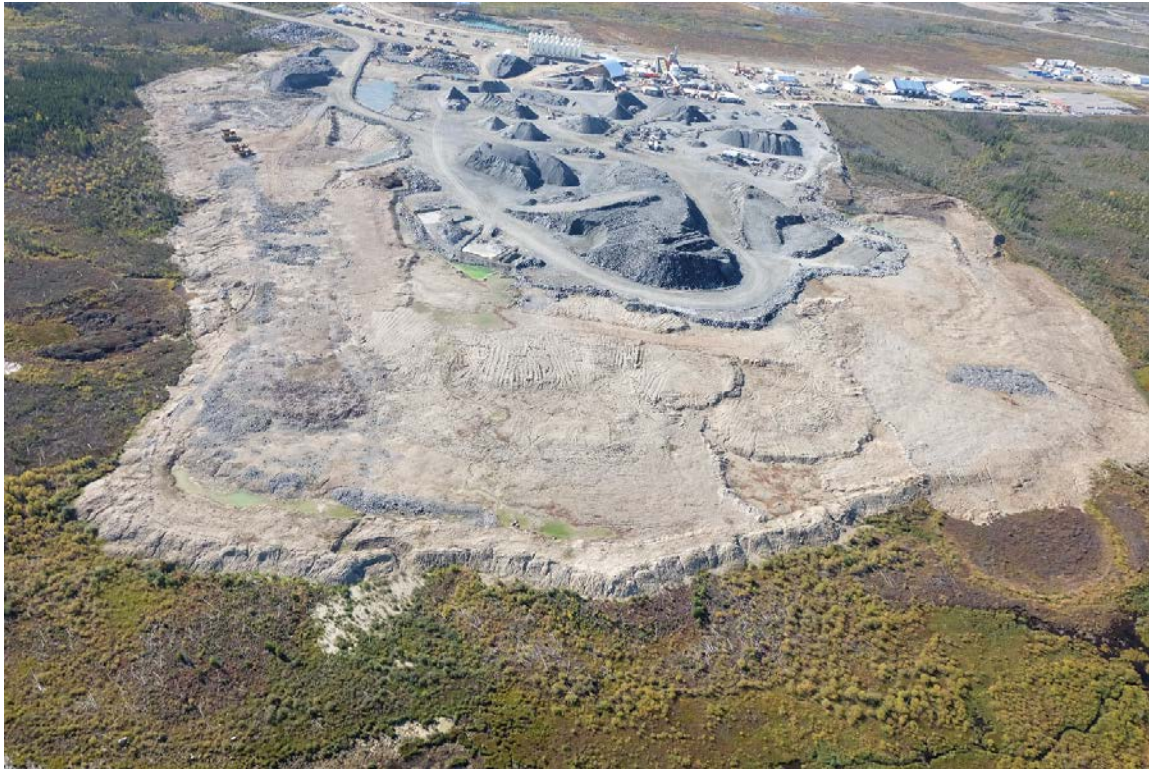
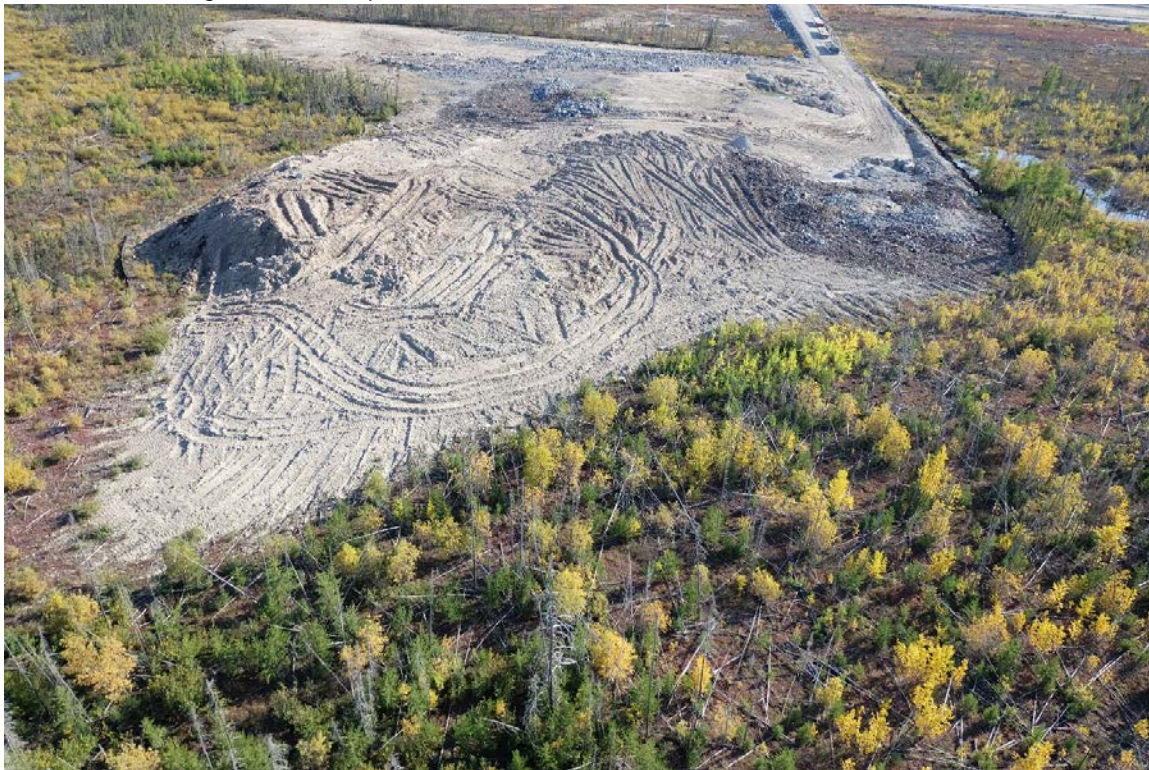
Figure 3–12: Excavated material placement areas in use

EMPA D16 (looking south) on September 19, 2017

EMPA D17 (looking south) on September 19, 2017

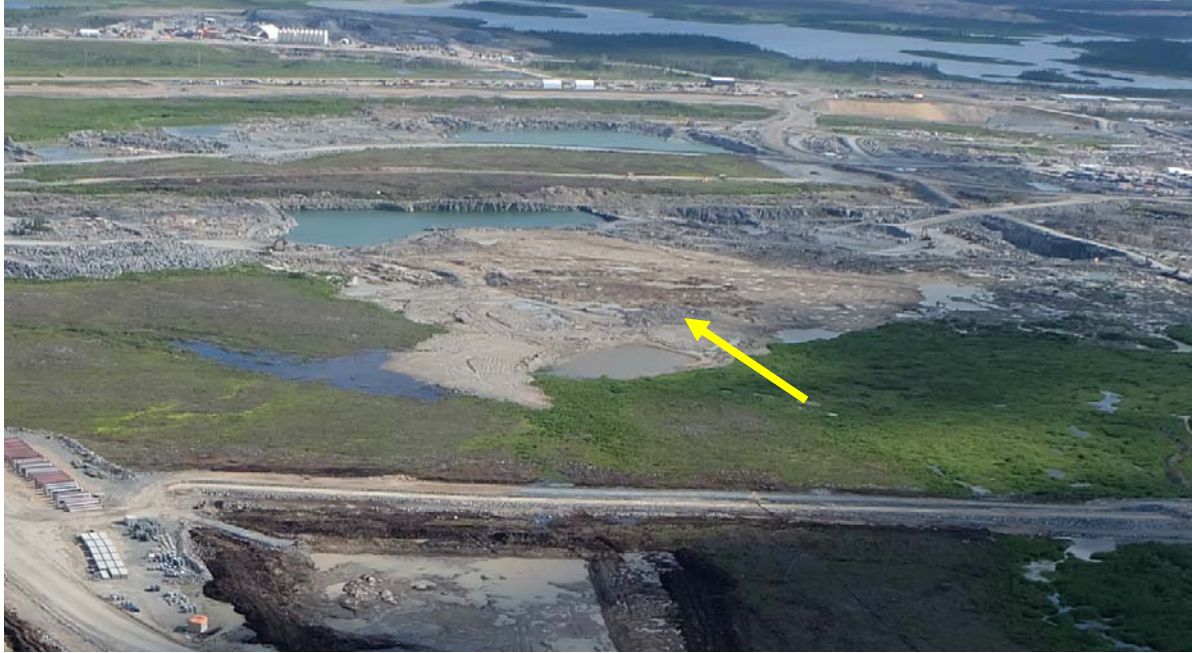
EMPA D19-I (looking north) on September 19, 2017. Yellow arrow identifies EMPA.

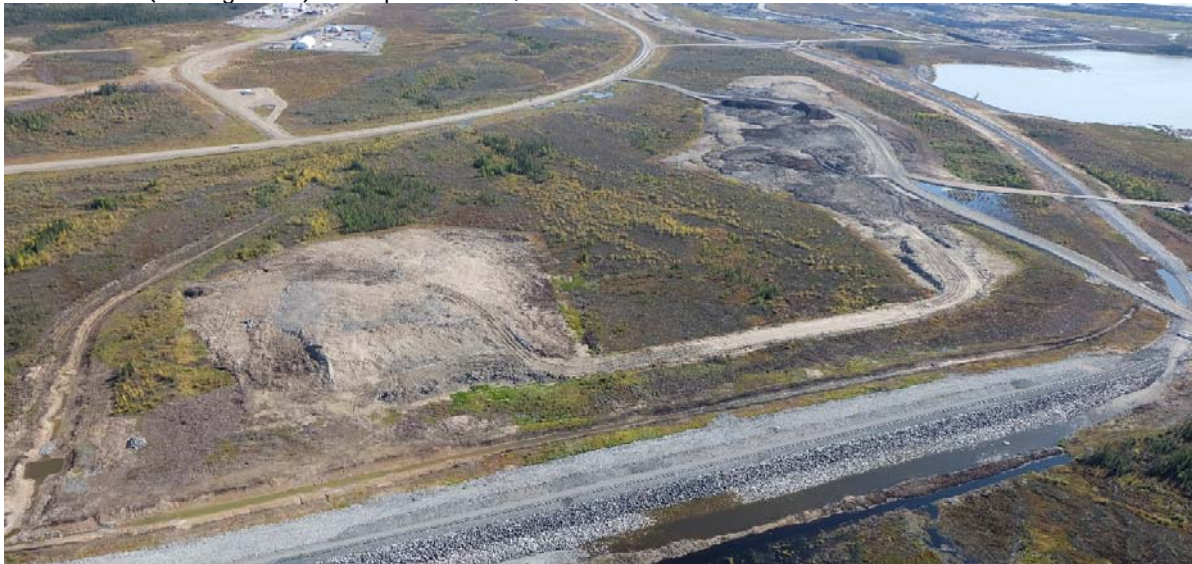
Portion of EMPA D12 (looking east) on September 19, 2017

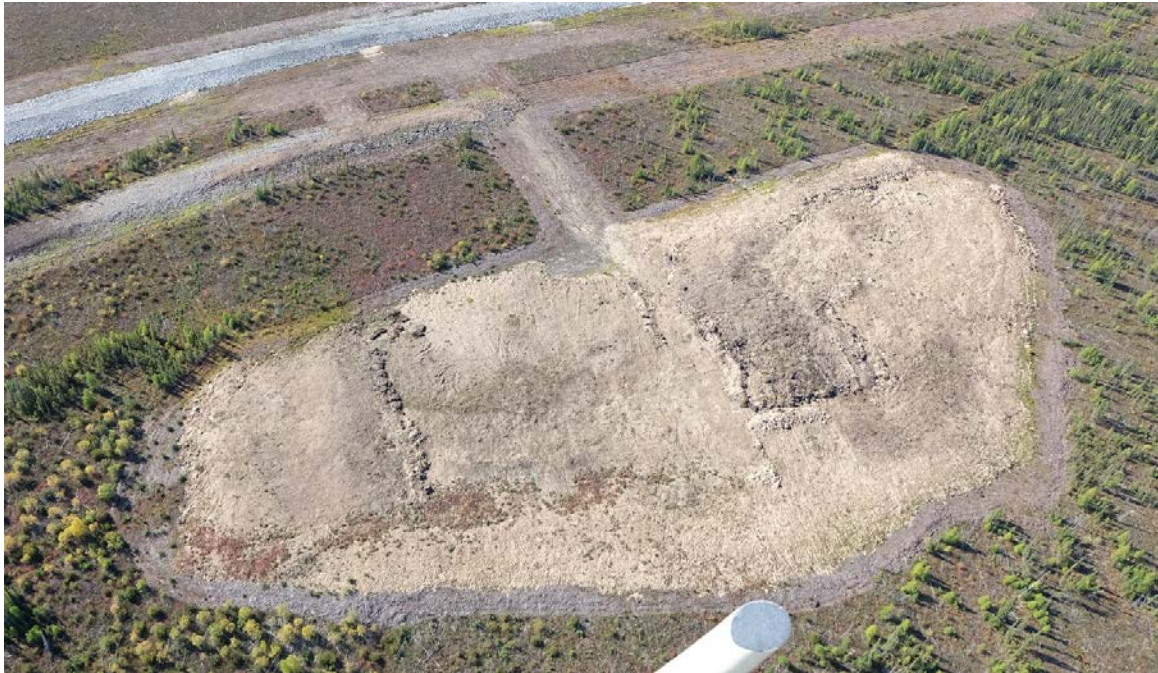
EMPA D3-E (looking southwest) on September 19, 2017

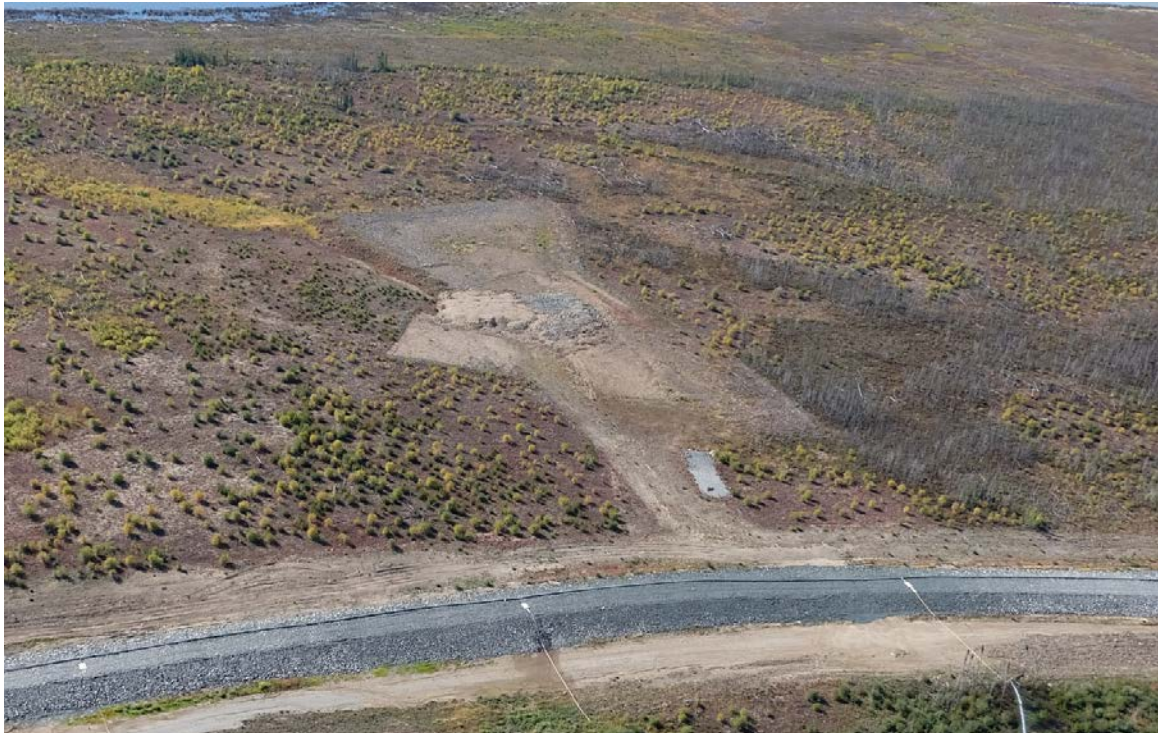
EMPA D9-I (looking south) on September 19, 2017

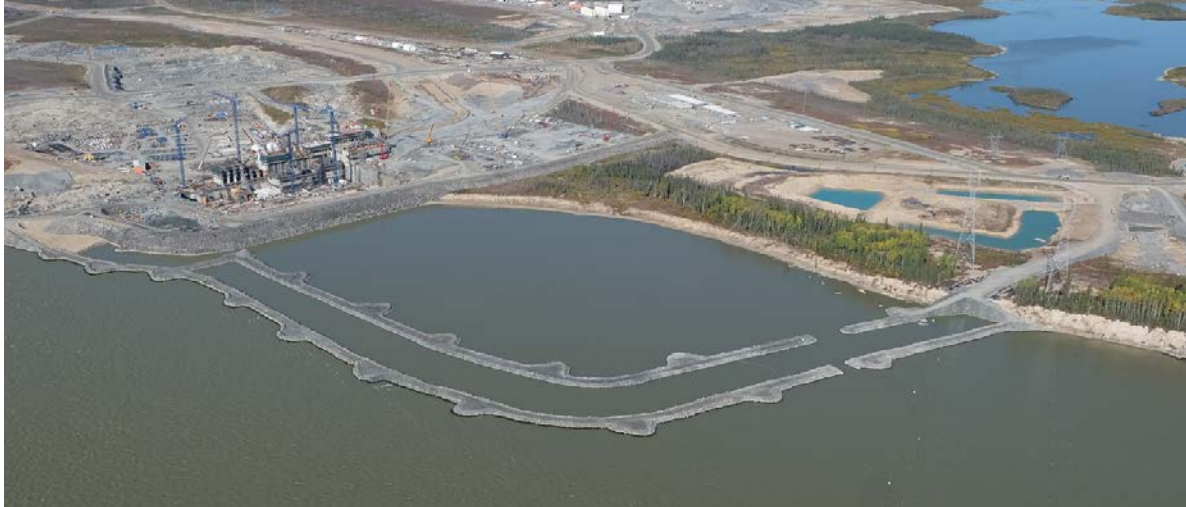
Powerhouse and tailrace channel summer cofferdam construction (looking northwest) on September 19, 2017

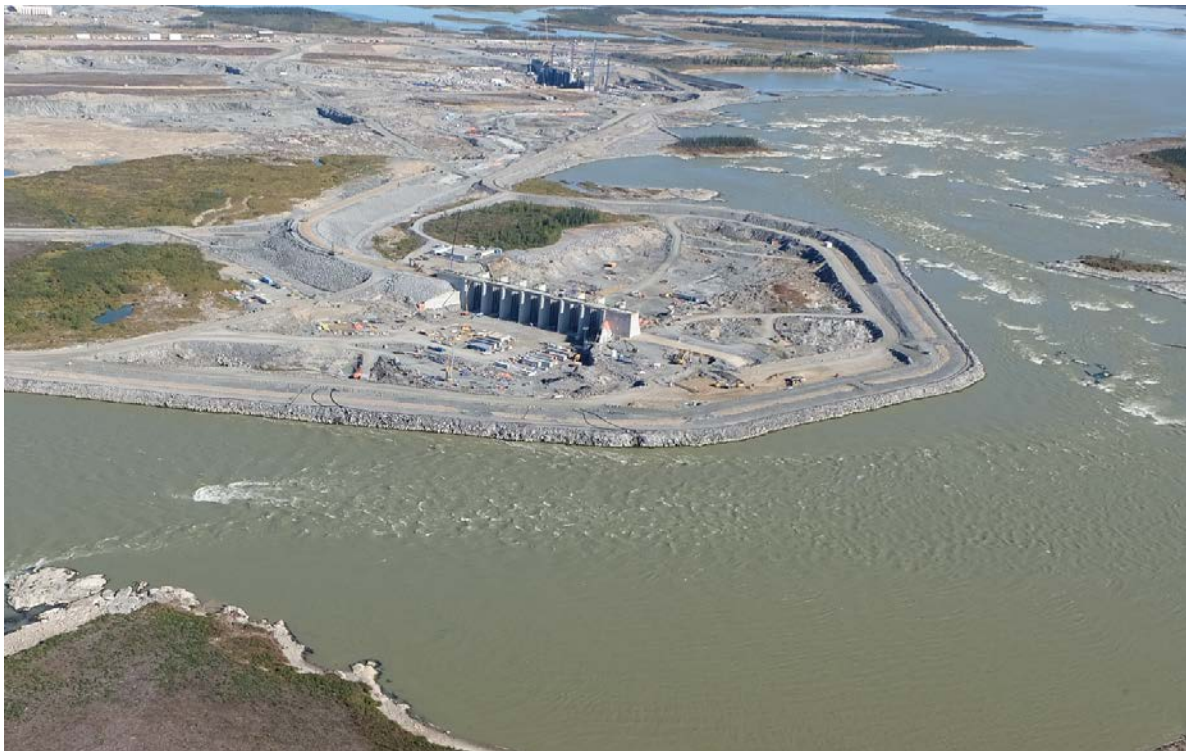
Spillway construction (looking north) on September 19, 2017

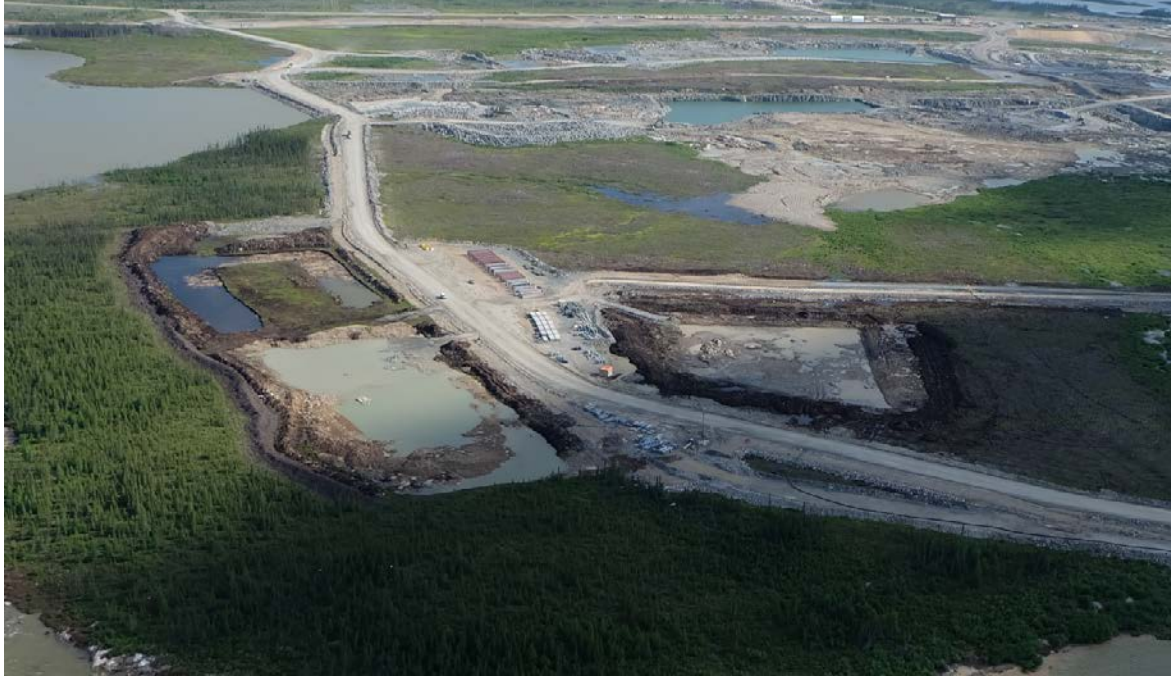
Spillway laydown area (looking north) on September 19, 2017

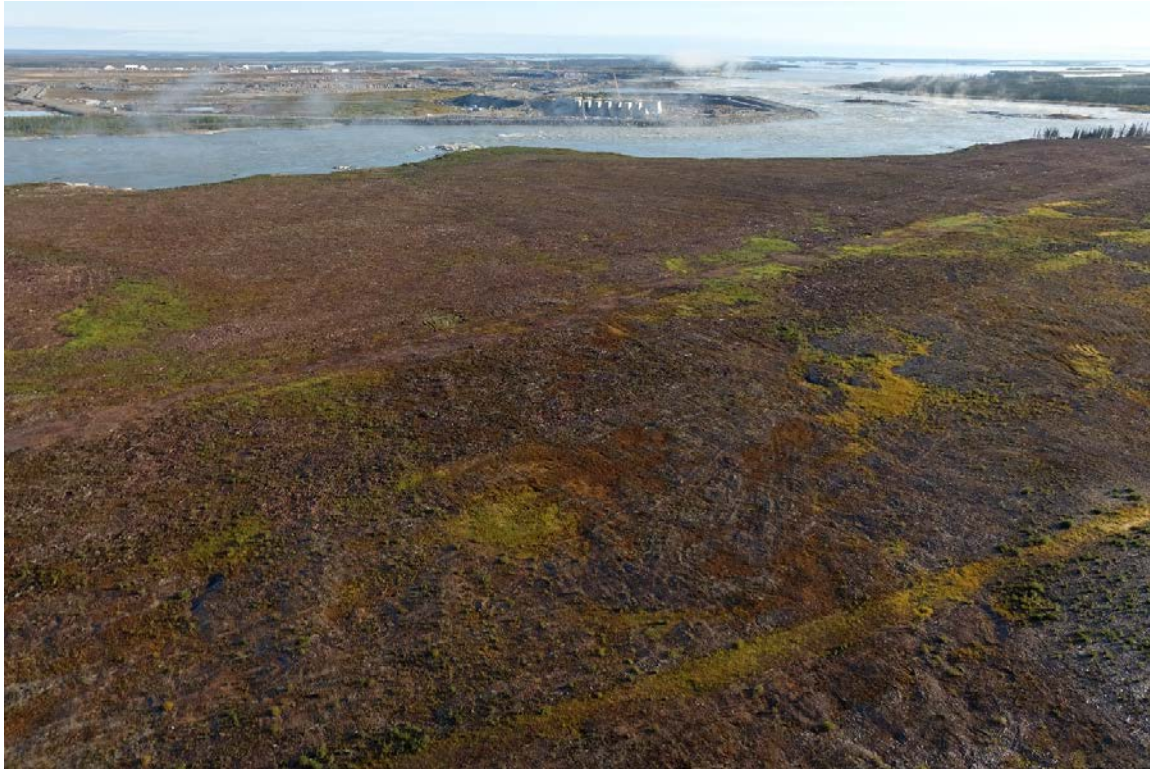
Reservoir clearing south of Nelson River (looking northeast) on September 19, 2017

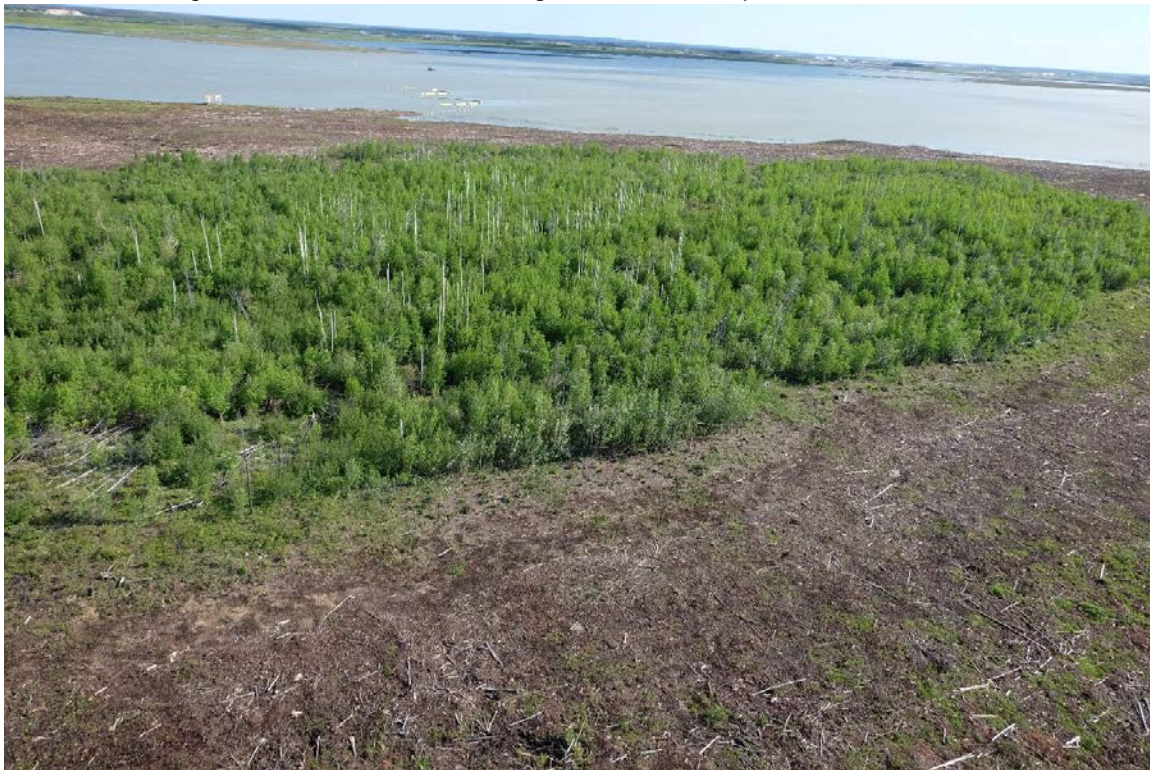
Reservoir clearing around future island south of Nelson River (looking north) on July 5, 2017
