Keeyask Generation Project
Terrestrial Effects Monitoring Plan

Habitat Loss and Disturbance Monitoring Report

TEMP-2018-01

June 2018

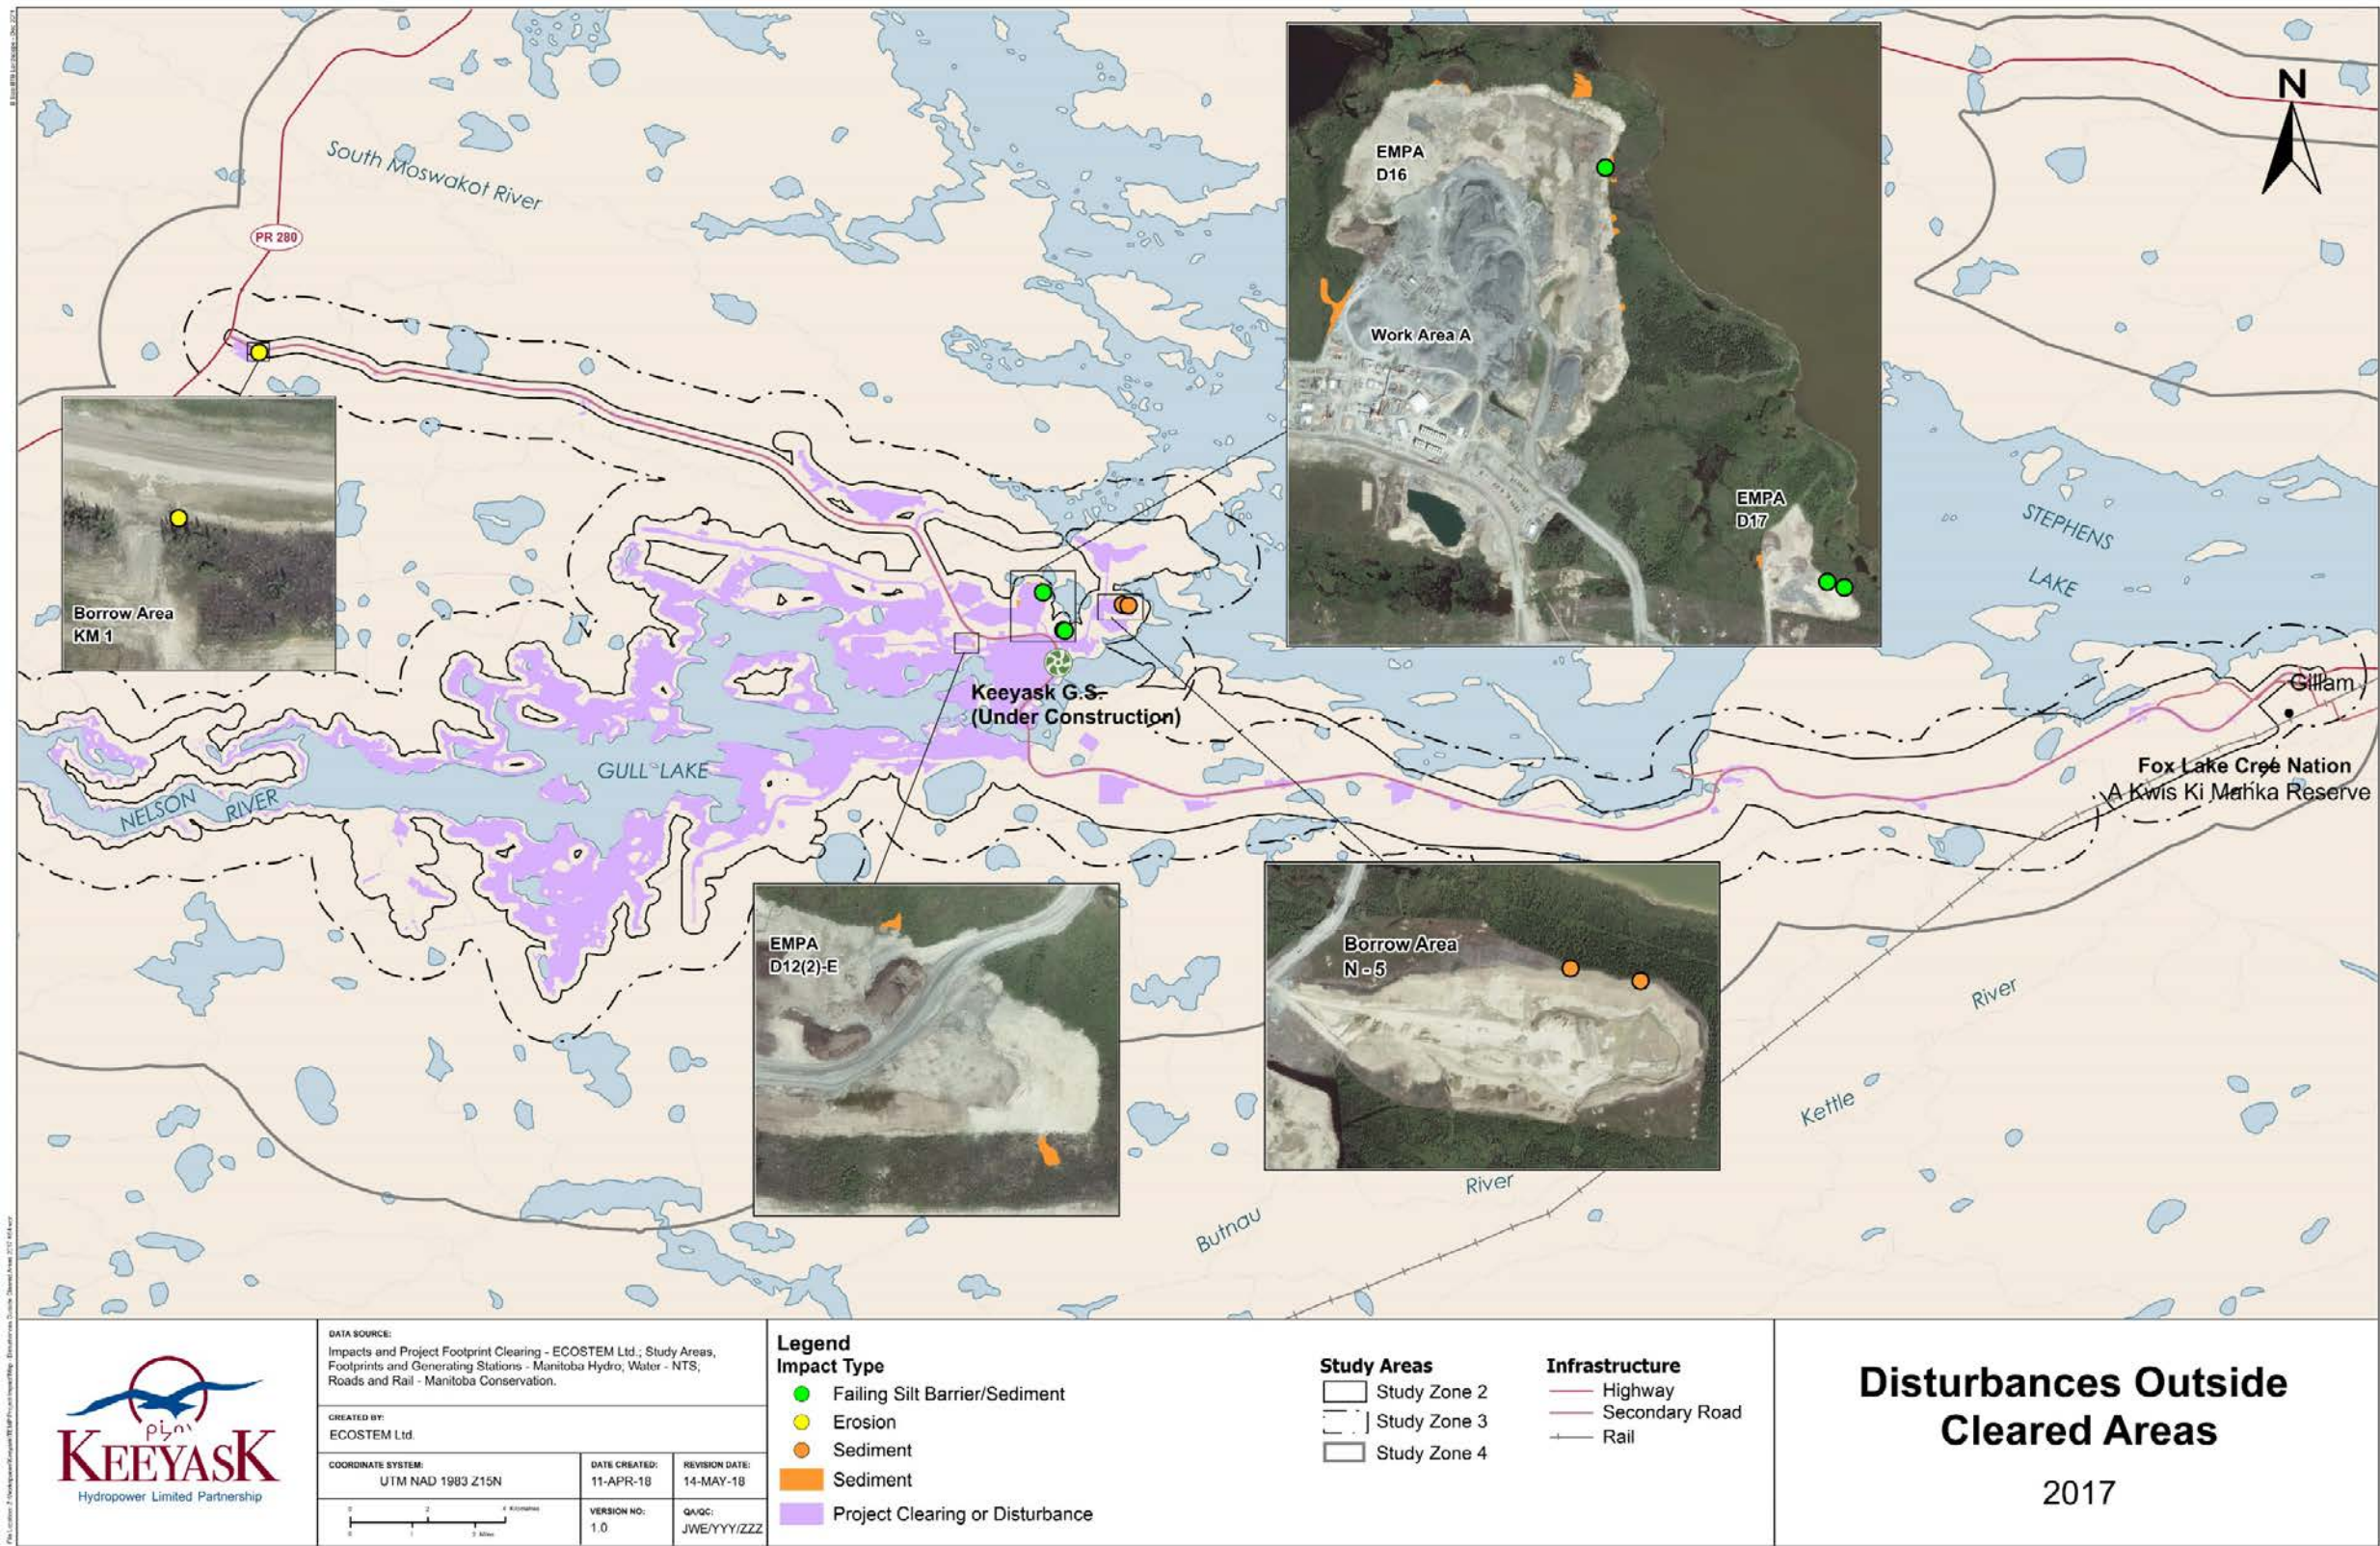
Map 3-3: Disturbances outside of cleared areas in 2017

The largest such disturbance was near the northeast corner of EMPA D16, where a large gully deposited sediment approximately 50 m into a wetland adjacent to Stephens Lake, disturbing approximately 0.13 ha (Map 3-3). At the time of the 2017 surveys, the sediment appeared to have reached the lake. It was recommended in the field reports that a barrier be erected to stop sediment entering the wetland north of EMPA D16, and that the silt fences along the east side of EMPA D16 be repaired and reinforced.

One disturbed area on the west side of EMPA D17 covered approximately 0.02 ha. The sediment was subsequently removed from the uncleared area using an excavator, and a silt fence was installed around the perimeter of the EMPA in fall, 2017. Removal of the sediment resulted in mechanical damage to the trees, their roots, and the surface organic substrate (Figure 3–13). Bark was stripped from some of the lower tree trunks, and roots were exposed

and/or torn from the organic substrate, and damaged by the excavator. Low vegetation and peat moss was removed along with the sediment.

Sedimentation from eroding slopes on the west side of EMPA D17 and on the northeast side of EMPA D16 caused disturbance to areas outside the approved Project footprint. Additional damage to some trees, their roots and the organic substrate in at the former location occurred when much of this sediment was subsequently removed by an excavator. In this case, sediment removal may have done more damage to the vegetation than if nothing had been done. In the absence of removal, future rains could wash some of the sediment into the same areas, providing a larger area of habitat alteration for non-native plant colonization. Some options for similar situations in the future include limiting the spatial extent of remedial excavation, leaving more or all of the sediment in place and/or strengthening silt fences to limit the risk of failure.
