Keeyask Generation Project
Terrestrial Effects Monitoring Plan

Habitat Rehabilitation Implementation and
Success Monitoring Report

TEMP-2018-07

Manitoba Hydro

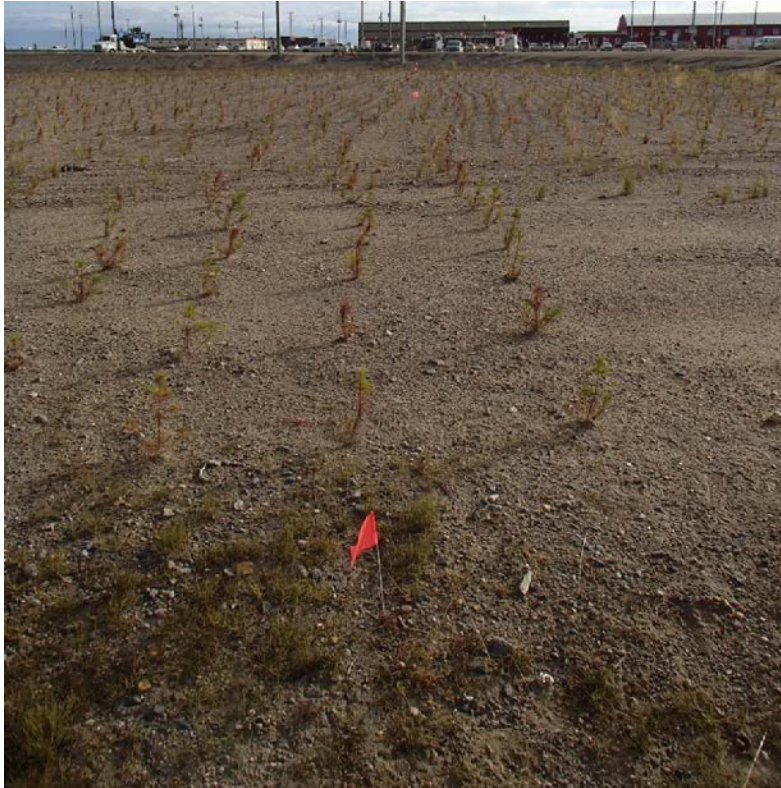
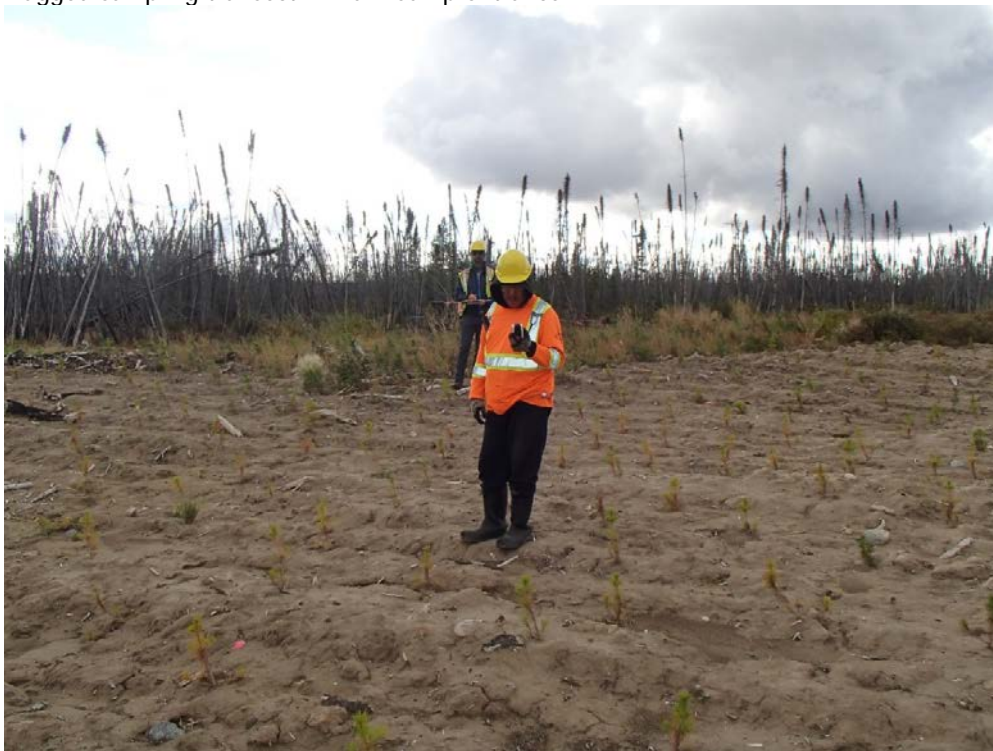
Figure 3-1: Tree regeneration sampling in 2017

Flagged sampling transect in Main Camp entrance

Sampling a transect in Borrow Area KM-1
