Keeyask Generation Project Terrestrial Effects Monitoring Plan

Habitat Loss and Disturbance Monitoring Report

TEMP-2019-01

By
ECOSTEM Ltd.

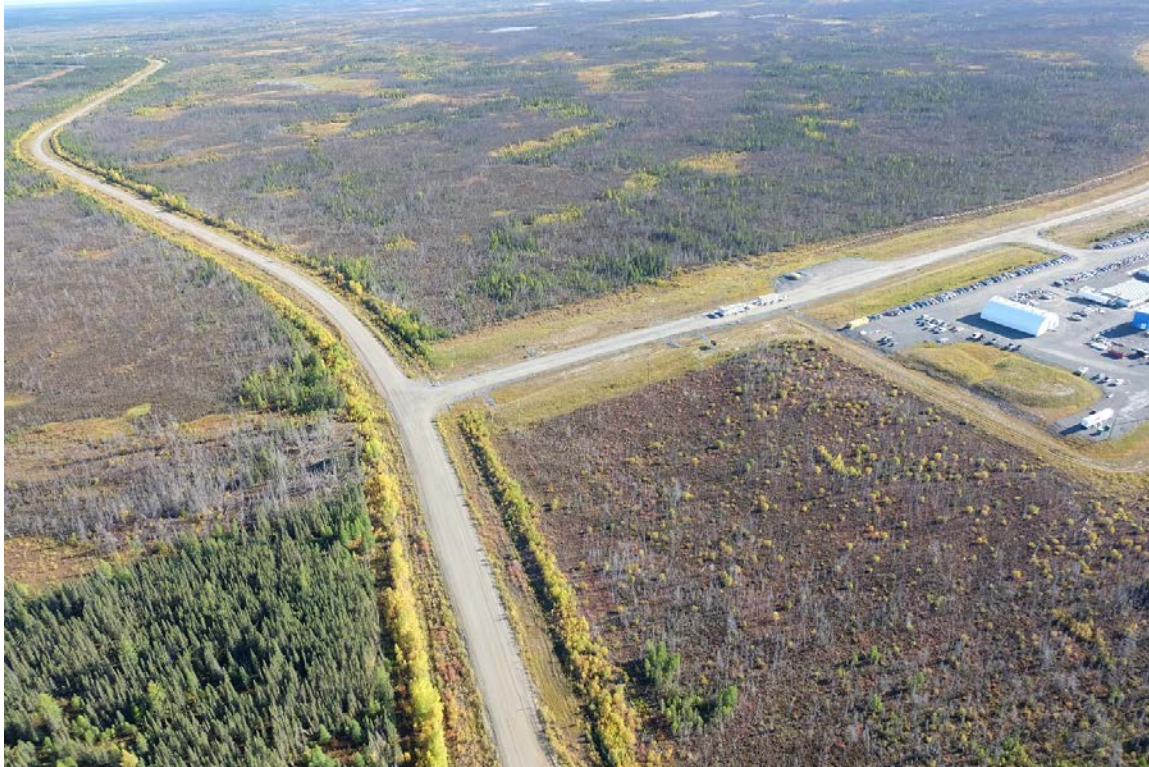
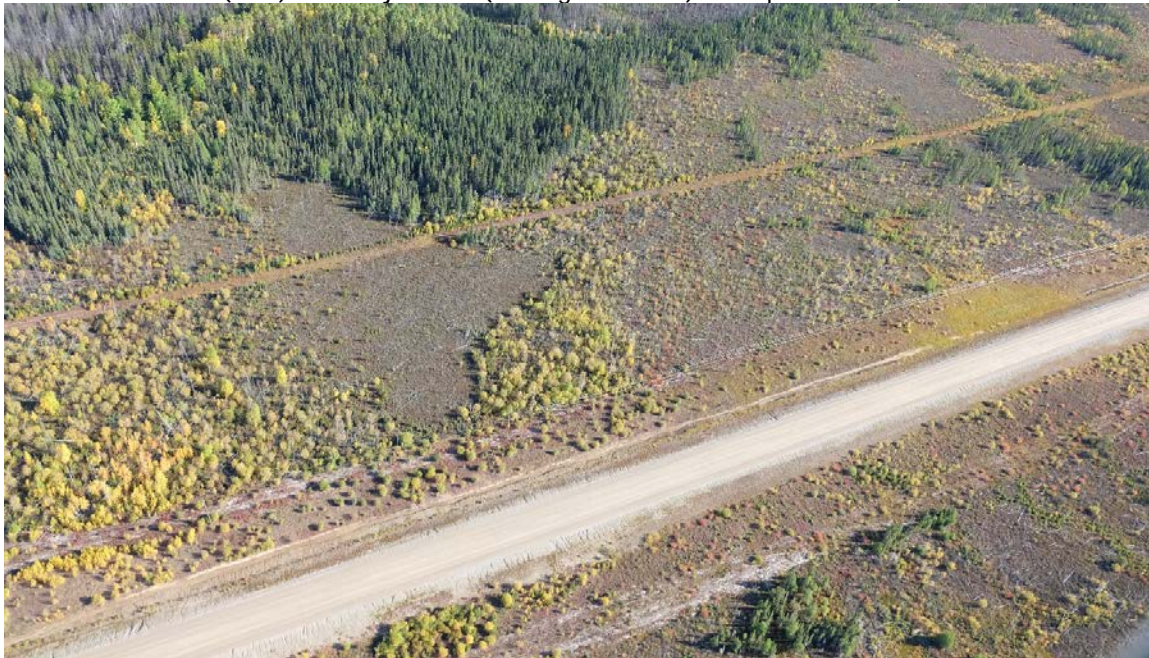
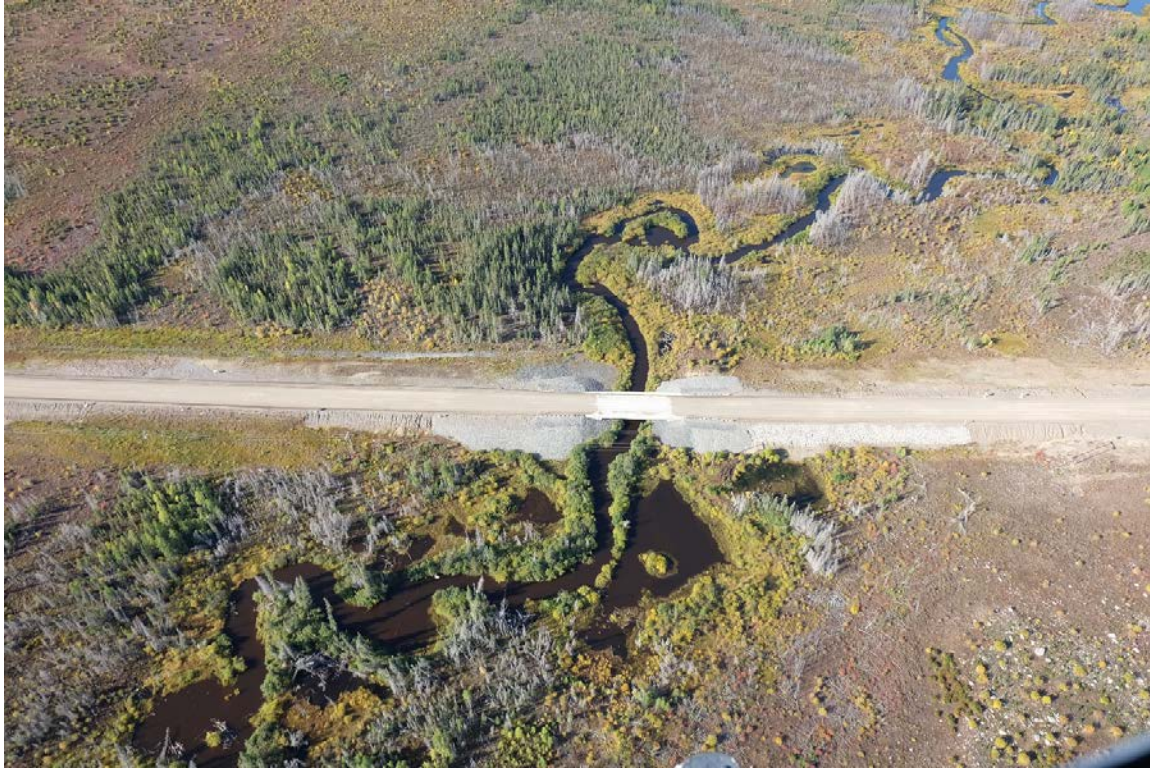
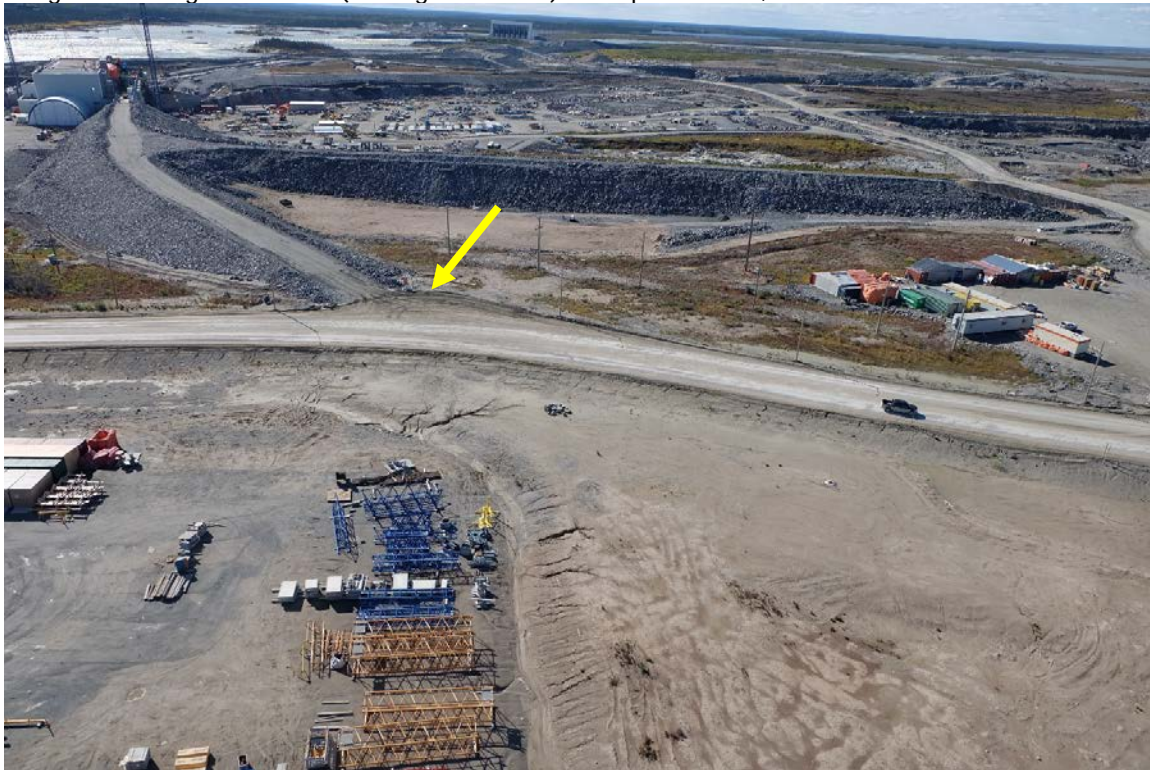
Figure 3-1: Clearing and other impacts along the NAR

North Access Road (NAR)/PR 280 junction (looking northeast) on September 15, 2018

Approximately halfway along the NAR (looking northeast) on September 15, 2018

Bridge at Looking Back Creek (looking southwest) on September 15, 2018

Southeast end of the NAR (indicated by arrow, looking south) on September 15, 2018

All NAR and SAR clearing mapped as of September 2018 was unchanged from September 2017 (Figure 3-1 and Figure 3-2; Table 3-1 and Table 3-3). No road construction activity was observed during 2018 surveys (road maintenance was ongoing).

One instance of disturbance was observed within the NAR footprint. Erosion on the south ditch bank adjacent to Borrow Area KM-1 had created a gully. This gully was first identified during 2016 surveys. Since then, erosion has expanded the gully and removed the mineral material under a treed area between the ditch and the borrow area (Map 3-3; Figure 3-19). Gully expansion between the 2017 and 2018 surveys was about 3 m², which was less than that observed between 2016 and 2017.

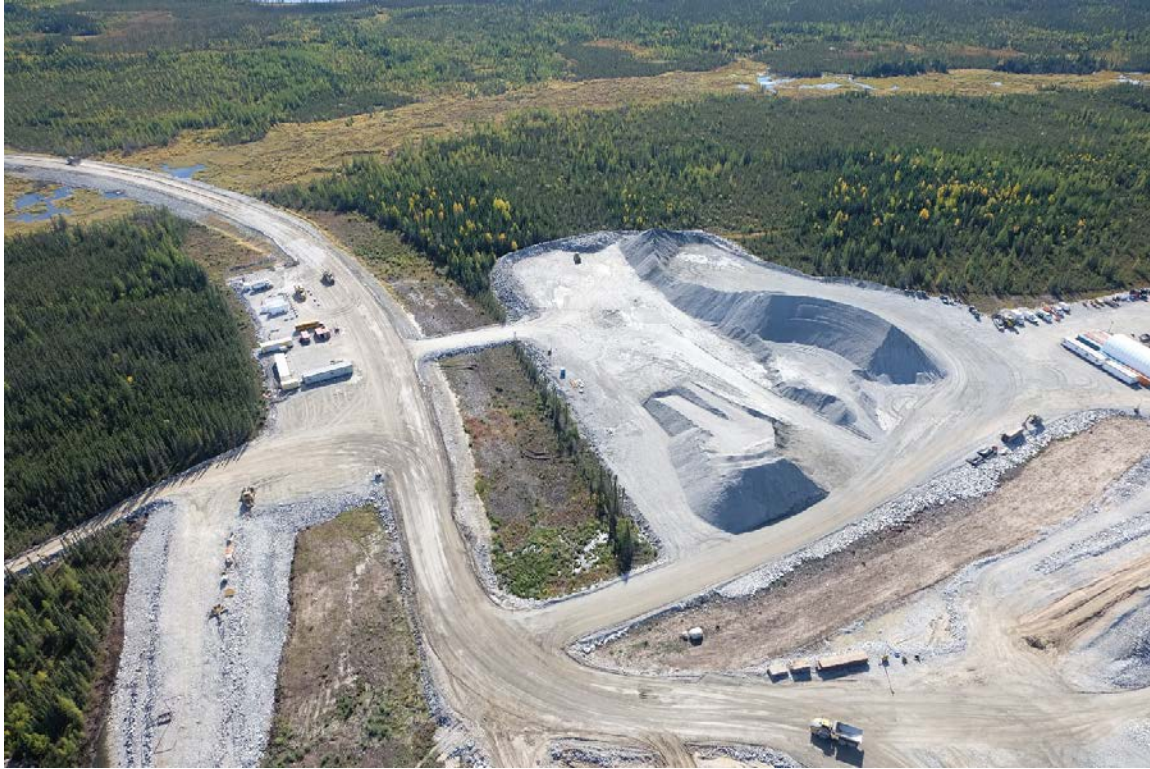
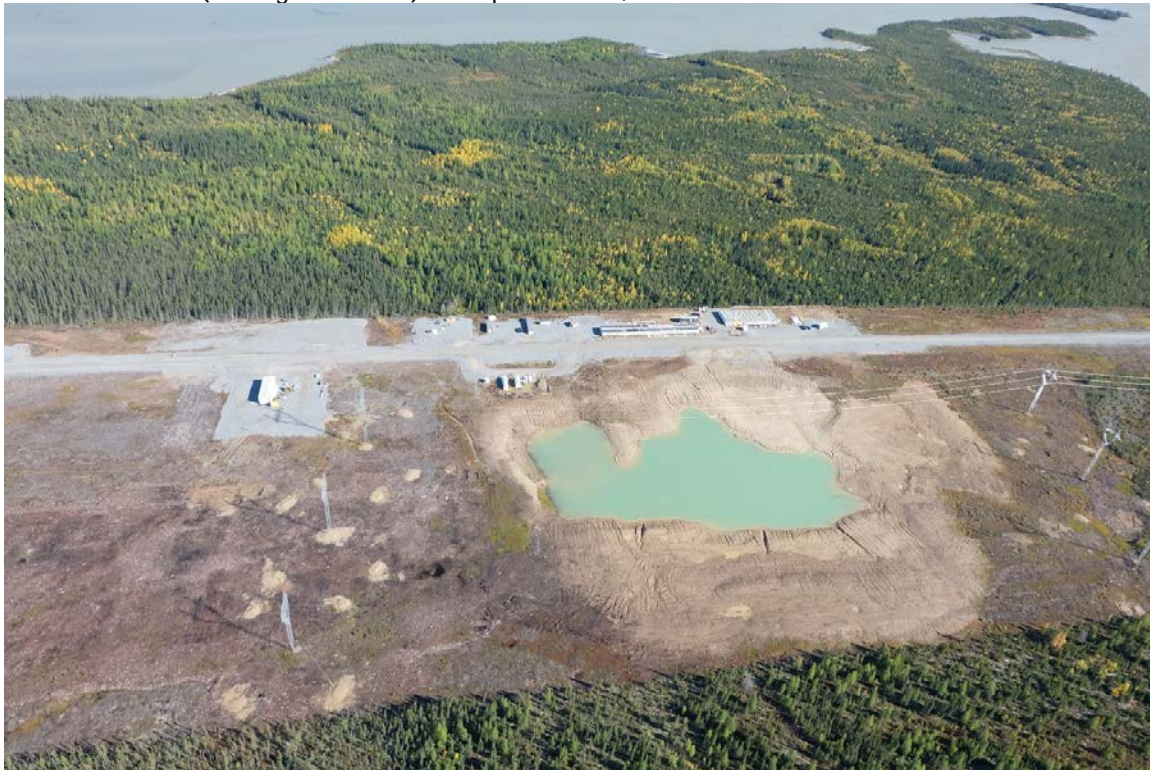
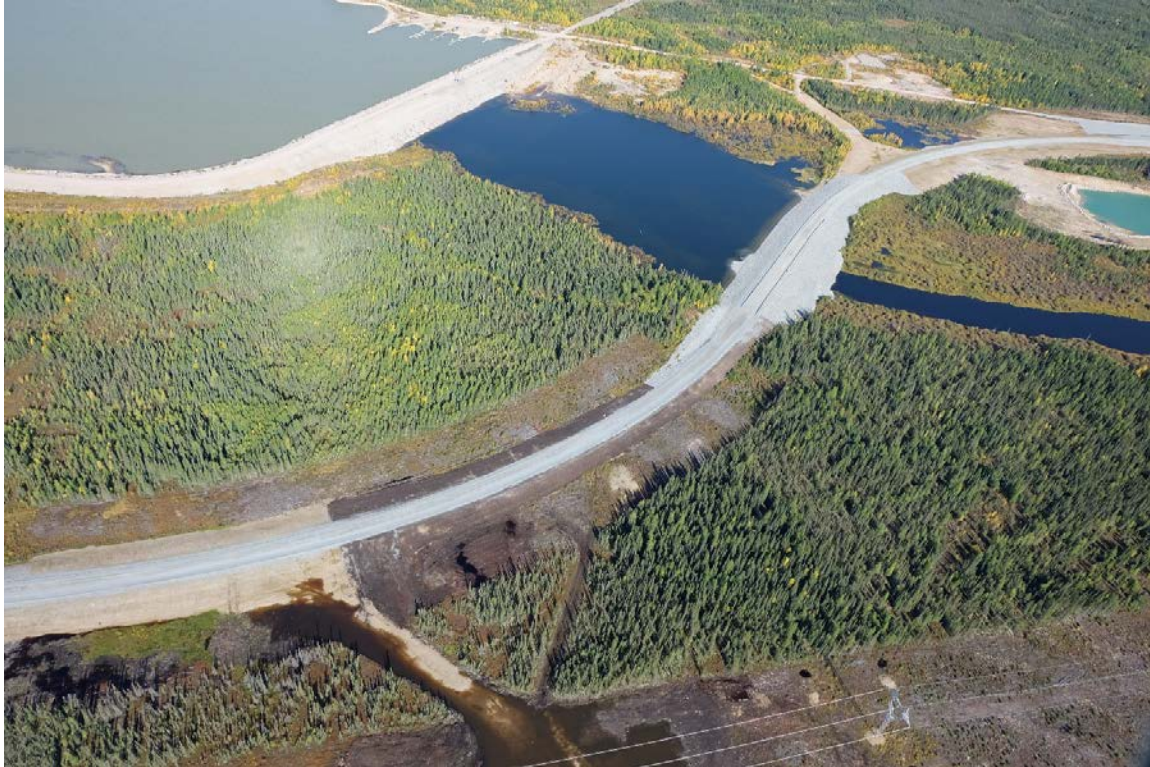
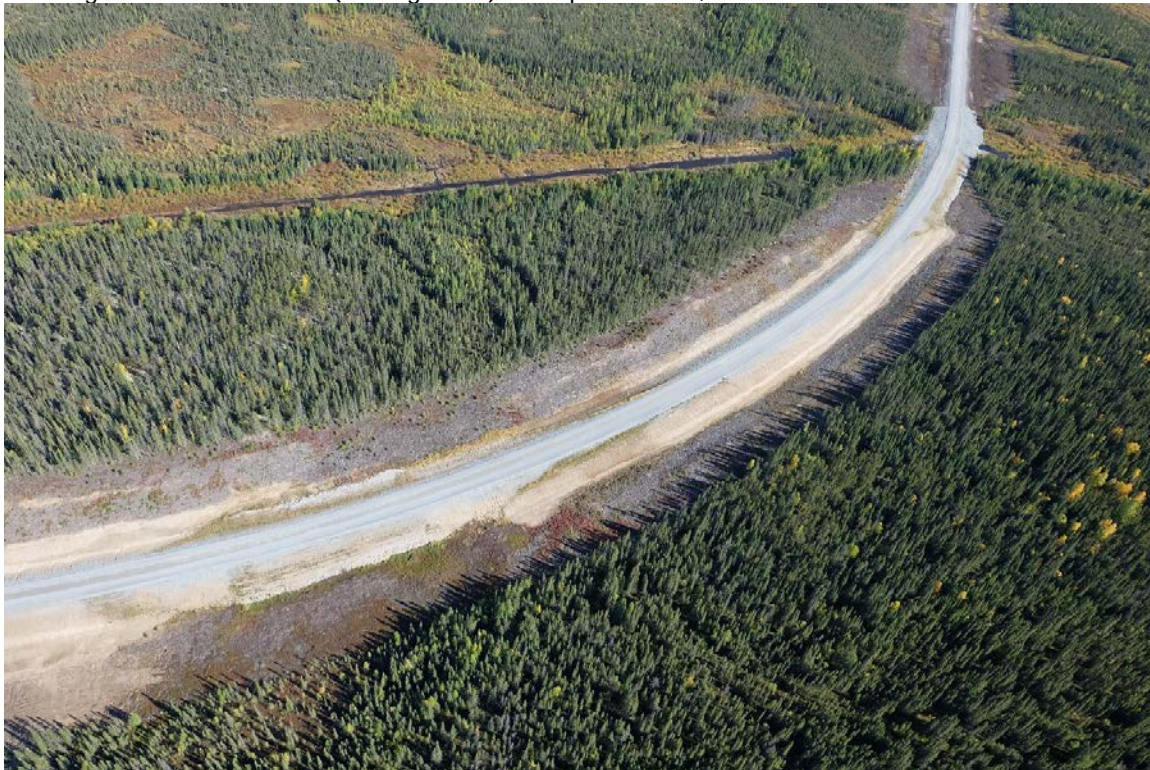
Figure 3-2: Clearing and other impacts along the SAR

West end of SAR (looking southwest) on September 15, 2018

View of the Sigfusson Northern/Voltage camp and borrow area B-3 (looking north) on Sept 15, 2018

Crossing at the Butnau River (looking north) on September 15, 2018

Near the east end (looking northeast) on September 15, 2018

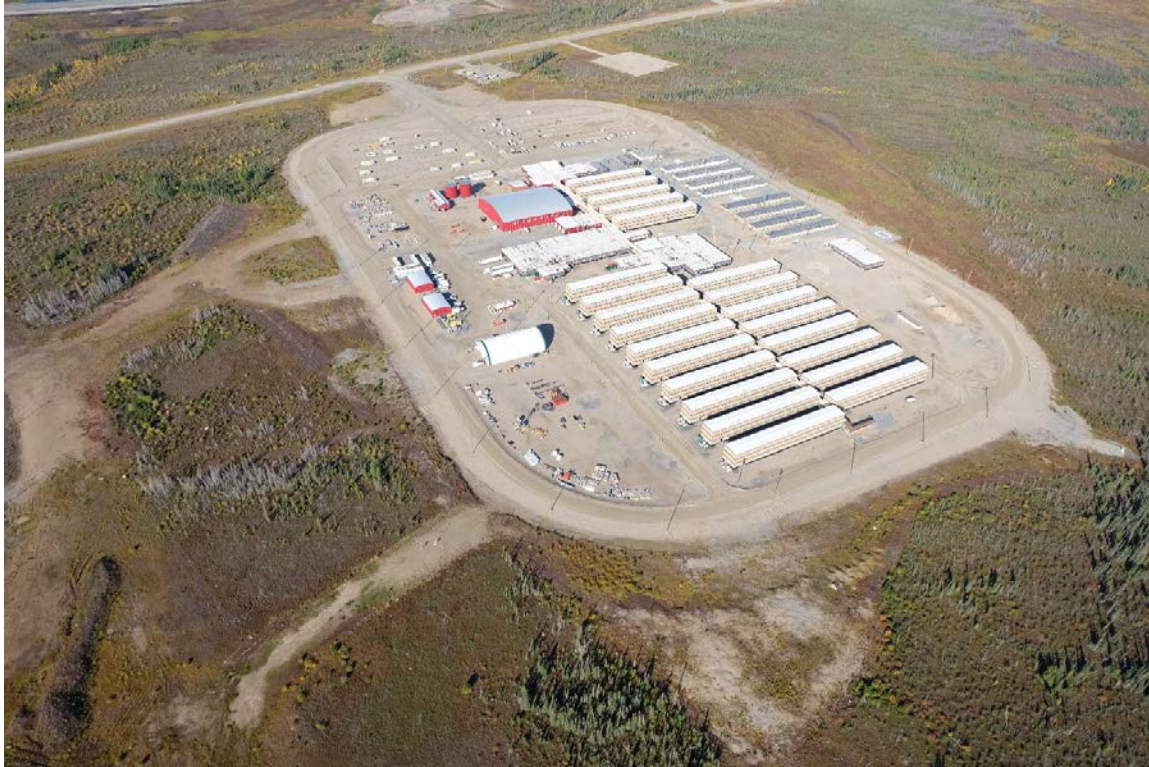
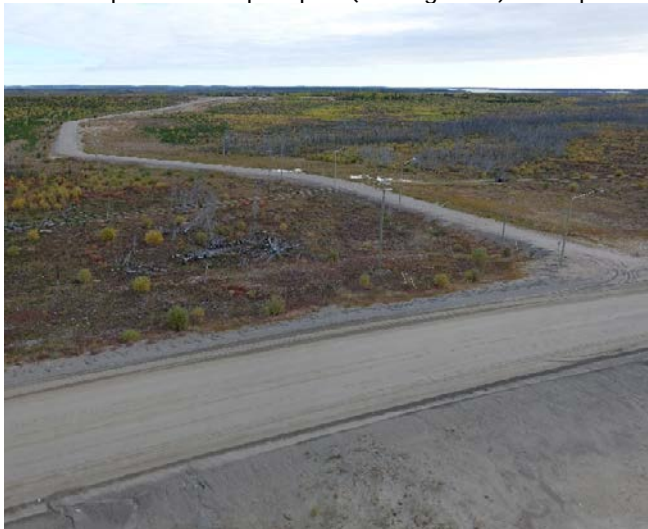
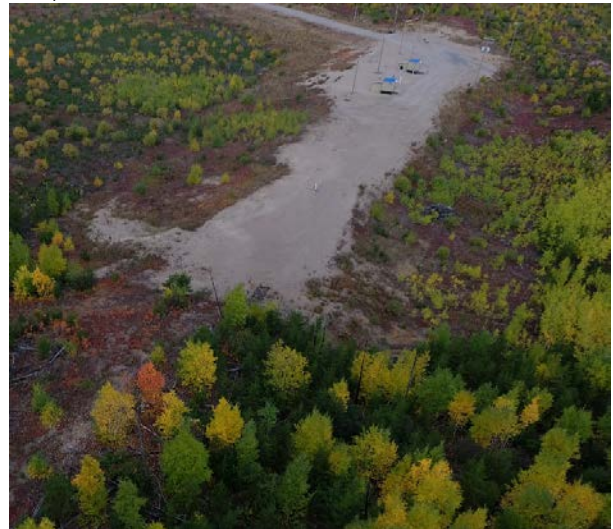
Figure 3-3: Main camp, helicopter pad and well road

Main camp and helicopter pad (looking west) on September 15, 2018

Well road entrance (looking northeast) on September 15, 2018

Well road north end (looking west) on September 15, 2018

The extent of clearing for the Main Camp, Well Road and Helicopter Pad did not change from September 2017 to 2018 (Figure 3-3).

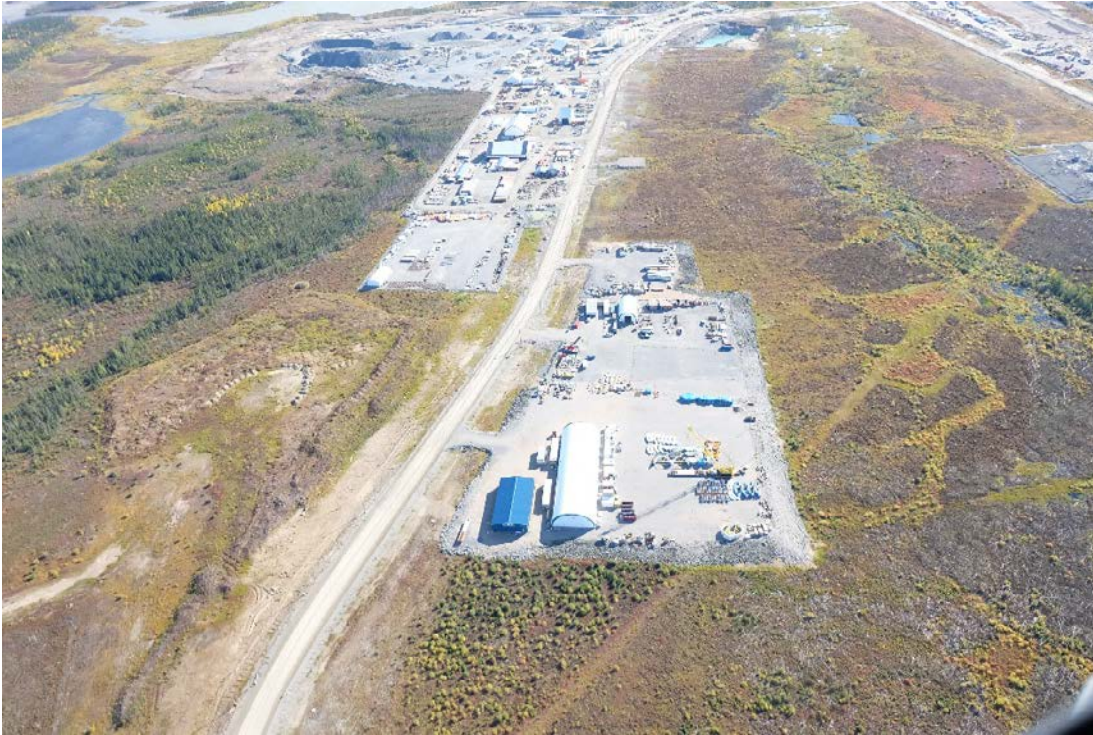
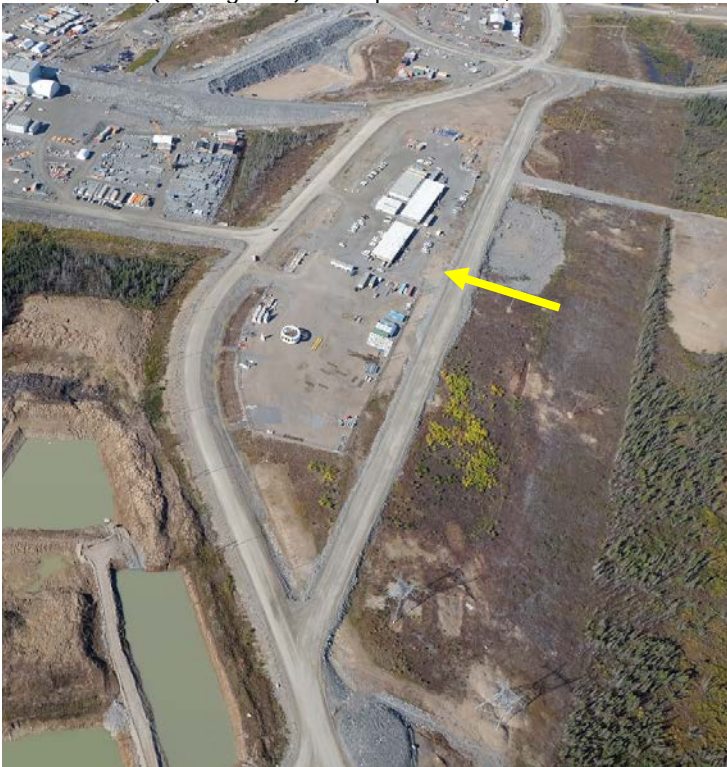
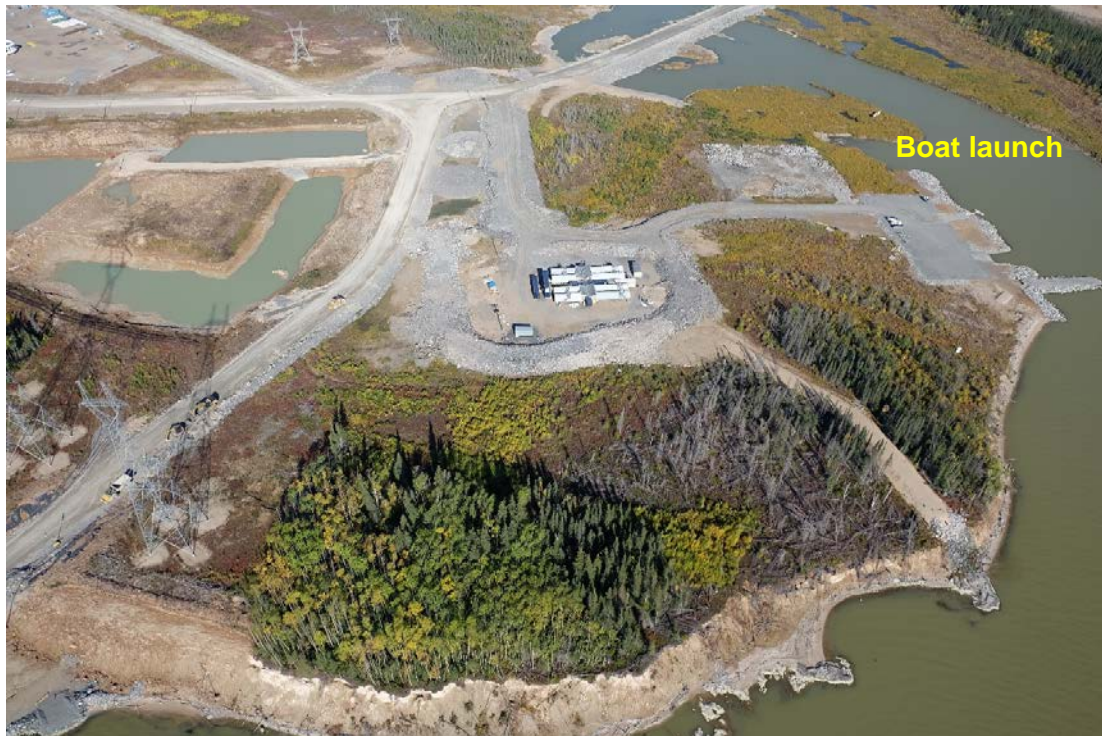
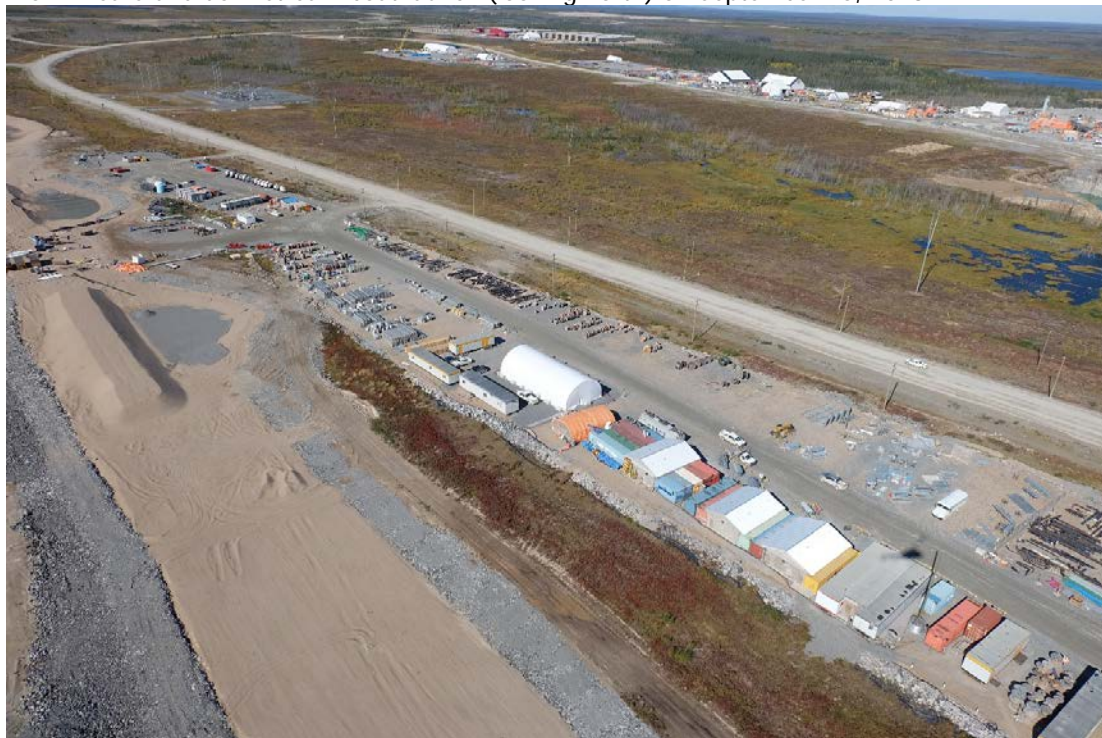
Figure 3-5: Work areas

Work Area A (looking east) on September 15, 2018

Work Area B (looking west) on September 15, 2018

Work Area C and downstream boat launch (looking north) on September 15, 2018

Work Area X (looking northwest) on September 15, 2018

The extent of clearing in work areas A, B and X north of the Nelson River has remained unchanged since 2015 (Figure 3-5).

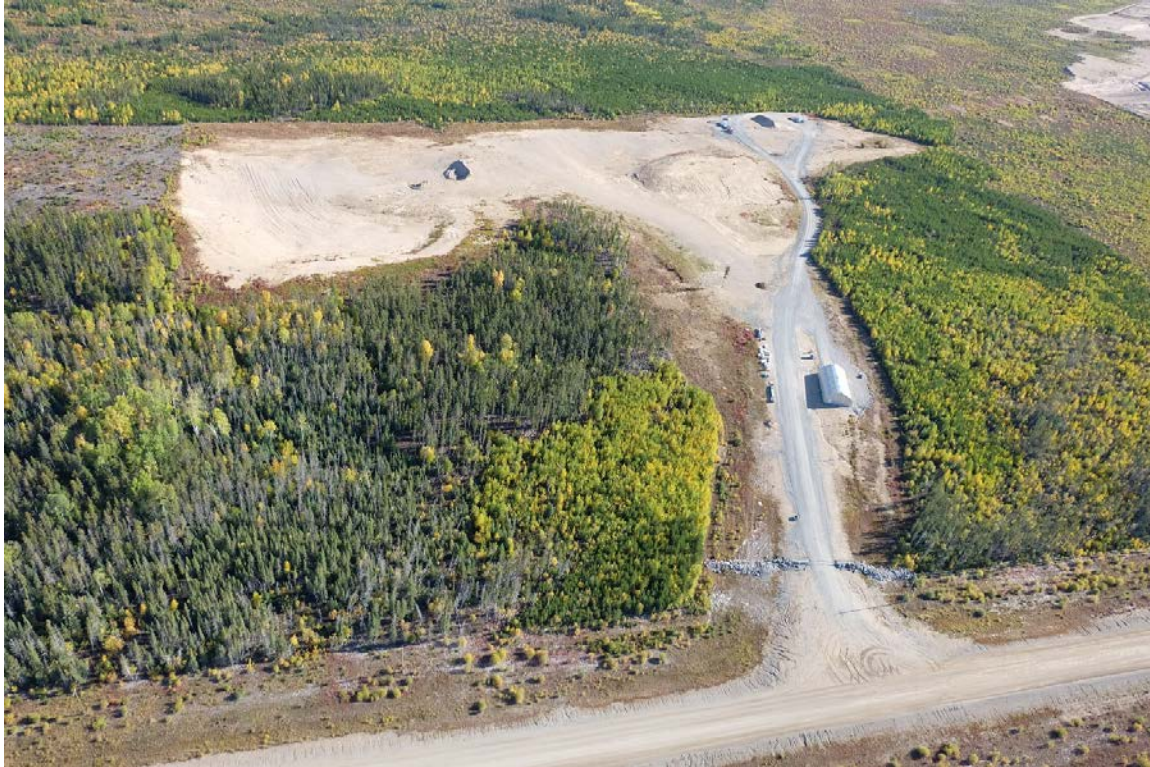
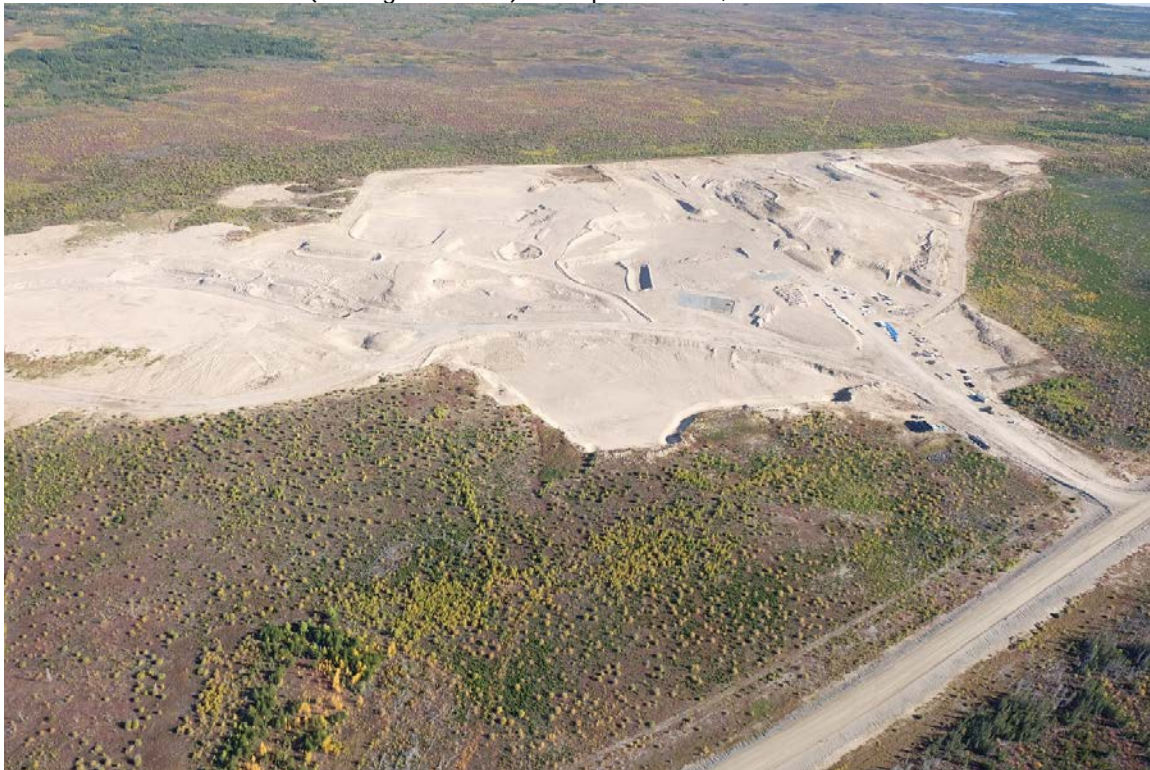
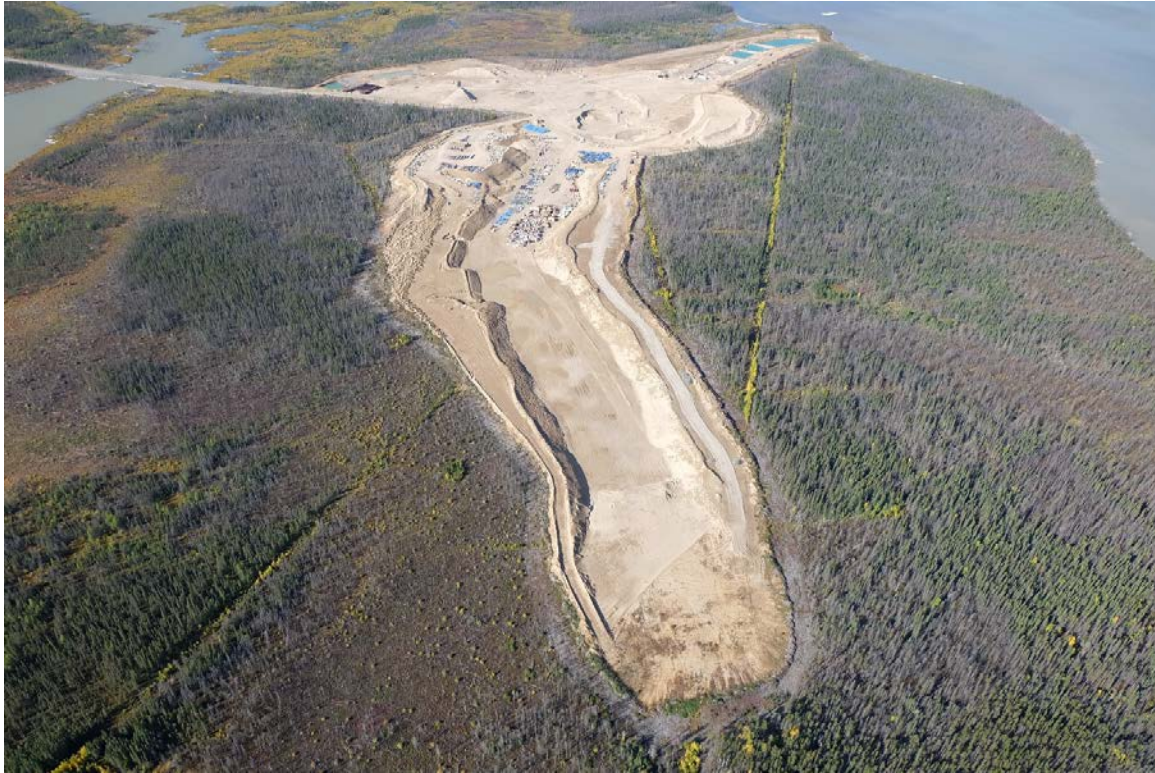
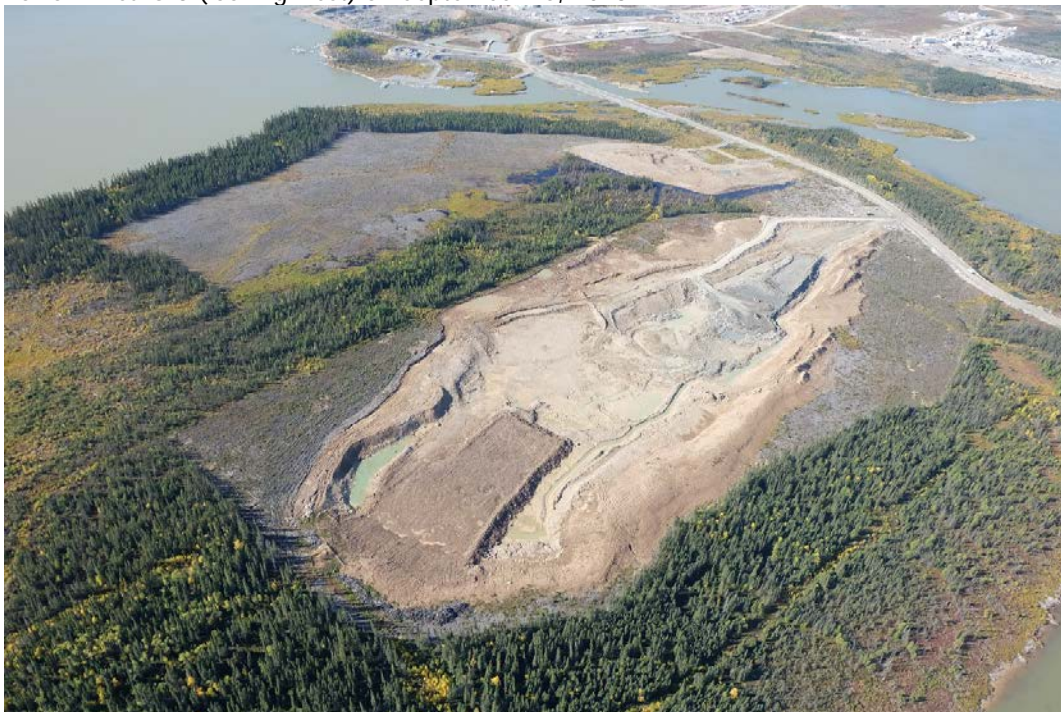
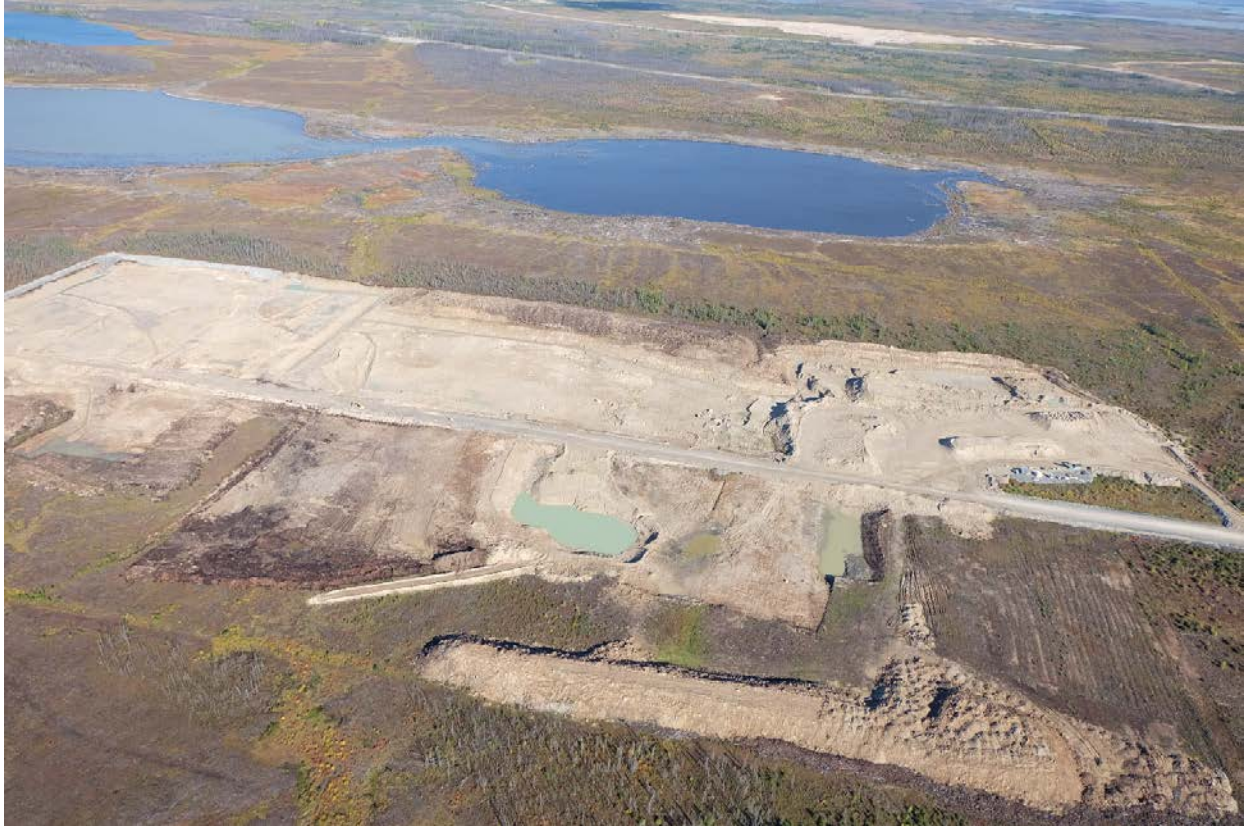
Figure 3-7: Clearing and excavation in borrow areas north of the Nelson River

Borrow Area G-1 at KM-15 (looking northeast) on September 15, 2018

Borrow Area G-1 at KM-17 (looking northeast) on September 15, 2018

Borrow Area G-3 (looking west) on September 15, 2018

Borrow Area N-5 and EMPA D35 (looking southwest) on September 18, 2018

Borrow Area N-21 (looking north) on September 15, 2018
